the **play inspection** company

## Annual Inspection

Winchester City Council

Stratton Bates Recreation Ground (New Alresford)

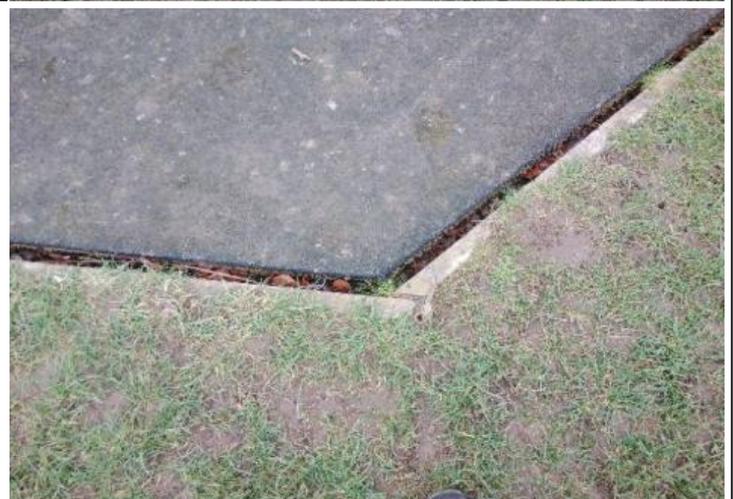
**Risk Level:** L - Low Risk  
**Surface:** N/A

**Finding:** The surface is lifting at the edges and creating trip points **Action:** Repair perimeter of surfacing to remove trip points

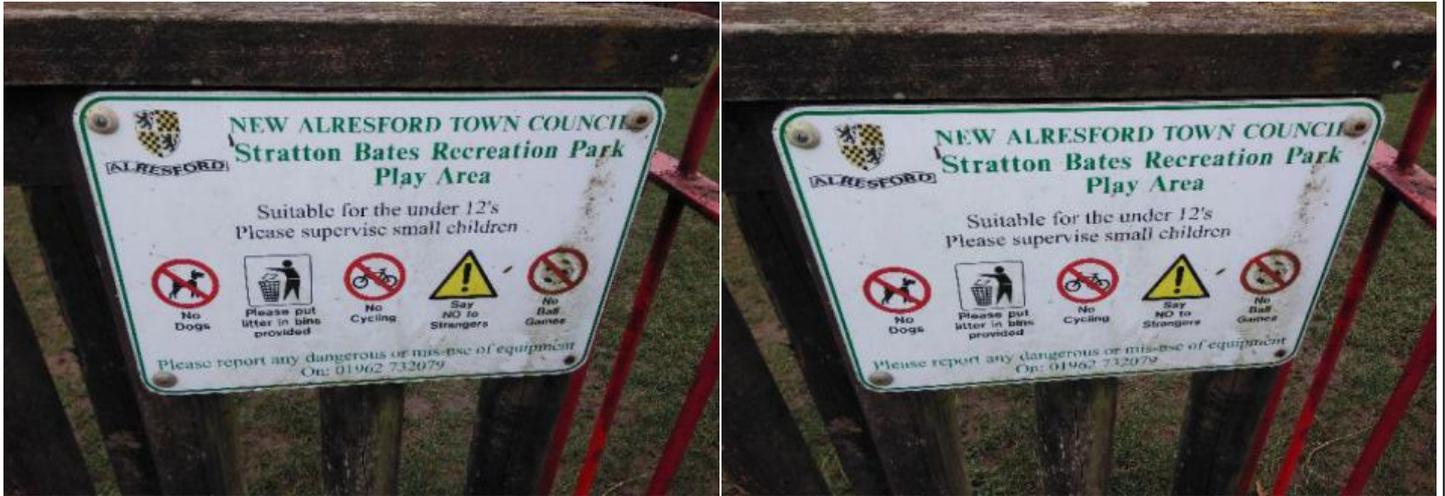
**Risk Level:** V - Very Low Risk  
**Surface:** N/A

**Finding:** BS EN 1176 Part 7 recommends that signage shall include the site name / address  
**Action:** Provide additional information

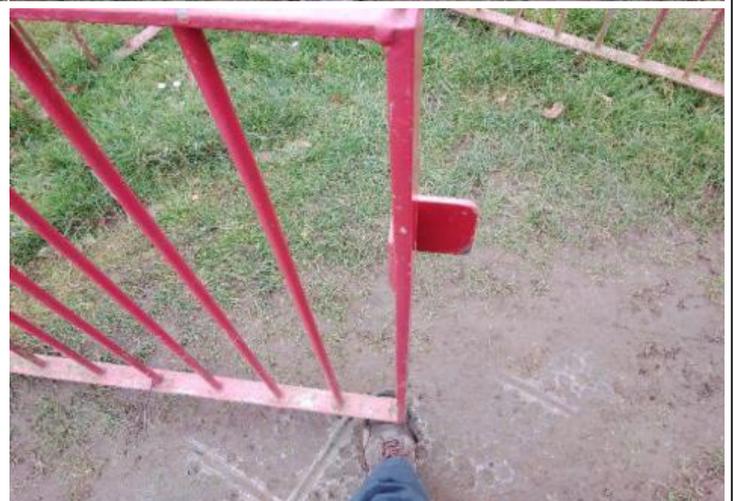
**Risk Level:** L - Low Risk  
**Surface:** Grass

**Finding:** The rubber buffer is missing from the latch plate

**Action:** Replace rubber buffer

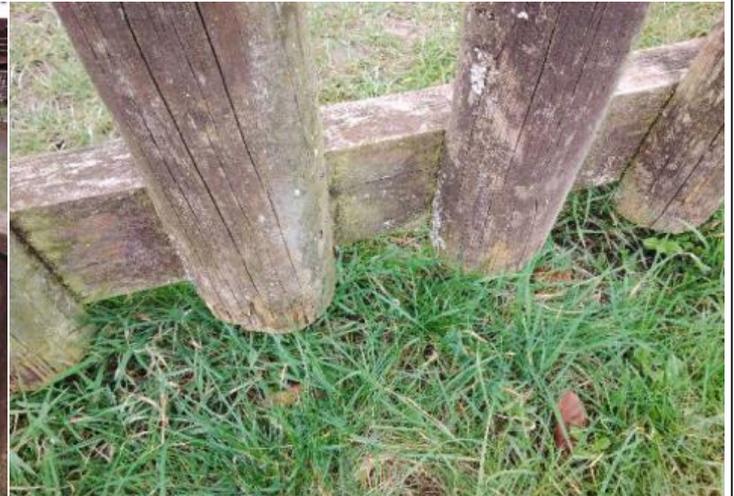
**Risk Level:** L - Low Risk  
**Surface:** Grass

**Finding:** There is some strimmer / machinery damage apparent on the posts, this can penetrate the preservative applied to the timber and accelerate the rotting process

**Action:** Monitor for any deterioration (rot) and replace as required

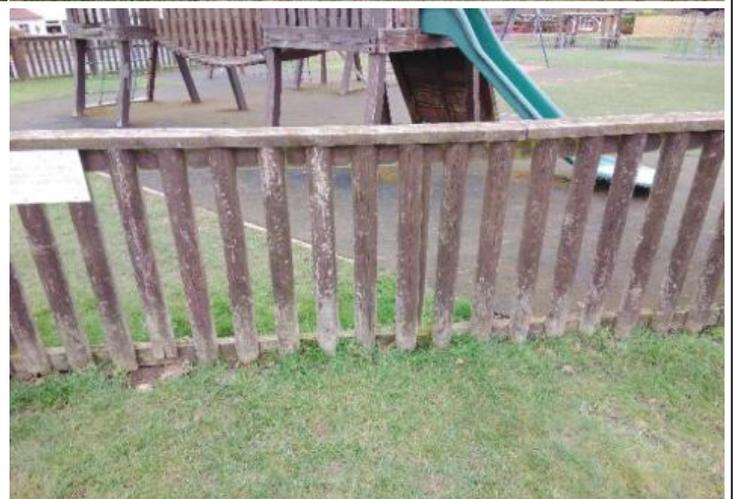
**Risk Level:** L - Low Risk  
**Surface:** Grass

**Finding:** There are a number of loose posts around the fence

**Action:** Monitor for any further deterioration and reset as required

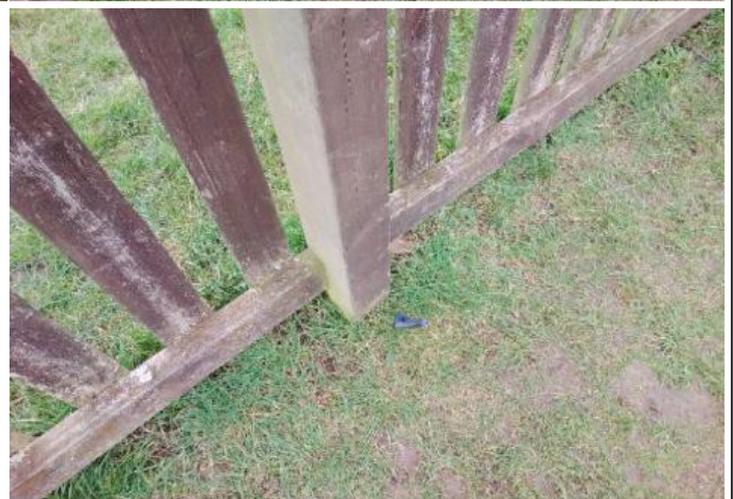
**Risk Level:** L - Low Risk  
**Surface:** Grass

**Finding:** There is some evidence of rot in the timber posts

**Action:** Monitor for any further deterioration and replace as required

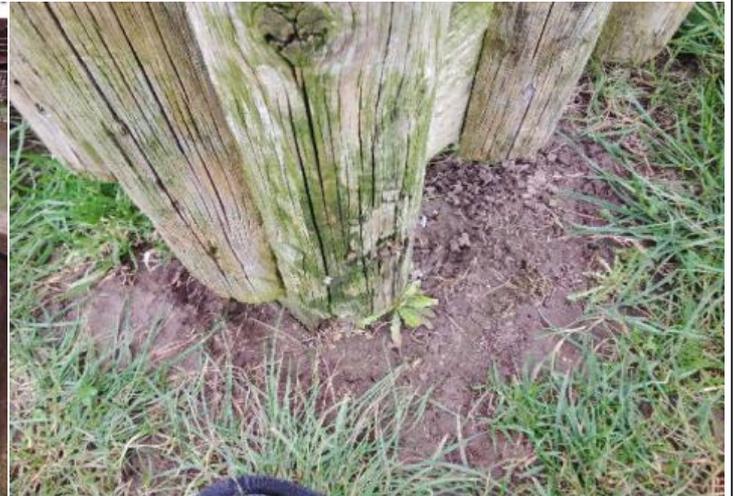
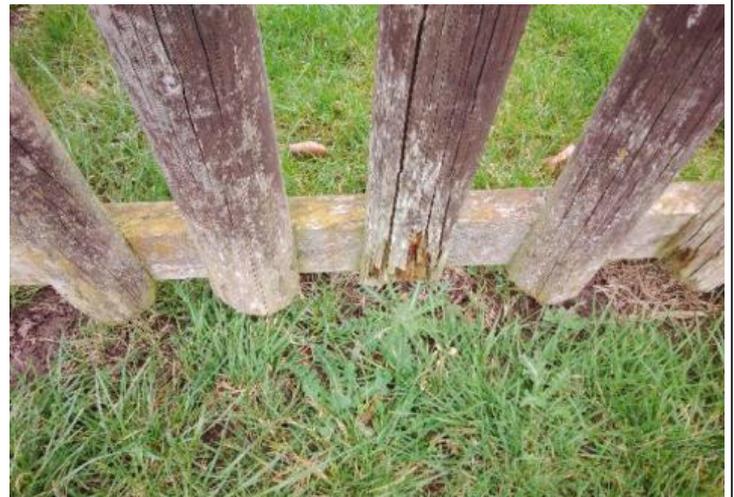
**Risk Level:** L - Low Risk  
**Surface:** Grass

**Finding:** A number of fixings have worked loose around the fencing  
**Action:** Secure all loose fixings

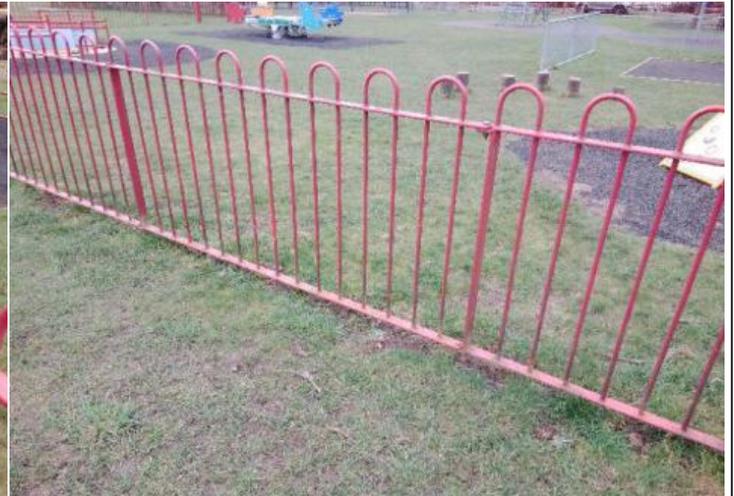
**Risk Level:** L - Low Risk  
**Surface:** Grass

**Finding:** There are a number of loose posts around the fence

**Action:** Monitor for any further deterioration and reset as required

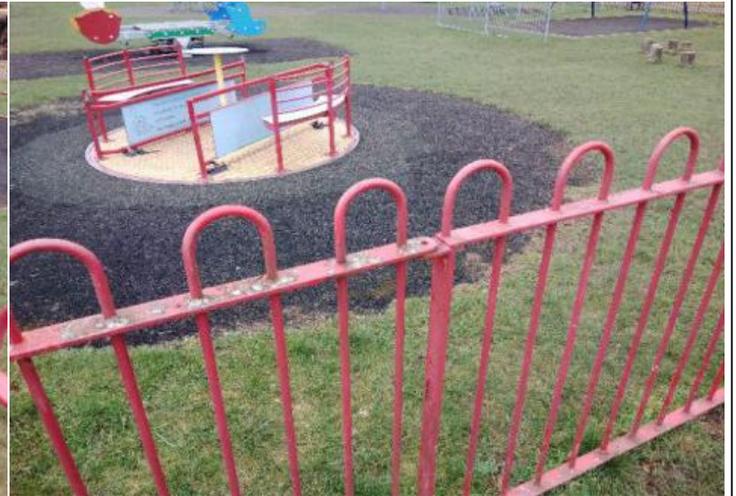
**Risk Level:** L - Low Risk  
**Surface:** Grass

**Finding:** There are a number of fixings missing from the fence

**Action:** Replace missing fixings

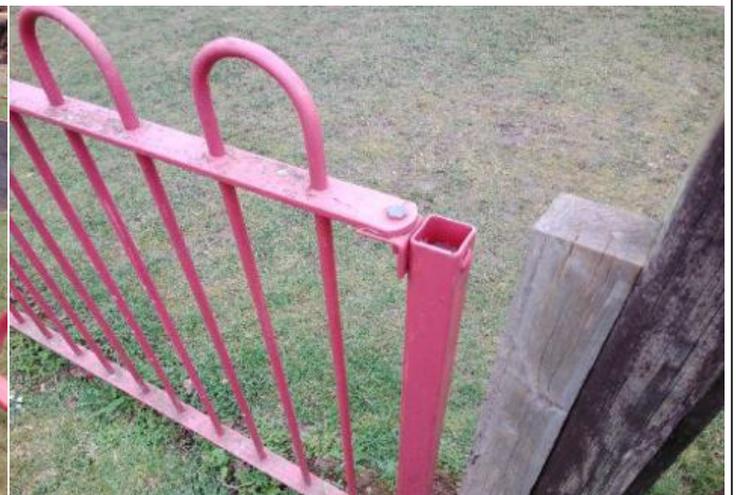
**Risk Level:** L - Low Risk  
**Surface:** Grass

**Finding:** There are a number of post caps missing from the fence

**Action:** Replace missing post caps

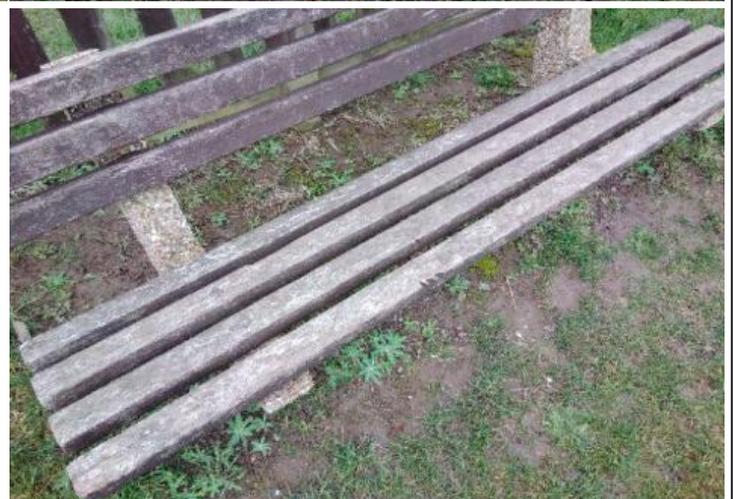
**Risk Level:** L - Low Risk  
**Surface:** Grass

**Finding:** The item has been damaged

**Action:** Monitor for any further deterioration and replace as required

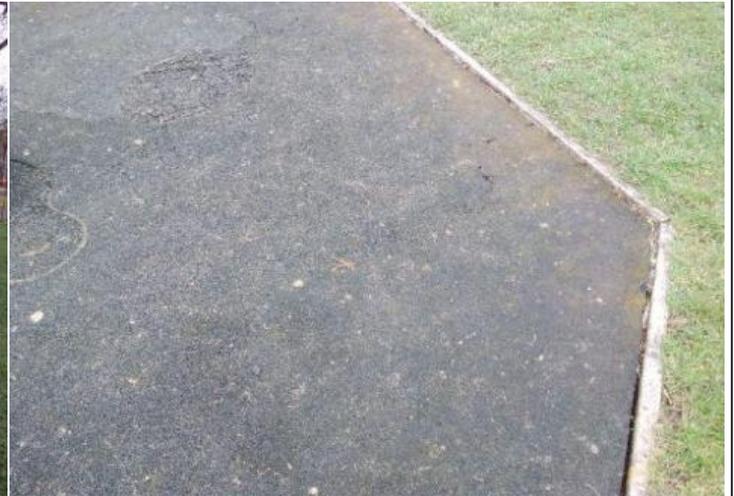
**Risk Level:** L - Low Risk  
**Surface:** Wet Pour

**Finding:** The surface has subsided in some areas

**Action:** Monitor for any further deterioration and repair as required

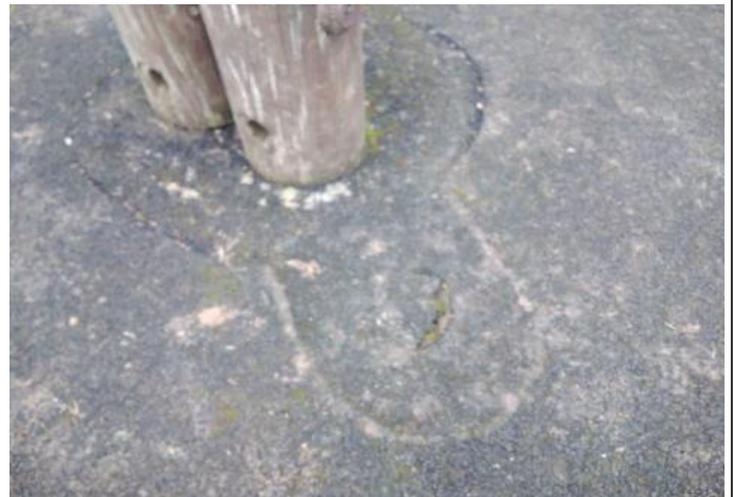
**Risk Level:** L - Low Risk  
**Surface:** Wet Pour

**Finding:** The surface has eroded and the old foundations are exposed

**Action:** Reinststate surrounding surfaces to cover the foundations

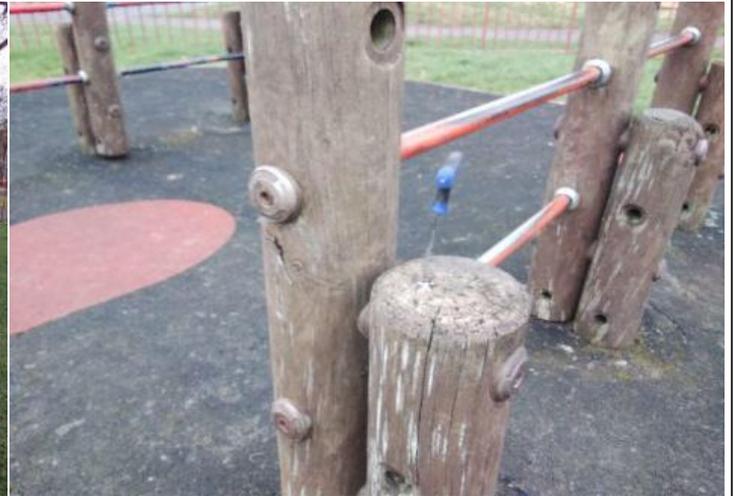
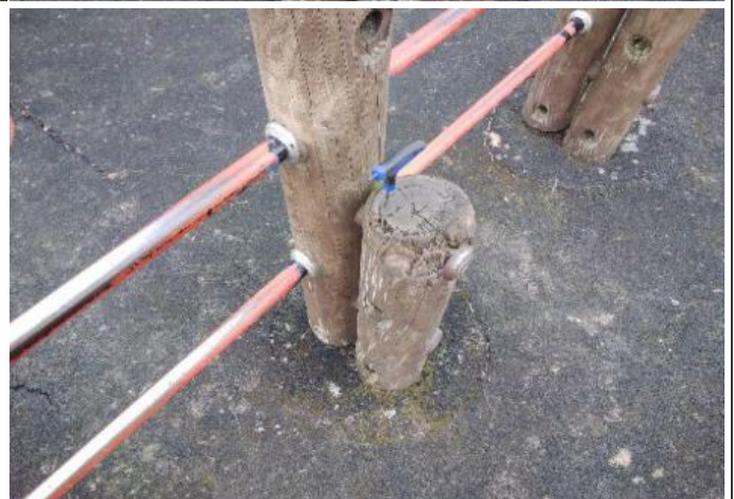
**Risk Level:** L - Low Risk  
**Surface:** Wet Pour

**Finding:** There is some evidence of rot in the timber

**Action:** Monitor for any further deterioration and replace as required

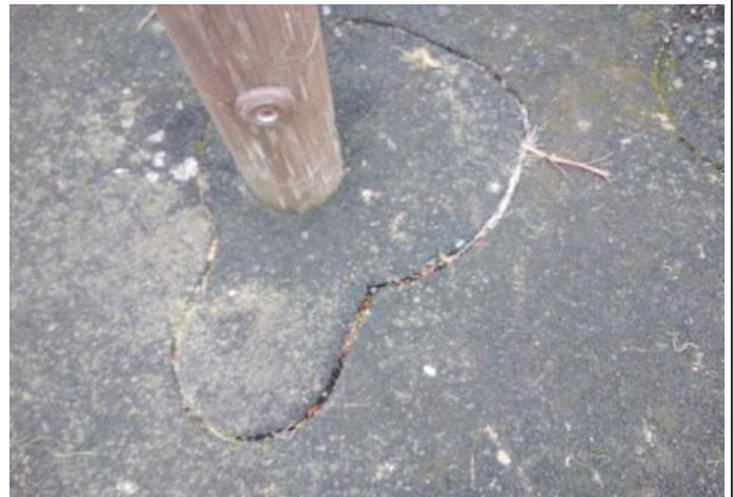
**Risk Level:** L - Low Risk  
**Surface:** Wet Pour

**Finding:** There are gaps opening between the surfacing and the edging surround or between the joints in the surfacing  
**Action:** Monitor for any further deterioration and repair as required

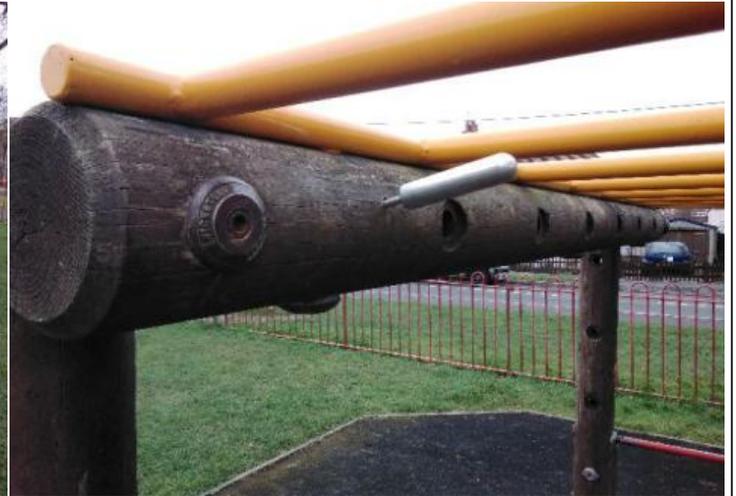
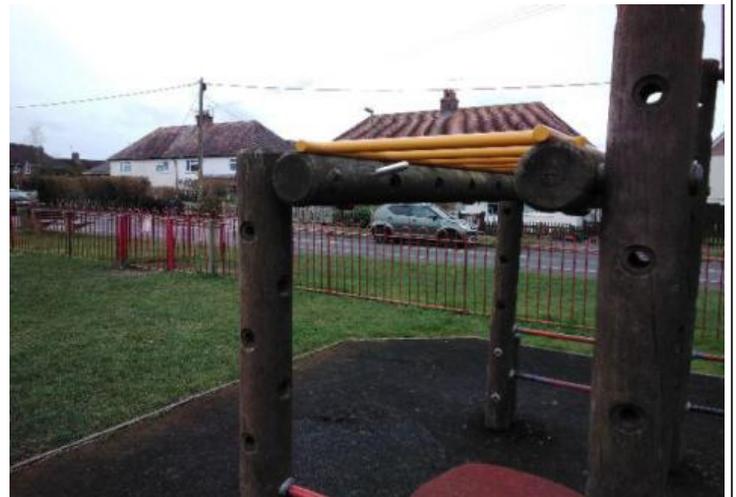
**Risk Level:** V - Very Low Risk  
**Surface:** Wet Pour

**Finding:** There is/are finger entrapment/s in the timber beam in a old knot hole and the item fails to meet the requirements of BS EN 1176 Part 1 4.2.7.6 Entrapment of fingers

**Action:** Monitor - No remedial work recommended

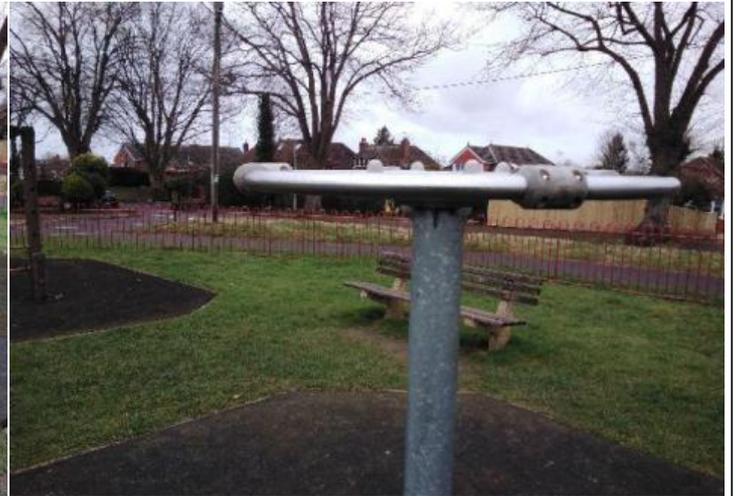
**Risk Level:** L - Low Risk  
**Surface:** Wet Pour

**Finding:** The bearing is not operating correctly

**Action:** Replace the bearing as required

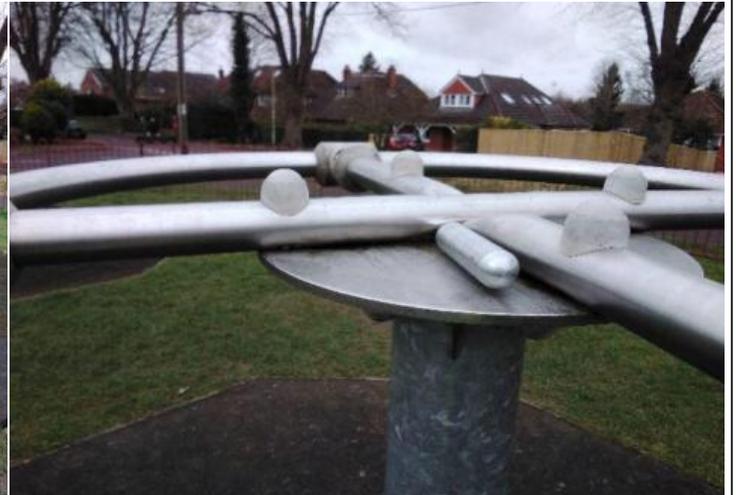
**Risk Level:** V - Very Low Risk  
**Surface:** Wet Pour

**Finding:** There is/are finger entrapment/s in the top of the rotator and the item fails to meet the requirements of BS EN 1176 Part 1 4.2.7.6 Entrapment of fingers

**Action:** Monitor - No remedial work recommended

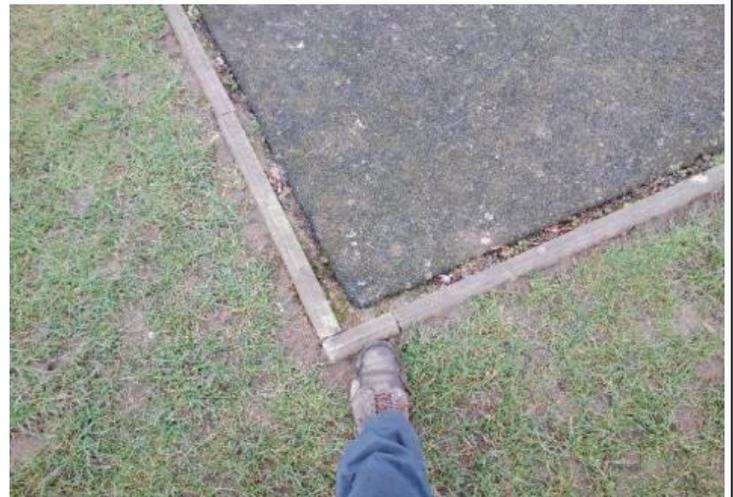
**Risk Level:** L - Low Risk  
**Surface:** Wet Pour

**Finding:** There are trip hazards at the edges of the surface

**Action:** Reinstate surrounding surface levels to remove the trip points

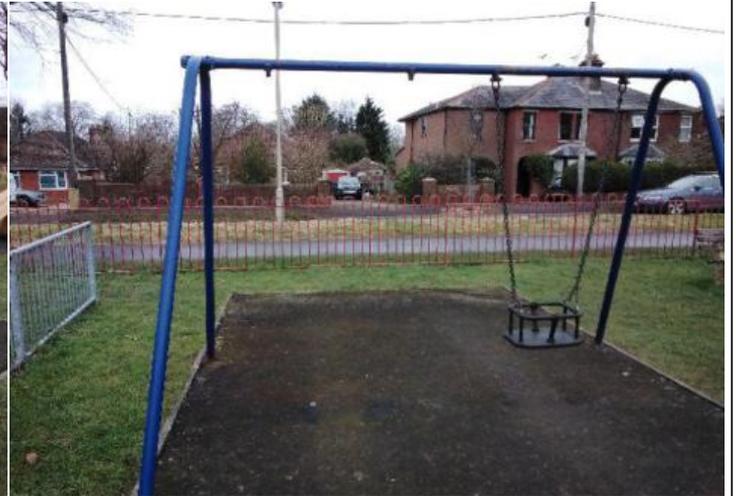
**Risk Level:** N - Risk Assessment not Undertaken  
**Surface:** Wet Pour

**Finding:** The seat(s) and suspension were missing at the time of inspection and the inspector was unable to make a full compliance assessment

**Action:** Replace missing seat(s) and suspension

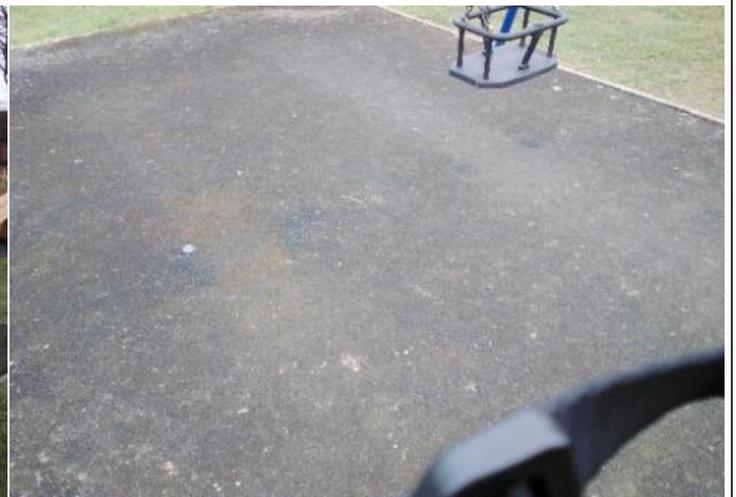
**Risk Level:** L - Low Risk  
**Surface:** Wet Pour

**Finding:** The safety surface around the area is beginning to wear

**Action:** Monitor for any further deterioration and repair as required

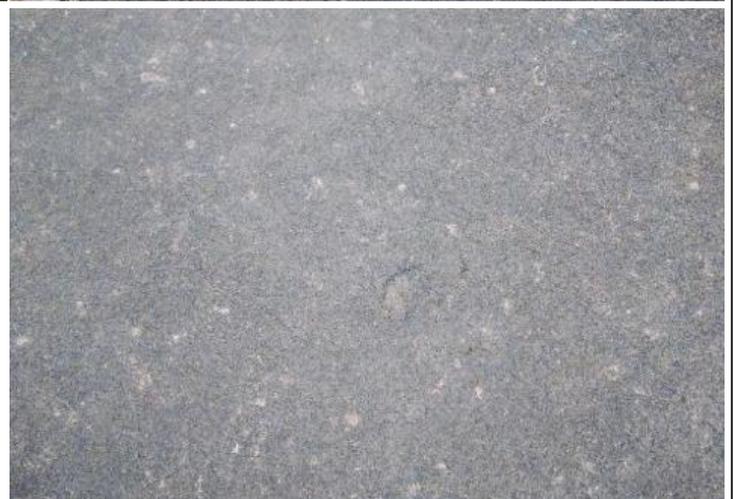
**Risk Level:** V - Very Low Risk  
**Surface:** Wet Pour

**Finding:** The safety surface under or around this unit has been damaged

**Action:** Monitor for any further deterioration and repair as required

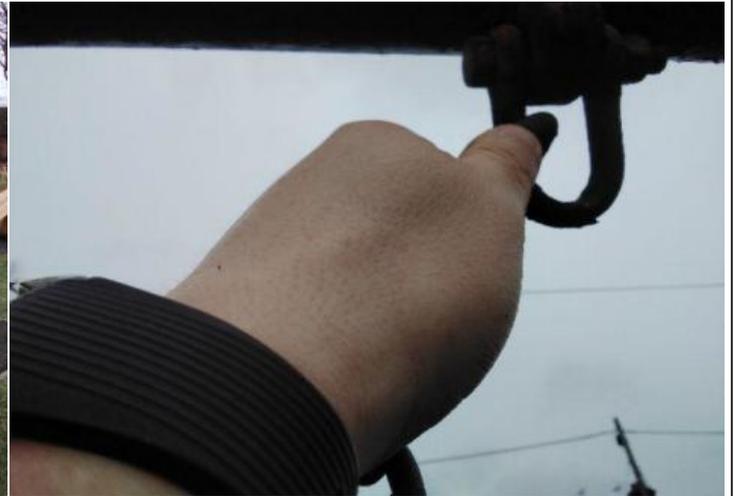
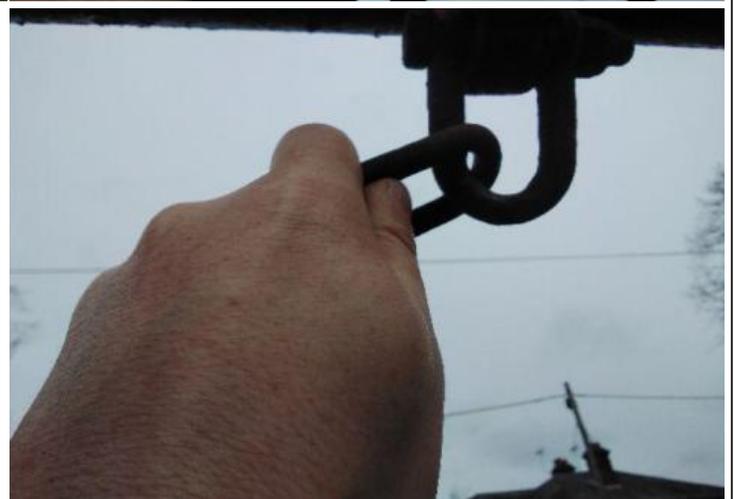
**Risk Level:** L - Low Risk  
**Surface:** Wet Pour

**Finding:** There is some wear to the shackles.

**Action:** Monitor for any further deterioration and replace when 40% worn

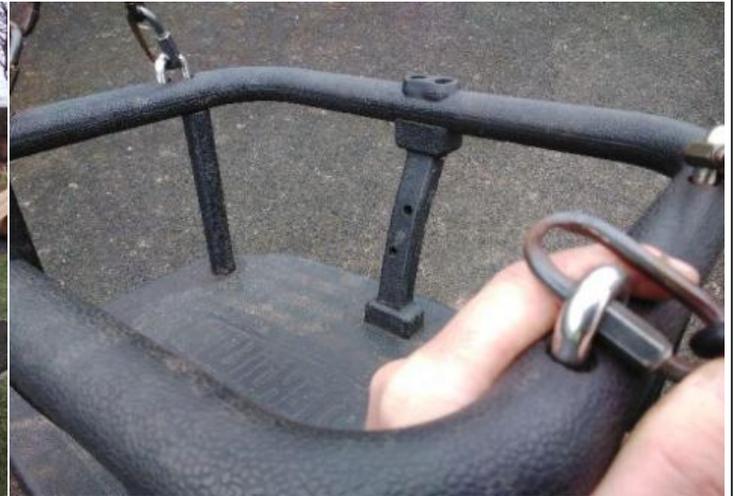
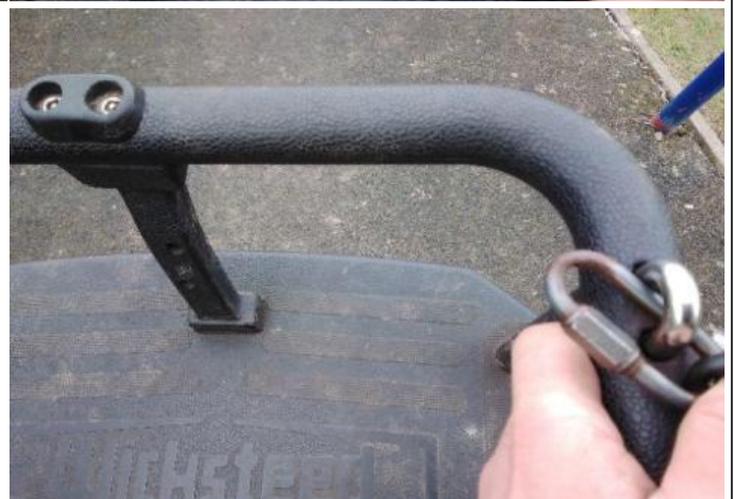
**Risk Level:** L - Low Risk  
**Surface:** Wet Pour

**Finding:** There is some notable evidence of connecting link wear

**Action:** Monitor for any further deterioration and replace when 40% worn

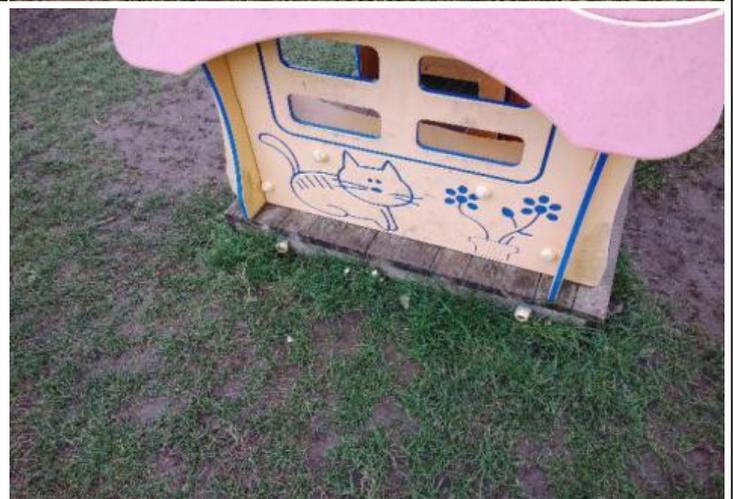
**Risk Level:** V - Very Low Risk  
**Surface:** Grass

**Finding:** There is/are bolt cap covers missing or damaged on the item

**Action:** Replace missing or damaged bolt cap covers

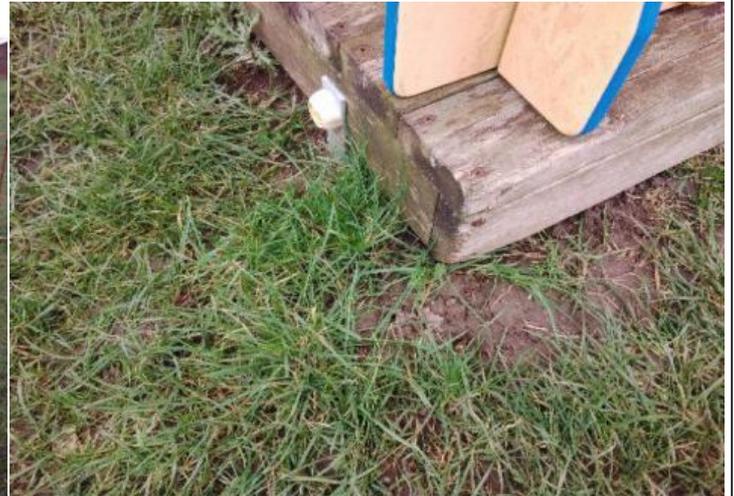
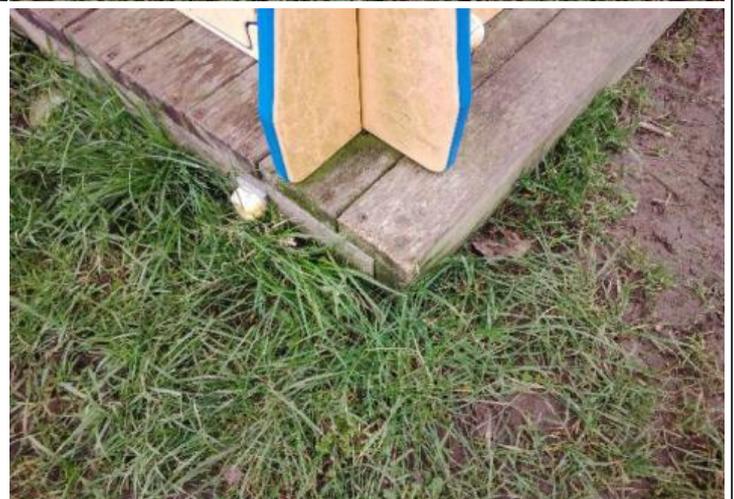
**Risk Level:** L - Low Risk  
**Surface:** Grass

**Finding:** There is some strimmer / machinery damage apparent on the posts, this can penetrate the preservative applied to the timber and accelerate the rotting process

**Action:** Monitor for any deterioration (rot) and replace as required

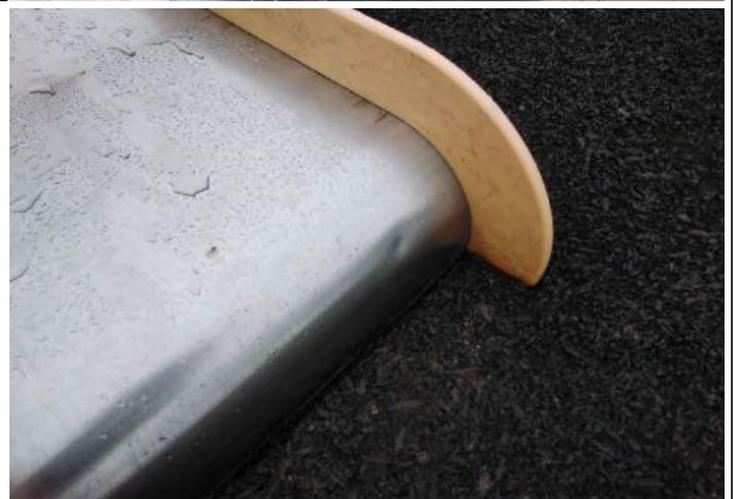
**Risk Level:** V - Very Low Risk  
**Surface:** Bonded Rubber Mulch

**Finding:** There are a number of dents in the slide surface

**Action:** Monitor for any further deterioration and repair as required

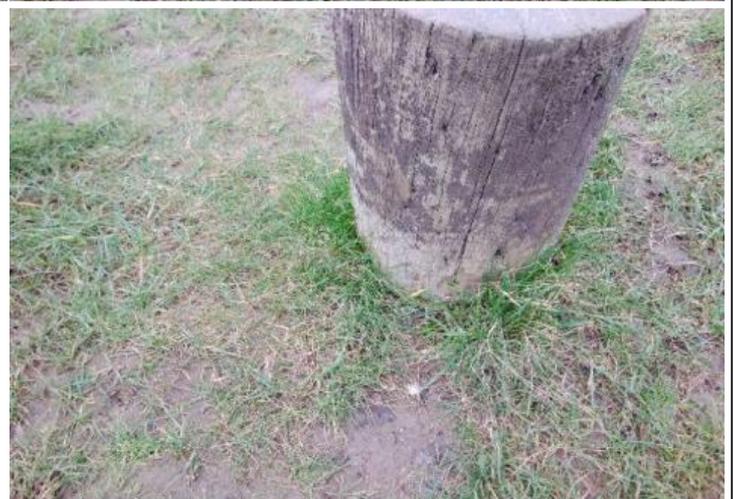
**Risk Level:** L - Low Risk  
**Surface:** Grass

**Finding:** There is some strimmer / machinery damage apparent on the posts, this can penetrate the preservative applied to the timber and accelerate the rotting process

**Action:** Monitor for any deterioration (rot) and replace as required

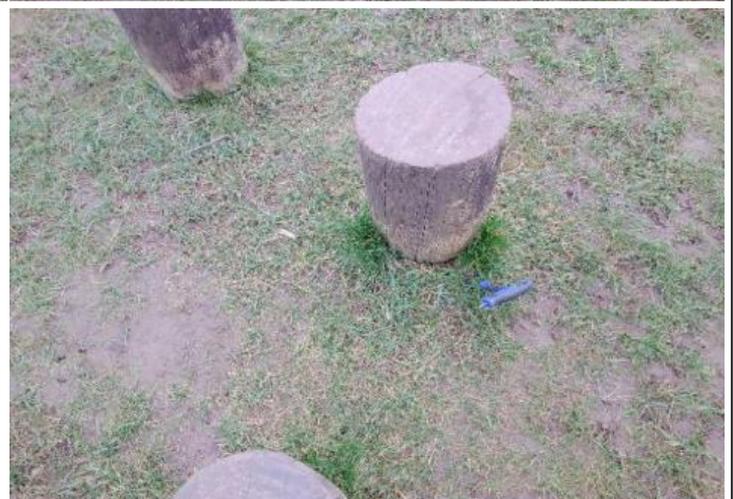
**Risk Level:** L - Low Risk  
**Surface:** Grass

**Finding:** There is some evidence of rot in the timber

**Action:** Monitor for any further deterioration and replace as required

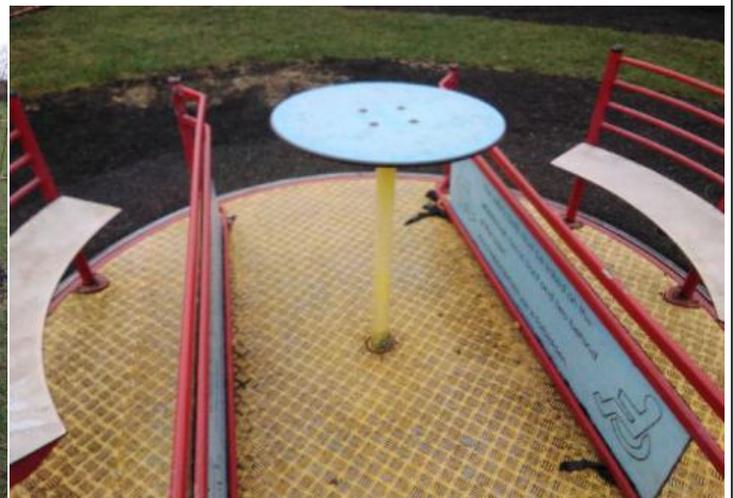
**Risk Level:** L - Low Risk  
**Surface:** Bonded Rubber Mulch

**Finding:** A number of fixing(s) have worked loose to the centre table

**Action:** Secure all loose fixings

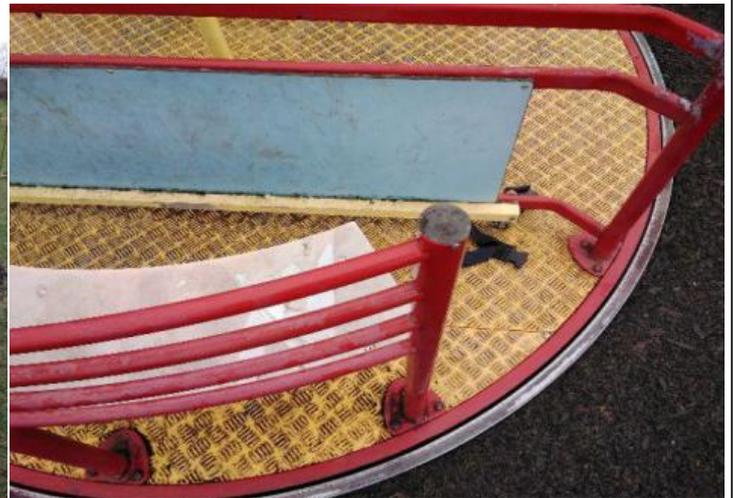
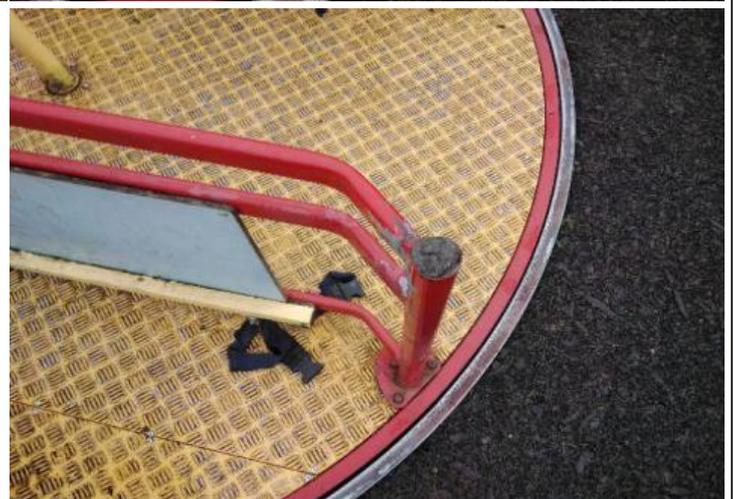
**Risk Level:** L - Low Risk  
**Surface:** Bonded Rubber Mulch

**Finding:** There is some evidence of fire damage to the post caps  
**Action:** Replace post end caps

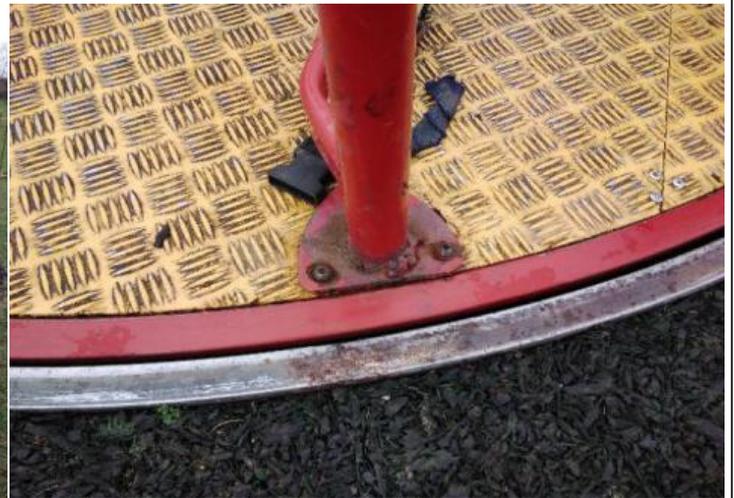
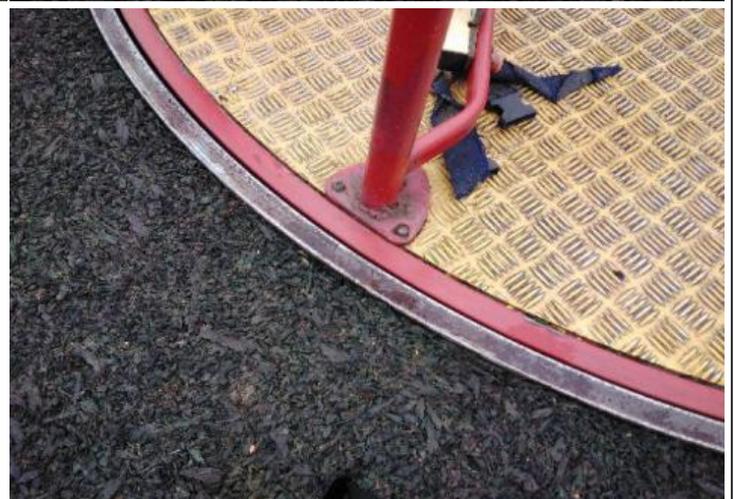
**Risk Level:** L - Low Risk  
**Surface:** Bonded Rubber Mulch

**Finding:** A number of fixing(s) have worked loose

**Action:** Secure all loose fixings

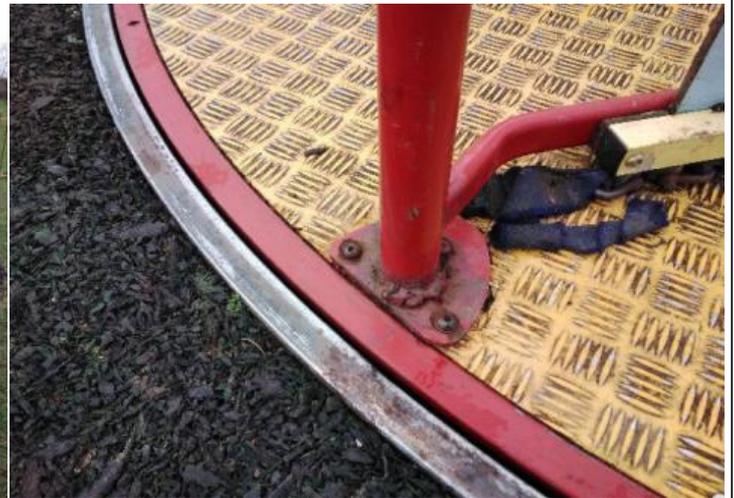
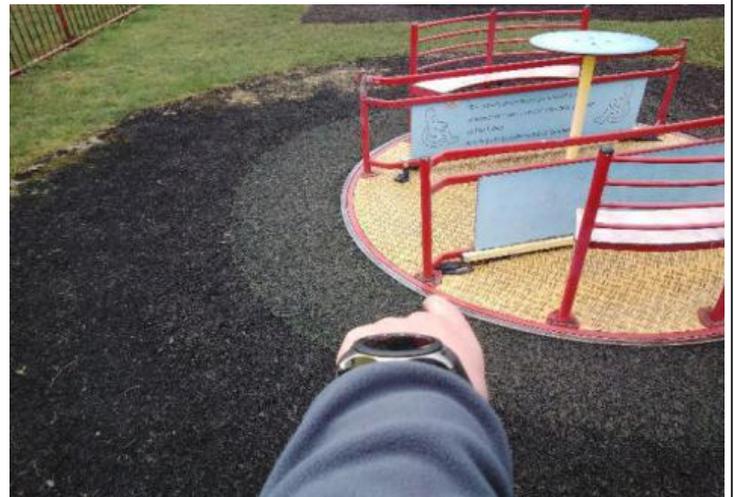
**Risk Level:** L - Low Risk  
**Surface:** Bonded Rubber Mulch

**Finding:** The weld(s) on this item have failed and the post is loose  
**Action:** Repair item

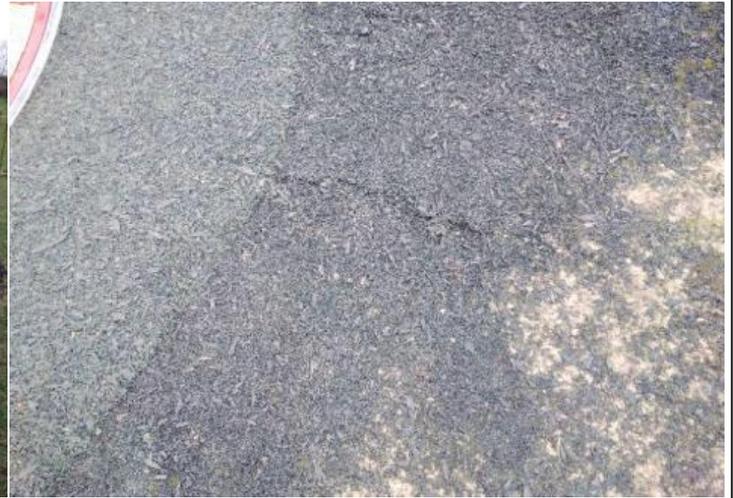
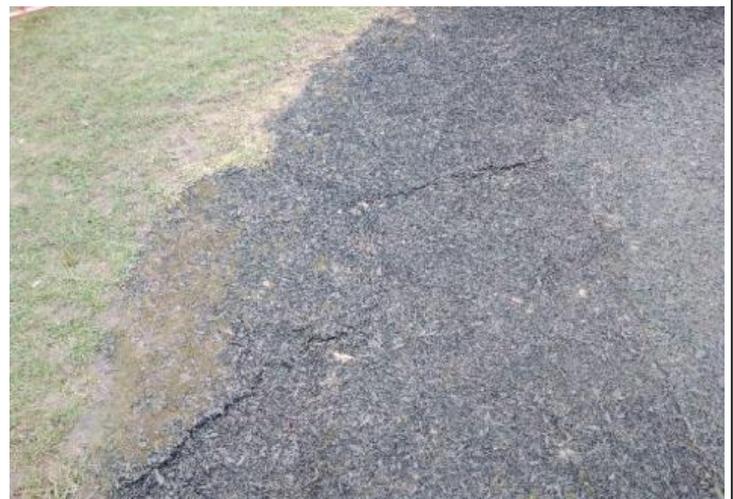
**Risk Level:** V - Very Low Risk  
**Surface:** Bonded Rubber Mulch

**Finding:** The safety surface under or around this unit has been damaged

**Action:** Monitor for any further deterioration and repair as required

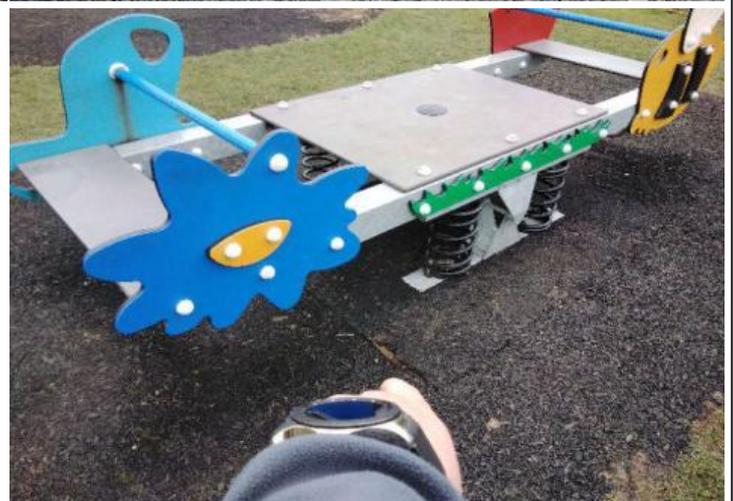
**Risk Level:** L - Low Risk  
**Surface:** Bonded Rubber Mulch

**Finding:** The safety surface has worn and the foundations are exposed

**Action:** Reinstall surrounding surfaces to cover the foundations

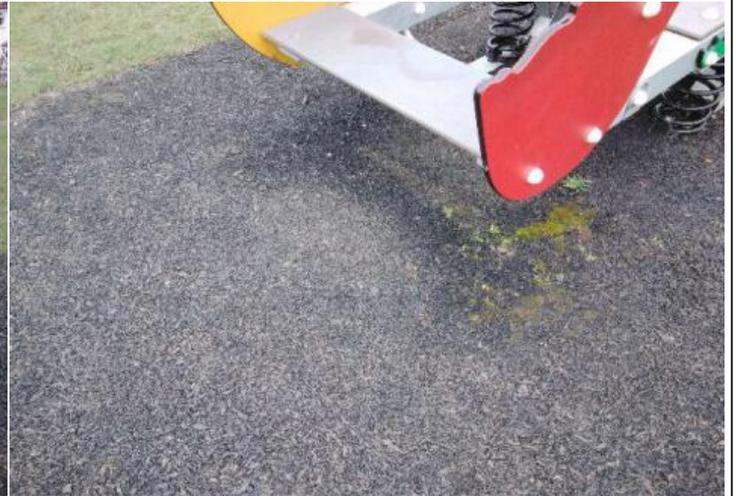
**Risk Level:** L - Low Risk  
**Surface:** Bonded Rubber Mulch

**Finding:** The safety surface around the area is beginning to wear

**Action:** Monitor for any further deterioration and repair as required

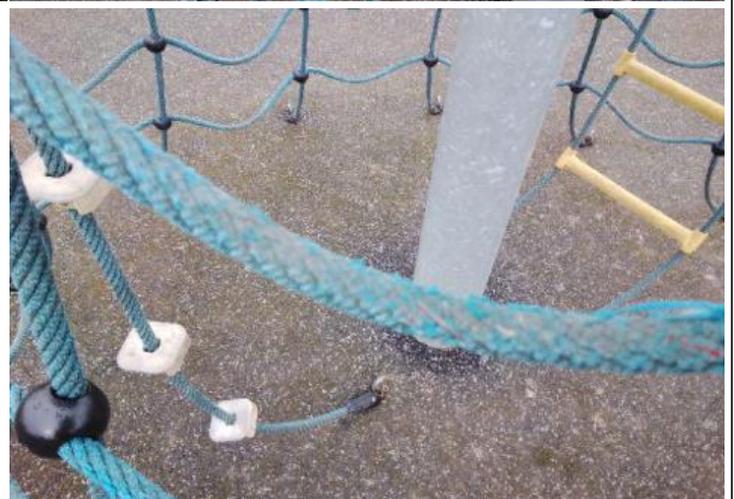
**Risk Level:** L - Low Risk  
**Surface:** Wet Pour

**Finding:** The ropes/nets are worn/damaged in places

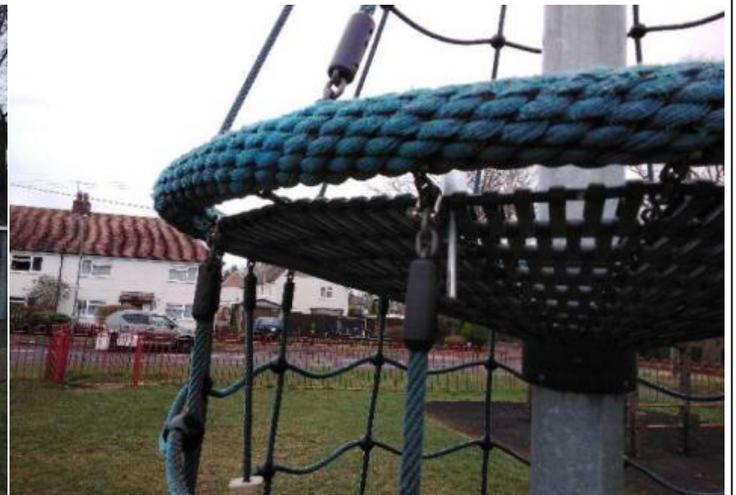
**Risk Level:** V - Very Low Risk  
**Surface:** Wet Pour

**Finding:** There is/are finger entrapment/s in the net and the item fails to meet the requirements of BS EN 1176 Part 1 4.2.7.6 Entrapment of fingers

**Action:** Monitor - No remedial work recommended

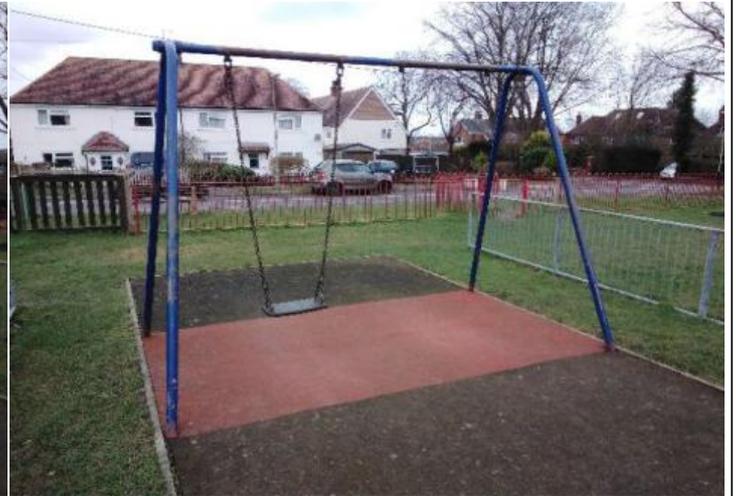
**Risk Level:** N - Risk Assessment not Undertaken  
**Surface:** Wet Pour

**Finding:** The seat(s) and suspension were missing at the time of inspection and the inspector was unable to make a full compliance assessment

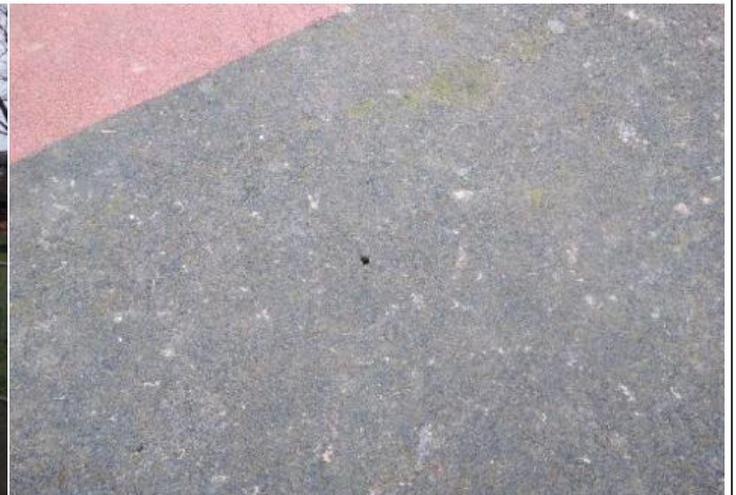
**Risk Level:** V - Very Low Risk  
**Surface:** Wet Pour

**Finding:** The safety surface under or around this unit has been damaged

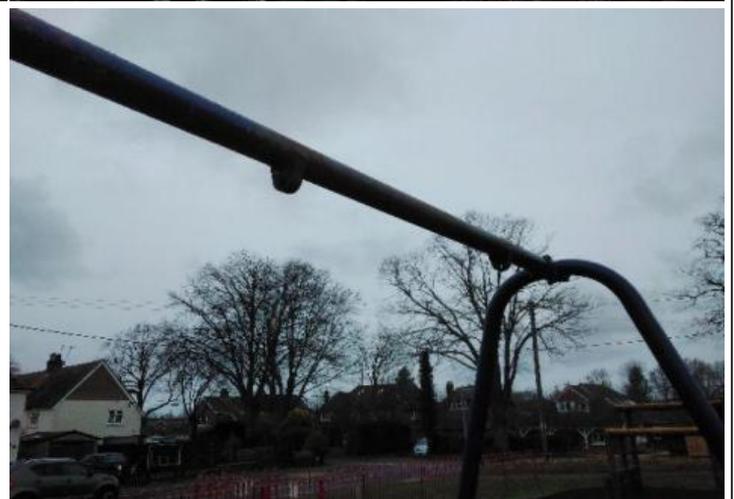
**Risk Level:** L - Low Risk  
**Surface:** Wet Pour

**Finding:** The paintwork on the crossbar has been damaged or worn exposing the metal underneath which is rusting  
**Action:** Treat any rusting components and repaint

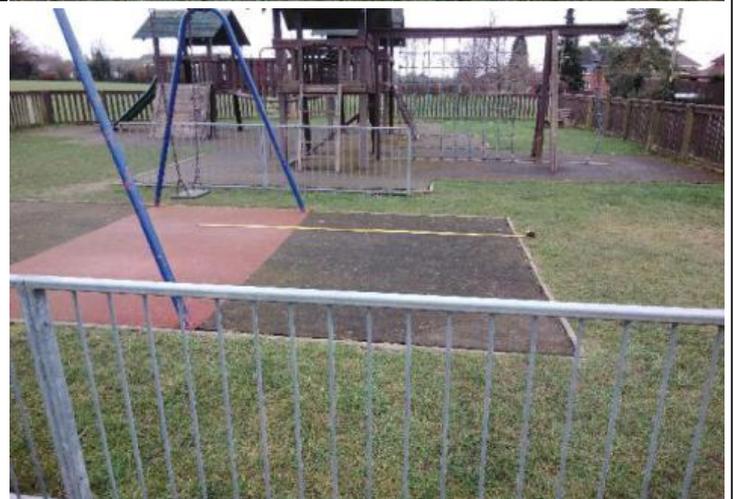
**Risk Level:** V - Very Low Risk  
**Surface:** Wet Pour

**Finding:** The surfacing dimensions are short and do not meet with the requirements of the current applicable standard

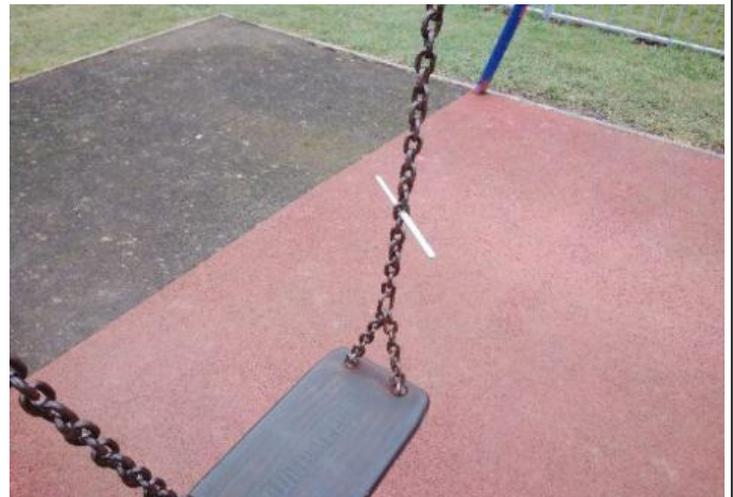
**Risk Level:** V - Very Low Risk  
**Surface:** Wet Pour

**Finding:** The chain openings are in excess of the 8.6mm as recommended by BS EN 1176 **Action:** Monitor - No remedial work recommended

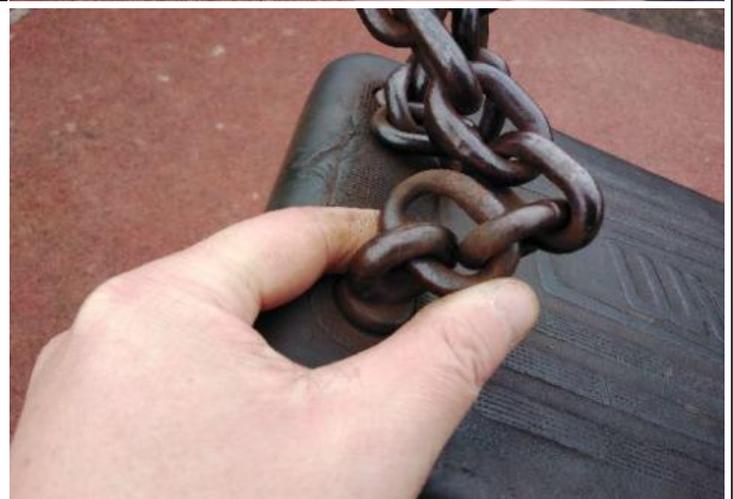
**Risk Level:** L - Low Risk  
**Surface:** Wet Pour

**Finding:** There is some notable evidence of chain wear
