the **play inspection** company

## Annual Inspection

Winchester City Council

Stratton Bates Recreation Ground (New Alresford)

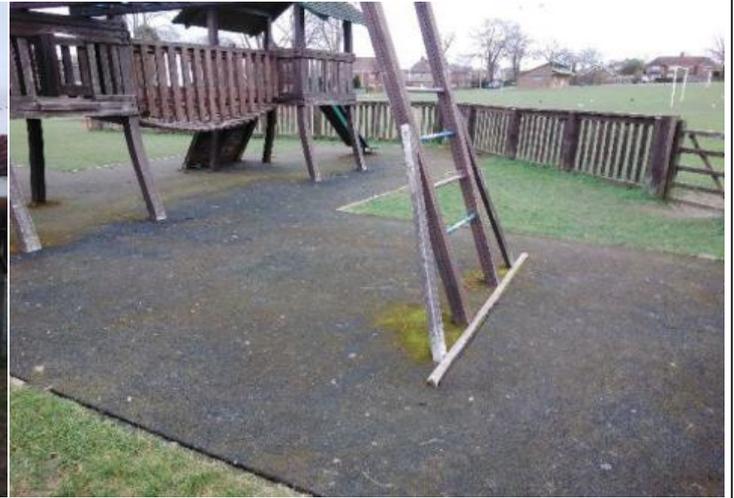
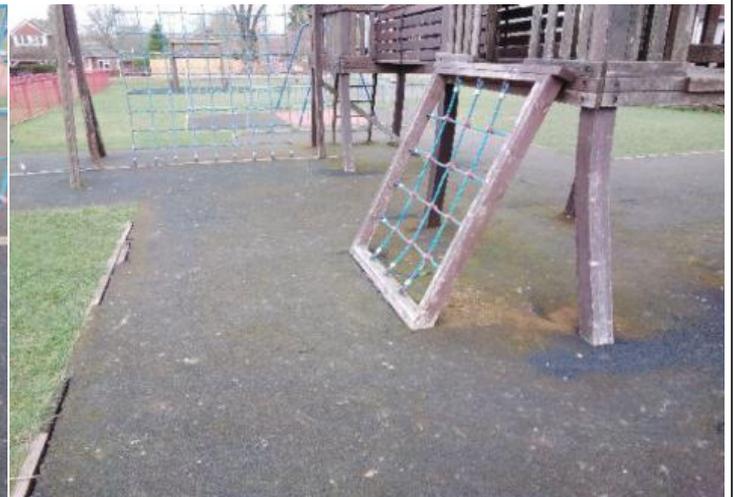
**Risk Level:** V - Very Low Risk  
**Surface:** Wet Pour

**Finding:** The rope and climber bases forms a hard object within the impact area of the equipment in contravention of the requirements of BS EN 1176 Part 1

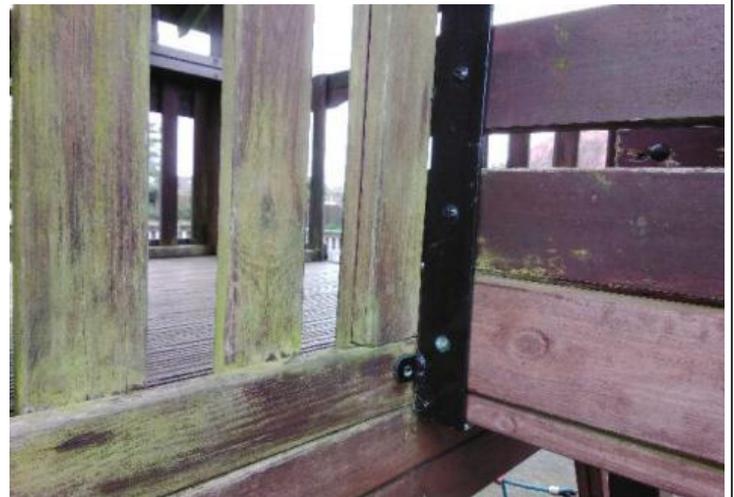
**Risk Level:** L - Low Risk  
**Surface:** Wet Pour

**Finding:** A number of fixing(s) have worked loose to the wooden tunnel framework

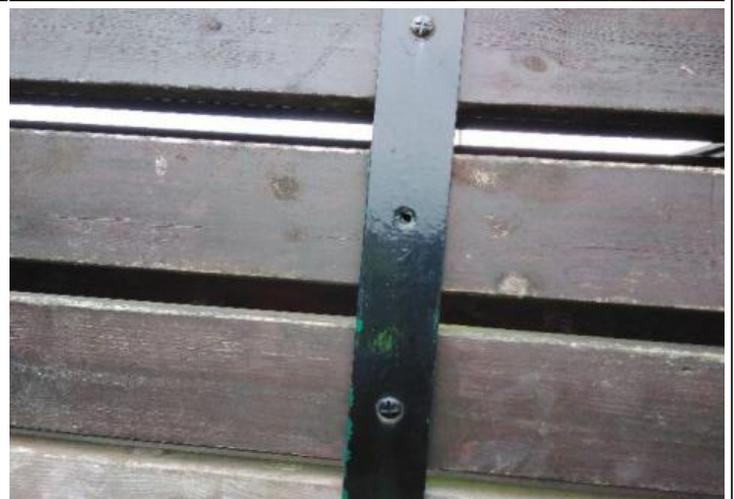
**Risk Level:** L - Low Risk  
**Surface:** Wet Pour

**Finding:** There is or are fixings missing on the item

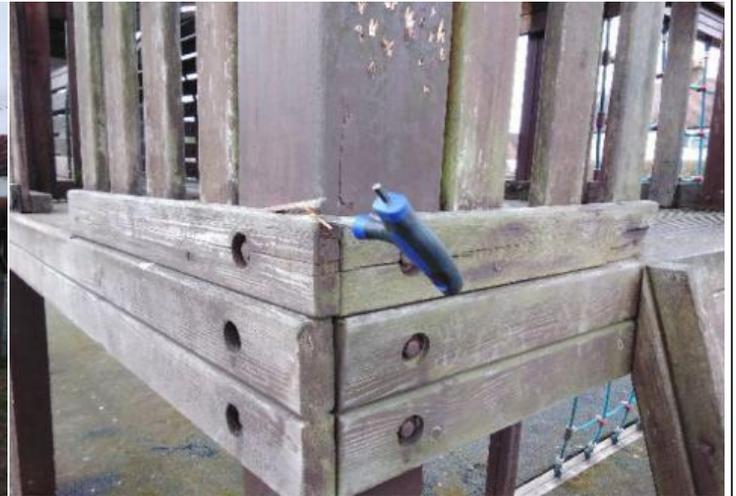
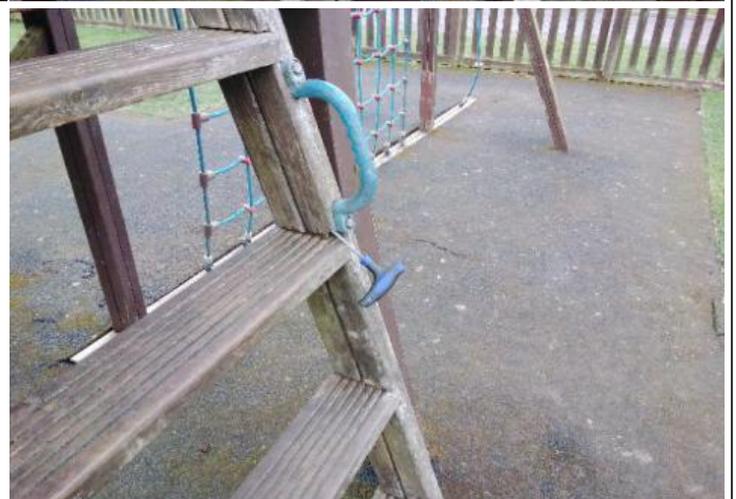
**Risk Level:** L - Low Risk  
**Surface:** Wet Pour

**Finding:** There is some evidence of rot in the timber framework

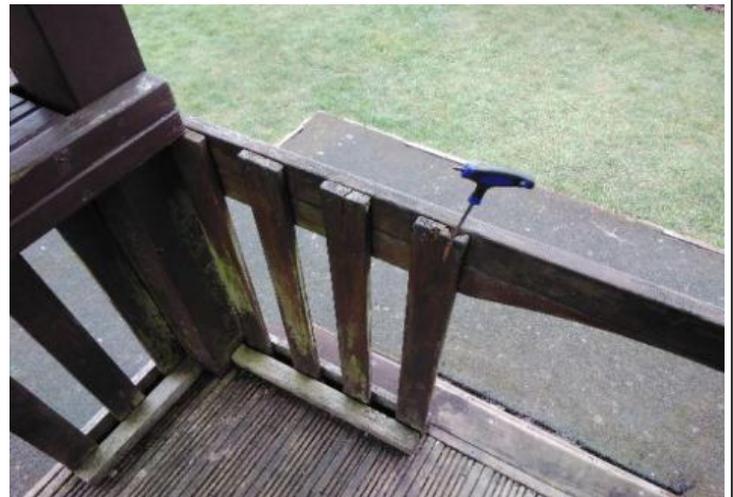
**Risk Level:** L - Low Risk  
**Surface:** Wet Pour

**Finding:** There is some evidence of rot in the timber

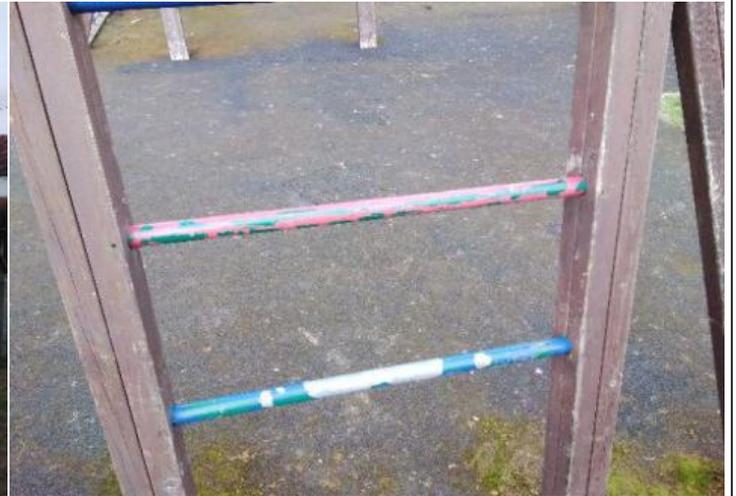
**Risk Level:** L - Low Risk  
**Surface:** Wet Pour

**Finding:** The Handgrips/Footrests rotate and may cause an unexpected movement for the user  
**Action:** Secure Handgrips/Footrests to prevent rotation.

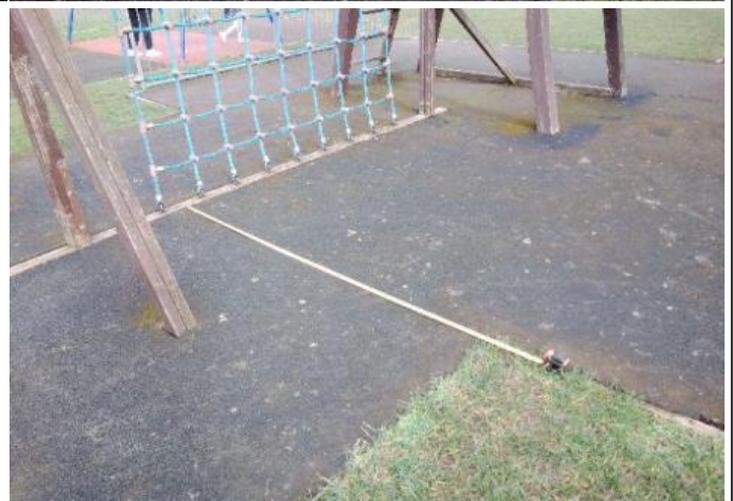
**Risk Level:** V - Very Low Risk  
**Surface:** Wet Pour

**Finding:** The surfacing dimensions are short and do not meet with the requirements of the current applicable standard

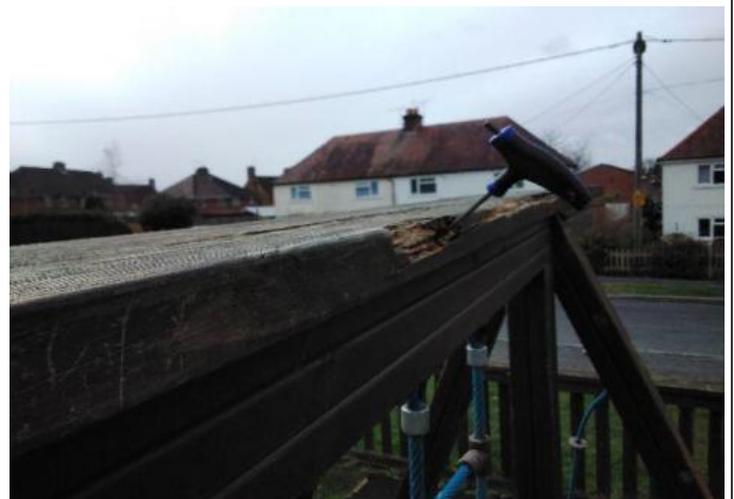
**Risk Level:** M - Moderate Risk  
**Surface:** Wet Pour

**Finding:** There are areas or parts of the timber crossbeam to the net climber that have rotted

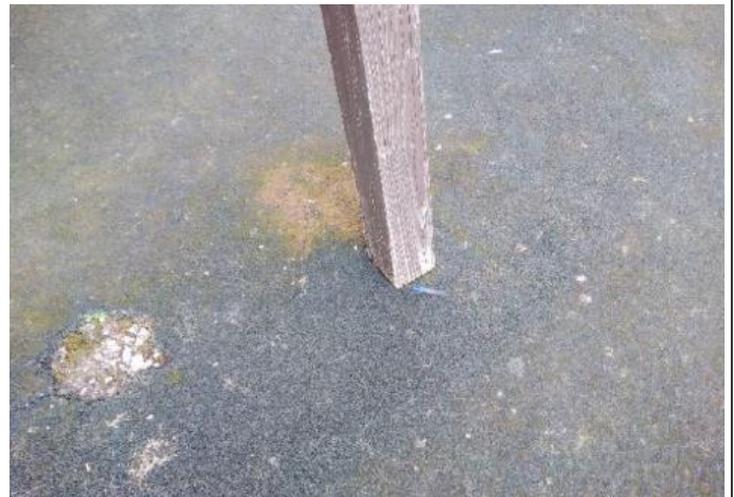
**Risk Level:** M - Moderate Risk  
**Surface:** Wet Pour

**Finding:** 2 x timber support posts on this item has severe rot

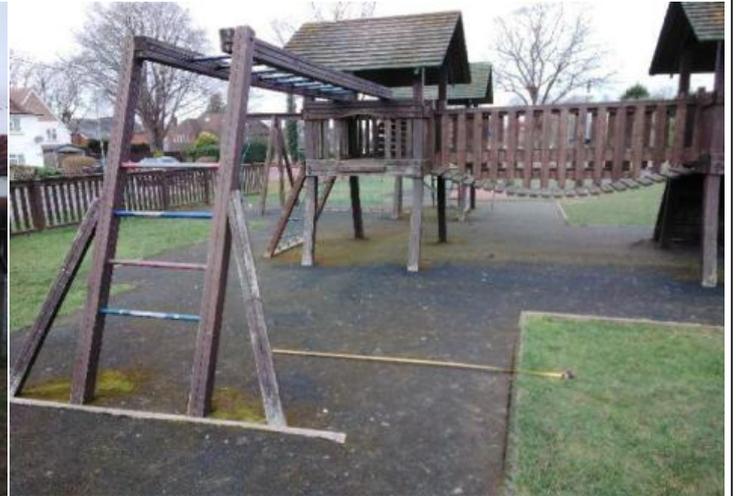
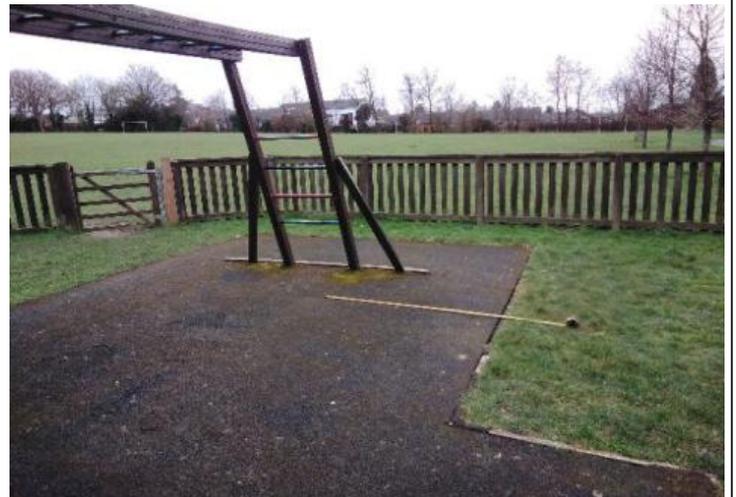
**Risk Level:** V - Very Low Risk  
**Surface:** Wet Pour

**Finding:** The surfacing dimensions are short and do not meet with the requirements of the current applicable standard

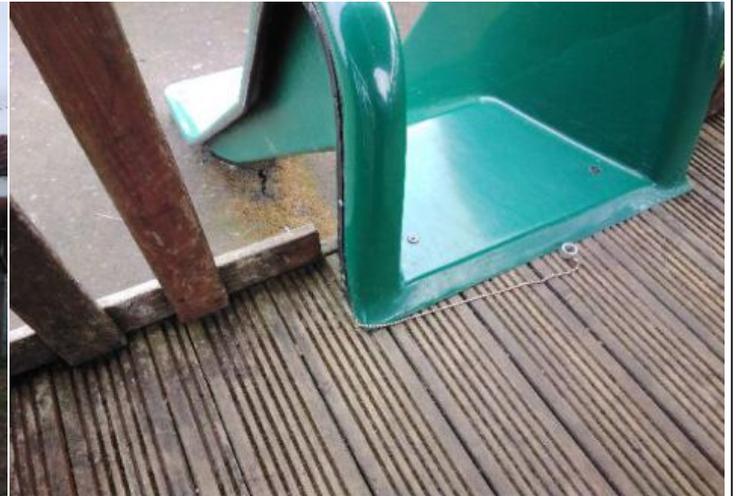
**Risk Level:** V - Very Low Risk  
**Surface:** Wet Pour

**Finding:** There is / are toggle entrapment/s present in contravention of the recommendations set out in BS EN 1176 Part 3

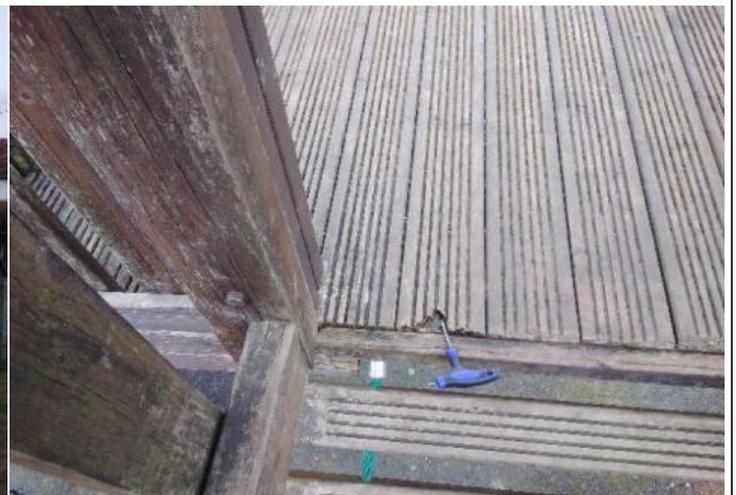
**Risk Level:** L - Low Risk  
**Surface:** Wet Pour

**Finding:** There are areas or parts of the timber on the structure that have rotted

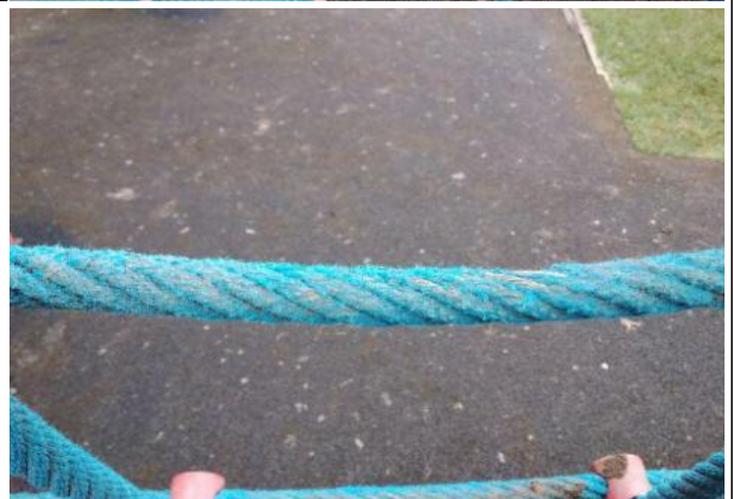
**Risk Level:** L - Low Risk  
**Surface:** Wet Pour

**Finding:** The ropes/nets are worn/damaged in places
