the **play inspection** company

Annual Inspection

Winchester City Council

Arlebury Park, Skate Park & Tennis(New Alresford)

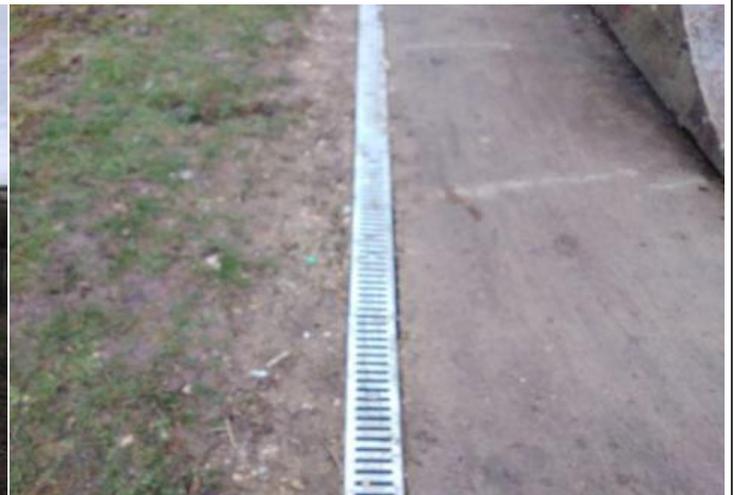
Item: Ancillary Items - Site General
Manufacturer: Owner/Operator

Finding: There are gaps opening between the surfacing and the acco drain to the skate area

Action: Monitor for any further deterioration and repair as required

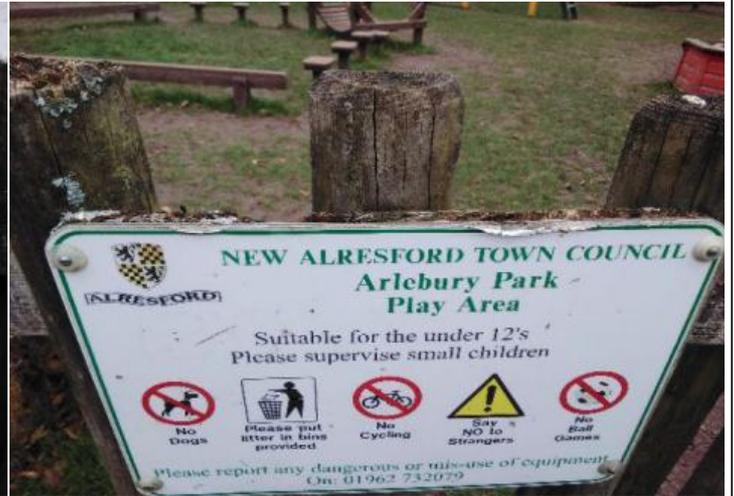
Item: Ancillary Items - Sign
Manufacturer: Owner/Operator

Finding: The item has been damaged

Action: Monitor for any further deterioration and replace as required

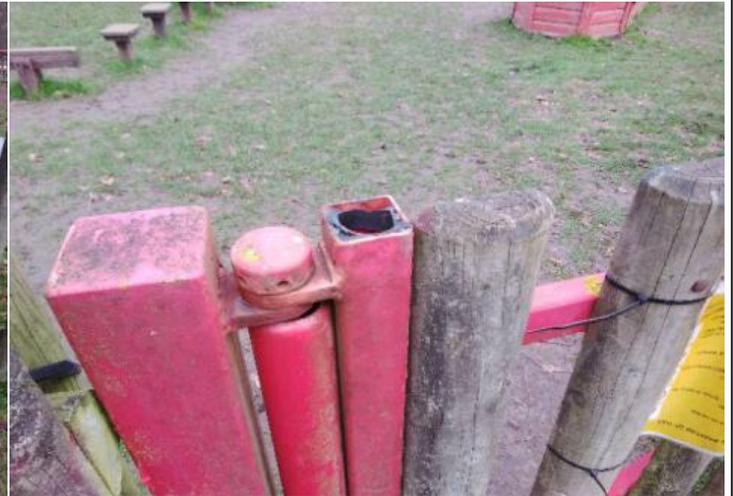
Item: Gates - Gate - Self Closing
Manufacturer: Unknown

Finding: Post/end caps have been damaged on this item

Action: Replace missing post caps

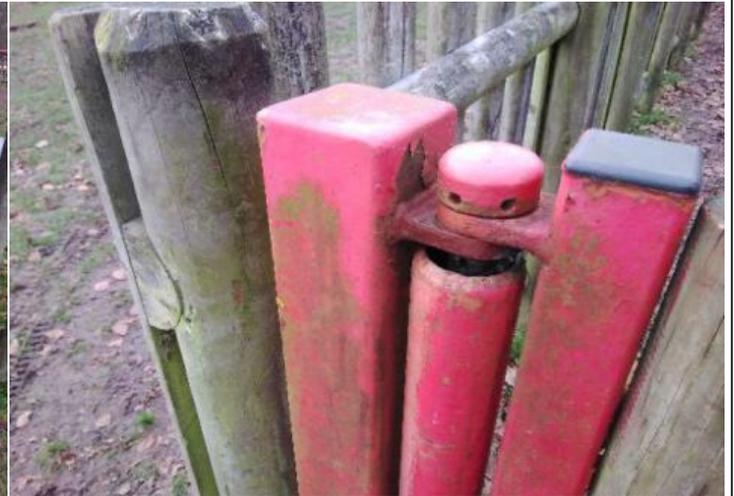
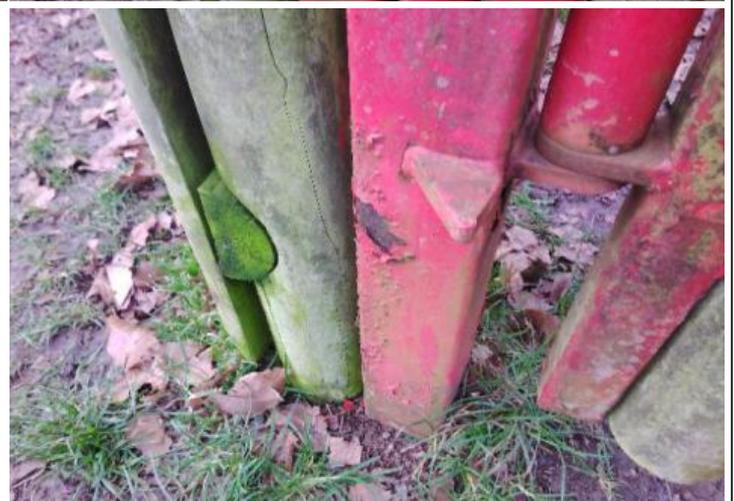
Item: Gates - Gate - Self Closing
Manufacturer: Unknown

Finding: The paintwork on this item has been damaged or worn exposing the metal underneath which is rusting

Action: Treat any rusting components and repaint

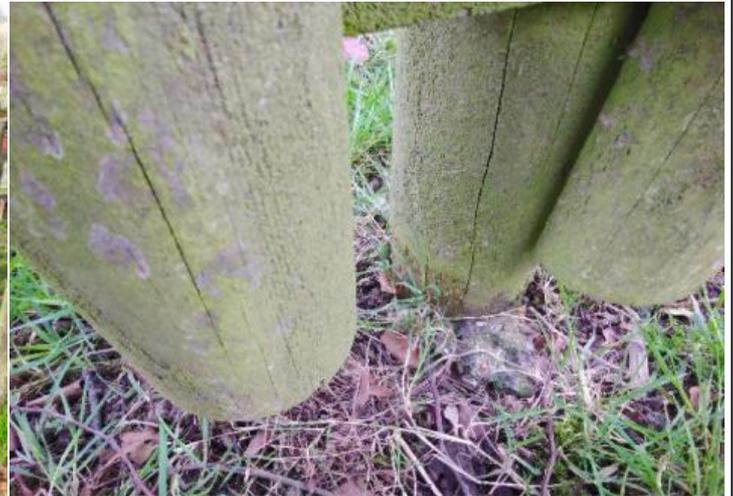
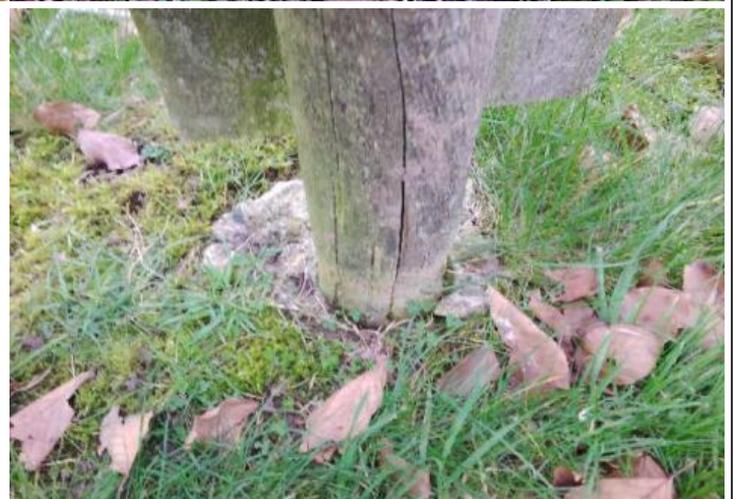
Item: Fences - Fencing - Timber
Manufacturer: Unknown

Finding: There is some strimmer / machinery damage apparent on the posts, this can penetrate the preservative applied to the timber and accelerate the rotting process

Action: Monitor for any deterioration (rot) and replace as required

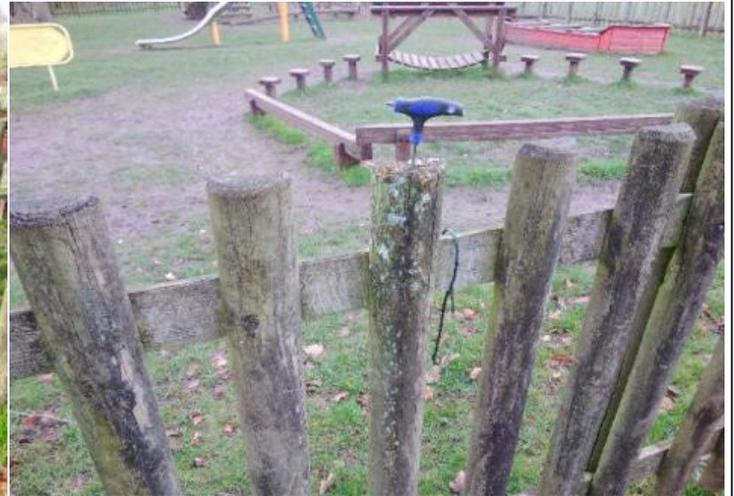
Item: Fences - Fencing - Timber
Manufacturer: Unknown

Finding: There is some evidence of rot in the timber fence spindles

Action: Monitor for any further deterioration and replace as required

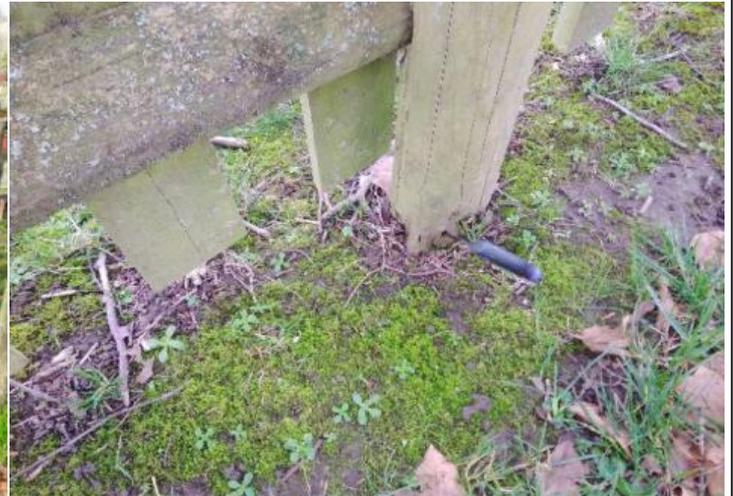
Item: Fences - Fencing - Timber
Manufacturer: Unknown

Finding: There are areas or parts of the timber posts that have rotted

Action: Replace all affected timbers

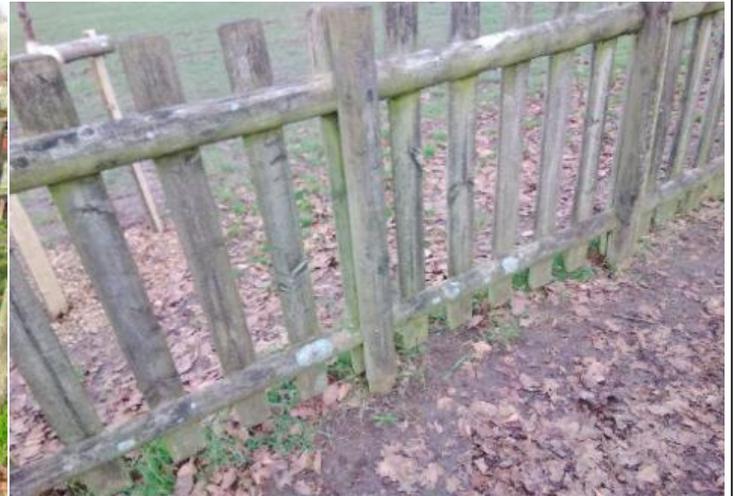
Item: Fences - Fencing - Timber
Manufacturer: Unknown

Finding: There are a number of loose posts around the fence

Action: Monitor for any further deterioration and reset as required

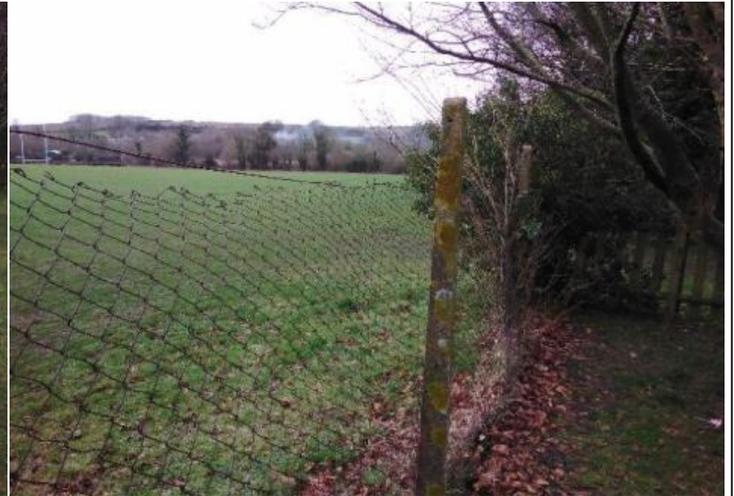
Item: Fences - Fence - Chainlink
Manufacturer: Unknown

Finding: There is some damage to the fence sections

Action: Monitor for any further deterioration and repair as required

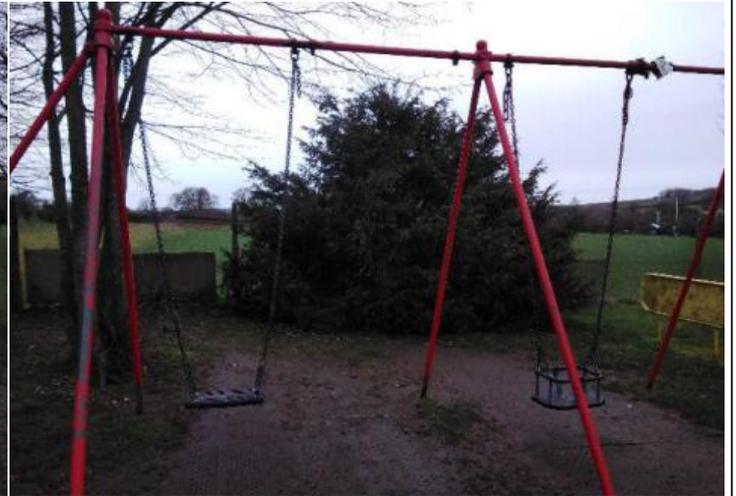
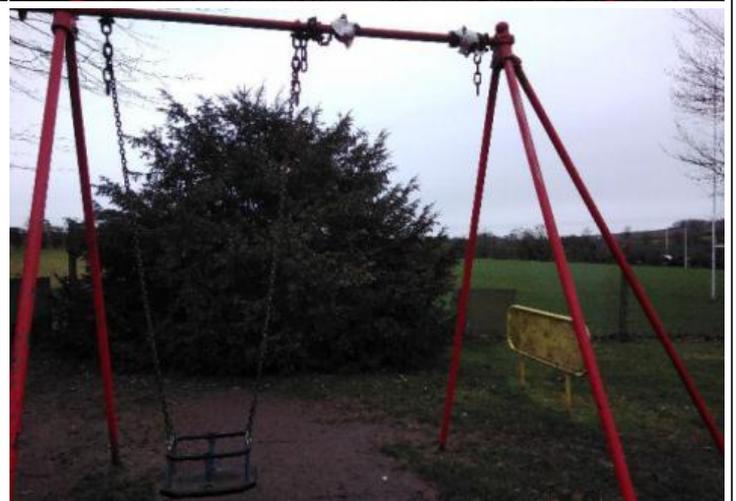
Item: Swings - 2 Bay (2 Flat, 2 Cradle)
Manufacturer: Wicksteed Playgrounds

Finding: The seat(s) and suspension were missing at the time of inspection and the inspector was unable to make a full compliance assessment

Action: Replace missing seat(s) and suspension

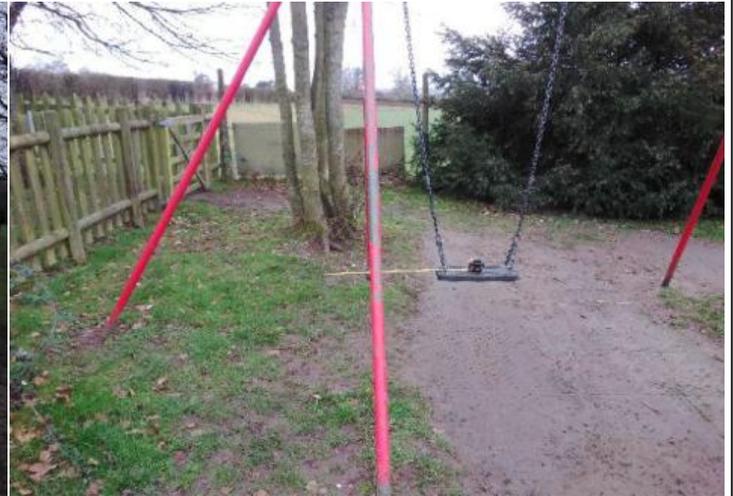
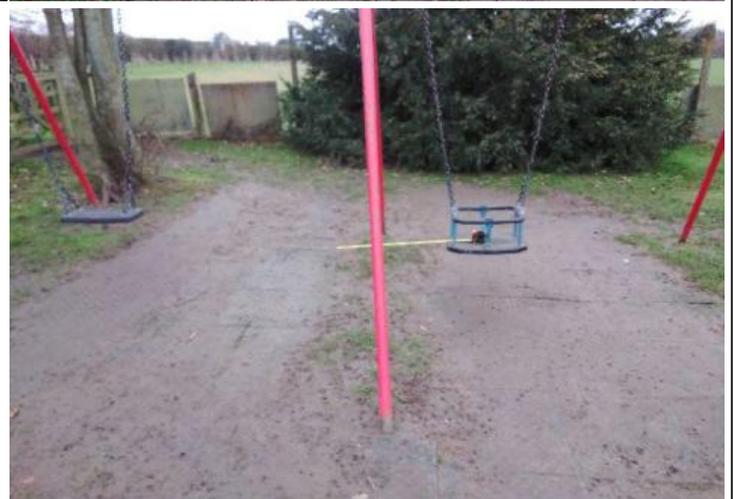
Item: Swings - 2 Bay (2 Flat, 2 Cradle)
Manufacturer: Wicksteed Playgrounds

Finding: The seats are too close to the frame as defined in BS EN 1176 Part 2; this is a low risk failure and no remedial action is required

Action: Monitor - No remedial work recommended

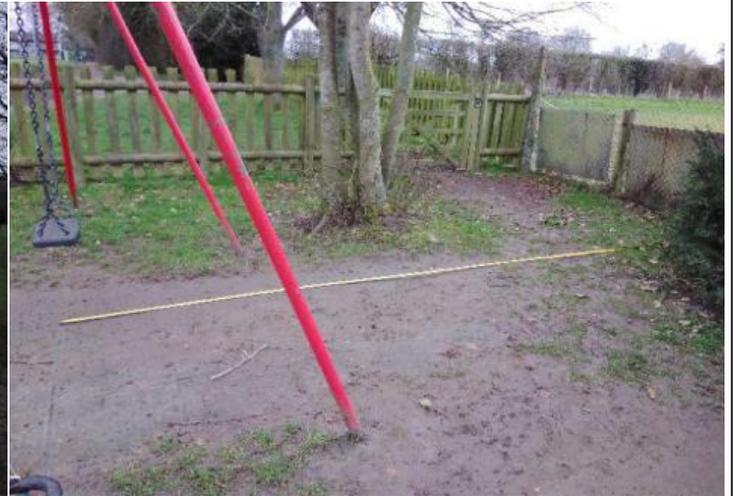
Item: Swings - 2 Bay (2 Flat, 2 Cradle)
Manufacturer: Wicksteed Playgrounds

Finding: BS EN 1176 Part 2: Annex A makes a recommendation that fences or enclosures should be upto 1.50m from the edges of the swing seat to the sides, and subject to risk assessment, from the edge of the impact area. This is however, a low risk finding and no remedial action is recommended.

Action: Monitor - No remedial work recommended

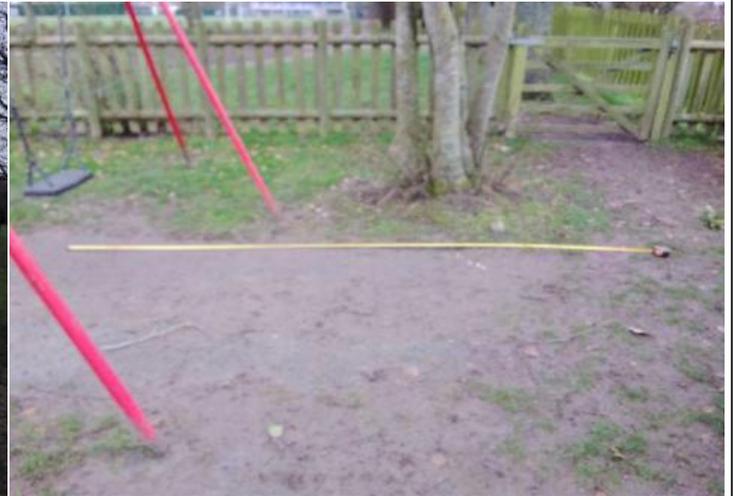
Finding: The tree root forms a hard object within the impact area of the equipment in contravention of the requirements of BS EN 1176 Part 1

Action: Monitor - No remedial work recommended

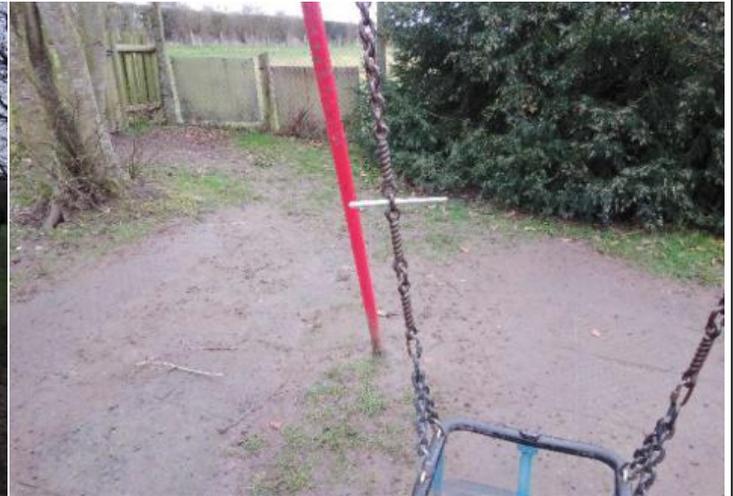
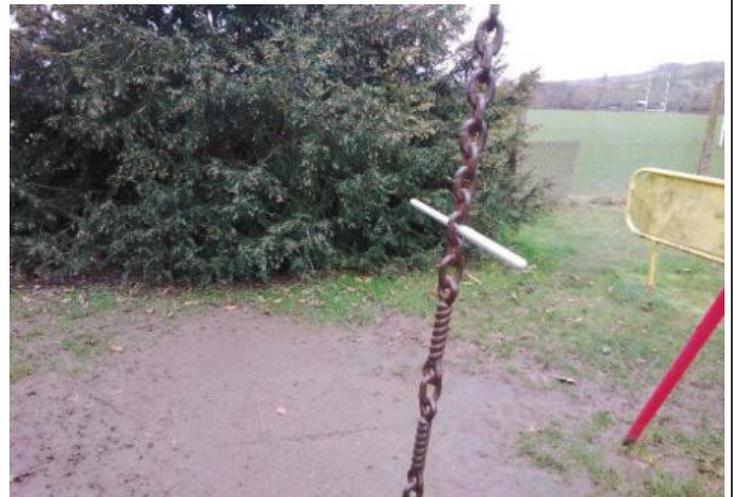
Finding: The chain openings are in excess of the 8.6mm as recommended by BS EN 1176 **Action:** Monitor - No remedial work recommended

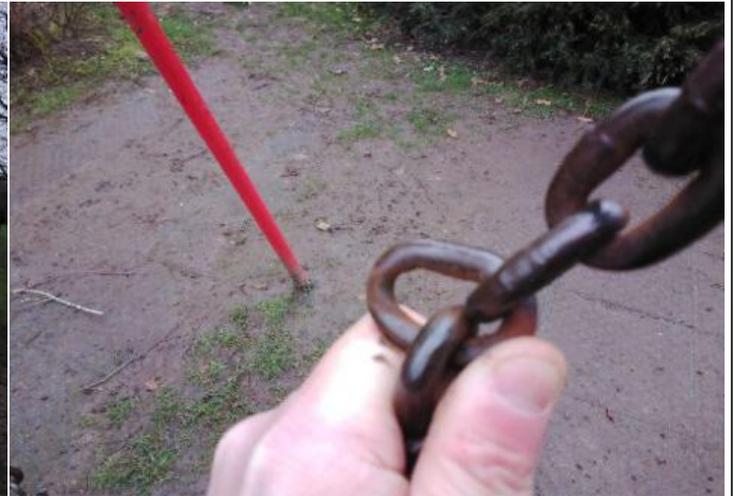
Finding: There is some notable evidence of chain wear

Action: Monitor for any further deterioration and replace when 40% worn

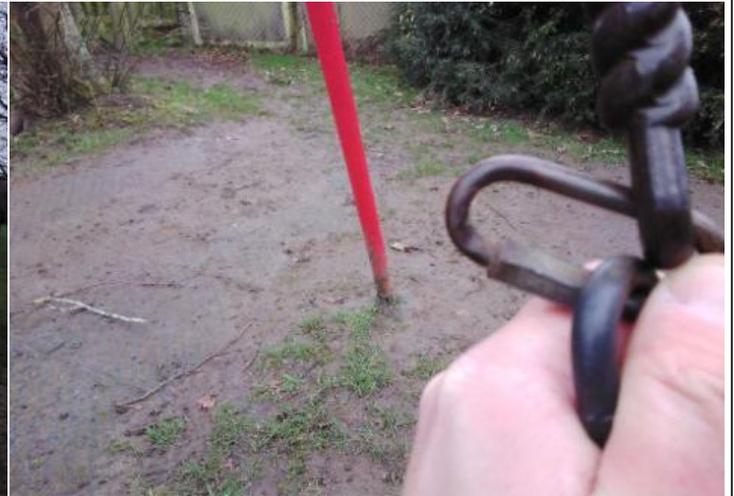
Finding: There is some notable evidence of wear in the connecting links

Action: Monitor for any further deterioration and replace when 40% worn

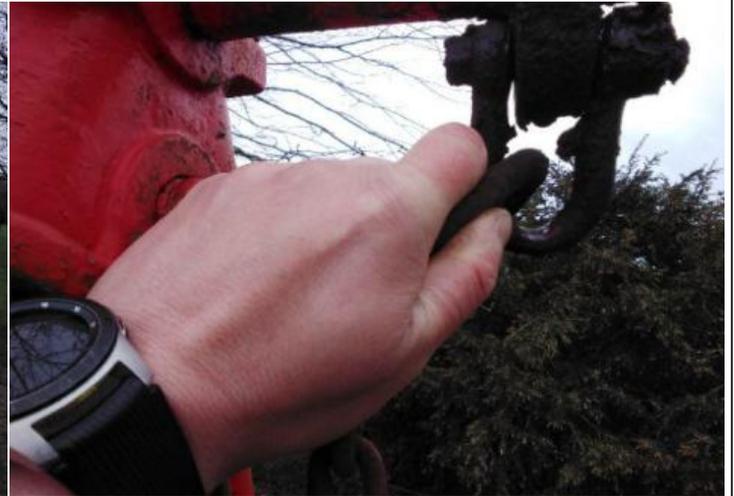
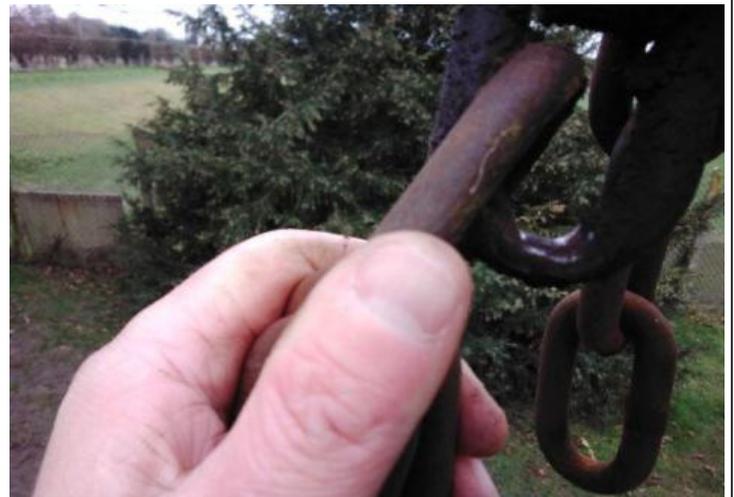
Finding: There is some wear to the shackles.

Action: Monitor for any further deterioration and replace when 40% worn

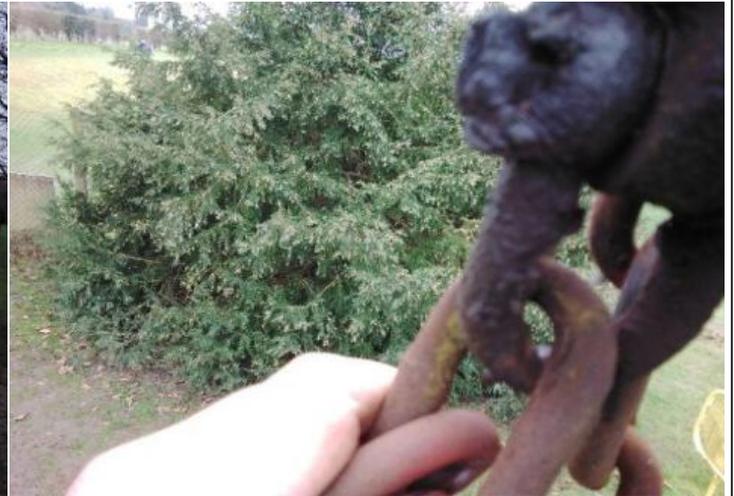
Finding: There is some notable evidence of wear in the connecting links

Action: Monitor for any further deterioration and replace when 40% worn

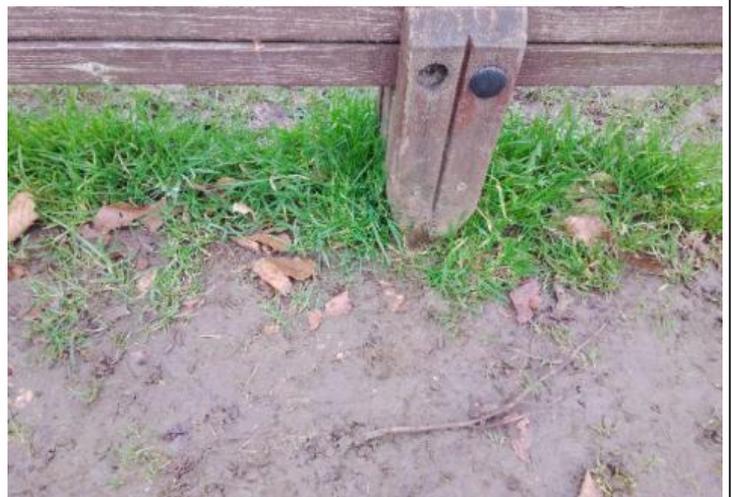
Finding: There is some strimmer / machinery damage apparent on the posts, this can penetrate the preservative applied to the timber and accelerate the rotting process

Action: Monitor for any deterioration (rot) and replace as required

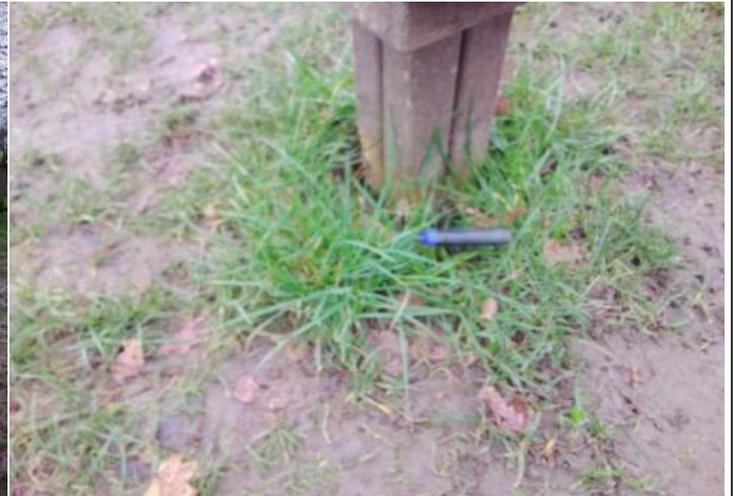
Finding: There is some evidence of rot in the timber

Action: Monitor for any further deterioration and replace as required

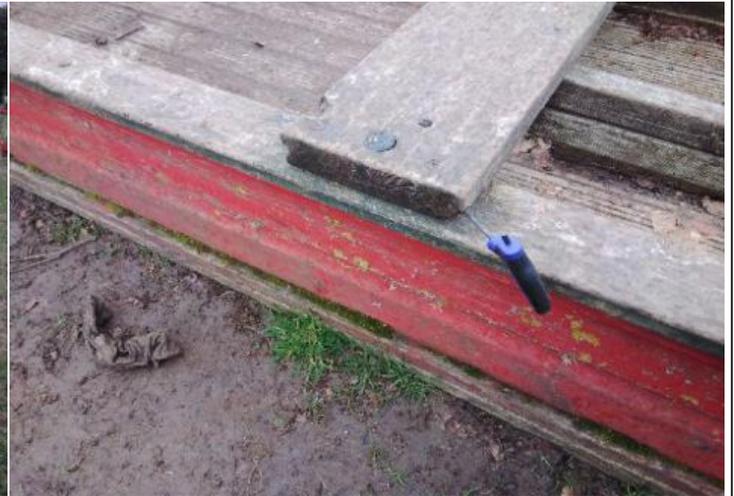
Finding: There is some evidence of rot in the timber

Action: Monitor for any further deterioration and replace as required

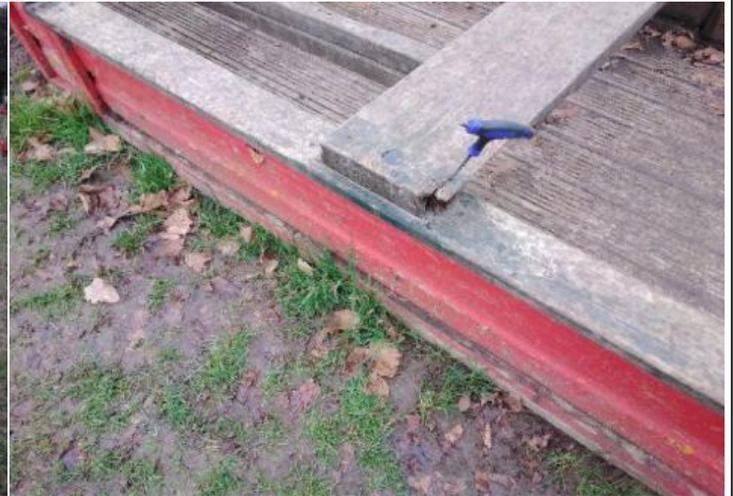
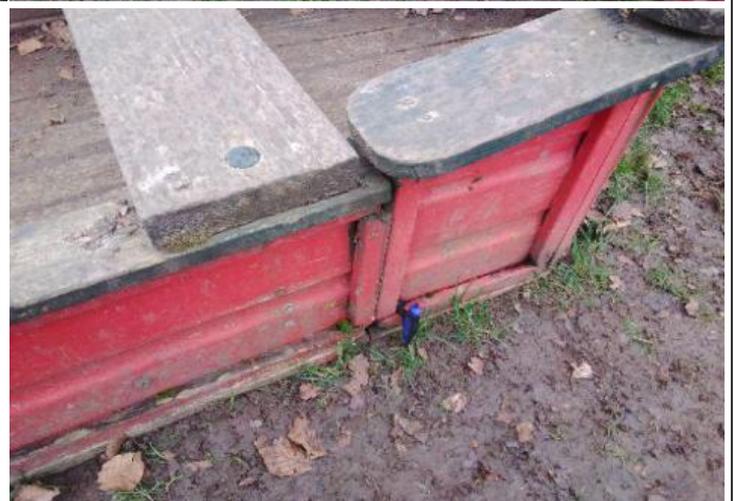
Finding: There are areas or parts of the timber on the structure that have rotted

Action: Replace all affected timbers

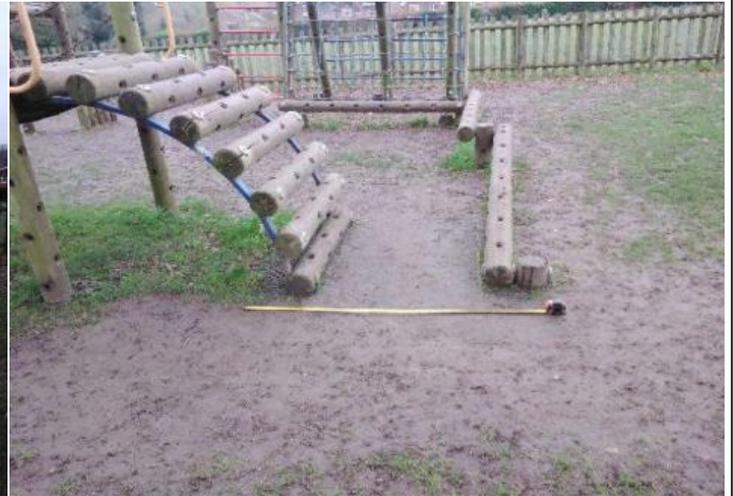
Finding: The balance beam forms a hard object within the impact area of the equipment in contravention of the requirements of BS EN 1176 Part 1

Action: Monitor - No remedial work recommended

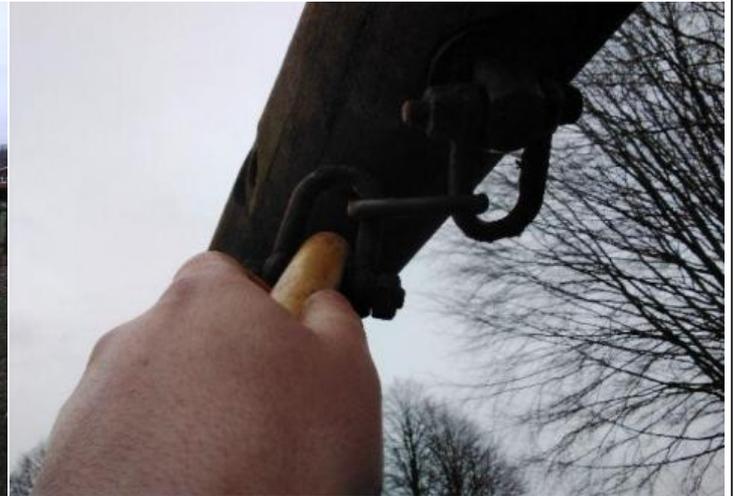
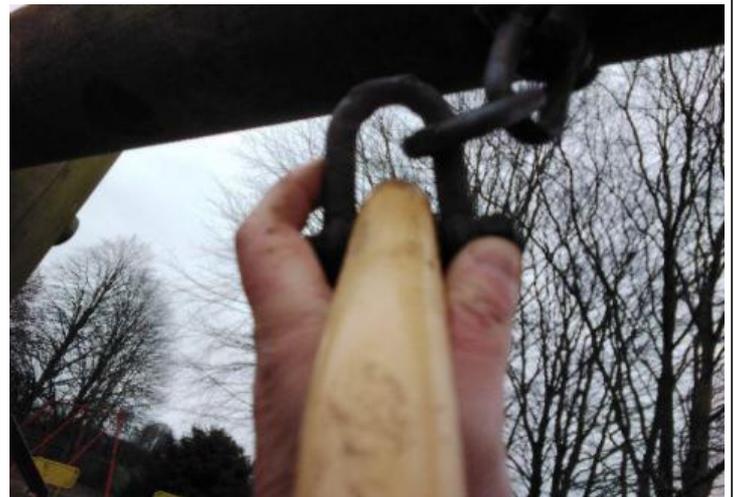
Finding: There is some wear to the shackles

Action: Monitor for any further deterioration and replace when 40% worn

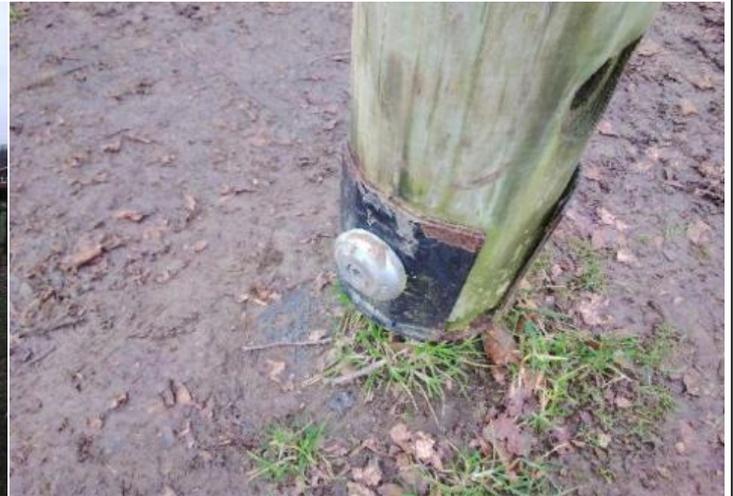
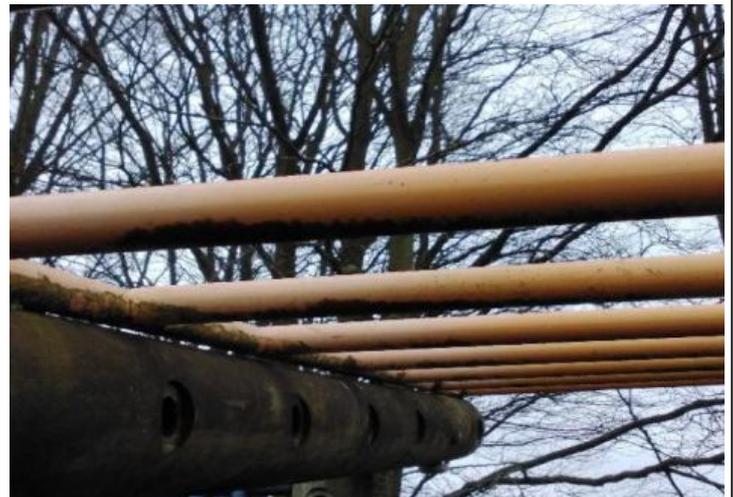
Finding: The paintwork on this item has been damaged or worn exposing the metal underneath which is rusting

Action: Treat any rusting components and repaint

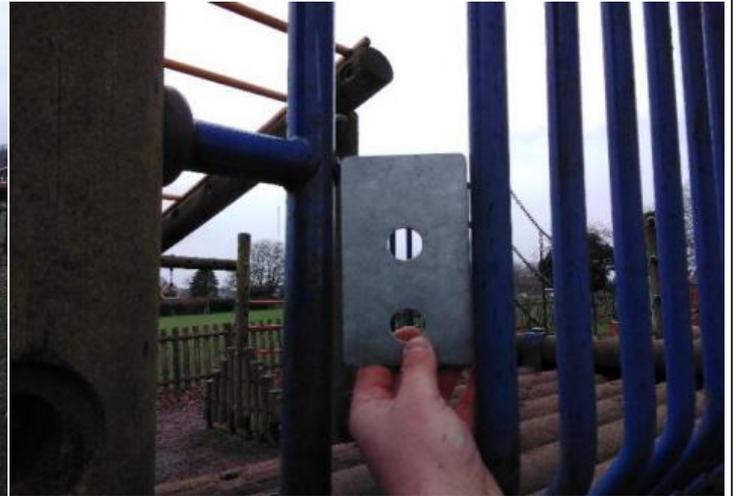
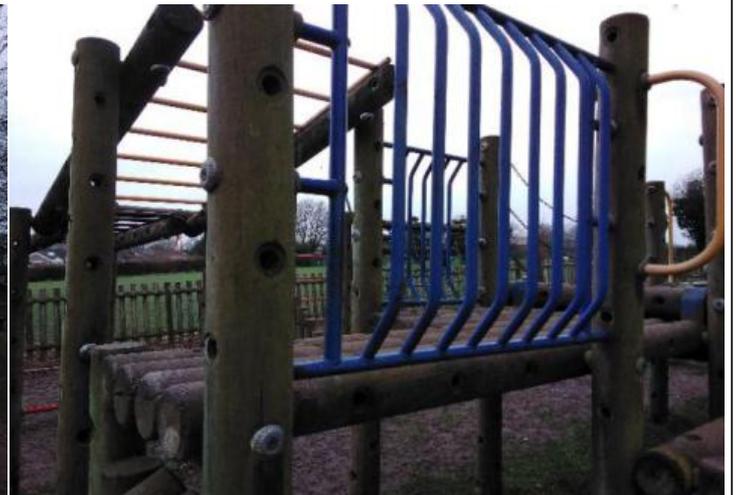
Finding: The item fails to meet the requirements of BS EN 1176 Part 1 4.2.7.2 head and neck entrapment in the barriers and/or steps

Action: Monitor - No remedial work recommended

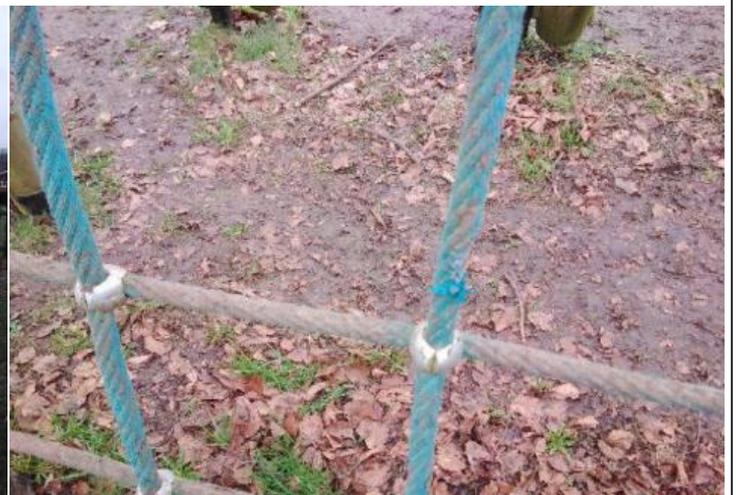
Finding: There is some evidence of fire damage to the item

Action: Monitor for any further deterioration and repair as required

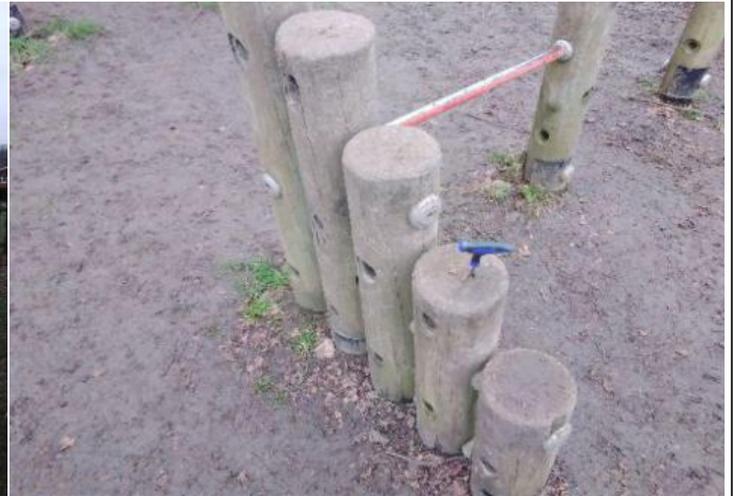
Finding: There is some evidence of rot in the timber

Action: Monitor for any further deterioration and replace as required

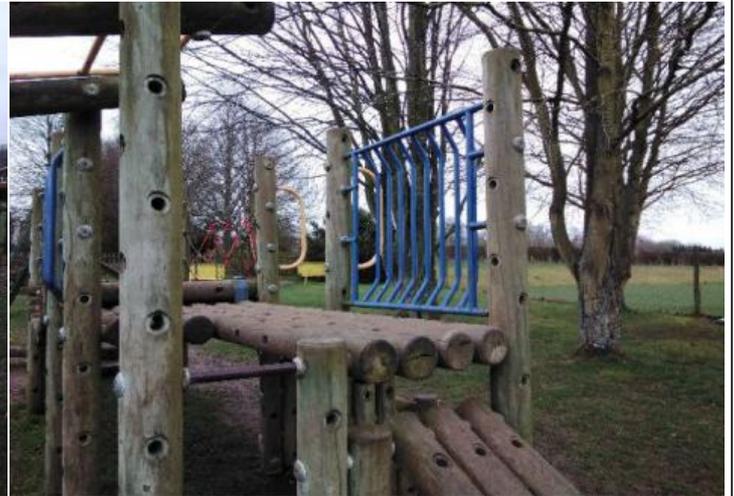
Finding: There is an opening in the barriers exceeding the width allowed (500mm) in BS EN 1176, and no guardrail has been provided; this is a low risk failure and no remedial action is required

Action: Monitor - No remedial work recommended

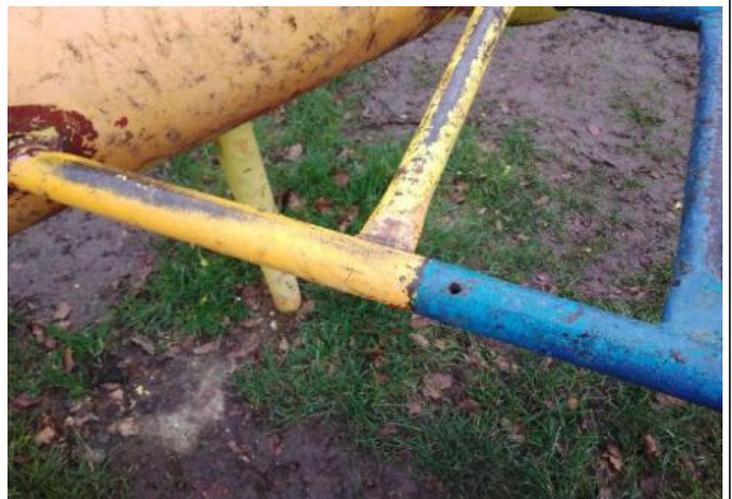
Finding: There is or are fixings missing on the item

Action: Replace all missing fixings

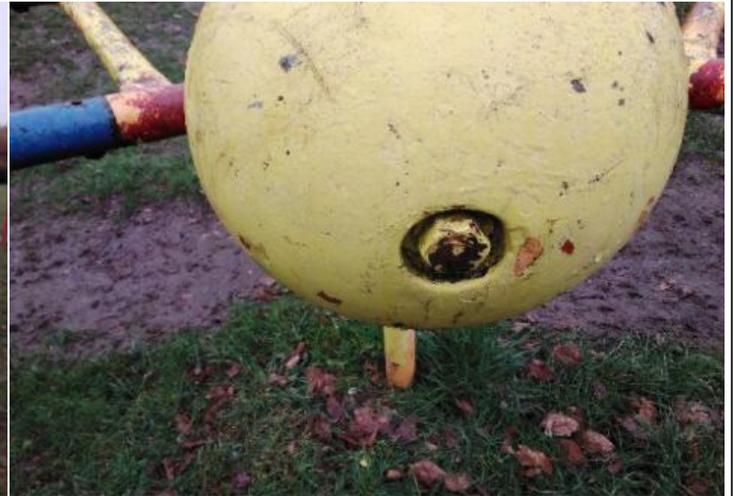
Finding: The paintwork on this item has been damaged or worn exposing the metal underneath which is rusting

Action: Treat any rusting components and repaint

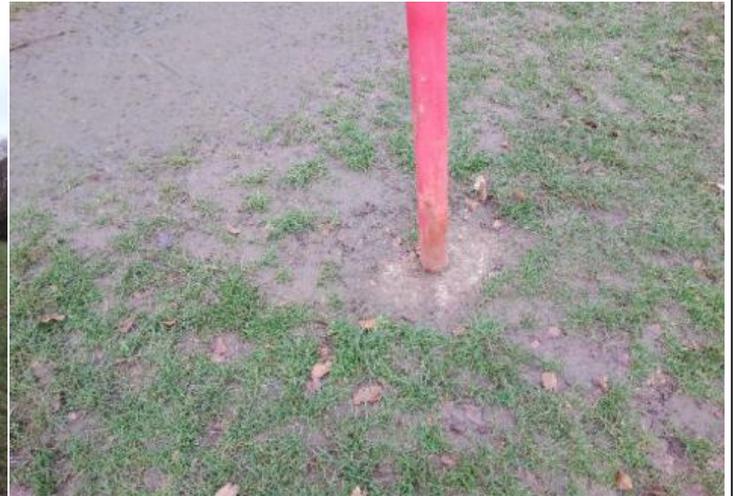
Finding: The surface has eroded and the foundations are exposed

Action: Reinststate surrounding surfaces to cover the foundations

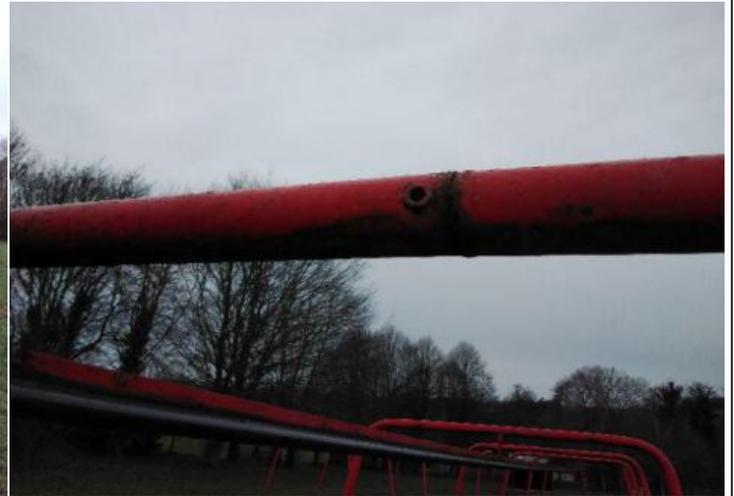
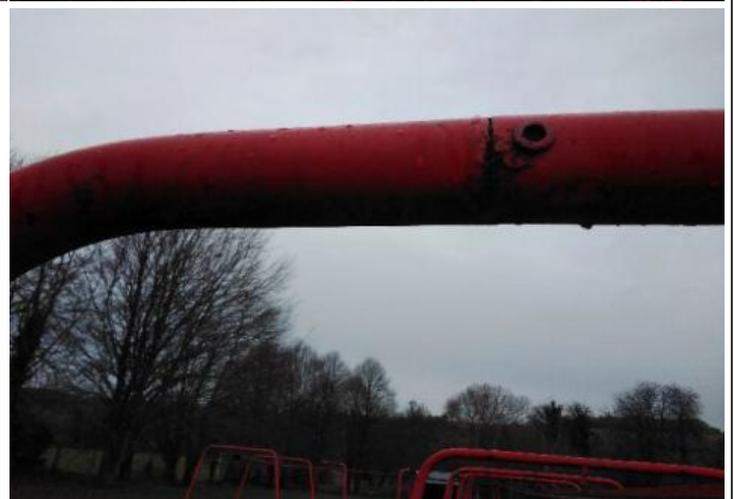
Finding: There is surface corrosion present on the item

Action: Consider treating the item

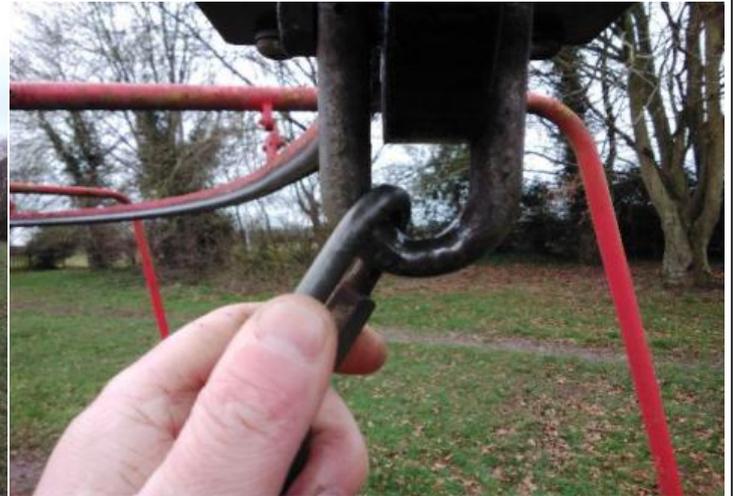
Finding: There is some wear to the shackles

Action: Monitor for any further deterioration and replace when 40% worn

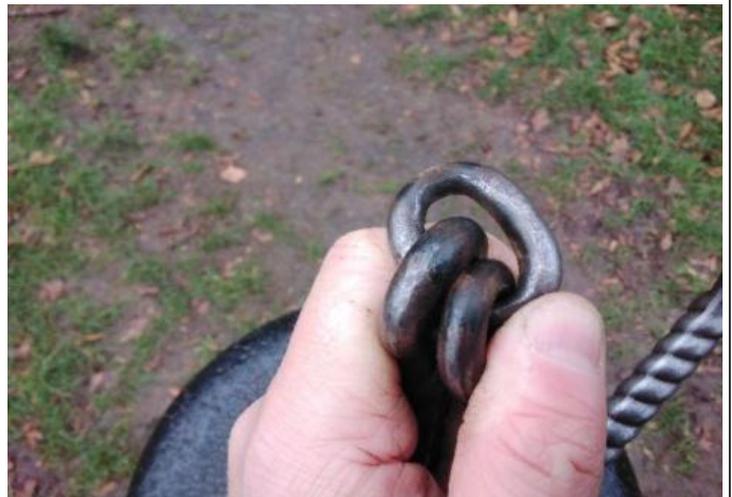
Finding: There is some notable evidence of chain wear

Action: Monitor for any further deterioration and replace when 40% worn

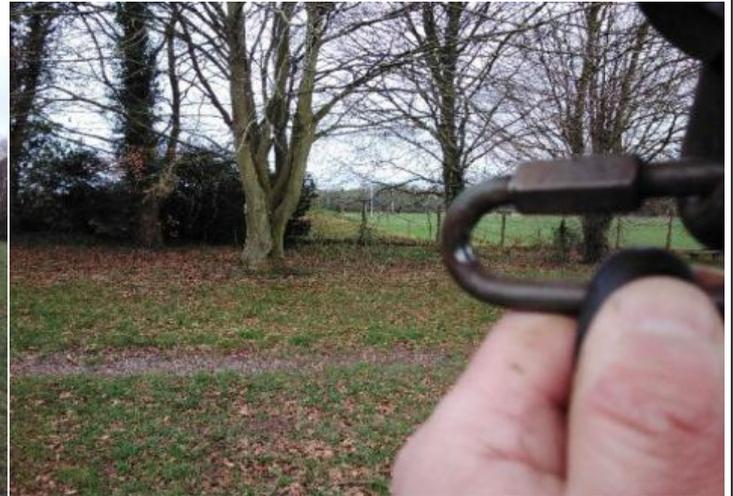
Finding: There is some notable evidence of connecting link wear

Action: Monitor for any further deterioration and replace when 40% worn

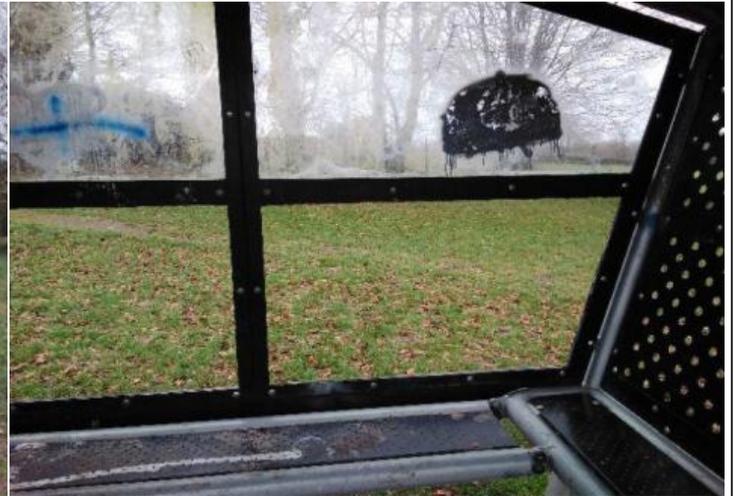
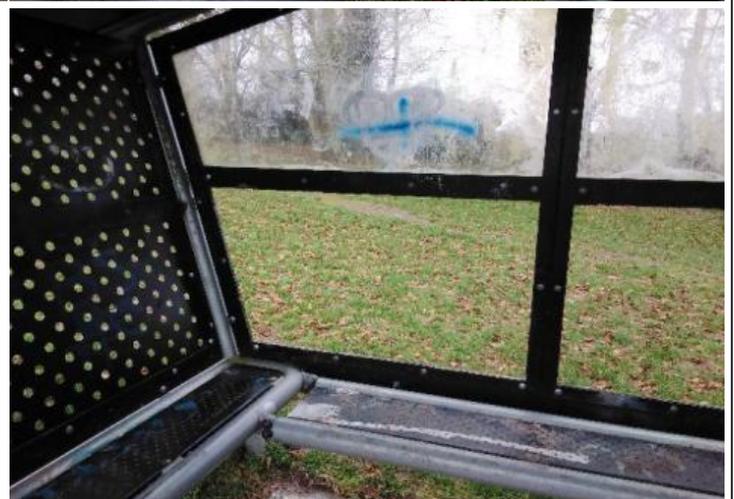
Finding: The item has missing component(s)

Action: Consider replacing missing components

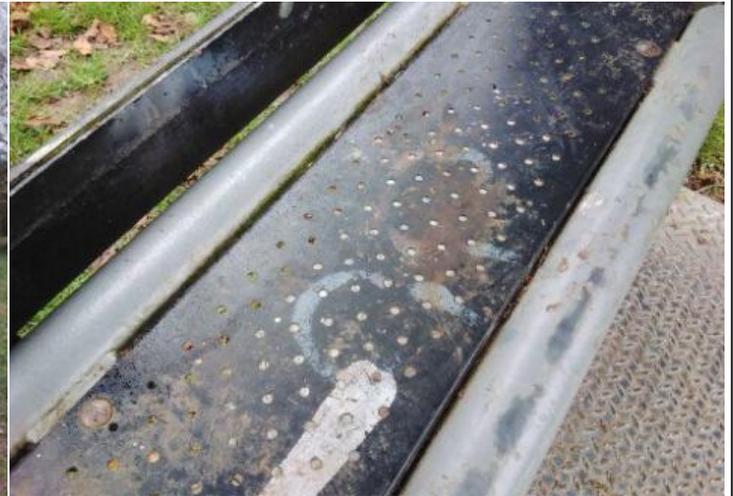
Finding: There is some evidence of fire damage to the item **Action:** Monitor for any further deterioration and repair as required

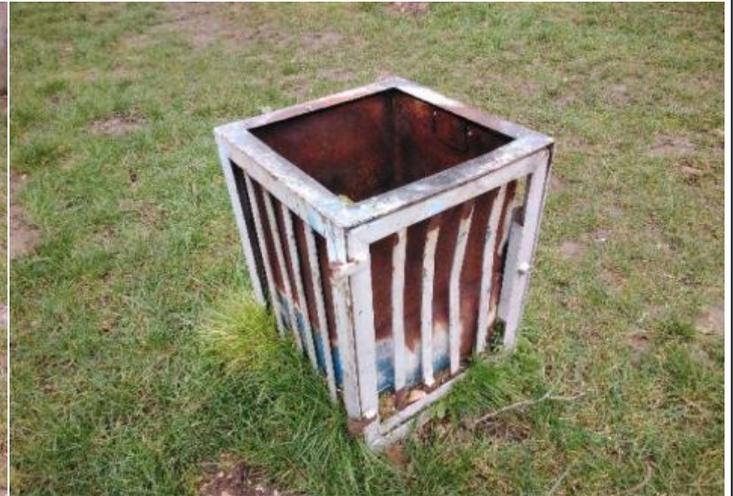
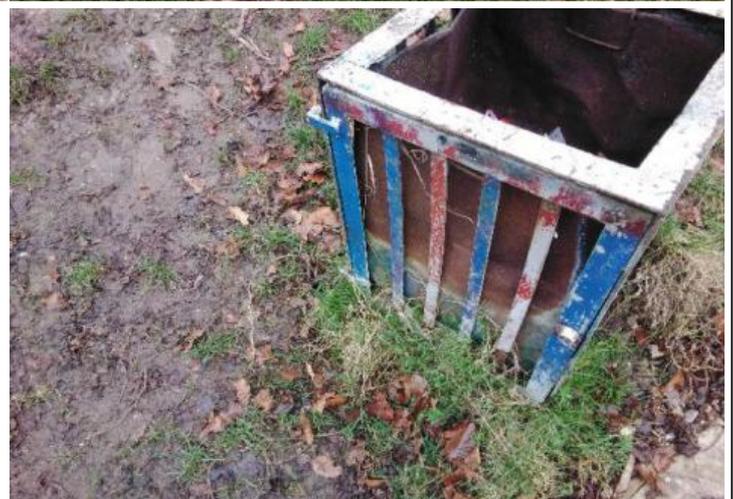
Finding: The item has been damaged

Action: Monitor for any further deterioration and replace as required

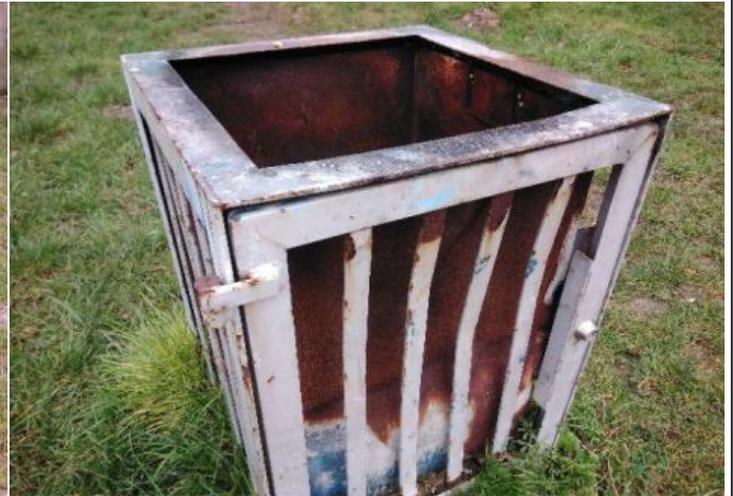
Finding: The paintwork on this item has been damaged or worn exposing the metal underneath which is rusting

Action: Treat any rusting components and repaint

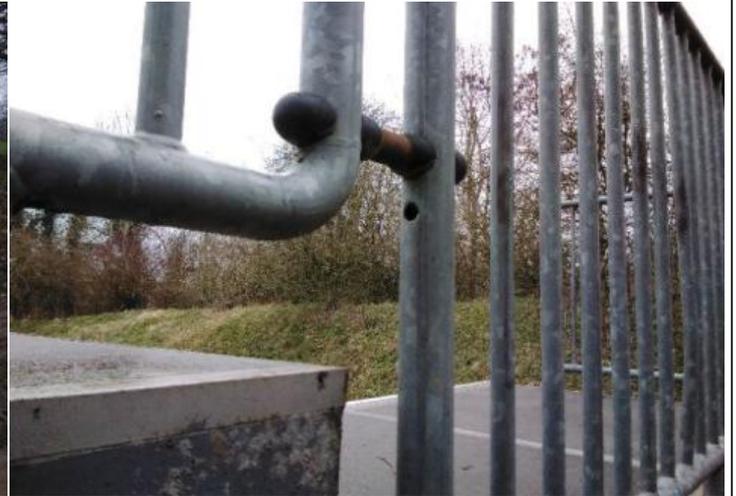
Finding: There is/are several inserts missing

Action: Replace missing inserts

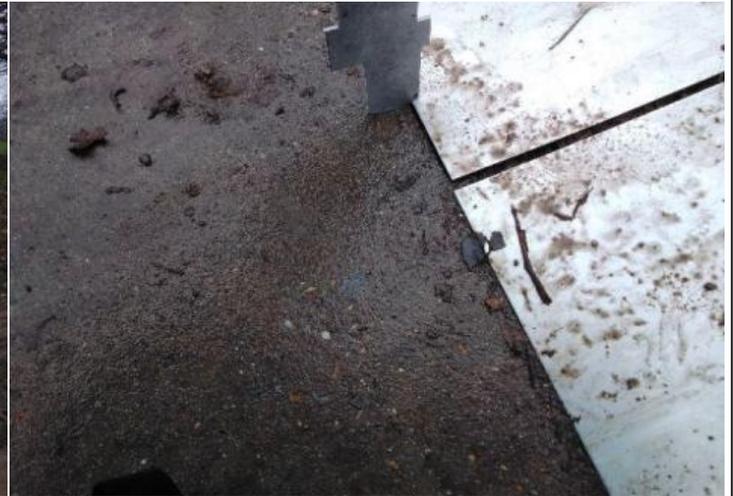
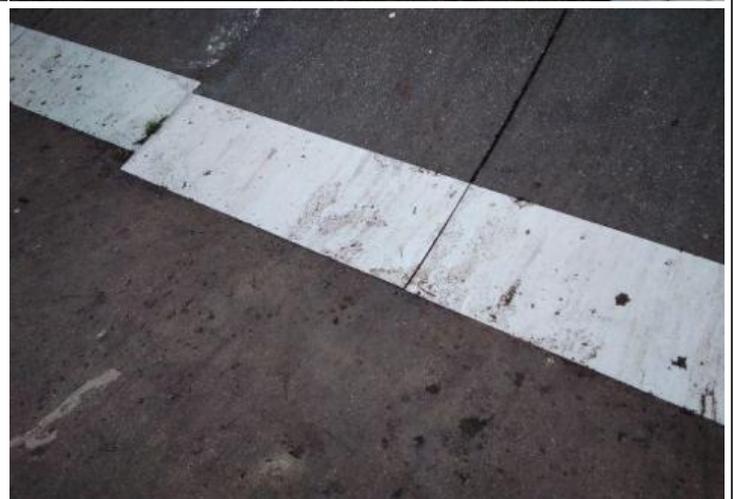
Finding: The kicker plate is loose and protrudes more than 5mm above the surrounding surface level, BS EN 14974 recommends a maximum of 5mm with 3mm preferred

Action: Adjust height to ensure a maximum of 5mm change in level

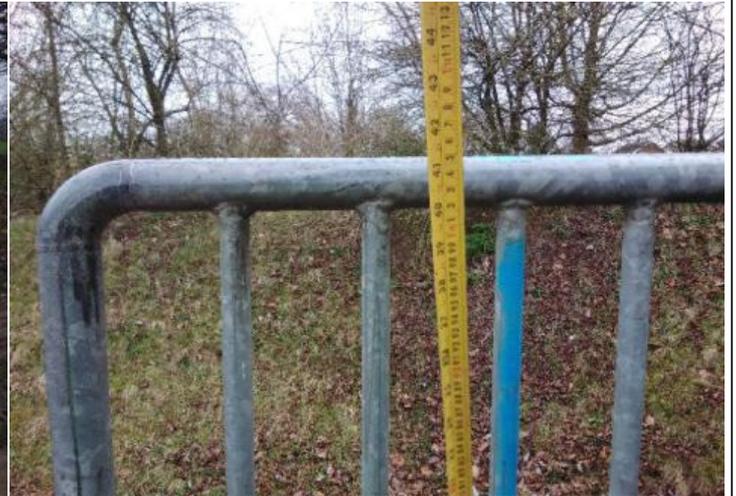
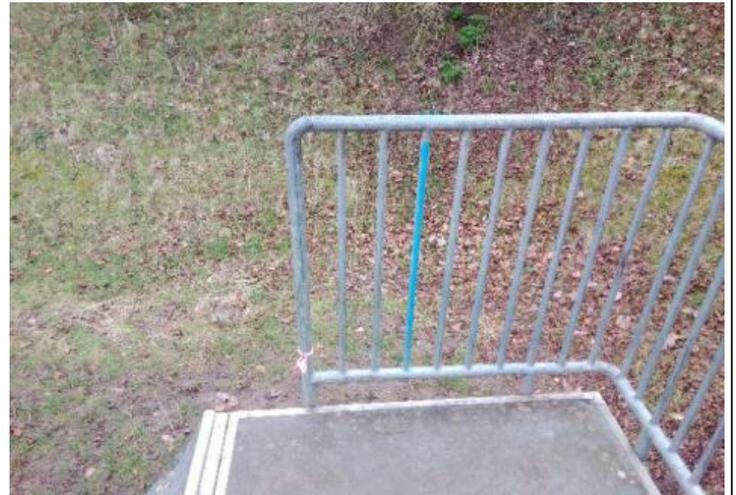
Finding: The height of the barrier is less than 1200mm and fails the requirements of BS EN 14974

Action: Monitor - No remedial work recommended
