the **play inspection** company

Annual Inspection

Winchester City Council

Arlebury Park, Skate Park & Tennis(New Alresford)

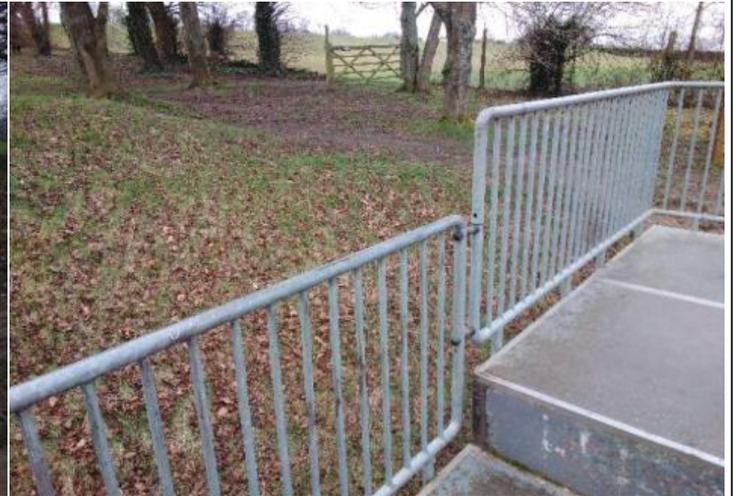
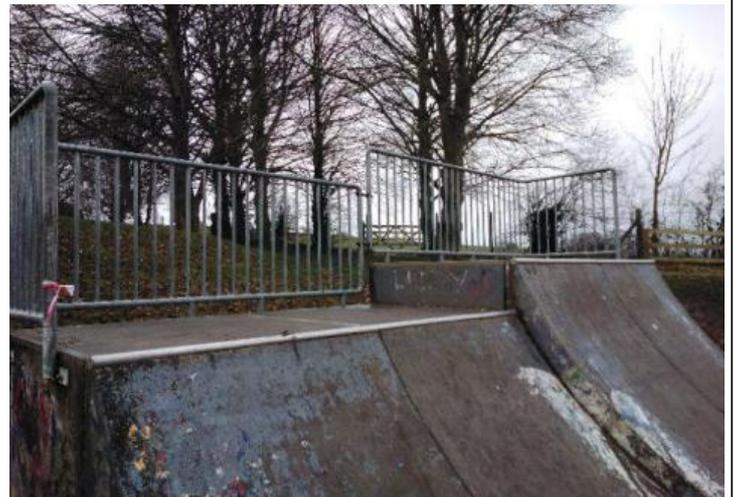
Finding: The height of the barrier should continue for a further 1m when there is a change in platform levels and fails the requirements of BS EN 14974

Action: Monitor - No remedial work recommended

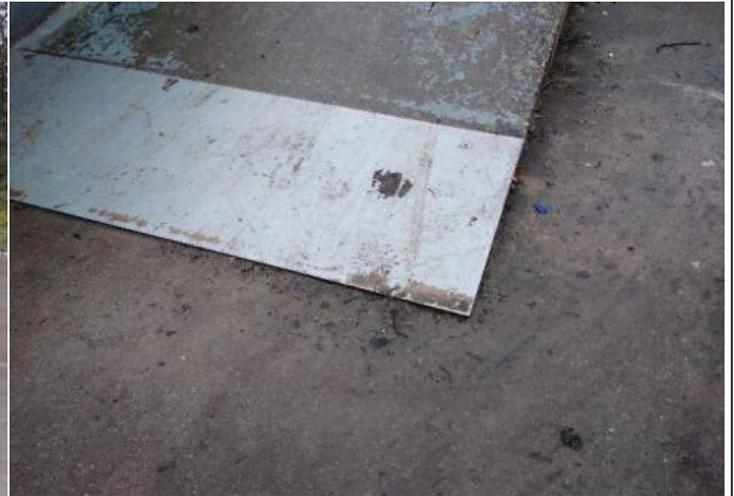
Finding: The kicker plate protrudes more than 5mm above the surrounding surface level, BS EN 14974 recommends a maximum of 5mm with 3mm preferred

Action: Adjust height to ensure a maximum of 5mm change in level

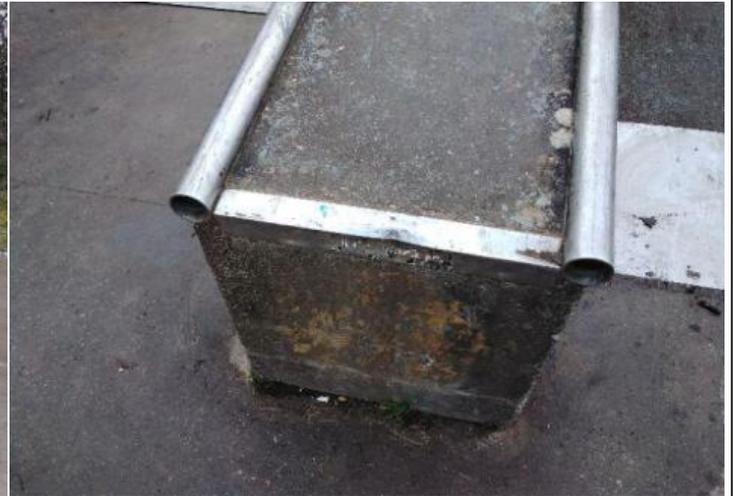
Finding: The item has been damaged

Action: Monitor for any further deterioration and replace as required

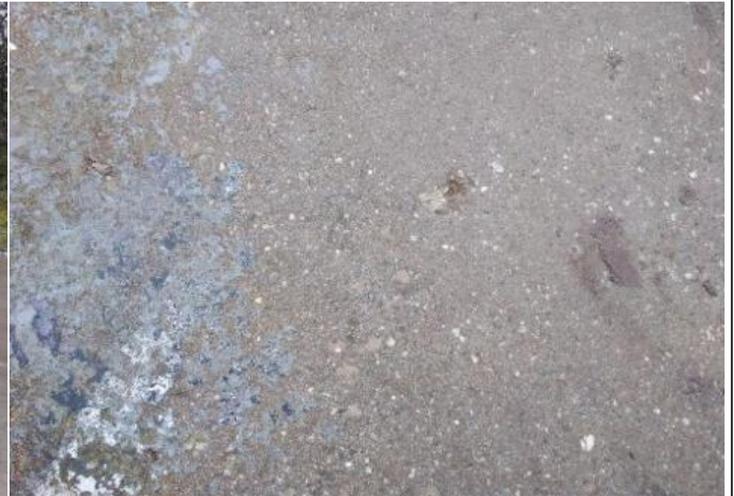
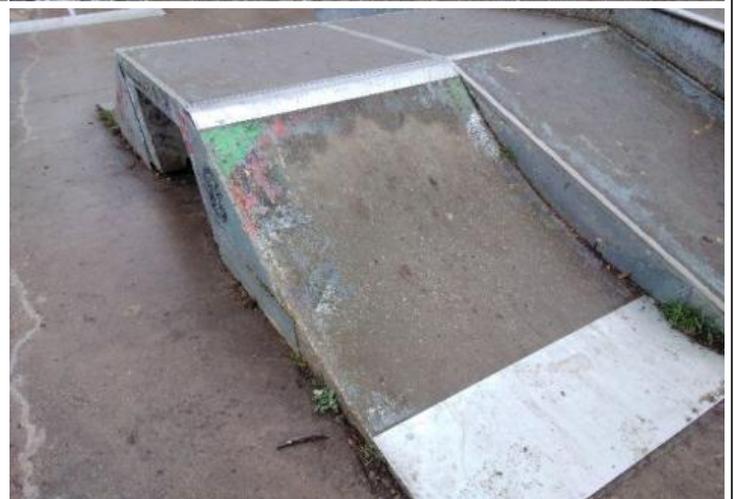
Finding: The riding surface of the ramp has some damage apparent

Action: Monitor for any further deterioration and repair as required

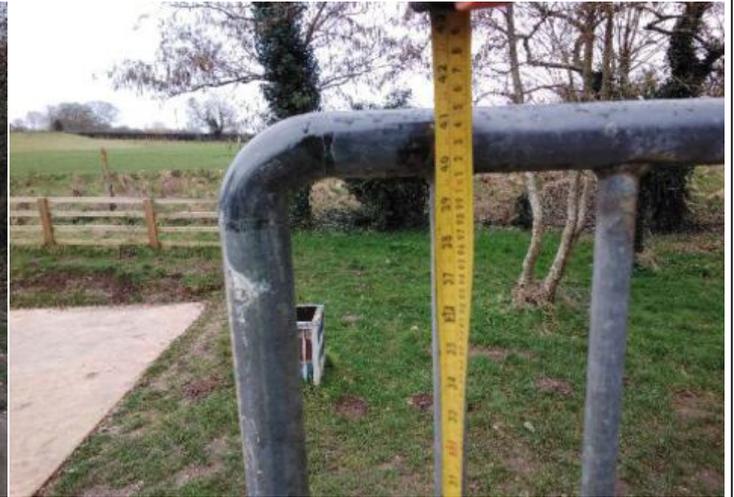
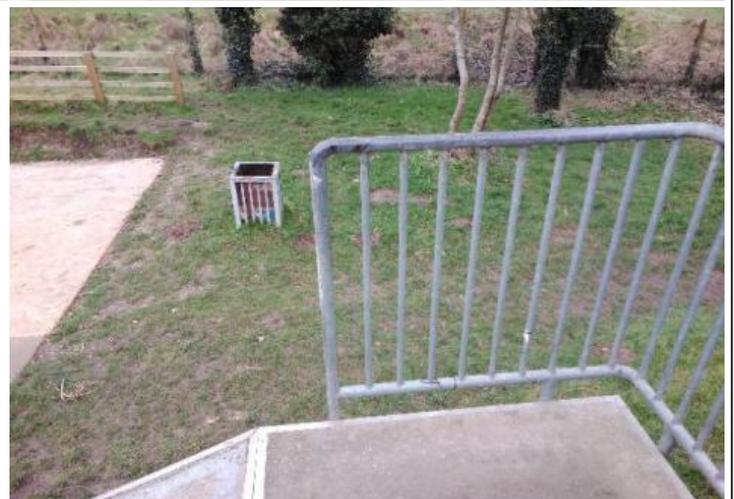
Finding: The height of the barrier is less than 1200mm and fails the requirements of BS EN 14974

Action: Monitor - No remedial work recommended

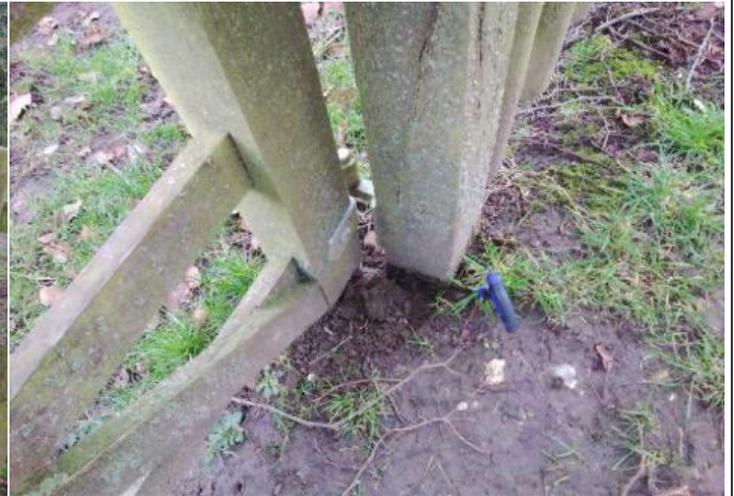
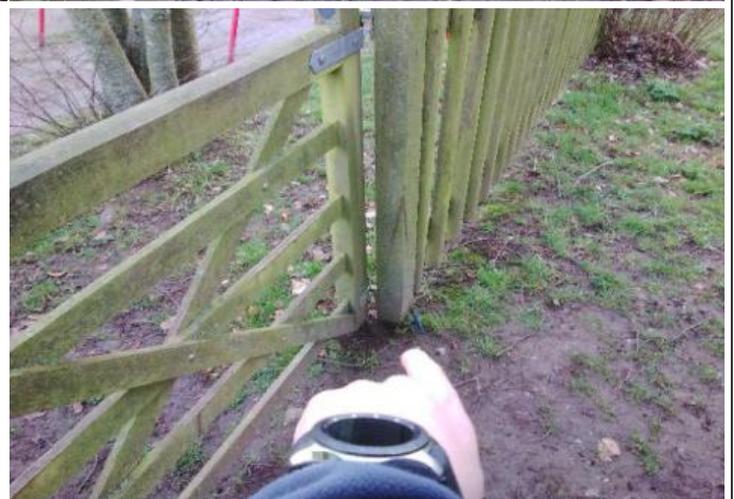
Finding: There is some evidence of rot in the timber

Action: Monitor for any further deterioration and replace as required
