Annual Inspection

Winchester City Council

Sun Hill Recreation Ground (New Alresford)

Derwent Gardens, Alresford, SO24 9NQ

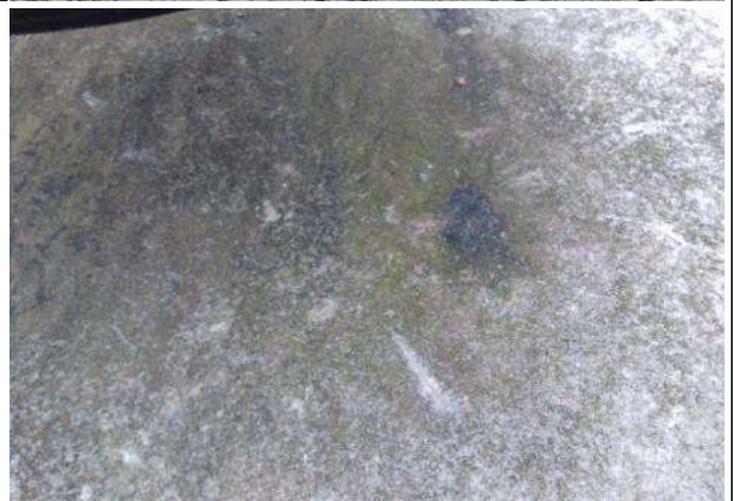
Finding: There is algae or moss growth on the surface resulting in slippery conditions

Action: Clean and treat appropriately

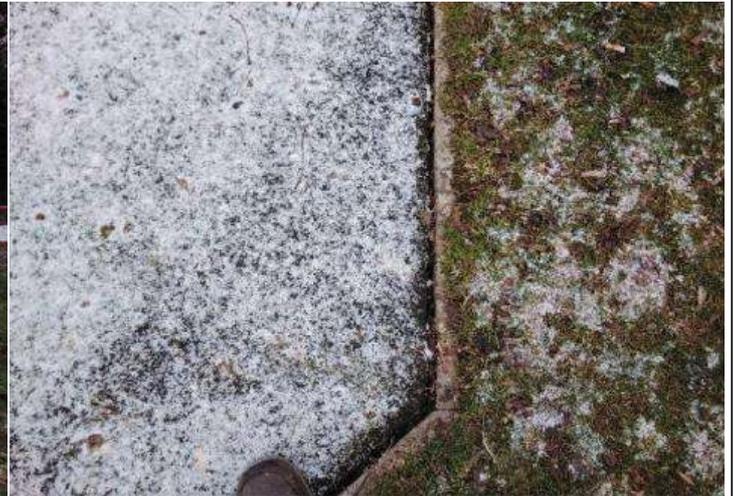
Finding: There are gaps opening between the surfacing and the edging surround or between the joints in the surfacing
Action: Monitor for any further deterioration and repair as required

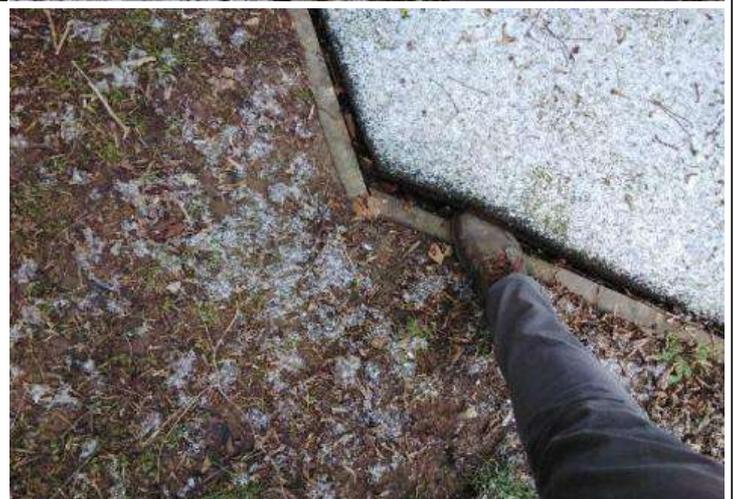
Finding: The surface is lifting at the edges and creating trip points

Action: Repair perimeter of surfacing to remove trip points

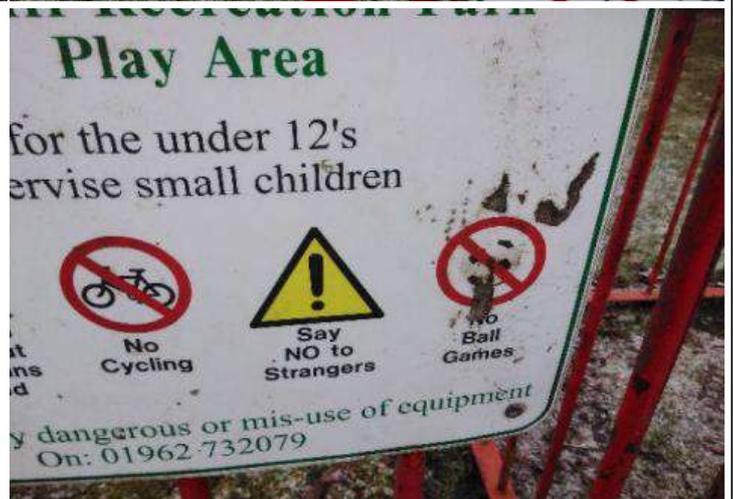
Finding: There is some damage to the item

Action: Monitor for any further deterioration and repair as required

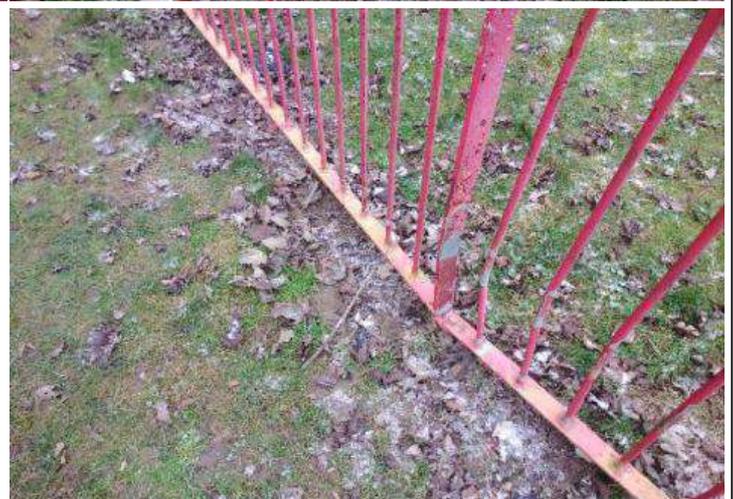
Finding: There is some damage to the fence sections

Action: Monitor for any further deterioration and repair as required

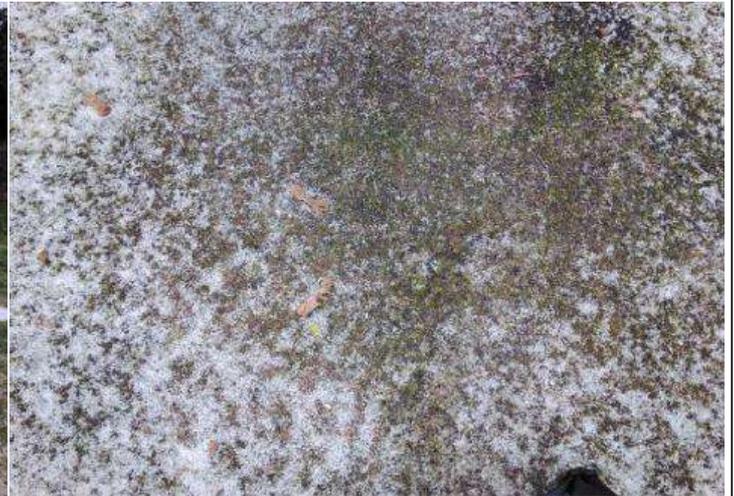
Finding: The safety surface under or around this unit has been damaged

Action: Monitor for any further deterioration and repair as required

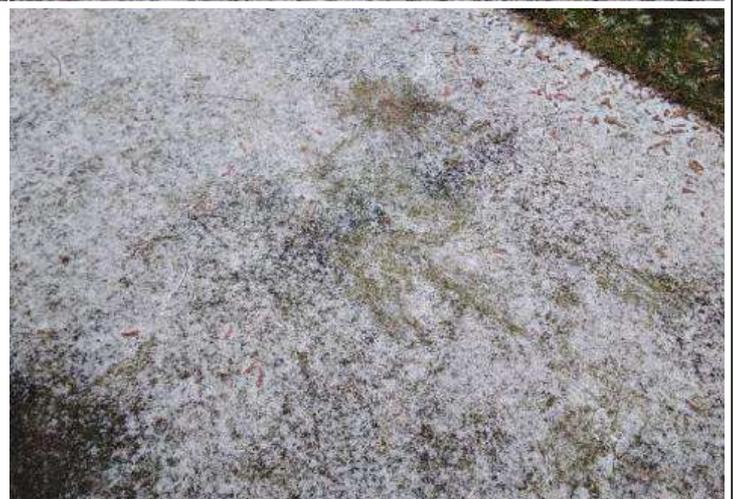
Finding: The safety surface around the area is beginning to wear

Action: Monitor for any further deterioration and repair as required

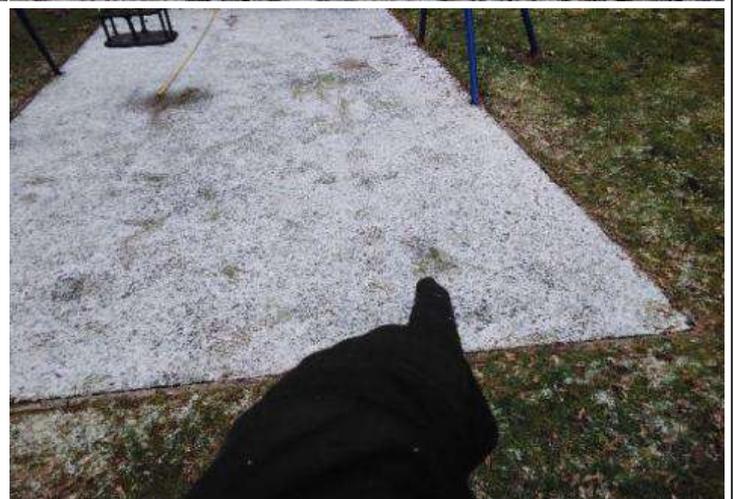
Finding: There is some evidence of fire damage to the surfacing

Action: Monitor for any further deterioration and repair as required

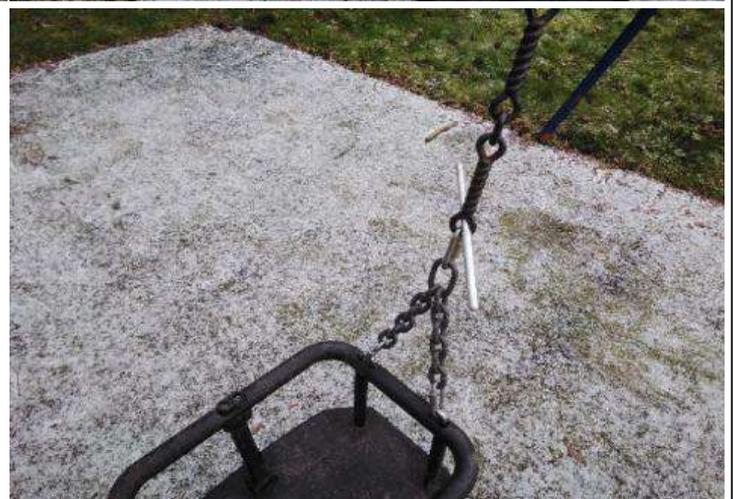
Finding: The chain openings are in excess of the 8.6mm as recommended by BS EN 1176 **Action:** Monitor - No remedial work recommended

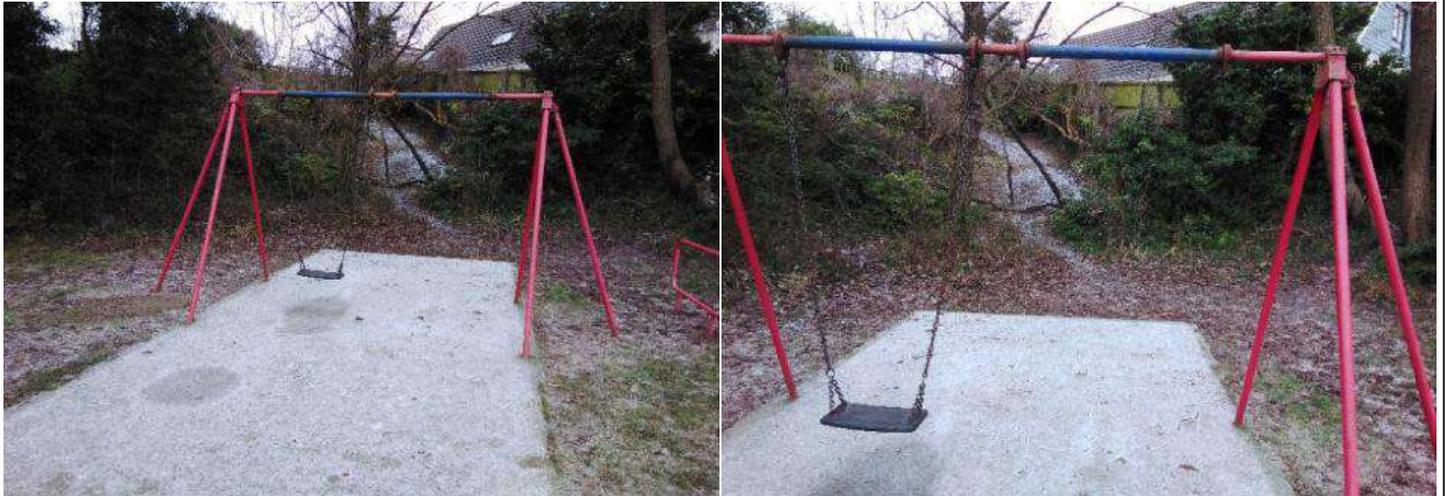
Finding: The seat(s) and suspension were missing at the time of inspection and the inspector was unable to make a full compliance assessment

Action: Replace missing seat(s) and suspension

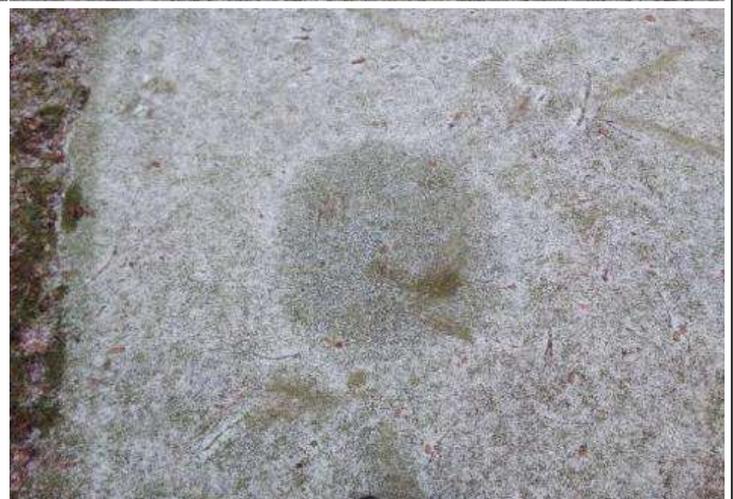
Finding: The safety surface around the area is beginning to wear

Action: Monitor for any further deterioration and repair as required

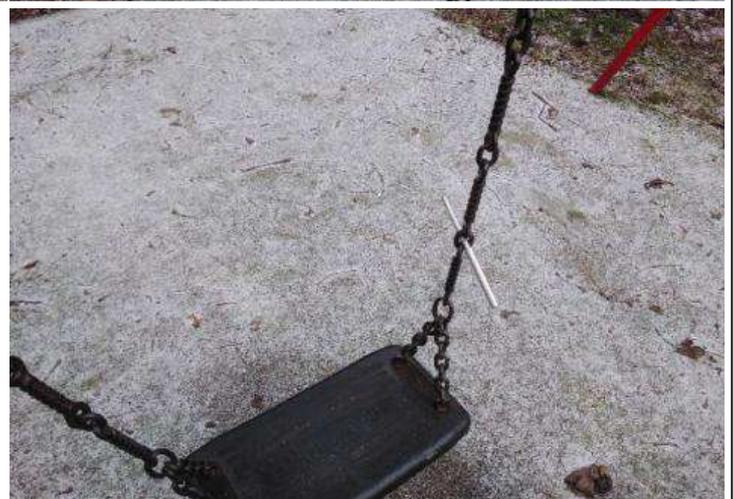
Finding: The chain openings are in excess of the 8.6mm as recommended by BS EN 1176 **Action:** Monitor - No remedial work recommended

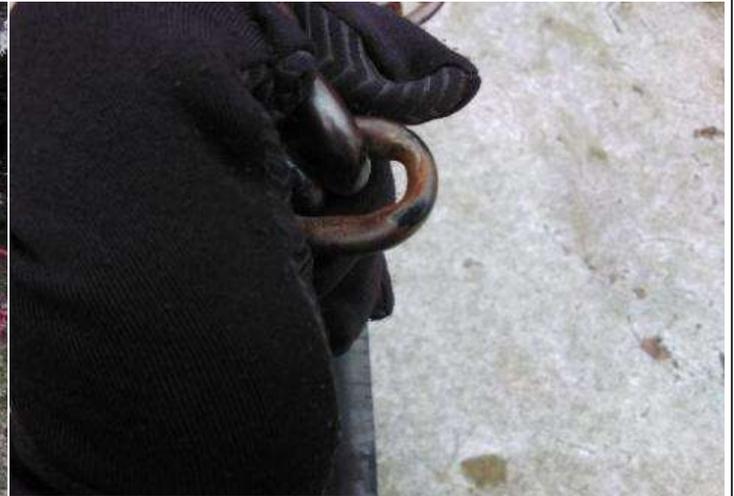
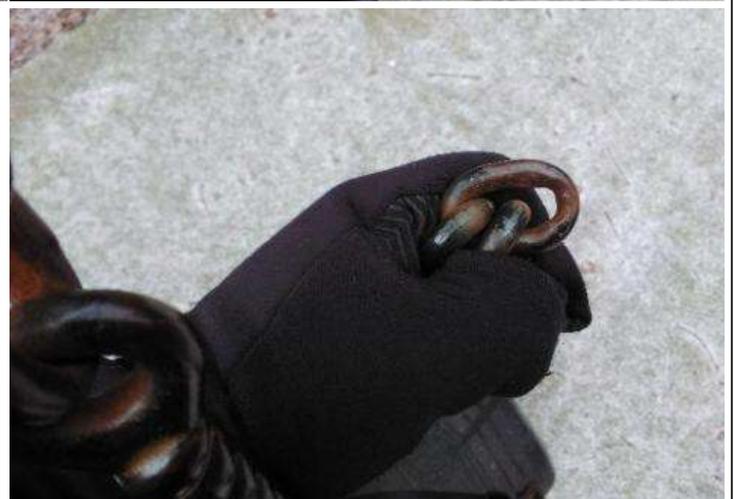
Finding: There is some notable evidence of chain wear

Action: Monitor for any further deterioration and replace when 40% worn

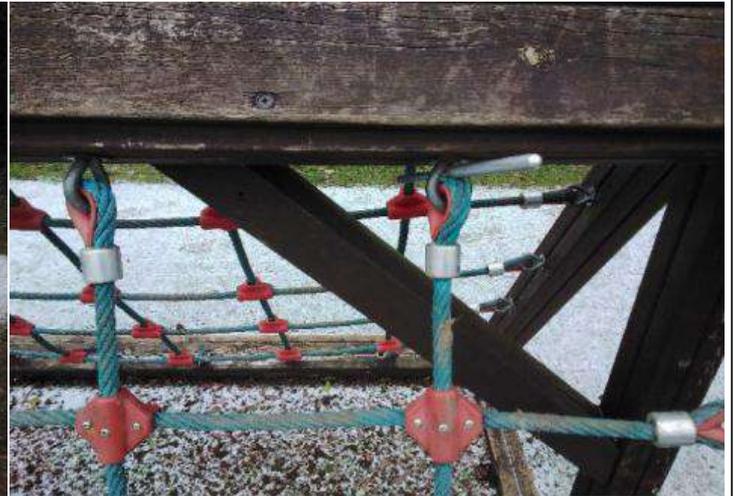
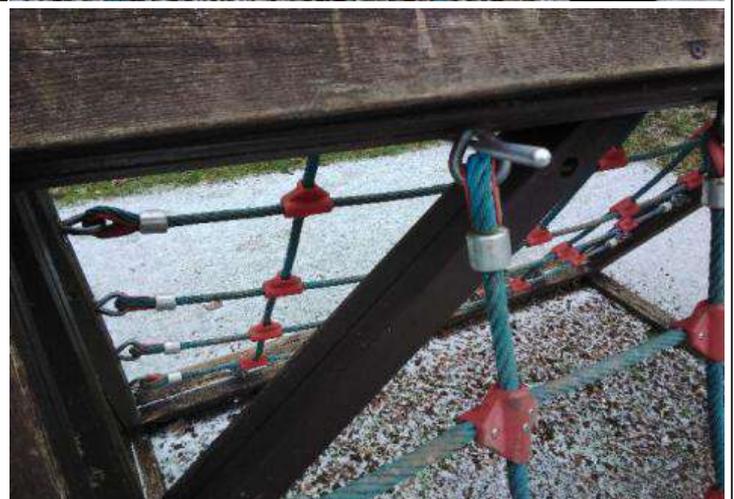
Finding: The connecting links are in excess of 8.6mm and less than 12mm and fail the requirements of BS EN 1176 Part 1; clause 4.2.13, Chains

Action: Monitor - No remedial work recommended

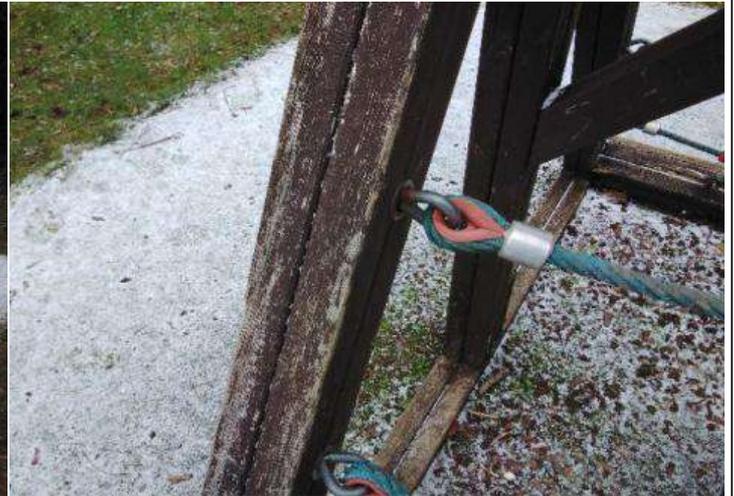
Finding: A number of fixing(s) have worked loose

Action: Secure all loose fixings

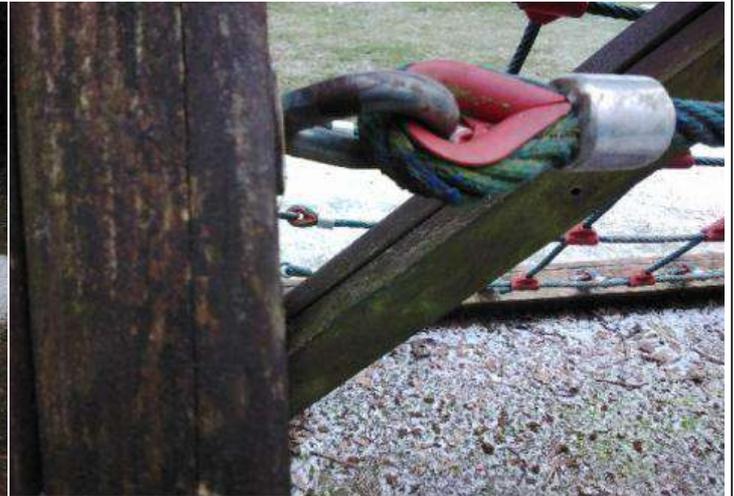
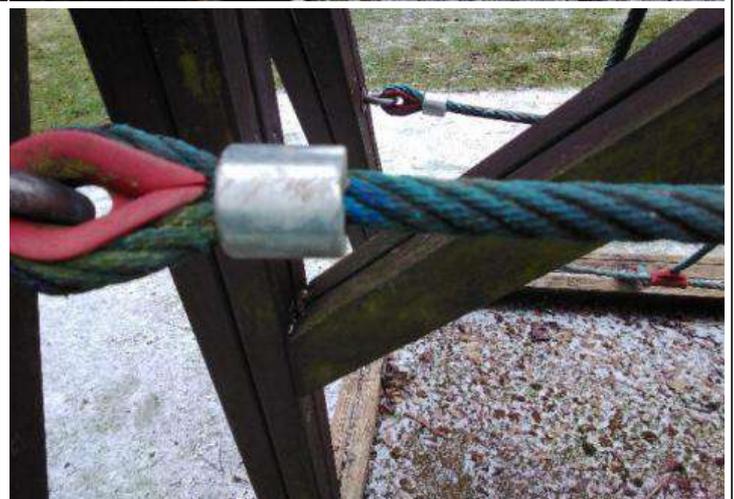
Finding: There is some evidence of fire damage to the item **Action:** Monitor for any further deterioration and repair as required

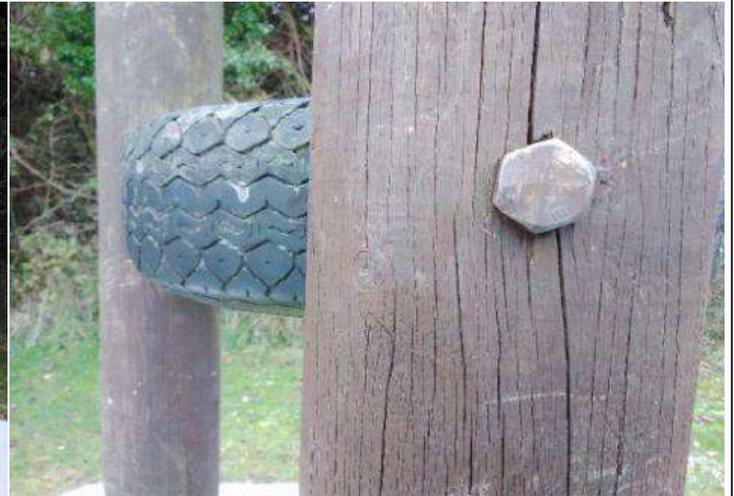
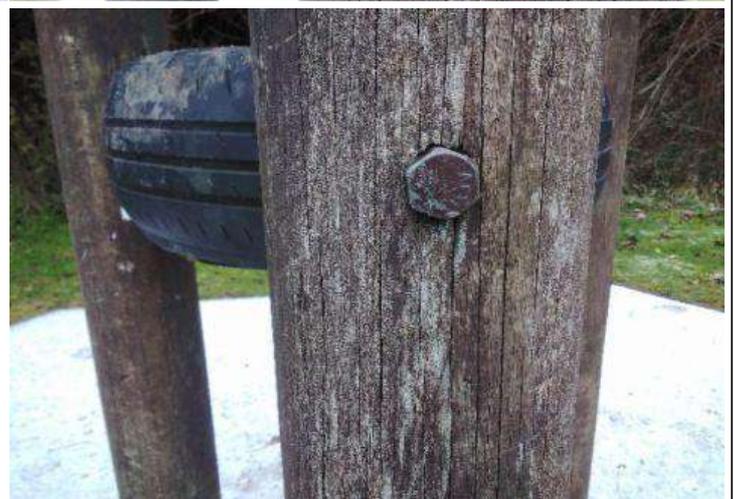
Finding: The timber has a number of splits/shakes or air cracks and this may affect the stability or allow water ingress which will accelerate the rotting process

Action: Monitor to ensure the splits do not cross through fixing points of the structure and/or cause any instability

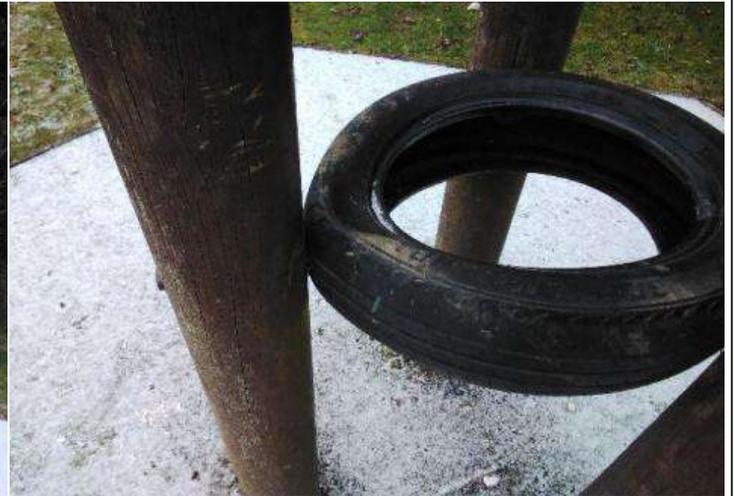
Finding: The item has been damaged

Action: Monitor for any further deterioration and replace as required

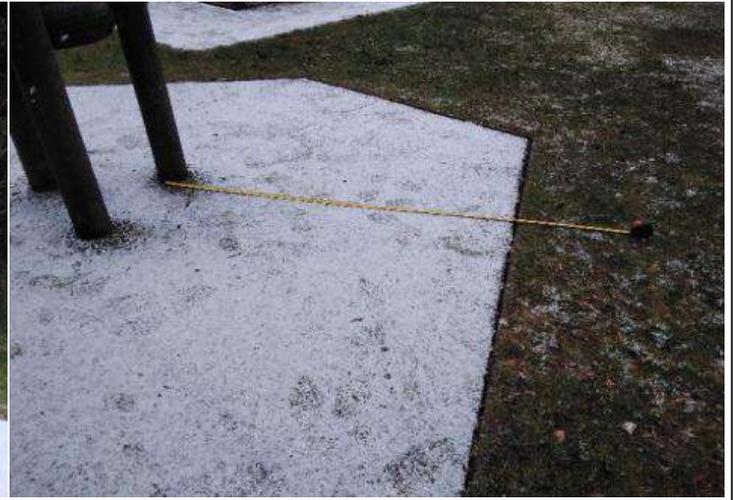
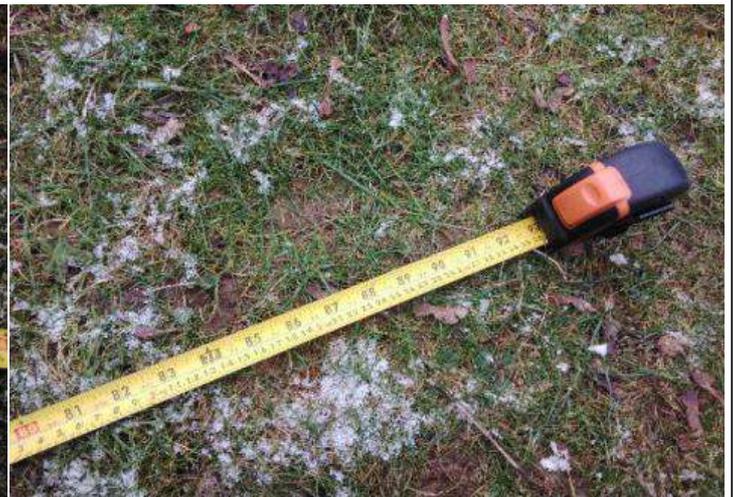
Finding: The surfacing dimensions are short and do not meet with the requirements of the current applicable standard (2360mm required / 1884mm provided)

Action: Monitor - No remedial work recommended

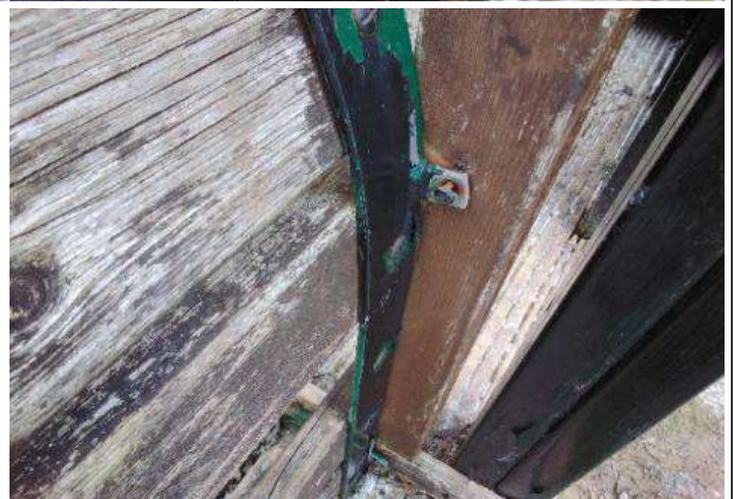
Finding: A number of fixing(s) have worked loose

Action: Secure all loose fixings

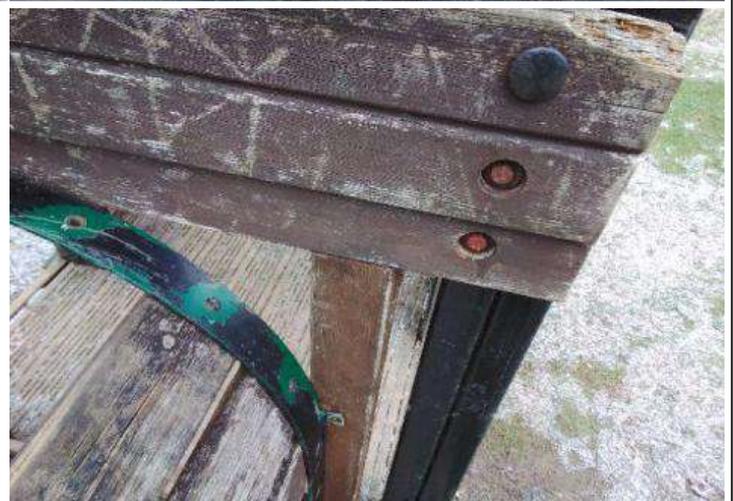
Finding: There is/are bolt cap covers missing or damaged on the item

Action: Replace missing or damaged bolt cap covers

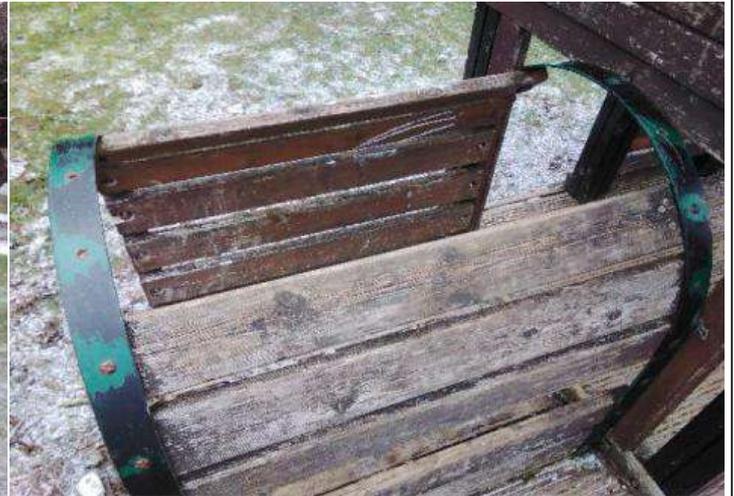
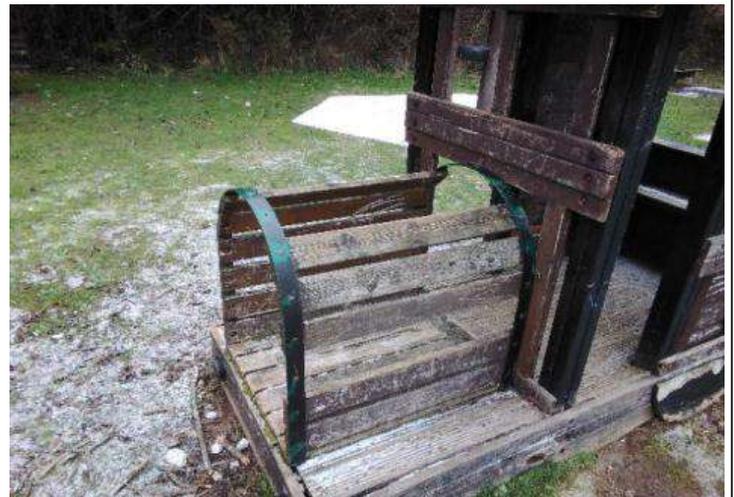
Finding: There is/are a number of missing or damaged slats.

Action: Repair or Replace as required

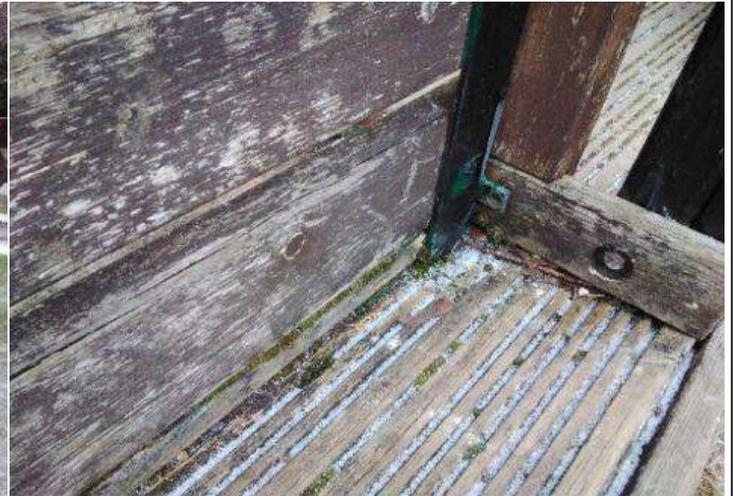
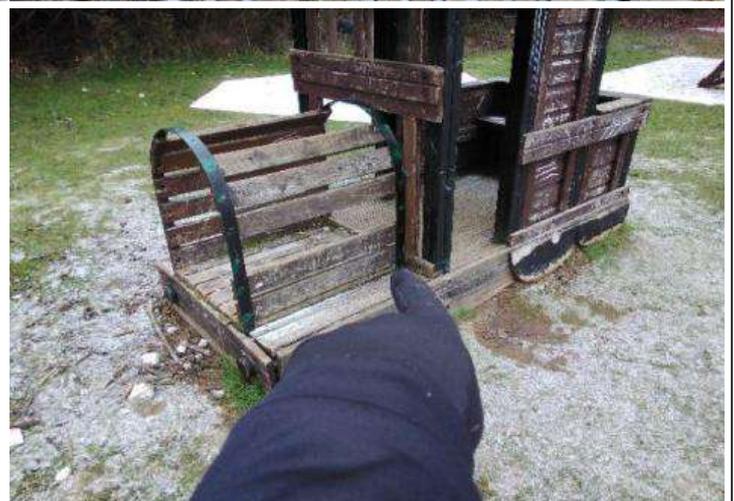
Finding: There is or are fixings missing on the item

Action: Replace all missing fixings

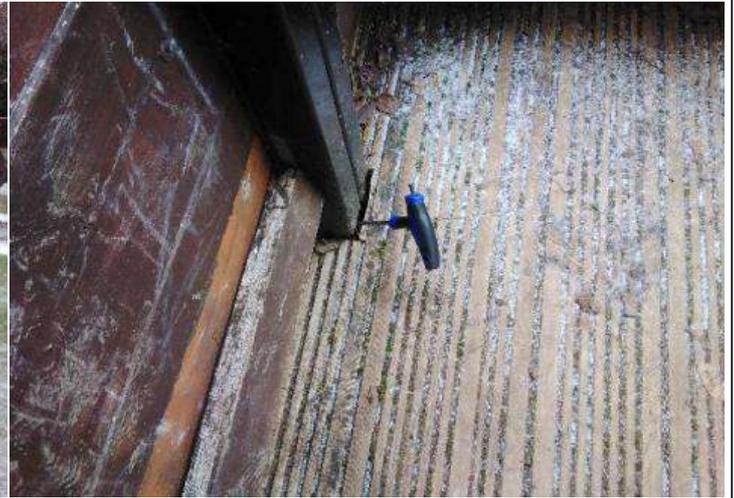
Finding: There are areas or parts of the timber on the structure that have rotted

Action: Replace all affected timbers

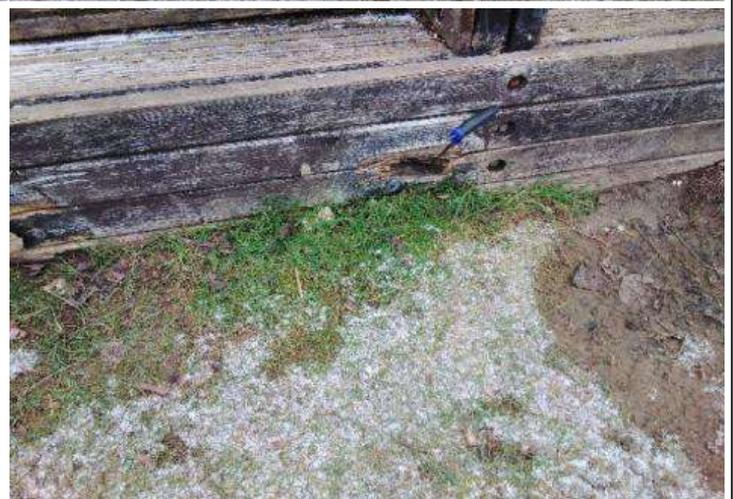
Finding: There are areas or parts of the timber on the structure that have rotted

Action: Replace all affected timbers

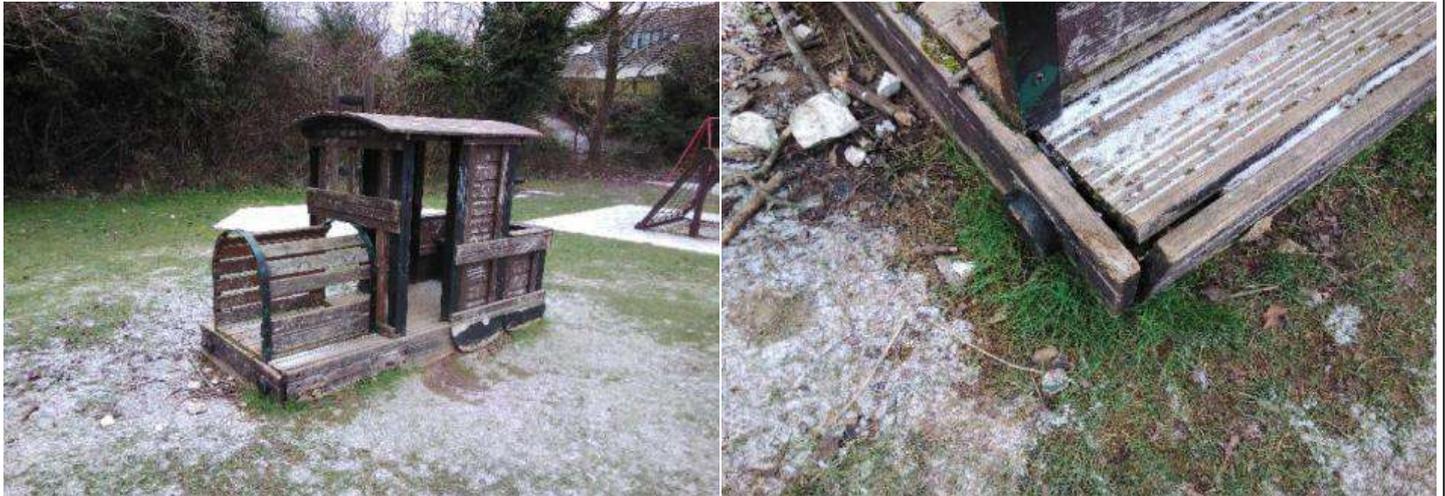
Finding: A number of fixing(s) have worked loose

Action: Secure all loose fixings

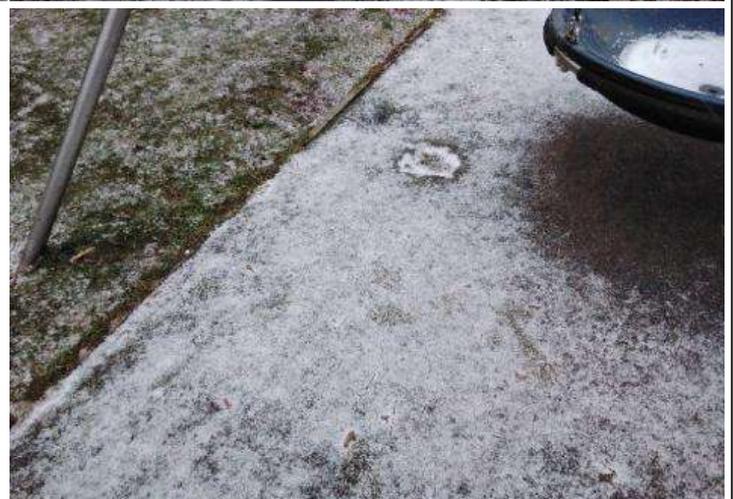
Finding: The safety surface under or around this unit has been damaged

Action: Monitor for any further deterioration and repair as required

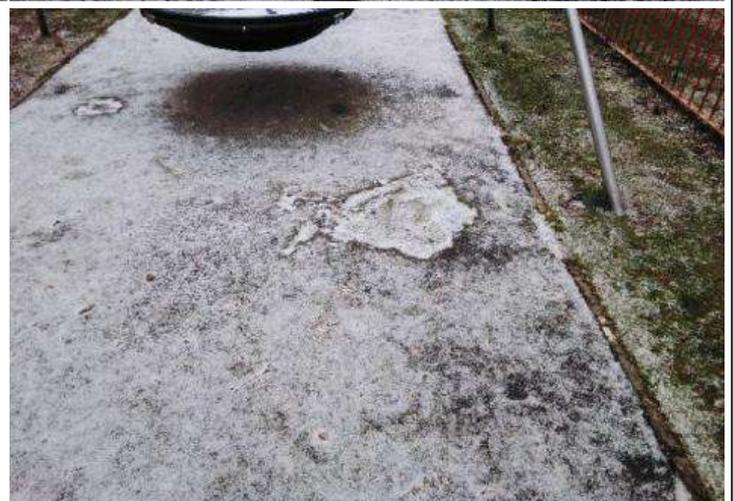
Finding: The surfacing is severely damaged

Action: Repair damaged areas of surfacing

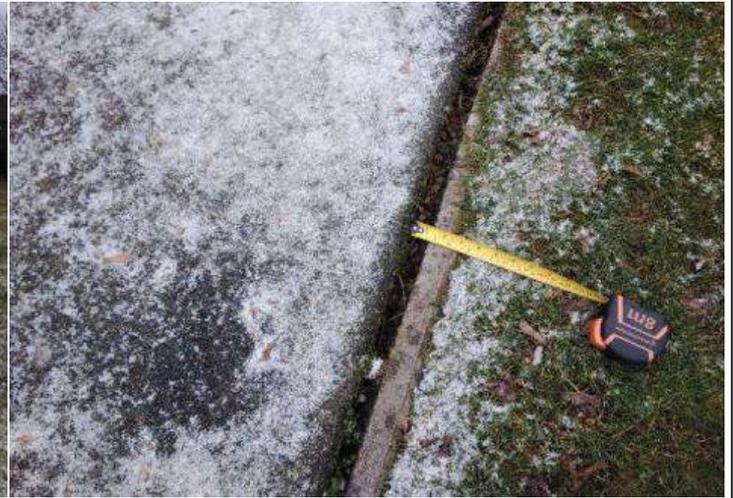
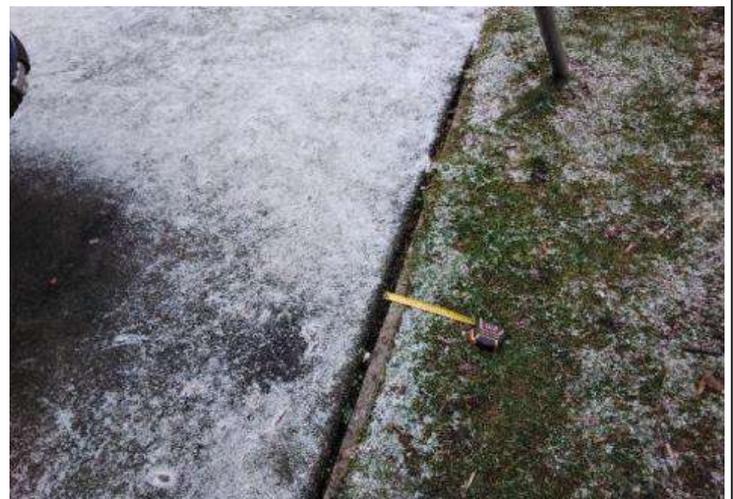
Finding: There are significant gaps (over 30mm) between the surface and the edging or between the joints in the surface; these are large enough for a small foot to enter

Action: Repair surfacing

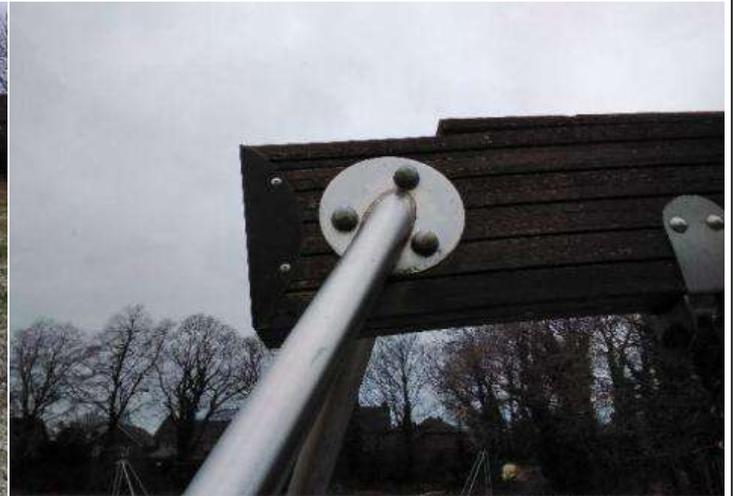
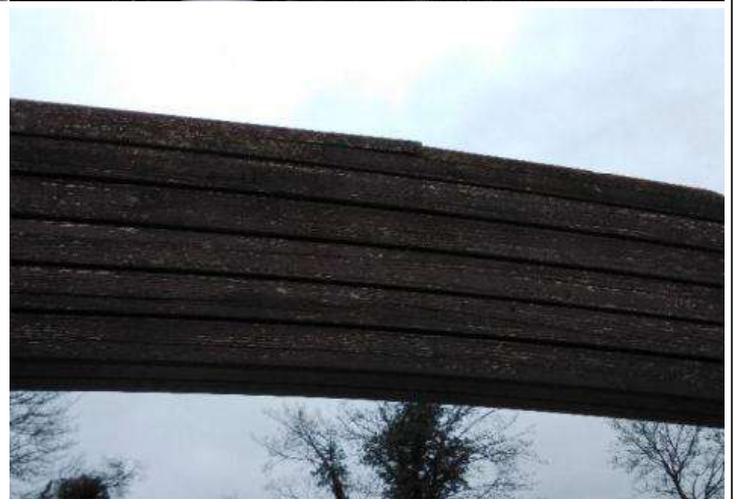
Finding: The cross beam has been damaged

Action: Monitor for any further deterioration and replace as required

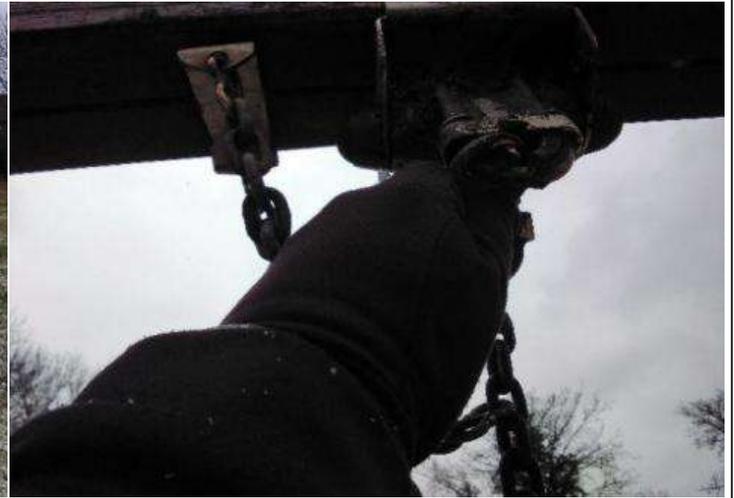
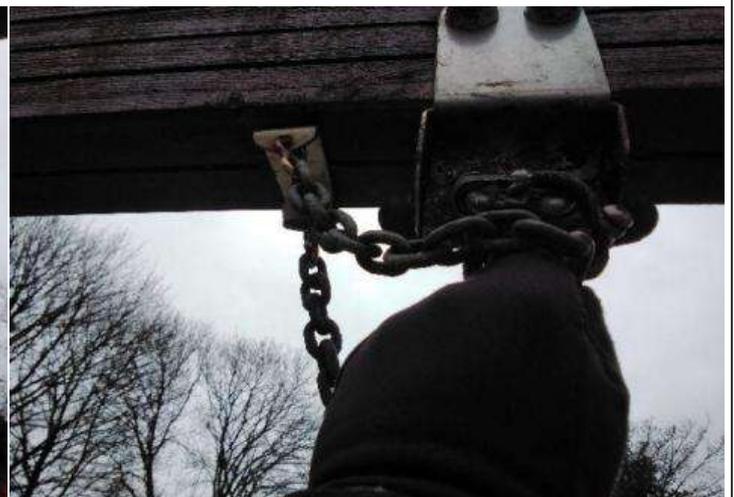
Finding: There is some notable evidence of chain wear

Action: Monitor for any further deterioration and replace when 40% worn

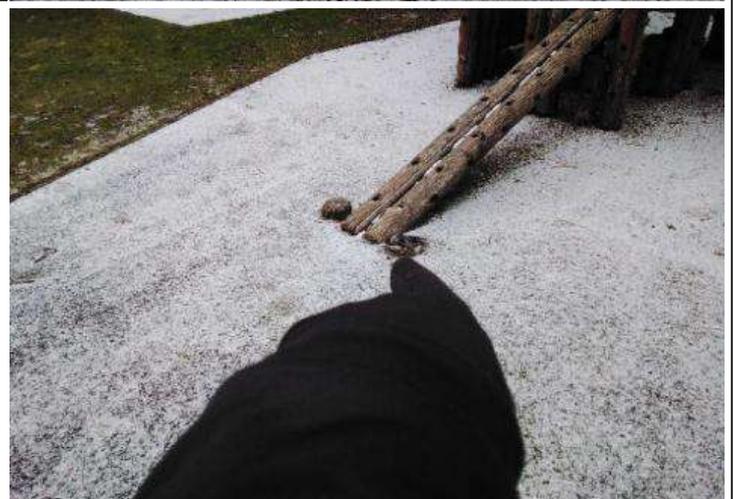
Finding: The timber on this item has severe rot

Action: Remove and replace all affected timber sections

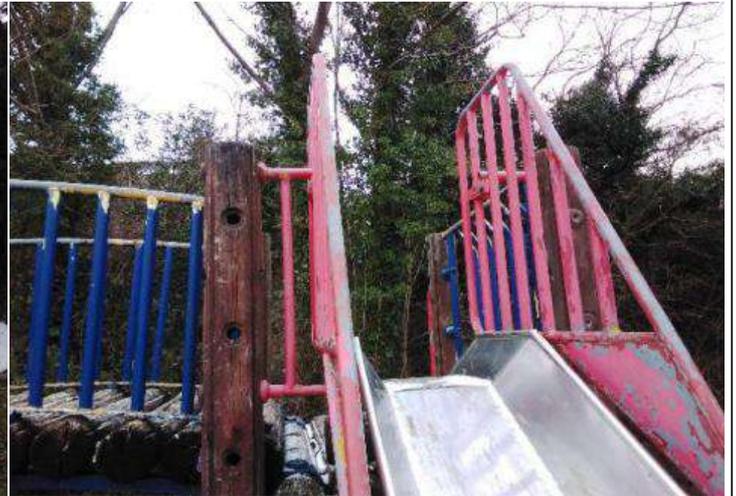
Finding: This item has no slide bar fitted as required by BS EN 1176 Part 3 **Action:** Monitor - No remedial work recommended

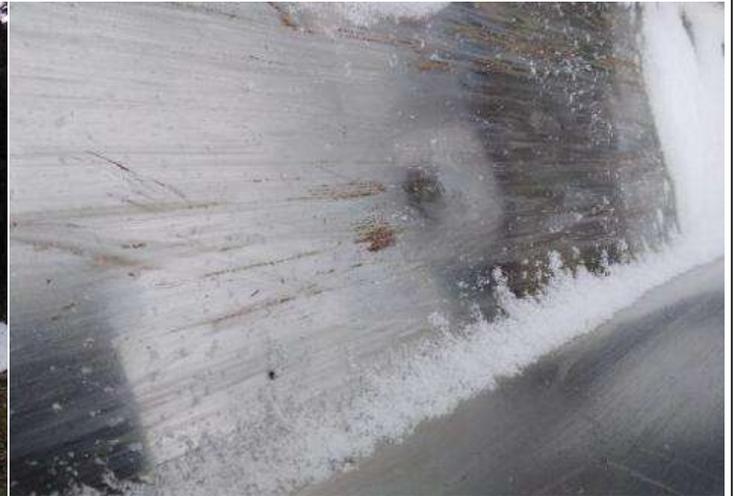
Finding: There are a number of dents in the slide surface

Action: Monitor for any further deterioration and repair as required

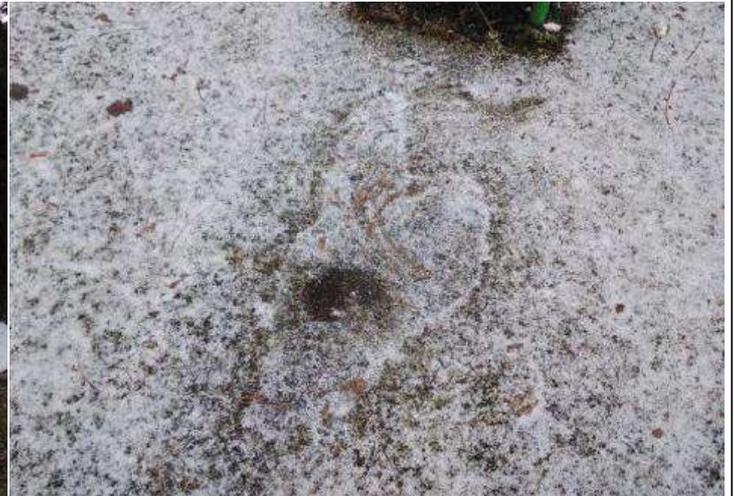
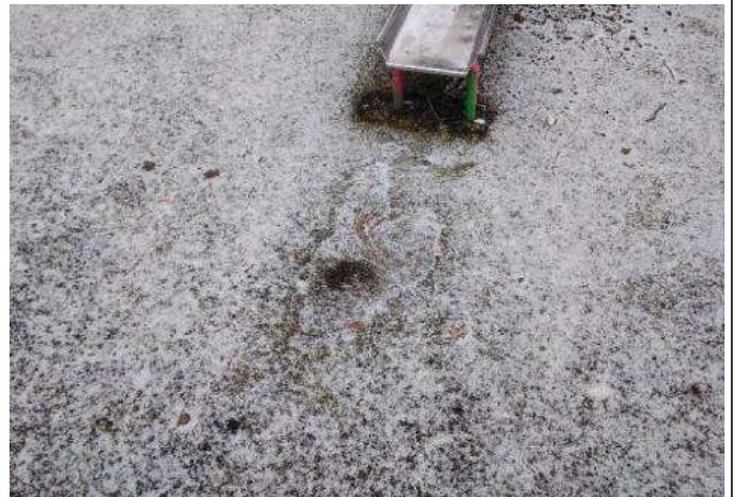
Finding: The surfacing is severely damaged

Action: Repair damaged areas of surfacing

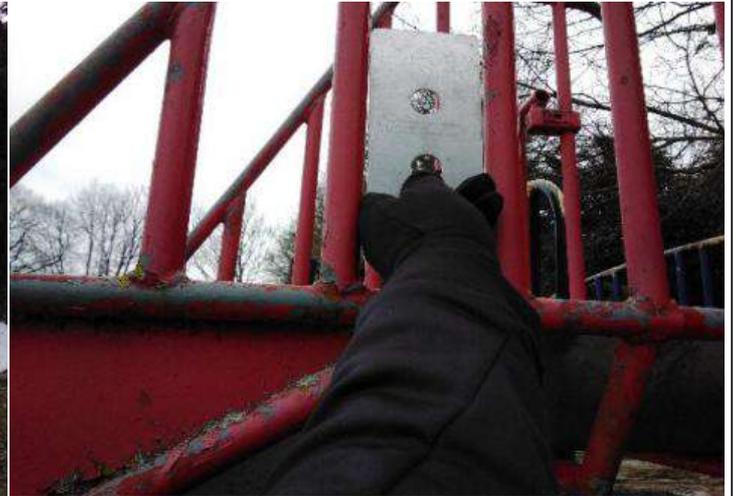
Finding: The item fails to meet the requirements of BS EN 1176 Part 1 4.2.7.2 head and neck entrapment in the barriers and/or steps

Action: Monitor - No remedial work recommended

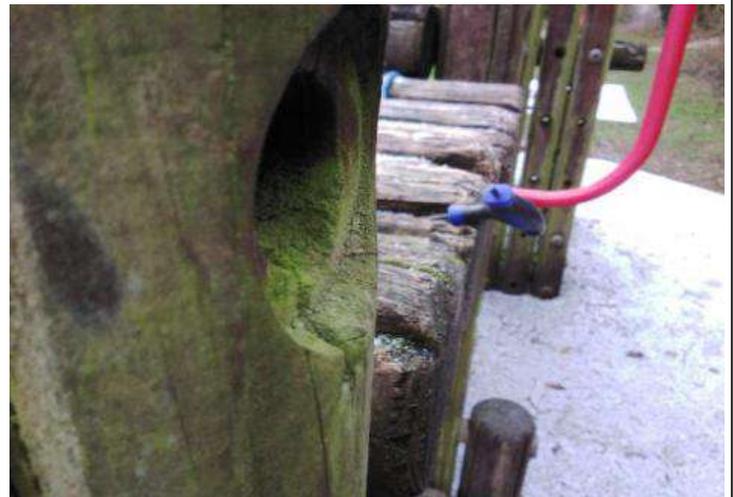
Finding: There are areas or parts of the timber on the structure that have rotted

Action: Replace all affected timbers

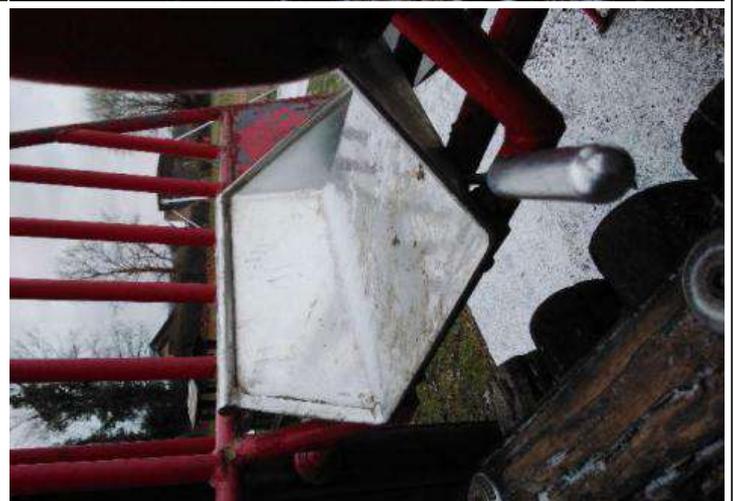
Finding: There is/are finger entrapment/s in the to the slide starting section and the item fails to meet the requirements of BS EN 1176 Part 1 4.2.7.6 Entrapment of fingers

Action: Monitor - No remedial work recommended

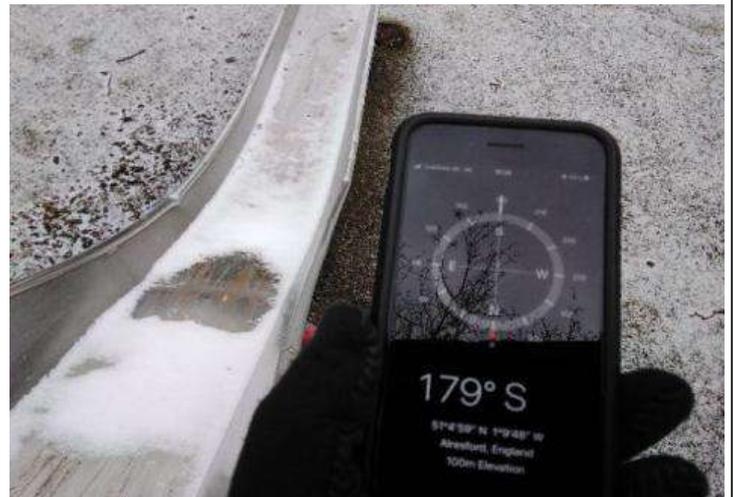
Finding: The slide is predominately south facing and will catch the majority of the sun's heat during the day. Slide surfaces can become very warm during periods of sustained sunny weather

Action: Monitor - No remedial work recommended

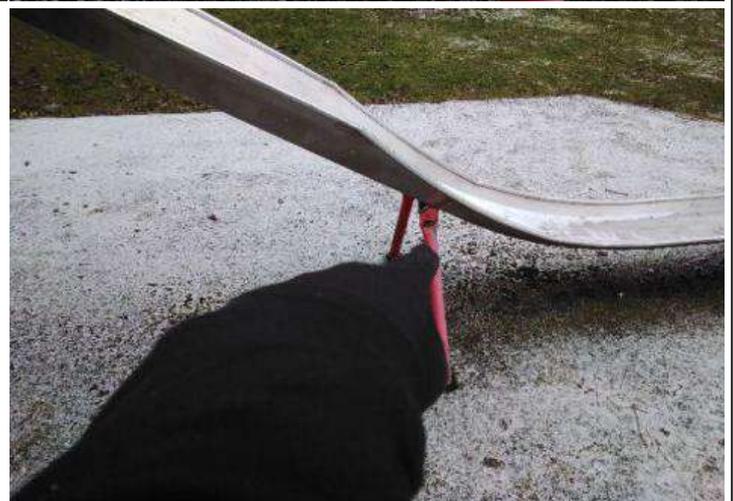
Finding: There is surface corrosion present on the item

Action: Consider treating the item

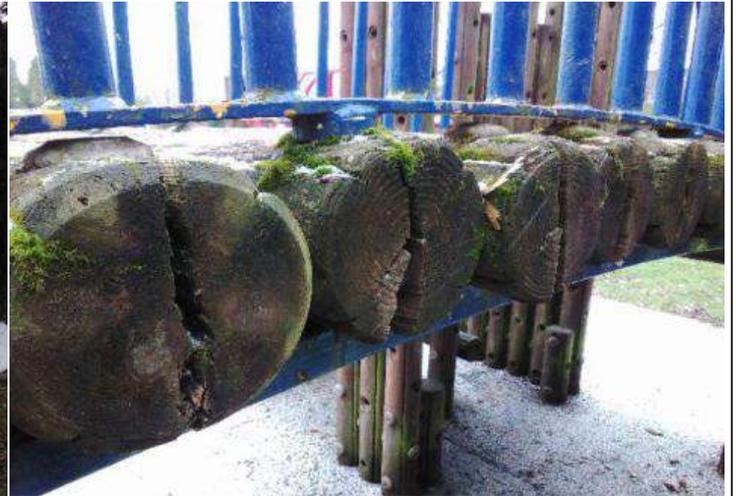
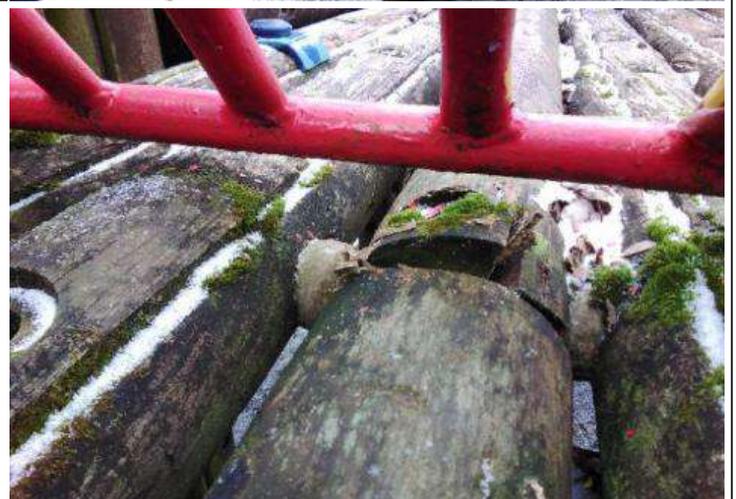
Finding: The timber has a number of splits/shakes or air cracks and this may affect the stability or allow water ingress which will accelerate the rotting process

Action: Monitor to ensure the splits do not cross through fixing points of the structure and/or cause any instability

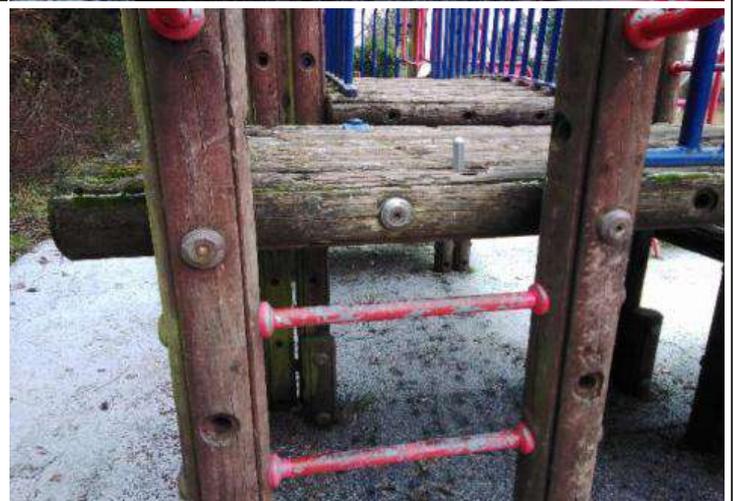
Finding: There is/are finger entrapment/s in the in the surface above the ladder and the item fails to meet the requirements of BS EN 1176 Part 1 4.2.7.6 Entrapment of fingers

Action: Monitor - No remedial work recommended

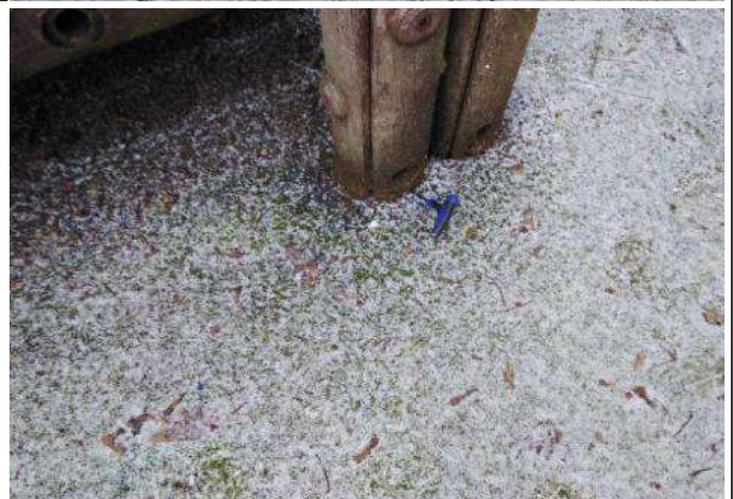
Finding: There is some evidence of rot in the timber posts

Action: Monitor for any further deterioration and replace as required
