Annual Inspection

Winchester City Council

Sun Hill Recreation Ground (New Alresford)

Derwent Gardens, Alresford, SO24 9NQ

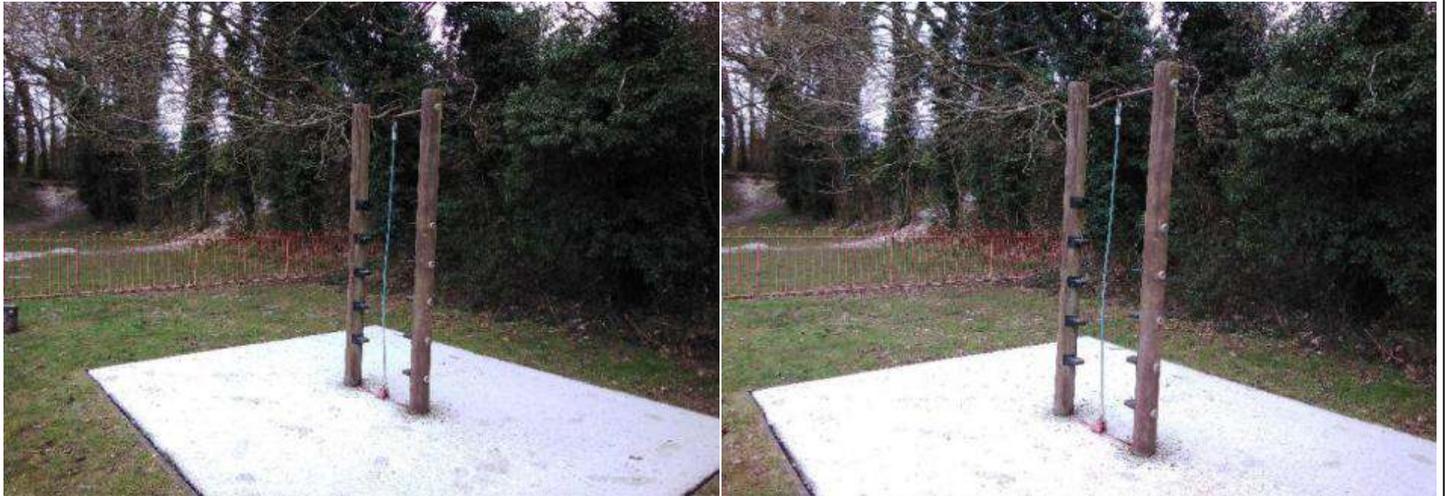
Finding: This item of equipment relies on a single post, or a line of posts, for stability and extra care needs to be taken with equipment of this nature to avoid the potential for catastrophic failure
Action: Ensure that regular detailed inspections are undertaken to assess for rot, corrosion and general stability

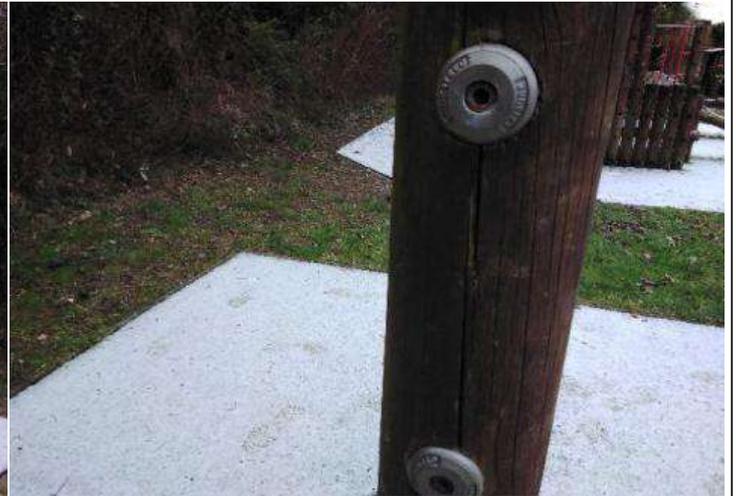
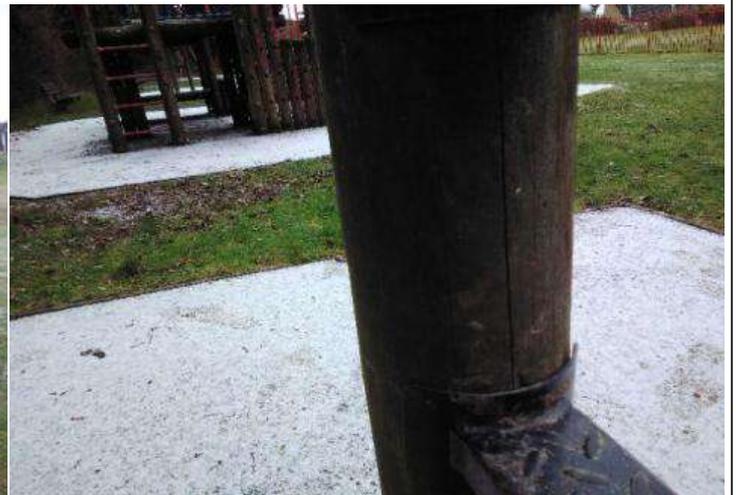
Finding: The timber has a number of splits/shakes or air cracks and this may affect the stability or allow water ingress which will accelerate the rotting process
Action: Monitor to ensure the splits do not cross through fixing points of the structure and/or cause any instability

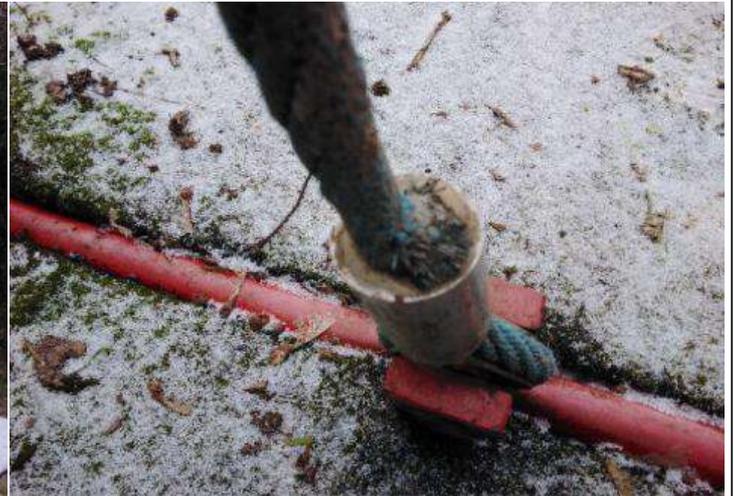
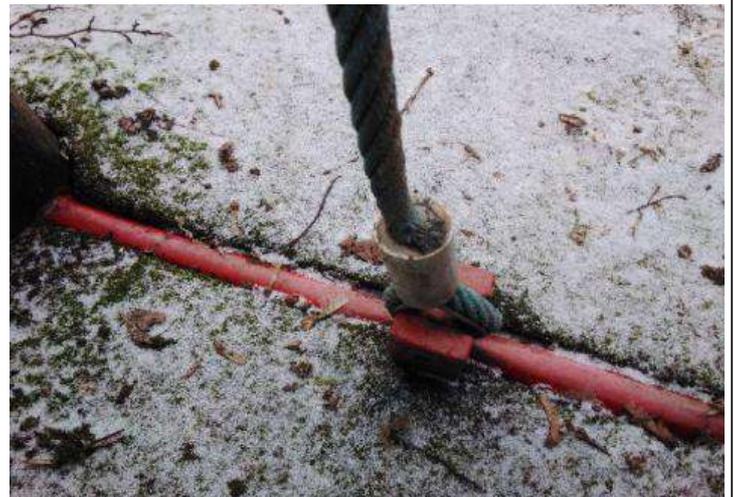
Finding: The rope has worn and wire strands are exposed

Action: Replace rope or net

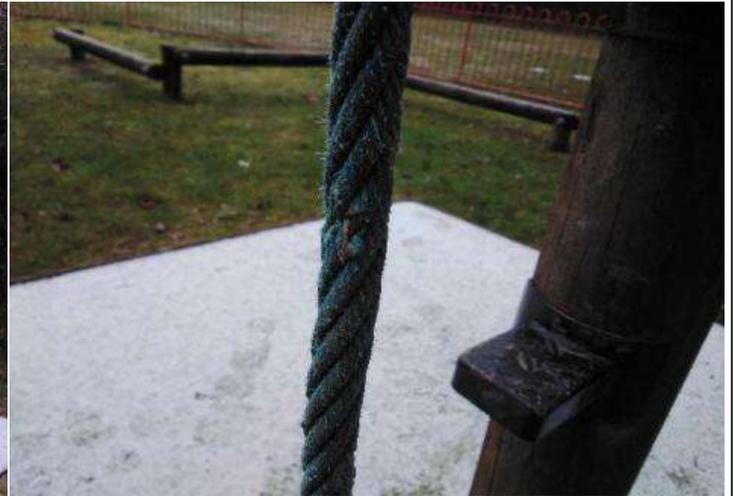
Finding: The ropes/nets are worn/damaged in places

Action: Monitor for any further deterioration and repair or replace as required

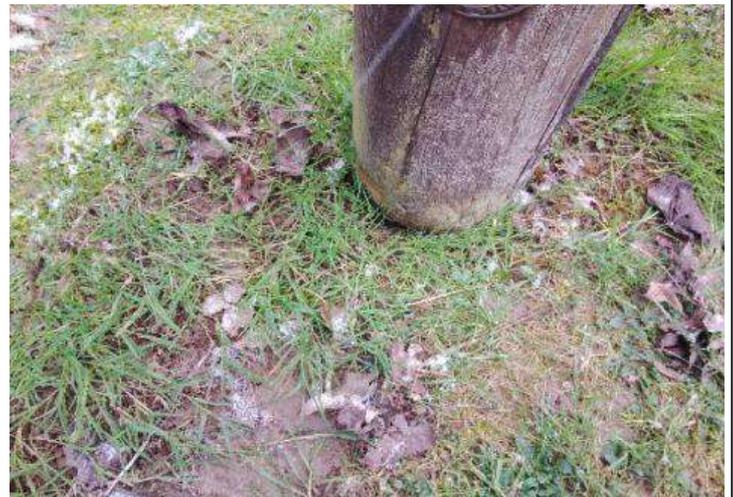
Finding: There is some strimmer / machinery damage apparent on the posts, this can penetrate the preservative applied to the timber and accelerate the rotting process

Action: Monitor for any deterioration (rot) and replace as required

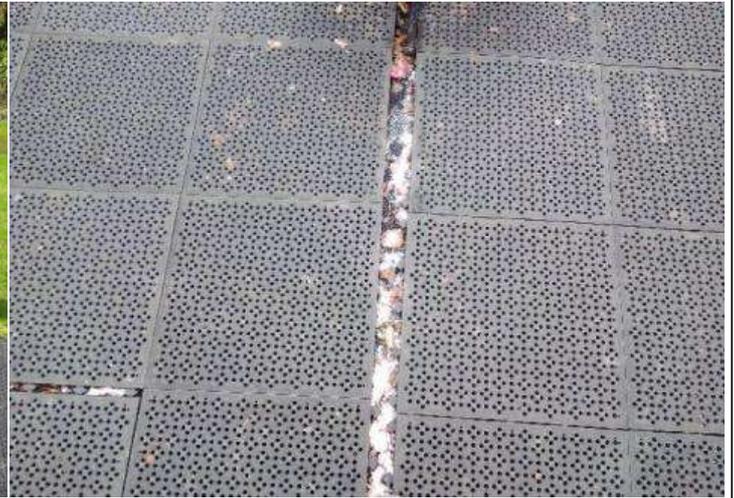
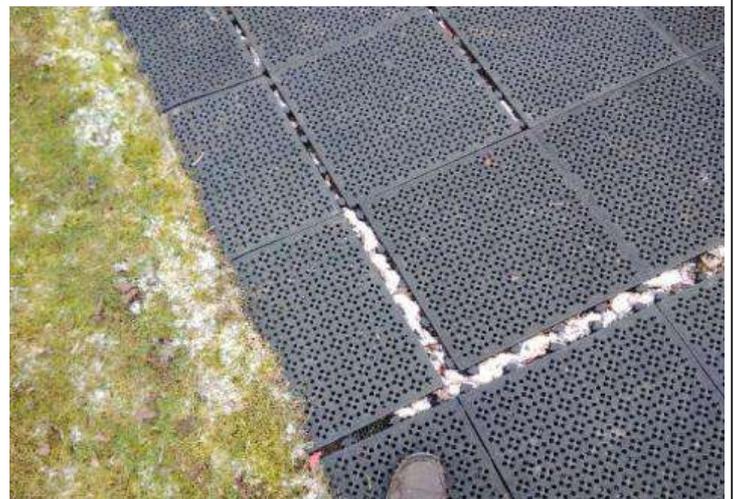
Finding: There are significant gaps (over 30mm) between the surface and the edging or between the joints in the surface; these are large enough for a small foot to enter

Action: Repair surfacing

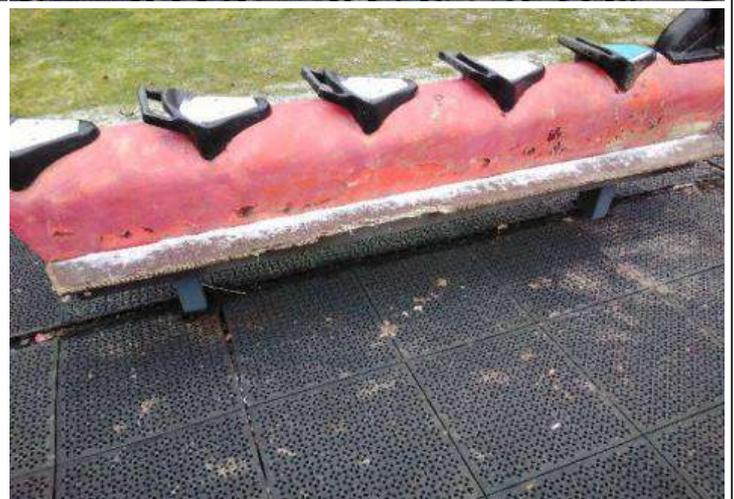
Finding: The item has been severely damaged

Action: Repair or replace the item

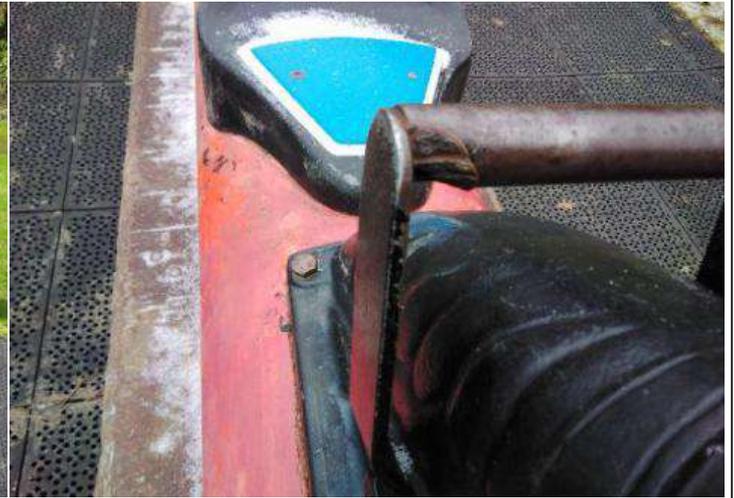
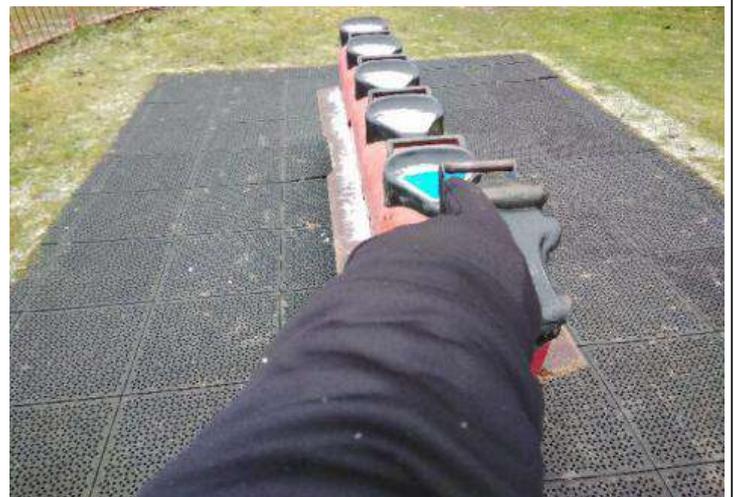
Finding: The handgrip has been damaged

Action: Monitor for any further deterioration and replace as required

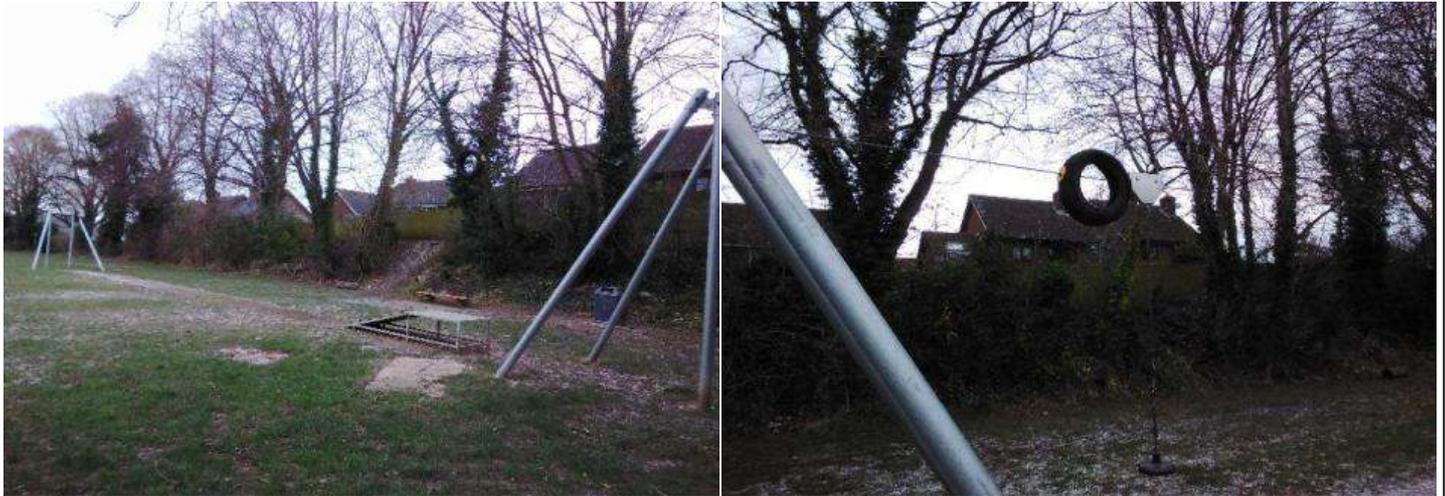
Finding: We have completed a visual inspection of the cable and fixing points from ground level, however it is not possible to fully inspect the cable and fixings without either hiring equipment to gain access or removing the cable and inspecting at ground level. We recommend that the main cable and fixing security is thoroughly inspected at least in accordance with the manufacturers recommendations to check for damage, security or internal rusting, this will help to ensure the continued safe use of the equipment

Action: Inspect in accordance with the manufacturers recommendations

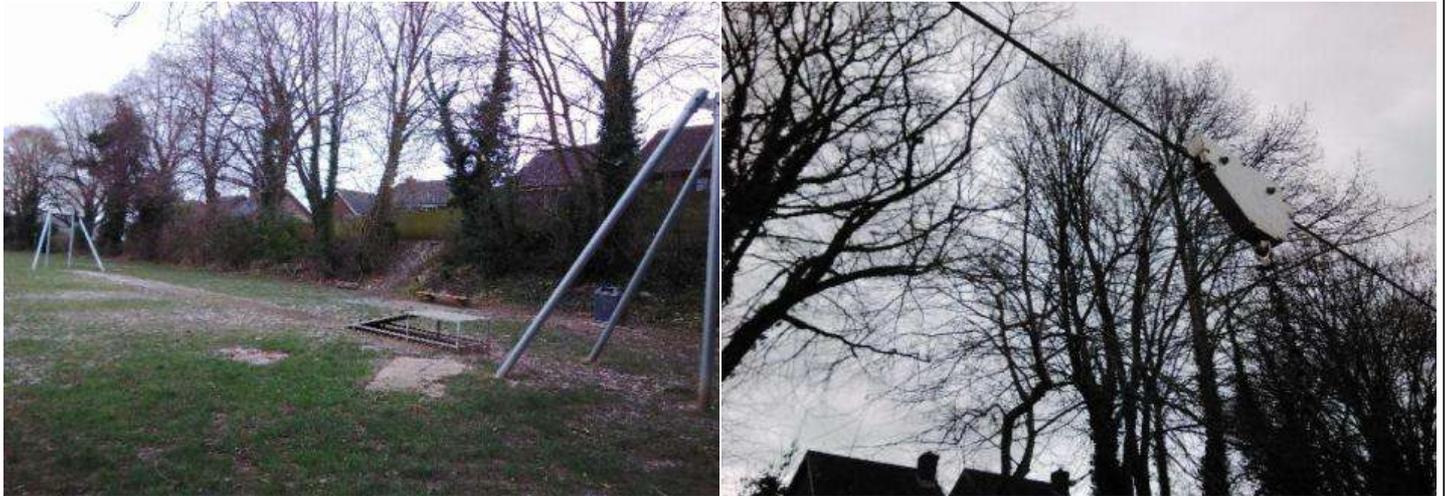
Finding: The nylon inserts are worn or missing at the point the cable enters the traveller

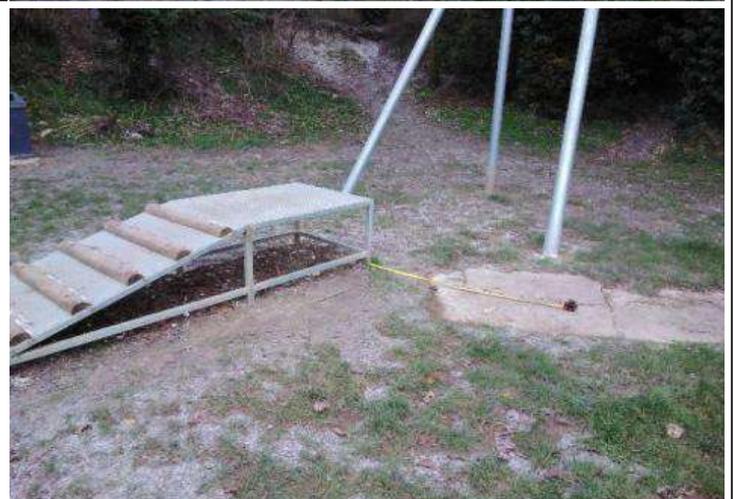
Finding: This item of equipment has a fall height in excess of 600mm and an impact absorbing surface is recommended to meet the recommendations of BS EN 1176 Part 1
