# Arlebury Park

ASBESTOS MANAGEMENT REVIEW  
AND  
ANNUAL REGISTER UPDATE

March 2021

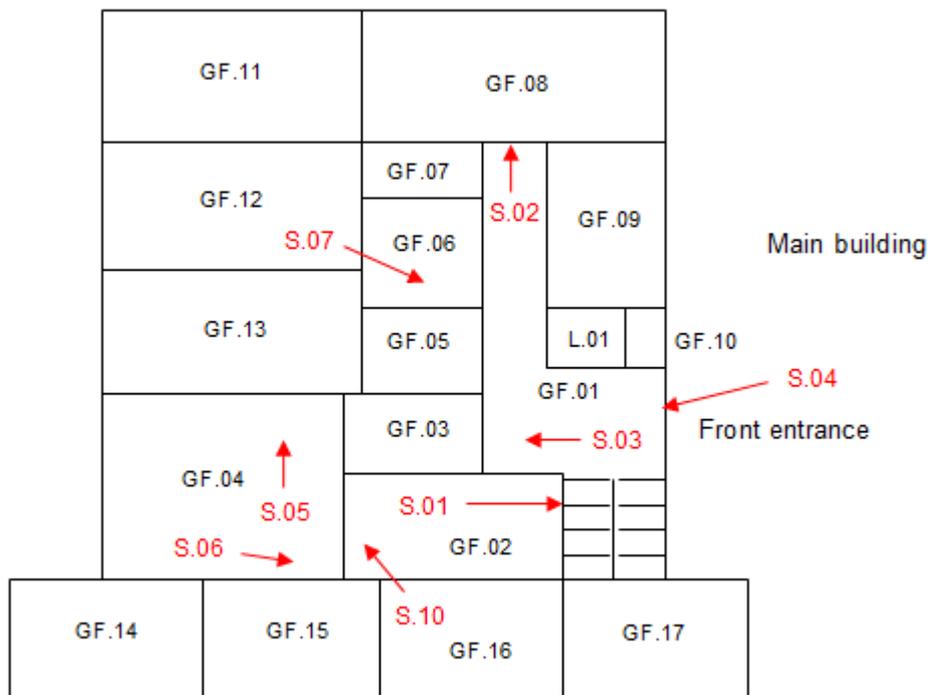
**Figure 1** Floor plan showing ground floor areas

Due to these internal alterations the floor plans from the original survey report have themselves been altered; as shown below in Figures 1 to 3. The latter now includes the garage outbuilding adjacent to the football pitch.

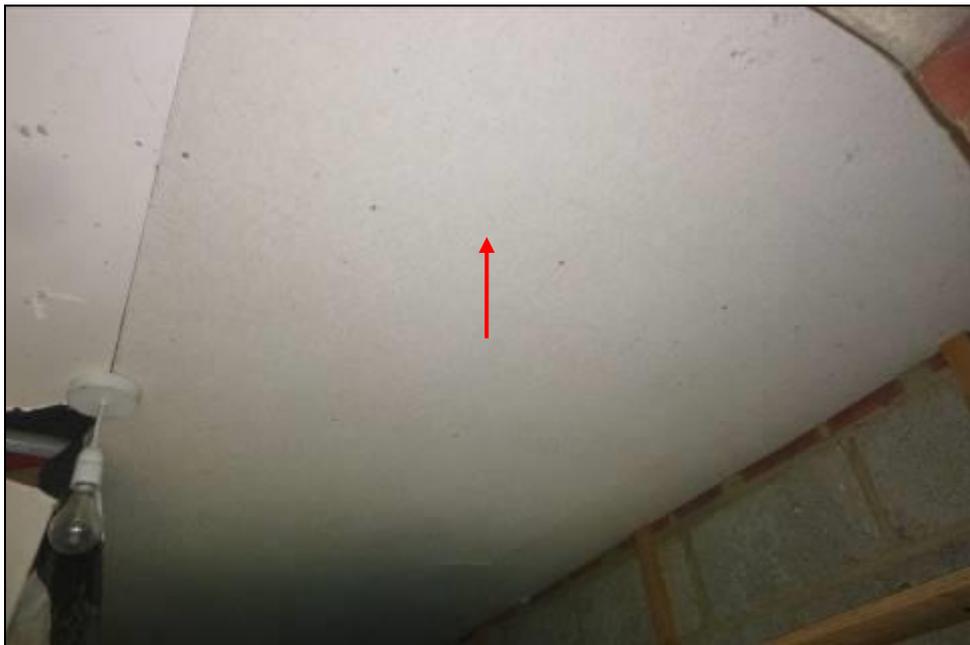
**Photograph 1** Sample location S.12

Sample ID	Location	Material	Asbestos detected
S.12/3149	Internal ceiling	Insulation board	No
S.13/3149	External soffit	Insulation board	No
S.14/3149	External undercloaking	Cement	Yes

SCOPE SAMPLE No.	CLIENT SAMPLE No.	Sample Location	Fibre Type Detected
1	S.12 / 3149	EXTERIOR GARAGE – RHS CEILING – INSULATION BOARD	NADIS
2	S.13 / 3149	EXTERIOR GARAGE – SOFFIT	NADIS
3	S.14 / 3149	EXTERIOR GARAGE – CEMENT	CHRYSOTILE
