the **play** inspection company

Annual Inspection

Winchester City Council

Arlebury Park, Skate Park & Tennis(New Alresford)

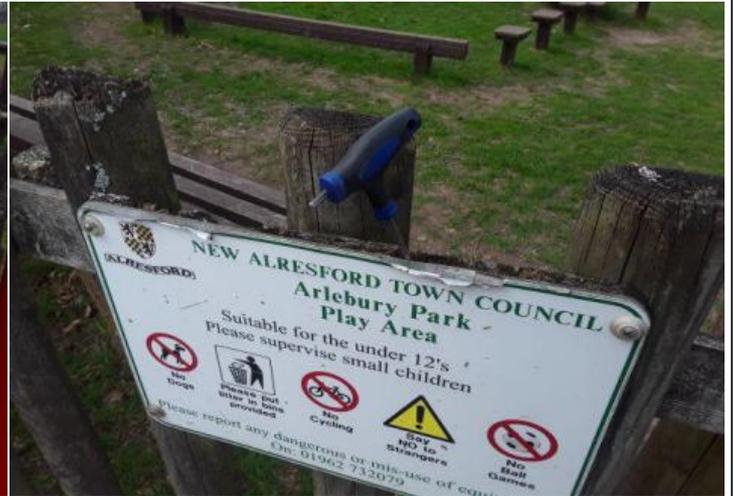
There are areas or parts of the timber that have rotted - Replace sign

Finding: There are areas or parts of the timber that have rotted

Action: Replace sign

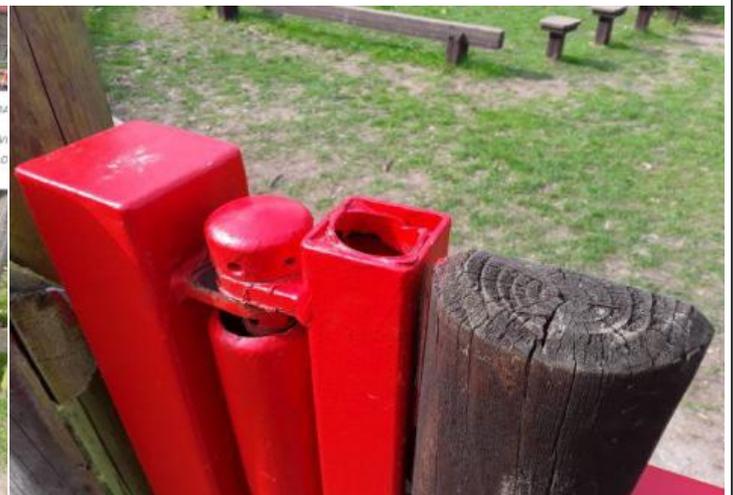
There are post / end caps missing / damaged - Replace post caps

Finding: There are post / end caps missing / damaged

Action: Replace post caps

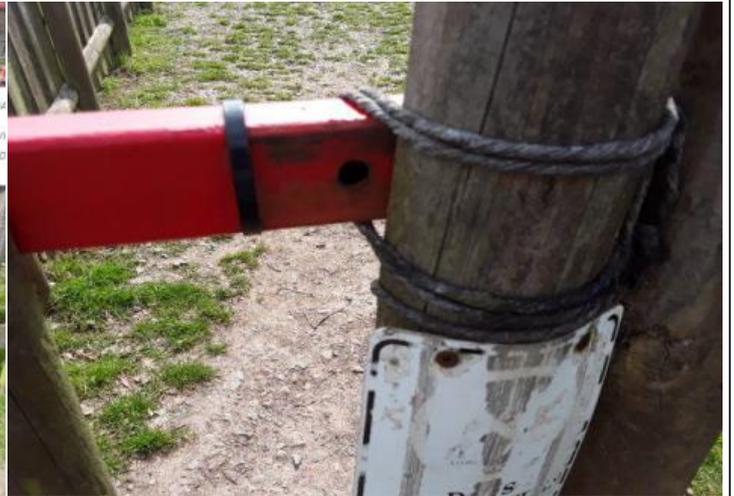
Finding: There is or are fixings missing on the item

Action: Replace all missing fixings

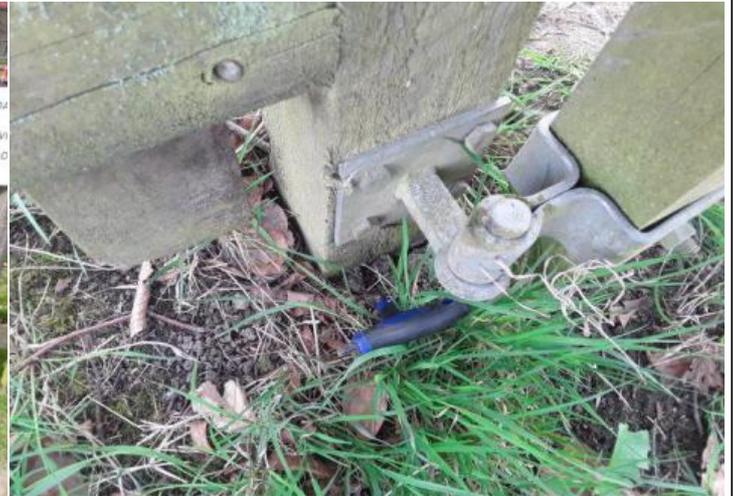
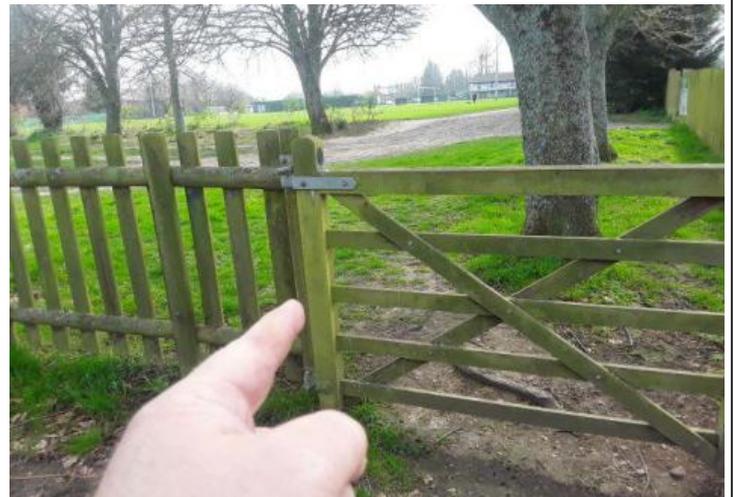
Finding: There are areas or parts of the timber on the structure that have rotted

Action: Replace all affected timbers

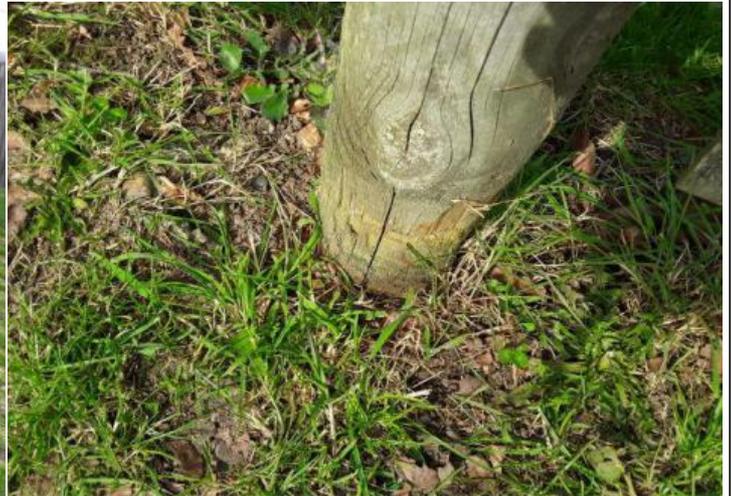
Finding: There is some strimmer / machinery damage apparent on the posts, this can penetrate the preservative applied to the timber and accelerate the rotting process

Action: Monitor for any deterioration (rot) and replace as required

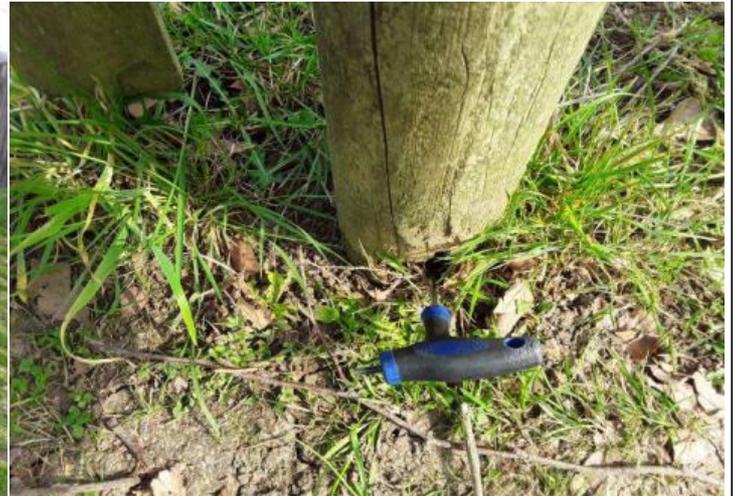
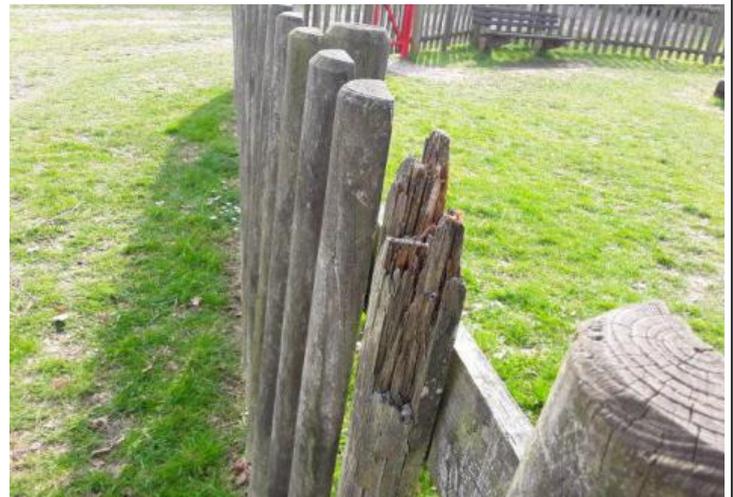
Finding: There are areas or parts of the timber on the structure that have rotted

Action: Replace all affected timbers

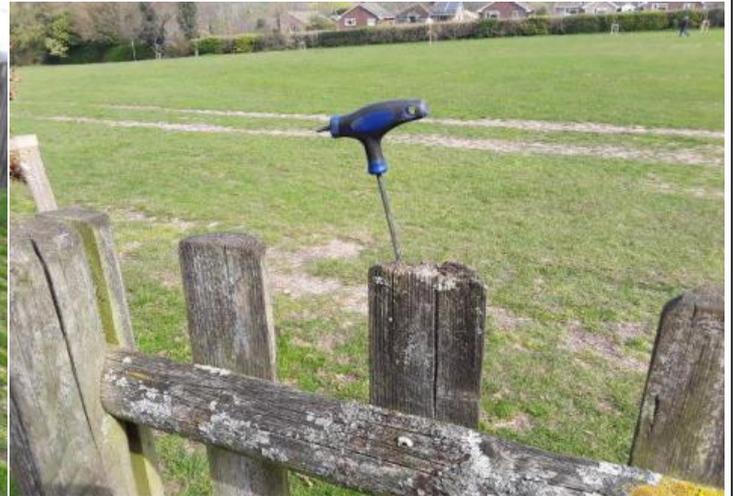
Finding: There is some evidence of rot in the timber

Action: Monitor for any further deterioration and replace as required

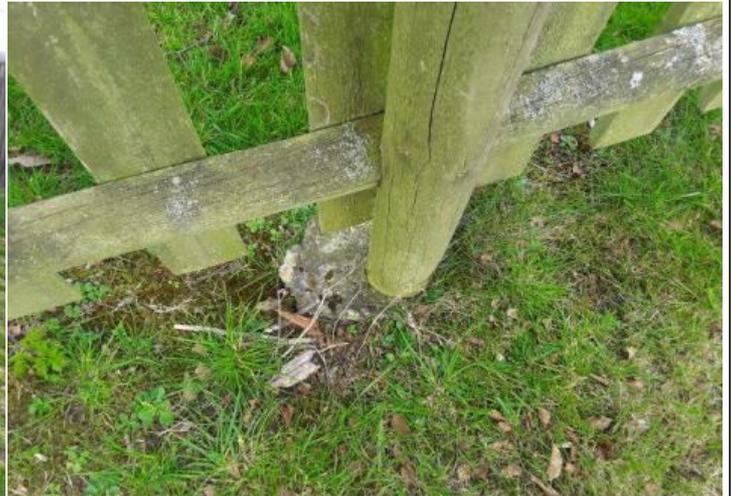
Finding: The surface has eroded and the foundations are exposed

Action: Reinstate surrounding surfaces to cover the foundations

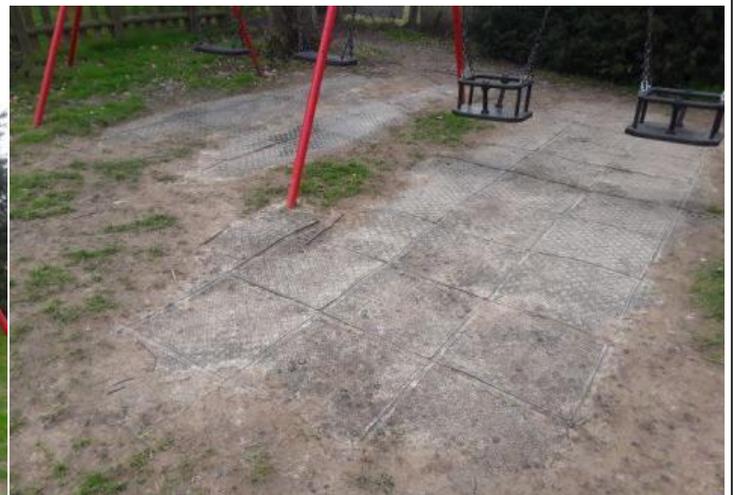
The surface has subsided in some areas - Monitor for any further deterioration and repair as required

Finding: The surface has subsided in some areas

Action: Monitor for any further deterioration and repair as required

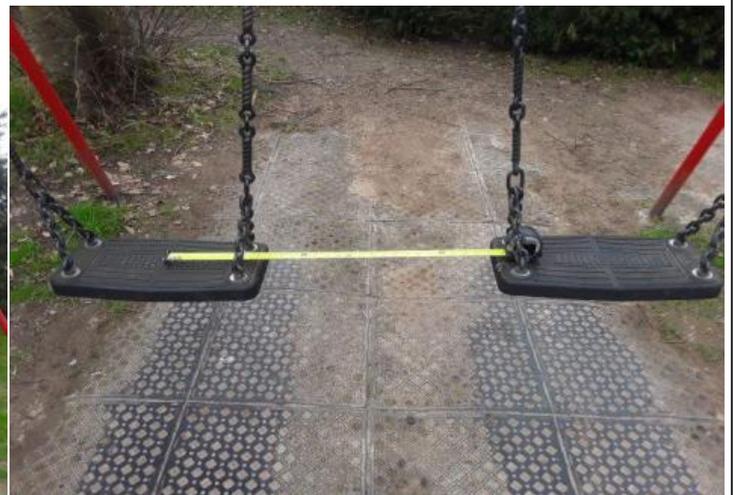
The seats are too close to each other as defined in BS EN 1176 Part 2; this is a low risk failure and no remedial action is required - Monitor - No remedial work recommended

Finding: The seats are too close to each other as defined in BS EN 1176 Part 2; this is a low risk failure and no remedial action is required

Action: Monitor - No remedial work recommended

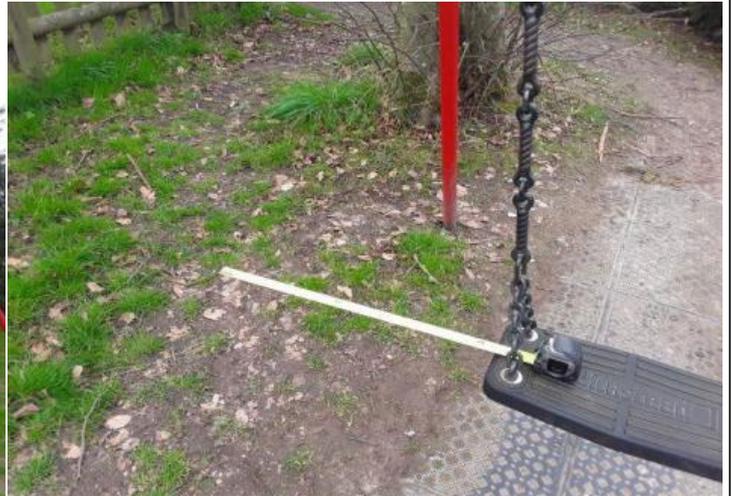
The seats are too close to the frame as defined in BS EN 1176 Part 2; this is a low risk failure and no remedial action is required - Monitor - No remedial work recommended

Finding: The seats are too close to the frame as defined in BS EN 1176 Part 2; this is a low risk failure and no remedial action is required

Action: Monitor - No remedial work recommended

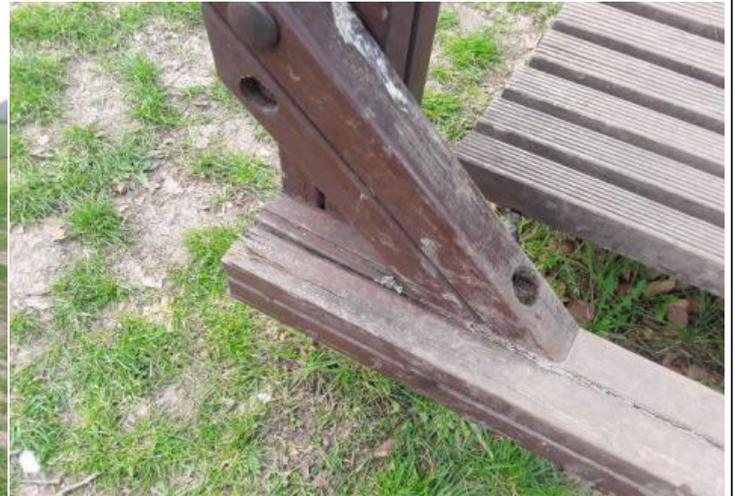
Finding: There is/are bolt cap covers missing or damaged on the item

Action: Replace missing or damaged bolt cap covers

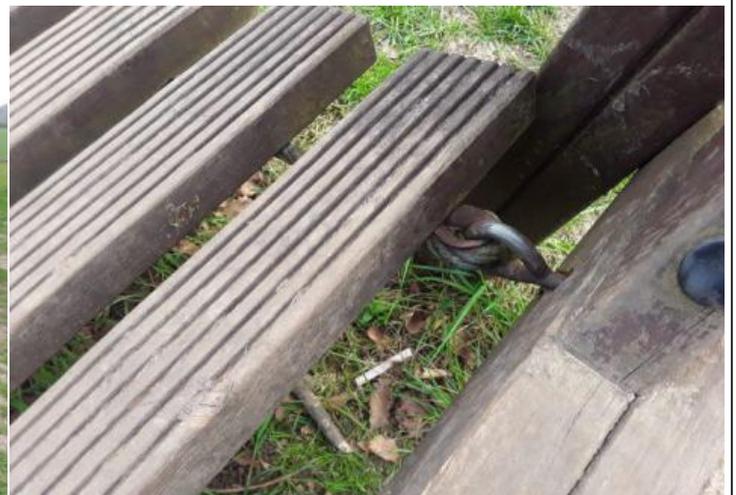
A number of eyebolt fixing(s) have worked loose - Secure all loose fixings

Finding: A number of eyebolt fixing(s) have worked loose

Action: Secure all loose fixings

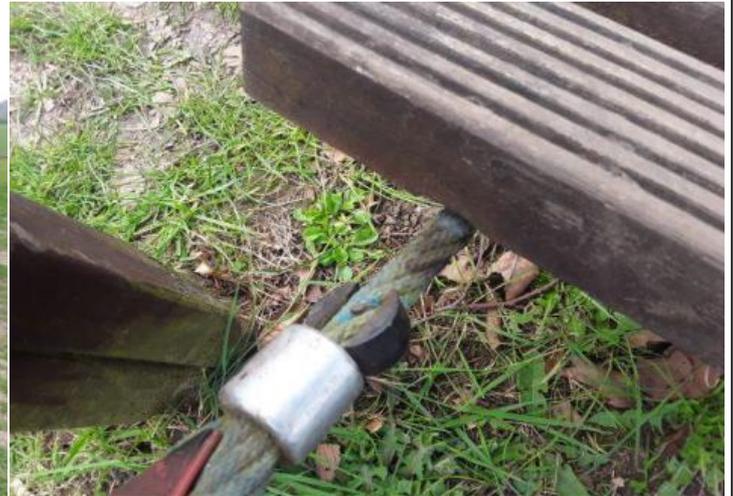
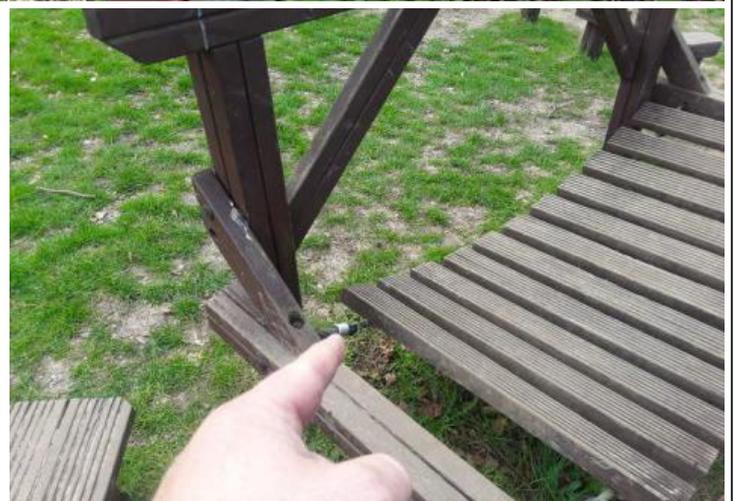
Fixings are damaged and/or have sharp edges - Repair or replace as required

Finding: Fixings are damaged and/or have sharp edges

Action: Repair or replace as required

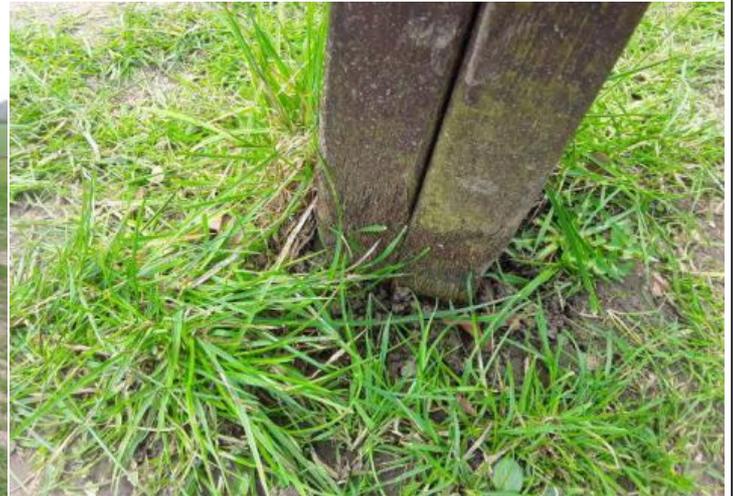
Finding: There is some strimmer / machinery damage apparent on the posts, this can penetrate the preservative applied to the timber and accelerate the rotting process

Action: Monitor for any deterioration (rot) and replace as required

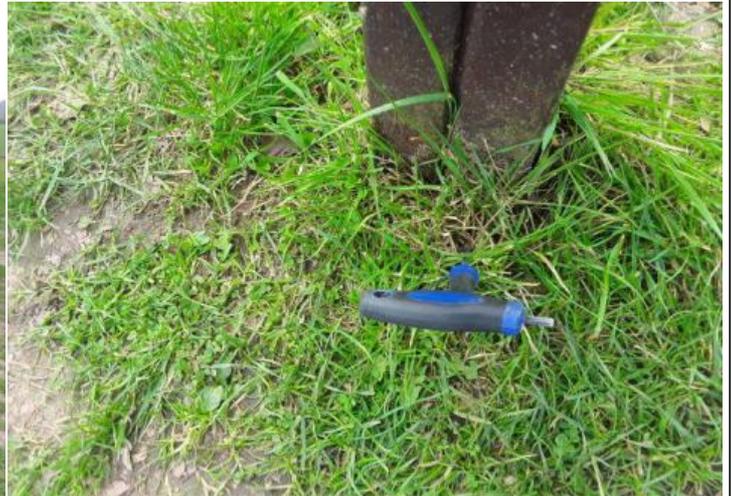
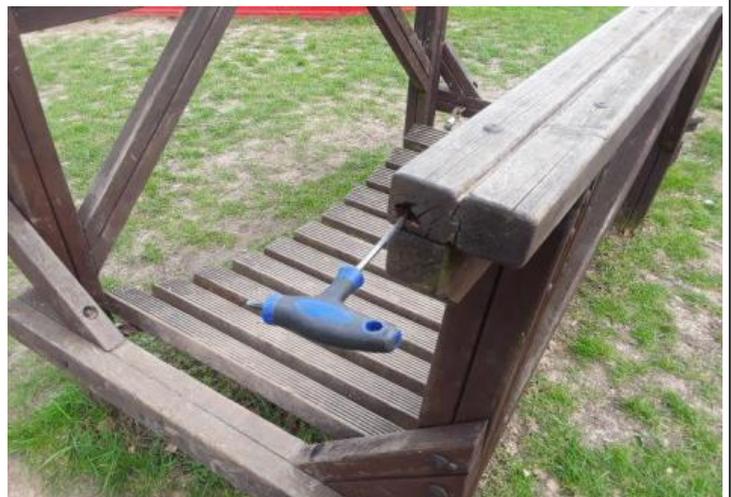
There is some evidence of rot in the timber throughout the trail - Monitor for any further deterioration and replace as required

Finding: There is some evidence of rot in the timber throughout the trail

Action: Monitor for any further deterioration and replace as required

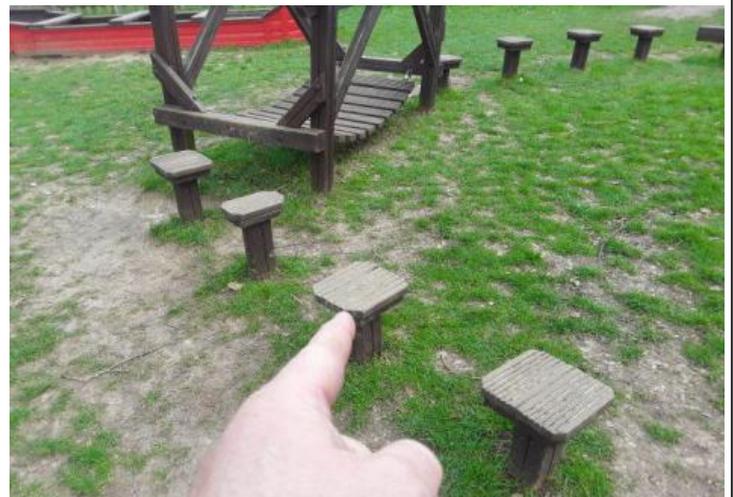
There are areas or parts of the stepping posts that have rotted - Replace all affected timbers

Finding: There are areas or parts of the stepping posts that have rotted **Action:** Replace all affected timbers

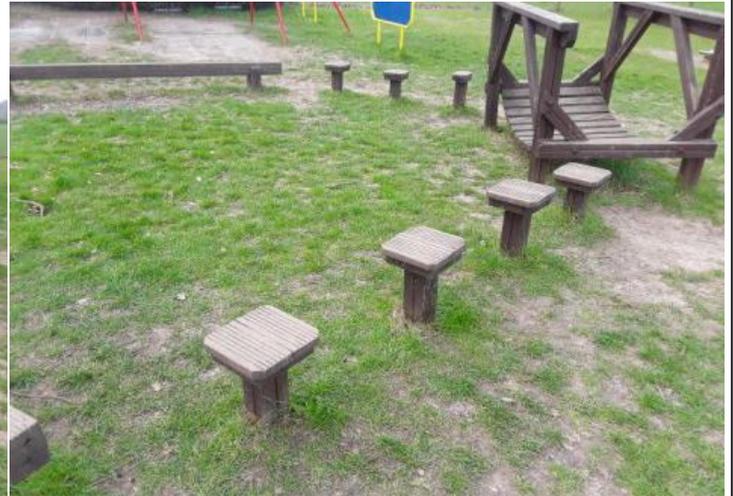
The stepping posts are becoming loose in the ground - Monitor for any further deterioration and repair as required

Finding: The stepping posts are becoming loose in the ground

Action: Monitor for any further deterioration and repair as required

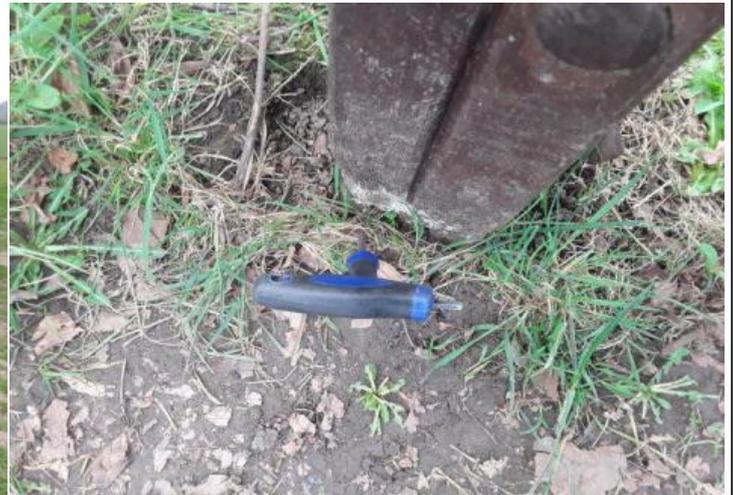
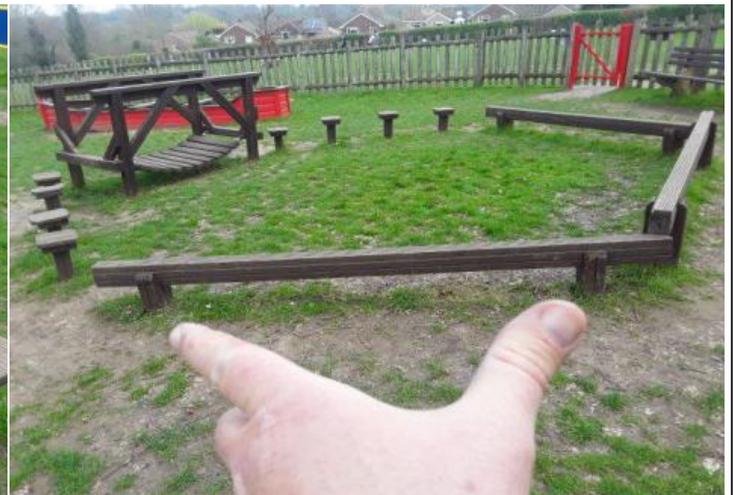
There are areas or parts of the posts x4 on the balance beams that have rotted with evidence of rot in the remaining posts - Replace all affected timbers

Finding: There are areas or parts of the posts x4 on the balance beams that have rotted with evidence of rot in the remaining posts

Action: Replace all affected timbers

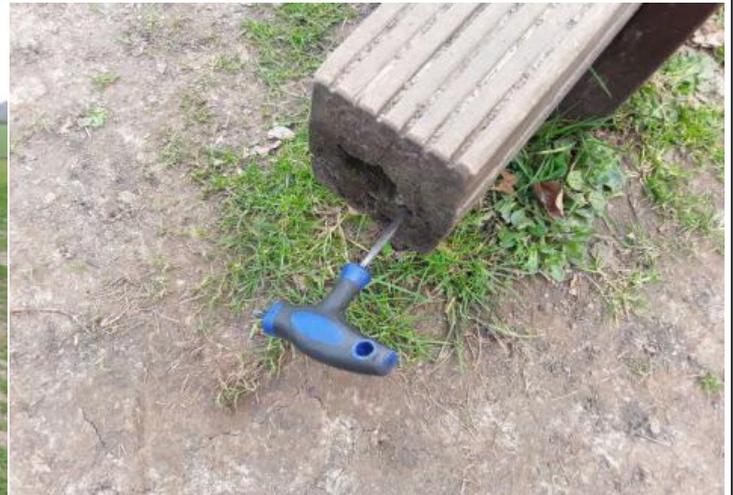
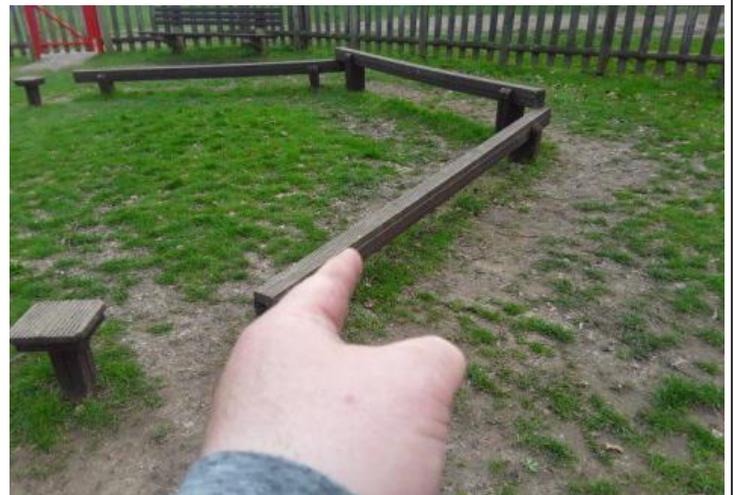
There are areas or parts of the balance beams that have rotted - Replace all affected timbers

Finding: There are areas or parts of the balance beams that have rotted **Action:** Replace all affected timbers

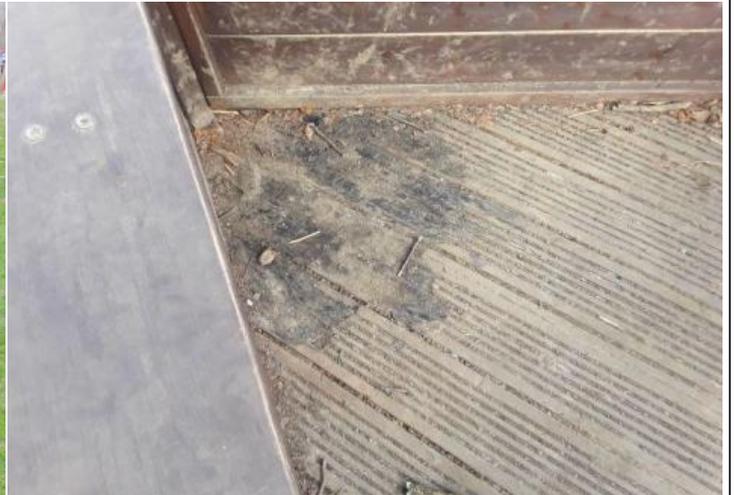
Finding: There is some evidence of fire damage to the item

Action: Monitor for any further deterioration and repair as required

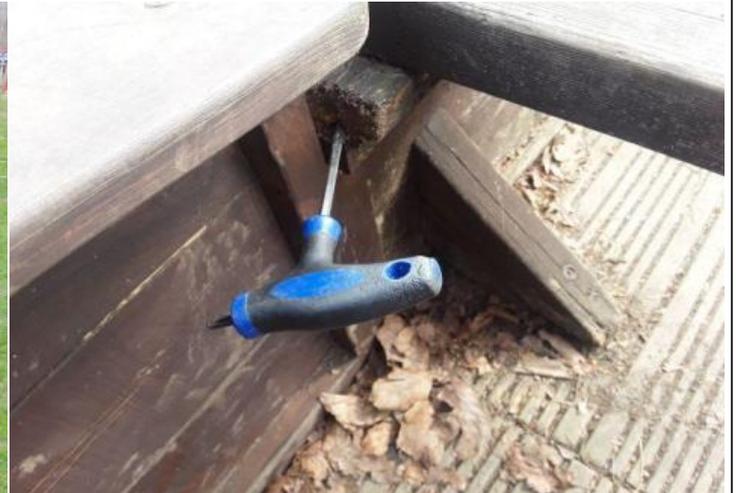
Finding: There is some evidence of rot in the timber

Action: Monitor for any further deterioration and replace as required

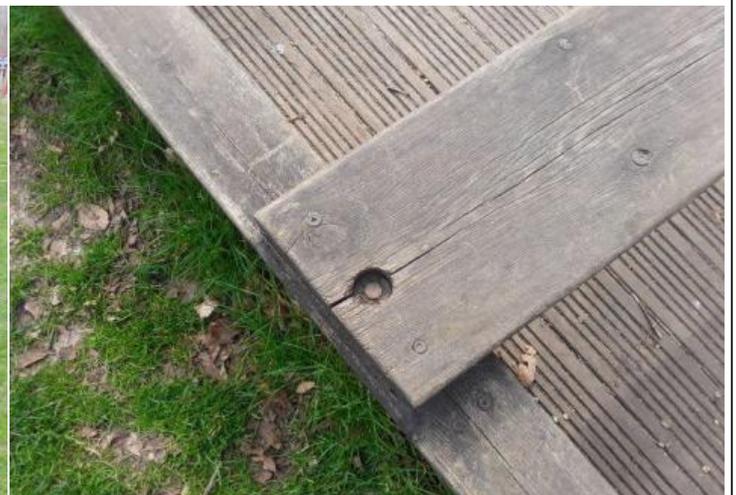
Finding: There is/are bolt cap covers missing or damaged on the item

Action: Replace missing or damaged bolt cap covers

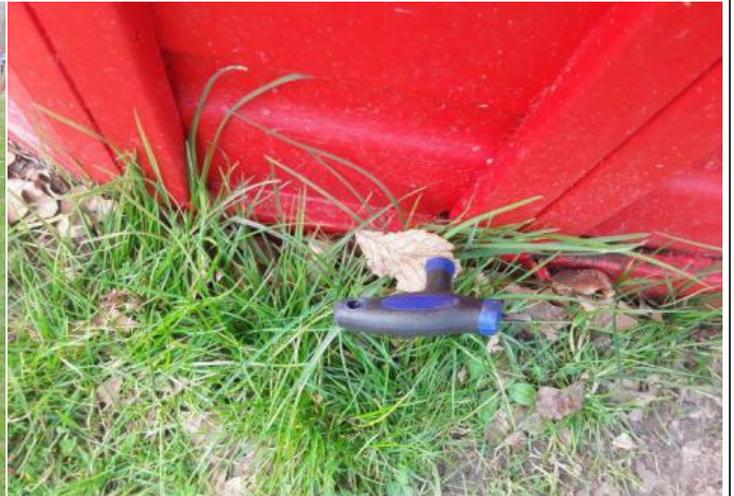
Finding: There are areas or parts of the timber on the structure that have rotted

Action: Replace all affected timbers

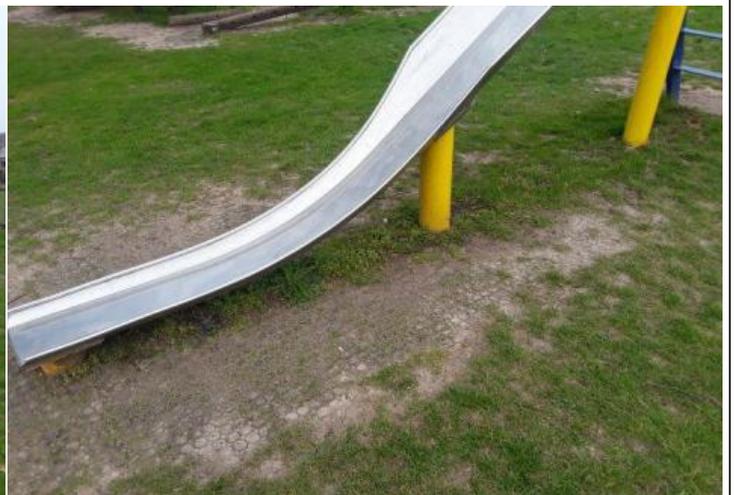
Finding: The grass mats are silted up and the soil is compacted; this may have an effect on the impact absorbing properties of the surface

Action: Consider HIC testing impact absorbing properties to ensure the correct surface qualities are maintained for the equipment and replace as required

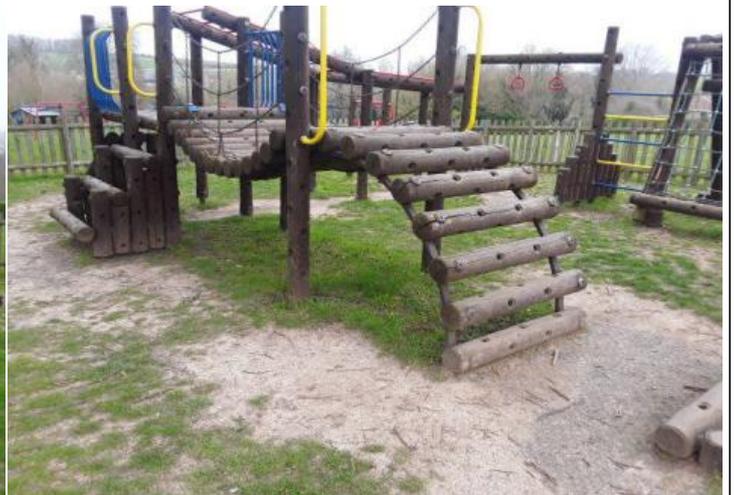
Finding: The grass mats are silted up and the soil is compacted; this may have an effect on the impact absorbing properties of the surface

Action: Consider HIC testing impact absorbing properties to ensure the correct surface qualities are maintained for the equipment and replace as required

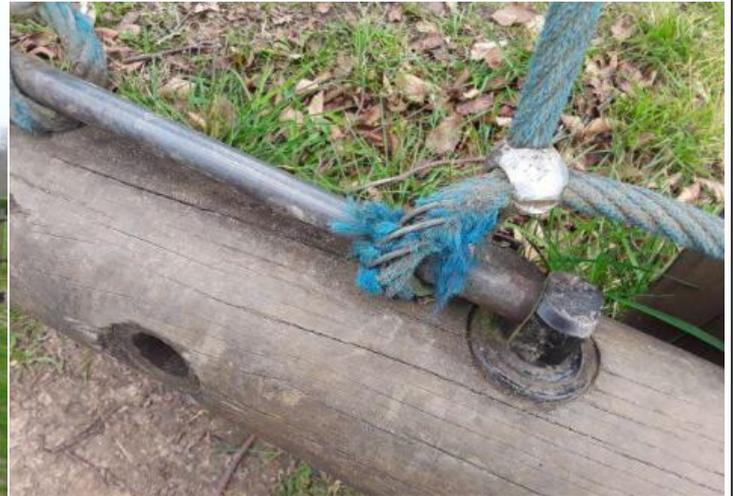
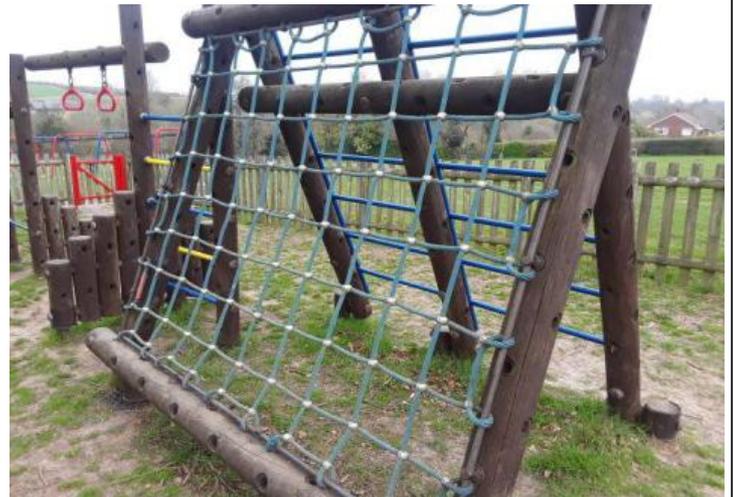
Finding: The rope has worn and wire strands are exposed

Action: Replace rope or net

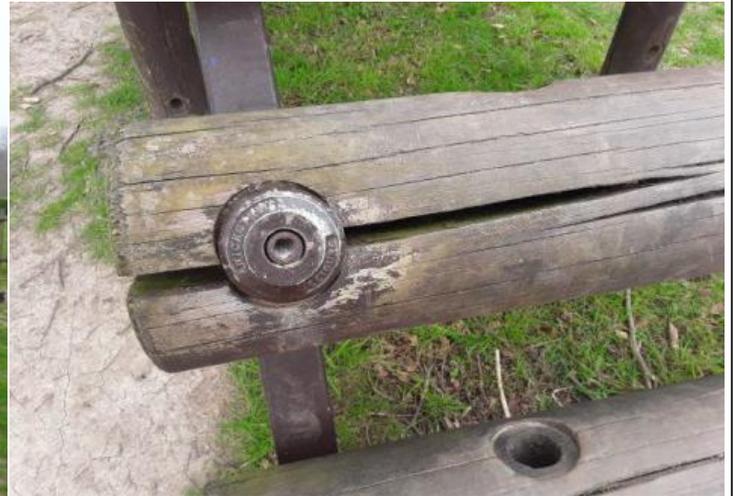
The timber has a number of splits/shakes or air cracks and this may affect the stability or allow water ingress which will accelerate the rotting process - Monitor to ensure the splits do not cross through fixing points of the structure and/or cause any instability

Finding: The timber has a number of splits/shakes or air cracks and this may affect the stability or allow water ingress which will accelerate the rotting process
Action: Monitor to ensure the splits do not cross through fixing points of the structure and/or cause any instability

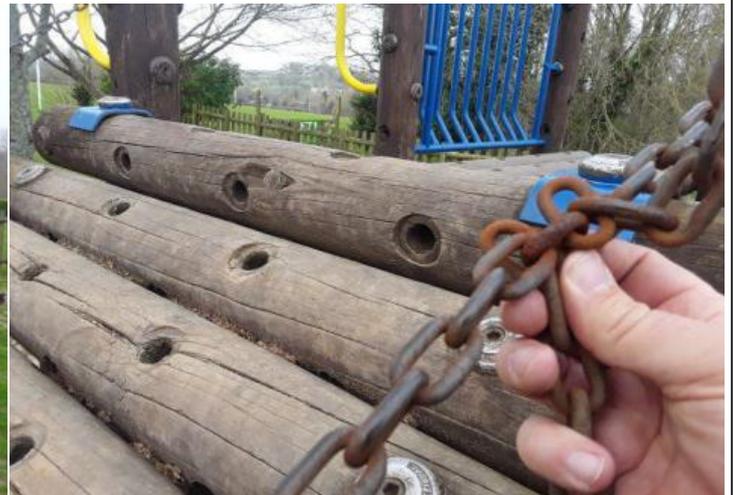
Finding: There is some notable evidence of chain wear
Action: Monitor for any further deterioration and replace when 40% worn

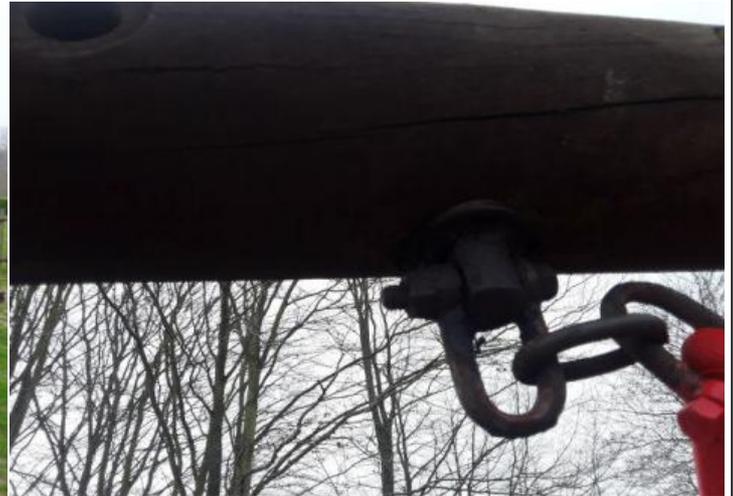
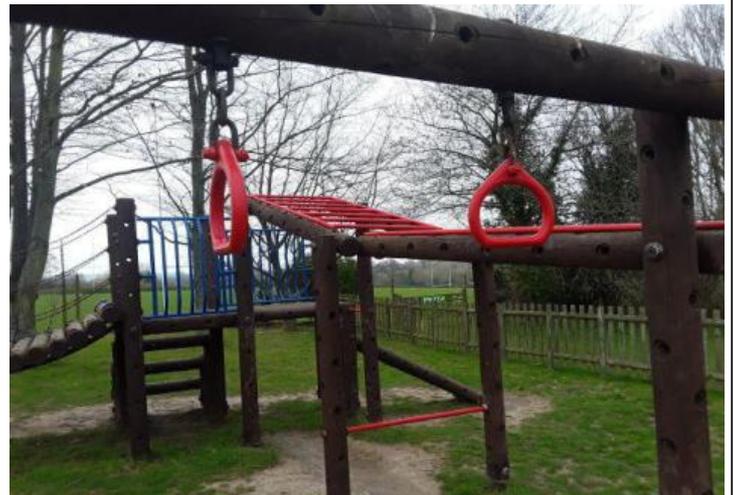
There is some wear to the trapeze ring shackles. - Monitor for any further deterioration and replace when 40% worn

Finding: There is some wear to the trapeze ring shackles.

Action: Monitor for any further deterioration and replace when 40% worn

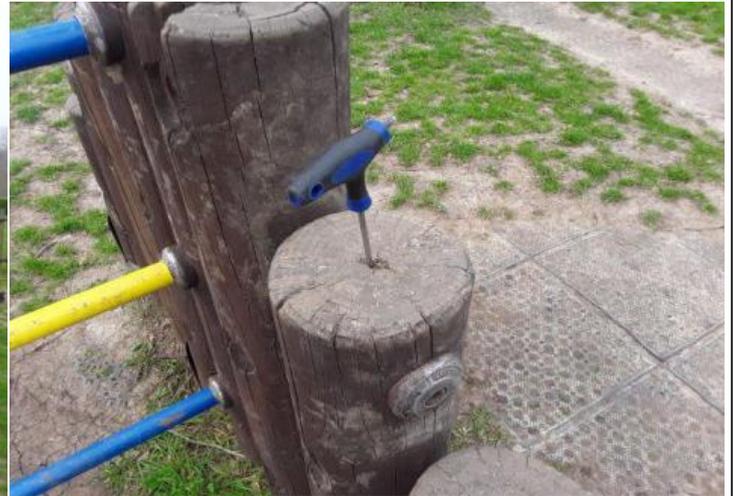
Finding: There is some evidence of rot in the timber

Action: Monitor for any further deterioration and replace as required

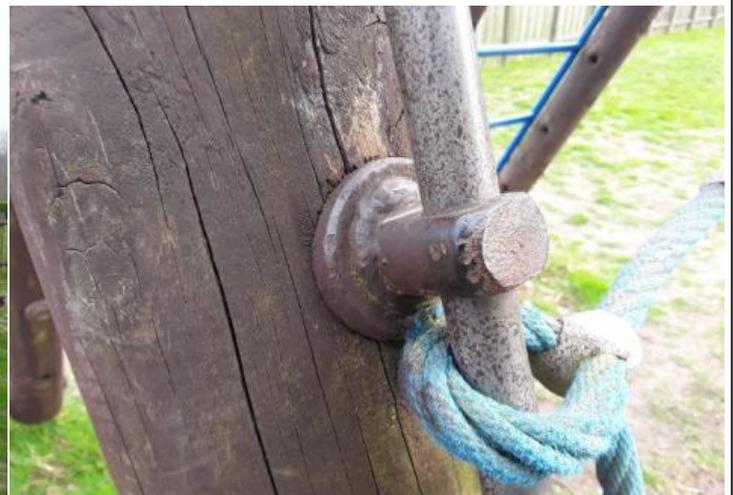
The paintwork on this item has been damaged or worn exposing the metal underneath which is rusting - Treat any rusting components and repaint

Finding: The paintwork on this item has been damaged or worn exposing the metal underneath which is rusting

Action: Treat any rusting components and repaint

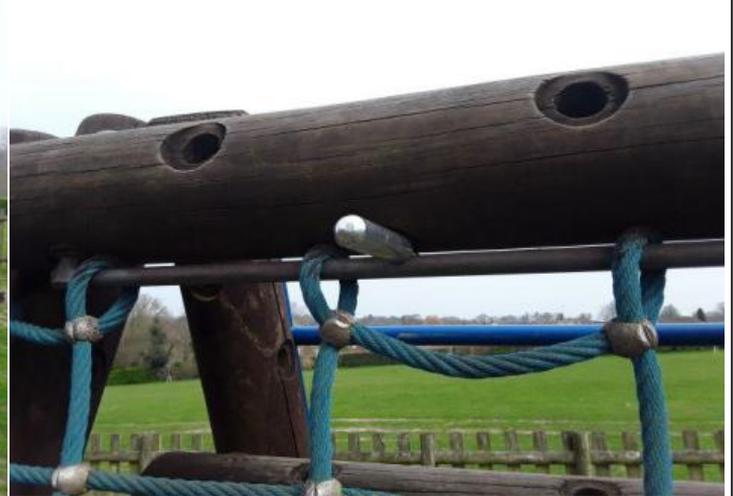
Finding: There is/are finger entrapment/s above the net climber and the item fails to meet the requirements of BS EN 1176 Part 1 4.2.7.6 Entrapment of fingers

Action: Monitor - No remedial work recommended

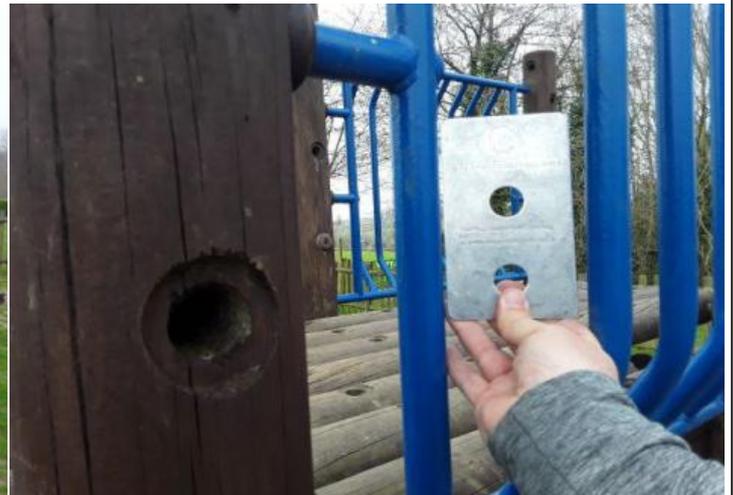
Finding: The item fails to meet the requirements of BS EN 1176 Part 1 4.2.7.2 head and neck entrapment in the barriers and/or steps

Action: Monitor - No remedial work recommended

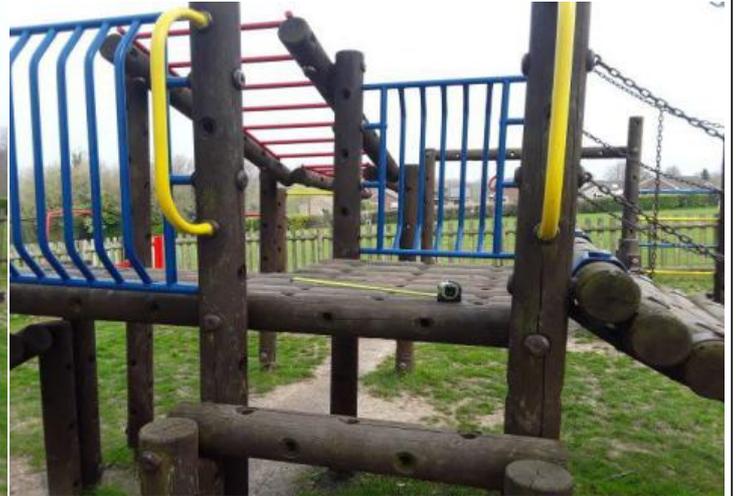
Finding: There is an opening to a play element exceeding the width allowed (500mm) in BS EN 1176 4.2.4.3 (Guardrails) and no guardrail has been provided

Action: Monitor - No remedial work recommended

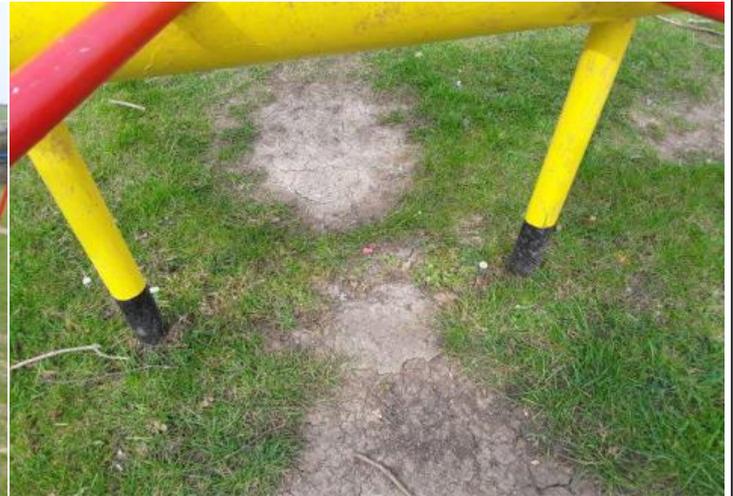
Finding: The surface has eroded and the foundations are exposed

Action: Reinstate surrounding surfaces to cover the foundations

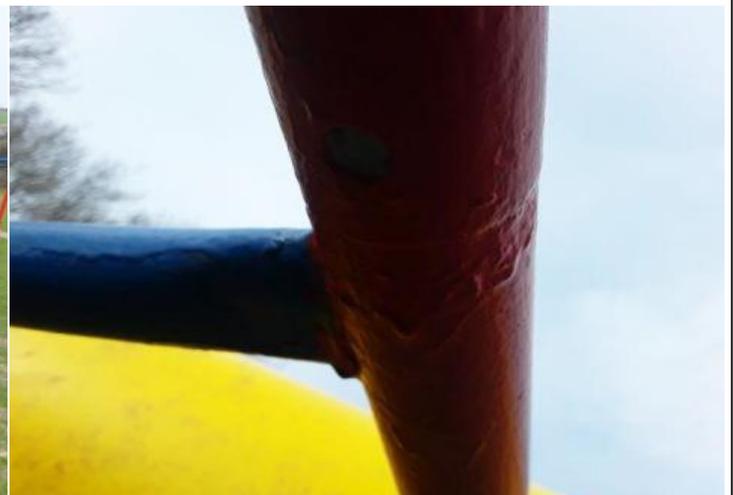
Finding: There are missing framework fixings

Action: Replace all missing fixings

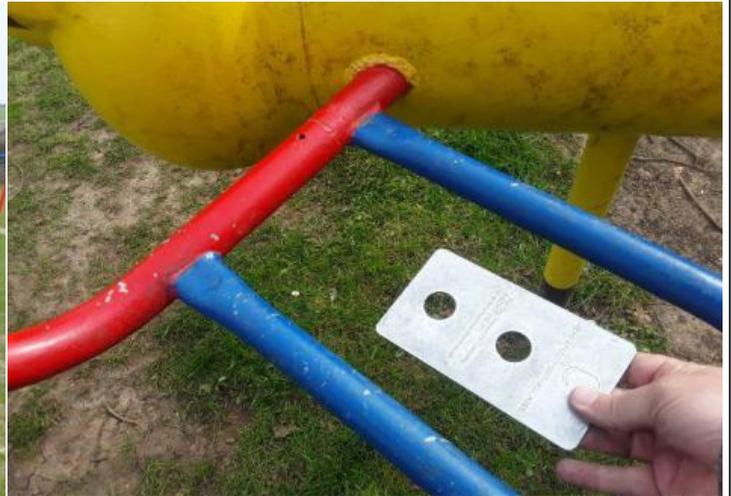
Finding: The item fails to meet the requirements of BS EN 1176 Part 1 4.2.7.2 for head and neck entrapment in the framework

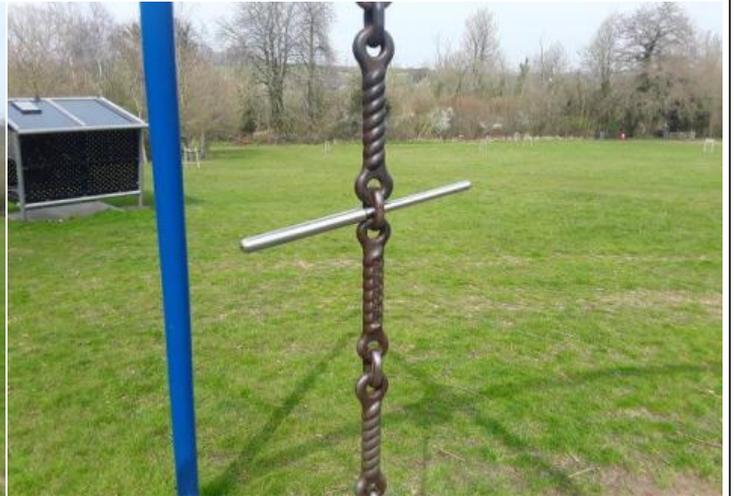
The chain openings are in excess of the 8.6mm as recommended by BS EN 1176 - Monitor - No remedial work recommended

Finding: The chain openings are in excess of the 8.6mm as recommended by BS EN 1176
Action: Monitor - No remedial work recommended

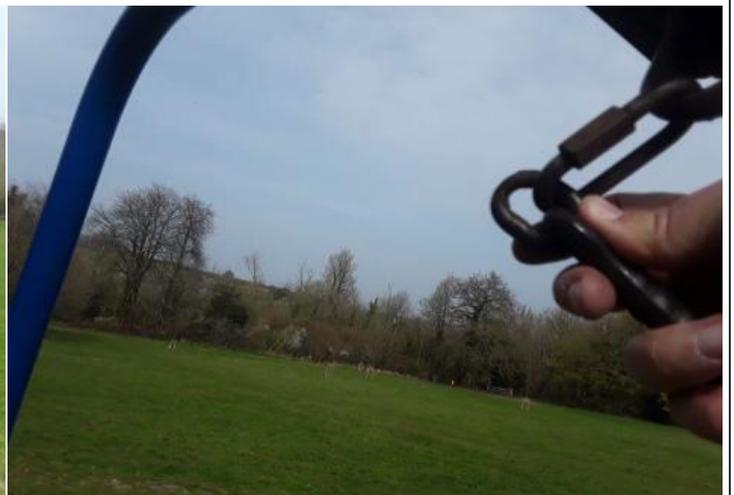
There is some notable evidence of chain wear - Monitor for any further deterioration and replace when 40% worn

Finding: There is some notable evidence of chain wear
Action: Monitor for any further deterioration and replace when 40% worn

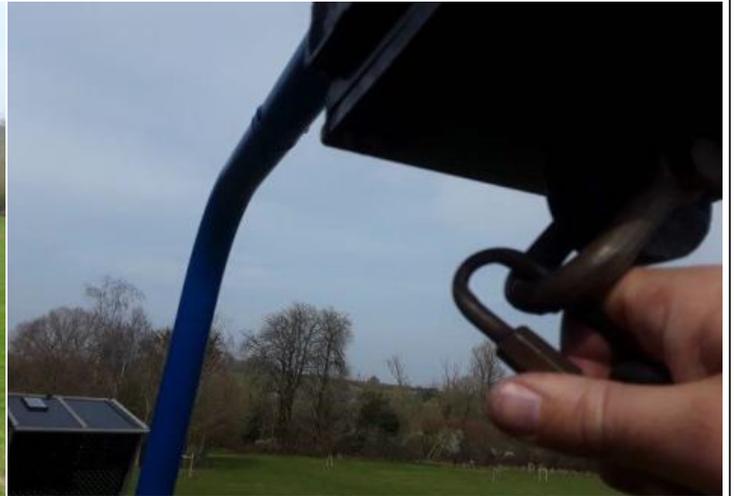
There is some wear to the connecting links - Monitor for any further deterioration and replace when 40% worn

Finding: There is some notable wear to the connecting links **Action:** Monitor for any further deterioration and replace when 40% worn

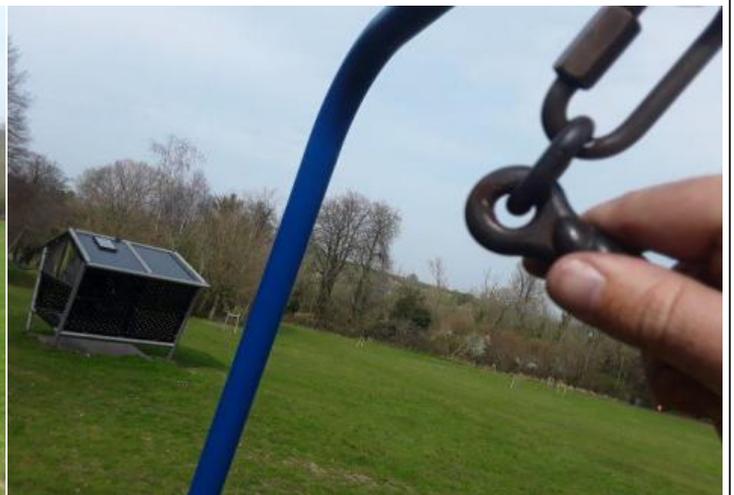
There is some wear to the chain bars - Monitor for any further deterioration and replace when 40% worn

Finding: There is some wear to the chain bars **Action:** Monitor for any further deterioration and replace when 40% worn

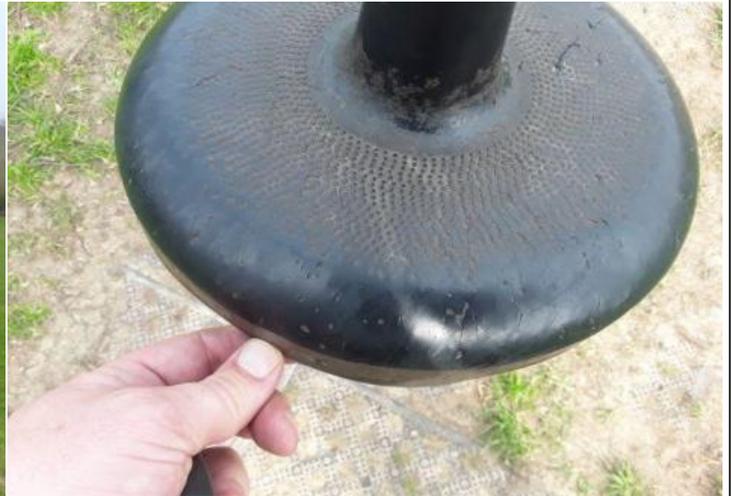
Finding: The seat has been damaged

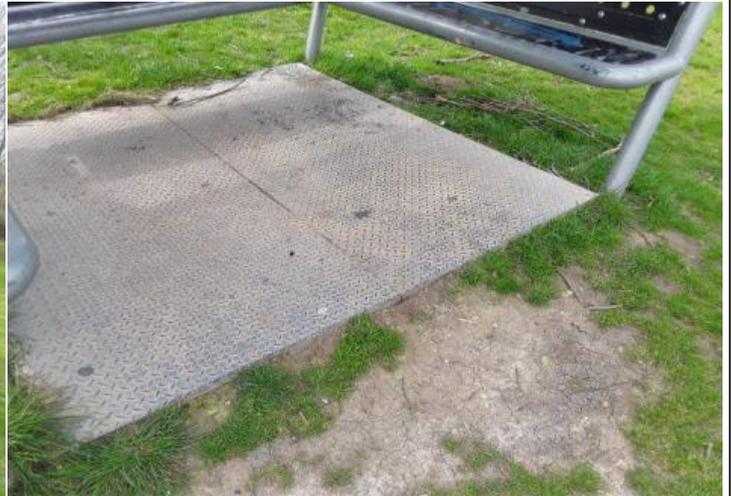
Finding: There are trip hazards at the edges of the surface

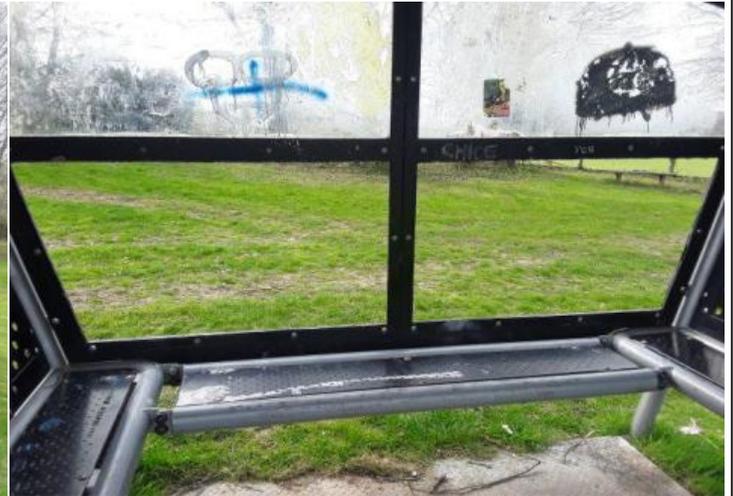
Finding: The item has missing component(s)

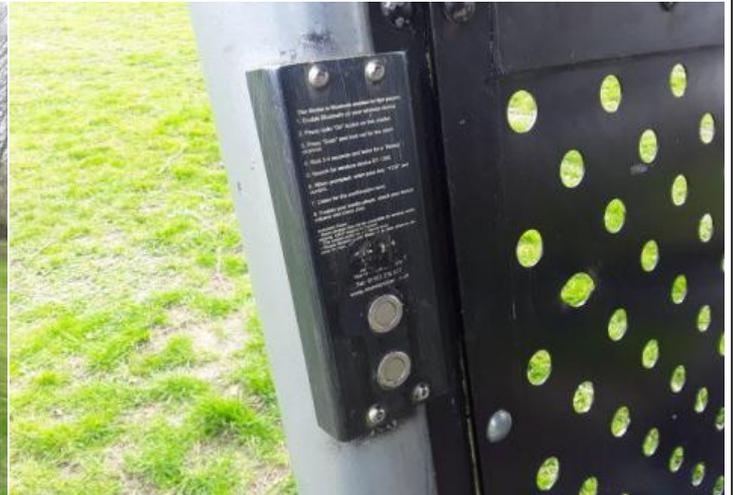
Finding: The item is not operating correctly

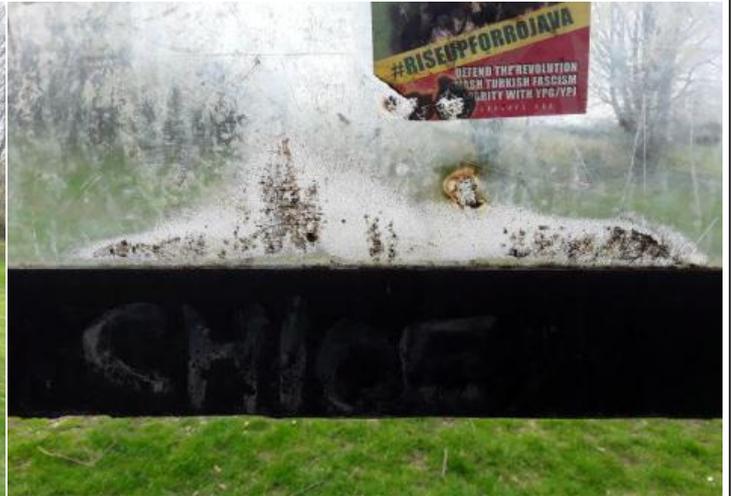
Finding: There is some evidence of fire damage to the item **Action:** Monitor for any further deterioration and repair as required

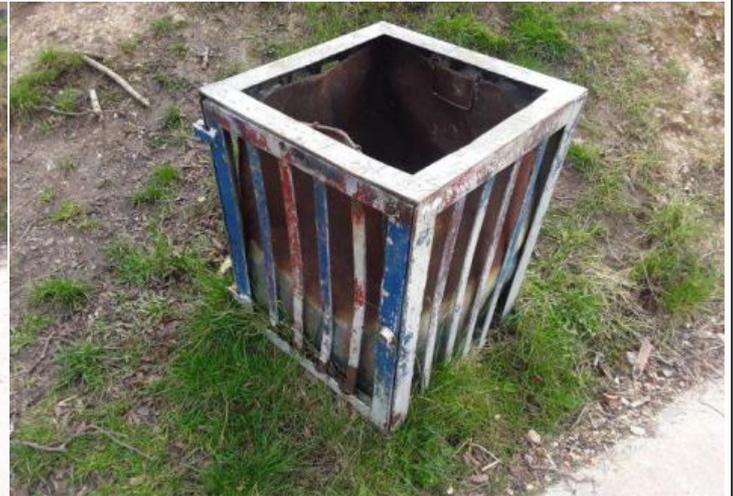
Finding: The bin is damaged
