the **play** inspection company

Annual Inspection

Winchester City Council

Arlebury Park, Skate Park & Tennis(New Alresford)

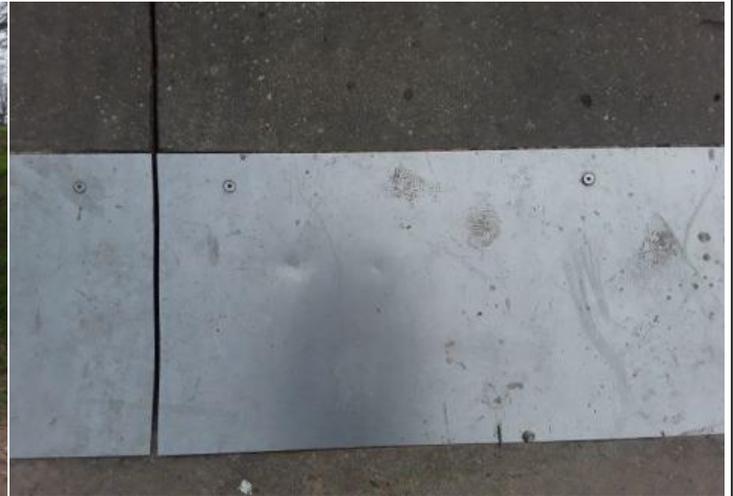
Finding: A number of fixing(s) have worked loose

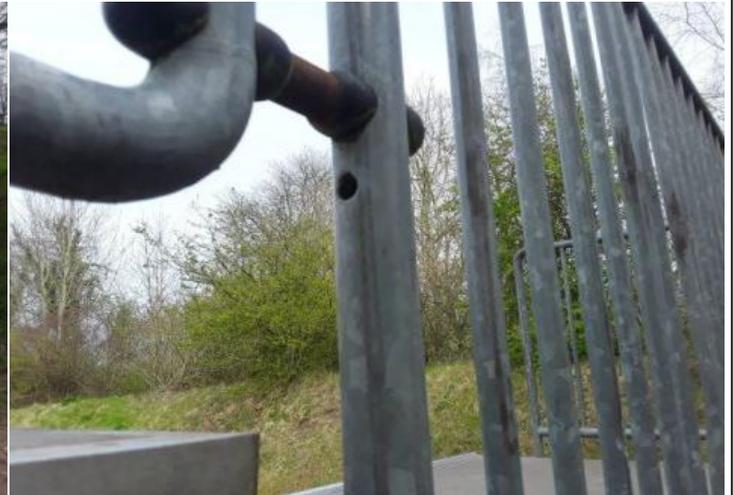
Finding: There is/are several inserts missing

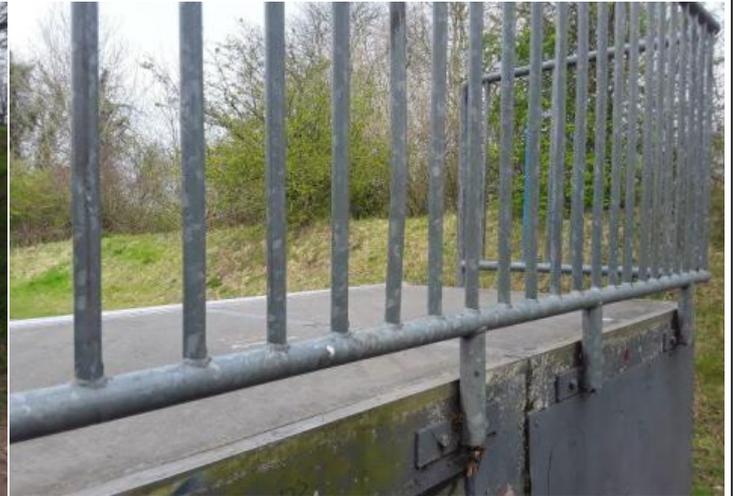
Finding: There is some damage to the barrier sections

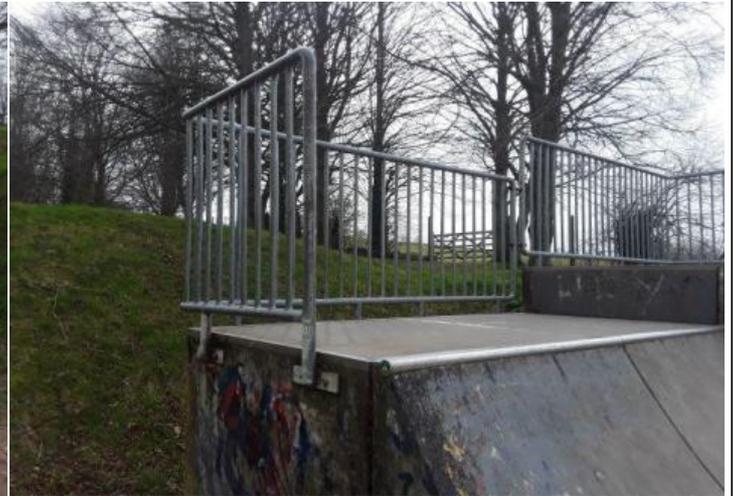
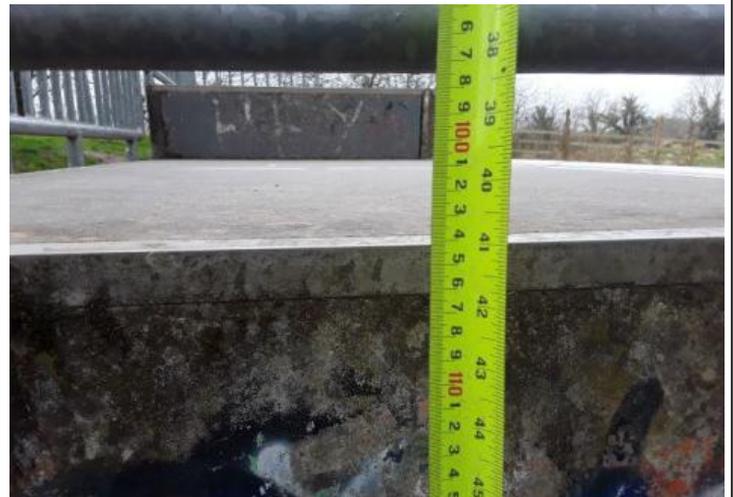
Finding: The height of the barrier is less than 1200mm and fails the requirements of BS EN 14974

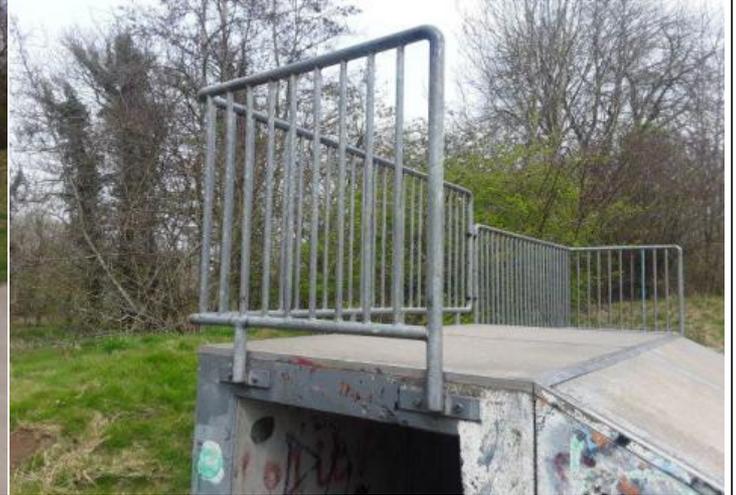
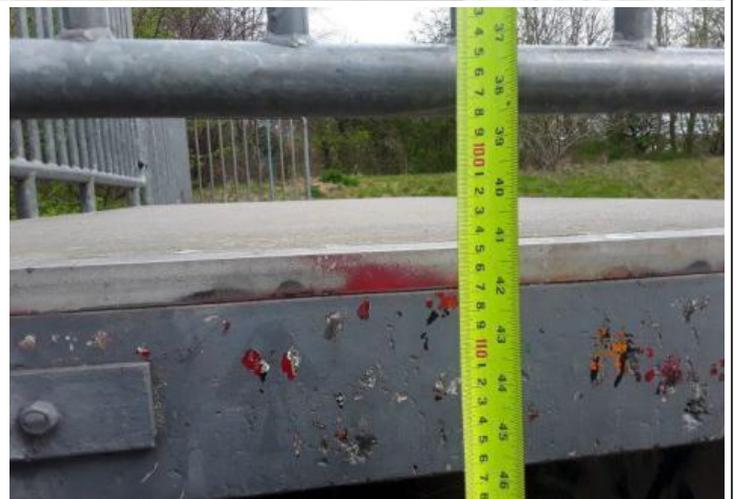
Finding: The height of the barrier is less than 1200mm and fails the requirements of BS EN 14974

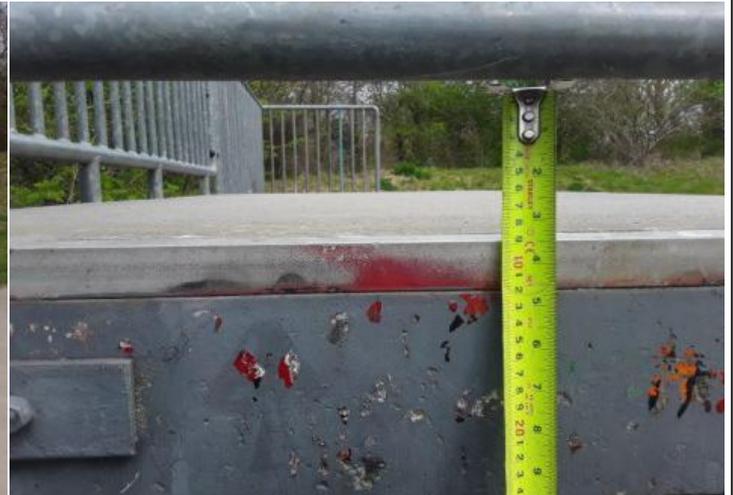
Finding: The gap between the underside of the barrier and the platform is in excess of 60mm and fails the requirements of BS EN 14974
Action: Monitor - No remedial work recommended

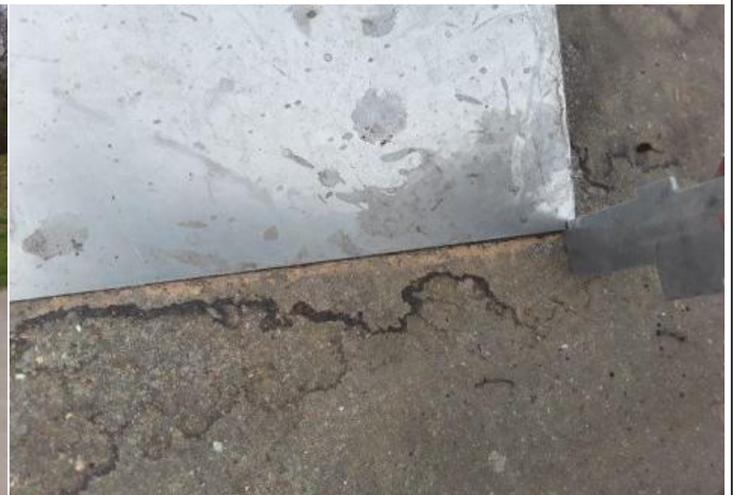
Finding: The kicker plate protrudes more than 5mm above the surrounding surface level, BS EN 14974 recommends a maximum of 5mm with 3mm preferred
Action: Adjust height to ensure a maximum of 5mm change in level

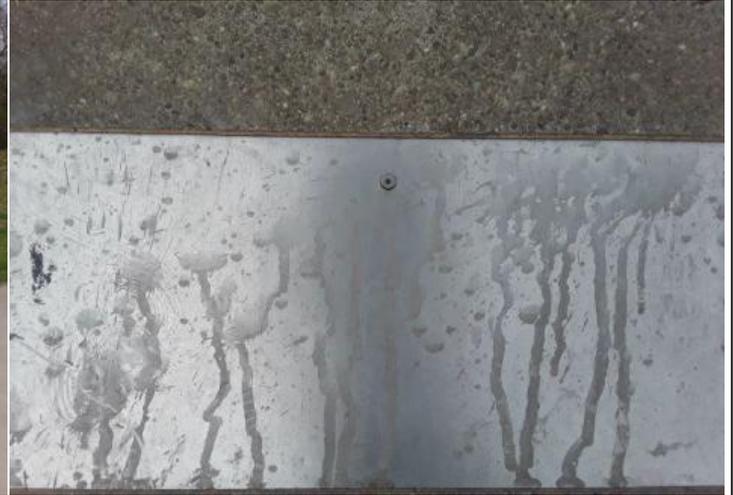
Finding: A number of fixing(s) have worked loose

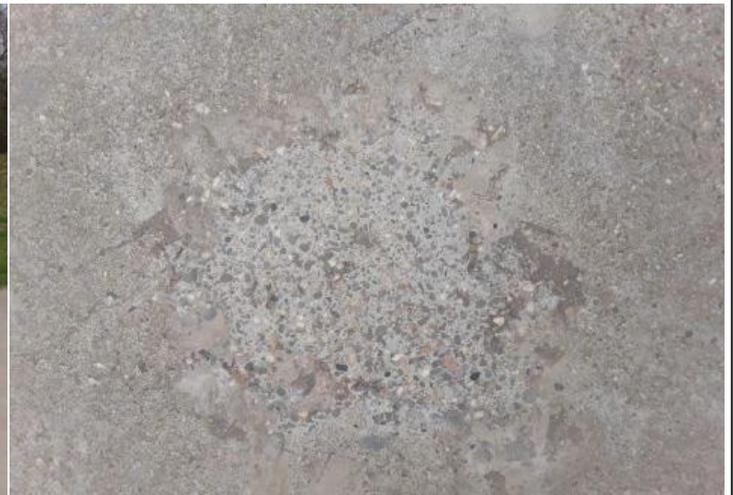
Finding: The riding surface of the ramp has some damage apparent

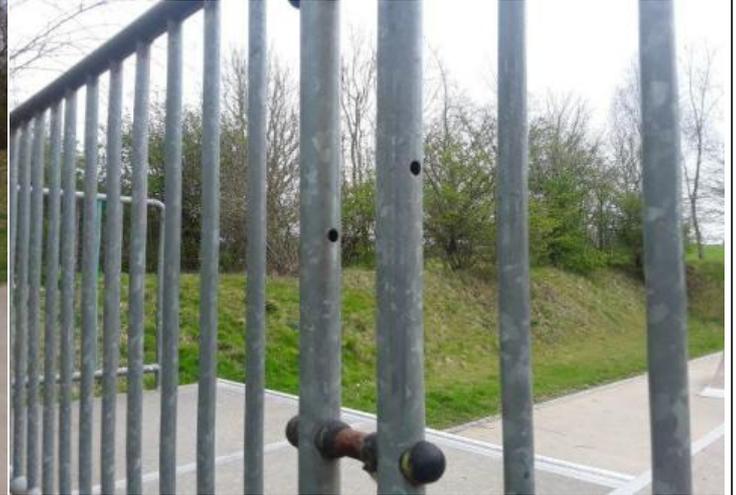
Finding: There is/are several inserts missing

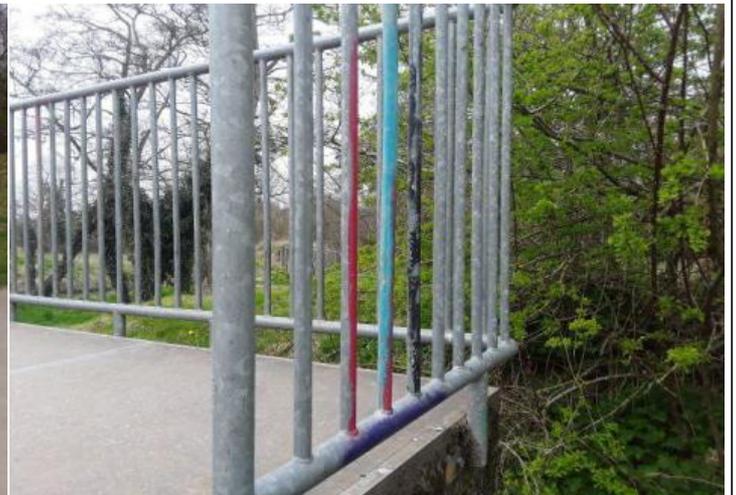
Finding: There is some damage to the barrier sections
