ASBESTOS SURVEY REPORT

Stratton Bates Recreation Ground
Alresford
Hampshire
SO24 9EP

March 2021

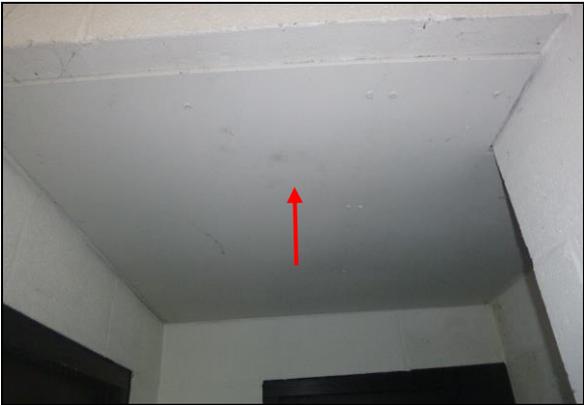
Room	GF.01 Lobby	Sample ID	S.01
Survey date	25.03.2021	Surveyor(s)	A. Whittle
Survey type	Management		L. Charman
Material location	Ceiling	Sampled	Yes
Internal / external	Internal	Product	Panelling
Asbestos type	None detected

Approx. amount	N/A		
Condition	N/A		
Surface treatment	N/A		
Vulnerability	N/A		
Exposure population	N/A		
Comments	Panel to the ceiling was not found to contain asbestos		
Risk rating	N/A		
Recommended action	None		
Recommended timescale	N/A

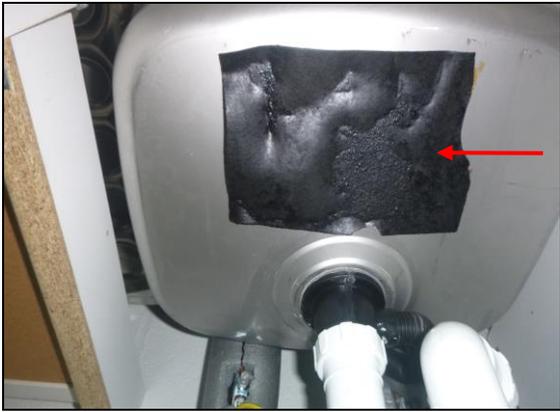
Room	GF.06 Kitchen area	Sample ID	S.02
Survey date	25.03.2021	Surveyor(s)	A. Whittle
Survey type	Management		L. Charman
Material location	Sink	Sampled	Yes
Internal / external	Internal	Product	Bitumen
Asbestos type	None detected

Approx. amount	N/A		
Condition	N/A		
Surface treatment	N/A		
Vulnerability	N/A		
Exposure population	N/A		
Comments	Bitumen, to the underside of the sink bowl was not found to contain asbestos		
Risk rating	N/A		
Recommended action	None		
Recommended timescale	N/A
