the play inspection company

Post Installation Report

Stratton Bates Rec

Inspection Ref: 1723632

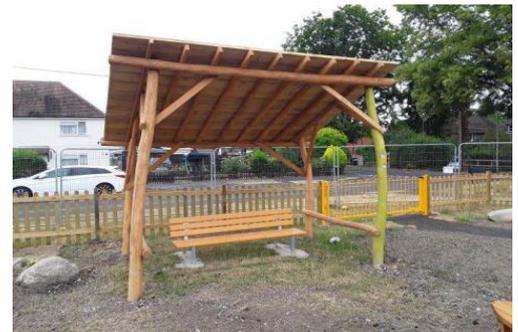
The foundations are exposed - Reinstate surrounding surfaces to cover the foundations

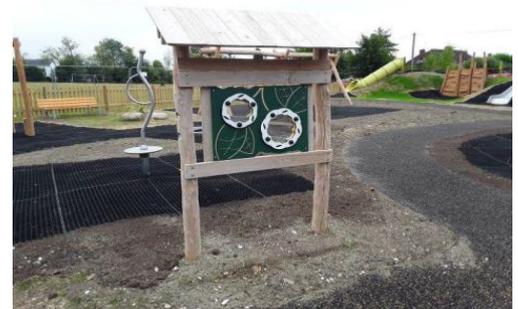
The item fails to meet the requirements of BS EN 1176 Part 1 4.2.7.2 for head and neck entrapment in the framework - Refer to contractor

There is/are finger entrapment/s in the framework and the item fails to meet the requirements of BS EN 1176 Part 1 4.2.7.6 Entrapment of fingers - Refer to contractor

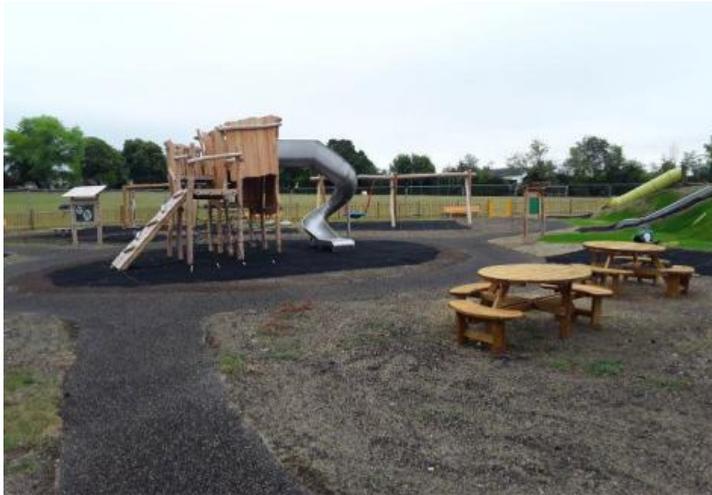
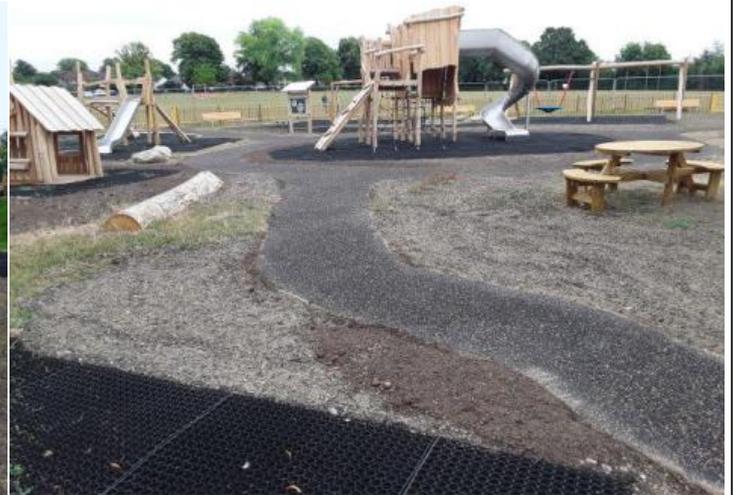
Item: Ancillary Items - Site General
Manufacturer: Owner/Operator

Finding: The surface is not established in some areas

Action: Monitor establishment of the surfaces

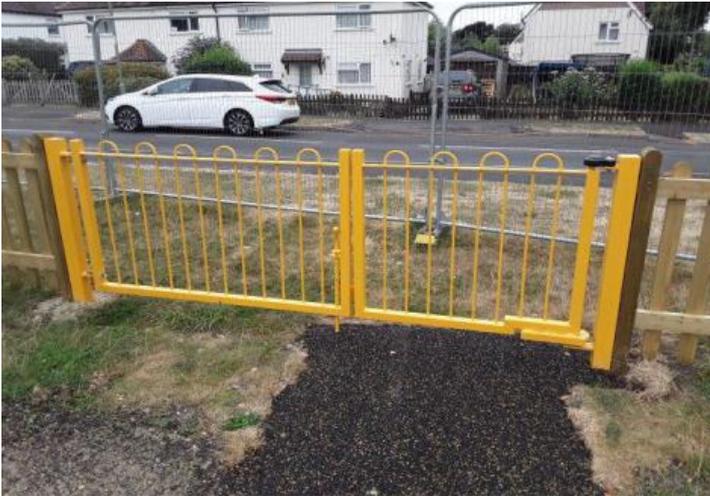
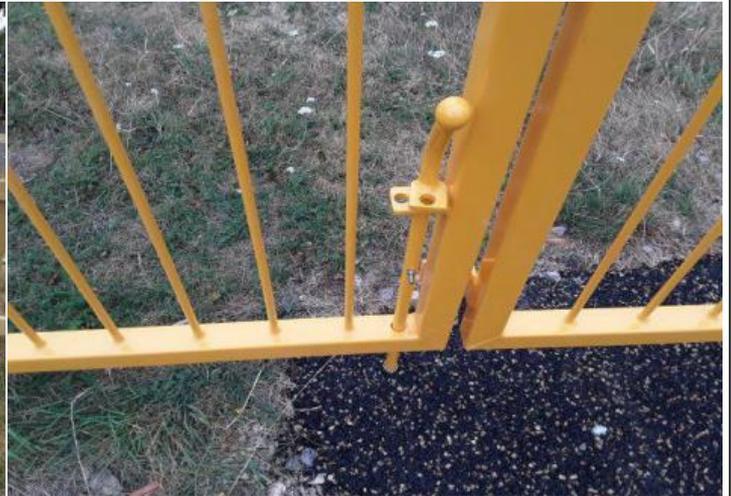
Item: Gates - Gate - Combination
Manufacturer: I.A.E. Fencing

Finding: There is no padlock on the maintenance gate

Action: Provide a padlock to secure the gate

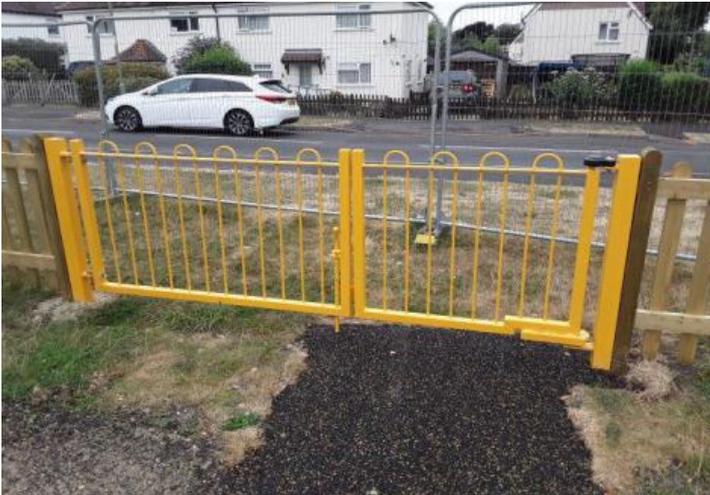
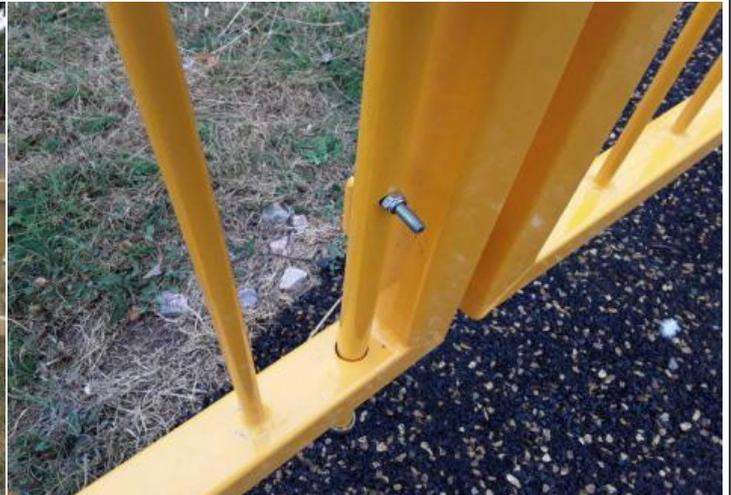
Item: Gates - Gate - Combination
Manufacturer: I.A.E. Fencing

Finding: There are projecting bolt thread(s) present

Action: Remove excess thread length and deburr or provide cap

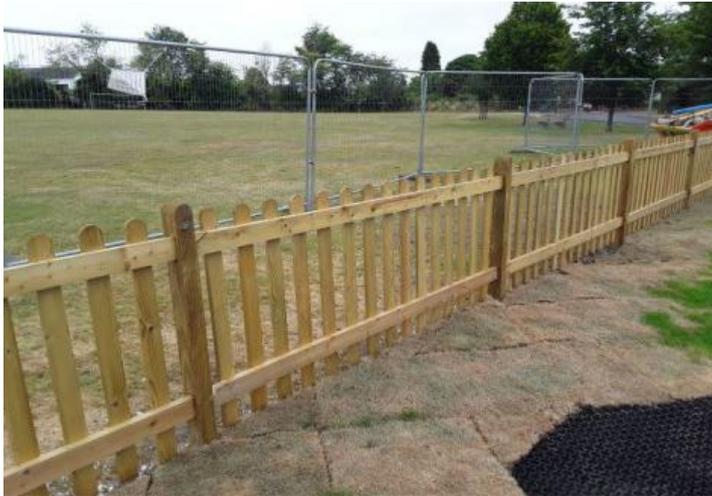
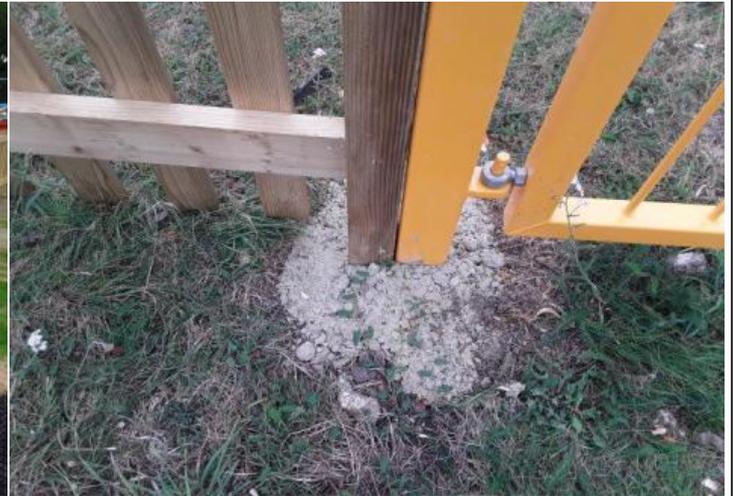
Item: Fences - Fencing - Timber
Manufacturer: Jacksons Fencing

Finding: The foundations are exposed

Action: Reinstate surrounding surfaces to cover the foundations

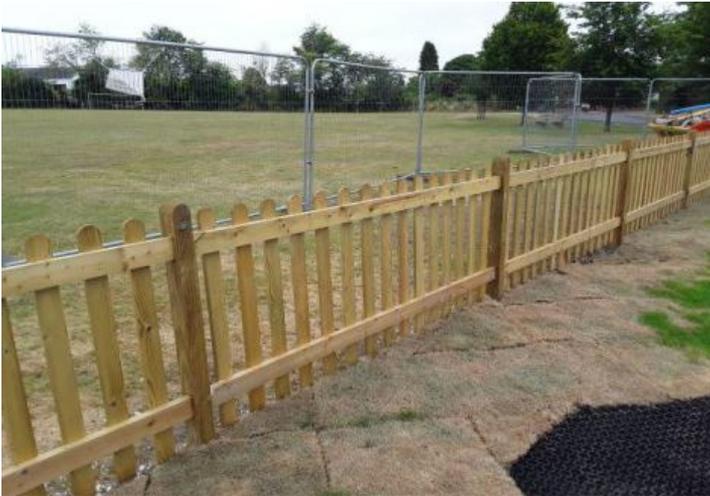
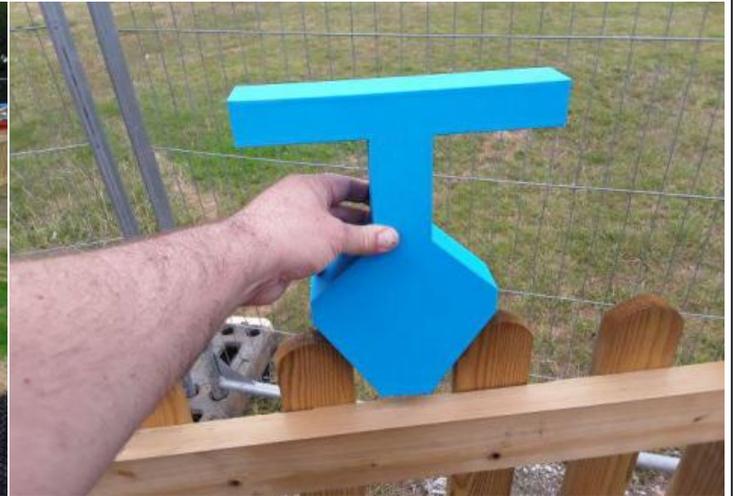
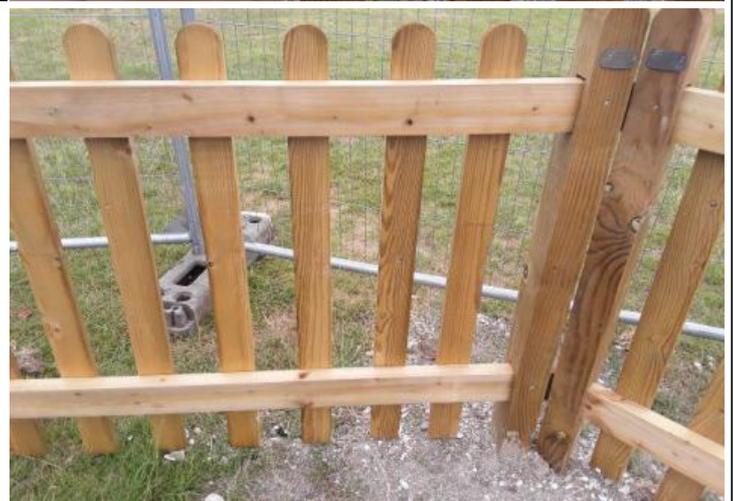
Item: Fences - Fencing - Timber
Manufacturer: Jacksons Fencing

Finding: There are head and neck entrapments in the fencing

Action: Refer to contractor

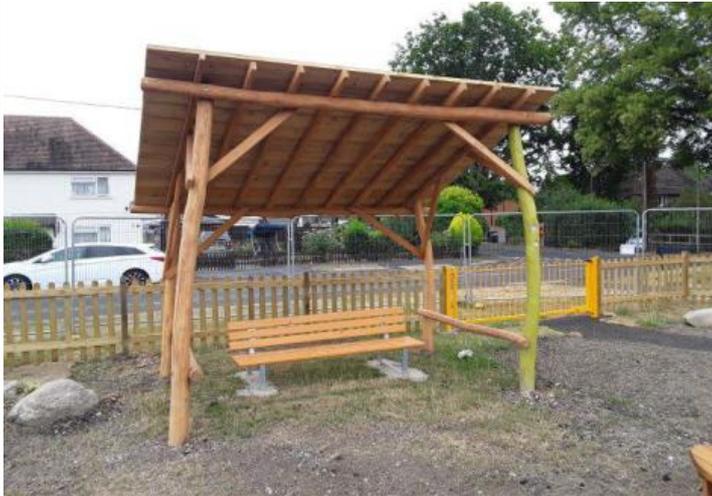
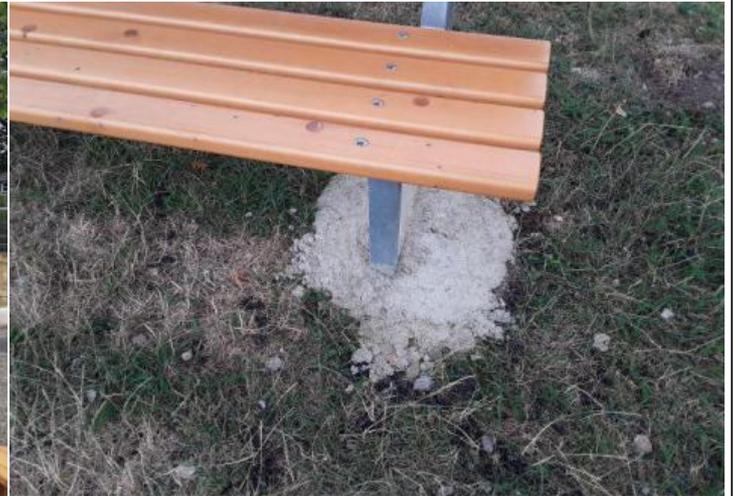
Item: Ancillary Items - Shelter
Manufacturer: Eibe Play Ltd

Finding: The foundations are exposed

Action: Reinstate surrounding surfaces to cover the foundations

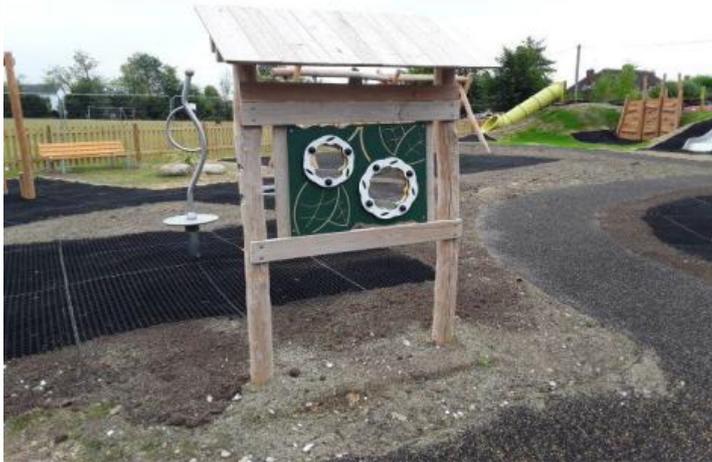
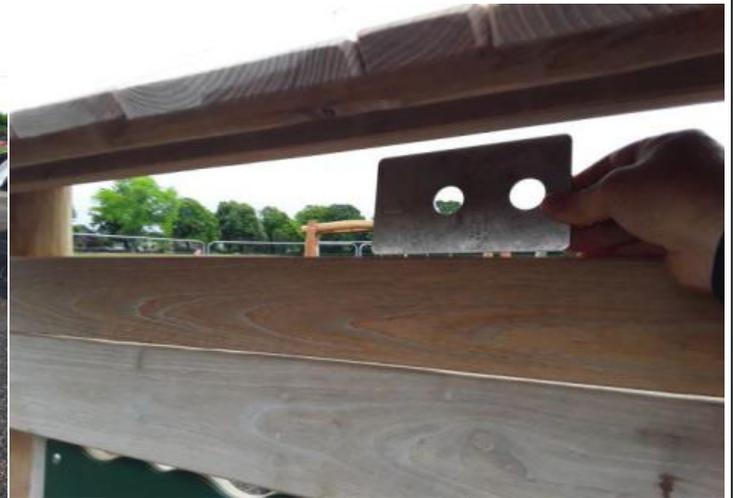
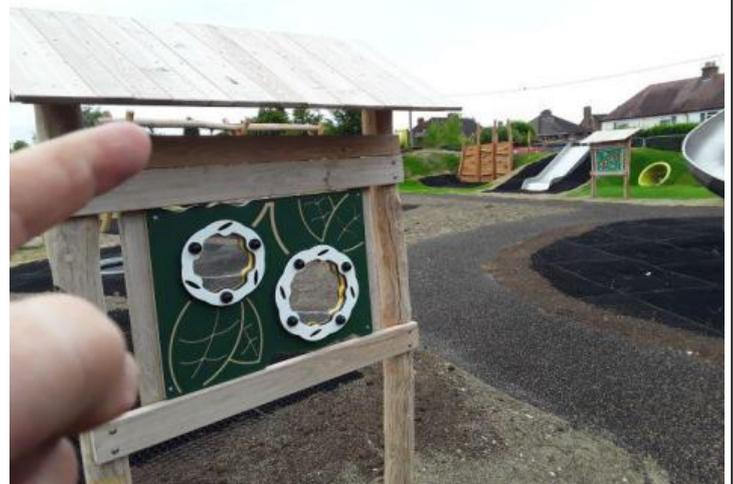
Item: Other - Play Panel
Manufacturer: Eibe Play Ltd

Finding: The item fails to meet the requirements of BS EN 1176 Part 1 4.2.7.2 for head and neck entrapment in the framework

Action: Refer to contractor

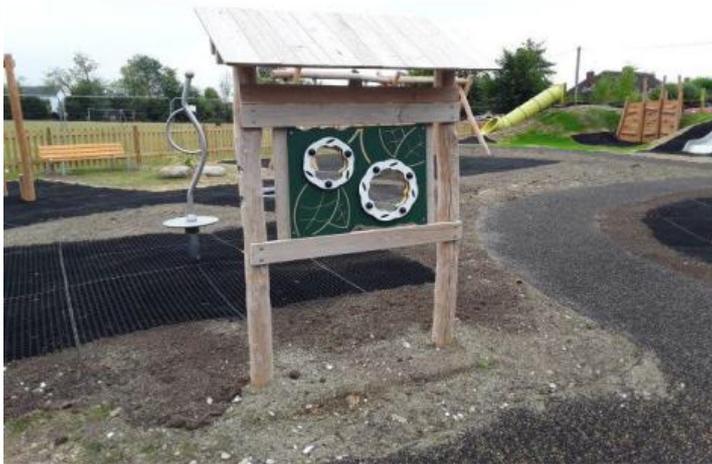
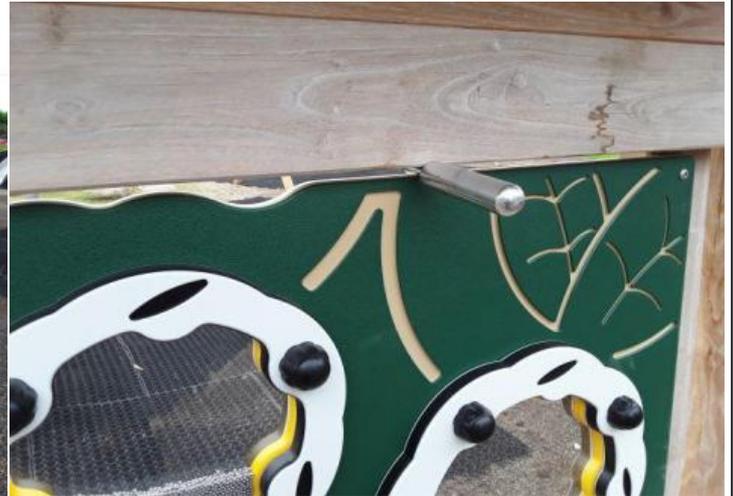
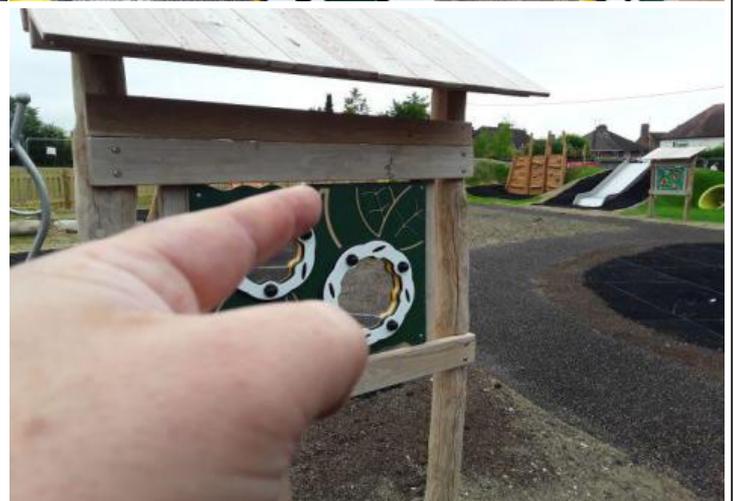
Item: Other - Play Panel
Manufacturer: Eibe Play Ltd

Finding: There is/are finger entrapment/s in the framework and the item fails to meet the requirements of BS EN 1176 Part 1 4.2.7.6 Entrapment of fingers

Action: Refer to contractor

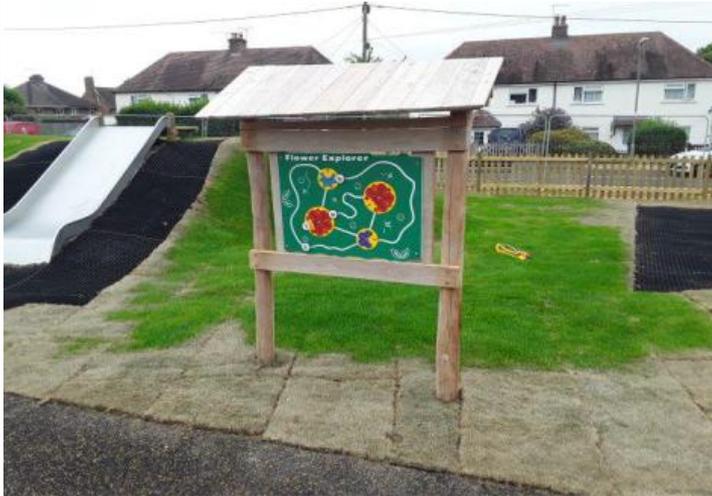
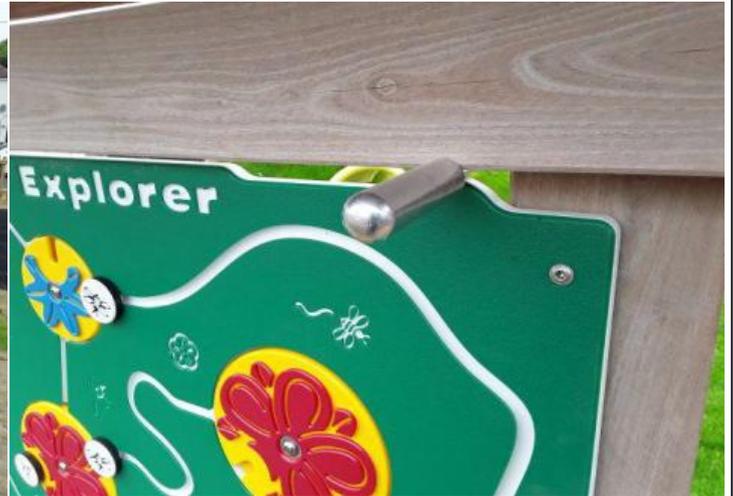
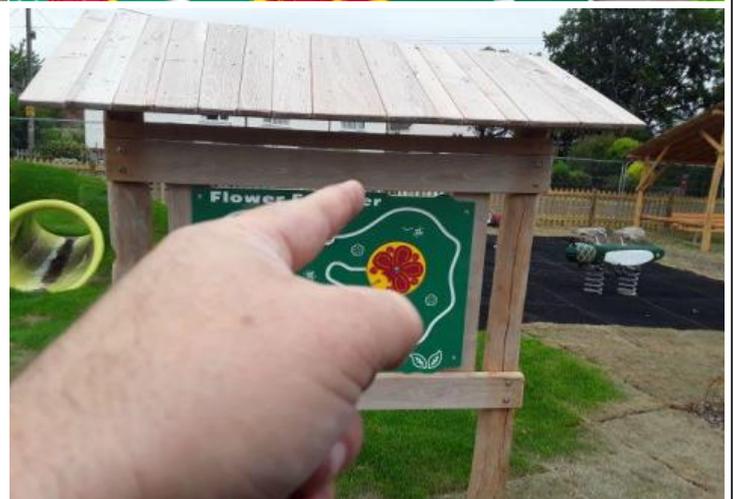
Item: Other - Play Panel
Manufacturer: Eibe Play Ltd

Finding: There is/are finger entrapment/s in the framework and the item fails to meet the requirements of BS EN 1176 Part 1 4.2.7.6 Entrapment of fingers

Action: Refer to contractor

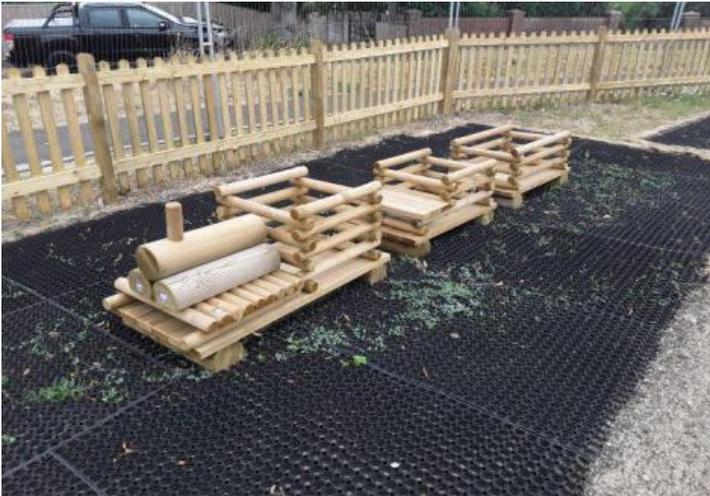
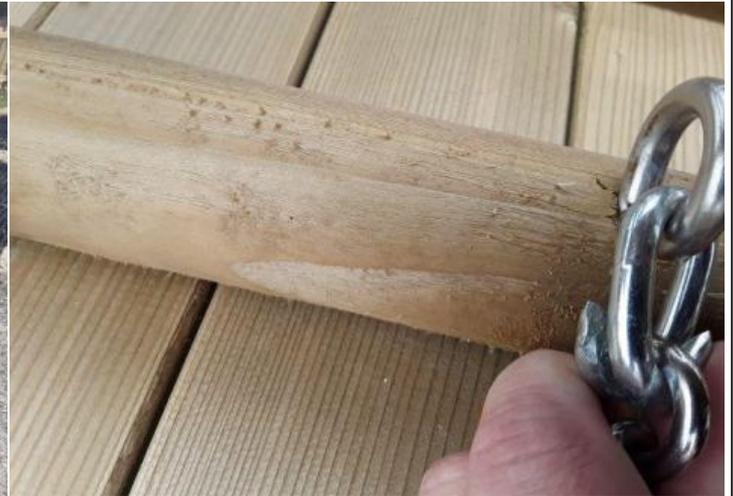
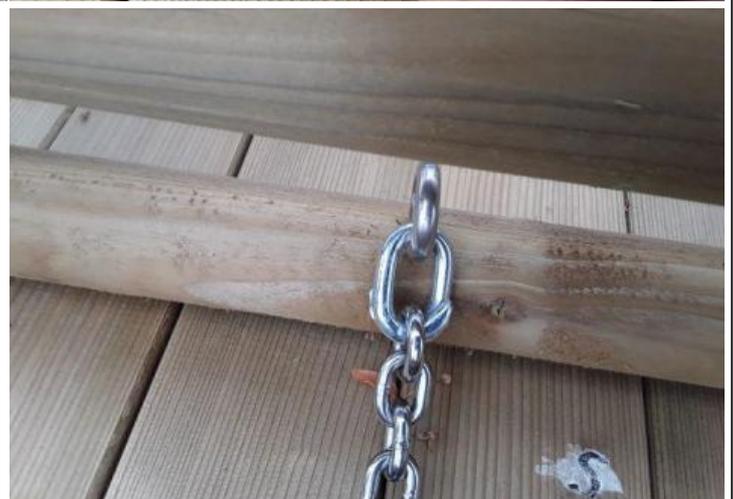
Item: Activity Equipment - Train
Manufacturer: Eibe Play Ltd

Finding: The shackles have sharp protruding edges

Action: Remove any rough or sharp edges

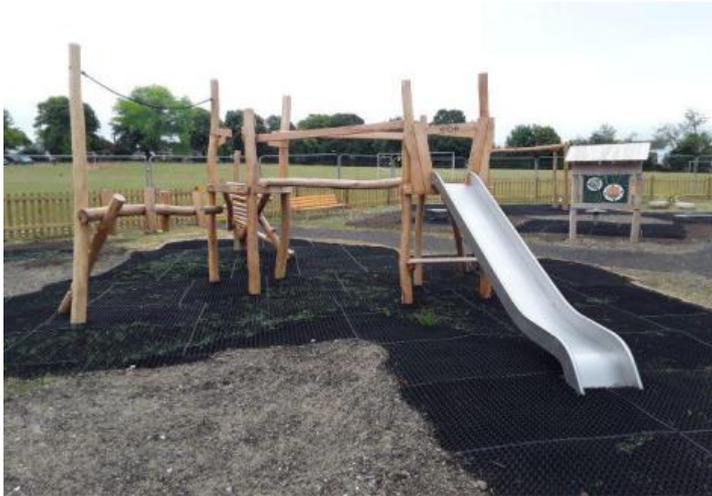
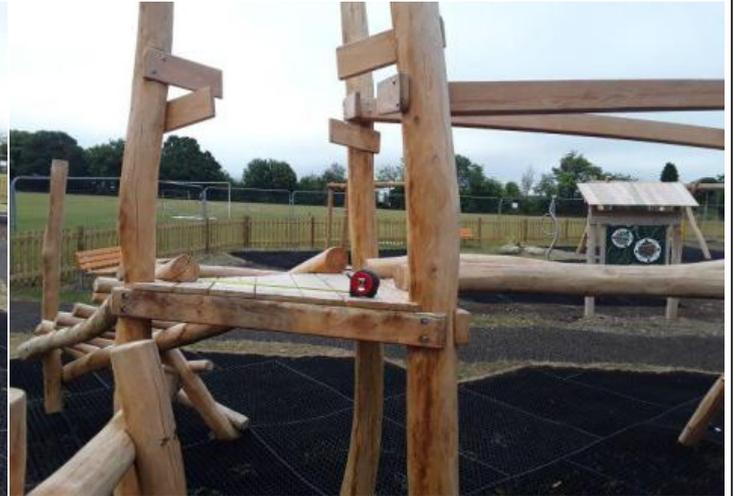
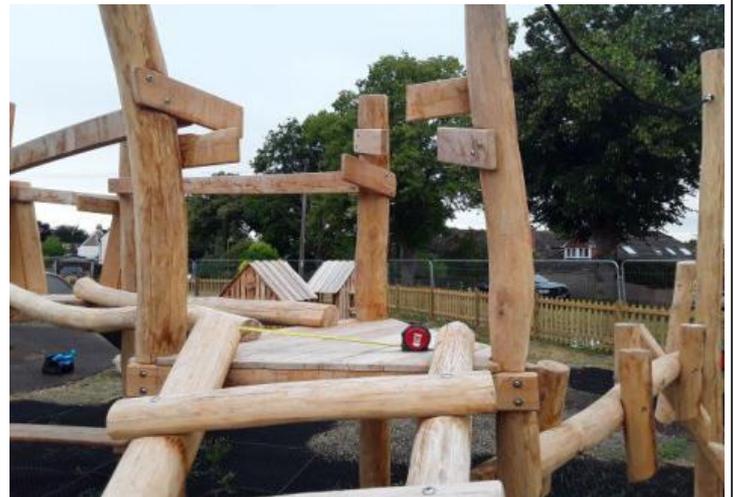
Item: Activity Equipment - Multi Play (Junior)
Manufacturer: Eibe Play Ltd

Finding: There is an opening to a play element exceeding the width allowed (500mm) in BS EN 1176 4.2.4.3 (Guardrails) and no guardrail has been provided

Action: Refer to contractor

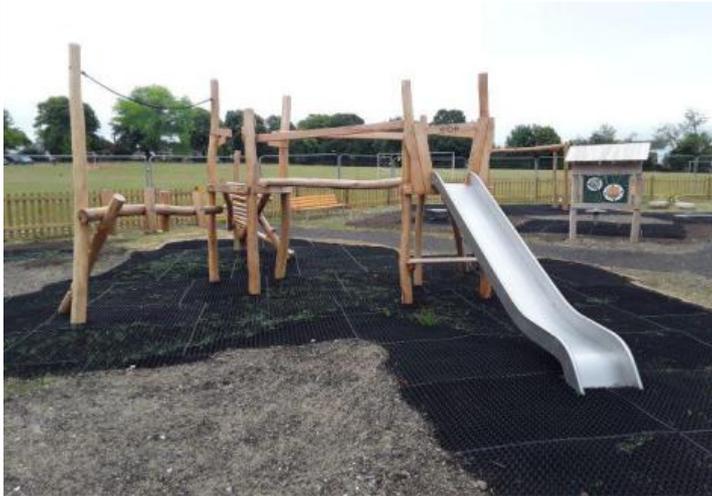
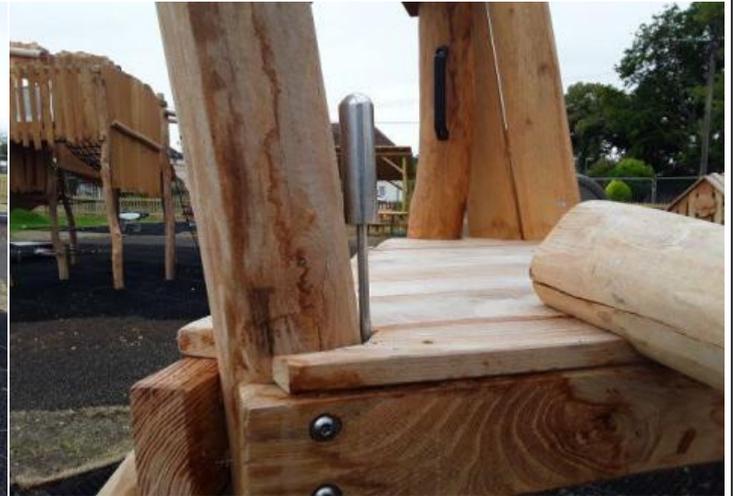
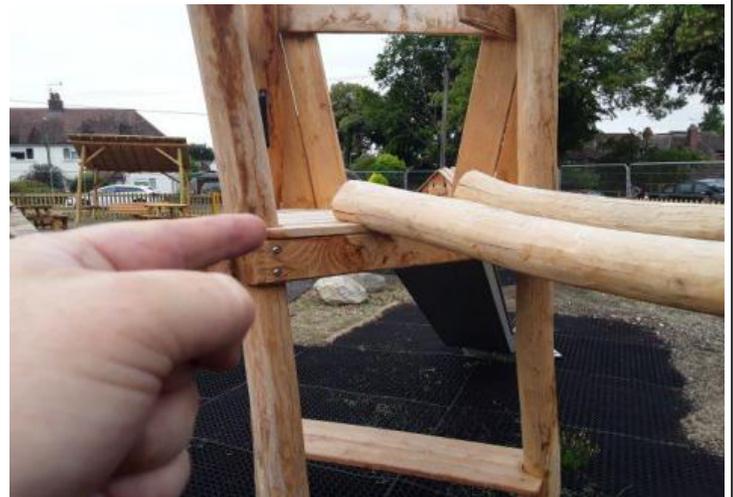
Item: Activity Equipment - Multi Play (Junior)
Manufacturer: Eibe Play Ltd

There is/are finger entrapment/s between platform and post and the item fails to meet the requirements of BS EN 1176 Part 1 4.2.7.6 Entrapment of fingers - Refer to contractor

Finding: There is/are finger entrapment/s between platform and post and the item fails to meet the requirements of BS EN 1176 Part 1 4.2.7.6 Entrapment of fingers

Action: Refer to contractor

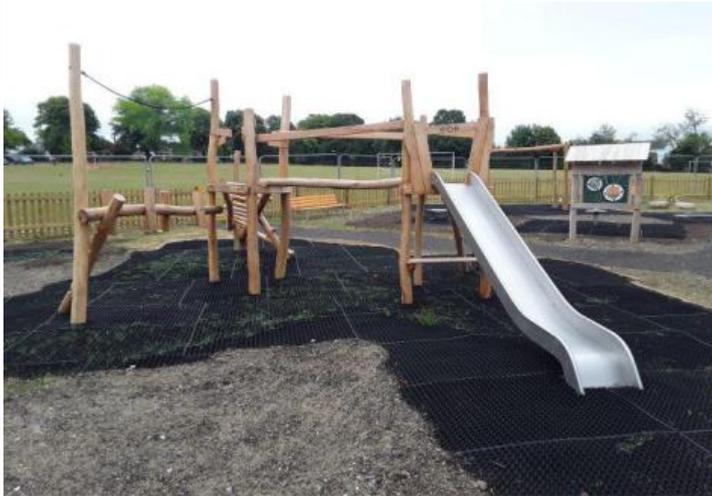
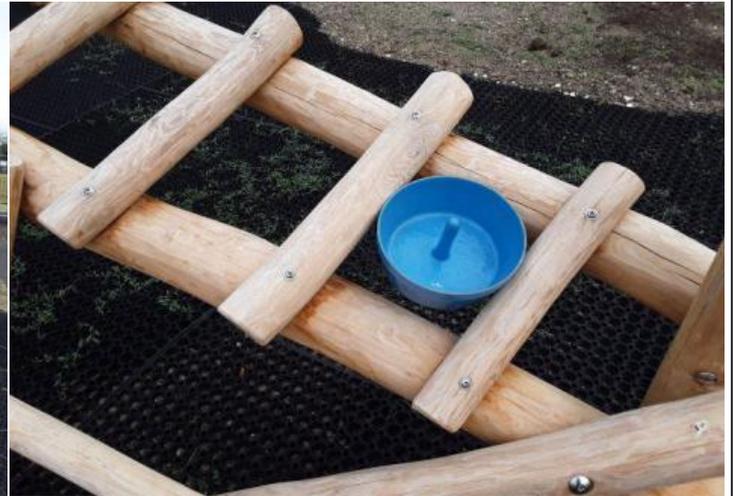
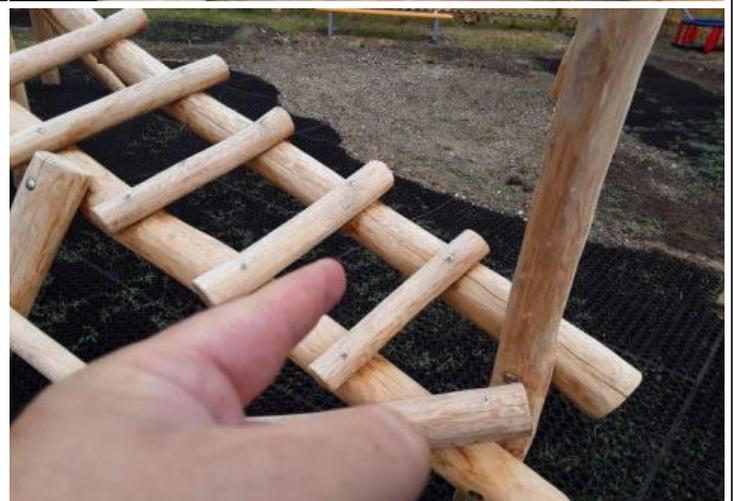
Item: Activity Equipment - Multi Play (Junior)
Manufacturer: Eibe Play Ltd

The item fails to meet the requirements of BS EN 1176 Part 1 4.2.7.2 for head and neck entrapment between the log climber - Refer to contractor

Finding: The item fails to meet the requirements of BS EN 1176 Part 1 4.2.7.2 for head and neck entrapment between the log climber

Action: Refer to contractor

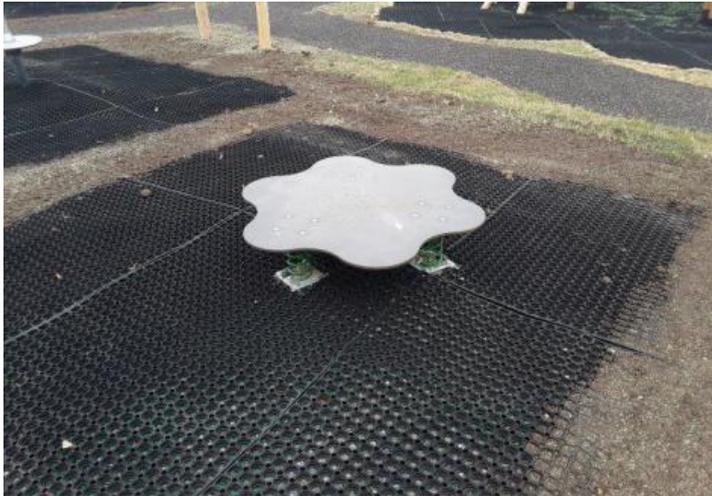
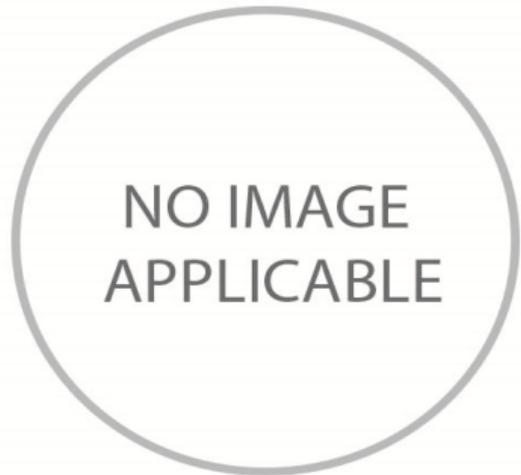
Item: Rocking Equipment - Spring Board
Manufacturer: Eibe Play Ltd

Finding: There is no identification label affixed to the equipment

Action: Provide an identification label

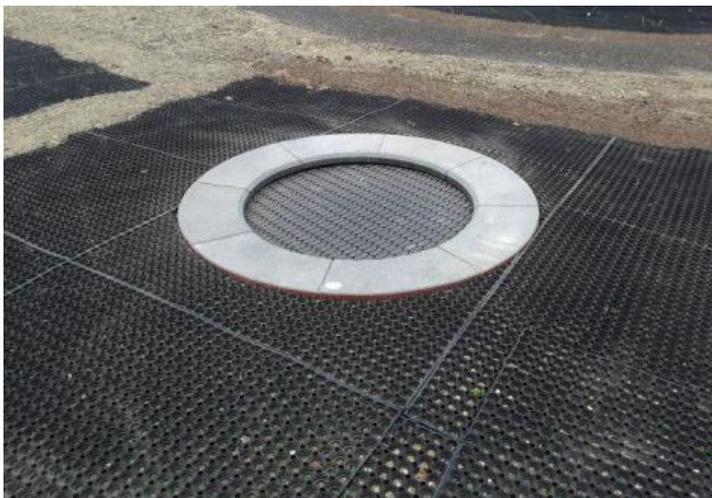
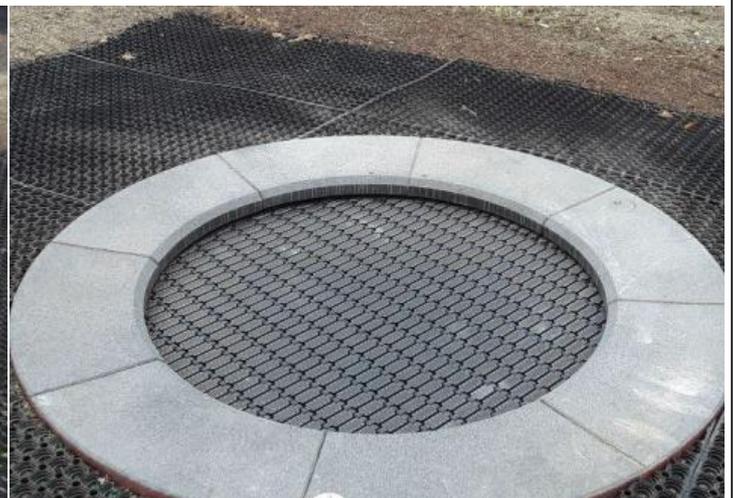
Item: Other - Bouncing Facility
Manufacturer: Seilfabrik Ullmann

On site visits it is not possible to test the ground clearance of the Bouncing Facility bed as specified in BS EN 1176; ensure that the clearance between the Bouncing Facility Bed and the ground underneath is in accordance with the manufacturers recommendations (unable to record nominal depth due to design of bed). - Refer to the manufacturers recommendations

Finding: On site visits it is not possible to test the ground clearance of the Bouncing Facility bed as specified in BS EN 1176; ensure that the clearance between the Bouncing Facility Bed and the ground underneath is in accordance with the manufacturers recommendations (unable to record nominal depth due to design of bed).

Action: Refer to the manufacturers recommendations

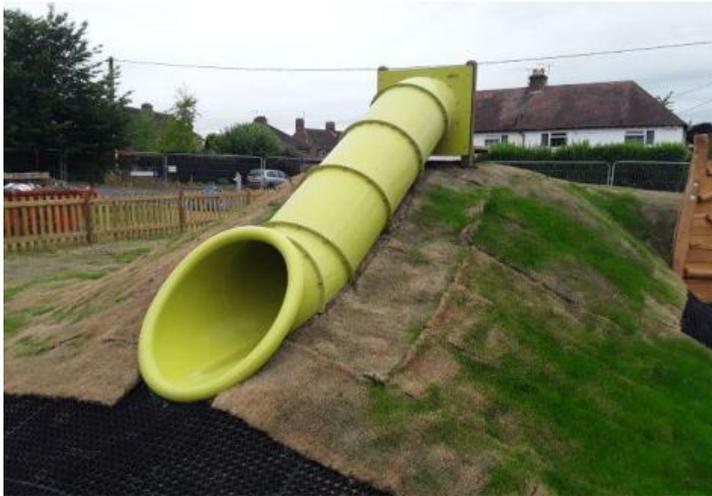
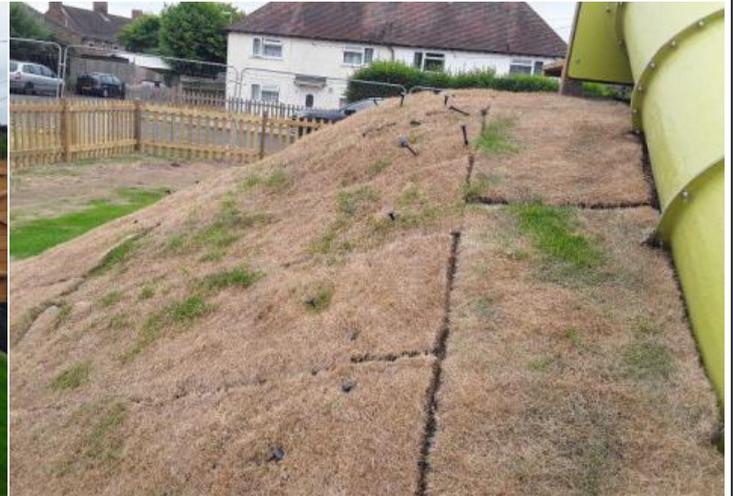
Item: Other - Embankment Slide
Manufacturer: Eibe Play Ltd

Finding: Fixing pins have been installed in the turf to aid settlement

Action: Remove pins prior to opening

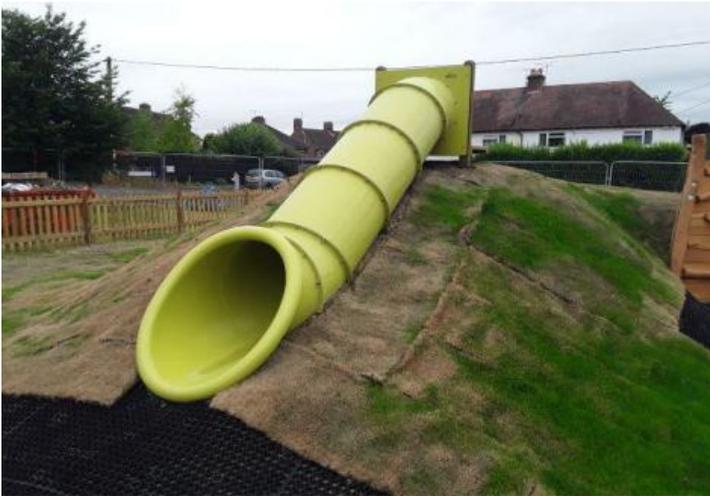
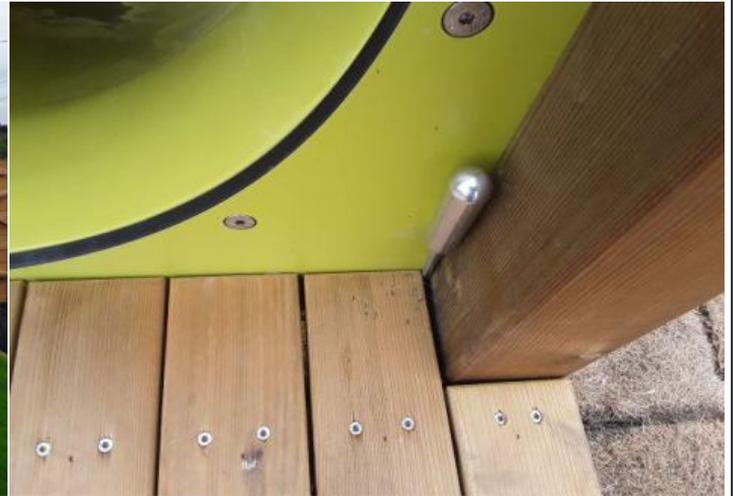
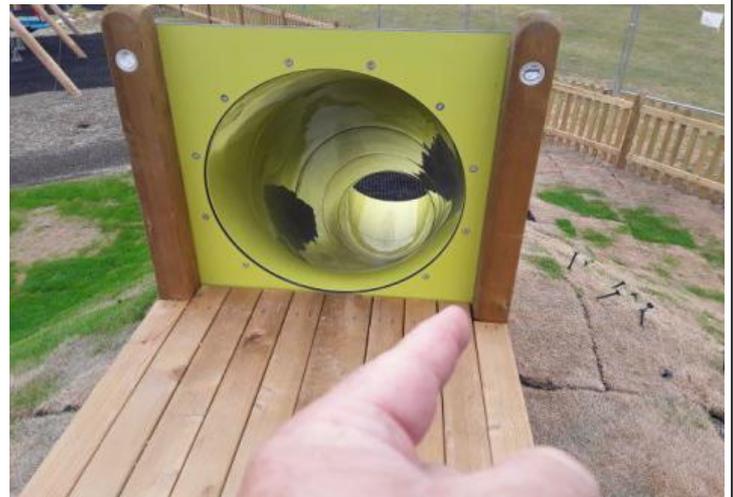
Item: Other - Embankment Slide
Manufacturer: Eibe Play Ltd

There is/are finger entrapment/s leading to the slide and the item fails to meet the requirements of BS EN 1176 Part 1 4.2.7.6 Entrapment of fingers - Refer to contractor

Finding: There is/are finger entrapment/s leading to the slide and the item fails to meet the requirements of BS EN 1176 Part 1 4.2.7.6 Entrapment of fingers

Action: Refer to contractor

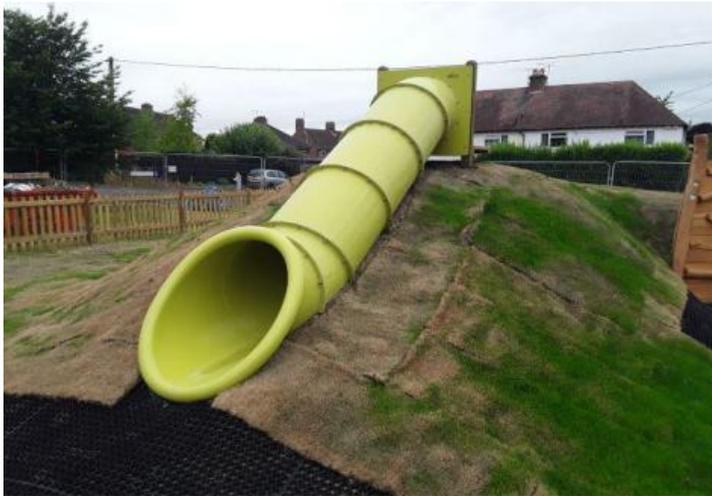
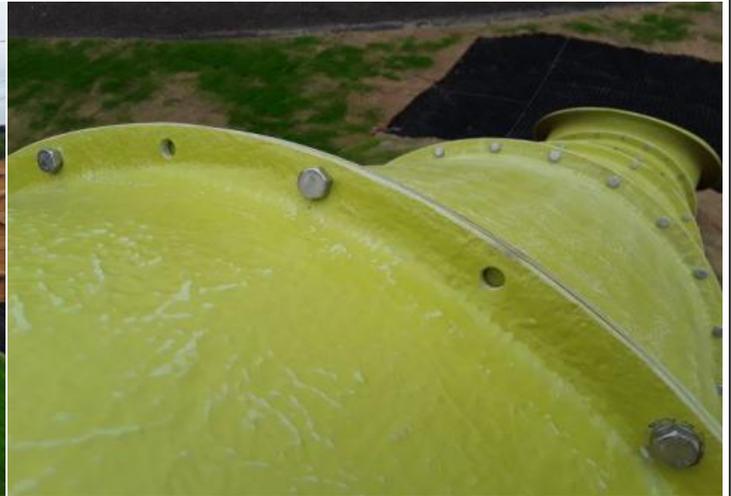
Item: Other - Embankment Slide
Manufacturer: Eibe Play Ltd

Finding: There are redundant fixing holes present

Action: Refer to manufacturer / contractor

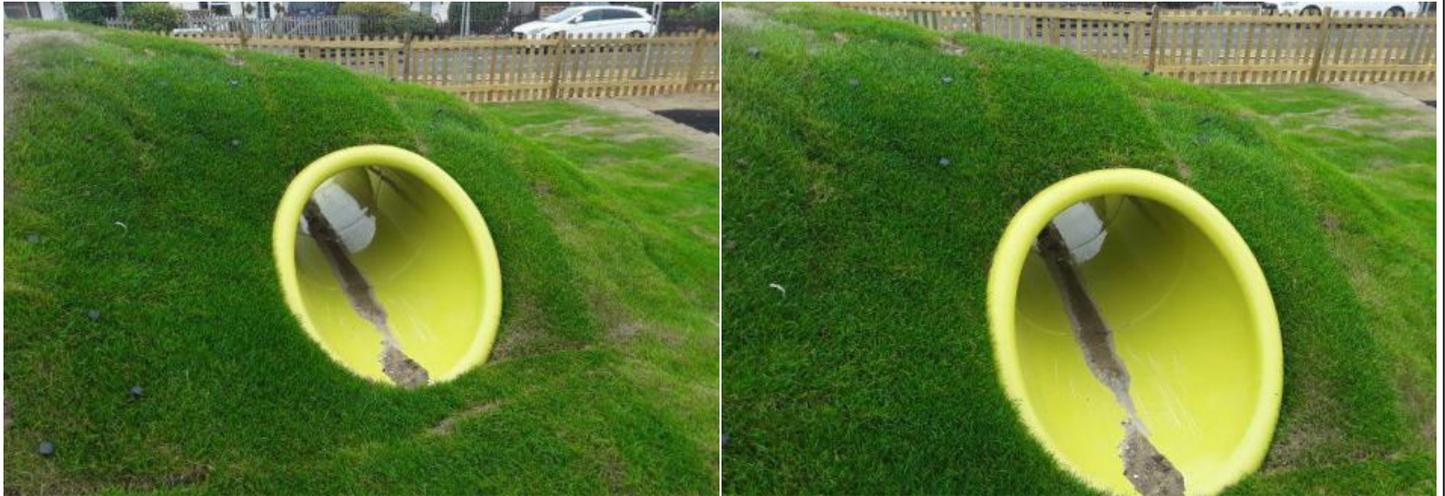
Item: Other - Tunnel Mound
Manufacturer: Eibe Play Ltd

This design / configuration of tunnel mound is well established and has been successfully included in large quantities of playgrounds throughout the UK. Whilst the design does not fully meet the requirements of BS EN 1176 with regards to falls in excess of 600mm over the edge of the tunnel to the surface below, it has been risk assessed as fit for purpose and no changes are recommended to the design - Monitor - No remedial work recommended

Finding: This design / configuration of tunnel mound is well established and has been successfully included in large quantities of playgrounds throughout the UK. Whilst the design does not fully meet the requirements of BS EN 1176 with regards to falls in excess of 600mm over the edge of the tunnel to the surface below, it has been risk assessed as fit for purpose and no changes are recommended to the design

Action: Monitor - No remedial work recommended

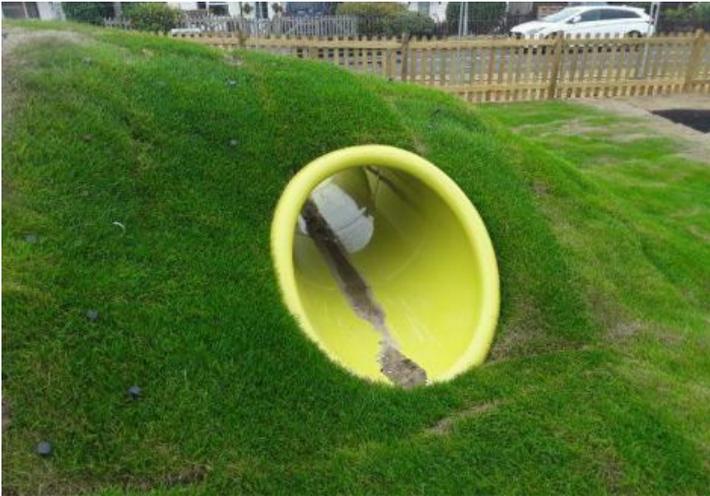
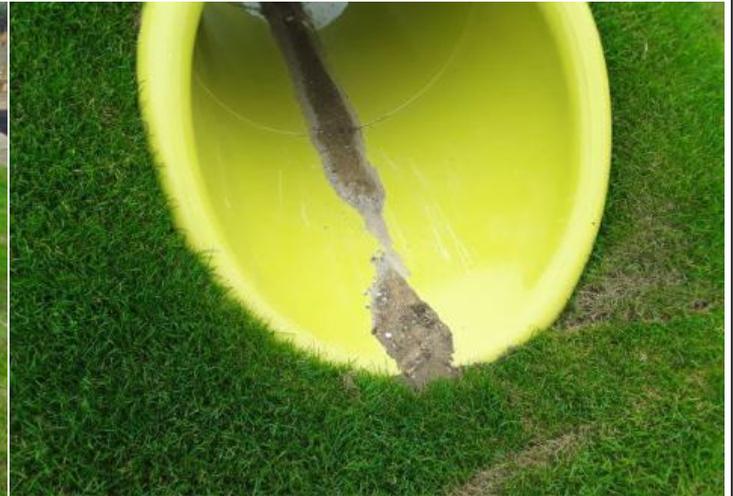
Item: Other - Tunnel Mound
Manufacturer: Eibe Play Ltd

Finding: There are silt deposits on the tunnel surface

Action: Clean tunnel surface

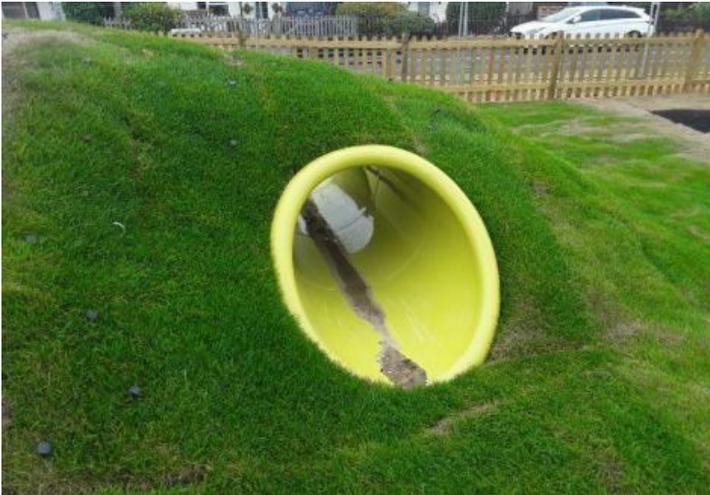
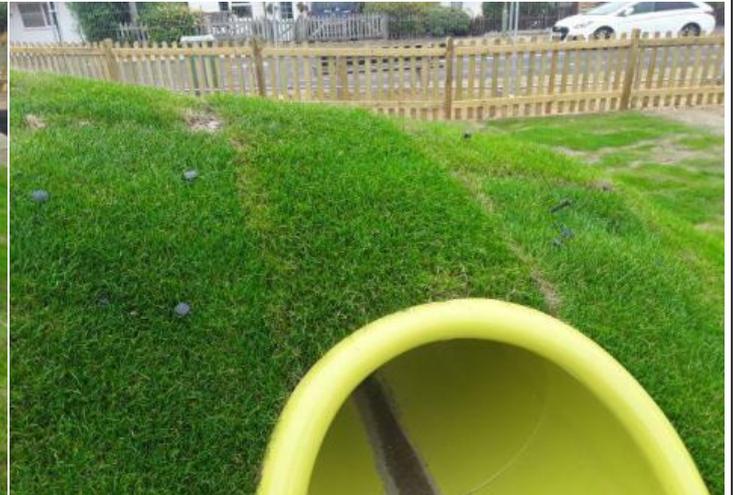
Item: Other - Tunnel Mound
Manufacturer: Eibe Play Ltd

Finding: Fixing pins have been installed in the turf to aid settlement

Action: Remove pins prior to opening

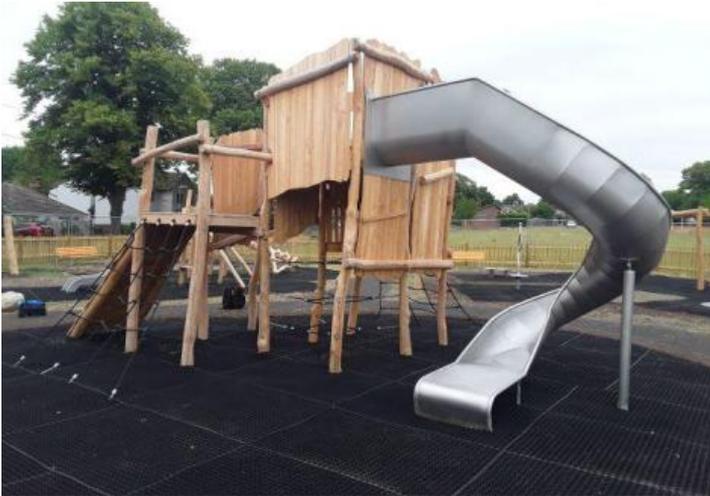
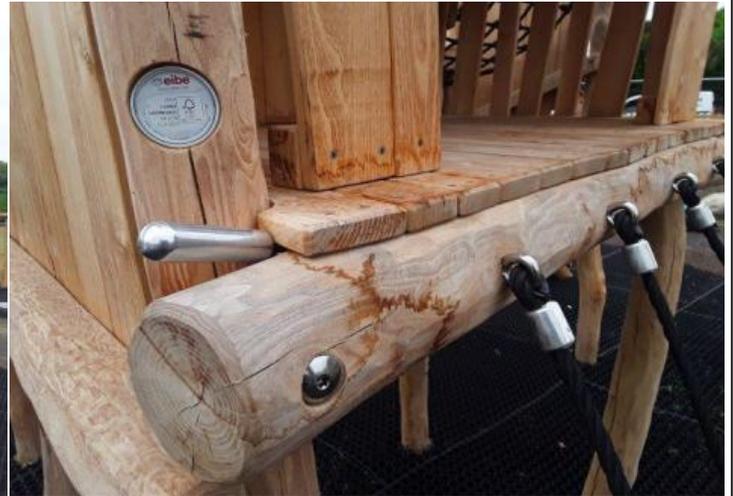
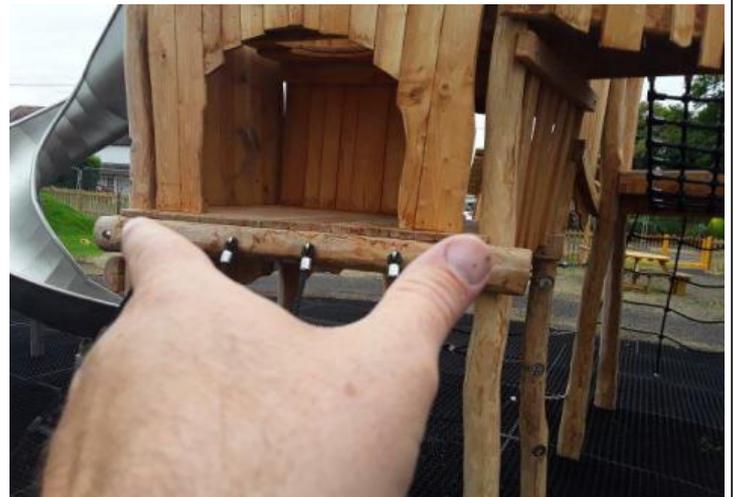
Item: Activity Equipment - Multi Play (Junior)
Manufacturer: Eibe Play Ltd

There is/are finger entrapment/s above the net climber and the item fails to meet the requirements of BS EN 1176 Part 1 4.2.7.6 Entrapment of fingers - Refer to contractor

Finding: There is/are finger entrapment/s above the net climber and the item fails to meet the requirements of BS EN 1176 Part 1 4.2.7.6 Entrapment of fingers

Action: Refer to contractor

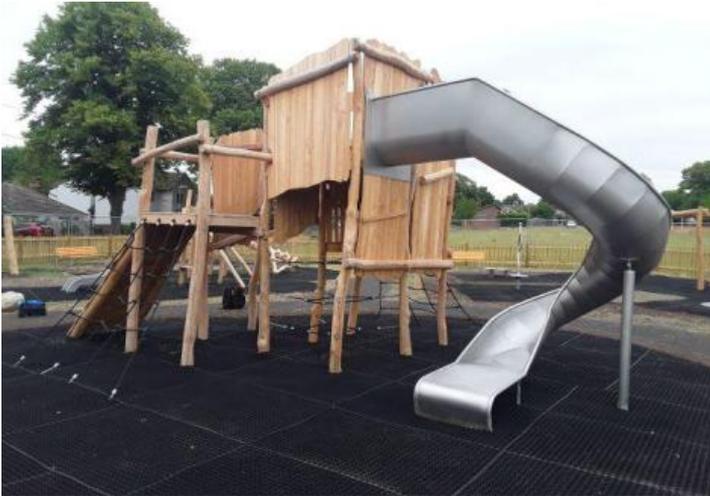
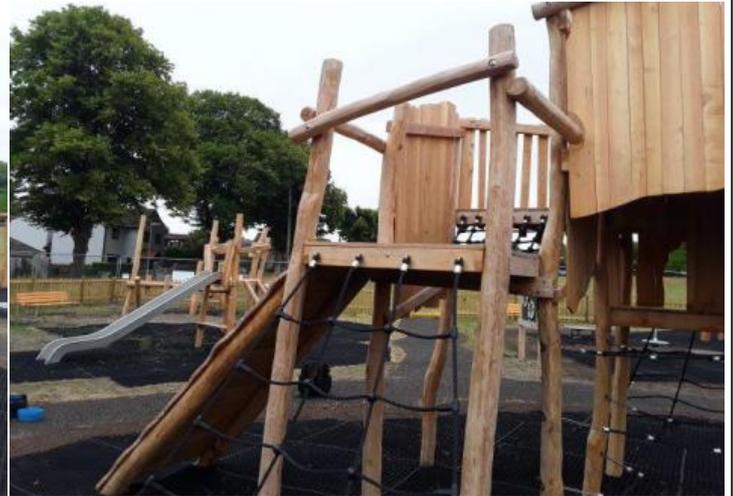
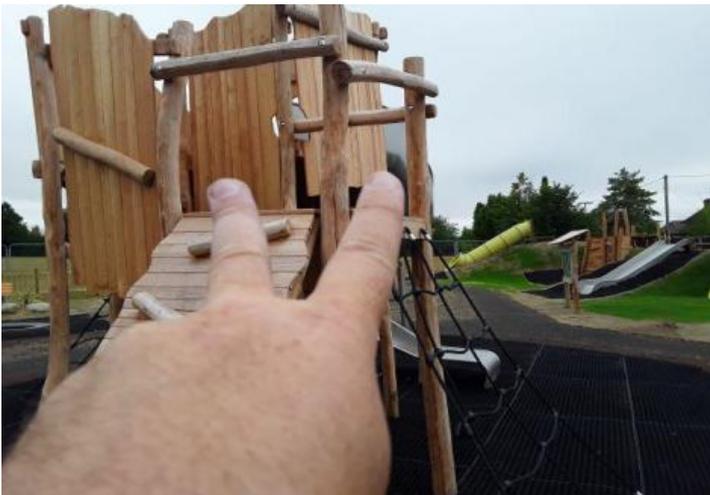
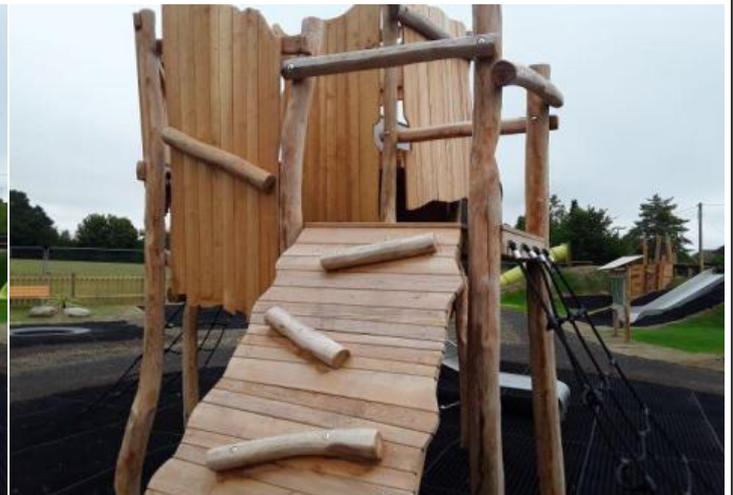
Item: Activity Equipment - Multi Play (Junior)
Manufacturer: Eibe Play Ltd

Finding: There are openings leading from platforms in excess of 1.0m in height to steep play elements and no hand supports complying with grip or grasp are provided, in contravention of BS EN 1176 Part 1: 4.2.9.4

Action: Refer to manufacturer
