the play inspection company

Post Installation Report

Stratton Bates Rec

Inspection Ref: 1723632

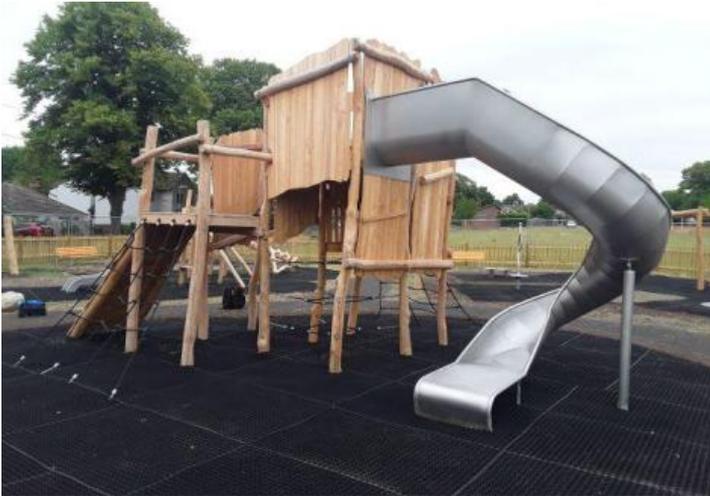
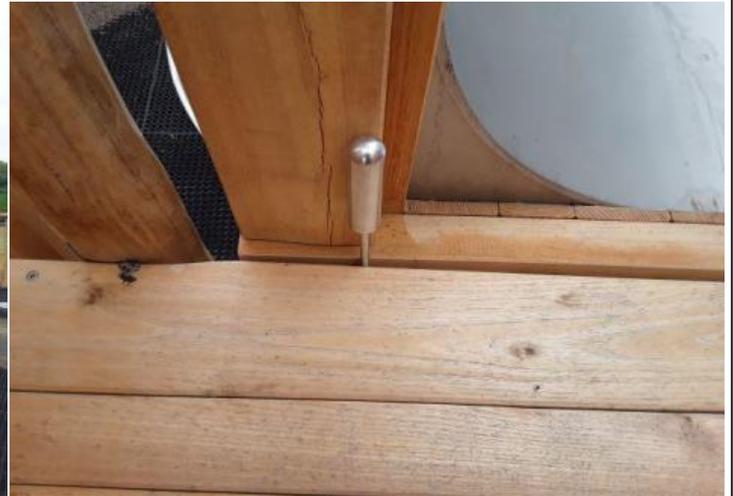
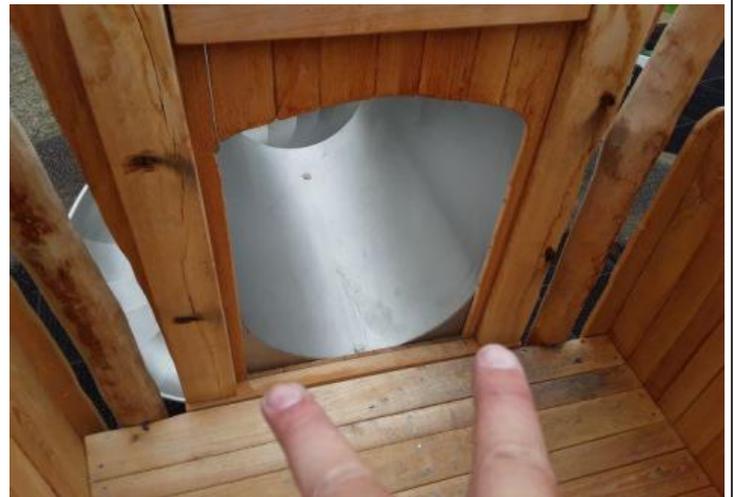
Item: Activity Equipment - Multi Play (Junior)
Manufacturer: Eibe Play Ltd

There is/are finger entrapment/s leading to the slide and the item fails to meet the requirements of BS EN 1176 Part 1 4.2.7.6 Entrapment of fingers - Refer to contractor

Finding: There is/are finger entrapment/s leading to the slide and the item fails to meet the requirements of BS EN 1176 Part 1 4.2.7.6 Entrapment of fingers

Action: Refer to contractor
