# the **play inspection** company

## Annual Inspection

Winchester City Council

Sun Hill Recreation Ground (New Alresford)

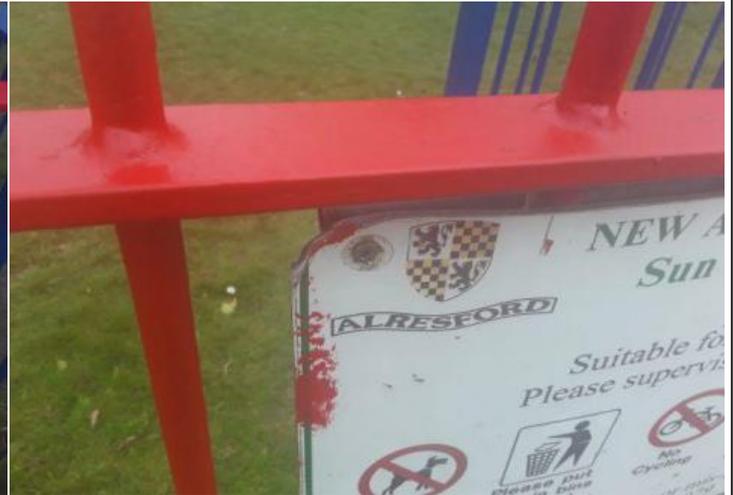
**Finding:** The signage is damaged

The signage is damaged - Replace signage as required

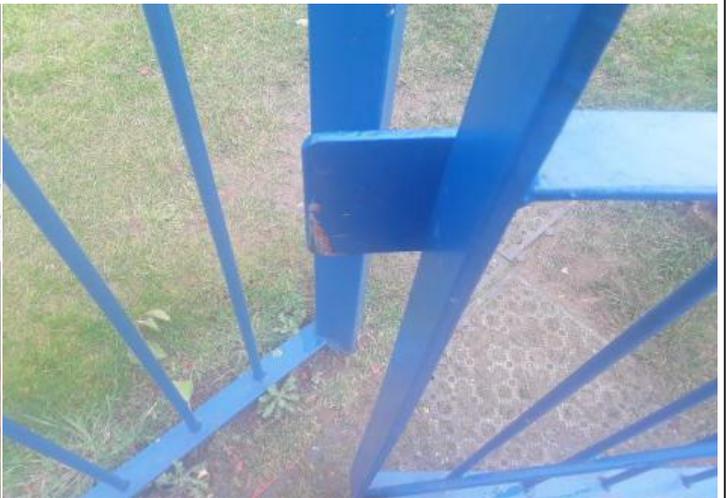
**Finding:** The rubber buffer is missing from the latch plate  
**Action:** Replace rubber buffer

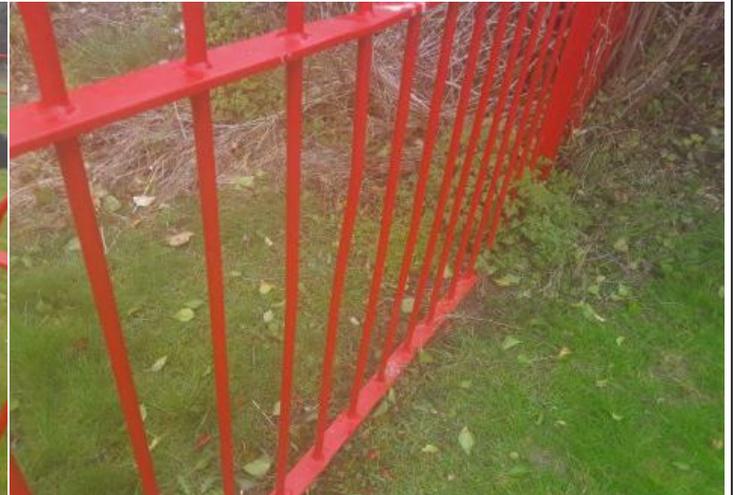
**Finding:** There is some damage to the fence sections

There is some damage to the fence sections - Monitor for any further deterioration and repair as required

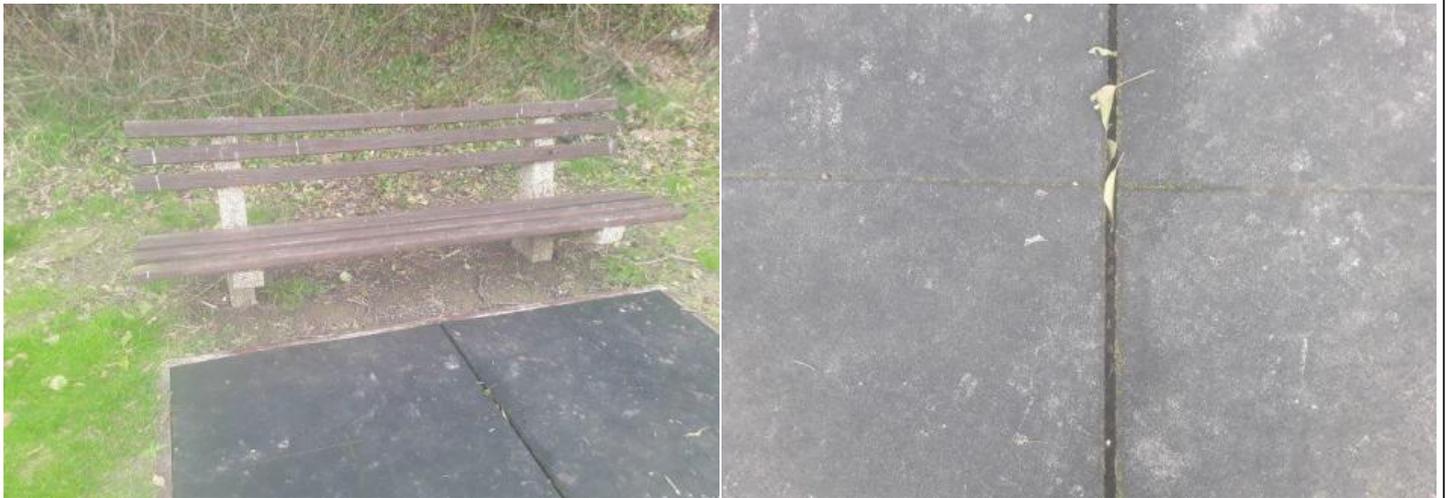
**Finding:** There are gaps opening in between the tiles  
**Action:** Monitor for any further deterioration and repair as required

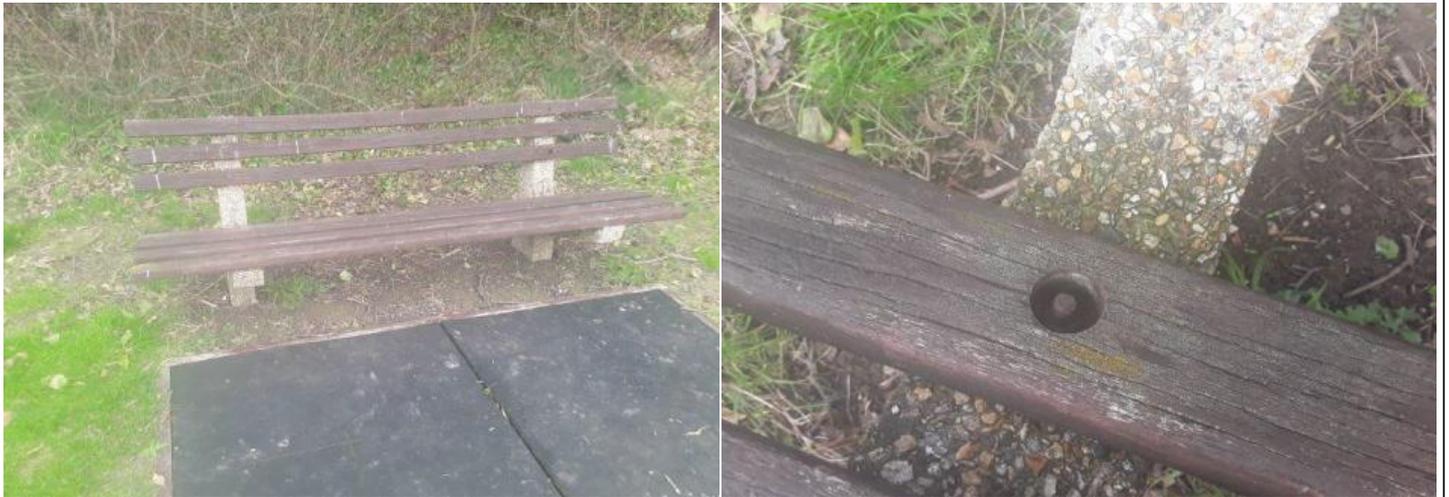
**Finding:** There is/are bolt cap covers missing or damaged on the item  
**Action:** Replace missing or damaged bolt cap covers

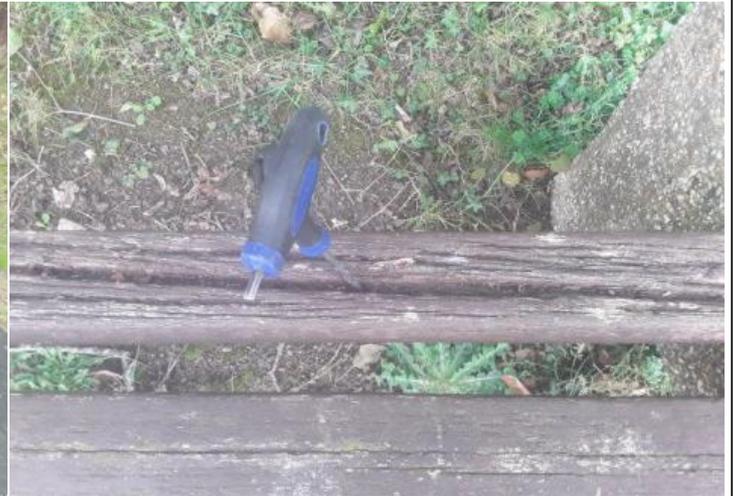
**Finding:** There is some evidence of rot in the timber

There is some evidence of rot in the timber - Monitor for any further deterioration and replace as required

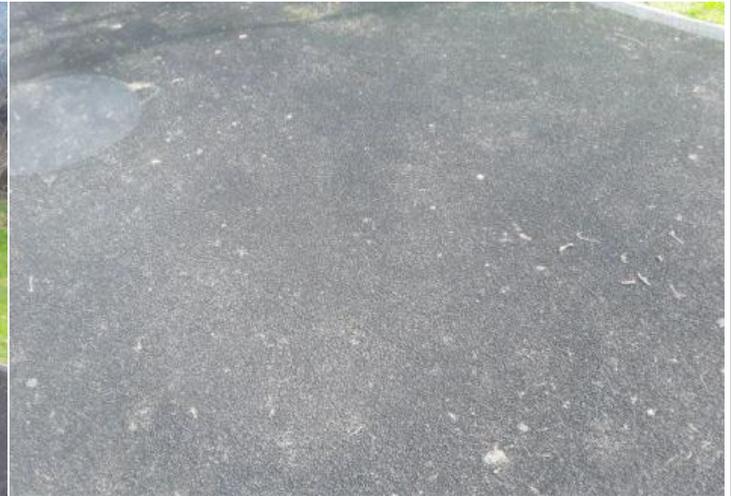
<b>Finding:</b>	The safety surfacing is beginning to wear	<b>Action:</b>	Monitor for any further deterioration and repair as required
-----------------	---	----------------	--

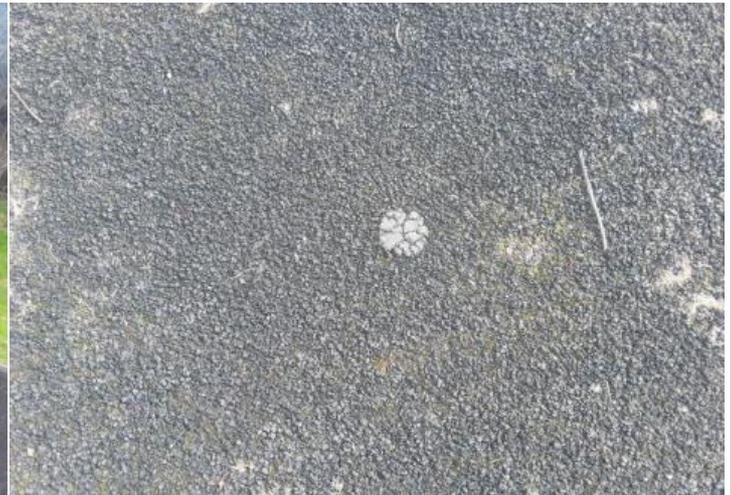
<b>Finding:</b>	There is some evidence of fire damage to the surfacing	<b>Action:</b>	Monitor for any further deterioration and repair as required
-----------------	--	----------------	--

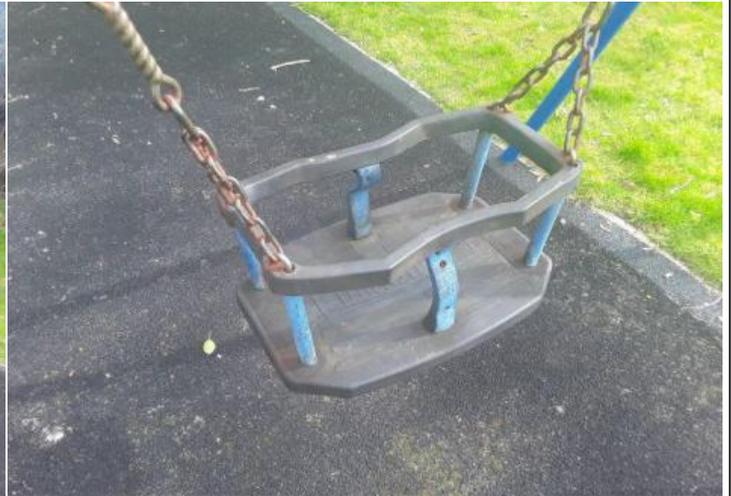
**Finding:** The seat has minor damage or wear

The seat has minor damage or wear - Monitor for any further deterioration and replace as required

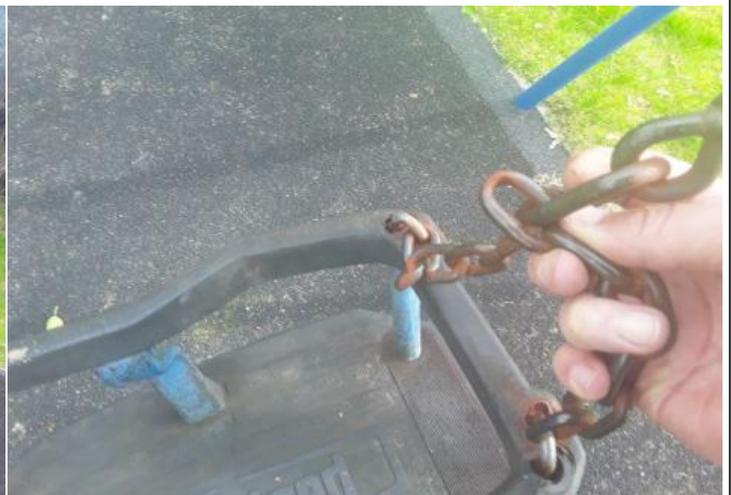
**Finding:** There is some notable evidence of chain wear

There is some notable evidence of chain wear - Monitor for any further deterioration and replace when 40% worn

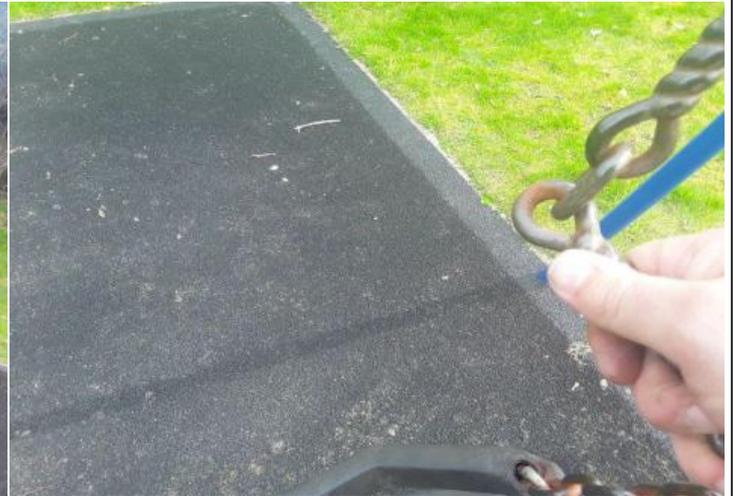
**Finding:** There is some wear to the chain bars

There is some wear to the chain bars - Monitor for any further deterioration and replace when 40% worn

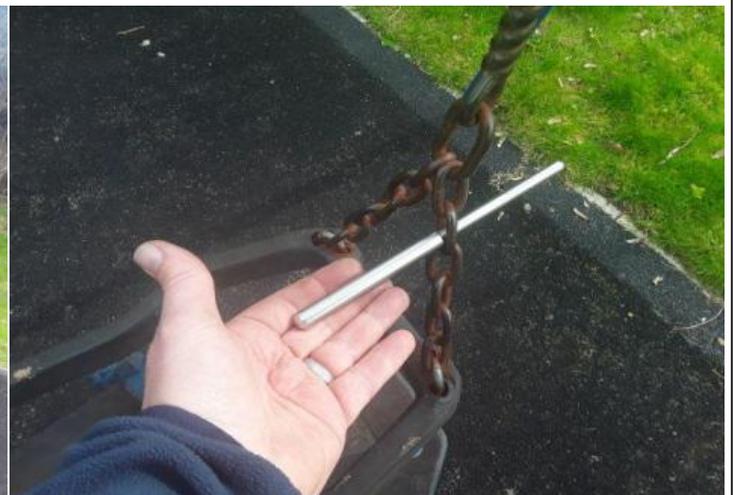
**Finding:** The chain openings are in excess of the 8.6mm as recommended by BS EN 1176

The chain openings are in excess of the 8.6mm as recommended by BS EN 1176 - Monitor - No remedial work recommended

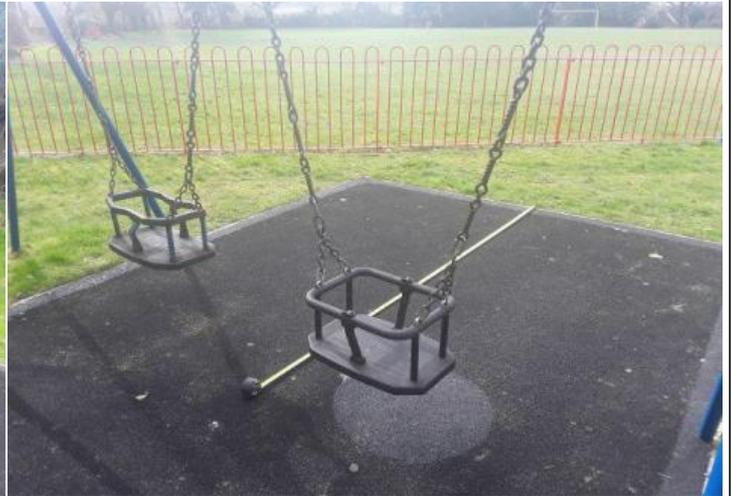
**Finding:** The surfacing dimensions are short and do not meet with the requirements of the current applicable standard

The surfacing dimensions are short and do not meet with the requirements of the current applicable standard - Monitor - no remedial action recommended

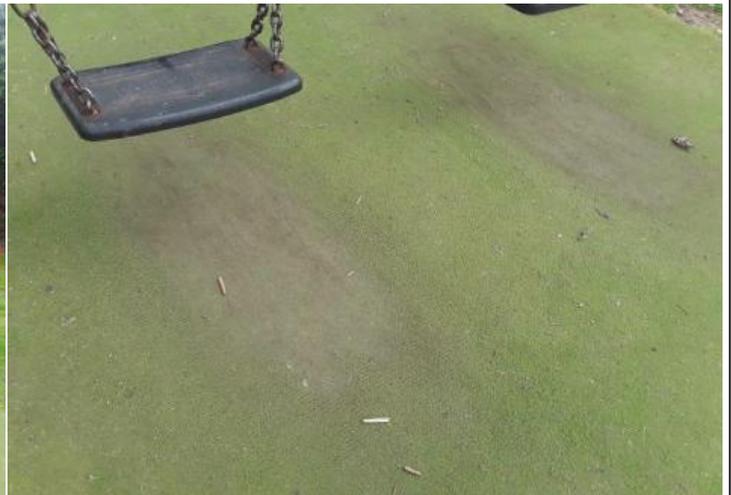
**Finding:** The safety surfacing is beginning to wear

The safety surfacing is beginning to wear - Monitor for any further deterioration and repair as required

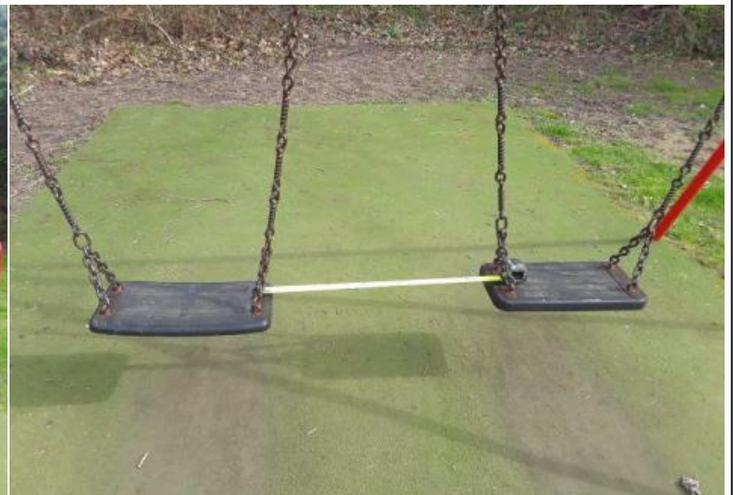
**Finding:** The seats are too close to each other as defined in BS EN 1176 Part 2; this is a low risk failure and no remedial action is required  
**Action:** Monitor - No remedial work recommended

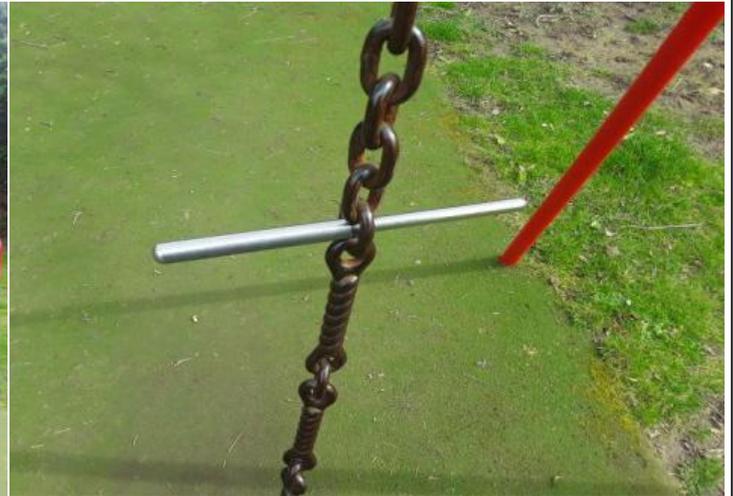
**Finding:** The chain openings are in excess of the 8.6mm as recommended by BS EN 1176  
**Action:** Monitor - No remedial work recommended

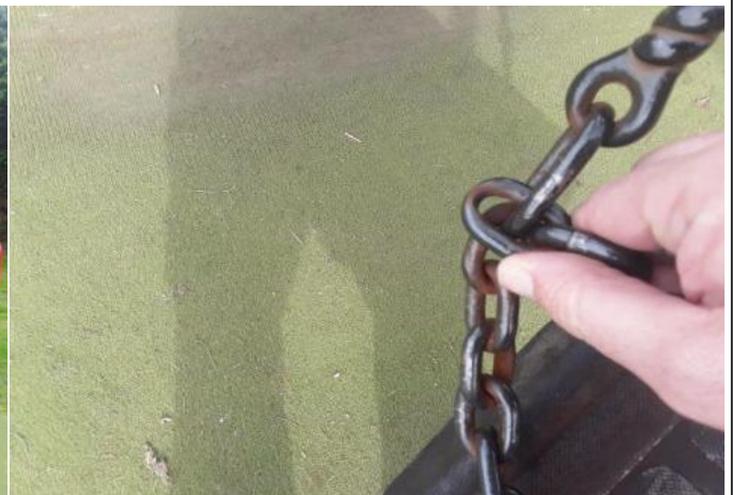
**Finding:** There is some notable evidence of chain wear  
**Action:** Monitor for any further deterioration and replace when 40% worn

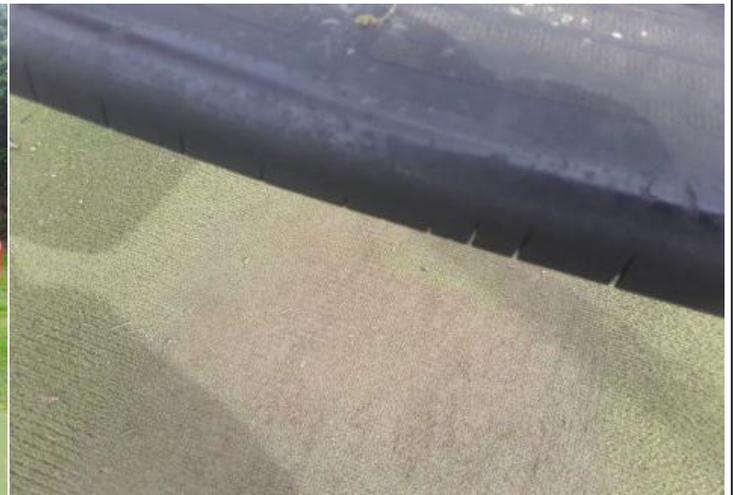
**Finding:** The seat has minor damage or wear      **Action:** Monitor for any further deterioration and replace as required

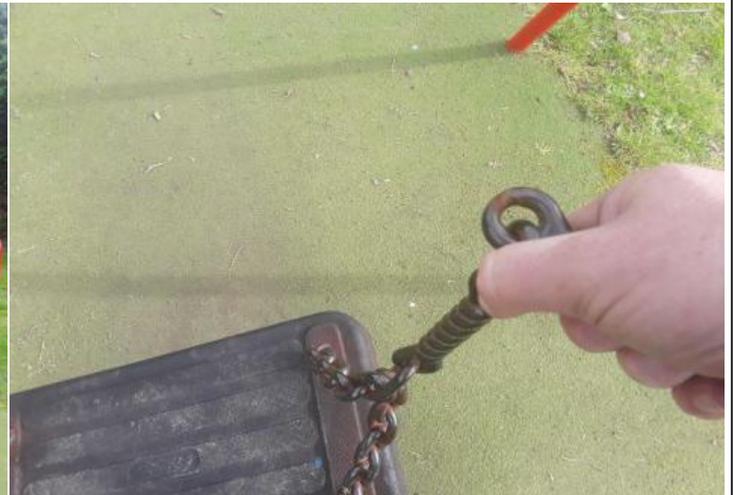
**Finding:** There is some wear to the chain bars      **Action:** Monitor for any further deterioration and replace when 40% worn

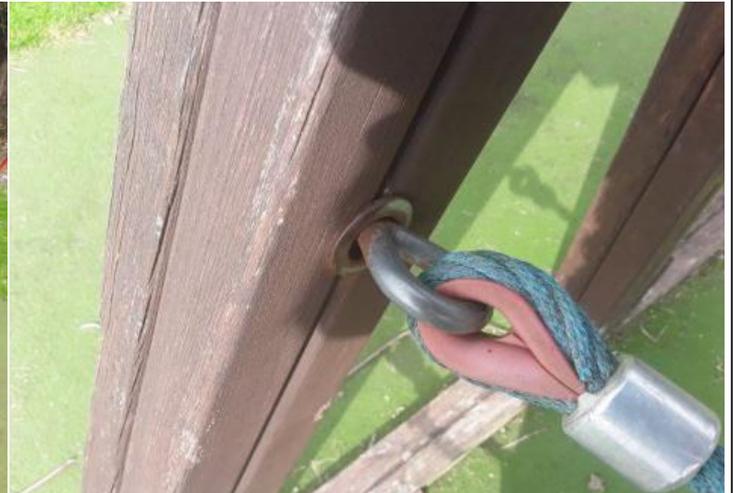
**Finding:** A number of eyebolt fixing(s) have worked loose

A number of eyebolt fixing(s) have worked loose - Secure all loose fixings

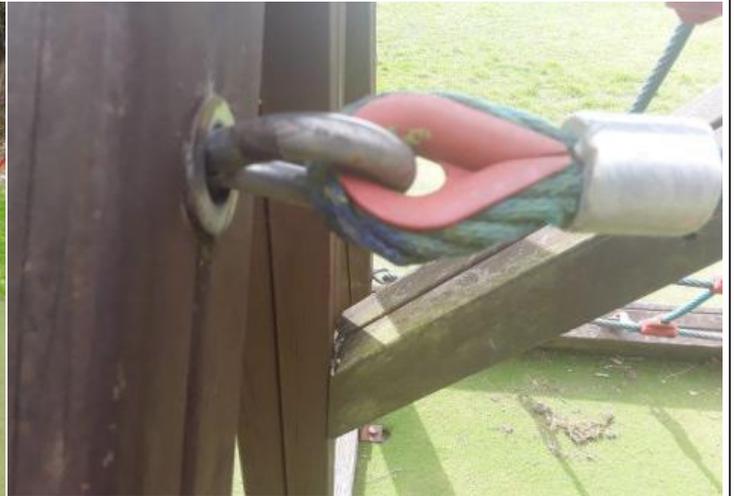
**Finding:** There is some evidence of fire damage to the item **Action:** Monitor for any further deterioration and repair as required

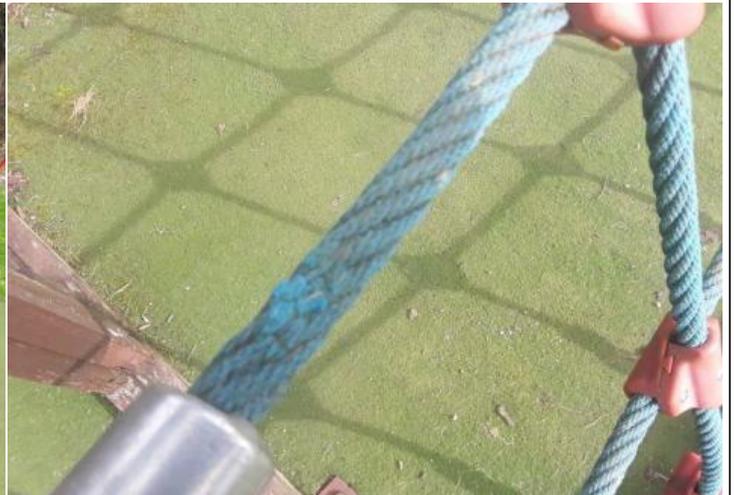
**Finding:** The ropes/nets are worn/damaged in places **Action:** Monitor for any further deterioration and repair or replace as required

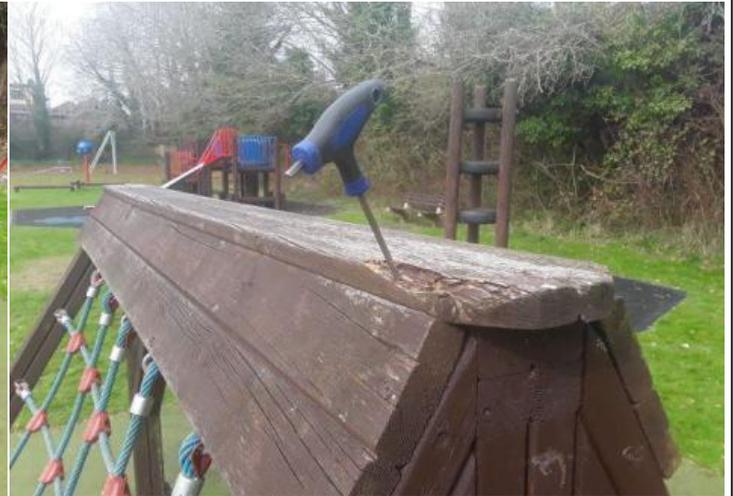
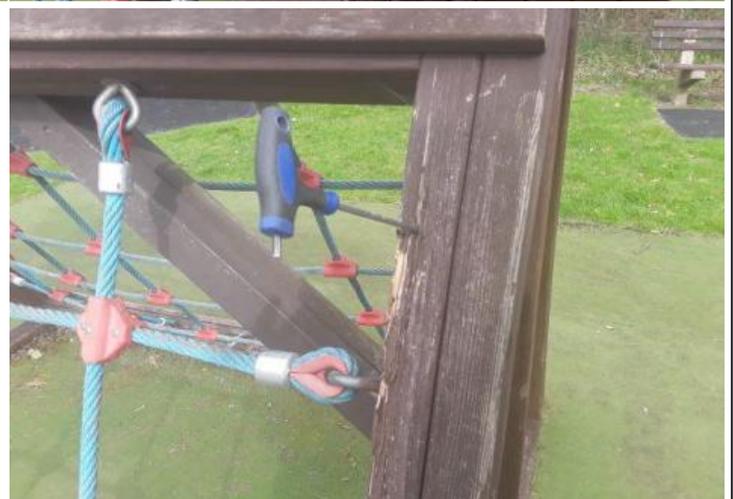
**Finding:** There is some evidence of rot in the timber

There is some evidence of rot in the timber - Monitor for any further deterioration and replace as required

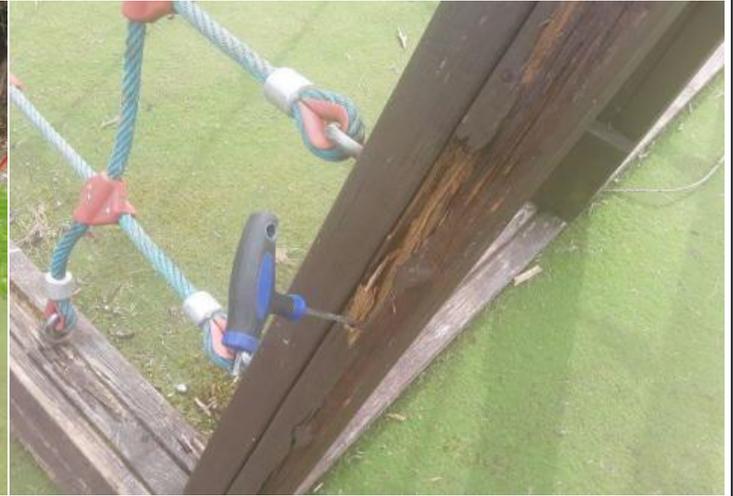
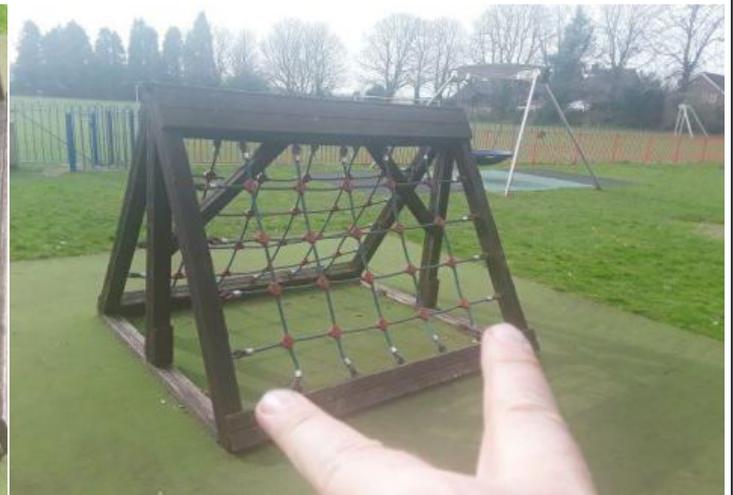
**Finding:** There are areas or parts of the timber on the structure that have rotted

There are areas or parts of the timber on the structure that have rotted - Replace all affected timbers

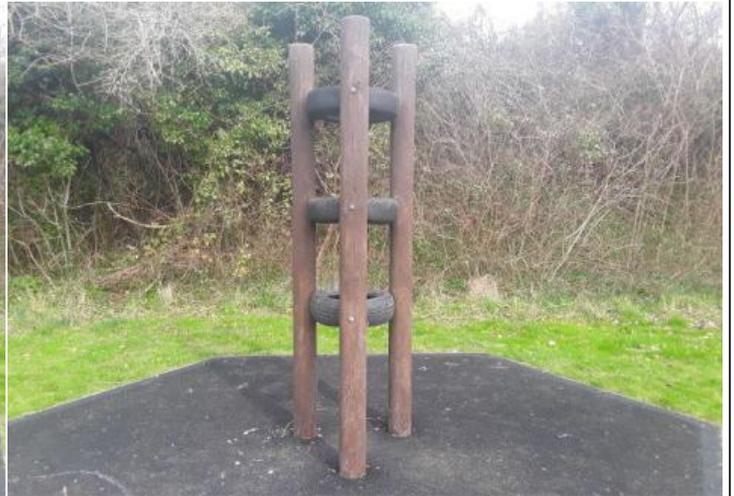
**Finding:** This item of equipment relies on a single post, or a line of posts, for stability and extra care needs to be taken with equipment of this nature to avoid the potential for catastrophic failure  
**Action:** Ensure that regular detailed inspections are undertaken to assess for rot, corrosion and general stability

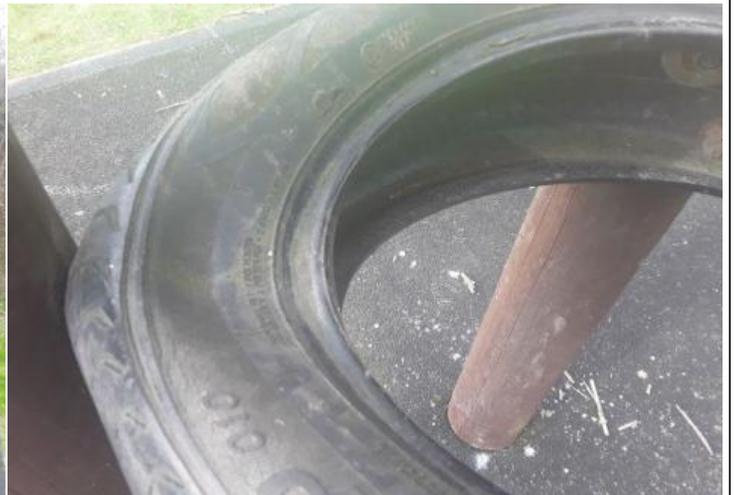
**Finding:** The tyres are showing signs of wear / damage  
**Action:** Monitor for any further deterioration and replace as required

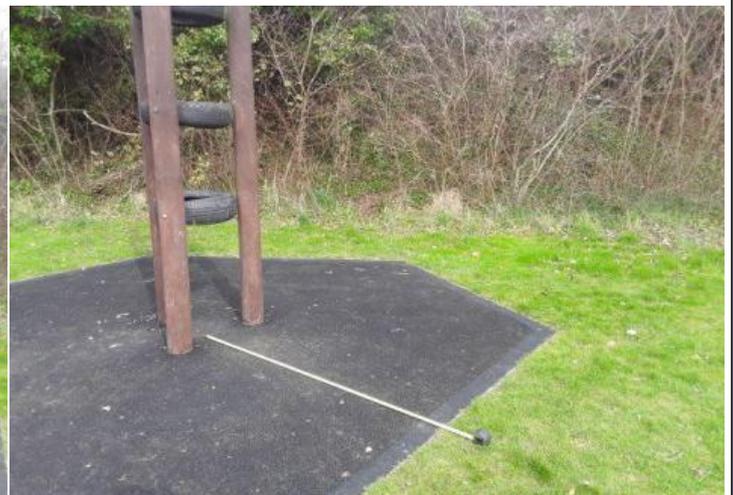
**Finding:** The surfacing dimensions are short and do not meet with the requirements of the current applicable standard

The surfacing dimensions are short and do not meet with the requirements of the current applicable standard - Monitor - no remedial action recommended

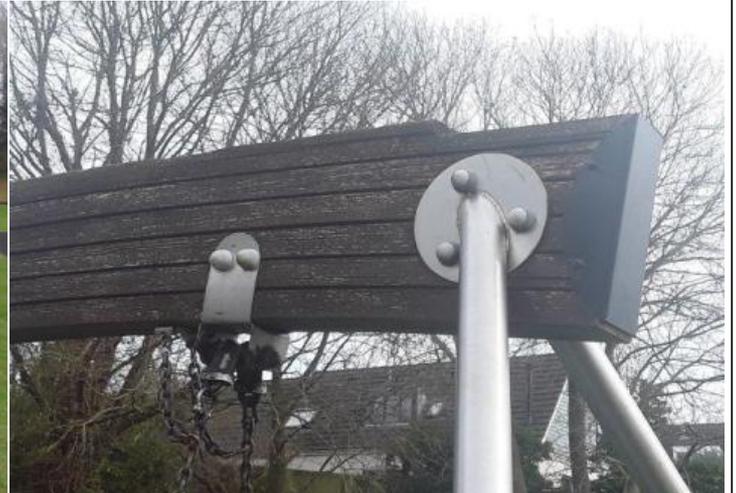
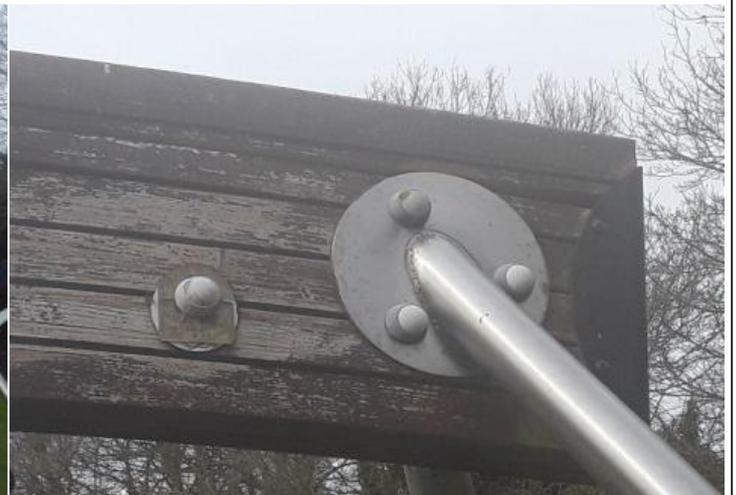
**Finding:** The timber crossbeam is damaged with evidence of rot **Action:** Replace of rot

The timber crossbeam is damaged with evidence of rot - Replace

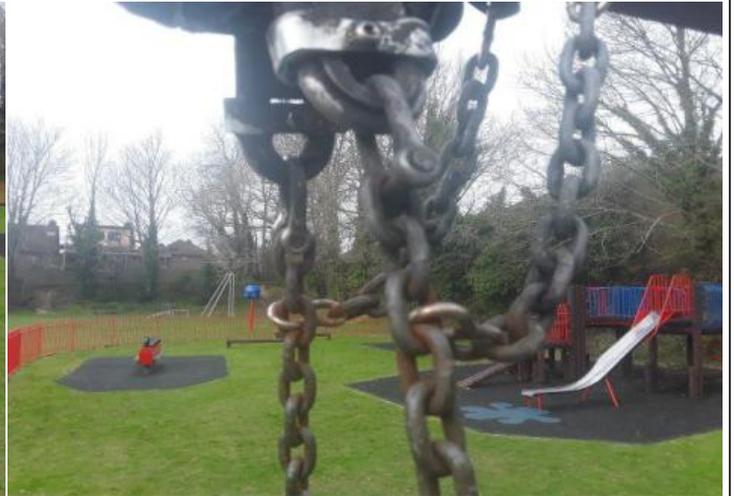
**Finding:** There is some notable evidence of chain wear

There is some notable evidence of chain wear - Monitor for any further deterioration and replace when 40% worn

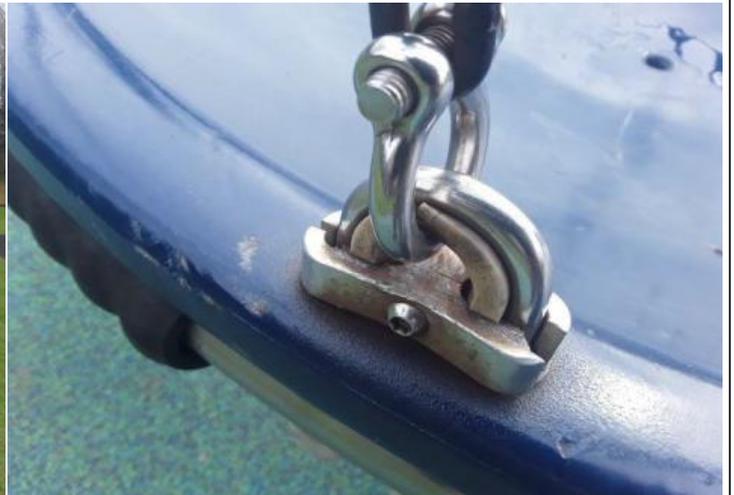
**Finding:** The seat inserts are showing signs of wear

The seat inserts are showing signs of wear - Monitor for any further deterioration and replace as required

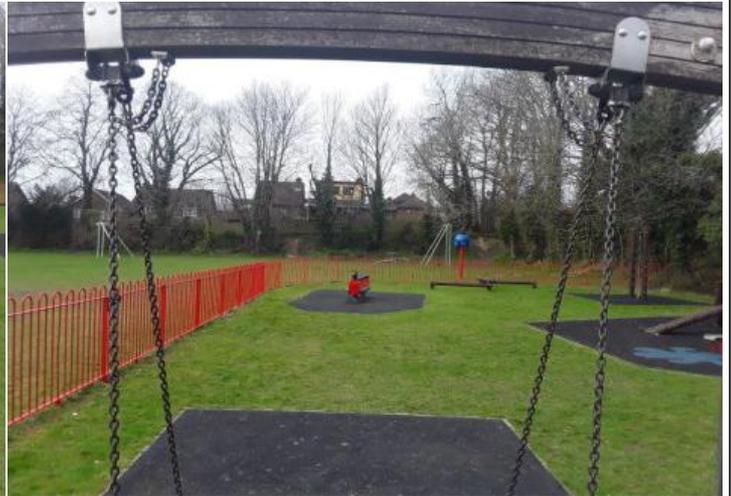
**Finding:** The lateral stability of the swing seat does not meet with the requirements of BS EN 1176 Part 2; the minimum distance between the suspension members should be the distance between the swing seat connections plus 30% of the suspension length

The lateral stability of the swing seat does not meet with the requirements of BS EN 1176 Part 2; the minimum distance between the suspension members should be the distance between the swing seat connections plus 30% of the suspension length - Monitor - no remedial work recommended

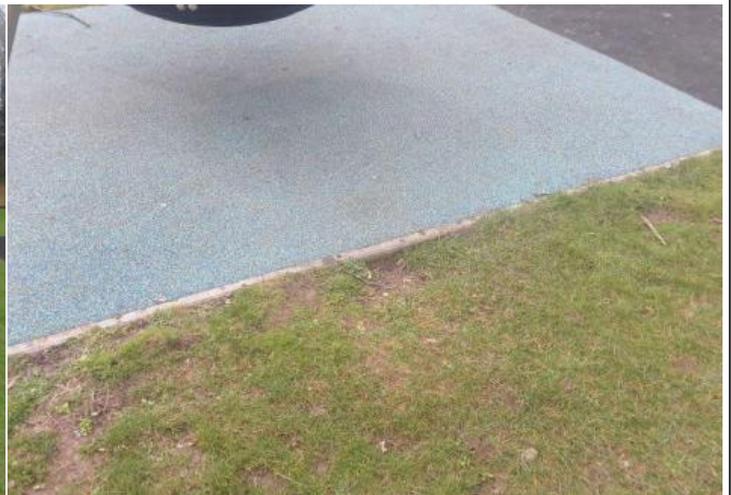
**Finding:** There are trip hazards at the edges of the surface

There are trip hazards at the edges of the surface - Reinstate surrounding surface levels to remove the trip points

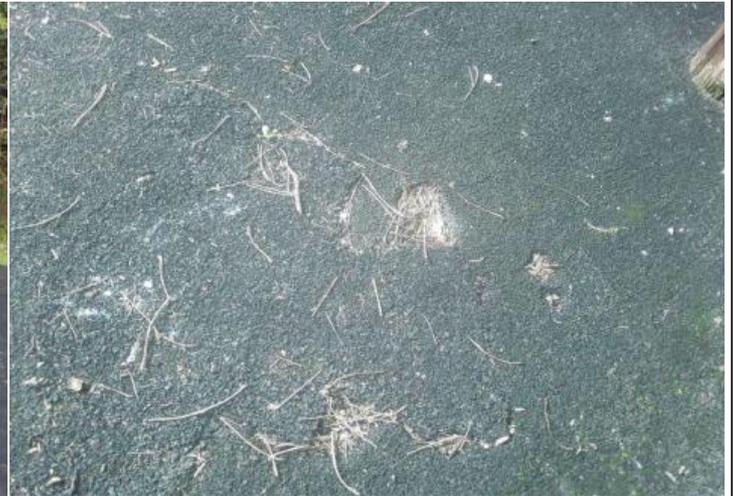
**Finding:** There is some minor damage to the surface

There is some minor damage to the surface - Monitor for any further deterioration and repair as required

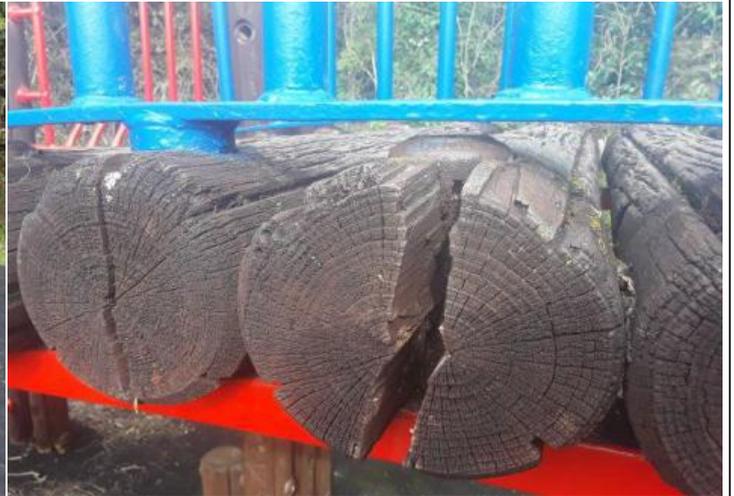
**Finding:** The timber has a number of splits/shakes or air cracks and this may affect the stability or allow water ingress which will accelerate the rotting process  
**Action:** Monitor to ensure the splits do not cross through fixing points of the structure and/or cause any instability

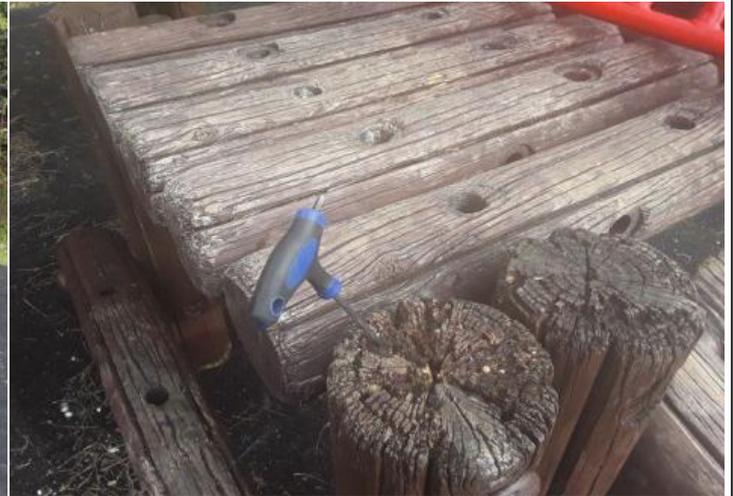
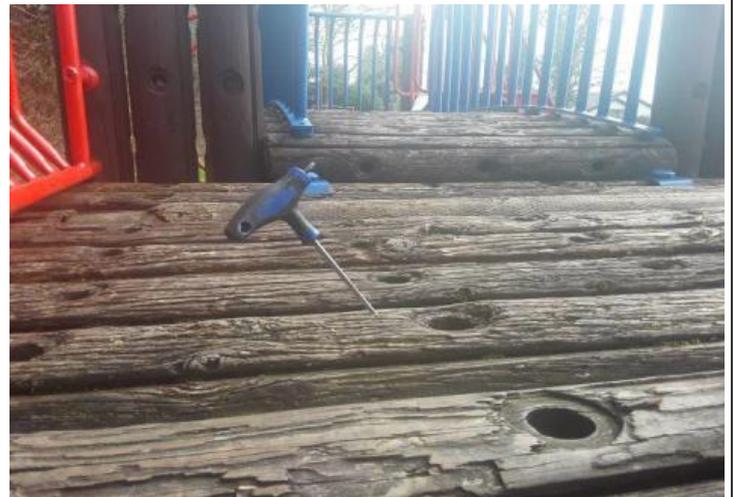
**Finding:** There is some evidence of rot in the timber throughout the structure

There is some evidence of rot in the timber throughout the structure - Monitor for any further deterioration and replace as required

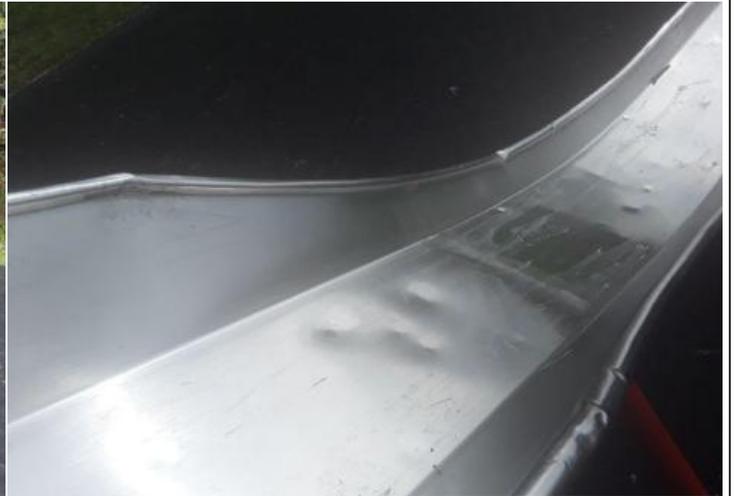
**Finding:** There are a number of dents in the slide surface

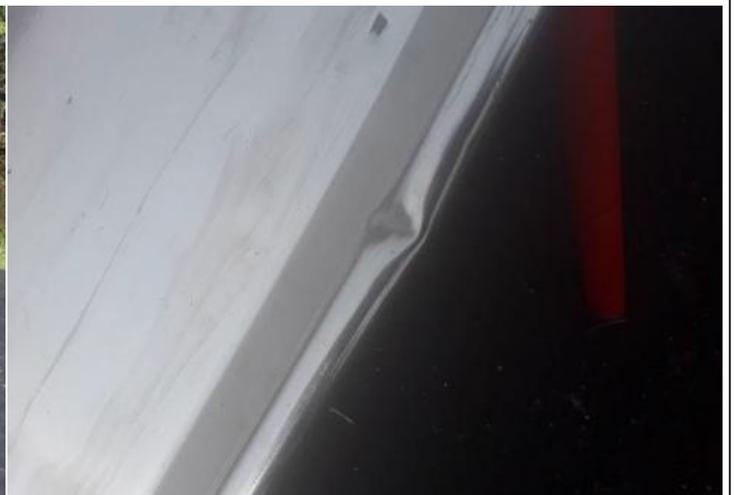
**Finding:** The side of the slide is damaged

The side of the slide is damaged - Monitor for any further deterioration and repair as required

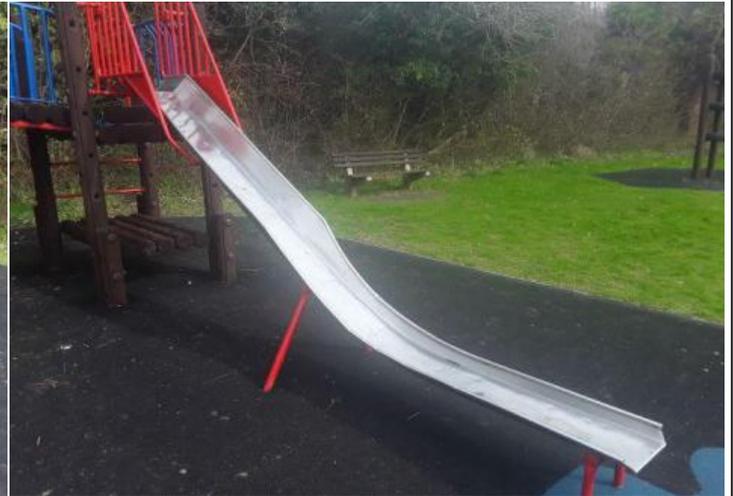
**Finding:** The slide is predominately south facing and will catch the majority of the sun's heat during the day. Slide surfaces can become very warm during periods of sustained sunny weather

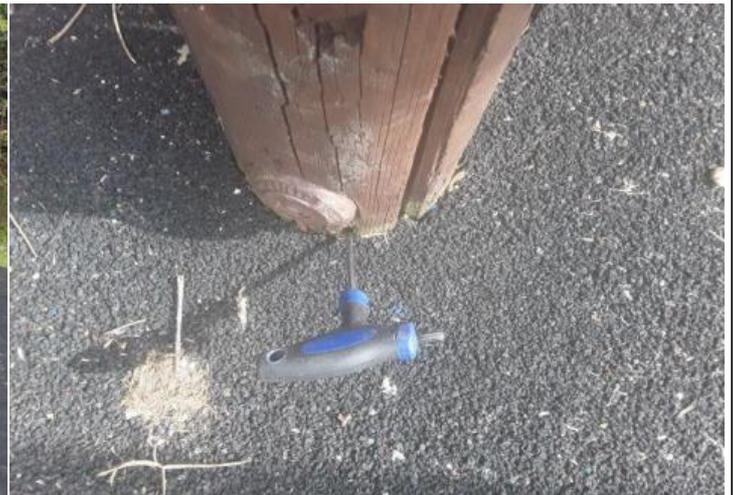
**Finding:** There is some evidence of rot in the posts

There is some evidence of rot in the posts - Monitor for any further deterioration and replace as required

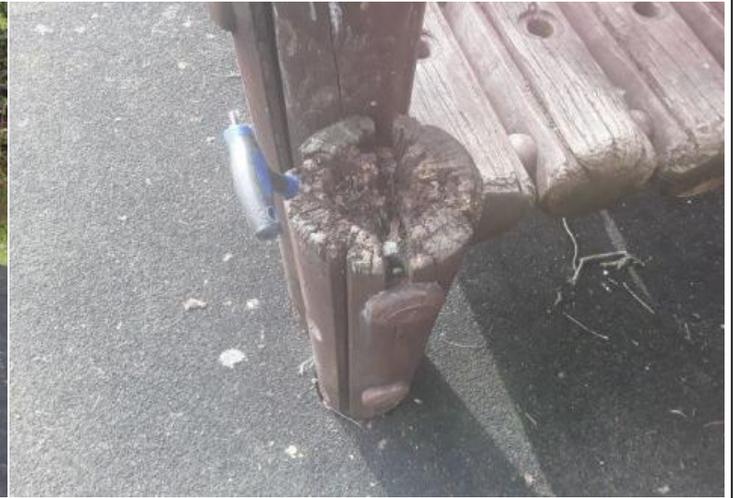
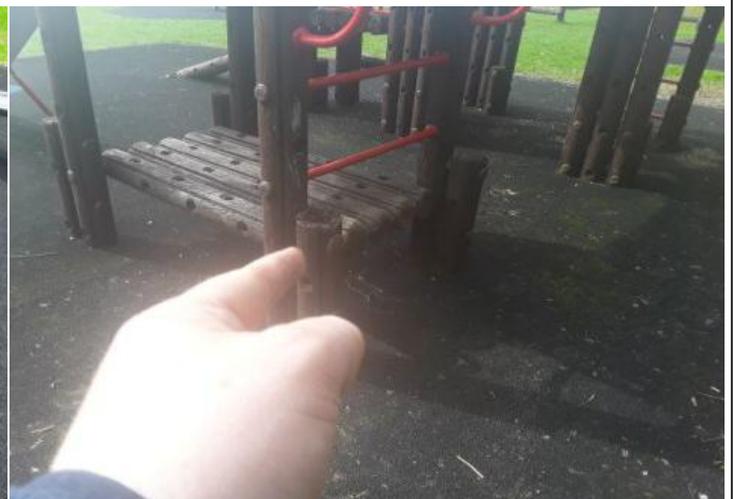
**Finding:** There are areas or parts of the timber on the structure that have rotted

There are areas or parts of the timber on the structure that have rotted - Replace all affected timbers

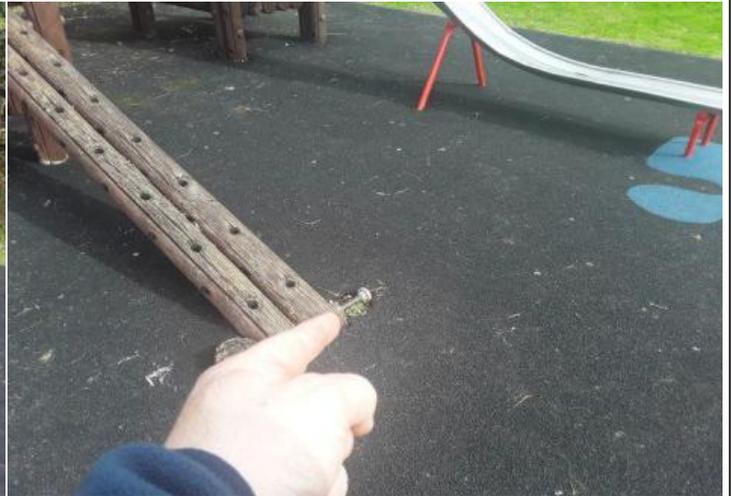
**Finding:** The item has missing component(s)

The item has missing component(s) - Replace missing support post

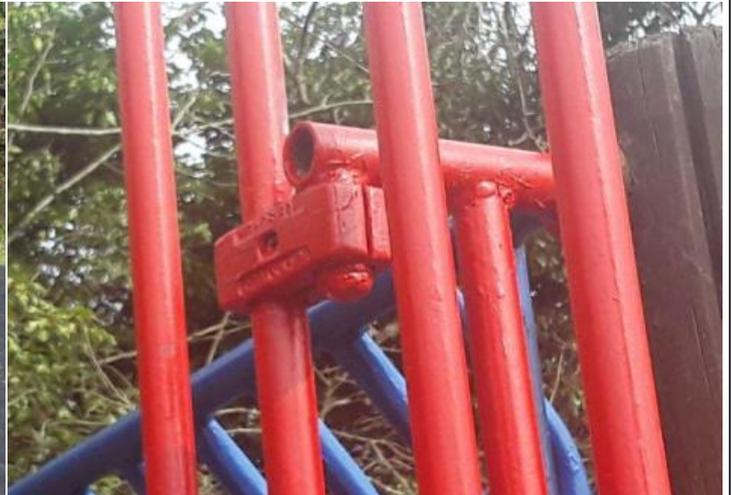
**Finding:** There are missing end caps

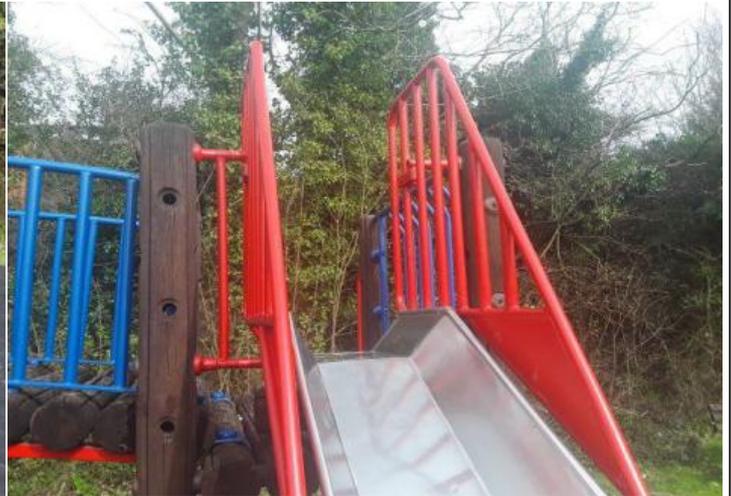
**Finding:** This item has no slide bar fitted as required by BS EN 1176 Part 3 **Action:** Monitor - No remedial work recommended

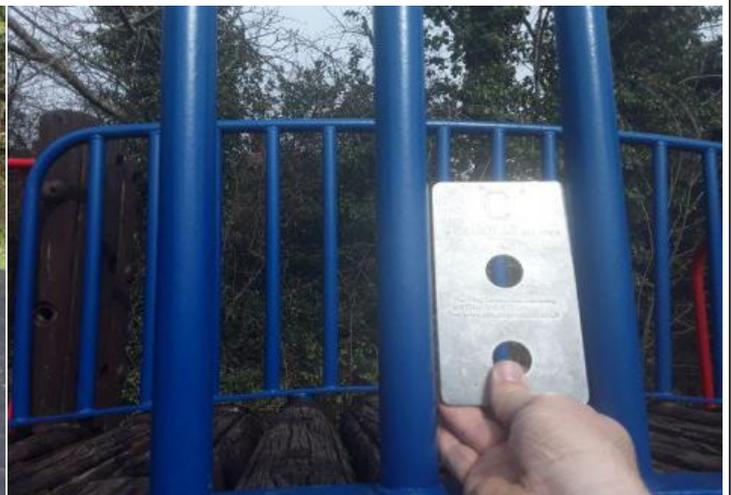
**Finding:** The item fails to meet the requirements of BS EN 1176 Part 1 4.2.7.2 head and neck entrapment in the barriers and/or steps **Action:** Monitor - No remedial work recommended

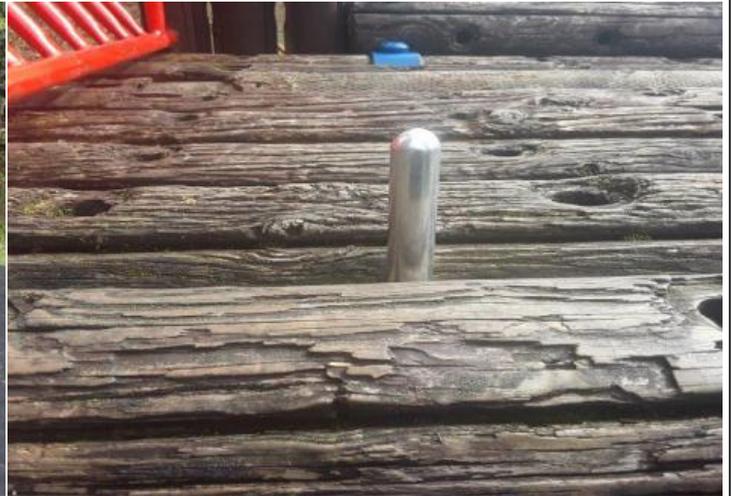
**Finding:** There is/are finger entrapment/s in the platforms and the item fails to meet the requirements of BS EN 1176 Part 1 4.2.7.6 Entrapment of fingers

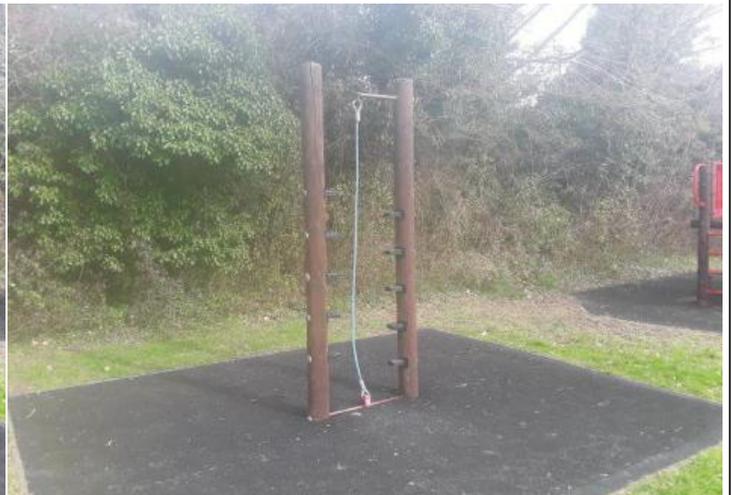
**Finding:** This item of equipment relies on a single post, or a line of posts, for stability and extra care needs to be taken with equipment of this nature to avoid the potential for catastrophic failure

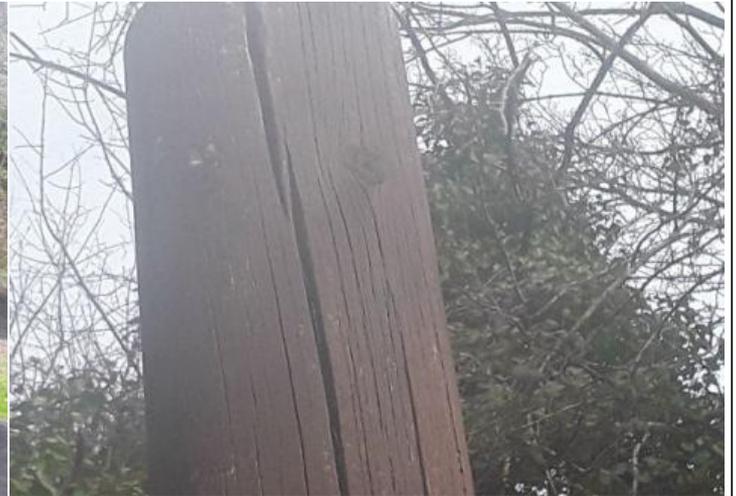
**Finding:** The timber has a number of splits/shakes or air cracks and this may affect the stability or allow water ingress which will accelerate the rotting process  
**Action:** Monitor to ensure the splits do not cross through fixing points of the structure and/or cause any instability

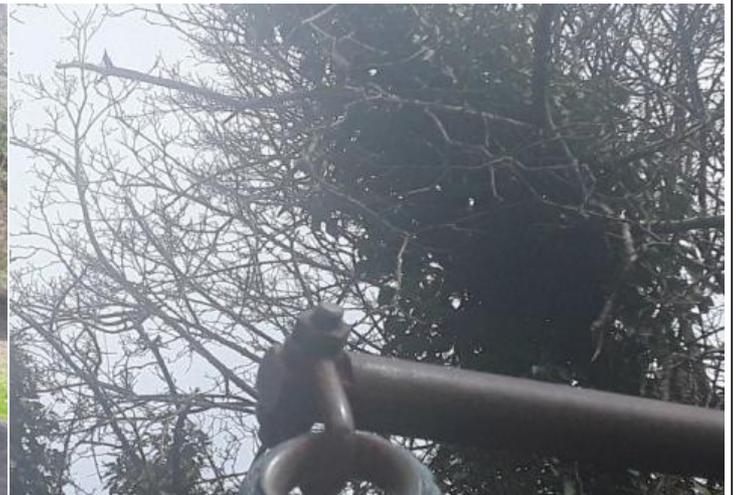
**Finding:** There is some wear to the shackles.  
**Action:** Monitor for any further deterioration and replace when 40% worn

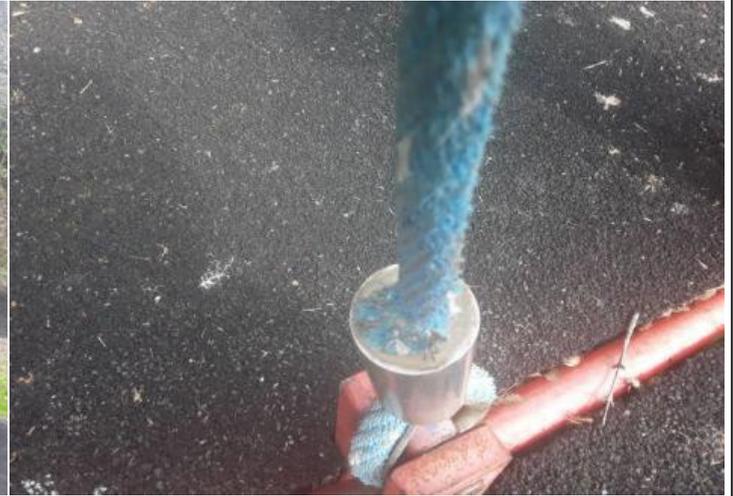
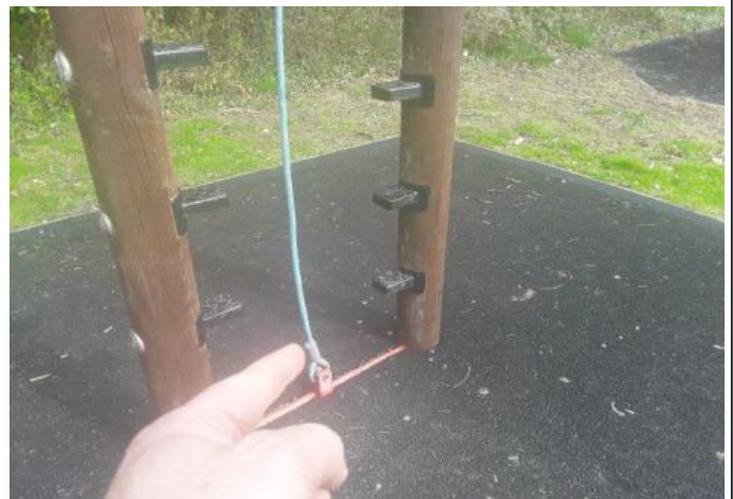
**Finding:** The rope has worn and there are sharp wire strands protruding
