# the **play inspection** company

## Annual Inspection

Winchester City Council

Sun Hill Recreation Ground (New Alresford)

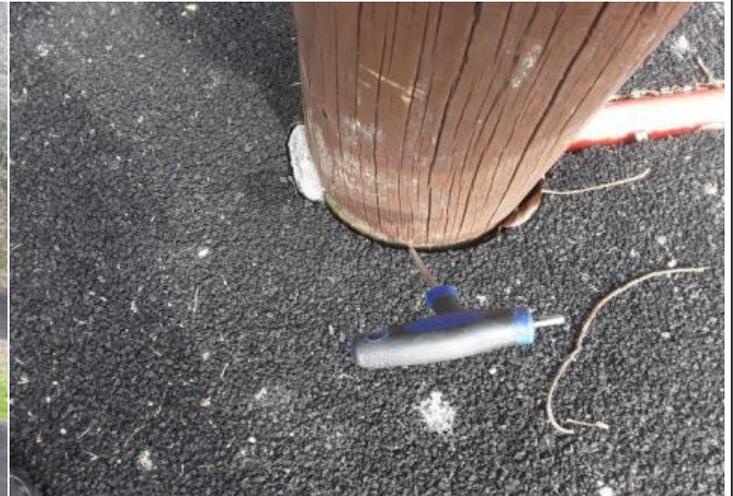
**Finding:** There is some evidence of rot in the posts

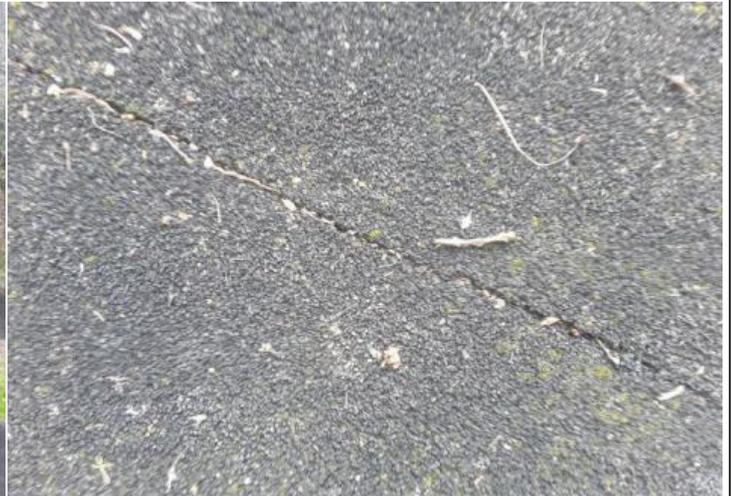
**Finding:** There is some minor damage to the surface

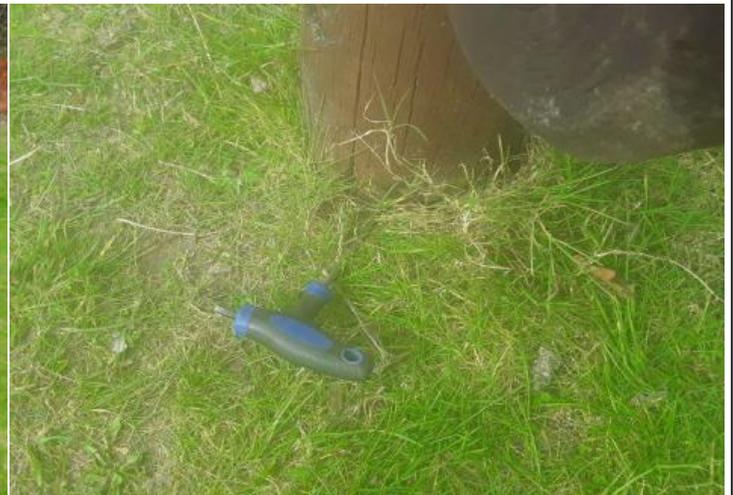
**Finding:** There is some evidence of rot in the posts  
**Action:** Monitor for any further deterioration and replace as required

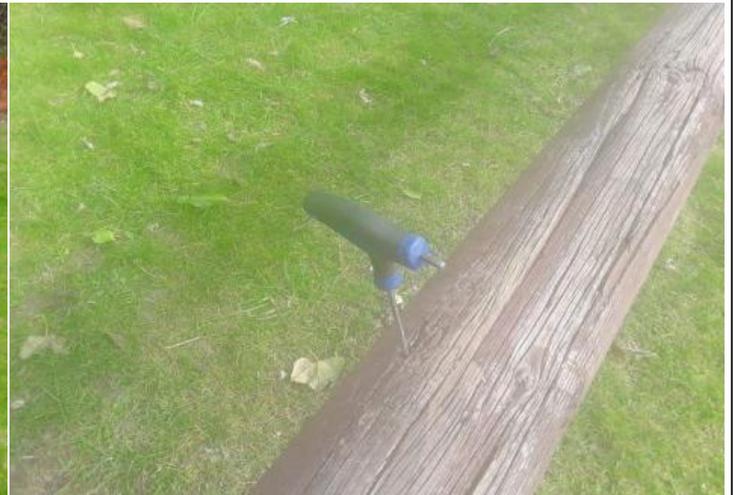
**Finding:** There is some evidence of rot in the timber  
**Action:** Monitor for any further deterioration and replace as required

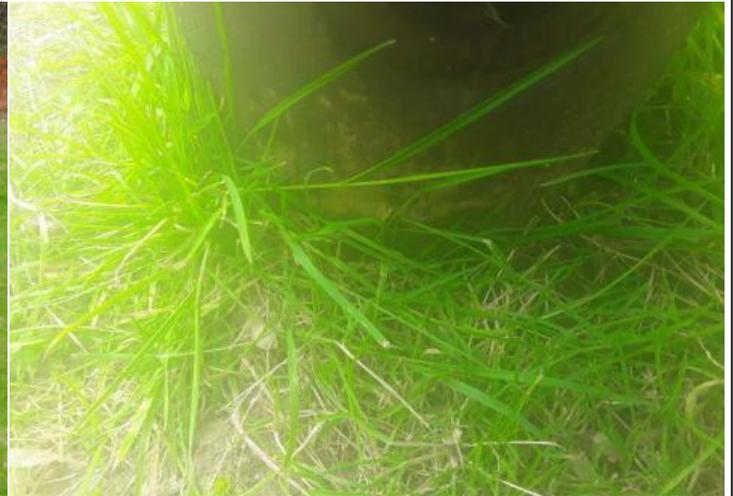
**Finding:** There is some strimmer / machinery damage apparent on the posts, this can penetrate the preservative applied to the timber and accelerate the rotting process

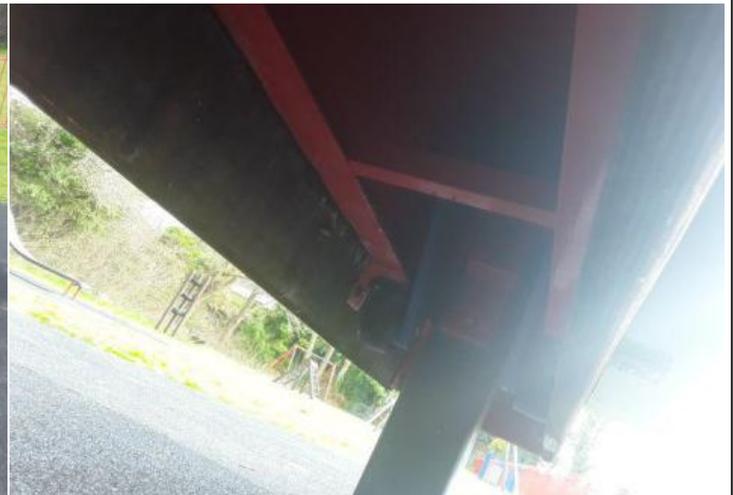
**Finding:** There is no gaiter protection for accessible moving parts (possible shear trap) as recommended in BS EN 1176 Part 1; 4.2.6 Moving Parts

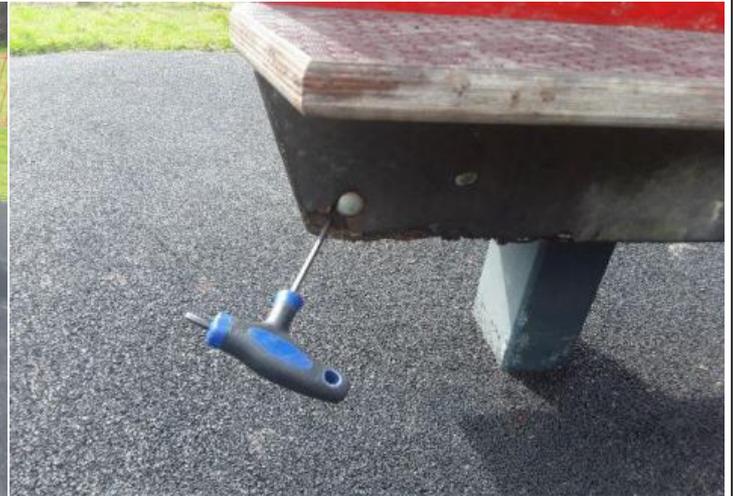
**Finding:** There is some evidence of rot in the timber

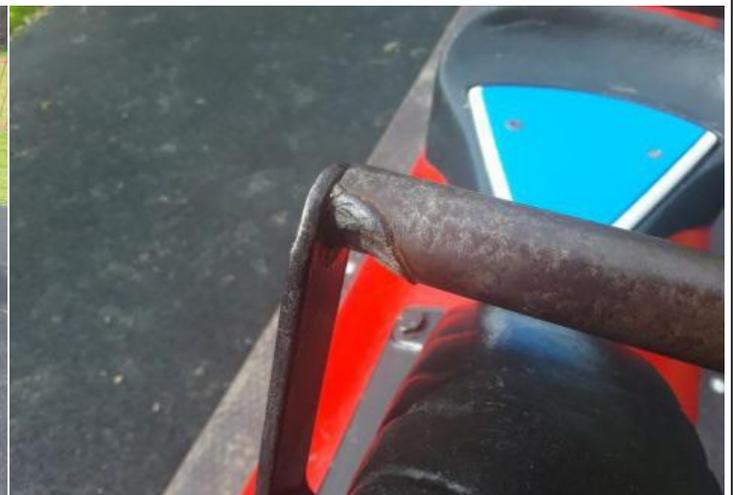
**Finding:** There is some evidence of fire damage to the item

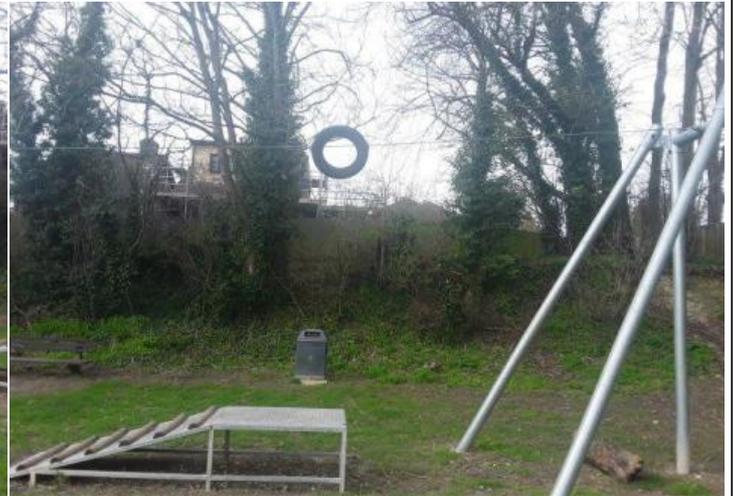
**Finding:** We have completed a visual inspection of the cable and fixing points from ground level, however it is not possible to fully inspect the cable and fixings without either hiring equipment to gain access or removing the cable and inspecting at ground level. We recommend that the main cable and fixing security is thoroughly inspected at least in accordance with the manufacturers recommendations to check for damage, security or internal rusting, this will help to ensure the continued safe use of the equipment

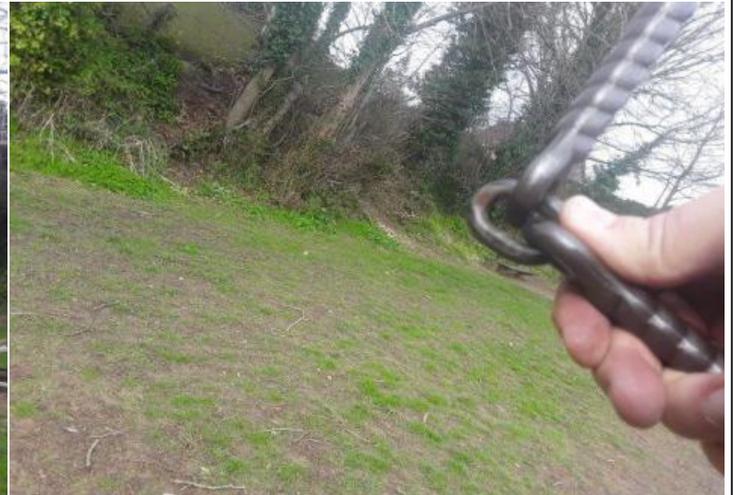
**Finding:** There is some notable evidence of chain wear

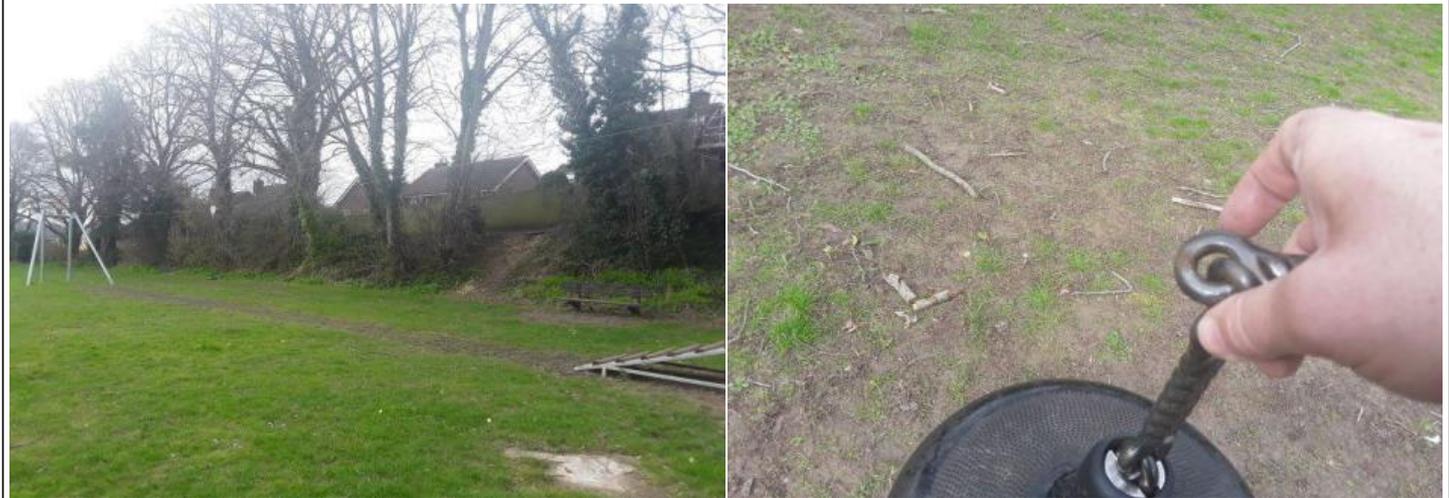
**Finding:** There is some wear to the chain bars  
**Action:** Monitor for any further deterioration and replace when 40% worn

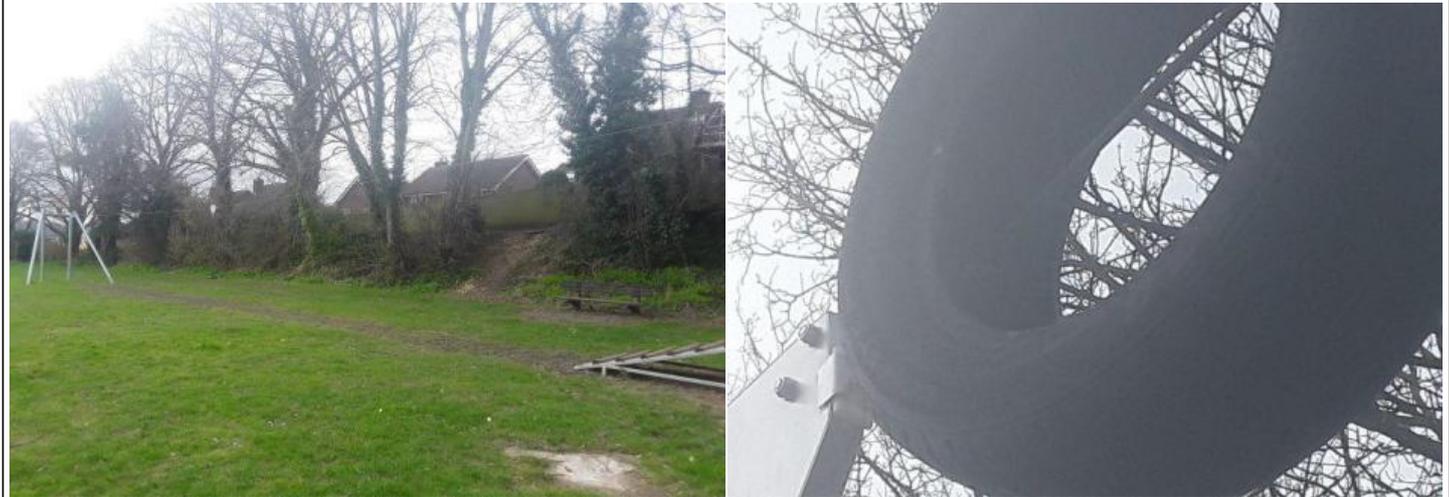
**Finding:** The tyre wall cable grips are loose  
**Action:** Rectify installation and repair to manufacturer instructions

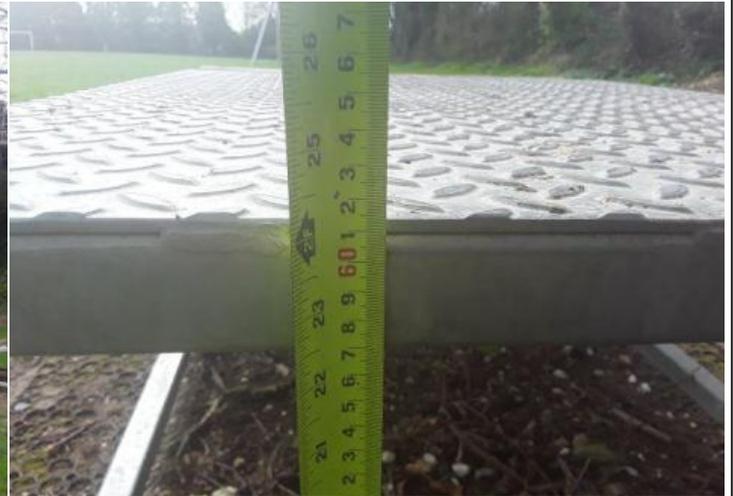
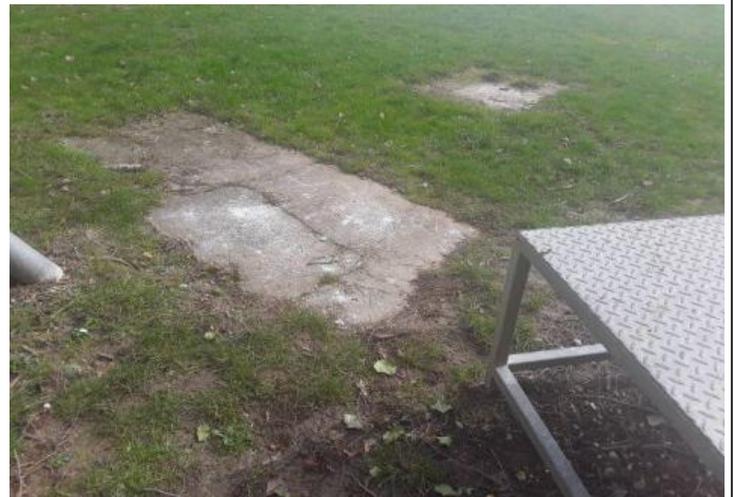
**Finding:** This platform has a fall height in excess of 600mm and an impact absorbing surface is recommended to meet the recommendations of BS EN 1176 Part 1

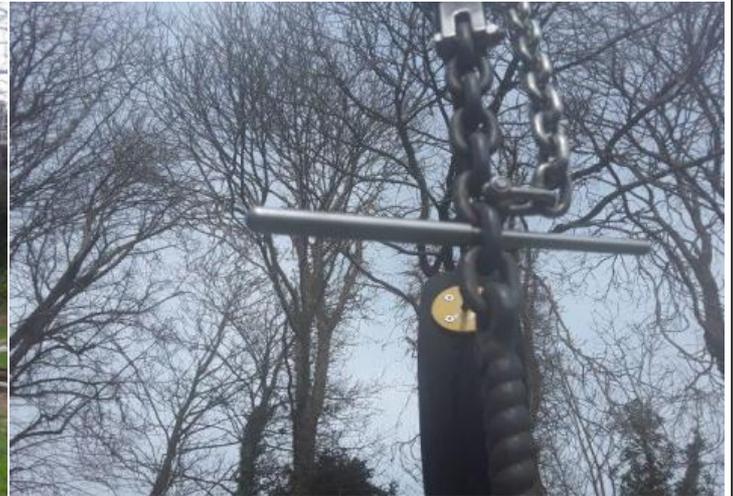
**Finding:** The chain openings are in excess of the 8.6mm as recommended by BS EN 1176 **Action:** Monitor - No remedial work recommended
