## Annual Inspection

Winchester City Council

Arlebury Park, Skate Park & Tennis(New Alresford)

The Avenue, Alresford, SO24 9EP

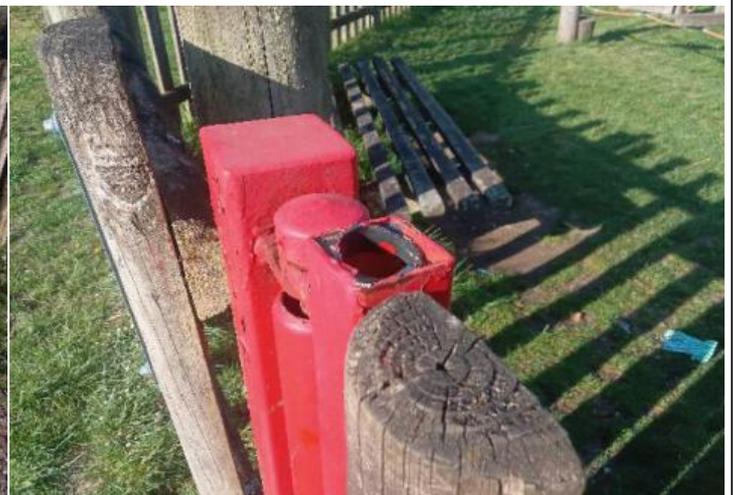
**Finding:** There is / are post or end caps missing / damaged on the item

**Action:** Replace missing / damaged post or end caps

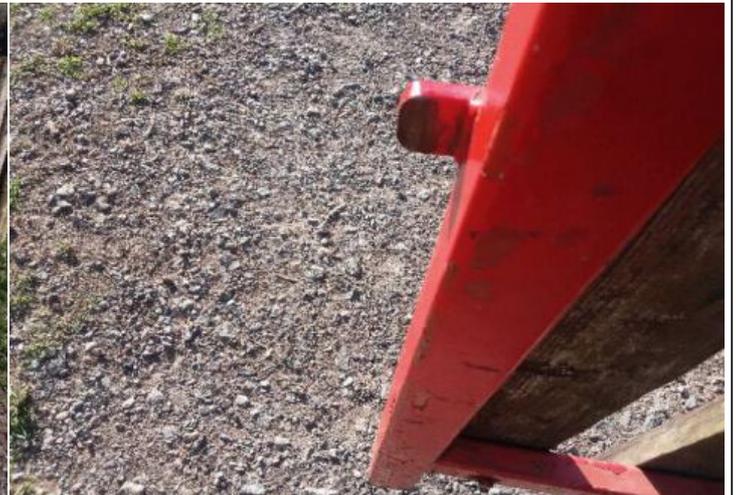
**Finding:** The rubber buffer is missing from the latch plate

**Action:** Replace rubber buffer

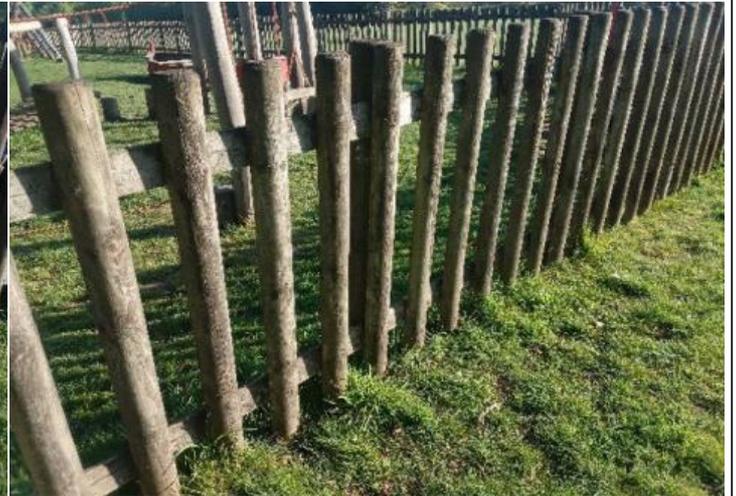
**Finding:** There are a number of loose posts around the fence

**Action:** Monitor for any further deterioration and reset as required

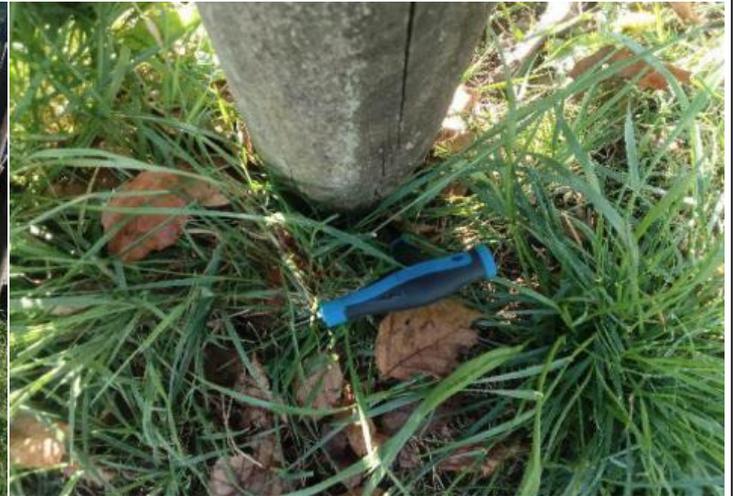
**Finding:** There are areas or parts of the timber on the structure that have rotted

**Action:** Replace all affected timbers

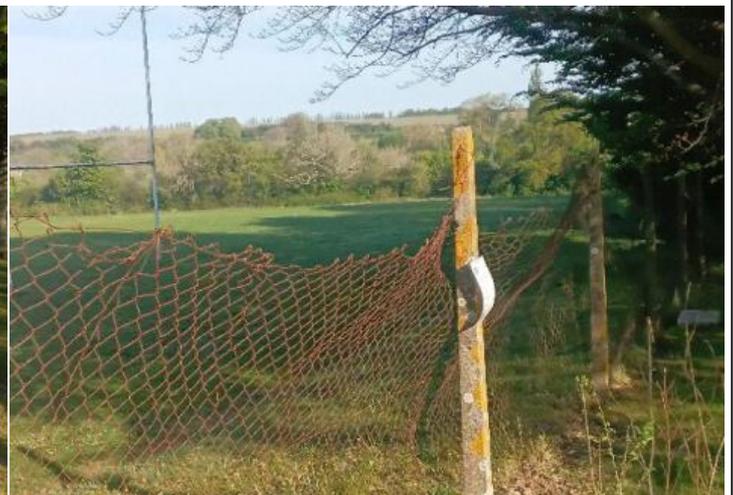
**Finding:** The fence is severely damaged in places

**Action:** Repair or replace all affected sections

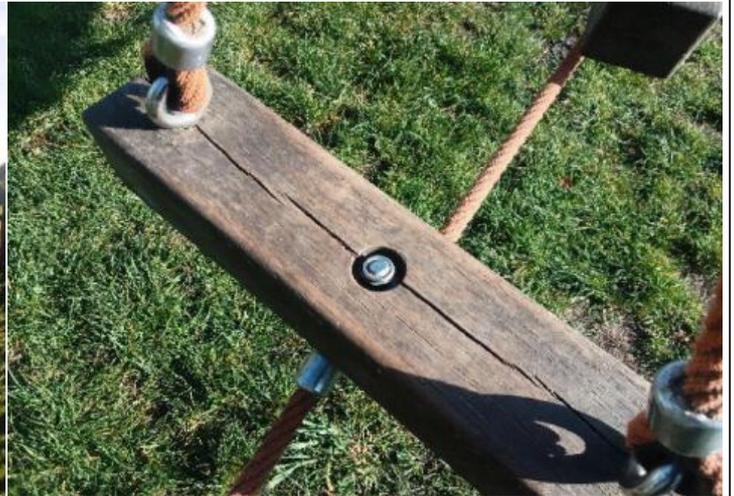
**Finding:** There is/are bolt cap covers missing or damaged on the item

**Action:** Replace missing or damaged bolt cap covers

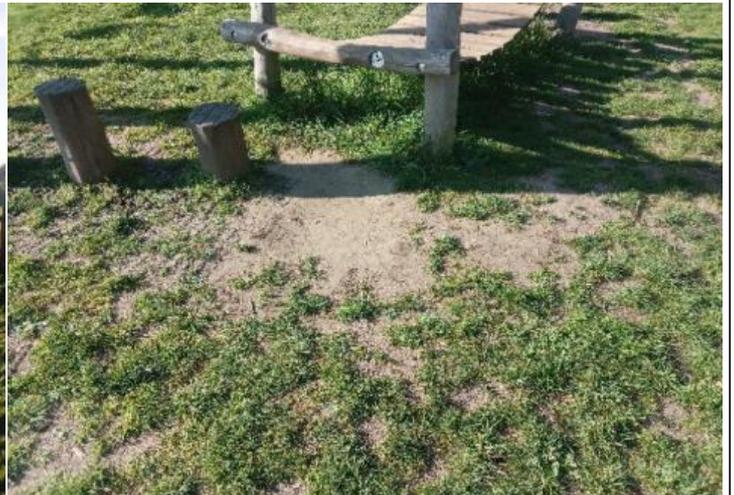
**Finding:** The surface has eroded in some areas and may be slippery in wet conditions

**Action:** Reinstate the surface

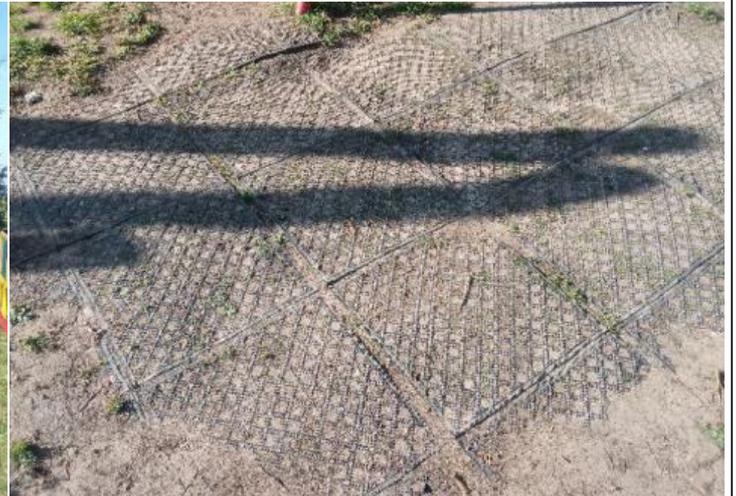
**Finding:** The surface has subsided in some areas

**Action:** Monitor for any further deterioration and repair as required

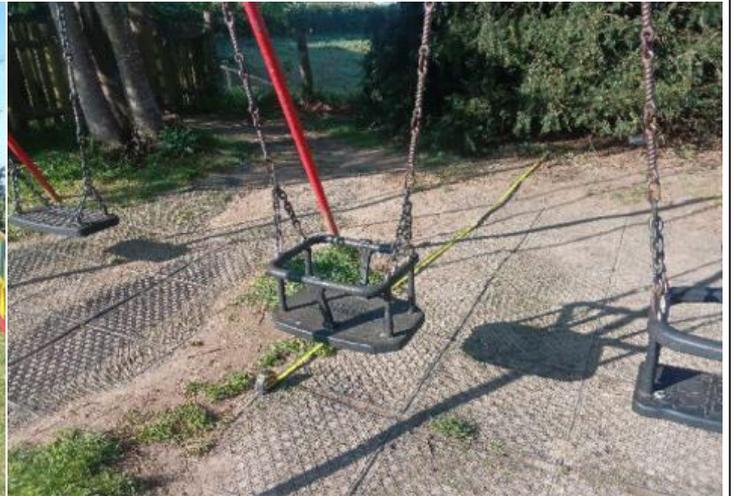
**Finding:** BS EN 1176 requires an additional 0.5m of unobstructed space at each end of the swing surfacing area. This is a relatively low risk finding and no remedial action is recommended at this point.

**Action:** Monitor - No action given the risk assessment

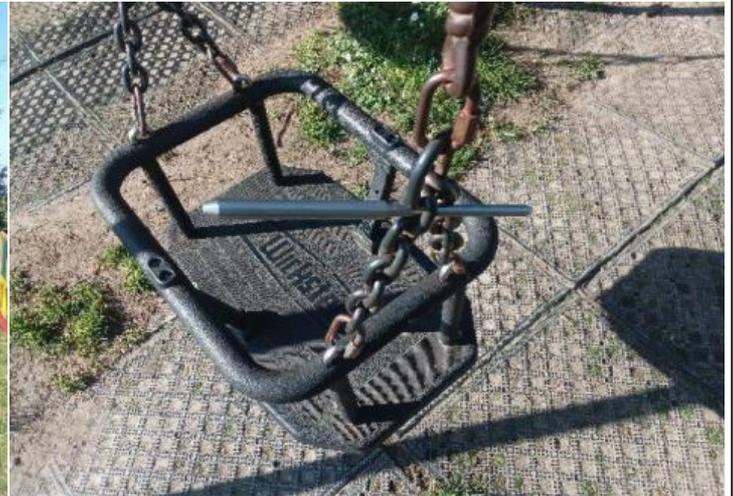
**Finding:** The chain openings are in excess of the 8.6mm as recommended by BS EN 1176  
**Action:** Monitor - No action given the risk assessment

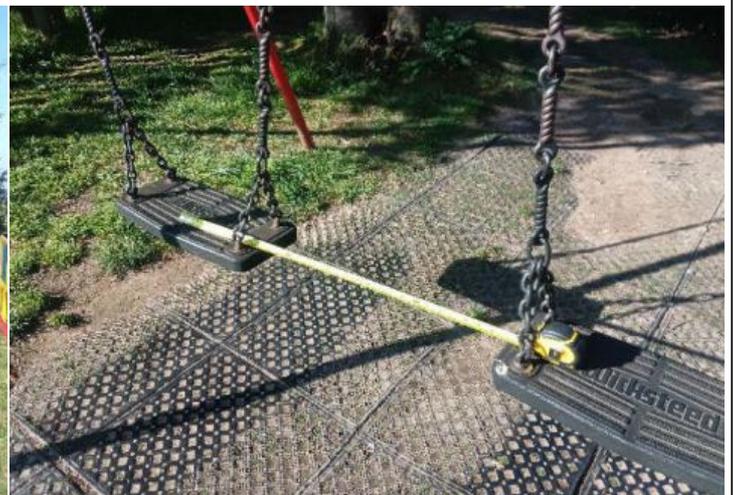
**Finding:** The seats are too close to each other as defined in BS EN 1176 Part 2; this is a low risk failure and no remedial action is required  
**Action:** Monitor - No action given the risk assessment

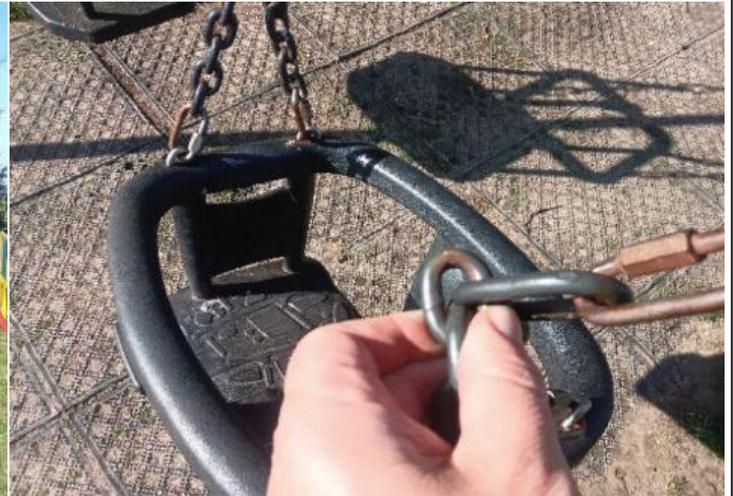
**Finding:** There is some notable evidence of chain wear

**Action:** Monitor for any further deterioration and replace when 40% worn

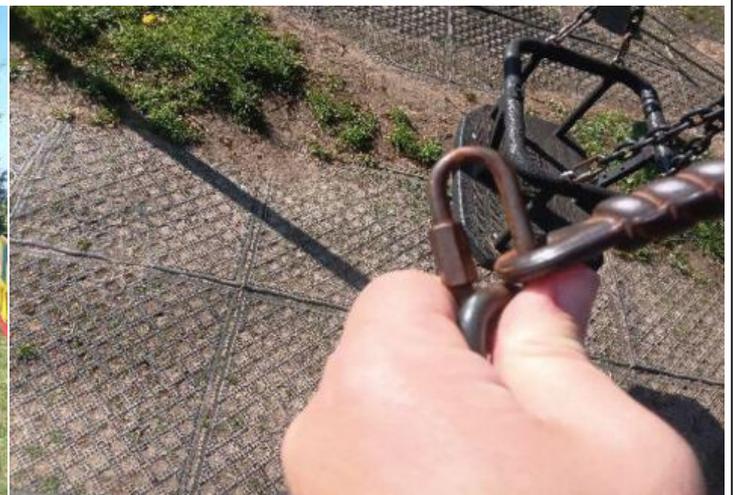
**Finding:** There is some wear to the connecting links

**Action:** Monitor for any further deterioration and replace when 40% worn

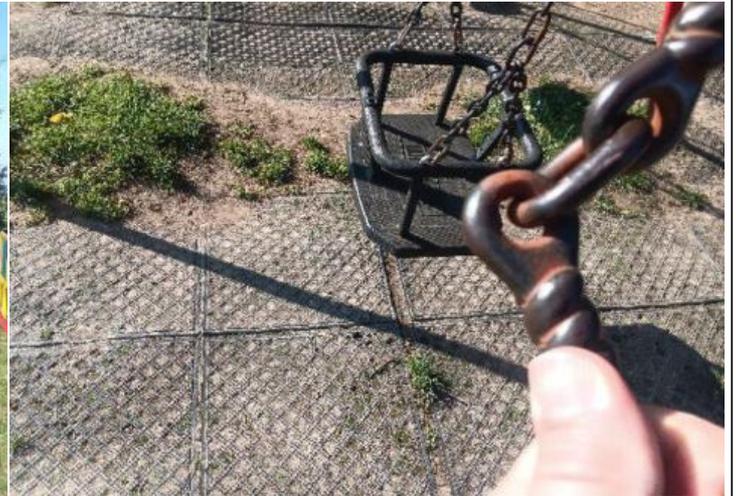
**Finding:** There is some wear to the chain bars

**Action:** Monitor for any further deterioration and replace when 40% worn

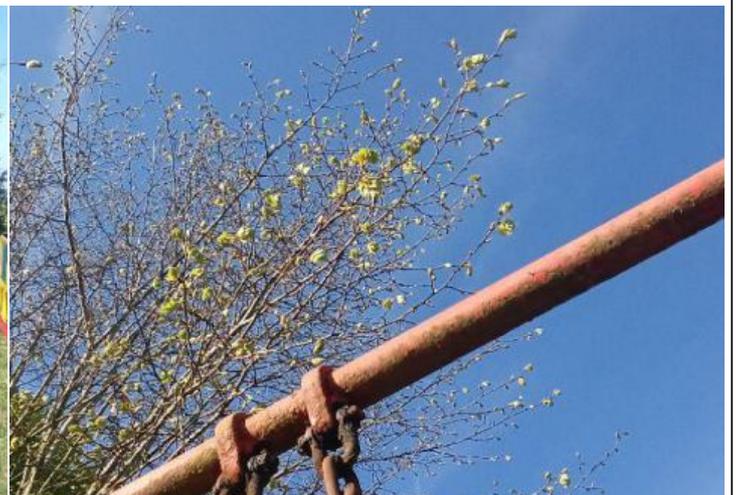
**Finding:** The bush / bushes is / are worn or missing

**Action:** Replace worn or missing bushes

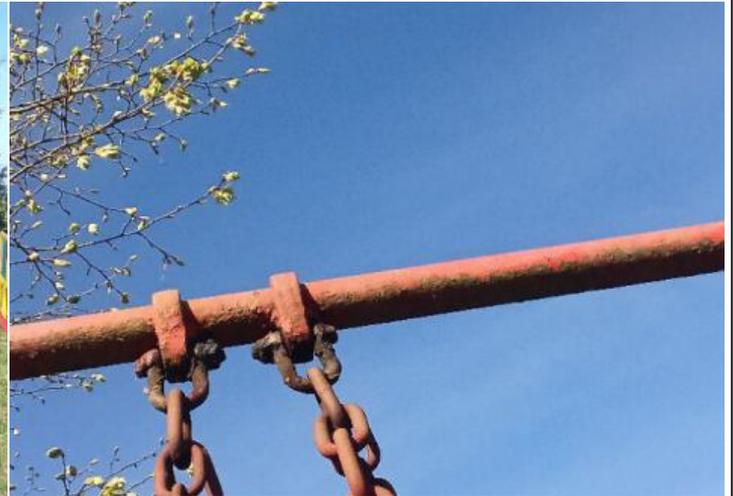
**Finding:** There is some wear to the shackles.

**Action:** Monitor for any further deterioration and replace when 40% worn

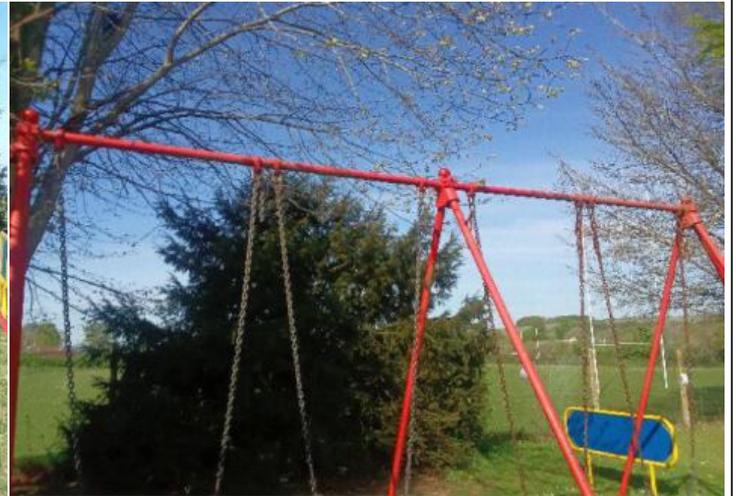
**Finding:** The fixings or components for this item were in excess of 2.5m above the standing surface and could not be fully accessed by the inspector. We have completed a visual inspection of the fixings from ground level but a maintenance inspection should be undertaken to assess the condition, security and wear of the components at intervals in accordance with the manufacturers recommendations.

**Action:** Inspect in accordance with the manufacturers recommendations

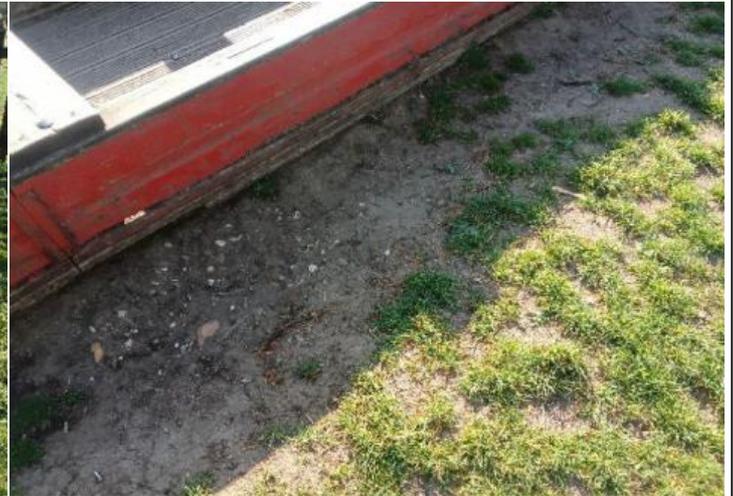
**Finding:** The surface has eroded in some areas and may be slippery in wet conditions  
**Action:** Reinststate the surface

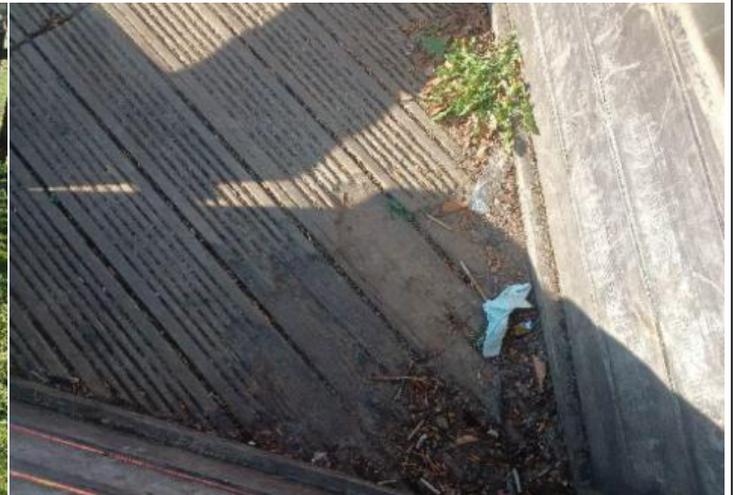
**Finding:** There is some evidence of fire damage to the item  
**Action:** Monitor for any further deterioration and repair as required

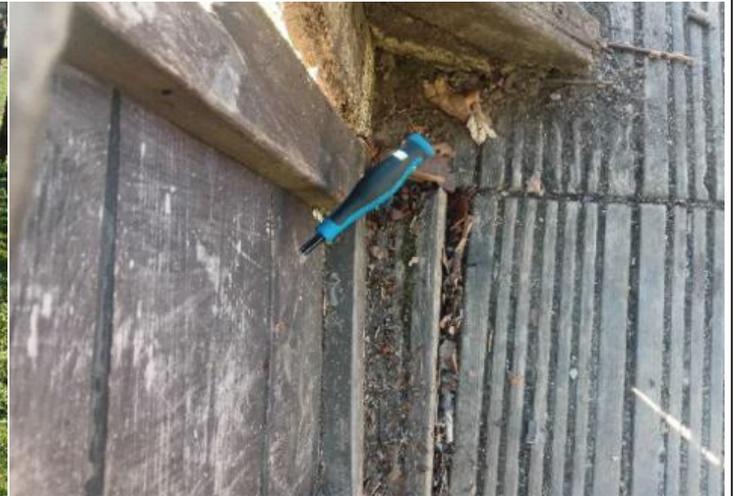
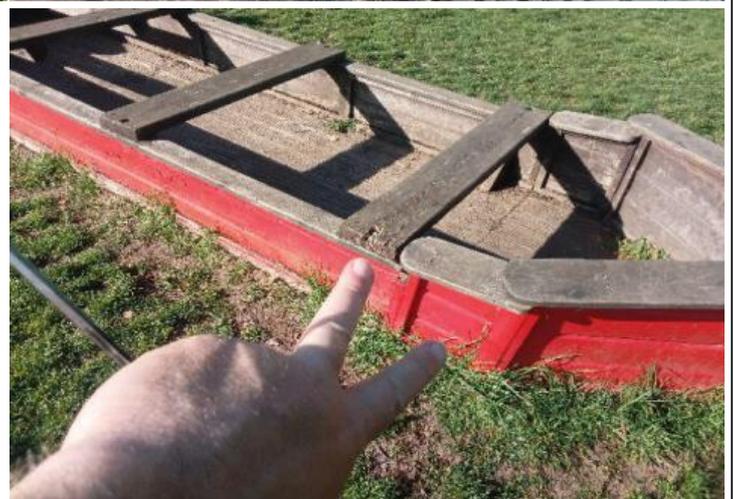
**Finding:** There are areas or parts of the timber on the structure that have rotted

**Action:** Replace all affected timbers

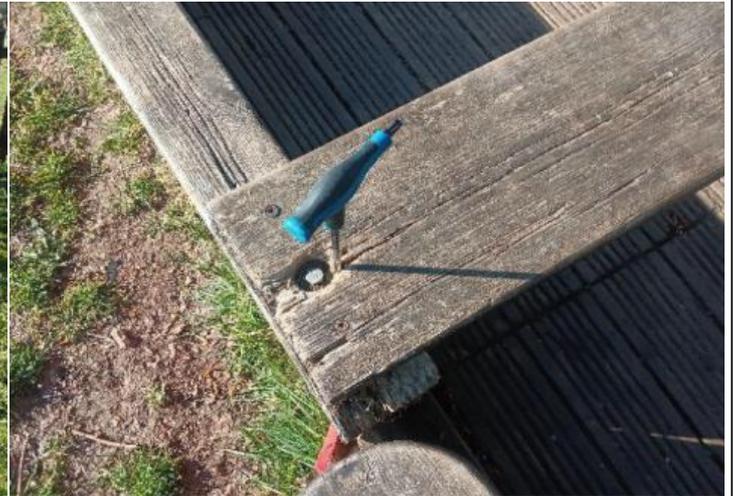
**Finding:** There is some evidence of rot in the timber

**Action:** Monitor for any further deterioration and replace as required

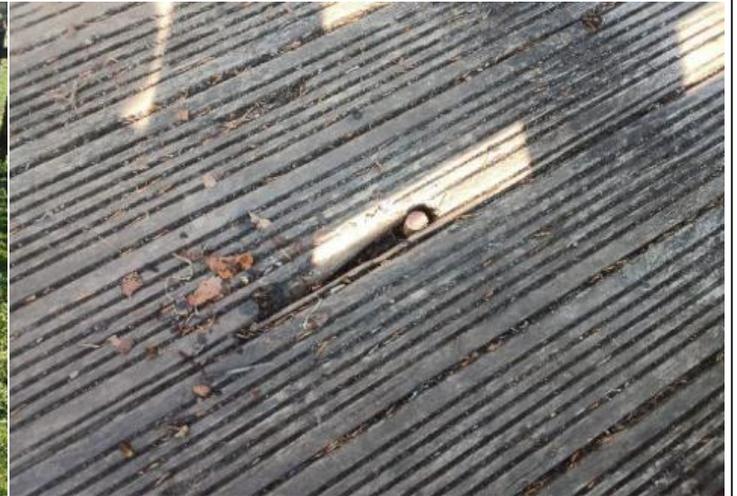
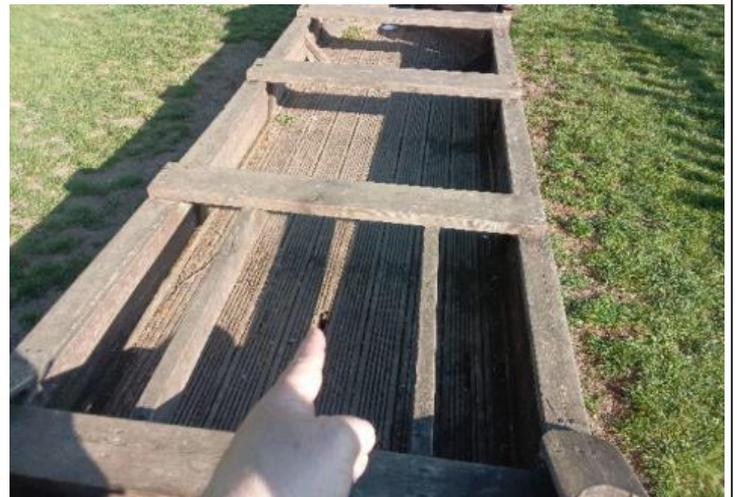
**Finding:** The decking is damaged exposing ground fixings

**Action:** Repair affected areas

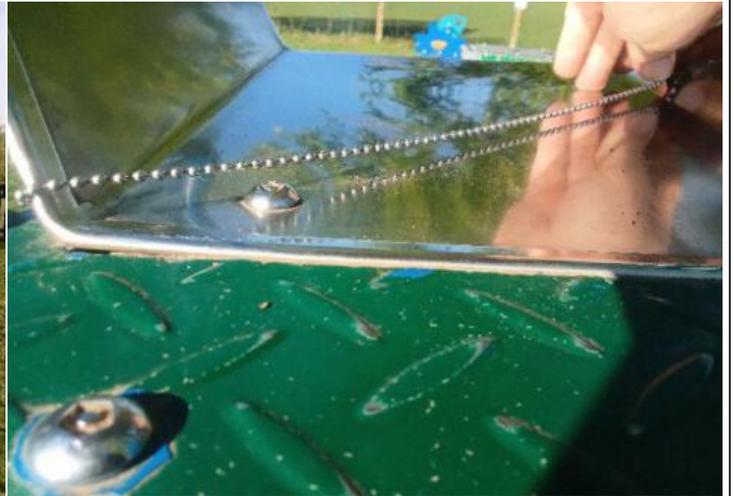
**Finding:** There is / are toggle entrapment/s present in contravention of the recommendations set out in BS EN 1176 Part 1

**Action:** Monitor - No action given the risk assessment

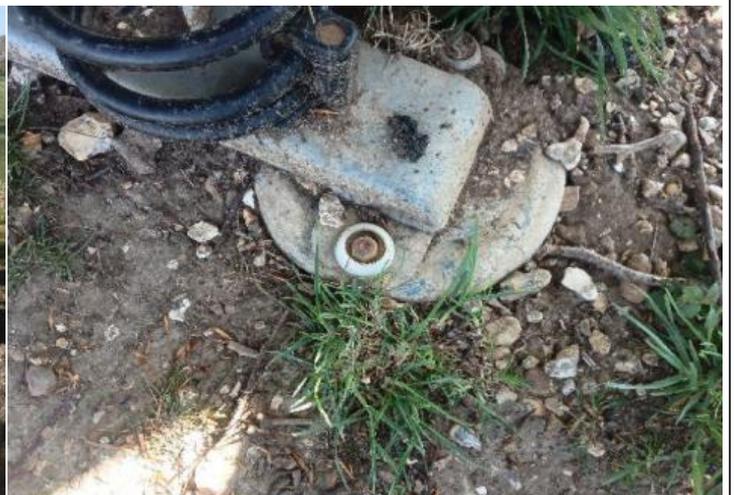
**Finding:** There is/are bolt cap covers missing or damaged on the item

**Action:** Replace missing or damaged bolt cap covers

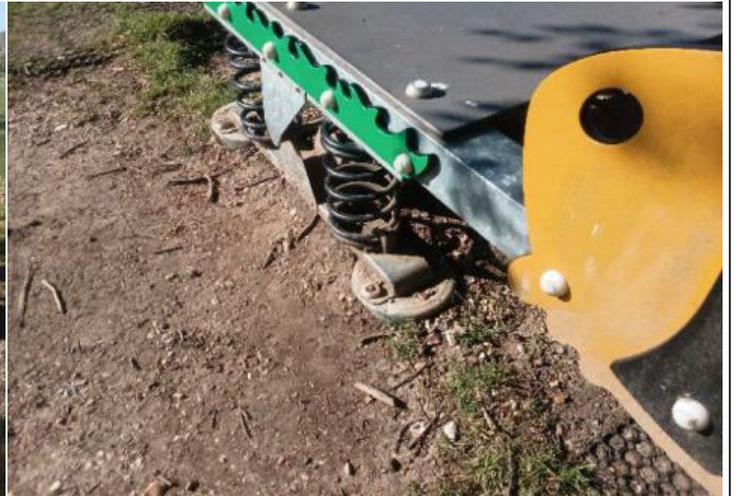
**Finding:** The spring mounting plate is slightly loose in the ground

**Action:** Monitor for any further deterioration and repair as required

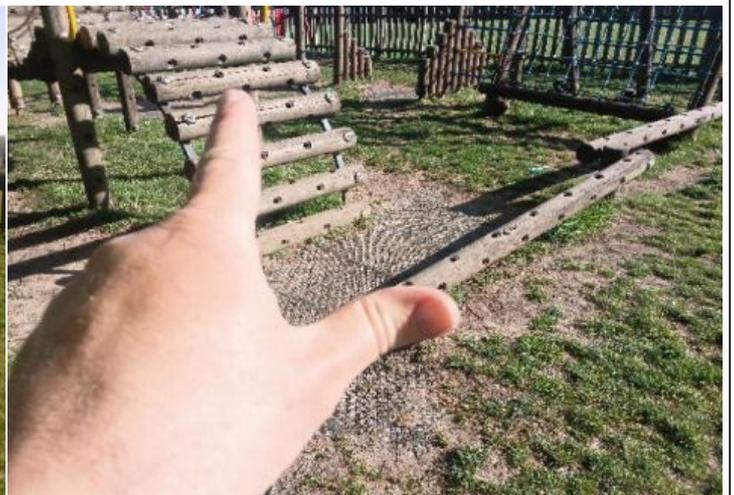
**Finding:** There are falls in excess of 600mm between adjacent components on the structure, in contravention of the recommendations set out in BS EN 1176 Part 1; 4.2.8.4

**Action:** Monitor - No action given the risk assessment

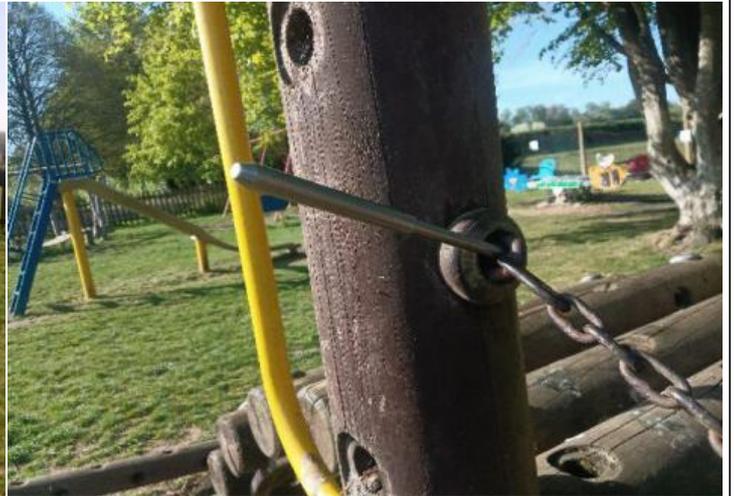
**Finding:** The connecting links are in excess of 8.6mm and less than 12mm and fail the requirements of BS EN 1176 Part 1; clause 4.2.13, Chains

**Action:** Monitor - No action given the risk assessment

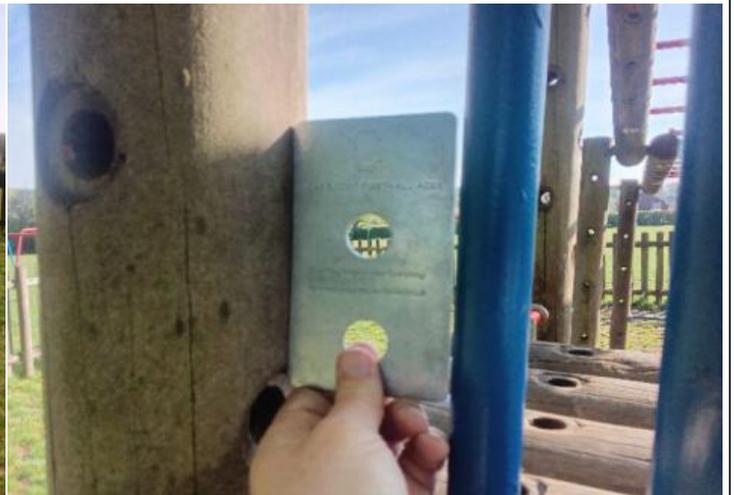
**Finding:** The item fails to meet the requirements of BS EN 1176 Part 1 4.2.7.2 head and neck entrapment in the barriers and/or steps

**Action:** Monitor - No action given the risk assessment

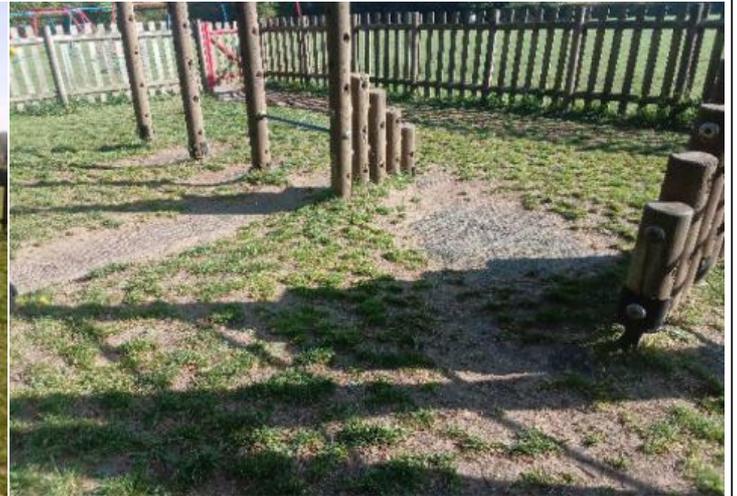
**Finding:** The surface has subsided in some areas

**Action:** Monitor for any further deterioration and repair as required

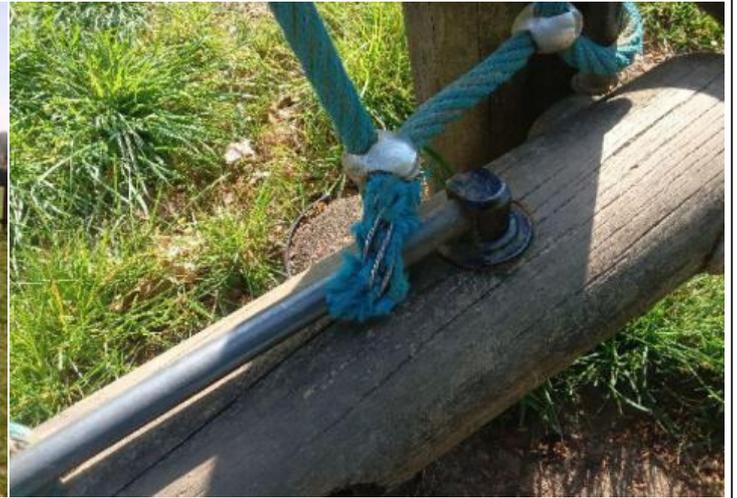
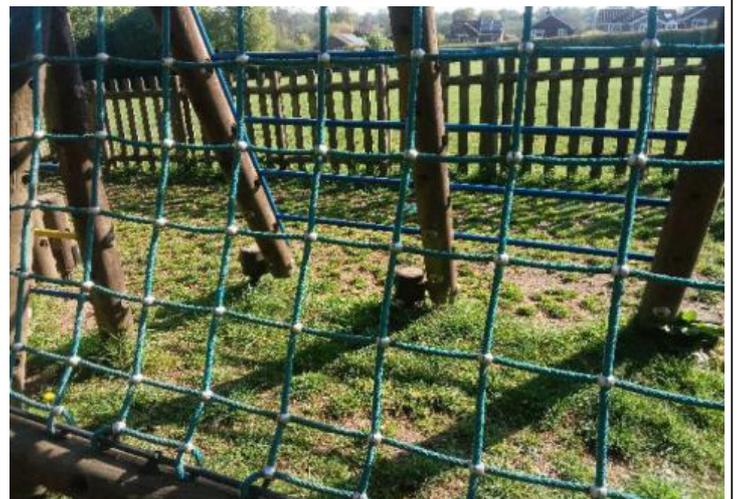
**Finding:** The rope has worn and wire strands are exposed

**Action:** Replace rope or net

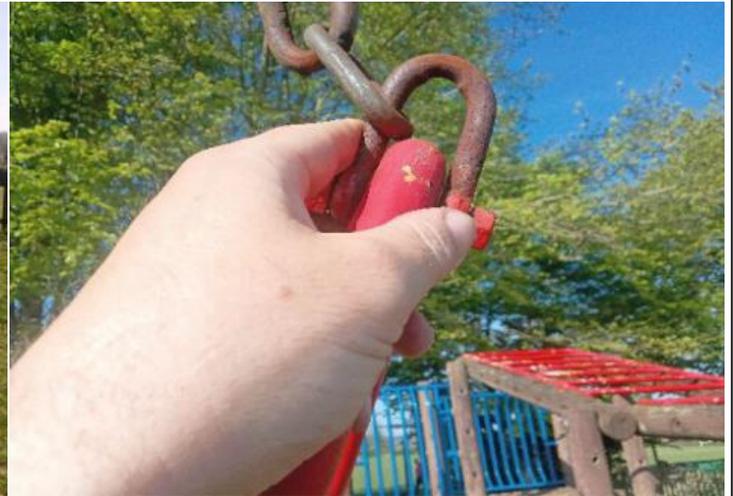
**Finding:** There is some wear to the shackles.

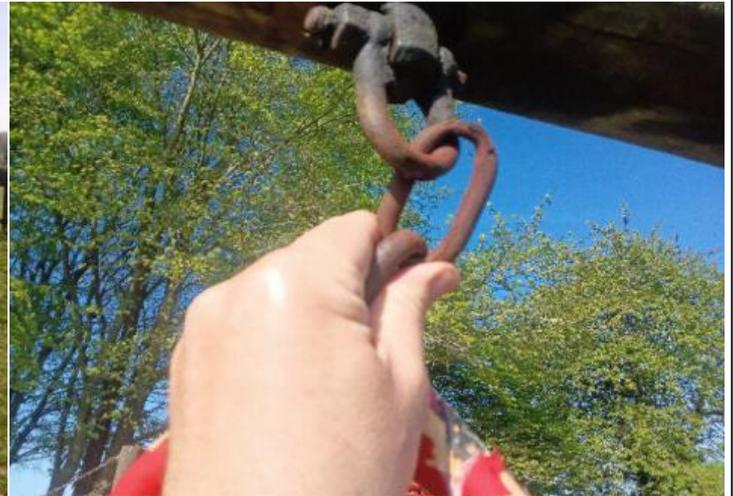
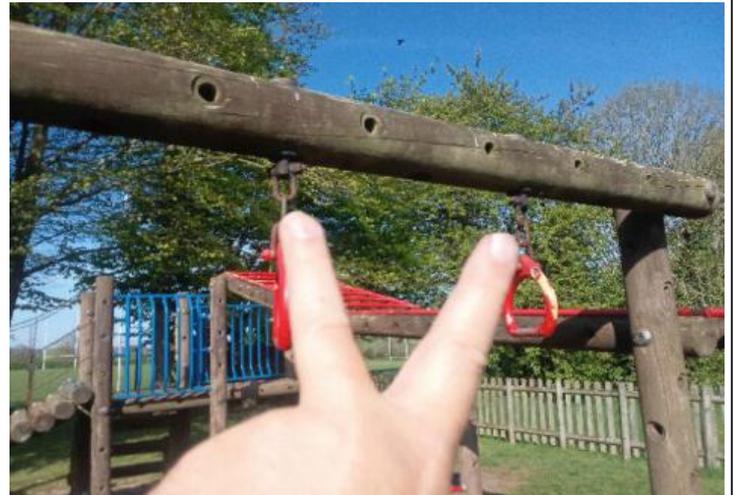
**Finding:** The chain links are worn excessively (50%) and require renewing

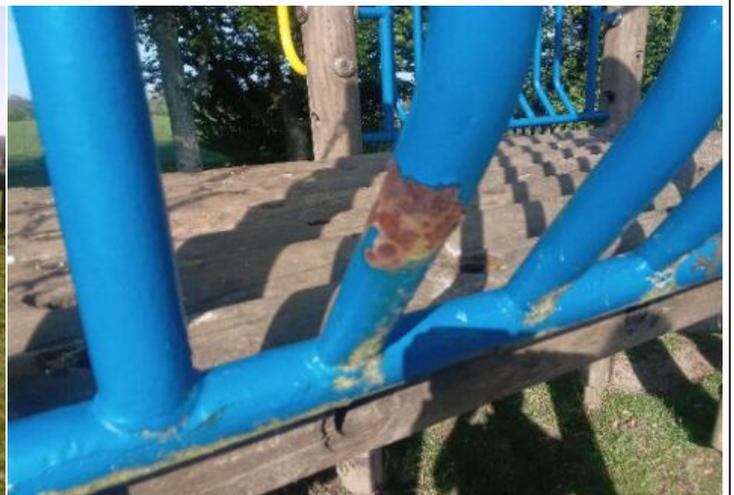
**Finding:** The paintwork on this item has been damaged or worn exposing the metal underneath which is rusting / corroding

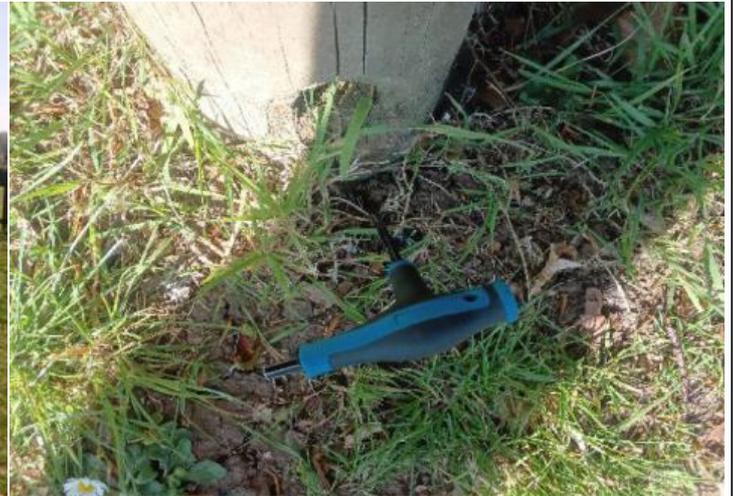
**Finding:** There is some evidence of rot in the timber

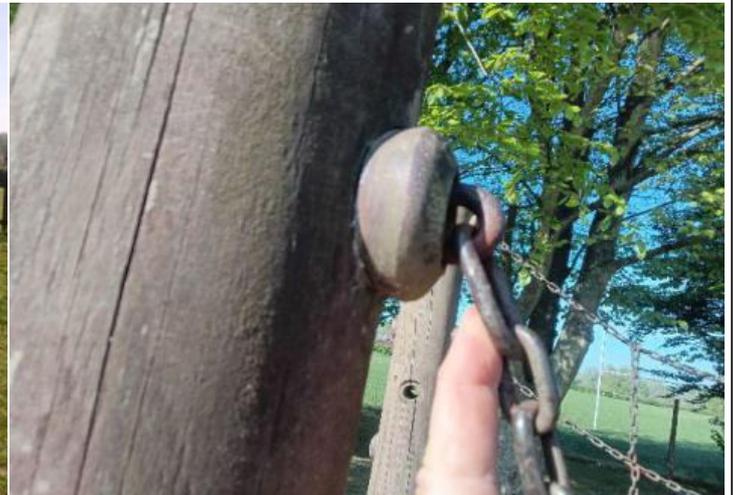
**Finding:** The connecting lugs are showing signs of wear

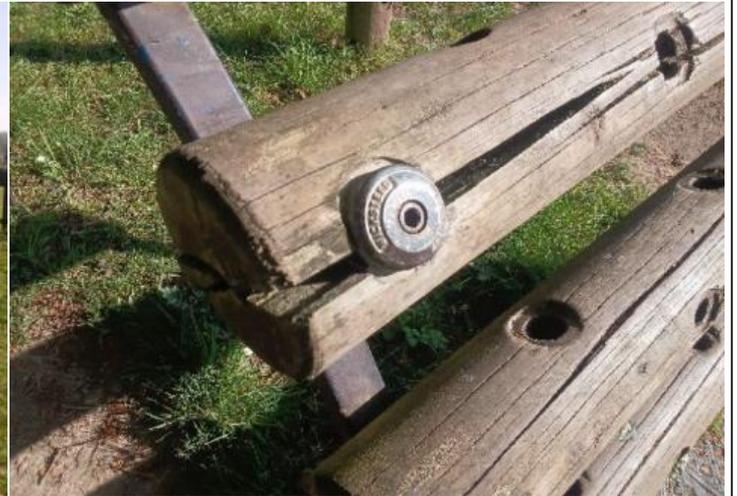
**Finding:** The timber has a number of splits/shakes or air cracks and this may affect the stability or allow water ingress which will accelerate the rotting process  
**Action:** Monitor to ensure the splits do not cross through fixing points of the structure and/or cause any instability

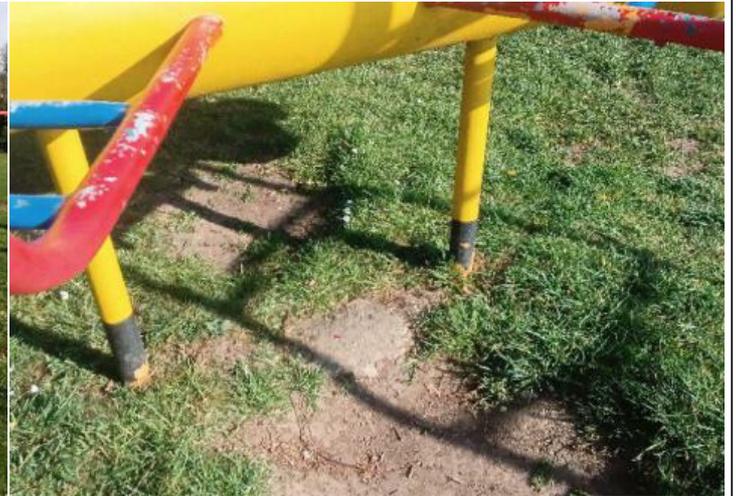
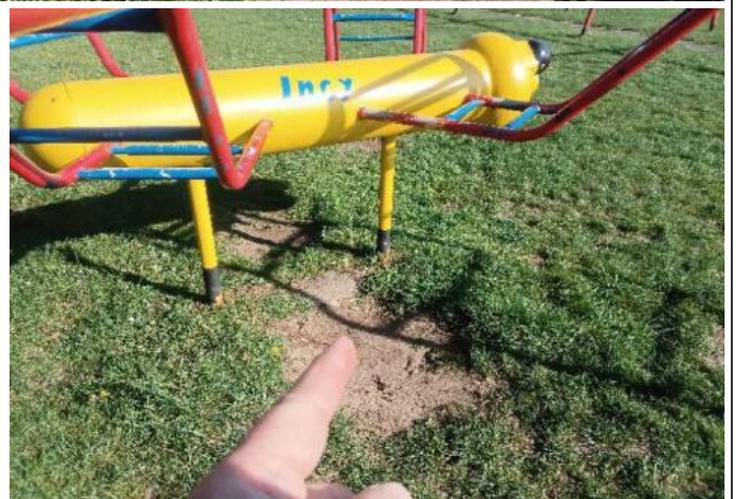
**Finding:** The surface has eroded and the foundations are exposed

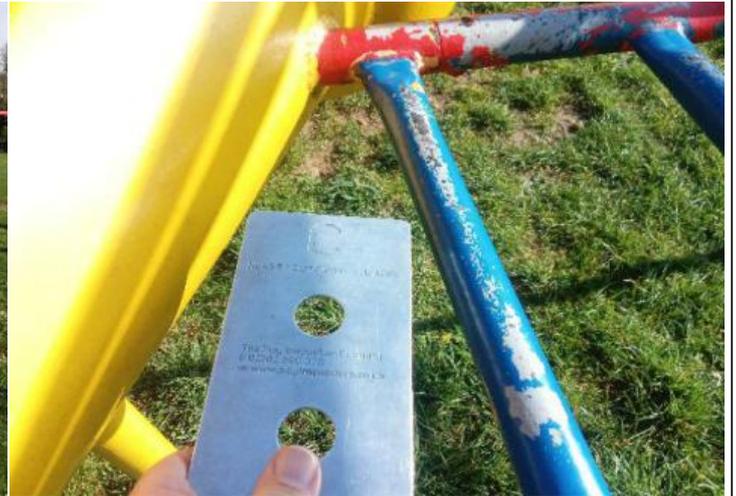
**Finding:** The item fails to meet the requirements of BS EN 1176 Part 1 4.2.7.2 for head and neck entrapment in the framework

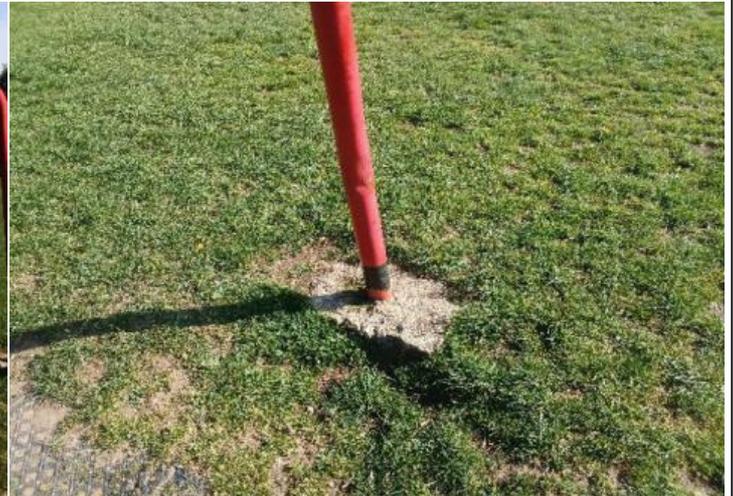
**Finding:** The surface has eroded and the foundations are exposed

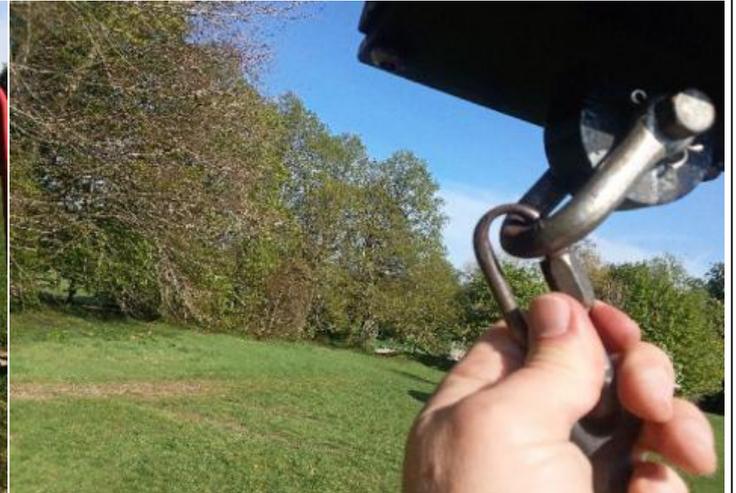
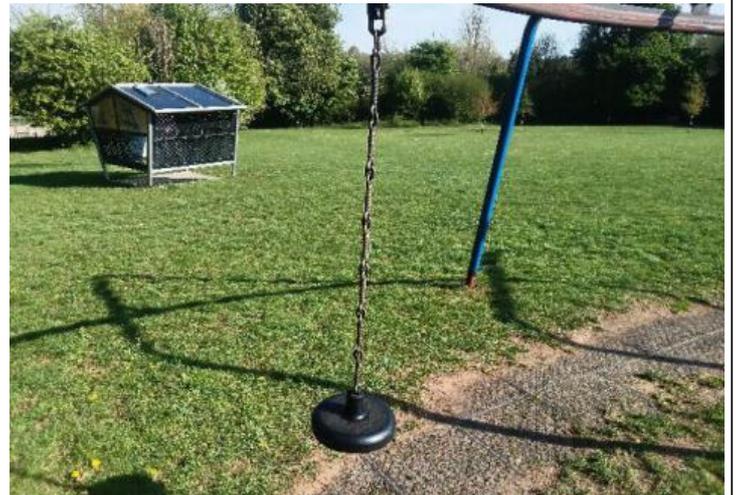
**Finding:** The connecting links are worn excessively (70%) and require renewing

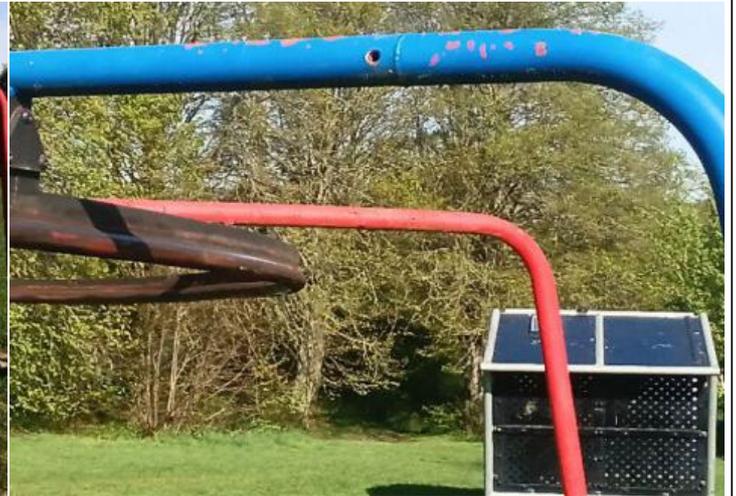
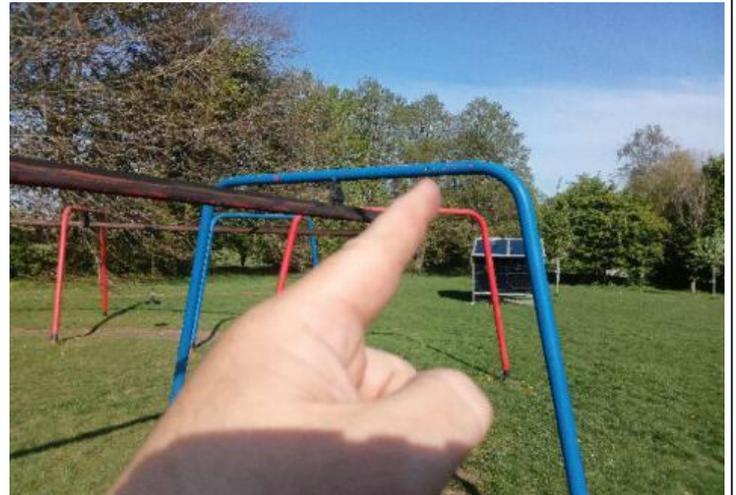
**Finding:** There is or are fixings missing on the item

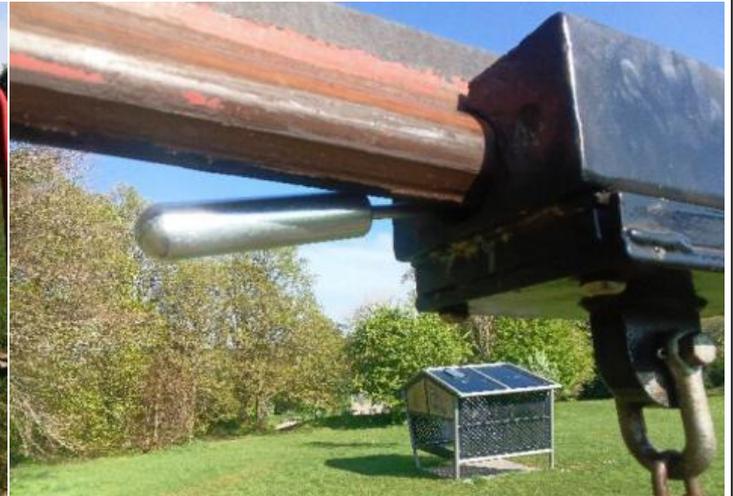
**Finding:** There is/are finger entrapment/s in the traveller and the item fails to meet the requirements of BS EN 1176 Part 1 4.2.7.6 Entrapment of fingers

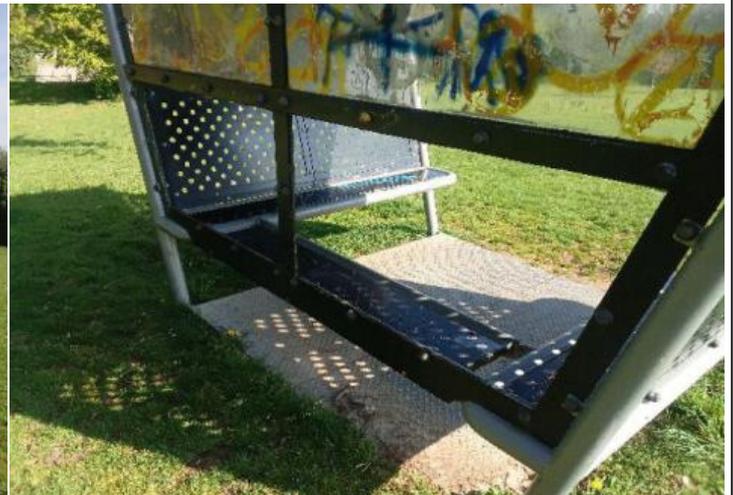
**Finding:** The item has missing component(s)

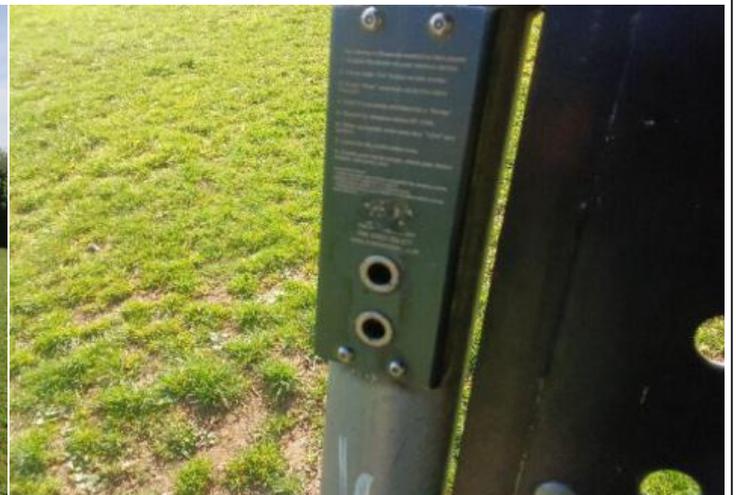
**Finding:** The communication panel is damaged

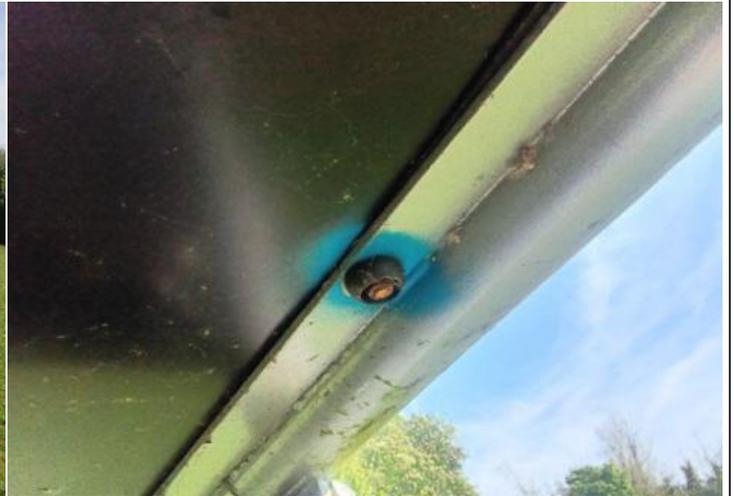
**Finding:** There is/are bolt cap covers missing or damaged on the item

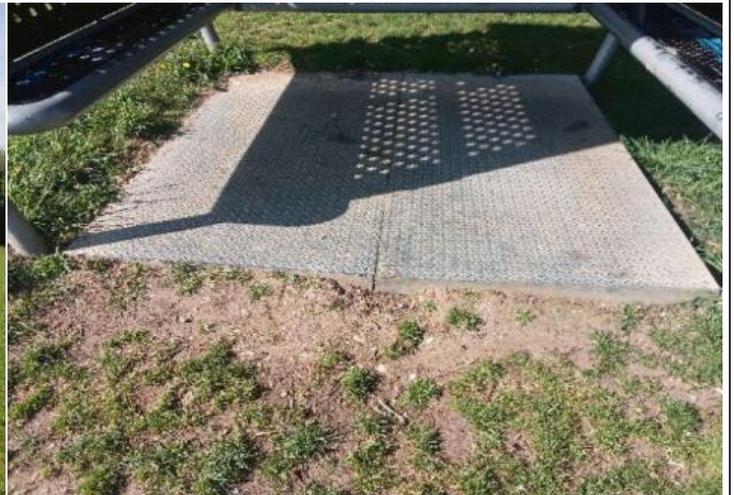
**Finding:** There are trip hazards at the edges of the surface

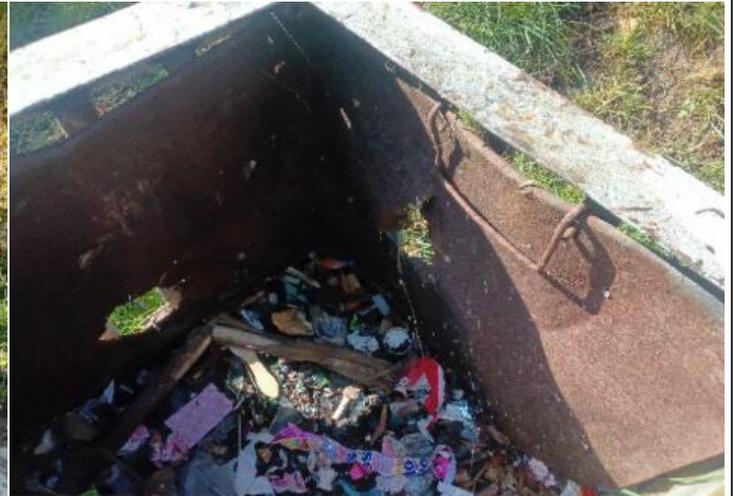
**Finding:** Parts of the steel on this item have corroded excessively and the metal has perforated in places

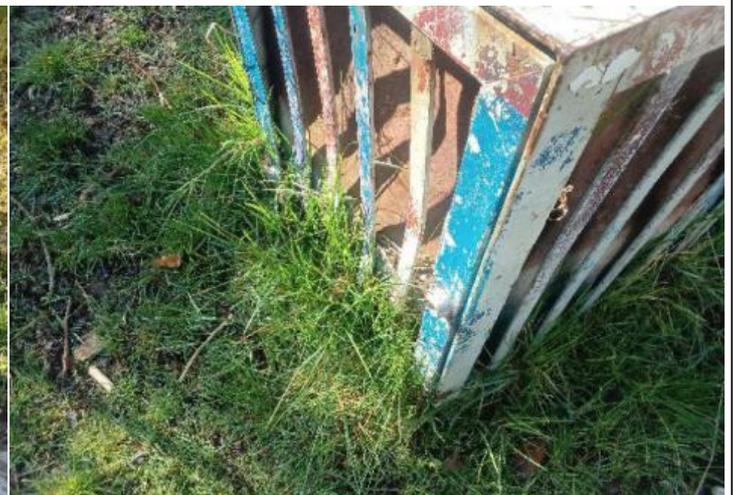
**Finding:** The bin has been damaged

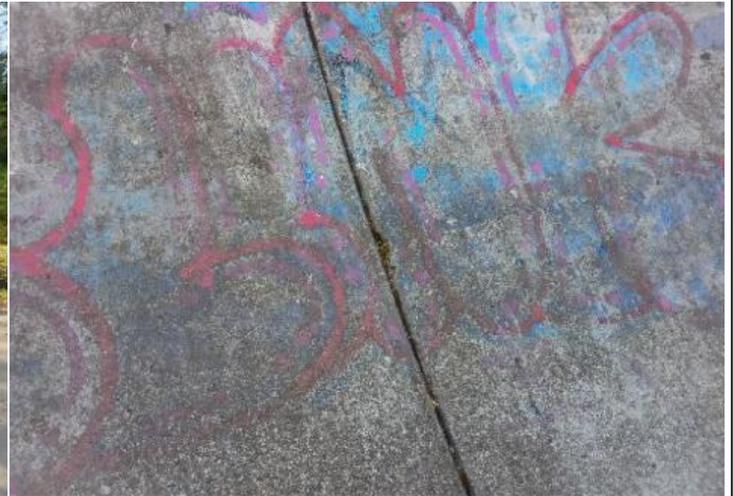
**Finding:** The riding surface has minor damage apparent

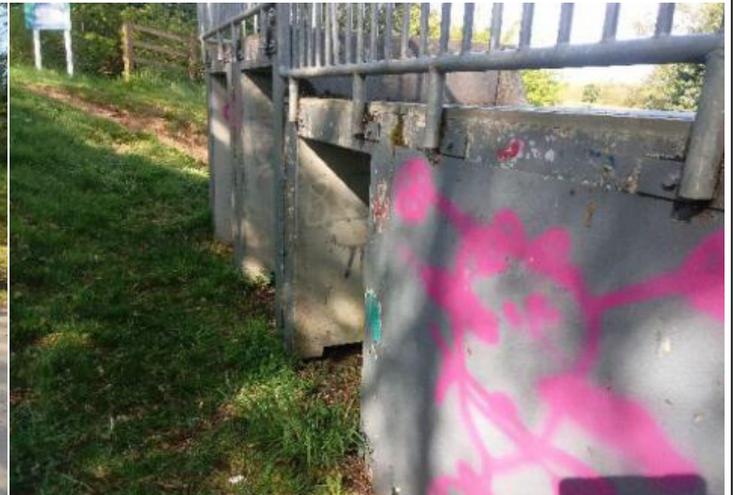
**Finding:** The rear panels are missing

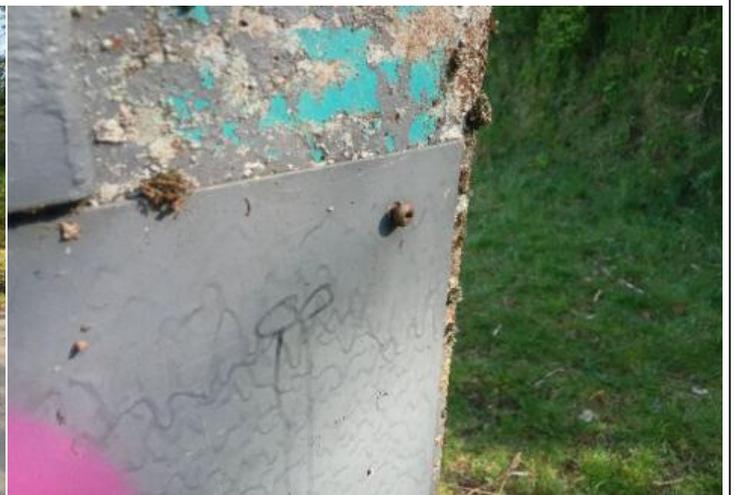
**Finding:** A number of fixing(s) have worked loose
