## Annual Inspection

Winchester City Council

Arlebury Park, Skate Park & Tennis(New Alresford)

The Avenue, Alresford, SO24 9EP

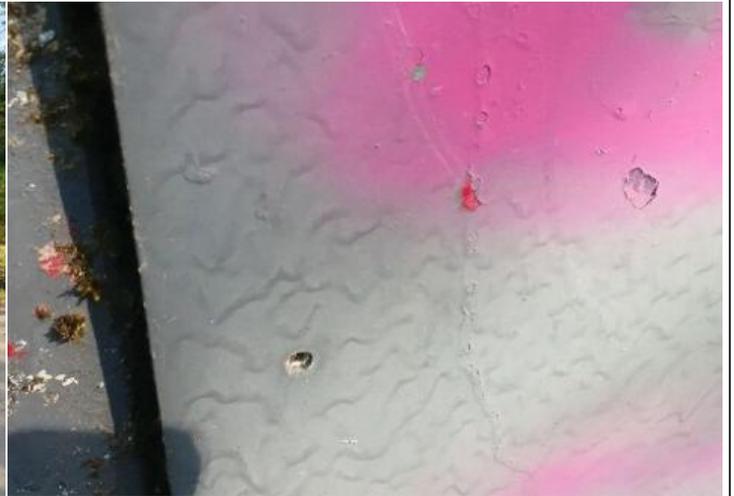
**Finding:** There is or are fixings missing on the item

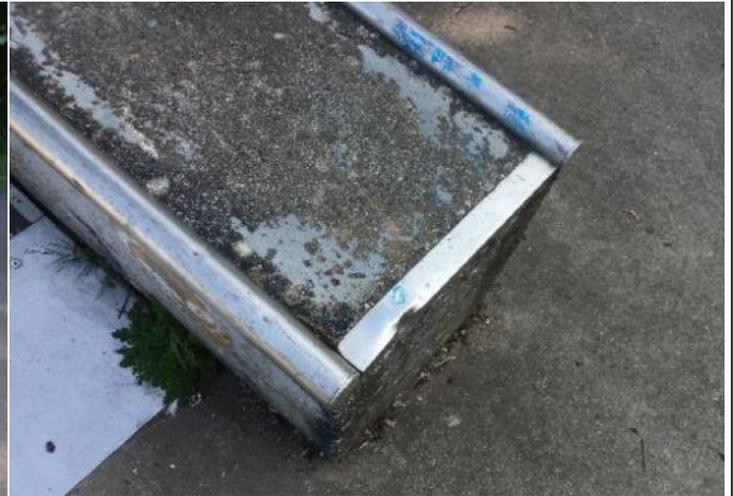
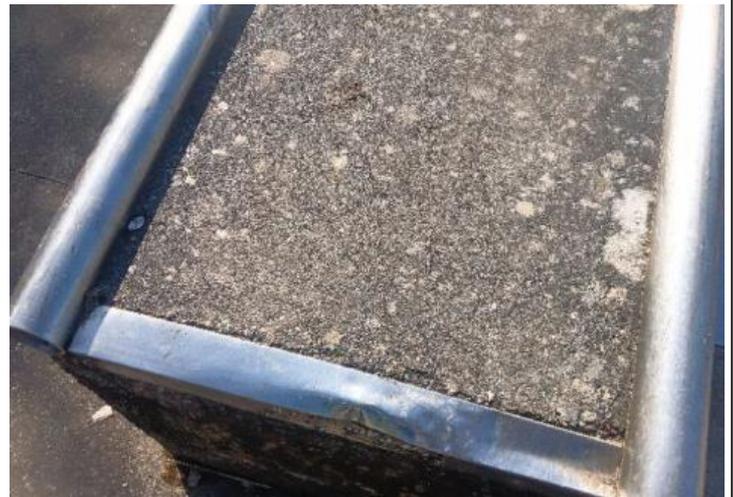
**Finding:** The riding surface has minor damage apparent

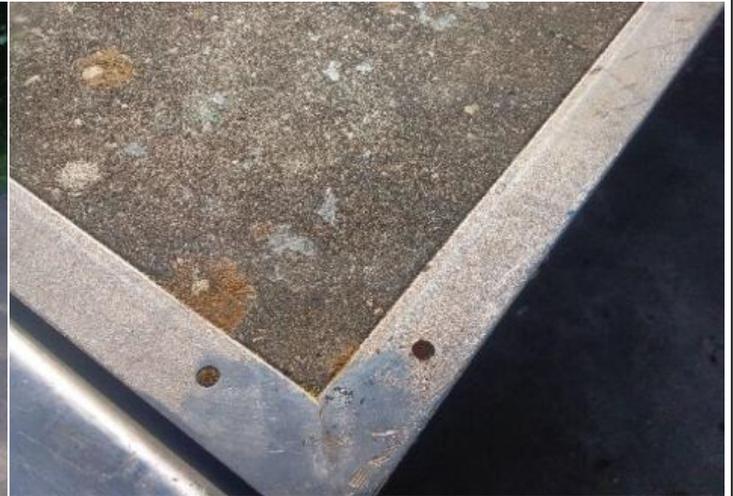
**Finding:** There is or are fixings missing on the item

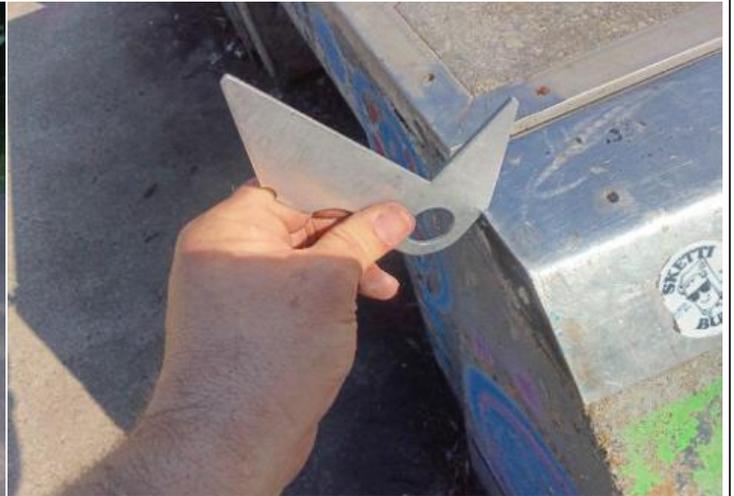
**Finding:** The item has exposed edges and corners with a radius of less than 3mm and fails the requirements of BS EN 14974

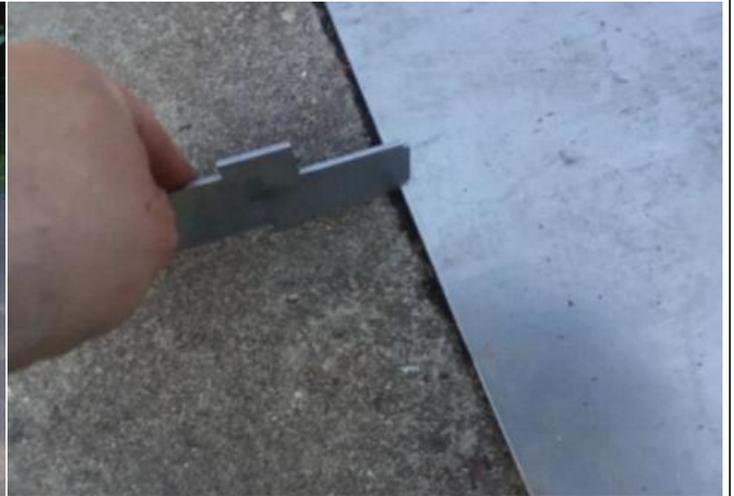
**Finding:** The kicker plate protrudes more than 5mm above the surrounding surface level, BS EN 14974 - 6.1.4 recommends a maximum of 5mm

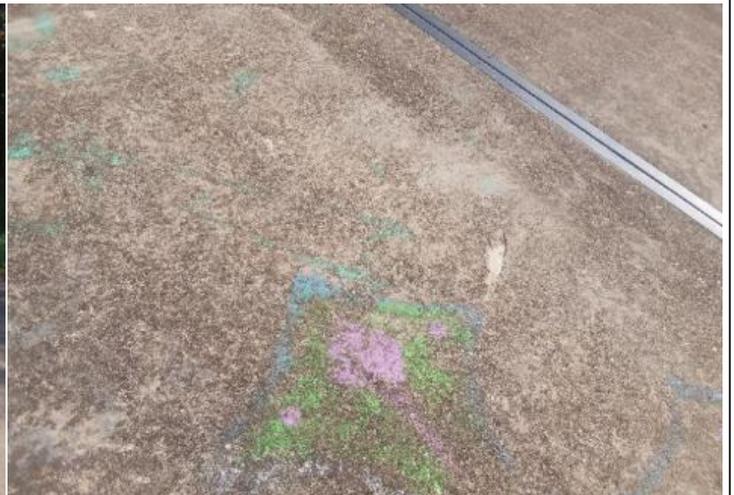
**Finding:** The riding surface has minor damage apparent

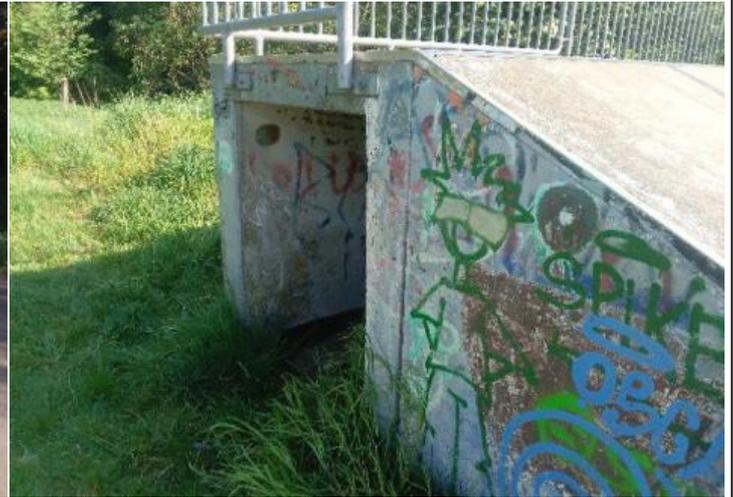
**Finding:** The end panels are missing

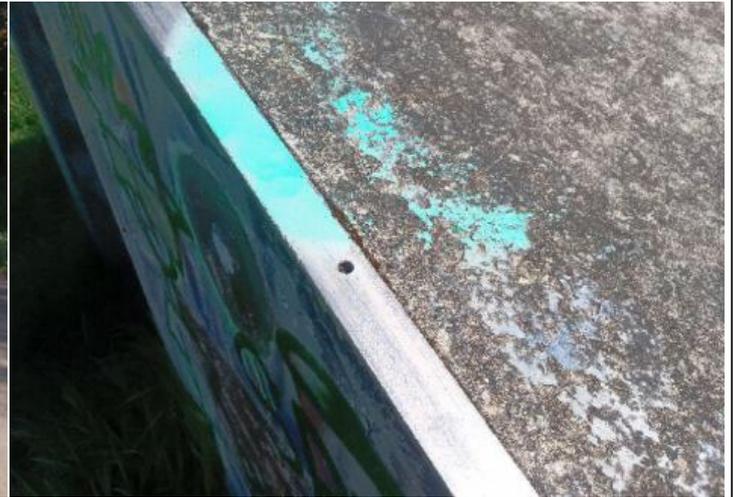
**Finding:** There is or are fixings missing on the item

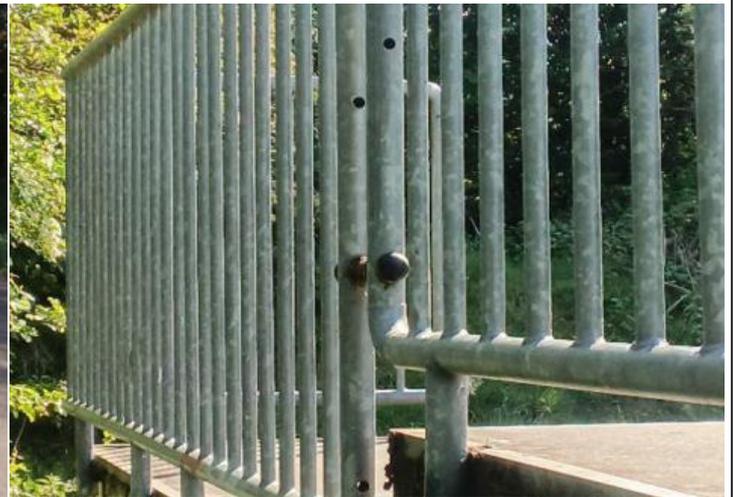
**Finding:** There is/are inserts missing

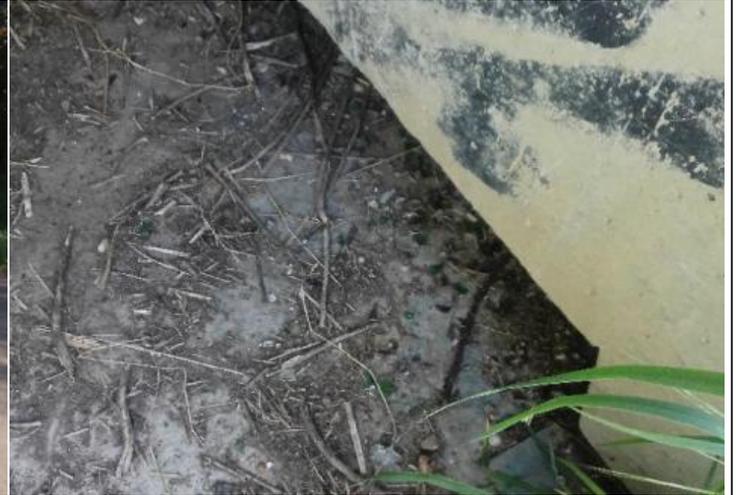
**Finding:** There is broken glass present on site

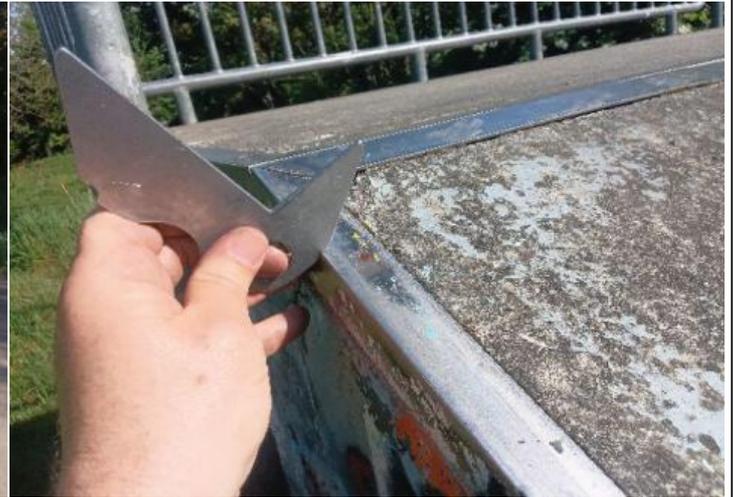
**Finding:** The item has exposed edges and corners with a radius of less than 3mm and fails the requirements of BS EN 14974
