# the **play inspection** company

## Annual Inspection

Winchester City Council

Stratton Bates Recreation Ground (New Alresford)

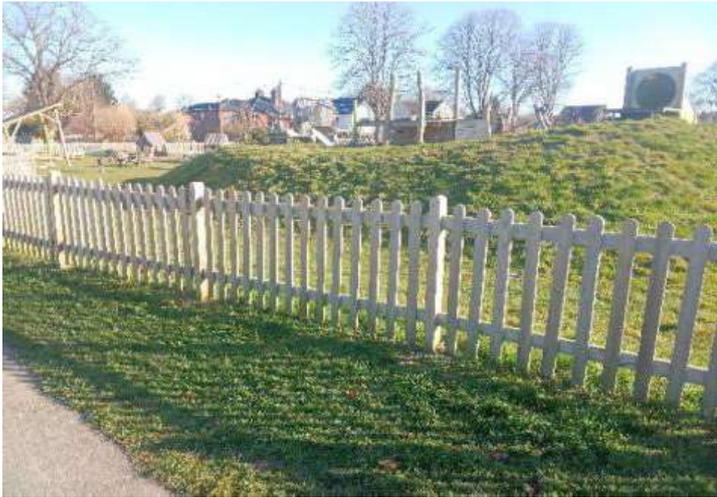
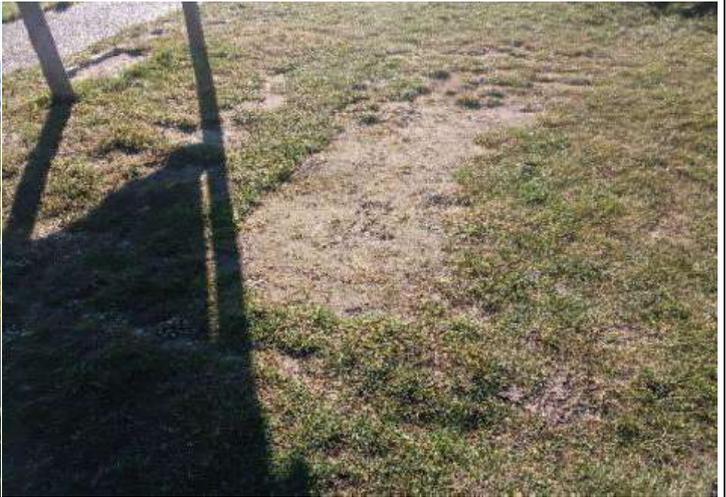
**Finding:** The surface has eroded in some areas and may be slippery in wet conditions  
**Action:** Reinstate the surface

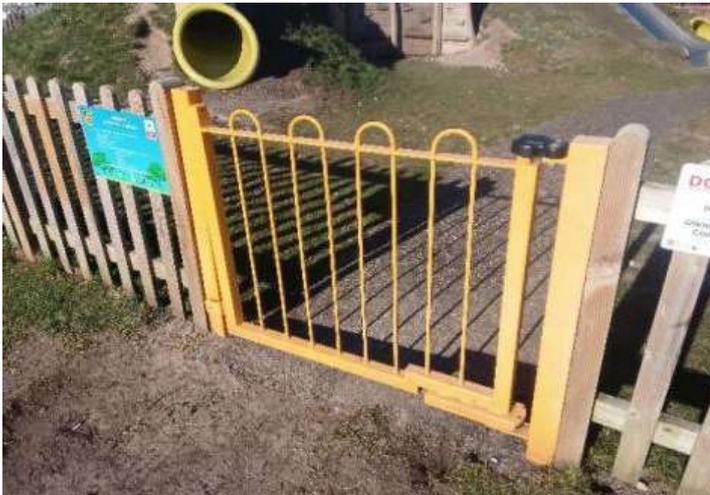
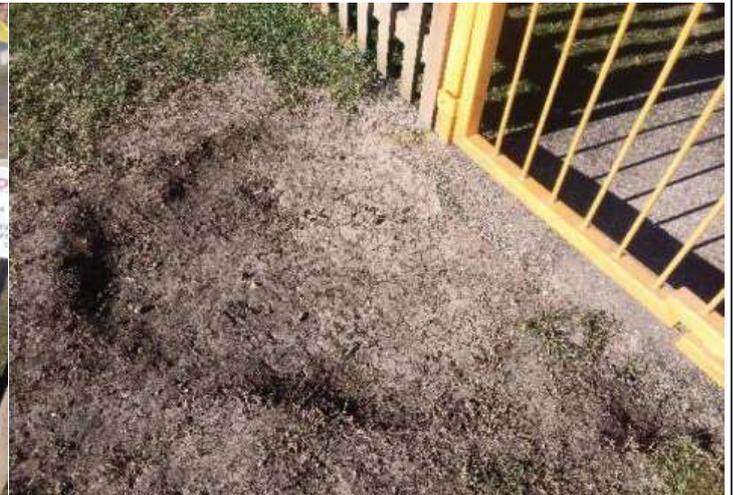
**Finding:** The surface has eroded in some areas and may be slippery in wet conditions

**Action:** Reinstate the surface

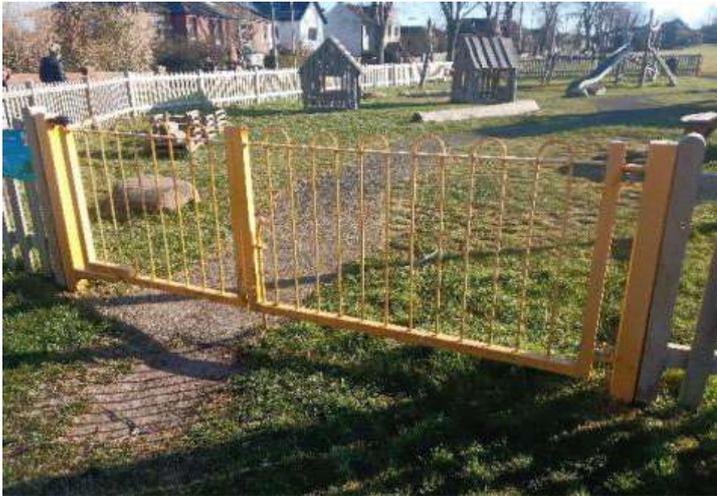
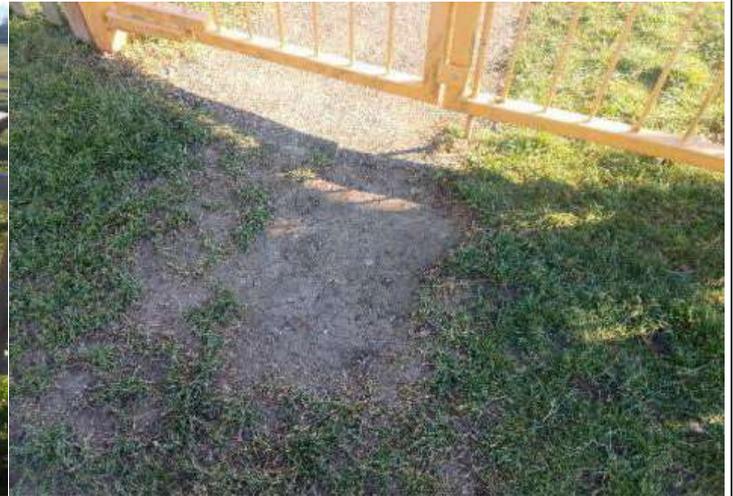
**Finding:** The surface has eroded in some areas and may be slippery in wet conditions  
**Action:** Reinstate the surface

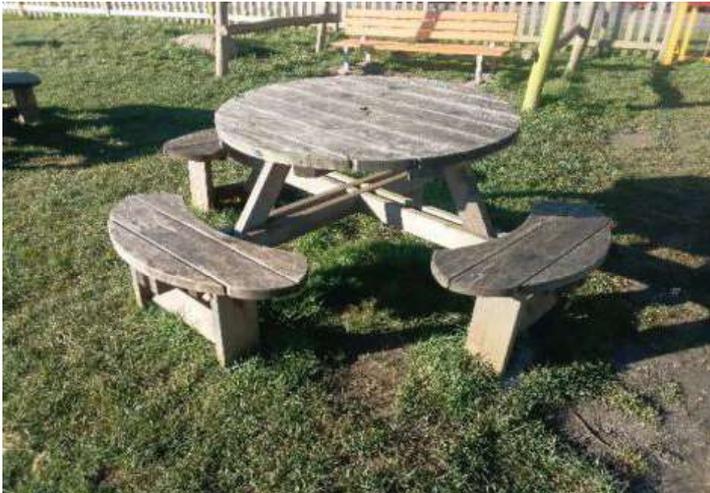
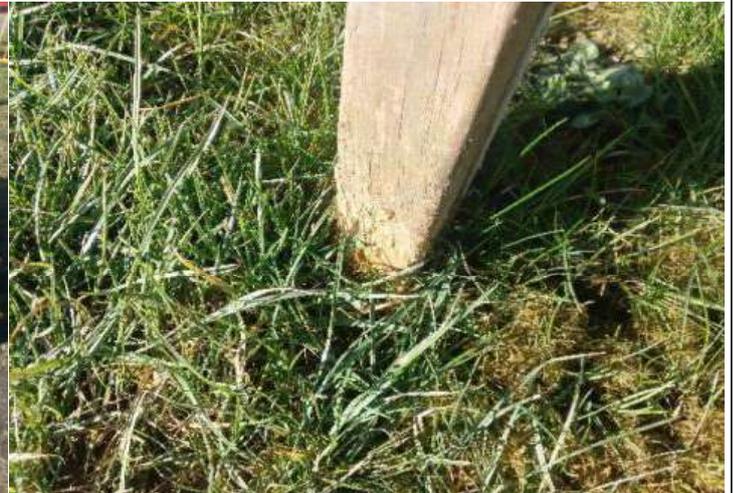
**Finding:** There is some strimmer / machinery damage apparent on the posts, this can penetrate the preservative applied to the timber and accelerate the rotting process

**Action:** Monitor for any deterioration (rot) and replace as required

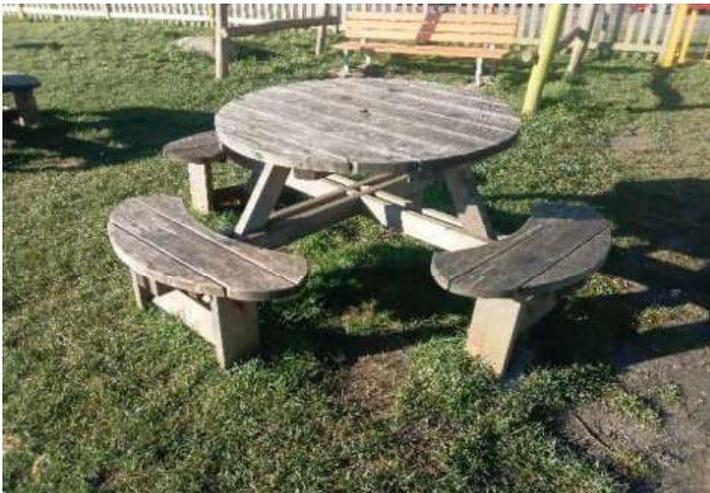
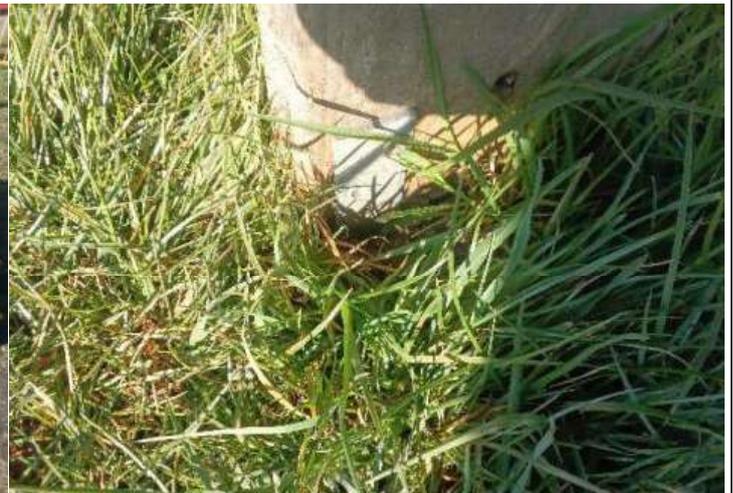
**Finding:** There is or are fixings missing on the item

**Action:** Replace all missing fixings

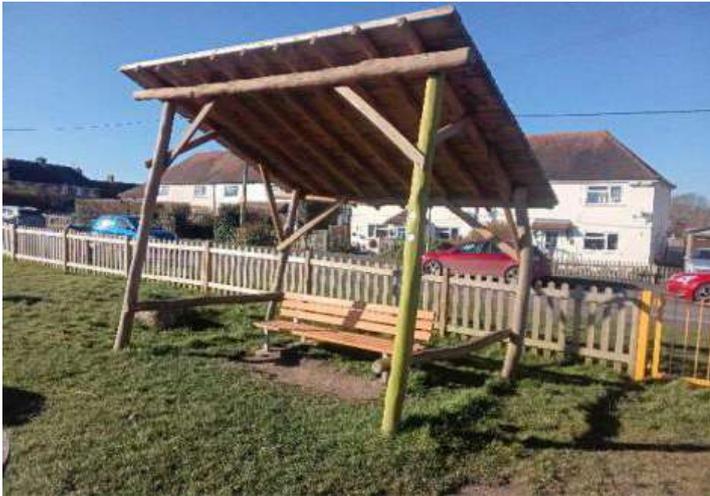
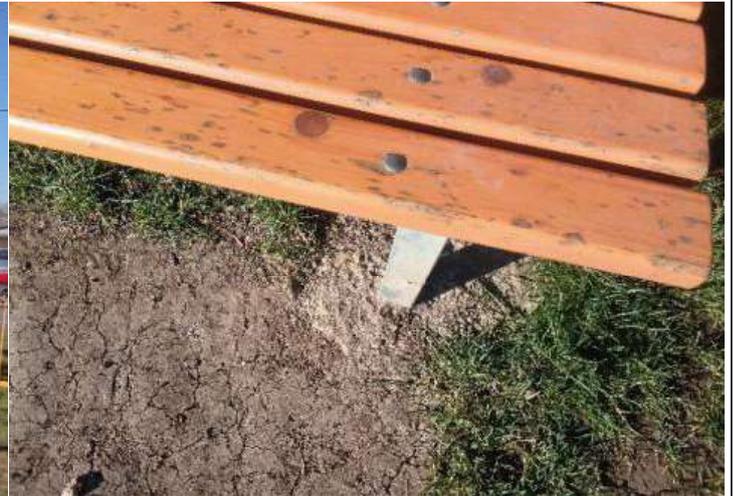
**Finding:** The surface has eroded and the foundations are exposed

**Action:** Reinstate surrounding surfaces to cover the foundations

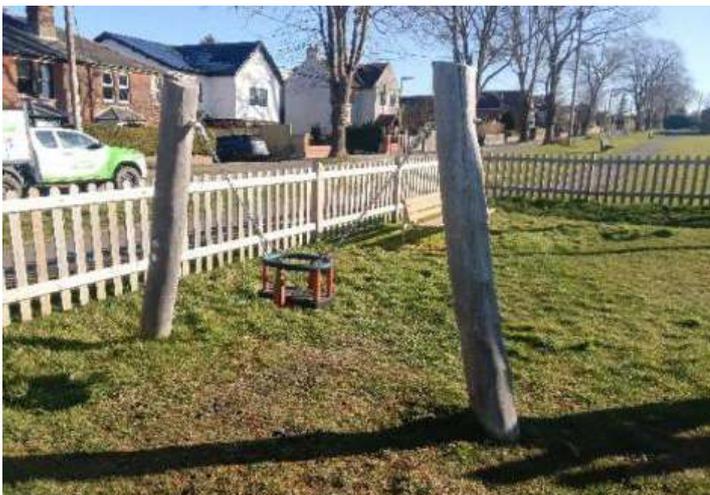
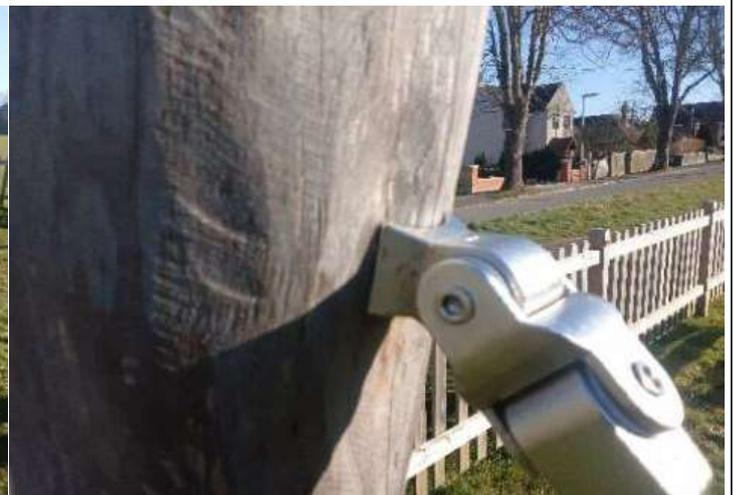
**Finding:** This design of swing joint has been known to fail on the weld connecting the joint to the threaded stud

**Action:** We would recommend that the joint be dismantled and checked on a regular basis or consulting with manufacturer on whether a Secondary Safety Device can be fitted

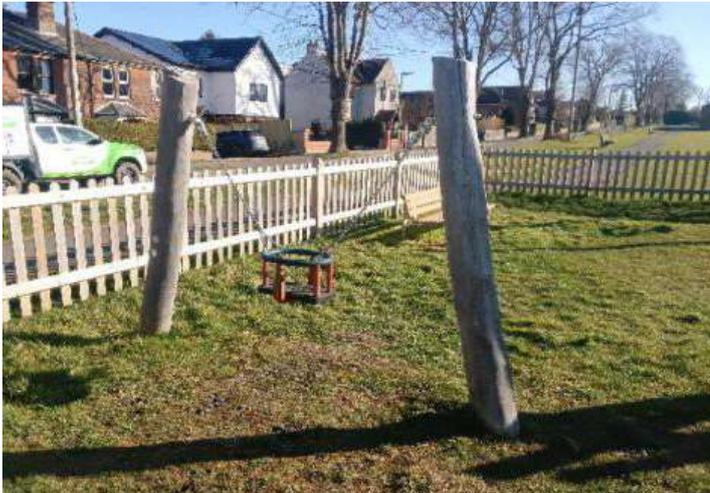
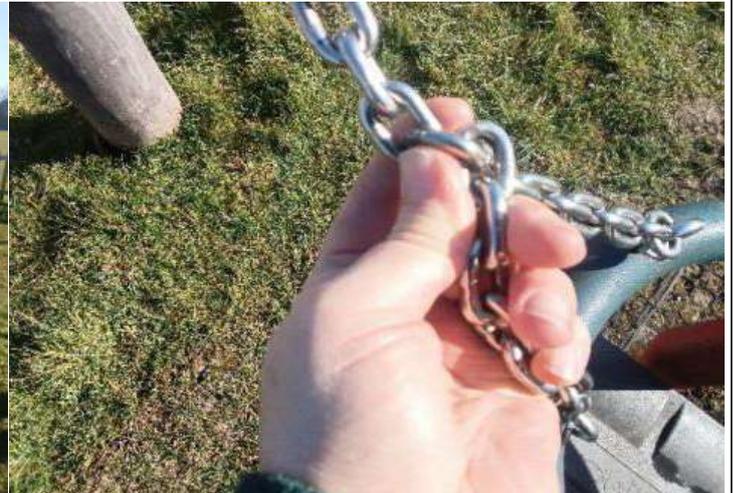
**Finding:** There is some notable evidence of chain wear

**Action:** Monitor for any further deterioration and replace when 40% worn

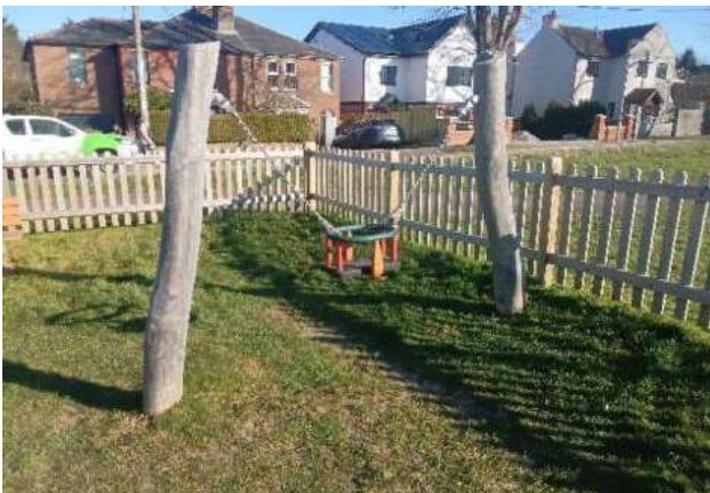
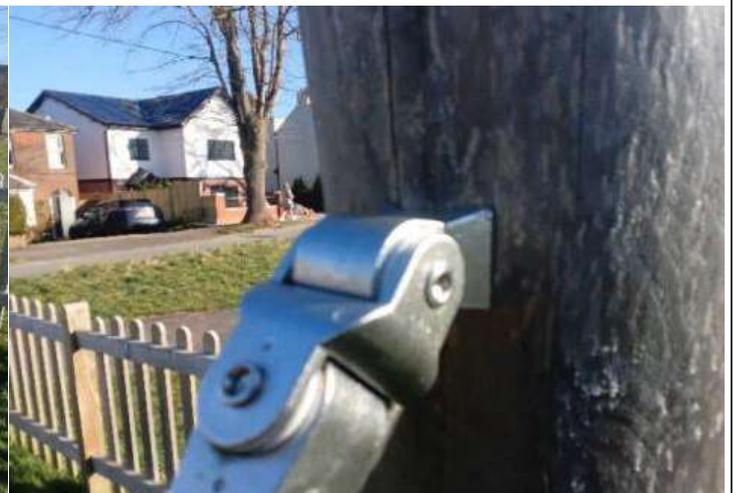
**Finding:** This design of swing joint has been known to fail on the weld connecting the joint to the threaded stud

**Action:** We would recommend that the joint be dismantled and checked on a regular basis or consulting with manufacturer on whether a Secondary Safety Device can be fitted

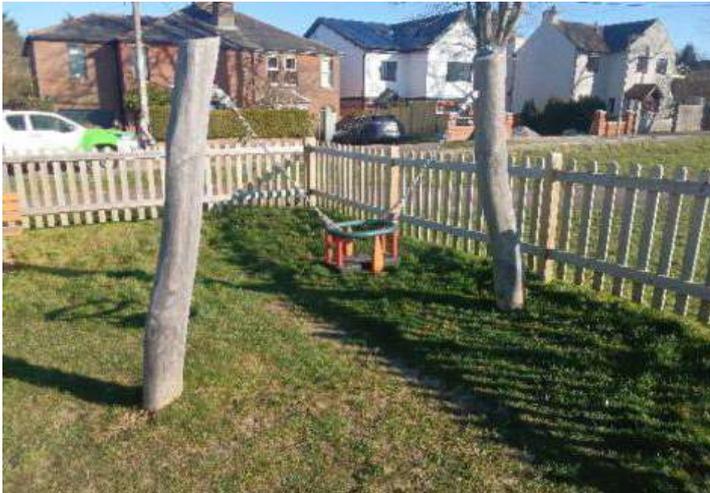
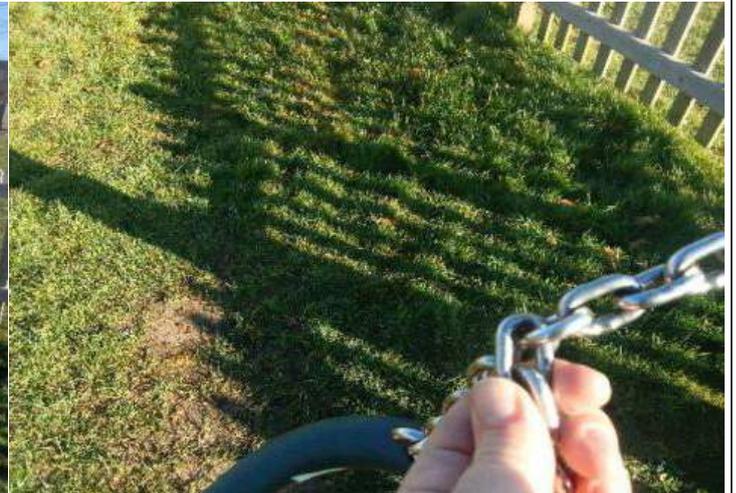
**Finding:** There is some notable evidence of chain wear

**Action:** Monitor for any further deterioration and replace when 40% worn

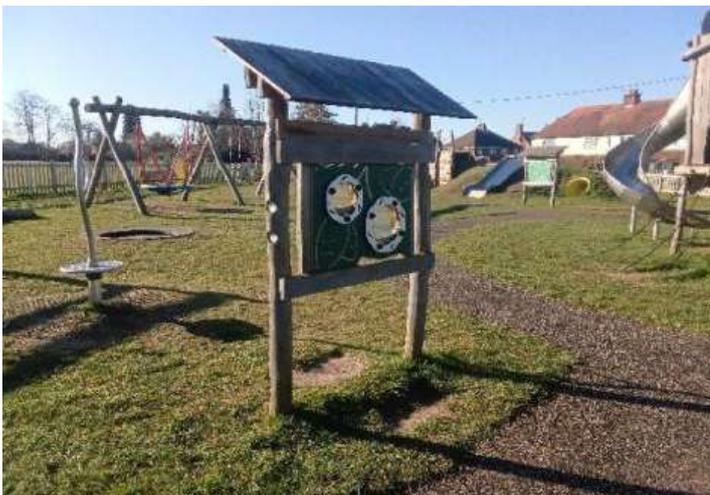
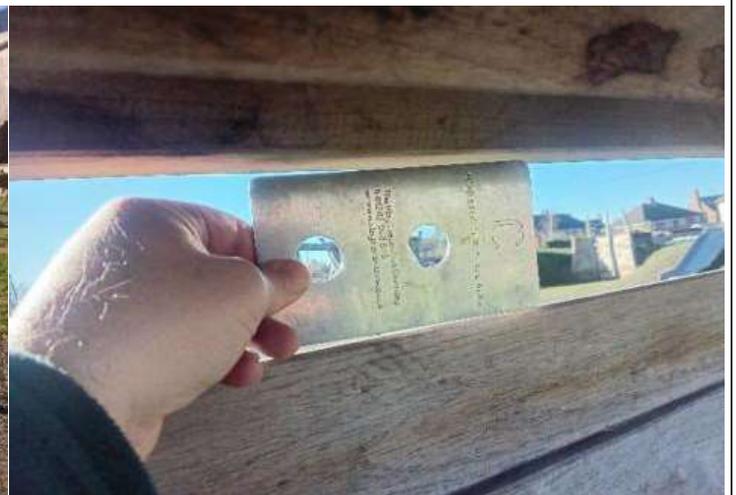
**Finding:** The item fails to meet the requirements of BS EN 1176 Part 1 4.2.7.2 for head and neck entrapment in the framework

**Action:** Monitor - No action given the risk assessment

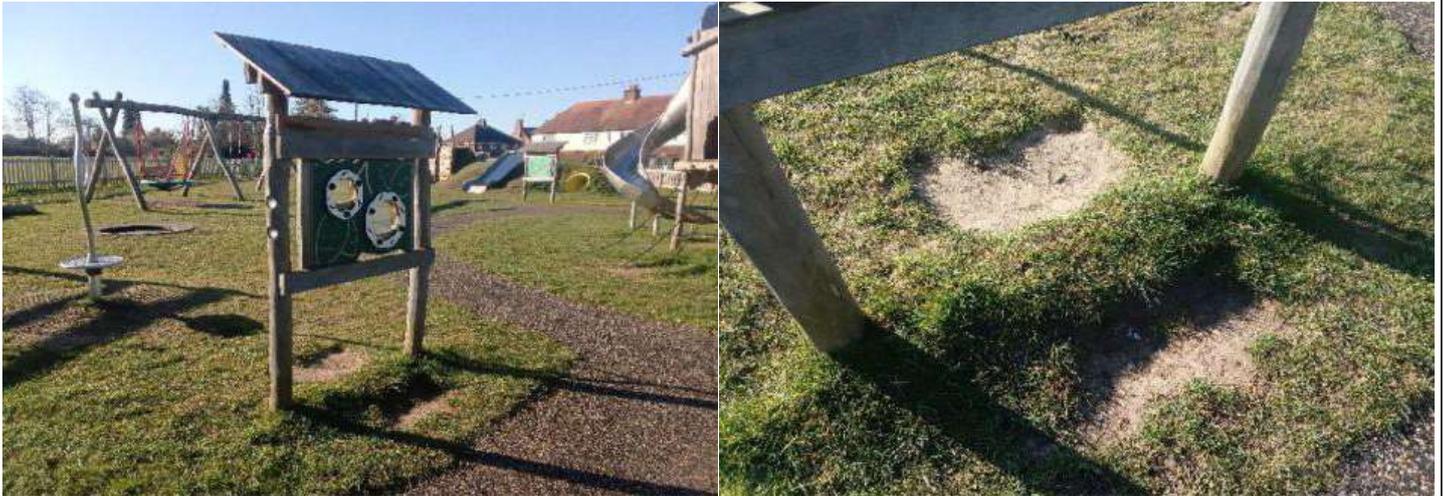
**Finding:** The surface has eroded in some areas and may be slippery in wet conditions  
**Action:** Reinstate the surface

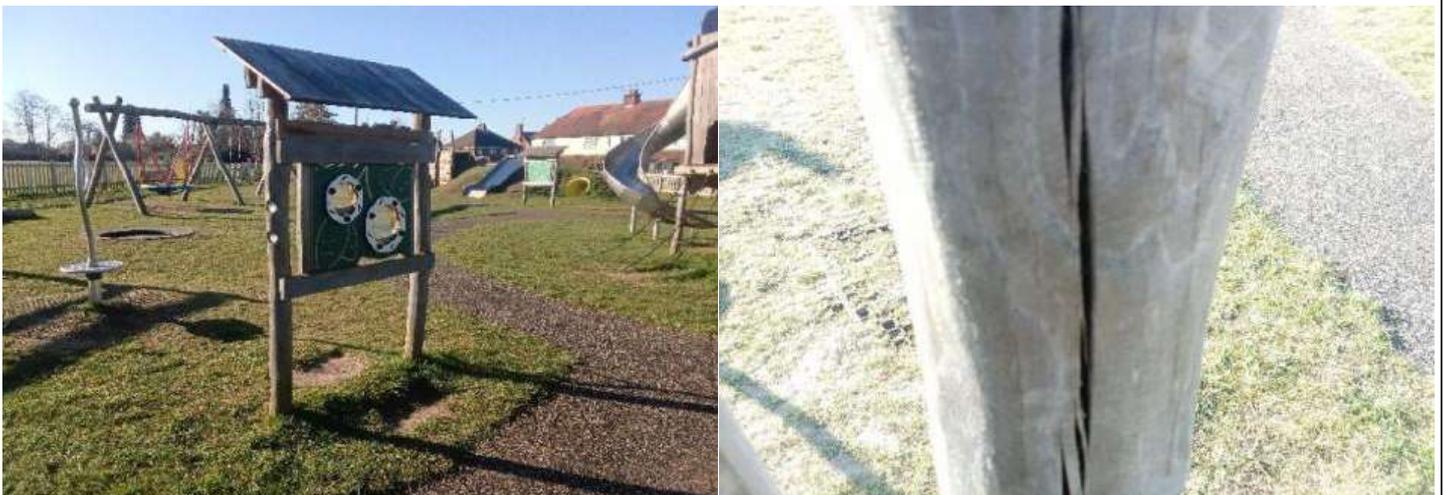
**Finding:** The timber has a number of splits/shakes or air cracks and this may affect the stability or allow water ingress which will accelerate the rotting process  
**Action:** Monitor to ensure the splits do not cross through fixing points of the structure and/or cause any instability

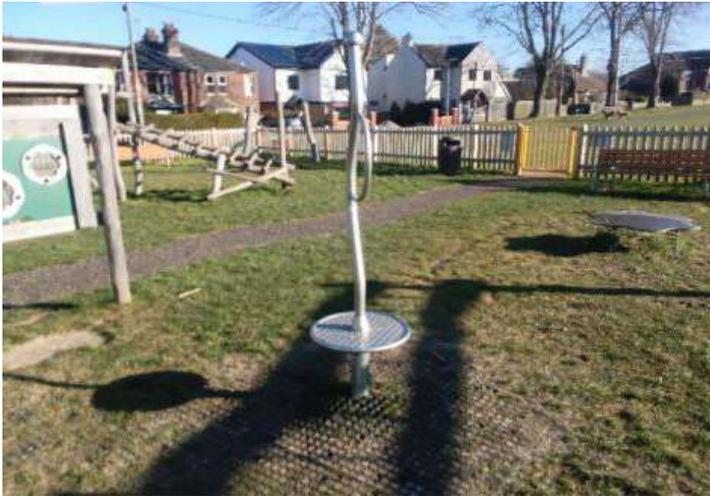
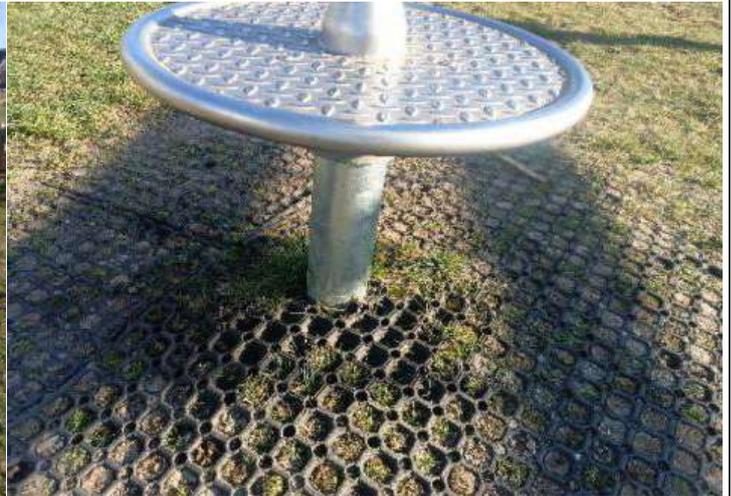
**Finding:** The bearing is showing signs of wear

**Action:** Monitor for any further deterioration and replace as required

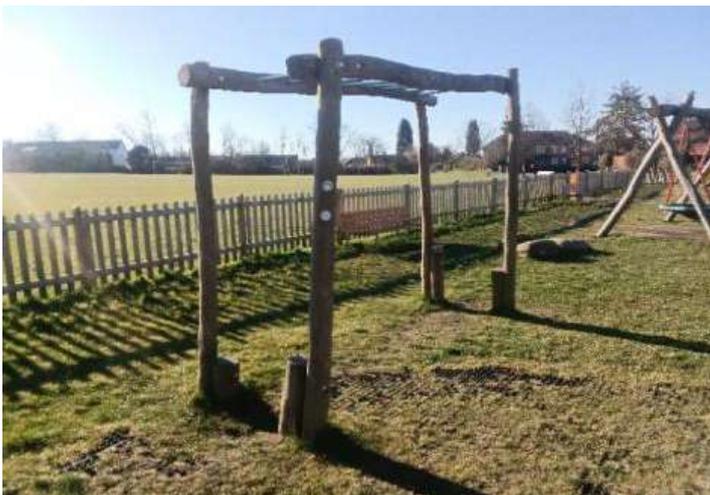
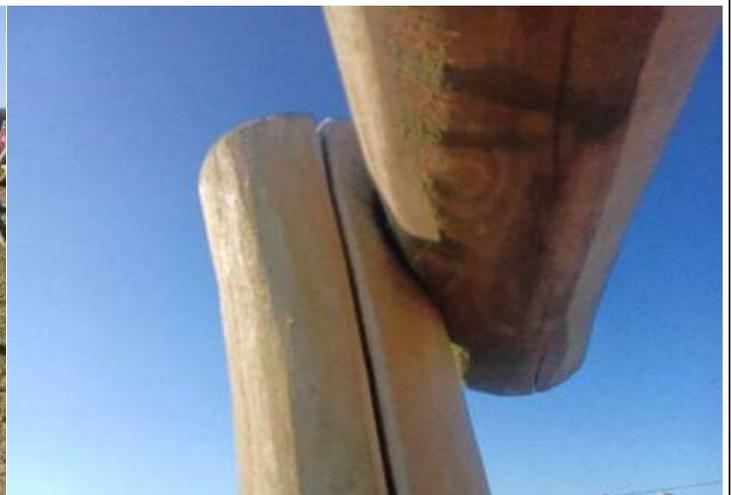
**Finding:** The timber has a number of splits/shakes or air cracks and this may affect the stability or allow water ingress which will accelerate the rotting process

**Action:** Monitor to ensure the splits do not cross through fixing points of the structure and/or cause any instability

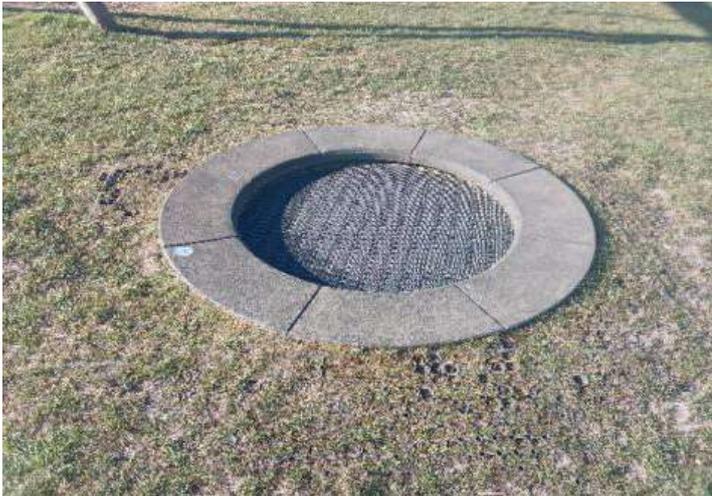
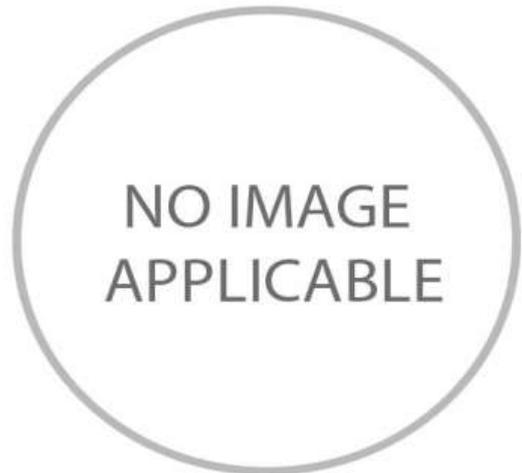
**Finding:** On site visits it is not possible to test the ground clearance of the Bouncing Facility bed as specified in BS EN 1176; ensure that the clearance between the Bouncing Facility Bed and the ground underneath is in accordance with the manufacturers recommendations (recorded nominal depth at time of inspection 330mm measured unloaded).

**Action:** Refer to the manufacturers recommendations

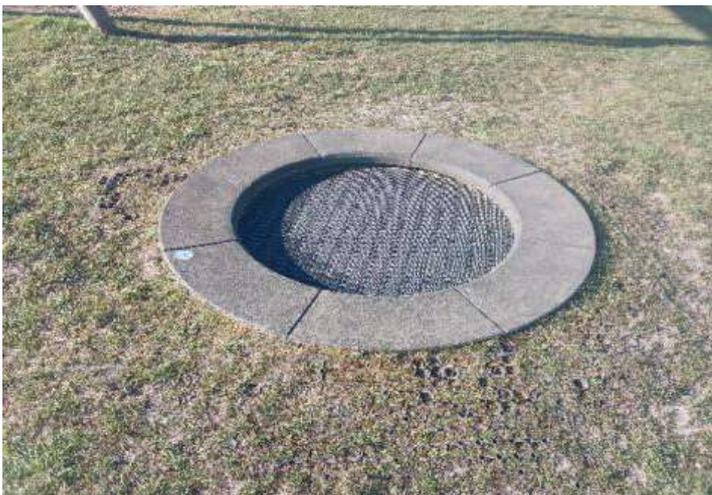
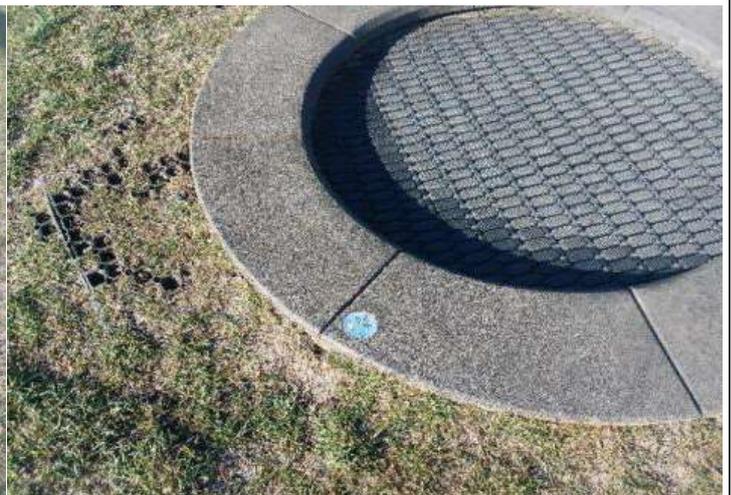
**Finding:** There are trip hazards at the edges of the surface

**Action:** Remove trip hazard

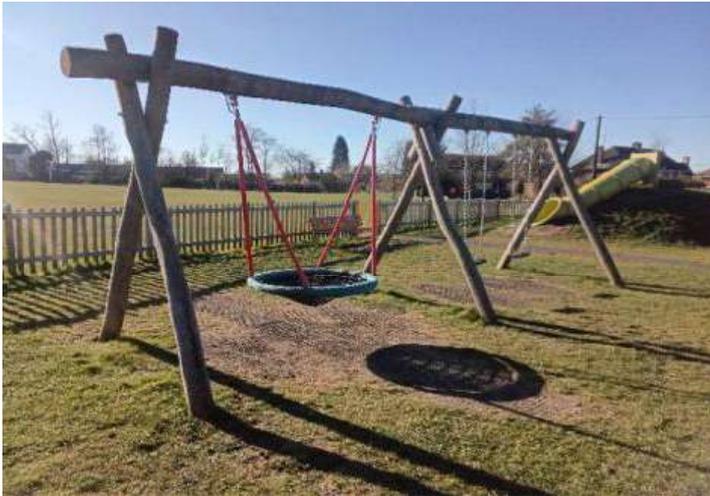
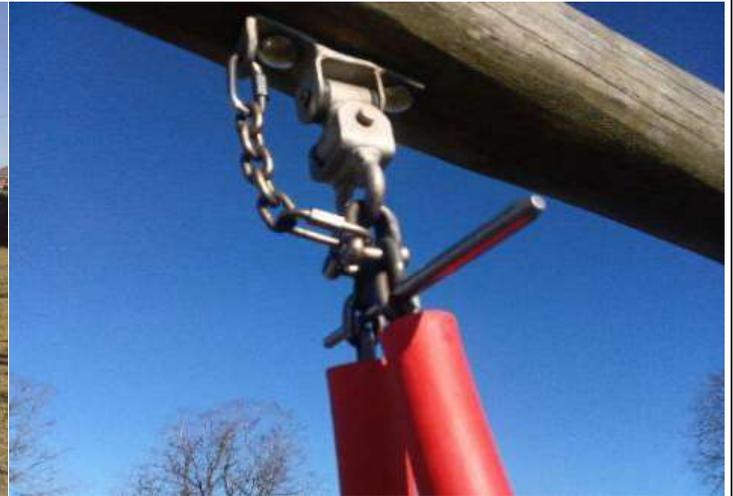
**Finding:** The chain openings are in excess of the 8.6mm as recommended by BS EN 1176  
**Action:** Monitor - No action given the risk assessment

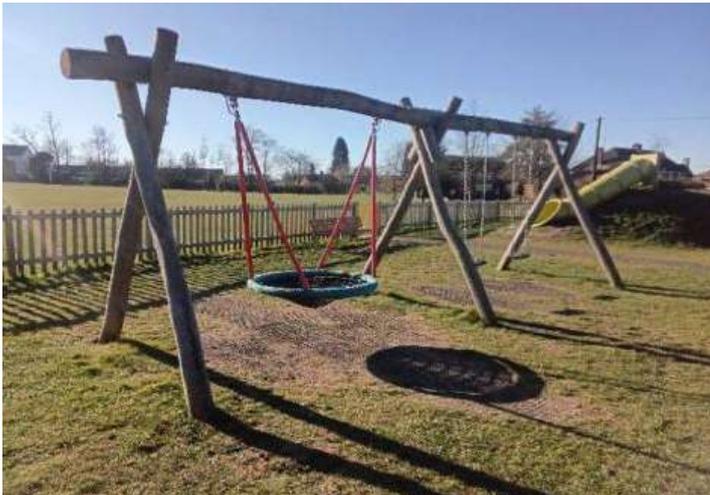
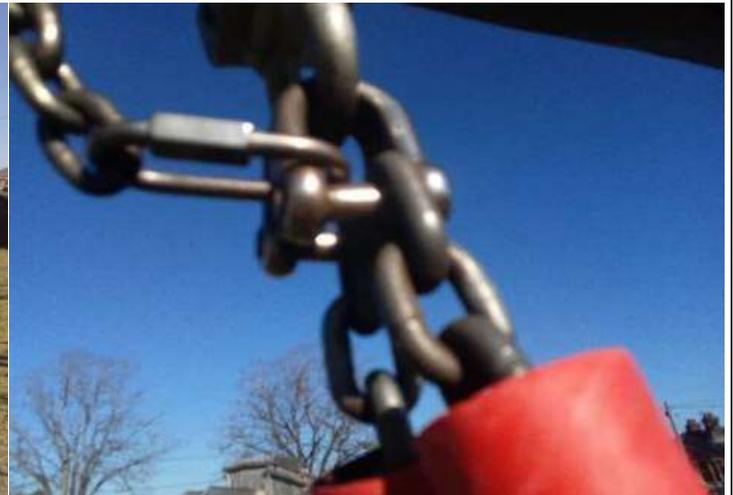
**Finding:** There is some notable evidence of chain wear  
**Action:** Monitor for any further deterioration and replace when 40% worn

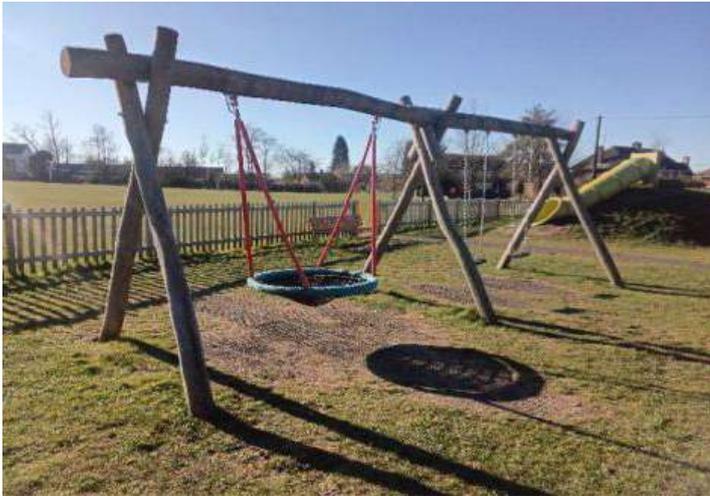
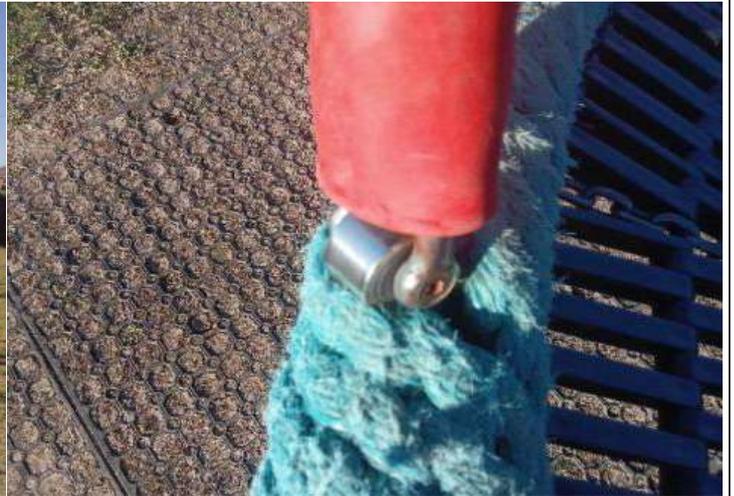
**Finding:** The seat bush / bushes is / are showing signs of wear

**Action:** Monitor for any further deterioration and replace as required

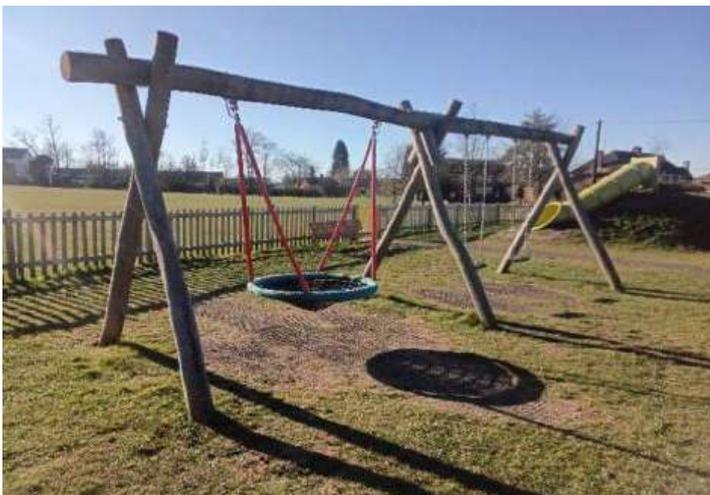
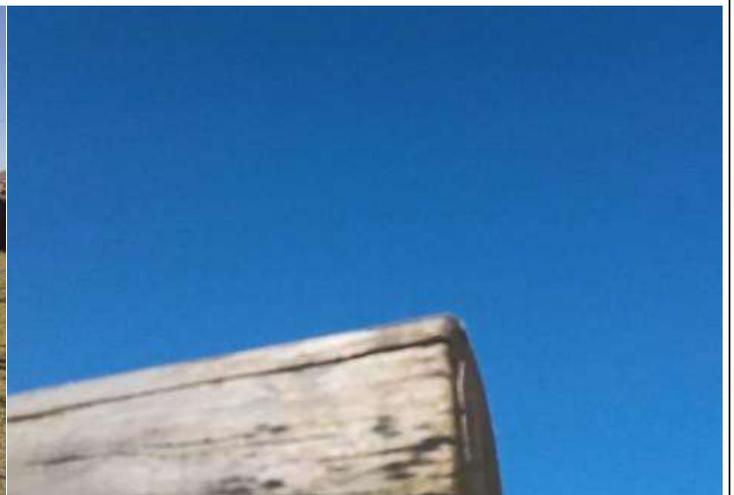
**Finding:** The timber has a number of splits/shakes or air cracks and this may affect the stability or allow water ingress which will accelerate the rotting process

**Action:** Monitor to ensure the splits do not cross through fixing points of the structure and/or cause any instability

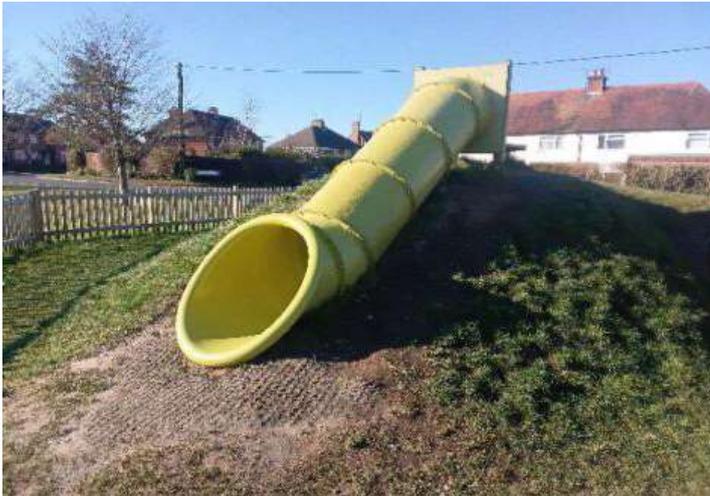
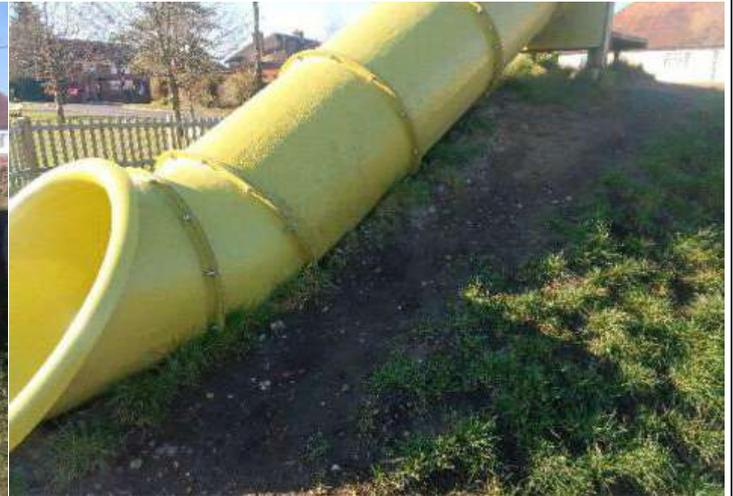
**Finding:** The surface has eroded in some areas and may be slippery in wet conditions  
**Action:** Reinststate the surface

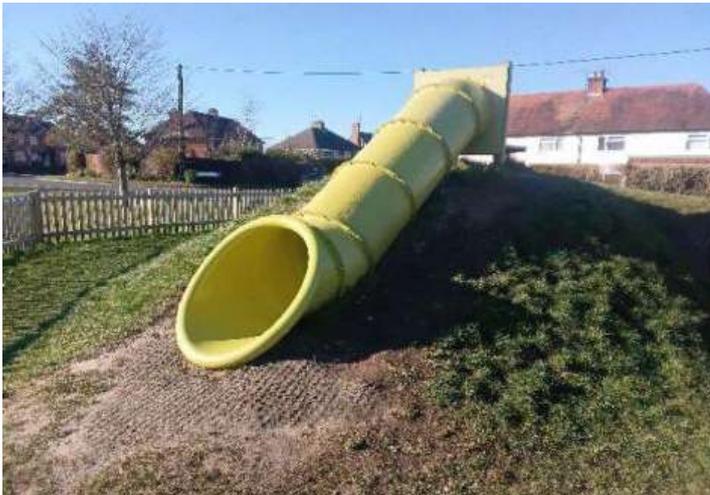
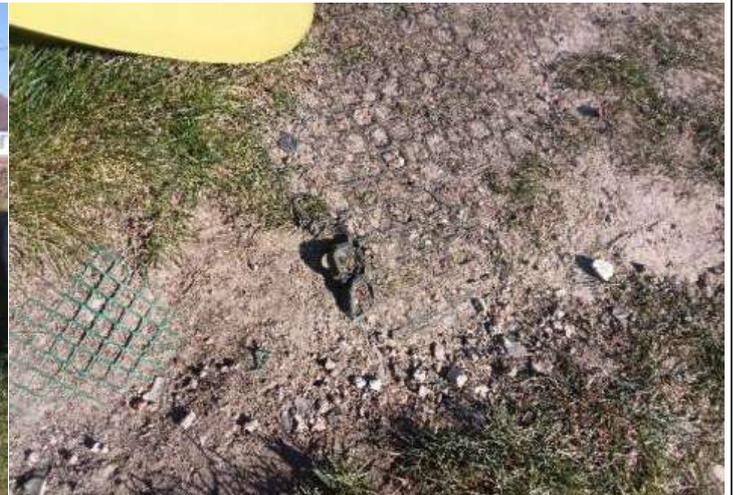
**Finding:** The surface is lifting at the edges and creating trip points **Action:** Repair perimeter of surfacing to remove trip points

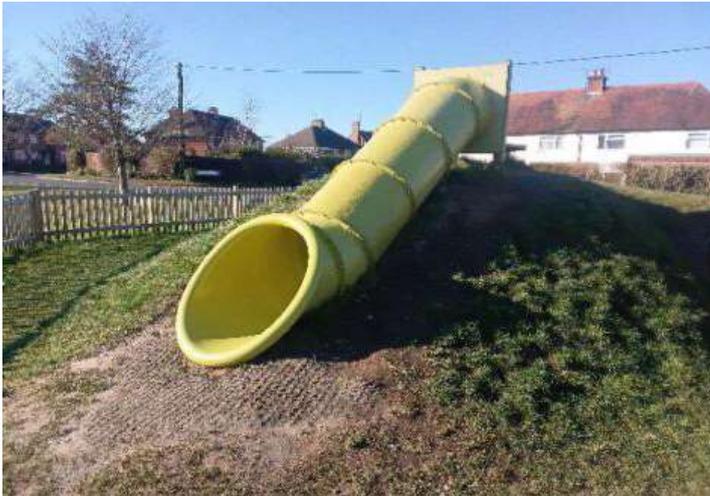
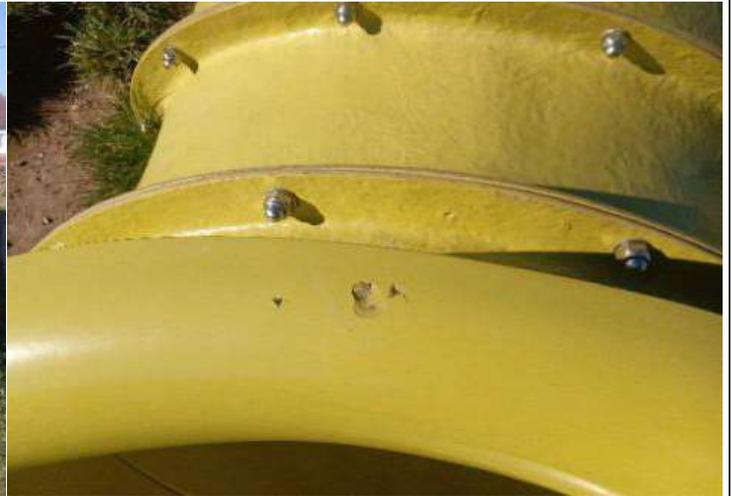
**Finding:** The gel coat on the slide surface is worn

**Action:** Re-dress the surface

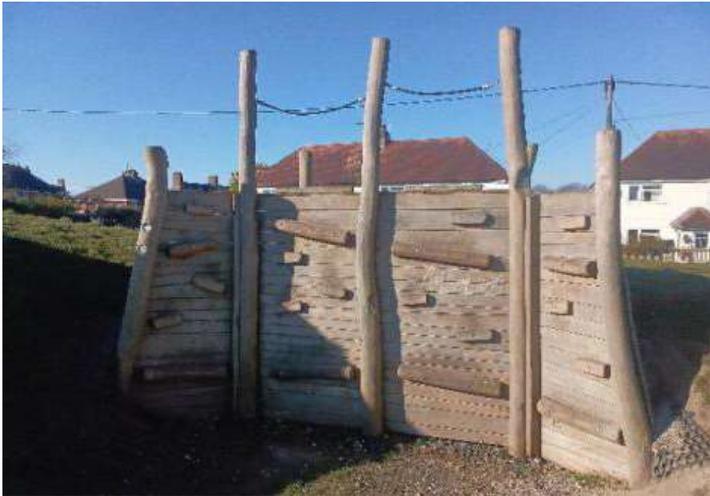
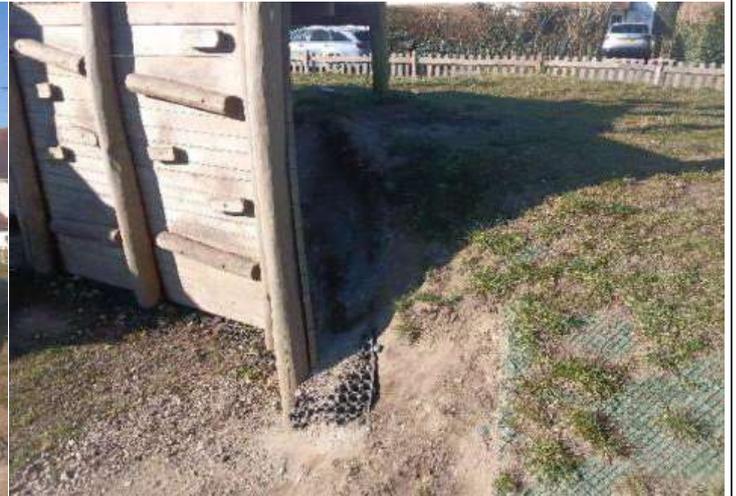
**Finding:** The surface has eroded in some areas and may be slippery in wet conditions  
**Action:** Reinststate the surface

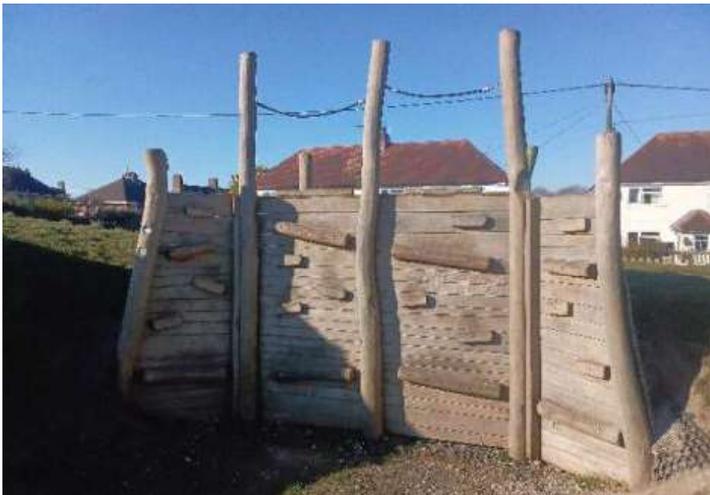
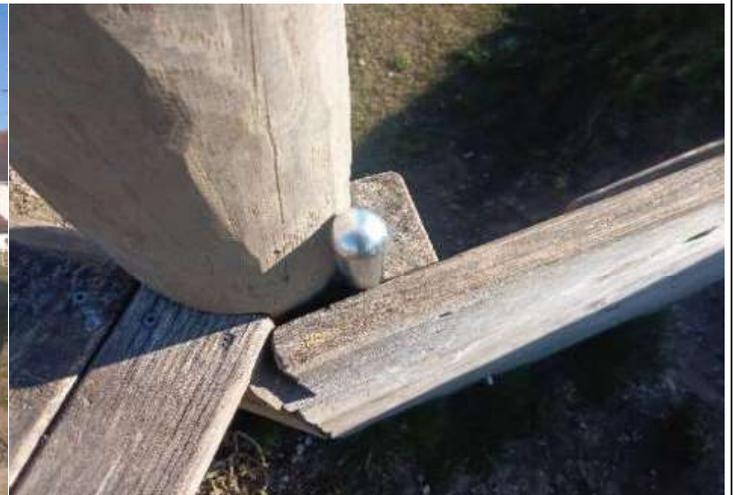
**Finding:** There is/are finger entrapment/s in the climbing panel and the item fails to meet the requirements of BS EN 1176 Part 1 4.2.7.6 Entrapment of fingers  
**Action:** Monitor - No action given the risk assessment

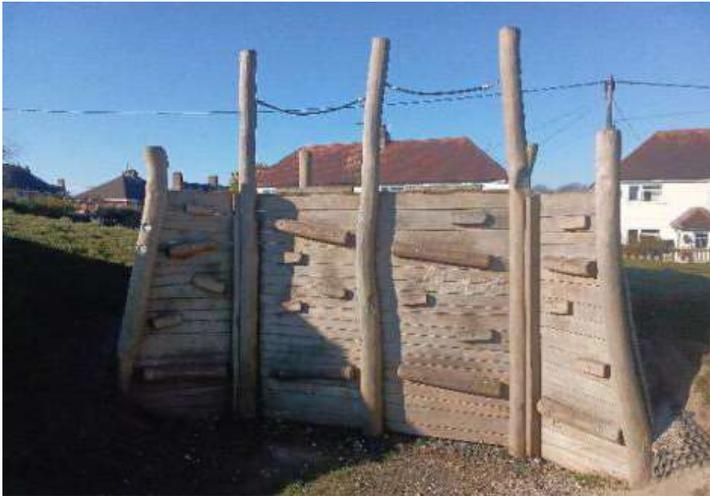
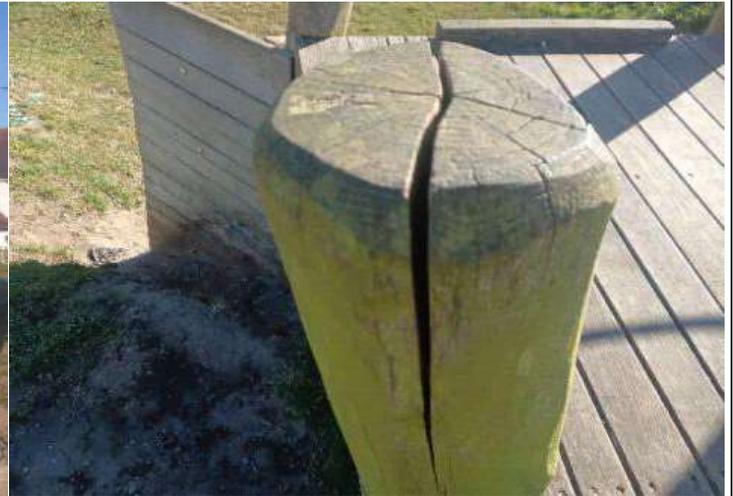
**Finding:** The timber has a number of splits/shakes or air cracks and this may affect the stability or allow water ingress which will accelerate the rotting process  
**Action:** Monitor to ensure the splits do not cross through fixing points of the structure and/or cause any instability

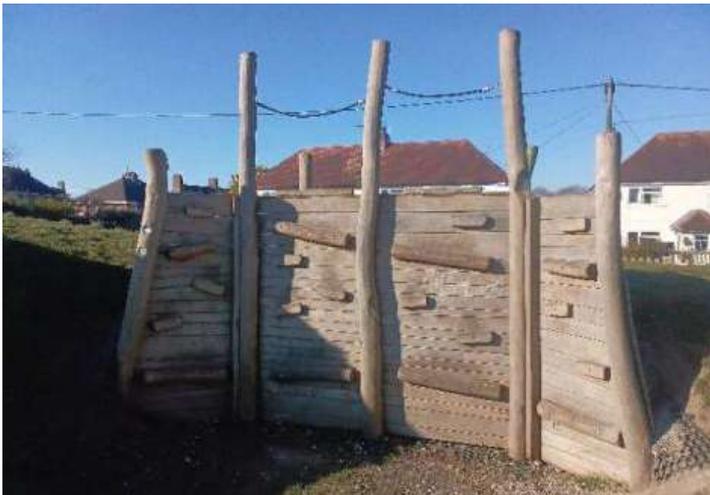
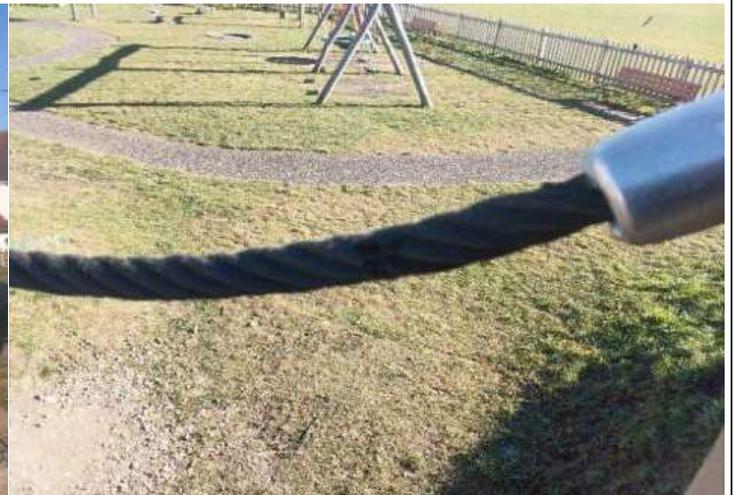
**Finding:** The ropes/nets are worn/damaged in places  
**Action:** Monitor for any further deterioration and repair or replace as required

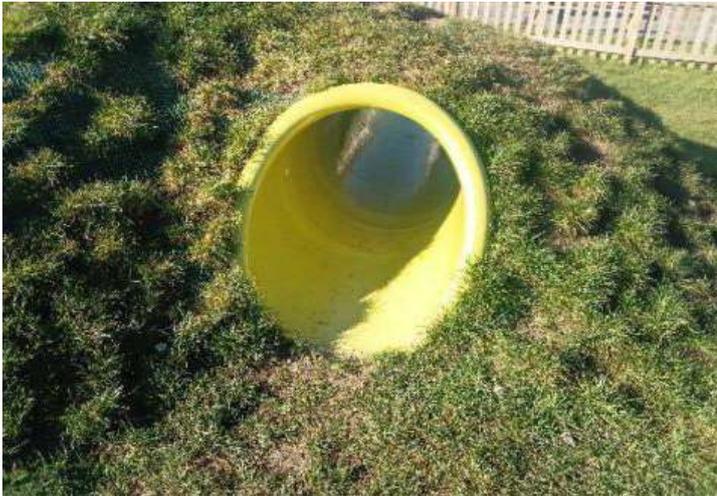
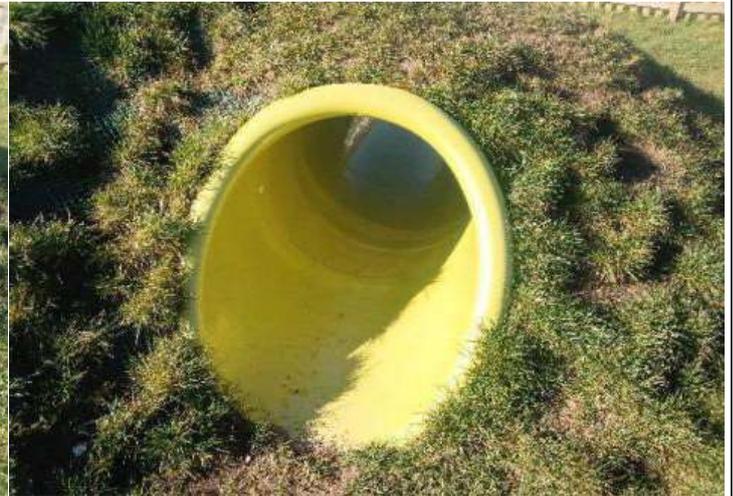
**Finding:** This design / configuration of tunnel mound is well established and has been successfully included in large quantities of playgrounds throughout the UK. Whilst the design does not fully meet the requirements of BS EN 1176 with regards to falls in excess of 600mm over the edge of the tunnel to the surface below, it has been risk assessed as fit for purpose in this regard and no changes are recommended to the design unless otherwise stated in additional findings

**Action:** Monitor - No action given the risk assessment

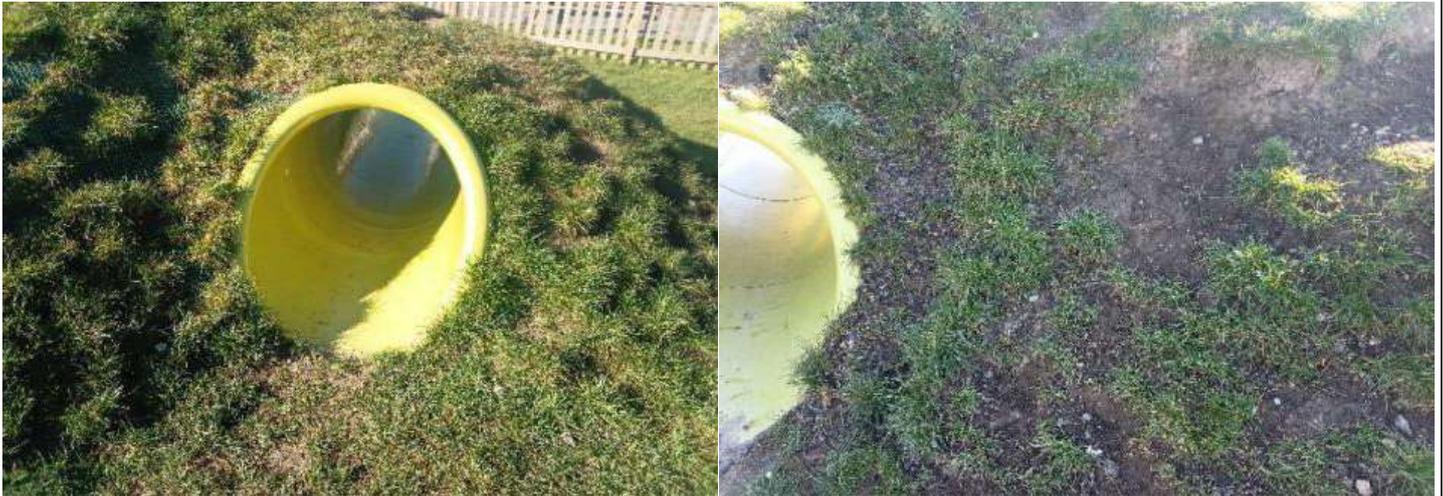
**Finding:** The surface has eroded in some areas and may be slippery in wet conditions  
**Action:** Reinstate the surface
