# the **play inspection** company

## Annual Inspection

Winchester City Council

Stratton Bates Recreation Ground (New Alresford)

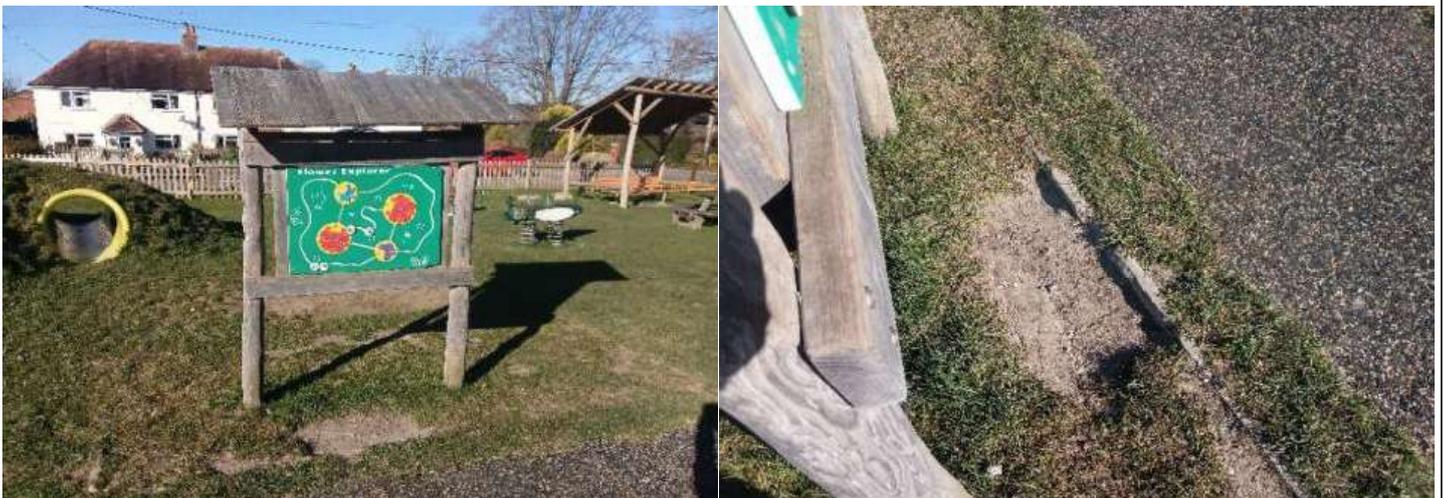
**Finding:** The surface has eroded in some areas and may be slippery in wet conditions  
**Action:** Reinstate the surface

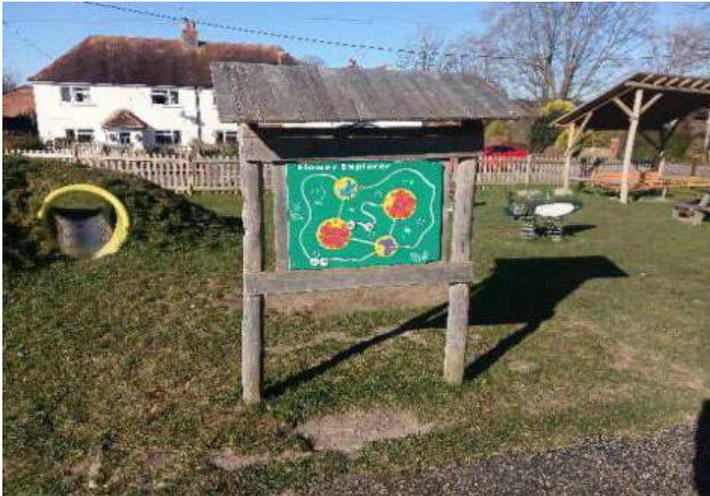
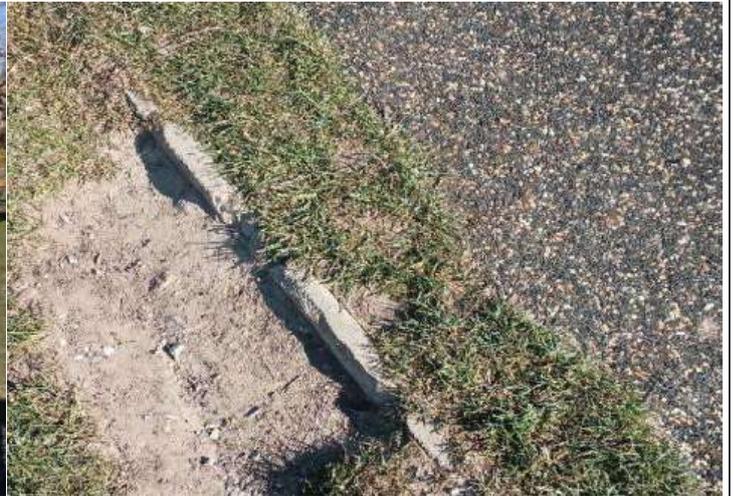
**Finding:** There are trip hazards at the edges of the surface **Action:** Remove trip hazard

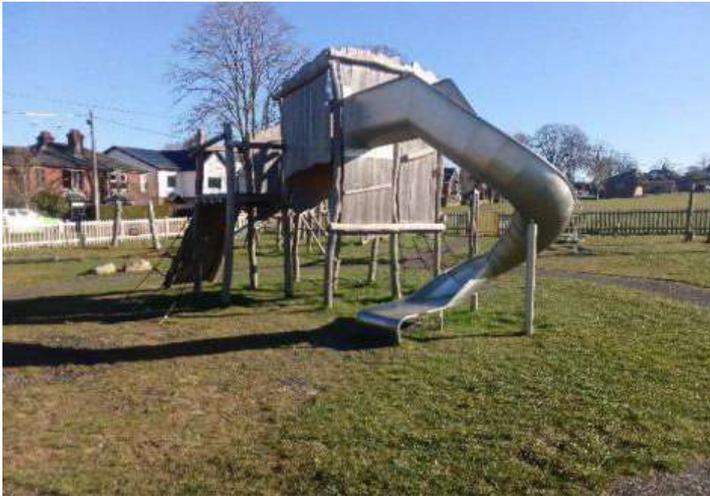
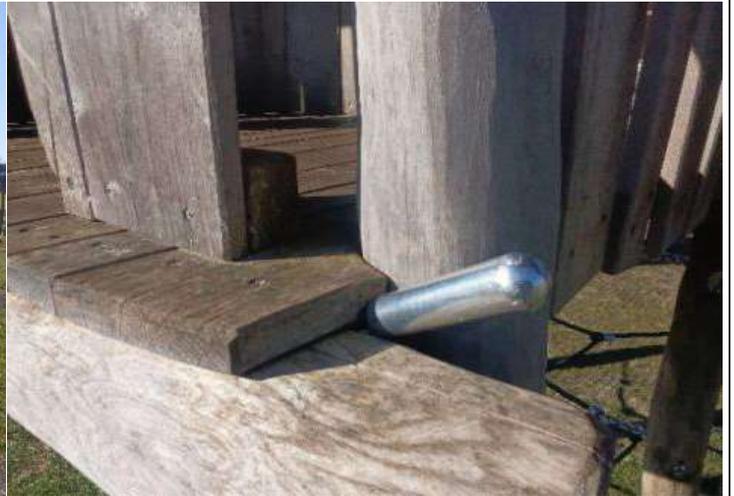
**Finding:** There is/are finger entrapment/s in the framework and the item fails to meet the requirements of BS EN 1176 Part 1 4.2.7.6 Entrapment of fingers

**Action:** Monitor - No action given the risk assessment

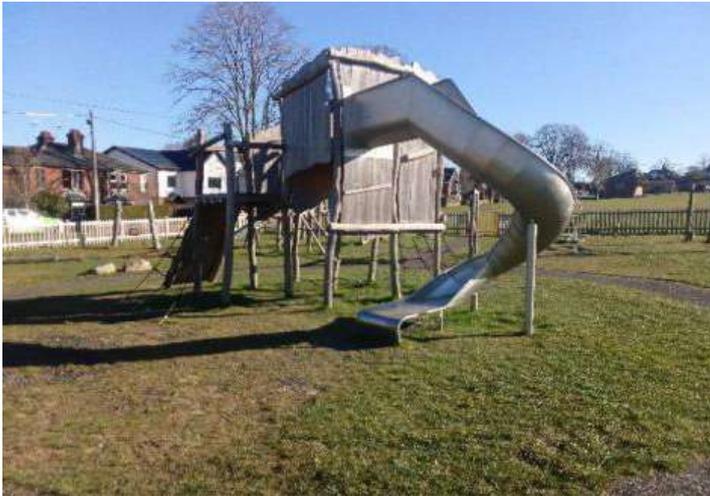
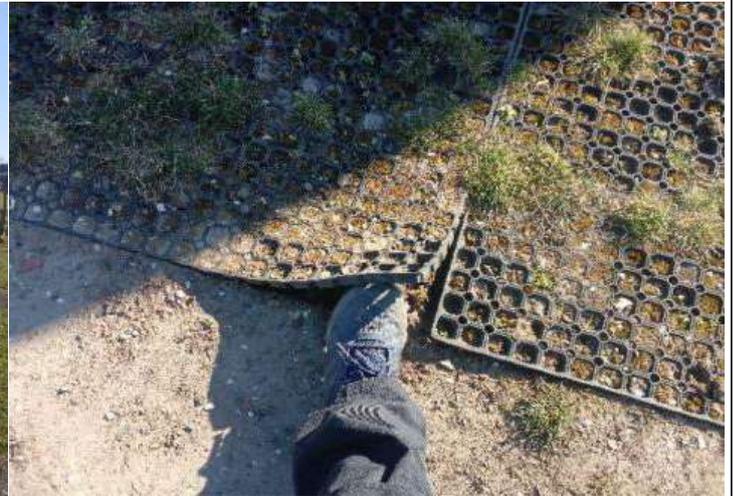
**Finding:** The edges of the grass mat surface are raised / lifting above the surrounding surface

**Action:** Tuck in or pin edges of grass mats as per the API Code of Practice to remove trip hazards

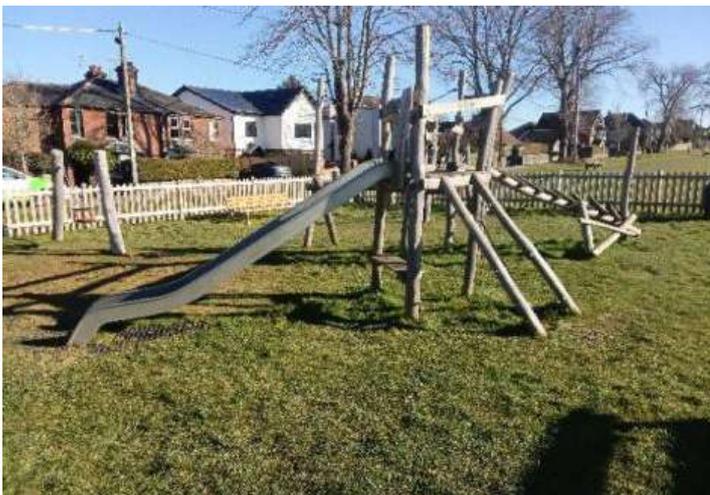
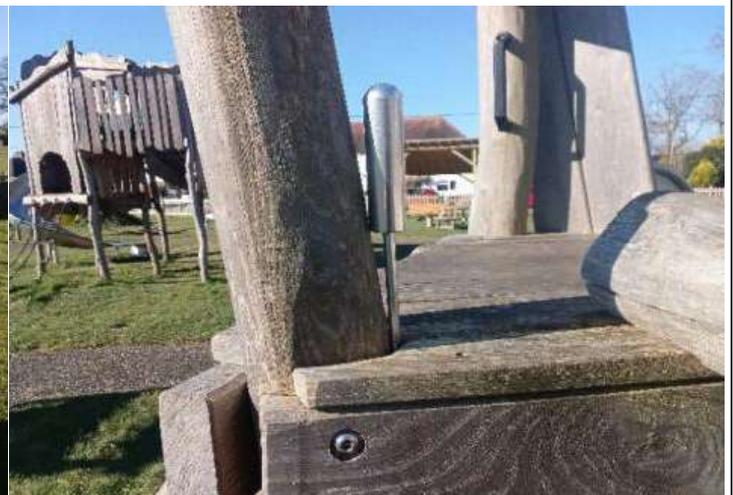
**Finding:** There is/are finger entrapment/s between platform and post and the item fails to meet the requirements of BS EN 1176 Part 1 4.2.7.6 Entrapment of fingers

**Action:** Monitor - No action given the risk assessment

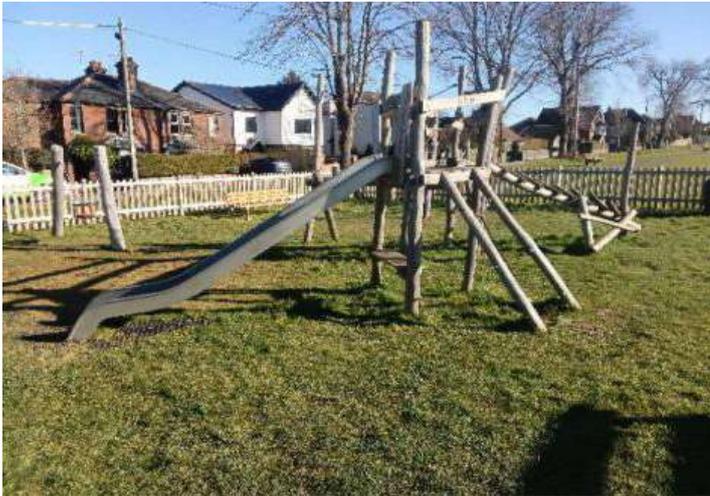
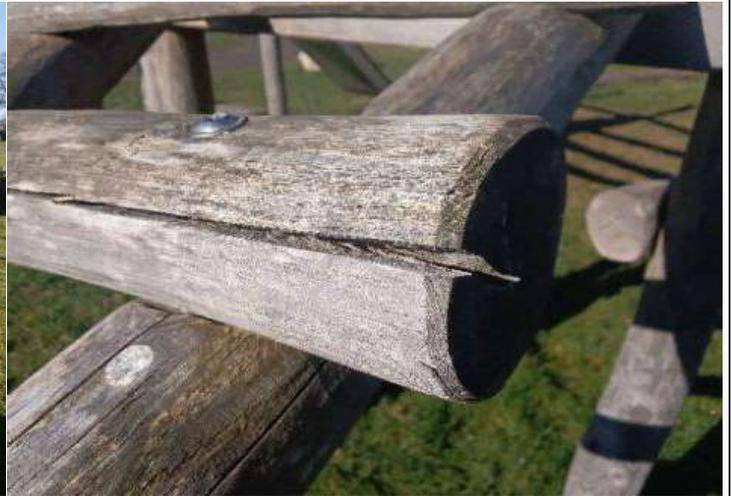
**Finding:** The timber has a number of splits/shakes or air cracks and this may affect the stability or allow water ingress which will accelerate the rotting process  
**Action:** Monitor to ensure the splits do not cross through fixing points of the structure and/or cause any instability
