## Annual Inspection

Winchester City Council

Sun Hill Recreation Ground (New Alresford)

Derwent Gardens, Alresford, SO24 9NQ

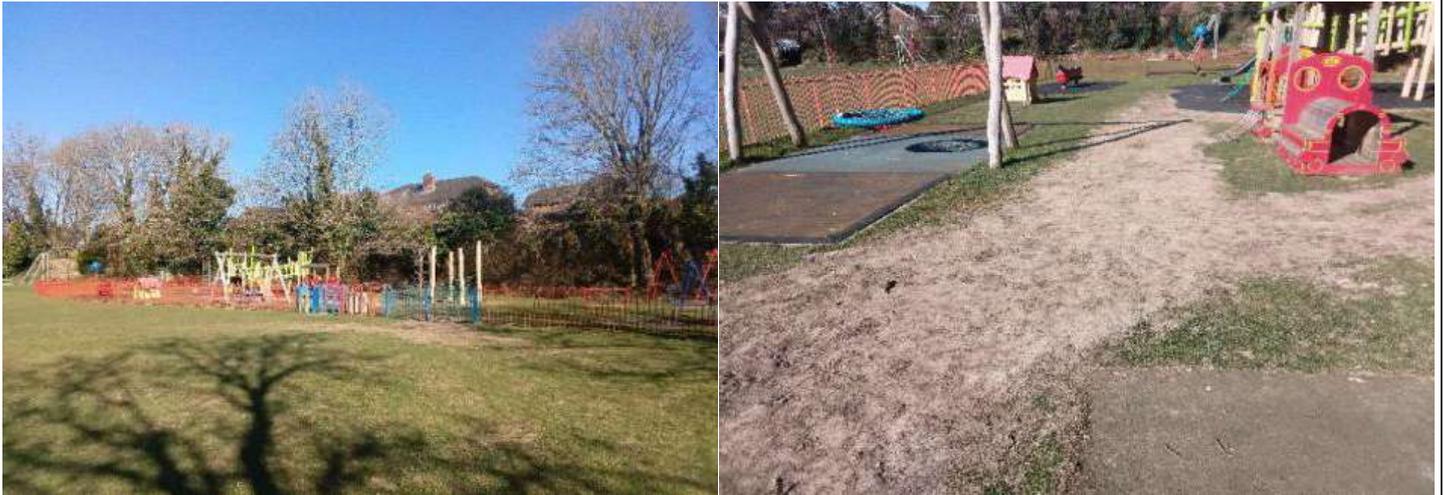
**Item:** Ancillary Items - Site General  
**Manufacturer:** Owner/Operator

**Finding:** The surface has eroded in some areas and may be slippery in wet conditions  
**Action:** Reinstate the surface

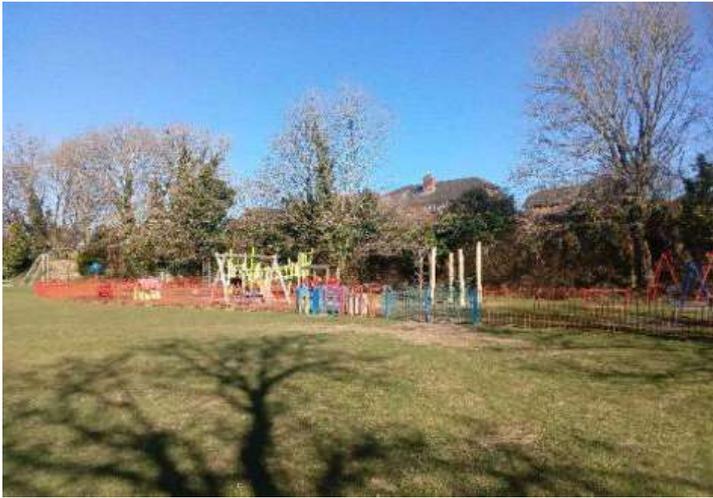
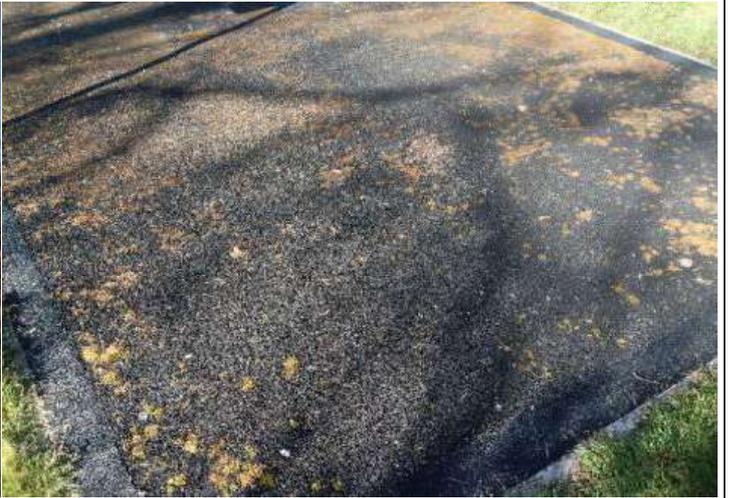
<b>Item:</b>	Ancillary Items - Site General	<b>Risk Level:</b>	L - Low Risk
<b>Manufacturer:</b>	Owner/Operator	<b>Surface:</b>	N/A

**Finding:** There is algae, silt or moss growth on the wet pour surfacing resulting in slippery conditions

**Action:** Clean and treat appropriately

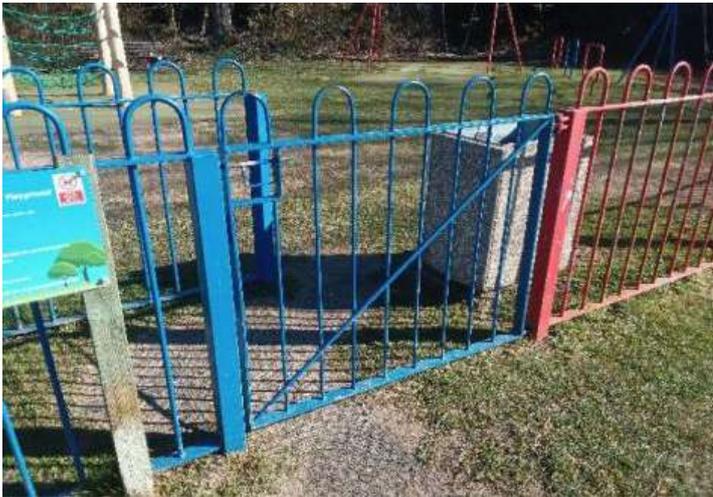
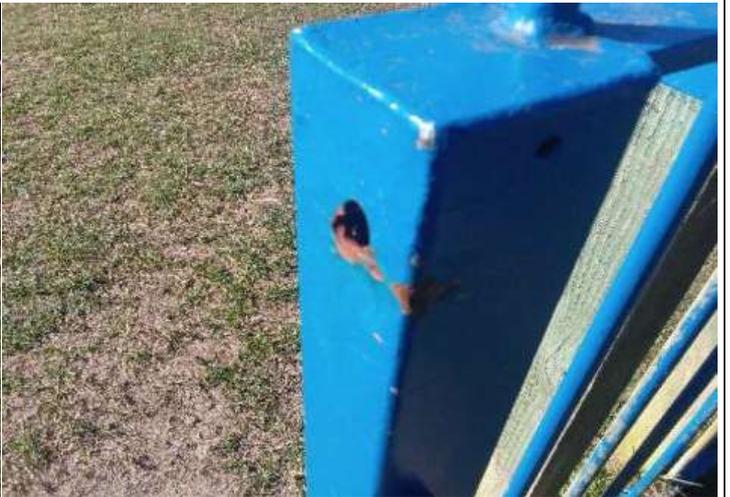
<b>Item:</b>	Gates - Kissing Gate	<b>Risk Level:</b>	L - Low Risk
<b>Manufacturer:</b>	Not Identified	<b>Surface:</b>	Grass Matrix Tiles

**Finding:** The paintwork on this item has been damaged or worn exposing the metal underneath which is rusting / corroding

**Action:** Treat affected areas and repaint

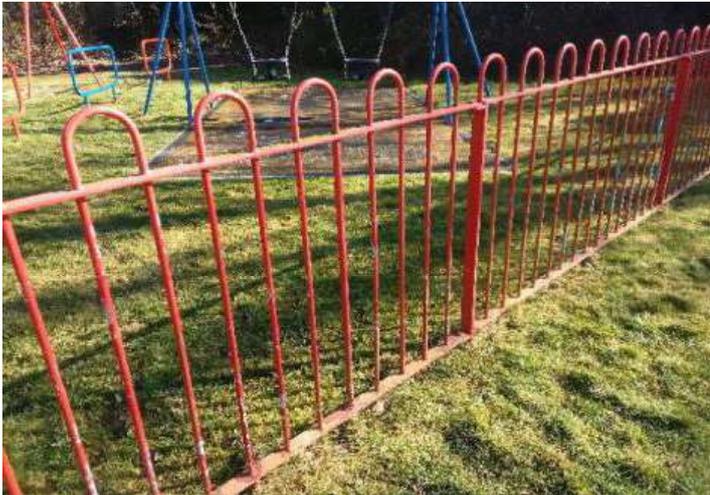
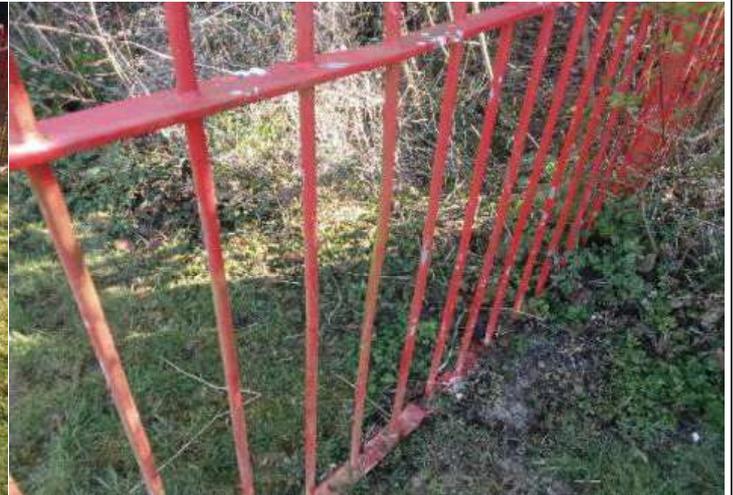
**Item:** Fences - Fence - Bow Top  
**Manufacturer:** Not Identified

**Finding:** There is some damage to the fence sections

**Action:** Monitor for any further deterioration and repair as required

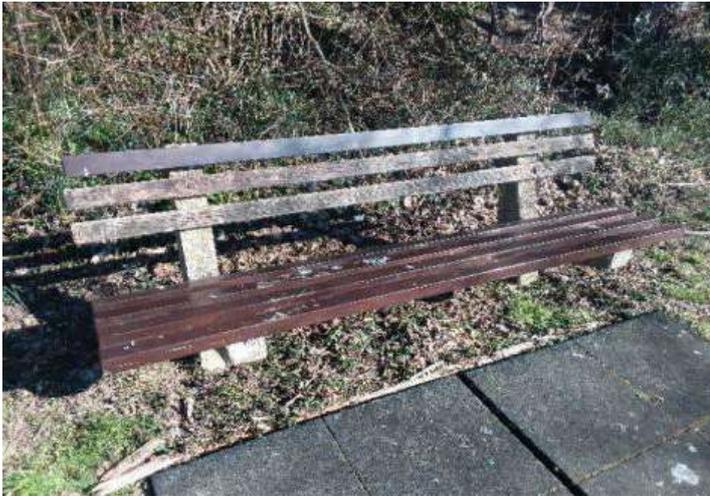
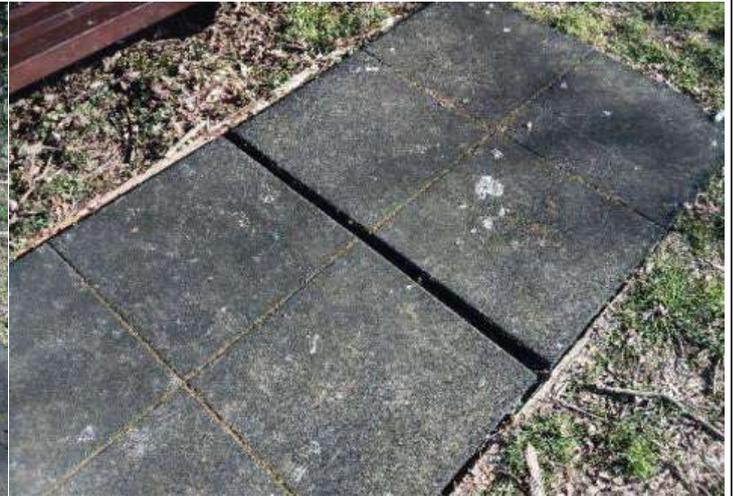
**Item:** Ancillary Items - Bench  
**Manufacturer:** Not Identified

**Finding:** There are gaps opening in between the tiles

**Action:** Monitor for any further deterioration and repair as required

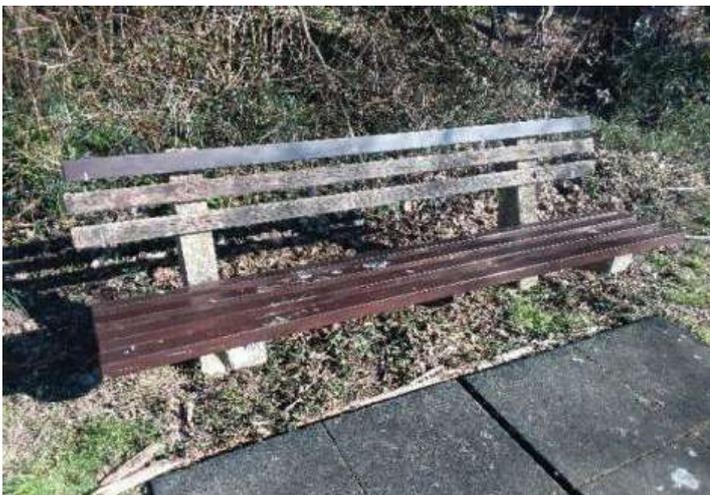
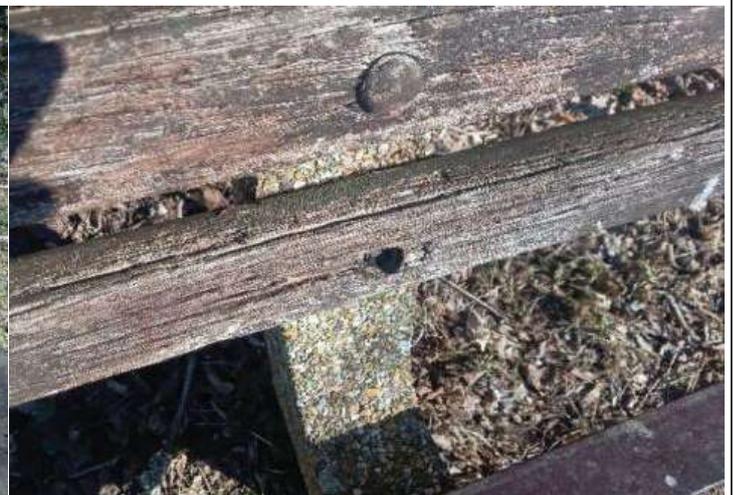
**Item:** Ancillary Items - Bench  
**Manufacturer:** Not Identified

**Finding:** There is/are inserts missing

**Action:** Replace missing inserts

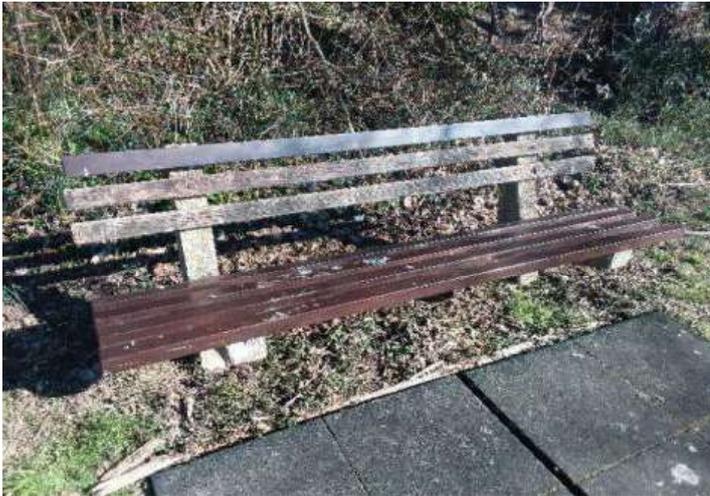
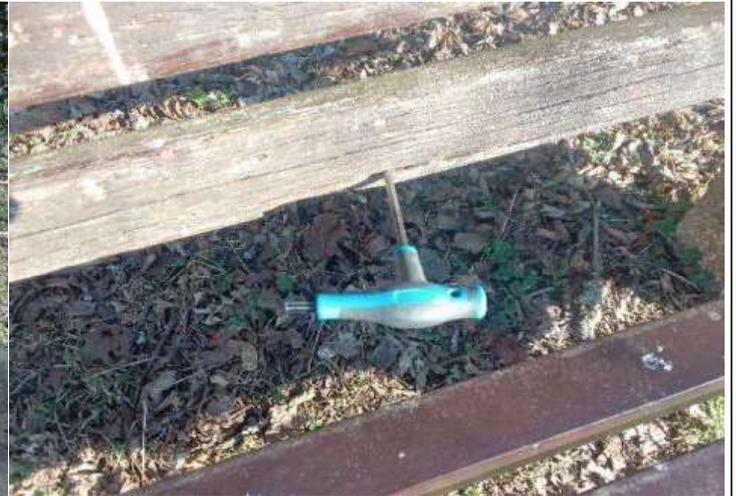
**Item:** Ancillary Items - Bench  
**Manufacturer:** Not Identified

**Finding:** There is some evidence of rot in the timber

**Action:** Monitor for any further deterioration and replace as required

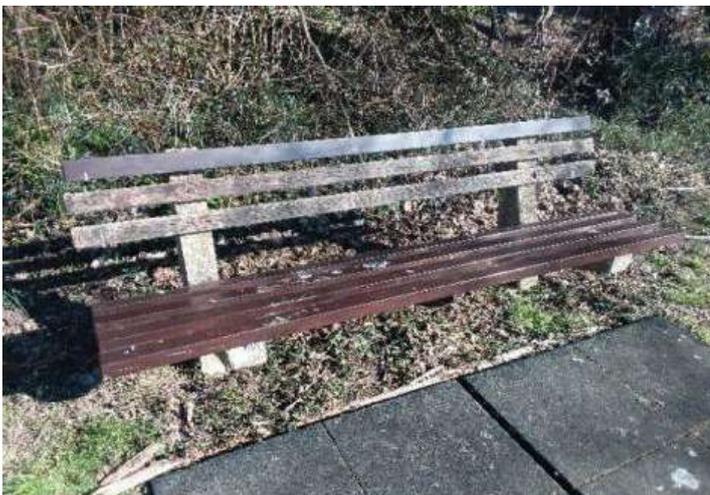
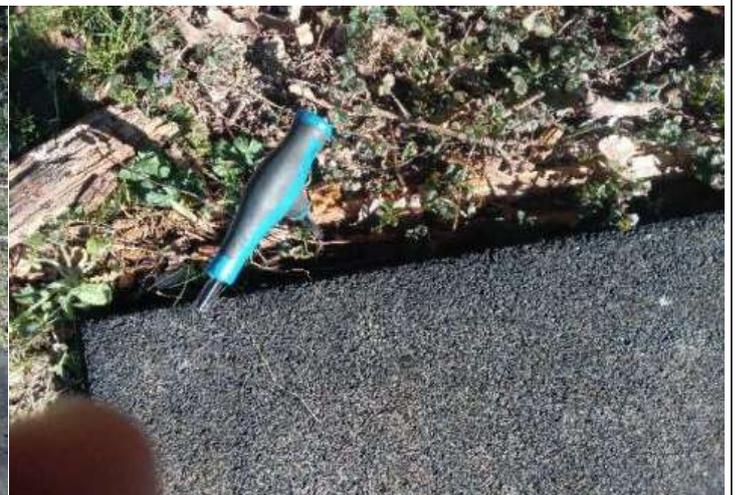
**Item:** Ancillary Items - Bench  
**Manufacturer:** Not Identified

**Finding:** There are areas or parts of the timber edging that have rotted

**Action:** Replace all affected timbers

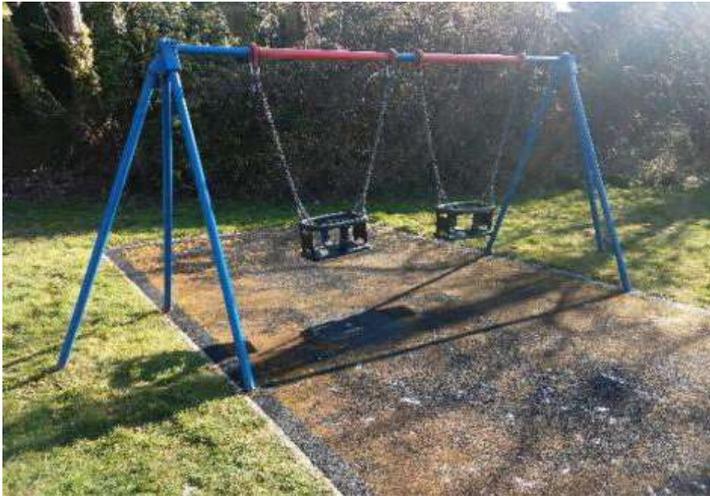
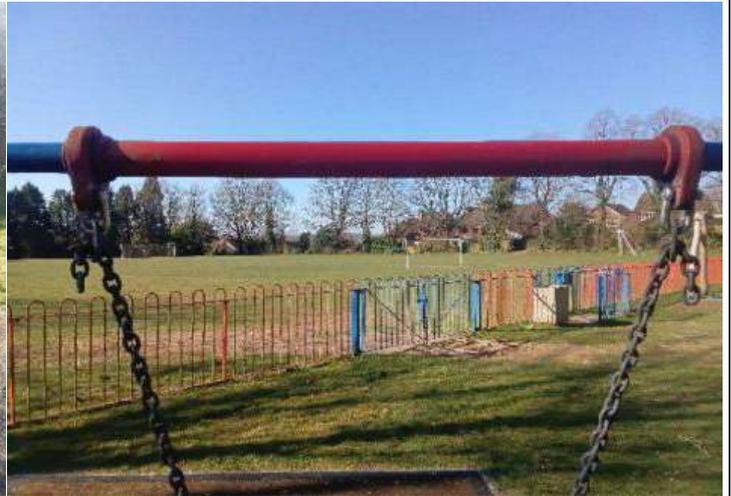
**Item:** Swings - 1 Bay 2 Seat (Cradle)  
**Manufacturer:** Wicksteed Playgrounds

**Finding:** The Anti Wrap bearings are dry and not moving freely

**Action:** Lubricate bearings in accordance with the manufacturers recommendations

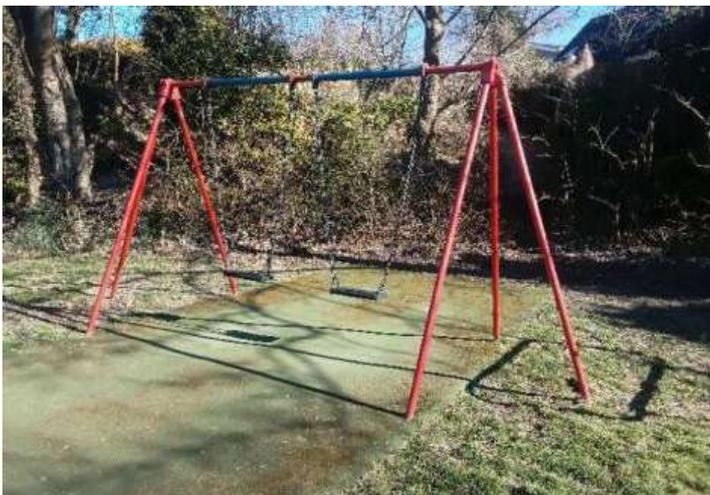
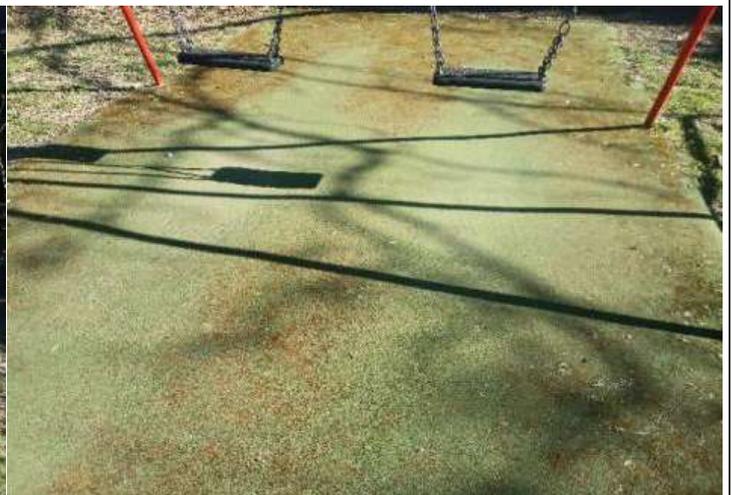
**Item:** Swings - 1 Bay 2 Seat (Flat)  
**Manufacturer:** Wicksteed Playgrounds

**Finding:** The safety surface is beginning to wear

**Action:** Monitor for any further deterioration and repair as required

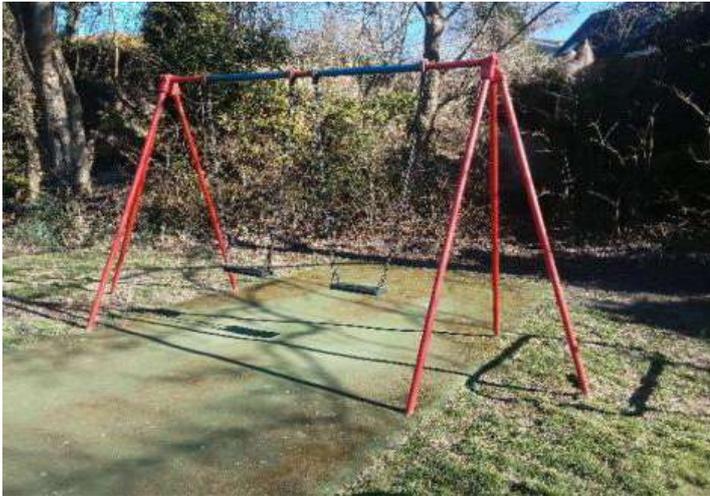
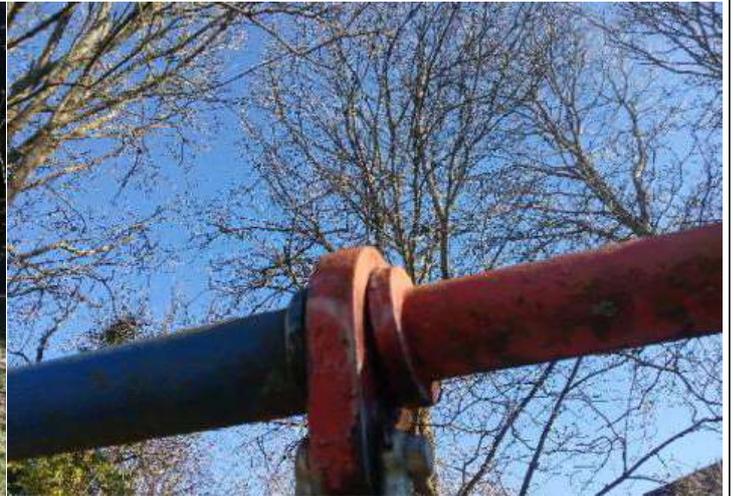
**Item:** Swings - 1 Bay 2 Seat (Flat)  
**Manufacturer:** Wicksteed Playgrounds

**Finding:** The anti wrap hanger bush / bushes is / are showing signs of wear

**Action:** Monitor for any further deterioration and replace as required

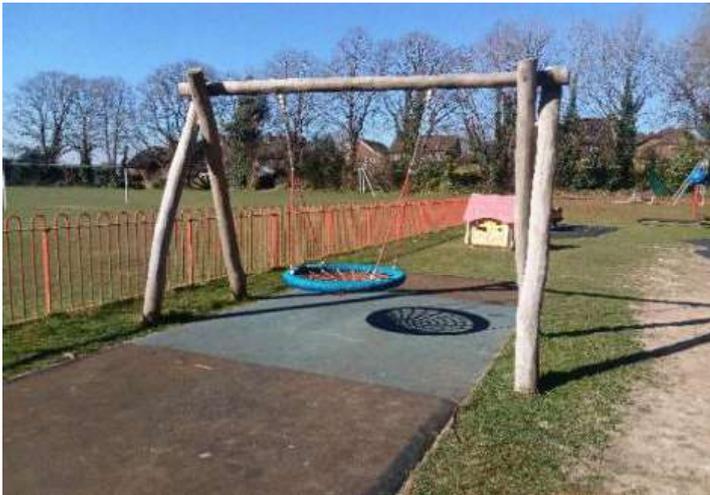
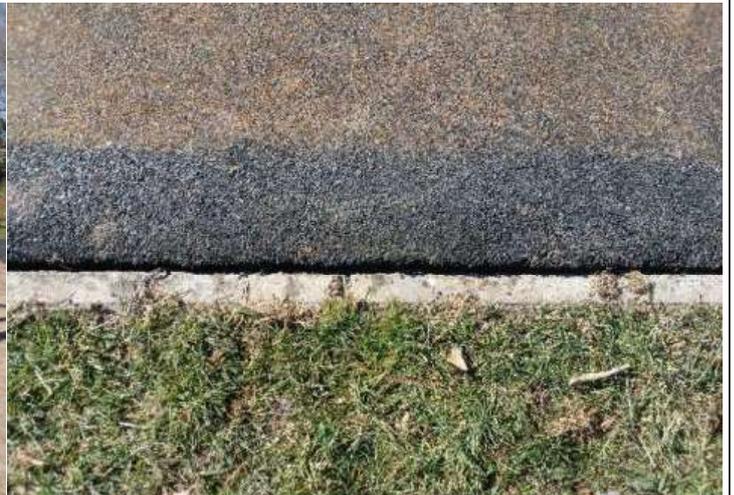
**Item:** Swings - Basket Swing - Type 1  
**Manufacturer:** Dylan Group Ltd

**Finding:** There are gaps opening between the surfacing and the edging surround or between the joints in the surfacing

**Action:** Monitor for any further deterioration and repair as required

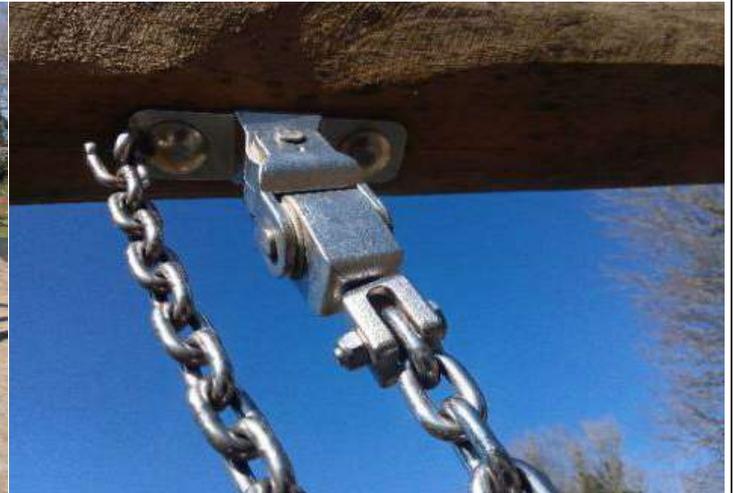
**Item:** Swings - Basket Swing - Type 1  
**Manufacturer:** Dylan Group Ltd

**Finding:** There is some notable evidence of chain wear

**Action:** Monitor for any further deterioration and replace when 40% worn

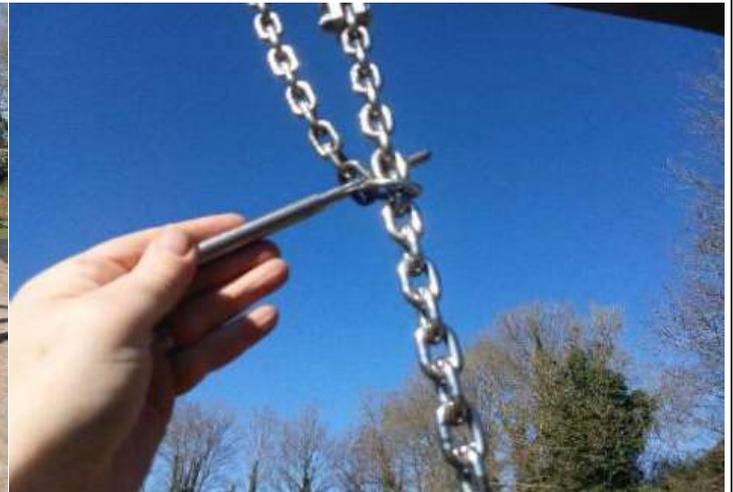
**Finding:** The connecting links are in excess of 8.6mm and less than 12mm and fail the requirements of BS EN 1176 Part 1; clause 4.2.13, Chains

**Action:** Monitor - No action given the risk assessment

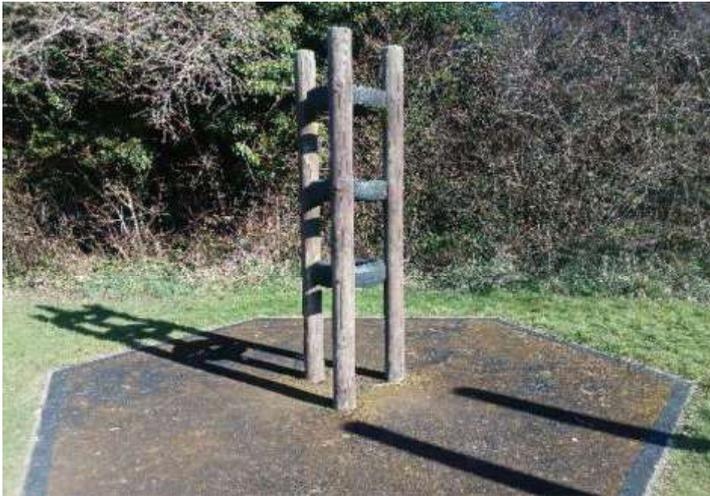
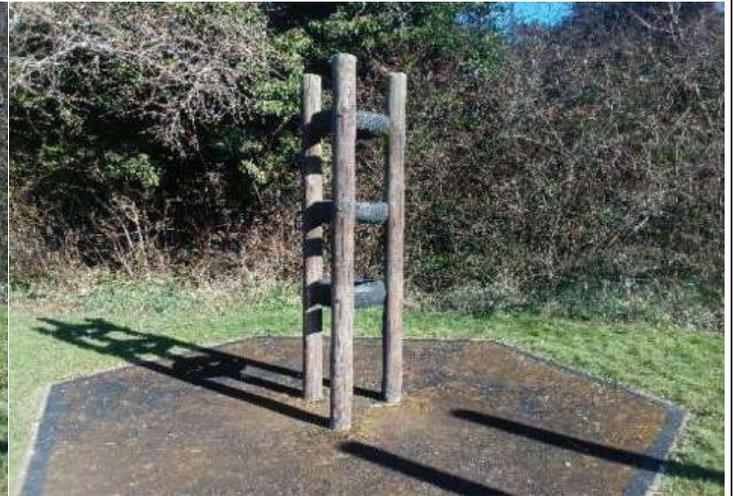
**Finding:** This item of equipment relies on a single post, or a line of posts, for stability and extra care needs to be taken with equipment of this nature to avoid the potential for catastrophic failure; it has been checked at the time of inspection however its important that particular attention is applied on all interim inspections

**Action:** Ensure that regular detailed inspections are undertaken to assess for rot, corrosion and general stability

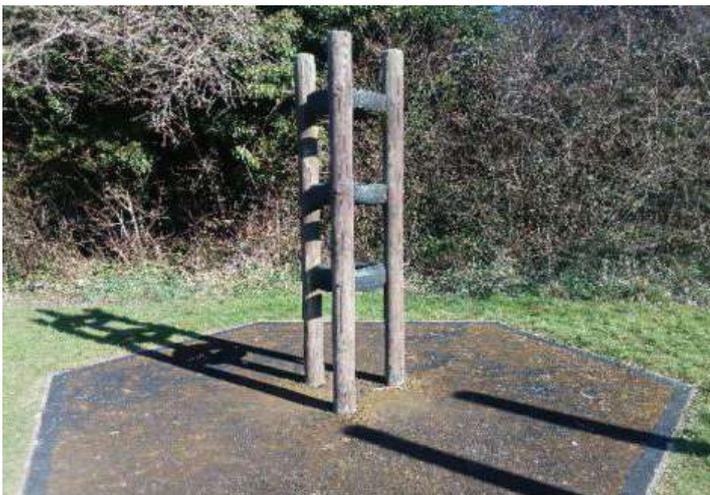
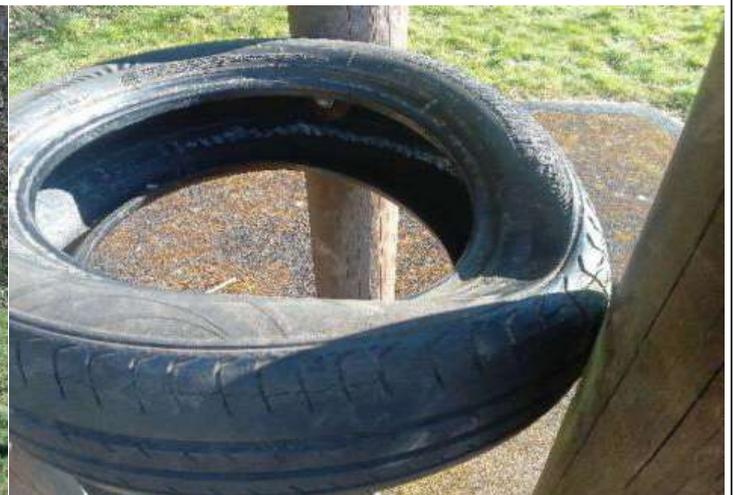
**Finding:** The tyres are losing their integrity

**Action:** Monitor for any further deterioration and replace as required

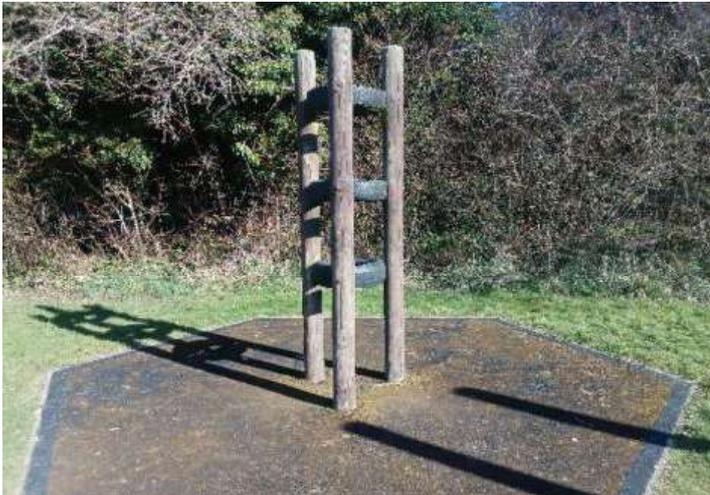
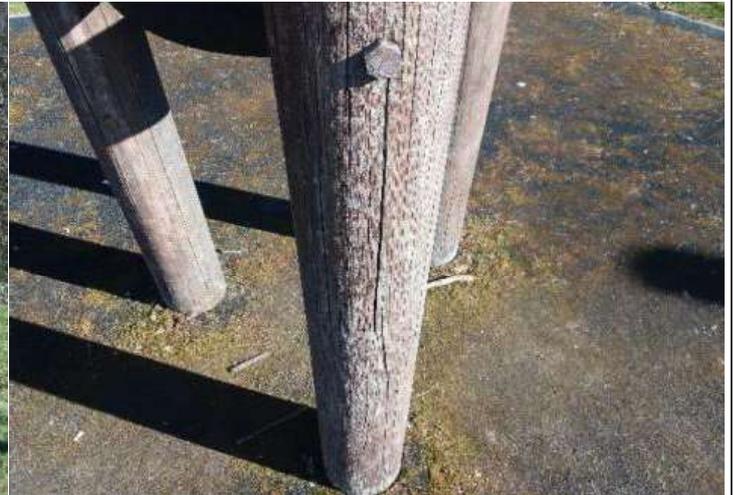
**Finding:** The timber stain is in poor condition

**Action:** Prepare all affected parts and re-stain with an appropriate preservative

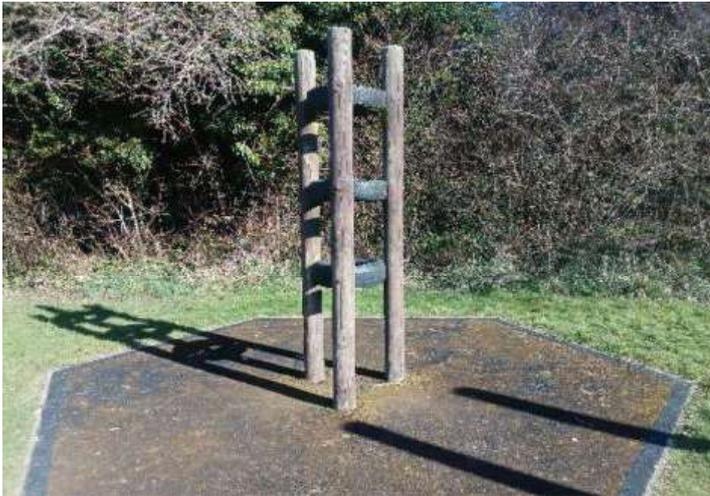
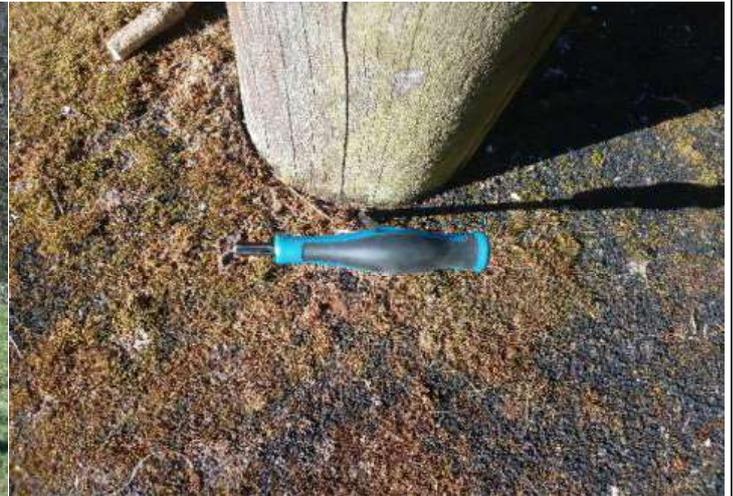
**Finding:** There is some evidence of rot in the posts

**Action:** Monitor for any further deterioration and replace as required

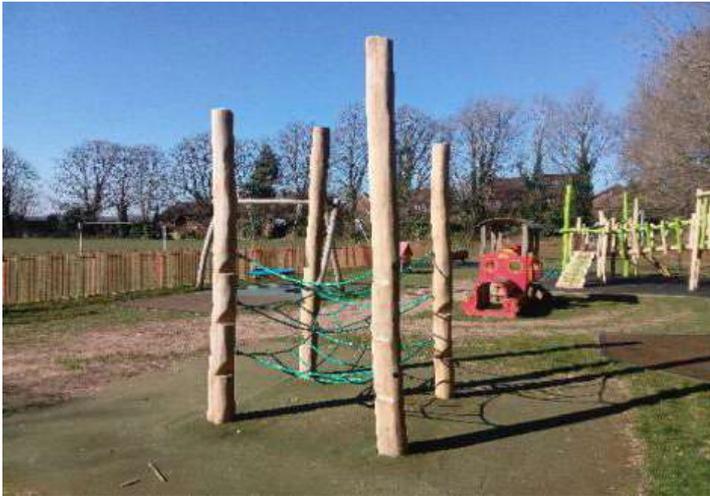
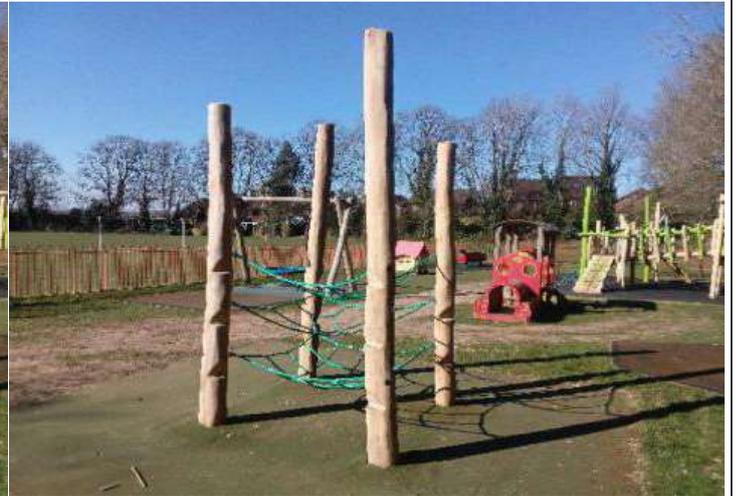
**Finding:** This item of equipment relies on a single post, or a line of posts, for stability and extra care needs to be taken with equipment of this nature to avoid the potential for catastrophic failure; it has been checked at the time of inspection however its important that particular attention is applied on all interim inspections

**Action:** Ensure that regular detailed inspections are undertaken to assess for rot, corrosion and general stability

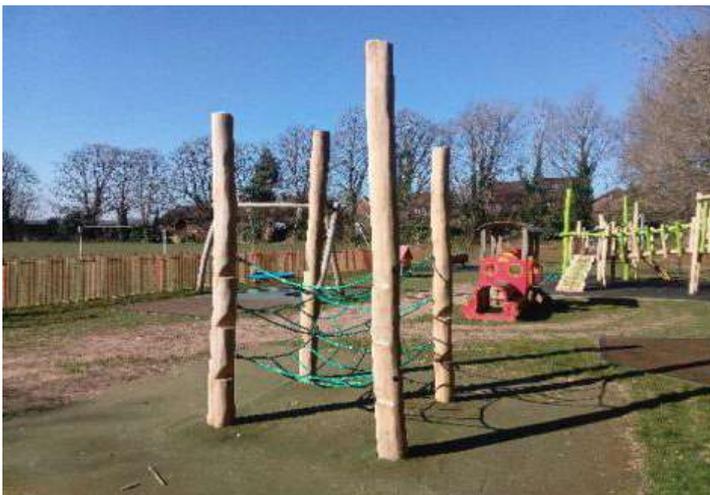
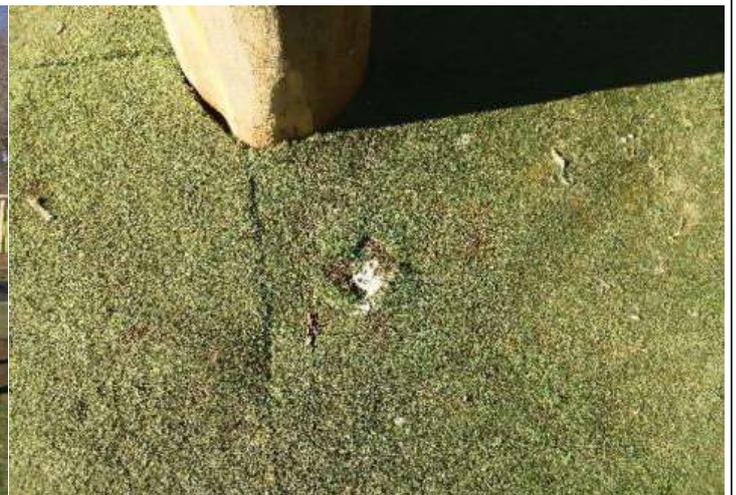
**Finding:** There is some evidence of fire damage to the surfacing

**Action:** Monitor for any further deterioration and repair as required

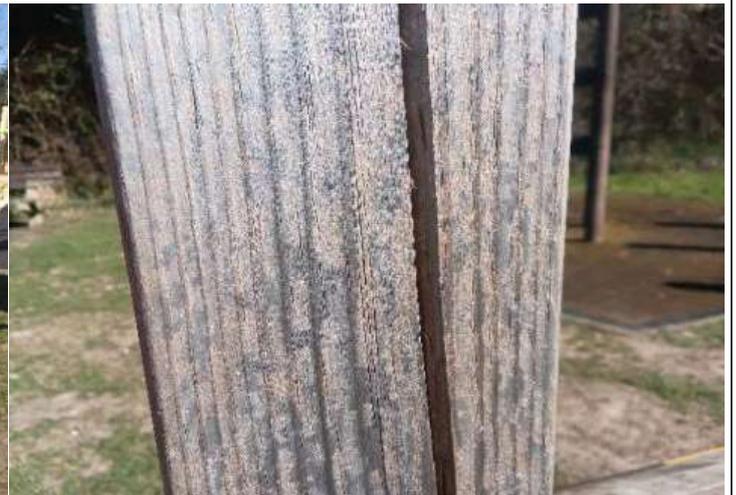
**Finding:** The timber has a number of splits/shakes or air cracks and this may affect the stability or allow water ingress which will accelerate the rotting process  
**Action:** Monitor to ensure the splits do not cross through fixing points of the structure and/or cause any instability

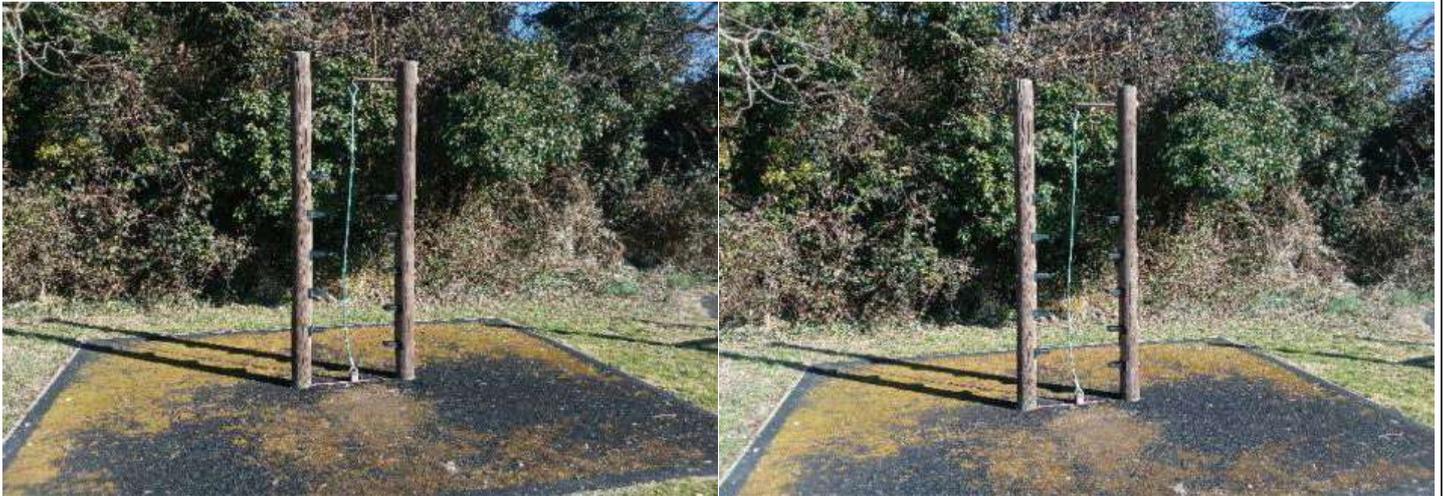
**Finding:** This item of equipment relies on a single post, or a line of posts, for stability and extra care needs to be taken with equipment of this nature to avoid the potential for catastrophic failure; it has been checked at the time of inspection however its important that particular attention is applied on all interim inspections

**Action:** Ensure that regular detailed inspections are undertaken to assess for rot, corrosion and general stability

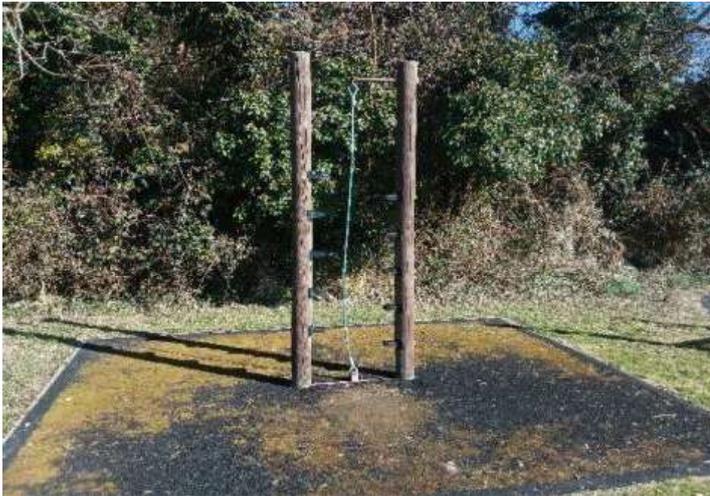
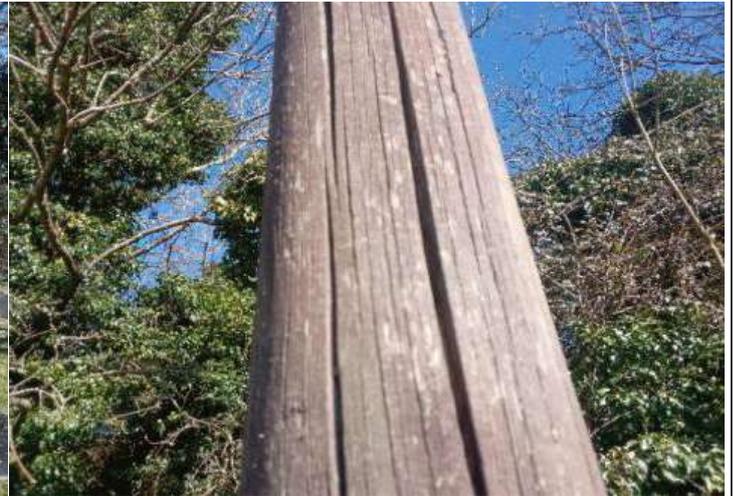
**Finding:** The timber has a number of splits/shakes or air cracks and this may affect the stability or allow water ingress which will accelerate the rotting process  
**Action:** Monitor to ensure the splits do not cross through fixing points of the structure and/or cause any instability

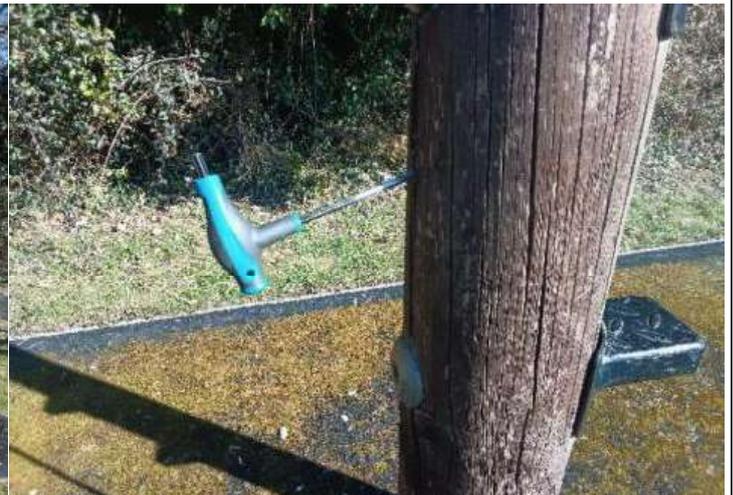
**Finding:** There is some evidence of rot in the posts  
**Action:** Monitor for any further deterioration and replace as required

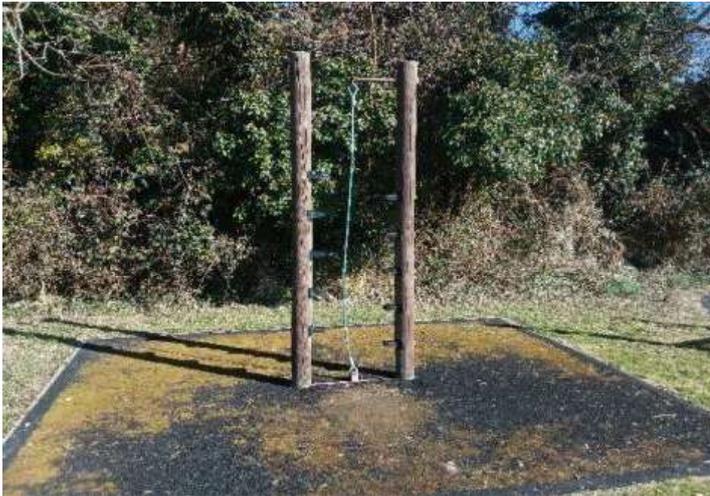
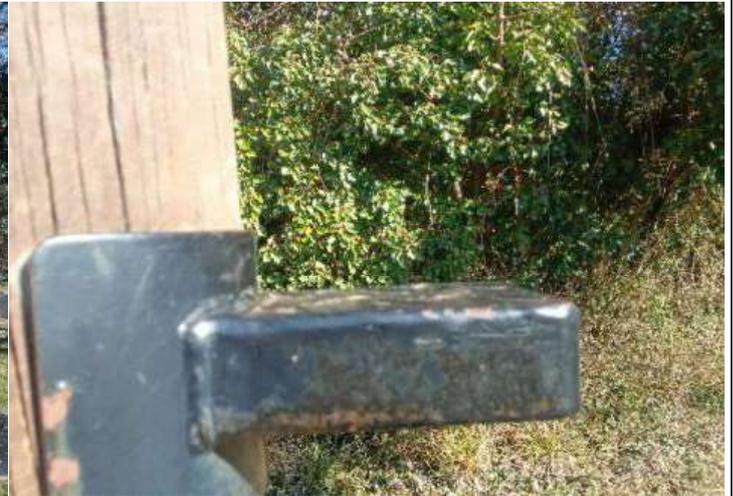
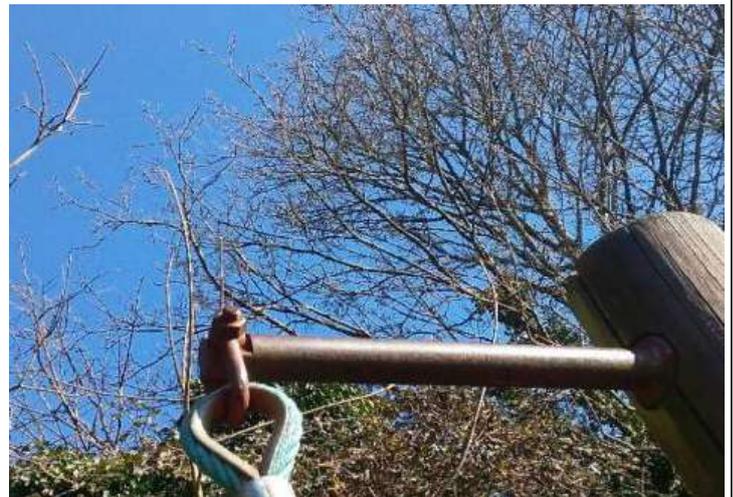
**Finding:** The paintwork on this item has been damaged or worn exposing the metal underneath which is rusting / corroding

**Action:** Treat affected areas and repaint

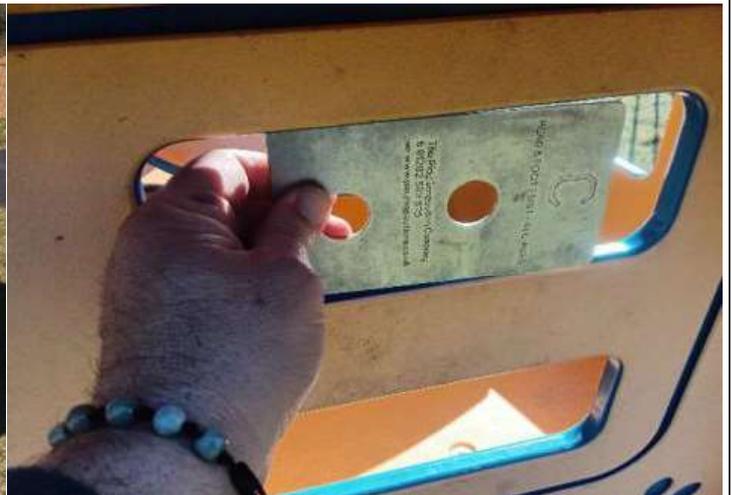
**Finding:** The item fails to meet the requirements of BS EN 1176 Part 1 4.2.7.2 for head and neck entrapment in the playhouse

**Action:** Monitor - No action given the risk assessment

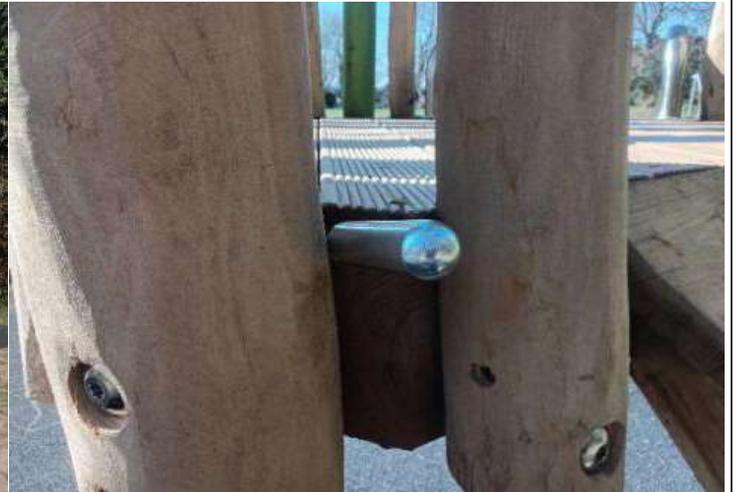
**Finding:** There is/are finger entrapment/s in the framework and the item fails to meet the requirements of BS EN 1176 Part 1 4.2.7.6 Entrapment of fingers

**Action:** Monitor - No action given the risk assessment

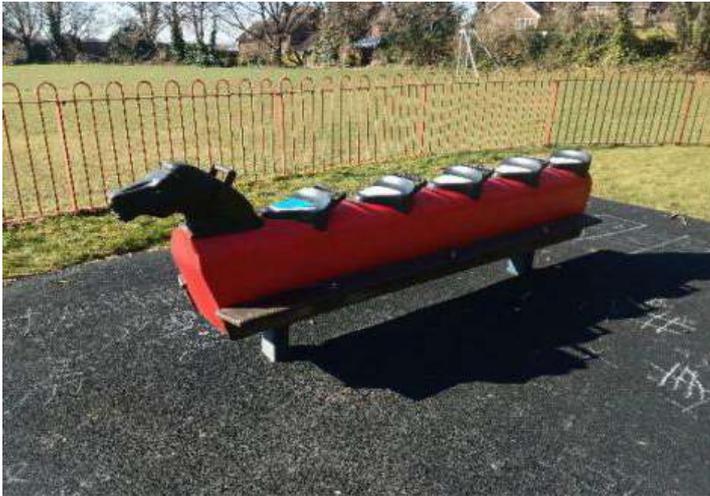
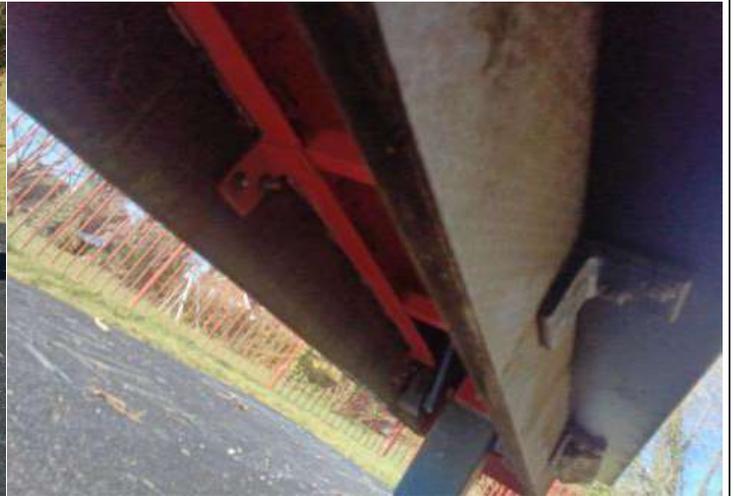
**Finding:** There is no gaiter protection for accessible moving parts (possible shear trap) as recommended in BS EN 1176 Part 1; 4.2.6 Moving Parts

**Action:** Monitor - No action given the risk assessment

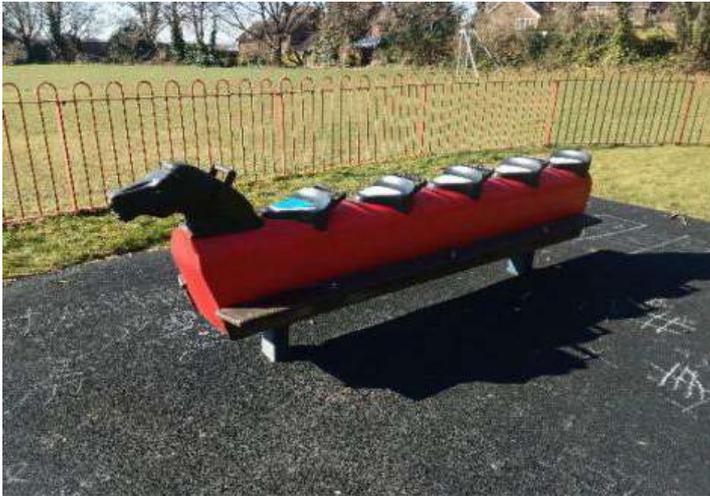
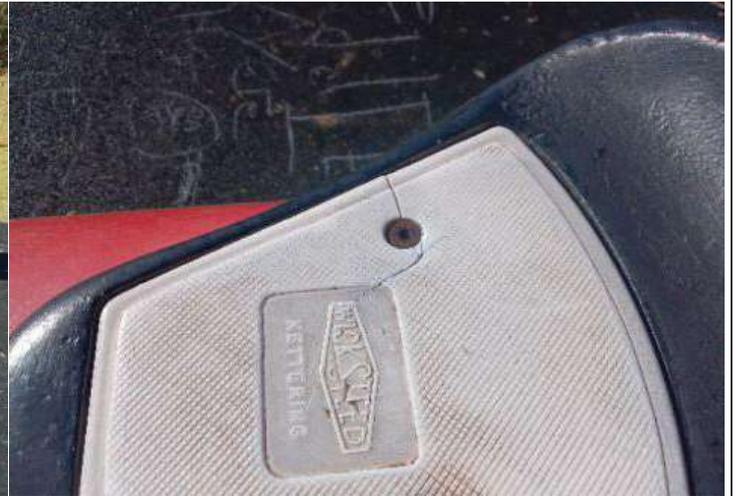
**Finding:** The seat has minor damage or wear

**Action:** Monitor for any further deterioration and replace as required

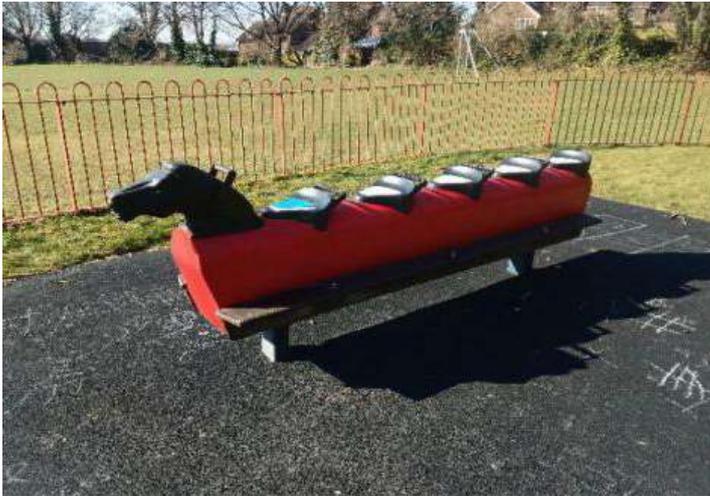
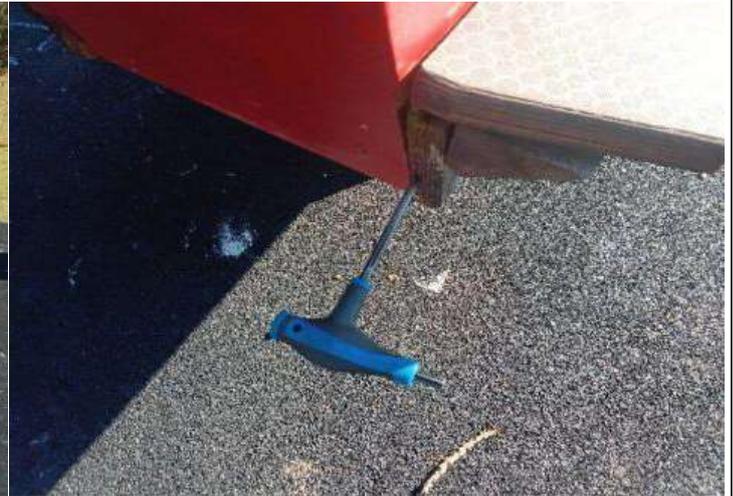
**Finding:** There is some evidence of rot in the timber

**Action:** Monitor for any further deterioration and replace as required

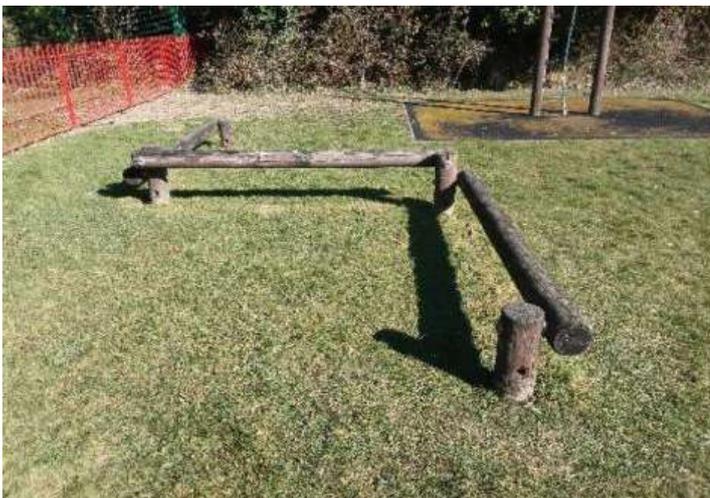
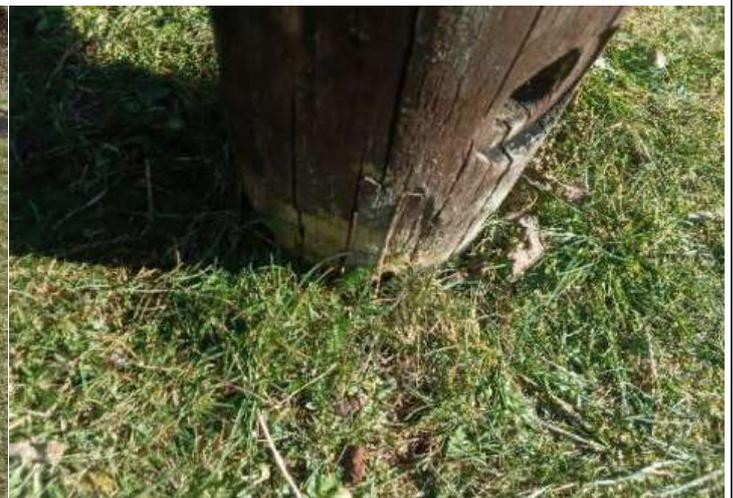
**Finding:** There is some strimmer / machinery damage apparent on the posts, this can penetrate the preservative applied to the timber and accelerate the rotting process

**Action:** Monitor for any deterioration (rot) and replace as required

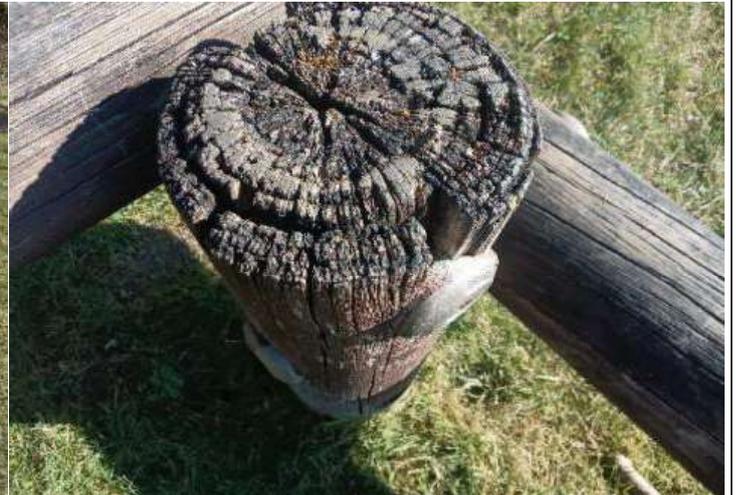
**Finding:** There is some damage to the posts

**Action:** Monitor for any further deterioration and replace as required
