## Annual Inspection

Winchester City Council

Sun Hill Recreation Ground (New Alresford)

Derwent Gardens, Alresford, SO24 9NQ

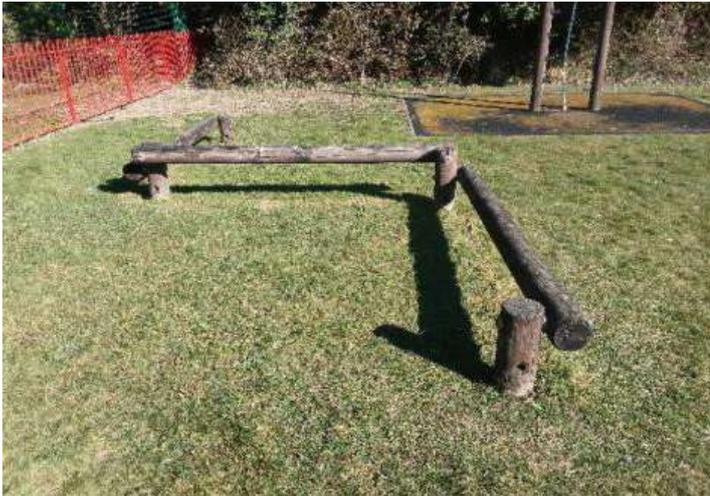
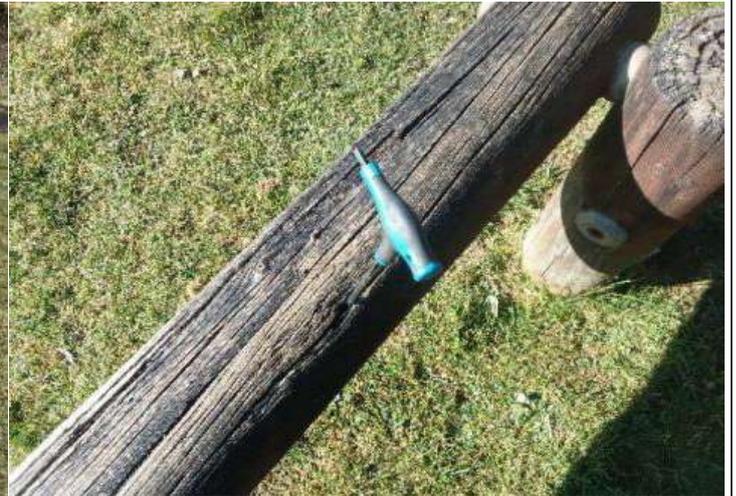
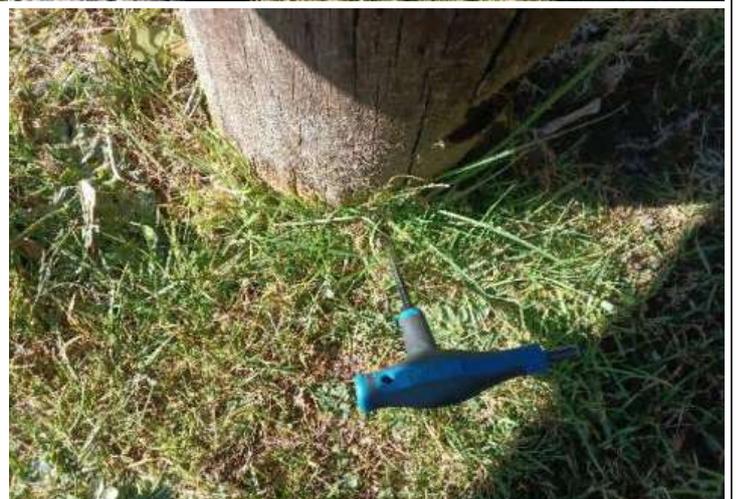
**Finding:** There is some evidence of rot in the timber

**Action:** Monitor for any further deterioration and replace as required

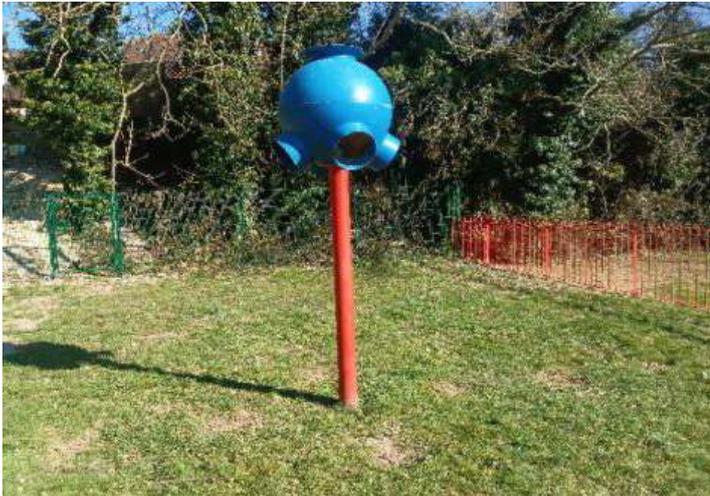
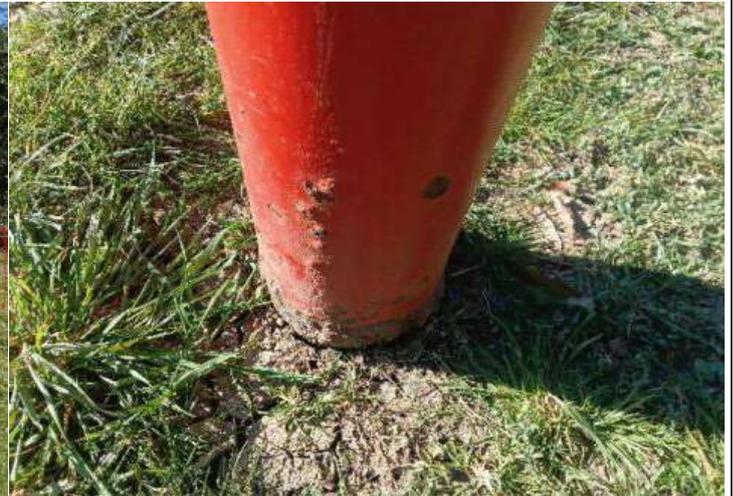
**Finding:** The paintwork on this item has been damaged or worn exposing the metal underneath which is rusting / corroding

**Action:** Treat affected areas and repaint

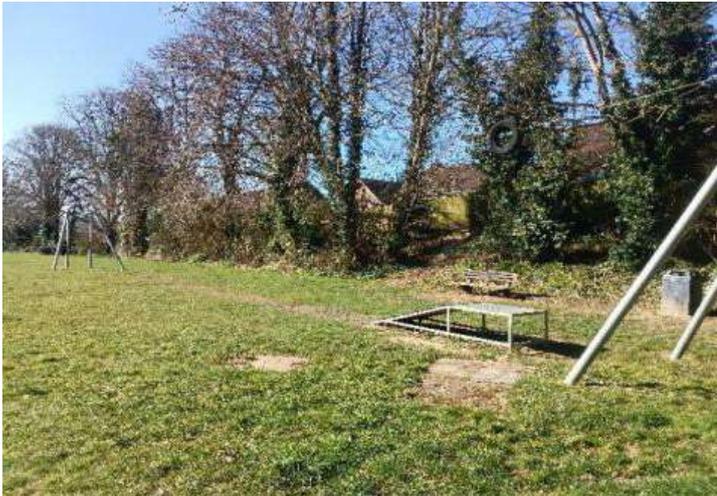
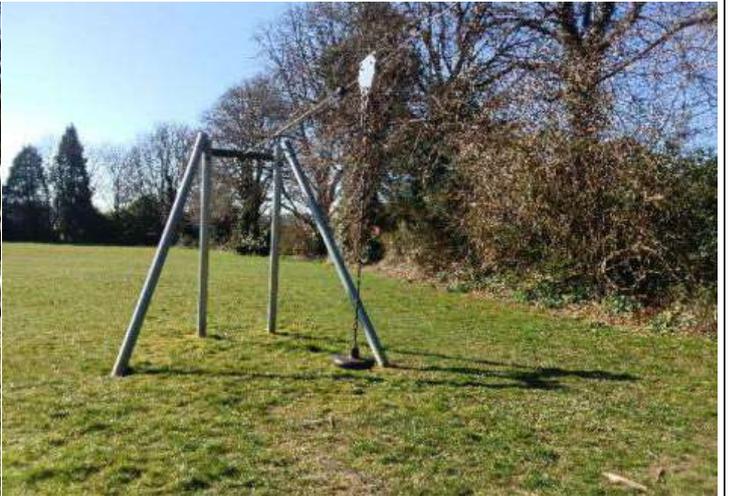
**Finding:** We have completed a visual inspection of the suspension links, cable and fixing points from ground level, however it is not possible to fully inspect these areas without either hiring equipment to gain access or removing the cable and suspension and inspecting at ground level. We recommend that the main cable and fixing security is thoroughly inspected at least in accordance with the manufacturers recommendations to check for wear, damage, security or internal rusting; this will help to ensure the continued safe use of the equipment

**Action:** Inspect in accordance with the manufacturers recommendations

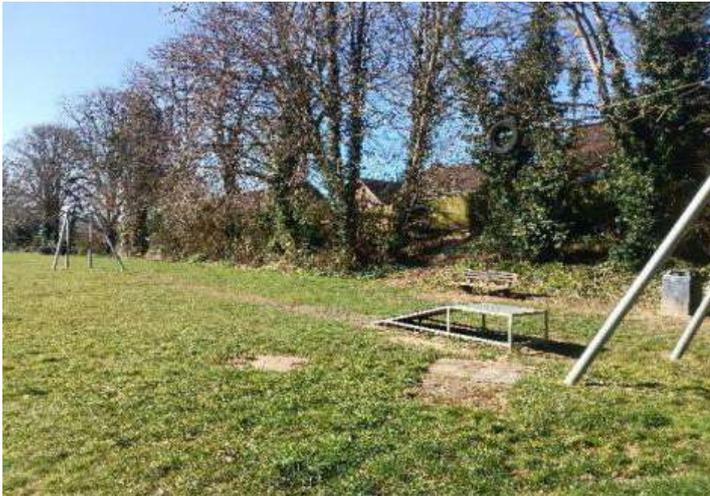
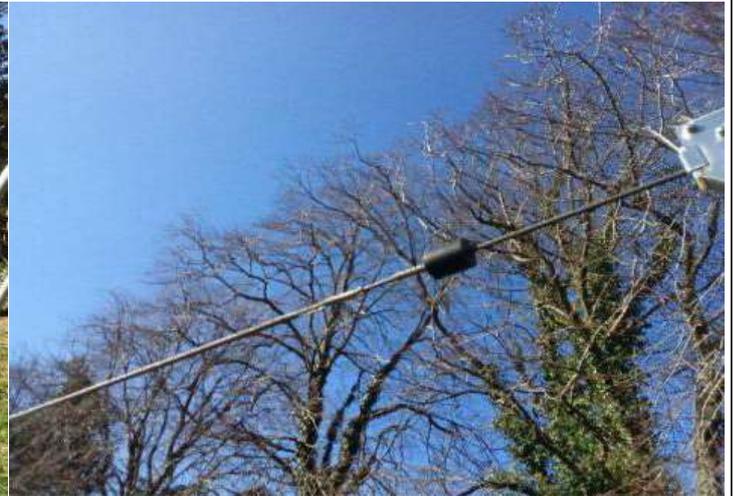
**Finding:** The dampening spring or tyre is damaged or broken on the item

**Action:** Replace spring or tyre

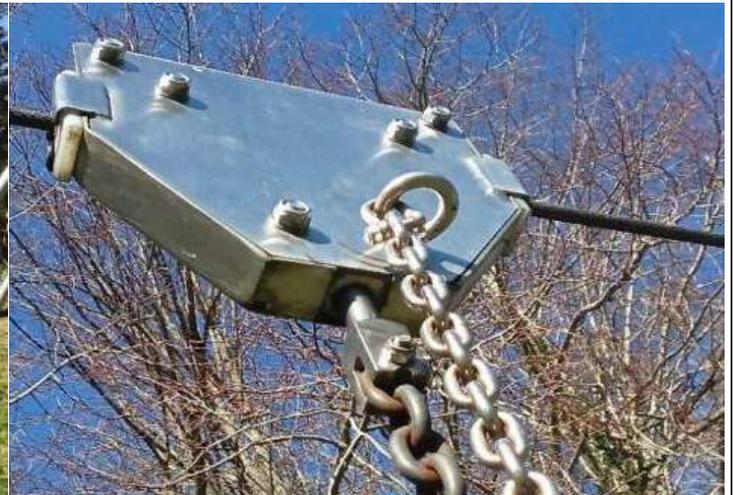
**Finding:** There is some notable evidence of chain wear

**Action:** Monitor for any further deterioration and replace when 40% worn

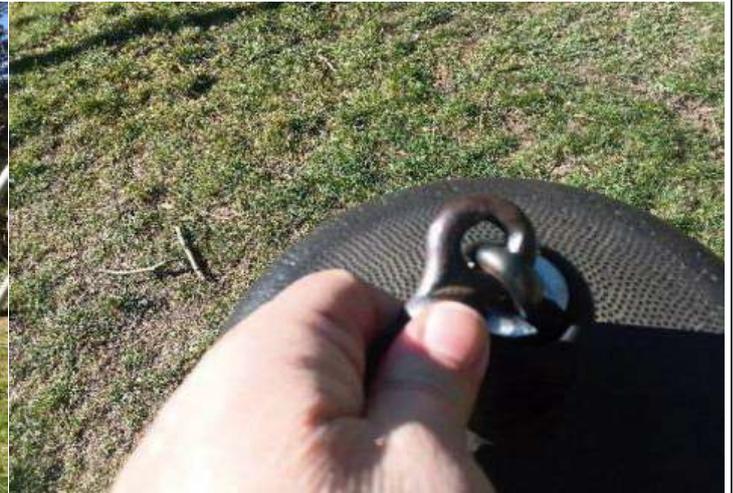
**Finding:** There is some wear to the chain bars

**Action:** Monitor for any further deterioration and replace when 40% worn

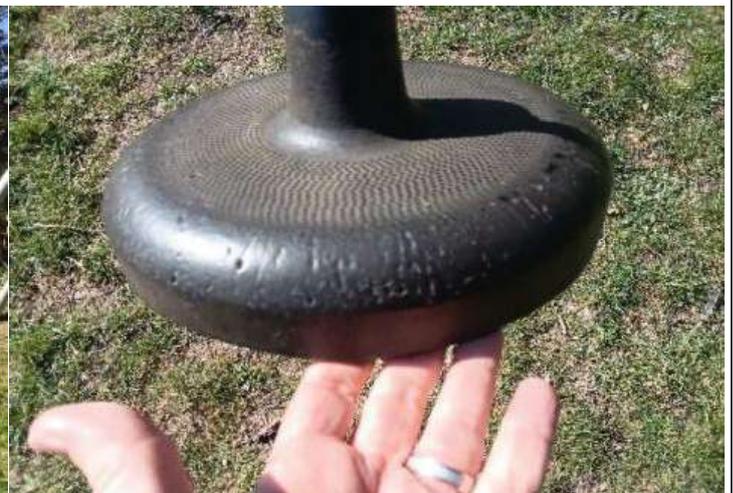
**Finding:** The cableway seat has been damaged

**Action:** Monitor for any further deterioration and replace as required

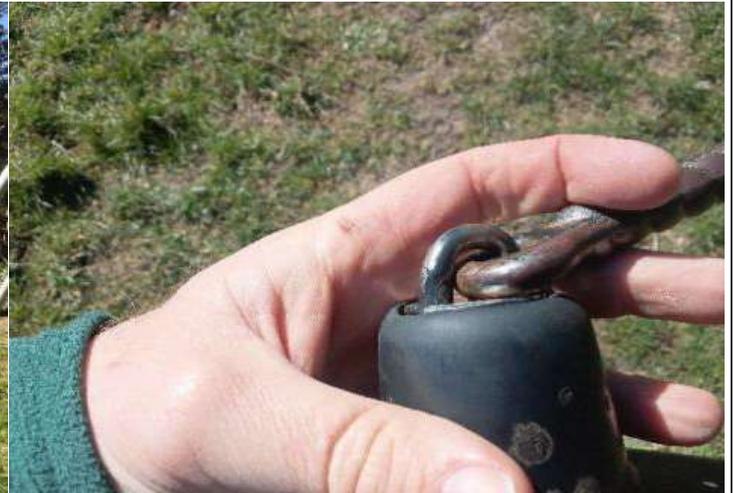
**Item:** Other - Cable Runway  
**Manufacturer:** Wicksteed Playgrounds  
**Risk Level:** L - Low Risk  
**Surface:** Grass Matrix Tiles

**Finding:** The swing seat connectors have some wear present  
**Action:** Monitor for further deterioration and replace when 40% worn

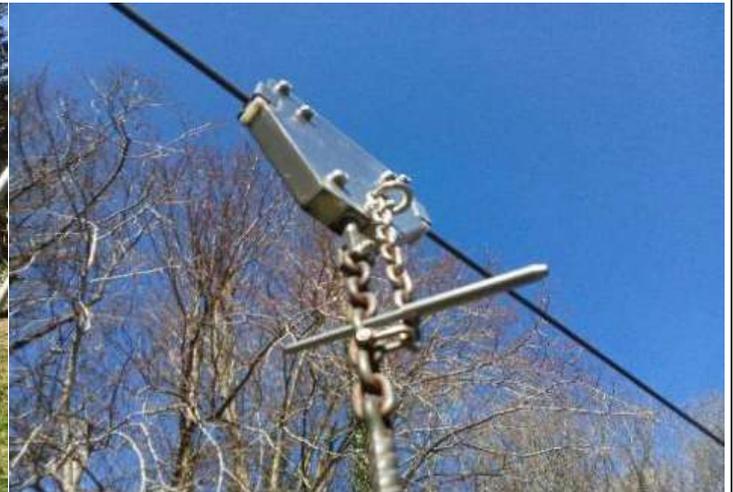
**Item:** Other - Cable Runway  
**Manufacturer:** Wicksteed Playgrounds  
**Risk Level:** V - Very Low Risk  
**Surface:** Grass Matrix Tiles

**Finding:** The chain openings are in excess of the 8.6mm as recommended by BS EN 1176  
**Action:** Monitor - No action given the risk assessment
