the **play inspection** company

## Annual Inspection

Winchester City Council

Stratton Bates Recreation Ground (New Alresford)

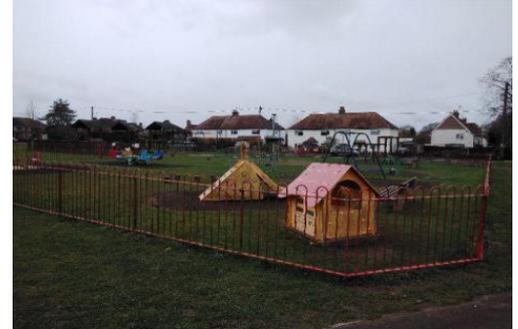
**Item:** Site General  
**Manufacturer:** Owner/Operator  
**Surface Type:** N/A  
**Item Quantity:** 1  
**Equipment Compliance:** N/A  
**Surface Area Compliance:** N/A

The site is accessible to the public during the COVID 19 pandemic. The government have released guidelines for safely re-opening these types of facilities which is available on the government website. - Ensure there is an appropriate risk assessment in place and review regularly

There are significant gaps (over 30mm) between the surface and the edging or between the joints in the surface; these are large enough for a small foot to enter - Repair surfacing

The surface is lifting at the edges and creating trip points - Repair perimeter of surfacing to remove trip points

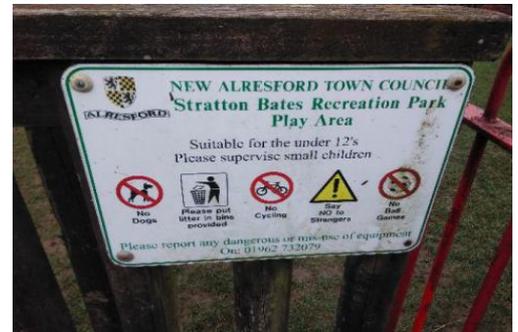
**Item:** Sign  
**Manufacturer:** Owner/Operator  
**Surface Type:** N/A  
**Item Quantity:** 1  
**Equipment Compliance:** N/A  
**Surface Area Compliance:** N/A

BS EN 1176 Part 7 recommends that signage shall include the site name / address - Provide additional information

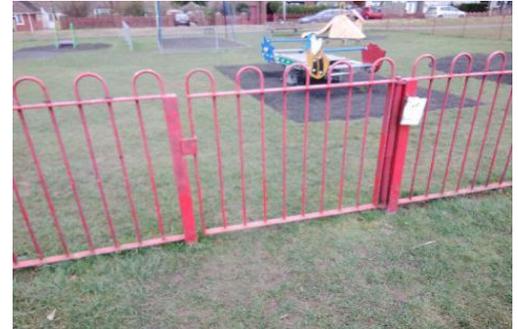
**Item:** Gate - Self Closing  
**Manufacturer:** Unknown  
**Surface Type:** Grass  
**Item Quantity:** 2  
**Equipment Compliance:** N/A  
**Surface Area Compliance:** N/A

The rubber buffer is missing from the latch plate - Replace rubber buffer

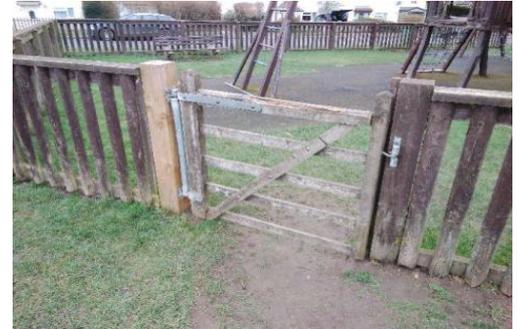
**Item:** Gate - Self Closing  
**Manufacturer:** Unknown  
**Surface Type:** Grass  
**Item Quantity:** 1  
**Equipment Compliance:** N/A  
**Surface Area Compliance:** N/A

The area under the gate has eroded leaving uneven areas, or the concrete foundations exposed, resulting in trip hazards at the entrance/exit to the playground - Reinstate to level with surrounding surfaces

There is some evidence of rot in the timber - Monitor for any further deterioration and replace as required

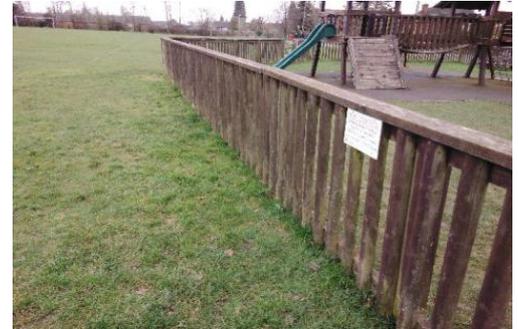
**Item:** Fencing - Timber  
**Manufacturer:** Unknown  
**Surface Type:** Grass  
**Item Quantity:** 1  
**Equipment Compliance:** N/A  
**Surface Area Compliance:** N/A

There is some strimmer / machinery damage apparent on the posts, this can penetrate the preservative applied to the timber and accelerate the rotting process - Monitor for any deterioration (rot) and replace as required

There are a number of loose posts around the fence - Monitor for any further deterioration and reset as required

A number of fixings have worked loose around the fencing - Secure all loose fixings

There are areas or parts of the timber on the structure that have rotted - Replace all affected timbers

The item has been damaged - Monitor for any further deterioration and replace as required

There is some evidence of rot in the timber posts - Monitor for any further deterioration and replace as required

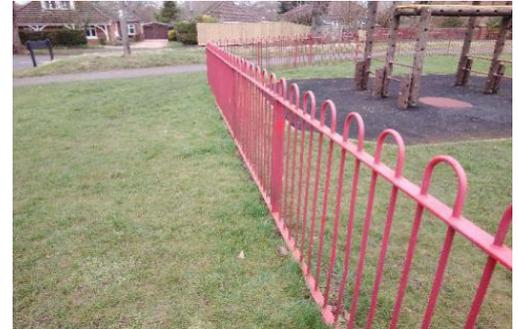
**Item:** Fence - Bow Top  
**Manufacturer:** Unknown  
**Surface Type:** Grass  
**Item Quantity:** 1  
**Equipment Compliance:** N/A  
**Surface Area Compliance:** N/A

The item has been damaged - Monitor for any further deterioration and replace as required

There are a number of loose posts around the fence - Monitor for any further deterioration and reset as required

There are a number of fixings missing from the fence - Replace missing fixings

There are a number of post caps missing from the fence - Replace missing post caps

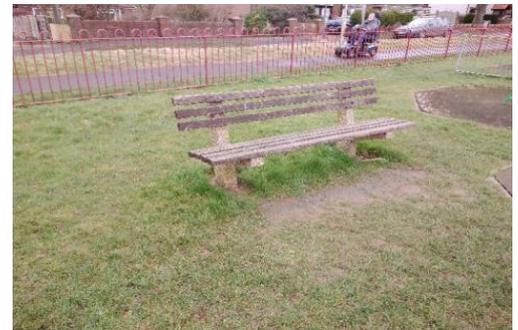
**Item:** Bench  
**Manufacturer:** Unknown  
**Surface Type:** Grass  
**Item Quantity:** 3  
**Equipment Compliance:** N/A  
**Surface Area Compliance:** N/A

There is/are several inserts missing - Replace missing inserts

The item has been damaged - Monitor for any further deterioration and replace as required

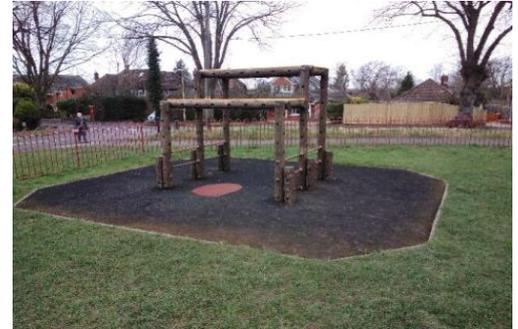
**Item:** Climbing Frame  
**Manufacturer:** Lappset UK Ltd  
**Surface Type:** Wet Pour  
**Item Quantity:** 1  
**Equipment Compliance:** No  
**Surface Area Compliance:** No  
**Life Expectancy:** 3 - 5 Years  
**Total Findings:** 8

The safety surface under or around this unit has been damaged - Monitor for any further deterioration and repair as required

The surface has subsided in some areas - Monitor for any further deterioration and repair as required

The surface has eroded and the old foundations are exposed - Reinststate surrounding surfaces to cover the foundations

There is some evidence of rot in the timber - Monitor for any further deterioration and replace as required

The surfacing dimensions are short and do not meet with the requirements of the current applicable standard - Monitor - no remedial action recommended

There are gaps opening between the surfacing and the edging surround or between the joints in the surfacing - Monitor for any further deterioration and repair as required

There is/are finger entrapment/s in the timber beam in a old knot hole and the item fails to meet the requirements of BS EN 1176 Part 1 4.2.7.6 Entrapment of fingers - Monitor - No remedial work recommended

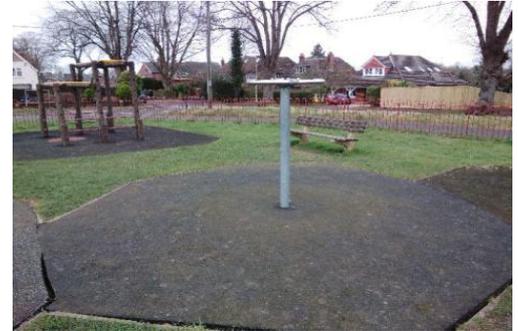
**Item:** Overhead Rotator  
**Manufacturer:** Proludic  
**Surface Type:** Wet Pour  
**Item Quantity:** 1  
**Equipment Compliance:** No  
**Surface Area Compliance:** Yes  
**Life Expectancy:** 3 - 5 Years  
**Total Findings:** 3

The bearing is not operating correctly - Replace the bearing as required

There is/are finger entrapment/s in the top of the rotator and the item fails to meet the requirements of BS EN 1176 Part 1 4.2.7.6 Entrapment of fingers - Monitor - No remedial work recommended

The safety surface around the area is beginning to wear - Monitor for any further deterioration and repair as required

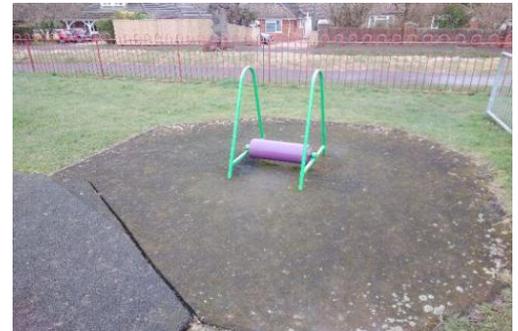
**Item:** Rotating Beam  
**Manufacturer:** Wicksteed Playgrounds  
**Surface Type:** Wet Pour  
**Item Quantity:** 1  
**Equipment Compliance:** Yes  
**Surface Area Compliance:** Yes  
**Life Expectancy:** 3 - 5 Years  
**Total Findings:** 3

The safety surface around the area is beginning to wear - Monitor for any further deterioration and repair as required

There is algae or moss growth on the surface resulting in slippery conditions - Clean and treat appropriately

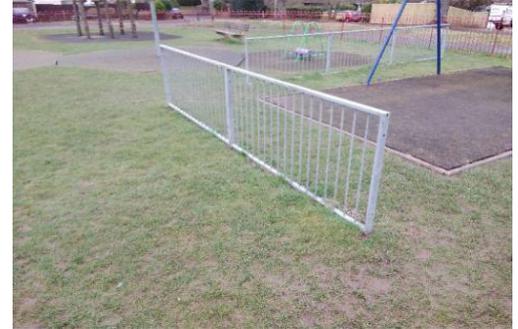
**Item:** Swing Barrier  
**Manufacturer:** Unknown  
**Surface Type:** Grass  
**Item Quantity:** 4  
**Equipment Compliance:** N/A  
**Surface Area Compliance:** N/A

There is/are several inserts missing - Replace missing inserts

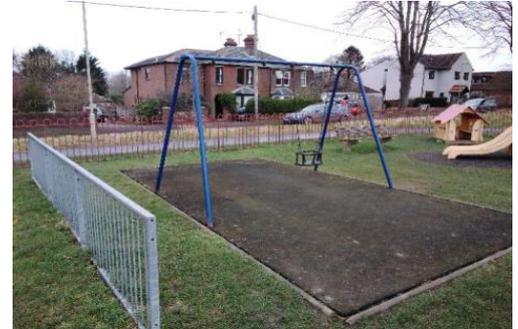
**Item:** 1 Bay 2 Seat (Cradle)  
**Manufacturer:** Wicksteed Playgrounds  
**Surface Type:** Wet Pour  
**Item Quantity:** 1  
**Equipment Compliance:** No  
**Surface Area Compliance:** No  
**Life Expectancy:** 3 - 5 Years  
**Total Findings:** 11

There are trip hazards at the edges of the surface - Reinstate surrounding surface levels to remove the trip points

The seat(s) and suspension were missing at the time of inspection and the inspector was unable to make a full compliance assessment - Replace missing seat(s) and suspension

The safety surface around the area is beginning to wear - Monitor for any further deterioration and repair as required

The surface has subsided in some areas - Monitor for any further deterioration and repair as required

The safety surface under or around this unit has been damaged - Monitor for any further deterioration and repair as required

The surfacing dimensions are short and do not meet with the requirements of the current applicable standard - Monitor - no remedial action recommended

There is some wear to the shackles. - Monitor for any further deterioration and replace when 40% worn

There is some notable evidence of chain wear - Monitor for any further deterioration and replace when 40% worn

There is some notable evidence of connecting link wear - Monitor for any further deterioration and replace when 40% worn

The chain openings are in excess of the 8.6mm as recommended by BS EN 1176 - Monitor - No remedial work recommended

The bushes are showing signs of wear - Monitor for any further deterioration and replace as required

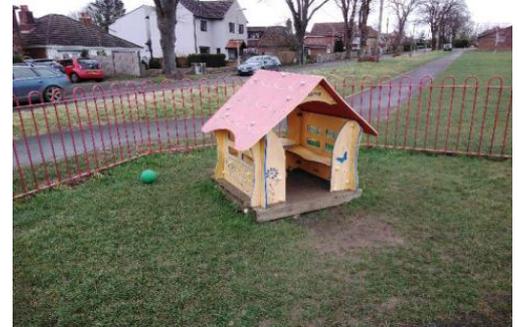
**Item:** Playhouse  
**Manufacturer:** Wicksteed Playgrounds  
**Surface Type:** Grass  
**Item Quantity:** 1  
**Equipment Compliance:** Yes  
**Surface Area Compliance:** N/A  
**Life Expectancy:** 3 - 5 Years  
**Total Findings:** 5

There is/are bolt cap covers missing or damaged on the item - Replace missing or damaged bolt cap covers

There is some strimmer / machinery damage apparent on the posts, this can penetrate the preservative applied to the timber and accelerate the rotting process - Monitor for any deterioration (rot) and replace as required

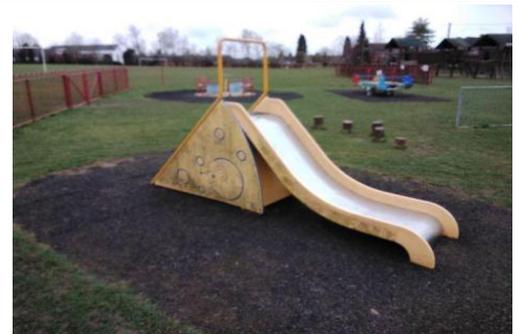
**Item:** Free Standing Slide  
**Manufacturer:** Wicksteed Playgrounds  
**Surface Type:** Bonded Rubber Mulch  
**Item Quantity:** 1  
**Equipment Compliance:** Yes  
**Surface Area Compliance:** Yes  
**Life Expectancy:** 5 -10 Years  
**Total Findings:** 3

There is algae or moss on the surface of the equipment - Clean and treat appropriately

A number of fixing(s) have worked loose to the slide side - Secure all loose fixings

There are a number of dents in the slide surface - Monitor for any further deterioration and repair as required

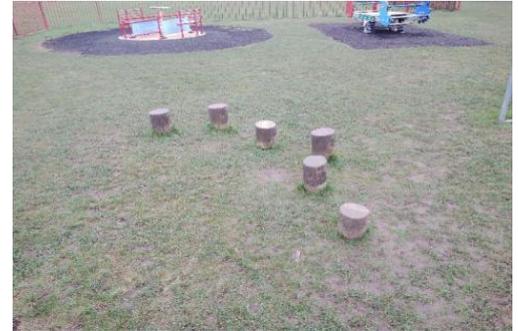
**Item:** Log Walk  
**Manufacturer:** Unknown  
**Surface Type:** Grass  
**Item Quantity:** 6  
**Equipment Compliance:** Yes  
**Surface Area Compliance:** Yes  
**Life Expectancy:** 1 - 3 Years  
**Total Findings:** 2

There is some strimmer / machinery damage apparent on the posts, this can penetrate the preservative applied to the timber and accelerate the rotting process - Monitor for any deterioration (rot) and replace as required

There is some evidence of rot in the timber - Monitor for any further deterioration and replace as required

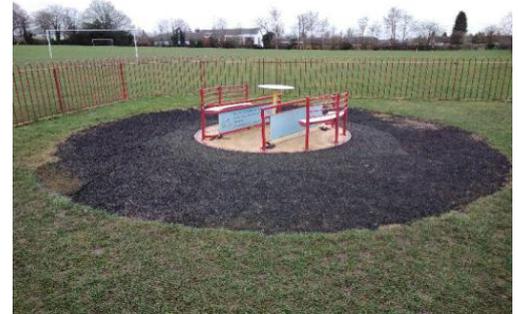
**Item:** Inclusive Roundabout  
**Manufacturer:** Wicksteed Playgrounds  
**Surface Type:** Bonded Rubber Mulch  
**Item Quantity:** 1  
**Equipment Compliance:** No  
**Surface Area Compliance:** Yes  
**Life Expectancy:** 3 - 5 Years  
**Total Findings:** 9

The bearing is showing signs of wear - Monitor for any further deterioration and replace as required

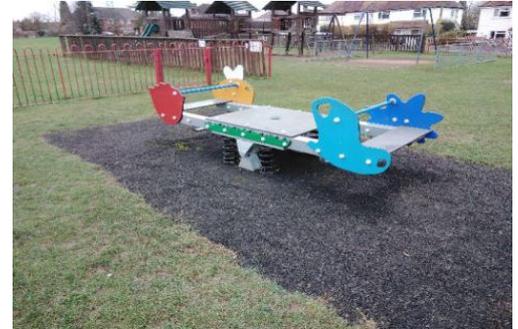
**Item:** Spring See-Saw  
**Manufacturer:** Kompan Ltd  
**Surface Type:** Bonded Rubber Mulch  
**Item Quantity:** 1  
**Equipment Compliance:** Yes  
**Surface Area Compliance:** Yes  
**Life Expectancy:** 5 -10 Years  
**Total Findings:** 2

The safety surface has worn and the foundations are exposed - Reinstate surrounding surfaces to cover the foundations

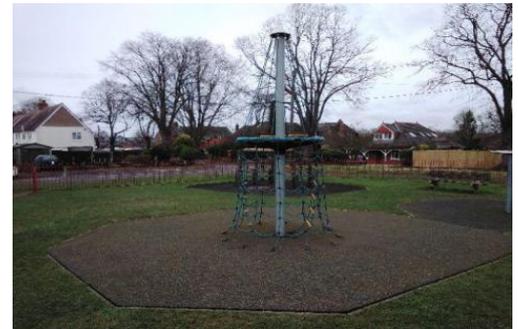
**Item:** Net Climber  
**Manufacturer:** Huck Nets (UK) Ltd  
**Surface Type:** Wet Pour  
**Item Quantity:** 1  
**Equipment Compliance:** No  
**Surface Area Compliance:** No  
**Life Expectancy:** 5 -10 Years  
**Total Findings:** 3

The ropes/nets are worn/damaged in places - Monitor for any further deterioration and repair or replace as required

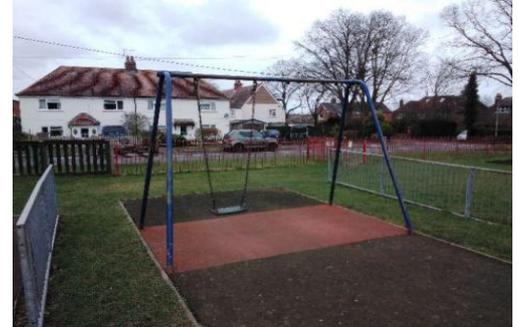
**Item:** 1 Bay 2 Seat (Flat)  
**Manufacturer:** Wicksteed Playgrounds  
**Surface Type:** Wet Pour  
**Item Quantity:** 1  
**Equipment Compliance:** No  
**Surface Area Compliance:** No  
**Life Expectancy:** 3 - 5 Years  
**Total Findings:** 8

The seat(s) and suspension were missing at the time of inspection and the inspector was unable to make a full compliance assessment - Replace missing seat(s) and suspension

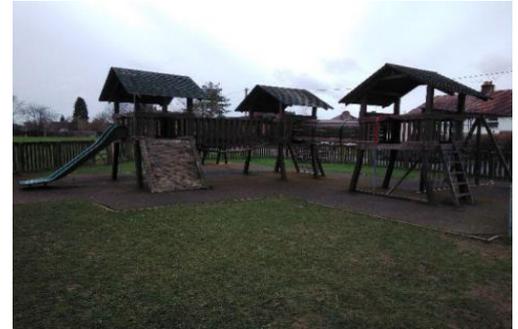
**Item:** Multi Play (Junior)  
**Manufacturer:** Lappset UK Ltd  
**Surface Type:** Wet Pour  
**Item Quantity:** 1  
**Equipment Compliance:** No  
**Surface Area Compliance:** No  
**Life Expectancy:** 3 - 5 Years  
**Total Findings:** 29

The safety surface under or around this unit has been damaged - Monitor for any further deterioration and repair as required

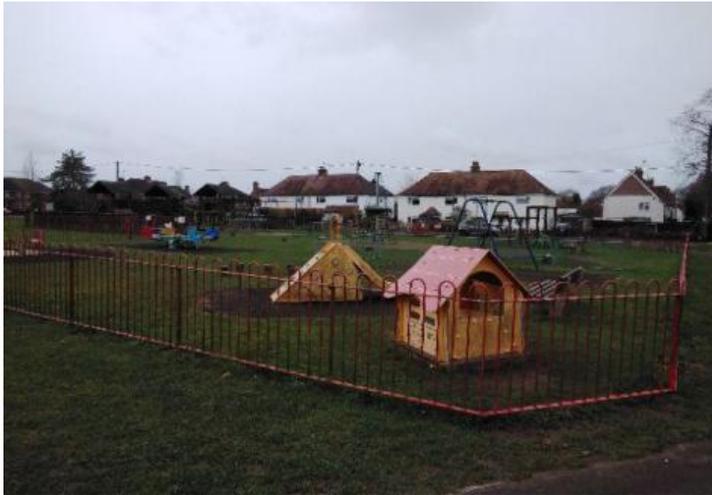
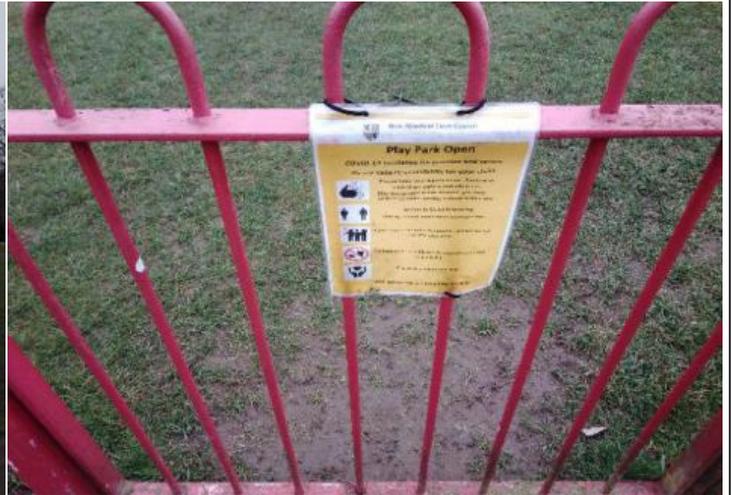
**Item:** Ancillary Items - Site General  
**Manufacturer:** Owner/Operator

**Finding:** The site is accessible to the public during the COVID 19 pandemic. The government have released guidelines for safely re-opening these types of facilities which is available on the government website.

**Action:** Ensure there is an appropriate risk assessment in place and review regularly

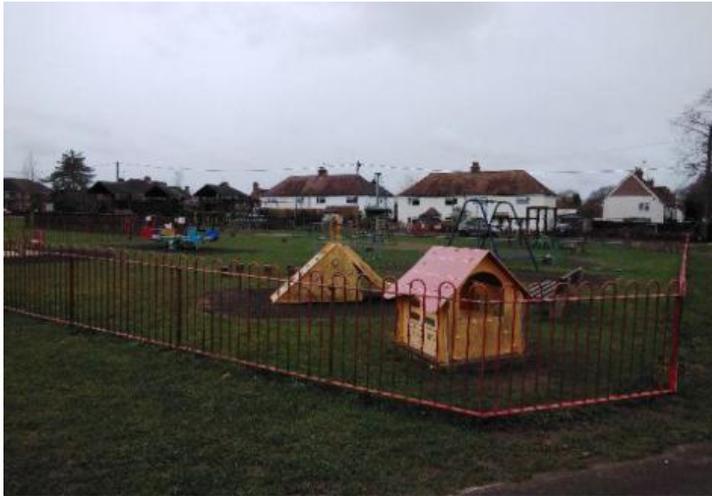
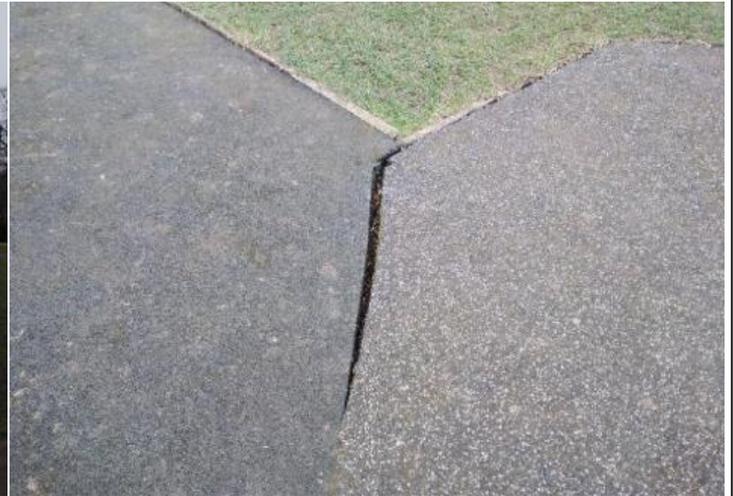
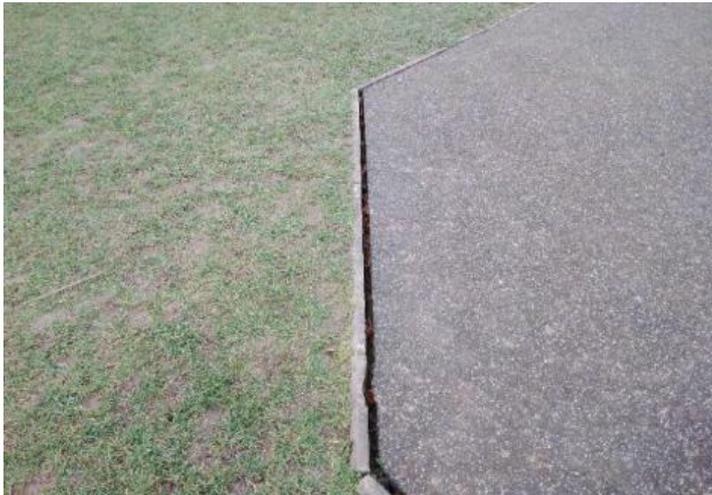
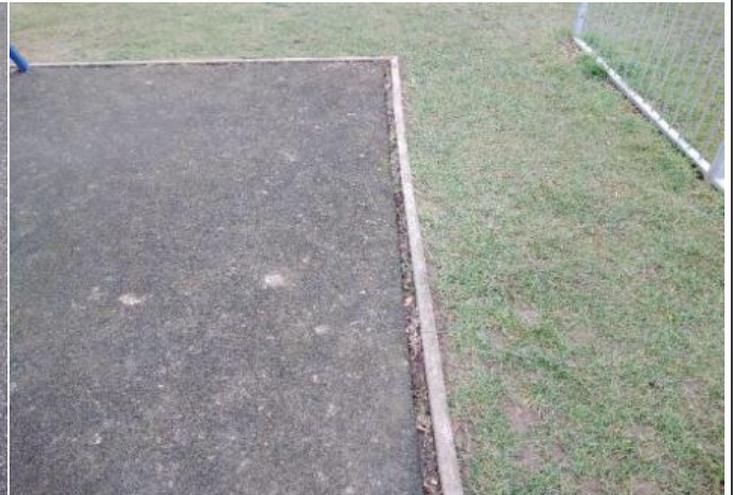
**Item:** Ancillary Items - Site General  
**Manufacturer:** Owner/Operator

**Finding:** There are significant gaps (over 30mm) between the surface and the edging or between the joints in the surface; these are large enough for a small foot to enter

**Action:** Repair surfacing

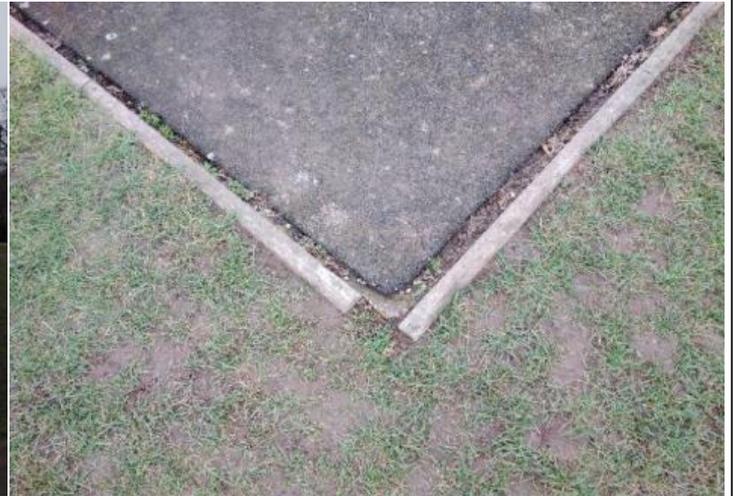
**Item:** Ancillary Items - Site General  
**Manufacturer:** Owner/Operator

**Finding:** The surface is lifting at the edges and creating trip points **Action:** Repair perimeter of surfacing to remove trip points

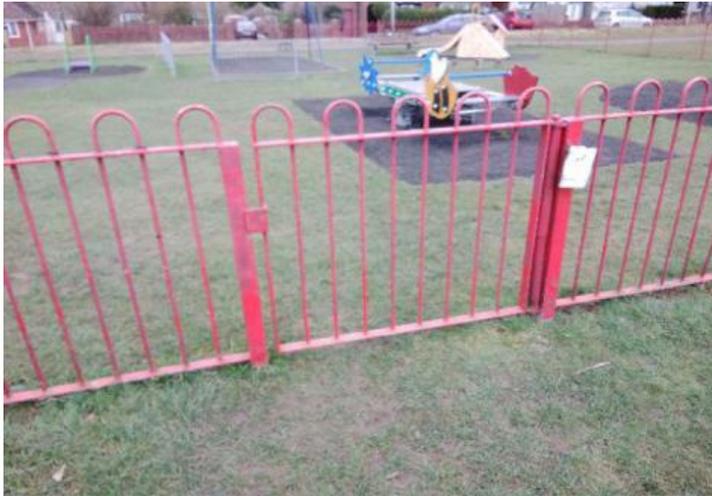
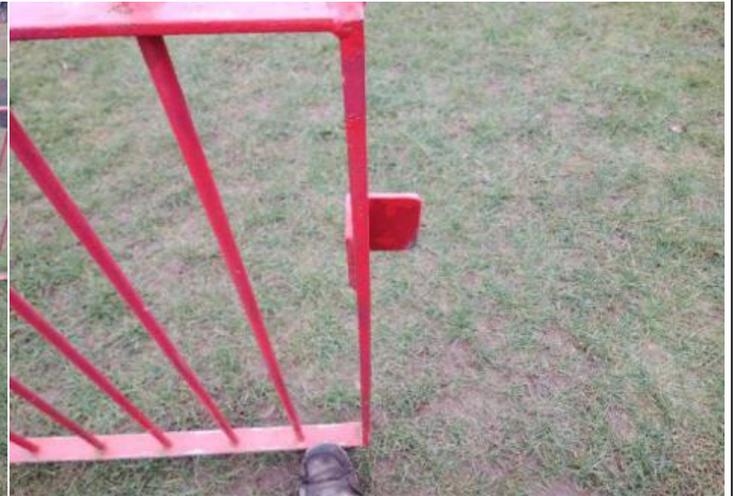
**Item:** Gates - Gate - Self Closing  
**Manufacturer:** Unknown

**Finding:** The rubber buffer is missing from the latch plate

**Action:** Replace rubber buffer

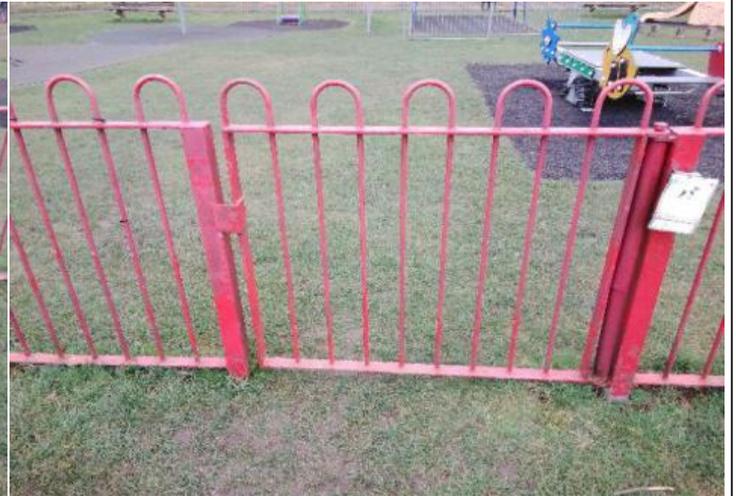
**Item:** Gates - Gate - Self Closing  
**Manufacturer:** Unknown

**Finding:** The gate is closing too quickly (less than 4 seconds)

**Action:** Take corrective action to ensure that the gate closes in 4-8 seconds

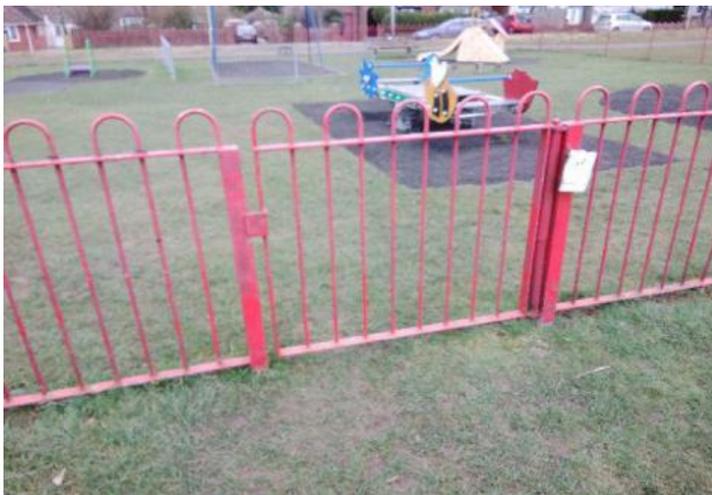
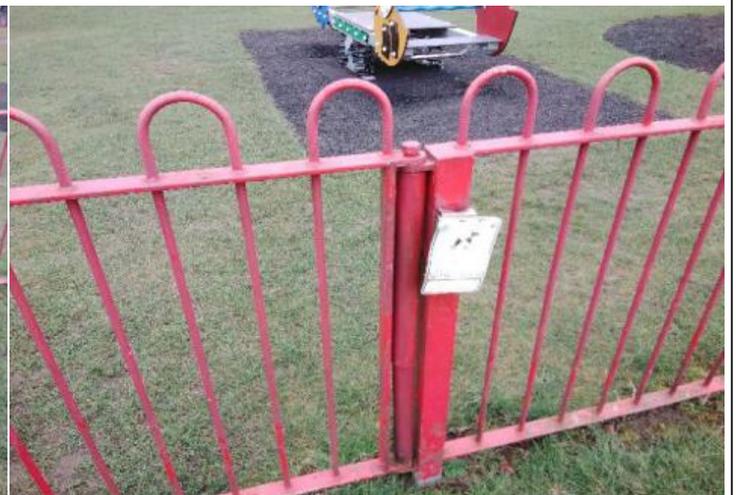
**Item:** Gates - Gate - Self Closing  
**Manufacturer:** Unknown

**Finding:** The gate is noisy in operation

**Action:** Consider greasing to the self closer

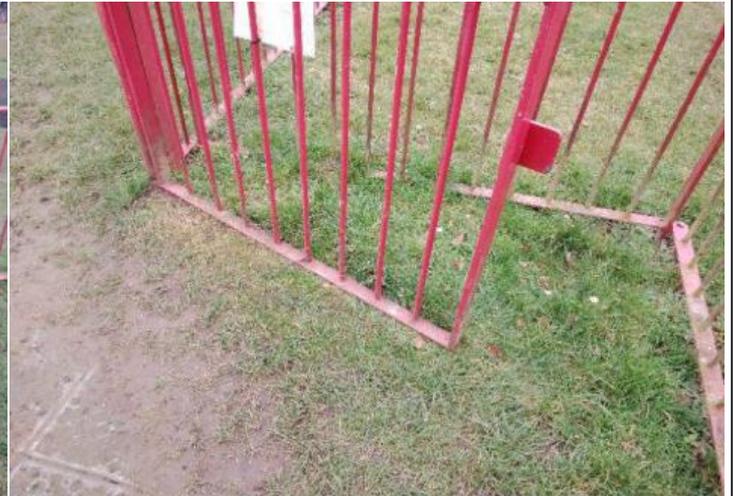
**Item:** Gates - Gate - Self Closing  
**Manufacturer:** Unknown

**Finding:** The gate is snagging on the surrounding surface preventing it from closing correctly

**Action:** Carry out remedial works to ensure the gate closes correctly

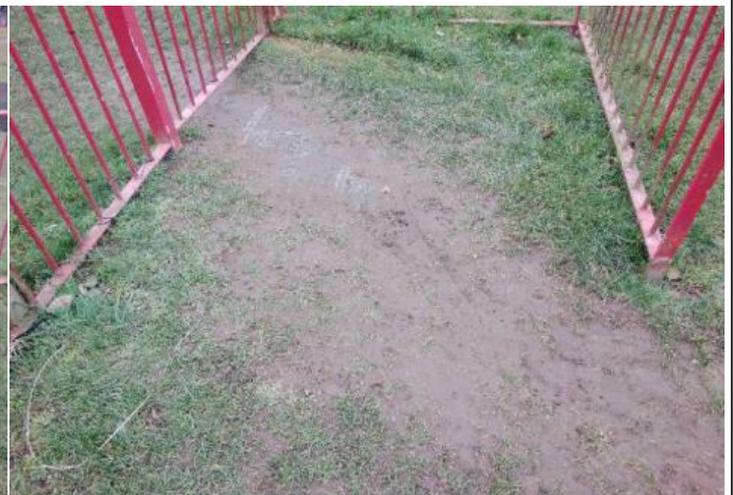
**Item:** Gates - Gate - Self Closing  
**Manufacturer:** Unknown

**Finding:** The area around the item has eroded and may become slippery

**Action:** Reinstate eroded area

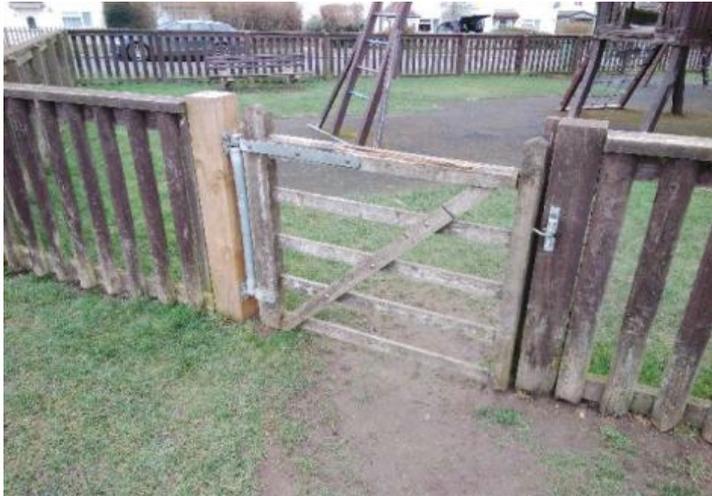
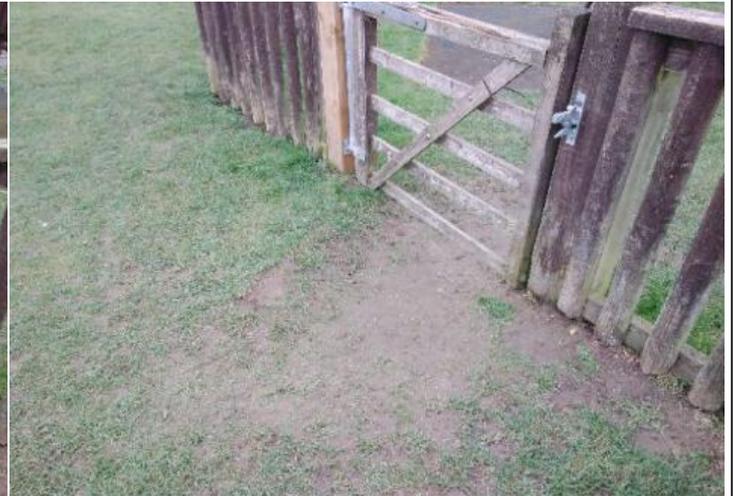
**Item:** Gates - Gate - Self Closing  
**Manufacturer:** Unknown

**Finding:** The area under the gate has eroded leaving uneven areas, or the concrete foundations exposed, resulting in trip hazards at the entrance/exit to the playground

**Action:** Reinststate to level with surrounding surfaces

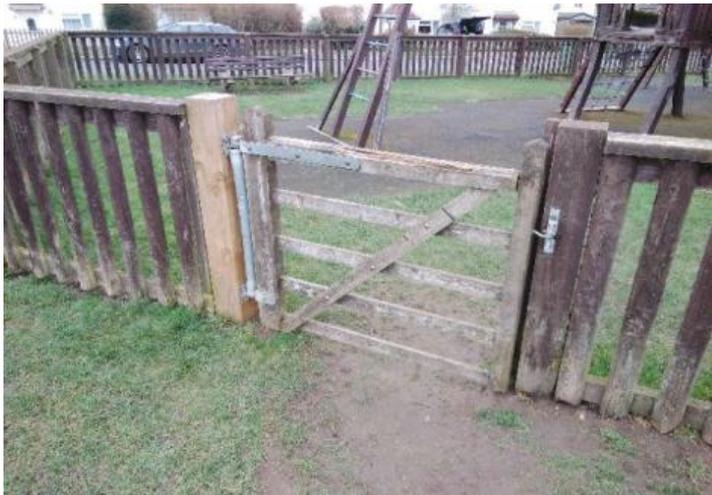
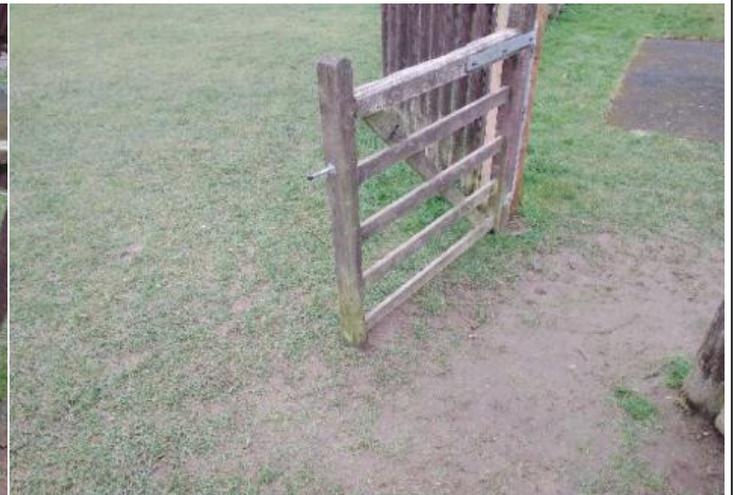
**Item:** Gates - Gate - Self Closing  
**Manufacturer:** Unknown

**Finding:** The gate is snagging on the surrounding surface preventing it from closing correctly

**Action:** Carry out remedial works to ensure the gate closes correctly

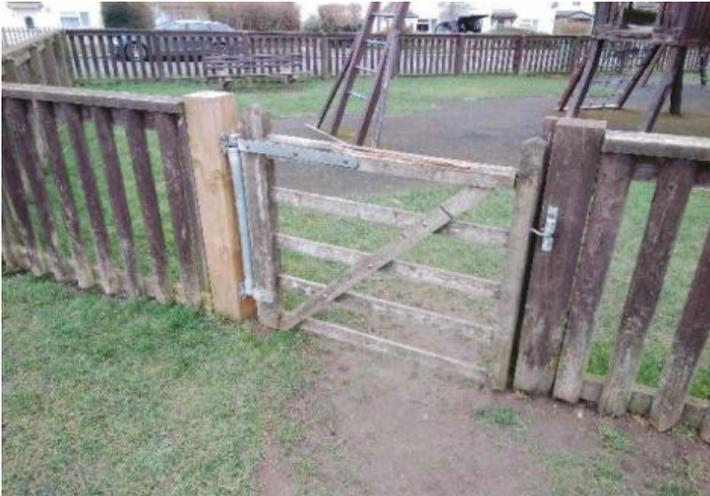
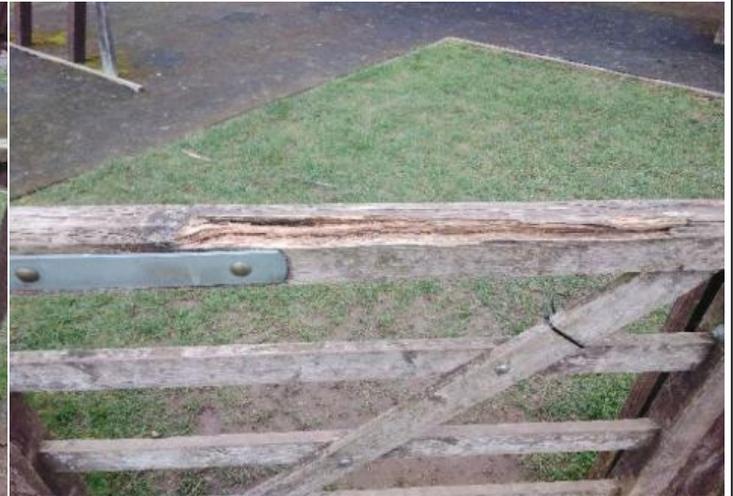
**Item:** Gates - Gate - Self Closing  
**Manufacturer:** Unknown

**Finding:** Parts of the timber are rough or splintered

**Action:** Remove all rough or sharp edges

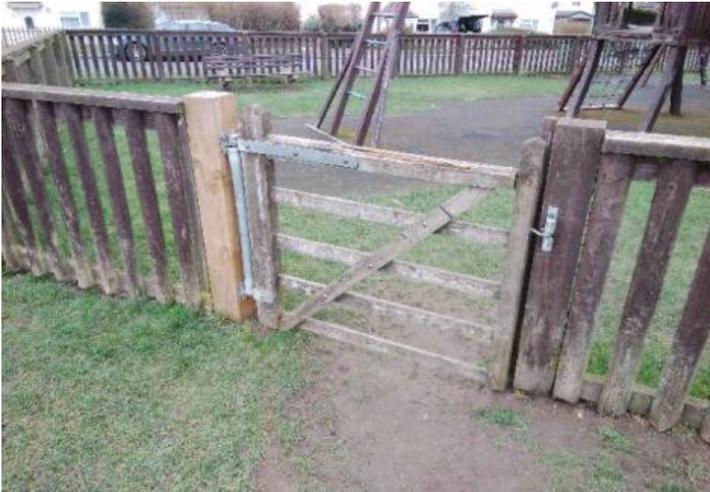
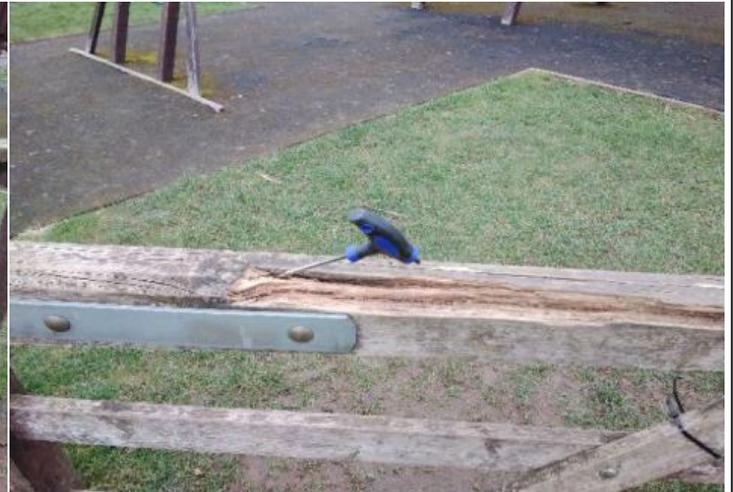
**Item:** Gates - Gate - Self Closing  
**Manufacturer:** Unknown

**Finding:** There is some evidence of rot in the timber

**Action:** Monitor for any further deterioration and replace as required

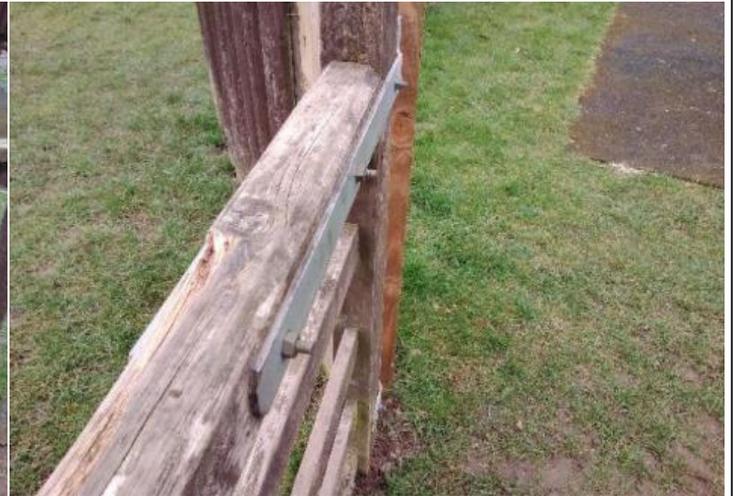
**Item:** Gates - Gate - Self Closing  
**Manufacturer:** Unknown

**Finding:** There are projecting bolt thread(s) present

**Action:** Remove excess thread length and deburr or provide cap

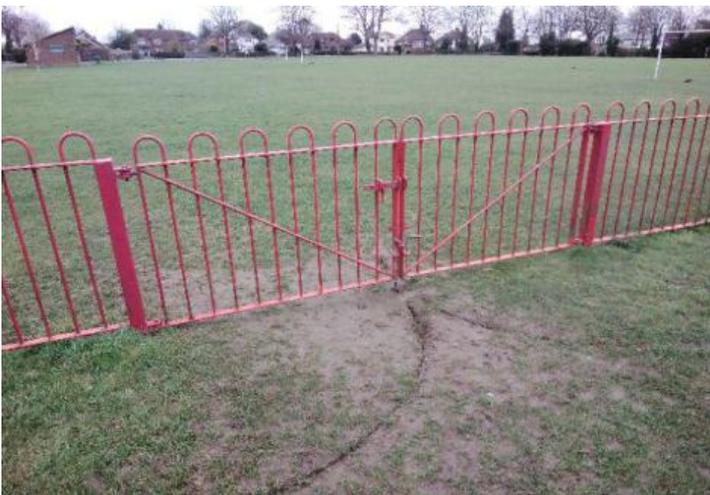
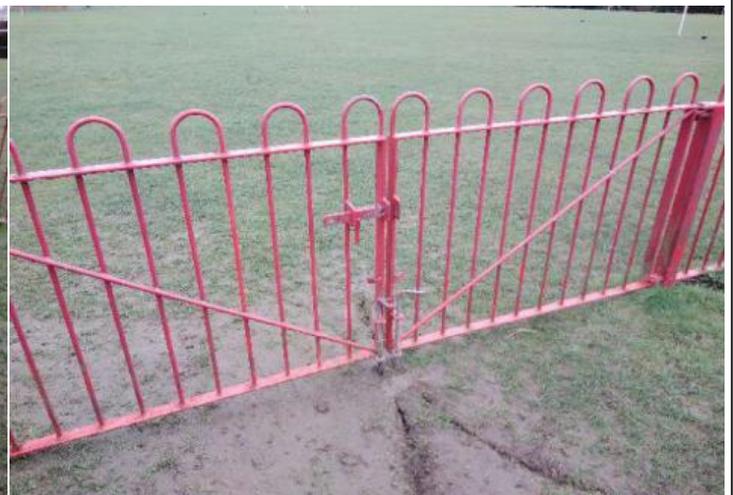
**Item:** Gates - Gate - Maintenance  
**Manufacturer:** Unknown

**Finding:** There is no padlock on the maintenance gate

**Action:** Provide a padlock to secure the gate

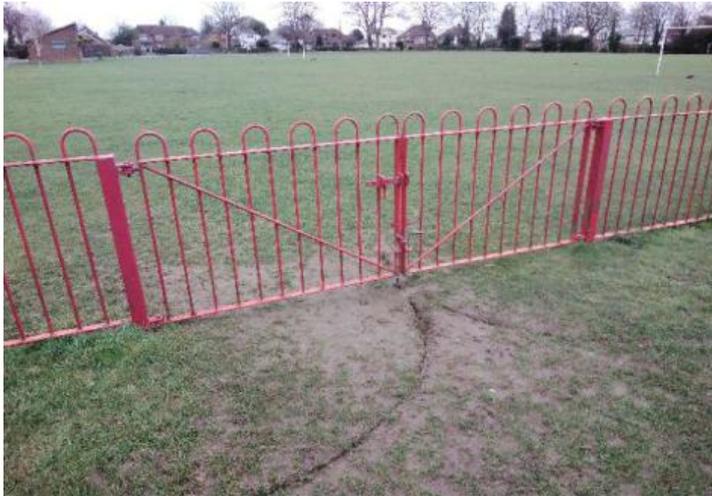
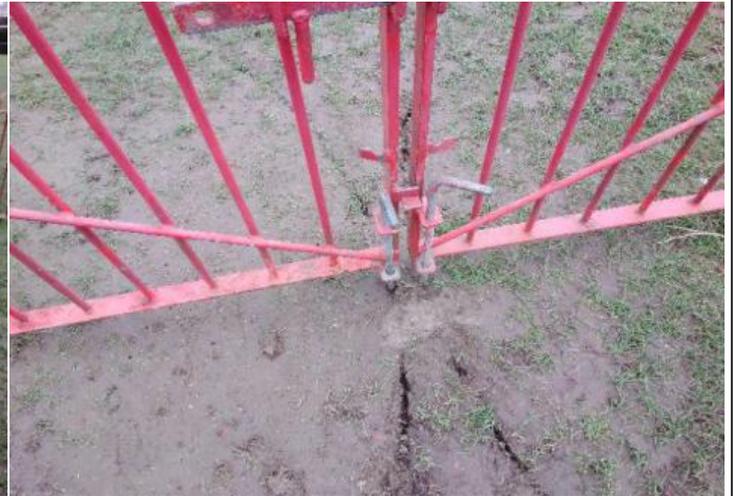
**Item:** Gates - Gate - Maintenance  
**Manufacturer:** Unknown

**Finding:** The gate has no drop bolt sleeves and/or drop bolts fitted

**Action:** Provide drop bolt sleeves and/or drop bolts

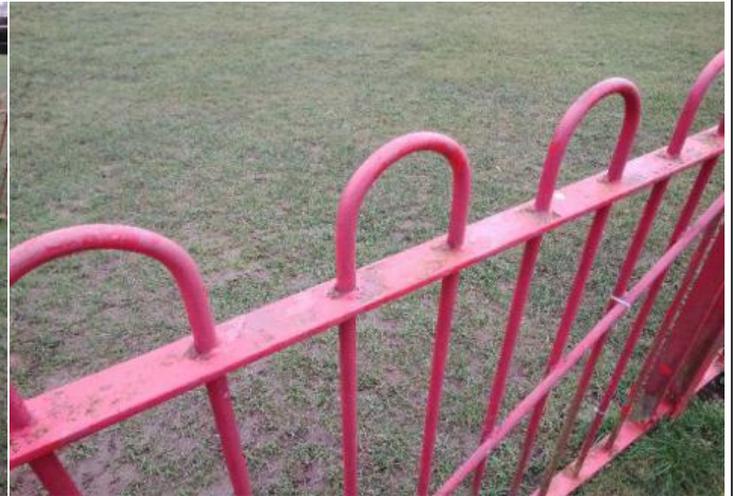
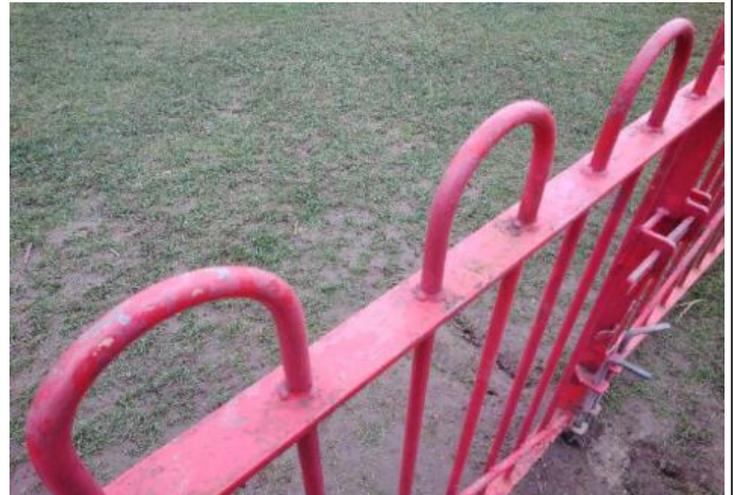
**Item:** Gates - Gate - Maintenance  
**Manufacturer:** Unknown

**Finding:** The paint is flaking off the metalwork

**Action:** Rub down and re-paint

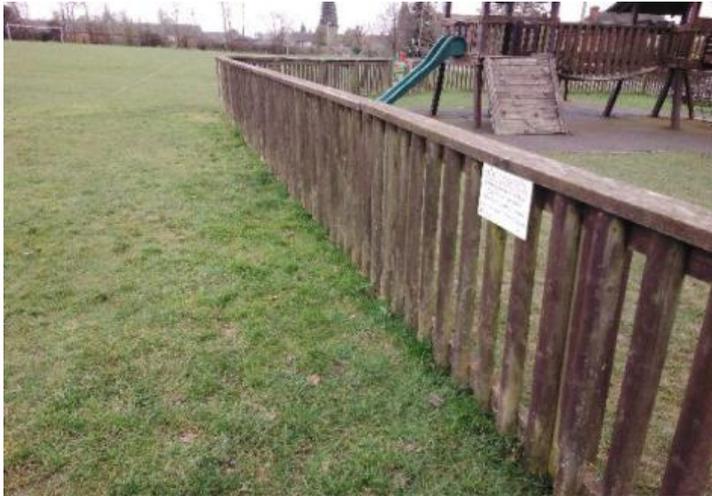
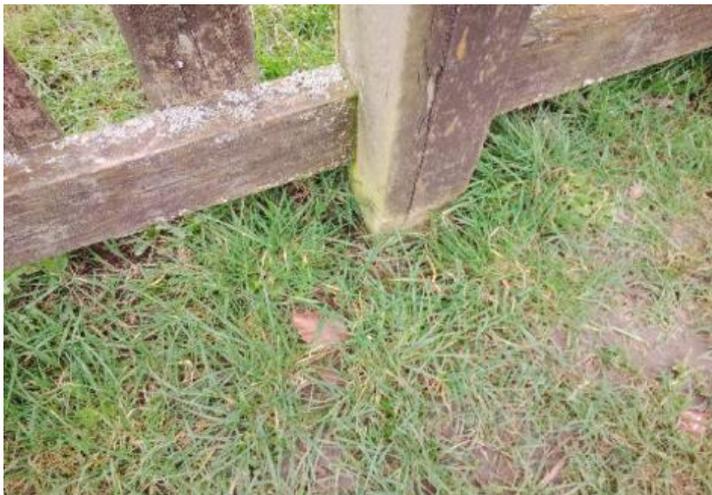
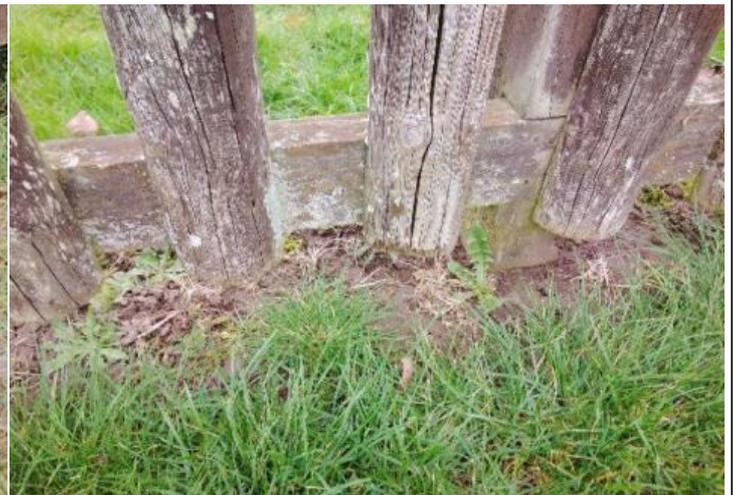
**Item:** Fences - Fencing - Timber  
**Manufacturer:** Unknown

**Finding:** There is some strimmer / machinery damage apparent on the posts, this can penetrate the preservative applied to the timber and accelerate the rotting process

**Action:** Monitor for any deterioration (rot) and replace as required

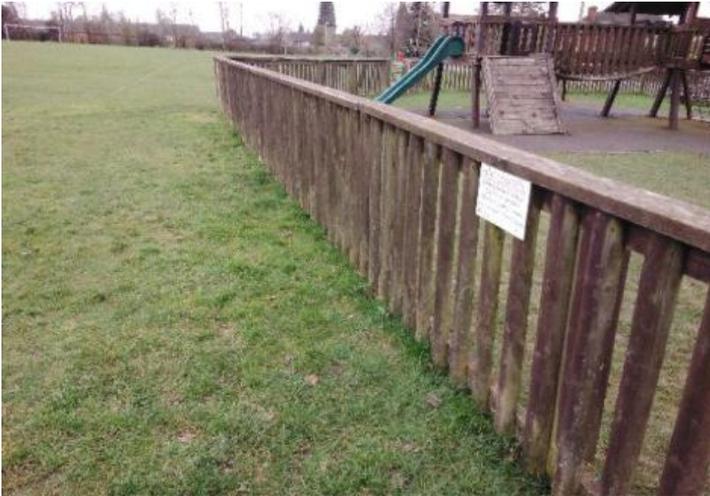
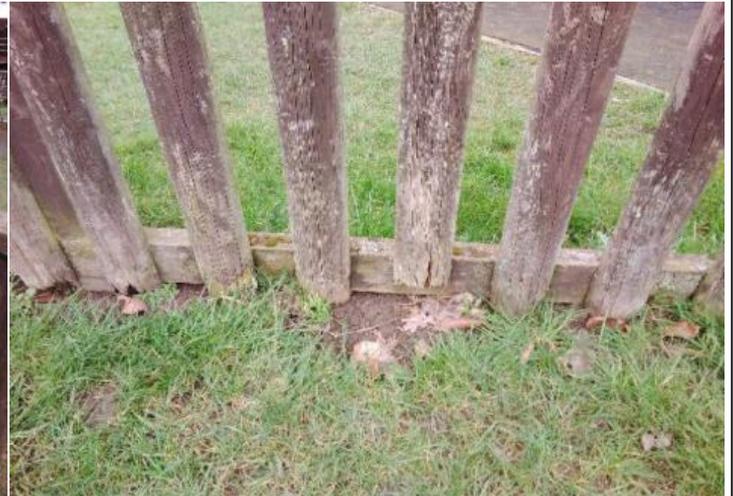
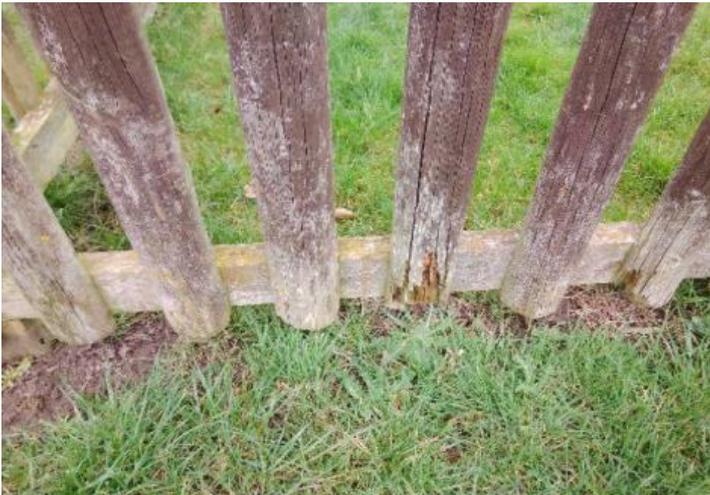
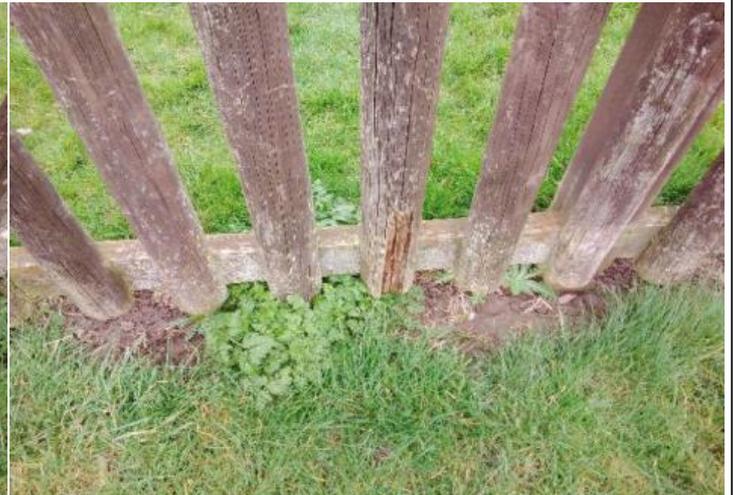
**Item:** Fences - Fencing - Timber  
**Manufacturer:** Unknown

**Finding:** The item has been damaged

**Action:** Monitor for any further deterioration and replace as required

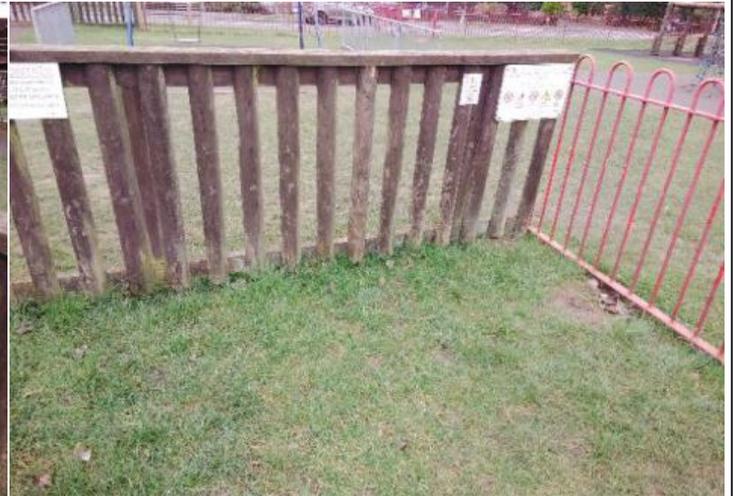
**Item:** Fences - Fencing - Timber  
**Manufacturer:** Unknown

**Finding:** There are a number of loose posts around the fence

**Action:** Monitor for any further deterioration and reset as required

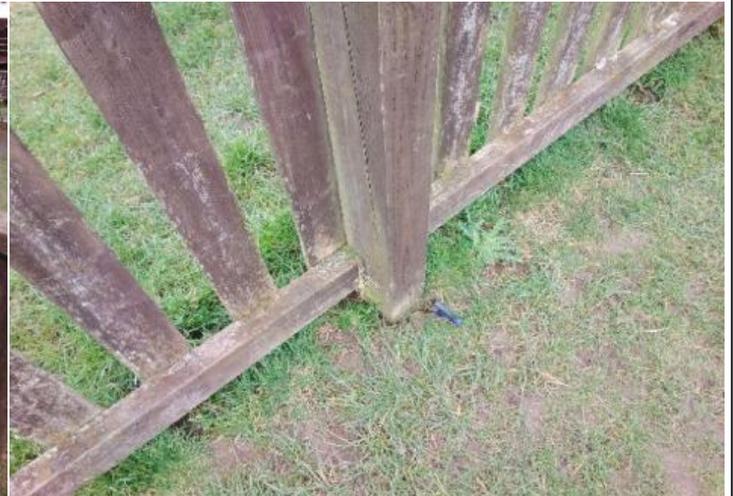
**Item:** Fences - Fencing - Timber  
**Manufacturer:** Unknown

**Finding:** There is some evidence of rot in the timber posts

**Action:** Monitor for any further deterioration and replace as required

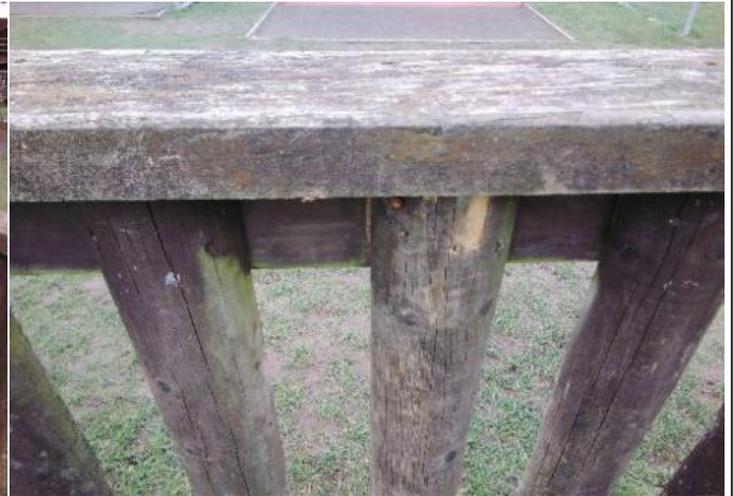
**Item:** Fences - Fencing - Timber  
**Manufacturer:** Unknown

**Finding:** Parts of the timber are rough or splintered

**Action:** Remove all rough or sharp edges

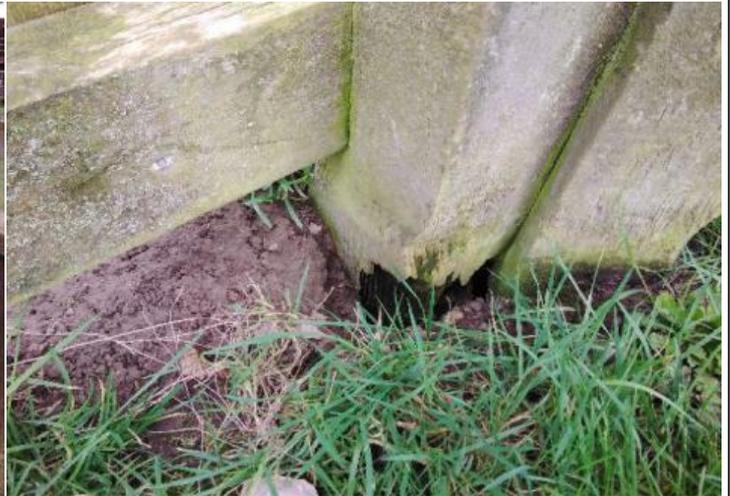
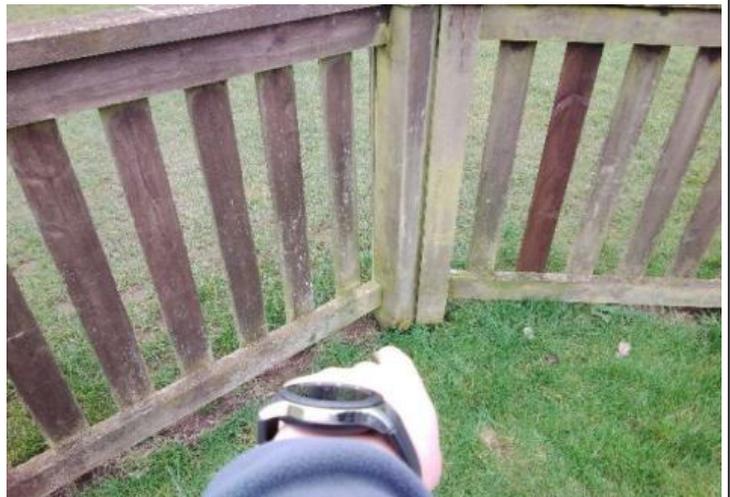
**Item:** Fences - Fencing - Timber  
**Manufacturer:** Unknown

**Finding:** There are areas or parts of the timber on the structure that have rotted

**Action:** Replace all affected timbers
