the **play inspection** company

## Annual Inspection

Winchester City Council

Stratton Bates Recreation Ground (New Alresford)

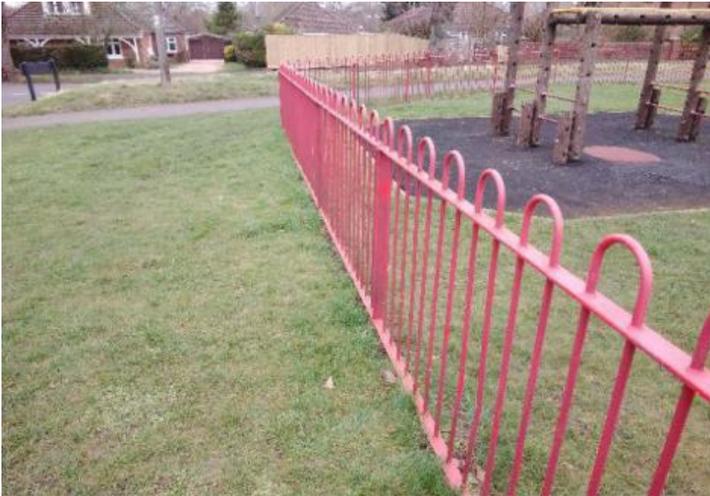
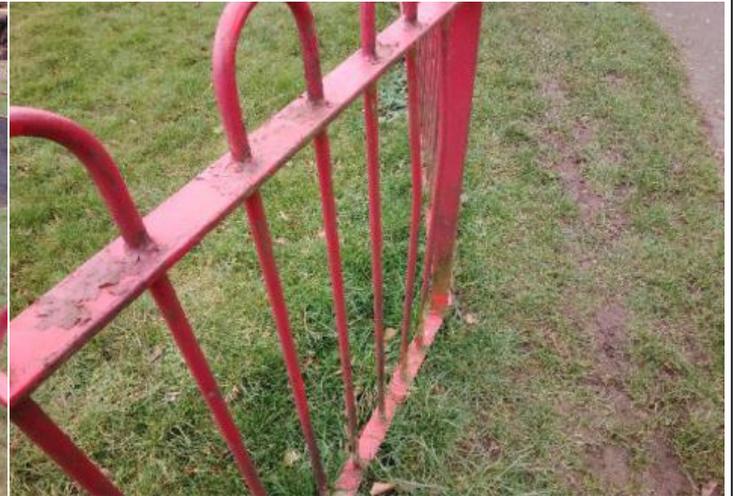
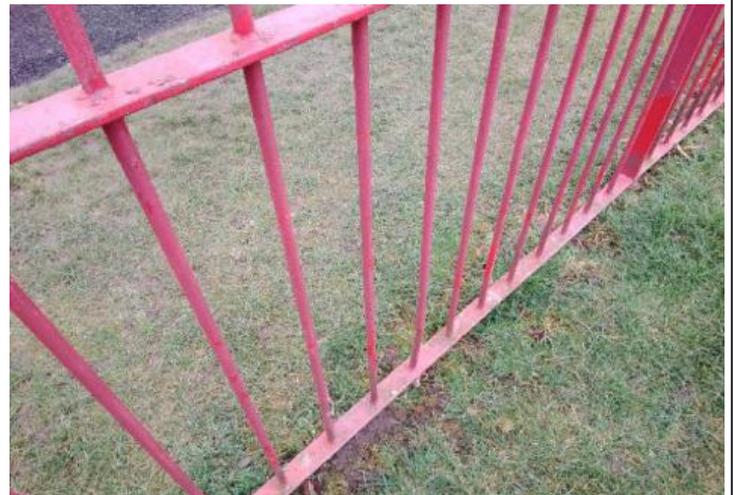
**Item:** Fences - Fence - Bow Top  
**Manufacturer:** Unknown

**Finding:** The item has been damaged

**Action:** Monitor for any further deterioration and replace as required

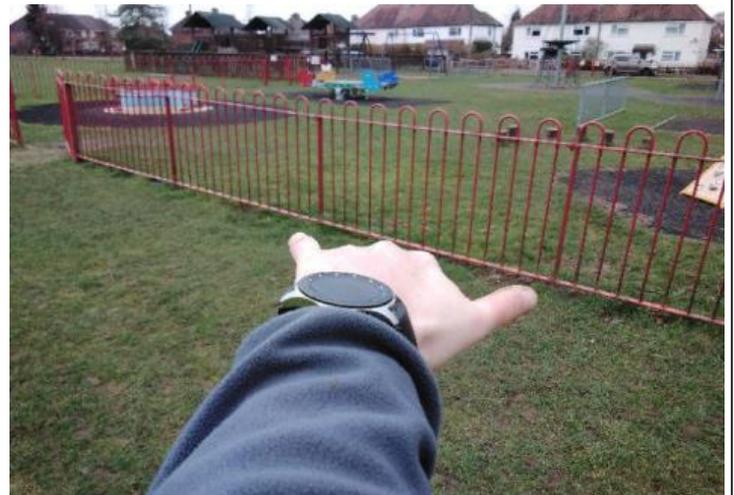
**Item:** Fences - Fence - Bow Top  
**Manufacturer:** Unknown

**Finding:** There are a number of loose posts around the fence

**Action:** Monitor for any further deterioration and reset as required

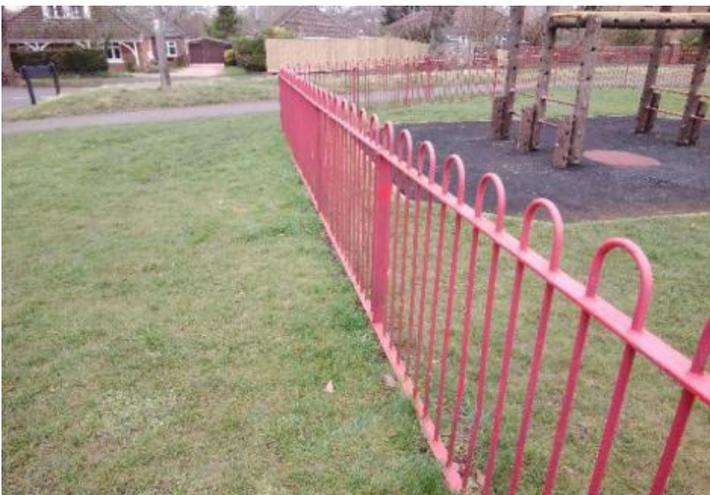
**Item:** Fences - Fence - Bow Top  
**Manufacturer:** Unknown

**Finding:** There are a number of post caps missing from the fence

**Action:** Replace missing post caps

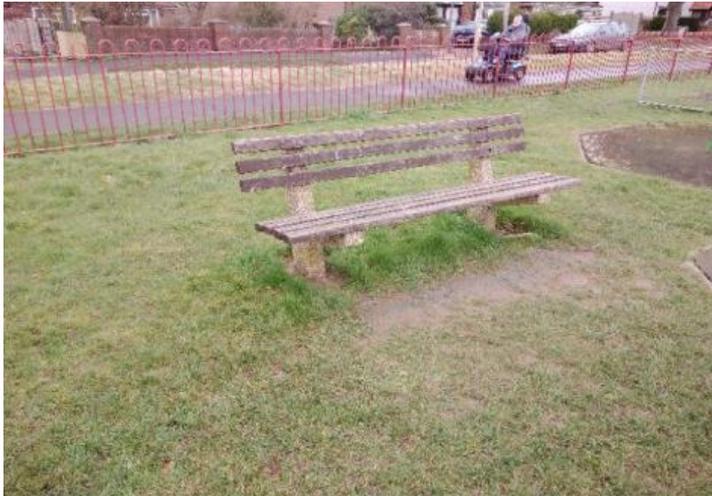
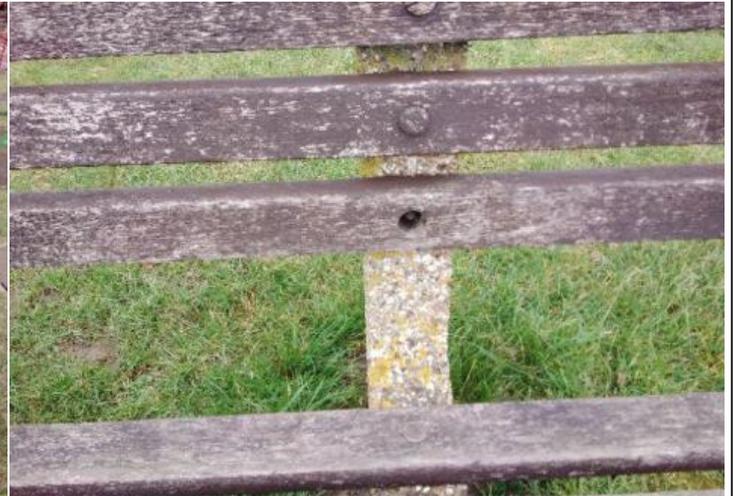
**Item:** Ancillary Items - Bench  
**Manufacturer:** Unknown

**Finding:** There is/are several inserts missing

**Action:** Replace missing inserts

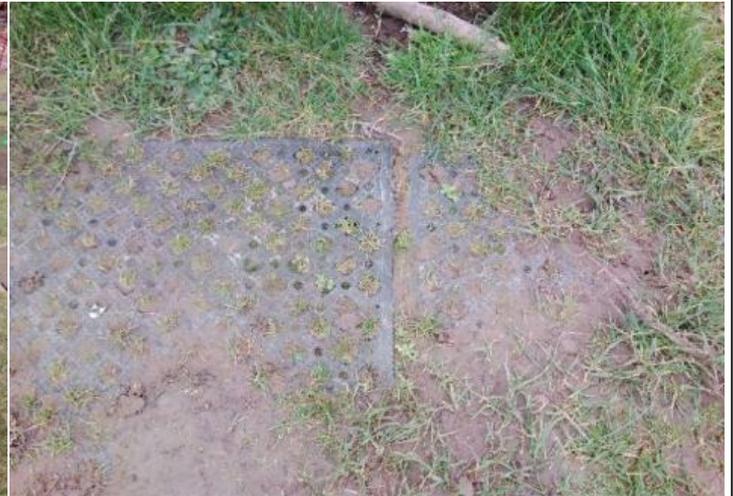
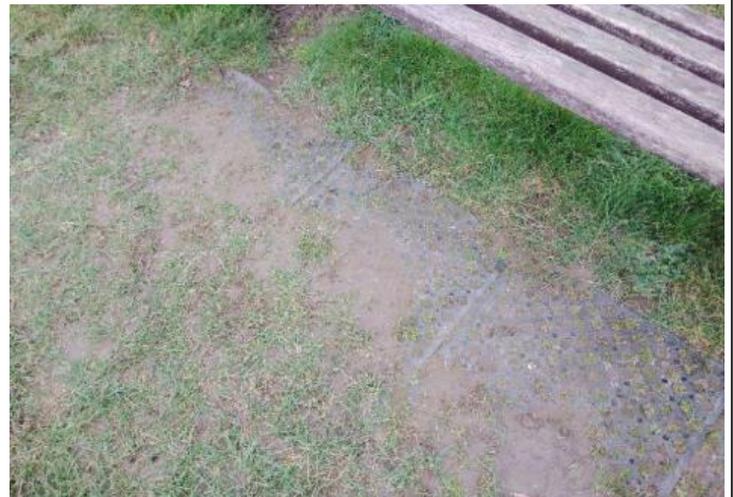
**Item:** Ancillary Items - Bench  
**Manufacturer:** Unknown

**Finding:** There are gaps opening between the grass mat tiles

**Action:** Reinststate surface

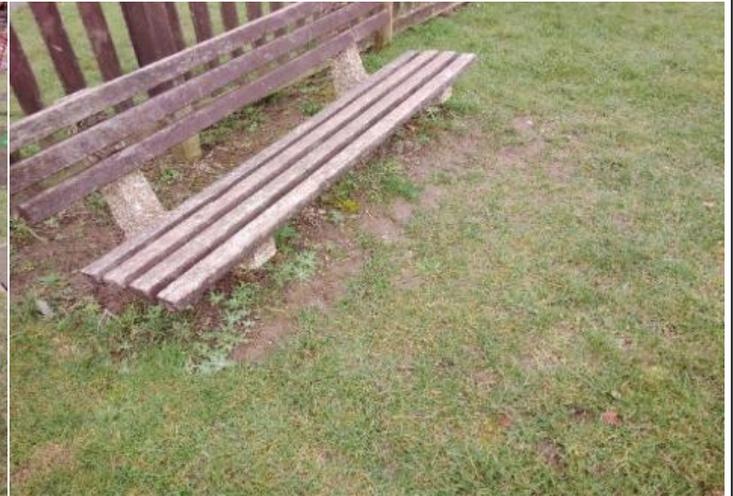
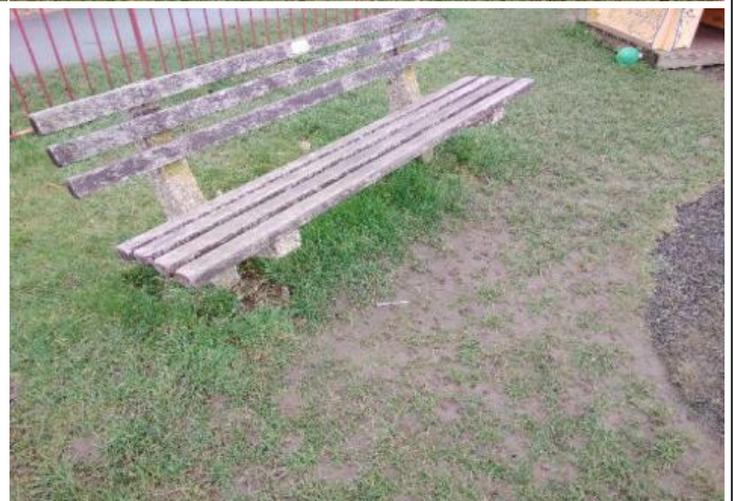
**Item:** Ancillary Items - Bench  
**Manufacturer:** Unknown

**Finding:** The area around the item has eroded and may become slippery

**Action:** Reinststate eroded area

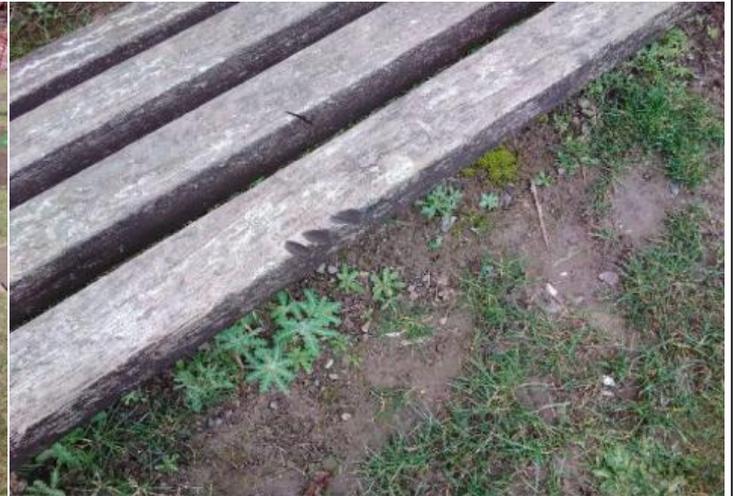
**Item:** Ancillary Items - Bench  
**Manufacturer:** Unknown

**Finding:** The item has been damaged

**Action:** Monitor for any further deterioration and replace as required

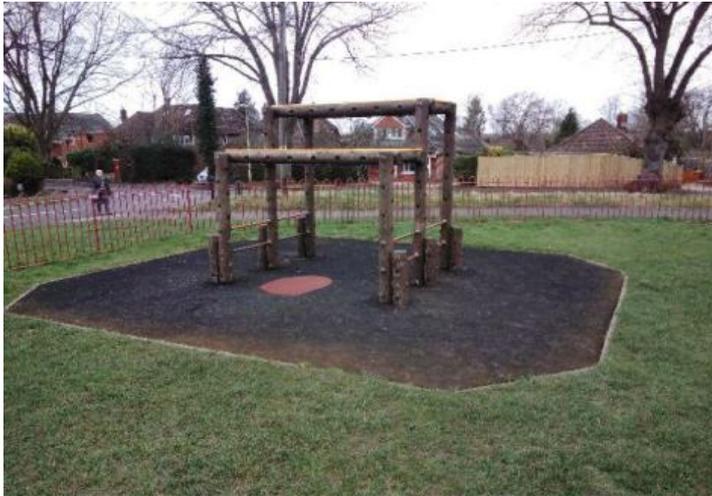
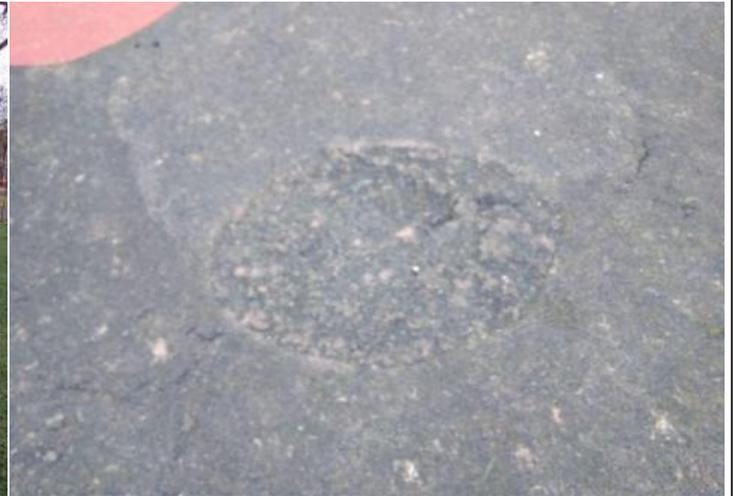
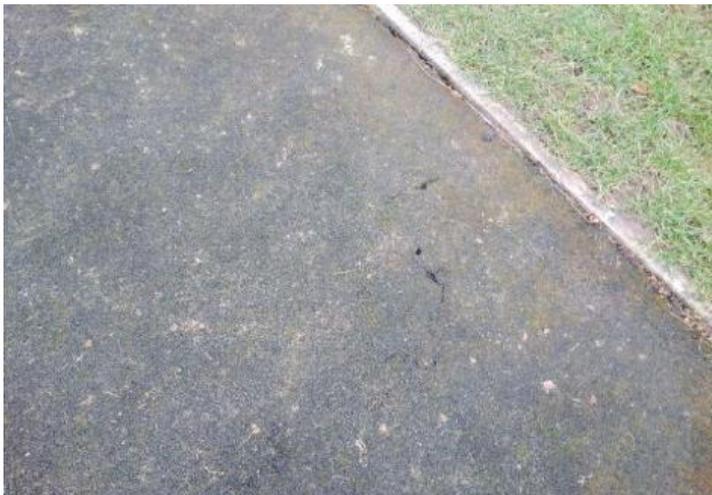
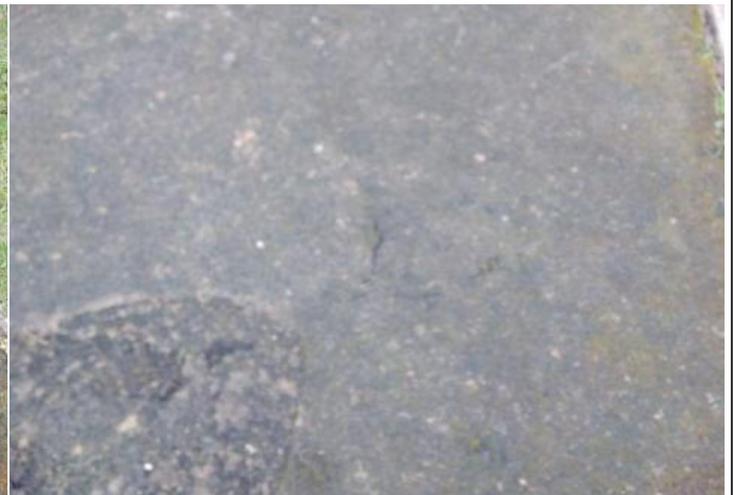
**Item:** Activity Equipment - Climbing Frame  
**Manufacturer:** Lappset UK Ltd

**Finding:** The safety surface under or around this unit has been damaged

**Action:** Monitor for any further deterioration and repair as required

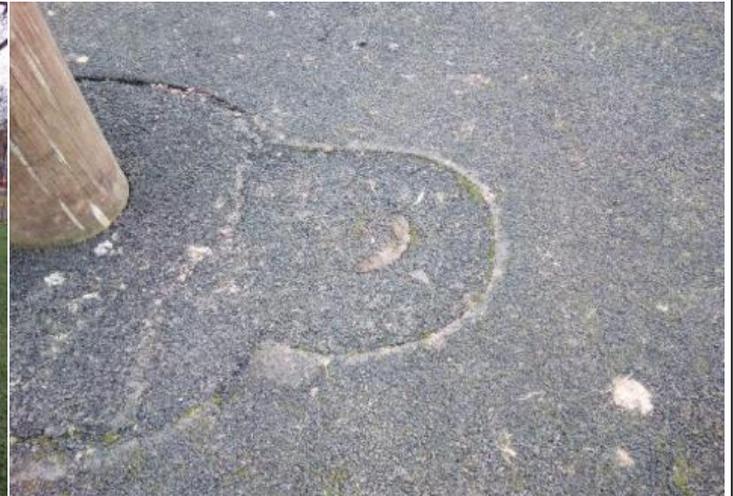
**Item:** Activity Equipment - Climbing Frame  
**Manufacturer:** Lappset UK Ltd

**Finding:** The surface has eroded and the old foundations are exposed

**Action:** Reinststate surrounding surfaces to cover the foundations

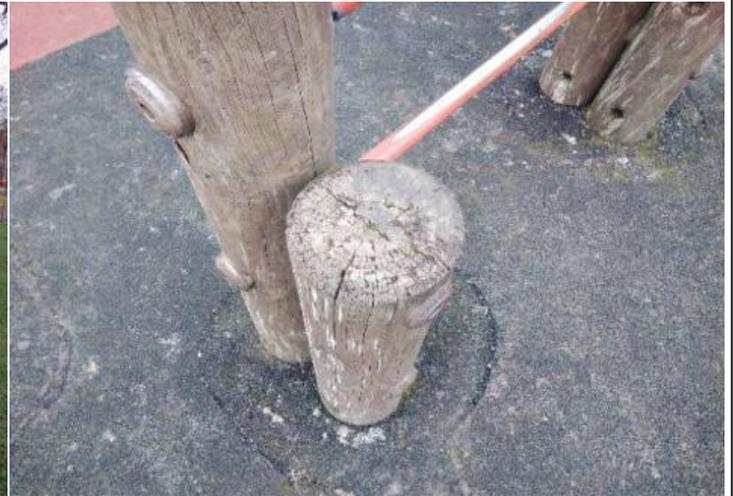
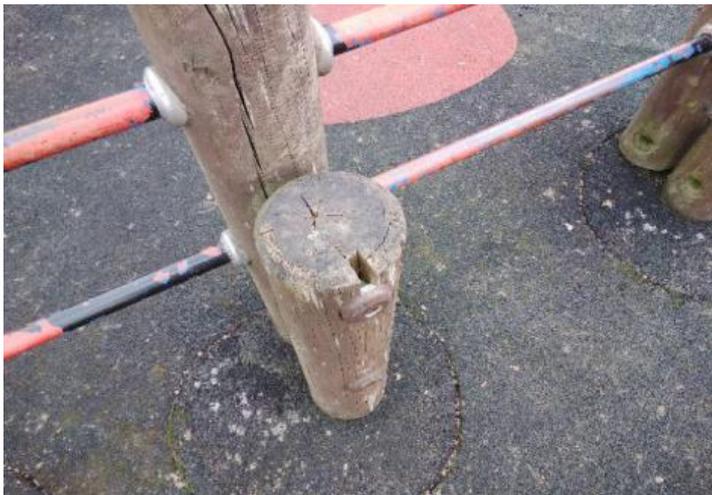
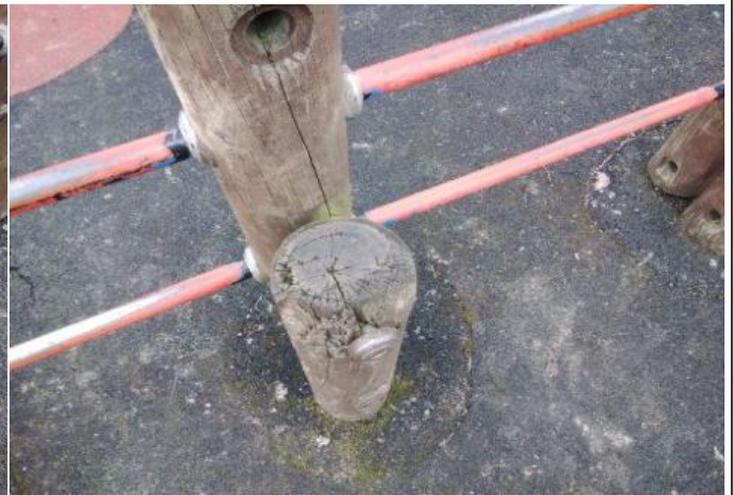
**Item:** Activity Equipment - Climbing Frame  
**Manufacturer:** Lappset UK Ltd

**Finding:** Parts of the timber are rough or splintered

**Action:** Remove all rough or sharp edges

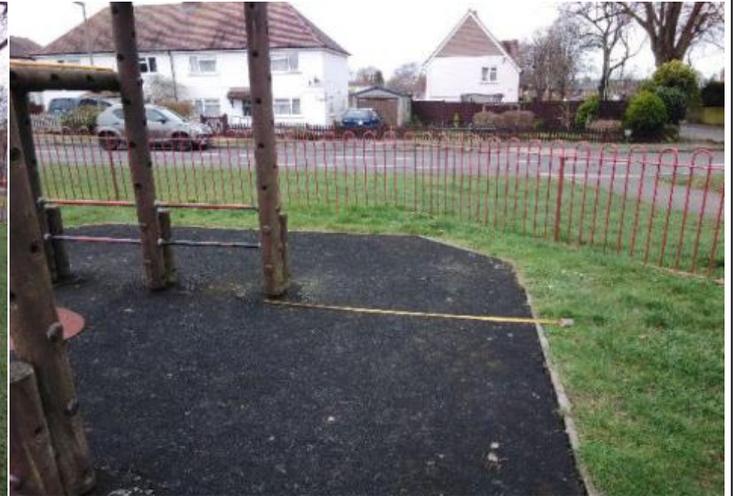
**Item:** Activity Equipment - Climbing Frame  
**Manufacturer:** Lappset UK Ltd

**Finding:** The surfacing dimensions are short and do not meet with the requirements of the current applicable standard

**Action:** Monitor - no remedial action recommended

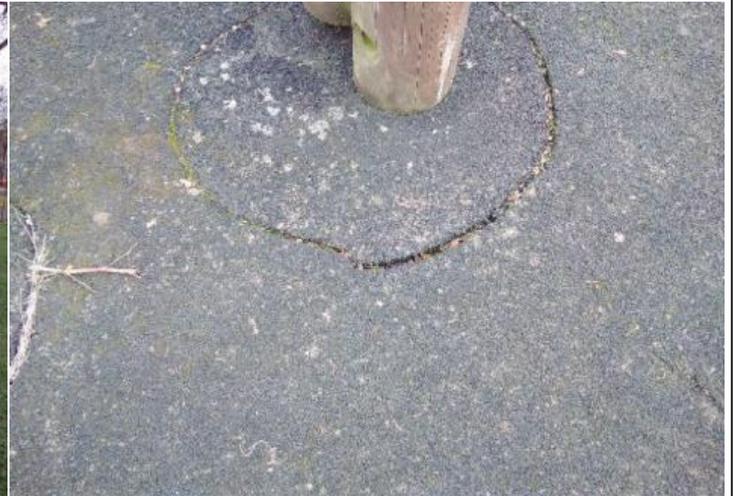
**Item:** Activity Equipment - Climbing Frame  
**Manufacturer:** Lappset UK Ltd

**Finding:** There are gaps opening between the surfacing and the edging surround or between the joints in the surfacing  
**Action:** Monitor for any further deterioration and repair as required

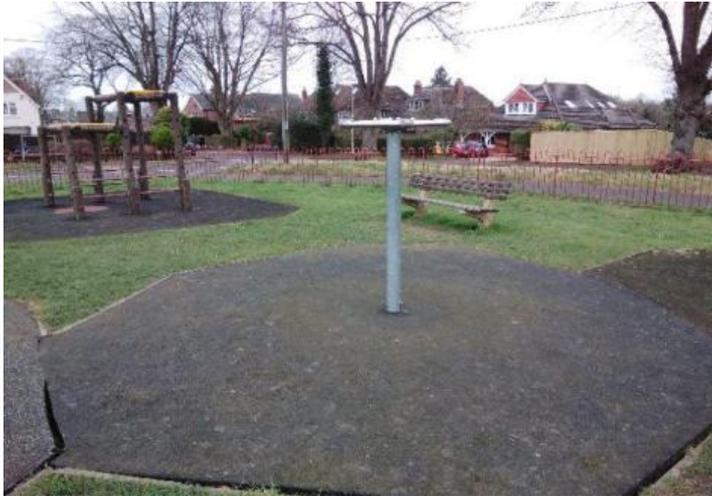
**Item:** Rotor Play - Overhead Rotator  
**Manufacturer:** Proludic

**Finding:** The bearing is not operating correctly

**Action:** Replace the bearing as required

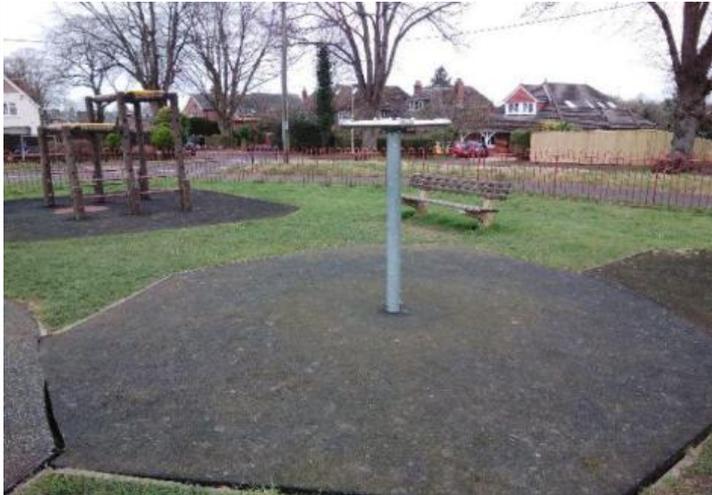
**Item:** Rotor Play - Overhead Rotator  
**Manufacturer:** Proludic

**Finding:** There is/are finger entrapment/s in the top of the rotator and the item fails to meet the requirements of BS EN 1176 Part 1 4.2.7.6 Entrapment of fingers

**Action:** Monitor - No remedial work recommended

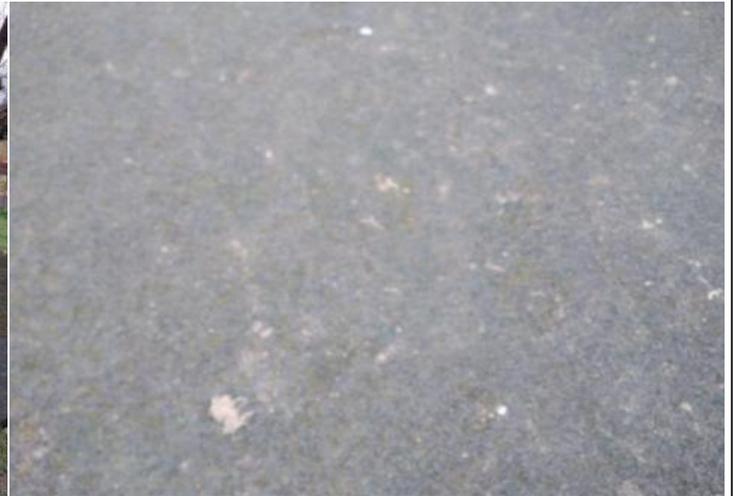
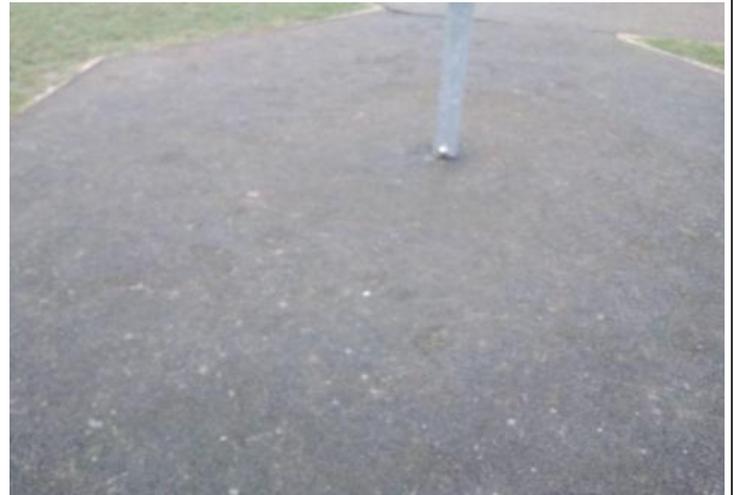
**Item:** Rotor Play - Overhead Rotator  
**Manufacturer:** Proludic

**Finding:** The safety surface around the area is beginning to wear

**Action:** Monitor for any further deterioration and repair as required

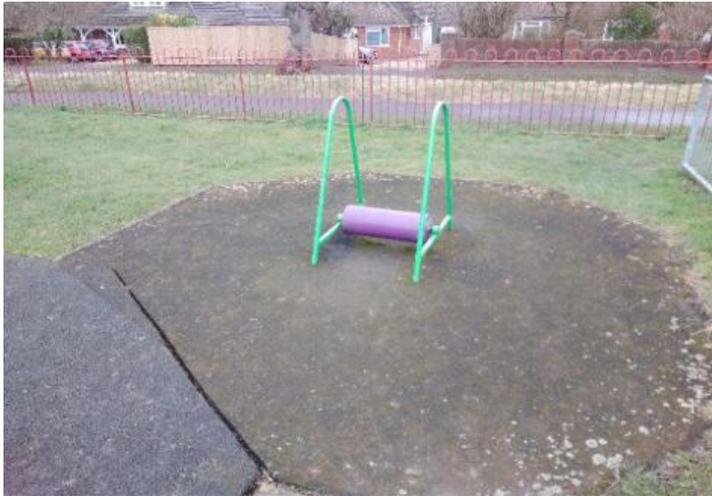
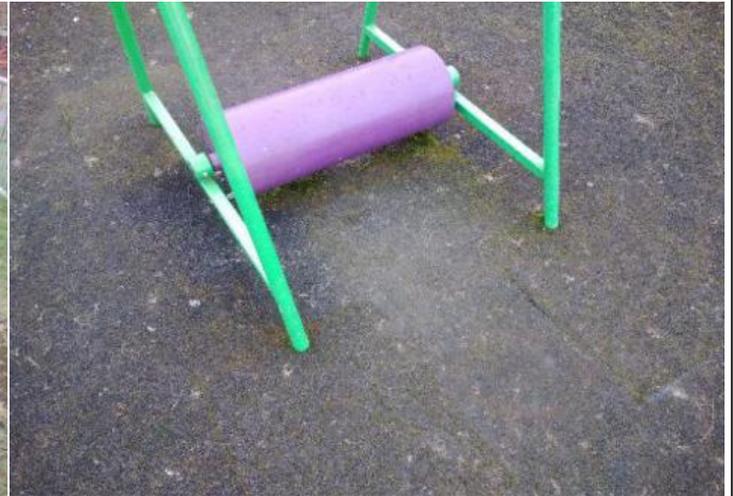
**Item:** Activity Equipment - Rotating Beam  
**Manufacturer:** Wicksteed Playgrounds

**Finding:** The safety surface around the area is beginning to wear

**Action:** Monitor for any further deterioration and repair as required

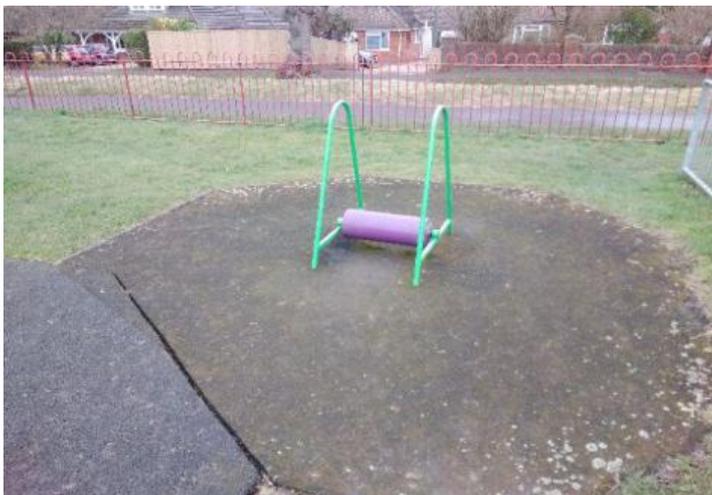
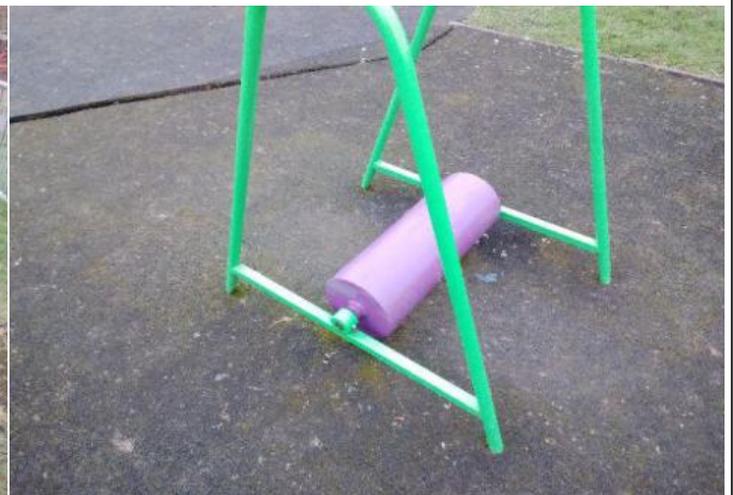
**Item:** Activity Equipment - Rotating Beam  
**Manufacturer:** Wicksteed Playgrounds

**Finding:** The bearing on the unit is dry

**Action:** Service and lubricate the bearing(s)

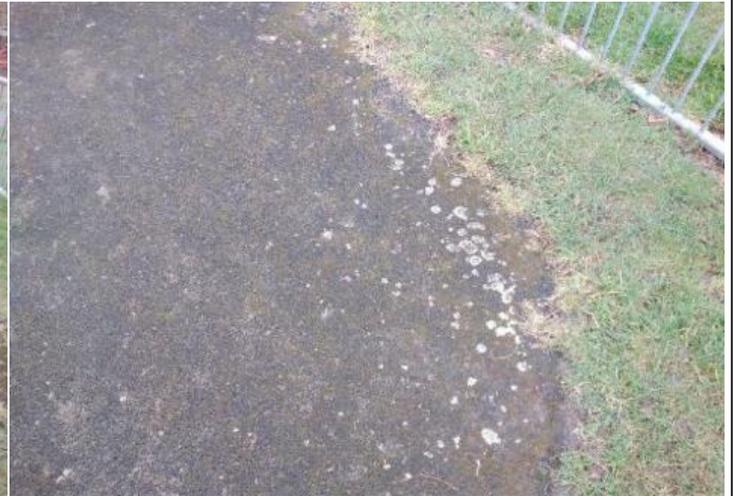
**Item:** Activity Equipment - Rotating Beam  
**Manufacturer:** Wicksteed Playgrounds

**Finding:** There is algae or moss growth on the surface resulting in slippery conditions

**Action:** Clean and treat appropriately

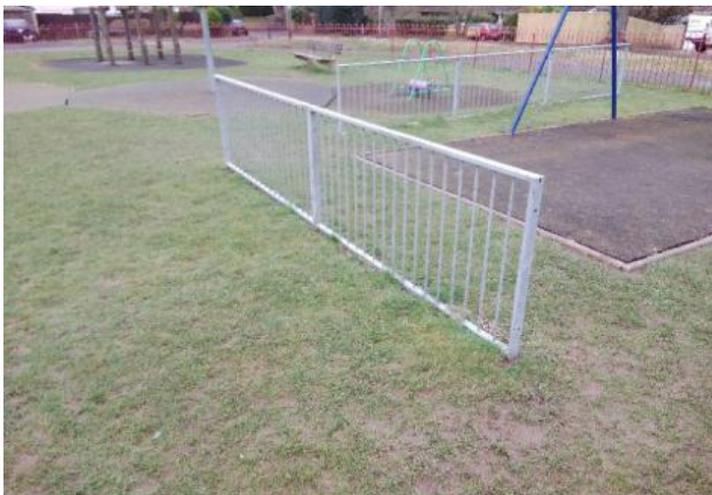
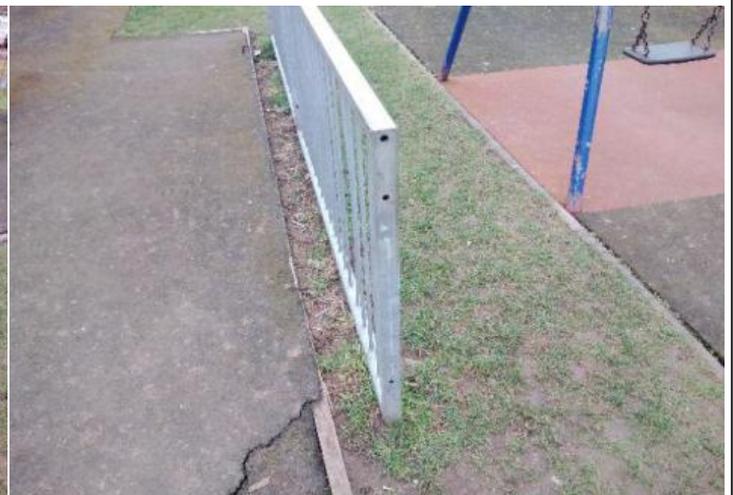
**Item:** Swings - Swing Barrier  
**Manufacturer:** Unknown

**Finding:** There is/are several inserts missing

**Action:** Replace missing inserts

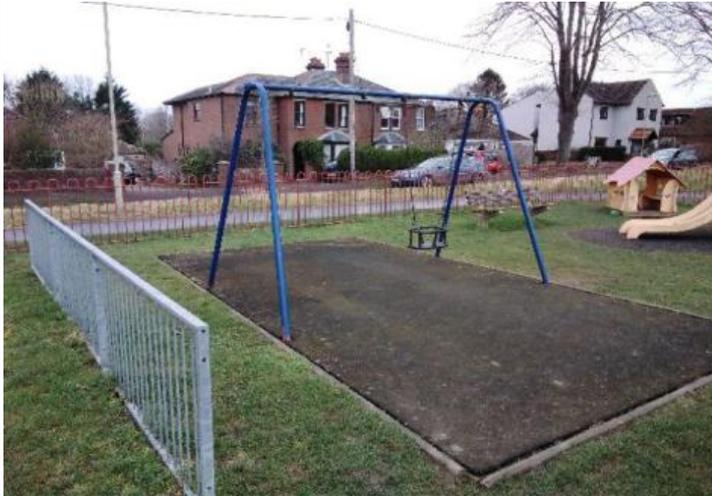
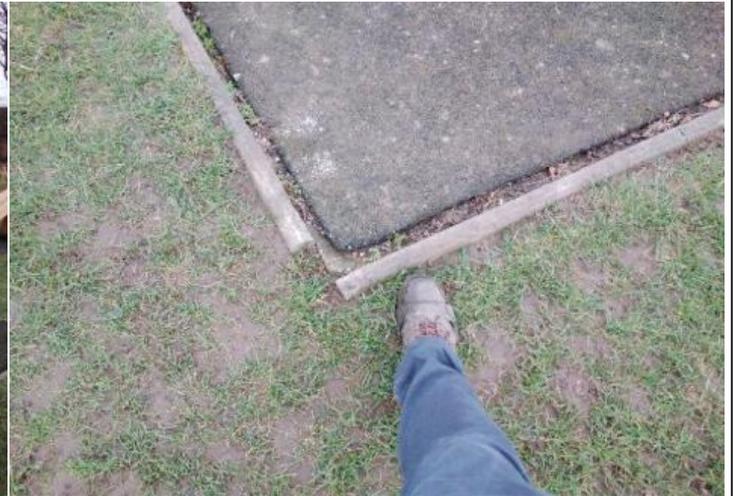
**Item:** Swings - 1 Bay 2 Seat (Cradle)  
**Manufacturer:** Wicksteed Playgrounds

**Finding:** There are trip hazards at the edges of the surface

**Action:** Reinstate surrounding surface levels to remove the trip points

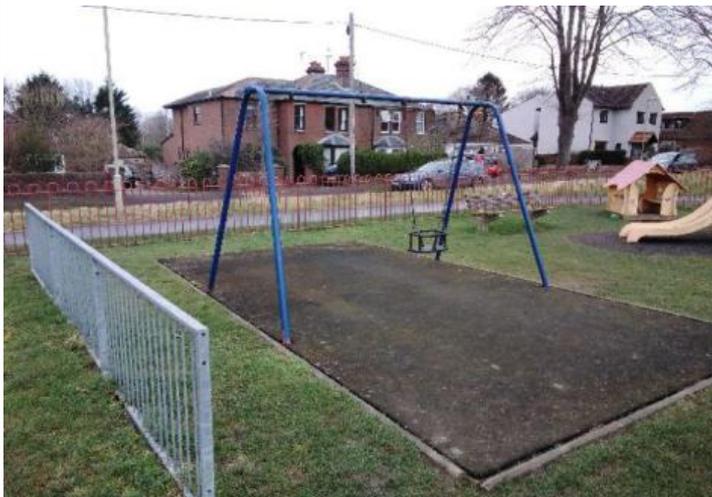
**Item:** Swings - 1 Bay 2 Seat (Cradle)  
**Manufacturer:** Wicksteed Playgrounds

**Finding:** The safety surface around the area is beginning to wear

**Action:** Monitor for any further deterioration and repair as required

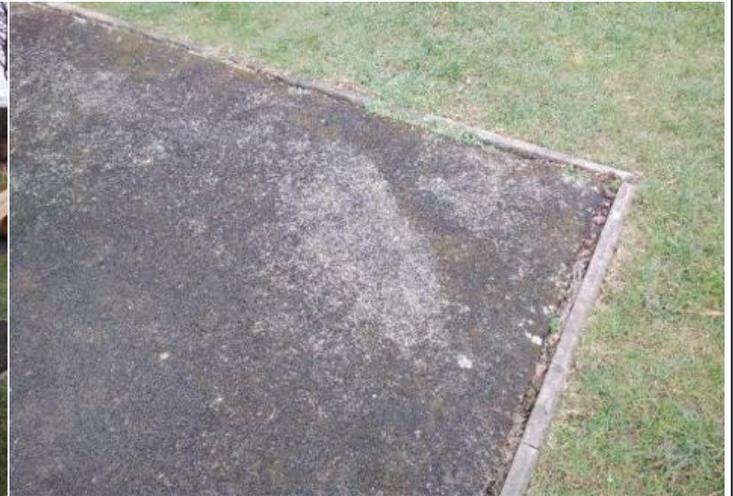
**Item:** Swings - 1 Bay 2 Seat (Cradle)  
**Manufacturer:** Wicksteed Playgrounds

**Finding:** The surface has subsided in some areas

**Action:** Monitor for any further deterioration and repair as required

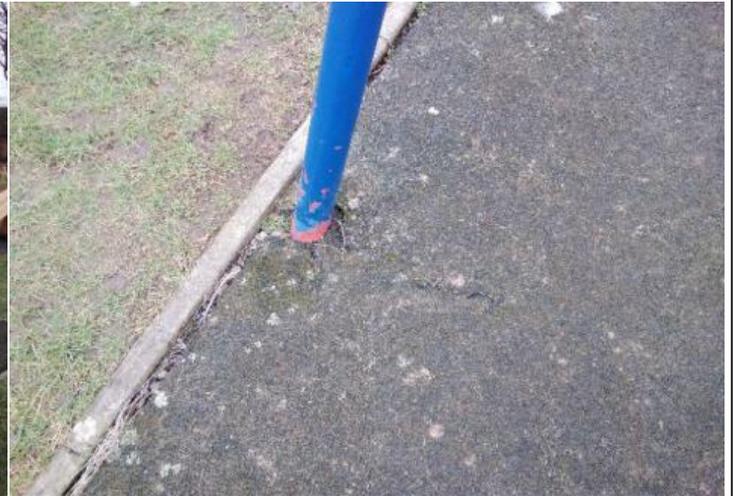
**Item:** Swings - 1 Bay 2 Seat (Cradle)  
**Manufacturer:** Wicksteed Playgrounds

**Finding:** The safety surface under or around this unit has been damaged

**Action:** Monitor for any further deterioration and repair as required

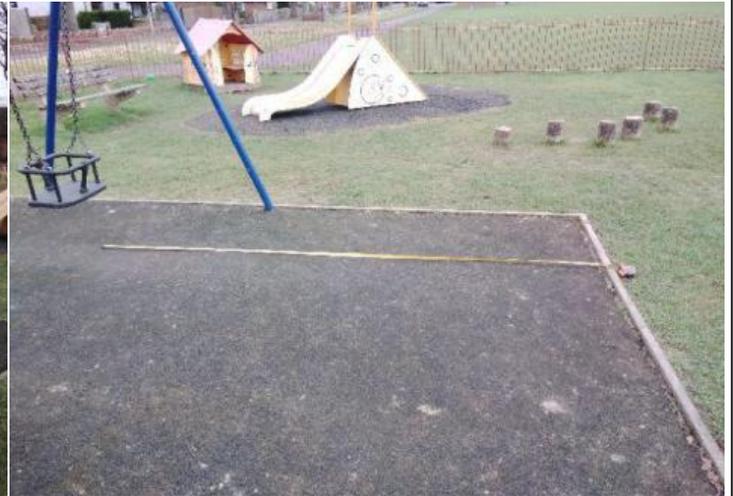
**Item:** Swings - 1 Bay 2 Seat (Cradle)  
**Manufacturer:** Wicksteed Playgrounds

**Finding:** The surfacing dimensions are short and do not meet with the requirements of the current applicable standard

**Action:** Monitor - no remedial action recommended

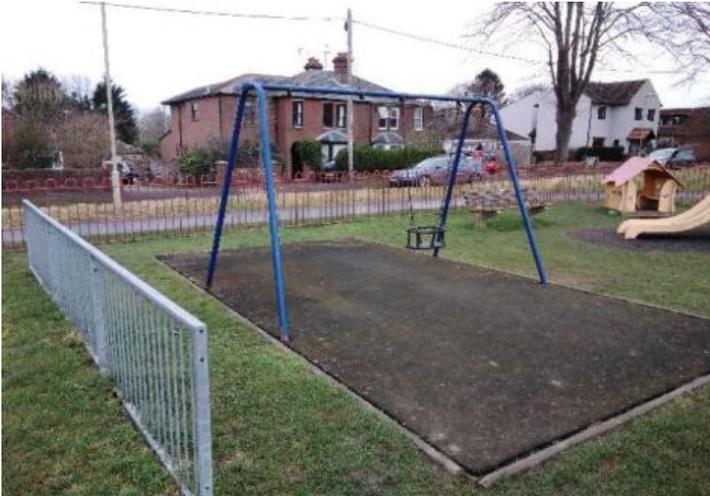
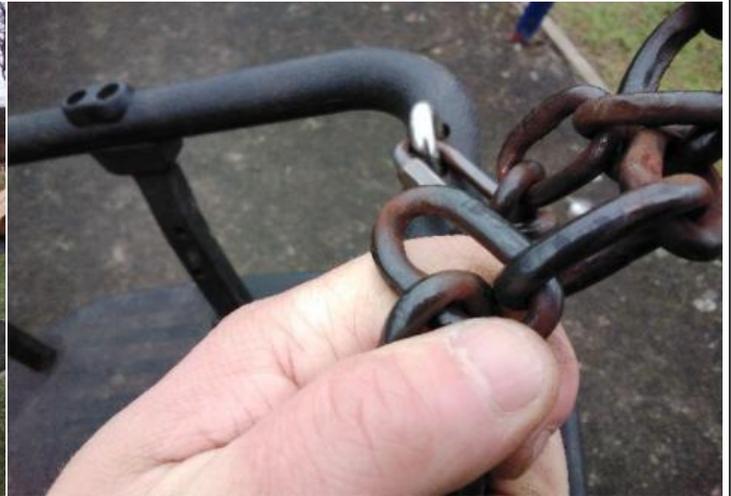
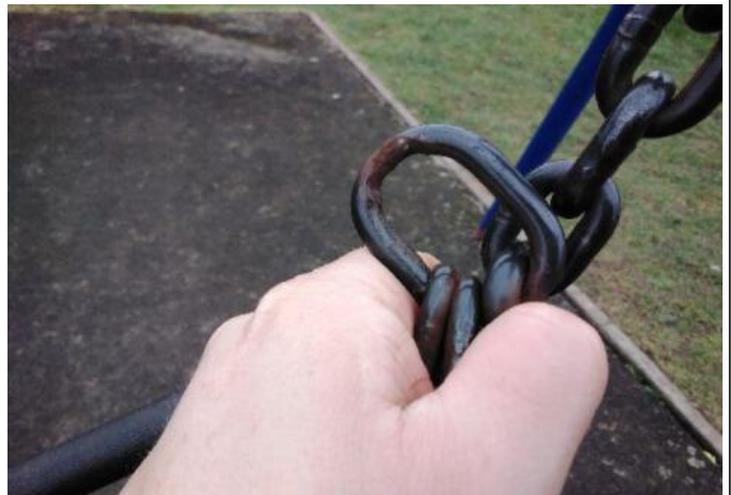
**Item:** Swings - 1 Bay 2 Seat (Cradle)  
**Manufacturer:** Wicksteed Playgrounds

**Finding:** There is some notable evidence of chain wear

**Action:** Monitor for any further deterioration and replace when 40% worn

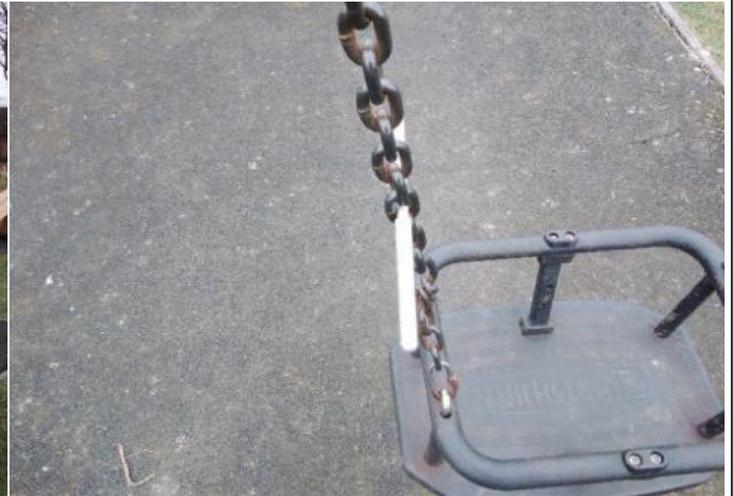
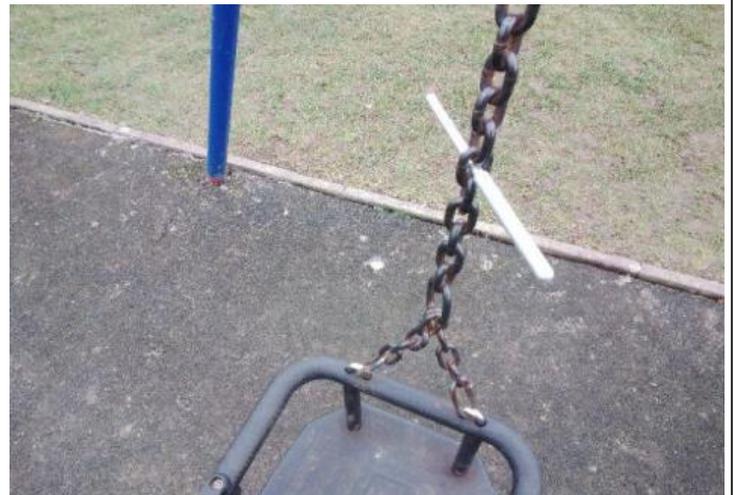
**Item:** Swings - 1 Bay 2 Seat (Cradle)  
**Manufacturer:** Wicksteed Playgrounds

**Finding:** The chain openings are in excess of the 8.6mm as recommended by BS EN 1176 **Action:** Monitor - No remedial work recommended

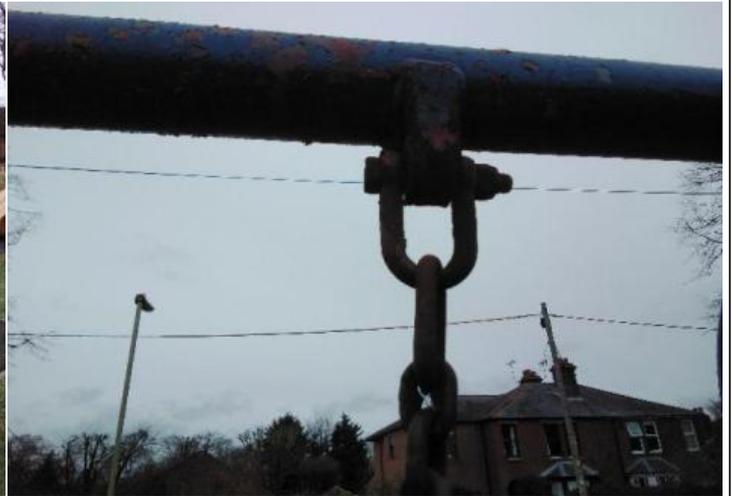
**Item:** Swings - 1 Bay 2 Seat (Cradle)  
**Manufacturer:** Wicksteed Playgrounds

**Finding:** The bushes are showing signs of wear

**Action:** Monitor for any further deterioration and replace as required

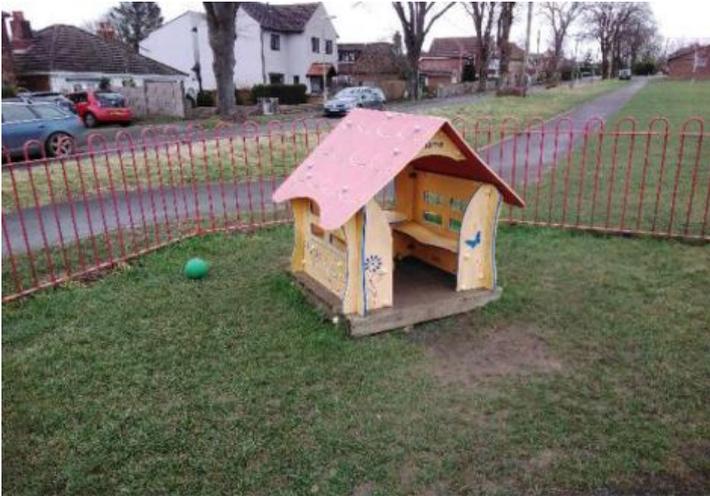
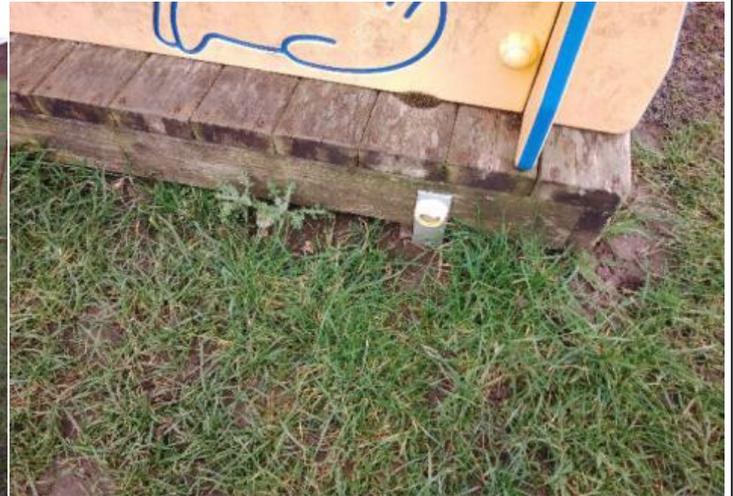
**Item:** Activity Equipment - Playhouse  
**Manufacturer:** Wicksteed Playgrounds

**Finding:** There is/are bolt cap covers missing or damaged on the item

**Action:** Replace missing or damaged bolt cap covers

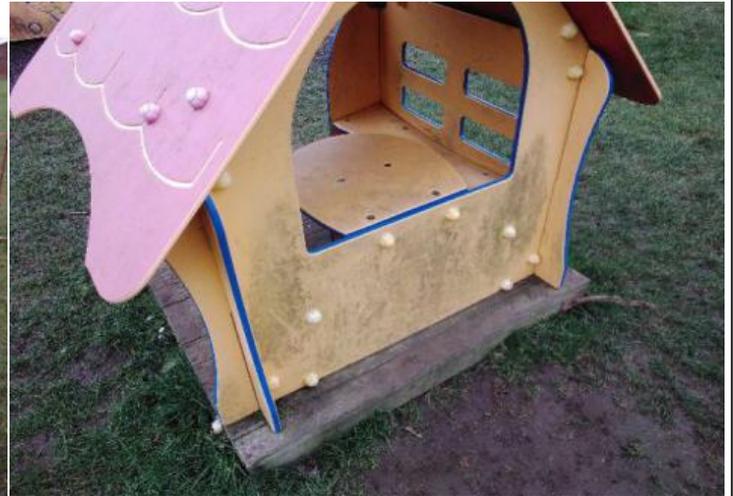
**Item:** Activity Equipment - Playhouse  
**Manufacturer:** Wicksteed Playgrounds

**Finding:** There is algae or moss on the surface of the equipment

**Action:** Clean and treat appropriately

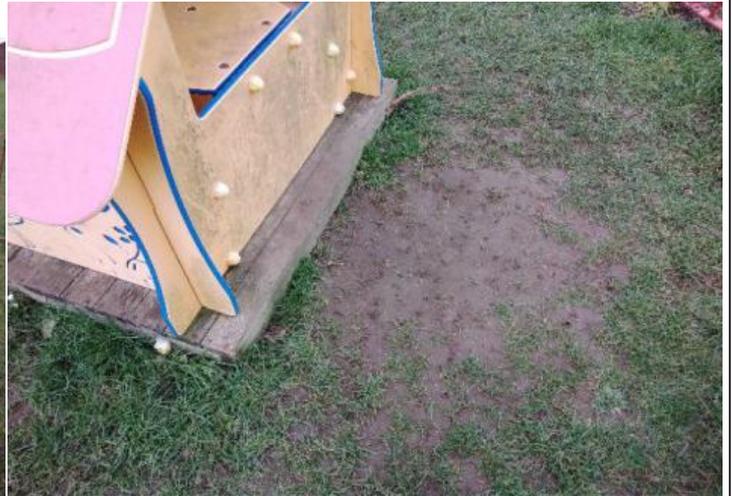
**Item:** Activity Equipment - Playhouse  
**Manufacturer:** Wicksteed Playgrounds

**Finding:** The area around the item has eroded and may become slippery

**Action:** Reinststate eroded area

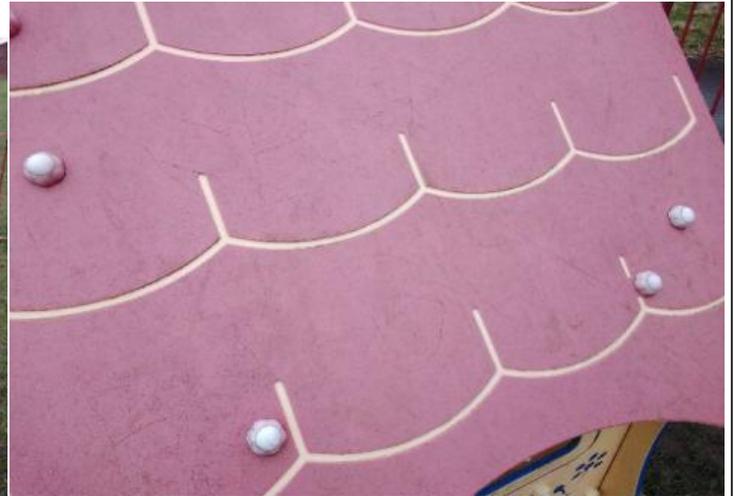
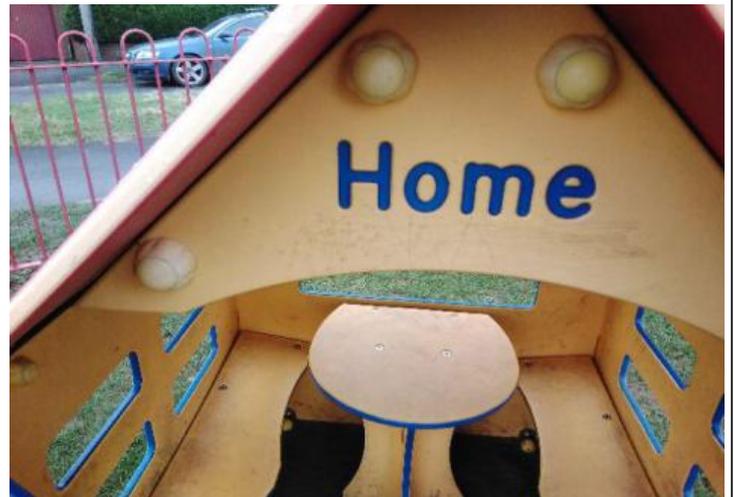
**Item:** Activity Equipment - Playhouse  
**Manufacturer:** Wicksteed Playgrounds

**Finding:** There is some graffiti present

**Action:** Remove the graffiti

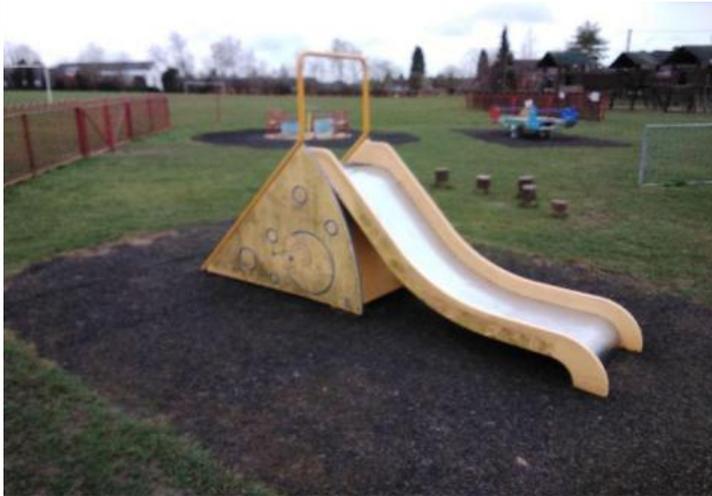
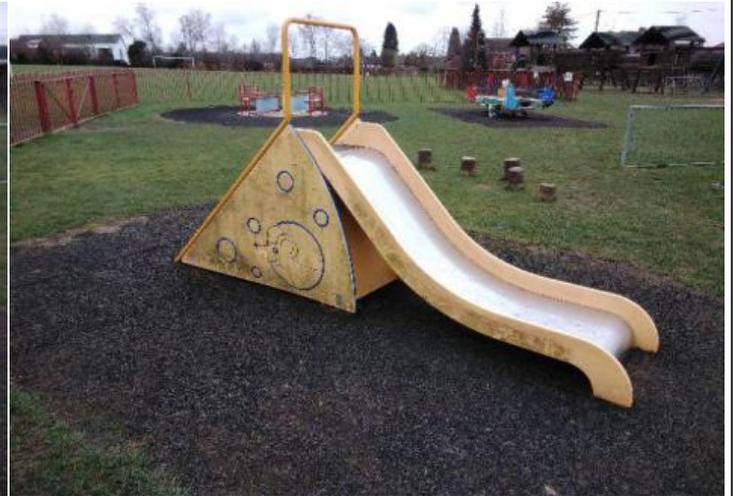
**Item:** Other - Free Standing Slide  
**Manufacturer:** Wicksteed Playgrounds

**Finding:** There is algae or moss on the surface of the equipment

**Action:** Clean and treat appropriately

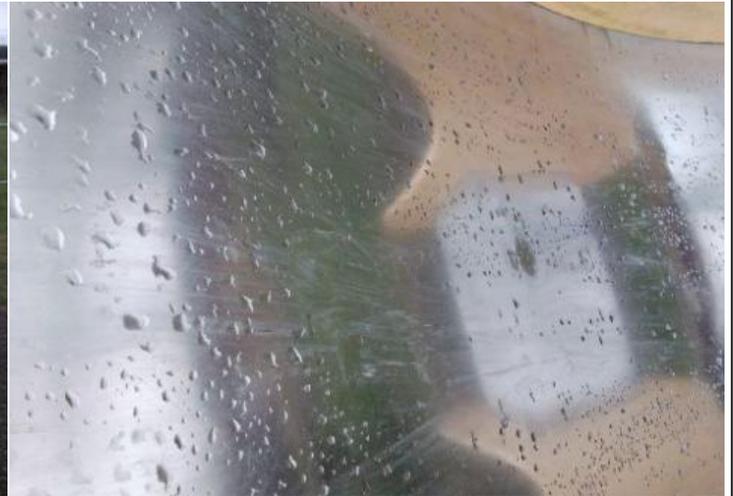
**Item:** Other - Free Standing Slide  
**Manufacturer:** Wicksteed Playgrounds

**Finding:** There are a number of dents in the slide surface

**Action:** Monitor for any further deterioration and repair as required

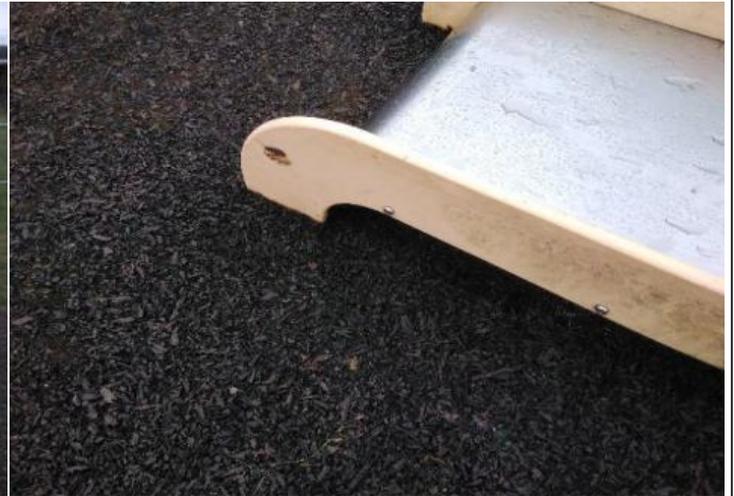
**Item:** Other - Free Standing Slide  
**Manufacturer:** Wicksteed Playgrounds

**Finding:** A number of fixing(s) have worked loose to the slide side

**Action:** Secure all loose fixings

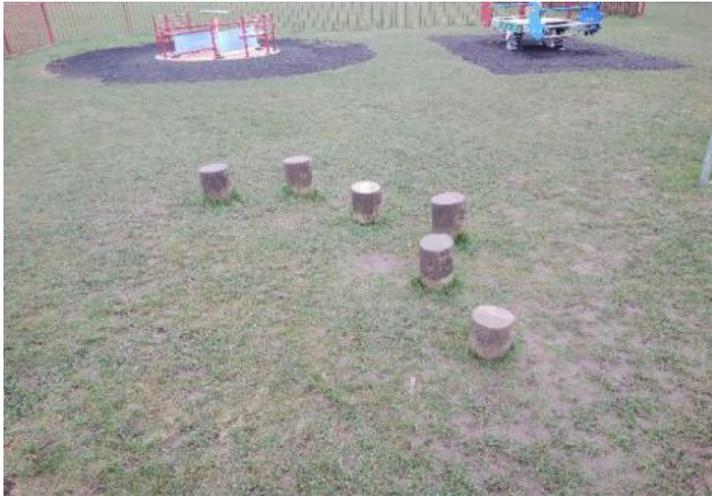
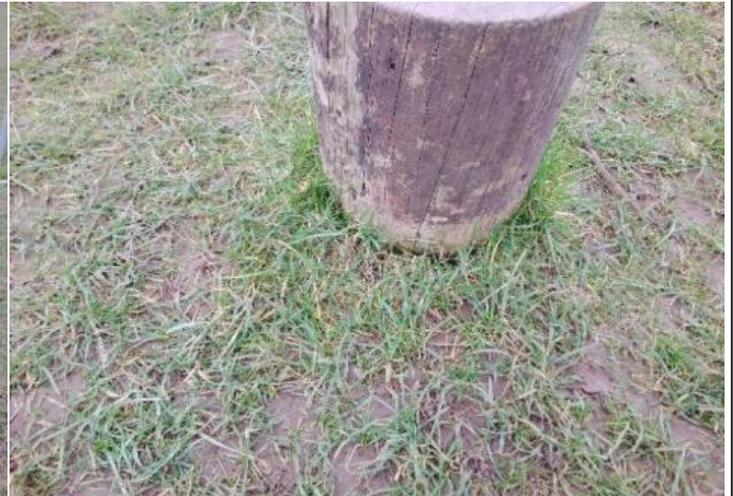
**Item:** Activity Equipment - Log Walk  
**Manufacturer:** Unknown

**Finding:** There is some strimmer / machinery damage apparent on the posts, this can penetrate the preservative applied to the timber and accelerate the rotting process

**Action:** Monitor for any deterioration (rot) and replace as required

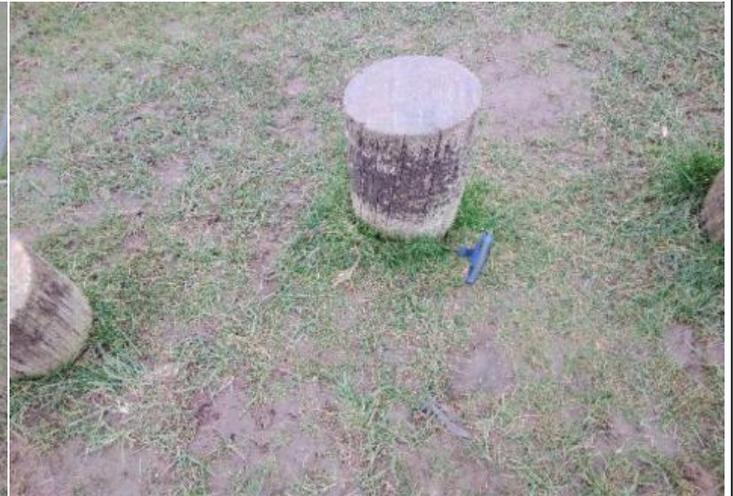
**Item:** Activity Equipment - Log Walk  
**Manufacturer:** Unknown

**Finding:** There is some evidence of rot in the timber

**Action:** Monitor for any further deterioration and replace as required
