the **play inspection** company

## Annual Inspection

Winchester City Council

Stratton Bates Recreation Ground (New Alresford)

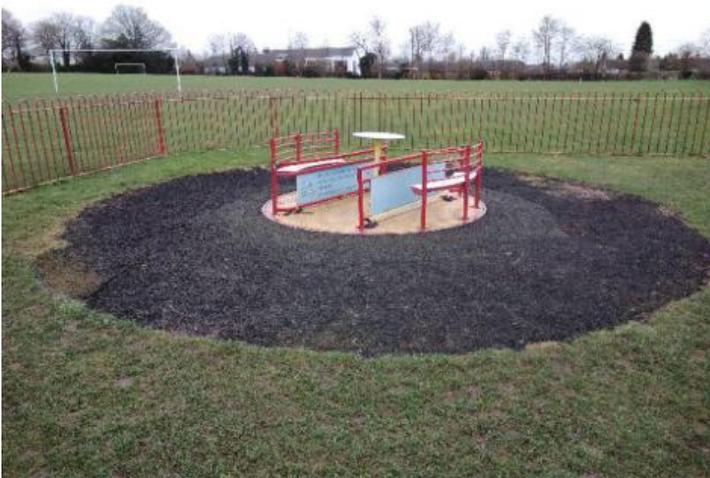
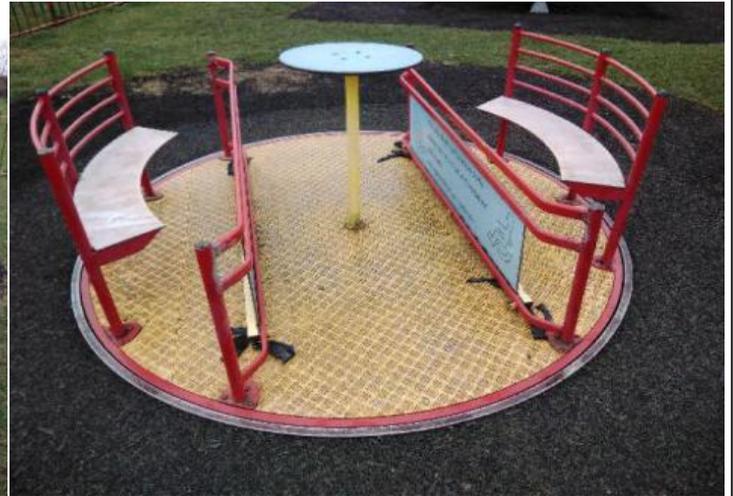
**Item:** Rotor Play - Inclusive Roundabout  
**Manufacturer:** Wicksteed Playgrounds

**Finding:** The bearing is showing signs of wear

**Action:** Monitor for any further deterioration and replace as required

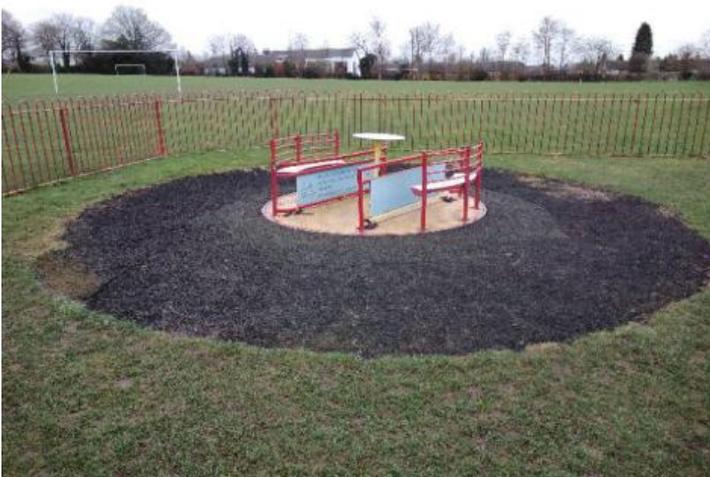
**Item:** Rotor Play - Inclusive Roundabout  
**Manufacturer:** Wicksteed Playgrounds

**Finding:** A number of fixing(s) have worked loose to the centre table

**Action:** Secure all loose fixings

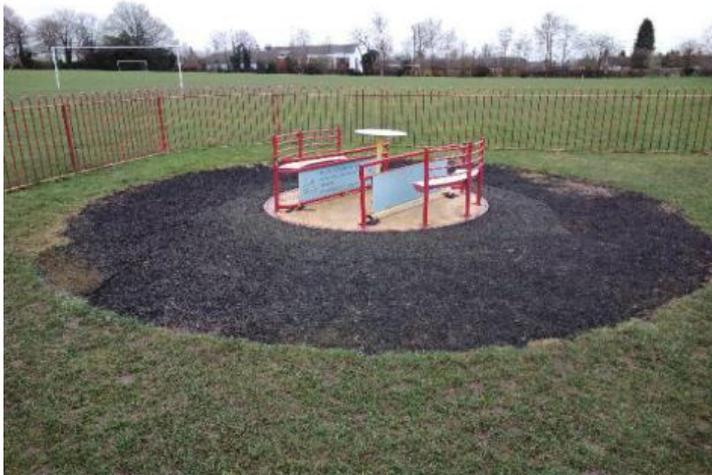
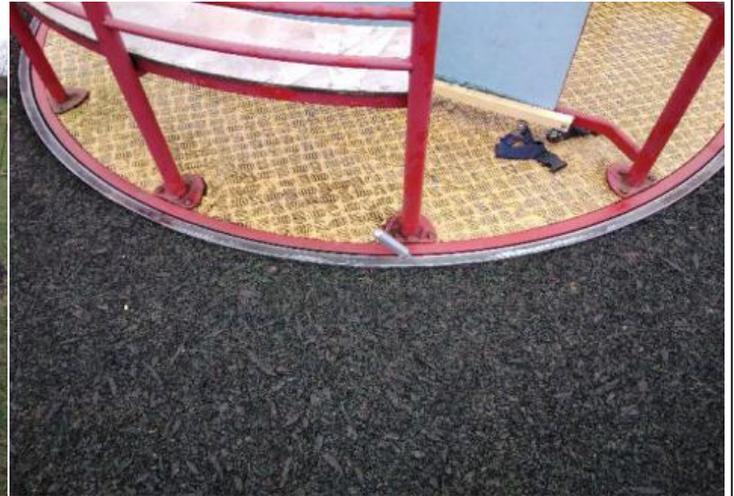
**Item:** Rotor Play - Inclusive Roundabout  
**Manufacturer:** Wicksteed Playgrounds

**Finding:** The opening to the side of the platform is in excess of 8mm and fails the requirements of BS EN 1176 Part 5 **Action:** Monitor - No remedial work recommended

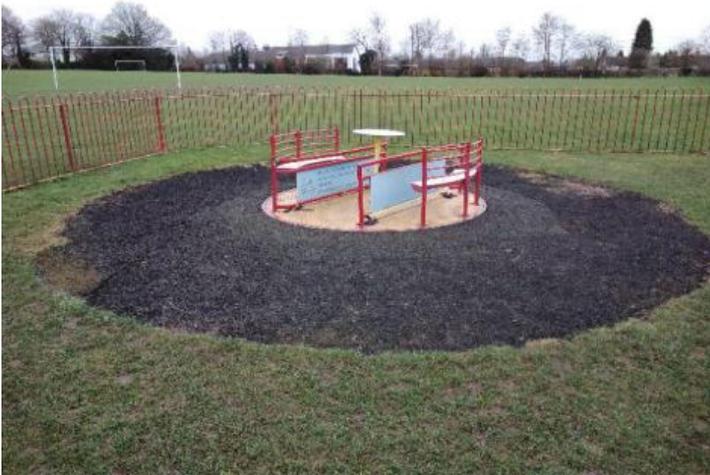
**Item:** Rotor Play - Inclusive Roundabout  
**Manufacturer:** Wicksteed Playgrounds

**Finding:** There is some evidence of fire damage to the post caps  
**Action:** Replace post end caps

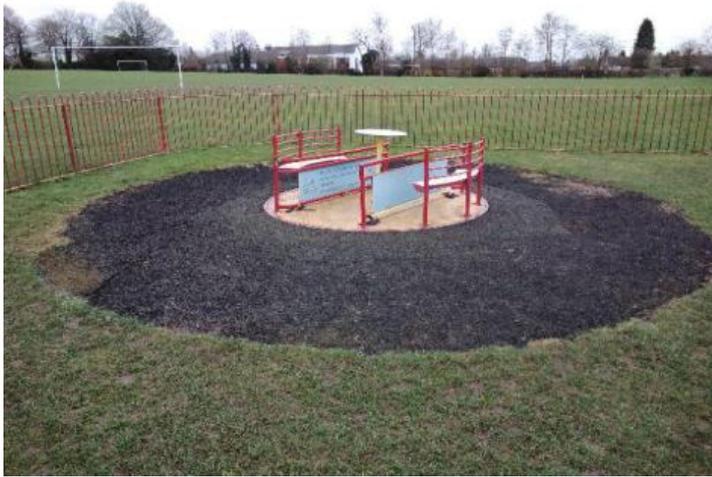
**Item:** Rotor Play - Inclusive Roundabout  
**Manufacturer:** Wicksteed Playgrounds

**Finding:** The safety surface under or around this unit has been damaged

**Action:** Monitor for any further deterioration and repair as required

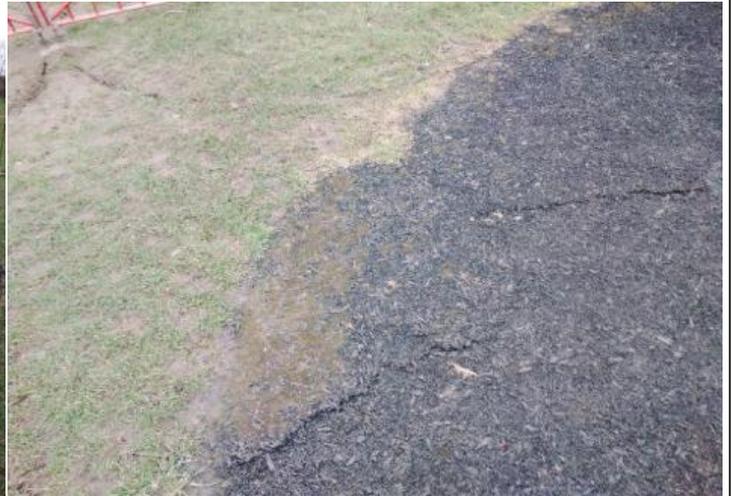
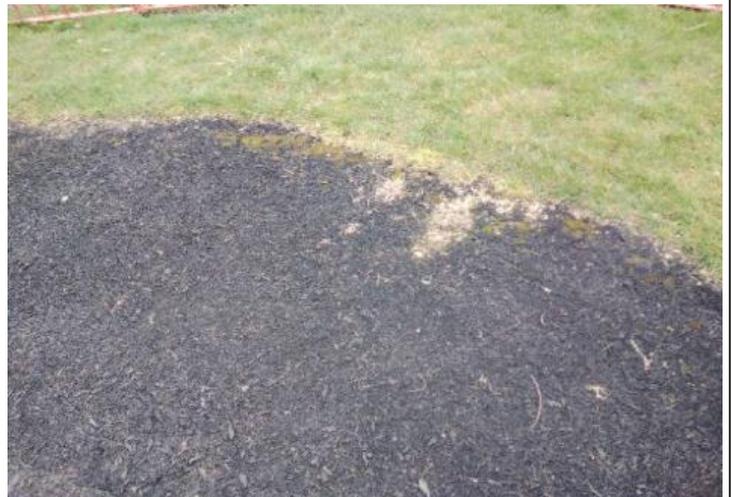
**Item:** Rotor Play - Inclusive Roundabout  
**Manufacturer:** Wicksteed Playgrounds

**Finding:** There is weed / vegetation growth on, between, or around the edges of the surfacing  
**Action:** Remove weed / vegetation growth

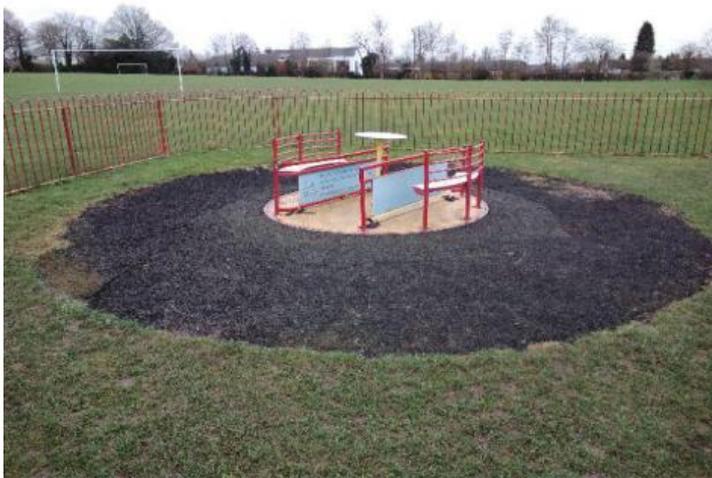
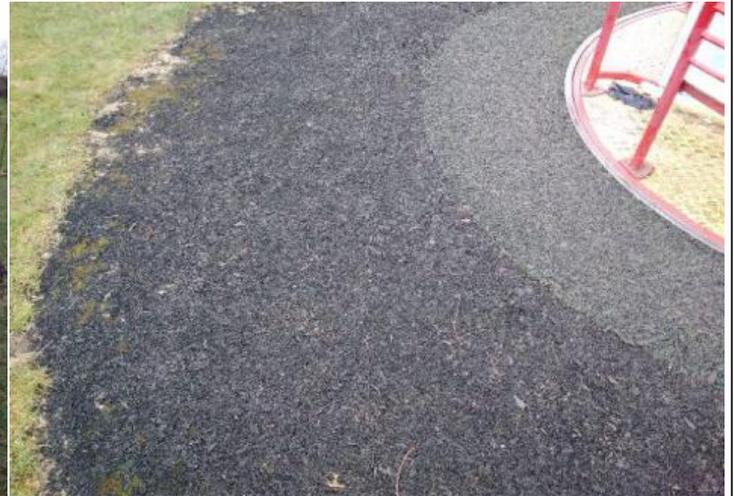
**Item:** Rotor Play - Inclusive Roundabout  
**Manufacturer:** Wicksteed Playgrounds

**Finding:** The wetpour is crumbling in areas

**Action:** Monitor for any further deterioration and repair as required

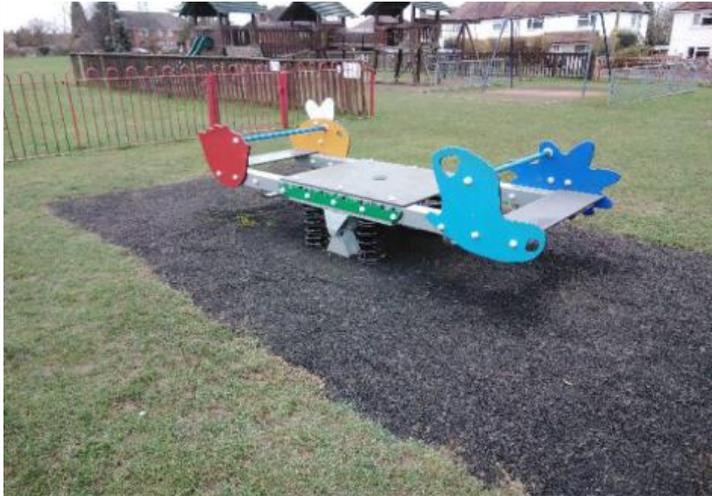
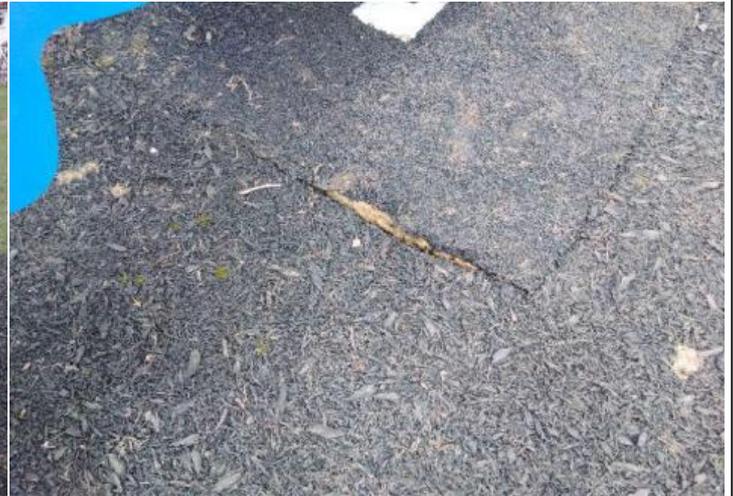
**Item:** Rocking Equipment - Spring See-Saw  
**Manufacturer:** Kompan Ltd

**Finding:** The safety surface has worn and the foundations are exposed

**Action:** Reinstall surrounding surfaces to cover the foundations

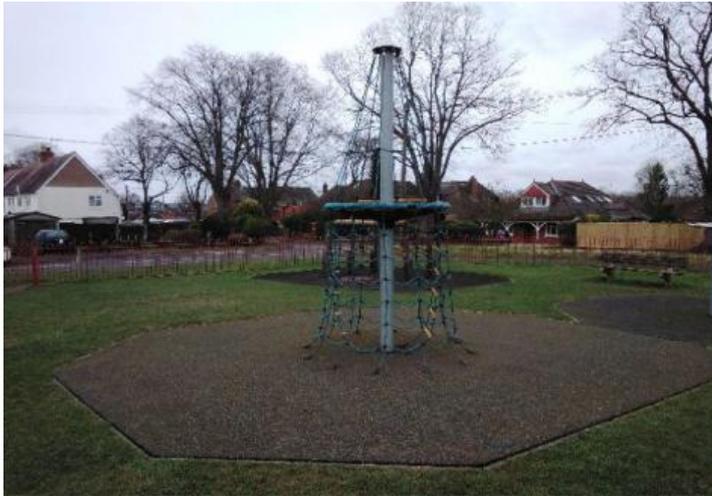
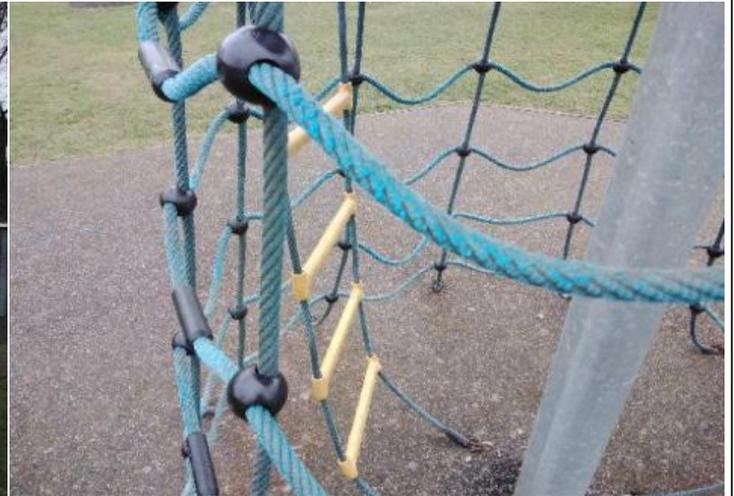
**Item:** Activity Equipment - Net Climber  
**Manufacturer:** Huck Nets (UK) Ltd

**Finding:** The ropes/nets are worn/damaged in places

**Action:** Monitor for any further deterioration and repair or replace as required

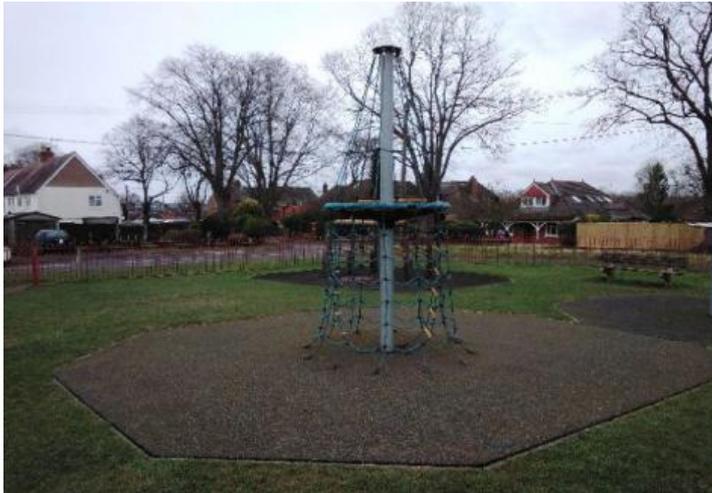
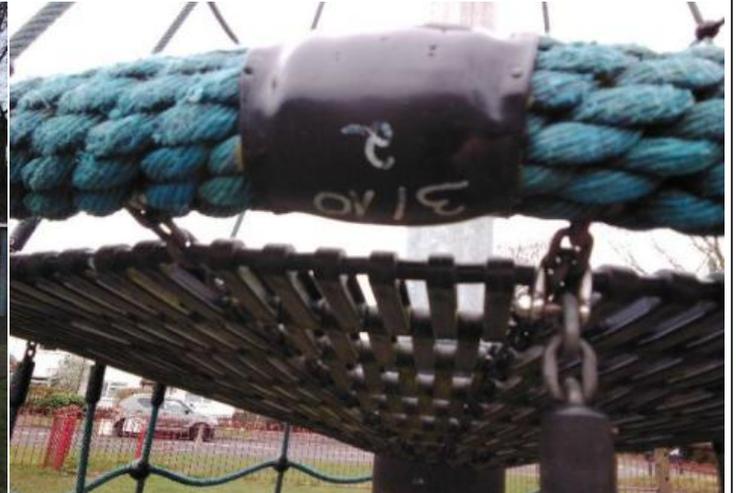
**Item:** Activity Equipment - Net Climber  
**Manufacturer:** Huck Nets (UK) Ltd

**Finding:** There is some graffiti present

**Action:** Remove the graffiti

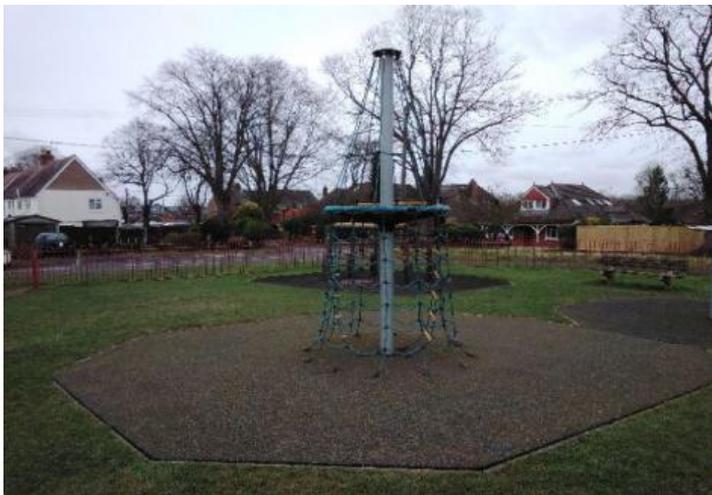
**Item:** Activity Equipment - Net Climber  
**Manufacturer:** Huck Nets (UK) Ltd

**Finding:** There is/are finger entrapment/s in the net and the item fails to meet the requirements of BS EN 1176 Part 1 4.2.7.6 Entrapment of fingers

**Action:** Monitor - No remedial work recommended

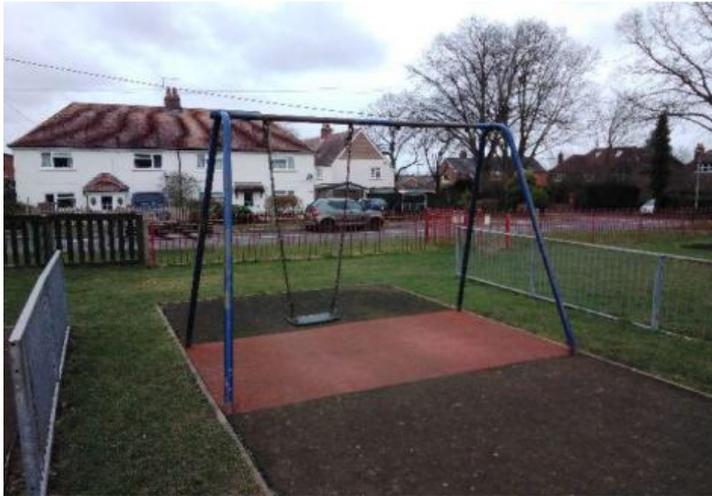
**Item:** Swings - 1 Bay 2 Seat (Flat)  
**Manufacturer:** Wicksteed Playgrounds

**Finding:** The seat(s) and suspension were missing at the time of inspection and the inspector was unable to make a full compliance assessment

**Action:** Replace missing seat(s) and suspension

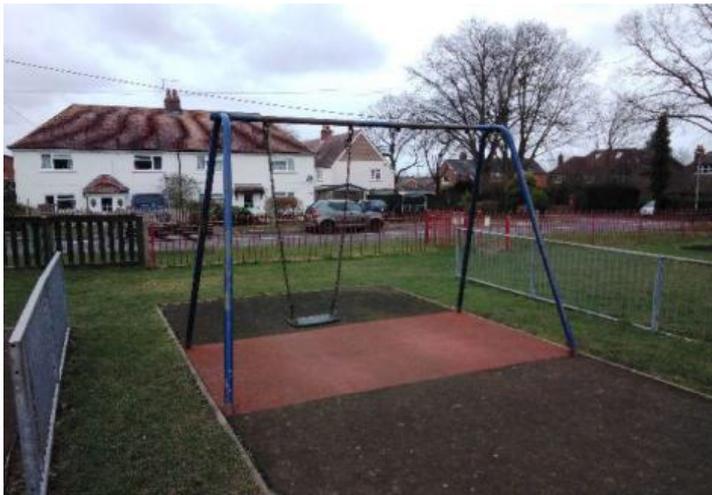
**Item:** Swings - 1 Bay 2 Seat (Flat)  
**Manufacturer:** Wicksteed Playgrounds

**Finding:** The safety surface under or around this unit has been damaged

**Action:** Monitor for any further deterioration and repair as required

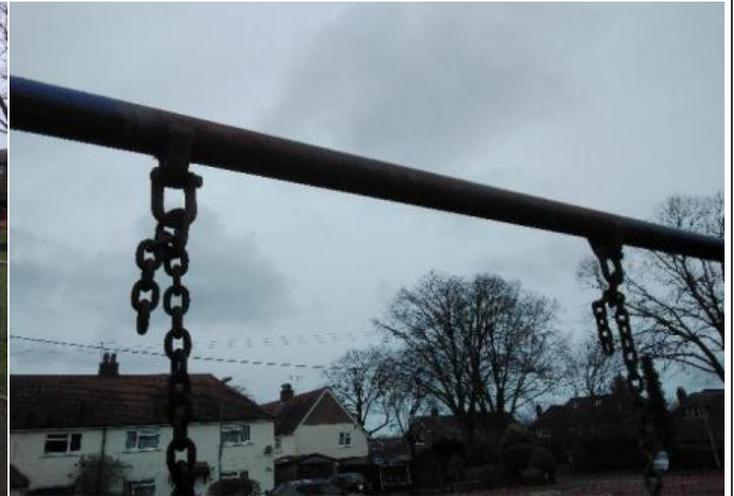
**Item:** Swings - 1 Bay 2 Seat (Flat)  
**Manufacturer:** Wicksteed Playgrounds

**Finding:** The paintwork on the crossbar has been damaged or worn exposing the metal underneath which is rusting  
**Action:** Treat any rusting components and repaint

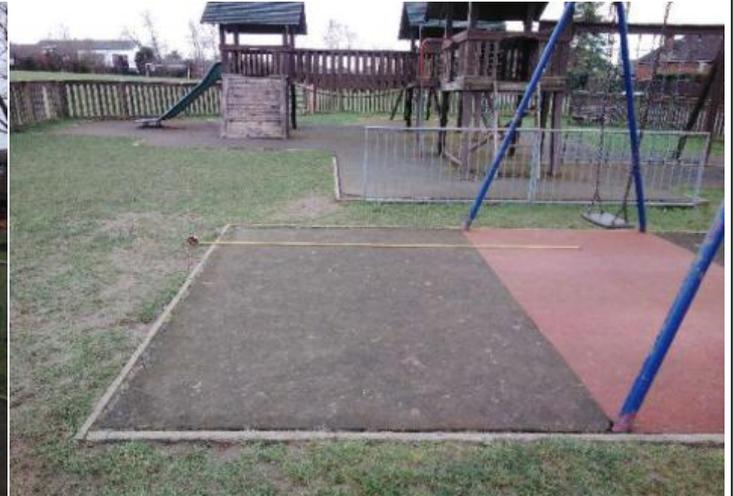
**Item:** Swings - 1 Bay 2 Seat (Flat)  
**Manufacturer:** Wicksteed Playgrounds

**Finding:** The surfacing dimensions are short and do not meet with the requirements of the current applicable standard

**Action:** Monitor - no remedial action recommended

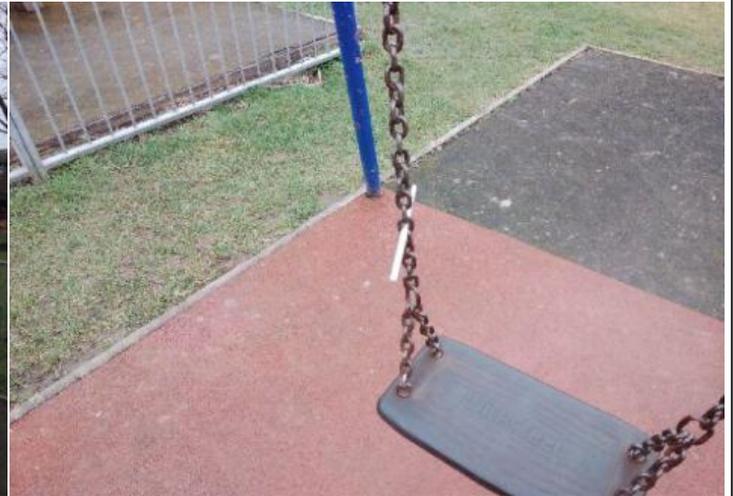
**Item:** Swings - 1 Bay 2 Seat (Flat)  
**Manufacturer:** Wicksteed Playgrounds

**Finding:** The chain openings are in excess of the 8.6mm as recommended by BS EN 1176 **Action:** Monitor - No remedial work recommended

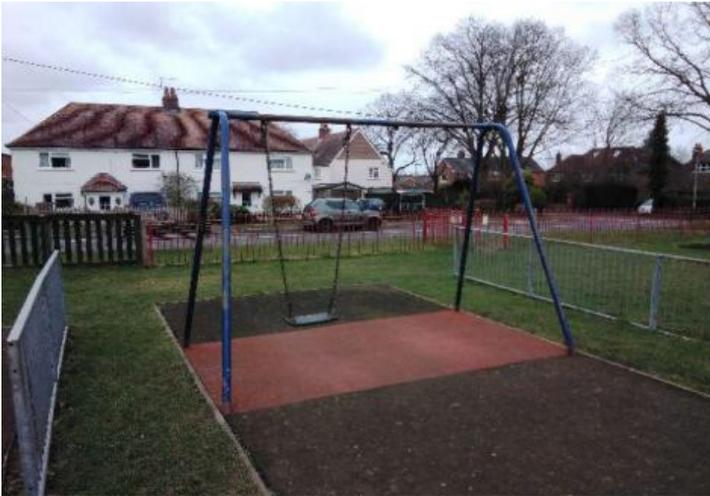
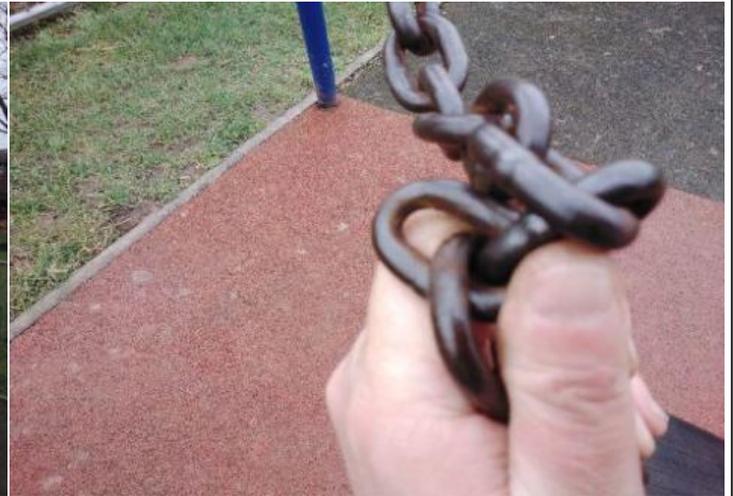
**Item:** Swings - 1 Bay 2 Seat (Flat)  
**Manufacturer:** Wicksteed Playgrounds

**Finding:** There is some notable evidence of chain wear

**Action:** Monitor for any further deterioration and replace when 40% worn

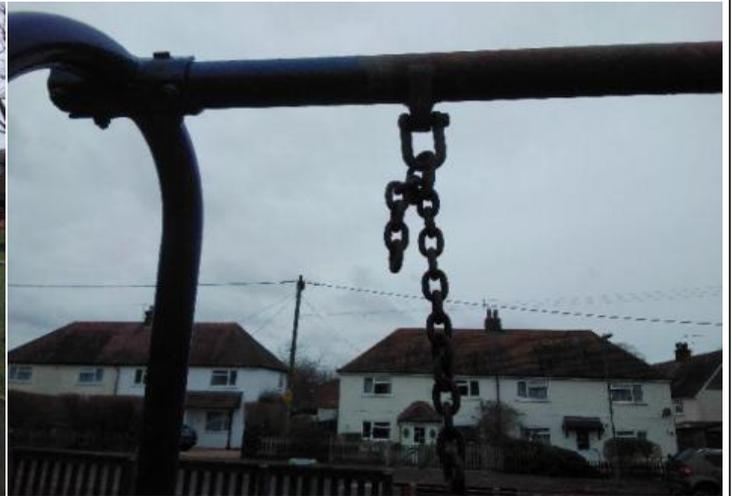
**Item:** Swings - 1 Bay 2 Seat (Flat)  
**Manufacturer:** Wicksteed Playgrounds

**Finding:** There are excessive chain tails

**Action:** Cut back excessive chain links

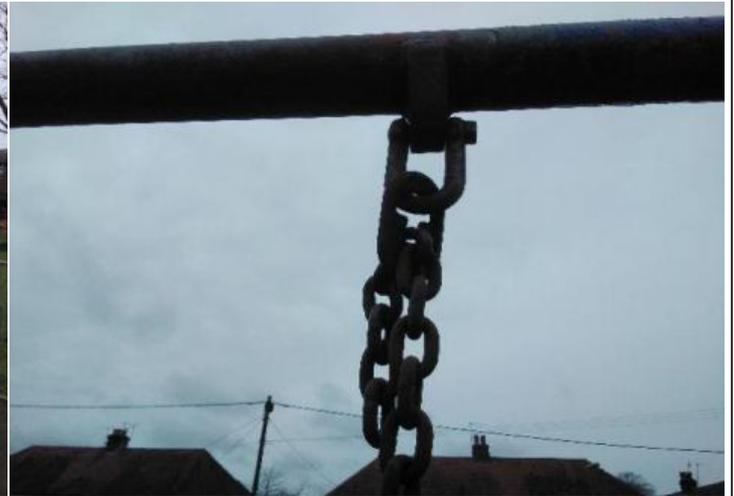
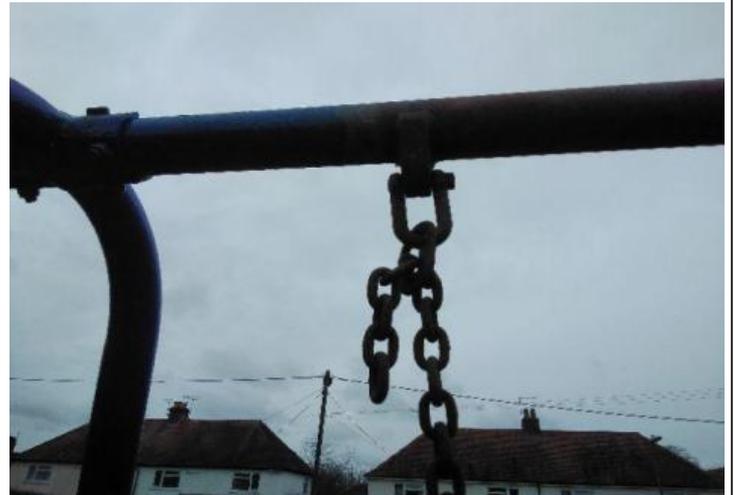
**Item:** Swings - 1 Bay 2 Seat (Flat)  
**Manufacturer:** Wicksteed Playgrounds

**Finding:** The bushes are showing signs of wear

**Action:** Monitor for any further deterioration and replace as required

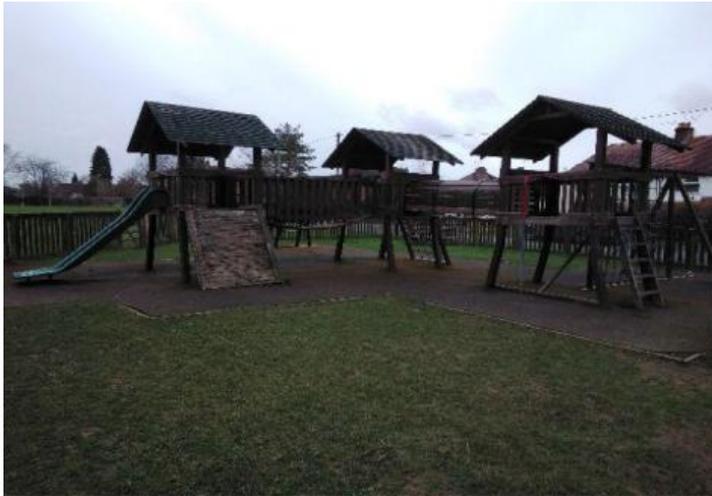
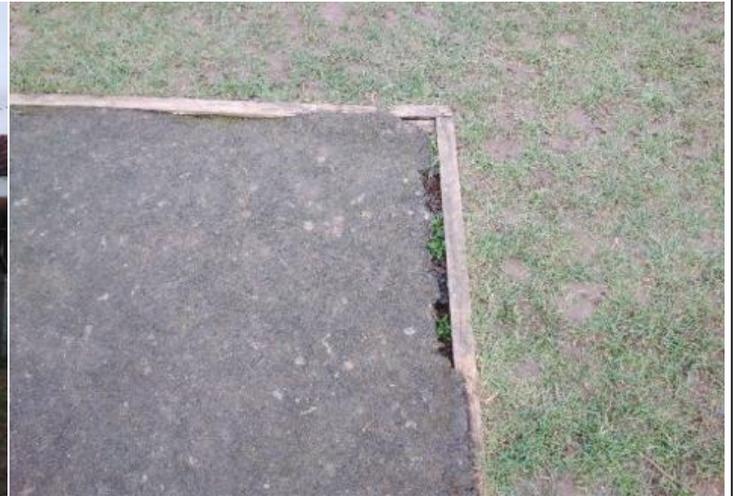
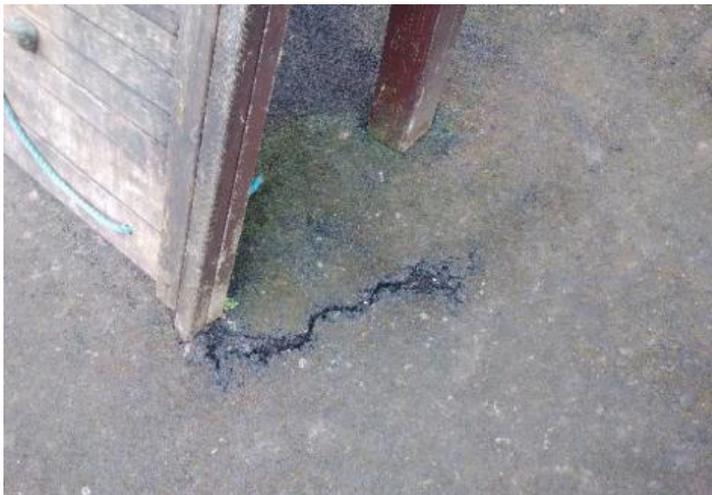
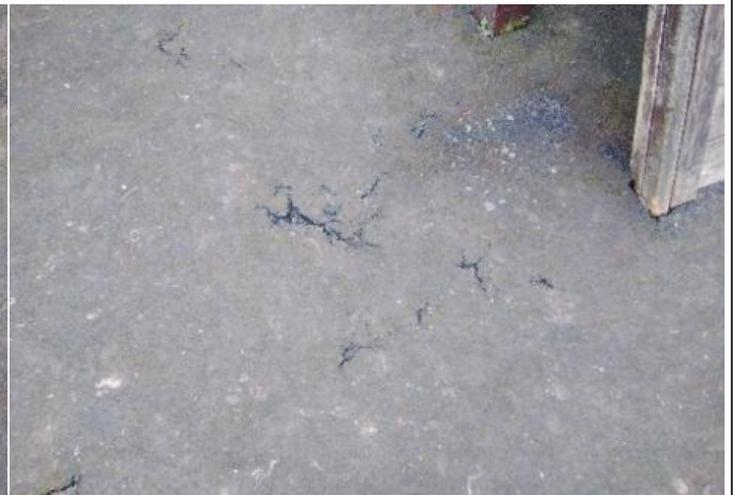
**Item:** Activity Equipment - Multi Play (Junior)  
**Manufacturer:** Lappset UK Ltd

**Finding:** The safety surface under or around this unit has been damaged

**Action:** Monitor for any further deterioration and repair as required

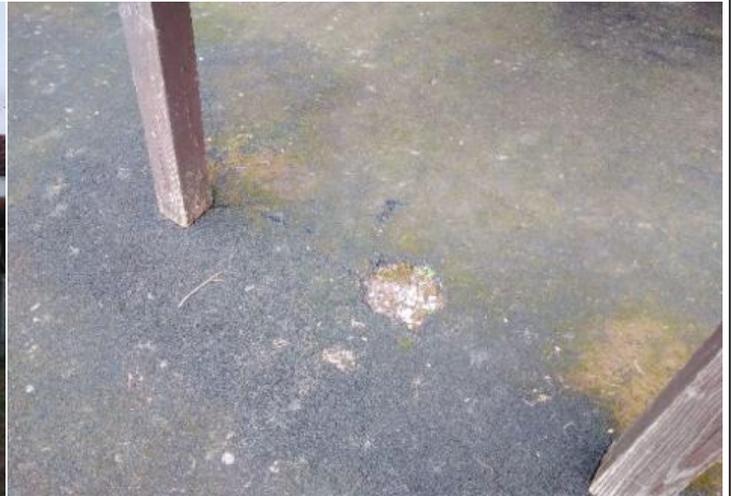
**Item:** Activity Equipment - Multi Play (Junior)  
**Manufacturer:** Lappset UK Ltd

**Finding:** The surfacing is severely damaged

**Action:** Repair damaged areas of surfacing

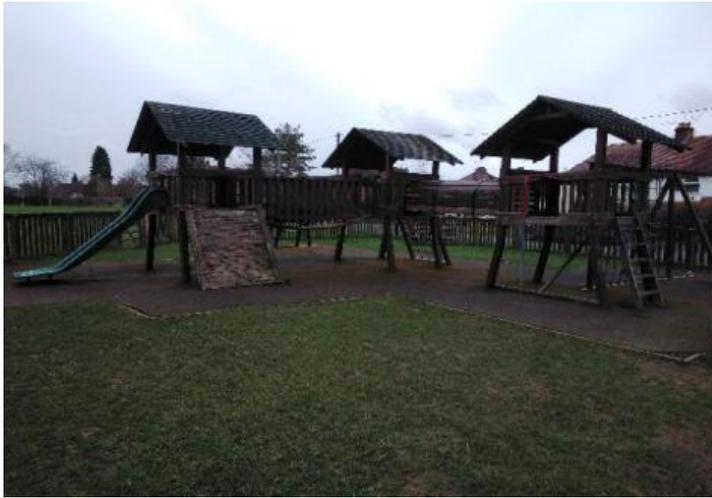
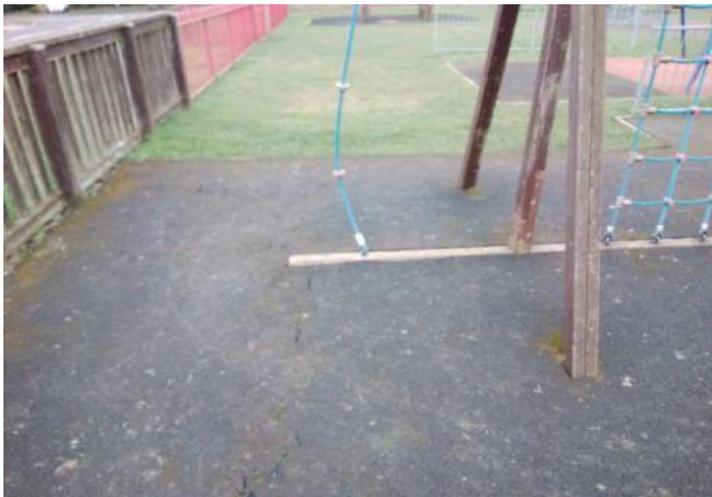
**Item:** Activity Equipment - Multi Play (Junior)  
**Manufacturer:** Lappset UK Ltd

**Finding:** The rope and climber bases forms a hard object within the impact area of the equipment in contravention of the requirements of BS EN 1176 Part 1

**Action:** Monitor - No remedial work recommended

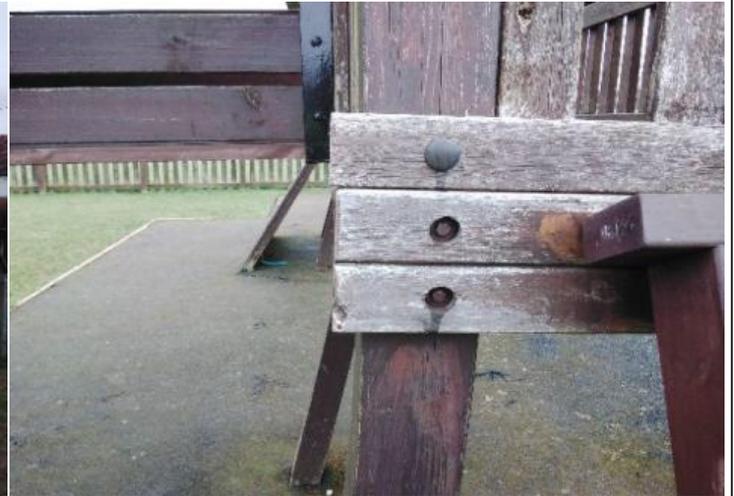
**Finding:** There is/are bolt cap covers missing or damaged on the item

**Action:** Replace missing or damaged bolt cap covers

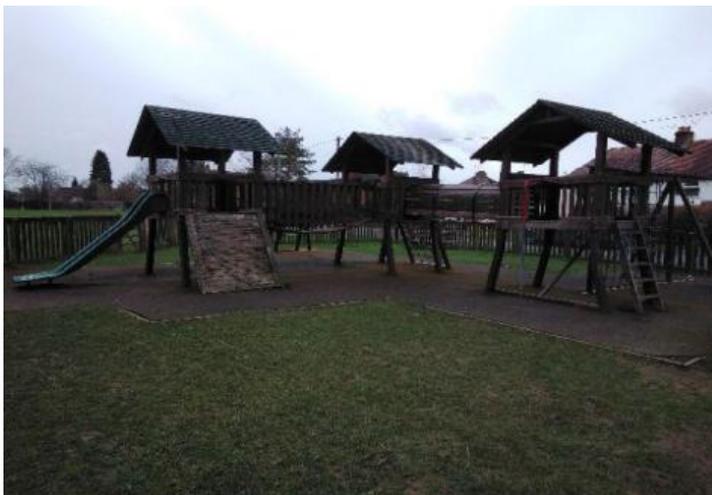
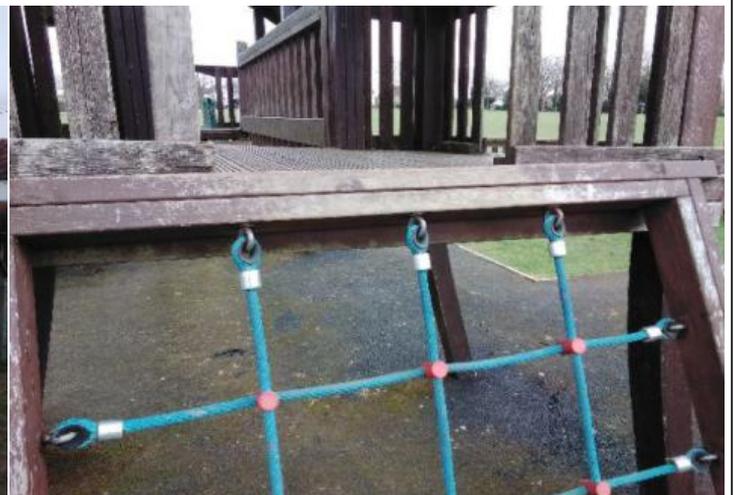
**Finding:** A number of fixing(s) have worked loose to the rope eyelets

**Action:** Secure all loose fixings

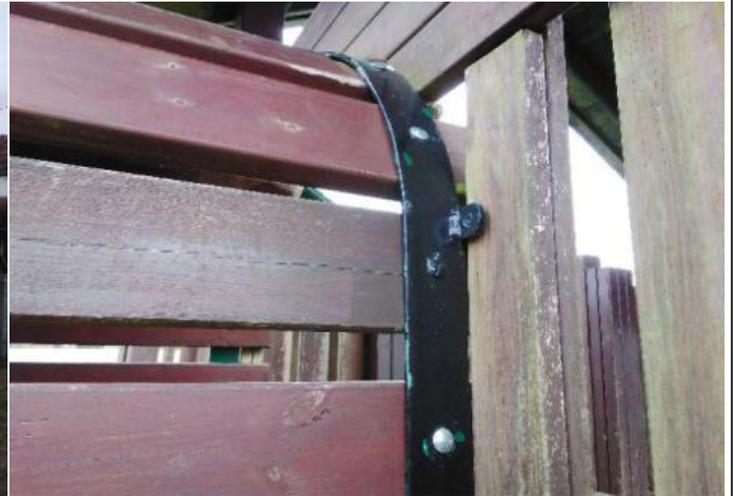
**Finding:** A number of fixing(s) have worked loose to the wooden tunnel framework

**Action:** Secure all loose fixings

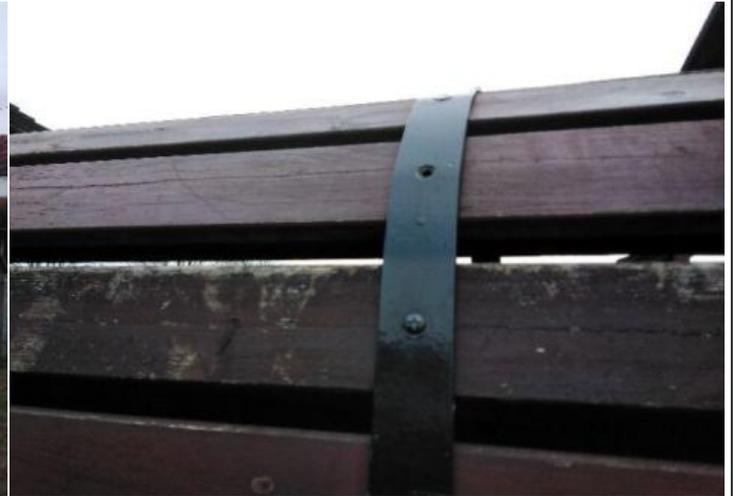
**Finding:** There is or are fixings missing on the item

**Action:** Replace all missing fixings

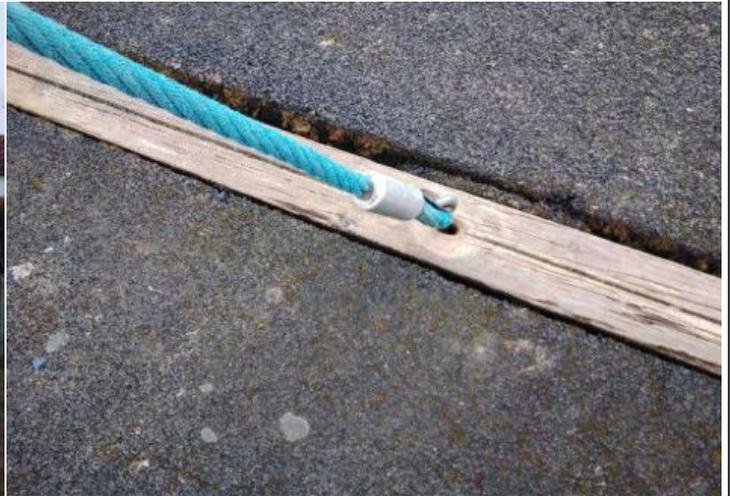
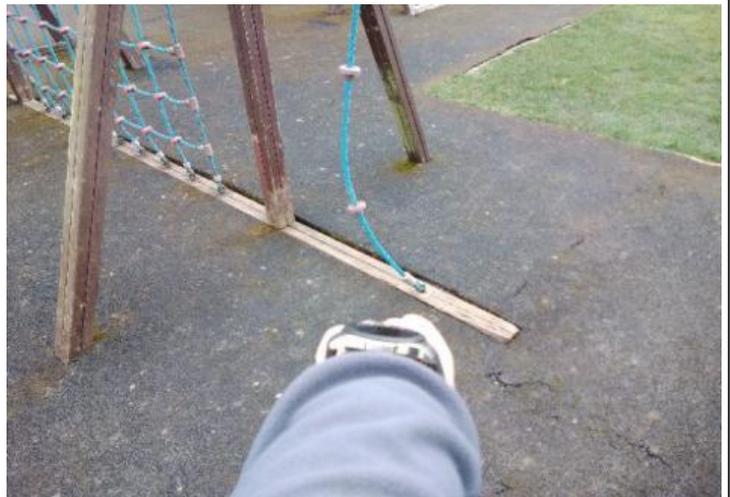
**Finding:** A number of fixing(s) have worked loose to the bottom of the climbing rope

**Action:** Secure all loose fixings

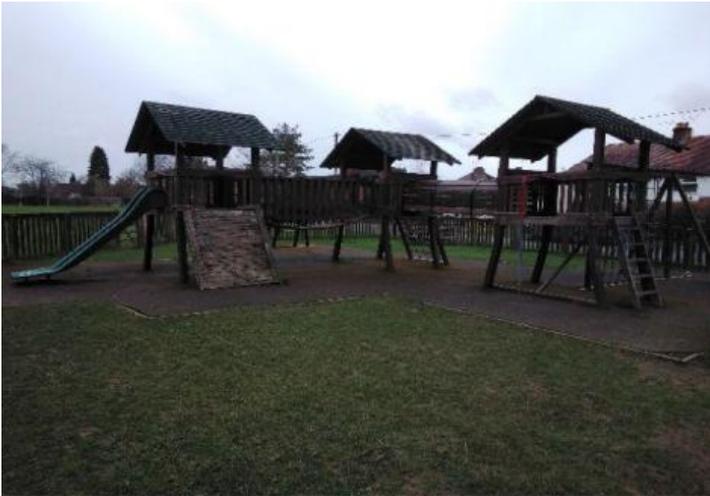
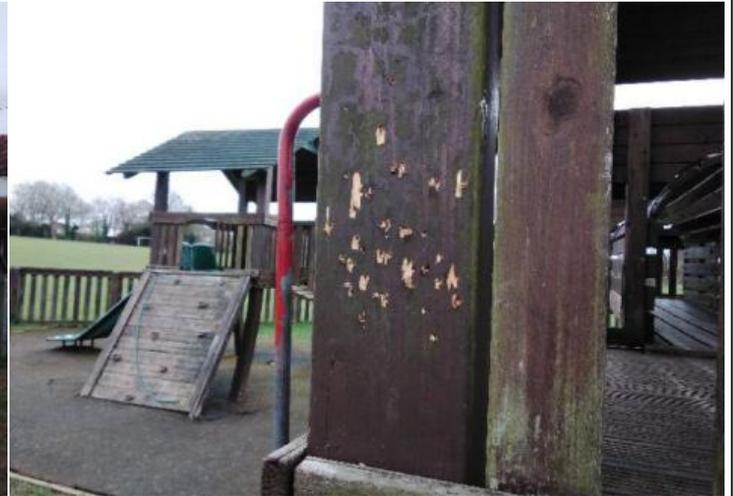
**Finding:** The item has been damaged

**Action:** Monitor for any further deterioration and replace as required

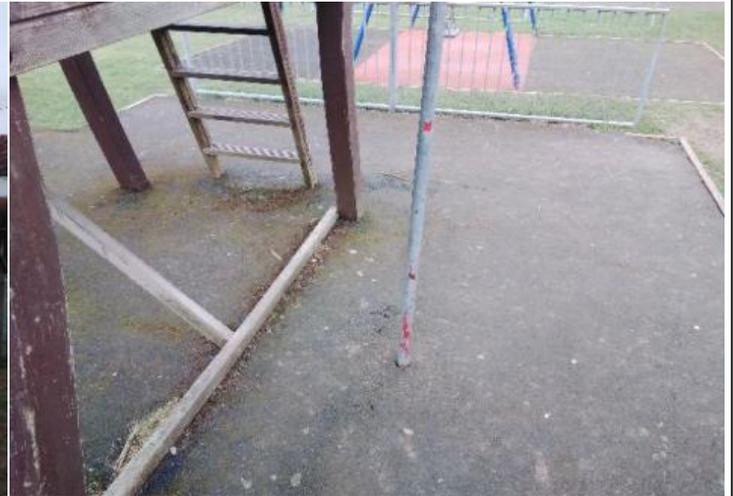
**Finding:** The fireman's pole is slightly loose in its foundations

**Action:** Monitor for any further deterioration and repair as required

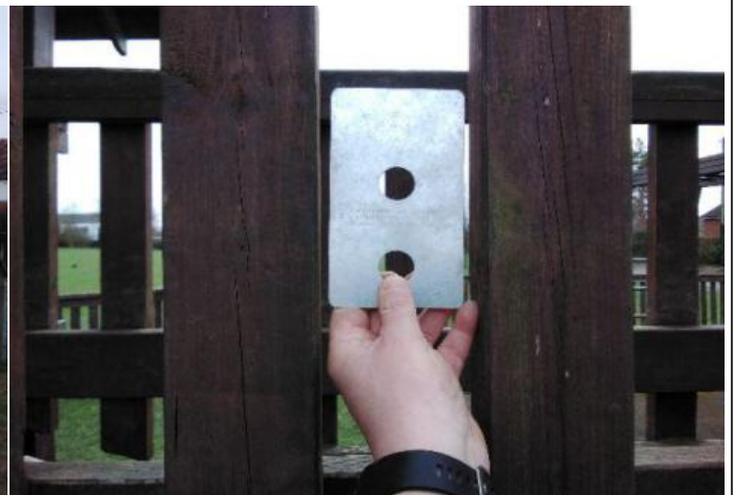
**Finding:** The item fails to meet the requirements of BS EN 1176 Part 1 4.2.7.2 head and neck entrapment in the barriers and/or steps

**Action:** Monitor - No remedial work recommended

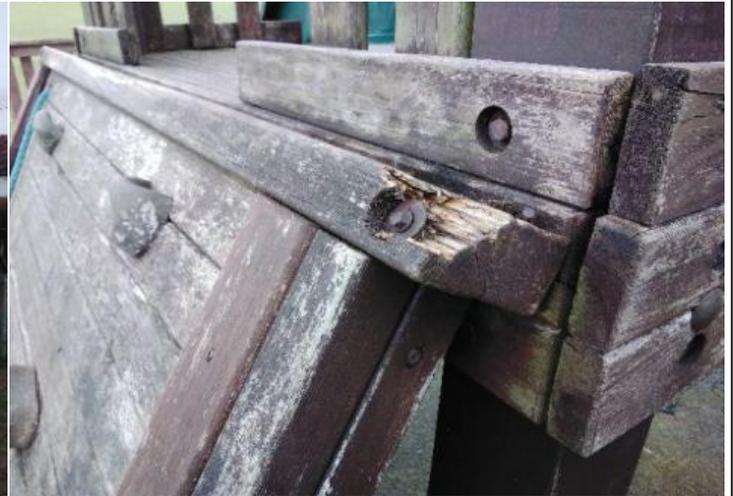
**Finding:** There is some evidence of rot in the timber

**Action:** Monitor for any further deterioration and replace as required

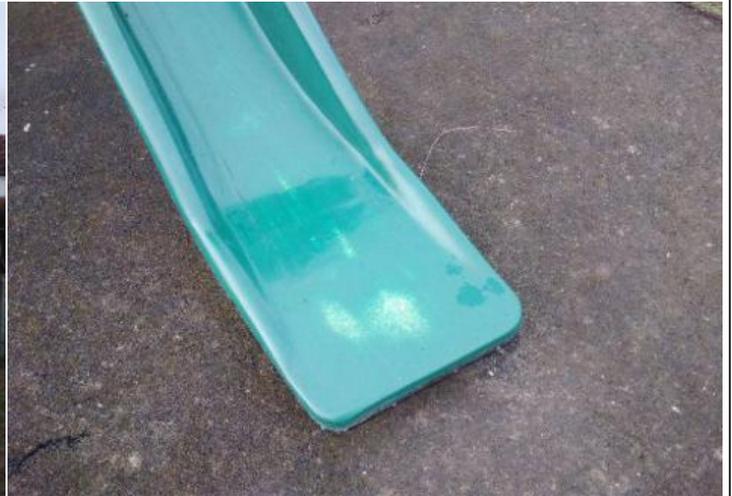
**Finding:** The gel coat on the slide surface is worn

**Action:** Re-dress the surface

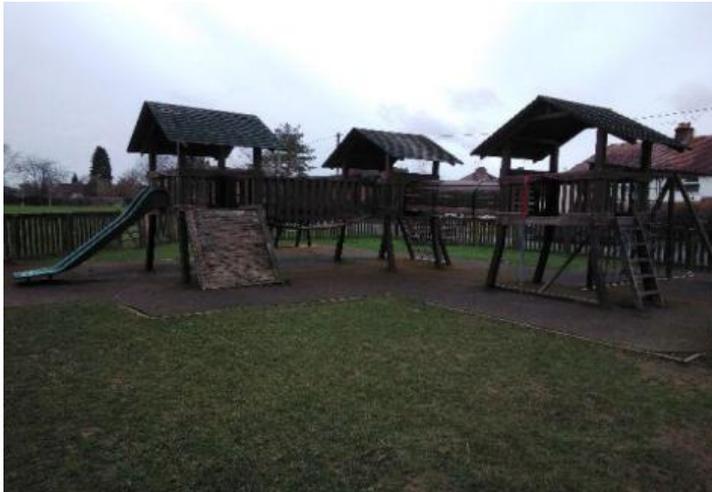
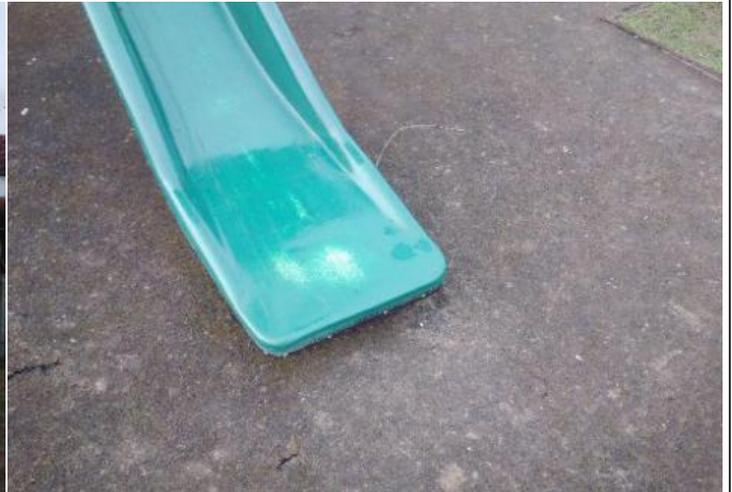
**Finding:** The end of the slide is loose and can be lifted a little

**Action:** Secure all loose fixings

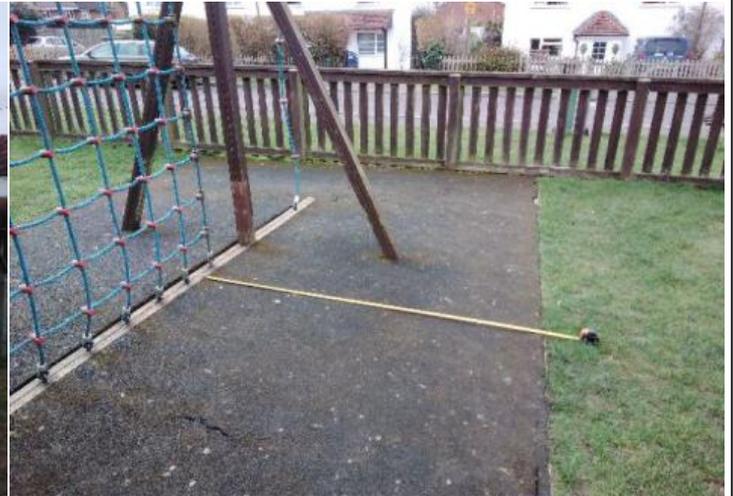
**Finding:** The surfacing dimensions are short and do not meet with the requirements of the current applicable standard

**Action:** Monitor - no remedial action recommended

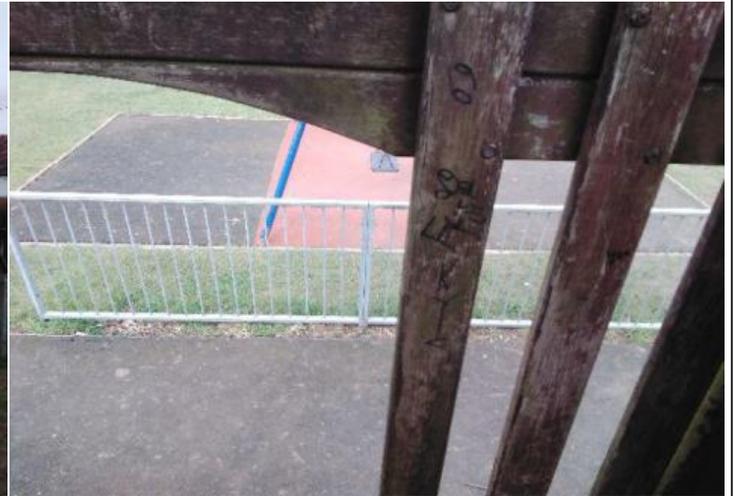
**Finding:** There is some graffiti present

**Action:** Remove the graffiti

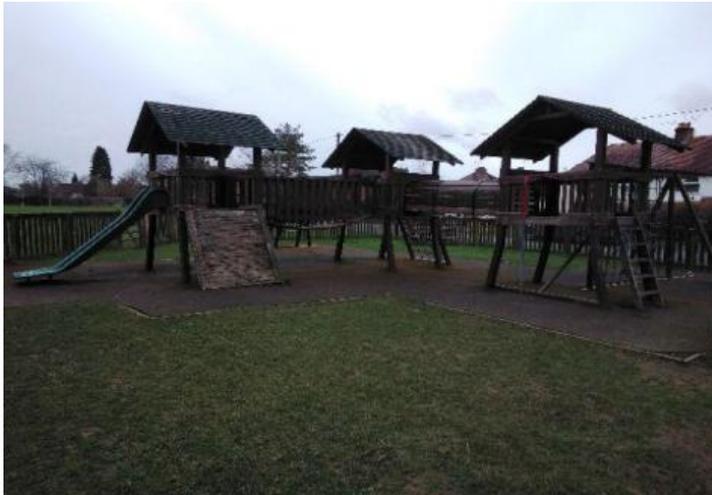
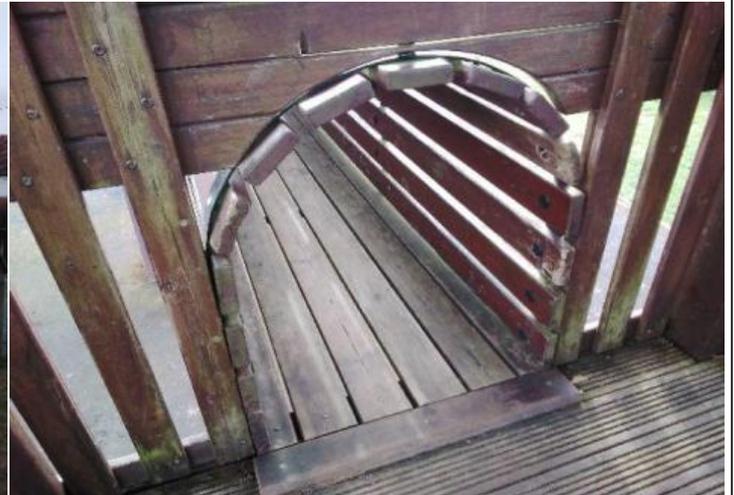
**Finding:** The internal dimensions of the tunnel do not meet the requirements of BS EN 1176 Part 1

**Action:** Monitor - No remedial work recommended

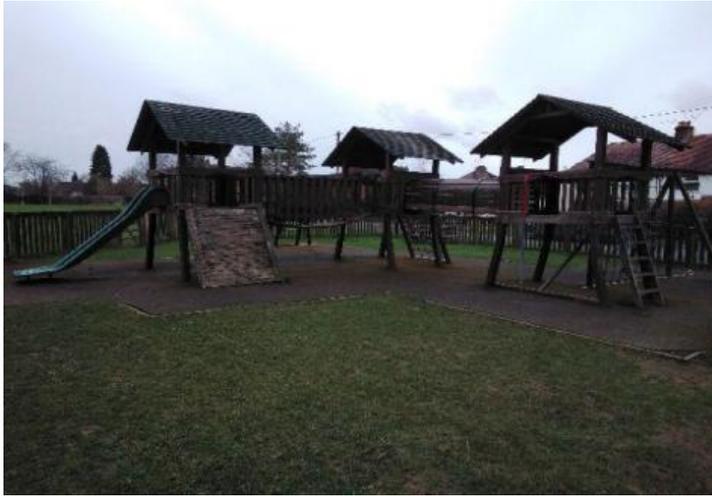
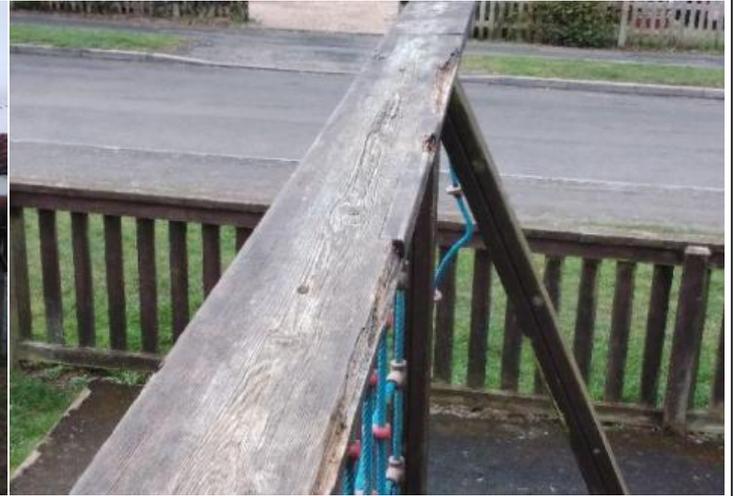
**Finding:** There are areas or parts of the timber crossbeam to the net climber that have rotted

**Action:** Replace all affected timbers

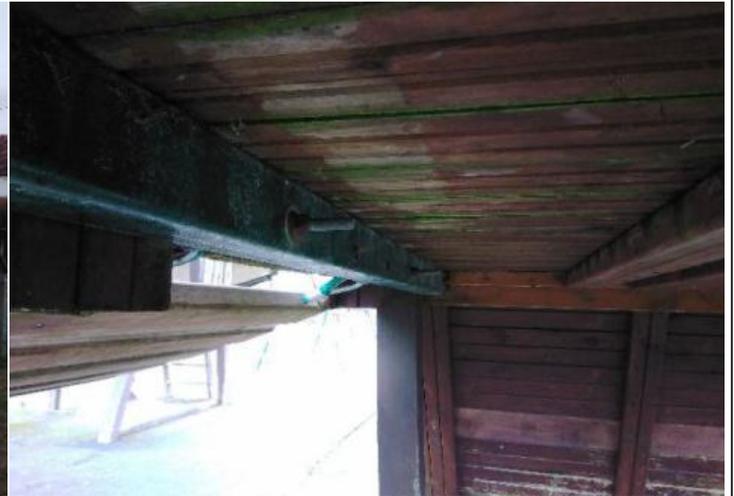
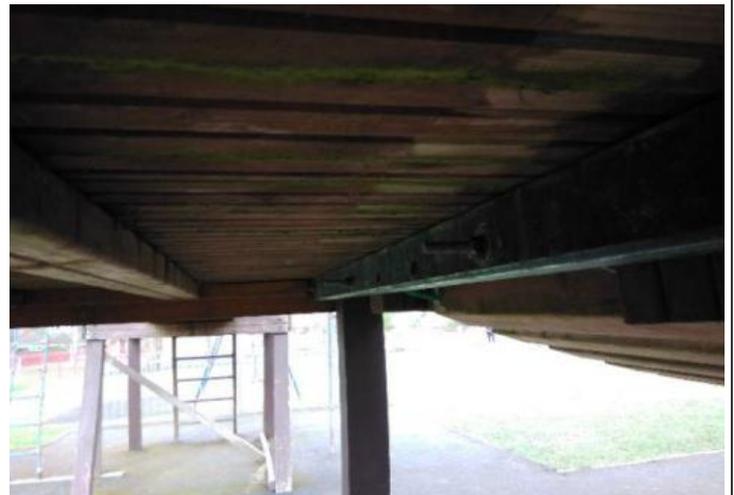
**Finding:** There are projecting bolt thread(s) present under platforms

**Action:** Remove excess thread length and deburr or provide cap
