the **play inspection** company

## Annual Inspection

Winchester City Council

Stratton Bates Recreation Ground (New Alresford)

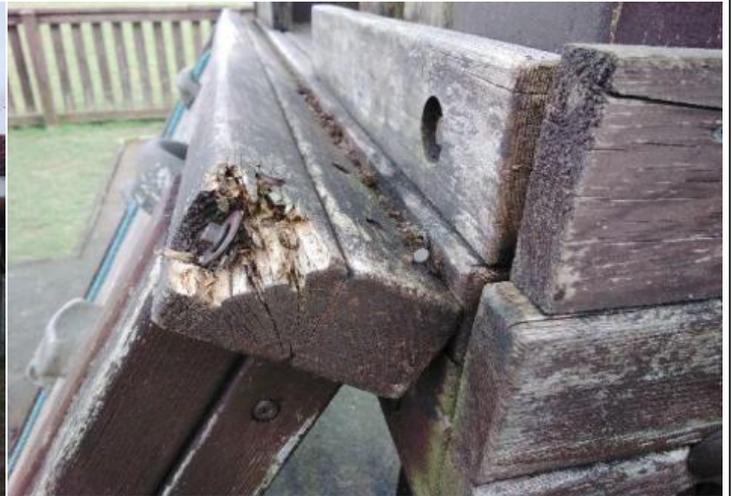
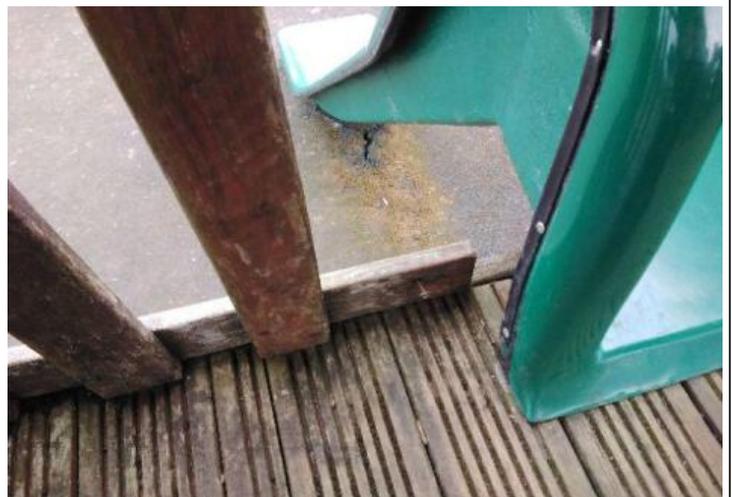
**Finding:** There are projecting nail ends present

**Action:** Remove and provide more appropriate fixings if required

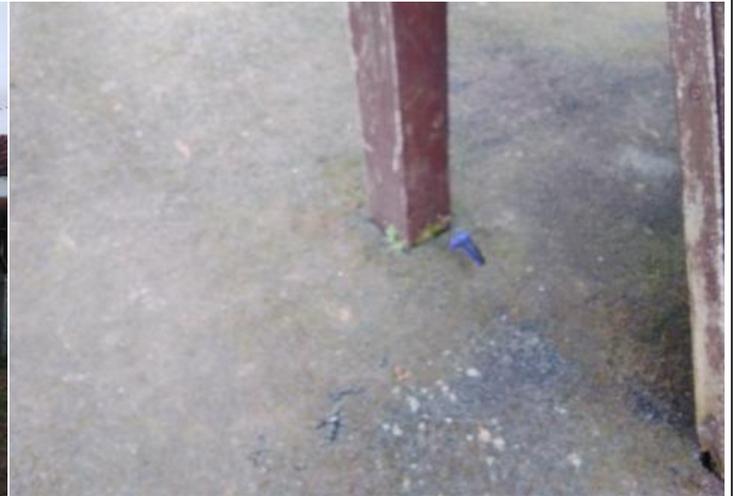
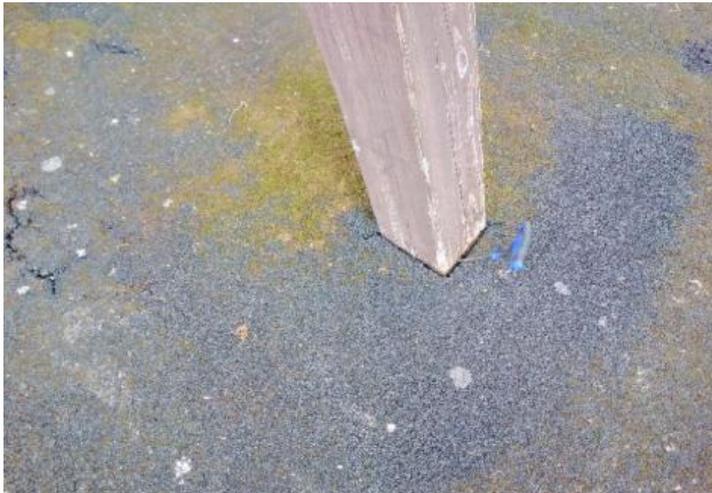
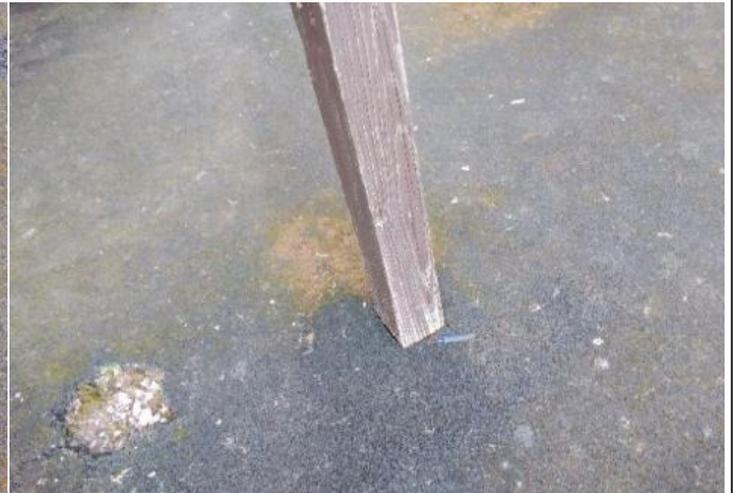
**Finding:** There is some evidence of rot in the timber support posts **Action:** Monitor for any further deterioration and replace as required

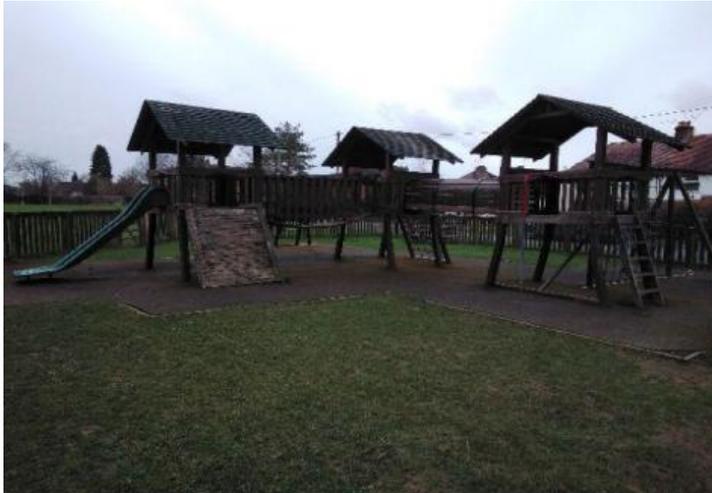
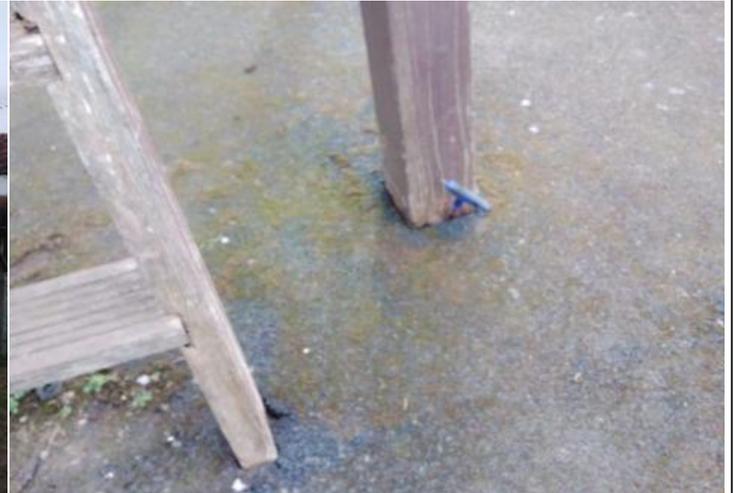
**Finding:** 2 x timber support posts on this item has severe rot

**Action:** Remove and replace all affected timber sections

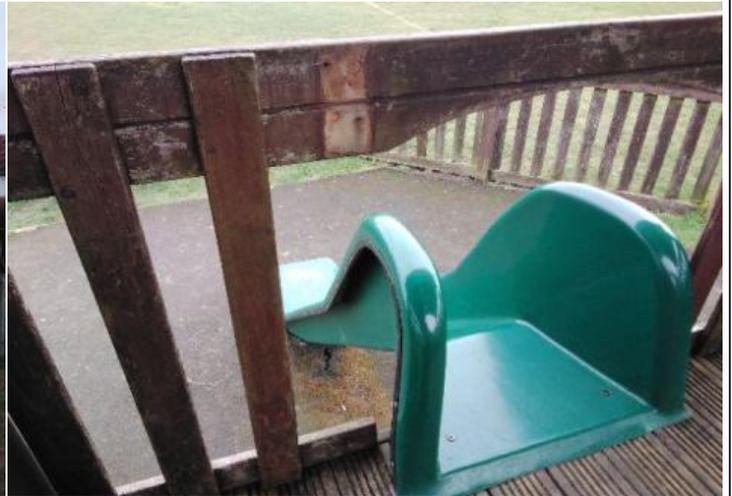
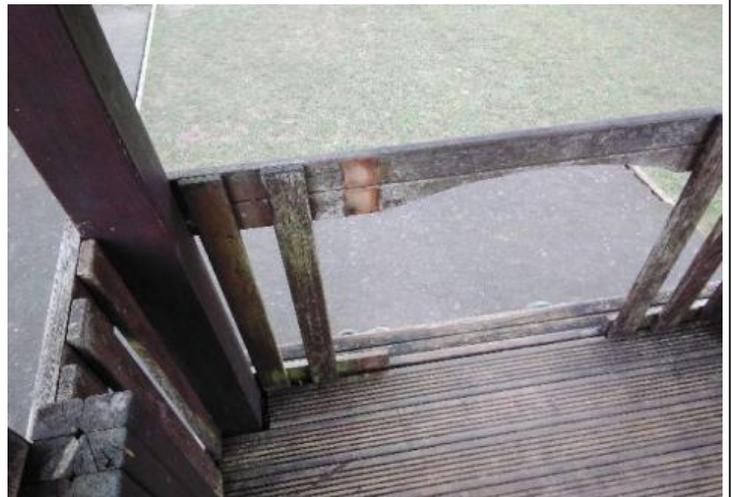
**Finding:** There is/are a number of missing or damaged slats **Action:** Replace to the start of the slide.

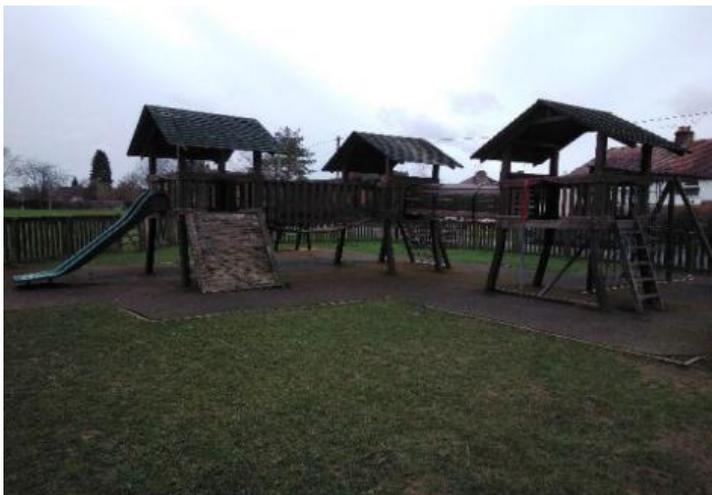
**Finding:** There are areas or parts of the timber on the structure that have rotted

**Action:** Replace all affected timbers

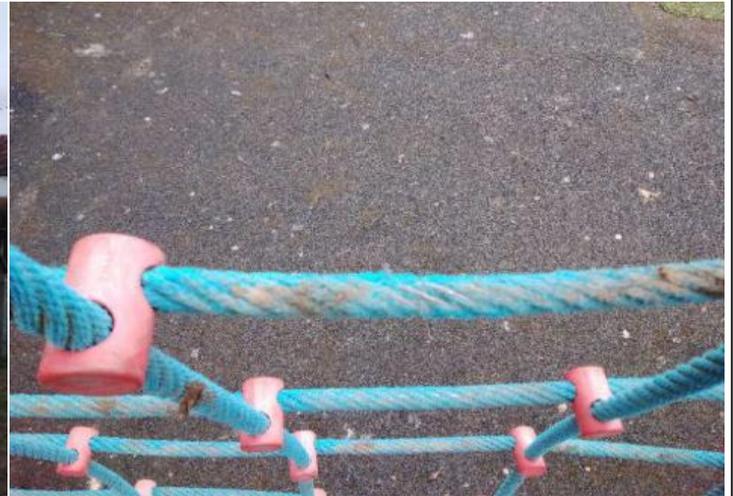
**Finding:** The ropes/nets are worn/damaged in places

**Action:** Monitor for any further deterioration and repair or replace as required
