the **play inspection** company

Annual Inspection

Winchester City Council

Arlebury Park, Skate Park & Tennis(New Alresford)

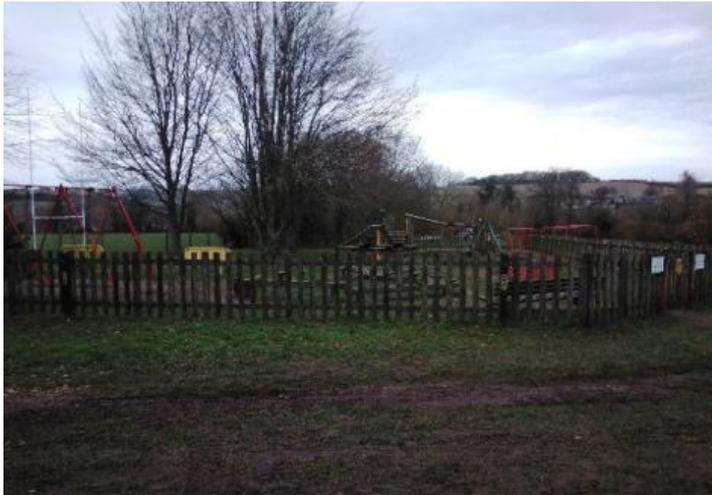
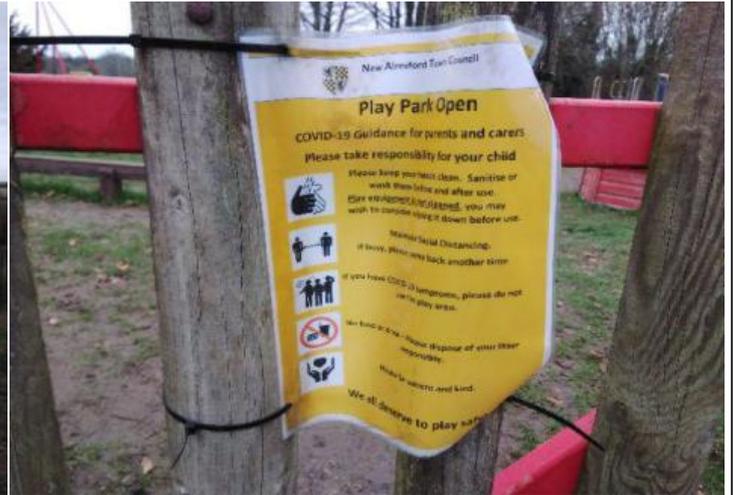
Finding: The site is accessible to the public during the COVID 19 pandemic. The government have released guidelines for safely re-opening these types of facilities which is available on the government website.

Action: Ensure there is an appropriate risk assessment in place and review regularly

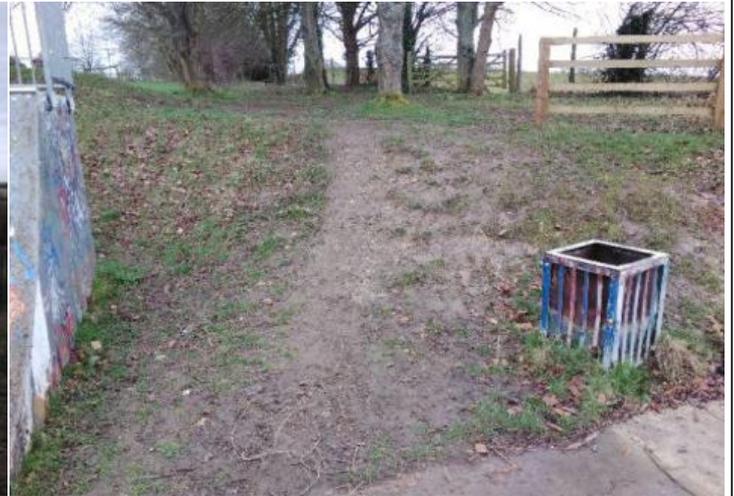
Finding: The bank to the skate area has eroded and may become slippery

Action: Reinststate eroded area

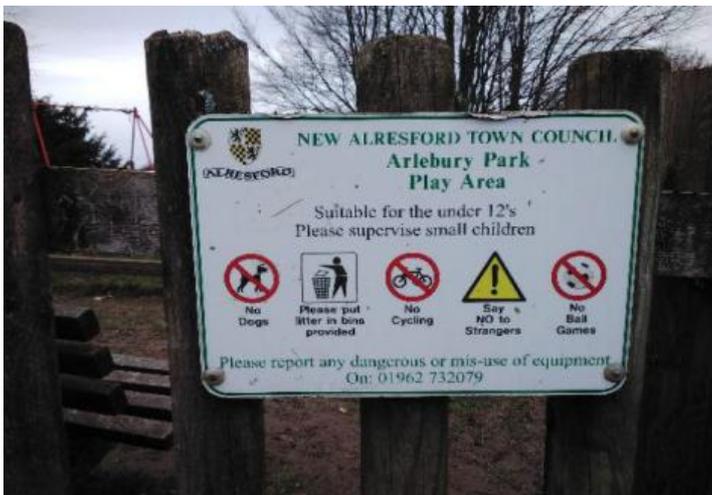
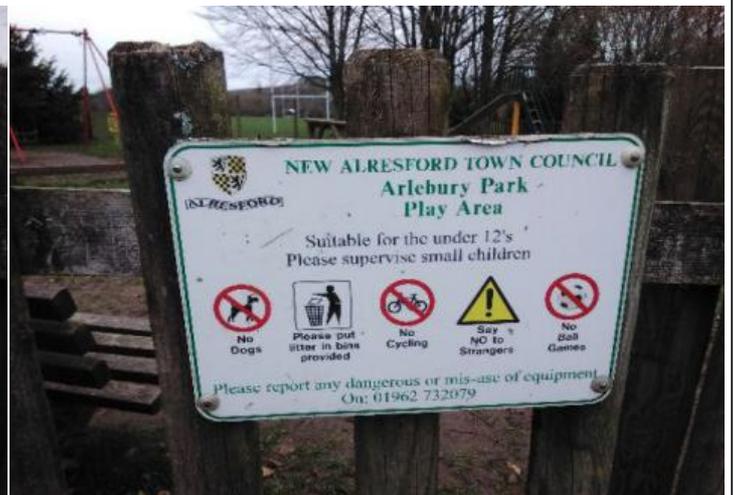
Finding: BS EN 1176 Part 7 recommends that signage shall include the site name / address

Action: Provide additional information

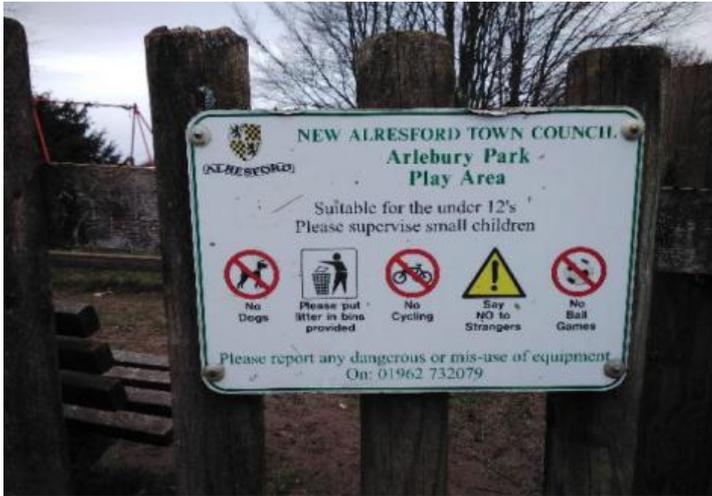
Finding: The item has been damaged

Action: Monitor for any further deterioration and replace as required

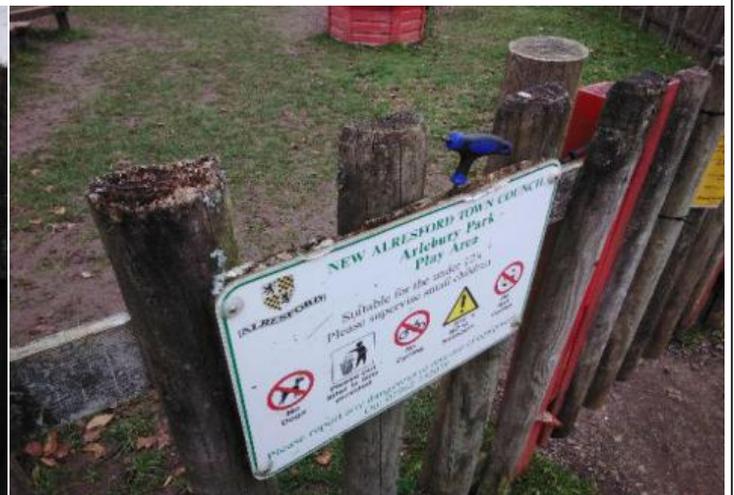
Finding: There is some evidence of rot in the timber backing

Action: Monitor for any further deterioration and replace as required

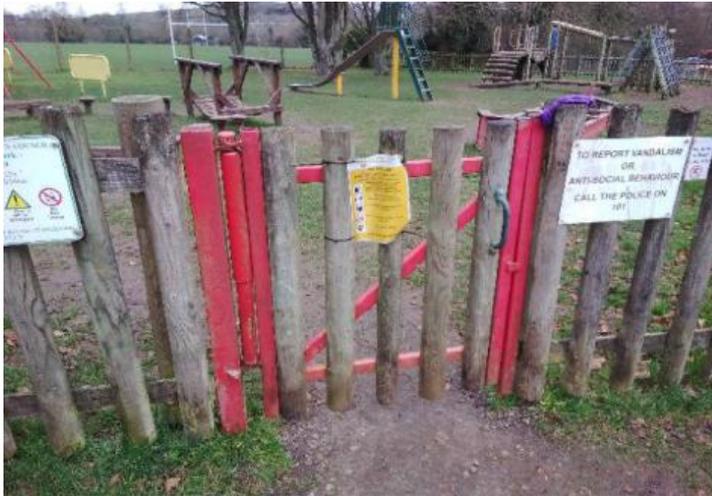
Finding: Post/end caps have been damaged on this item

Action: Replace missing post caps

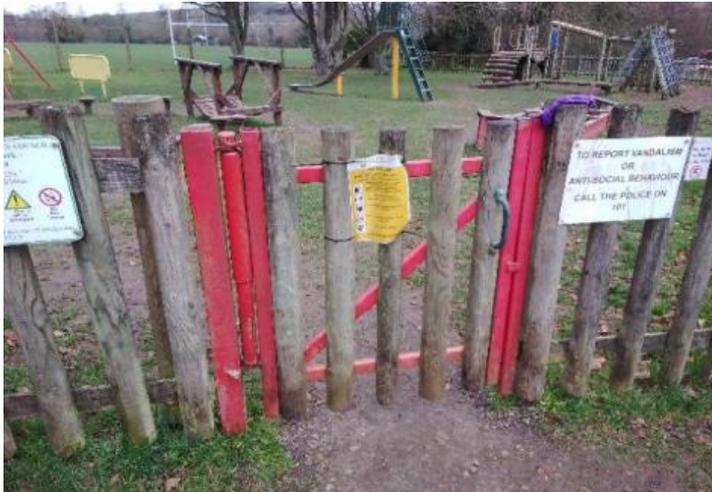
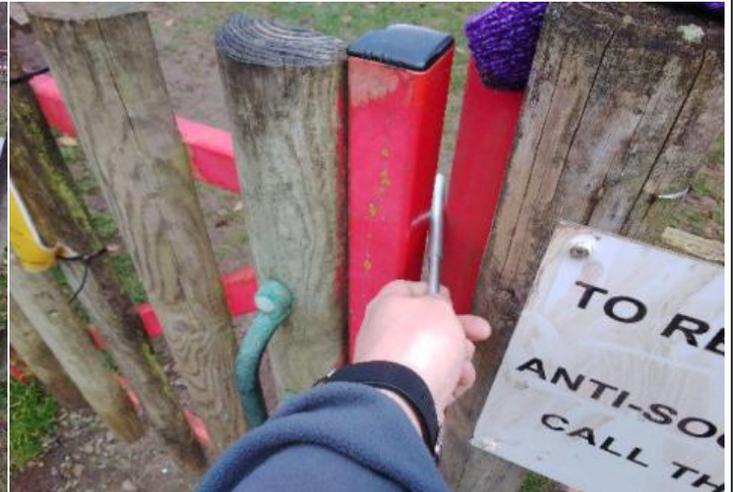
Finding: There are openings that are less than 12mm that could trap or crush fingers

Action: Where possible a 12mm gap should be maintained on both sides or between the gate leaves

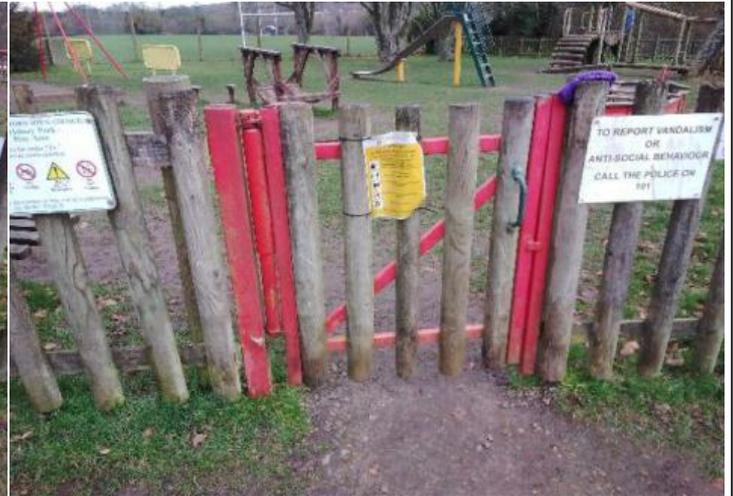
Finding: The gate is closing too quickly (less than 4 seconds)

Action: Take corrective action to ensure that the gate closes in 4-8 seconds

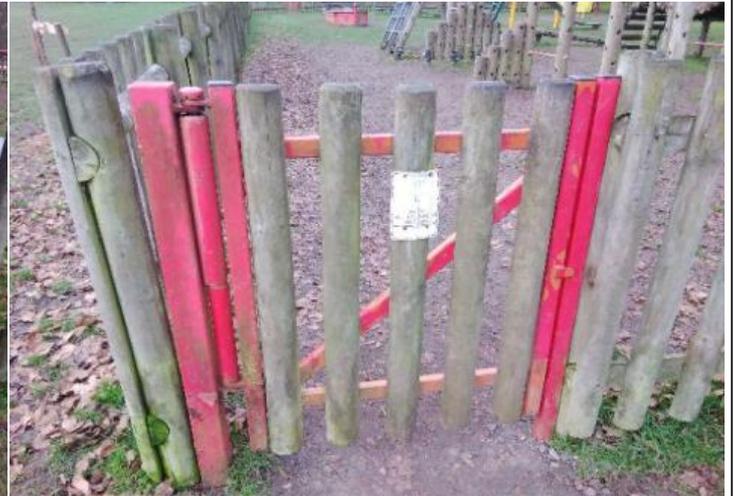
Finding: Both gates are noisy in operation

Action: Grease self closing mechanism

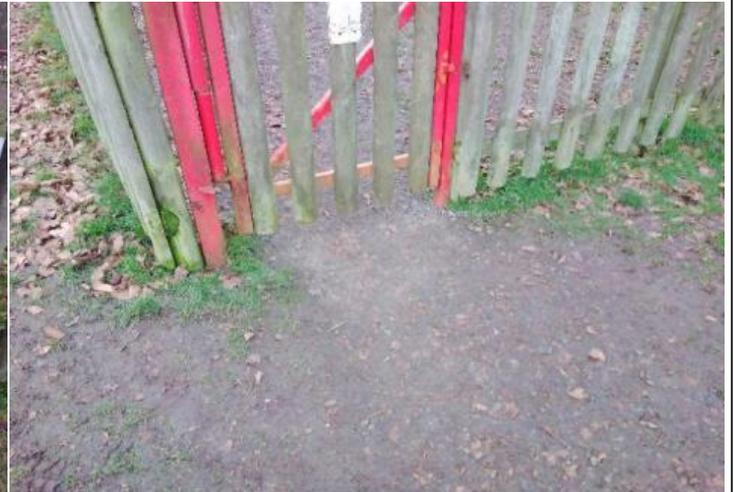
Finding: The area around the item has eroded and may become slippery

Action: Reinstate eroded area

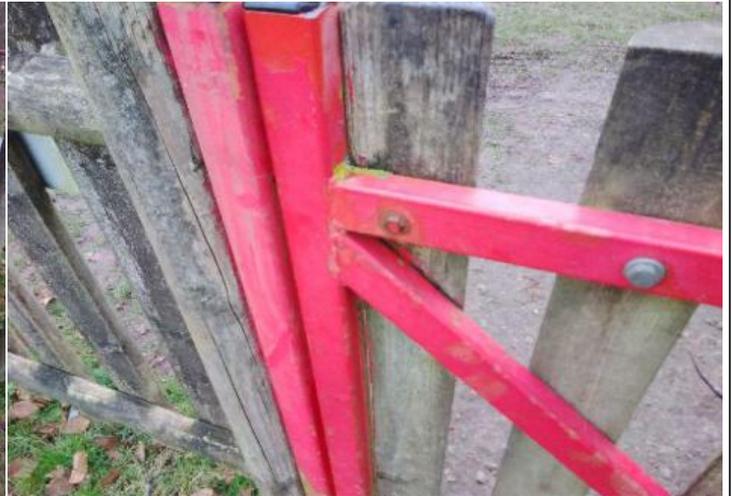
Finding: A number of fixing(s) have worked loose

Action: Secure all loose fixings

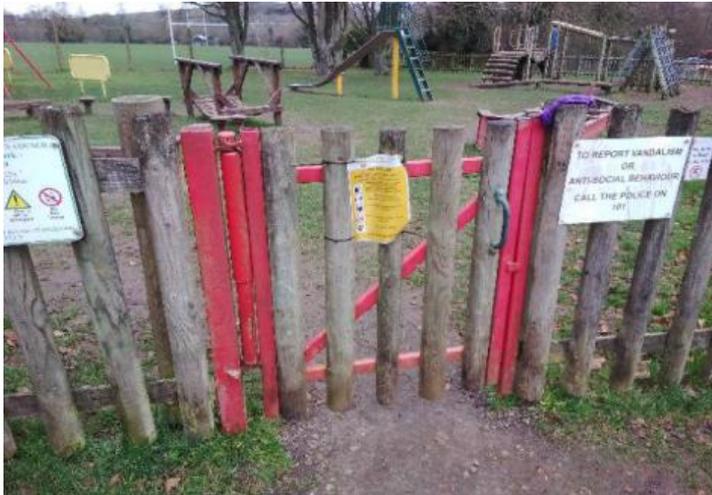
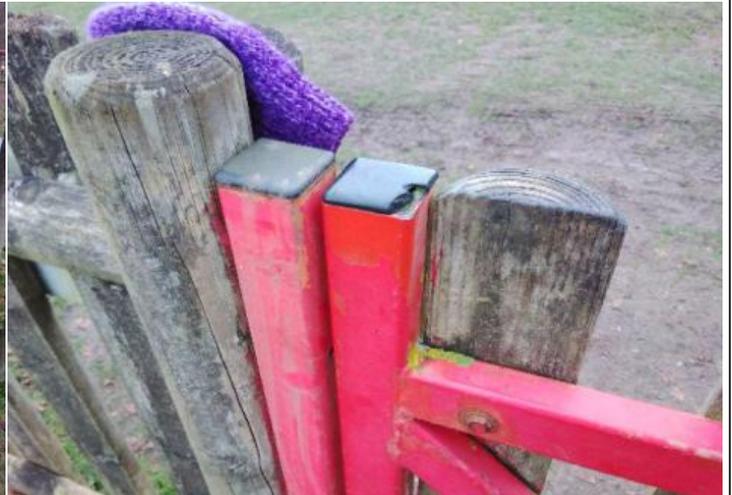
Finding: The item has been damaged

Action: Monitor for any further deterioration and replace as required

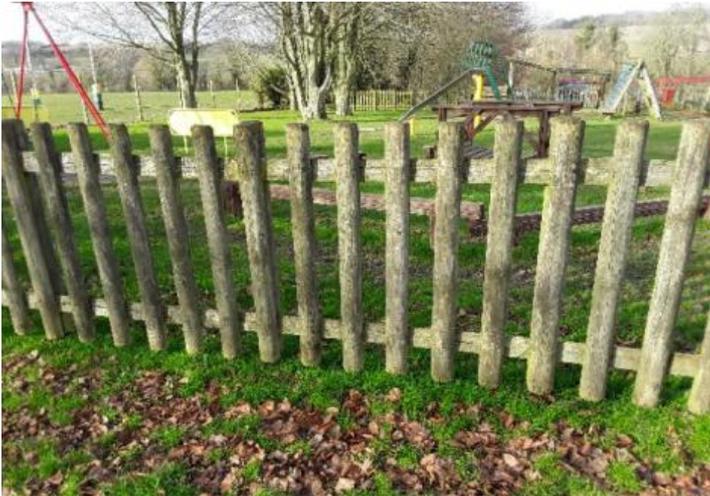
Item: Fences - Fencing - Timber
Manufacturer: Unknown

Finding: There is some strimmer / machinery damage apparent on the posts, this can penetrate the preservative applied to the timber and accelerate the rotting process

Action: Monitor for any deterioration (rot) and replace as required

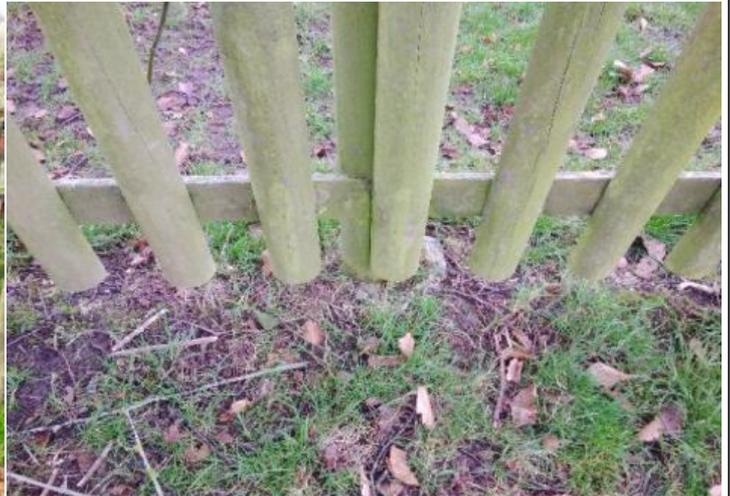
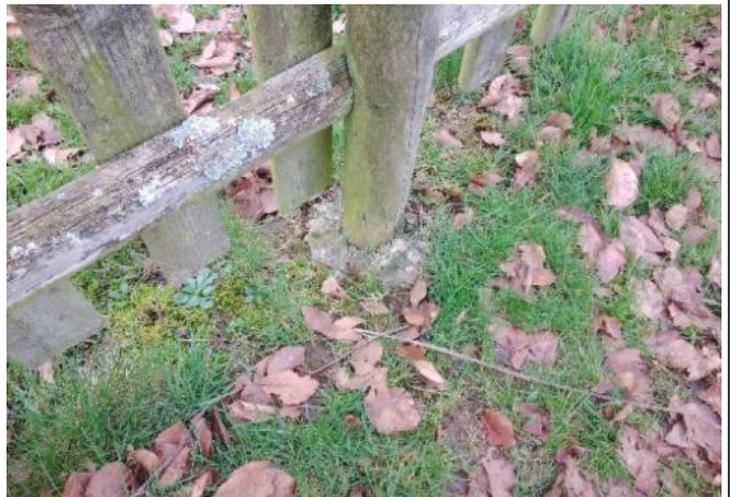
Item: Fences - Fencing - Timber
Manufacturer: Unknown

Finding: The surface has eroded and the foundations are exposed

Action: Reinststate surrounding surfaces to cover the foundations

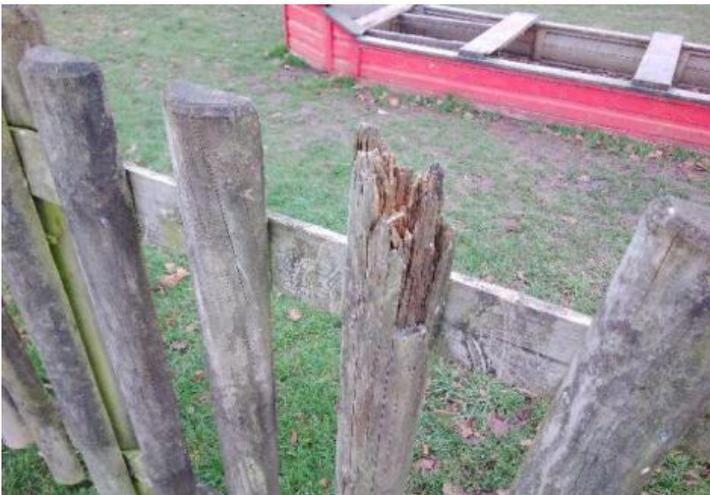
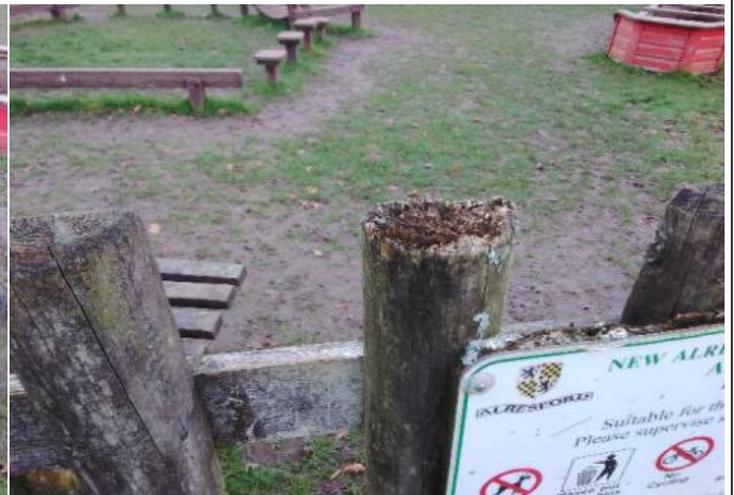
Item: Fences - Fencing - Timber
Manufacturer: Unknown

Finding: There is some evidence of rot in the timber fence spindles

Action: Monitor for any further deterioration and replace as required

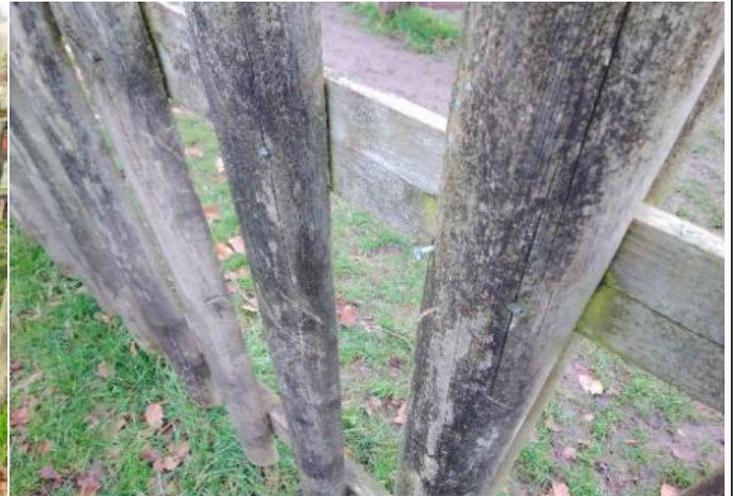
Item: Fences - Fencing - Timber
Manufacturer: Unknown

Finding: There are projecting nail ends present

Action: Remove and provide more appropriate fixings if required

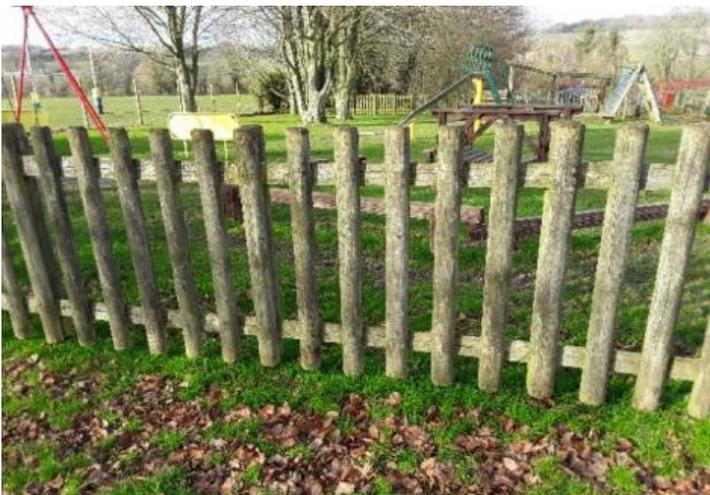
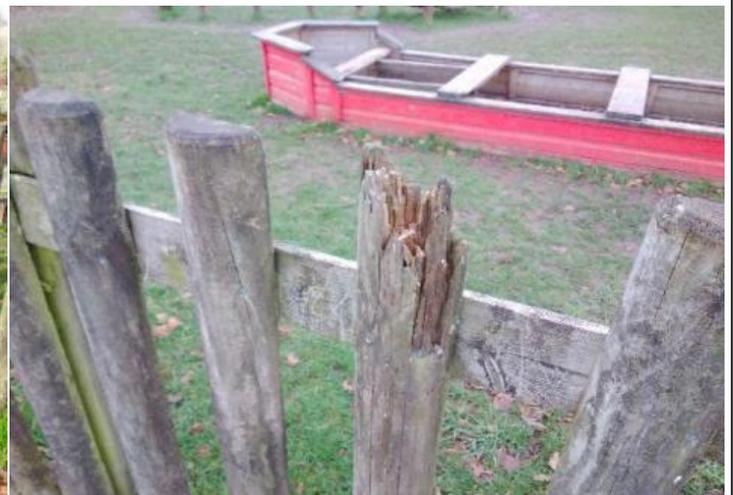
Item: Fences - Fencing - Timber
Manufacturer: Unknown

Finding: Parts of the timber are rough or splintered

Action: Remove all rough or sharp edges

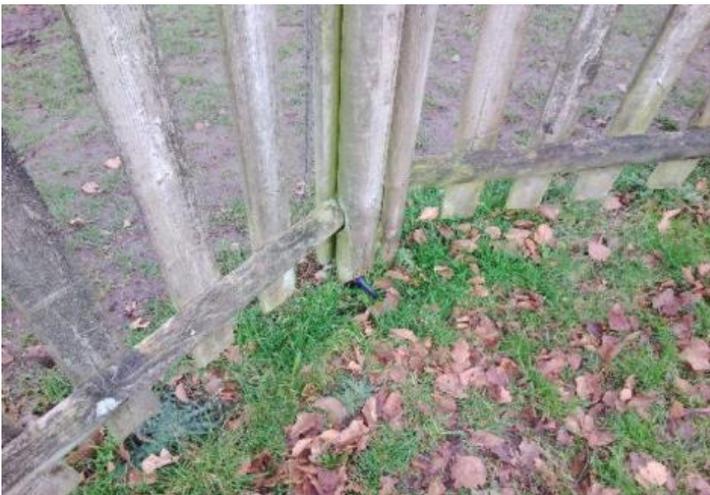
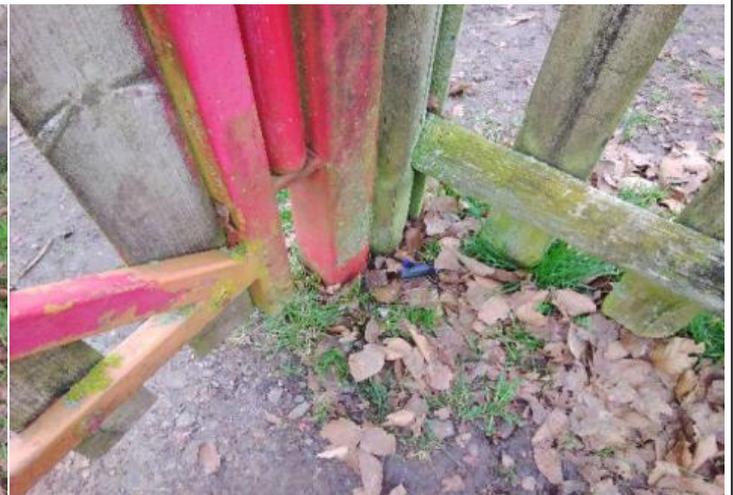
Item: Fences - Fencing - Timber
Manufacturer: Unknown

Finding: There are areas or parts of the timber posts that have rotted

Action: Replace all affected timbers

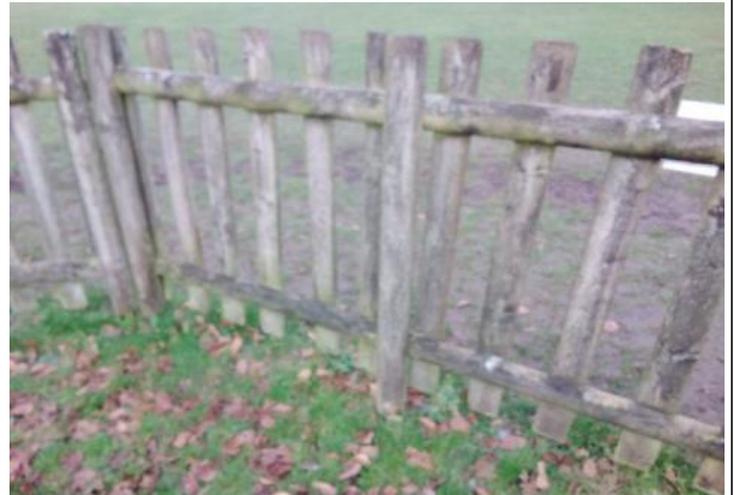
Item: Fences - Fencing - Timber
Manufacturer: Unknown

Finding: There are a number of loose posts around the fence

Action: Monitor for any further deterioration and reset as required

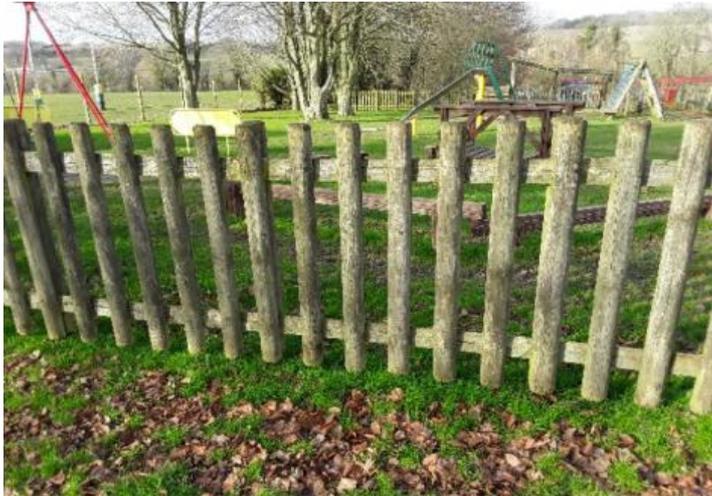
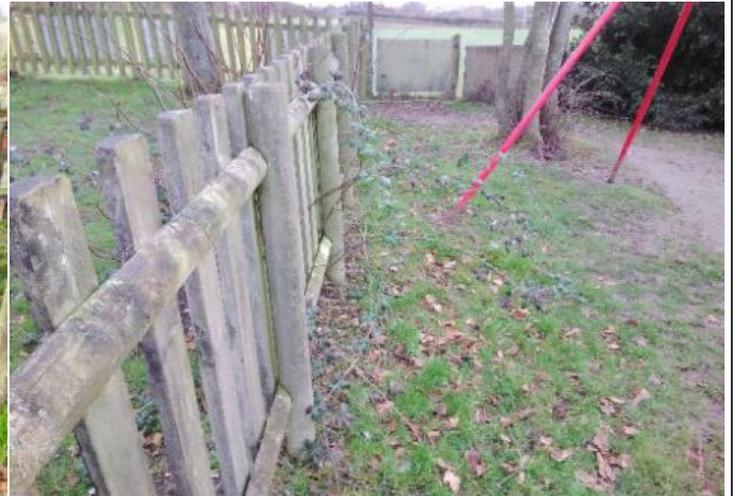
Item: Fences - Fencing - Timber
Manufacturer: Unknown

Finding: The adjacent foliage is overhanging

Action: Cut back and maintain

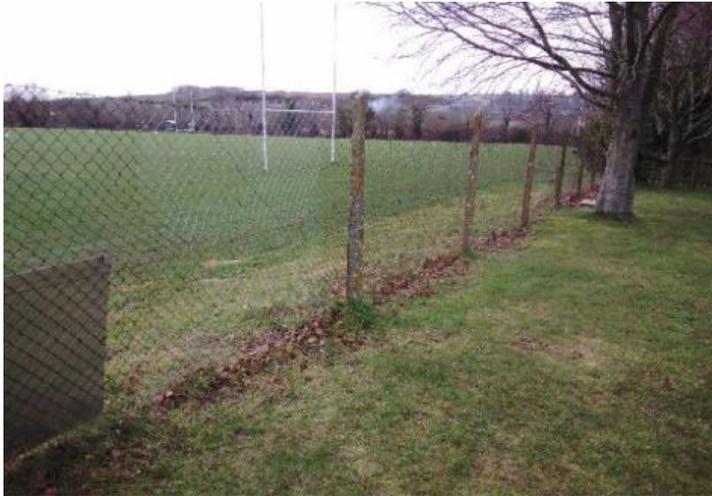
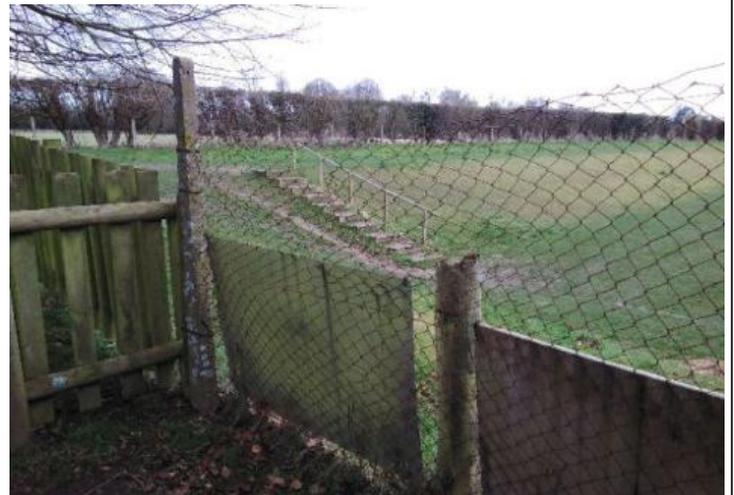
Item: Fences - Fence - Chainlink
Manufacturer: Unknown

Finding: There is some damage to the fence sections

Action: Monitor for any further deterioration and repair as required

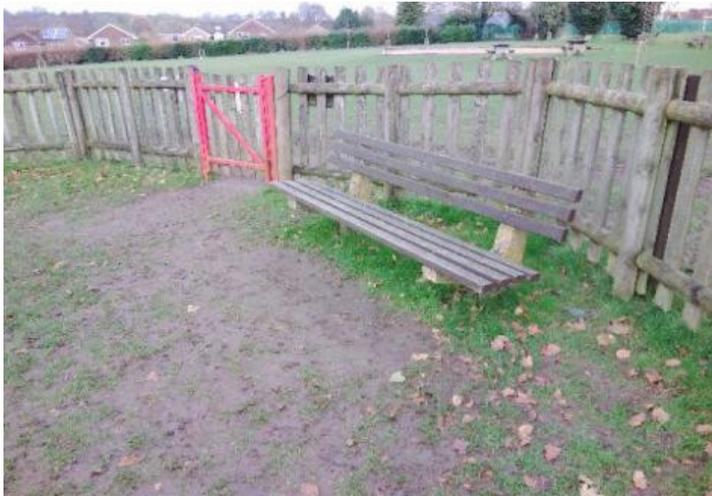
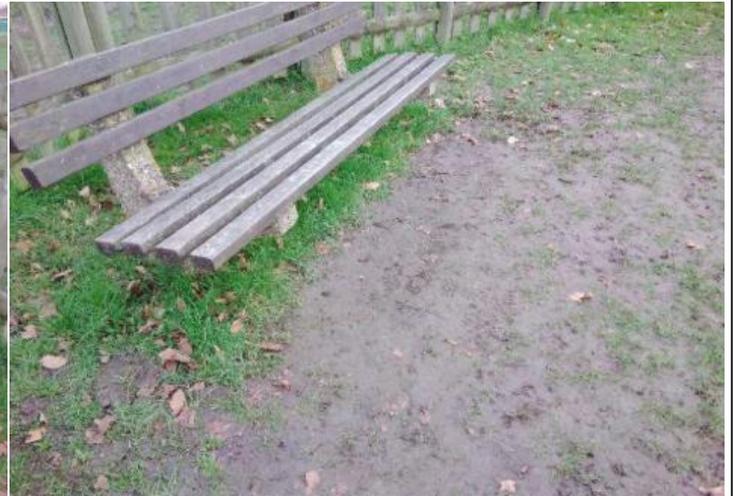
Item: Ancillary Items - Bench
Manufacturer: Unknown

Finding: The area around the item has eroded and may become slippery

Action: Reinststate eroded area

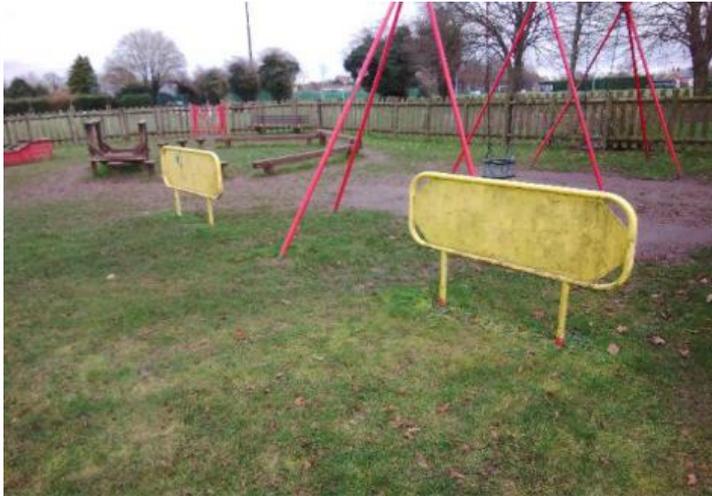
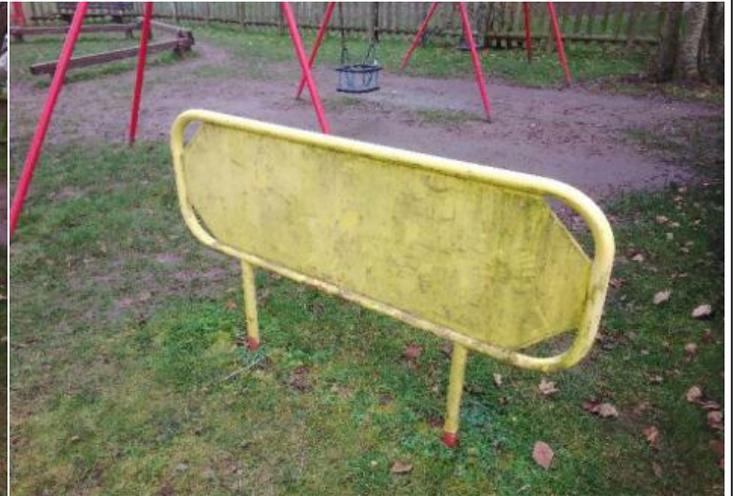
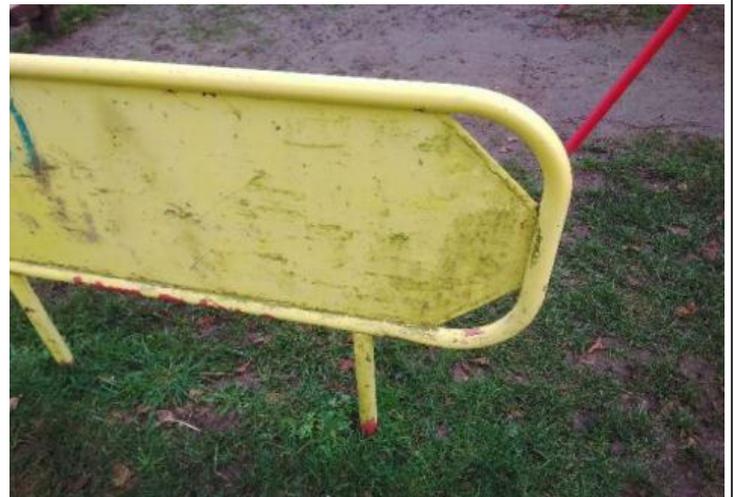
Item: Swings - Swing Barrier
Manufacturer: Wicksteed Playgrounds

Finding: There is algae or moss on the surface of the equipment

Action: Clean and treat appropriately

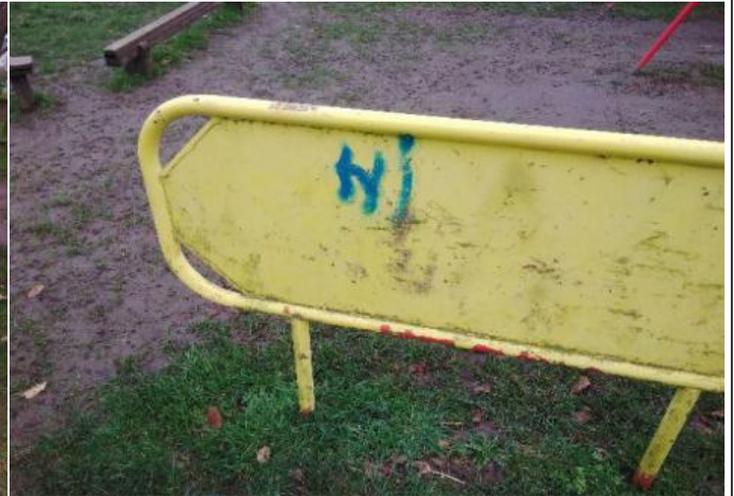
Item: Swings - Swing Barrier
Manufacturer: Wicksteed Playgrounds

Finding: There is some graffiti present

Action: Remove the graffiti

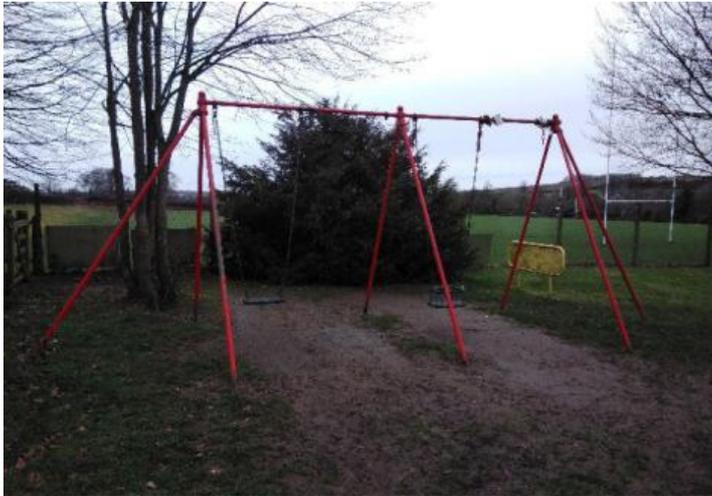
Item: Swings - 2 Bay (2 Flat, 2 Cradle)
Manufacturer: Wicksteed Playgrounds

Finding: The seat(s) and suspension were missing at the time of inspection and the inspector was unable to make a full compliance assessment

Action: Replace missing seat(s) and suspension

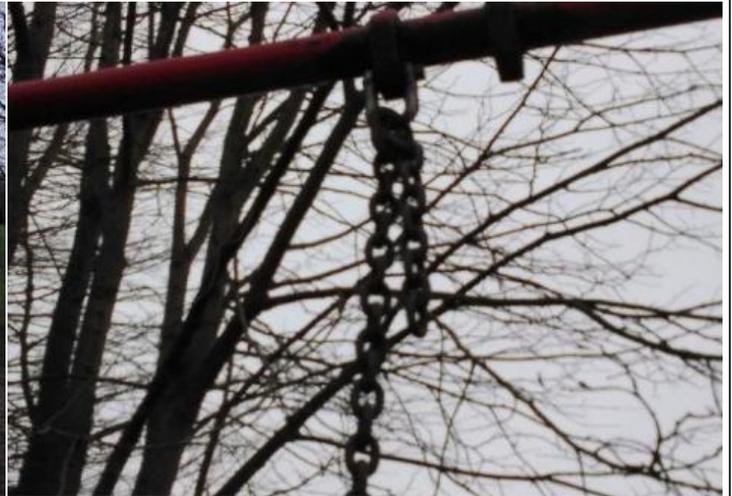
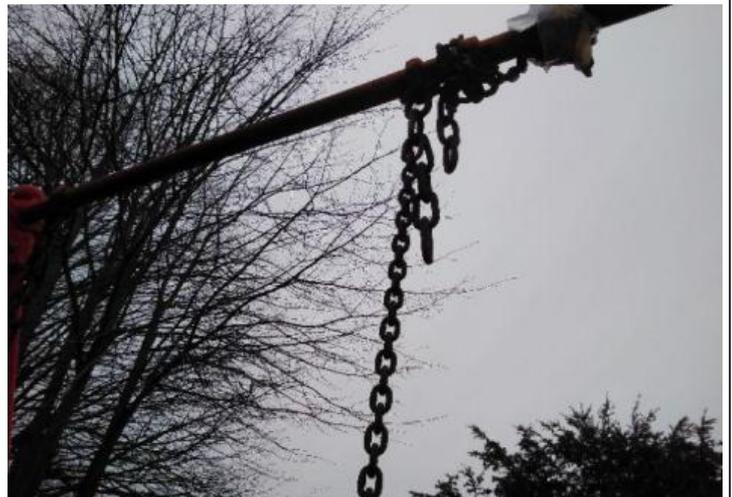
Item: Swings - 2 Bay (2 Flat, 2 Cradle)
Manufacturer: Wicksteed Playgrounds

Finding: There are excessive chain tails

Action: Cut back excessive chain links

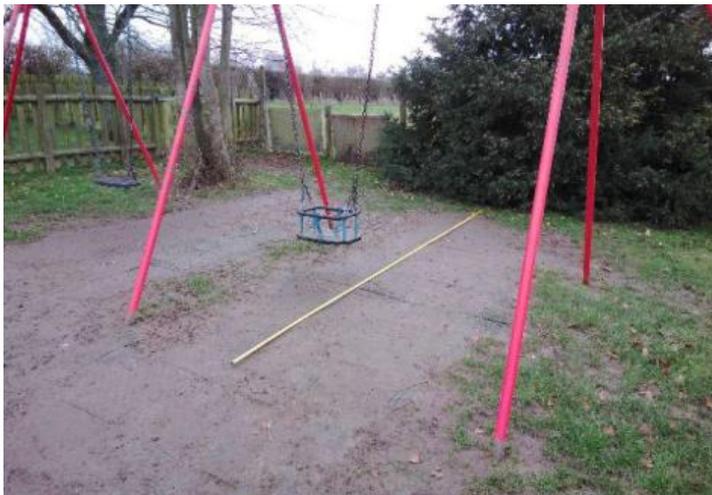
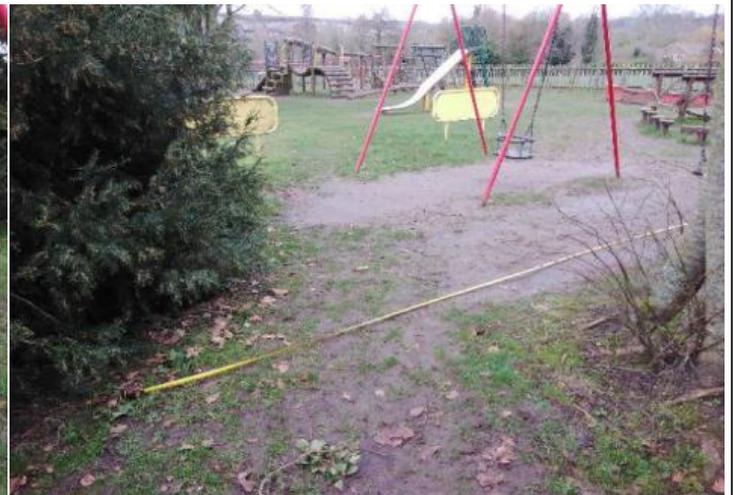
Item: Swings - 2 Bay (2 Flat, 2 Cradle)
Manufacturer: Wicksteed Playgrounds

Finding: BS EN 1176 Part 2: Annex A makes a recommendation that fences or enclosures should be upto 1.50m from the edges of the swing seat to the sides, and subject to risk assessment, from the edge of the impact area. This is however, a low risk finding and no remedial action is recommended.

Action: Monitor - No remedial work recommended

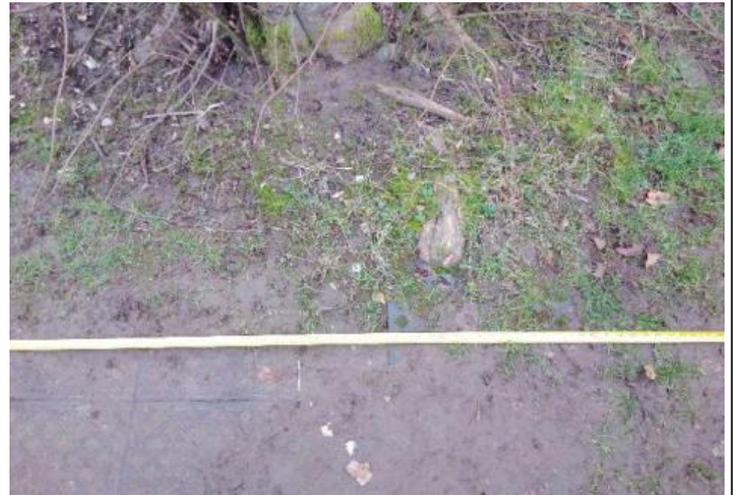
Item: Swings - 2 Bay (2 Flat, 2 Cradle)
Manufacturer: Wicksteed Playgrounds

Finding: The tree root forms a hard object within the impact area of the equipment in contravention of the requirements of BS EN 1176 Part 1

Action: Monitor - No remedial work recommended

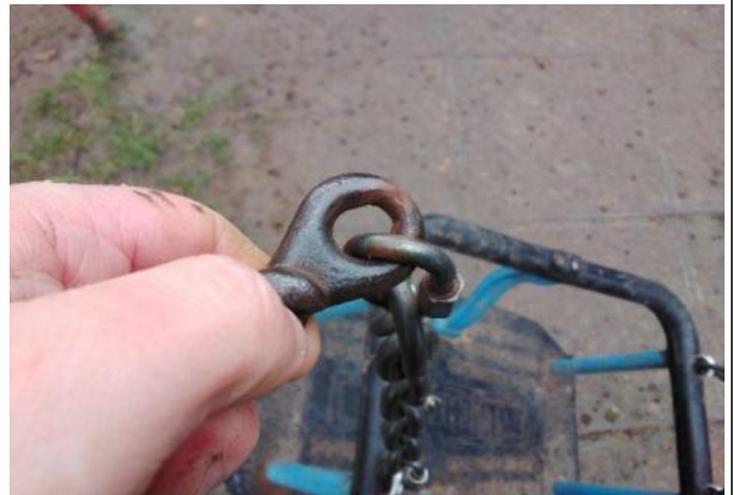
Item: Swings - 2 Bay (2 Flat, 2 Cradle)
Manufacturer: Wicksteed Playgrounds

Finding: There is some notable evidence of chain wear

Action: Monitor for any further deterioration and replace when 40% worn

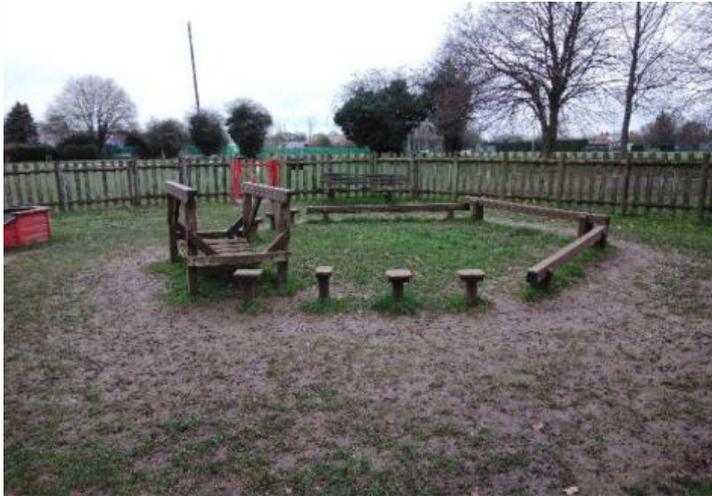
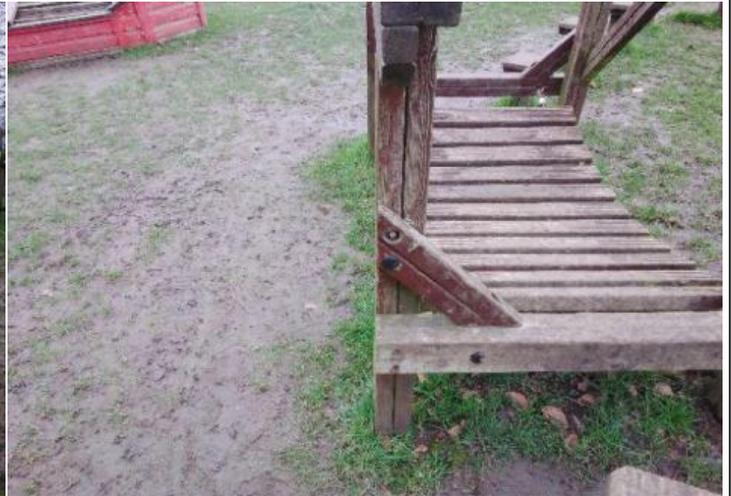
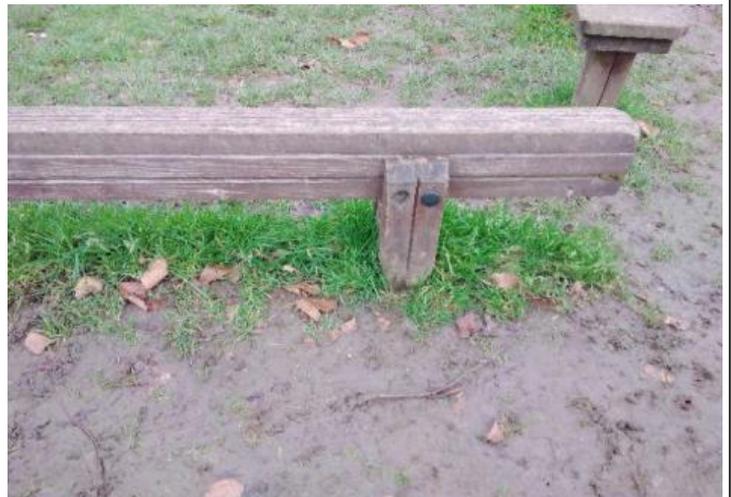
Item: Activity Equipment - Activity Trail
Manufacturer: Lappset UK Ltd

Finding: There is/are bolt cap covers missing or damaged on the item

Action: Replace missing or damaged bolt cap covers

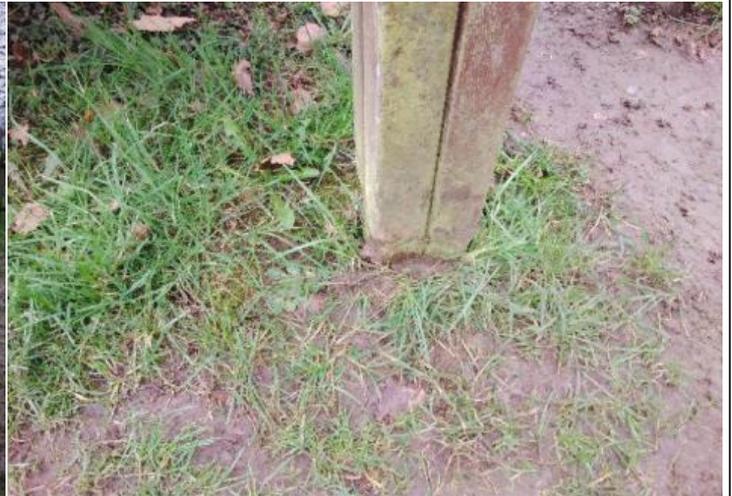
Item: Activity Equipment - Activity Trail
Manufacturer: Lappset UK Ltd

Finding: There is some strimmer / machinery damage apparent on the posts, this can penetrate the preservative applied to the timber and accelerate the rotting process

Action: Monitor for any deterioration (rot) and replace as required

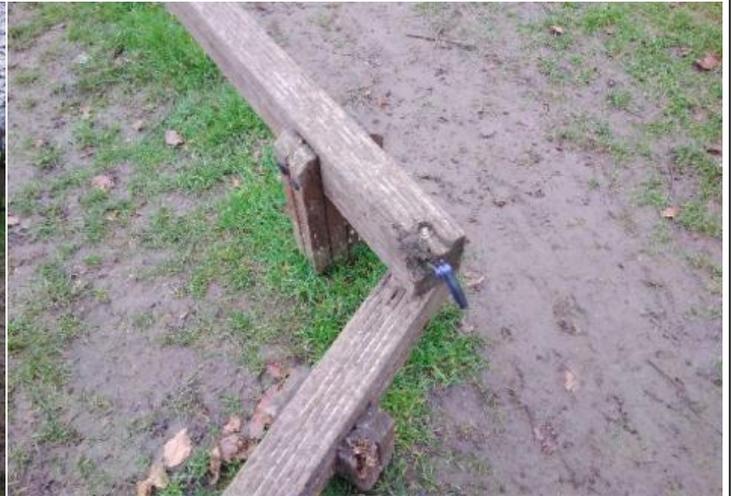
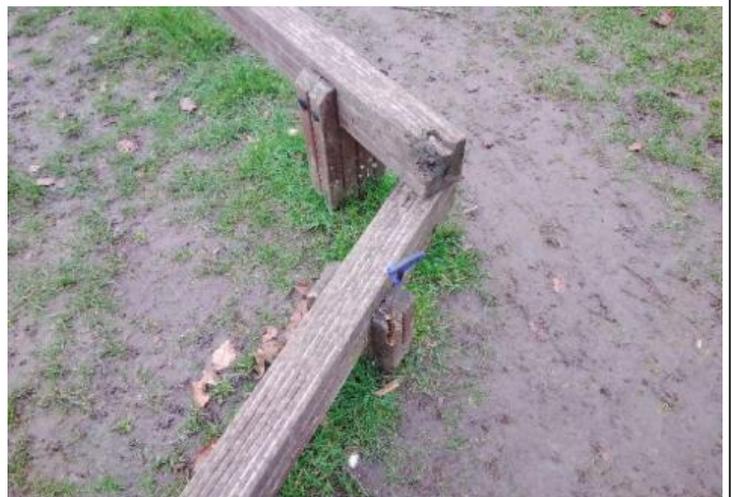
Item: Activity Equipment - Activity Trail
Manufacturer: Lappset UK Ltd

Finding: There is some evidence of rot in the timber

Action: Monitor for any further deterioration and replace as required

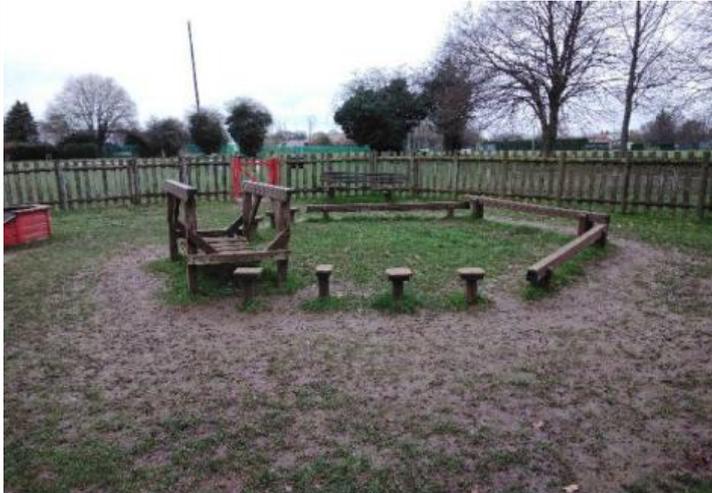
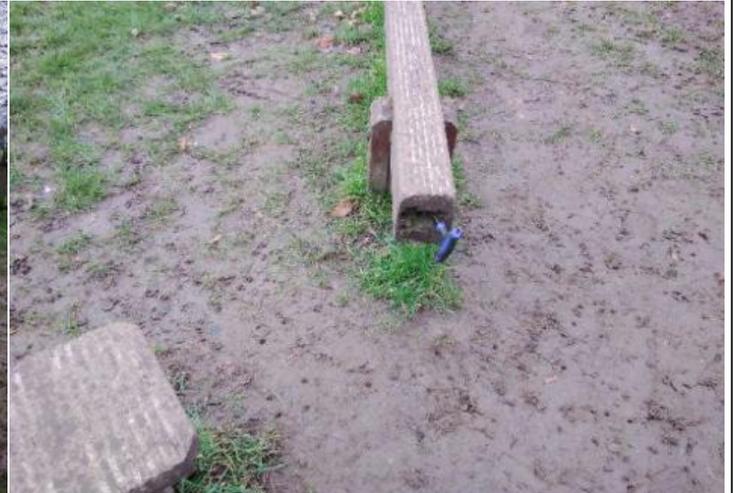
Item: Activity Equipment - Activity Trail
Manufacturer: Lappset UK Ltd

Finding: There are areas or parts of the timber on the structure that have rotted

Action: Replace all affected timbers

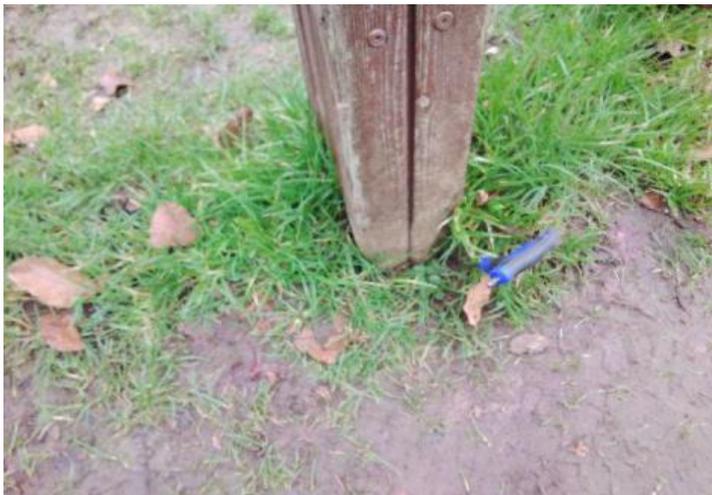
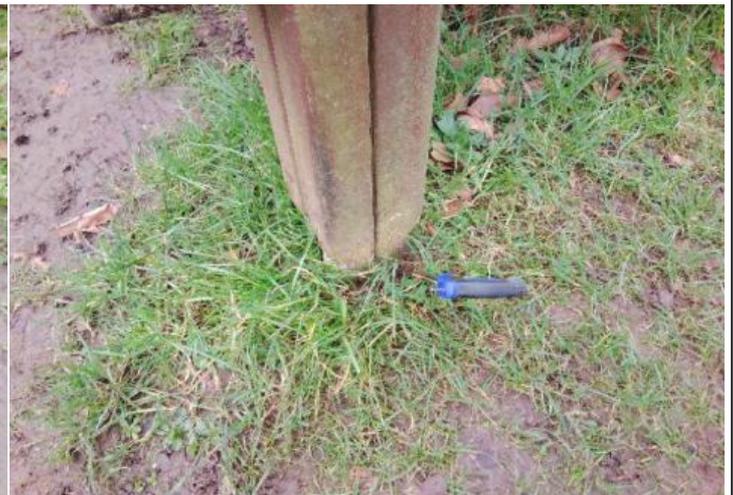
Item: Activity Equipment - Activity Trail
Manufacturer: Lappset UK Ltd

Finding: There is some evidence of rot in the timber

Action: Monitor for any further deterioration and replace as required

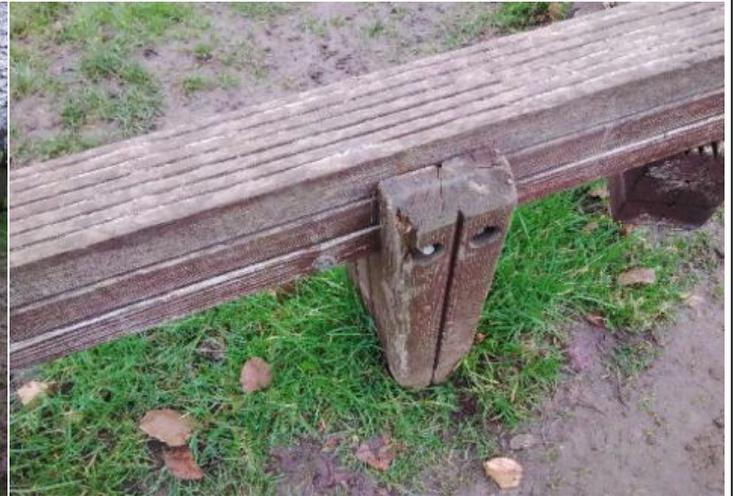
Item: Activity Equipment - Activity Trail
Manufacturer: Lappset UK Ltd

Finding: Parts of the timber are rough or splintered

Action: Remove all rough or sharp edges

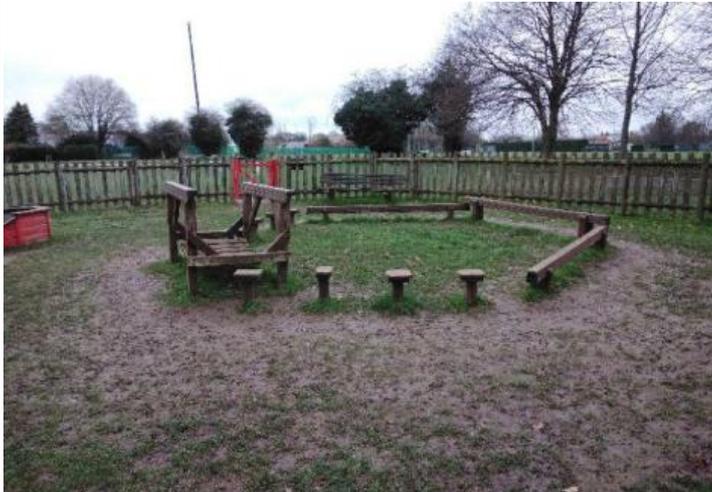
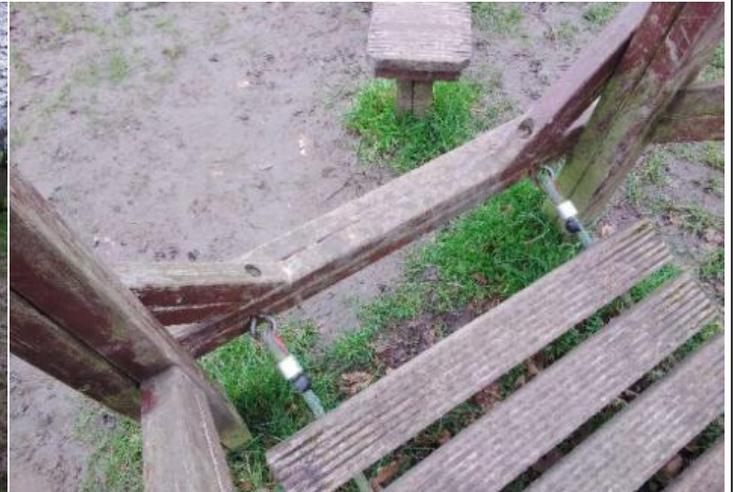
Item: Activity Equipment - Activity Trail
Manufacturer: Lappset UK Ltd

Finding: The rope eyelet's have worked loose

Action: Secure all loose fixings

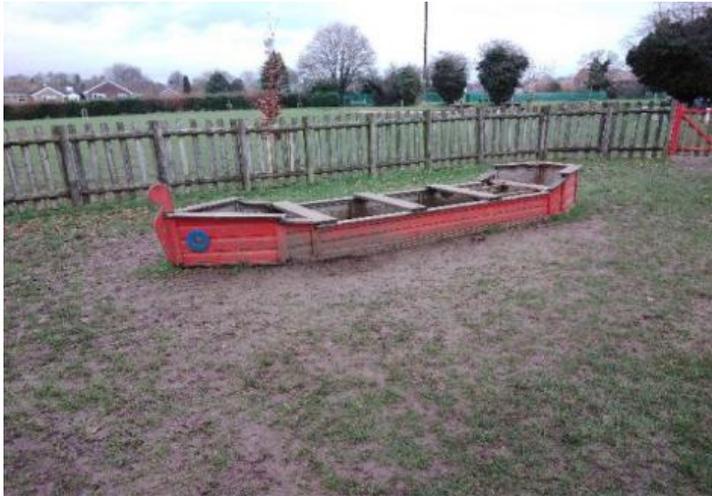
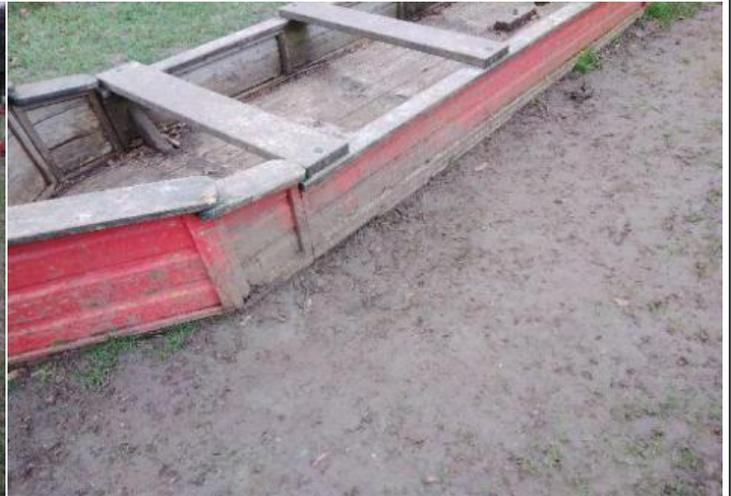
Item: Activity Equipment - Boat
Manufacturer: Lappset UK Ltd

Finding: The area around the item has eroded and may become slippery

Action: Reinststate eroded area
