the **play inspection** company

Annual Inspection

Winchester City Council

Arlebury Park, Skate Park & Tennis(New Alresford)

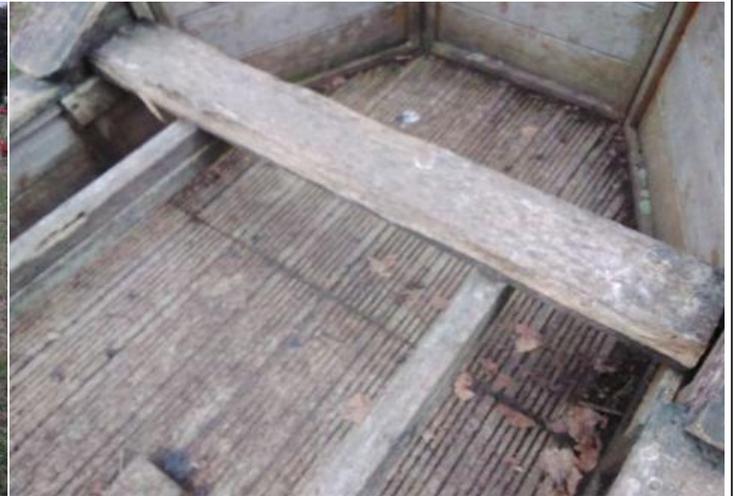
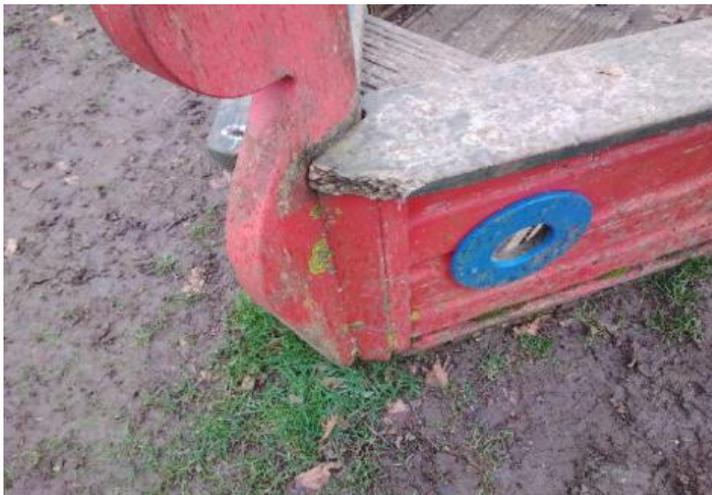
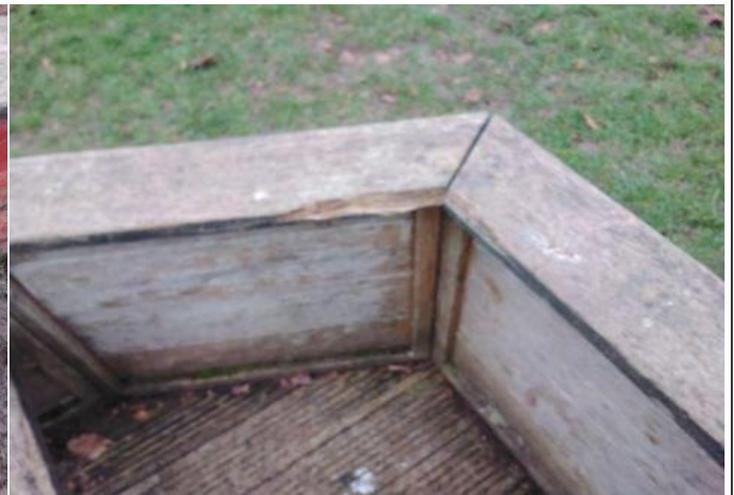
Item: Activity Equipment - Boat
Manufacturer: Lappset UK Ltd

Finding: Parts of the timber are rough or splintered

Action: Remove all rough or sharp edges

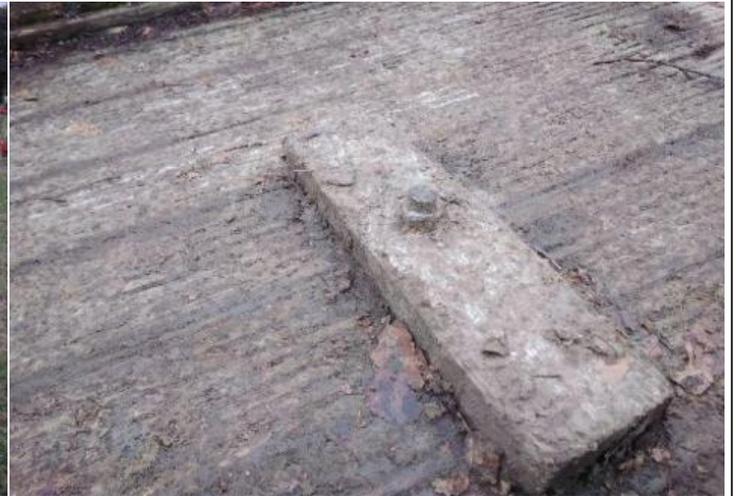
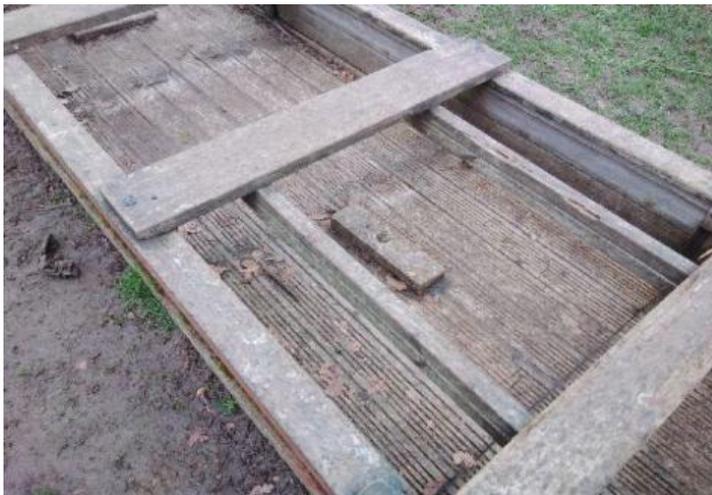
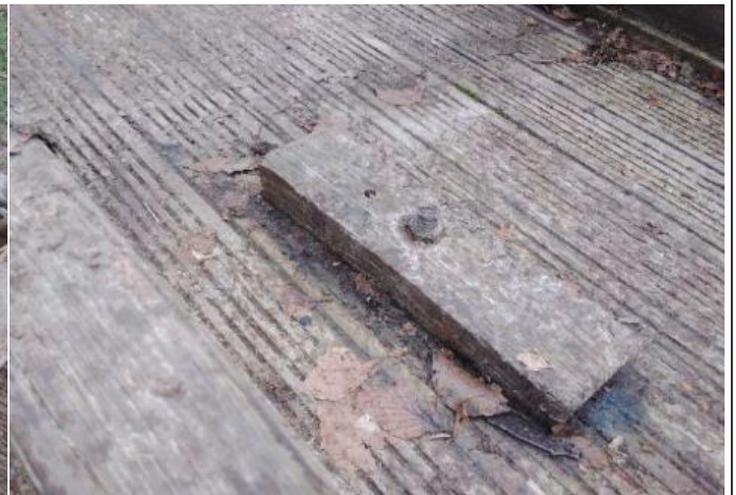
Item: Activity Equipment - Boat
Manufacturer: Lappset UK Ltd

Finding: There are projecting bolt thread(s) present

Action: Remove excess thread length and deburr or provide cap

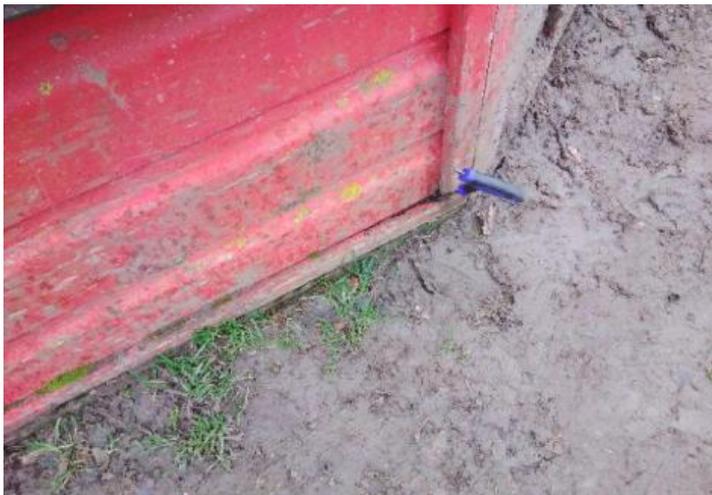
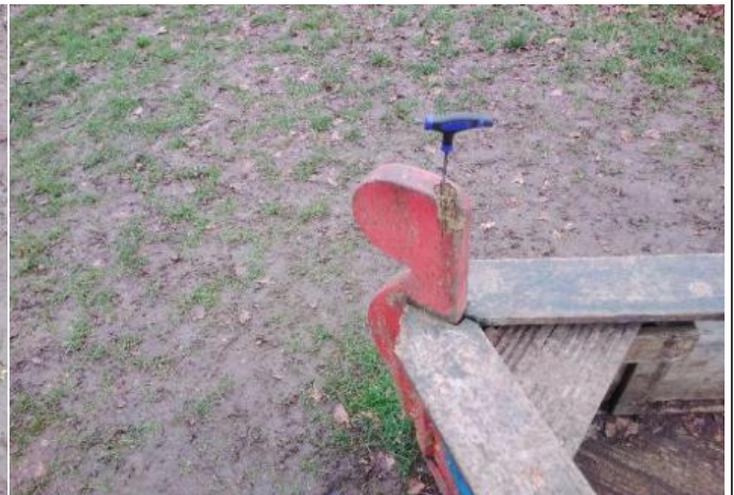
Item: Activity Equipment - Boat
Manufacturer: Lappset UK Ltd

Finding: There is some evidence of rot in the timber

Action: Monitor for any further deterioration and replace as required

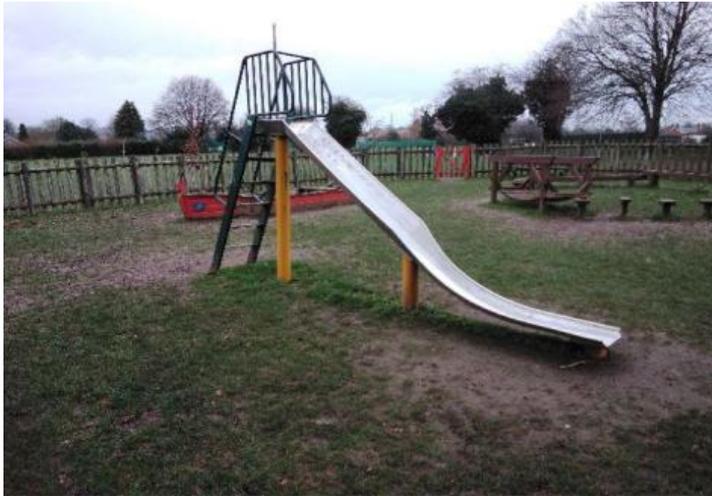
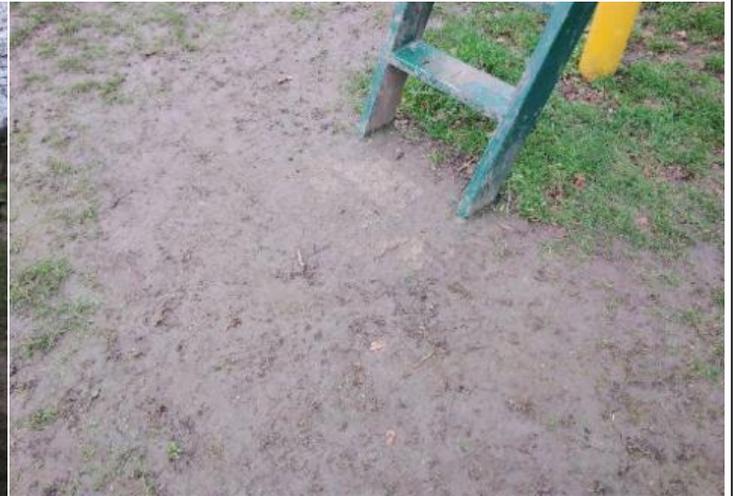
Item: Other - Free Standing Slide
Manufacturer: Wicksteed Playgrounds

Finding: The grass mats are silted up, the soil is compacted and the area will become very slippery when the soil is wet. **Action:** Reinststate as required

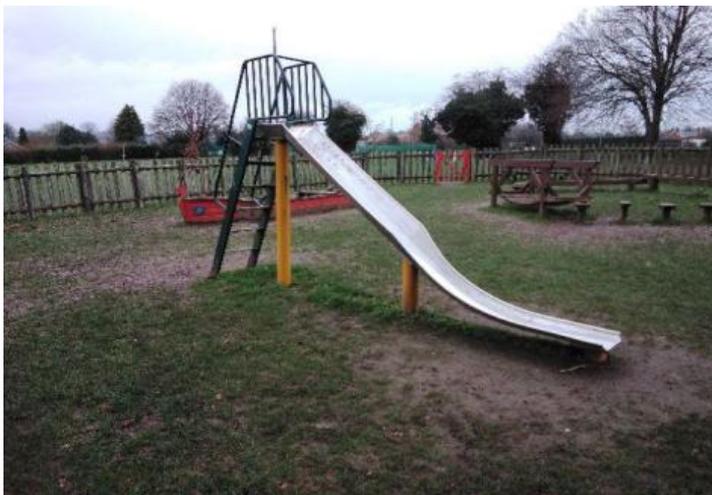
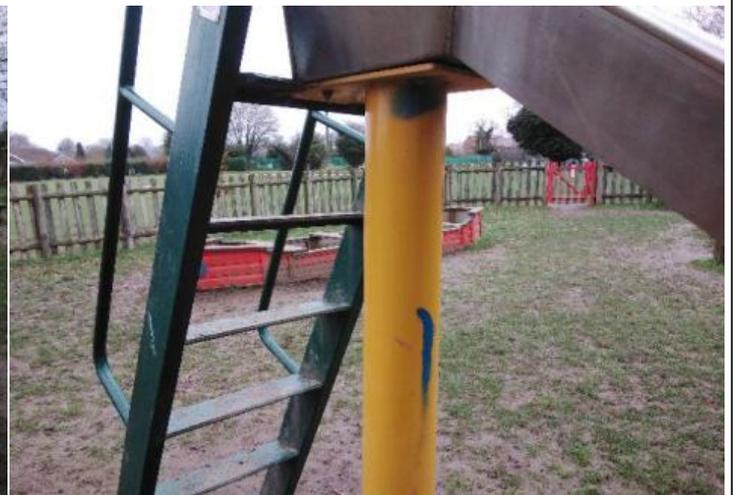
Item: Other - Free Standing Slide
Manufacturer: Wicksteed Playgrounds

Finding: There is some graffiti present

Action: Remove the graffiti

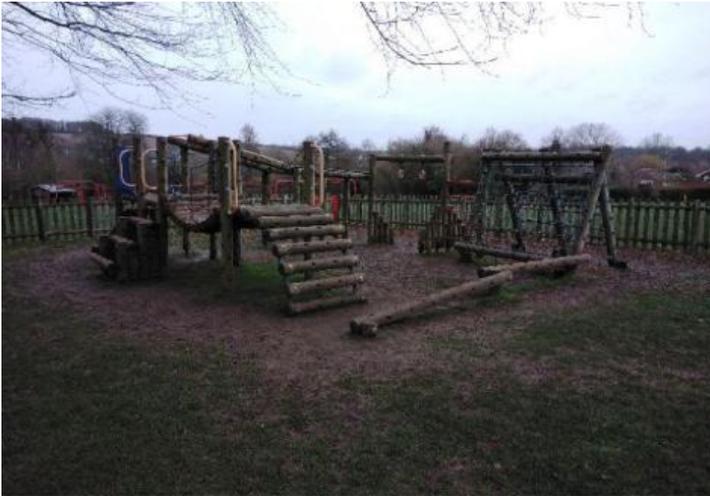
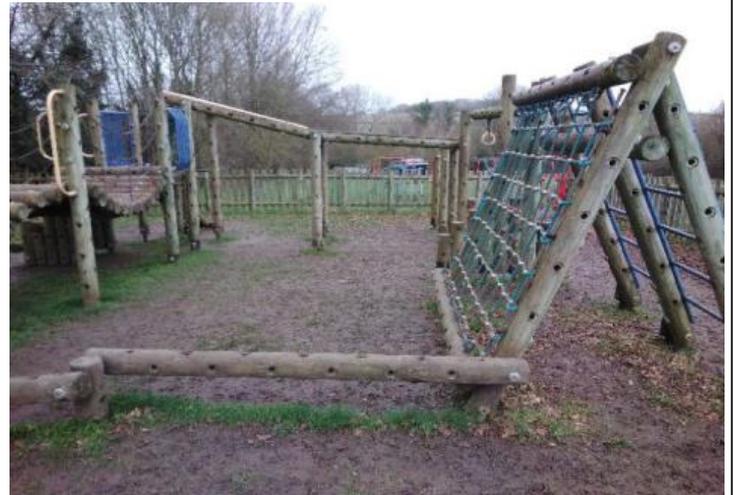
Item: Activity Equipment - Multi Play (Junior)
Manufacturer: Unknown

Finding: The balance beam forms a hard object within the impact area of the equipment in contravention of the requirements of BS EN 1176 Part 1

Action: Monitor - No remedial work recommended

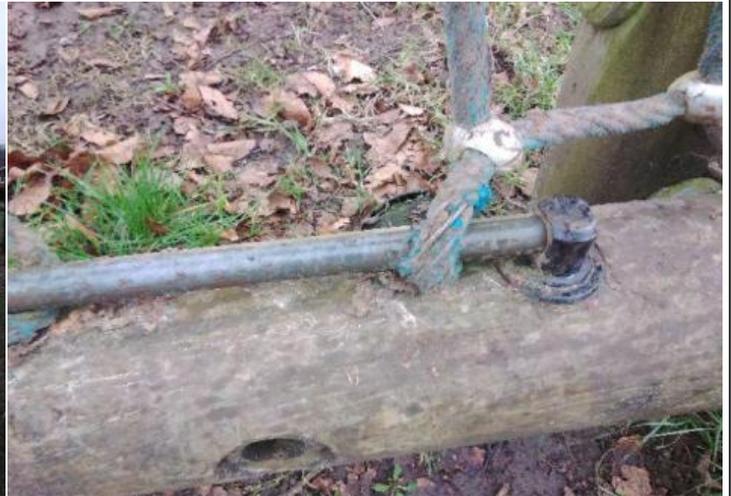
Item: Activity Equipment - Multi Play (Junior)
Manufacturer: Unknown

Finding: The ropes/nets are worn/damaged in places

Action: Monitor for any further deterioration and repair or replace as required

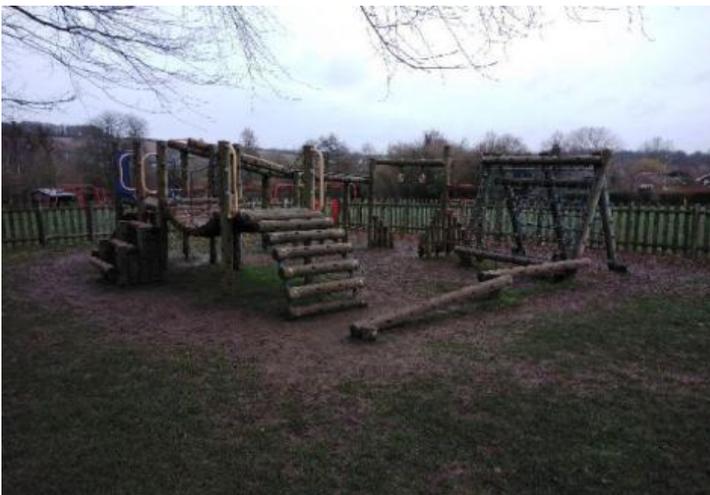
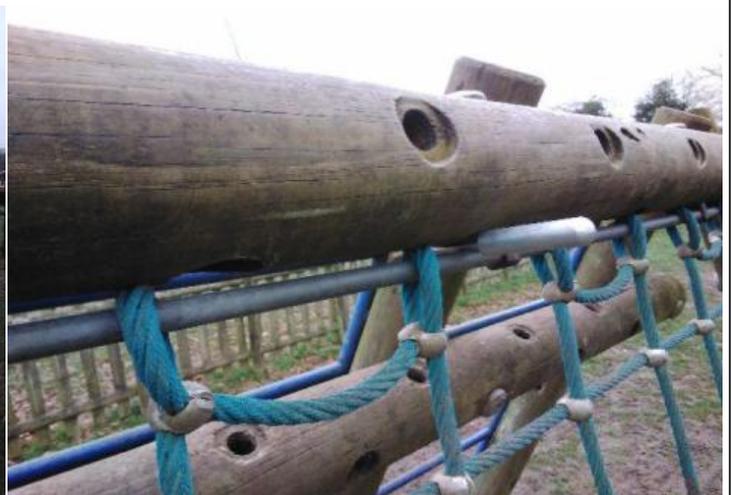
Item: Activity Equipment - Multi Play (Junior)
Manufacturer: Unknown

Finding: There is/are finger entrapment/s in the top of the climbing net frame and the item fails to meet the requirements of BS EN 1176 Part 1 4.2.7.6 Entrapment of fingers

Action: Monitor - No remedial work recommended

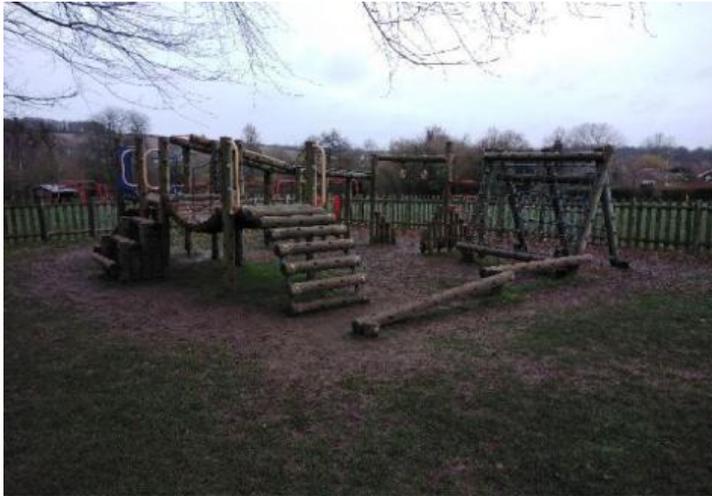
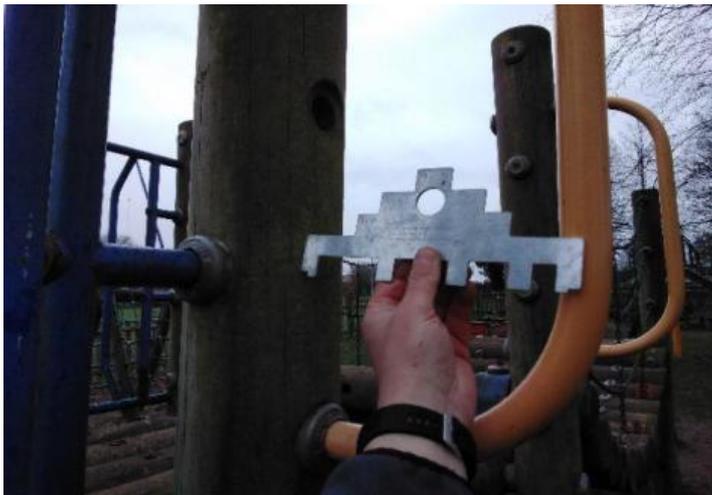
Item: Activity Equipment - Multi Play (Junior)
Manufacturer: Unknown

Finding: The item fails to meet the requirements of BS EN 1176 Part 1 4.2.7.2 head and neck entrapment in the barriers and/or steps

Action: Monitor - No remedial work recommended

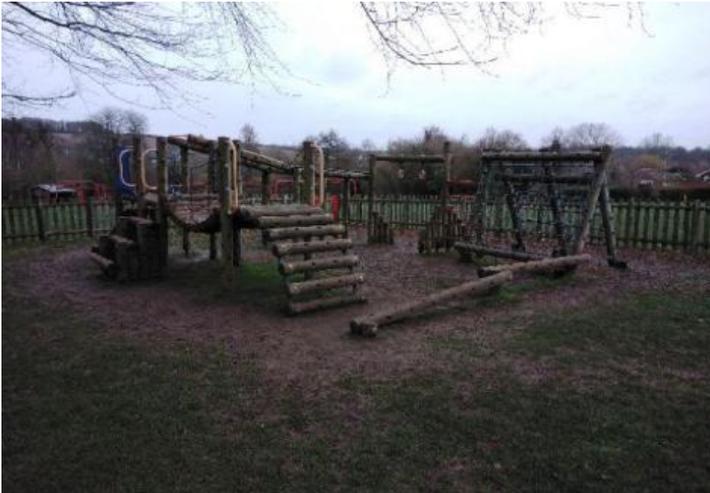
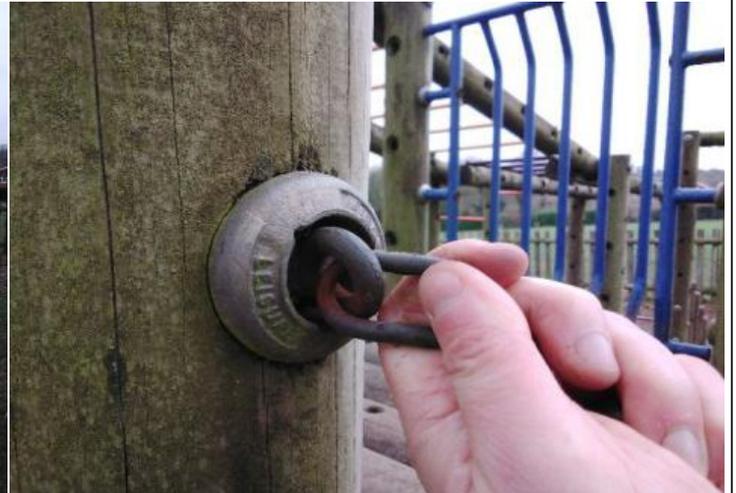
Item: Activity Equipment - Multi Play (Junior)
Manufacturer: Unknown

Finding: There is some notable evidence of chain wear

Action: Monitor for any further deterioration and replace when 40% worn

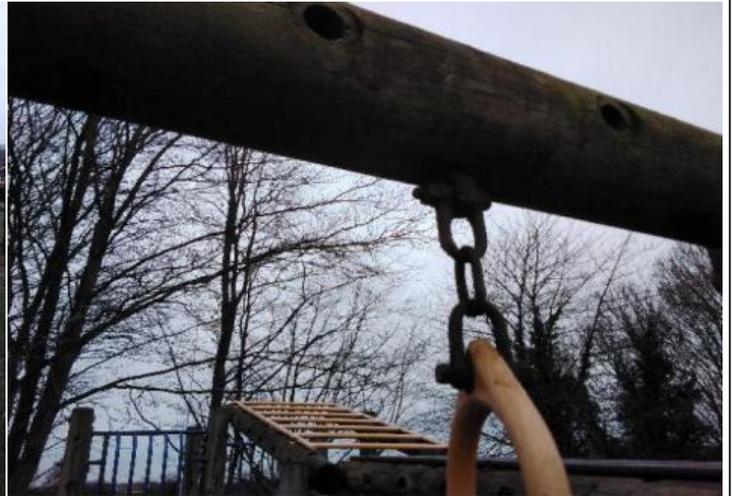
Item: Activity Equipment - Multi Play (Junior)
Manufacturer: Unknown

Finding: A number of fixing(s) have worked loose to the hand grips

Action: Secure all loose fixings

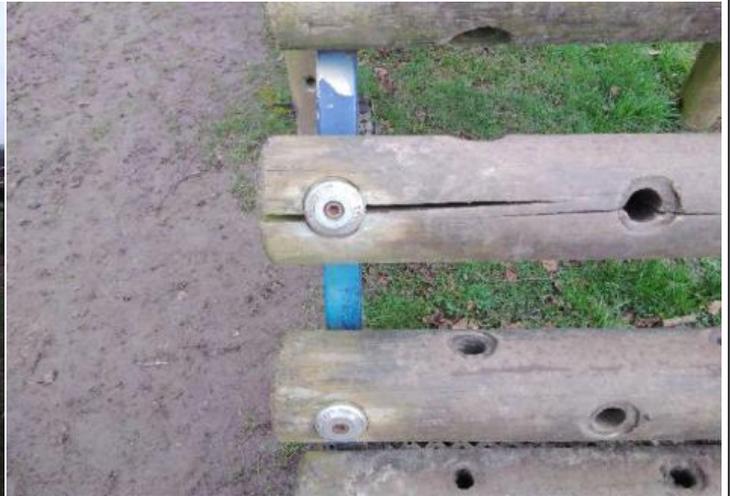
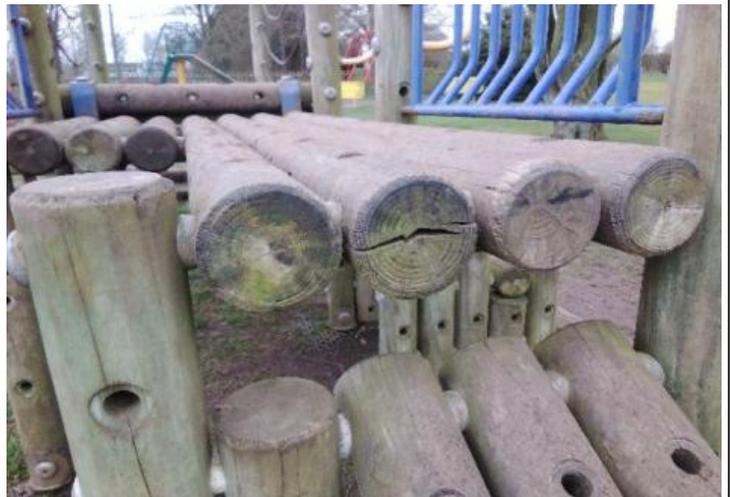
Item: Activity Equipment - Multi Play (Junior)
Manufacturer: Unknown

Finding: The timber has a number of splits/shakes or air cracks and this may affect the stability or allow water ingress which will accelerate the rotting process

Action: Monitor to ensure the splits do not cross through fixing points of the structure and/or cause any instability

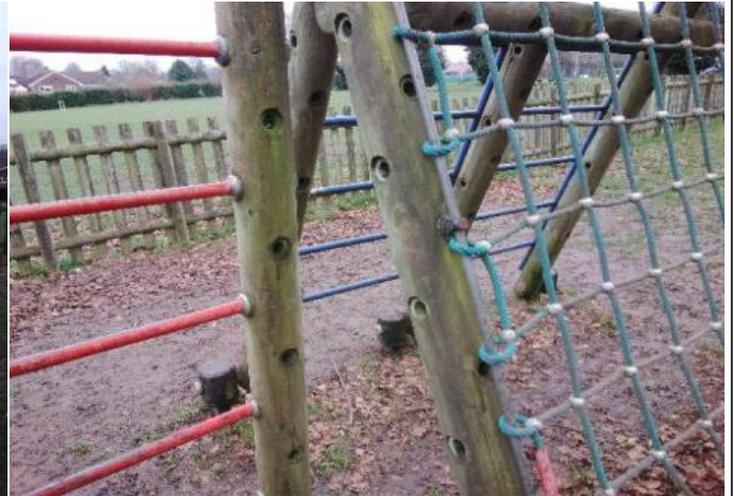
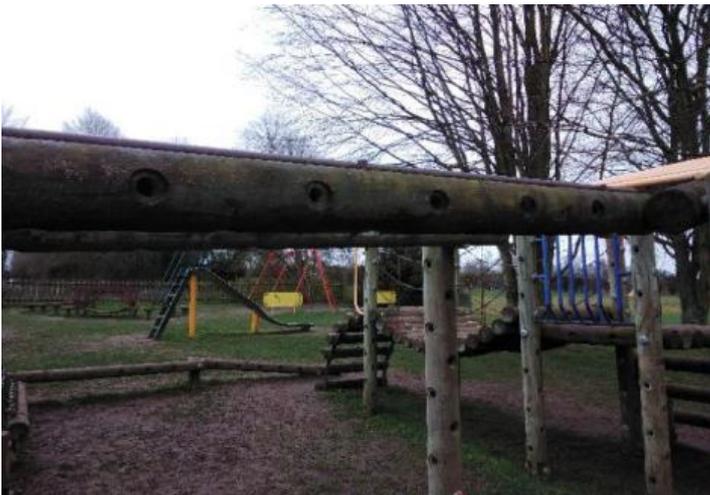
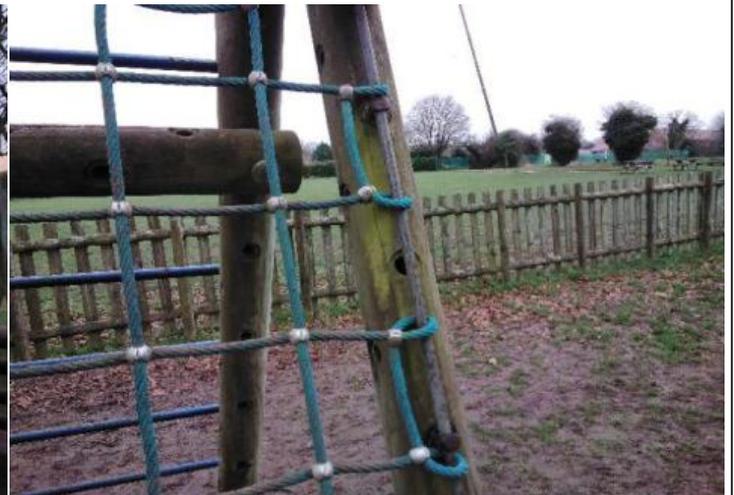
Item: Activity Equipment - Multi Play (Junior)
Manufacturer: Unknown

Finding: There is algae or moss on the surface of the equipment

Action: Clean and treat appropriately

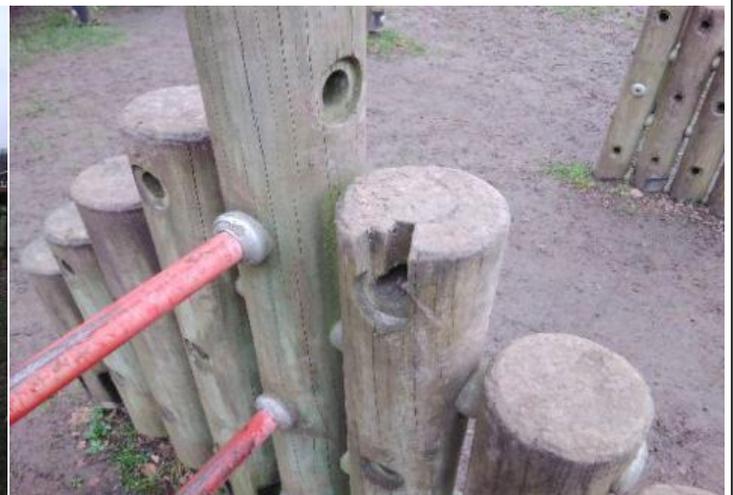
Item: Activity Equipment - Multi Play (Junior)
Manufacturer: Unknown

Finding: Parts of the timber are rough or splintered

Action: Remove all rough or sharp edges

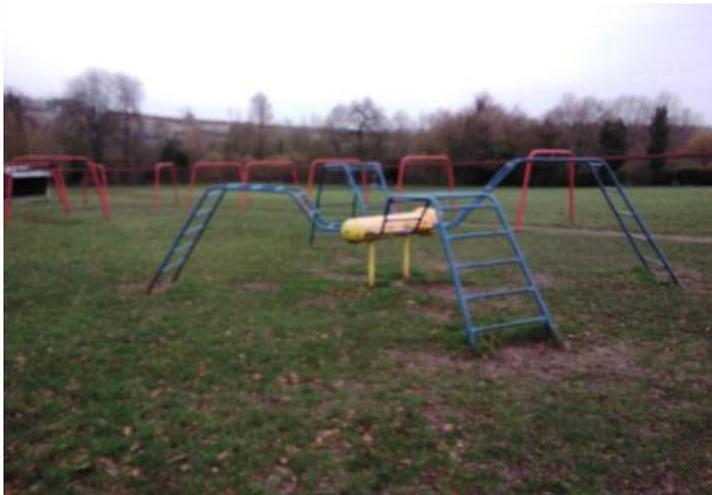
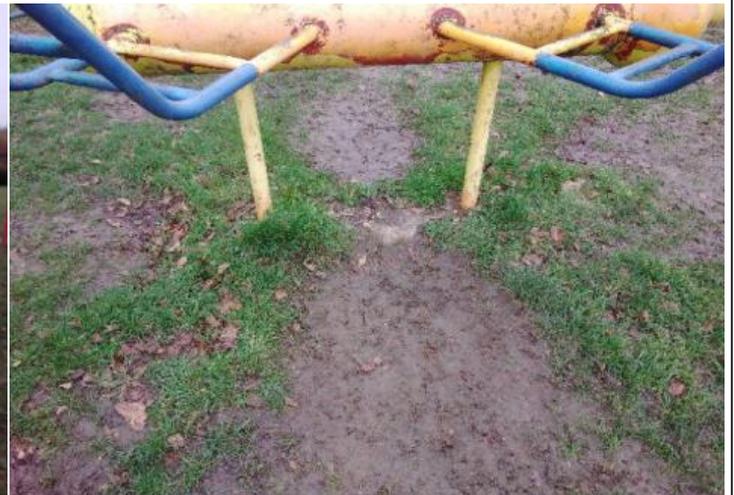
Item: Activity Equipment - Climbing Frame
Manufacturer: Unknown

Finding: The surface has eroded and the foundations are exposed

Action: Reinststate surrounding surfaces to cover the foundations

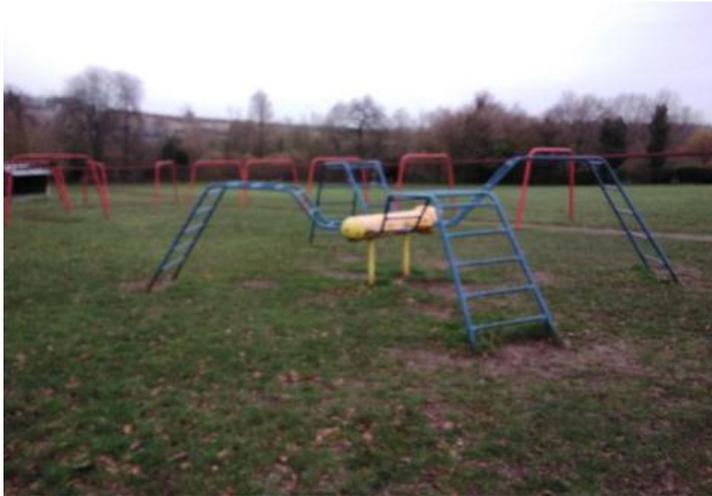
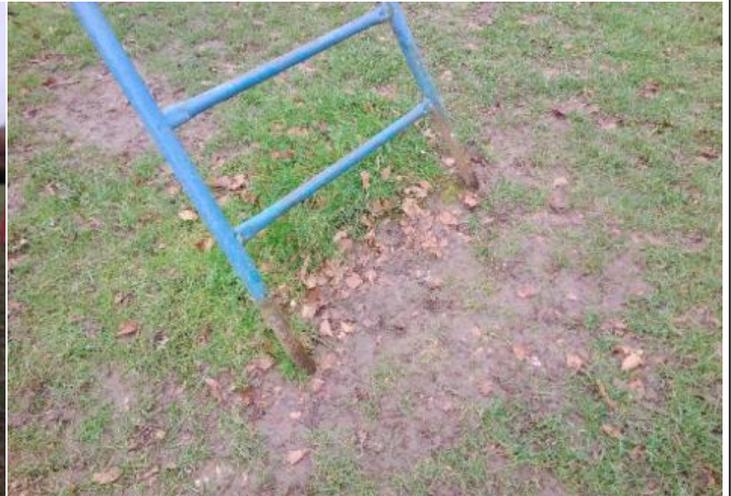
Item: Activity Equipment - Climbing Frame
Manufacturer: Unknown

Finding: The area around the item has eroded and may become slippery

Action: Reinststate eroded area

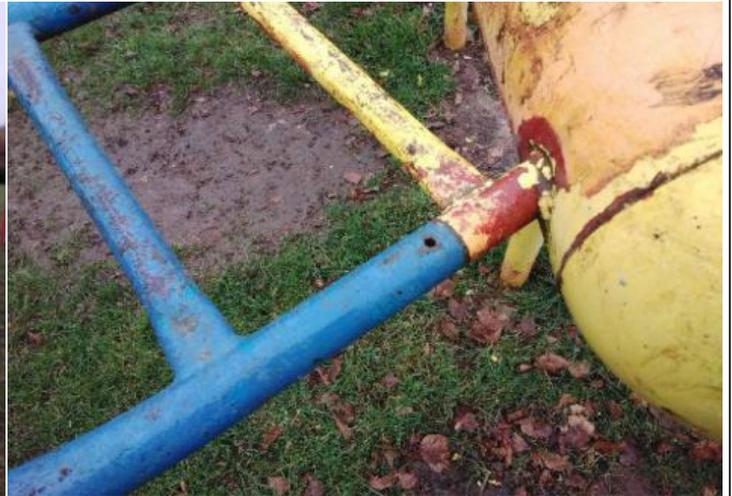
Item: Activity Equipment - Climbing Frame
Manufacturer: Unknown

Finding: There is or are fixings missing on the item

Action: Replace all missing fixings

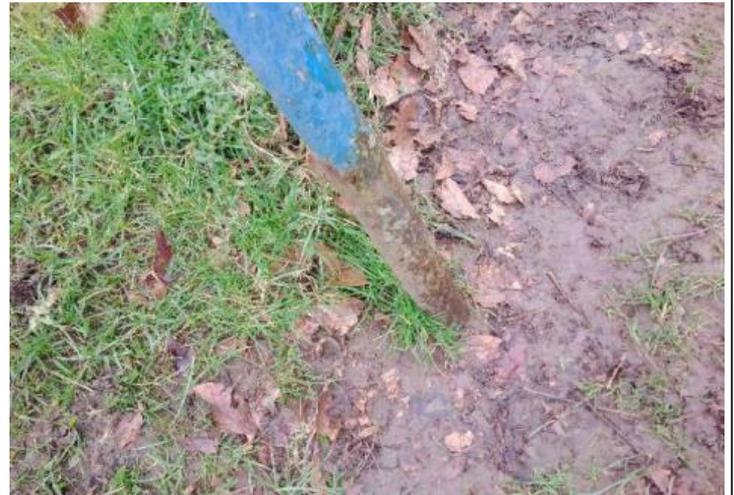
Item: Activity Equipment - Climbing Frame
Manufacturer: Unknown

Finding: The paintwork on this item has been damaged or worn exposing the metal underneath which is rusting

Action: Treat any rusting components and repaint

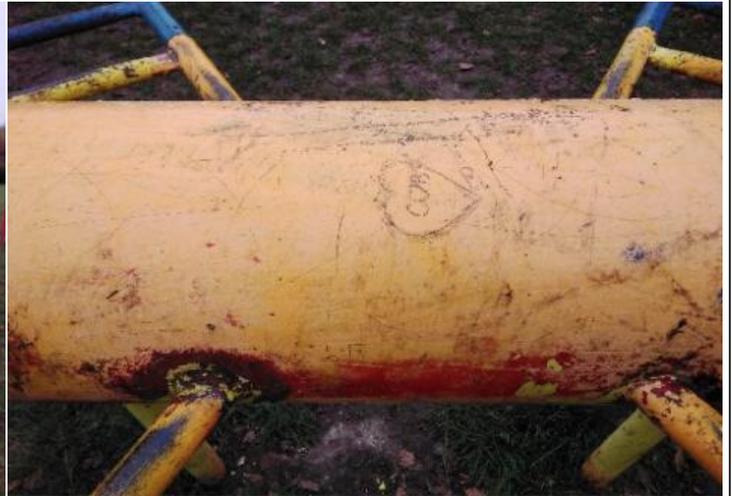
Item: Activity Equipment - Climbing Frame
Manufacturer: Unknown

Finding: There is some graffiti present

Action: Remove the graffiti

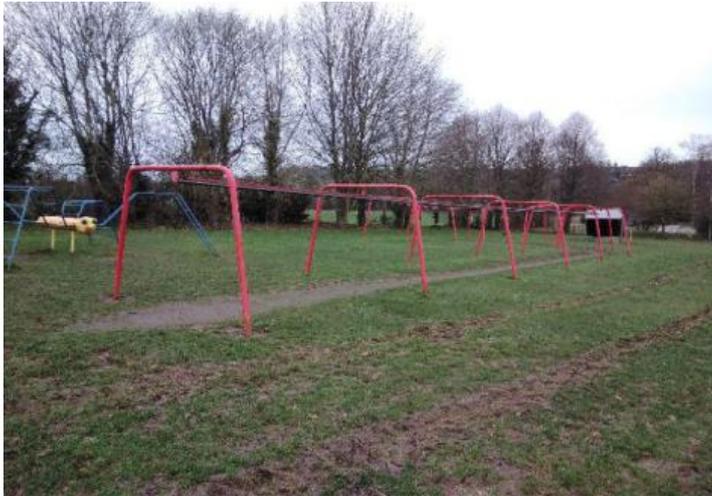
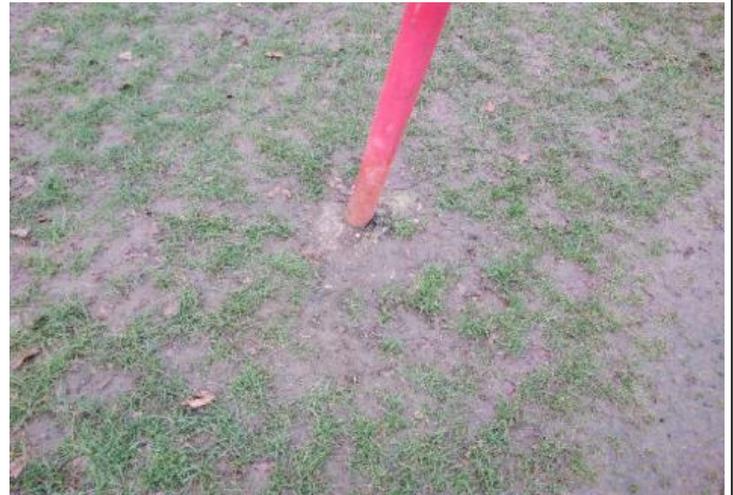
Item: Activity Equipment - Overhead Glider
Manufacturer: Unknown

Finding: The surface has eroded and the foundations are exposed

Action: Reinststate surrounding surfaces to cover the foundations

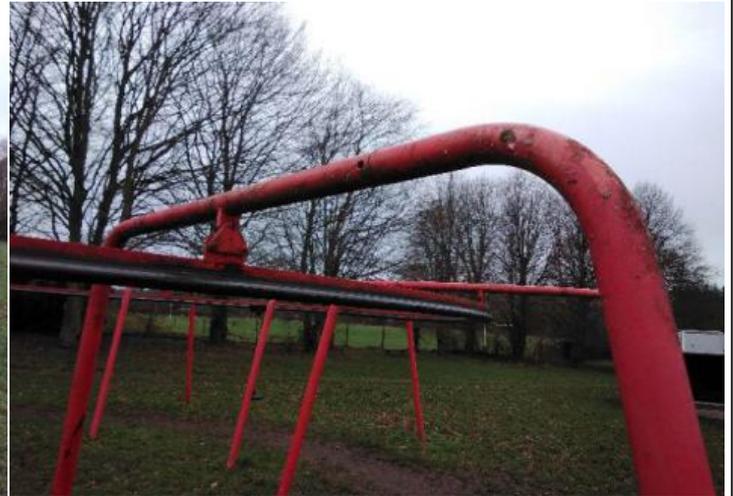
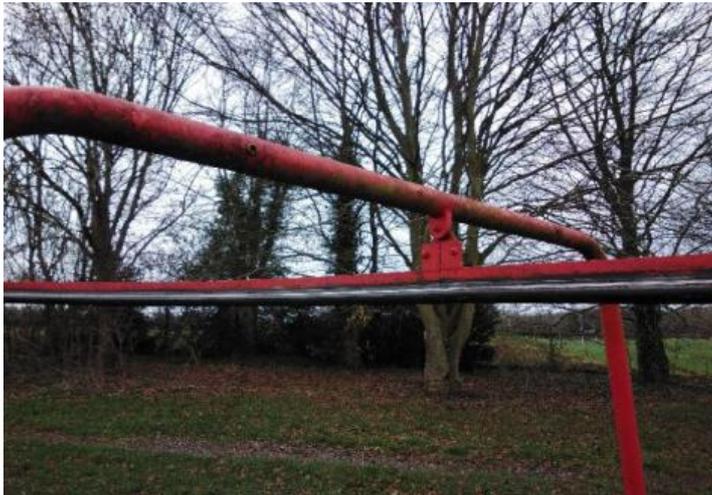
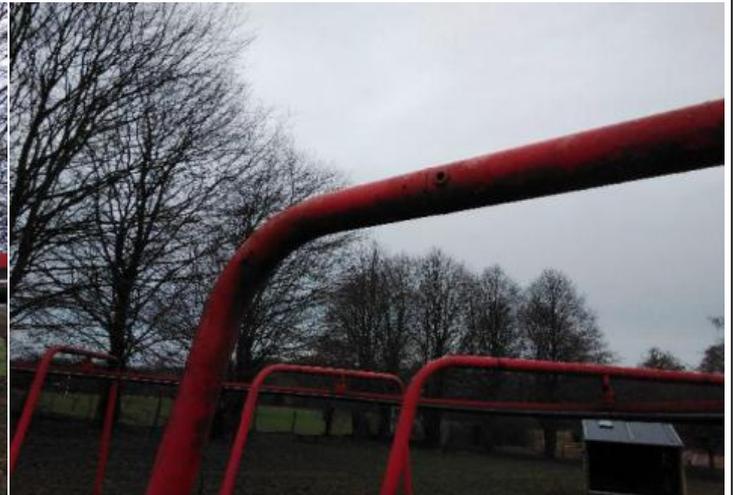
Item: Activity Equipment - Overhead Glider
Manufacturer: Unknown

Finding: There is algae or moss on the surface of the equipment

Action: Clean and treat appropriately

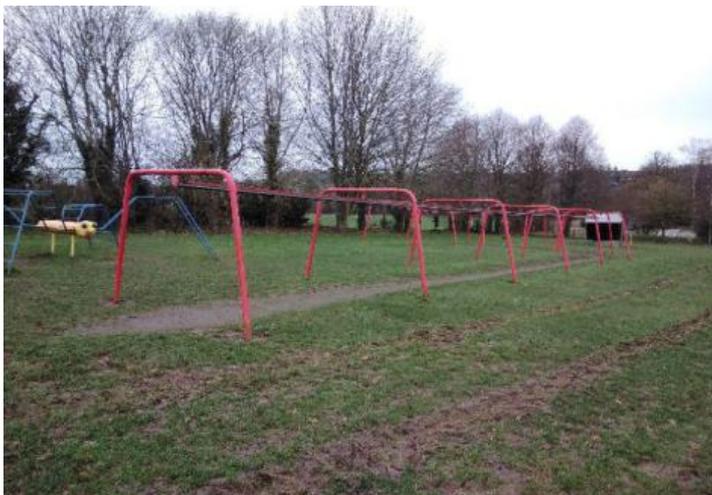
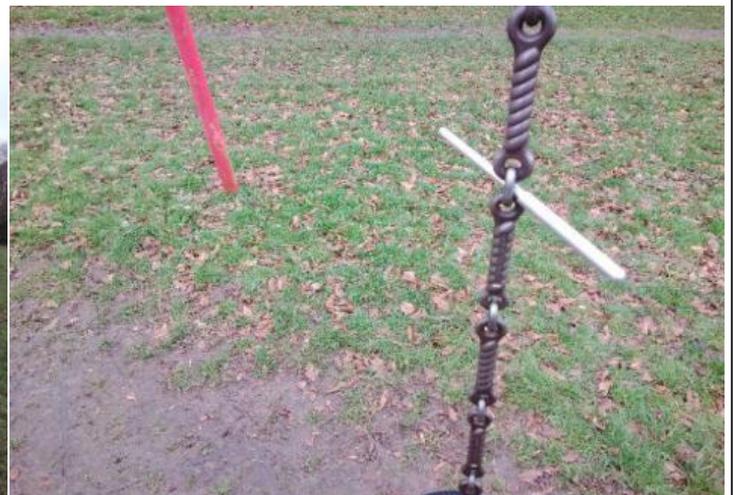
Item: Activity Equipment - Overhead Glider
Manufacturer: Unknown

Finding: The chain openings are in excess of the 8.6mm as recommended by BS EN 1176

Action: Monitor - No remedial work recommended

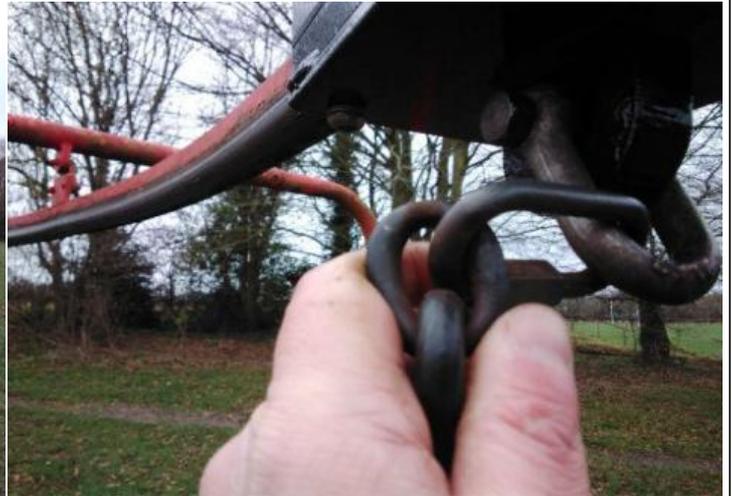
Item: Activity Equipment - Overhead Glider
Manufacturer: Unknown

Finding: There is some notable evidence of chain wear

Action: Monitor for any further deterioration and replace when 40% worn

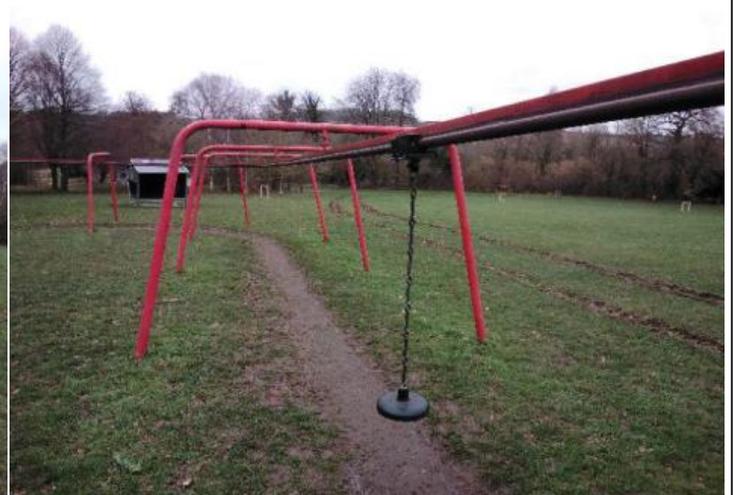
Item: Activity Equipment - Overhead Glider
Manufacturer: Unknown

Finding: Sliding rail is dry, and the glider can become stuck in movement.

Action: Service the item

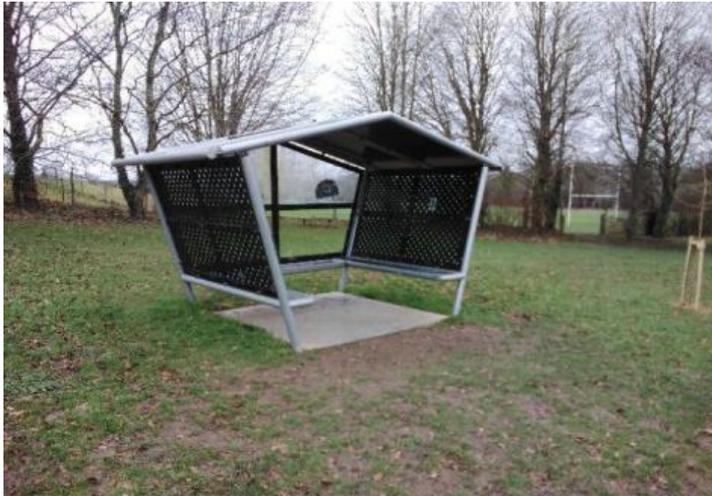
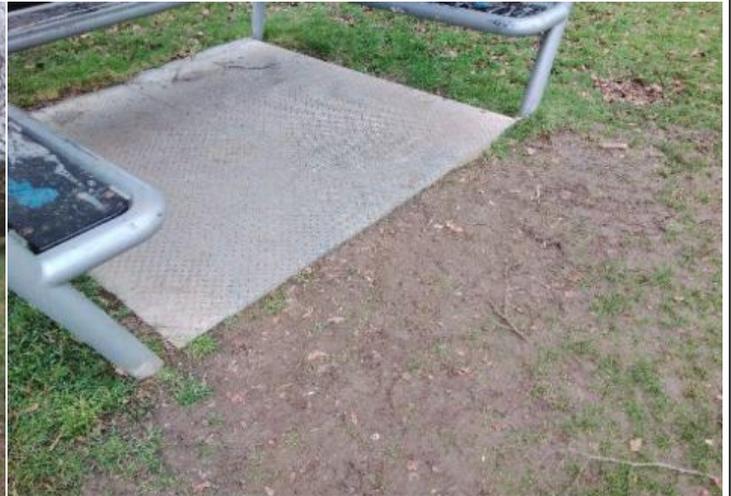
Item: Ancillary Items - Teenage Shelter
Manufacturer: Unknown

Finding: The area around the item has eroded and may become slippery

Action: Reinststate eroded area

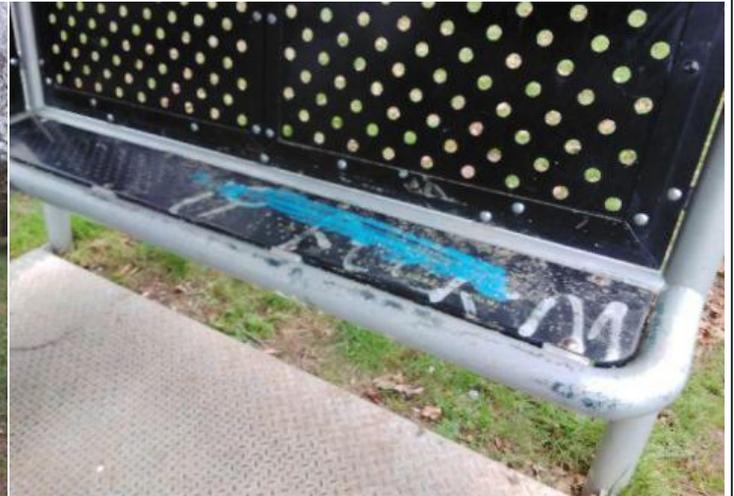
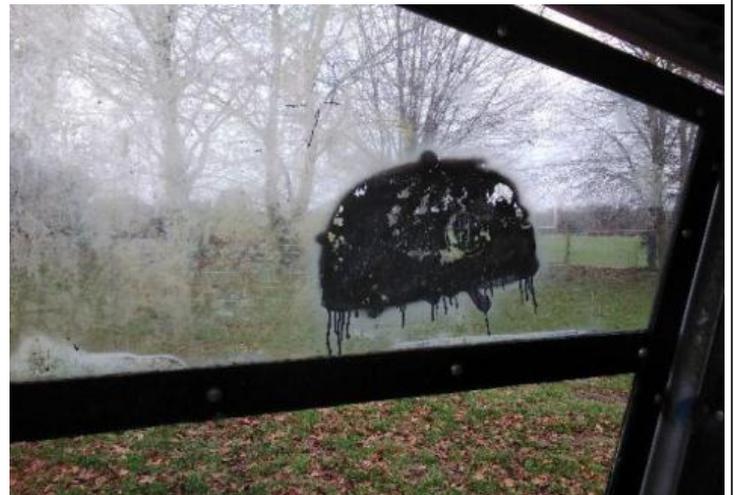
Item: Ancillary Items - Teenage Shelter
Manufacturer: Unknown

Finding: There is some graffiti present

Action: Remove the graffiti

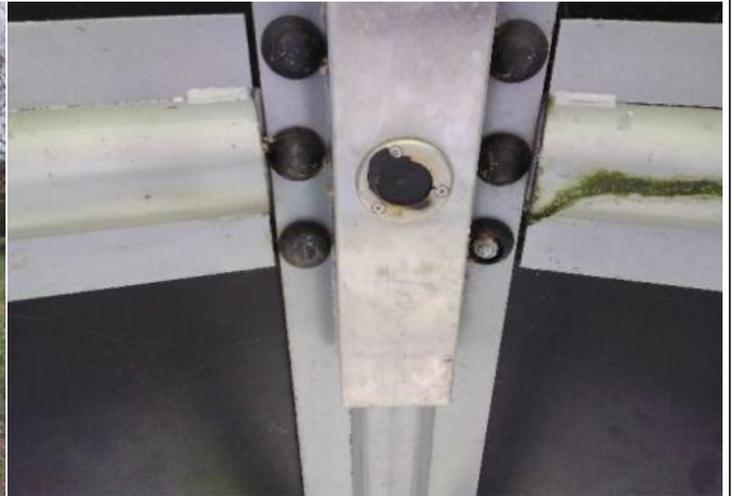
Item: Ancillary Items - Teenage Shelter
Manufacturer: Unknown

Finding: There is/are bolt cap covers missing or damaged on the item

Action: Replace missing or damaged bolt cap covers

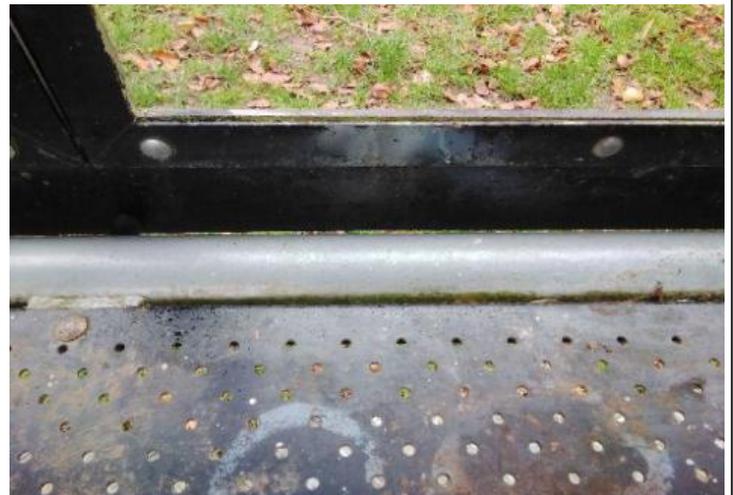
Item: Ancillary Items - Teenage Shelter
Manufacturer: Unknown

Finding: There is some evidence of fire damage to the item **Action:** Monitor for any further deterioration and repair as required

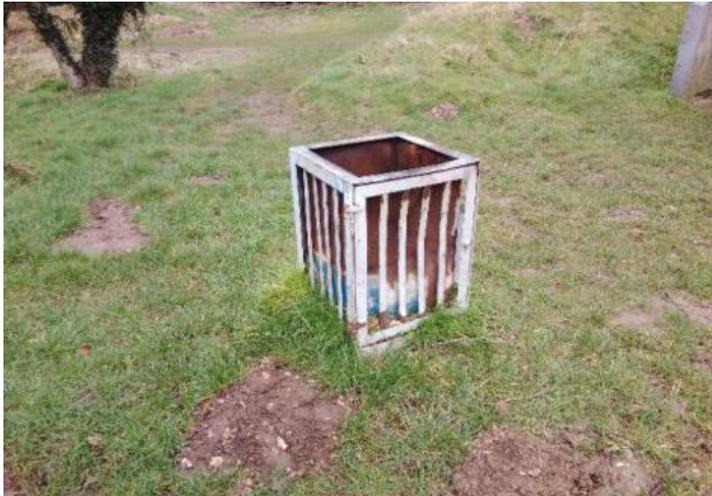
Item: Ancillary Items - Litter Bin
Manufacturer: Unknown

Finding: The item has been damaged

Action: Monitor for any further deterioration and replace as required

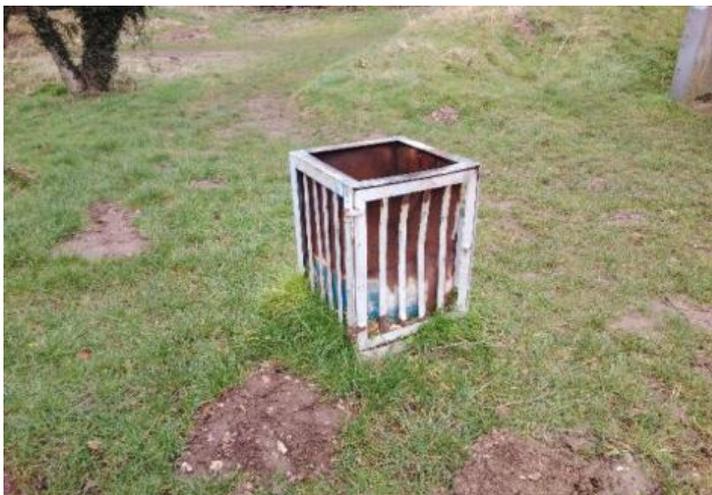
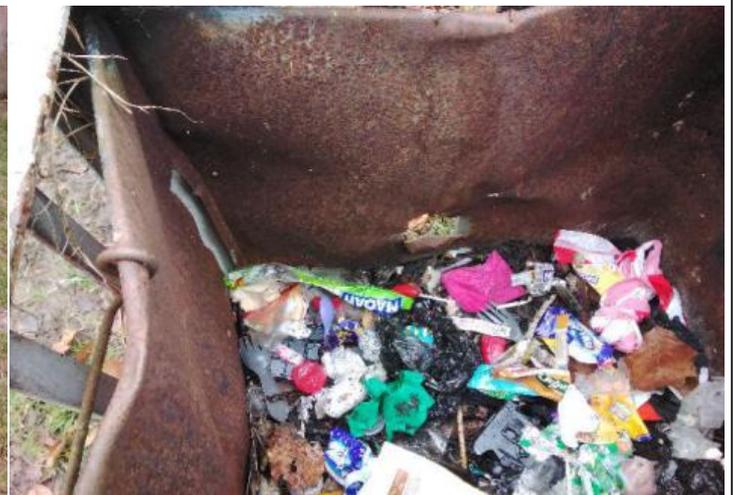
Item: Ancillary Items - Litter Bin
Manufacturer: Unknown

Finding: Parts of the steel on this bin liner have corroded excessively and the metal has perforated in places

Action: Ensure all affected areas are treated and repaired

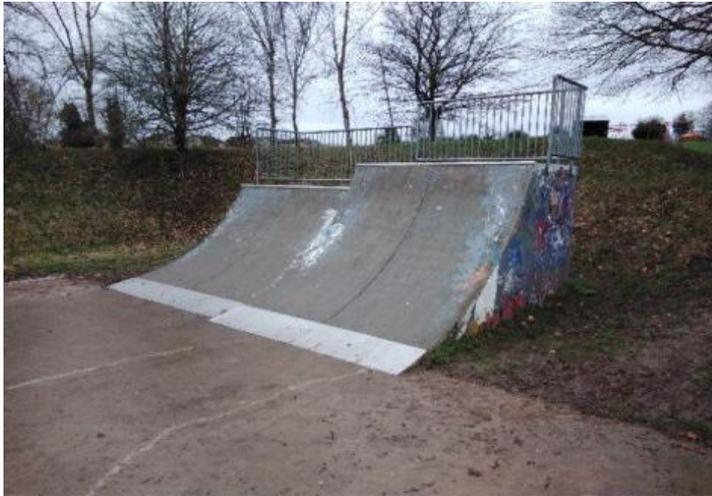
Item: Wheeled Sports - Start Ramp
Manufacturer: Unknown

Finding: There is/are several inserts missing

Action: Replace missing inserts

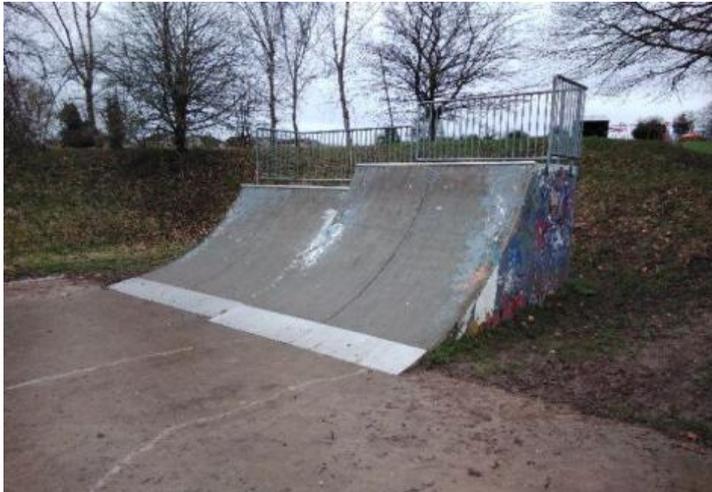
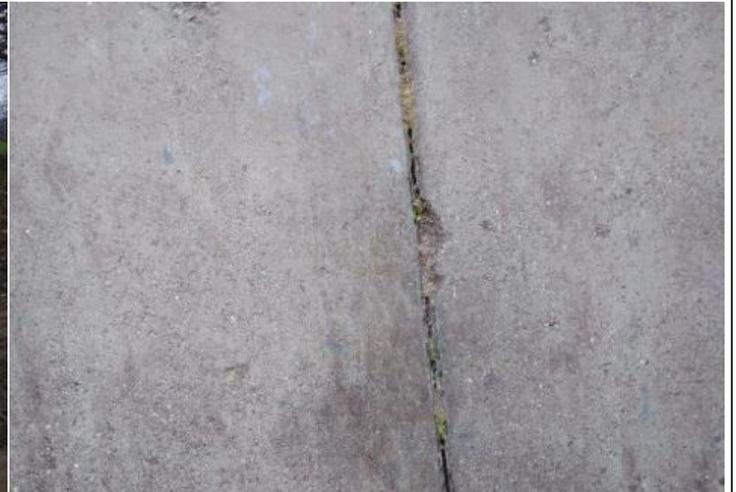
Item: Wheeled Sports - Start Ramp
Manufacturer: Unknown

Finding: The riding surface of the ramp has some damage apparent

Action: Monitor for any further deterioration and repair as required

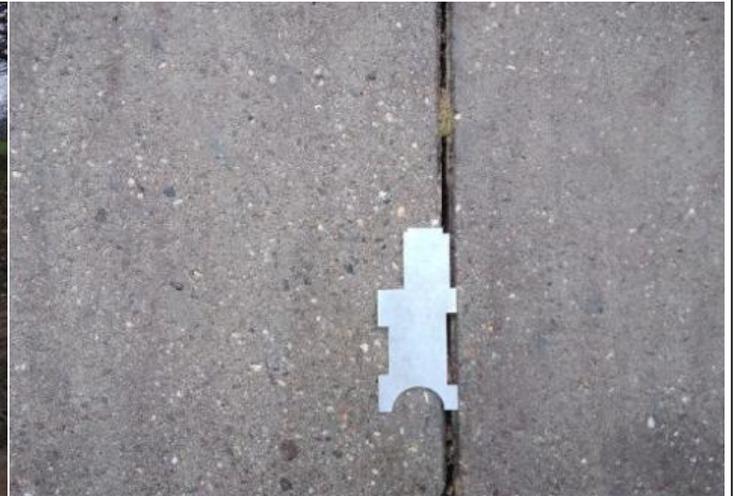
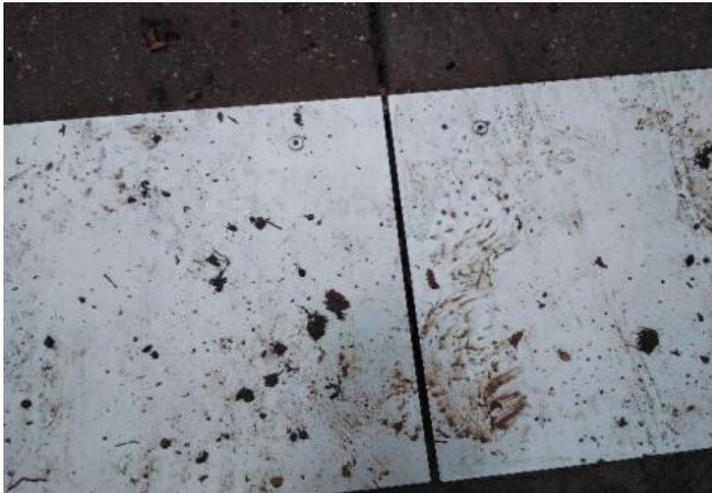
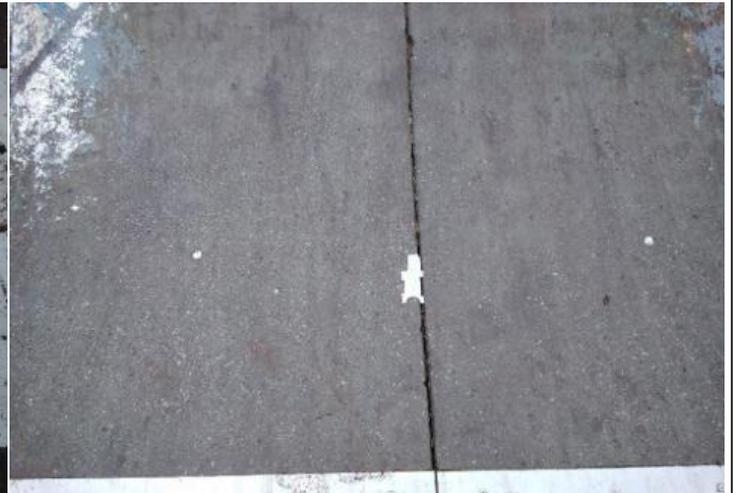
Item: Wheeled Sports - Start Ramp
Manufacturer: Unknown

Finding: Joints between the riding surfaces should not be greater than 5mm to meet the requirements of BS EN 14974 **Action:** Take corrective action to ensure that the gaps between the joints do not exceed 5mm
