the **play inspection** company

Annual Inspection

Winchester City Council

Arlebury Park, Skate Park & Tennis(New Alresford)

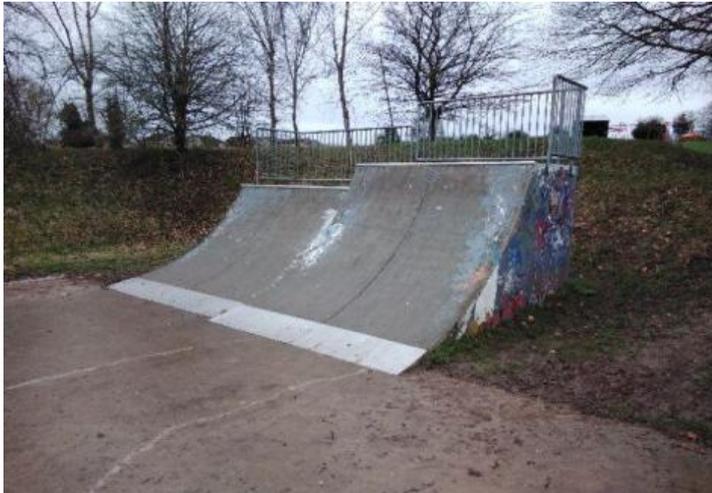
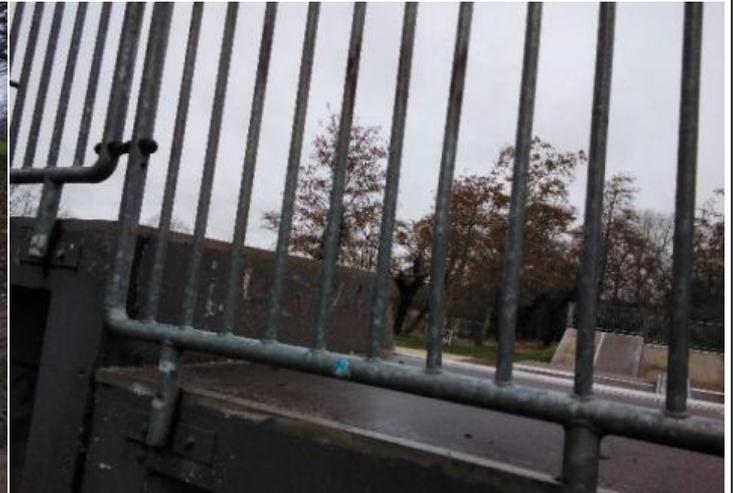
Item: Wheeled Sports - Start Ramp
Manufacturer: Unknown

Finding: The item has been damaged

Action: Monitor for any further deterioration and replace as required

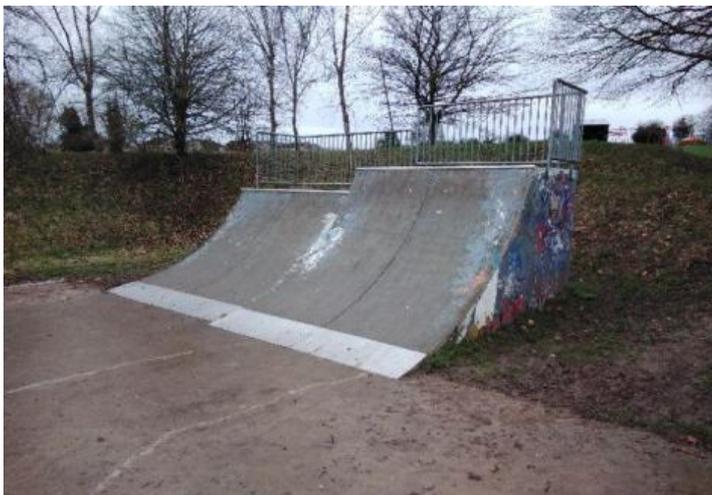
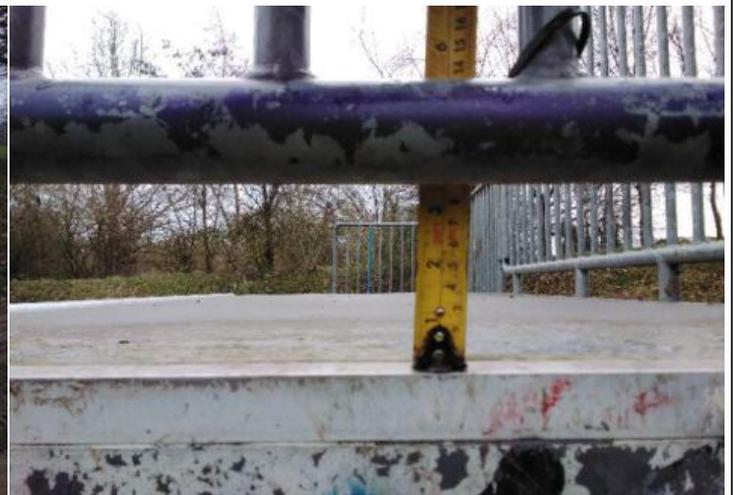
Item: Wheeled Sports - Start Ramp
Manufacturer: Unknown

Finding: The gap between the underside of the barrier and the platform is in excess of 60mm and fails the requirements of BS EN 14974

Action: Monitor - No remedial work recommended

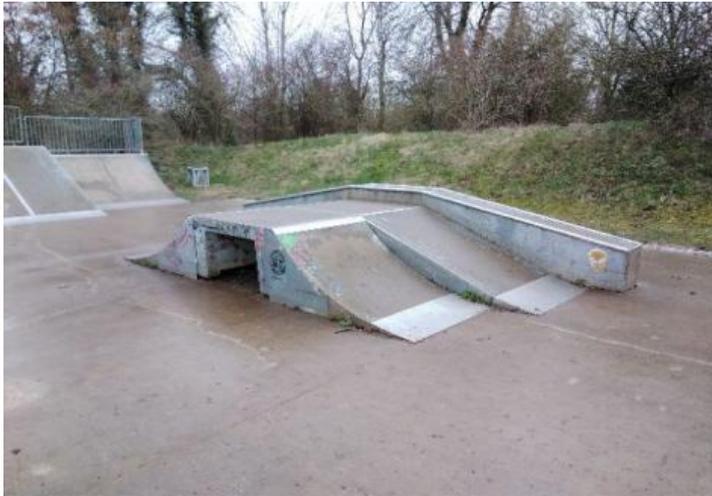
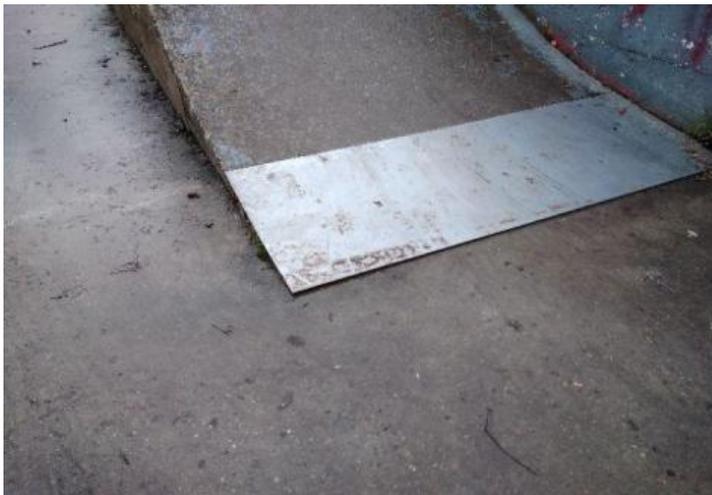
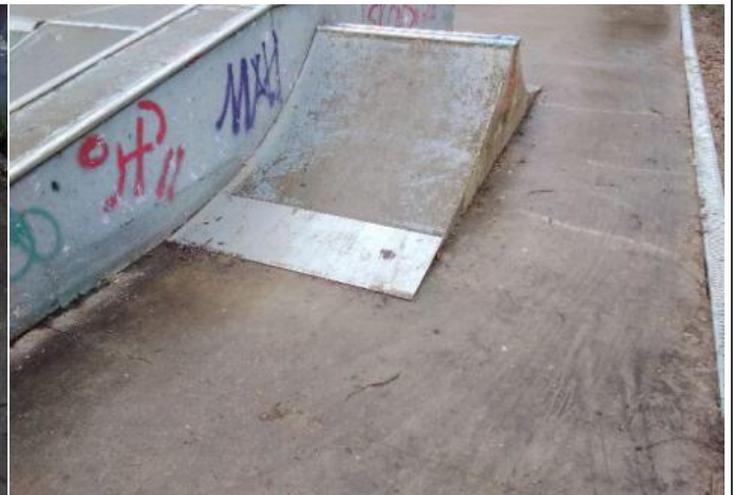
Item: Wheeled Sports - Fun Box
Manufacturer: Unknown

Finding: The kicker plate protrudes more than 5mm above the surrounding surface level, BS EN 14974 recommends a maximum of 5mm with 3mm preferred

Action: Adjust height to ensure a maximum of 5mm change in level

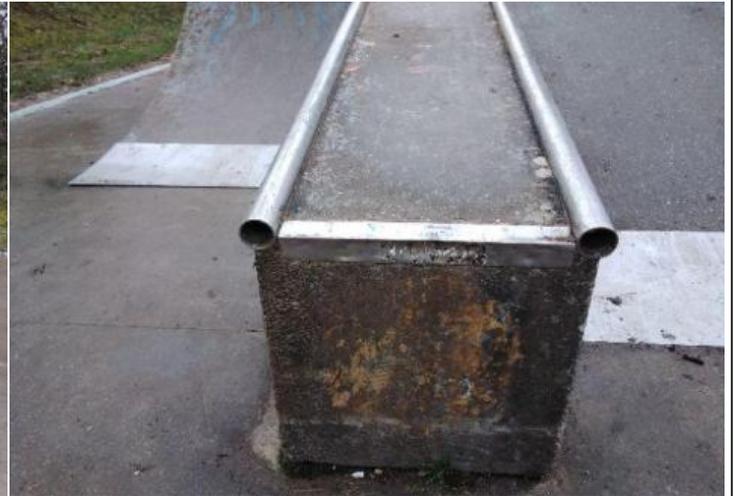
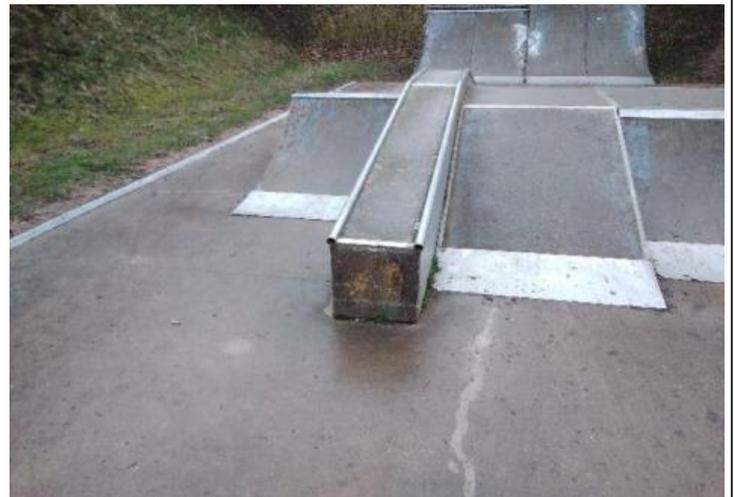
Item: Wheeled Sports - Fun Box
Manufacturer: Unknown

Finding: The ends of all coping rails should be sealed to meet the requirements of BS EN 14974

Action: Ensure all coping ends are sealed

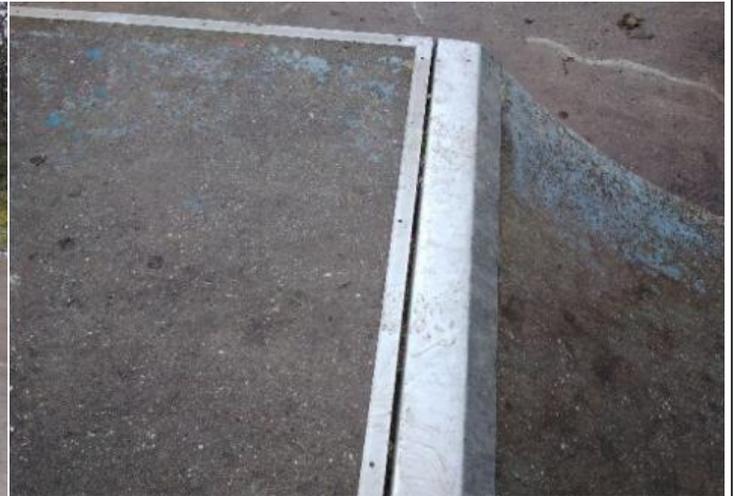
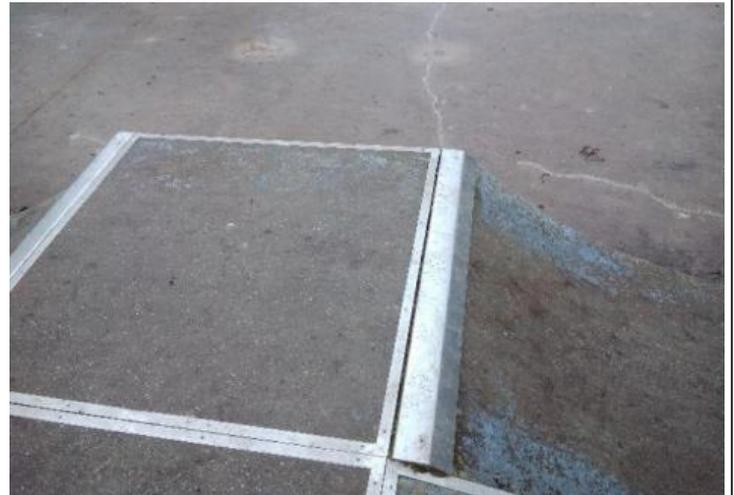
Item: Wheeled Sports - Fun Box
Manufacturer: Unknown

Finding: Joints between the riding surfaces should not be greater than 5mm to meet the requirements of BS EN 14974 **Action:** Take corrective action to ensure that the gaps between the joints do not exceed 5mm

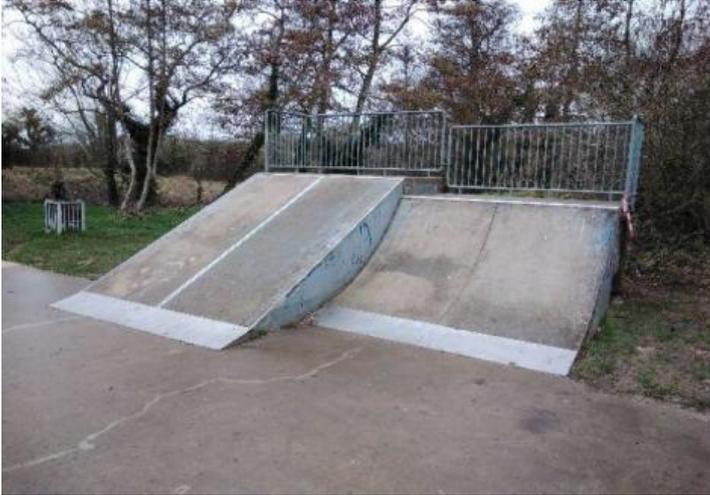
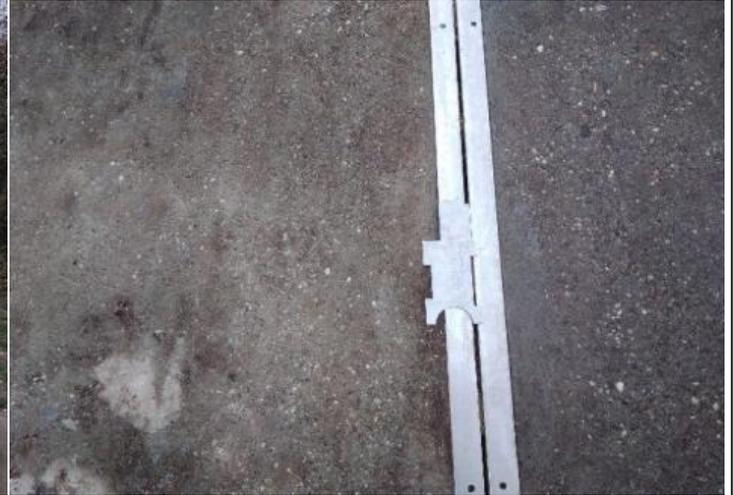
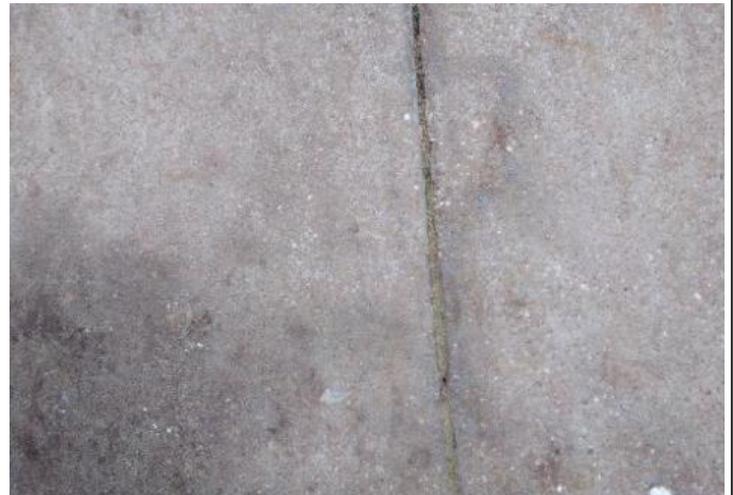
Item: Wheeled Sports - End Transition & Wall Ramp
Manufacturer: Unknown

Finding: Joints between the riding surfaces should not be greater than 5mm to meet the requirements of BS EN 14974

Action: Take corrective action to ensure that the gaps between the joints do not exceed 5mm

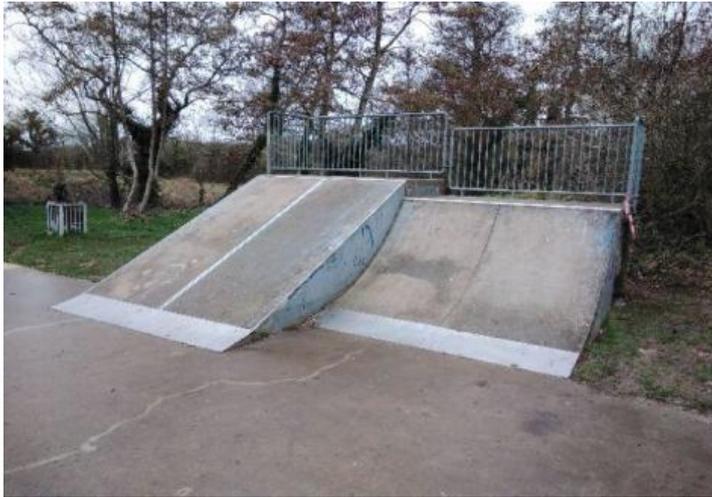
Item: Wheeled Sports - End Transition & Wall Ramp
Manufacturer: Unknown

Finding: The height of the barrier is less than 1200mm and fails the requirements of BS EN 14974

Action: Monitor - No remedial work recommended

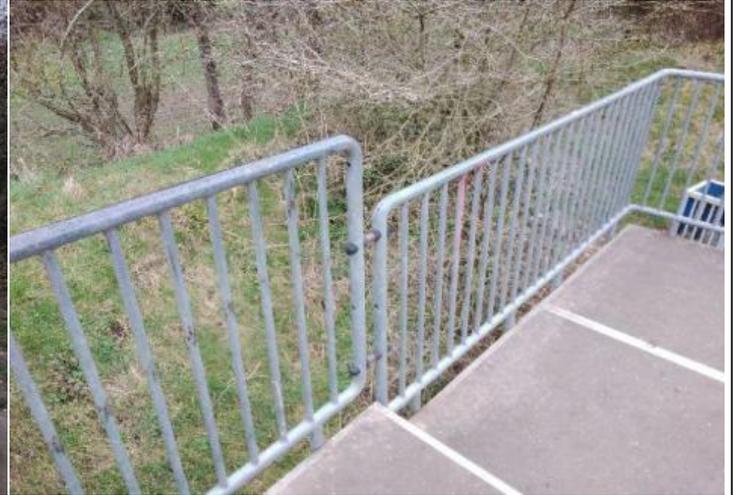
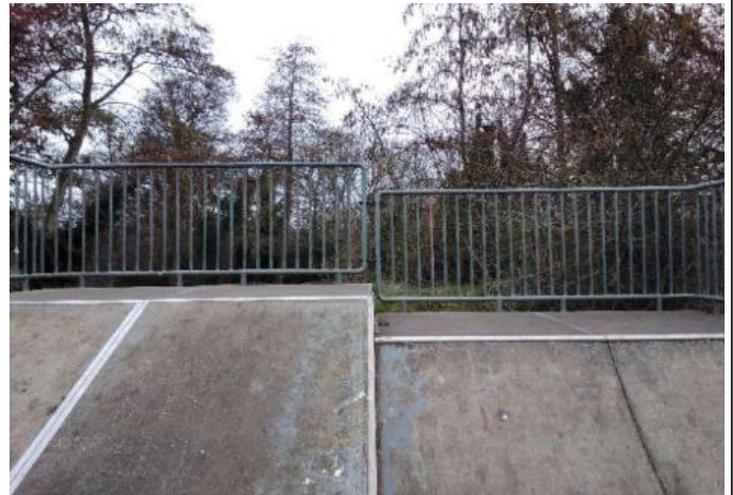
Item: Wheeled Sports - End Transition & Wall Ramp
Manufacturer: Unknown

Finding: The height of the barrier should continue for a further 1m when there is a change in platform levels and fails the requirements of BS EN 14974

Action: Monitor - No remedial work recommended

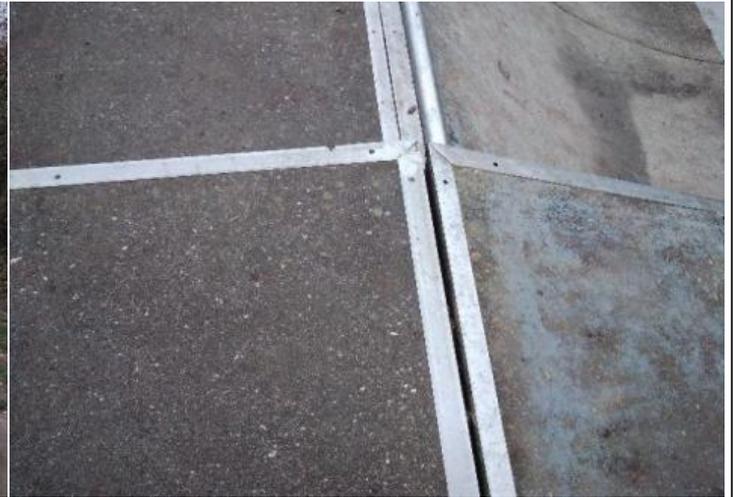
Item: Wheeled Sports - End Transition & Wall Ramp
Manufacturer: Unknown

Finding: Joints between the riding surfaces should not be greater than 5mm to meet the requirements of BS EN 14974
Action: Take corrective action to ensure that the gaps between the joints do not exceed 5mm

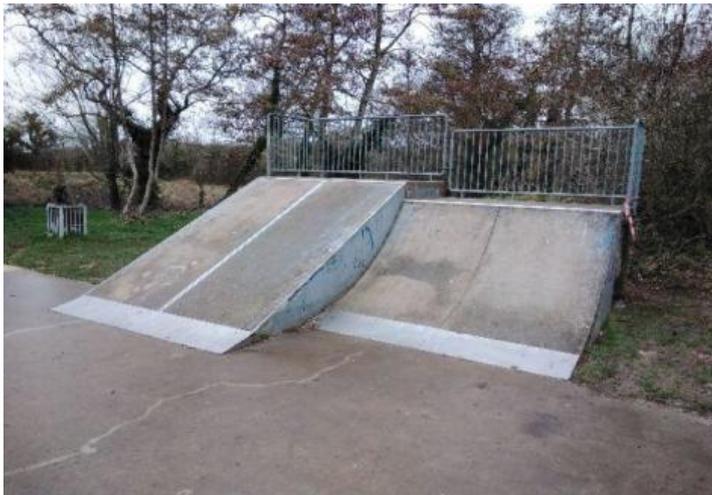
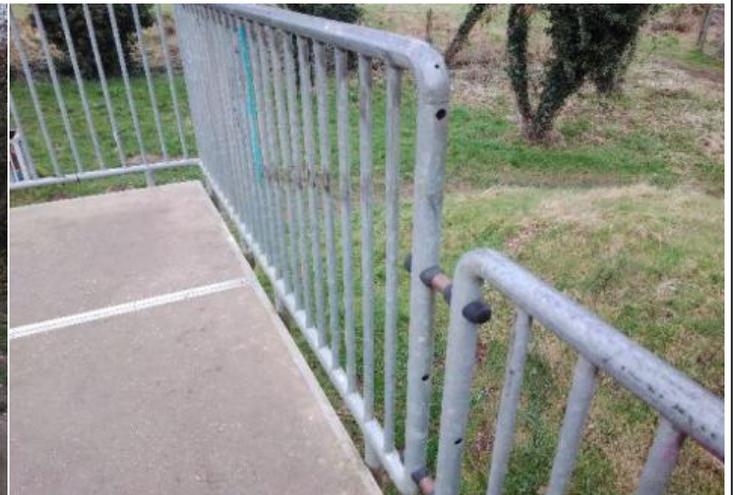
i 4 - Very Low Risk (Finding 5)

Item: Wheeled Sports - End Transition & Wall Ramp
Manufacturer: Unknown

Finding: There is/are several inserts missing
Action: Replace missing inserts

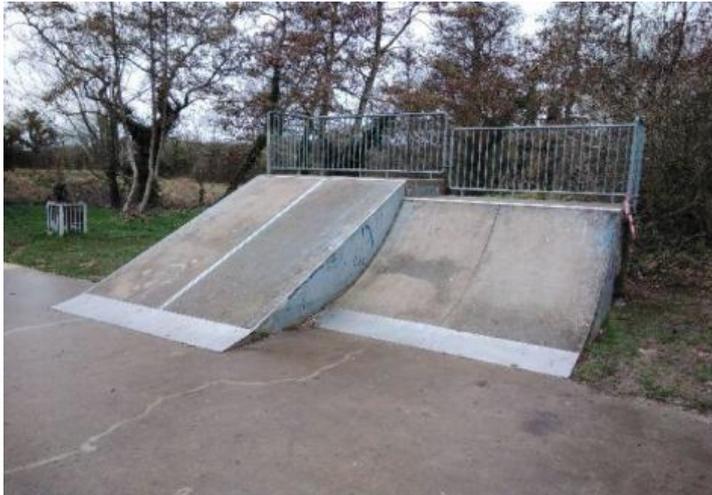
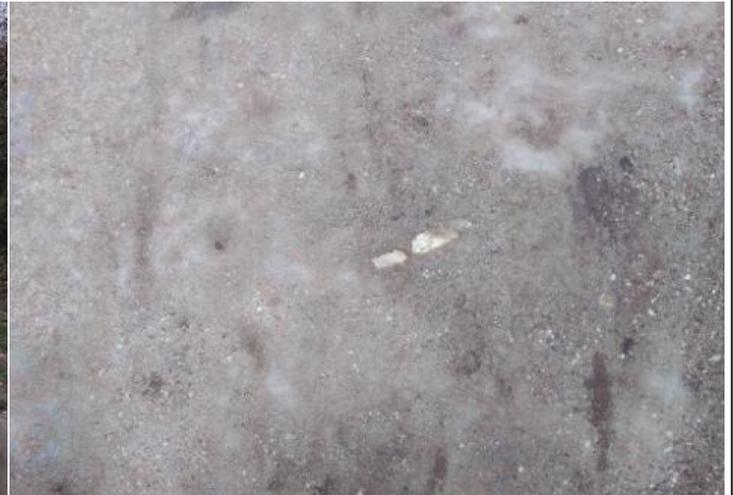
Item: Wheeled Sports - End Transition & Wall Ramp
Manufacturer: Unknown

Finding: The riding surface of the ramp has some damage apparent

Action: Monitor for any further deterioration and repair as required

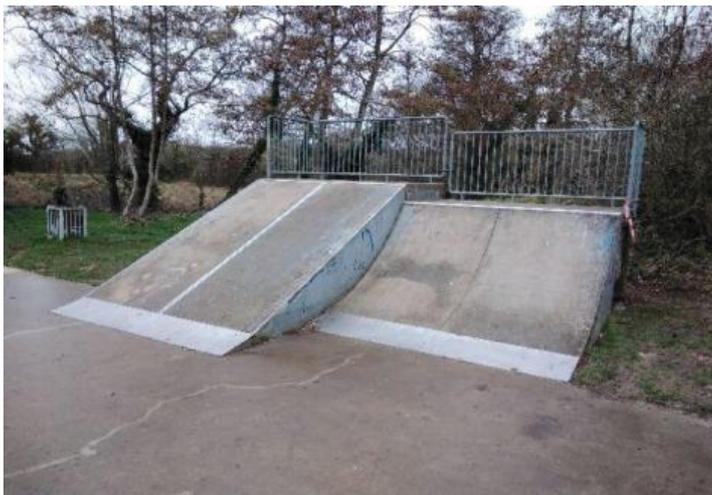
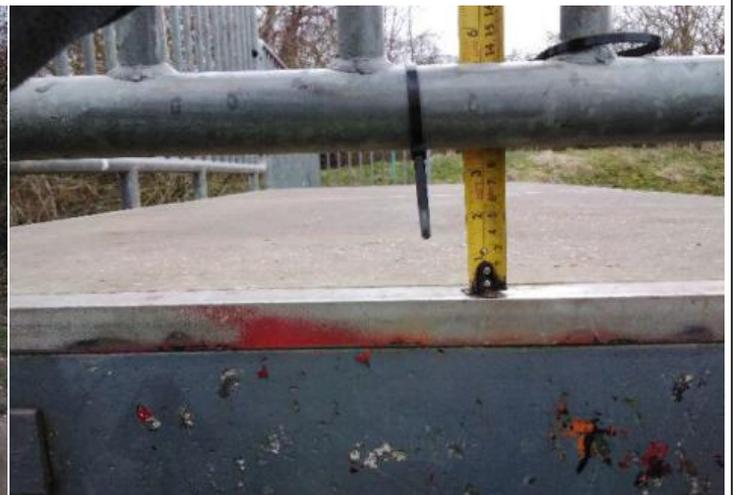
Item: Wheeled Sports - End Transition & Wall Ramp
Manufacturer: Unknown

Finding: The gap between the underside of the barrier and the platform is in excess of 60mm and fails the requirements of BS EN 14974

Action: Monitor - No remedial work recommended

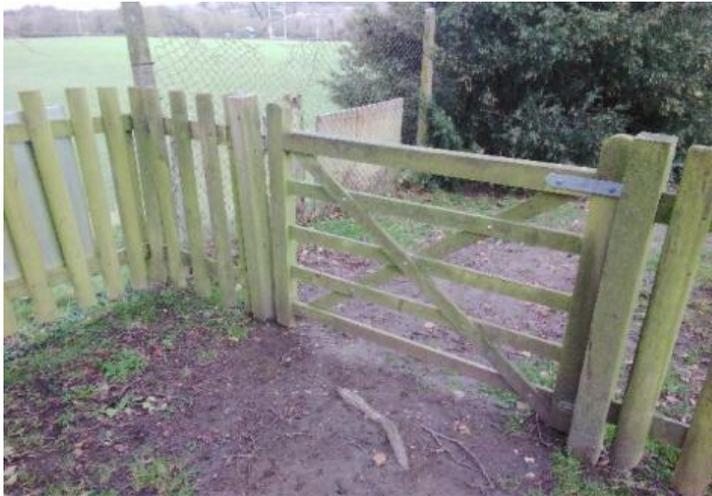
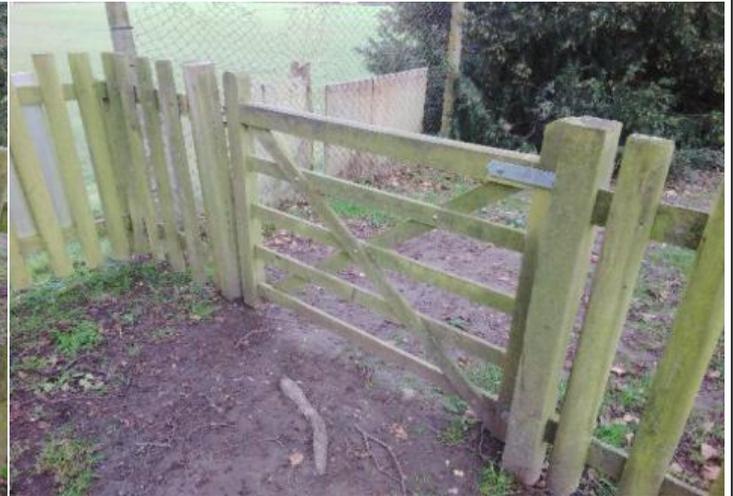
Item: Gates - Gate
Manufacturer: Owner/Operator

Finding: There is algae or moss on the surface of the equipment

Action: Clean and treat appropriately

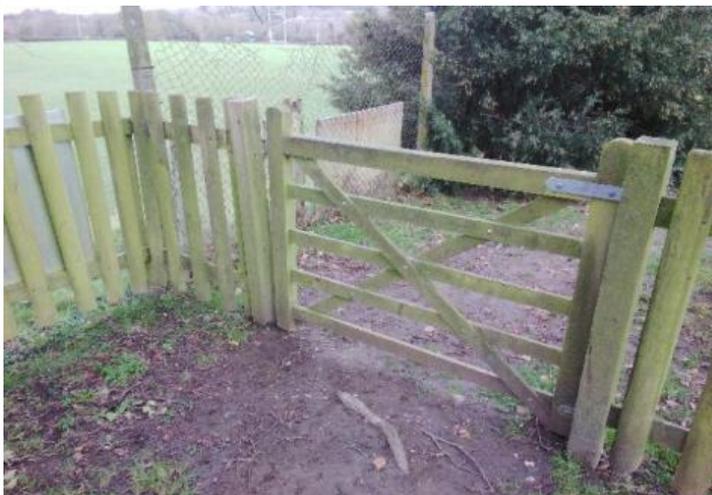
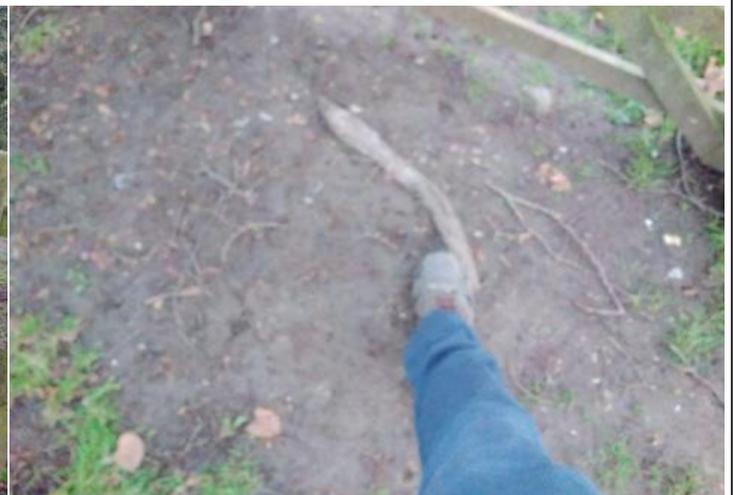
Item: Gates - Gate
Manufacturer: Owner/Operator

Finding: There are trip hazards present

Action: Reinstate surrounding surfaces to level to remove the trip points
