Annual Inspection

Winchester City Council

Sun Hill Recreation Ground (New Alresford)

Derwent Gardens, Alresford, SO24 9NQ

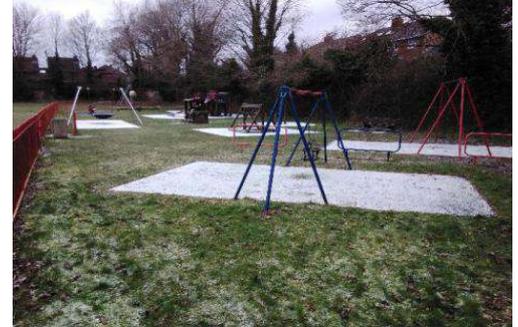
Item: Site General
Manufacturer: Owner/Operator
Surface Type: N/A
Item Quantity: 1
Equipment Compliance: N/A
Surface Area Compliance: N/A

There are trip hazards at the edges of the surface - Reinstate surrounding surface levels to remove the trip points

There is algae or moss growth on the surface resulting in slippery conditions - Clean and treat appropriately

There are gaps opening between the surfacing and the edging surround or between the joints in the surfacing - Monitor for any further deterioration and repair as required

The surface is lifting at the edges and creating trip points - Repair perimeter of surfacing to remove trip points

BMX track has been created outside of the play area and between the cableway - Repair damaged areas of surfacing

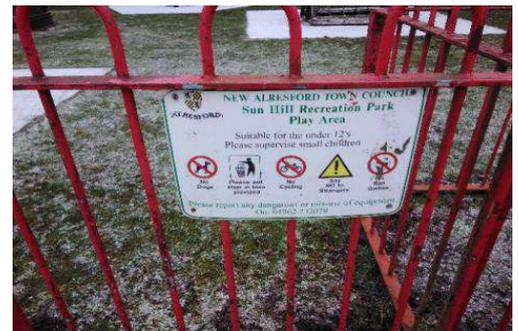
Item: Sign
Manufacturer: Owner/Operator
Surface Type: N/A
Item Quantity: 1
Equipment Compliance: N/A
Surface Area Compliance: N/A

There is some damage to the item - Monitor for any further deterioration and repair as required

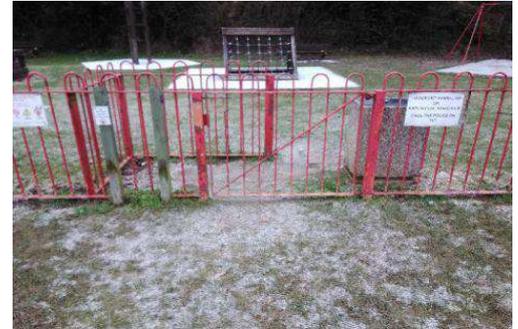
Item: Kissing Gate
Manufacturer: Unknown
Surface Type: Grass Matrix Tiles
Item Quantity: 1
Equipment Compliance: N/A
Surface Area Compliance: N/A

The safety surface under or around this unit has been damage creating a trip hazard - Monitor for any further deterioration and repair as required

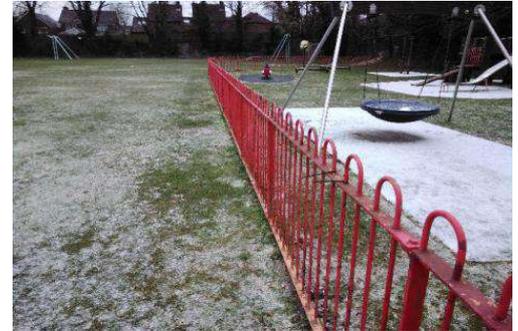
Item: Fence - Bow Top
Manufacturer: Unknown
Surface Type: Grass
Item Quantity: 1
Equipment Compliance: N/A
Surface Area Compliance: N/A

There is some damage to the fence sections - Monitor for any further deterioration and repair as required

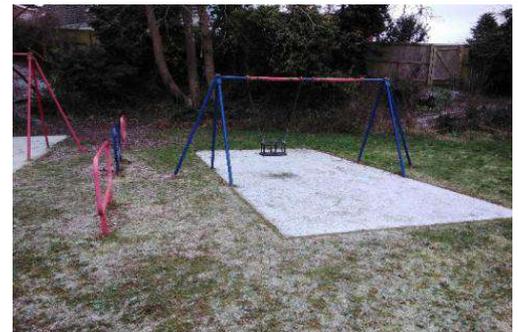
Item: 1 Bay 2 Seat (Cradle)
Manufacturer: Wicksteed Playgrounds
Surface Type: Wet Pour
Item Quantity: 1
Equipment Compliance: No
Surface Area Compliance: No
Life Expectancy: 5 -10 Years
Total Findings: 8

The seat(s) and suspension were missing at the time of inspection and the inspector was unable to make a full compliance assessment - Replace missing seat(s) and suspension

The safety surface under or around this unit has been damaged - Monitor for any further deterioration and repair as required

The safety surface around the area is beginning to wear - Monitor for any further deterioration and repair as required

There is some evidence of fire damage to the surfacing - Monitor for any further deterioration and repair as required

The surfacing dimensions are short and do not meet with the requirements of the current applicable standard - Monitor - no remedial action recommended

The chain openings are in excess of the 8.6mm as recommended by BS EN 1176 - Monitor - No remedial work recommended

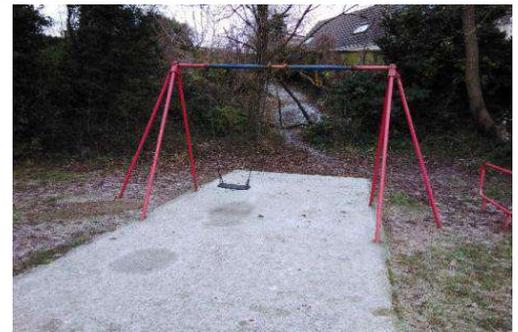
Item: 1 Bay 2 Seat (Flat)
Manufacturer: Wicksteed Playgrounds
Surface Type: Carpet System
Item Quantity: 1
Equipment Compliance: No
Surface Area Compliance: Yes
Life Expectancy: 5 -10 Years
Total Findings: 7

The seat(s) and suspension were missing at the time of inspection and the inspector was unable to make a full compliance assessment - Replace missing seat(s) and suspension

The chain openings are in excess of the 8.6mm as recommended by BS EN 1176 - Monitor - No remedial work recommended

The safety surface around the area is beginning to wear - Monitor for any further deterioration and repair as required

There is some notable evidence of chain wear - Monitor for any further deterioration and replace when 40% worn

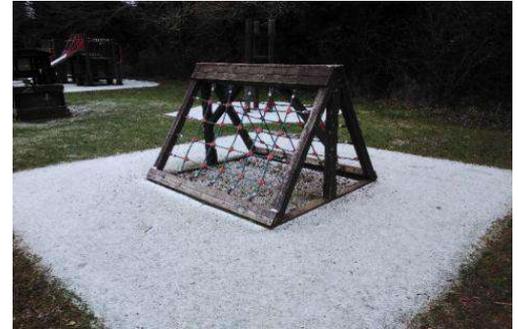
Item: A Frame Climber
Manufacturer: Lappset UK Ltd
Surface Type: Carpet System
Item Quantity: 1
Equipment Compliance: No
Surface Area Compliance: Yes
Life Expectancy: 3 - 5 Years
Total Findings: 6

Parts of the timber are rough or splintered - Remove all rough or sharp edges

The connecting links are in excess of 8.6mm and less than 12mm and fail the requirements of BS EN 1176 Part 1; clause 4.2.13, Chains - Monitor - No remedial work recommended

A number of fixing(s) have worked loose - Secure all loose fixings

There is some evidence of rot in the timber - Monitor for any further deterioration and replace as required

The ropes/nets are worn/damaged in places - Monitor for any further deterioration and repair or replace as required

There is some evidence of fire damage to the item - Monitor for any further deterioration and repair as required

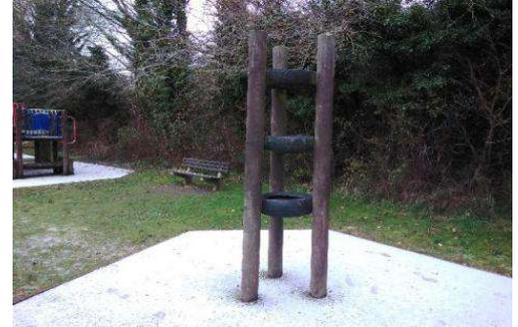
Item: Tyre Climber
Manufacturer: Lappset UK Ltd
Surface Type: Wet Pour
Item Quantity: 1
Equipment Compliance: Yes
Surface Area Compliance: No
Life Expectancy: 3 - 5 Years
Total Findings: 6

Parts of the timber are rough or splintered - Remove all rough or sharp edges

The item has been damaged - Monitor for any further deterioration and replace as required

The item has been damaged top tyre - Monitor for any further deterioration and replace as required

The timber has a number of splits/shakes or air cracks and this may affect the stability or allow water ingress which will accelerate the rotting process - Monitor to ensure the splits do not cross through fixing points of the structure and/or cause any instability

The surfacing dimensions are short and do not meet with the requirements of the current applicable standard (2360mm required / 1884mm provided) - Monitor - No remedial work recommended

This item of equipment relies on a single post, or a line of posts, for stability and extra care needs to be taken with equipment of this nature to avoid the potential for catastrophic failure - Ensure that regular detailed inspections are undertaken to assess for rot, corrosion and general stability

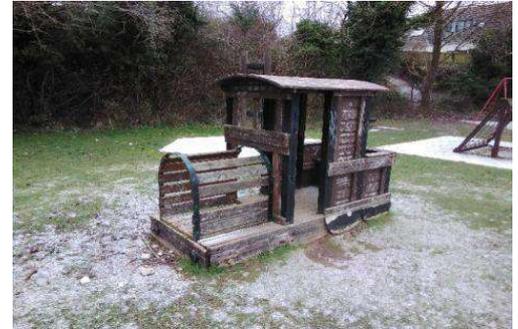
Item: Train
Manufacturer: Lappset UK Ltd
Surface Type: Grass
Item Quantity: 1
Equipment Compliance: Yes
Surface Area Compliance: Yes
Life Expectancy: 3 - 5 Years
Total Findings: 11

There is some graffiti present - Remove the graffiti

A number of fixing(s) have worked loose - Secure all loose fixings

There is/are bolt cap covers missing or damaged on the item - Replace missing or damaged bolt cap covers

There is/are a number of missing or damaged slats. - Repair or Replace as required

There is or are fixings missing on the item - Replace all missing fixings

There are areas or parts of the timber on the structure that have rotted - Replace all affected timbers

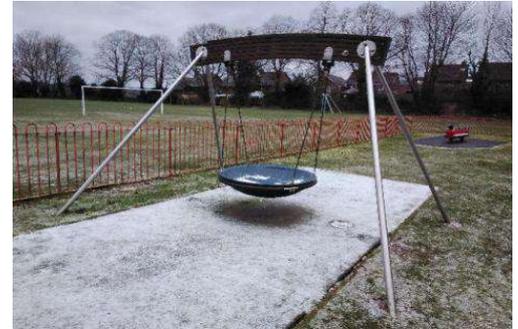
Item: Basket Swing - Type 1
Manufacturer: Proludic
Surface Type: Wet Pour
Item Quantity: 1
Equipment Compliance: No
Surface Area Compliance: Yes
Life Expectancy: 5 -10 Years
Total Findings: 6

The safety surface under or around this unit has been damaged - Monitor for any further deterioration and repair as required

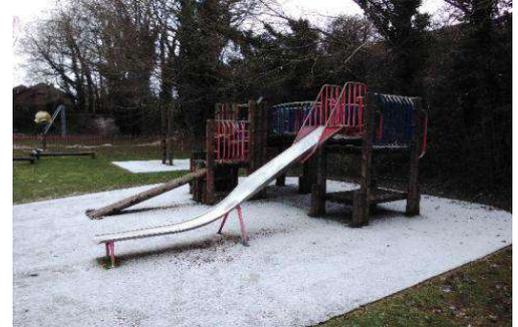
Item: Multi Play (Junior)
Manufacturer: Wicksteed Playgrounds
Surface Type: Wet Pour
Item Quantity: 1
Equipment Compliance: No
Surface Area Compliance: Yes
Life Expectancy: 3 - 5 Years
Total Findings: 16

The timber on this item has severe rot - Remove and replace all affected timber sections

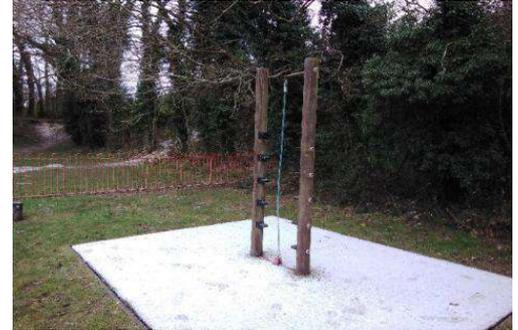
Item: Climbing Post
Manufacturer: Lappset UK Ltd
Surface Type: Wet Pour
Item Quantity: 1
Equipment Compliance: Yes
Surface Area Compliance: Yes
Life Expectancy: 3 - 5 Years
Total Findings: 6

This item of equipment relies on a single post, or a line of posts, for stability and extra care needs to be taken with equipment of this nature to avoid the potential for catastrophic failure - Ensure that regular detailed inspections are undertaken to assess for rot, corrosion and general stability

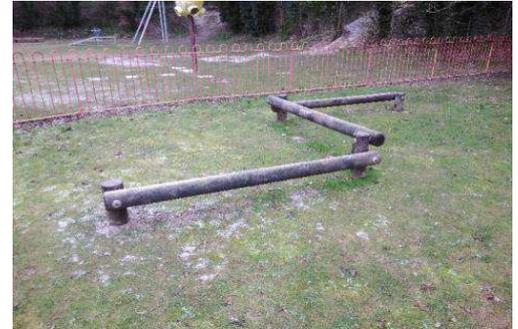
Item: Balance Beam
Manufacturer: Lappset UK Ltd
Surface Type: Grass
Item Quantity: 1
Equipment Compliance: Yes
Surface Area Compliance: Yes
Life Expectancy: 3 - 5 Years
Total Findings: 3

Parts of the timber are rough or splintered - Remove all rough or sharp edges

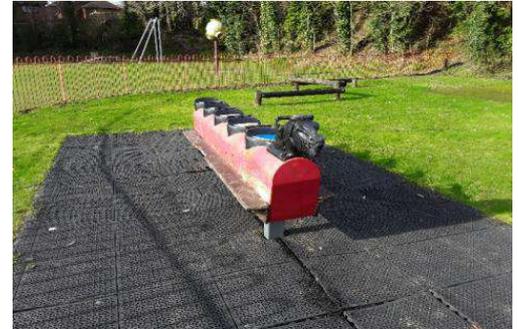
Item: Rocking Horse
Manufacturer: Wicksteed Playgrounds
Surface Type: Matta
Item Quantity: 1
Equipment Compliance: No
Surface Area Compliance: Yes
Life Expectancy: 3 - 5 Years
Total Findings: 8

There are significant gaps (over 30mm) between the surface and the edging or between the joints in the surface; these are large enough for a small foot to enter - Repair surfacing

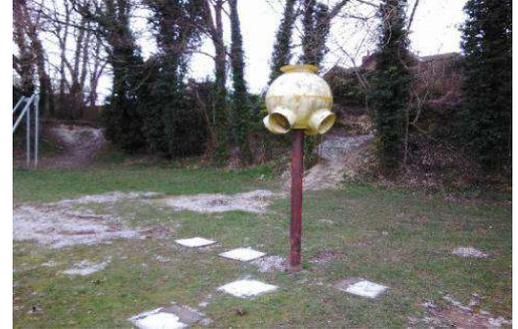
Item: Ball Shoot
Manufacturer: Wicksteed Playgrounds
Surface Type: Grass
Item Quantity: 1
Equipment Compliance: Yes
Surface Area Compliance: N/A
Life Expectancy: 3 - 5 Years
Total Findings: 4

The paint is flaking off the metalwork - Rub down and re-paint

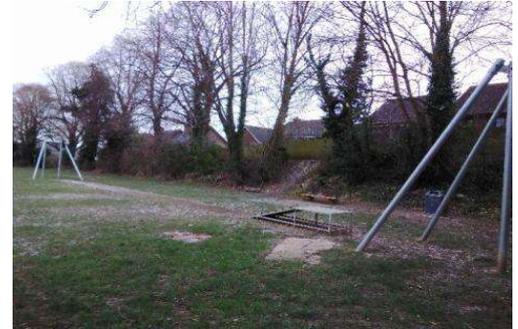
Item: Cable Runway
Manufacturer: Wicksteed Playgrounds
Surface Type: Grass Matrix Tiles
Item Quantity: 1
Equipment Compliance: No
Surface Area Compliance: Yes
Life Expectancy: 5 -10 Years
Total Findings: 6

We have completed a visual inspection of the cable and fixing points from ground level, however it is not possible to fully inspect the cable and fixings without either hiring equipment to gain access or removing the cable and inspecting at ground level. We recommend that the main cable and fixing security is thoroughly inspected at least in accordance with the manufacturers recommendations to check for damage, security or internal rusting, this will help to ensure the continued safe use of the equipment - Inspect in accordance with the manufacturers recommendations

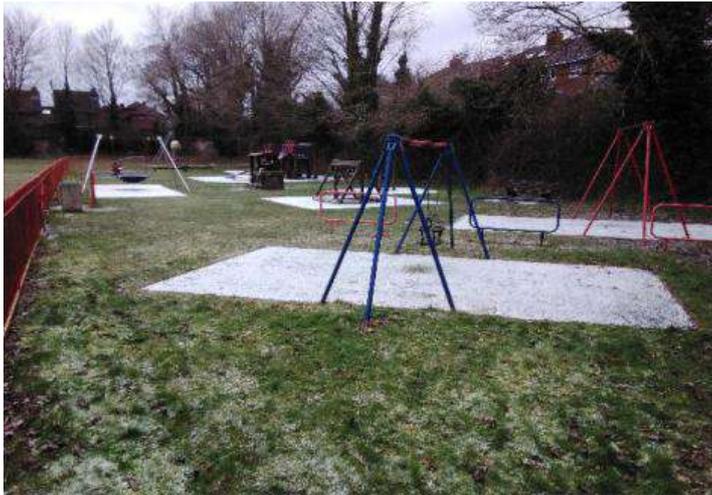
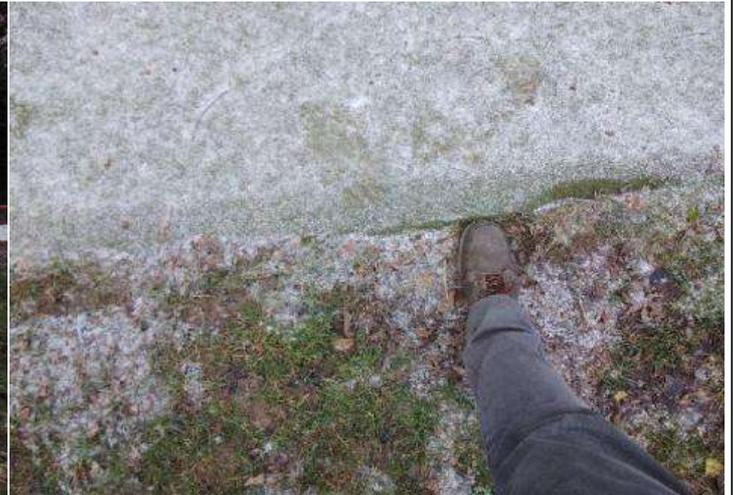
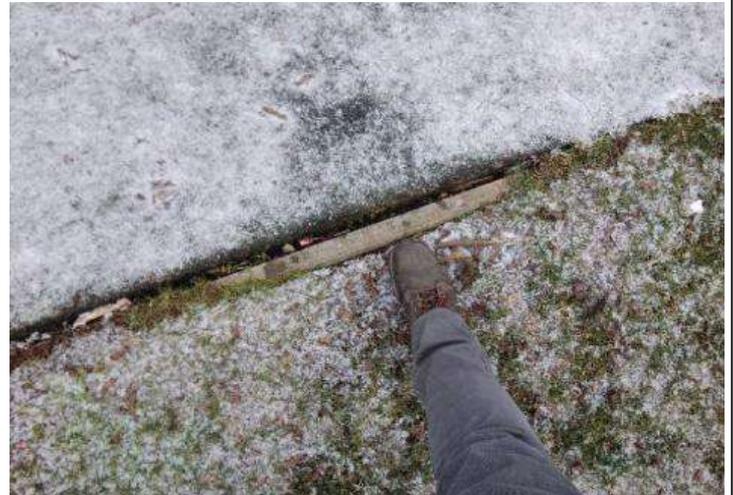
Finding: There are trip hazards at the edges of the surface

Action: Reinststate surrounding surface levels to remove the trip points

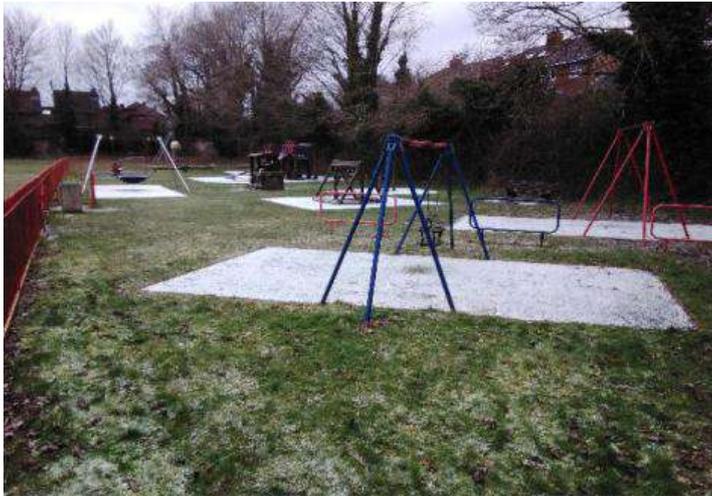
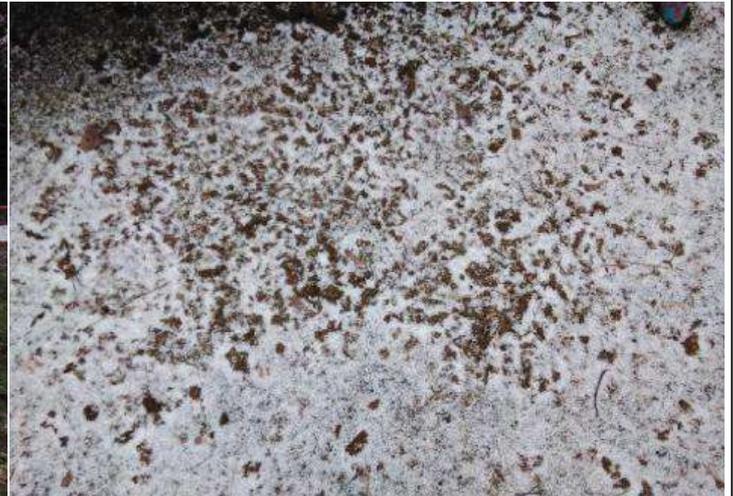
Finding: There is algae or moss growth on the surface resulting in slippery conditions

Action: Clean and treat appropriately

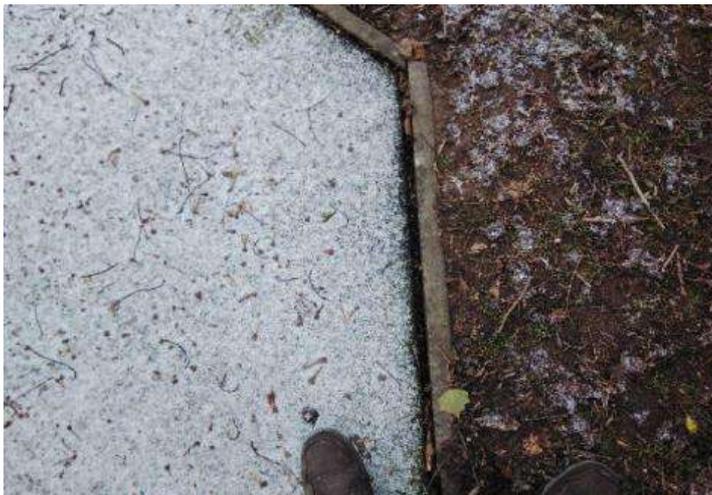
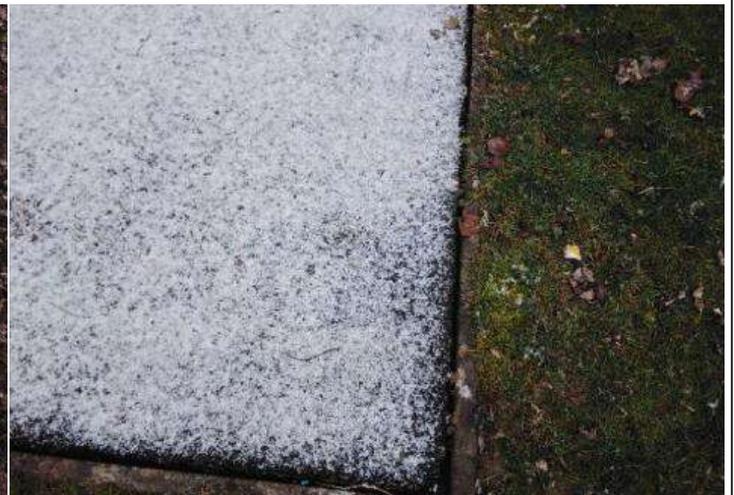
Finding: There are gaps opening between the surfacing and the edging surround or between the joints in the surfacing
Action: Monitor for any further deterioration and repair as required

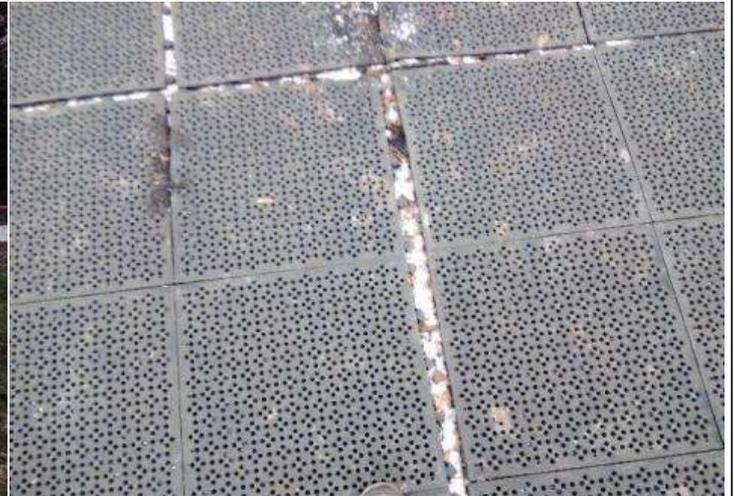
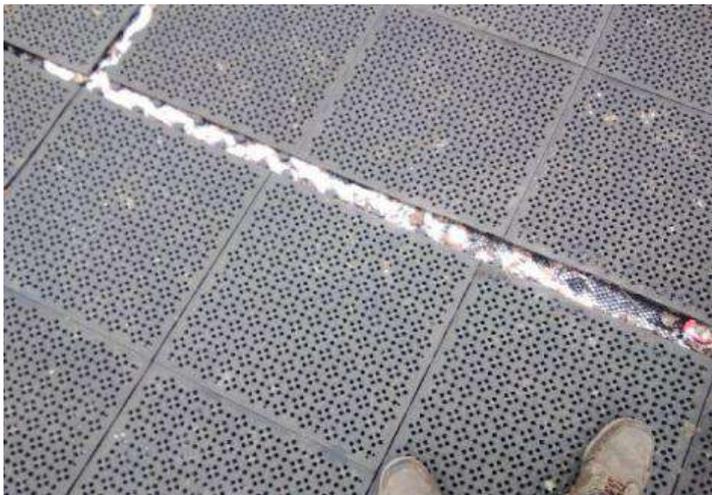
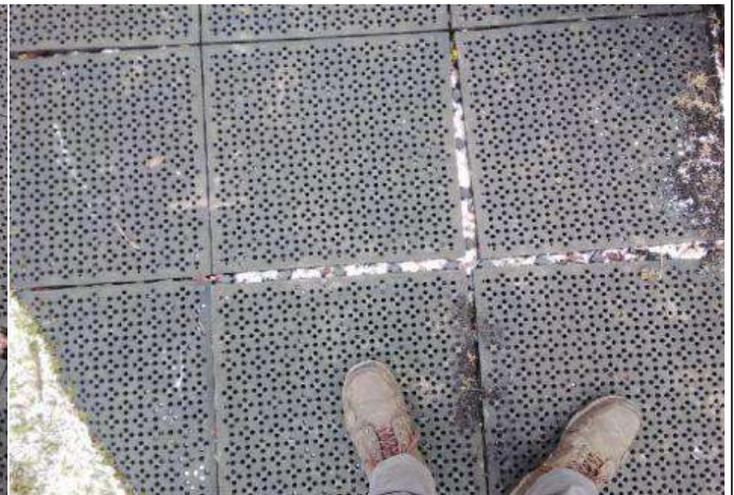
Finding: There are gaps opening between the grass mat tiles

Action: Reinststate surface

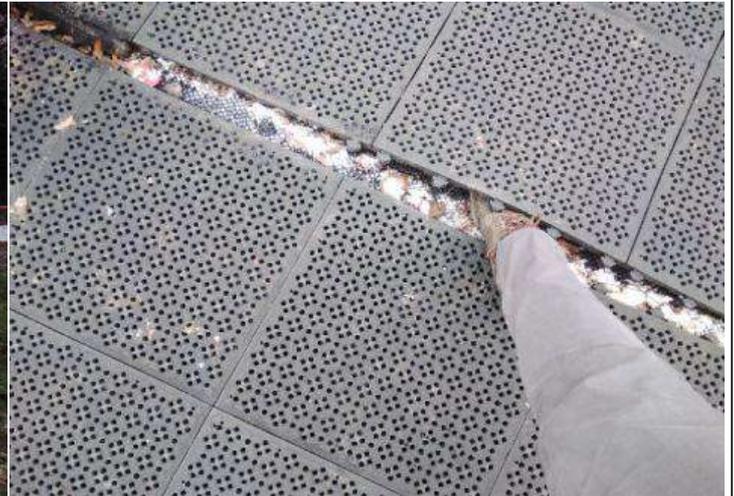
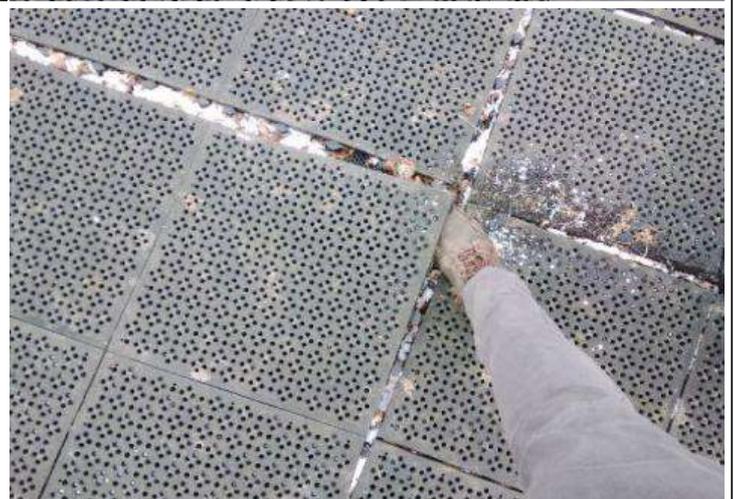
Finding: The tiles can easily be lifted or are lifting along the edges of the area
Action: Lift and re-glue tiles to secure

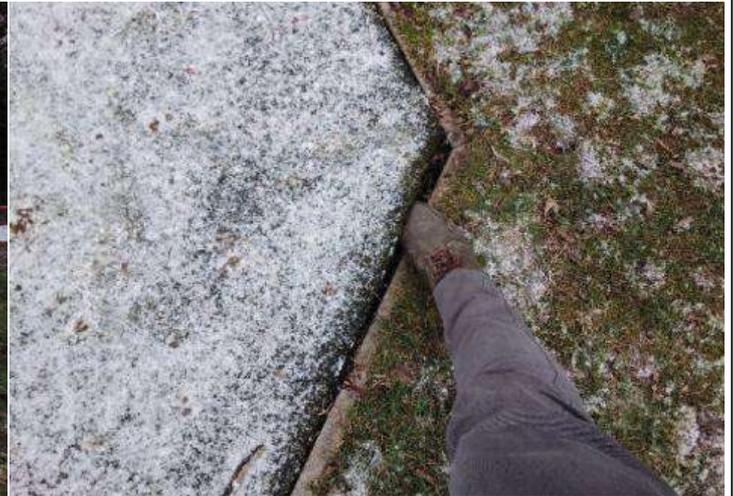
Finding: The surface is lifting at the edges and creating trip points

Action: Repair perimeter of surfacing to remove trip points

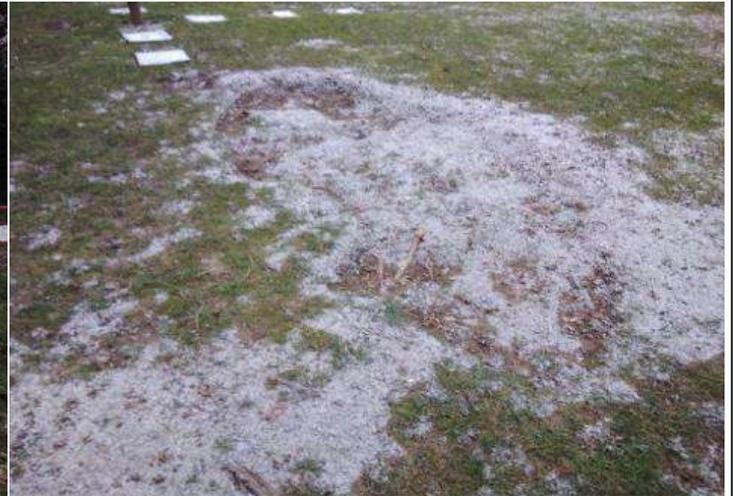
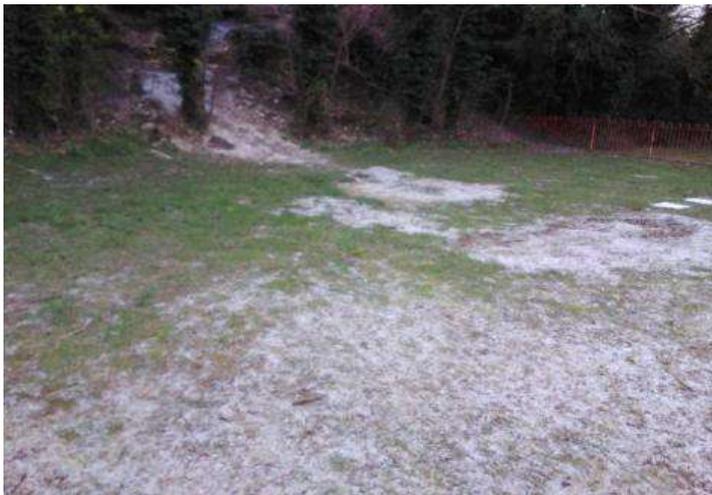
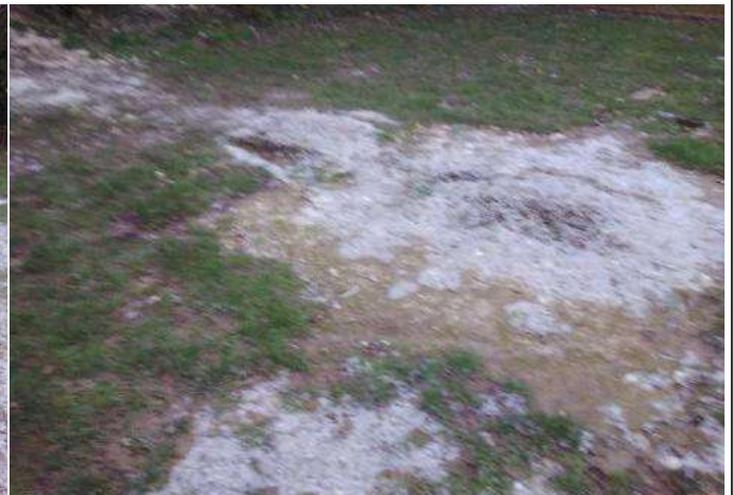
Finding: BMX track has been created outside of the play area and between the cableway

Action: Repair damaged areas of surfacing

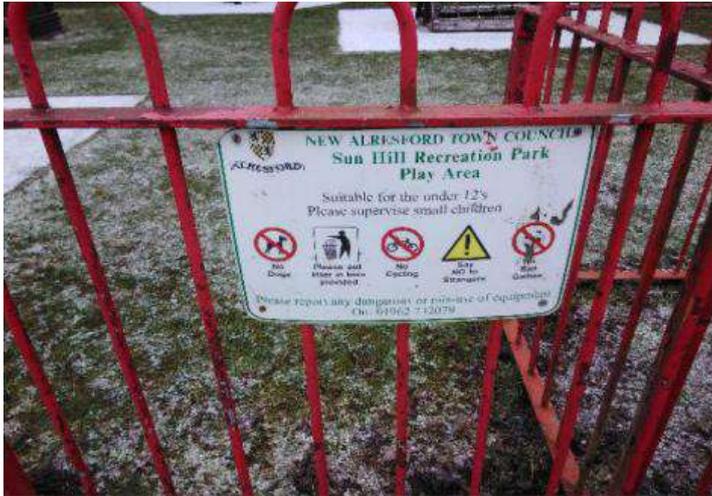
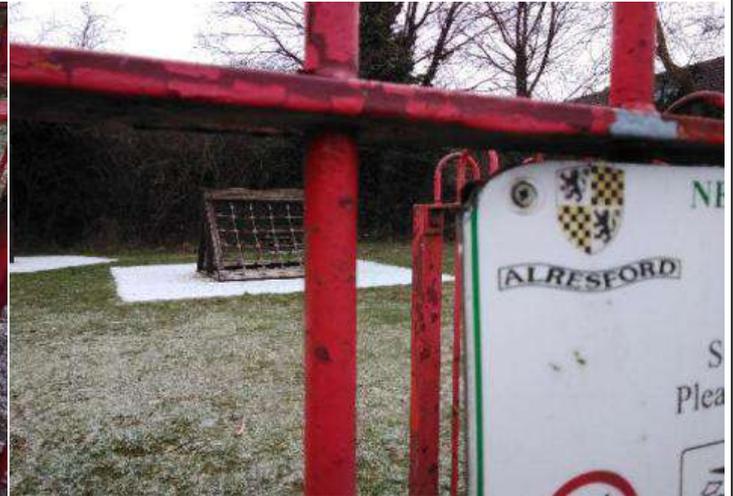
Finding: There is some damage to the item

Action: Monitor for any further deterioration and repair as required

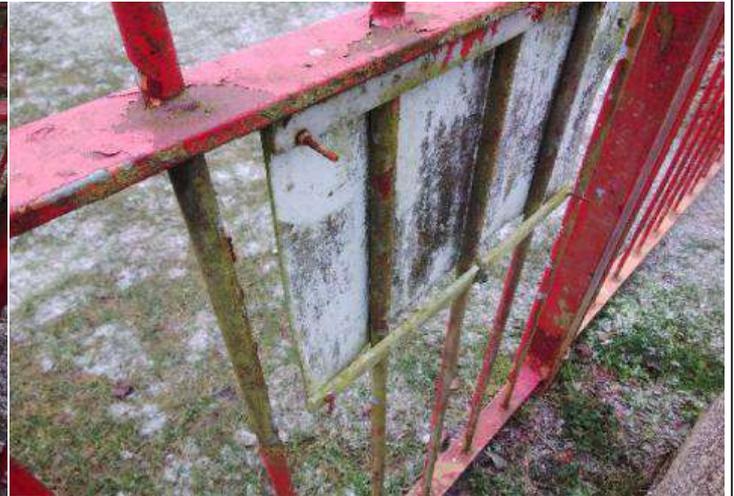
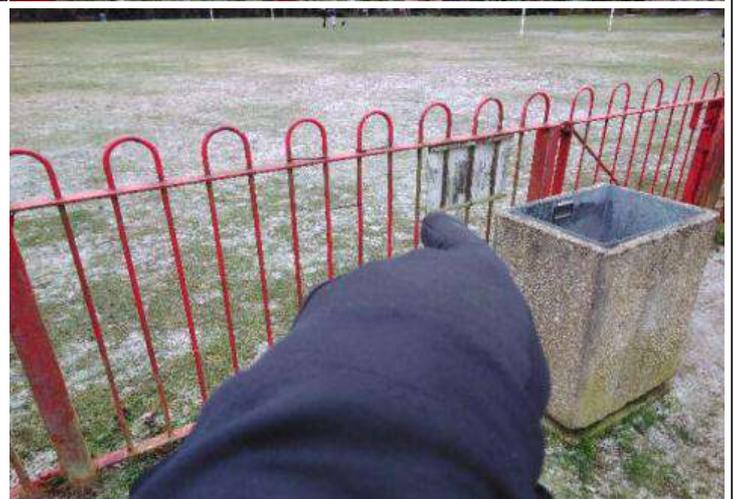
Item: Ancillary Items - Sign
Manufacturer: Owner/Operator

Finding: There are projecting bolt thread(s) present

Action: Remove excess thread length and deburr or provide cap

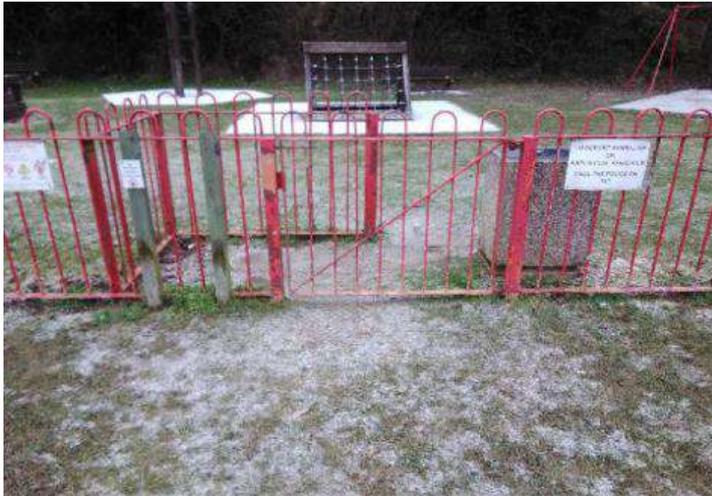
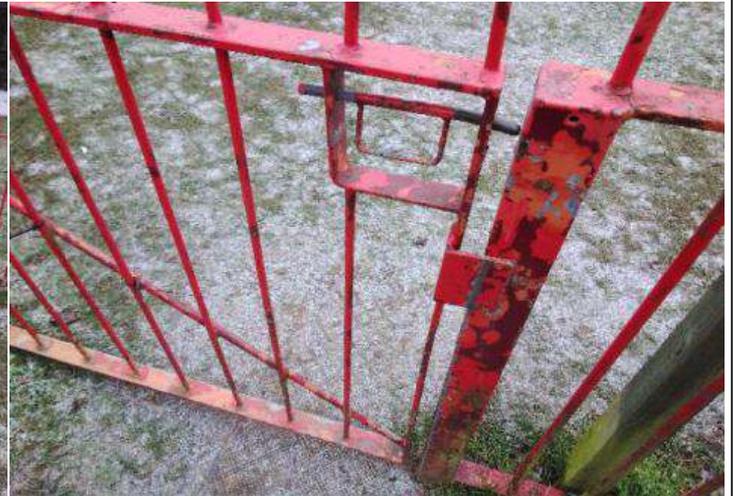
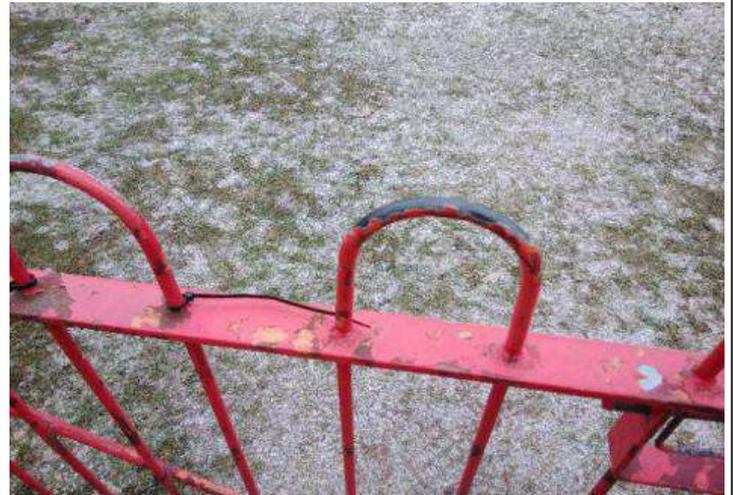
Item: Gates - Kissing Gate
Manufacturer: Unknown

Finding: The paint is flaking off the metalwork

Action: Rub down and re-paint

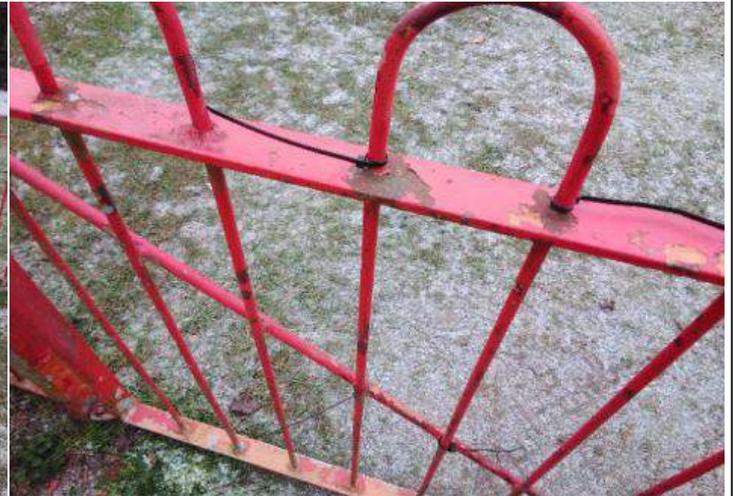
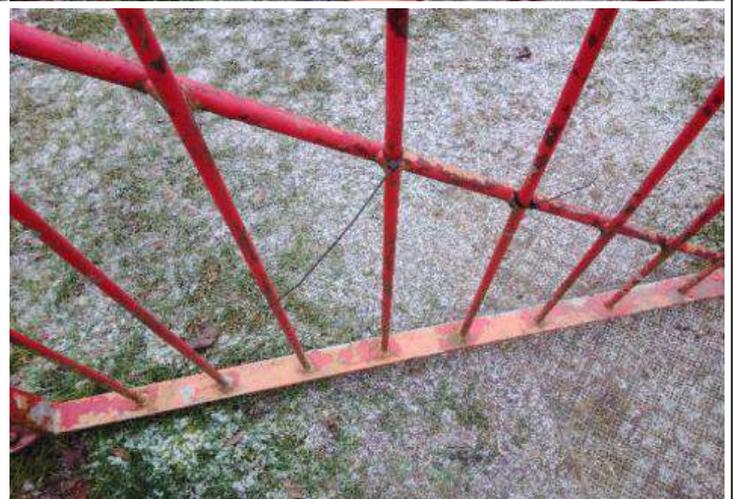
Item: Gates - Kissing Gate
Manufacturer: Unknown

Finding: Cable ties present

Action: Remove cable ties

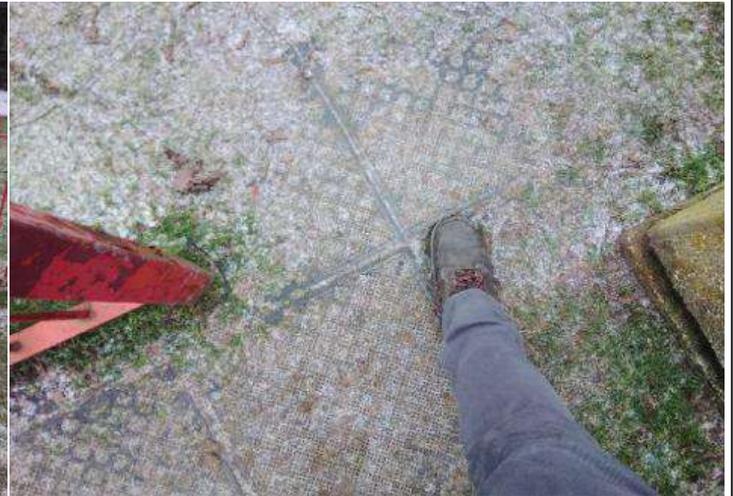
Item: Gates - Kissing Gate
Manufacturer: Unknown

Finding: The safety surface under or around this unit has been damaged creating a trip hazard

Action: Monitor for any further deterioration and repair as required

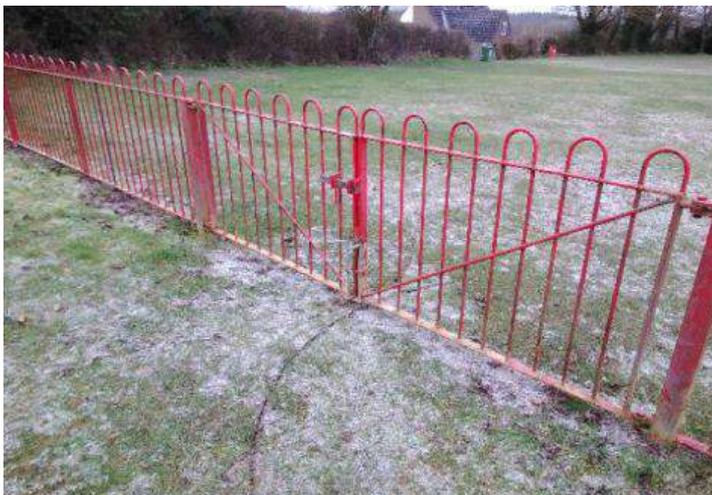
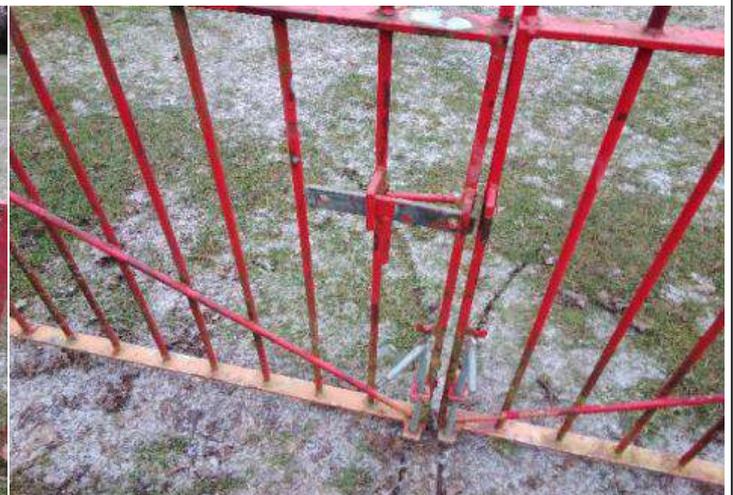
Item: Gates - Gate - Maintenance
Manufacturer: Unknown

Finding: There is no padlock on the maintenance gate

Action: Provide a padlock to secure the gate

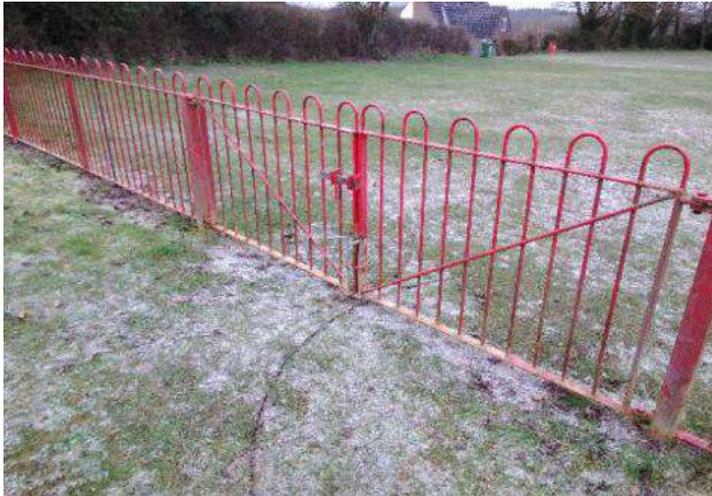
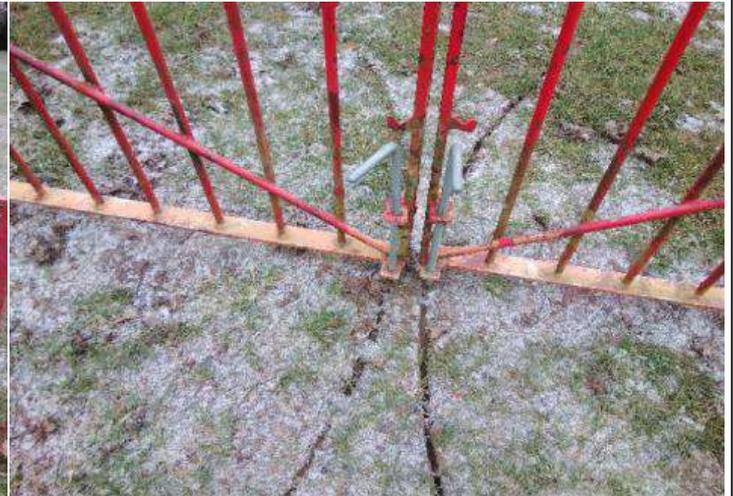
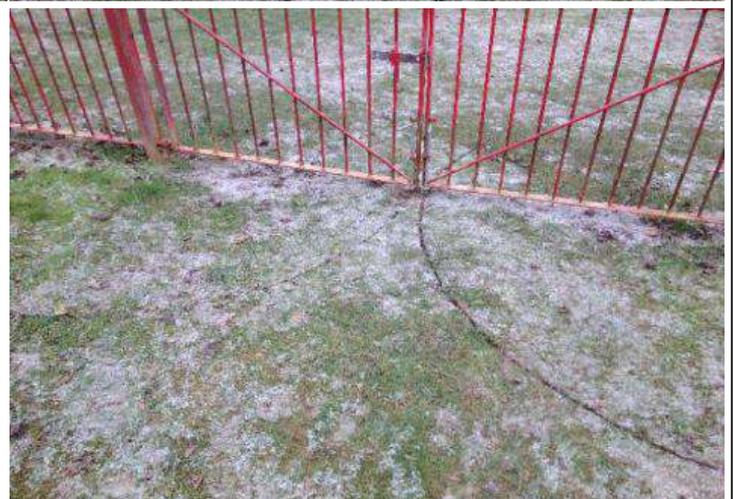
Item: Gates - Gate - Maintenance
Manufacturer: Unknown

Finding: The gate has no drop bolt sleeves and/or drop bolts fitted

Action: Provide drop bolt sleeves and/or drop bolts

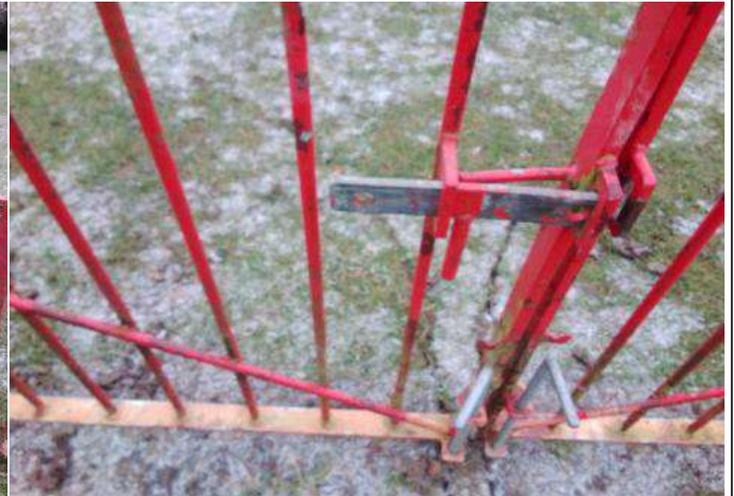
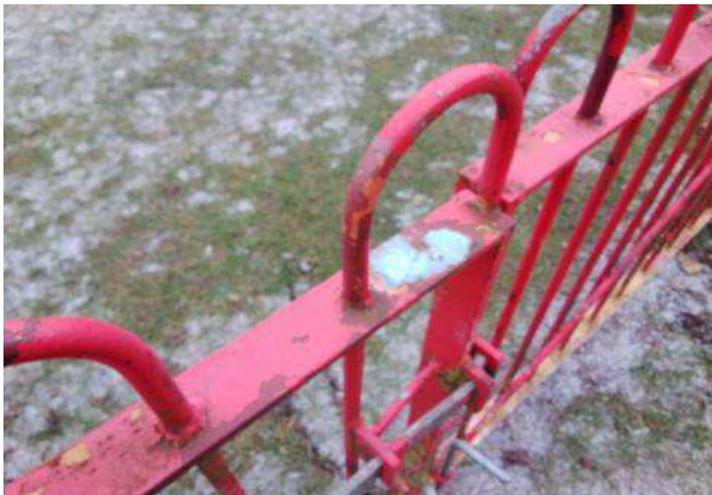
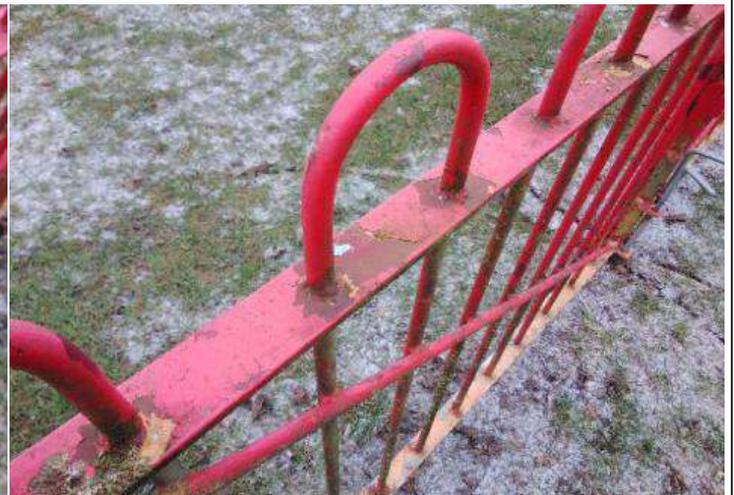
Item: Gates - Gate - Maintenance
Manufacturer: Unknown

Finding: The paint is flaking off the metalwork

Action: Rub down and re-paint

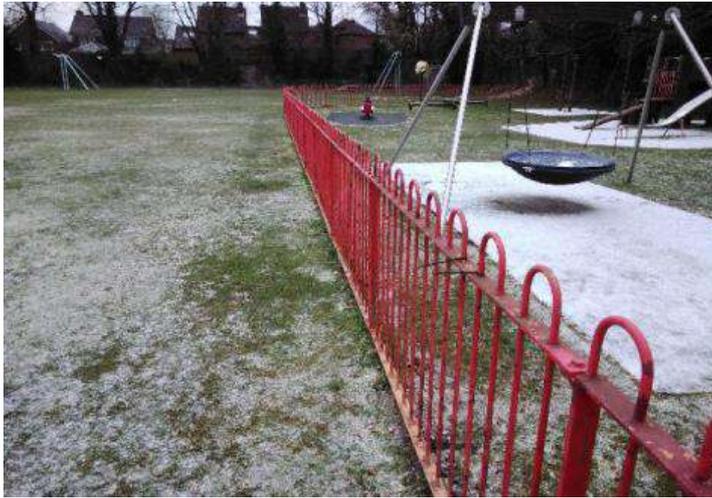
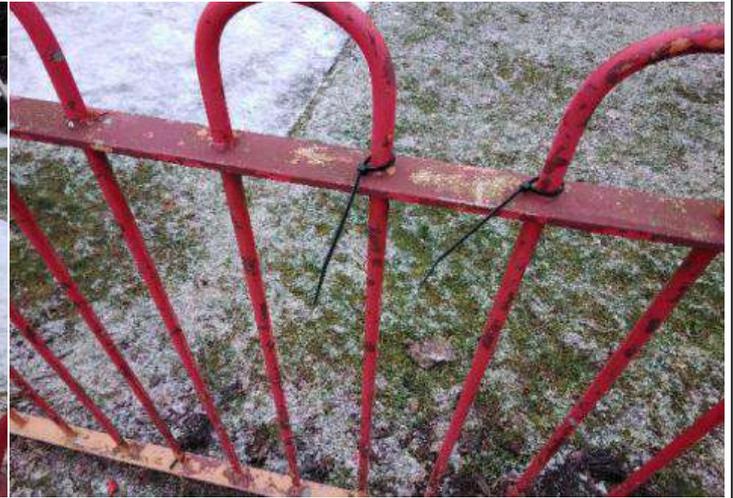
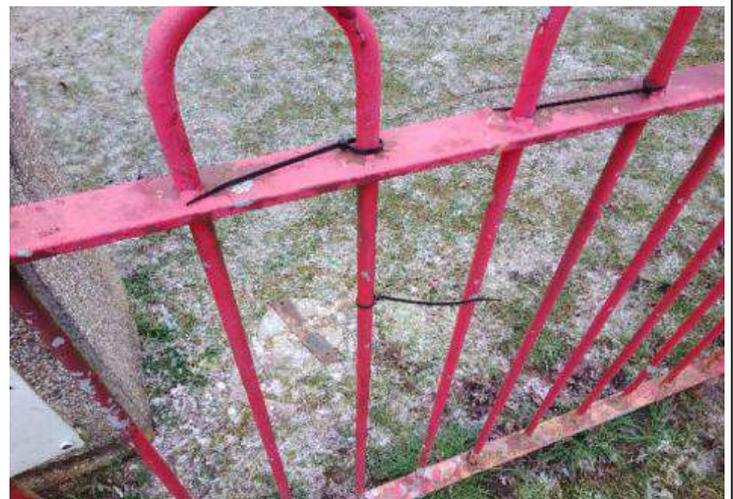
Item: Fences - Fence - Bow Top
Manufacturer: Unknown

Finding: Cable ties present

Action: Remove cable ties

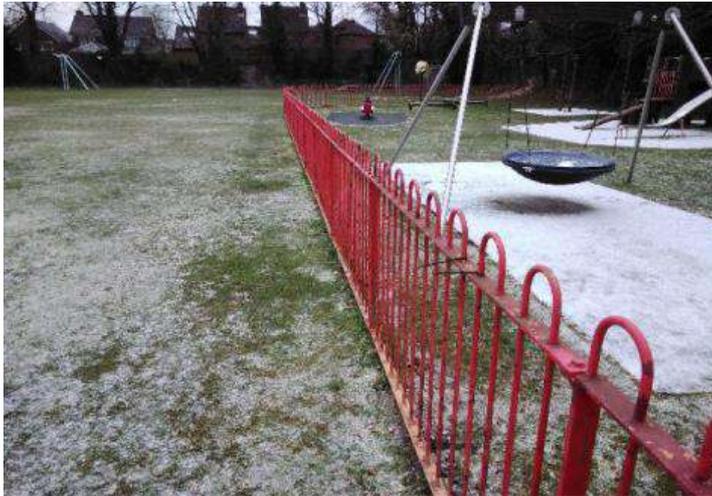
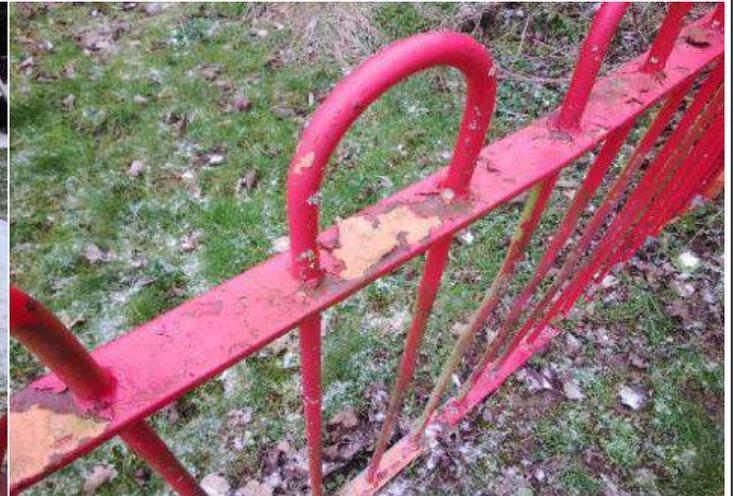
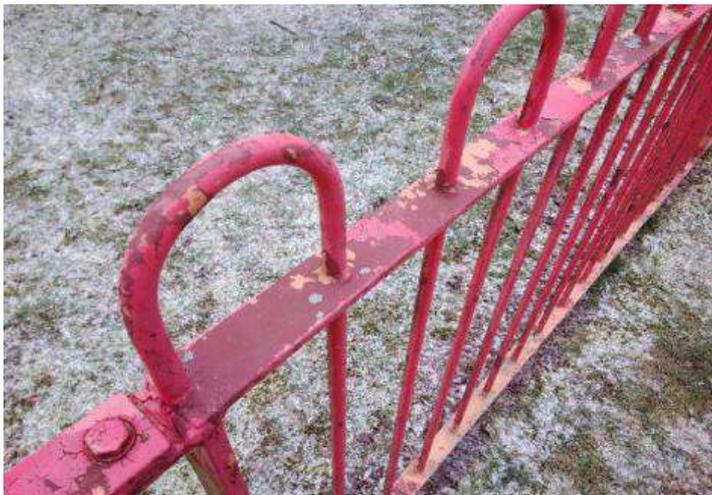
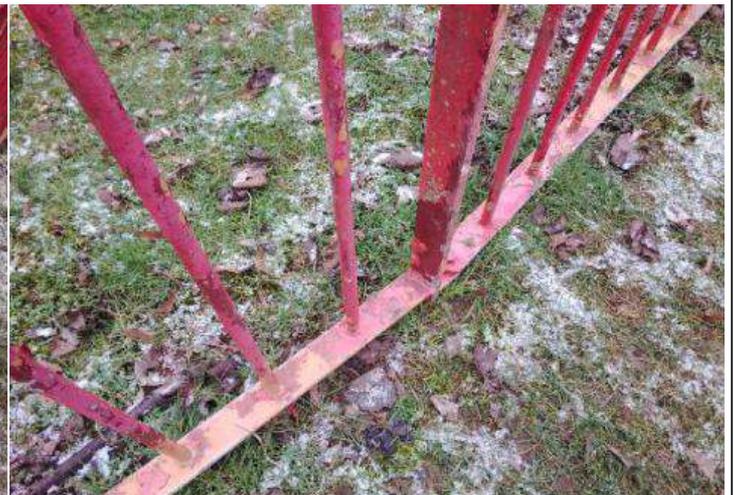
Item: Fences - Fence - Bow Top
Manufacturer: Unknown

Finding: The paint is flaking off the metalwork

Action: Rub down and re-paint

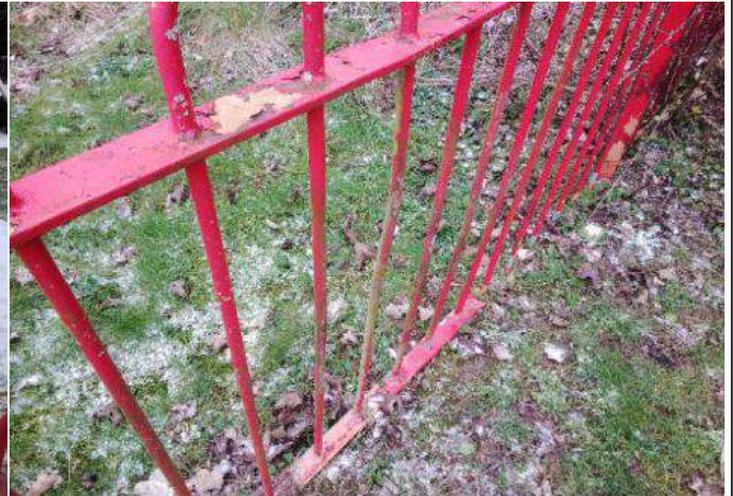
Item: Fences - Fence - Bow Top
Manufacturer: Unknown

Finding: There is some damage to the fence sections

Action: Monitor for any further deterioration and repair as required

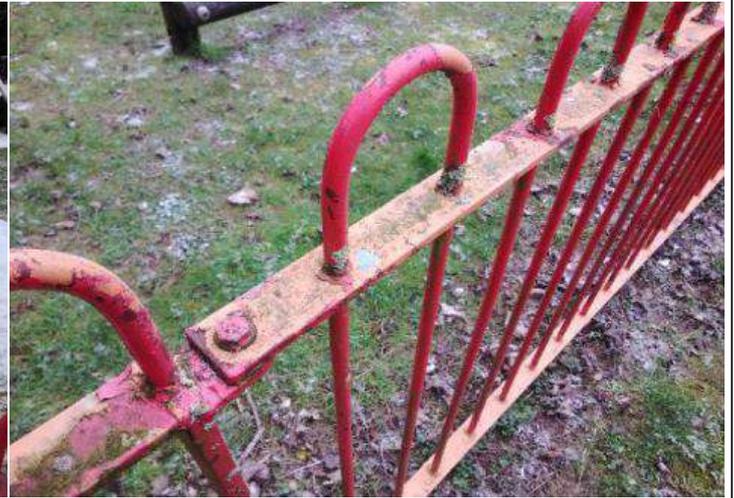
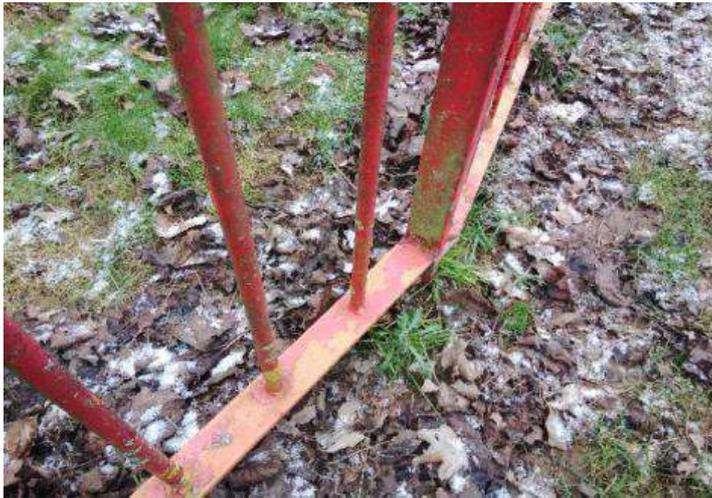
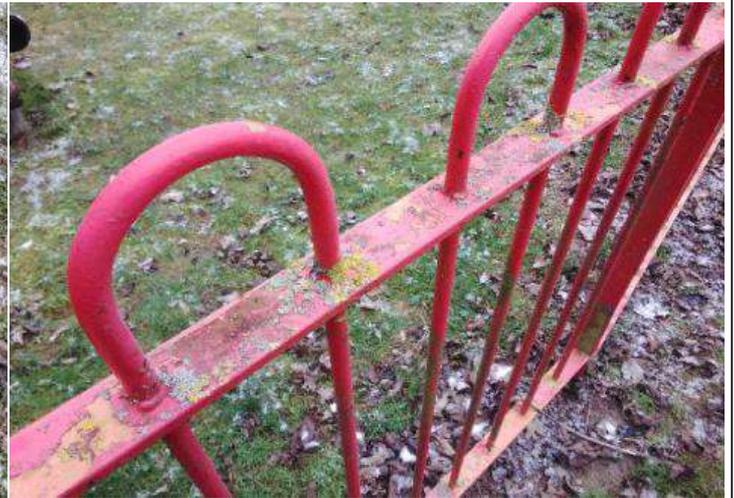
Item: Fences - Fence - Bow Top
Manufacturer: Unknown

Finding: There is algae or moss on the surface of the equipment

Action: Clean and treat appropriately

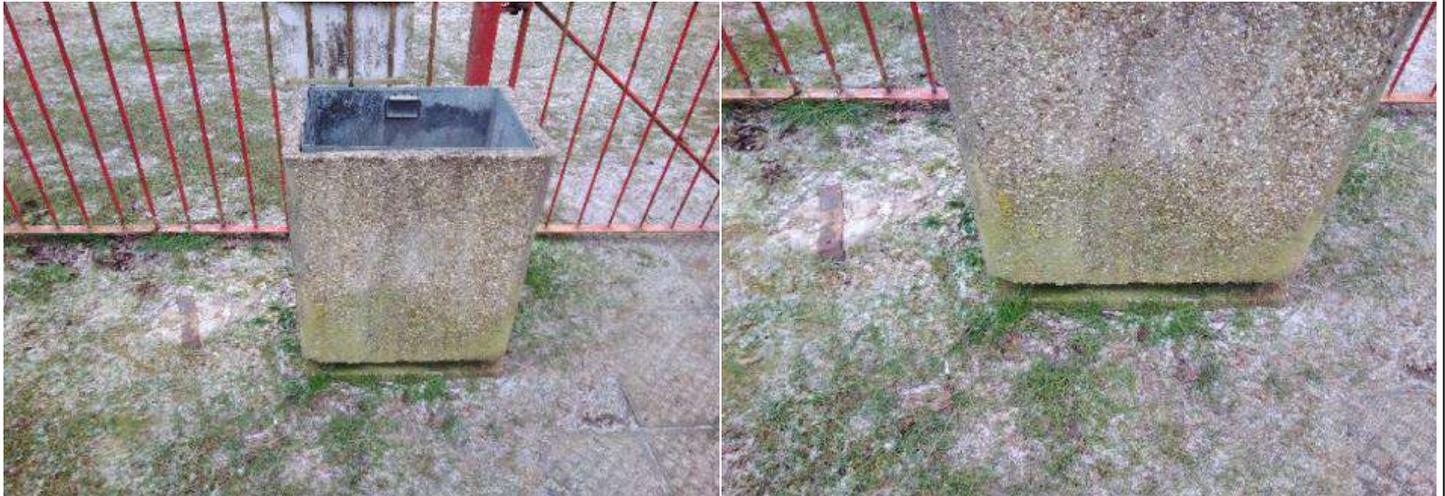
Item: Ancillary Items - Litter Bin
Manufacturer: Unknown

Finding: There is algae or moss on the surface of the equipment

Action: Clean and treat appropriately
