Annual Inspection

Winchester City Council

Sun Hill Recreation Ground (New Alresford)

Derwent Gardens, Alresford, SO24 9NQ

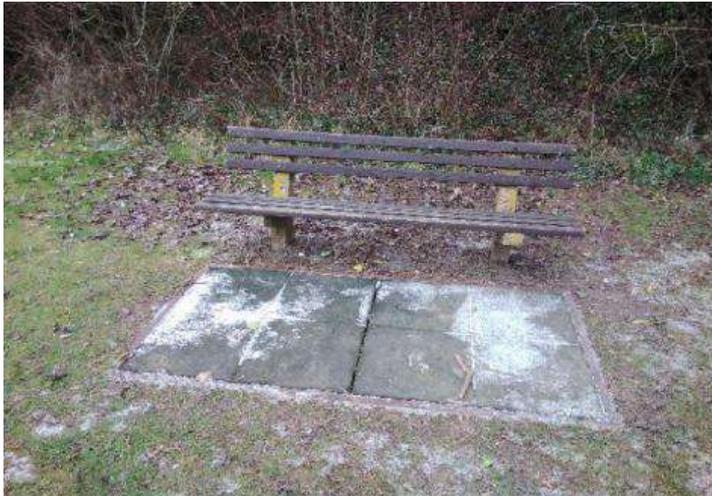
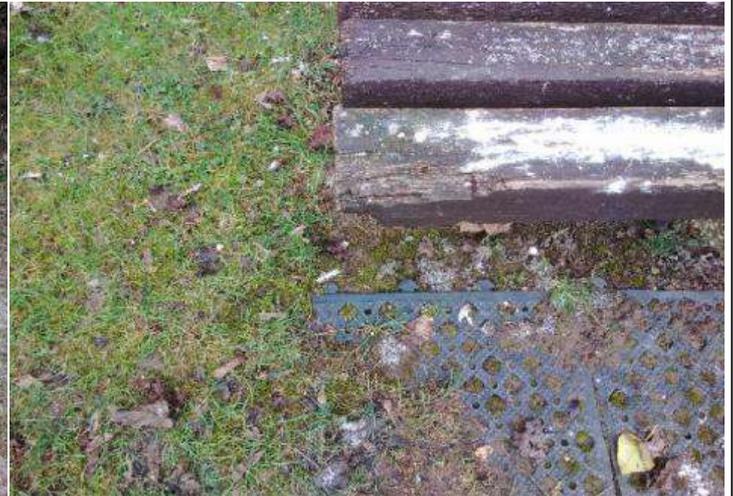
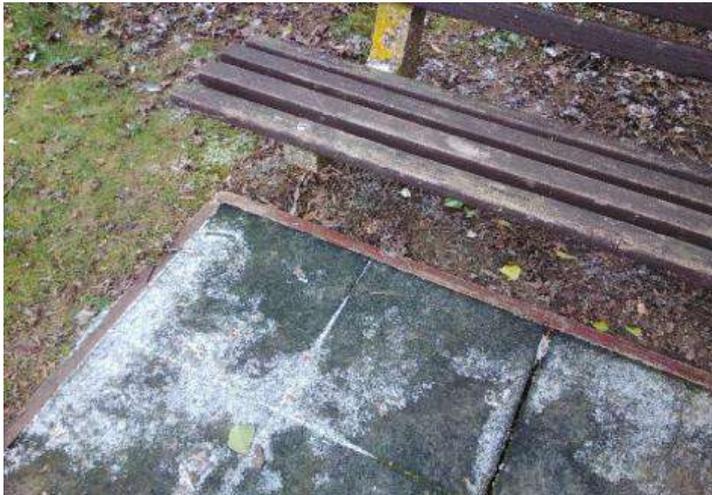
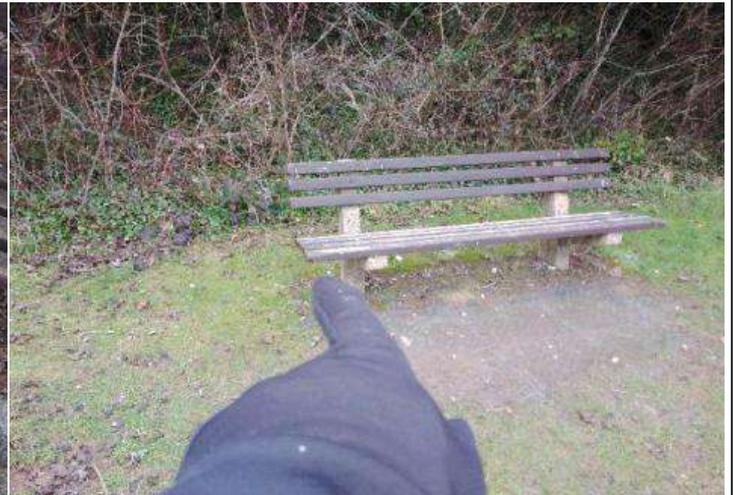
Item: Ancillary Items - Bench
Manufacturer: Unknown

Finding: Parts of the timber are rough or splintered

Action: Remove all rough or sharp edges

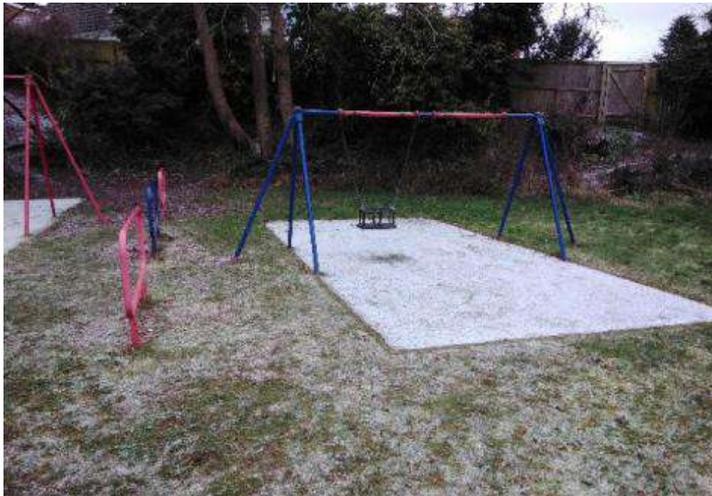
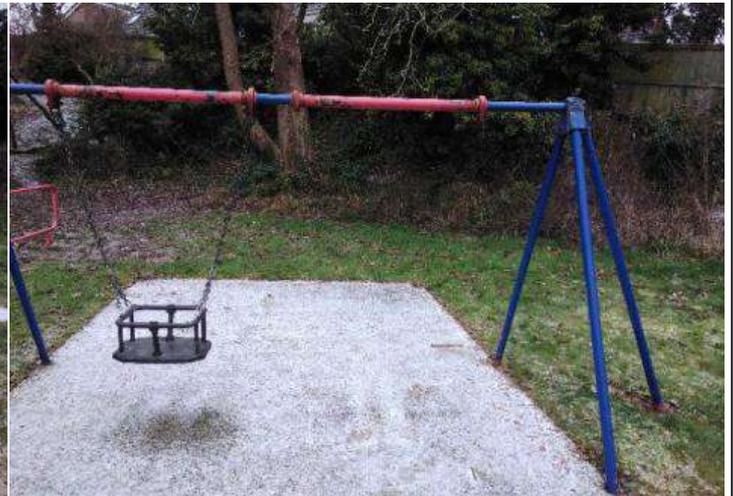
Item: Swings - 1 Bay 2 Seat (Cradle)
Manufacturer: Wicksteed Playgrounds

Finding: The seat(s) and suspension were missing at the time of inspection and the inspector was unable to make a full compliance assessment

Action: Replace missing seat(s) and suspension

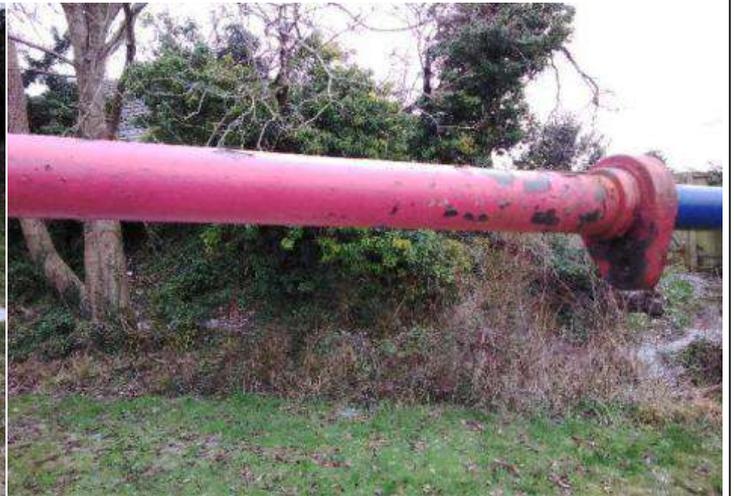
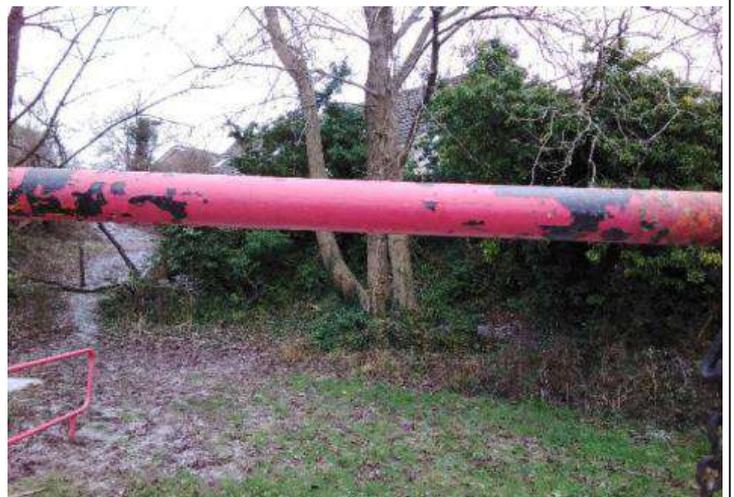
Item: Swings - 1 Bay 2 Seat (Cradle)
Manufacturer: Wicksteed Playgrounds

Finding: The paint is flaking off the metalwork

Action: Rub down and re-paint

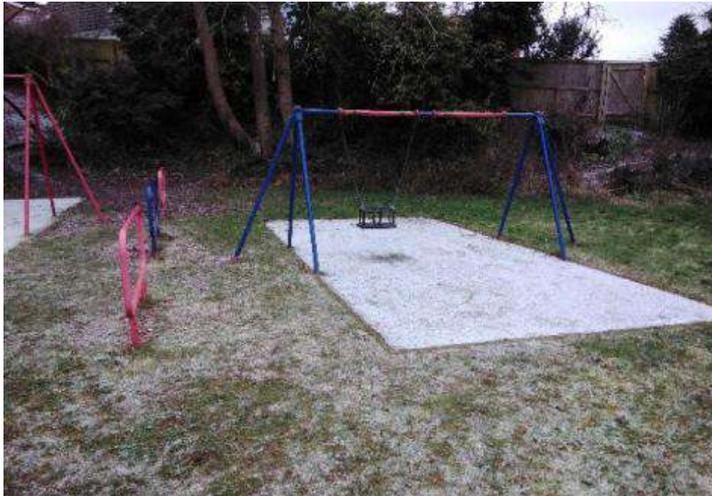
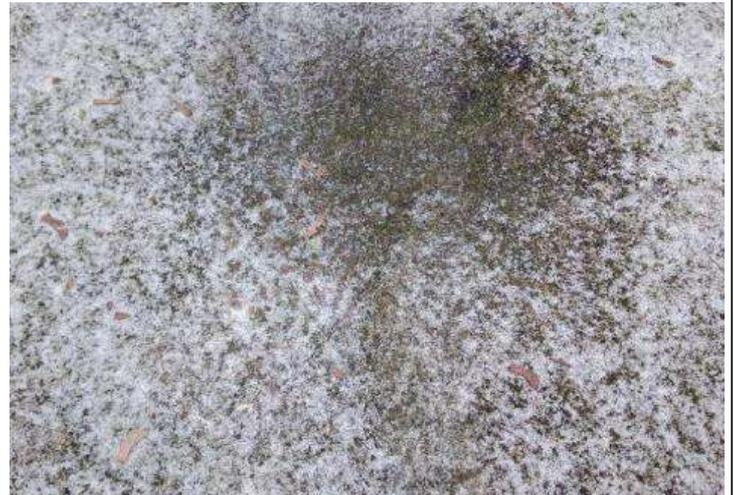
Item: Swings - 1 Bay 2 Seat (Cradle)
Manufacturer: Wicksteed Playgrounds

Finding: The safety surface under or around this unit has been damaged

Action: Monitor for any further deterioration and repair as required

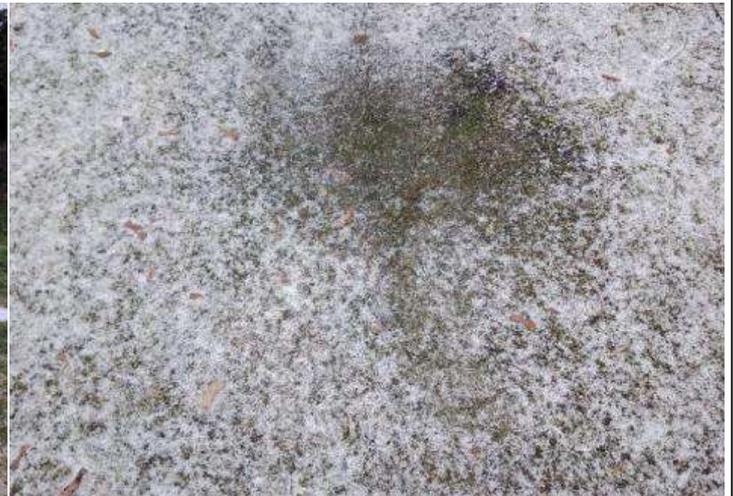
Item: Swings - 1 Bay 2 Seat (Cradle)
Manufacturer: Wicksteed Playgrounds

Finding: The safety surface around the area is beginning to wear

Action: Monitor for any further deterioration and repair as required

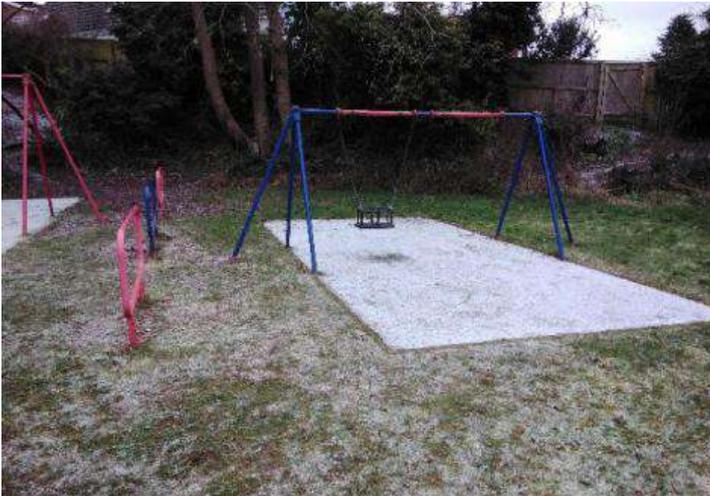
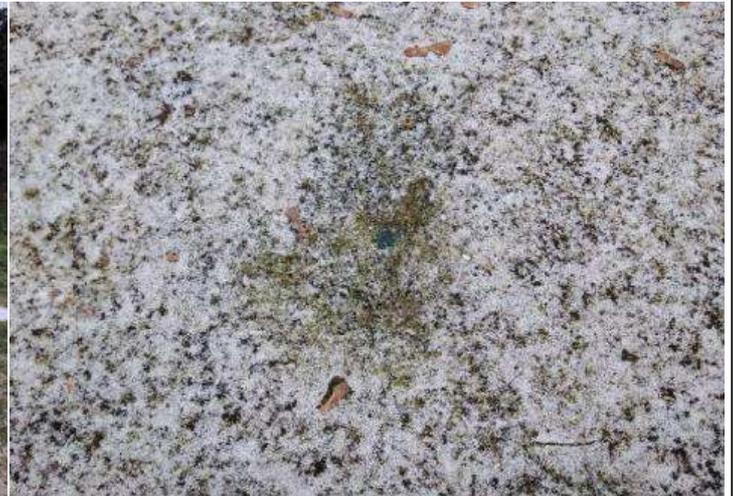
Item: Swings - 1 Bay 2 Seat (Cradle)
Manufacturer: Wicksteed Playgrounds

Risk Level: L - Low Risk
Surface: Wet Pour

Finding: There is some evidence of fire damage to the surfacing

Action: Monitor for any further deterioration and repair as required

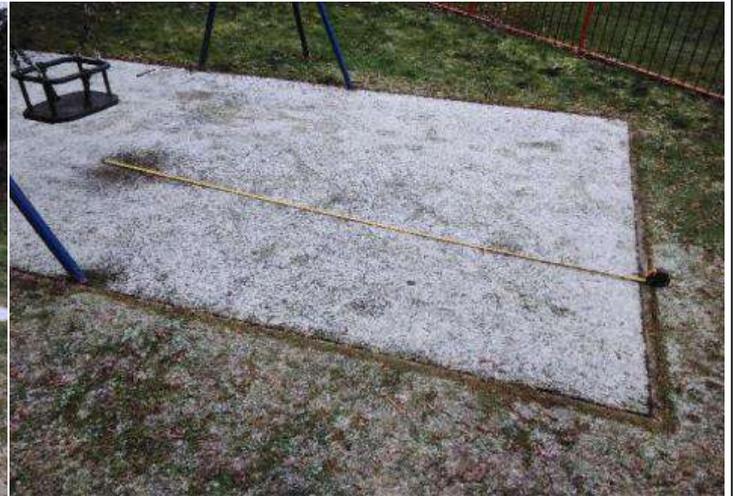
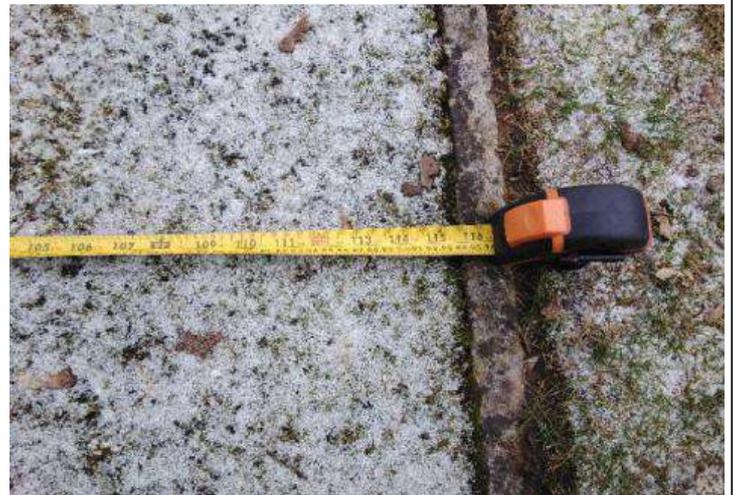
Item: Swings - 1 Bay 2 Seat (Cradle)
Manufacturer: Wicksteed Playgrounds

Risk Level: V - Very Low Risk
Surface: Wet Pour

Finding: The surfacing dimensions are short and do not meet with the requirements of the current applicable standard

Action: Monitor - no remedial action recommended

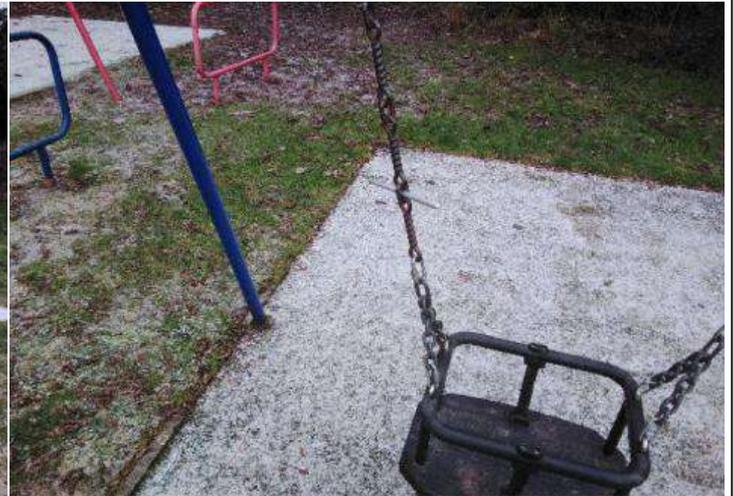
Item: Swings - 1 Bay 2 Seat (Cradle)
Manufacturer: Wicksteed Playgrounds

Risk Level: V - Very Low Risk
Surface: Wet Pour

Finding: The chain openings are in excess of the 8.6mm as recommended by BS EN 1176 **Action:** Monitor - No remedial work recommended

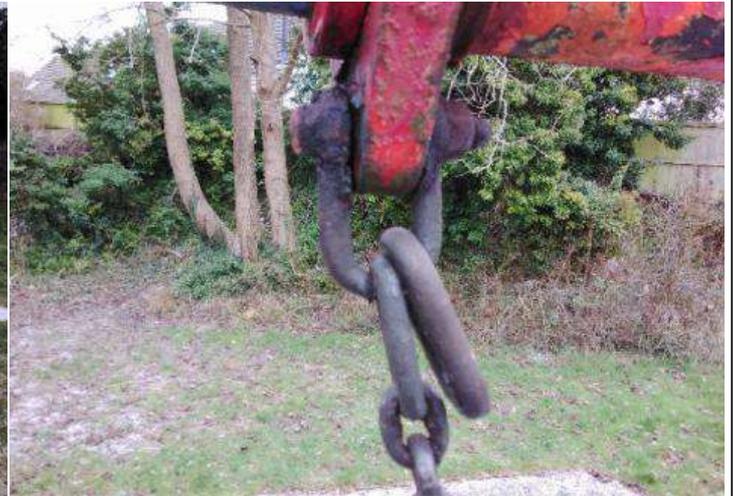
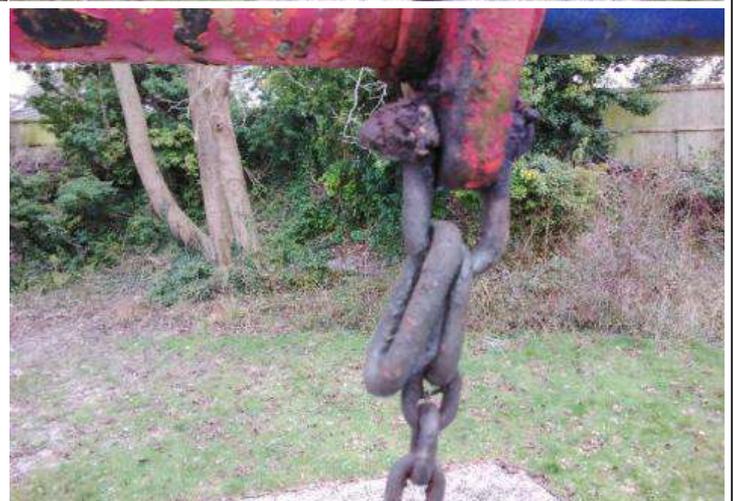
Item: Swings - 1 Bay 2 Seat (Cradle)
Manufacturer: Wicksteed Playgrounds

Risk Level: V - Very Low Risk
Surface: Wet Pour

Finding: There is excess grease on the shackles

Action: Remove excess

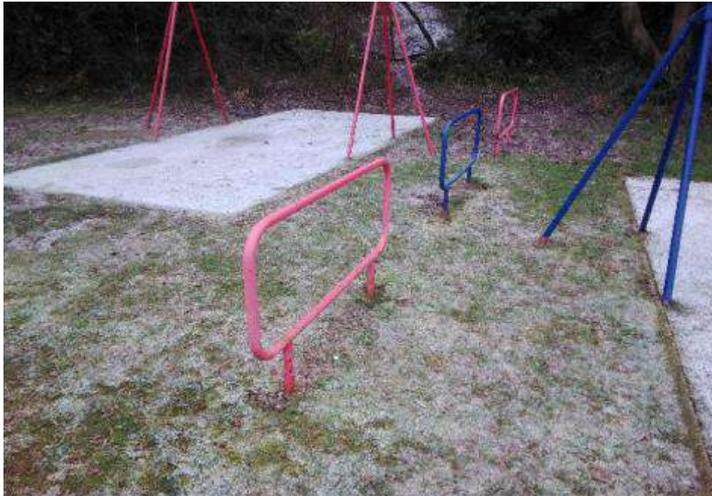
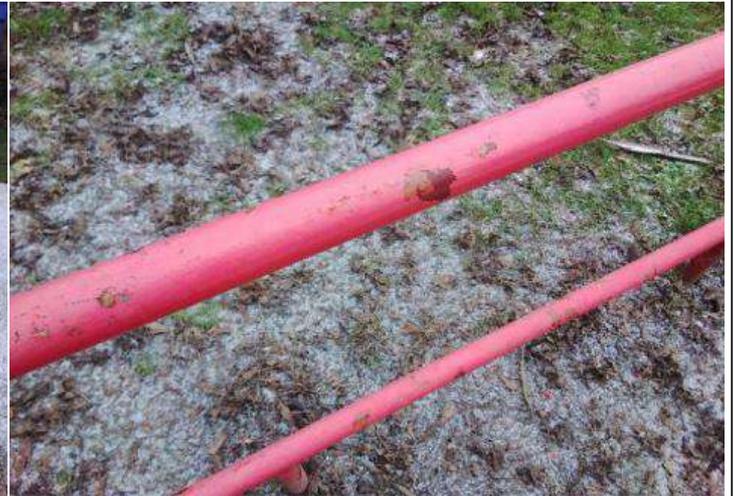
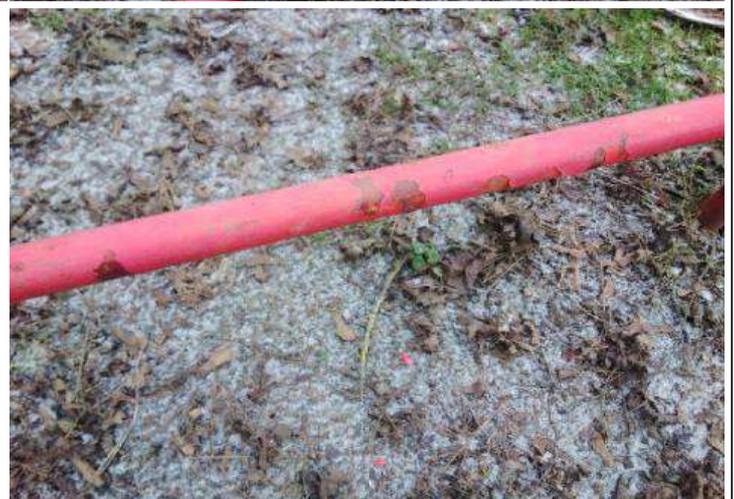
Item: Swings - Swing Barrier
Manufacturer: Unknown

Risk Level: L - Low Risk
Surface: Grass

Finding: The paint is flaking off the metalwork

Action: Rub down and re-paint

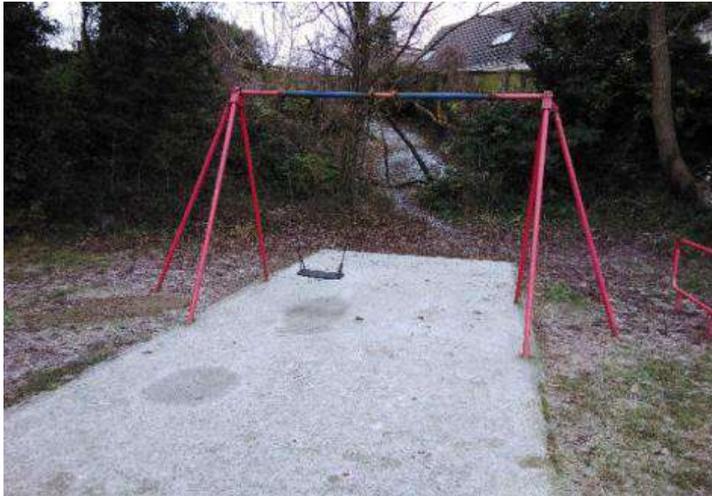
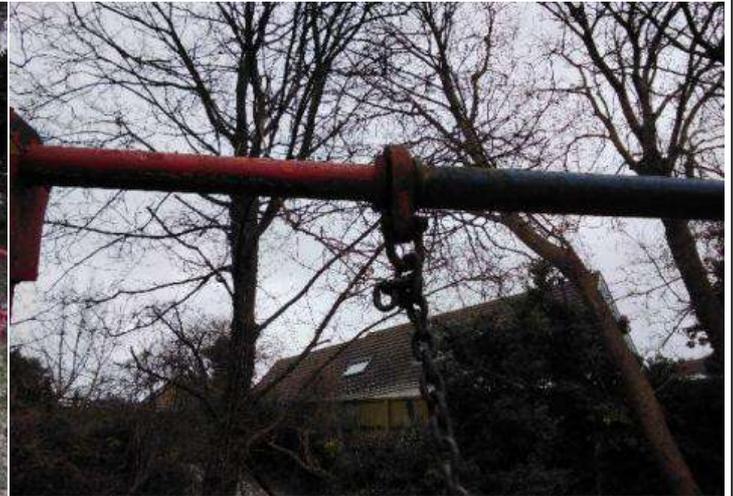
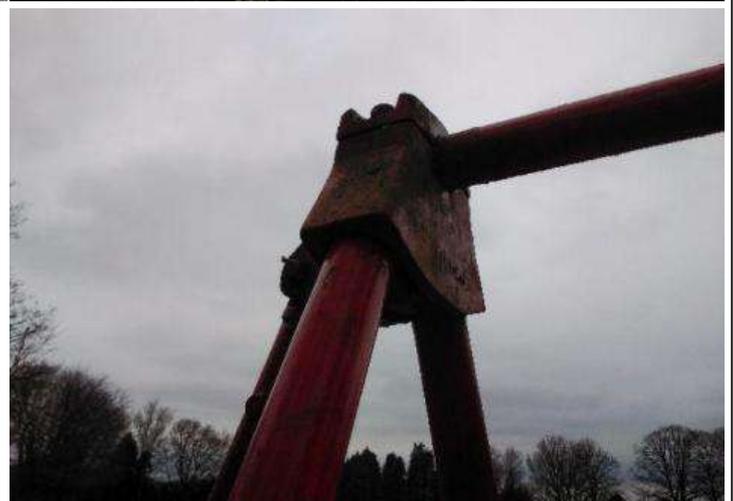
Item: Swings - 1 Bay 2 Seat (Flat)
Manufacturer: Wicksteed Playgrounds

Risk Level: L - Low Risk
Surface: Carpet System

Finding: There is algae or moss on the surface of the equipment

Action: Clean and treat appropriately

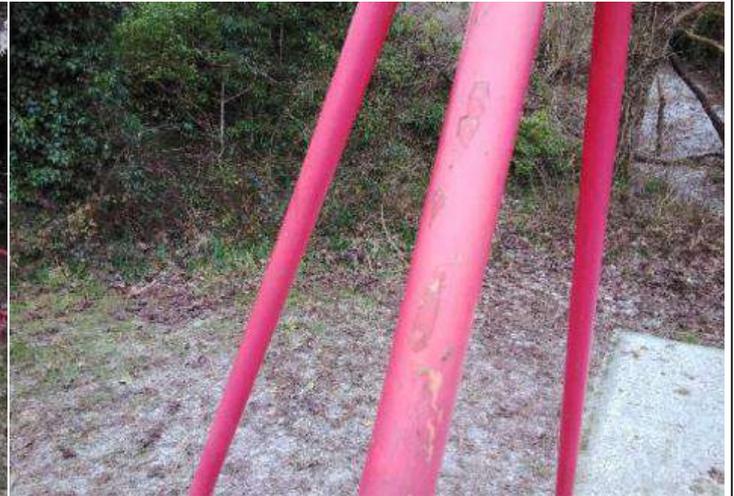
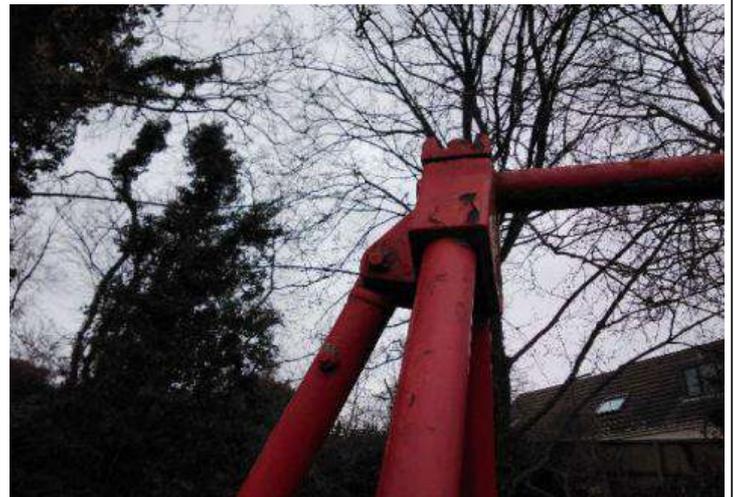
Item: Swings - 1 Bay 2 Seat (Flat)
Manufacturer: Wicksteed Playgrounds

Risk Level: L - Low Risk
Surface: Carpet System

Finding: The paint is flaking off the metalwork

Action: Rub down and re-paint

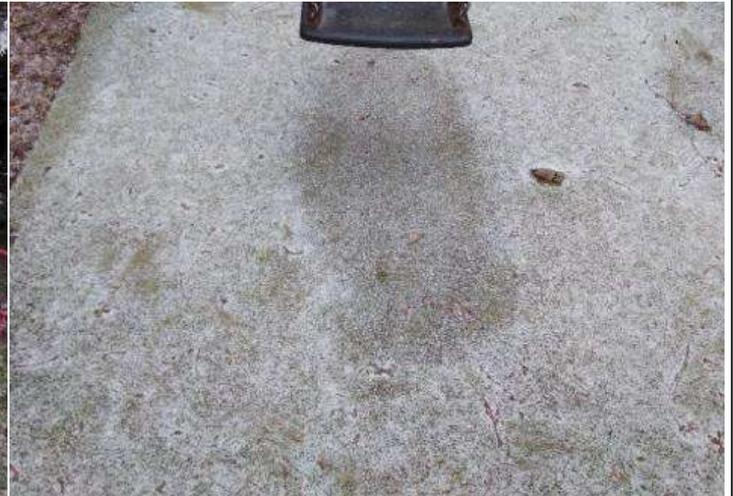
Item: Swings - 1 Bay 2 Seat (Flat)
Manufacturer: Wicksteed Playgrounds

Risk Level: L - Low Risk
Surface: Carpet System

Finding: The safety surface around the area is beginning to wear

Action: Monitor for any further deterioration and repair as required

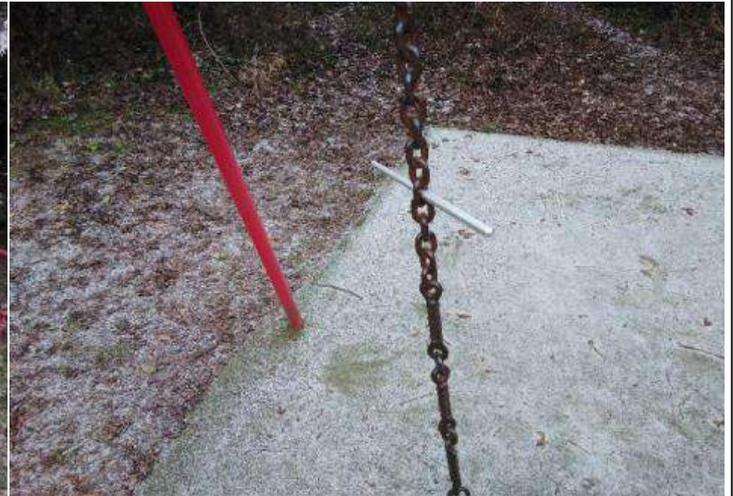
Item: Swings - 1 Bay 2 Seat (Flat)
Manufacturer: Wicksteed Playgrounds

Risk Level: V - Very Low Risk
Surface: Carpet System

Finding: The chain openings are in excess of the 8.6mm as recommended by BS EN 1176 **Action:** Monitor - No remedial work recommended

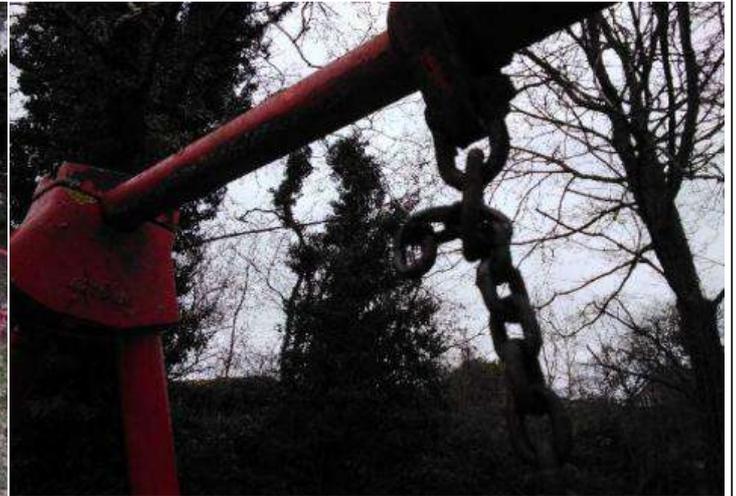
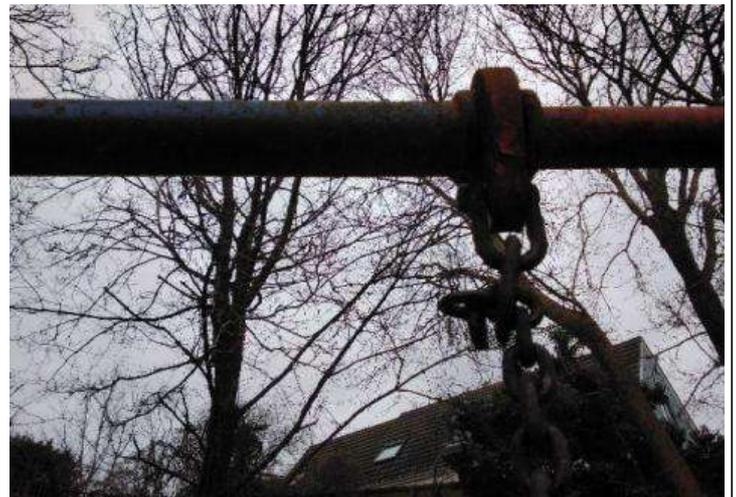
Item: Swings - 1 Bay 2 Seat (Flat)
Manufacturer: Wicksteed Playgrounds

Risk Level: V - Very Low Risk
Surface: Carpet System

Finding: There is excess grease on the shackles

Action: Remove excess

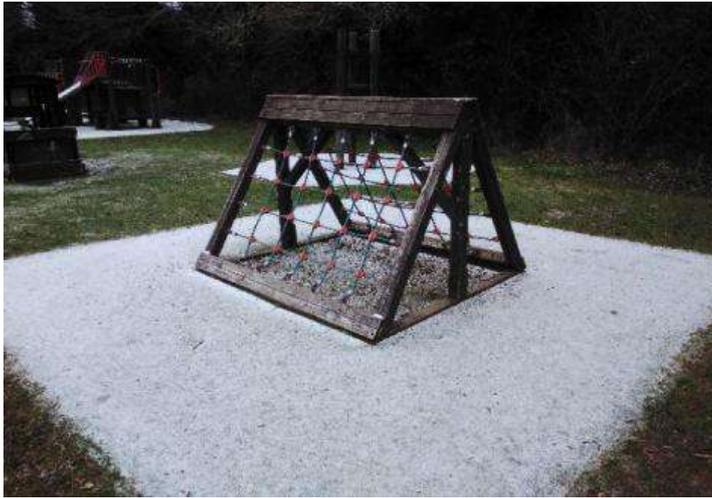
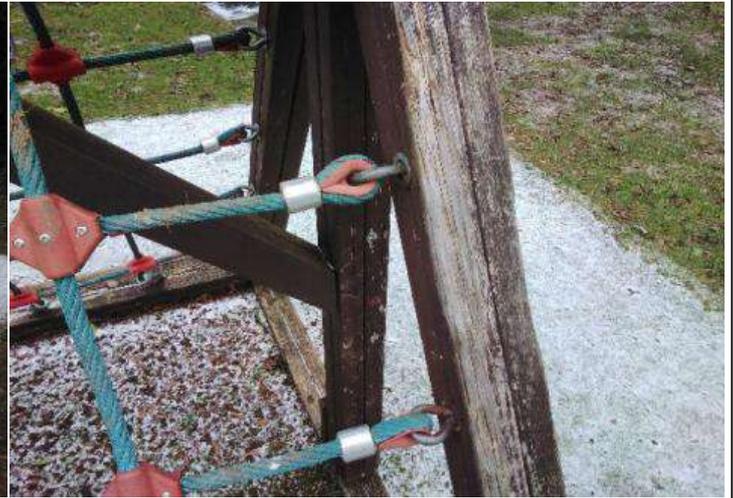
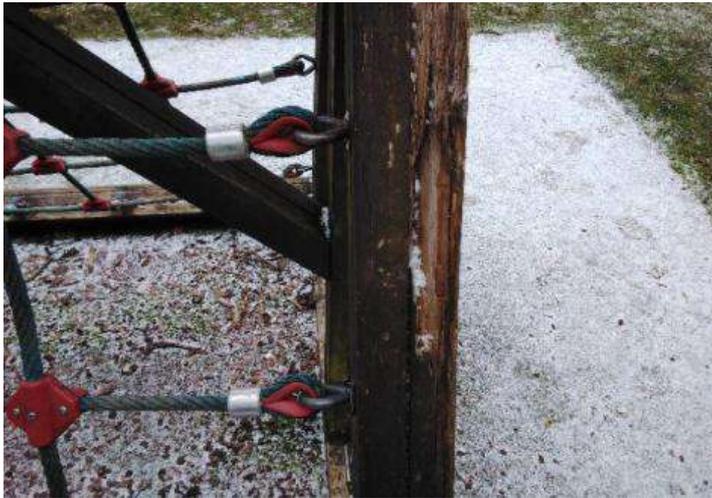
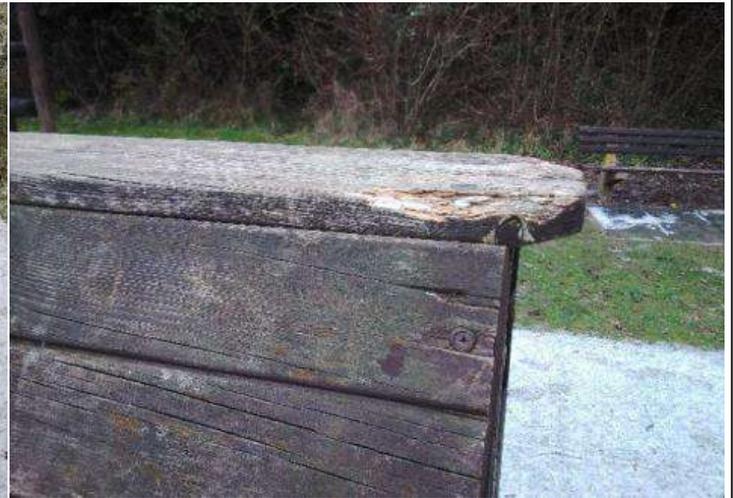
Item: Activity Equipment - A Frame Climber
Manufacturer: Lappset UK Ltd

Risk Level: L - Low Risk
Surface: Carpet System

Finding: Parts of the timber are rough or splintered

Action: Remove all rough or sharp edges

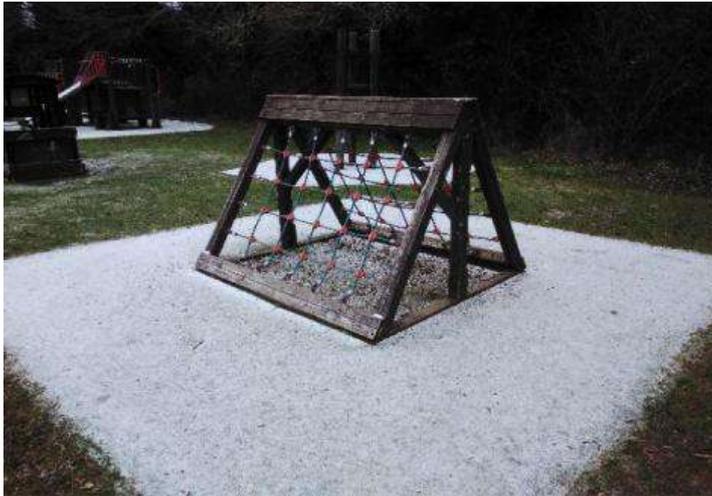
Item: Activity Equipment - A Frame Climber
Manufacturer: Lappset UK Ltd

Risk Level: V - Very Low Risk
Surface: Carpet System

Finding: The connecting links are in excess of 8.6mm and less than 12mm and fail the requirements of BS EN 1176 Part 1; clause 4.2.13, Chains

Action: Monitor - No remedial work recommended

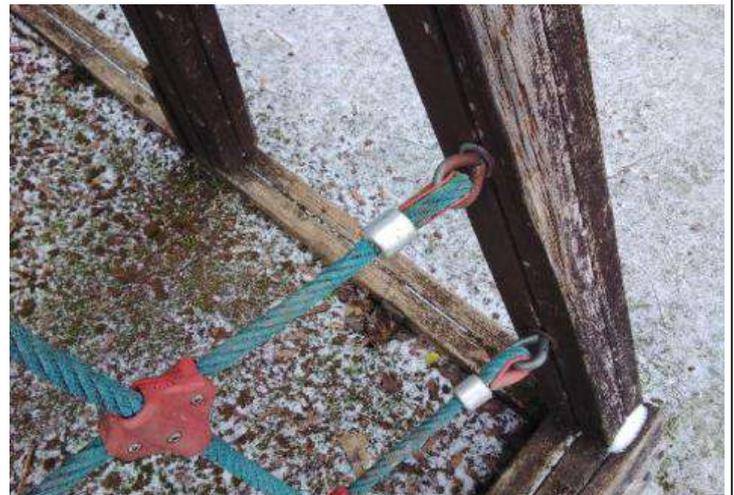
Item: Activity Equipment - A Frame Climber
Manufacturer: Lappset UK Ltd

Risk Level: L - Low Risk
Surface: Carpet System

Finding: A number of fixing(s) have worked loose

Action: Secure all loose fixings

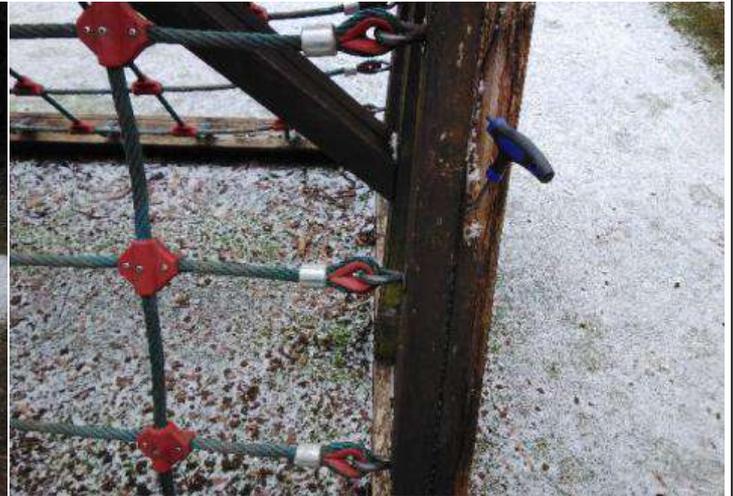
Item: Activity Equipment - A Frame Climber
Manufacturer: Lappset UK Ltd

Risk Level: L - Low Risk
Surface: Carpet System

Finding: There is some evidence of rot in the timber

Action: Monitor for any further deterioration and replace as required

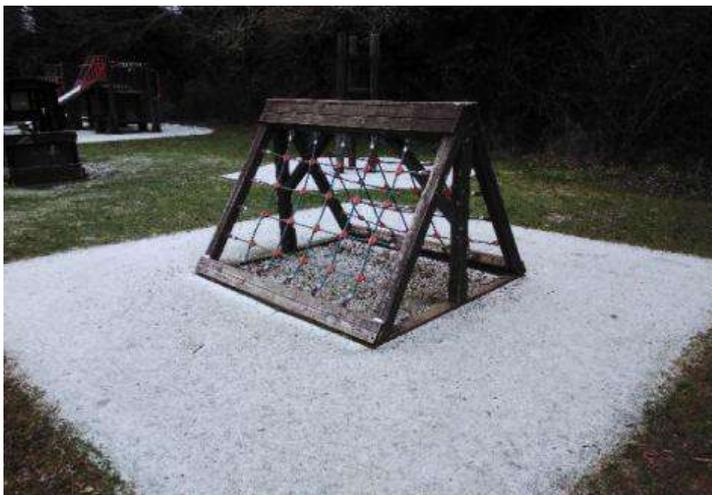
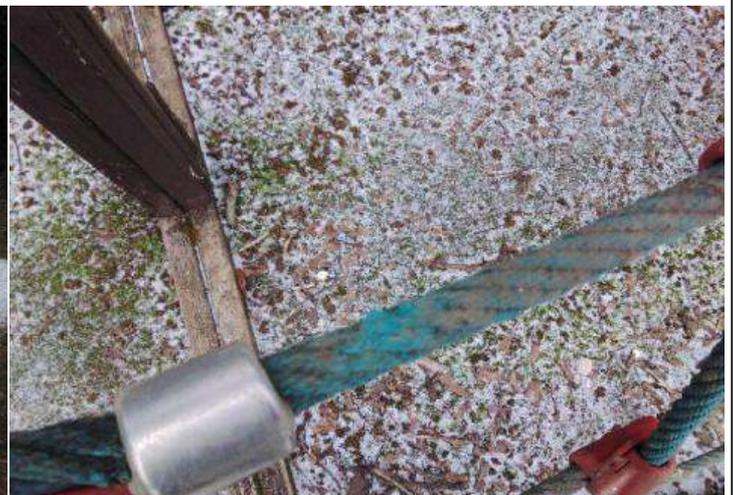
Item: Activity Equipment - A Frame Climber
Manufacturer: Lappset UK Ltd

Risk Level: L - Low Risk
Surface: Carpet System

Finding: The ropes/nets are worn/damaged in places

Action: Monitor for any further deterioration and repair or replace as required

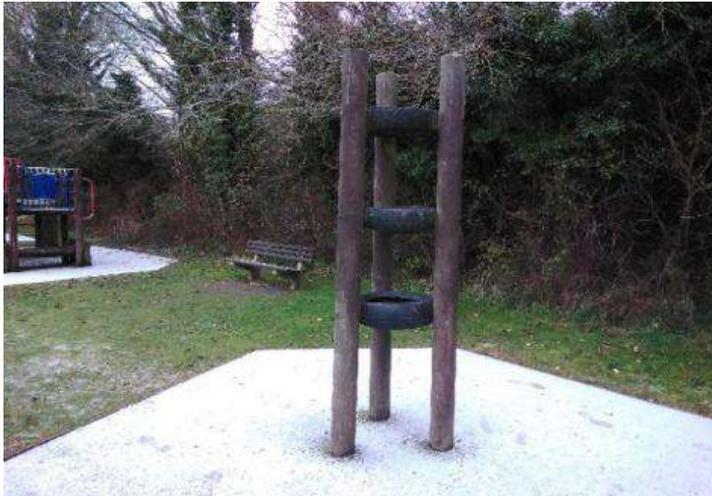
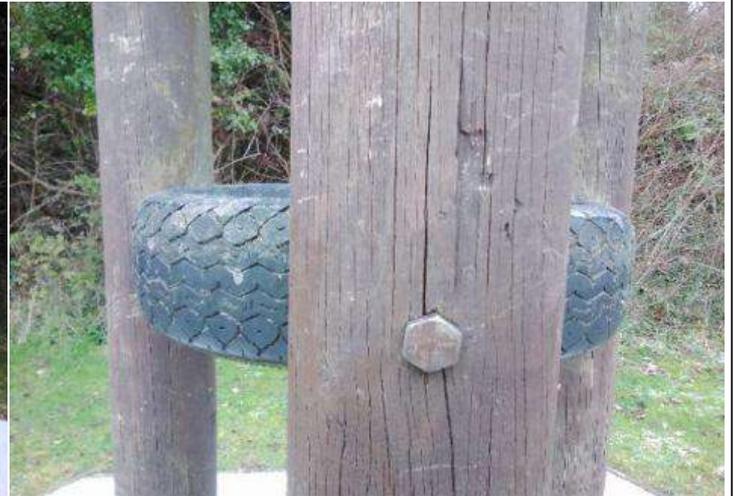
Item: Activity Equipment - Tyre Climber
Manufacturer: Lappset UK Ltd

Risk Level: L - Low Risk
Surface: Wet Pour

Finding: Parts of the timber are rough or splintered

Action: Remove all rough or sharp edges

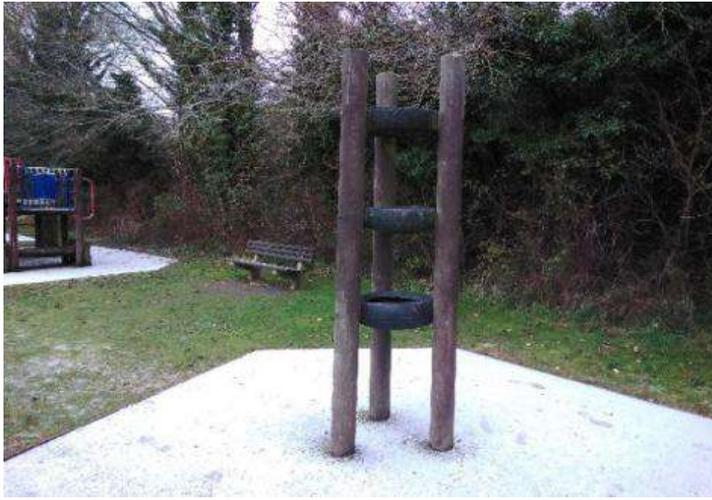
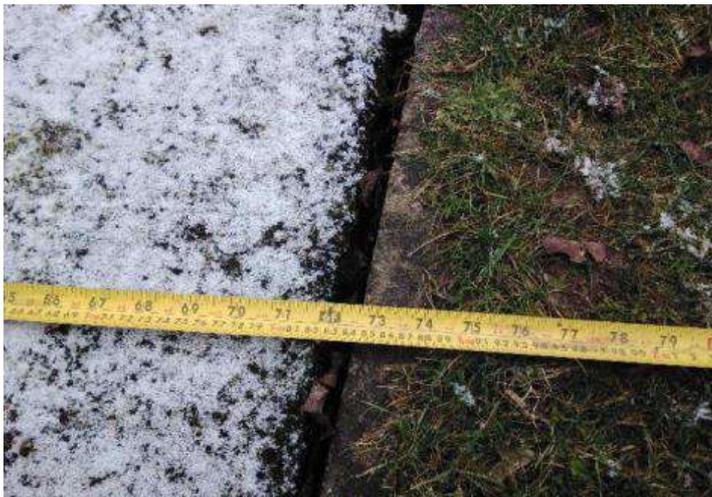
Item: Activity Equipment - Tyre Climber
Manufacturer: Lappset UK Ltd

Risk Level: V - Very Low Risk
Surface: Wet Pour

Finding: The surfacing dimensions are short and do not meet with the requirements of the current applicable standard (2360mm required / 1884mm provided)

Action: Monitor - No remedial work recommended

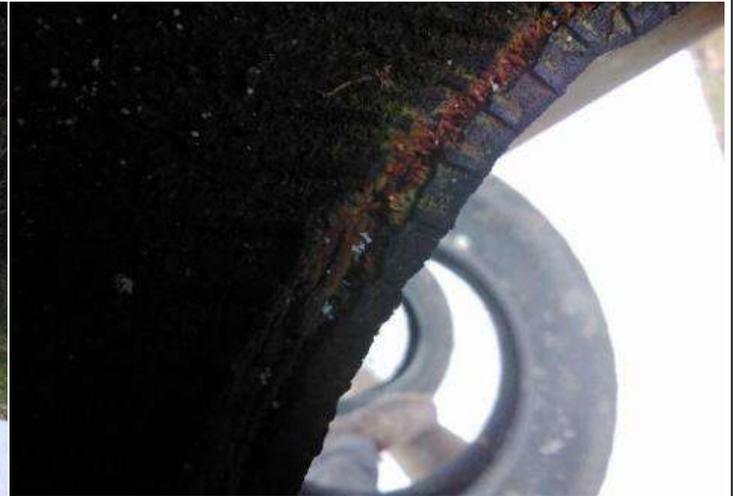
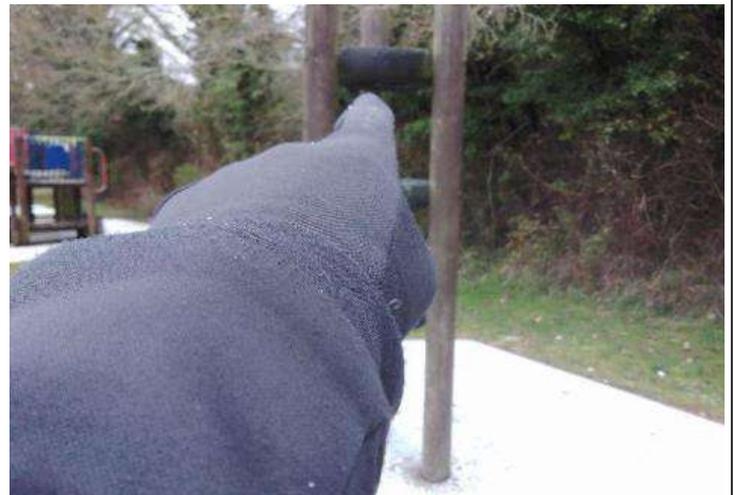
Item: Activity Equipment - Tyre Climber
Manufacturer: Lappset UK Ltd

Risk Level: L - Low Risk
Surface: Wet Pour

Finding: The item has been damaged top tyre

Action: Monitor for any further deterioration and replace as required

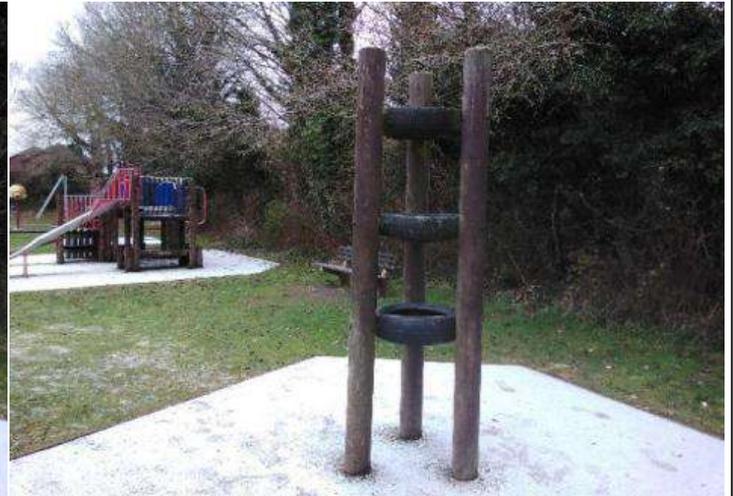
Item: Activity Equipment - Tyre Climber
Manufacturer: Lappset UK Ltd

Risk Level: N - Risk Assessment not Undertaken
Surface: Wet Pour

Finding: This item of equipment relies on a single post, or a line of posts, for stability and extra care needs to be taken with equipment of this nature to avoid the potential for catastrophic failure

Action: Ensure that regular detailed inspections are undertaken to assess for rot, corrosion and general stability

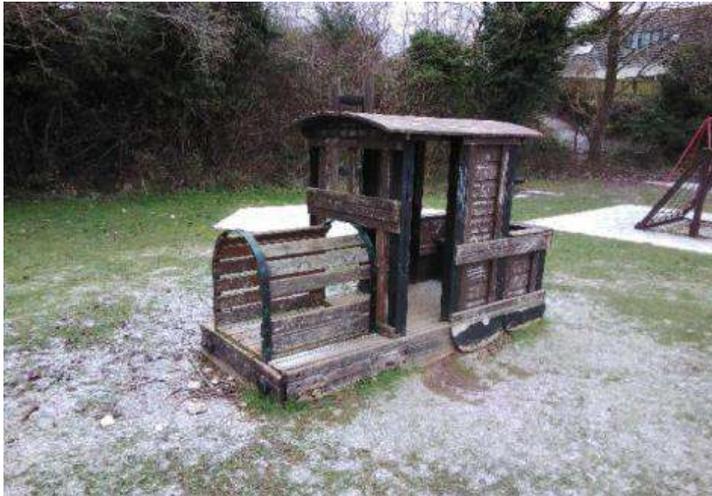
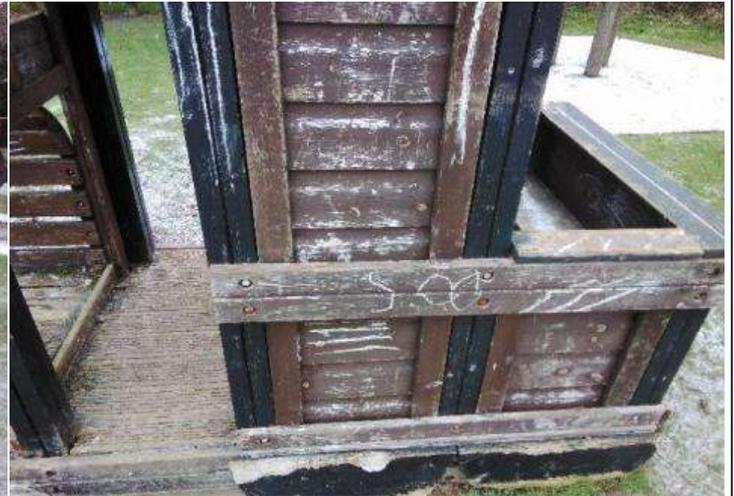
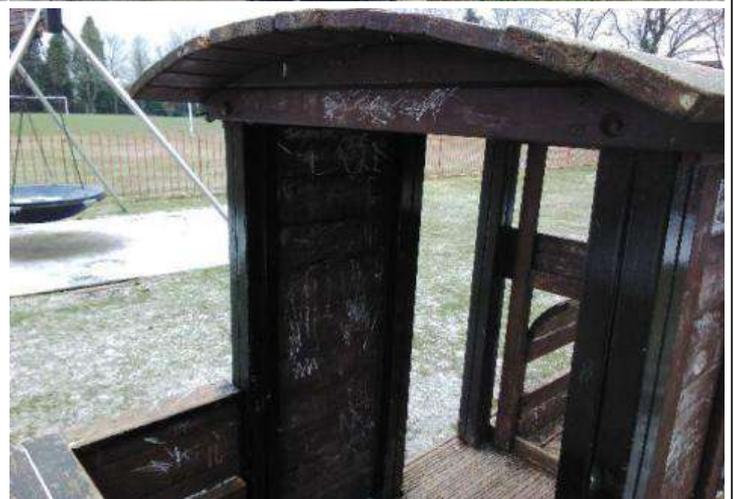
Item: Activity Equipment - Train
Manufacturer: Lappset UK Ltd

Risk Level: N - Risk Assessment not Undertaken
Surface: Grass

Finding: There is some graffiti present

Action: Remove the graffiti

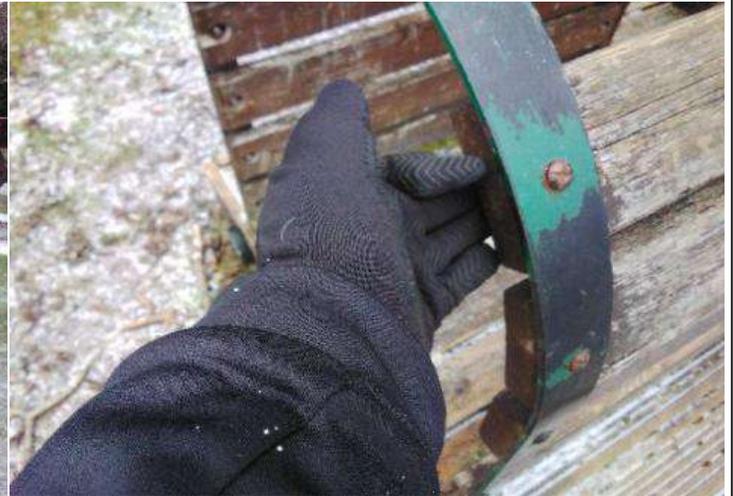
Item: Activity Equipment - Train
Manufacturer: Lappset UK Ltd

Risk Level: L - Low Risk
Surface: Grass

Finding: A number of fixing(s) have worked loose

Action: Secure all loose fixings

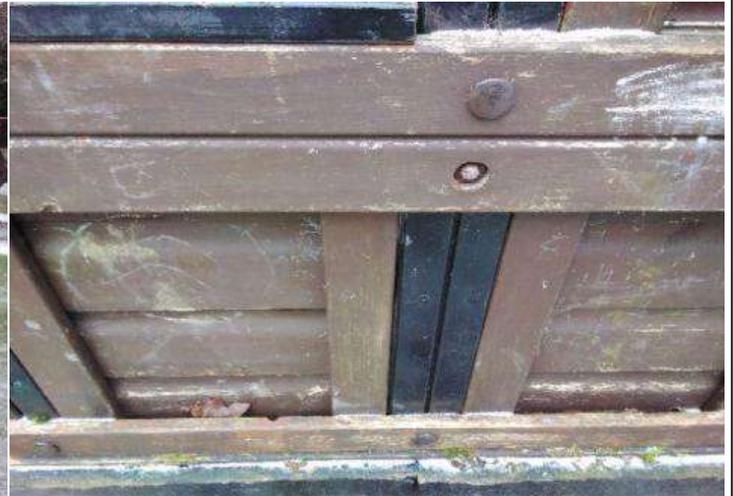
Item: Activity Equipment - Train
Manufacturer: Lappset UK Ltd

Risk Level: V - Very Low Risk
Surface: Grass

Finding: There is/are bolt cap covers missing or damaged on the item

Action: Replace missing or damaged bolt cap covers

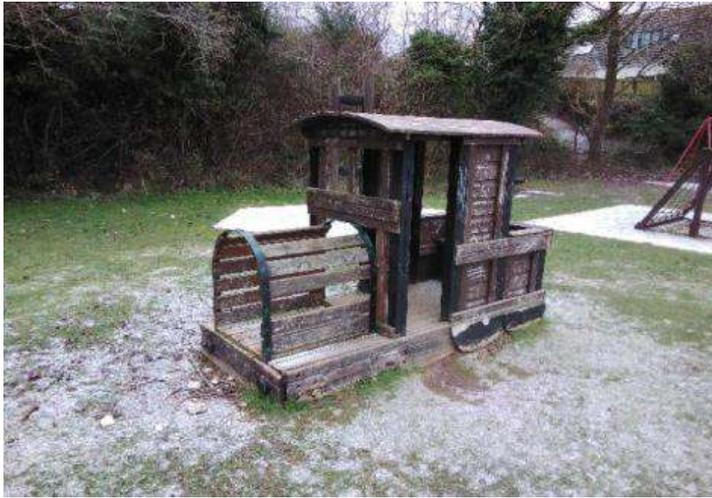
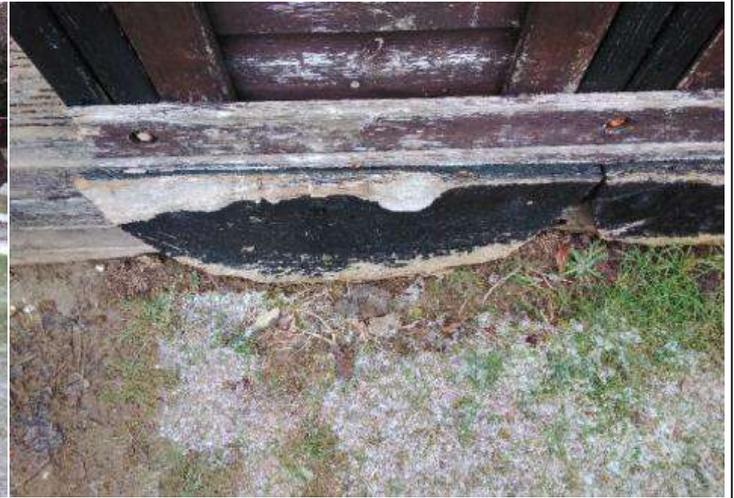
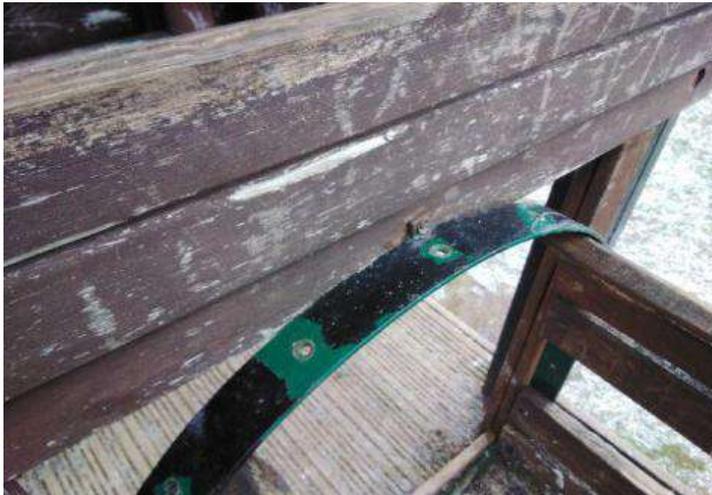
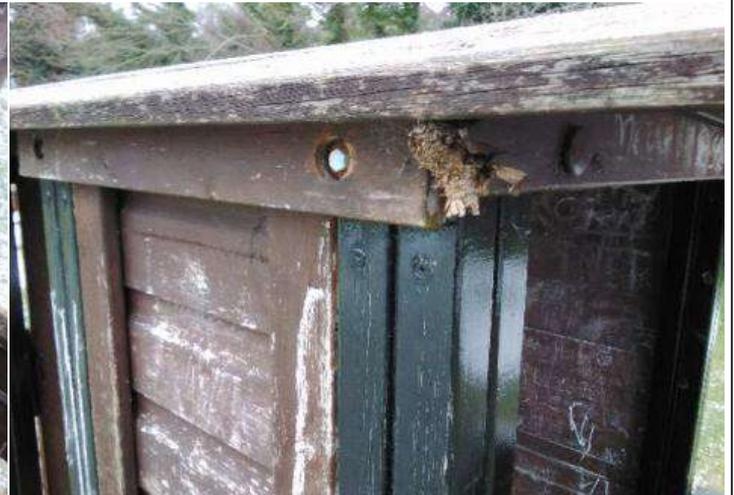
Item: Activity Equipment - Train
Manufacturer: Lappset UK Ltd

Finding: Parts of the timber are rough or splintered

Action: Remove all rough or sharp edges

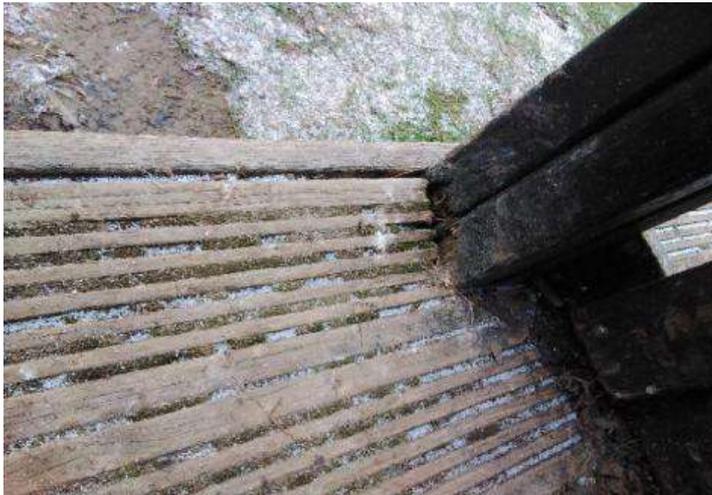
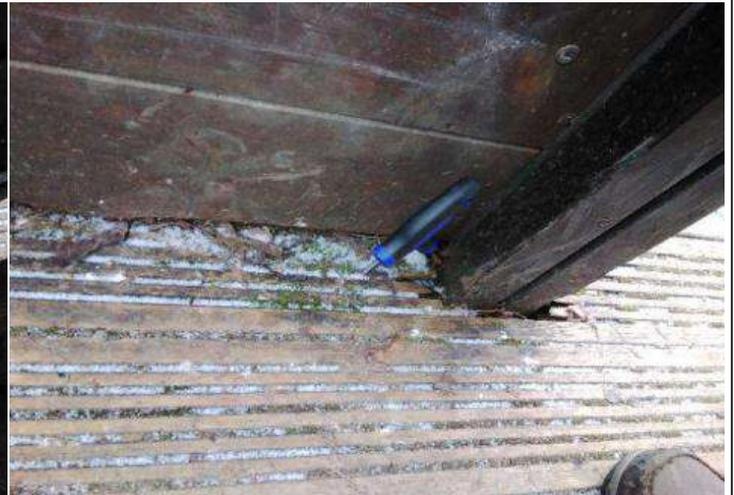
Item: Activity Equipment - Train
Manufacturer: Lappset UK Ltd

Finding: There are areas or parts of the timber on the structure that have rotted

Action: Replace all affected timbers
