Annual Inspection

Winchester City Council

Sun Hill Recreation Ground (New Alresford)

Derwent Gardens, Alresford, SO24 9NQ

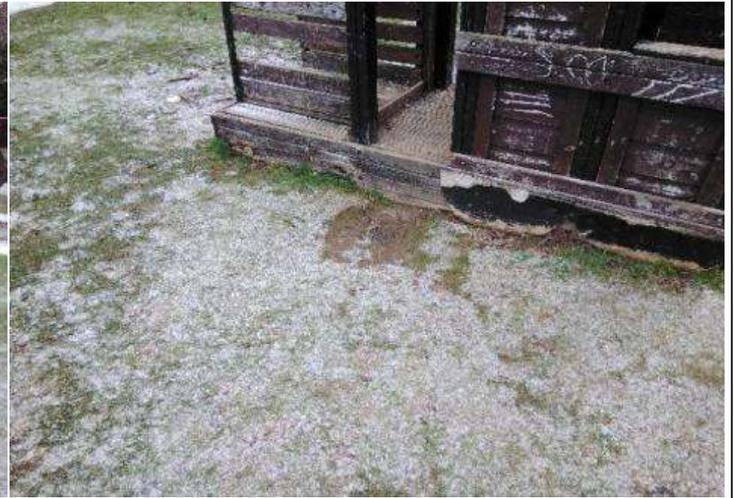
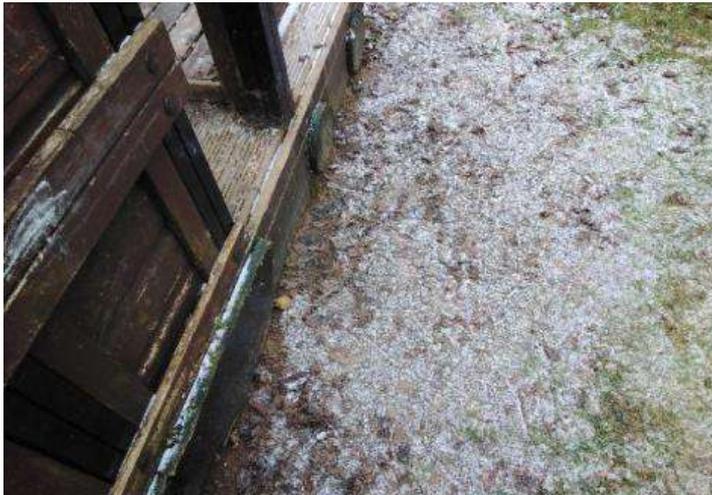
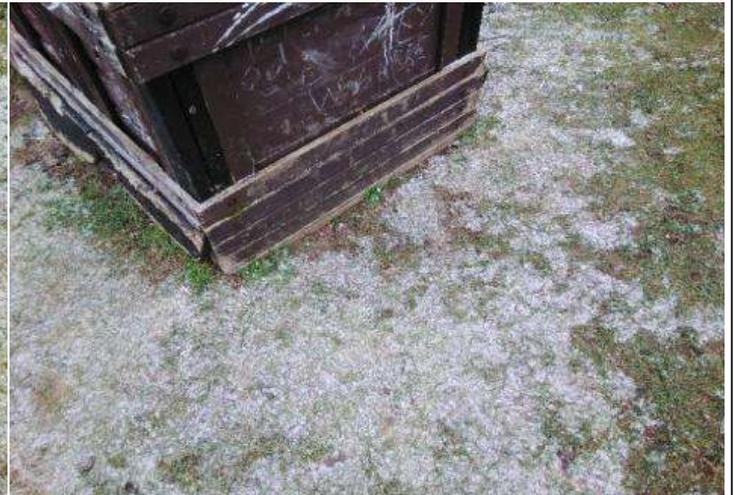
Item: Activity Equipment - Train
Manufacturer: Lappset UK Ltd

Finding: The area around the item has eroded and may become slippery

Action: Reinststate eroded area

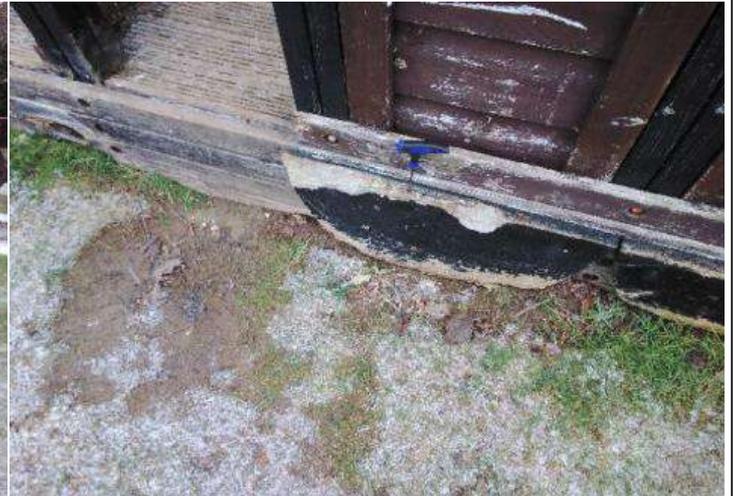
Item: Activity Equipment - Train
Manufacturer: Lappset UK Ltd

Finding: There are areas or parts of the timber on the structure that have rotted

Action: Replace all affected timbers

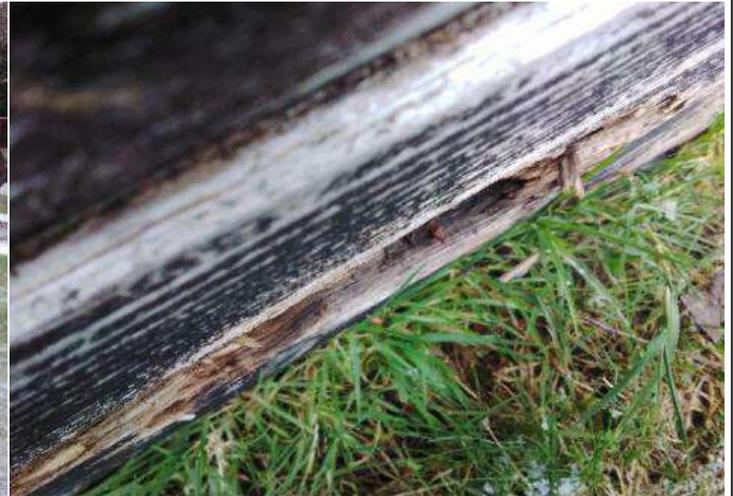
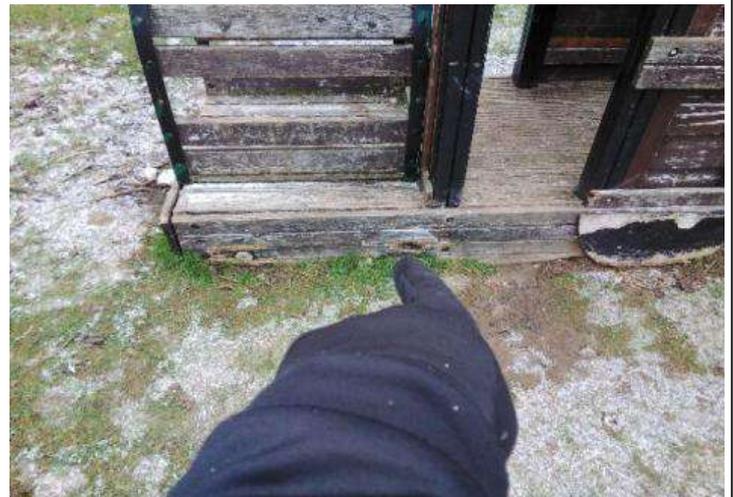
Item: Activity Equipment - Train
Manufacturer: Lappset UK Ltd

Finding: There are projecting screw ends present

Action: Remove and provide more appropriate fixings if required

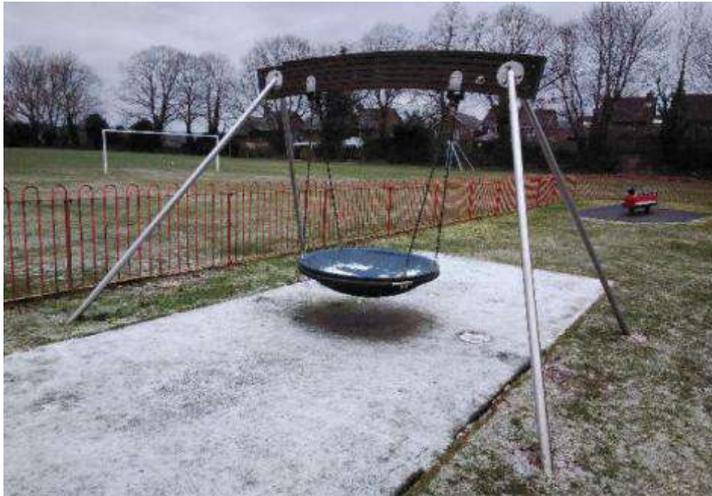
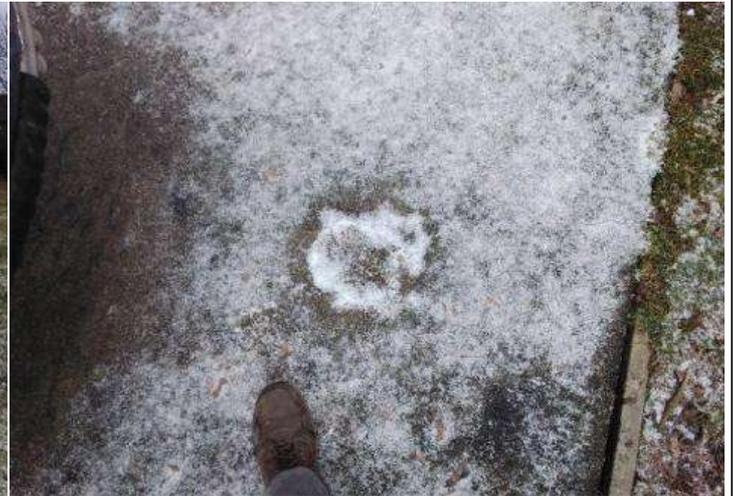
Item: Swings - Basket Swing - Type 1
Manufacturer: Pro ludic

Finding: The safety surface under or around this unit has been damaged

Action: Monitor for any further deterioration and repair as required

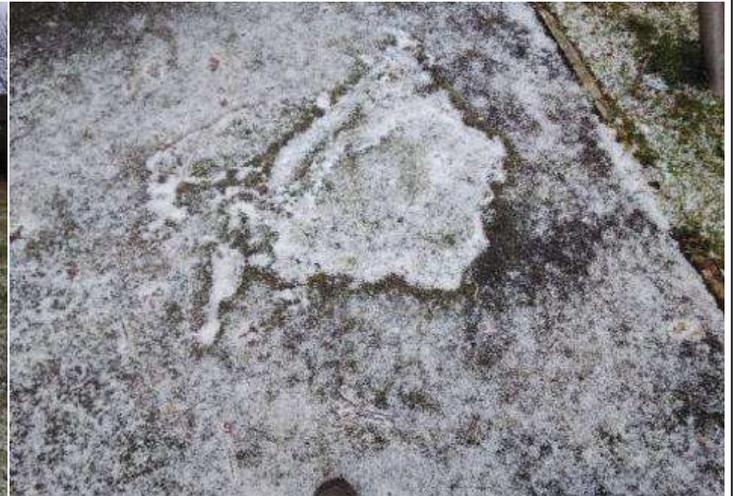
Item: Swings - Basket Swing - Type 1
Manufacturer: Proludic

Finding: The surfacing is severely damaged

Action: Repair damaged areas of surfacing

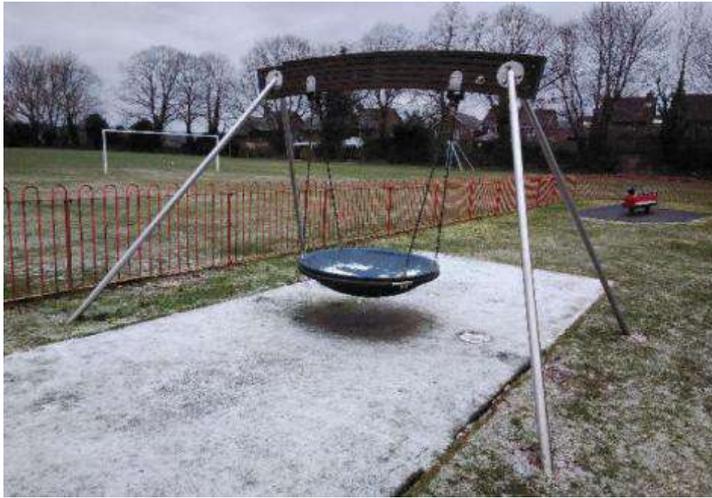
Item: Swings - Basket Swing - Type 1
Manufacturer: Proludic

Finding: There are significant gaps (over 30mm) between the surface and the edging or between the joints in the surface; these are large enough for a small foot to enter

Action: Repair surfacing

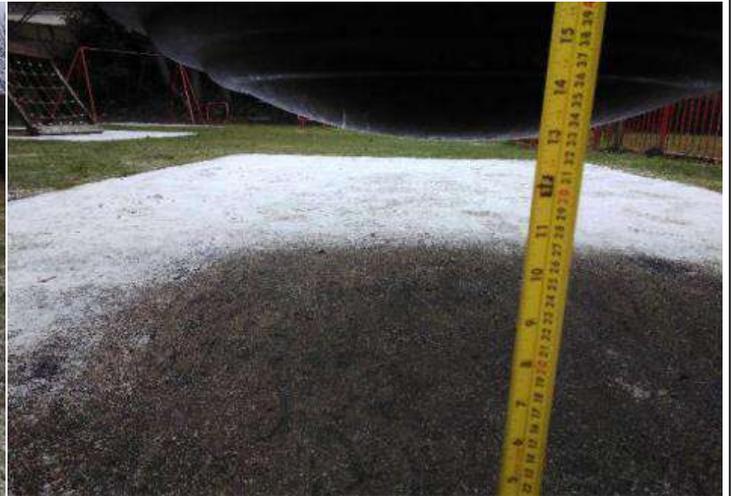
Item: Swings - Basket Swing - Type 1
Manufacturer: Proludic

Finding: The seat clearance from finished surface level to the underside of the seat is too low when measured in its most onerous position and does not meet the requirements of BS EN 1176 Part 2

Action: Install seats to a minimum height of 400mm for Group Swing Seats

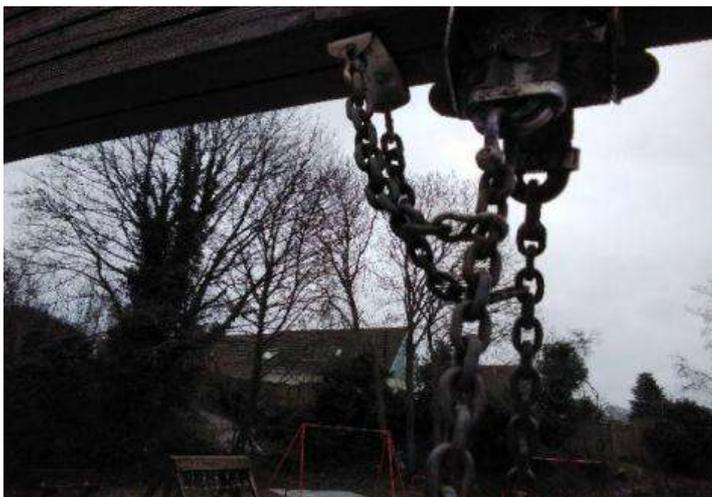
Item: Swings - Basket Swing - Type 1
Manufacturer: Proludic

Finding: There is some notable evidence of chain wear

Action: Monitor for any further deterioration and replace when 40% worn

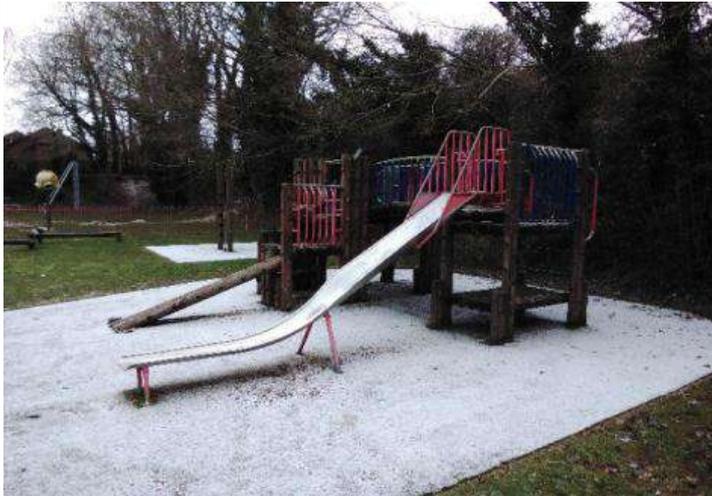
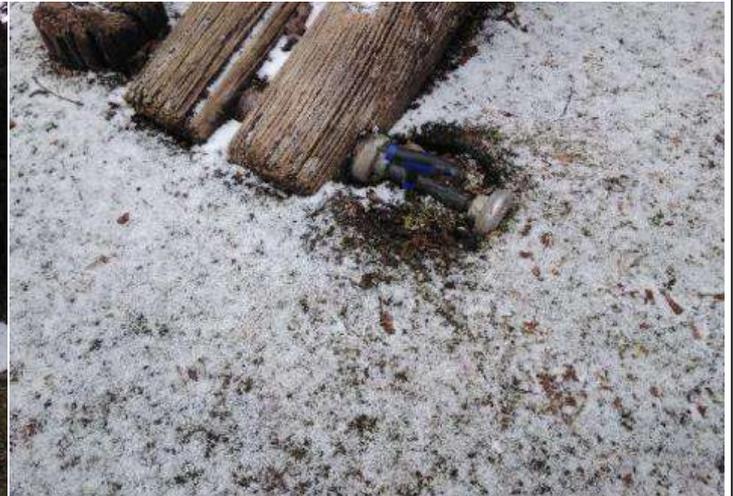
Item: Activity Equipment - Multi Play (Junior)
Manufacturer: Wicksteed Playgrounds

Finding: The timber on this item has severe rot

Action: Remove and replace all affected timber sections

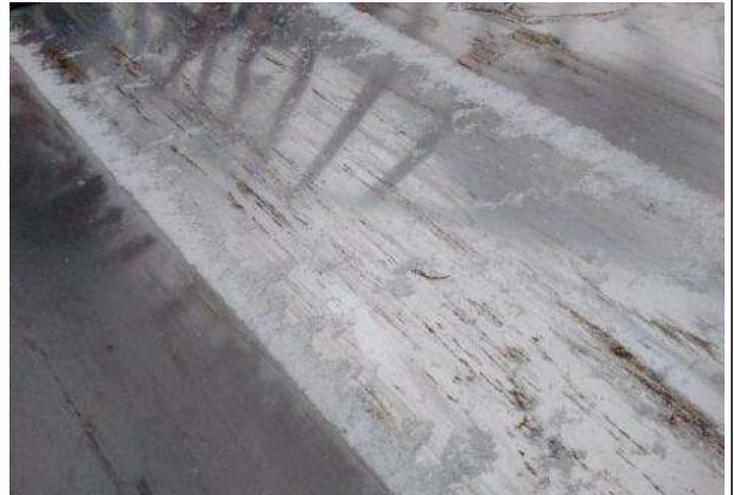
Item: Activity Equipment - Multi Play (Junior)
Manufacturer: Wicksteed Playgrounds

Finding: There are a number of dents in the slide surface

Action: Monitor for any further deterioration and repair as required

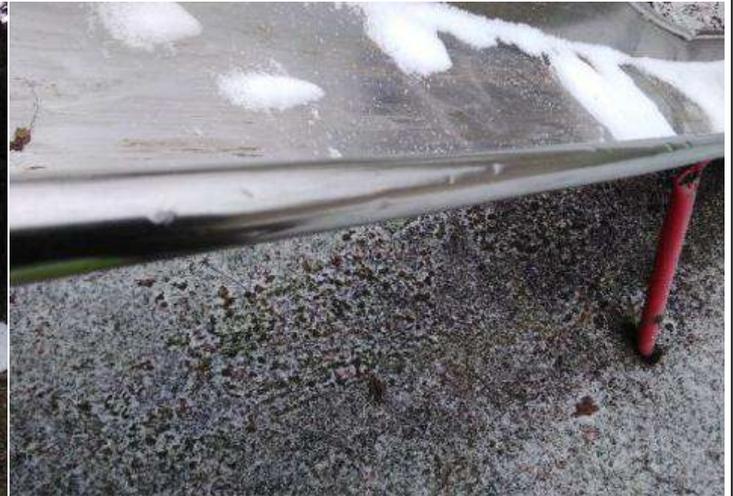
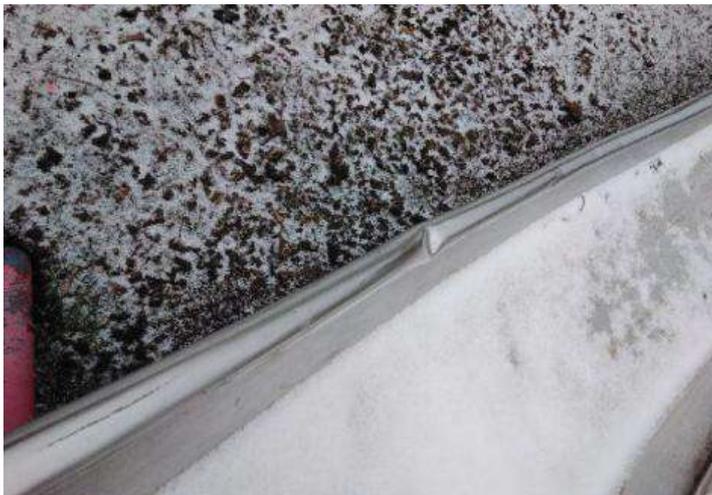
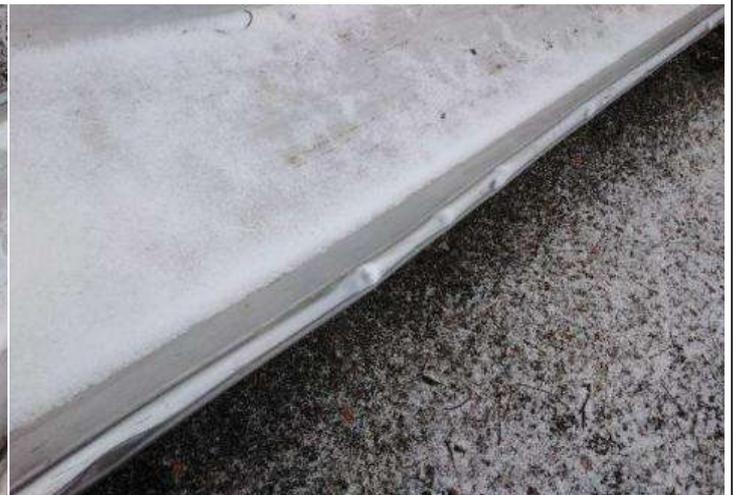
Item: Activity Equipment - Multi Play (Junior)
Manufacturer: Wicksteed Playgrounds

Finding: The side of the slide is damaged

Action: Monitor for any further deterioration and repair as required

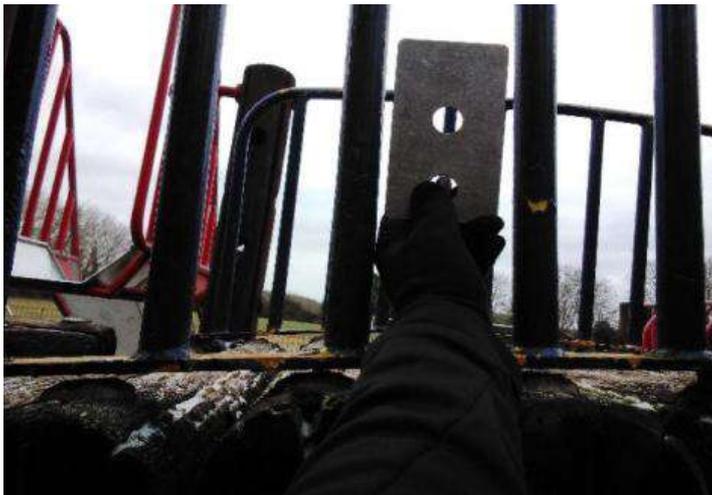
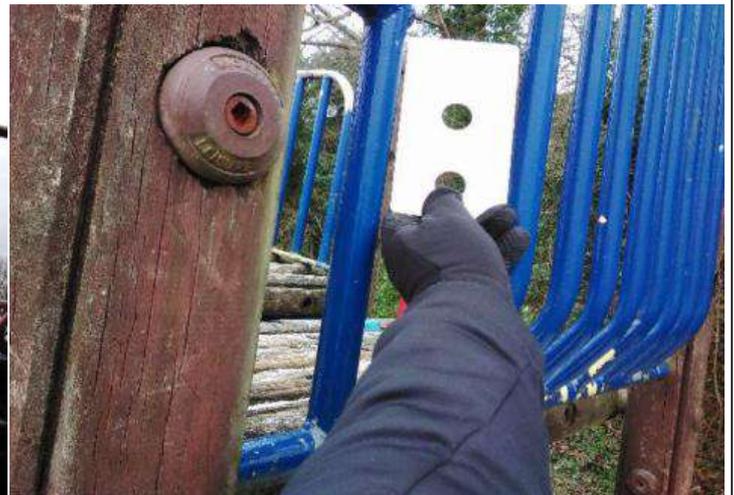
Item: Activity Equipment - Multi Play (Junior)
Manufacturer: Wicksteed Playgrounds

Finding: The item fails to meet the requirements of BS EN 1176 Part 1 4.2.7.2 head and neck entrapment in the barriers and/or steps

Action: Monitor - No remedial work recommended

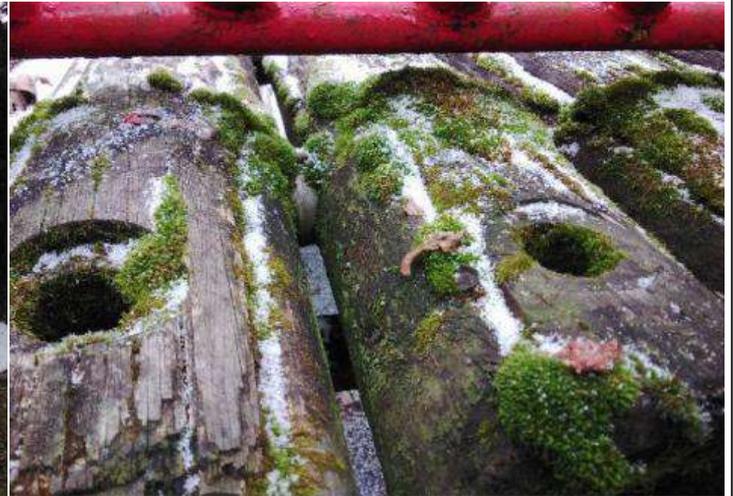
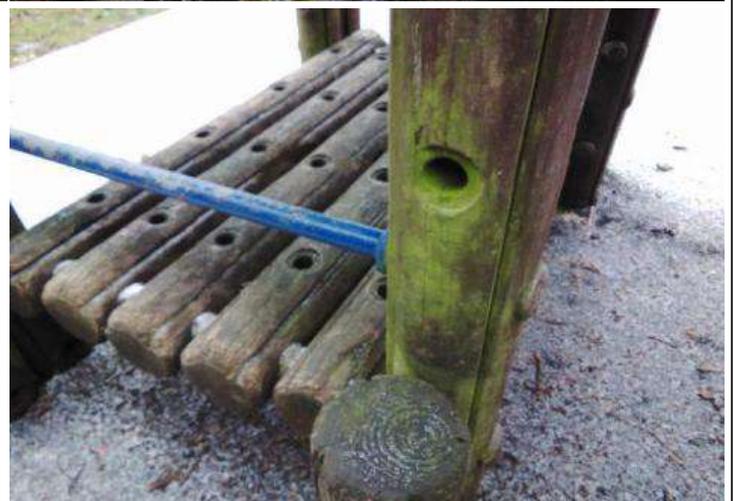
Item: Activity Equipment - Multi Play (Junior)
Manufacturer: Wicksteed Playgrounds

Finding: There is algae or moss on the surface of the equipment

Action: Clean and treat appropriately

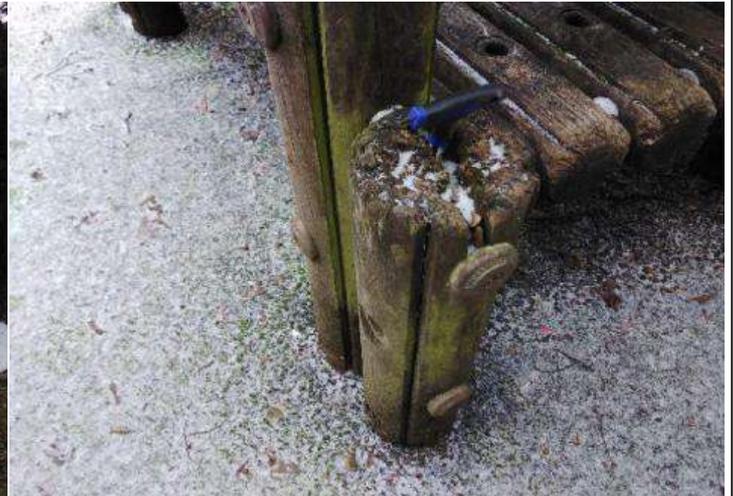
Item: Activity Equipment - Multi Play (Junior)
Manufacturer: Wicksteed Playgrounds

Finding: There are areas or parts of the timber on the structure that have rotted

Action: Replace all affected timbers

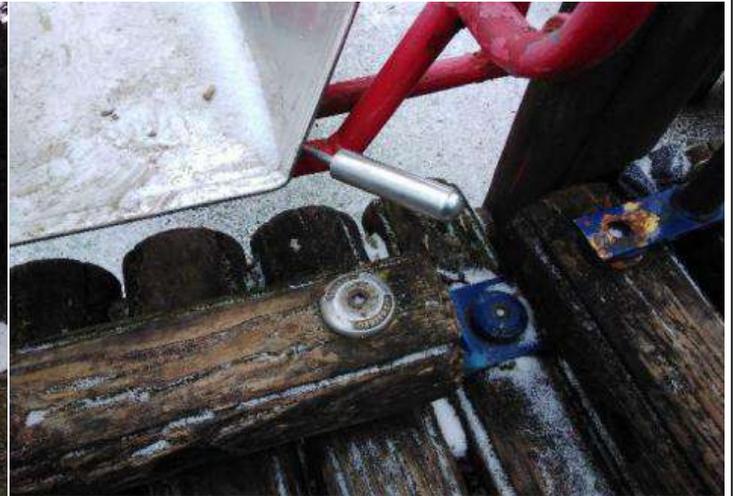
Item: Activity Equipment - Multi Play (Junior)
Manufacturer: Wicksteed Playgrounds

Finding: There is/are finger entrapment/s in the to the slide starting section and the item fails to meet the requirements of BS EN 1176 Part 1 4.2.7.6 Entrapment of fingers

Action: Monitor - No remedial work recommended

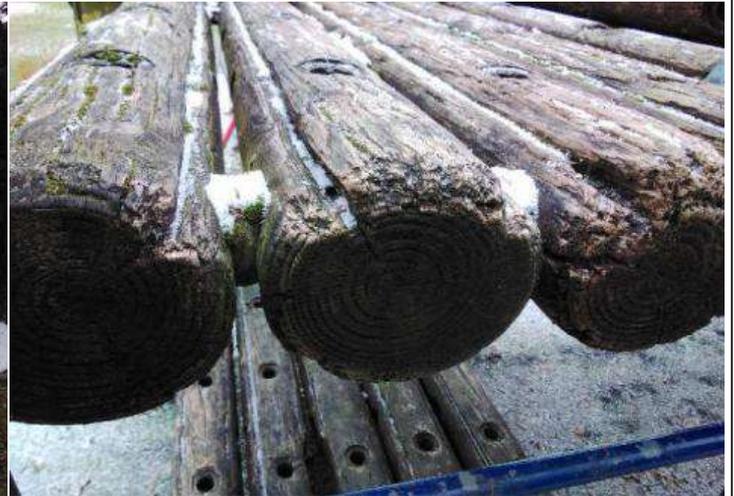
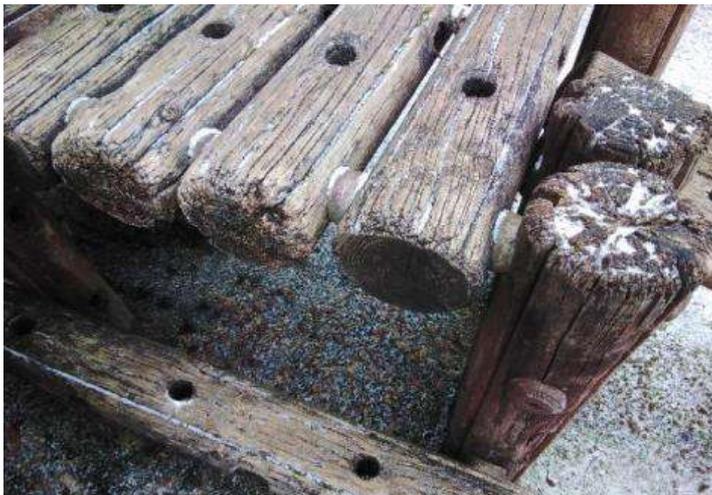
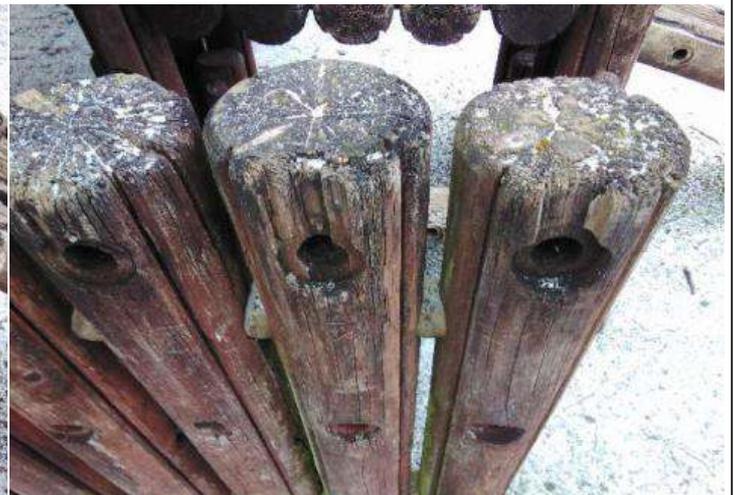
Item: Activity Equipment - Multi Play (Junior)
Manufacturer: Wicksteed Playgrounds

Finding: Parts of the timber are rough or splintered

Action: Remove all rough or sharp edges

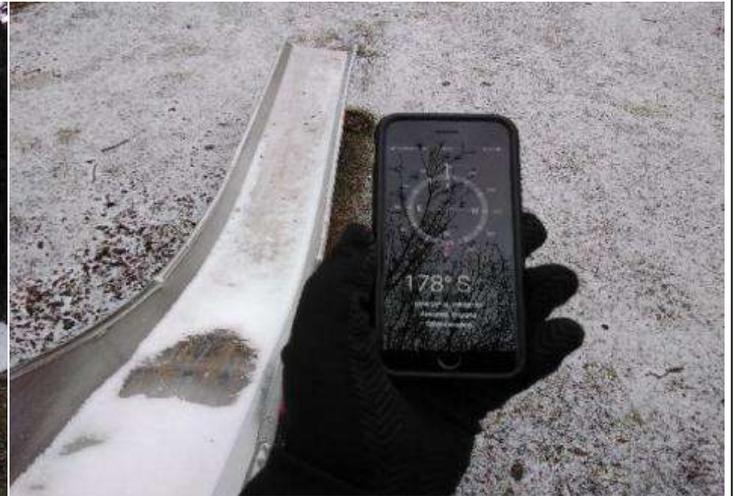
Item: Activity Equipment - Multi Play (Junior)
Manufacturer: Wicksteed Playgrounds

Finding: The slide is predominately south facing and will catch the majority of the sun's heat during the day. Slide surfaces can become very warm during periods of sustained sunny weather

Action: Monitor - No remedial work recommended

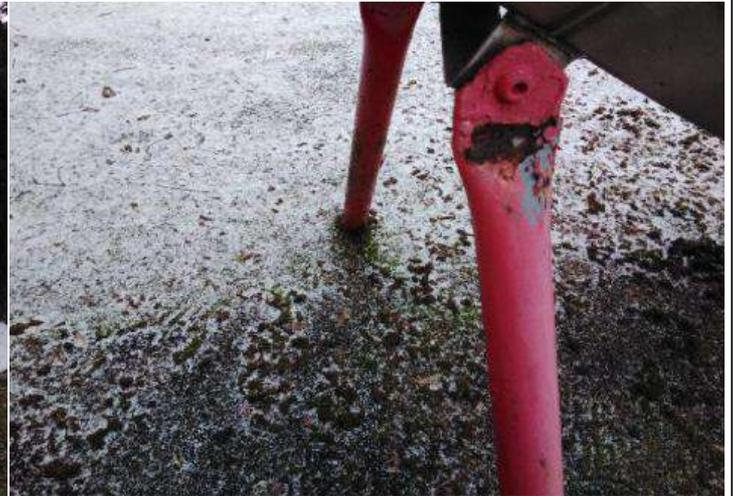
Item: Activity Equipment - Multi Play (Junior)
Manufacturer: Wicksteed Playgrounds

Finding: There is surface corrosion present on the item

Action: Consider treating the item

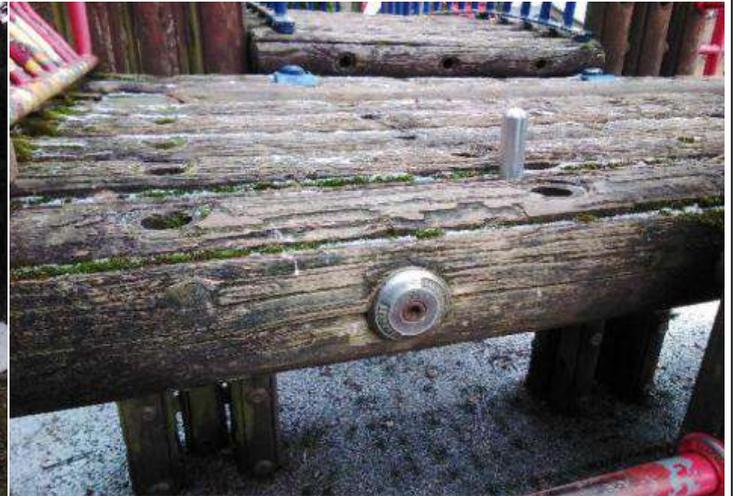
Item: Activity Equipment - Multi Play (Junior)
Manufacturer: Wicksteed Playgrounds

Finding: There is/are finger entrapment/s in the in the surface above the ladder and the item fails to meet the requirements of BS EN 1176 Part 1 4.2.7.6 Entrapment of fingers

Action: Monitor - No remedial work recommended

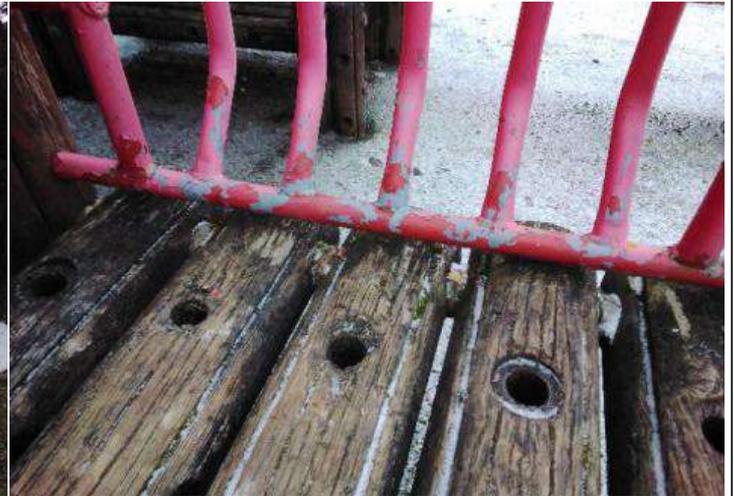
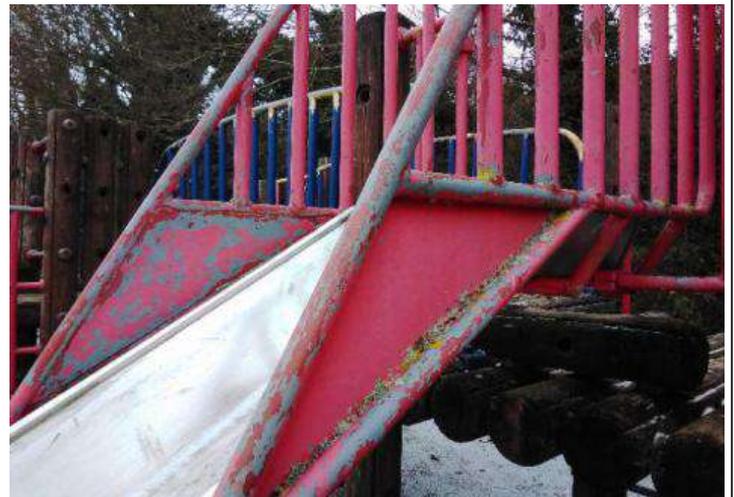
Item: Activity Equipment - Multi Play (Junior)
Manufacturer: Wicksteed Playgrounds

Finding: The paint is flaking off the metalwork

Action: Rub down and re-paint

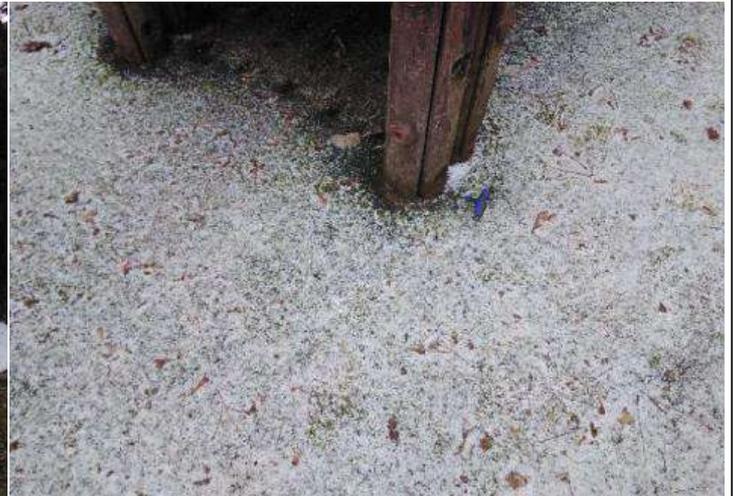
Item: Activity Equipment - Multi Play (Junior)
Manufacturer: Wicksteed Playgrounds

Finding: There is some evidence of rot in the timber posts

Action: Monitor for any further deterioration and replace as required

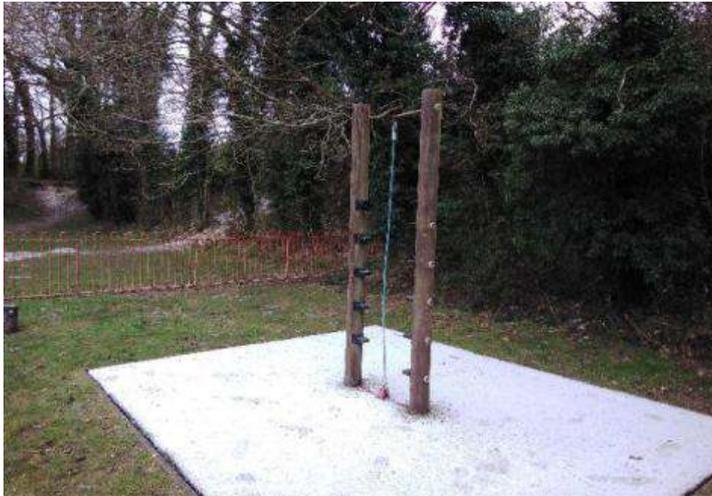
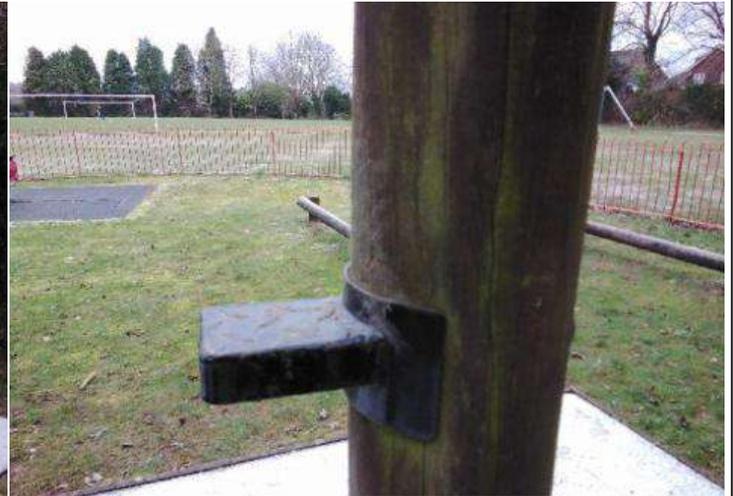
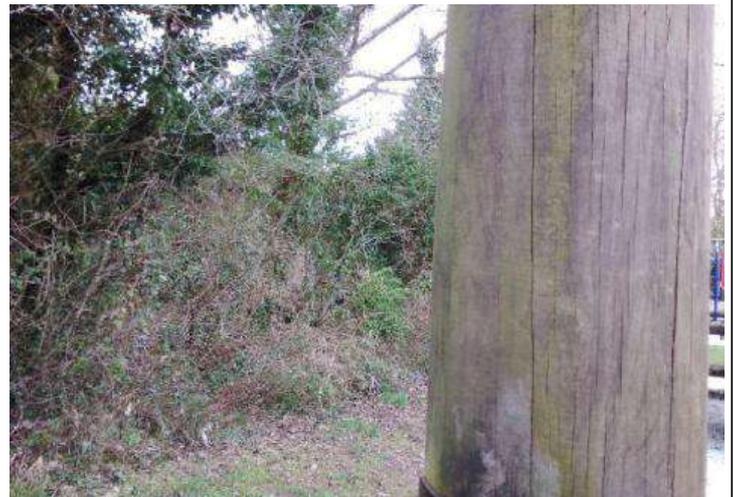
Item: Activity Equipment - Climbing Post
Manufacturer: Lappset UK Ltd

Finding: There is algae or moss on the surface of the equipment

Action: Clean and treat appropriately

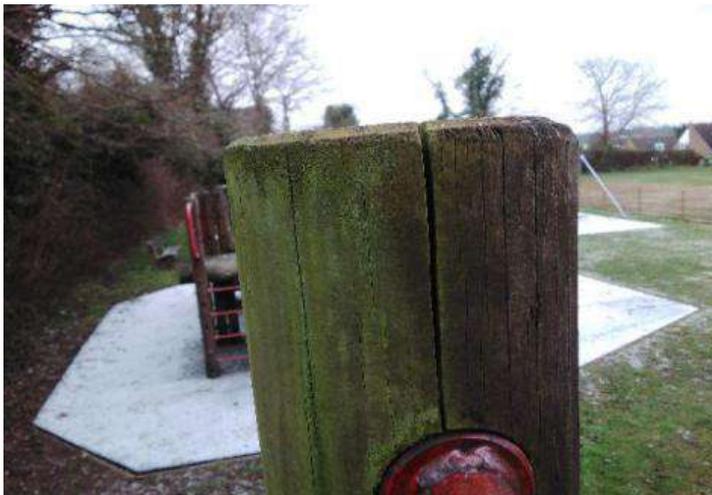
Item: Activity Equipment - Climbing Post
Manufacturer: Lappset UK Ltd

Finding: The timber has a number of splits/shakes or air cracks and this may affect the stability or allow water ingress which will accelerate the rotting process
Action: Monitor to ensure the splits do not cross through fixing points of the structure and/or cause any instability

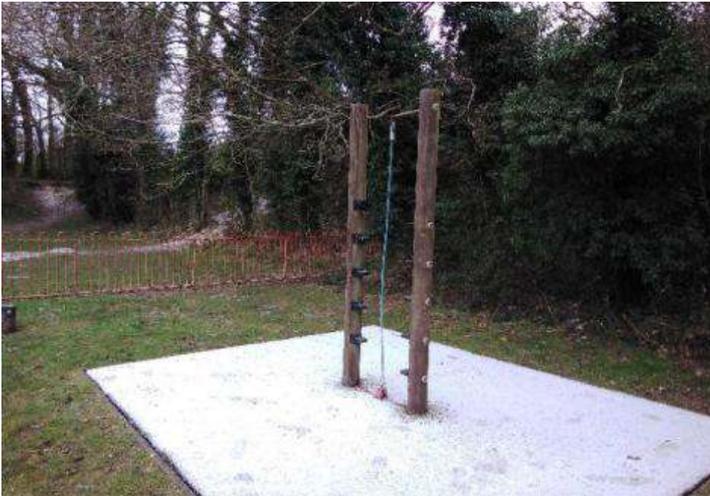
Item: Activity Equipment - Climbing Post
Manufacturer: Lappset UK Ltd

Finding: The ropes/nets are worn/damaged in places

Action: Monitor for any further deterioration and repair or replace as required

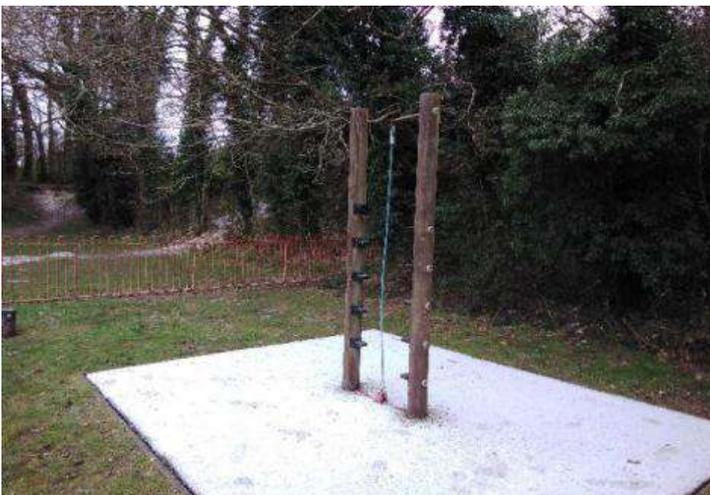
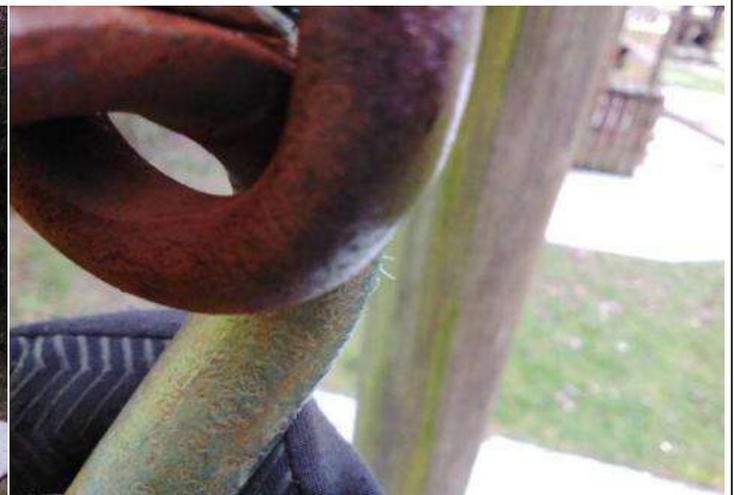
Item: Activity Equipment - Climbing Post
Manufacturer: Lappset UK Ltd

Finding: There is some wear to the shackles

Action: Monitor for any further deterioration and replace when 40% worn

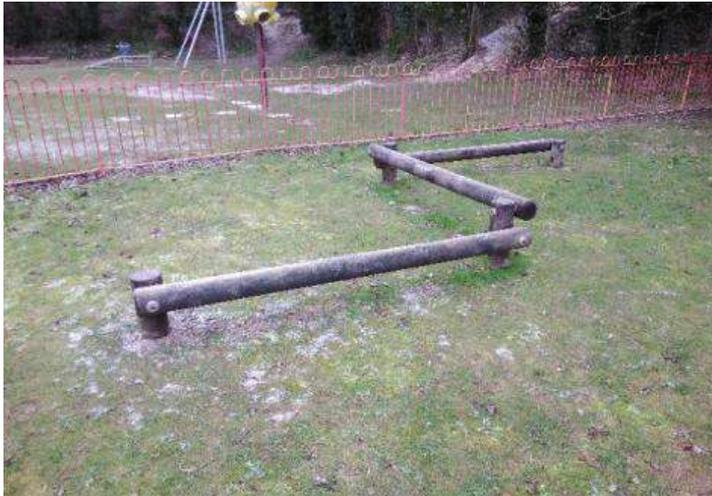
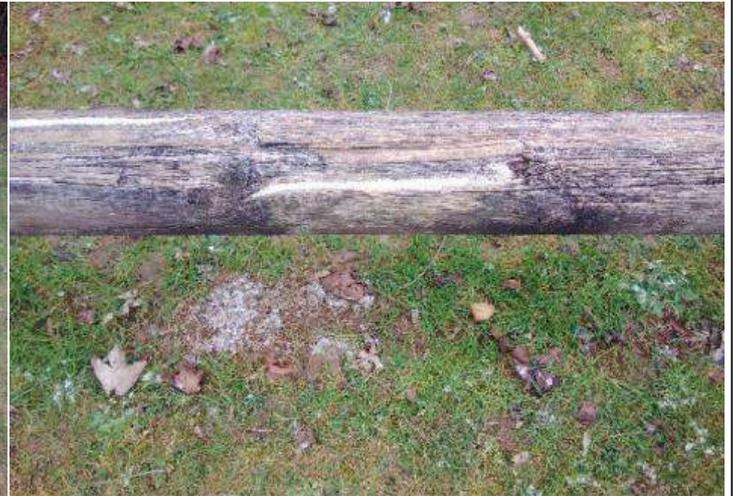
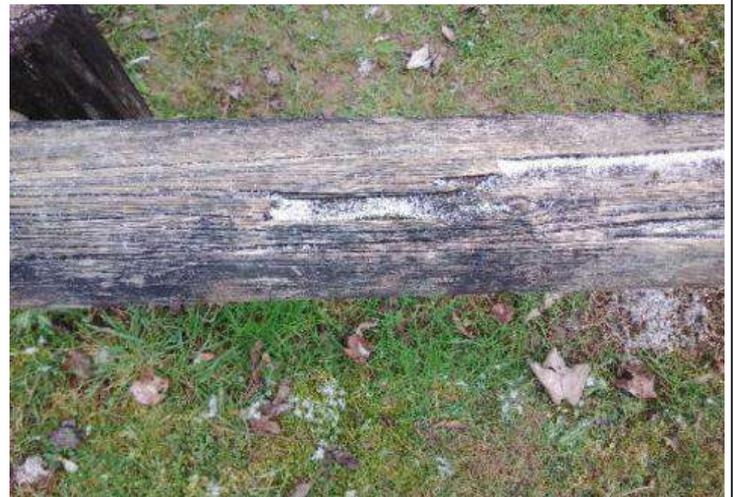
Item: Activity Equipment - Balance Beam
Manufacturer: Lappset UK Ltd

Finding: Parts of the timber are rough or splintered

Action: Remove all rough or sharp edges

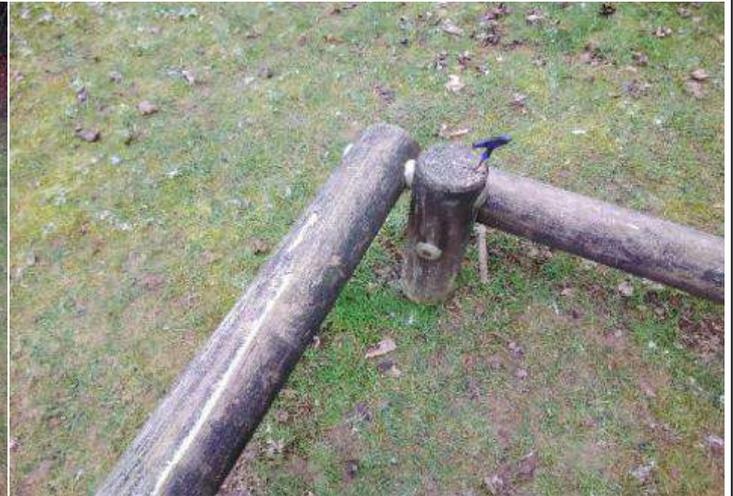
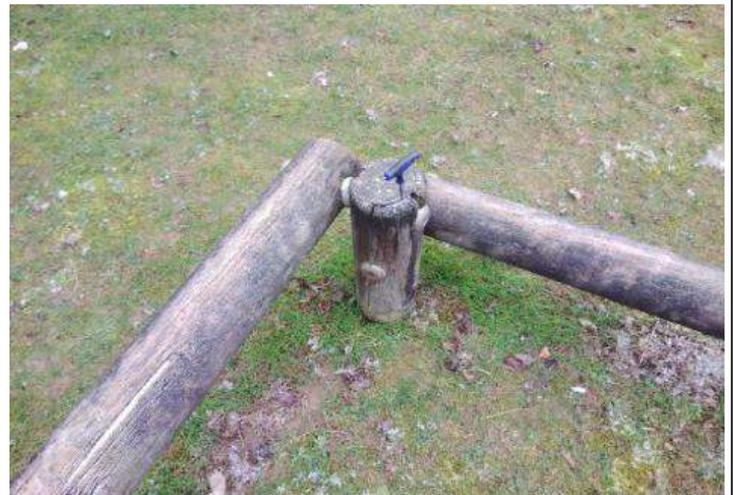
Item: Activity Equipment - Balance Beam
Manufacturer: Lappset UK Ltd

Finding: There is some evidence of rot in the timber

Action: Monitor for any further deterioration and replace as required

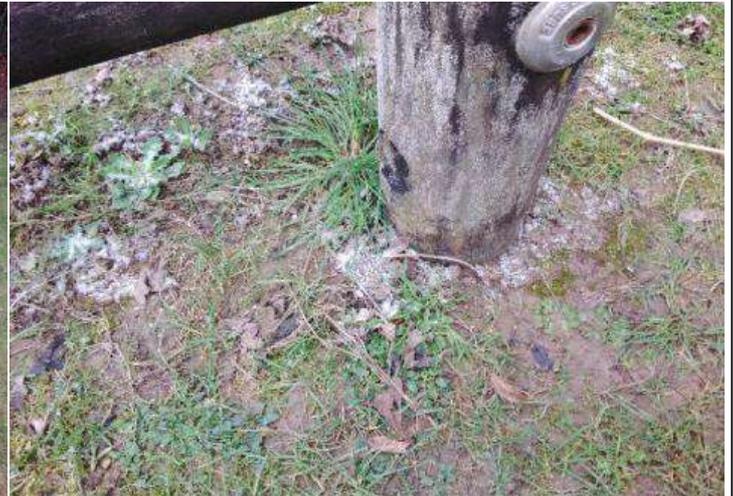
Item: Activity Equipment - Balance Beam
Manufacturer: Lappset UK Ltd

Finding: There is some strimmer / machinery damage apparent on the posts, this can penetrate the preservative applied to the timber and accelerate the rotting process

Action: Monitor for any deterioration (rot) and replace as required

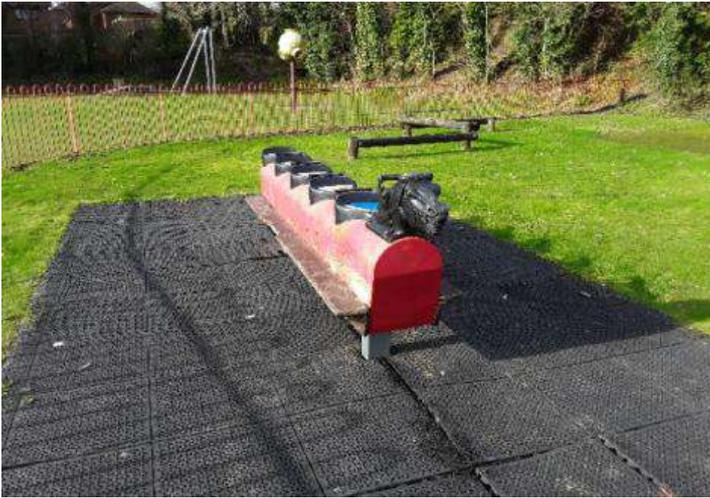
Item: Rocking Equipment - Rocking Horse
Manufacturer: Wicksteed Playgrounds

Finding: There are significant gaps (over 30mm) between the surface and the edging or between the joints in the surface; these are large enough for a small foot to enter

Action: Repair surfacing

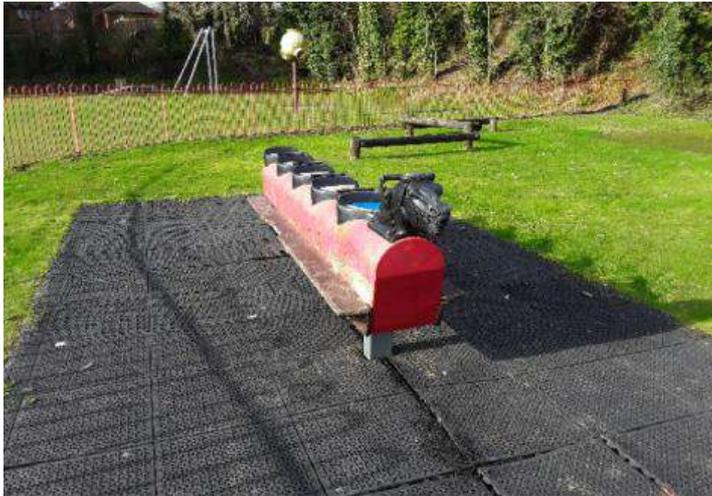
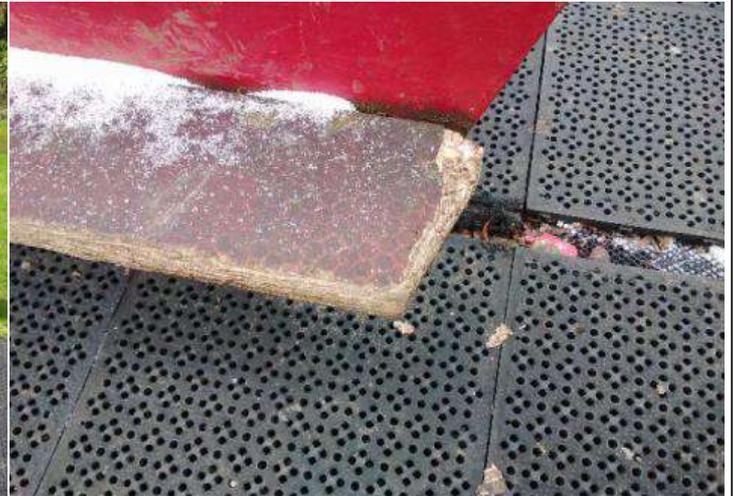
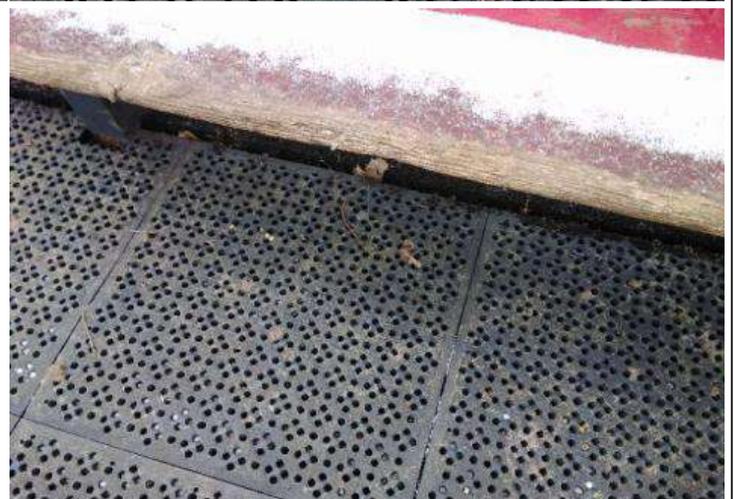
Item: Rocking Equipment - Rocking Horse
Manufacturer: Wicksteed Playgrounds

Finding: Parts of the timber are rough or splintered

Action: Remove all rough or sharp edges

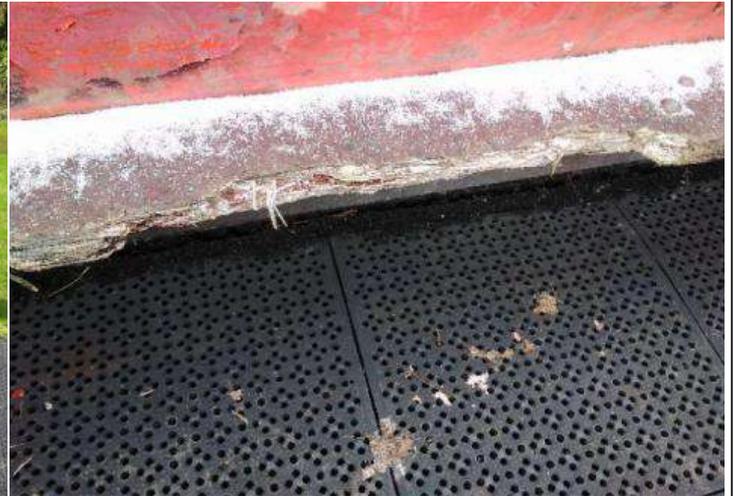
Item: Rocking Equipment - Rocking Horse
Manufacturer: Wicksteed Playgrounds

Finding: The item has been severely damaged

Action: Repair or replace the item

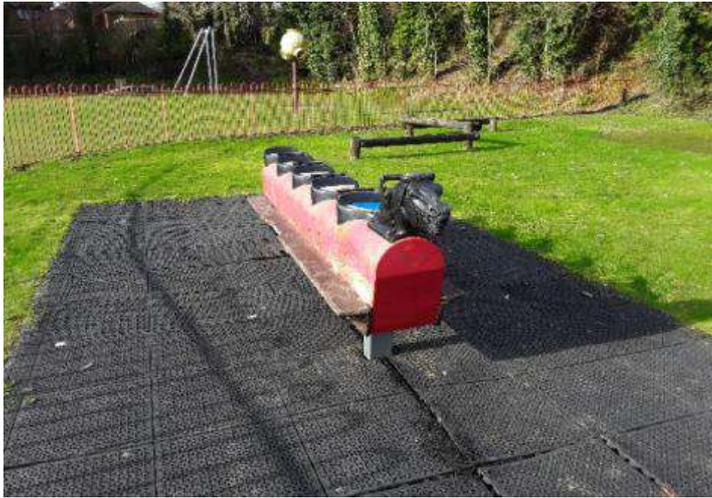
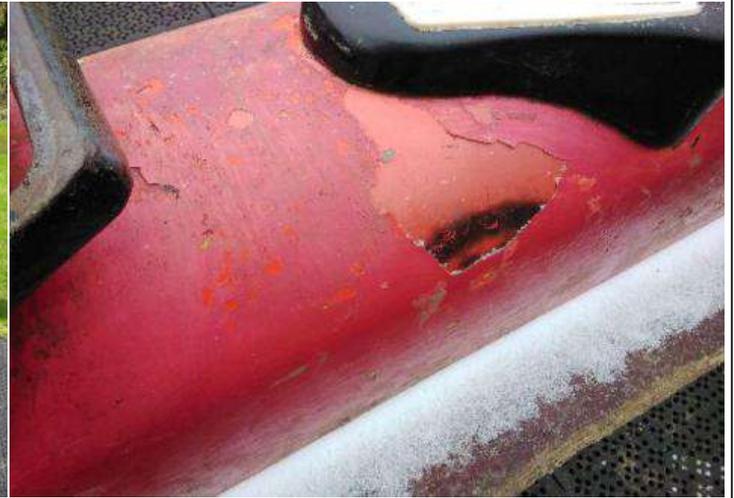
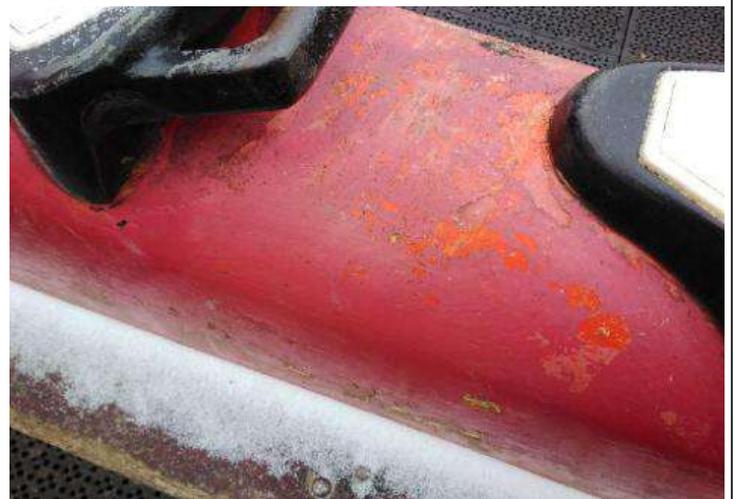
Item: Rocking Equipment - Rocking Horse
Manufacturer: Wicksteed Playgrounds

Finding: The paint is flaking off the metalwork

Action: Rub down and re-paint

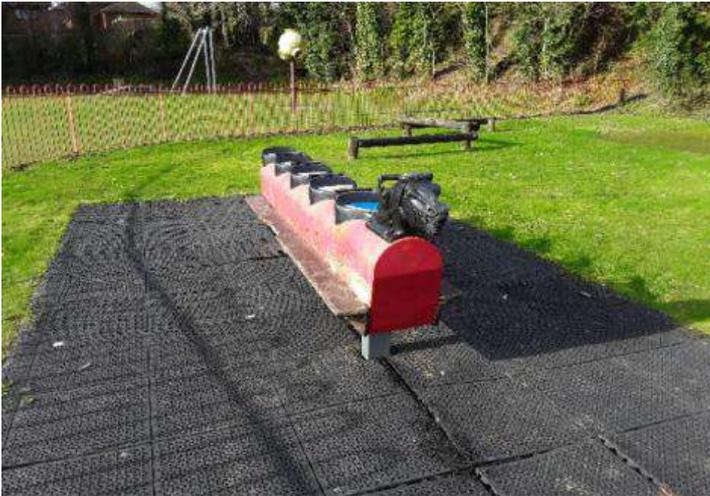
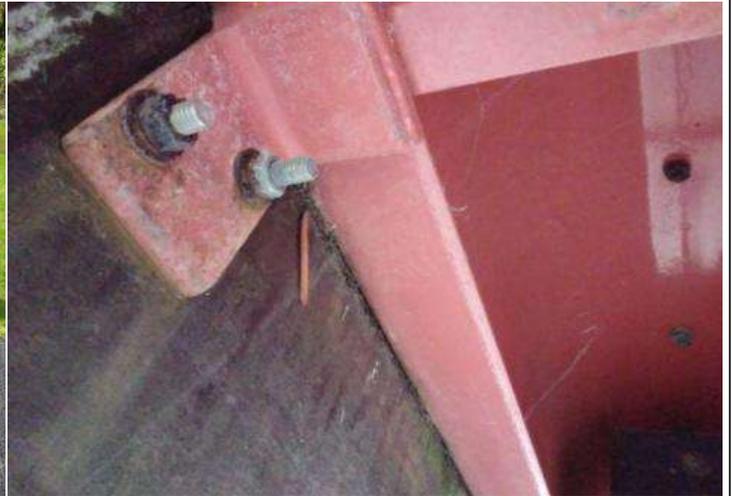
Item: Rocking Equipment - Rocking Horse
Manufacturer: Wicksteed Playgrounds

Finding: There are projecting bolt thread(s) present

Action: Remove excess thread length and deburr or provide cap

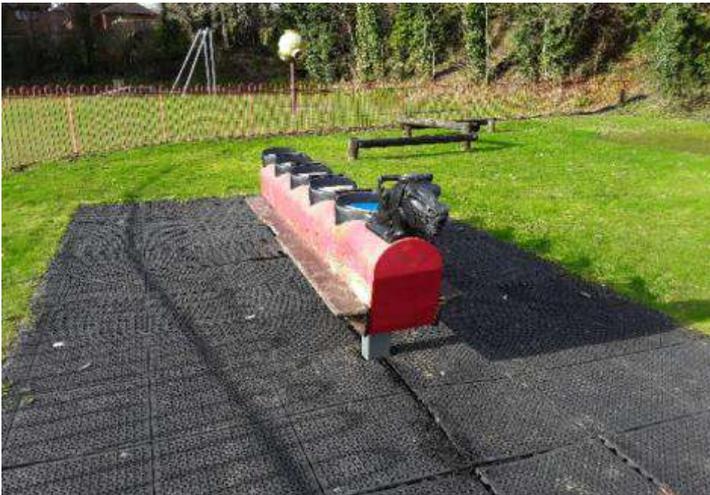
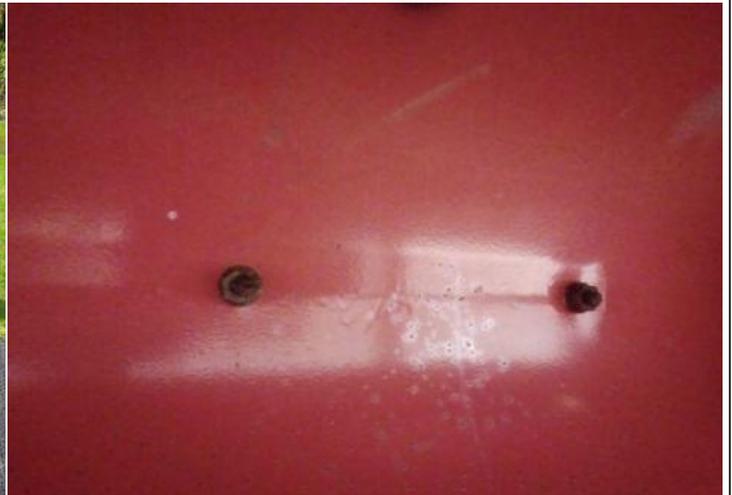
Item: Rocking Equipment - Rocking Horse
Manufacturer: Wicksteed Playgrounds

Finding: The fixings have corroded excessively

Action: Replace all corroded fixings
