Annual Inspection

Winchester City Council

Sun Hill Recreation Ground (New Alresford)

Derwent Gardens, Alresford, SO24 9NQ

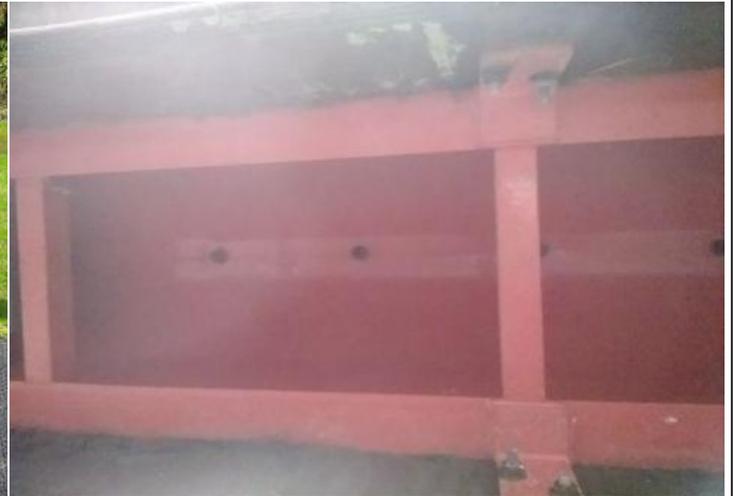
Item: Rocking Equipment - Rocking Horse
Manufacturer: Wicksteed Playgrounds

Finding: There is no gaiter protection for accessible moving parts (possible shear trap) as recommended in BS EN 1176 Part 1; 4.2.6 Moving Parts
Action: Monitor - No remedial work recommended

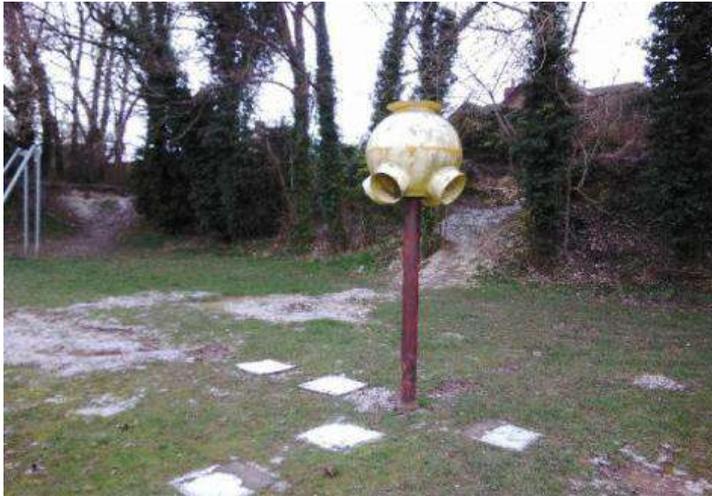
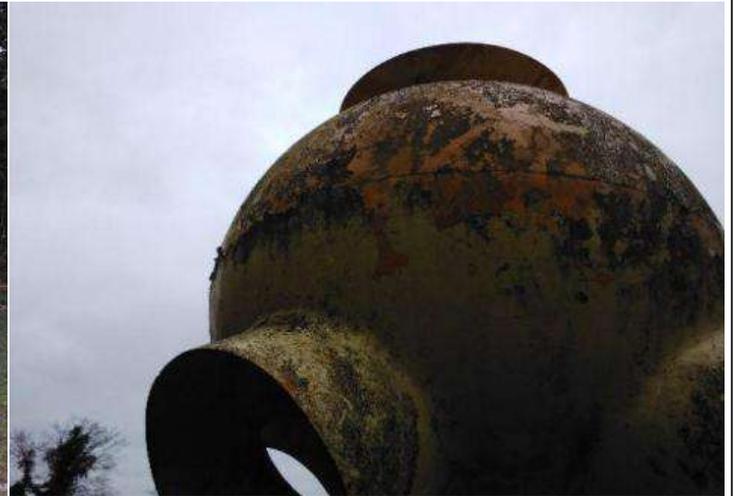
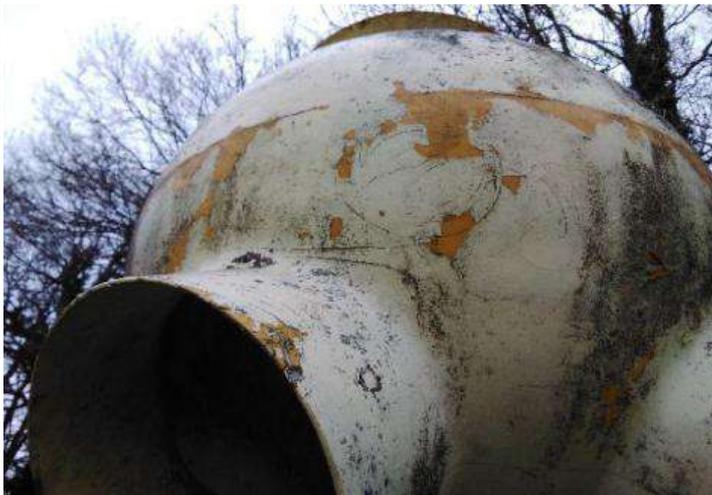
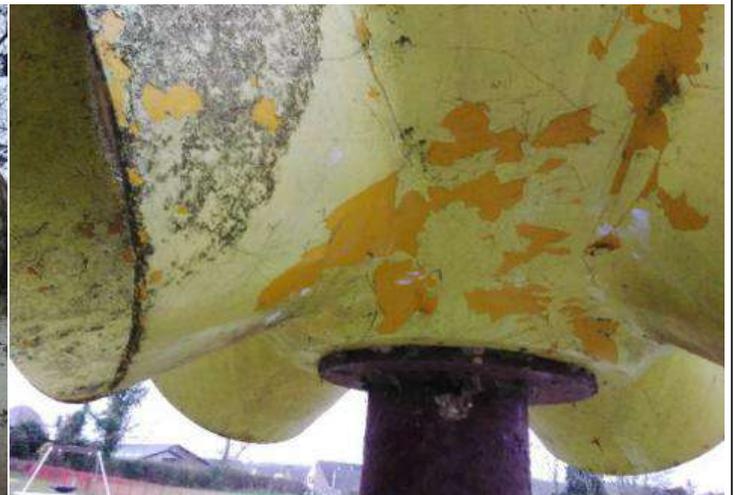
Item: Other - Ball Shoot
Manufacturer: Wicksteed Playgrounds

Finding: The paint is flaking off the metalwork

Action: Rub down and re-paint

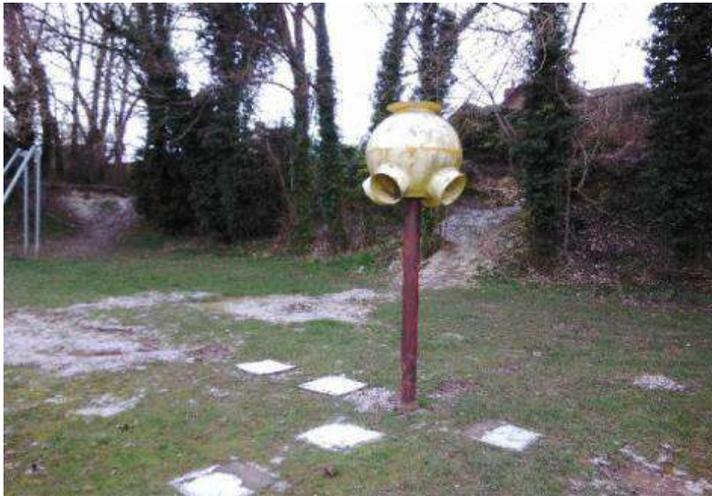
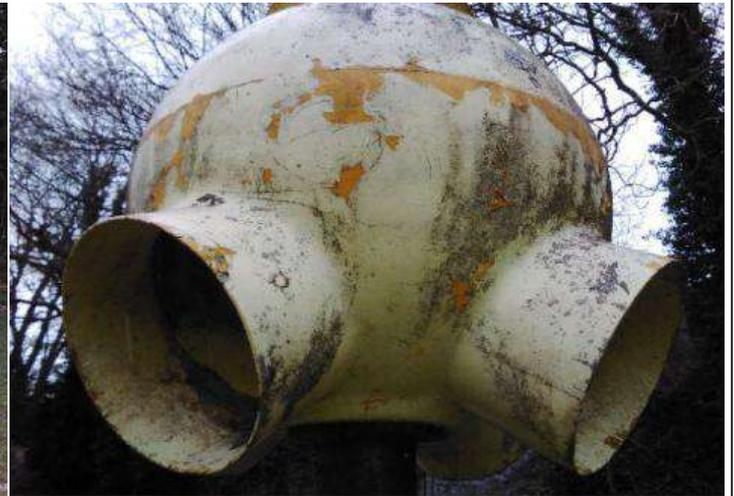
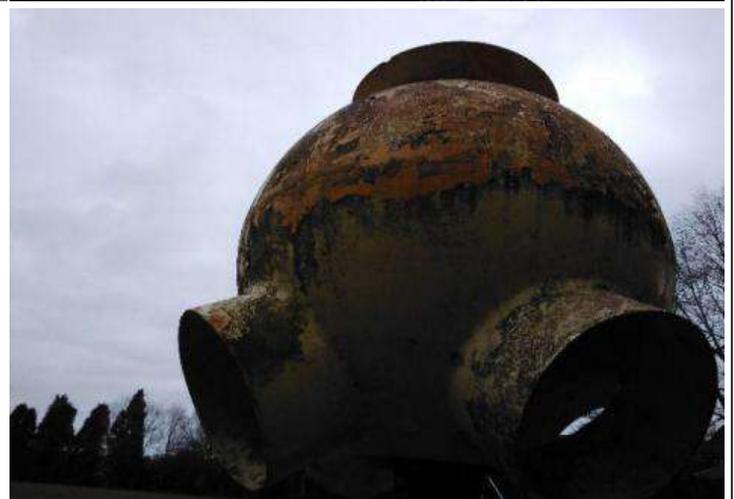
Item: Other - Ball Shoot
Manufacturer: Wicksteed Playgrounds

Finding: There is algae or moss on the surface of the equipment

Action: Clean and treat appropriately

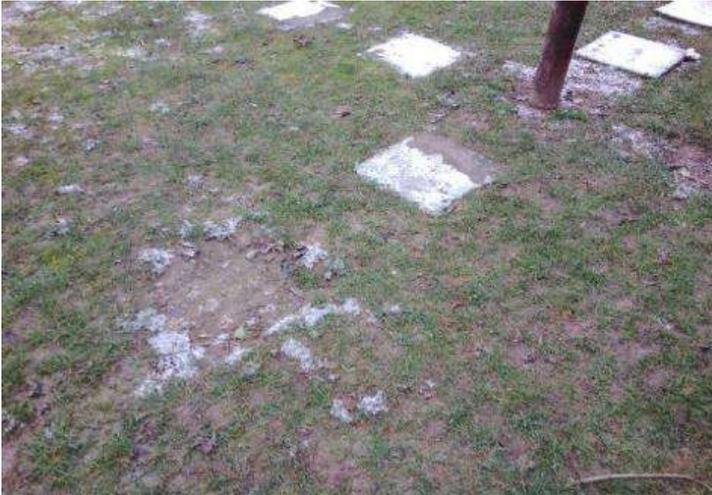
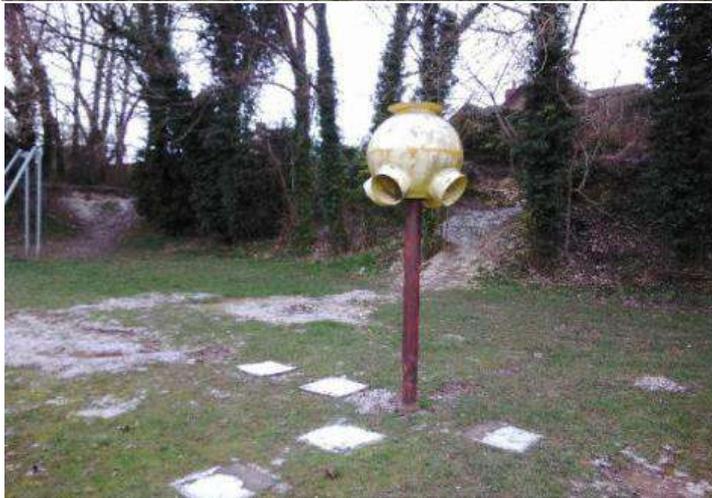
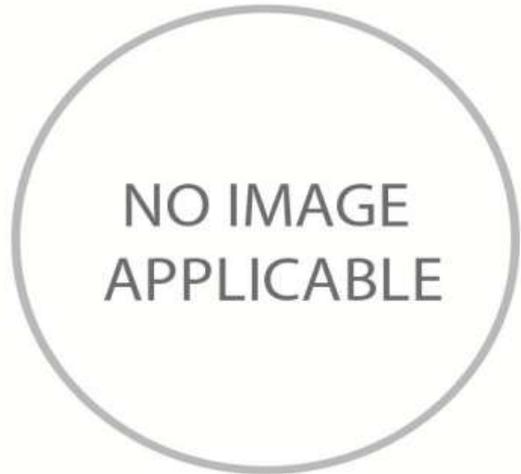
Item: Other - Ball Shoot
Manufacturer: Wicksteed Playgrounds

Finding: There are trip hazards at the edges of the paving slabs

Action: Reinstate surrounding surface levels to remove the trip points

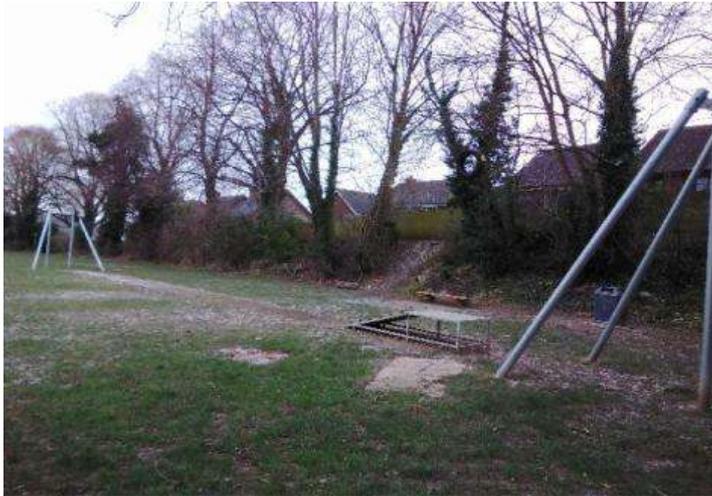
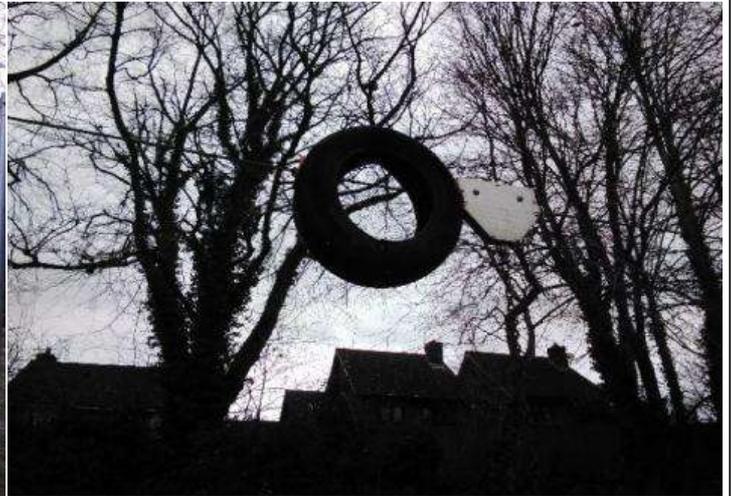
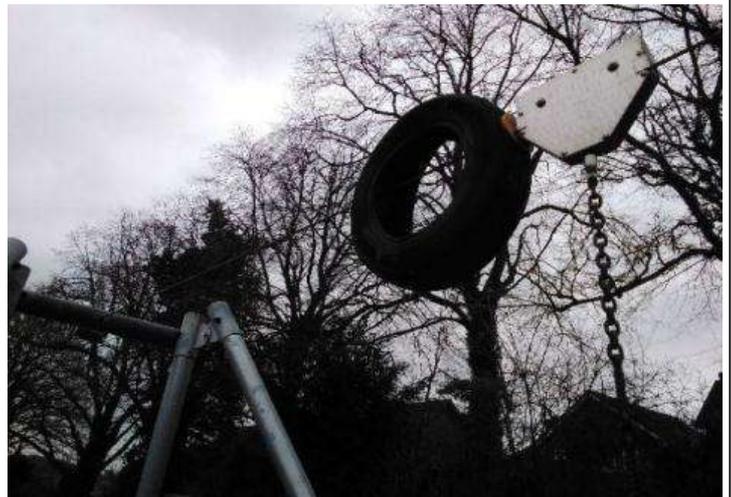
Item: Other - Cable Runway
Manufacturer: Wicksteed Playgrounds

Finding: The dampening spring or tyre is damaged or broken on the item

Action: Replace spring or tyre

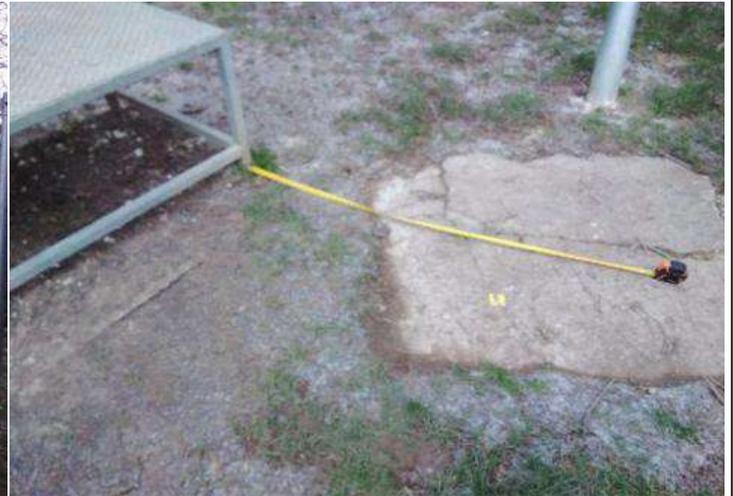
Item: Other - Cable Runway
Manufacturer: Wicksteed Playgrounds

Risk Level: V - Very Low Risk
Surface: Grass Matrix Tiles

Finding: This item of equipment has a fall height in excess of 600mm and an impact absorbing surface is recommended to meet the recommendations of BS EN 1176 Part 1

Action: Provide an appropriate impact absorbing surface

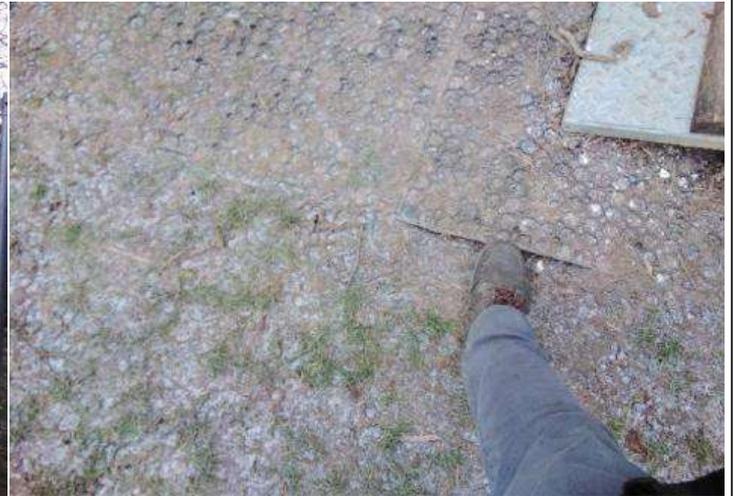
Item: Other - Cable Runway
Manufacturer: Wicksteed Playgrounds

Risk Level: L - Low Risk
Surface: Grass Matrix Tiles

Finding: There are trip hazards at the edges of the surface

Action: Reinstate surrounding surface levels to remove the trip points

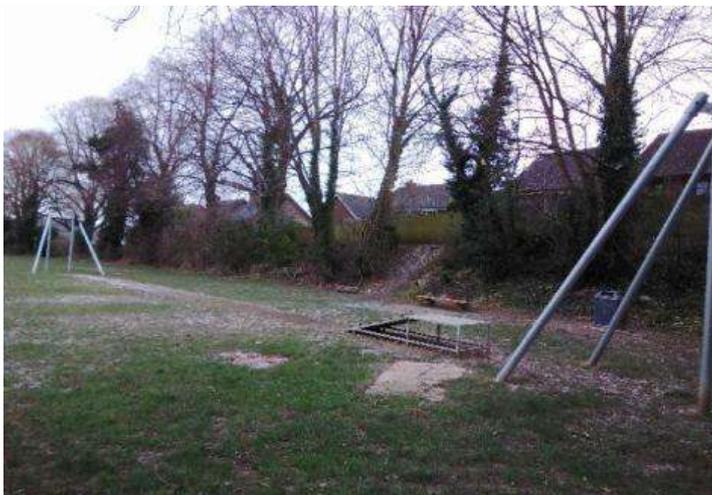
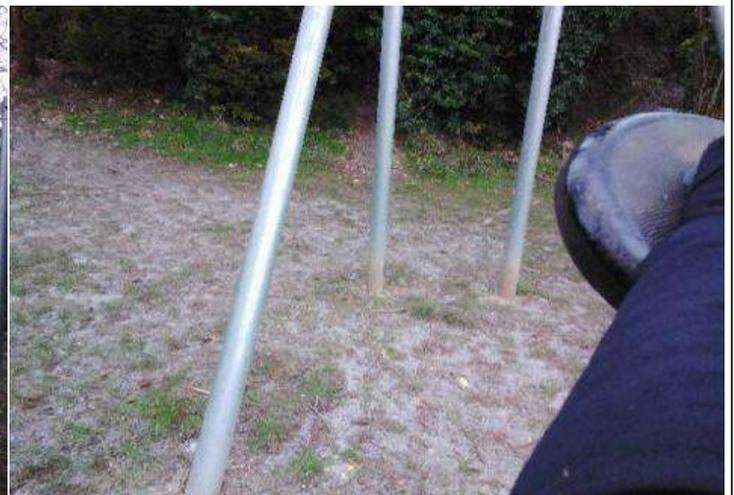
Item: Other - Cable Runway
Manufacturer: Wicksteed Playgrounds

Risk Level: L - Low Risk
Surface: Grass Matrix Tiles

Finding: The seat is less than 2.0 metres from the post when extended at 45 degrees at the end of the area of travel and does not meet the requirements of BS EN 1176 Part 4

Action: Adjust the cable stop position to ensure the minimum distance is maintained
