the **play** inspection company

Annual Inspection

Winchester City Council

Arlebury Park, Skate Park & Tennis(New Alresford)

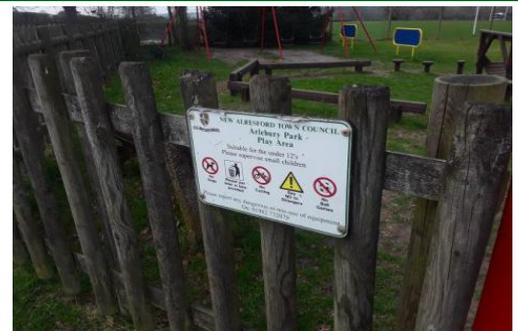
There are areas or parts of the timber that have rotted - Replace sign

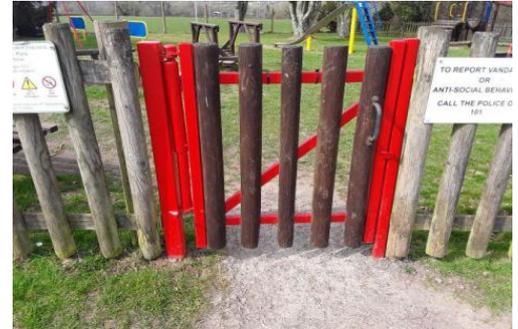
There are post / end caps missing / damaged - Replace post caps

There is or are fixings missing on the item - Replace all missing fixings

There are areas or parts of the timber on the structure that have rotted - Replace all affected timbers

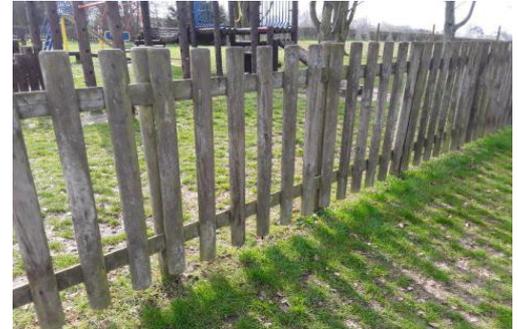
There is some strimmer / machinery damage apparent on the posts, this can penetrate the preservative applied to the timber and accelerate the rotting process - Monitor for any deterioration (rot) and replace as required

There are a number of loose posts around the fence - Monitor for any further deterioration and reset as required

There are areas or parts of the timber on the structure that have rotted - Replace all affected timbers

There is some evidence of rot in the timber - Monitor for any further deterioration and replace as required

The surface has eroded and the foundations are exposed - Reinstate surrounding surfaces to cover the foundations

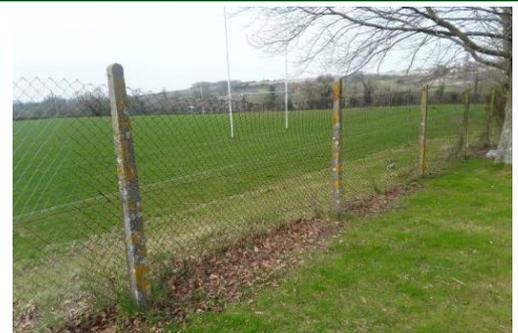
There is some damage to the fence sections - Monitor for any further deterioration and repair as required

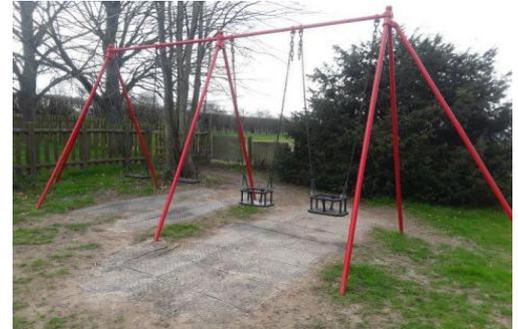
The surface has subsided in some areas - Monitor for any further deterioration and repair as required

The seats are too close to each other as defined in BS EN 1176 Part 2; this is a low risk failure and no remedial action is required - Monitor - No remedial work recommended

The seats are too close to the frame as defined in BS EN 1176 Part 2; this is a low risk failure and no remedial action is required - Monitor - No remedial work recommended

The chain openings are in excess of the 8.6mm as recommended by BS EN 1176 - Monitor - No remedial work recommended

There is some notable evidence of chain wear - Monitor for any further deterioration and replace when 40% worn

There is some wear to the chain bars - Monitor for any further deterioration and replace when 40% worn

There is some wear to the connecting links - Monitor for any further deterioration and replace when 40% worn

There is some wear to the shackles. - Monitor for any further deterioration and replace when 40% worn

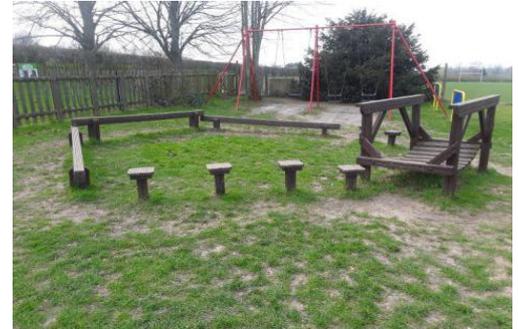
A number of eyebolt fixing(s) have worked loose - Secure all loose fixings

There is some strimmer / machinery damage apparent on the posts, this can penetrate the preservative applied to the timber and accelerate the rotting process - Monitor for any deterioration (rot) and replace as required

There are areas or parts of the stepping posts that have rotted - Replace all affected timbers

There are areas or parts of the balance beams that have rotted - Replace all affected timbers

There is/are bolt cap covers missing or damaged on the item - Replace missing or damaged bolt cap covers

Fixings are damaged and/or have sharp edges - Repair or replace as required

There is some evidence of rot in the timber throughout the trail - Monitor for any further deterioration and replace as required

The stepping posts are becoming loose in the ground - Monitor for any further deterioration and repair as required

There are areas or parts of the posts x4 on the balance beams that have rotted with evidence of rot in the remaining posts - Replace all affected timbers

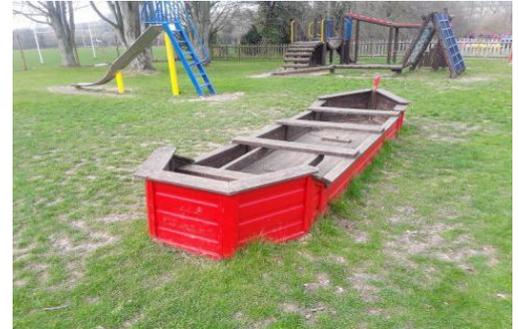
There is some evidence of fire damage to the item - Monitor for any further deterioration and repair as required

There is some evidence of rot in the timber - Monitor for any further deterioration and replace as required

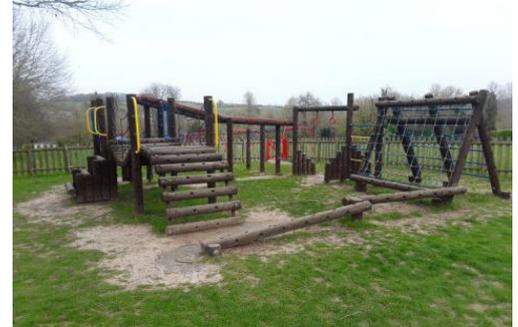
The grass mats are silted up and the soil is compacted; this may have an effect on the impact absorbing properties of the surface - Consider HIC testing impact absorbing properties to ensure the correct surface qualities are maintained for the equipment and replace as required

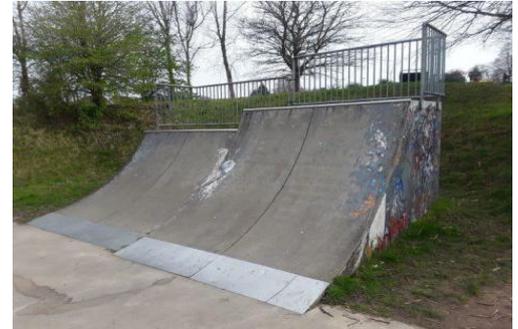
Finding 1	Finding 2
The riding surface of the ramp has some damage apparent - Monitor for any further deterioration and repair as required	A number of fixing(s) have worked loose - Secure all loose fixings
Finding 3	Finding 4
There is/are several inserts missing - Replace missing inserts	There is some damage to the barrier sections - Monitor for any further deterioration and repair as required
Finding 5	Finding 6
The height of the barrier is less than 1200mm and fails the requirements of BS EN 14974 - Monitor - No remedial work recommended	The kicker plate protrudes more than 5mm above the surrounding surface level, BS EN 14974 recommends a maximum of 5mm with 3mm preferred - Adjust height to ensure a maximum of 5mm change in level
Finding 7	Finding 8
Joints between the riding surfaces should not be greater than 5mm to meet the requirements of BS EN 14974 - Take corrective action to ensure that the gaps between the joints do not exceed 5mm	The gap between the underside of the barrier and the platform is in excess of 60mm and fails the requirements of BS EN 14974 - Monitor - No remedial work recommended

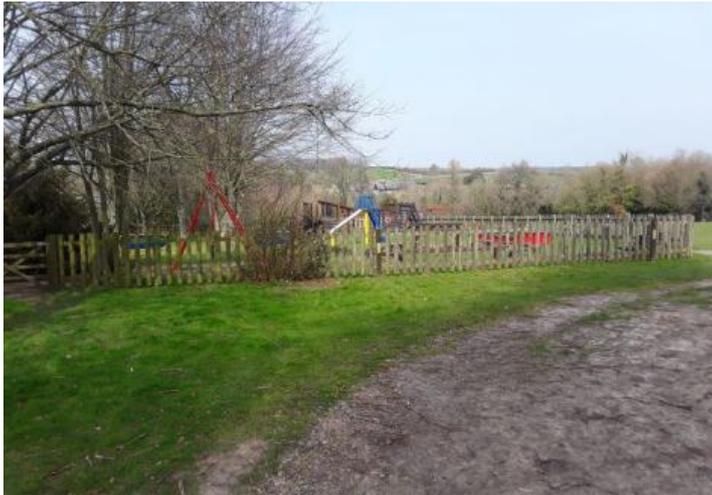
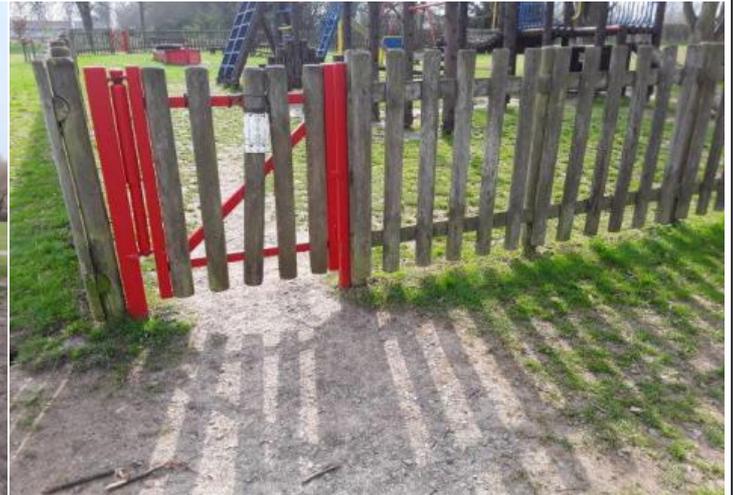
Finding: The surface has eroded in some areas leading to the entrance / exit to the play area
Action: Reinstate the surface

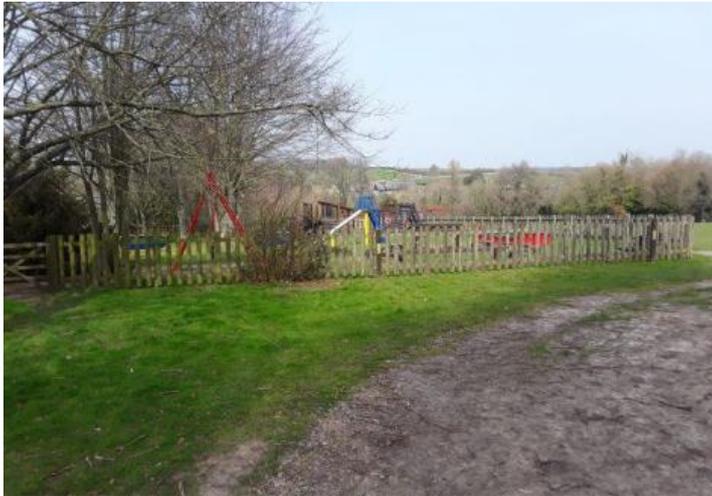
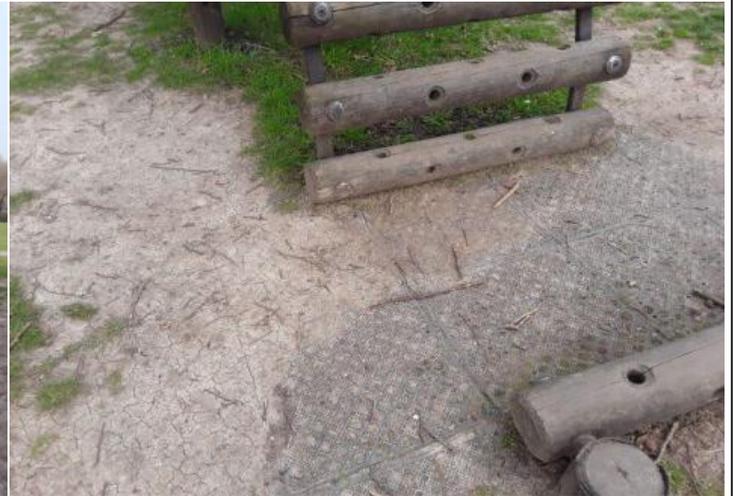
Finding: There is some tree debris on the surfacing

Action: Remove and maintain

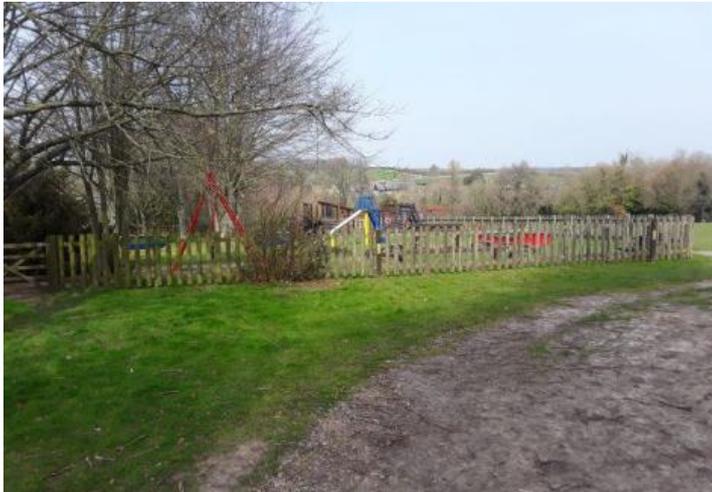
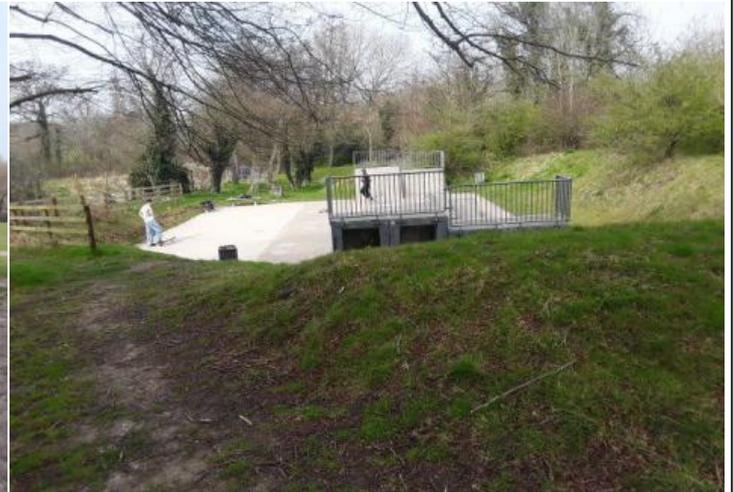
Finding: Signage of the wheeled sports area should be provided as recommended in BS EN 14974; this will include, but not exclusively, the use of the area, a recommendation to wear protective equipment, emergency contact details etc.

Action: Provide signage as recommended by BS EN 14974 for wheeled sports areas

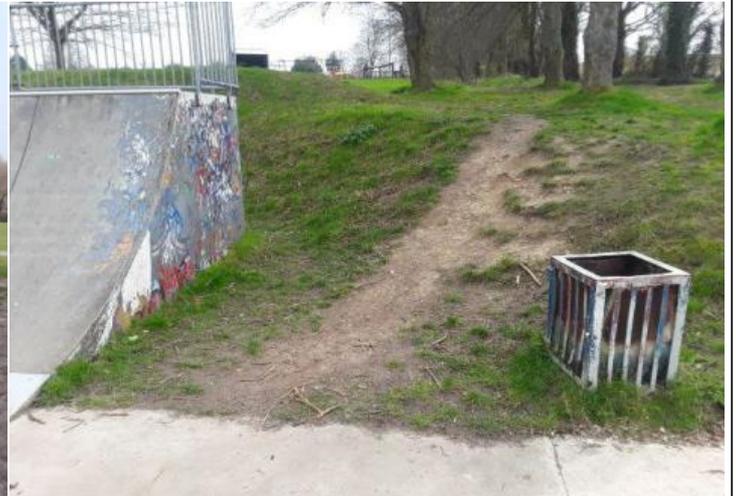
Finding: The surface has eroded in some areas around the skate park
Action: Reinstate the surface

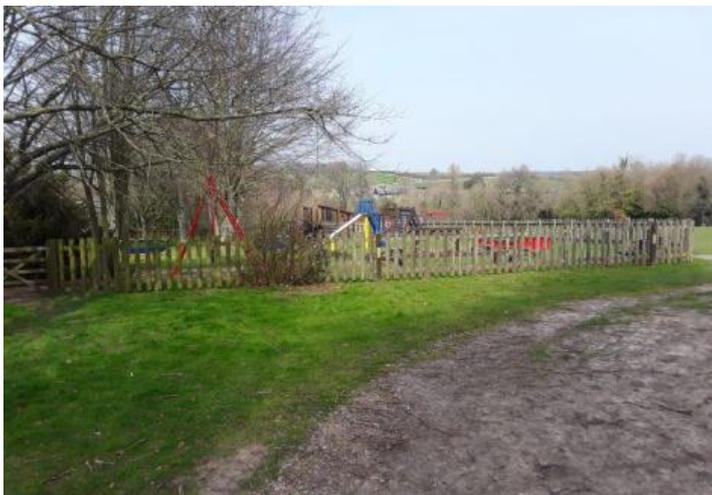
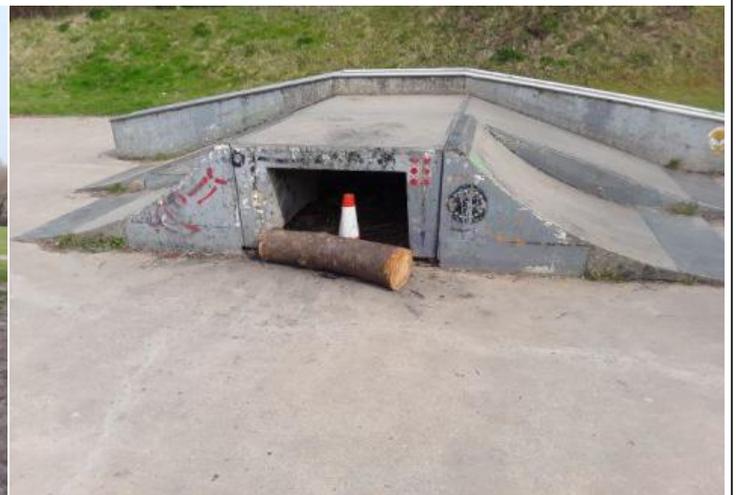
Finding: There is litter/debris in the skate park
Action: Remove litter/debris from the area and maintain

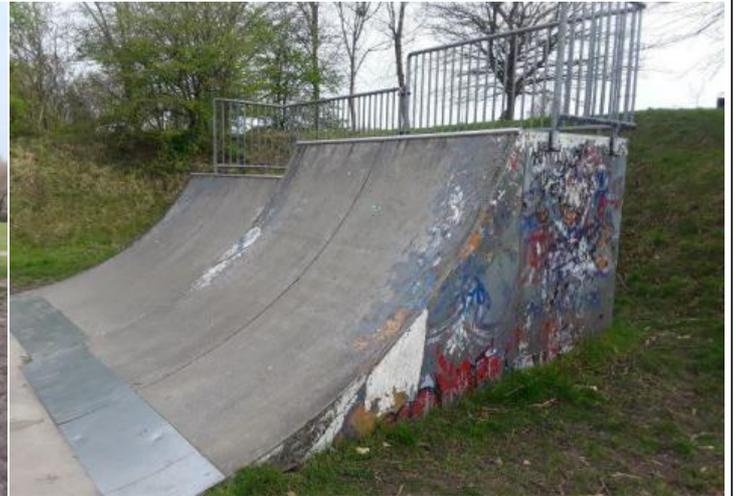
Finding: There is some graffiti present on the skate ramps **Action:** Remove the graffiti if deemed appropriate

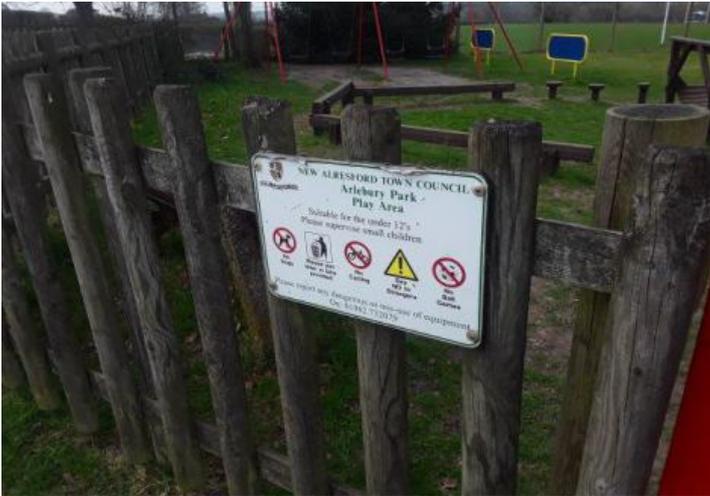
Finding: There are areas or parts of the timber that have rotted

Action: Replace sign

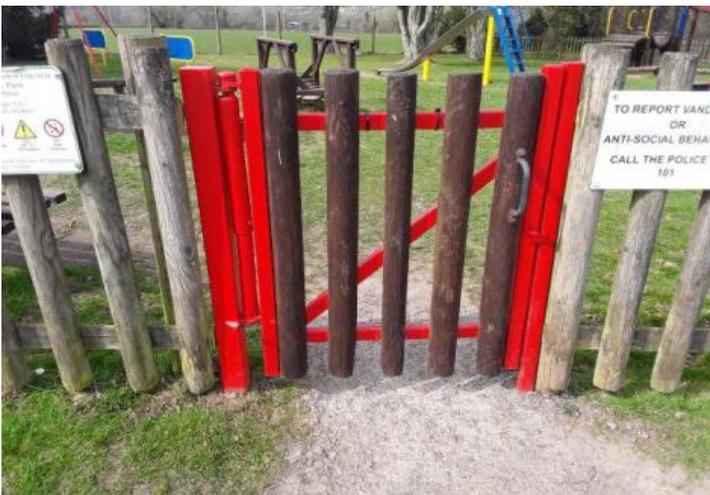
Finding: There are post / end caps missing / damaged

Action: Replace post caps

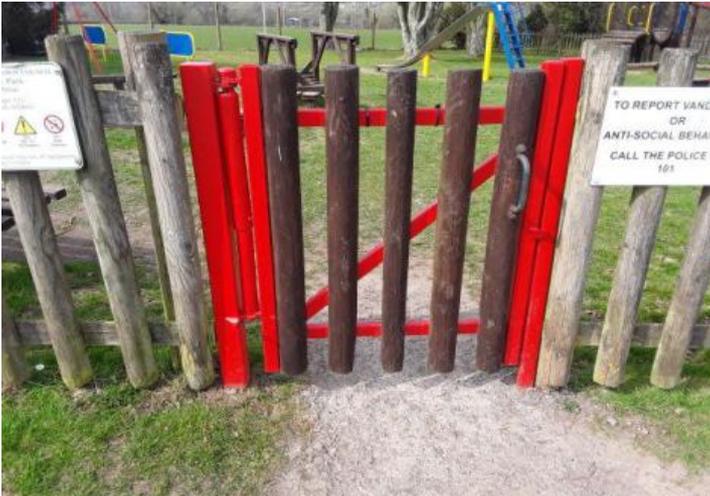
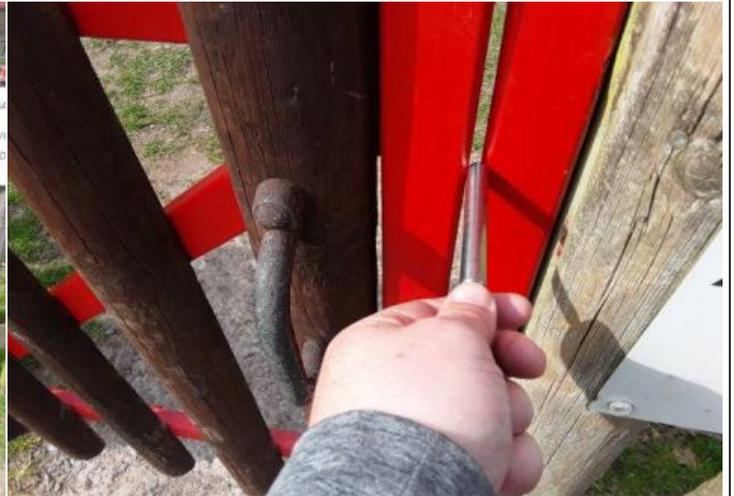
Finding: There are openings that are less than 12mm that could trap or crush fingers

Action: Where possible a 12mm gap should be maintained on both sides or between the gate leaves

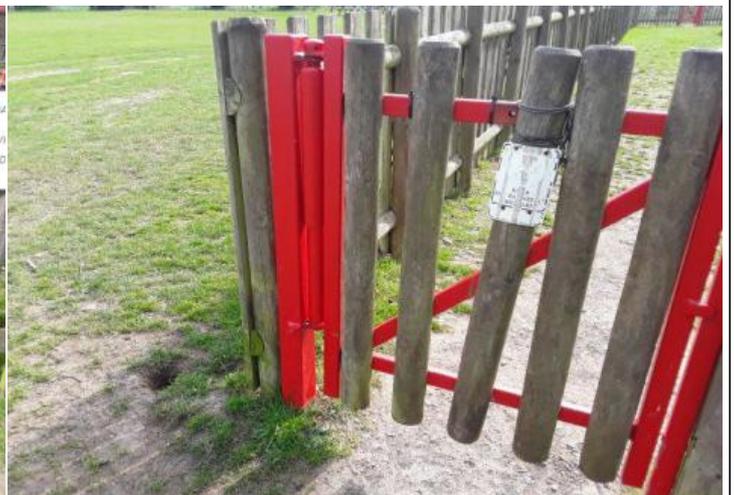
Finding: The gate is closing too quickly (less than 4 seconds)

Action: Take corrective action to ensure that the gate closes in 4-8 seconds

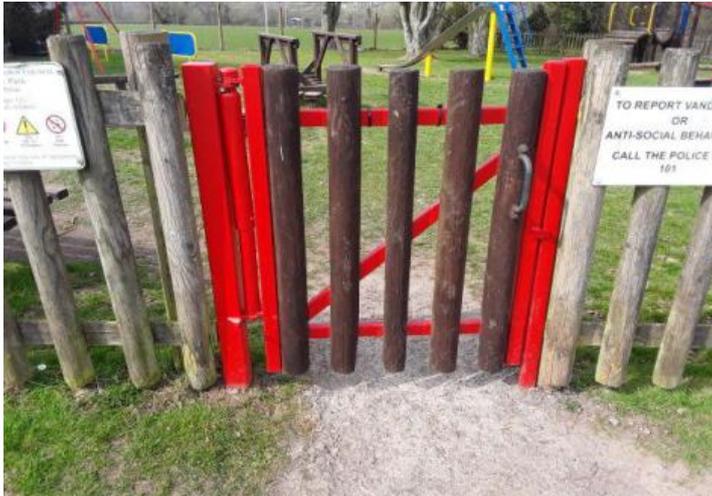
Finding: There is or are fixings missing on the item

Action: Replace all missing fixings

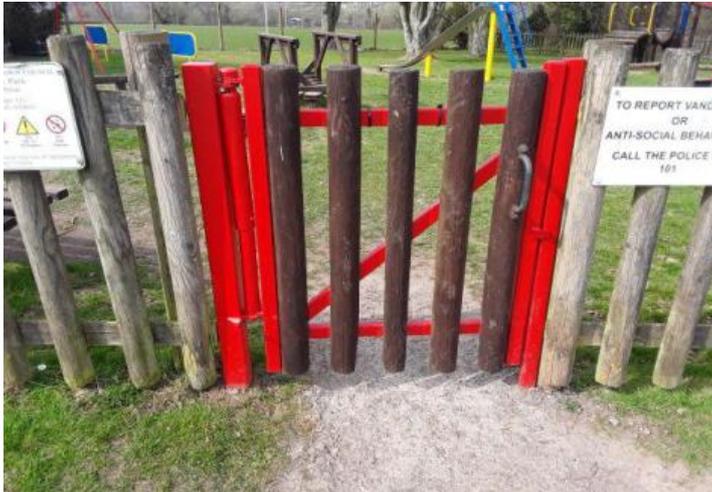
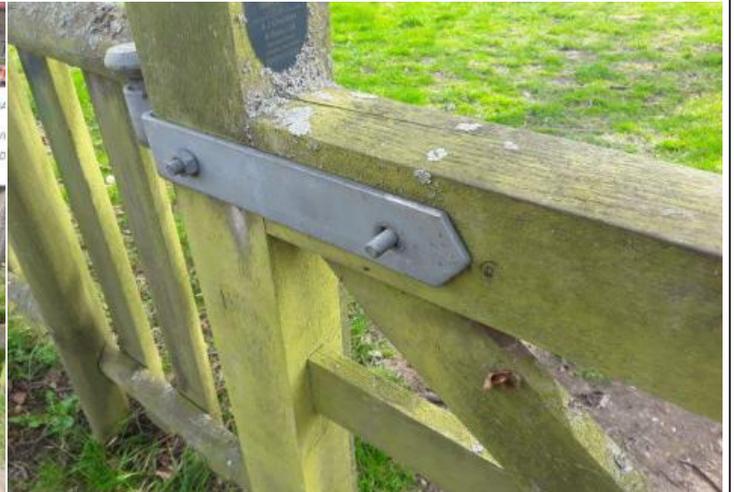
Finding: There is or are fixings missing on the item

Action: Replace all missing fixings

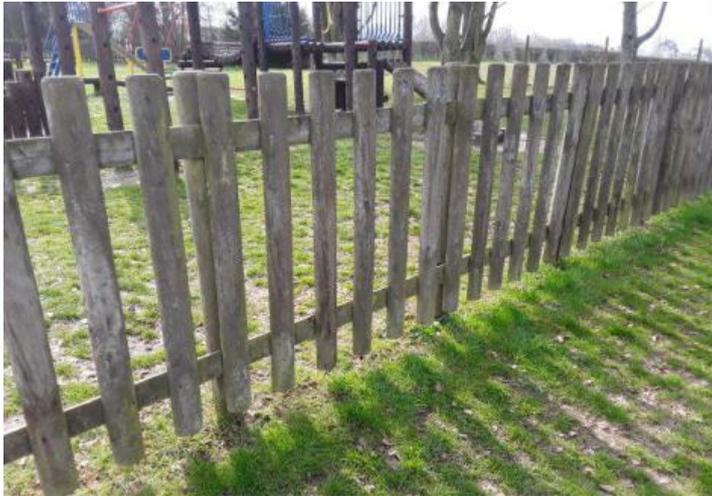
Item: Fences - Fencing - Timber
Manufacturer: Not Identified

Finding: There is some strimmer / machinery damage apparent on the posts, this can penetrate the preservative applied to the timber and accelerate the rotting process

Action: Monitor for any deterioration (rot) and replace as required

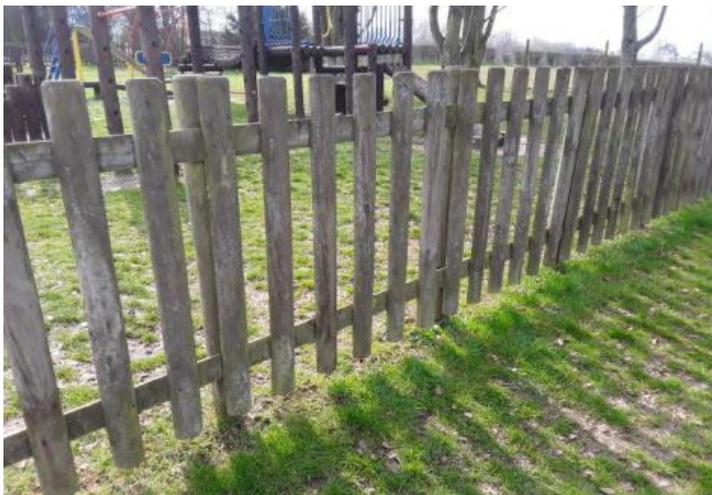
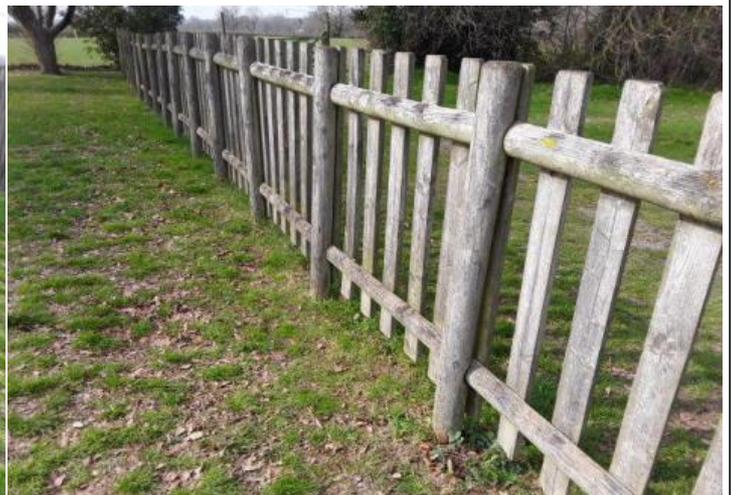
Item: Fences - Fencing - Timber
Manufacturer: Not Identified

Finding: There are a number of loose posts around the fence

Action: Monitor for any further deterioration and reset as required

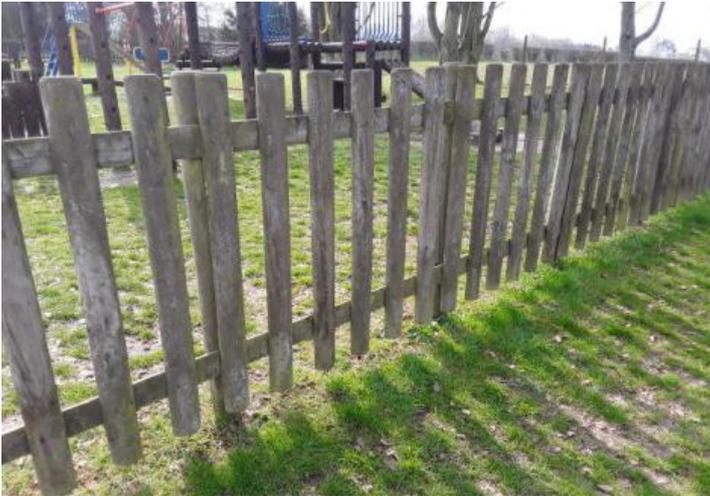
Item: Fences - Fencing - Timber
Manufacturer: Not Identified

Finding: There is some evidence of rot in the timber

Action: Monitor for any further deterioration and replace as required

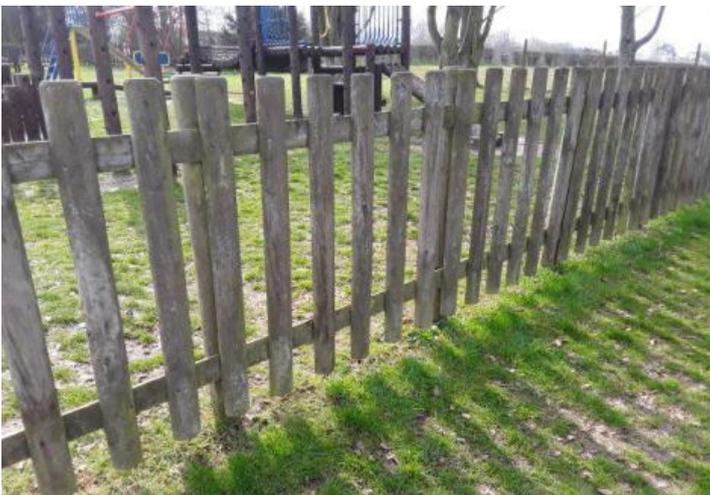
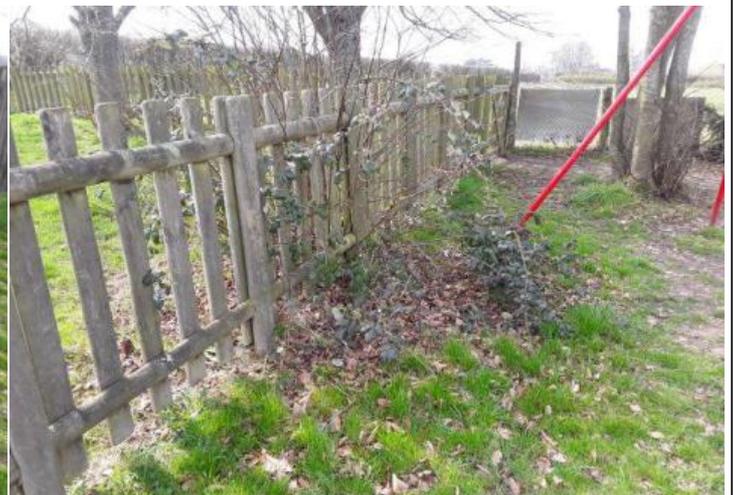
Item: Fences - Fencing - Timber
Manufacturer: Not Identified

Finding: The adjacent foliage is overhanging

Action: Cut back and maintain

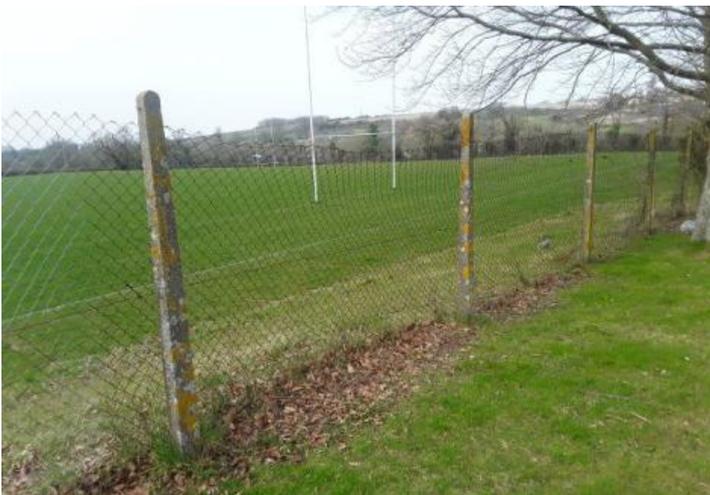
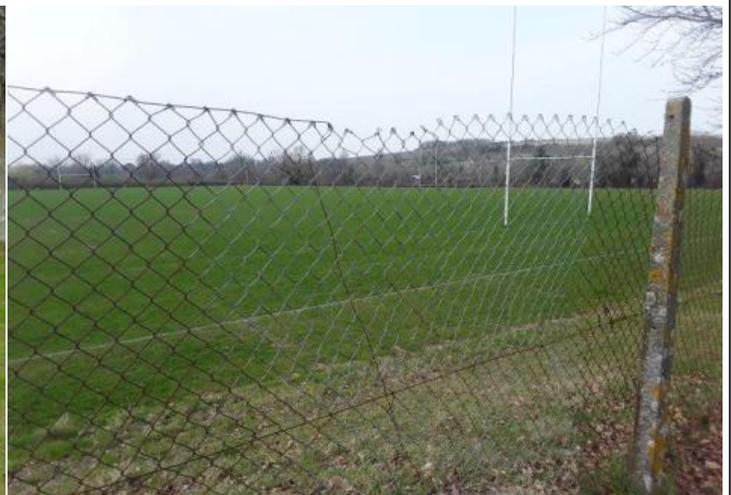
Item: Fences - Fence - Chainlink
Manufacturer: Not Identified

Finding: There is some damage to the fence sections

Action: Monitor for any further deterioration and repair as required

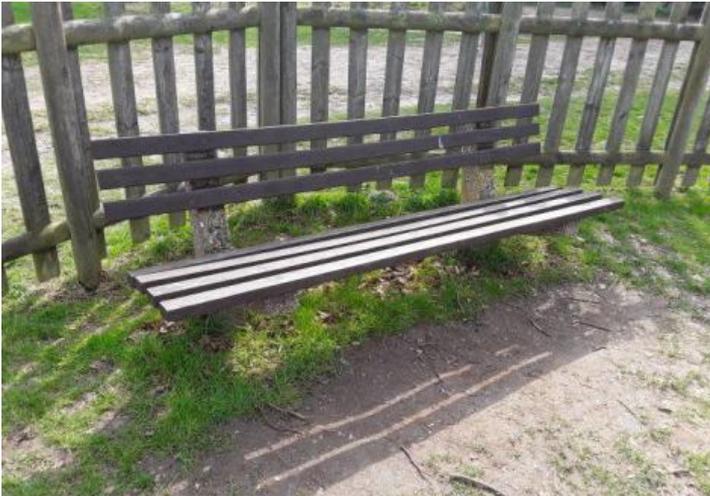
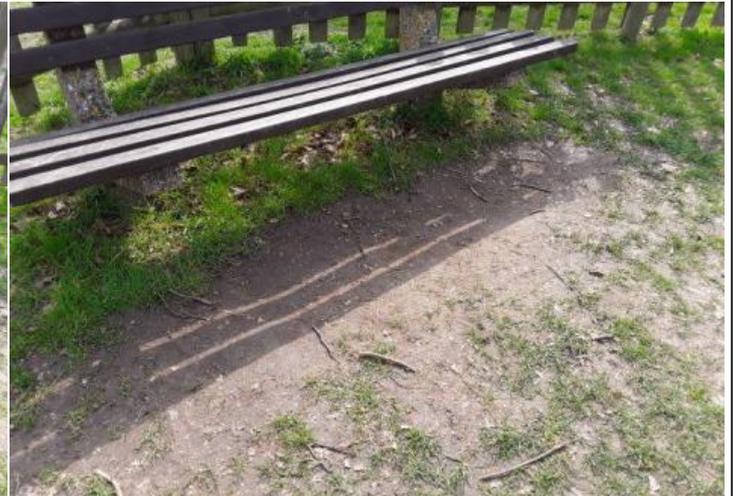
Item: Ancillary Items - Bench
Manufacturer: Not Identified

Finding: The area around the item has eroded and may become slippery

Action: Reinststate eroded area

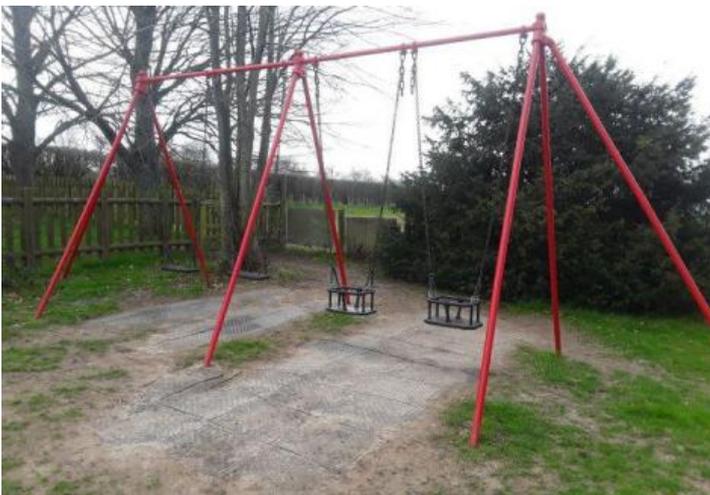
Item: Swings - 2 Bay (2 Flat, 2 Cradle)
Manufacturer: Wicksteed Playgrounds

Finding: The surface has subsided in some areas

Action: Monitor for any further deterioration and repair as required

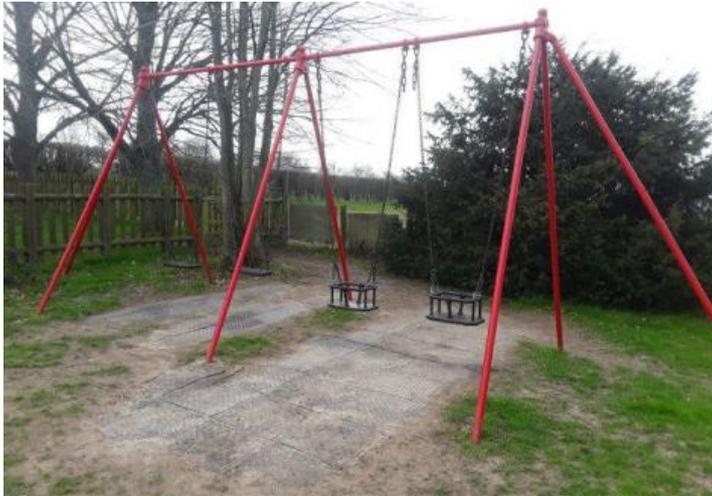
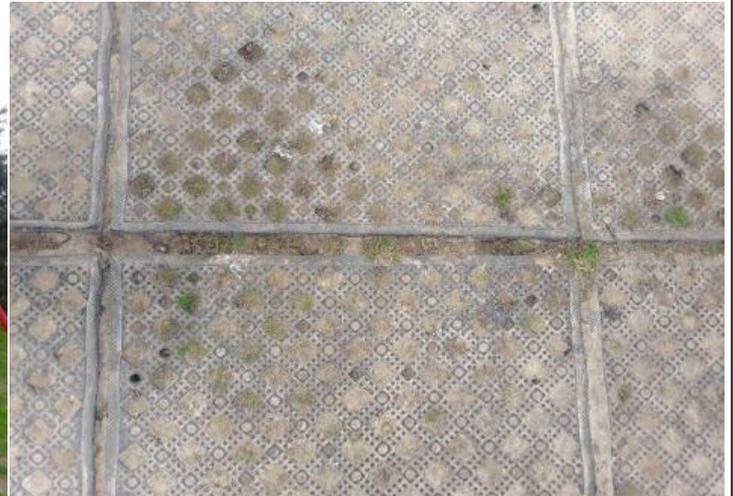
Item: Swings - 2 Bay (2 Flat, 2 Cradle)
Manufacturer: Wicksteed Playgrounds

Finding: There are gaps opening between the grass mat tiles

Action: Provide additional ties or secure / reinstate surface tiles

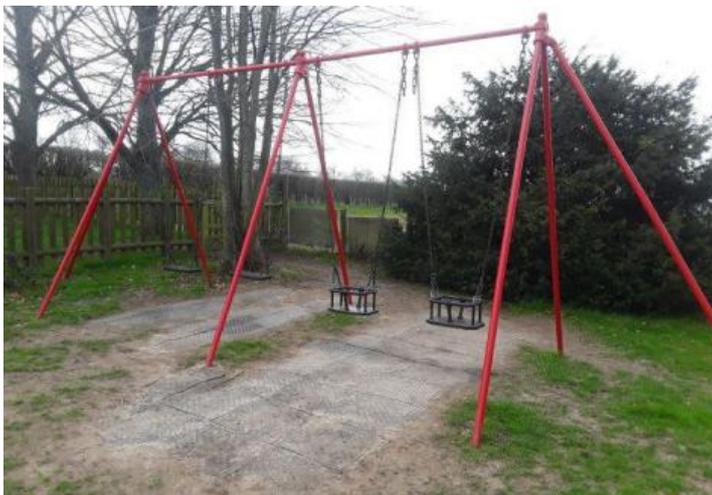
Item: Swings - 2 Bay (2 Flat, 2 Cradle)
Manufacturer: Wicksteed Playgrounds

Finding: The seats are too close to each other as defined in BS EN 1176 Part 2; this is a low risk failure and no remedial action is required

Action: Monitor - No remedial work recommended

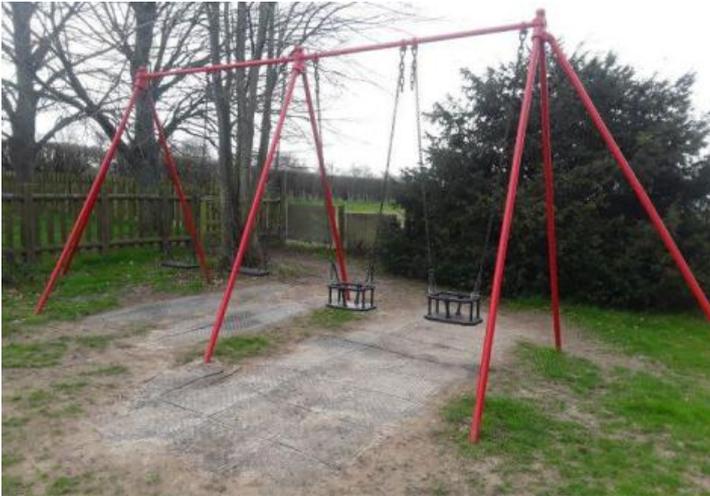
Item: Swings - 2 Bay (2 Flat, 2 Cradle)
Manufacturer: Wicksteed Playgrounds

Finding: The seats are too close to the frame as defined in BS EN 1176 Part 2; this is a low risk failure and no remedial action is required

Action: Monitor - No remedial work recommended

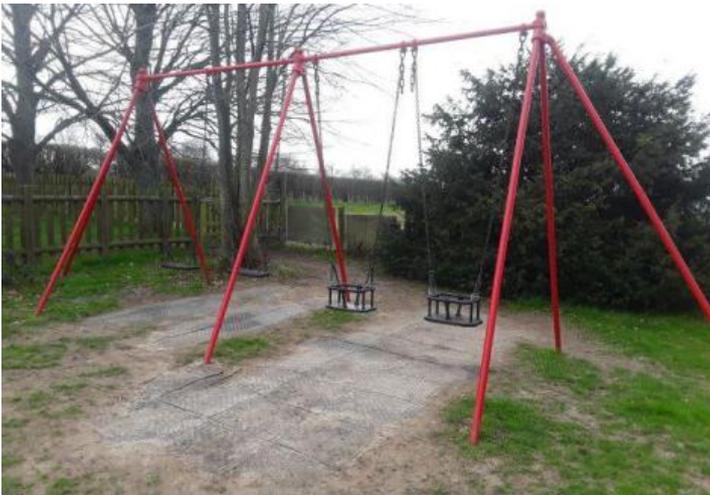
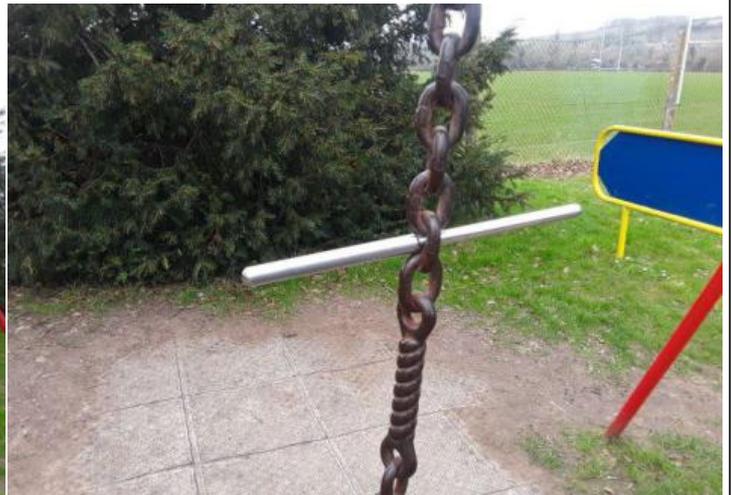
Item: Swings - 2 Bay (2 Flat, 2 Cradle)
Manufacturer: Wicksteed Playgrounds

Finding: The chain openings are in excess of the 8.6mm as recommended by BS EN 1176

Action: Monitor - No remedial work recommended

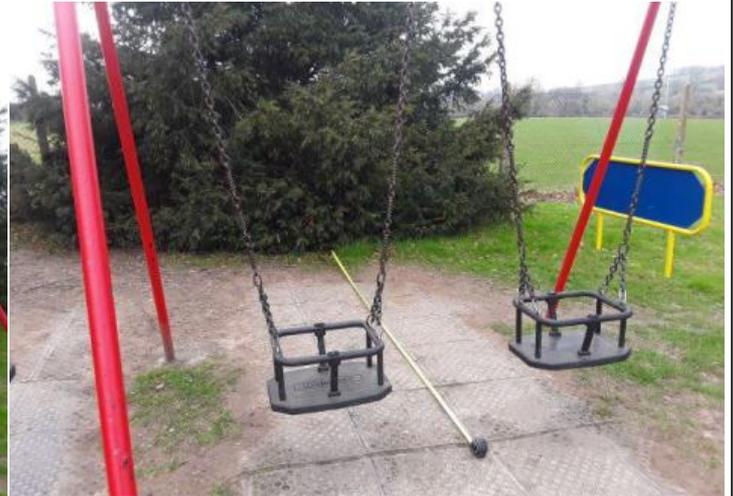
Item: Swings - 2 Bay (2 Flat, 2 Cradle)
Manufacturer: Wicksteed Playgrounds

Finding: The adjacent foliage is encroaching into the falling space of the equipment
Action: Cut back and maintain

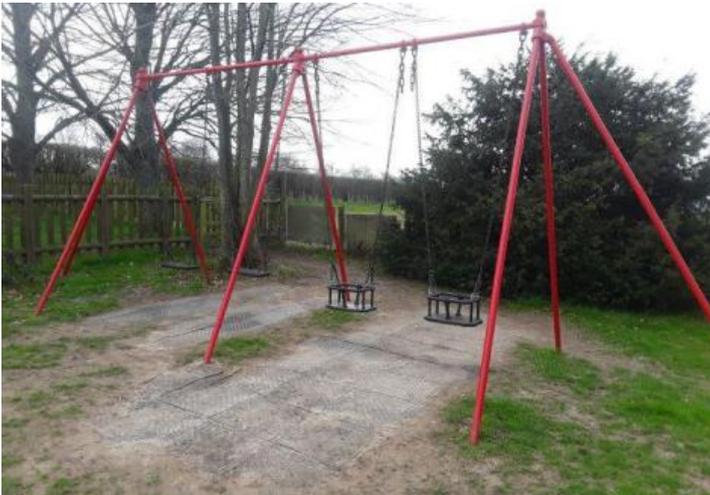
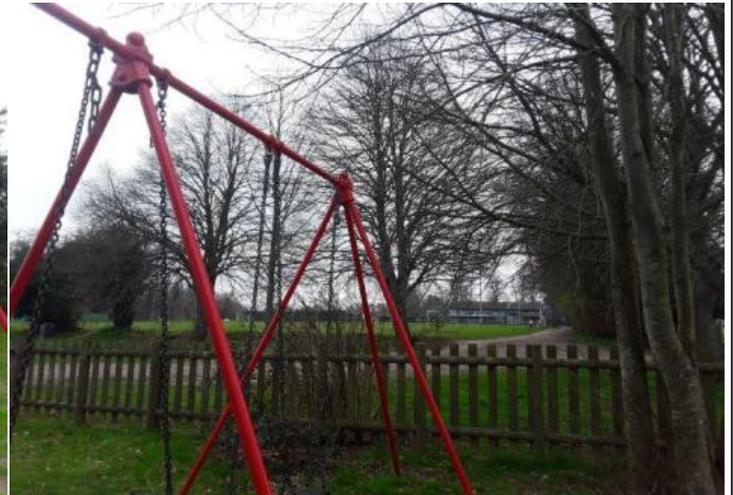
Item: Swings - 2 Bay (2 Flat, 2 Cradle)
Manufacturer: Wicksteed Playgrounds

Finding: The tree canopy overhangs the equipment and is less than 2.0m away
Action: Lift tree canopy to ensure a minimum clearance of 2.0m from the equipment

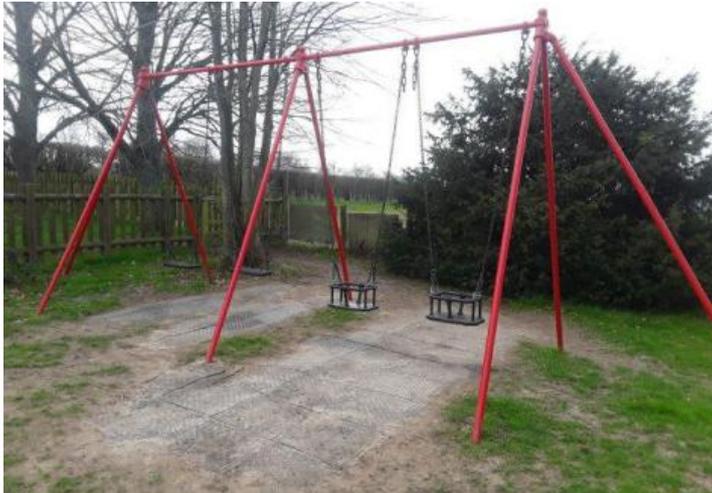
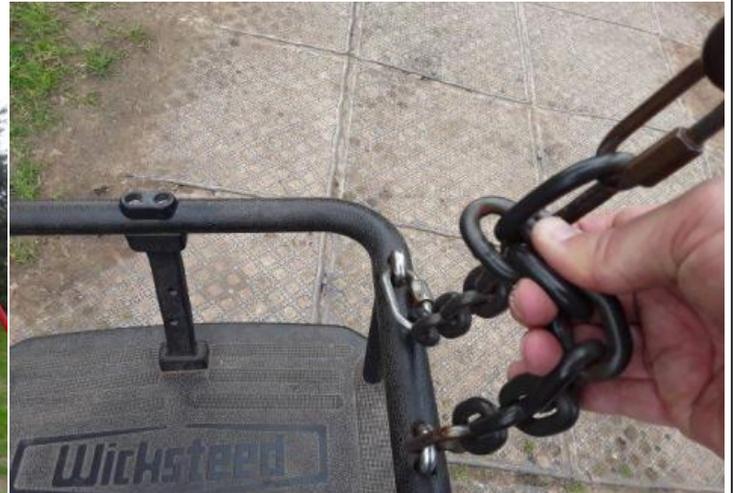
Item: Swings - 2 Bay (2 Flat, 2 Cradle)
Manufacturer: Wicksteed Playgrounds

Finding: There is some notable evidence of chain wear

Action: Monitor for any further deterioration and replace when 40% worn

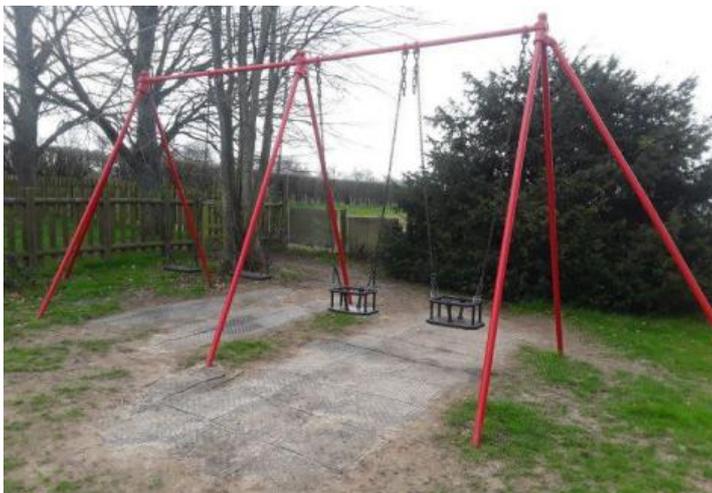
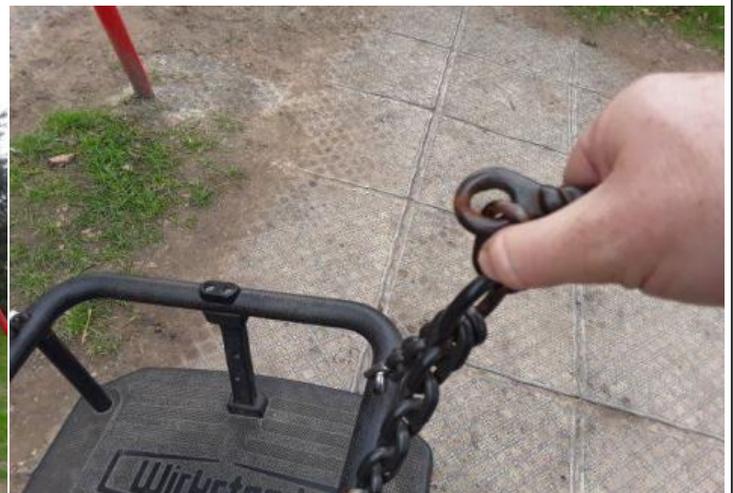
Item: Swings - 2 Bay (2 Flat, 2 Cradle)
Manufacturer: Wicksteed Playgrounds

Finding: There is some wear to the chain bars

Action: Monitor for any further deterioration and replace when 40% worn

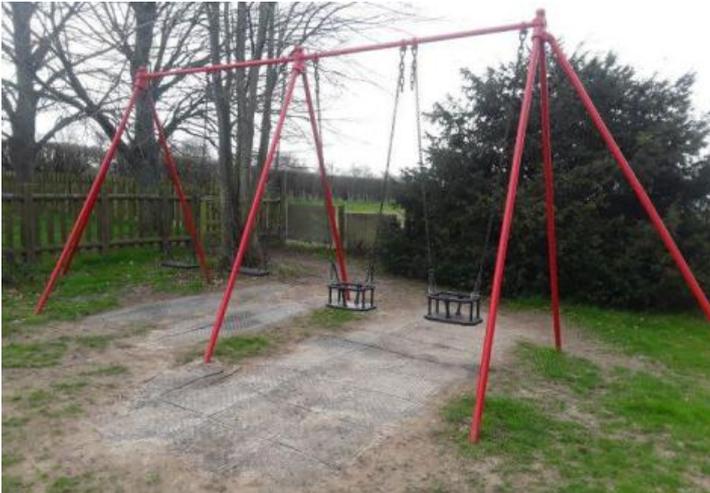
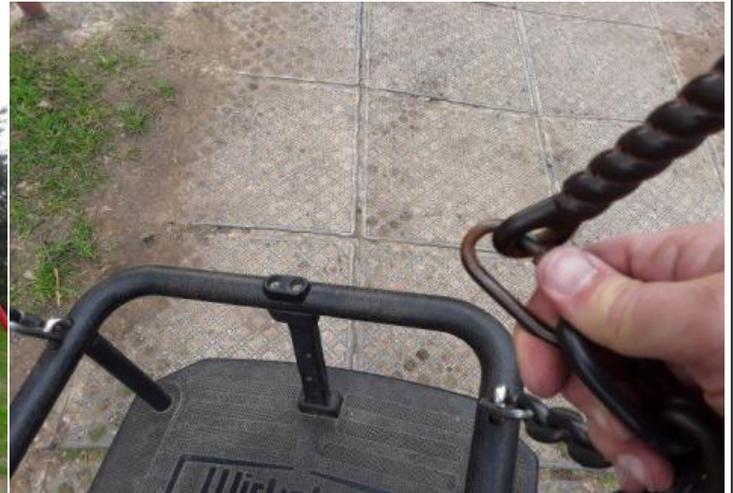
Item: Swings - 2 Bay (2 Flat, 2 Cradle)
Manufacturer: Wicksteed Playgrounds

Finding: There is some wear to the connecting links

Action: Monitor for any further deterioration and replace when 40% worn

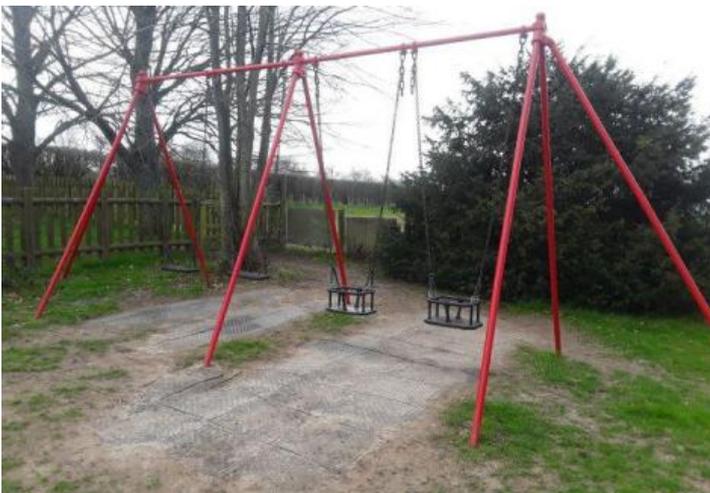
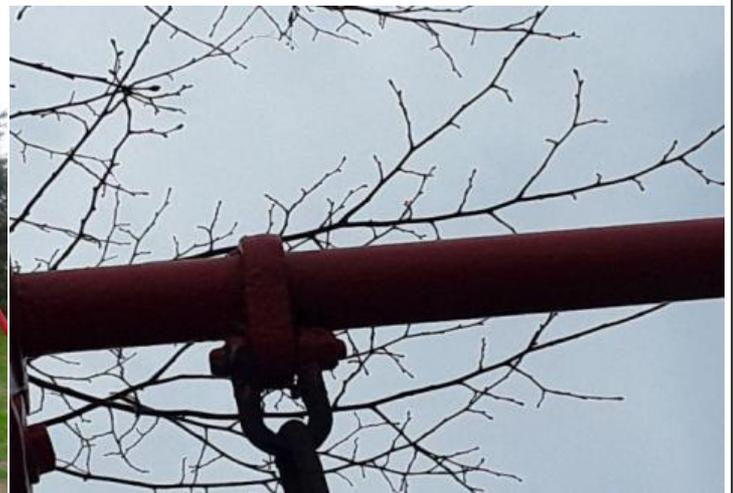
Item: Swings - 2 Bay (2 Flat, 2 Cradle)
Manufacturer: Wicksteed Playgrounds

Finding: There is some wear to the shackles.

Action: Monitor for any further deterioration and replace when 40% worn

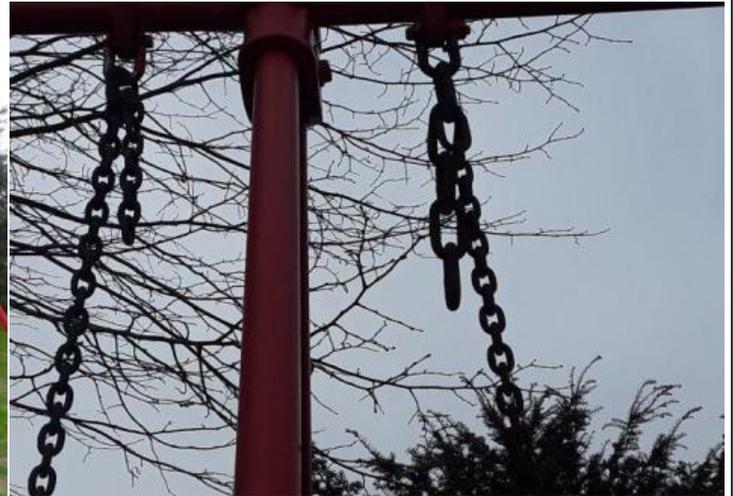
Item: Swings - 2 Bay (2 Flat, 2 Cradle)
Manufacturer: Wicksteed Playgrounds

Finding: There are excessive chain tails

Action: Cut back excessive chain links

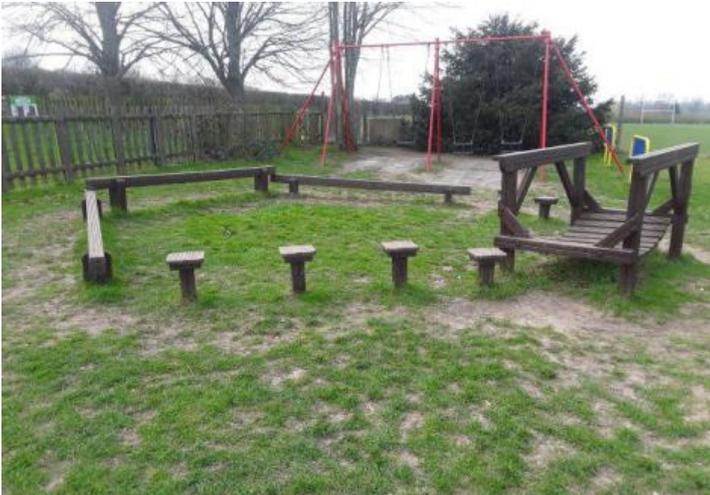
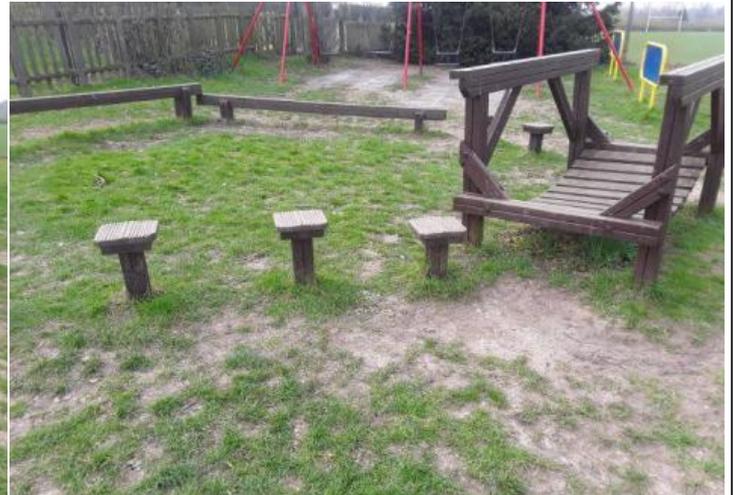
Item: Activity Equipment - Activity Trail
Manufacturer: Not Identified

Finding: The surface has eroded in some areas

Action: Reinstate the surface

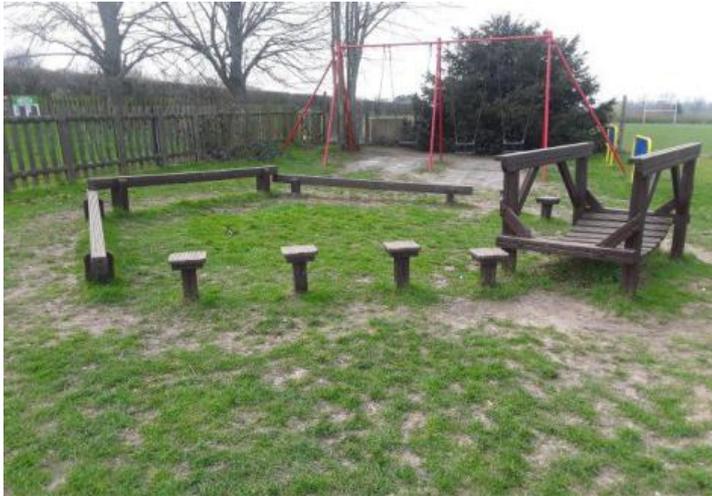
Item: Activity Equipment - Activity Trail
Manufacturer: Not Identified

Finding: There is/are bolt cap covers missing or damaged on the item

Action: Replace missing or damaged bolt cap covers

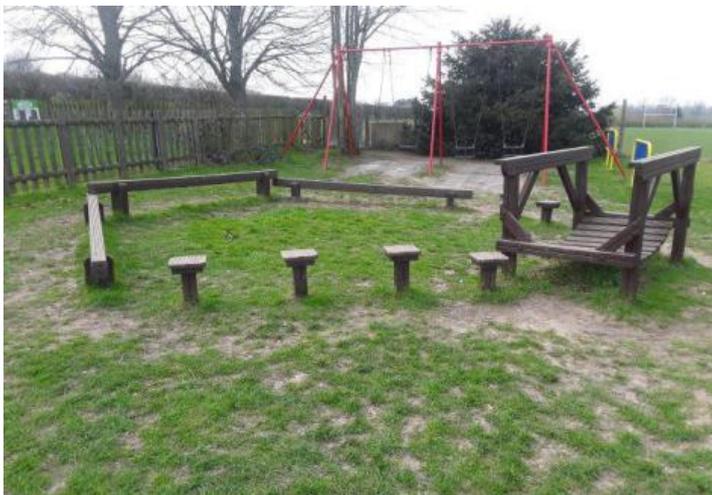
Item: Activity Equipment - Activity Trail
Manufacturer: Not Identified

Finding: A number of eyebolt fixing(s) have worked loose

Action: Secure all loose fixings
