the **play** inspection company

Annual Inspection

Winchester City Council

Arlebury Park, Skate Park & Tennis(New Alresford)

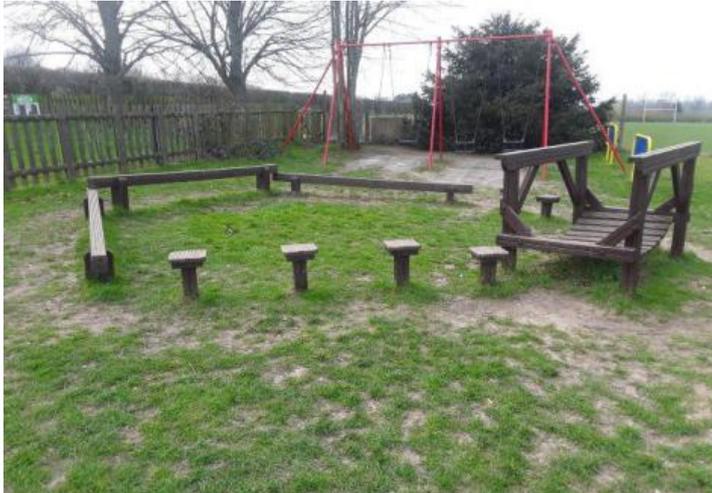
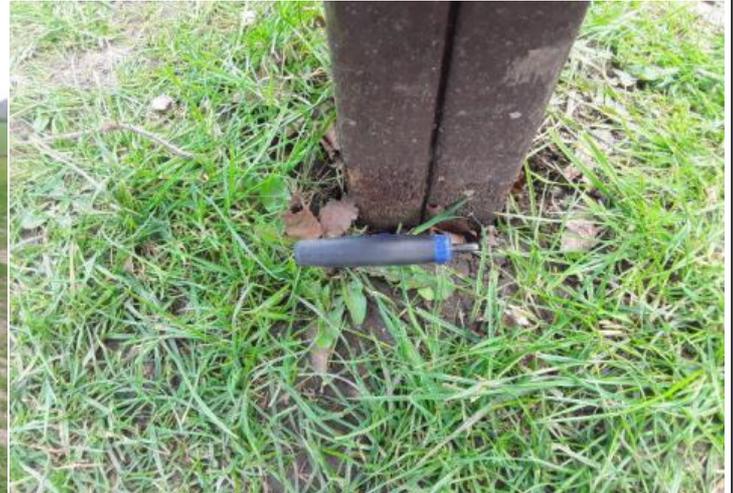
Item: Activity Equipment - Activity Trail
Manufacturer: Not Identified

Finding: There are areas or parts of the stepping posts that have rotted **Action:** Replace all affected timbers

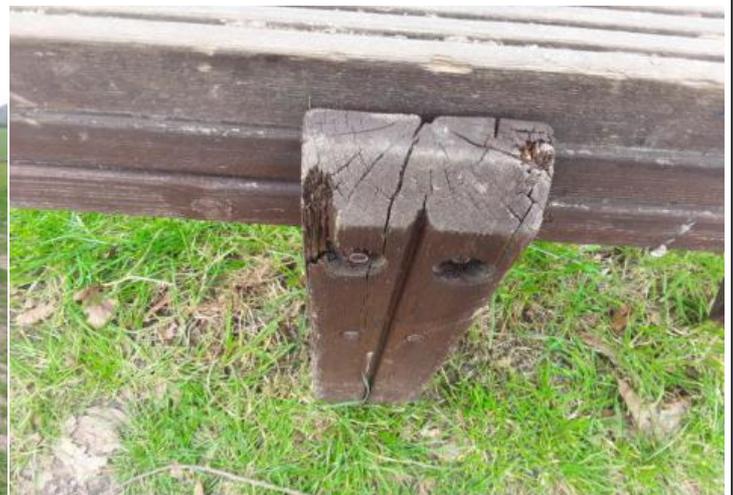
Item: Activity Equipment - Activity Trail
Manufacturer: Not Identified

Finding: Parts of the timber are rough or splintered

Action: Remove all rough or sharp edges

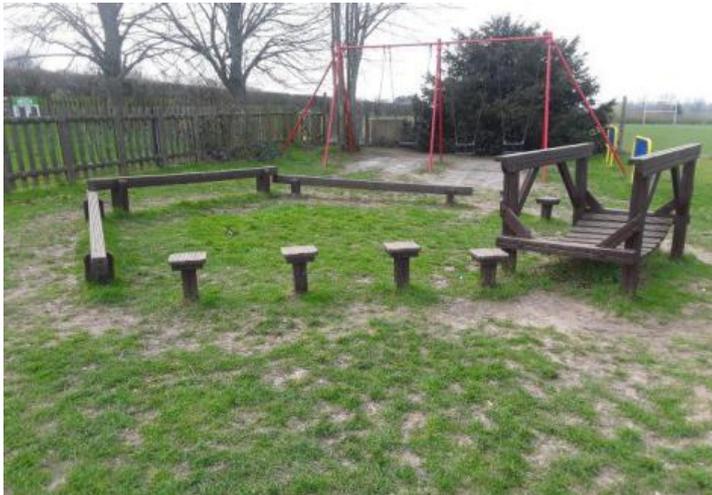
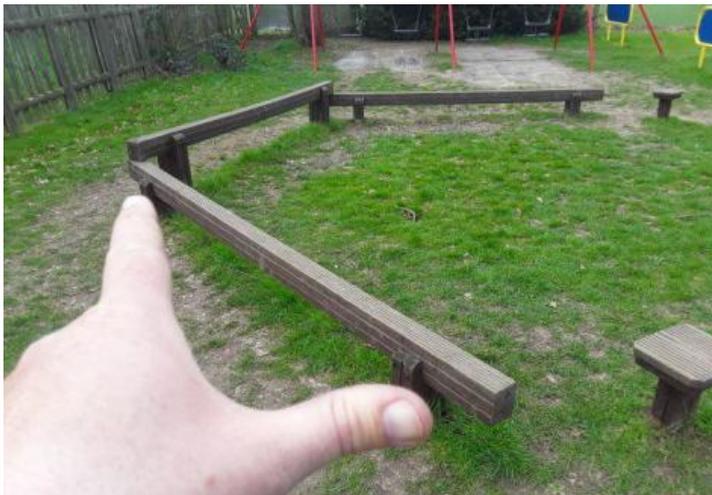
Item: Activity Equipment - Activity Trail
Manufacturer: Not Identified

Finding: There are areas or parts of the posts x4 on the balance beams that have rotted with evidence of rot in the remaining posts

Action: Replace all affected timbers

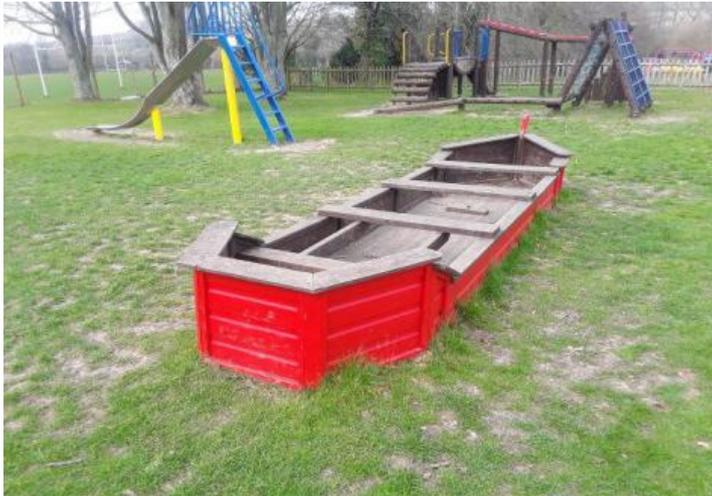
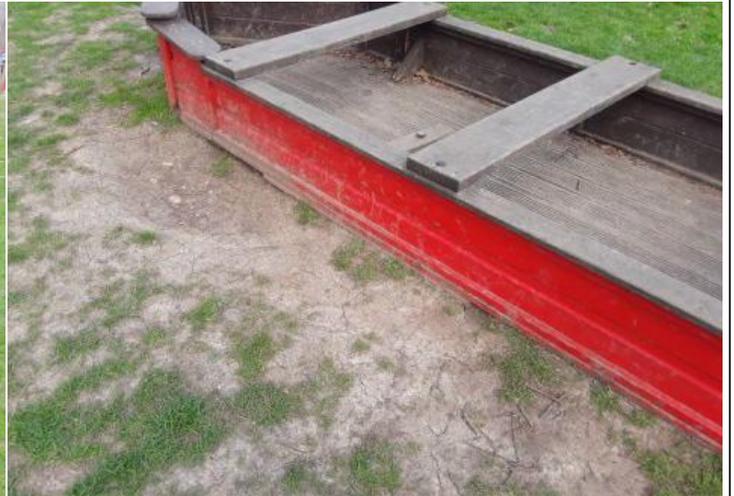
Item: Activity Equipment - Boat
Manufacturer: Not Identified

Finding: The surface has eroded in some areas

Action: Reinstate the surface

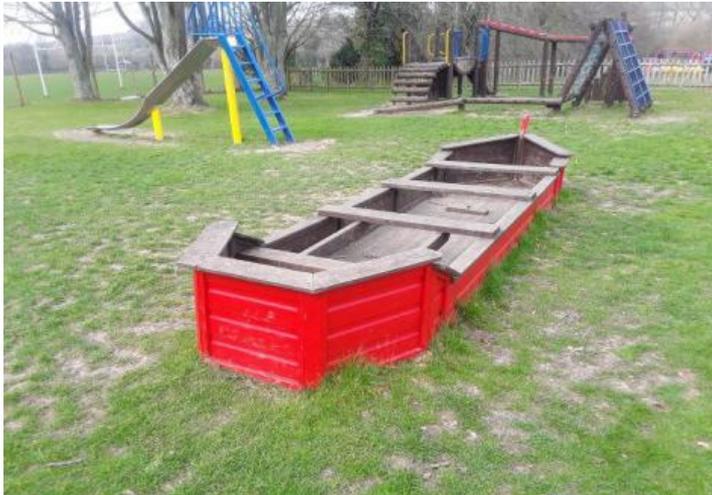
Item: Activity Equipment - Boat
Manufacturer: Not Identified

Finding: There is some evidence of fire damage to the item

Action: Monitor for any further deterioration and repair as required

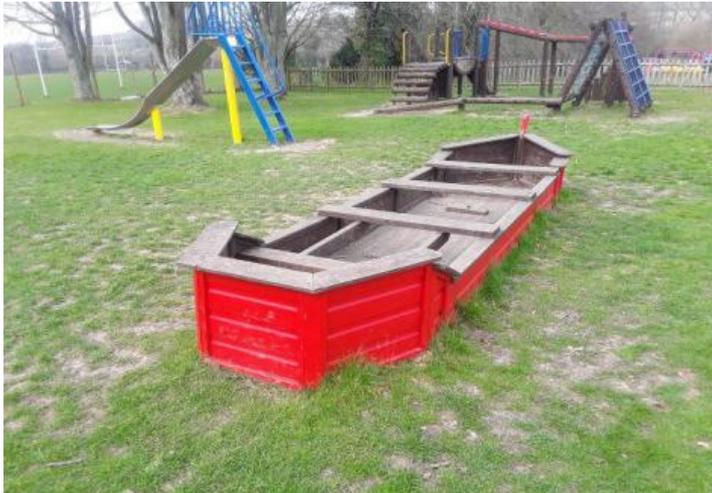
Item: Activity Equipment - Boat
Manufacturer: Not Identified

Finding: There is some evidence of rot in the timber

Action: Monitor for any further deterioration and replace as required

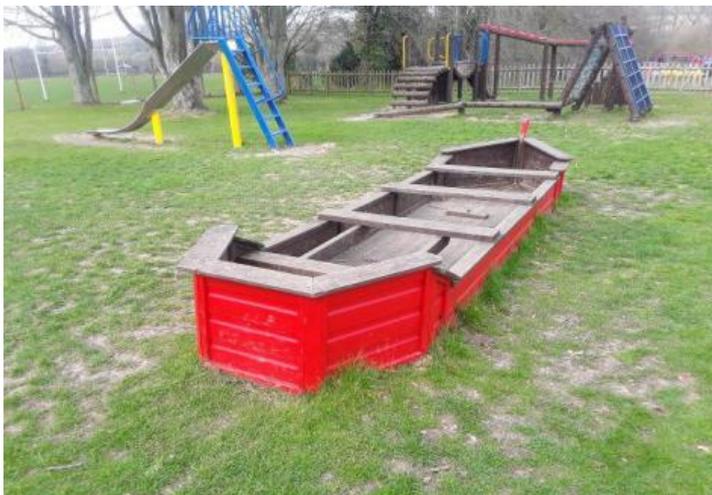
Item: Activity Equipment - Boat
Manufacturer: Not Identified

Finding: There is/are bolt cap covers missing or damaged on the item

Action: Replace missing or damaged bolt cap covers

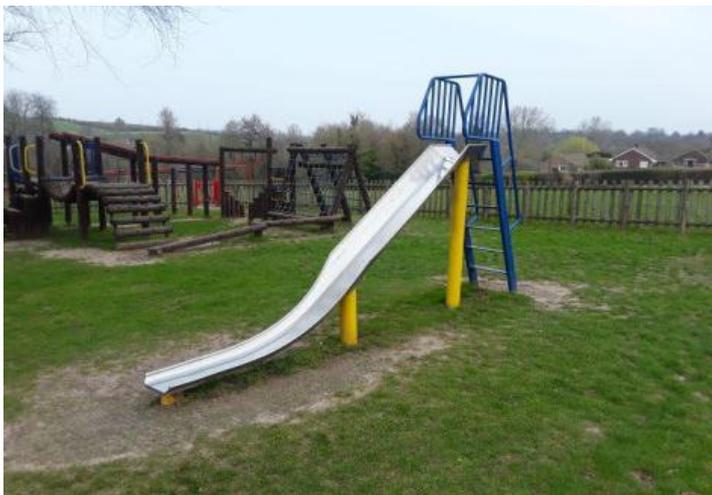
Item: Other - Free Standing Slide
Manufacturer: Wicksteed Playgrounds

Finding: The grass mats are silted up and the soil is compacted; this may have an effect on the impact absorbing properties of the surface

Action: Consider HIC testing impact absorbing properties to ensure the correct surface qualities are maintained for the equipment and replace as required

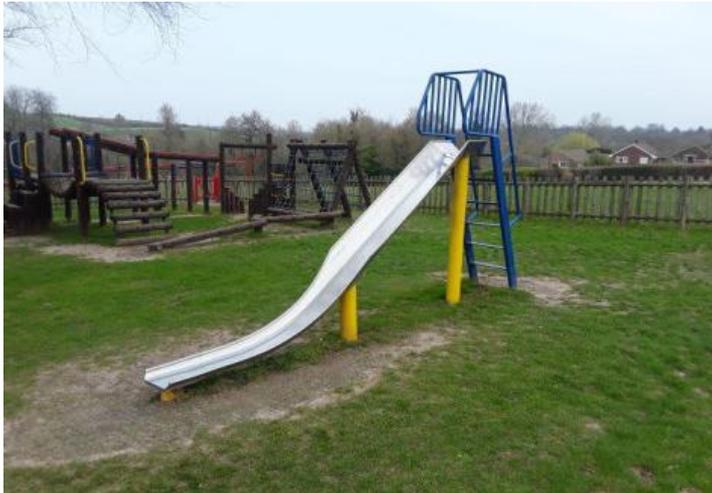
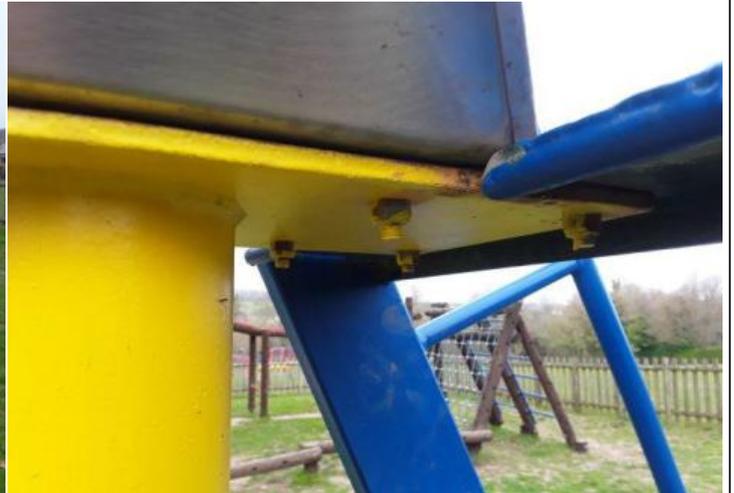
Item: Other - Free Standing Slide
Manufacturer: Wicksteed Playgrounds

Finding: There are projecting bolt thread(s) present

Action: Remove excess thread length and deburr or provide cap

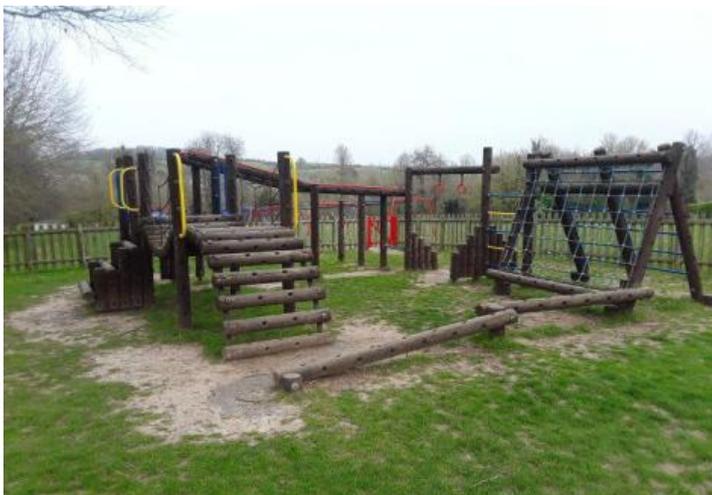
Item: Activity Equipment - Multi Play (Junior)
Manufacturer: Not Identified

Finding: The grass mats are silted up and the soil is compacted; this may have an effect on the impact absorbing properties of the surface

Action: Consider HIC testing impact absorbing properties to ensure the correct surface qualities are maintained for the equipment and replace as required

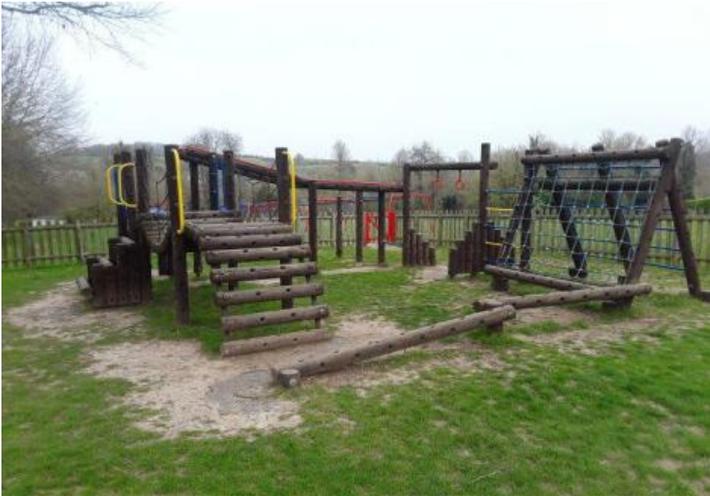
Item: Activity Equipment - Multi Play (Junior)
Manufacturer: Not Identified

Finding: The rope has worn and wire strands are exposed

Action: Replace rope or net

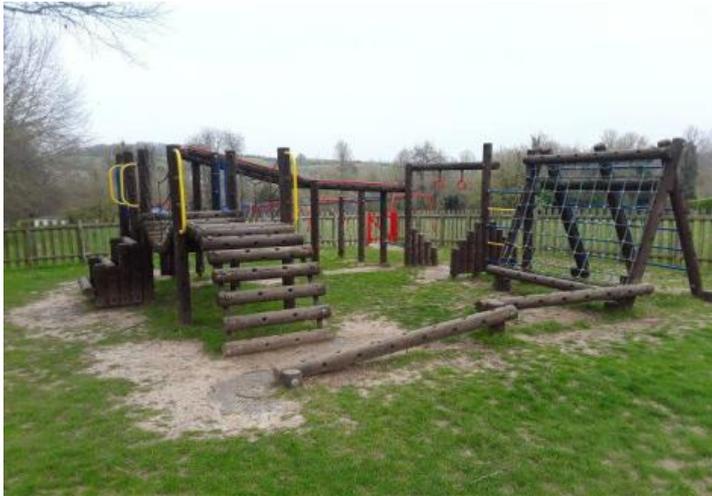
Item: Activity Equipment - Multi Play (Junior)
Manufacturer: Not Identified

Finding: The timber has a number of splits/shakes or air cracks and this may affect the stability or allow water ingress which will accelerate the rotting process
Action: Monitor to ensure the splits do not cross through fixing points of the structure and/or cause any instability

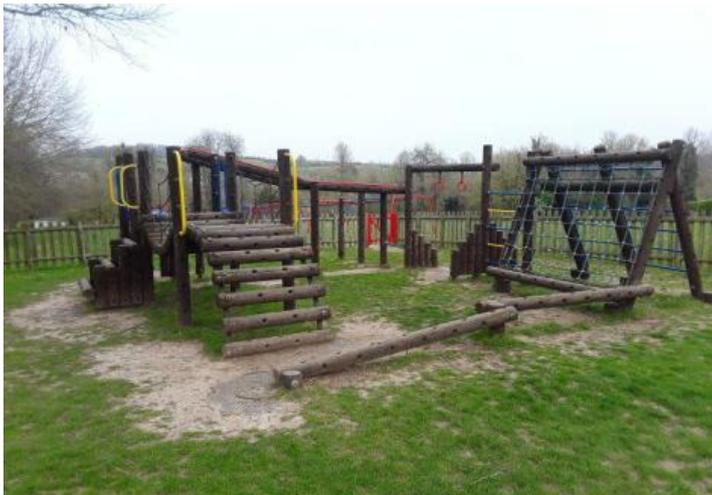
Item: Activity Equipment - Multi Play (Junior)
Manufacturer: Not Identified

Finding: There is some notable evidence of chain wear
Action: Monitor for any further deterioration and replace when 40% worn

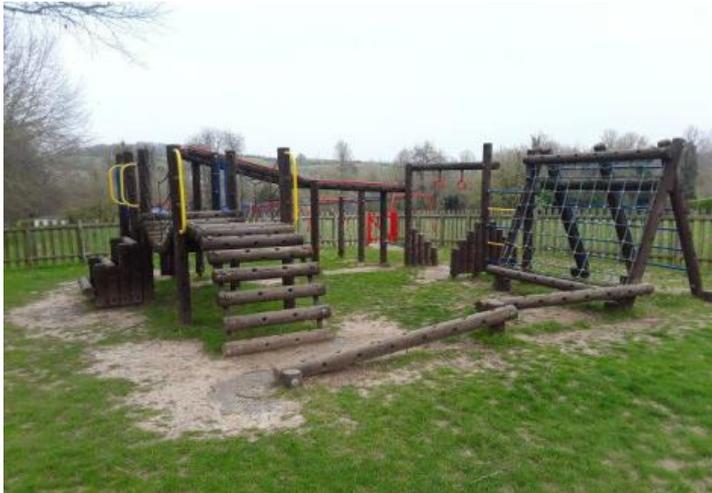
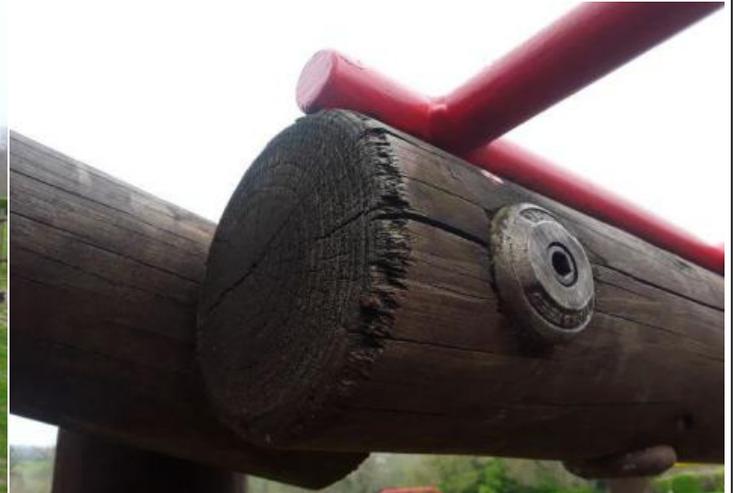
Item: Activity Equipment - Multi Play (Junior)
Manufacturer: Not Identified

Finding: Parts of the timber are rough or splintered

Action: Remove all rough or sharp edges

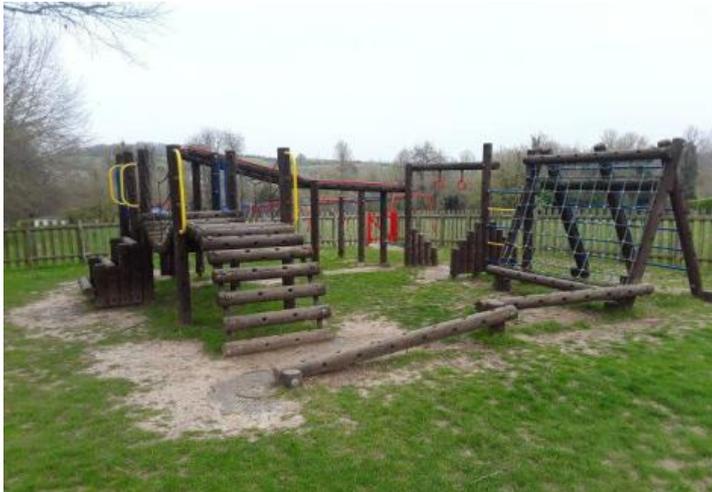
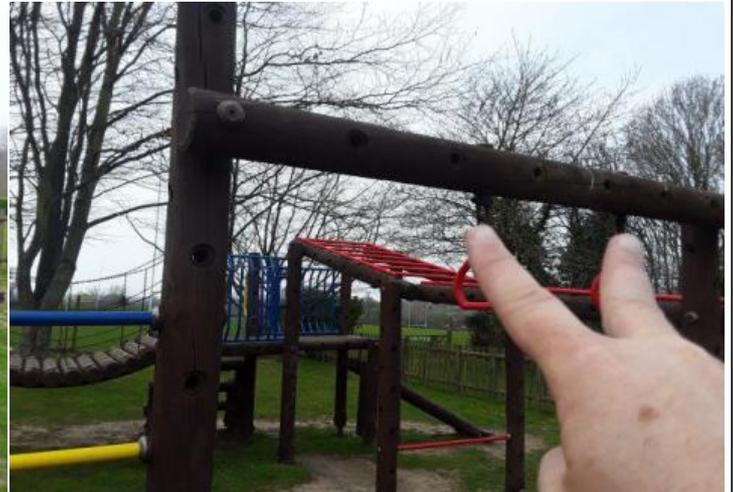
Item: Activity Equipment - Multi Play (Junior)
Manufacturer: Not Identified

Finding: A number of trapeze ring fixing(s) have worked loose

Action: Secure all loose fixings

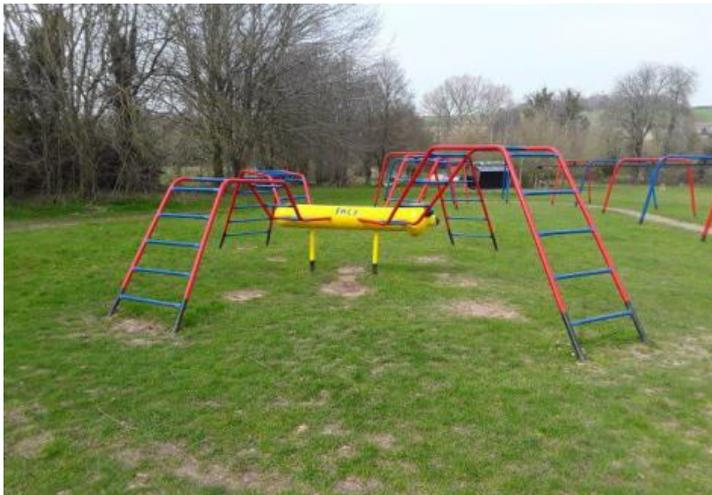
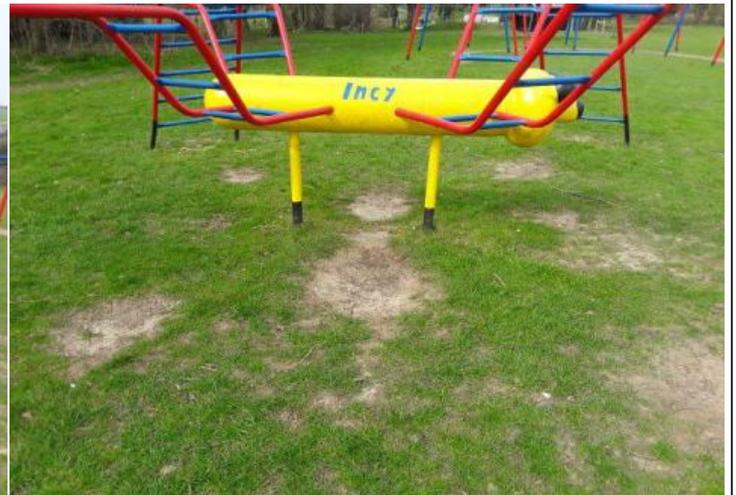
Item: Activity Equipment - Climbing Frame
Manufacturer: Not Identified

Finding: The surface has eroded in some areas

Action: Reinstate the surface

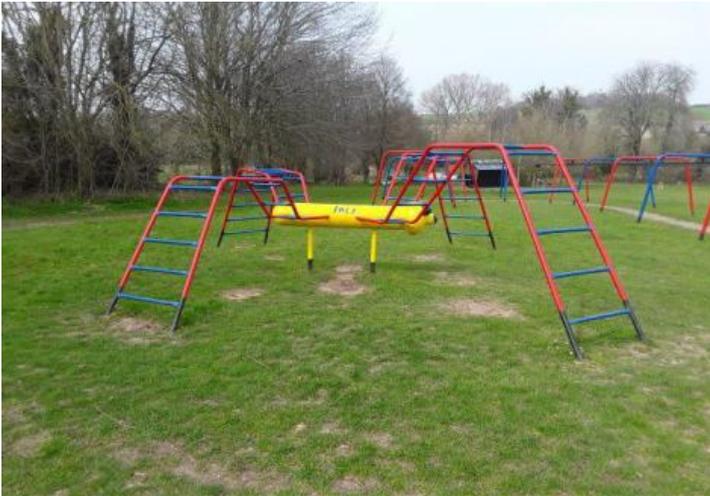
Item: Activity Equipment - Climbing Frame
Manufacturer: Not Identified

Finding: The surface has eroded and the foundations are exposed

Action: Reinstate surrounding surfaces to cover the foundations

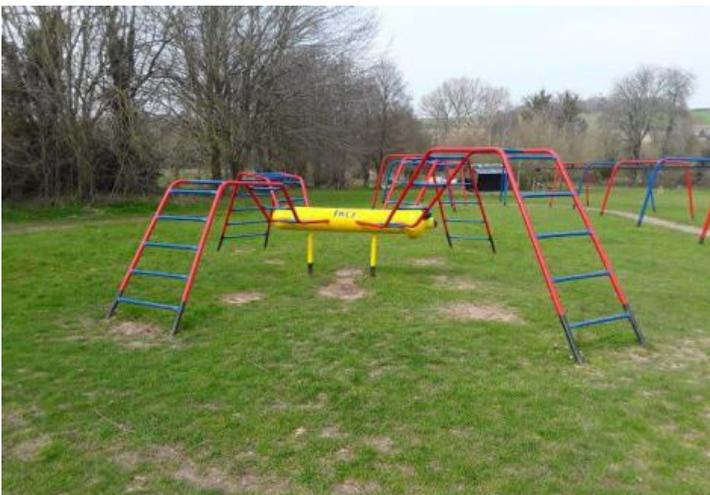
Item: Activity Equipment - Climbing Frame
Manufacturer: Not Identified

Finding: There are missing framework fixings

Action: Replace all missing fixings

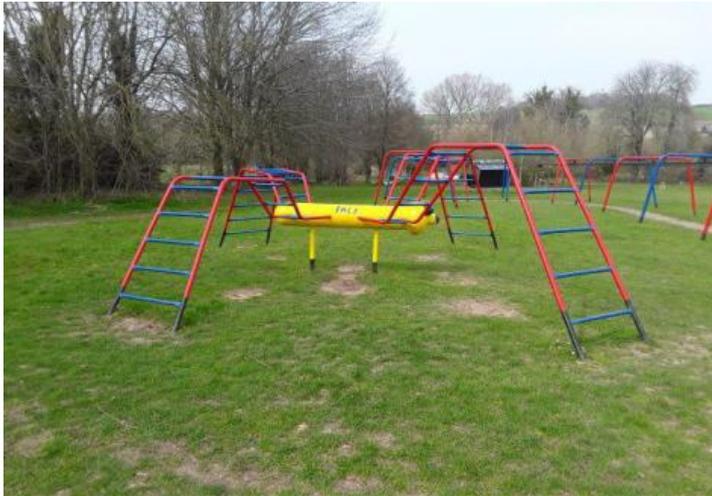
Item: Activity Equipment - Climbing Frame
Manufacturer: Not Identified

Finding: The item fails to meet the requirements of BS EN 1176 Part 1 4.2.7.2 for head and neck entrapment in the framework

Action: Monitor - No remedial work recommended

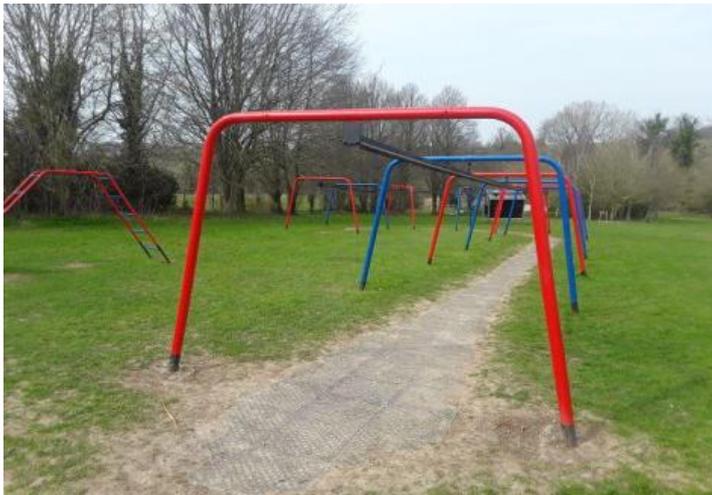
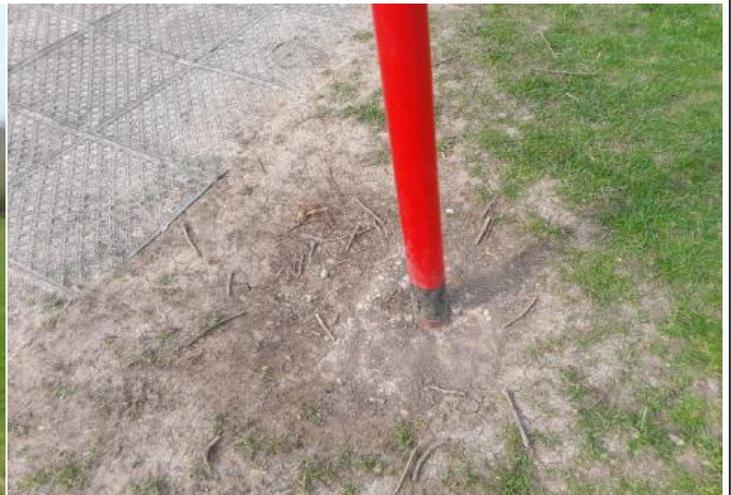
Item: Activity Equipment - Overhead Glider
Manufacturer: Not Identified

Finding: The surface has eroded and the foundations are exposed

Action: Reinststate surrounding surfaces to cover the foundations

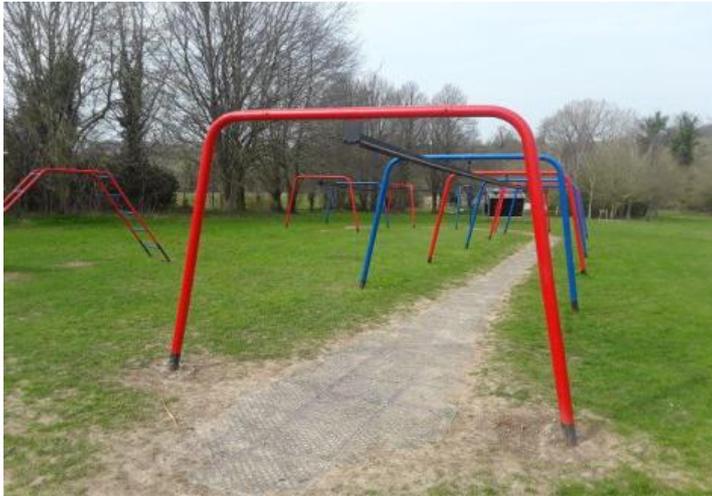
Item: Activity Equipment - Overhead Glider
Manufacturer: Not Identified

Finding: The chain openings are in excess of the 8.6mm as recommended by BS EN 1176
Action: Monitor - No remedial work recommended

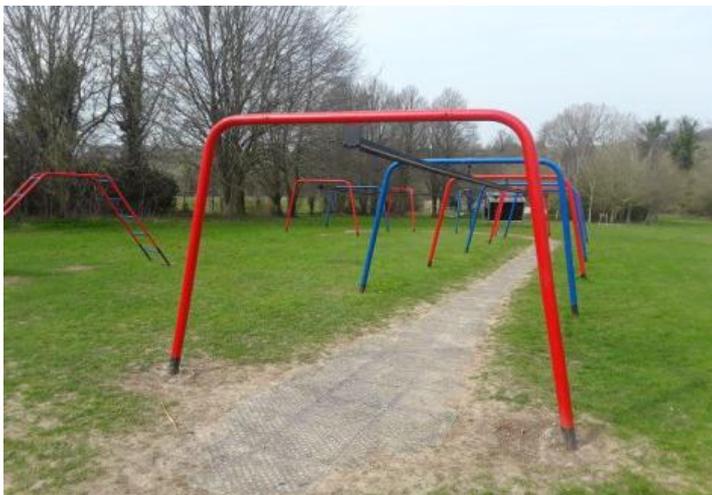
Item: Activity Equipment - Overhead Glider
Manufacturer: Not Identified

Finding: There is some notable evidence of chain wear
Action: Monitor for any further deterioration and replace when 40% worn

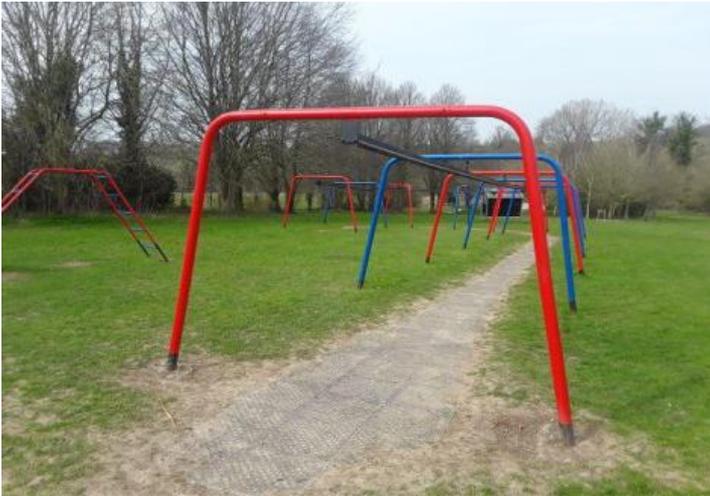
Item: Activity Equipment - Overhead Glider
Manufacturer: Not Identified

Finding: The seat has been damaged

Action: Monitor for any further deterioration and replace as required

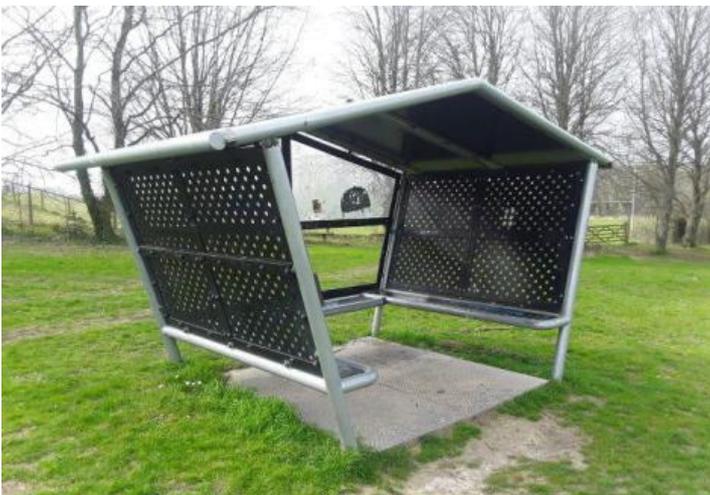
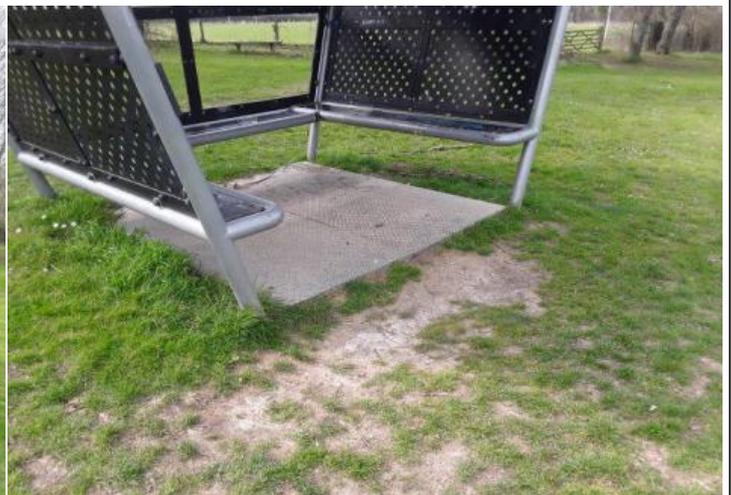
Item: Ancillary Items - Teenage Shelter
Manufacturer: Monster Play Systems

Finding: The surface has eroded in some areas

Action: Reinstate the surface

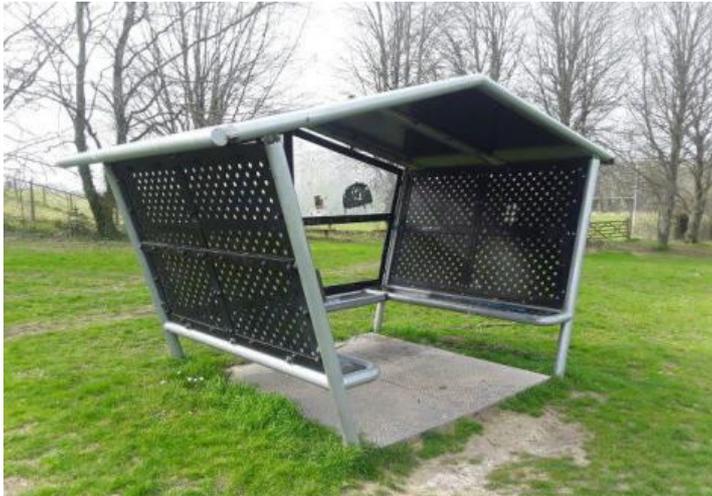
Item: Ancillary Items - Teenage Shelter
Manufacturer: Monster Play Systems

Finding: There are trip hazards at the edges of the surface

Action: Reinstate surrounding surface levels to remove the trip points

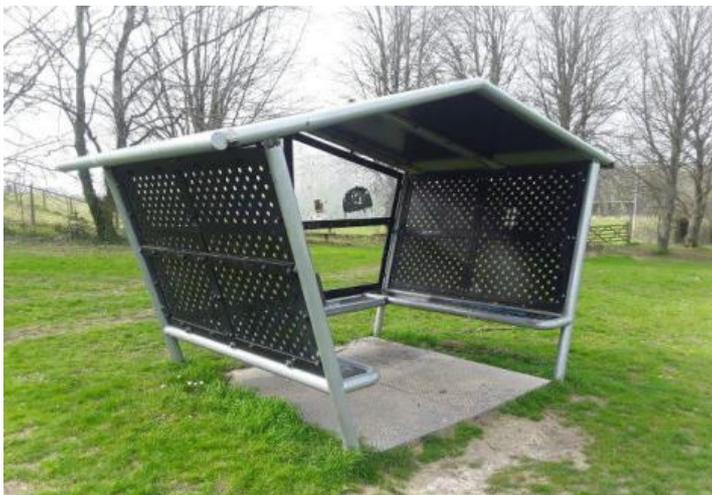
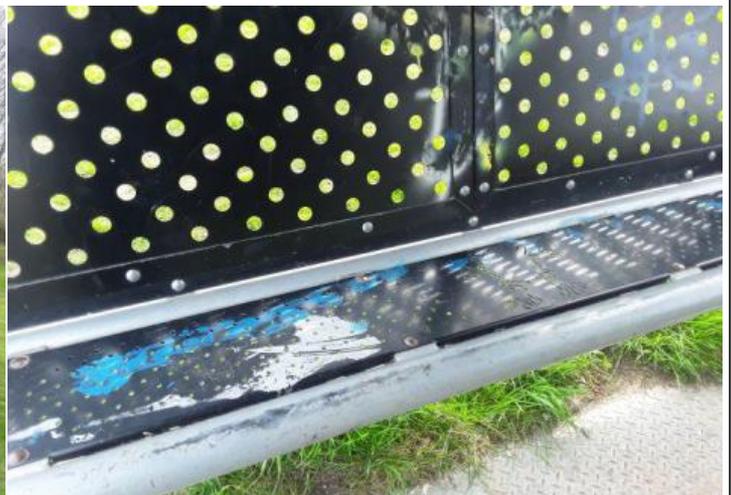
Item: Ancillary Items - Teenage Shelter
Manufacturer: Monster Play Systems

Finding: There is some graffiti present

Action: Remove the graffiti

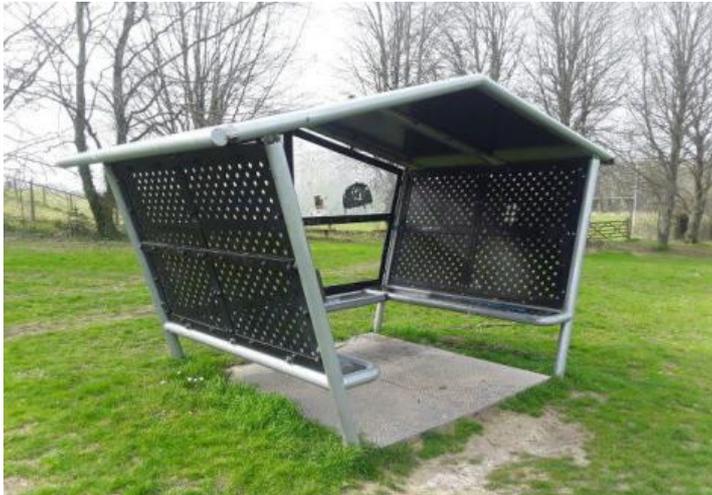
Item: Ancillary Items - Teenage Shelter
Manufacturer: Monster Play Systems

Finding: The item is not operating correctly

Action: Investigate and repair as required

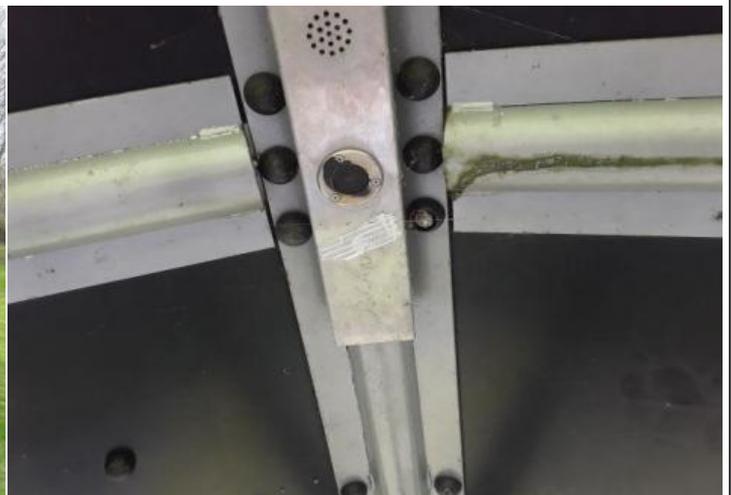
Item: Ancillary Items - Teenage Shelter
Manufacturer: Monster Play Systems

Finding: There is/are bolt cap covers missing or damaged on the item **Action:** Replace missing or damaged bolt cap covers

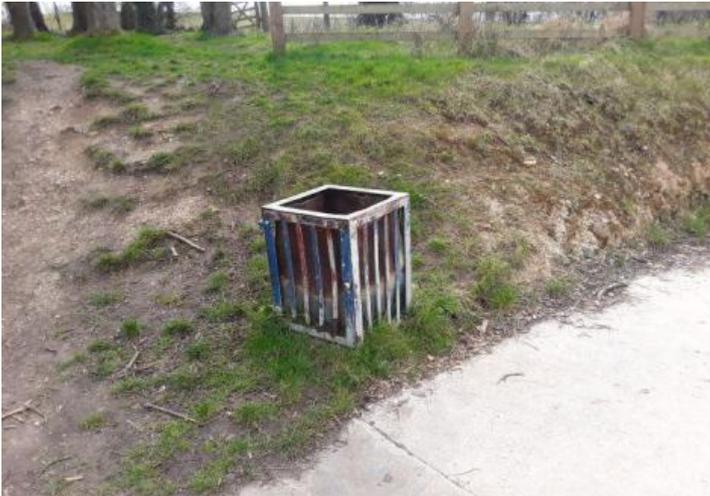
Item: Ancillary Items - Litter Bin
Manufacturer: Not Identified

Finding: The bin is damaged

Action: Replace

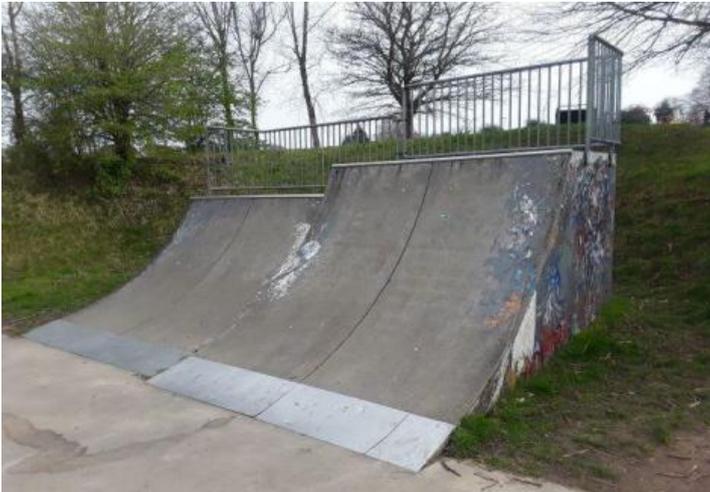
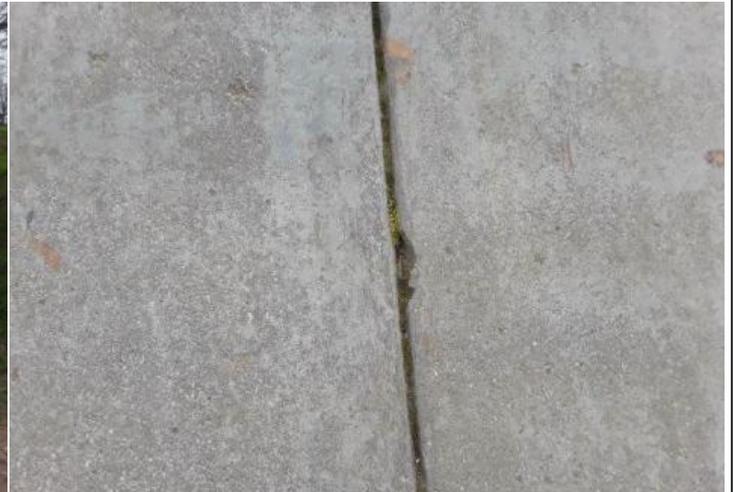
Item: Wheeled Sports - Start Ramp
Manufacturer: Not Identified

Finding: The riding surface of the ramp has some damage apparent

Action: Monitor for any further deterioration and repair as required

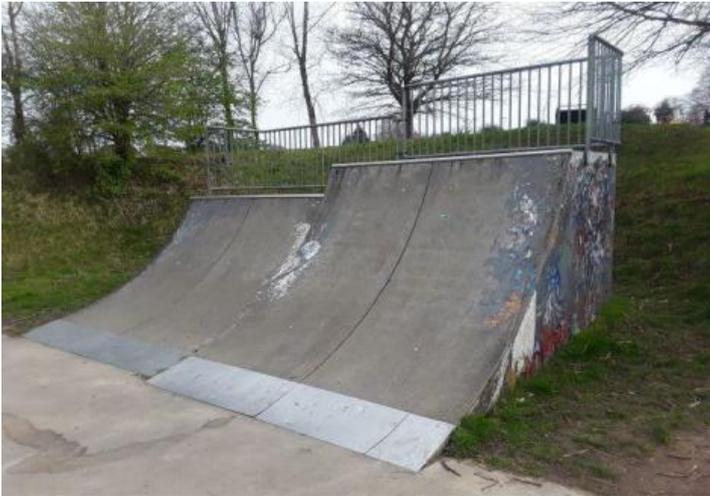
Item: Wheeled Sports - Start Ramp
Manufacturer: Not Identified

Finding: A number of fixing(s) have worked loose

Action: Secure all loose fixings

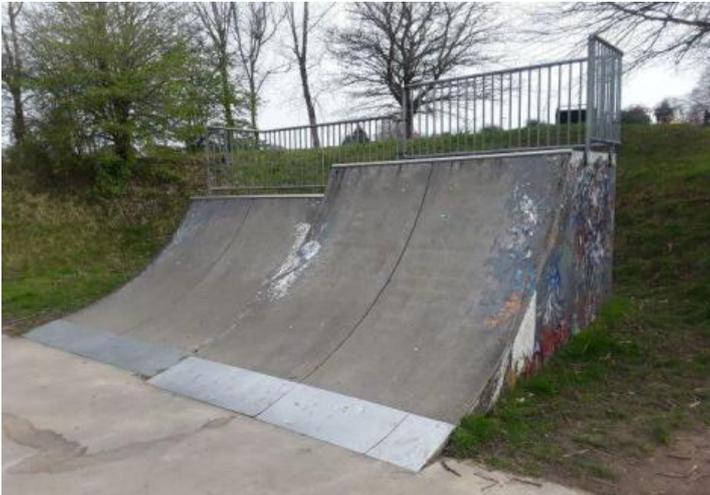
Item: Wheeled Sports - Start Ramp
Manufacturer: Not Identified

Finding: There is/are several inserts missing

Action: Replace missing inserts

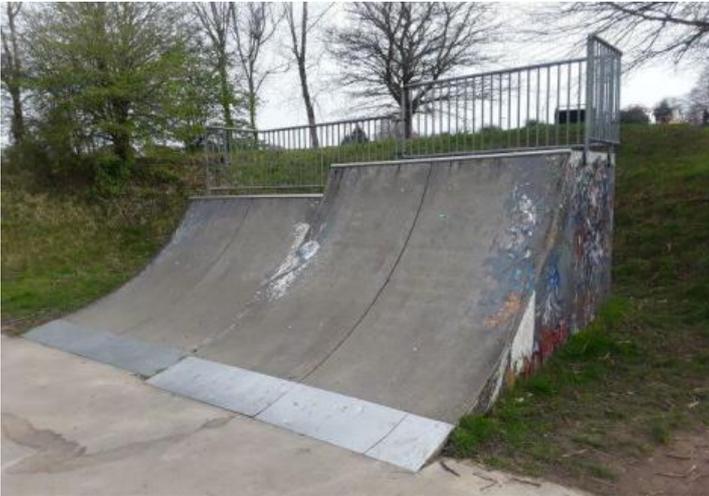
Item: Wheeled Sports - Start Ramp
Manufacturer: Not Identified

Finding: There is some damage to the barrier sections

Action: Monitor for any further deterioration and repair as required

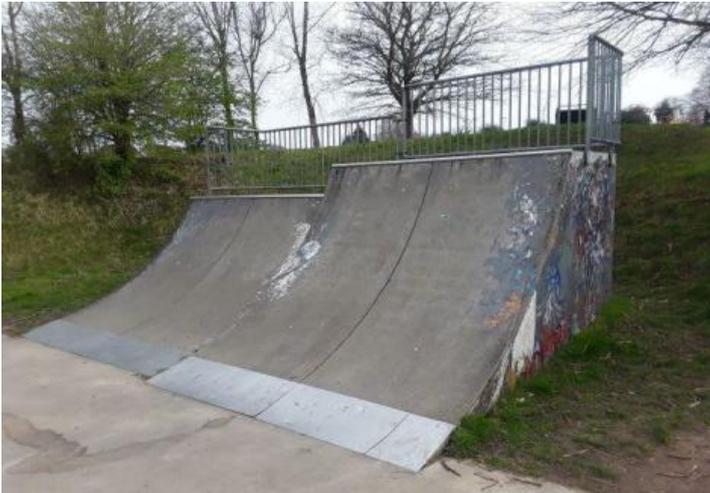
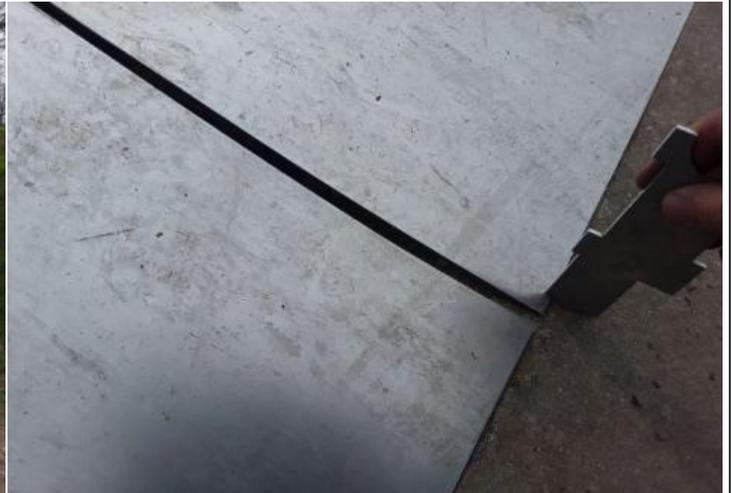
Item: Wheeled Sports - Start Ramp
Manufacturer: Not Identified

Finding: The kicker plate protrudes more than 5mm above the surrounding surface level, BS EN 14974 recommends a maximum of 5mm with 3mm preferred
Action: Adjust height to ensure a maximum of 5mm change in level

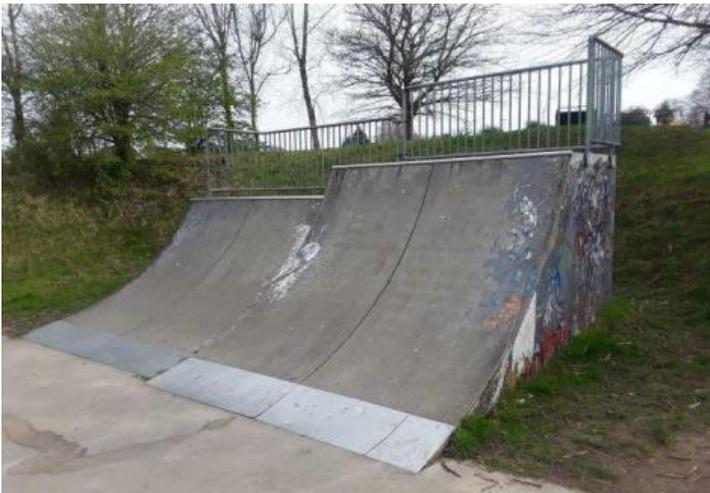
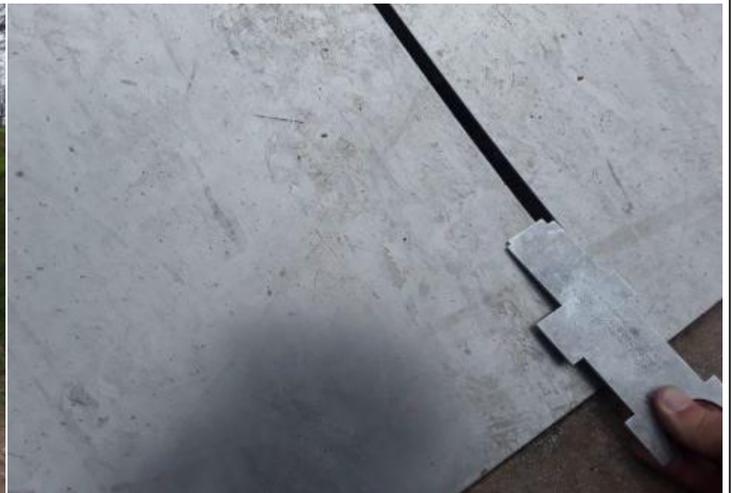
Item: Wheeled Sports - Start Ramp
Manufacturer: Not Identified

Risk Level: L - Low Risk
Surface: Grass

Finding: Joints between the riding surfaces should not be greater than 5mm to meet the requirements of BS EN 14974
Action: Take corrective action to ensure that the gaps between the joints do not exceed 5mm

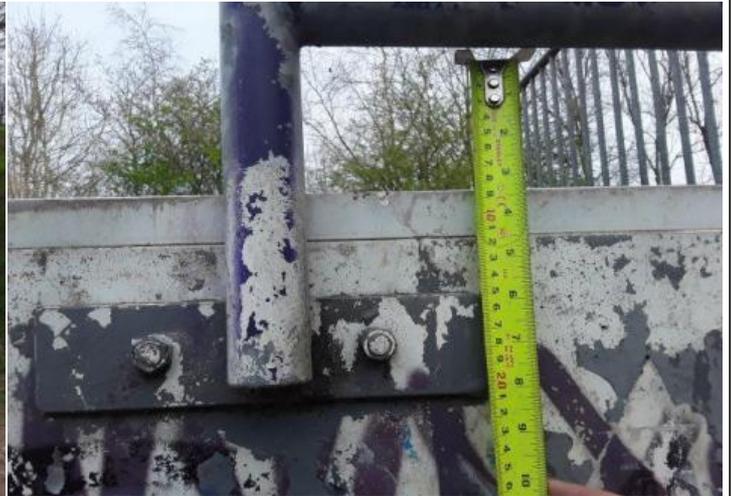
Item: Wheeled Sports - Start Ramp
Manufacturer: Not Identified

Risk Level: L - Low Risk
Surface: Grass

Finding: The gap between the underside of the barrier and the platform is in excess of 60mm and fails the requirements of BS EN 14974

Action: Monitor - No remedial work recommended

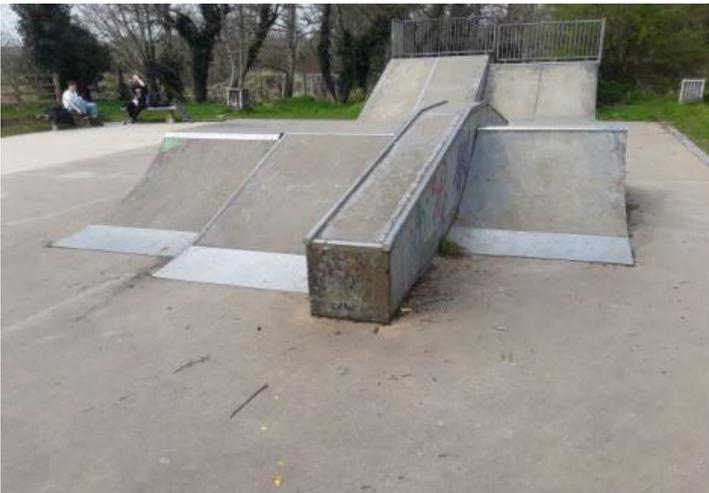
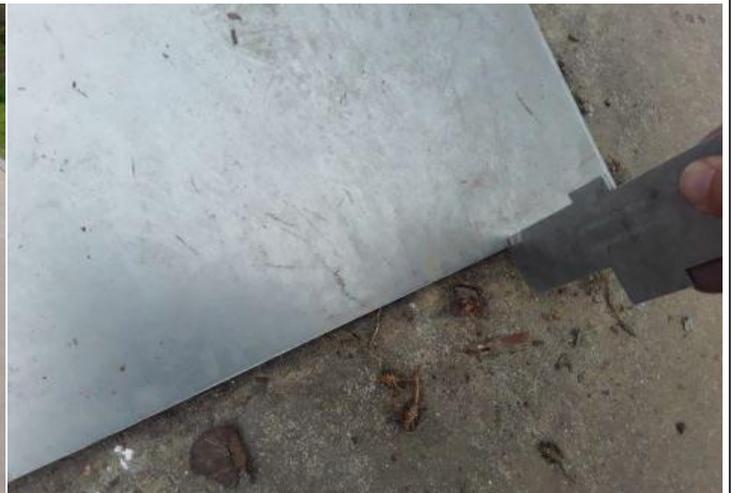
Item: Wheeled Sports - Fun Box
Manufacturer: Not Identified

Risk Level: L - Low Risk
Surface: Concrete

Finding: The kicker plate protrudes more than 5mm above the surrounding surface level, BS EN 14974 recommends a maximum of 5mm with 3mm preferred

Action: Adjust height to ensure a maximum of 5mm change in level

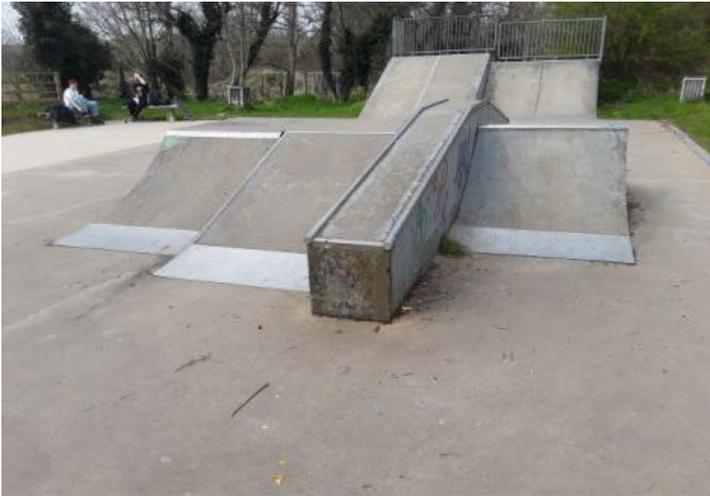
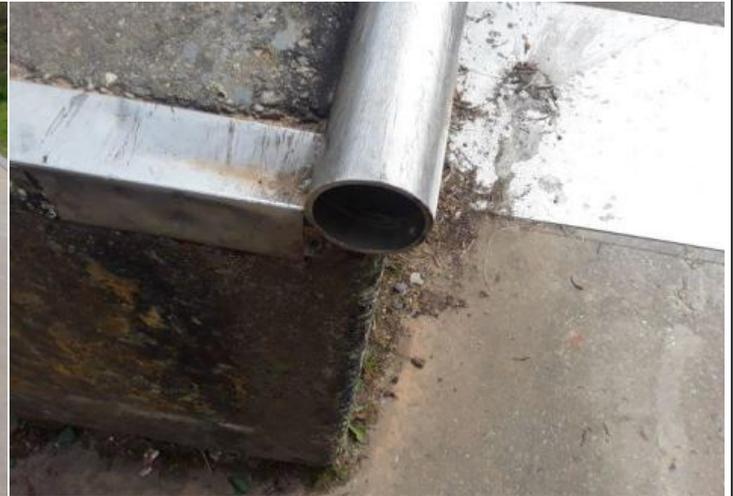
Item: Wheeled Sports - Fun Box
Manufacturer: Not Identified

Risk Level: L - Low Risk
Surface: Concrete

Finding: The ends of all coping rails should be sealed to meet the requirements of BS EN 14974

Action: Ensure all coping ends are sealed

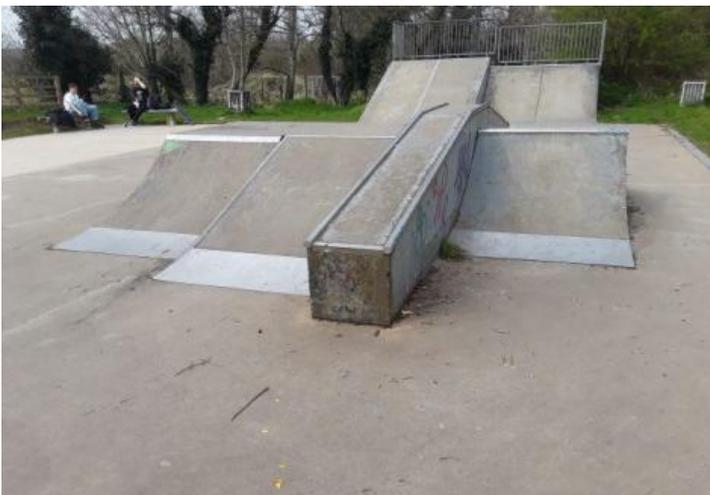
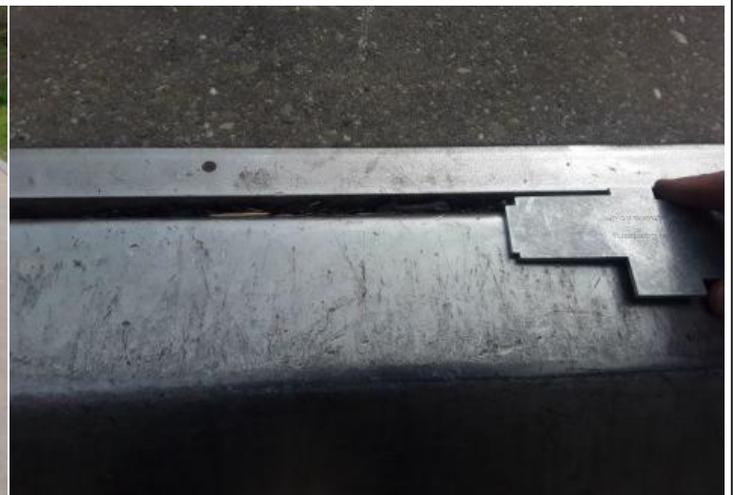
Item: Wheeled Sports - Fun Box
Manufacturer: Not Identified

Risk Level: L - Low Risk
Surface: Concrete

Finding: Joints between the riding surfaces should not be greater than 5mm to meet the requirements of BS EN 14974

Action: Take corrective action to ensure that the gaps between the joints do not exceed 5mm

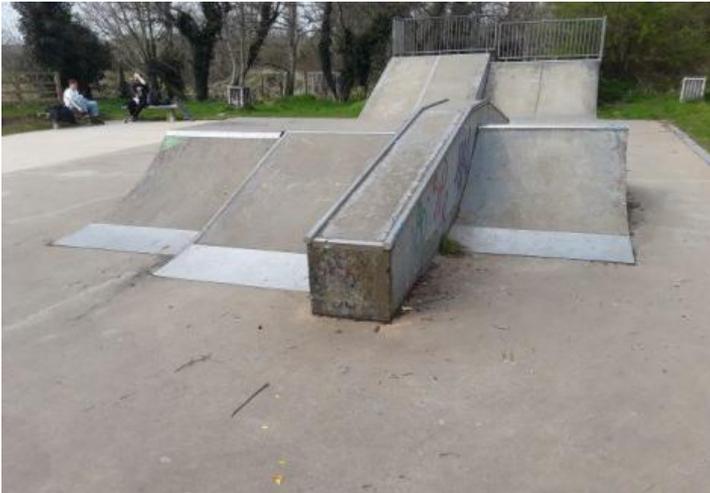
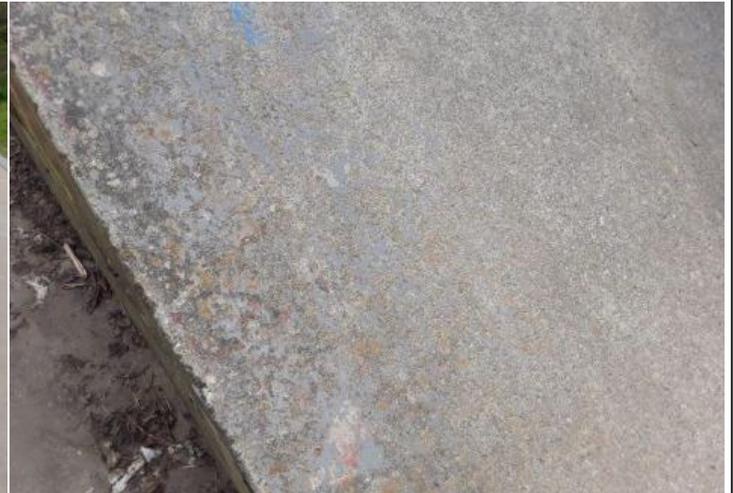
Item: Wheeled Sports - Fun Box
Manufacturer: Not Identified
Risk Level: L - Low Risk
Surface: Concrete

Finding: The riding surface of the ramp has some damage apparent
Action: Monitor for any further deterioration and repair as required
