the **play** inspection company

Annual Inspection

Winchester City Council

Arlebury Park, Skate Park & Tennis(New Alresford)

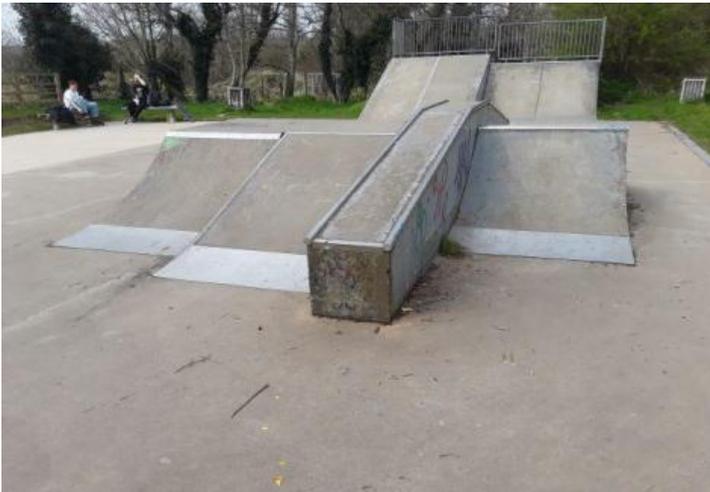
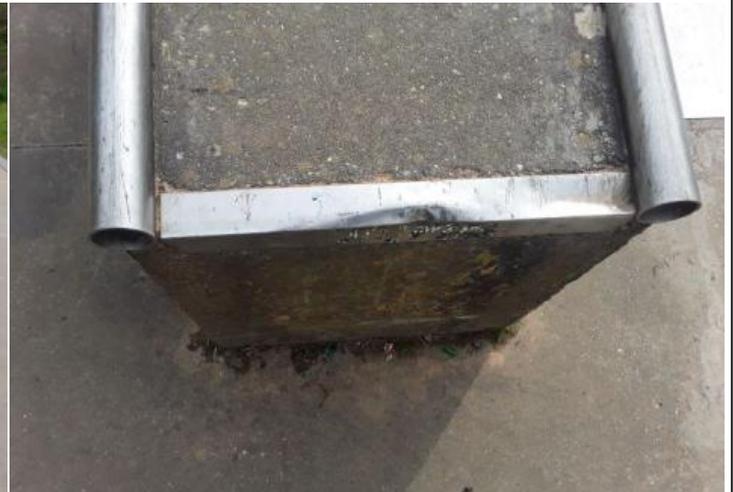
Item: Wheeled Sports - Fun Box
Manufacturer: Not Identified
Risk Level: L - Low Risk
Surface: Concrete

Finding: The ramp has been damaged
Action: Monitor for any further deterioration and repair as required

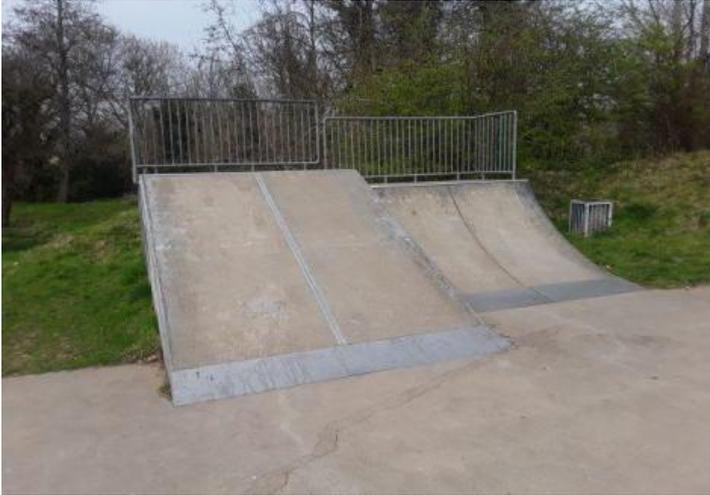
Item: Wheeled Sports - End Transition & Wall Ramp
Manufacturer: Not Identified

Risk Level: L - Low Risk
Surface: Concrete

Finding: The height of the barrier is less than 1200mm and fails the requirements of BS EN 14974

Action: Monitor - No remedial work recommended

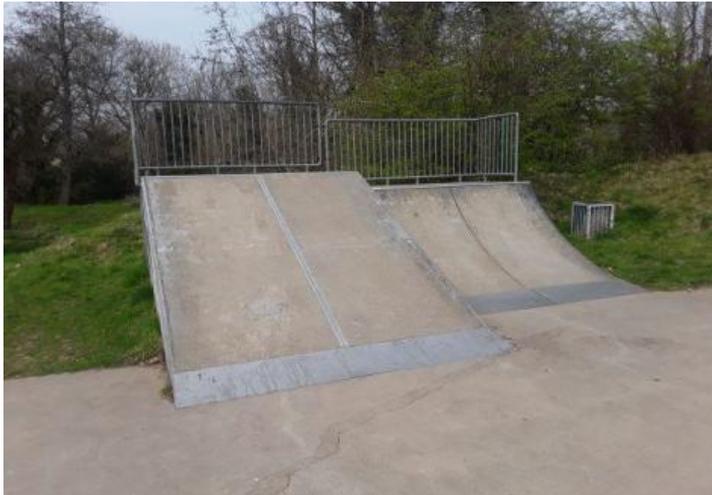
Item: Wheeled Sports - End Transition & Wall Ramp
Manufacturer: Not Identified

Risk Level: L - Low Risk
Surface: Concrete

Finding: The gap between the underside of the barrier and the platform is in excess of 60mm and fails the requirements of BS EN 14974
Action: Monitor - No remedial work recommended

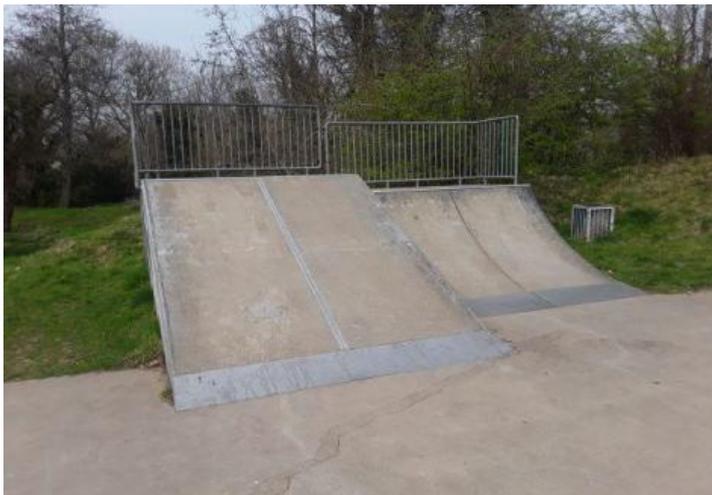
Item: Wheeled Sports - End Transition & Wall Ramp
Manufacturer: Not Identified

Risk Level: L - Low Risk
Surface: Concrete

Finding: The kicker plate protrudes more than 5mm above the surrounding surface level, BS EN 14974 recommends a maximum of 5mm with 3mm preferred
Action: Adjust height to ensure a maximum of 5mm change in level

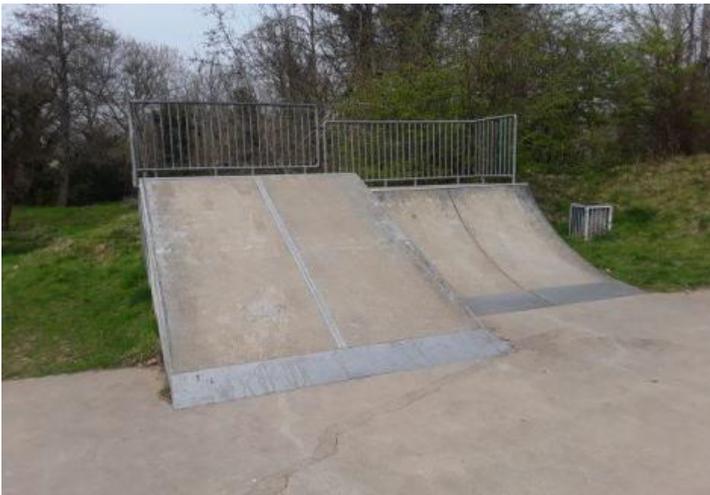
Item: Wheeled Sports - End Transition & Wall Ramp
Manufacturer: Not Identified

Risk Level: L - Low Risk
Surface: Concrete

Finding: The riding surface of the ramp has some damage apparent

Action: Monitor for any further deterioration and repair as required

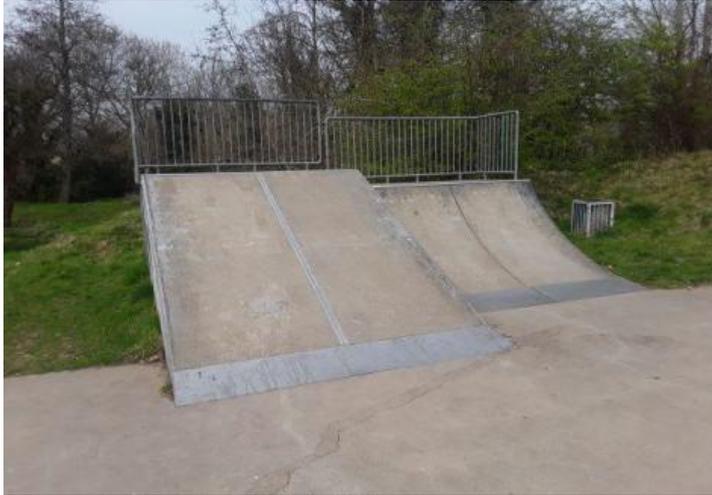
Item: Wheeled Sports - End Transition & Wall Ramp
Manufacturer: Not Identified

Risk Level: V - Very Low Risk
Surface: Concrete

Finding: There is/are several inserts missing

Action: Replace missing inserts

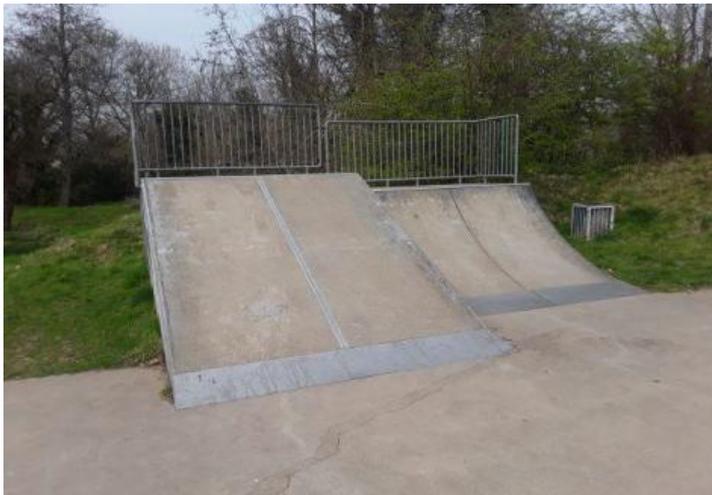
Item: Wheeled Sports - End Transition & Wall Ramp
Manufacturer: Not Identified

Risk Level: L - Low Risk
Surface: Concrete

Finding: There is some damage to the barrier sections

Action: Monitor for any further deterioration and repair as required
