the play inspection company

Post Installation Report

Stratton Bates Rec

Inspection Ref: 1723632

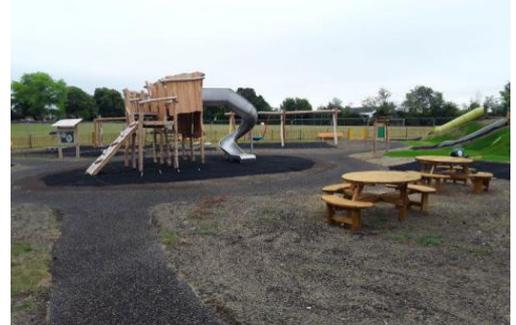
The surface is not established in some areas - Monitor establishment of the surfaces

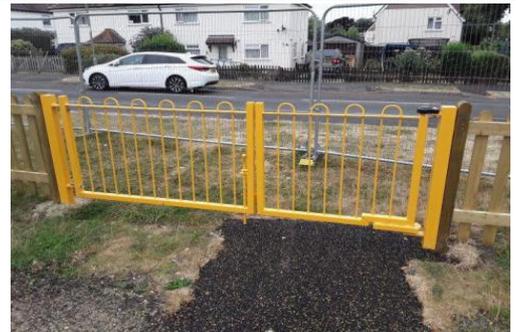
There is no padlock on the maintenance gate - Provide a padlock to secure the gate

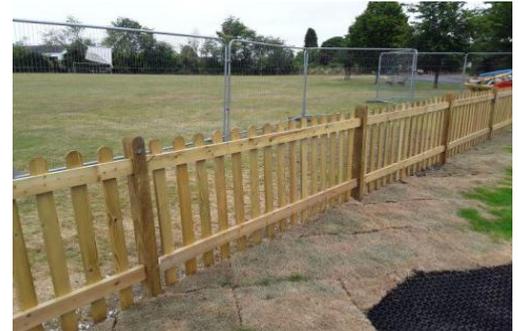
The foundations are exposed - Reinstall surrounding surfaces to cover the foundations

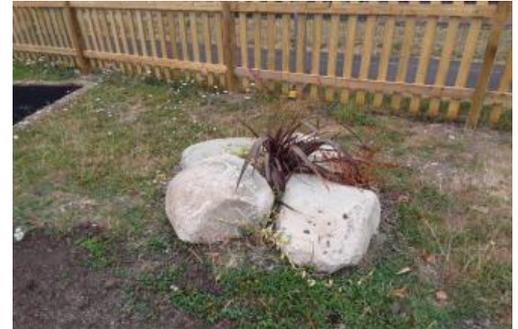
This item is satisfactory - no work required -

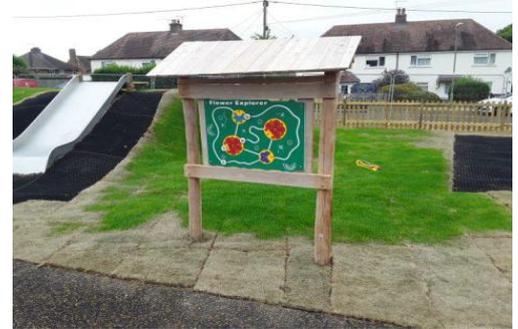
There is/are finger entrapment/s in the framework and the item fails to meet the requirements of BS EN 1176 Part 1 4.2.7.6 Entrapment of fingers - Refer to contractor

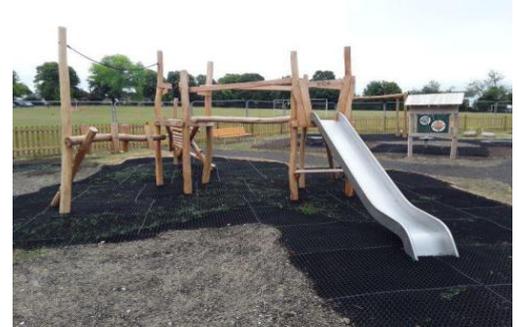
There is/are finger entrapment/s between platform and post and the item fails to meet the requirements of BS EN 1176 Part 1 4.2.7.6 Entrapment of fingers - Refer to contractor

The item fails to meet the requirements of BS EN 1176 Part 1 4.2.7.2 for head and neck entrapment between the log climber - Refer to contractor

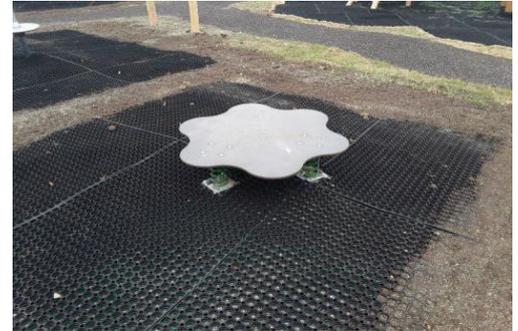
There is no identification label affixed to the equipment - Provide an identification label

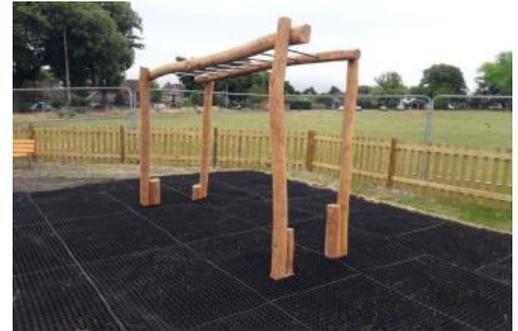
This item is satisfactory - no work required -

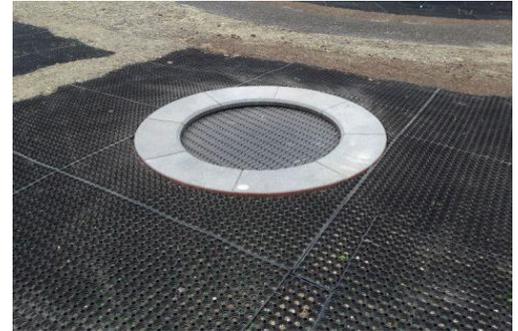
On site visits it is not possible to test the ground clearance of the Bouncing Facility bed as specified in BS EN 1176; ensure that the clearance between the Bouncing Facility Bed and the ground underneath is in accordance with the manufacturers recommendations (unable to record nominal depth due to design of bed). - Refer to the manufacturers recommendations

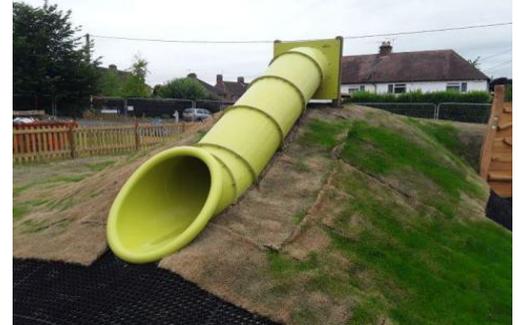
There is/are finger entrapment/s leading to the slide and the item fails to meet the requirements of BS EN 1176 Part 1 4.2.7.6 Entrapment of fingers - Refer to contractor

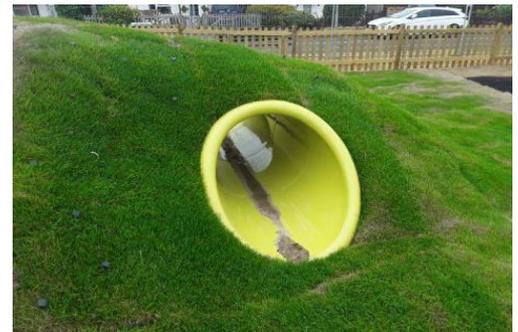
This design / configuration of tunnel mound is well established and has been successfully included in large quantities of playgrounds throughout the UK. Whilst the design does not fully meet the requirements of BS EN 1176 with regards to falls in excess of 600mm over the edge of the tunnel to the surface below, it has been risk assessed as fit for purpose and no changes are recommended to the design - Monitor - No remedial work recommended

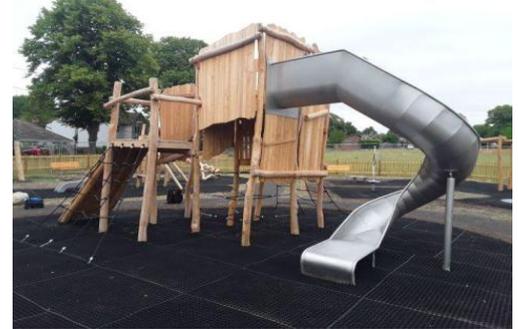
There is/are finger entrapment/s above the net climber and the item fails to meet the requirements of BS EN 1176 Part 1 4.2.7.6 Entrapment of fingers - Refer to contractor

There is/are finger entrapment/s leading to the slide and the item fails to meet the requirements of BS EN 1176 Part 1 4.2.7.6 Entrapment of fingers - Refer to contractor
