# the **play inspection** company

## Annual Inspection

Winchester City Council

Sun Hill Recreation Ground (New Alresford)

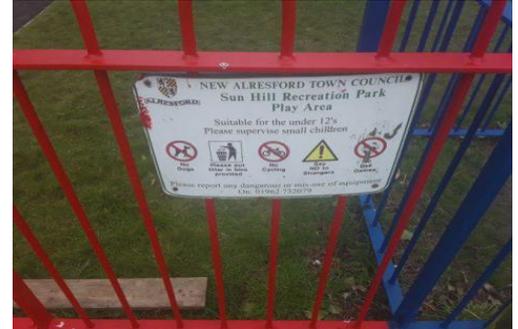
The signage is damaged - Replace signage as required

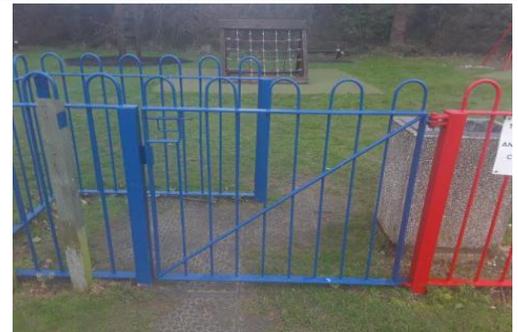
The rubber buffer is missing from the latch plate - Replace rubber buffer

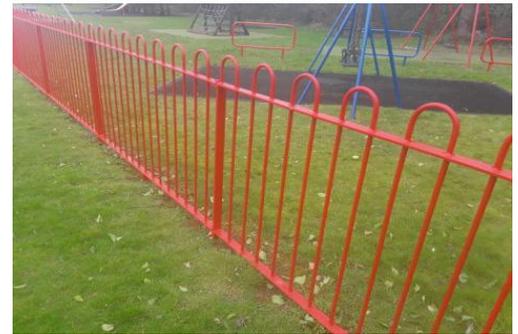
There is some damage to the fence sections - Monitor for any further deterioration and repair as required

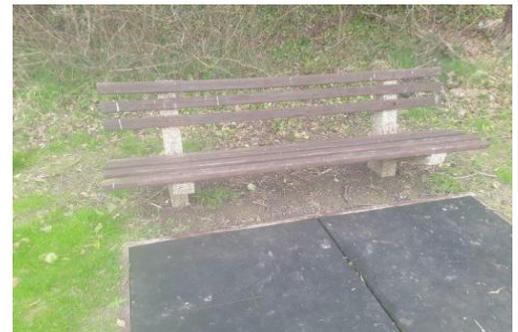
There are gaps opening in between the tiles - Monitor for any further deterioration and repair as required

There is/are bolt cap covers missing or damaged on the item - Replace missing or damaged bolt cap covers

There is some evidence of rot in the timber - Monitor for any further deterioration and replace as required

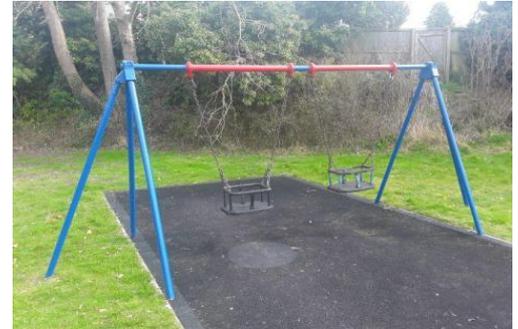
The safety surfacing is beginning to wear - Monitor for any further deterioration and repair as required

There is some evidence of fire damage to the surfacing - Monitor for any further deterioration and repair as required

The seat has minor damage or wear - Monitor for any further deterioration and replace as required

There is some notable evidence of chain wear - Monitor for any further deterioration and replace when 40% worn

There is some wear to the chain bars - Monitor for any further deterioration and replace when 40% worn

The chain openings are in excess of the 8.6mm as recommended by BS EN 1176 - Monitor - No remedial work recommended

The surfacing dimensions are short and do not meet with the requirements of the current applicable standard - Monitor - no remedial action recommended

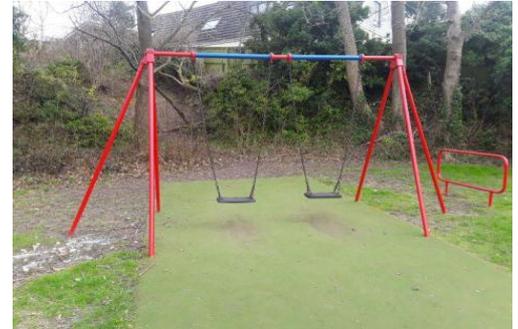
The safety surfacing is beginning to wear - Monitor for any further deterioration and repair as required

The seats are too close to each other as defined in BS EN 1176 Part 2; this is a low risk failure and no remedial action is required - Monitor - No remedial work recommended

The chain openings are in excess of the 8.6mm as recommended by BS EN 1176 - Monitor - No remedial work recommended

There is some notable evidence of chain wear - Monitor for any further deterioration and replace when 40% worn

The seat has minor damage or wear - Monitor for any further deterioration and replace as required

There is some wear to the chain bars - Monitor for any further deterioration and replace when 40% worn

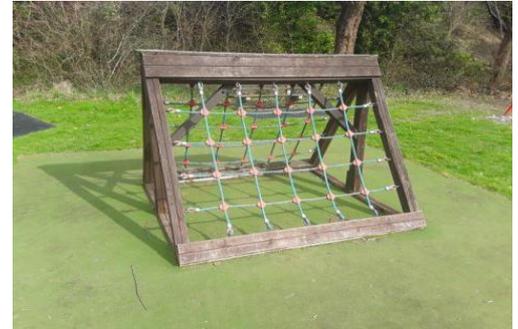
A number of eyebolt fixing(s) have worked loose - Secure all loose fixings

There is some evidence of fire damage to the item - Monitor for any further deterioration and repair as required

There is some evidence of rot in the timber - Monitor for any further deterioration and replace as required

The connecting links are in excess of 8.6mm and less than 12mm and fail the requirements of BS EN 1176 Part 1; clause 4.2.13, Chains - Monitor - No remedial work recommended

The ropes/nets are worn/damaged in places - Monitor for any further deterioration and repair or replace as required

There are areas or parts of the timber on the structure that have rotted - Replace all affected timbers

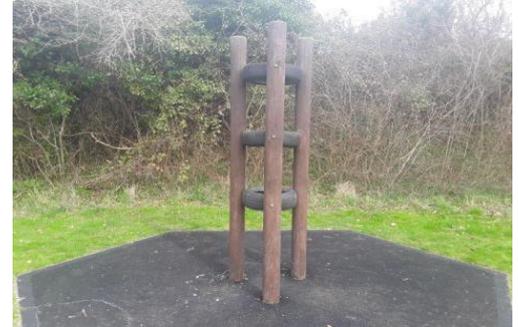
This item of equipment relies on a single post, or a line of posts, for stability and extra care needs to be taken with equipment of this nature to avoid the potential for catastrophic failure - Ensure that regular detailed inspections are undertaken to assess for rot, corrosion and general stability

The tyres are showing signs of wear / damage - Monitor for any further deterioration and replace as required

There is some minor damage to the surface - Monitor for any further deterioration and repair as required

The surfacing dimensions are short and do not meet with the requirements of the current applicable standard - Monitor - no remedial action recommended

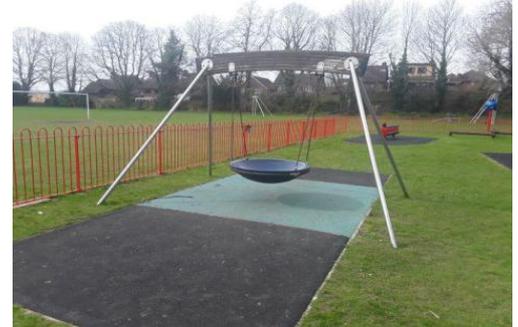
The timber crossbeam is damaged with evidence of rot - Replace

There is some notable evidence of chain wear - Monitor for any further deterioration and replace when 40% worn

The seat inserts are showing signs of wear - Monitor for any further deterioration and replace as required

The lateral stability of the swing seat does not meet with the requirements of BS EN 1176 Part 2; the minimum distance between the suspension members should be the distance between the swing seat connections plus 30% of the suspension length - Monitor - no remedial work recommended

There are trip hazards at the edges of the surface - Reinstate surrounding surface levels to remove the trip points

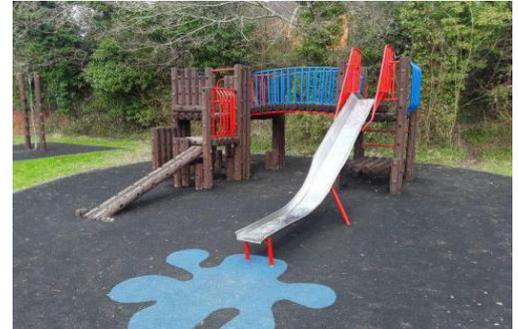
There is some minor damage to the surface - Monitor for any further deterioration and repair as required

The timber has a number of splits/shakes or air cracks and this may affect the stability or allow water ingress which will accelerate the rotting process - Monitor to ensure the splits do not cross through fixing points of the structure and/or cause any instability

There is some evidence of rot in the timber throughout the structure - Monitor for any further deterioration and replace as required

The side of the slide is damaged - Monitor for any further deterioration and repair as required

There is some evidence of rot in the posts - Monitor for any further deterioration and replace as required

The item has missing component(s) - Replace missing support post

There are missing end caps - Replace

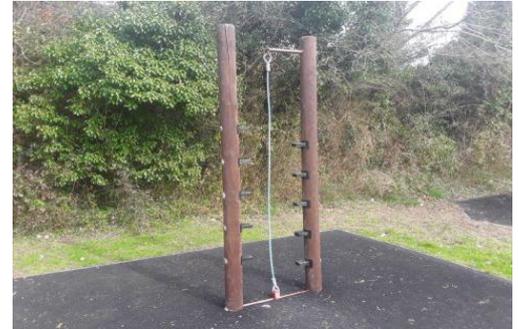
**Finding 1**  
 This item of equipment relies on a single post, or a line of posts, for stability and extra care needs to be taken with equipment of this nature to avoid the potential for catastrophic failure - Ensure that regular detailed inspections are undertaken to assess for rot, corrosion and general stability

**Finding 2**  
 The timber has a number of splits/shakes or air cracks and this may affect the stability or allow water ingress which will accelerate the rotting process - Monitor to ensure the splits do not cross through fixing points of the structure and/or cause any instability

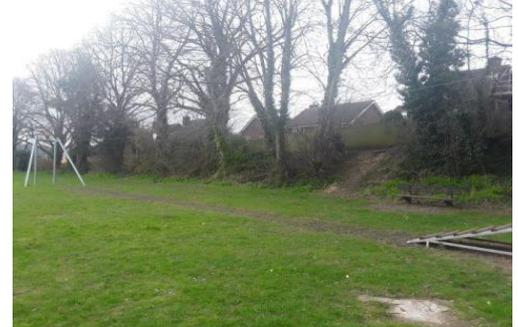
We have completed a visual inspection of the cable and fixing points from ground level, however it is not possible to fully inspect the cable and fixings without either hiring equipment to gain access or removing the cable and inspecting at ground level. We recommend that the main cable and fixing security is thoroughly inspected at least in accordance with the manufacturers recommendations to check for damage, security or internal rusting, this will help to ensure the continued safe use of the equipment - Inspect in accordance with the manufacturers recommendations

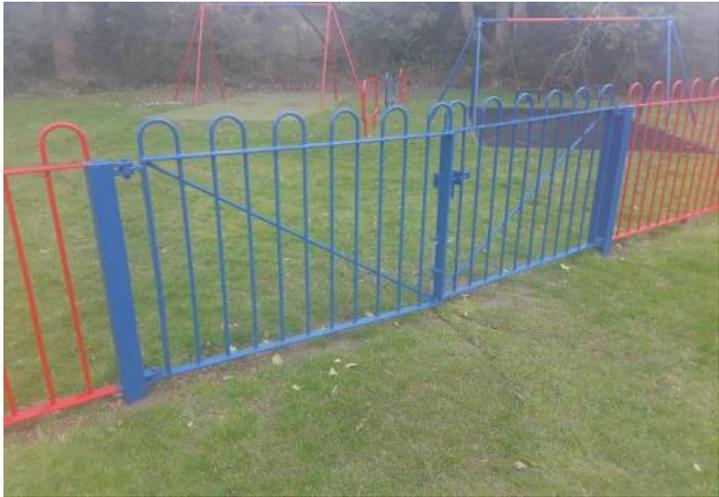
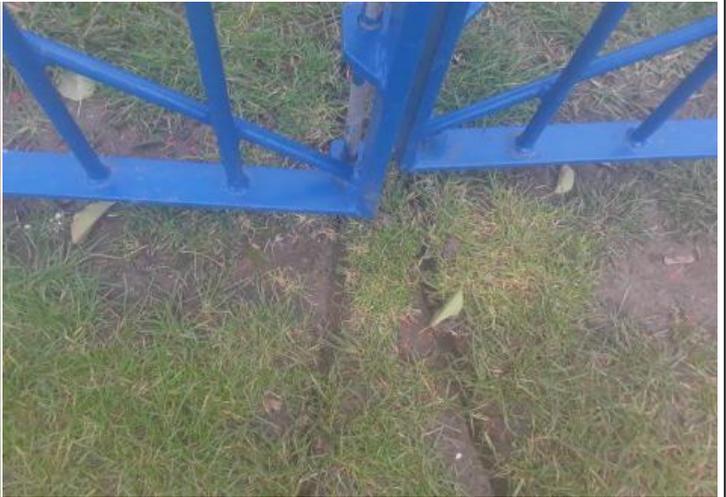
**Finding:** The gate has no drop bolt sleeves and/or drop bolts fitted  
**Action:** Provide drop bolt sleeves and/or drop bolts

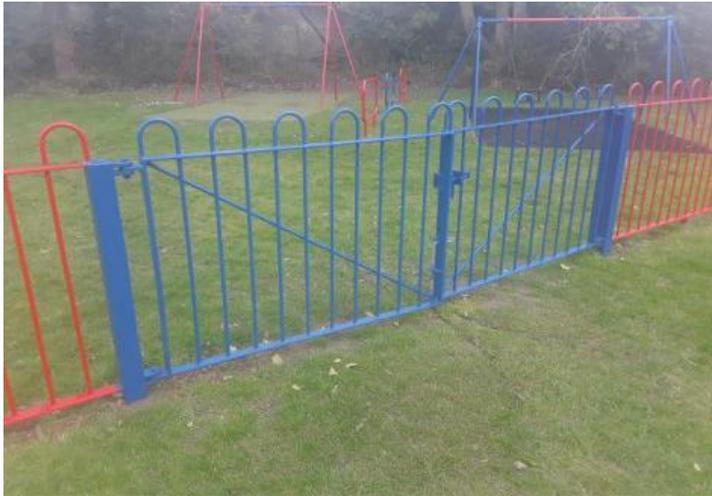
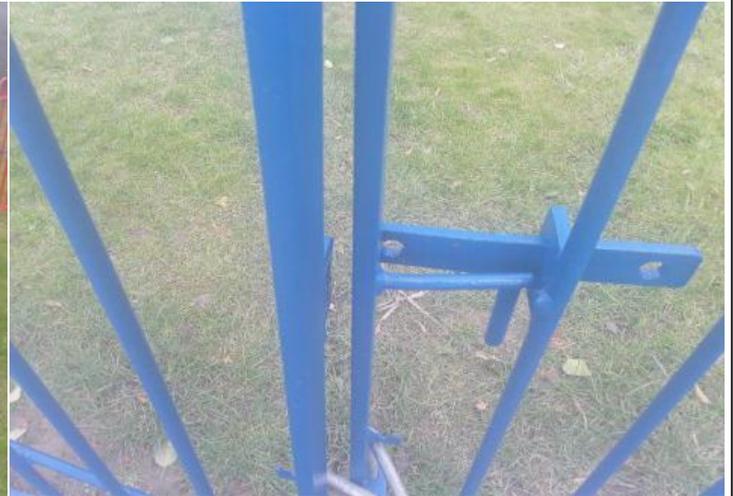
**Finding:** There is no padlock on the maintenance gate

**Action:** Provide a padlock to secure the gate

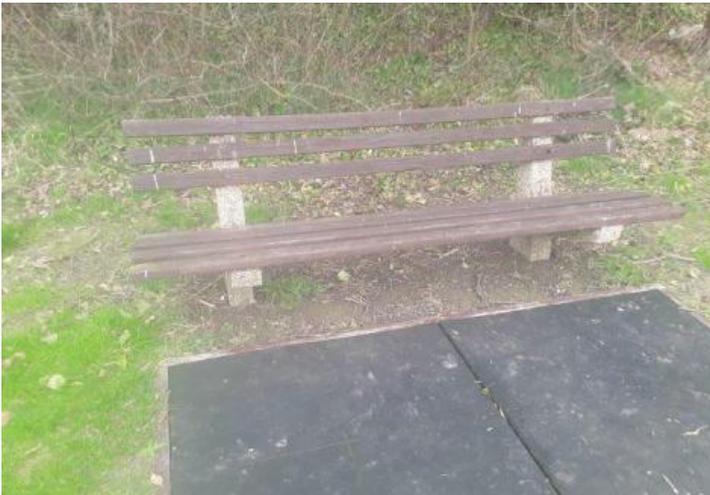
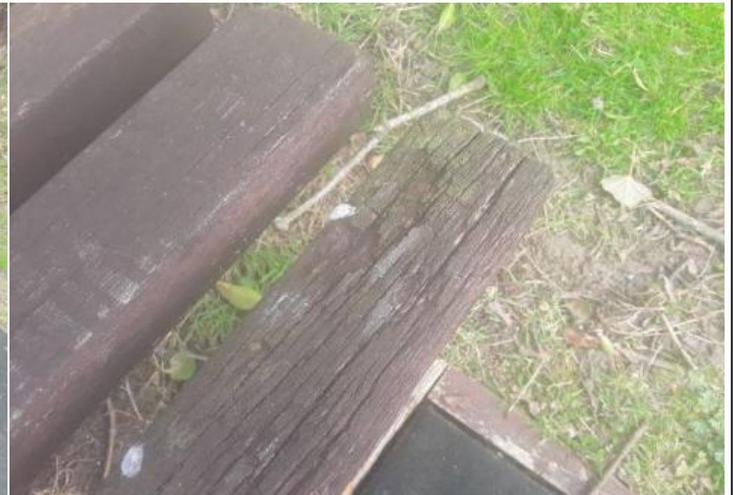
**Finding:** Parts of the timber are rough or splintered

**Action:** Remove all rough or sharp edges

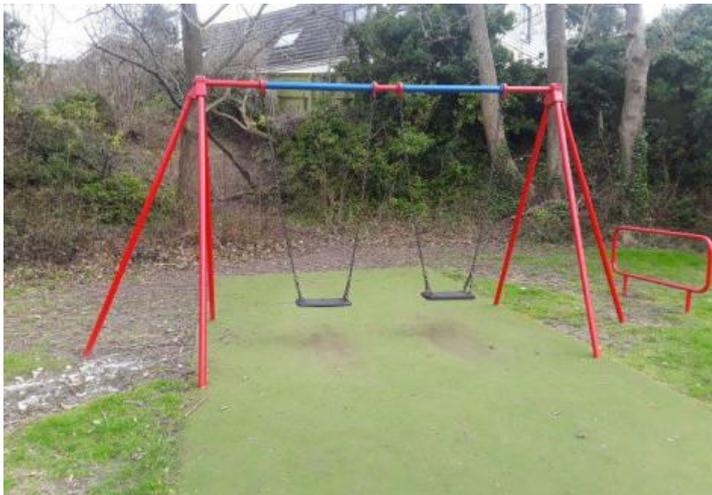
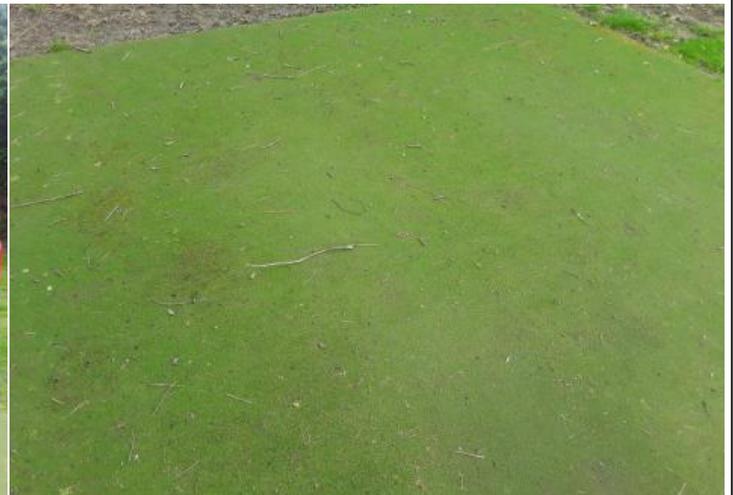
**Finding:** There is some tree debris on the surfacing  
**Action:** Remove and maintain

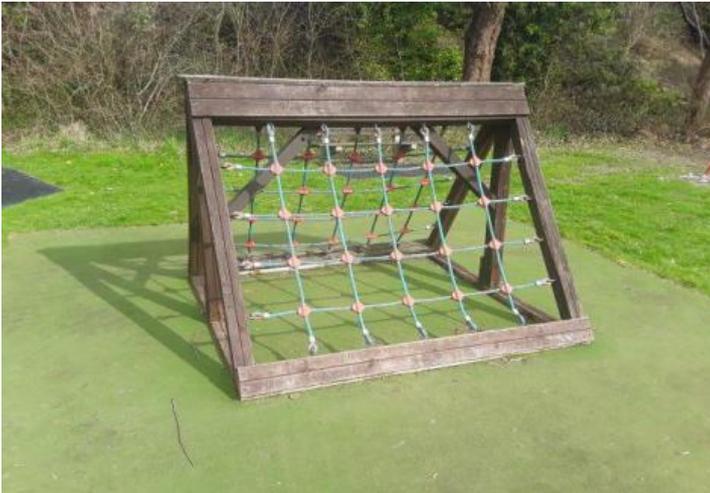
**Finding:** A number of eyebolt fixing(s) have worked loose

**Action:** Secure all loose fixings

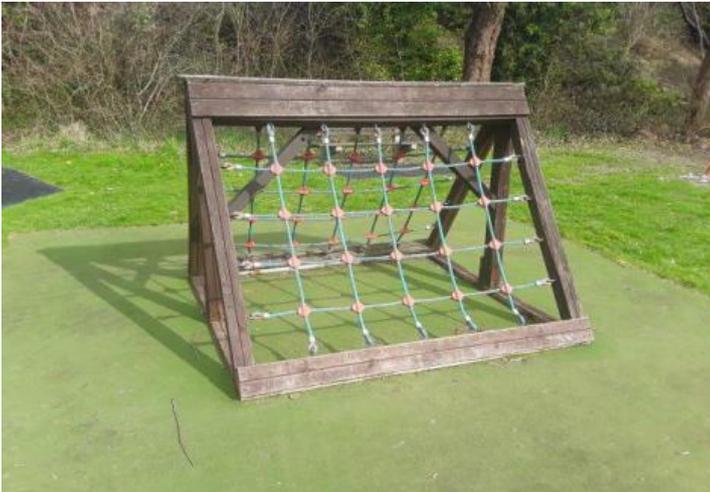
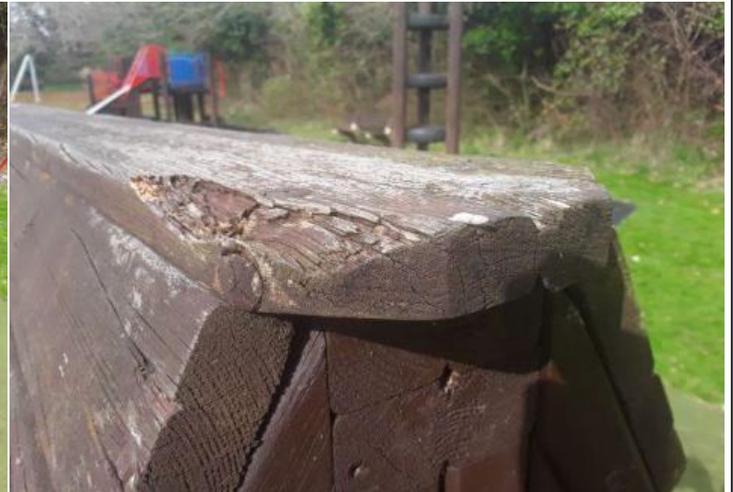
**Finding:** Parts of the timber are rough or splintered

**Action:** Remove all rough or sharp edges

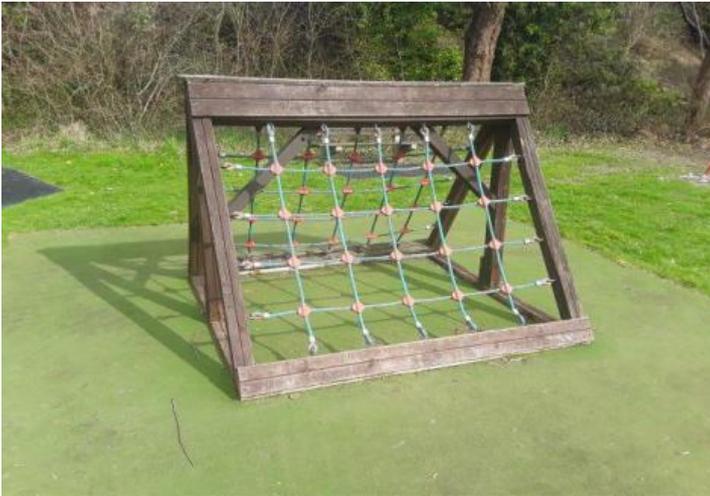
**Finding:** There is some evidence of fire damage to the item **Action:** Monitor for any further deterioration and repair as required

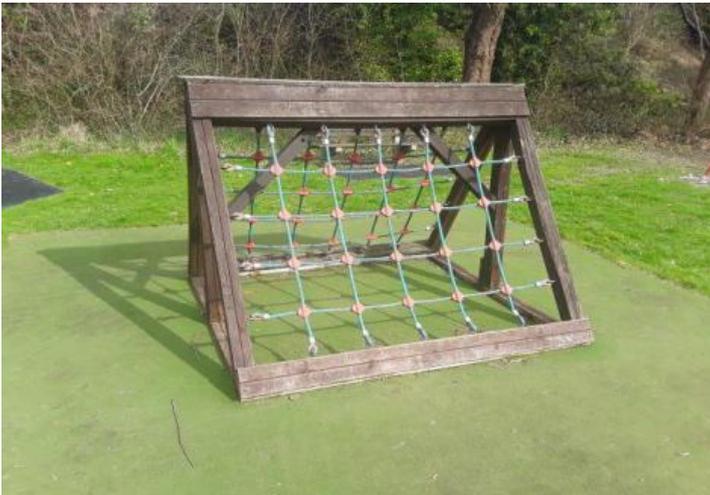
**Finding:** The ropes/nets are worn/damaged in places **Action:** Monitor for any further deterioration and repair or replace as required

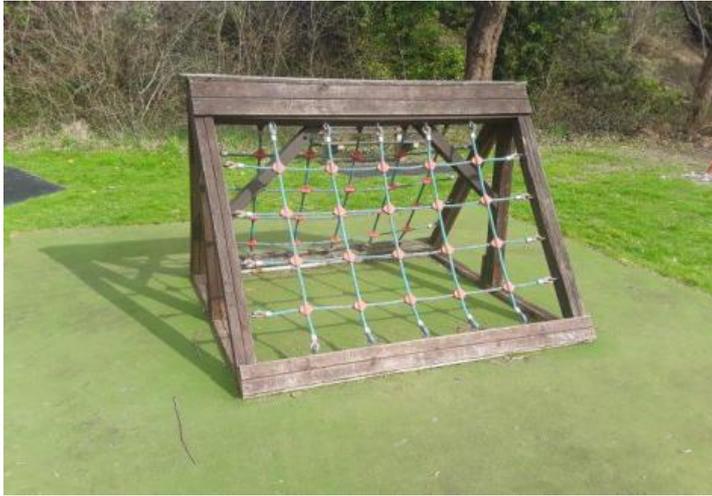
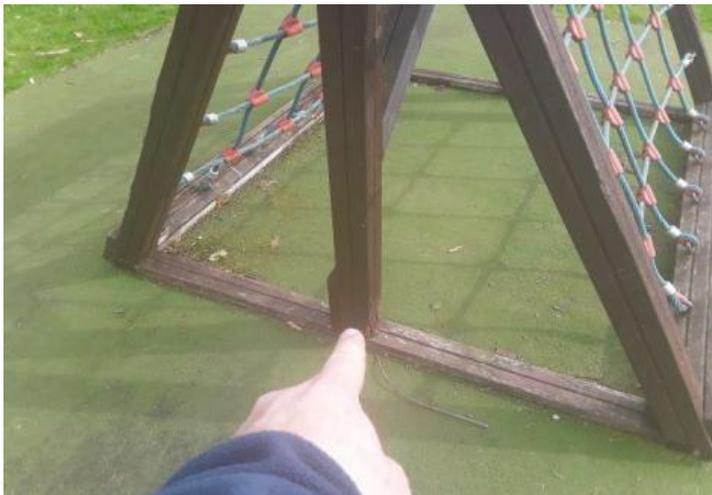
**Finding:** There are areas or parts of the timber on the structure that have rotted

**Action:** Replace all affected timbers

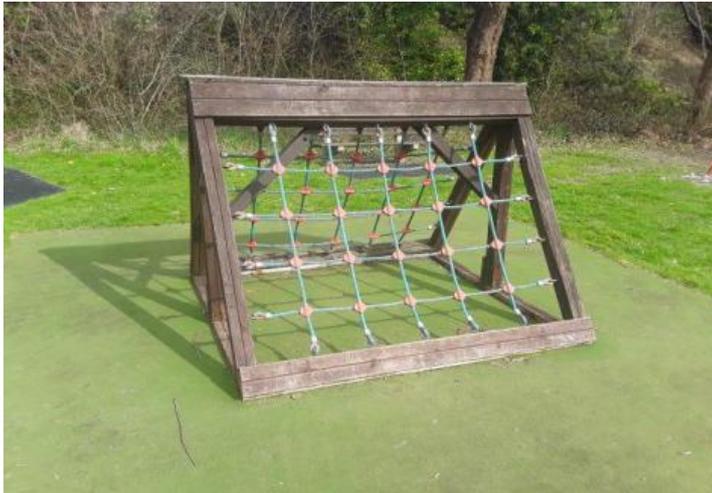
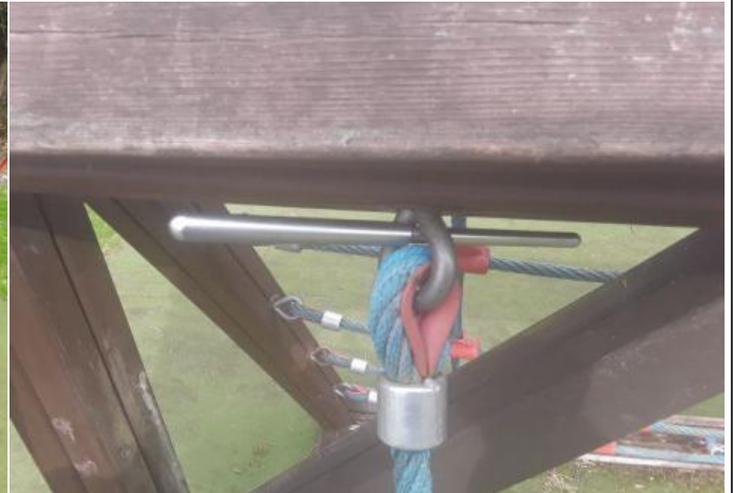
**Finding:** The connecting links are in excess of 8.6mm and less than 12mm and fail the requirements of BS EN 1176 Part 1; clause 4.2.13, Chains

**Action:** Monitor - No remedial work recommended

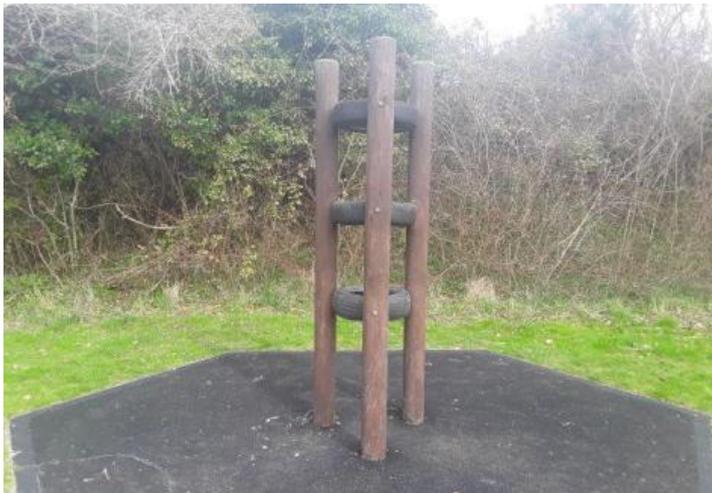
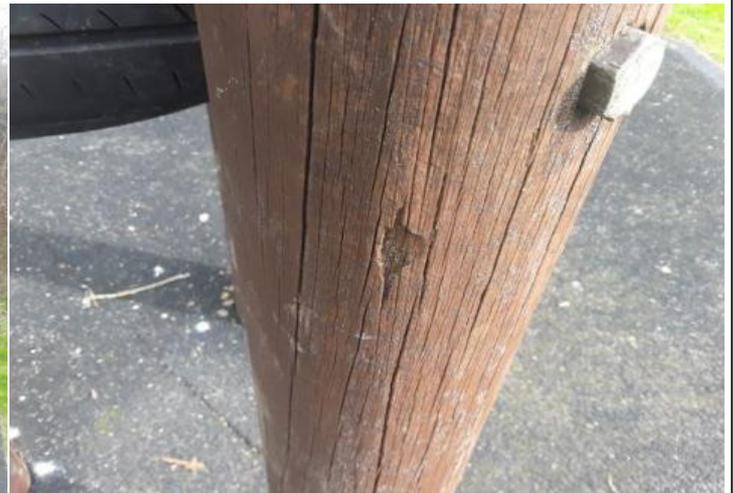
**Finding:** Parts of the timber are rough or splintered

**Action:** Remove all rough or sharp edges

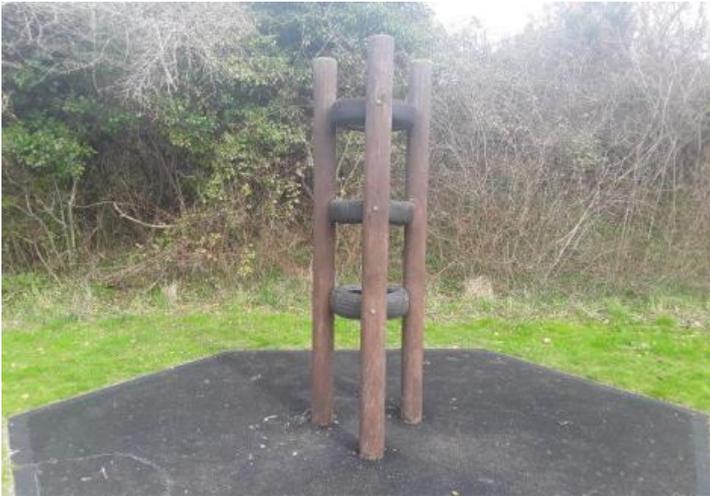
**Finding:** This item of equipment relies on a single post, or a line of posts, for stability and extra care needs to be taken with equipment of this nature to avoid the potential for catastrophic failure  
**Action:** Ensure that regular detailed inspections are undertaken to assess for rot, corrosion and general stability

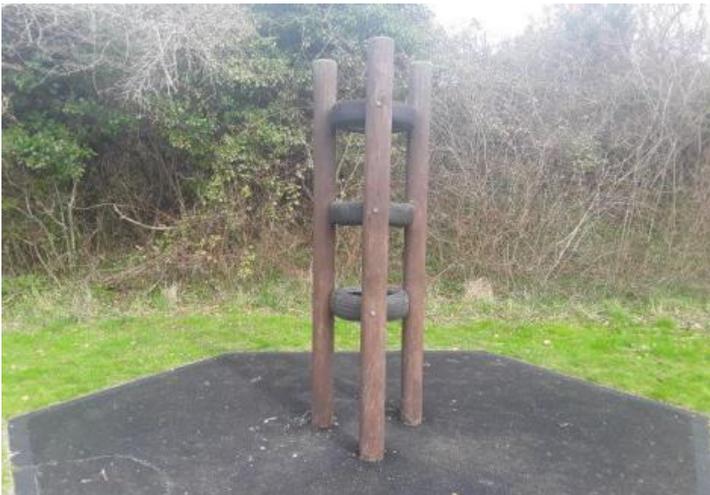
**Finding:** The tyres are showing signs of wear / damage  
**Action:** Monitor for any further deterioration and replace as required

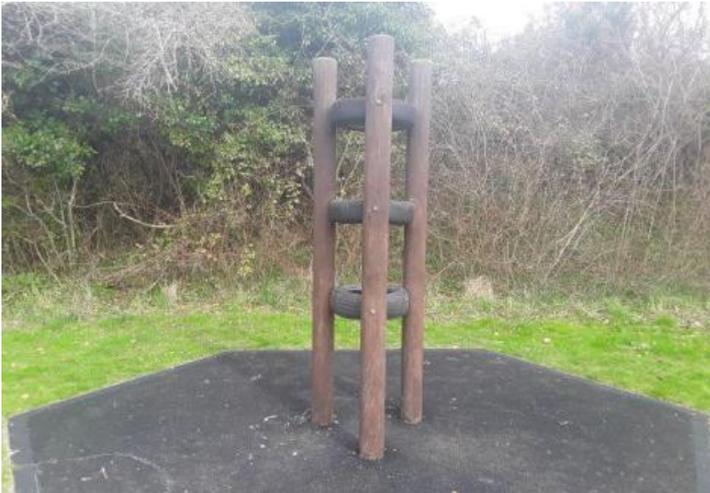
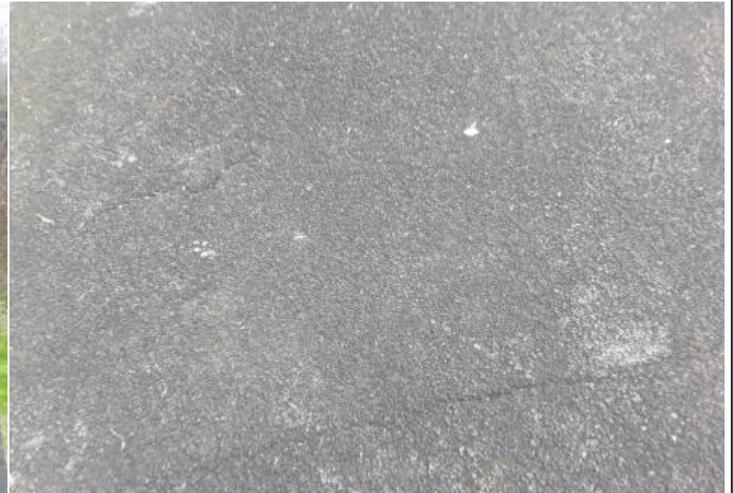
**Finding:** There is some minor damage to the surface

**Action:** Monitor for any further deterioration and repair as required

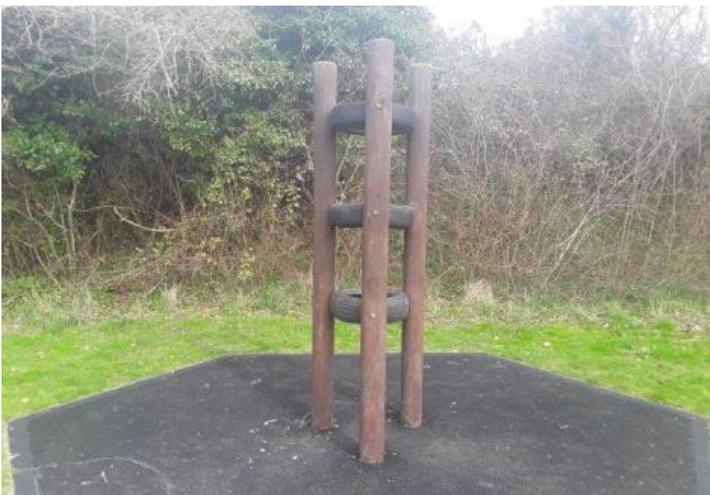
**Finding:** The surfacing dimensions are short and do not meet with the requirements of the current applicable standard

**Action:** Monitor - no remedial action recommended

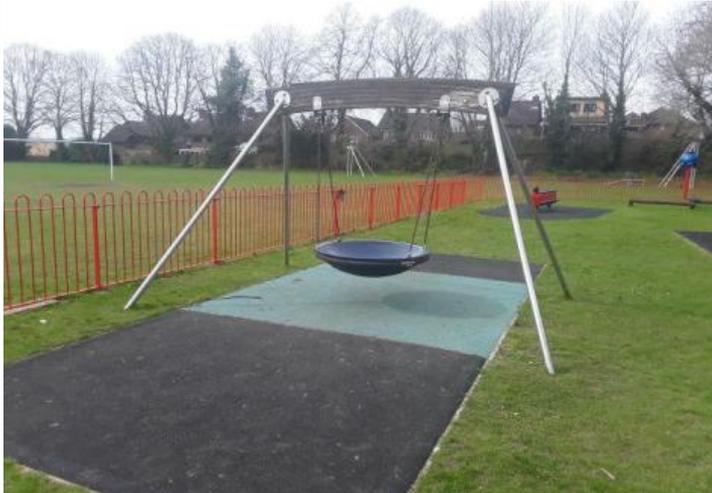
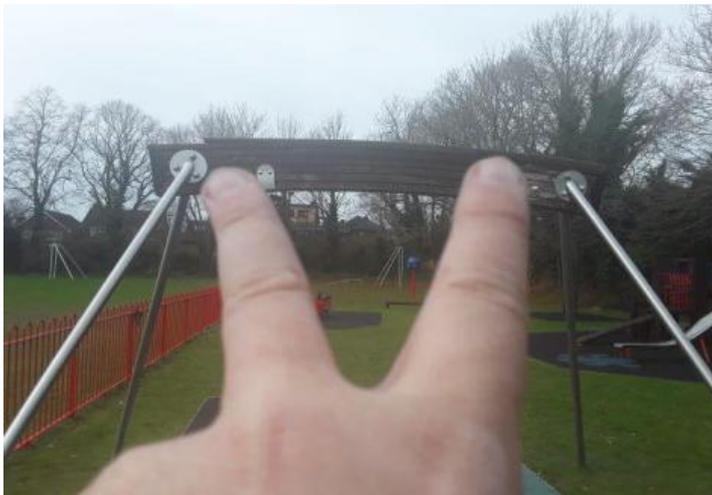
**Finding:** The timber crossbeam is damaged with evidence of rot **Action:** Replace of rot

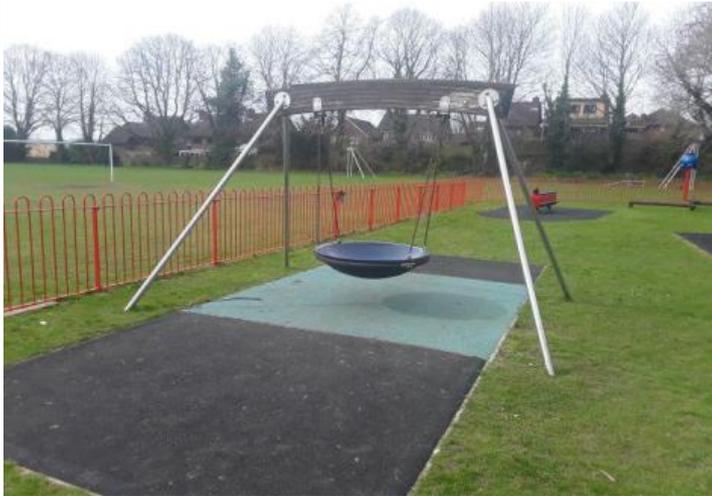
**Finding:** There is some notable evidence of chain wear

**Action:** Monitor for any further deterioration and replace when 40% worn

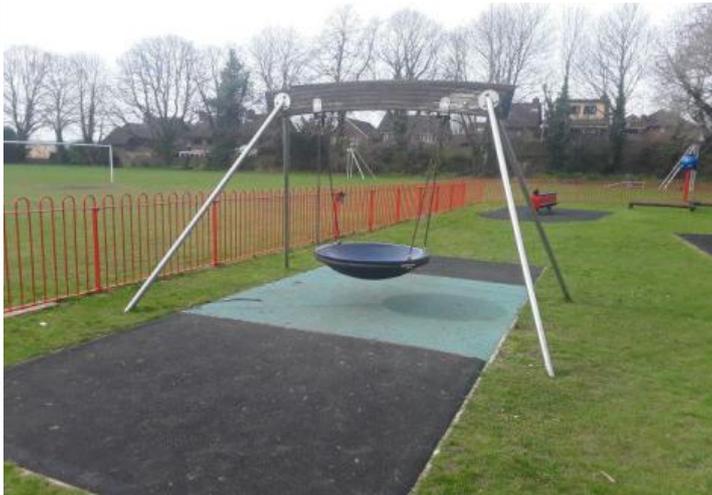
**Finding:** The seat inserts are showing signs of wear

**Action:** Monitor for any further deterioration and replace as required

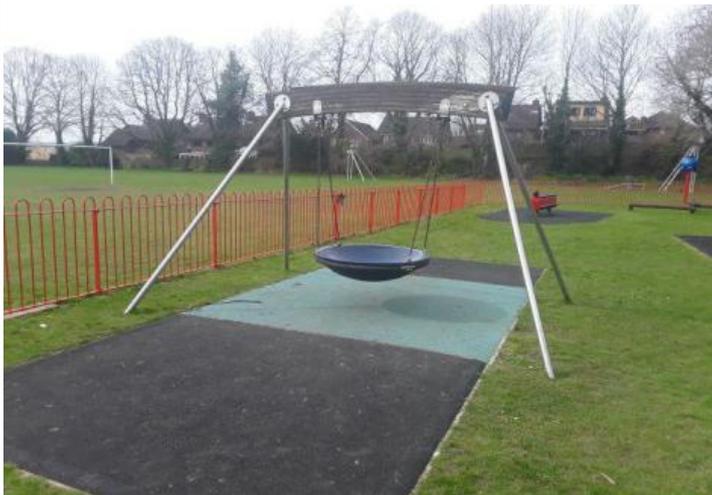
**Finding:** There are trip hazards at the edges of the surface

**Action:** Reinstate surrounding surface levels to remove the trip points

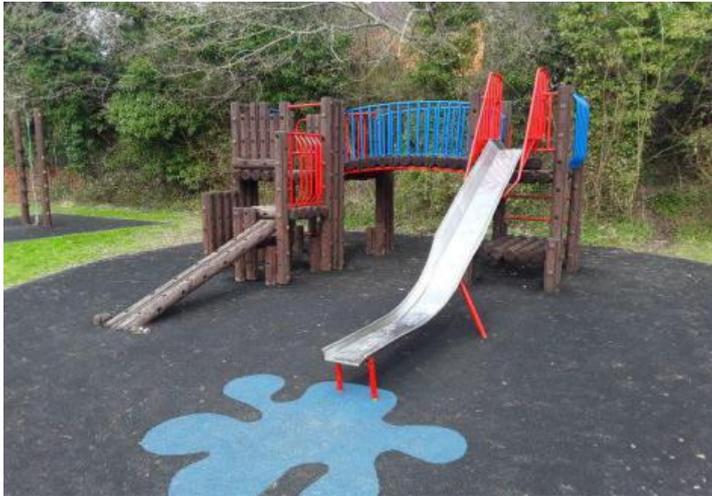
**Finding:** There is some minor damage to the surface

**Action:** Monitor for any further deterioration and repair as required

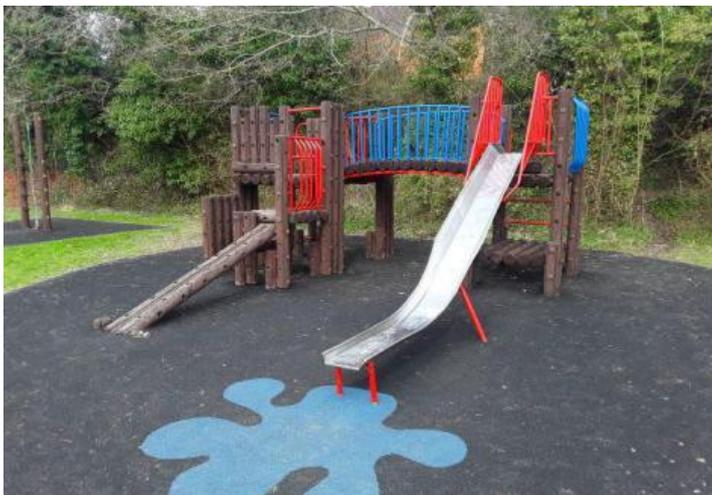
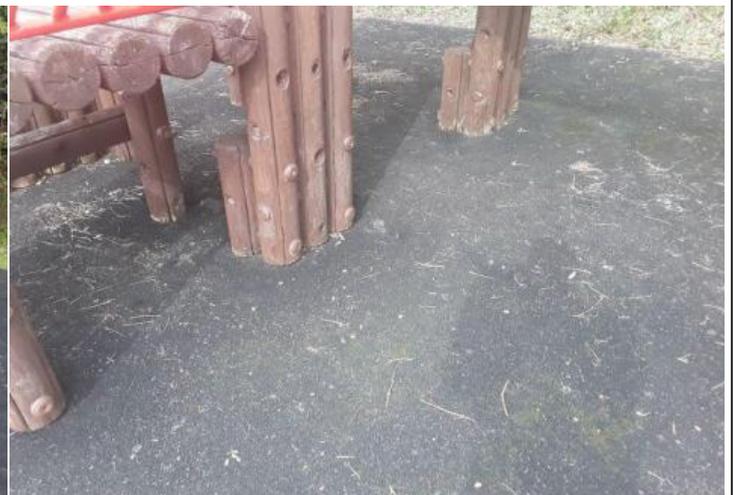
**Finding:** There is some tree debris on the surfacing

**Action:** Remove and maintain

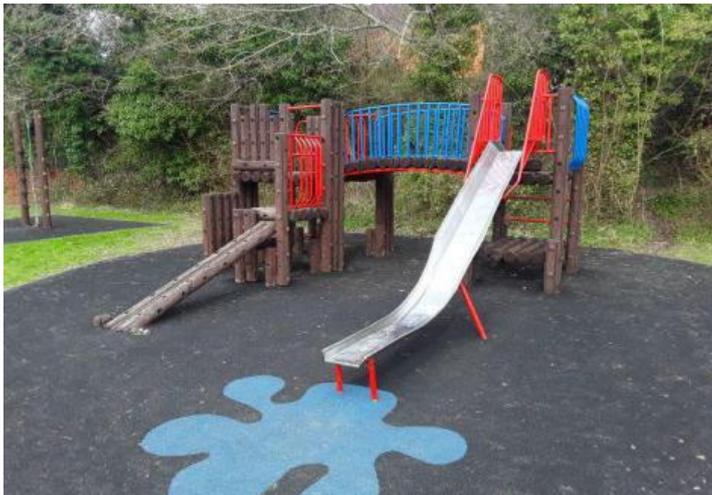
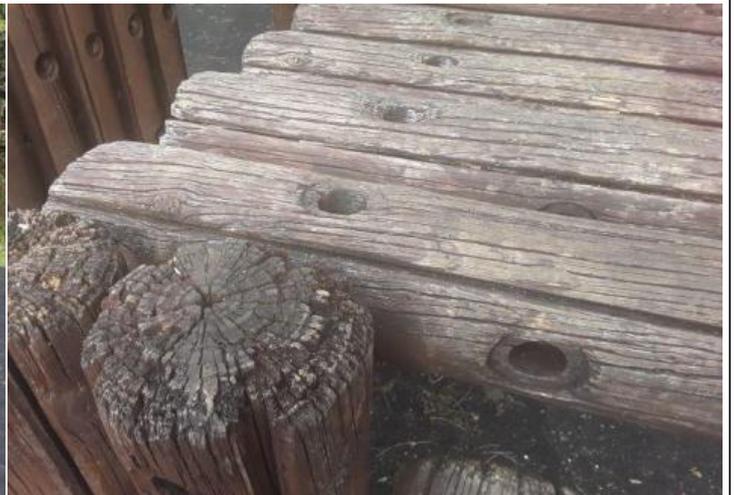
**Finding:** Parts of the timber are rough or splintered  
**Action:** Remove all rough or sharp edges

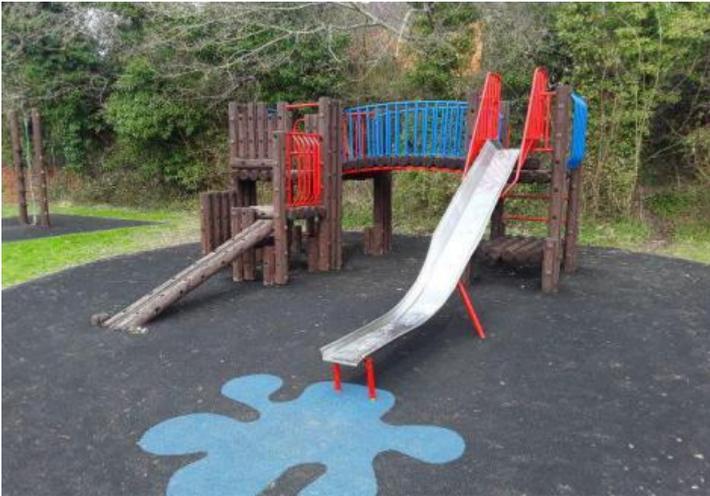
**Finding:** There is some evidence of rot in the timber throughout the structure

**Action:** Monitor for any further deterioration and replace as required

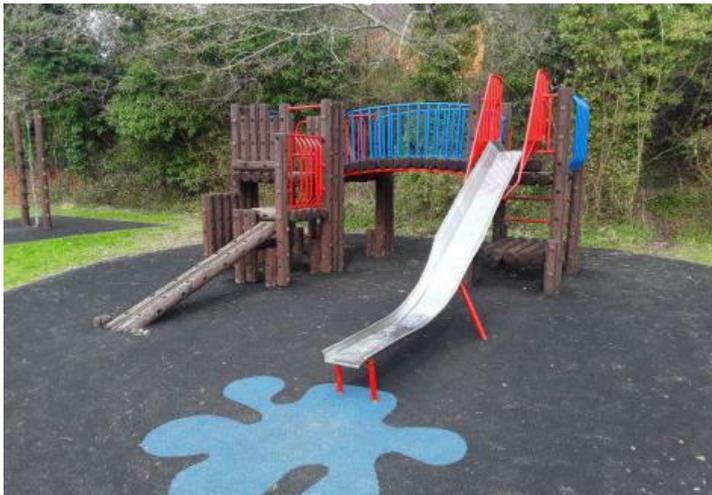
**Finding:** There is some evidence of rot in the posts

**Action:** Monitor for any further deterioration and replace as required

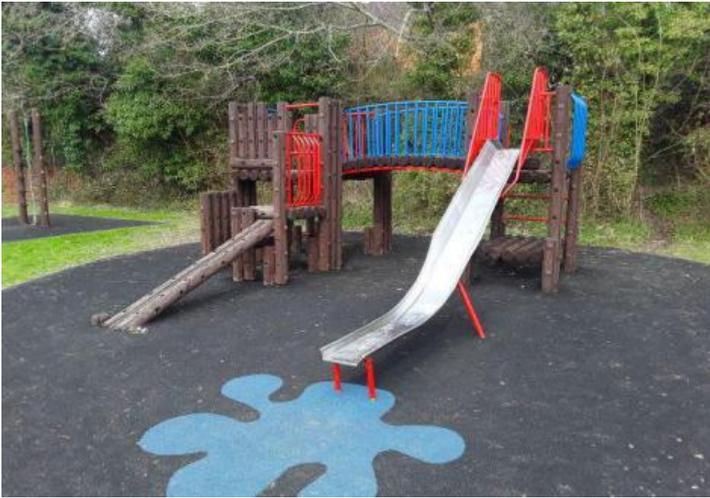
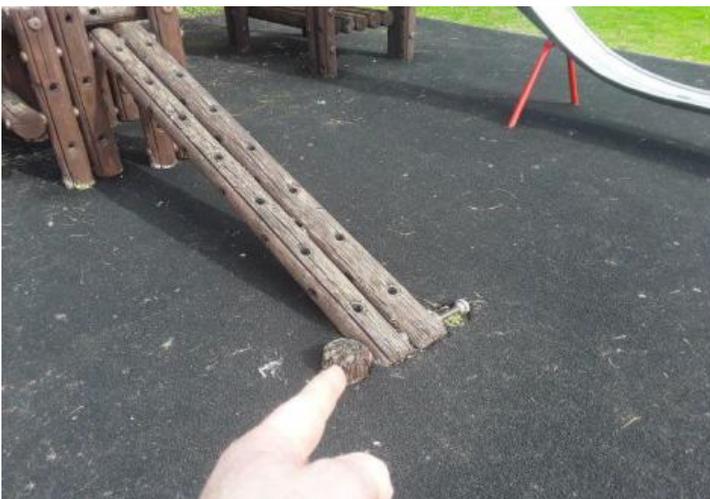
**Finding:** There are areas or parts of the timber on the structure that have rotted

**Action:** Replace all affected timbers

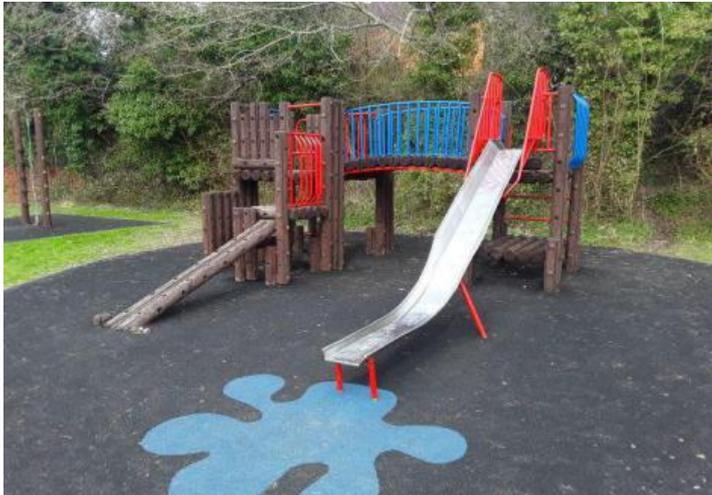
**Finding:** There are missing end caps

**Action:** Replace

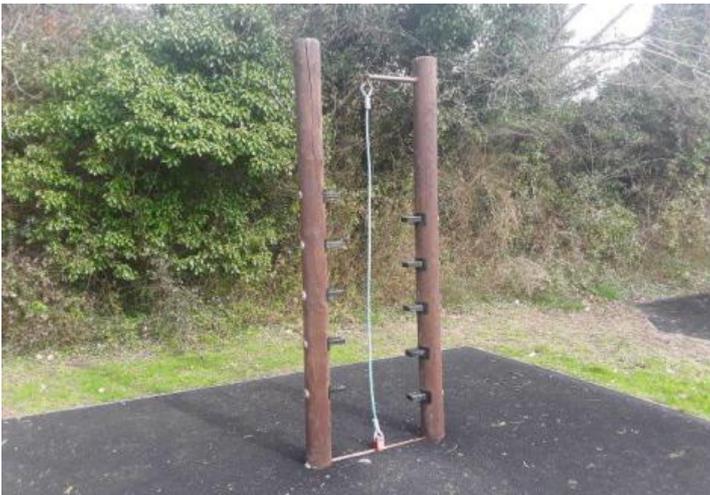
**Finding:** This item of equipment relies on a single post, or a line of posts, for stability and extra care needs to be taken with equipment of this nature to avoid the potential for catastrophic failure

**Action:** Ensure that regular detailed inspections are undertaken to assess for rot, corrosion and general stability

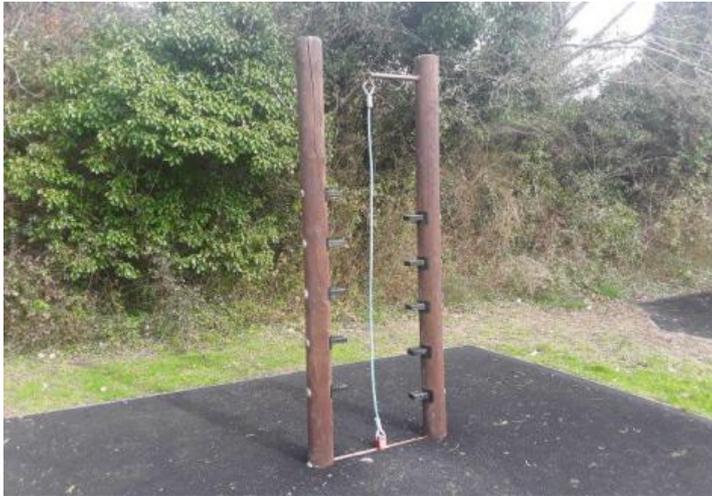
**Finding:** The timber has a number of splits/shakes or air cracks and this may affect the stability or allow water ingress which will accelerate the rotting process  
**Action:** Monitor to ensure the splits do not cross through fixing points of the structure and/or cause any instability

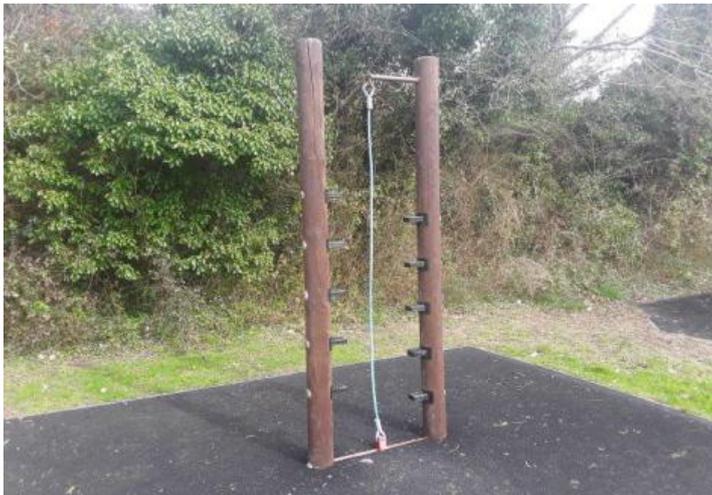
**Finding:** There is some wear to the shackles.  
**Action:** Monitor for any further deterioration and replace when 40% worn

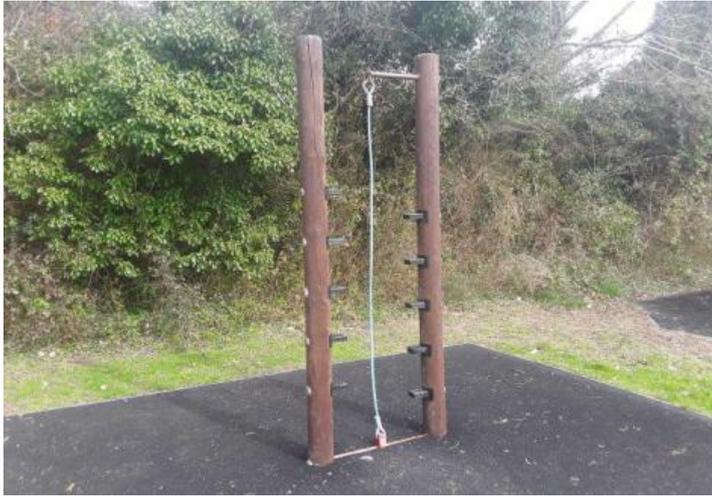
**Finding:** The rope has worn and there are sharp wire strands protruding

**Action:** Replace rope

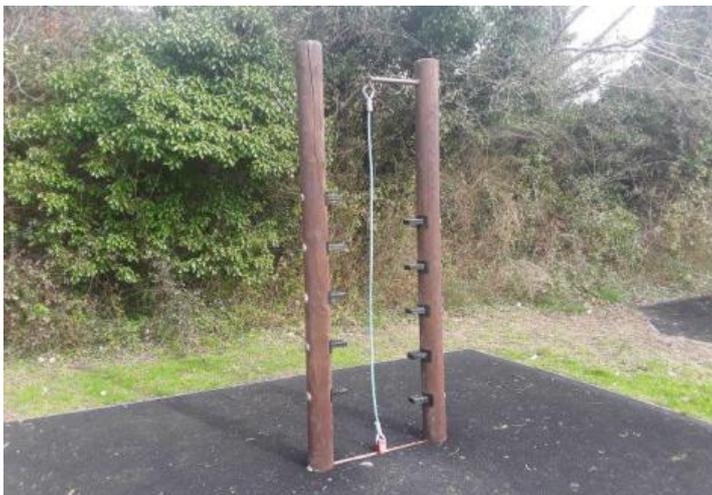
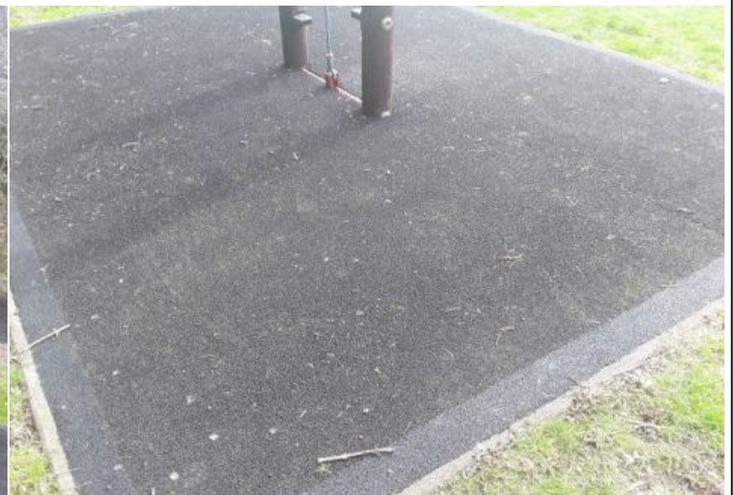
**Finding:** There is some tree debris on the surfacing

**Action:** Remove and maintain

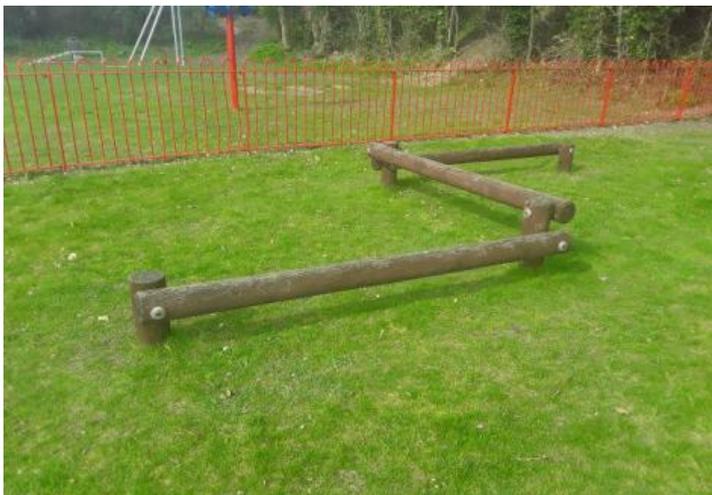
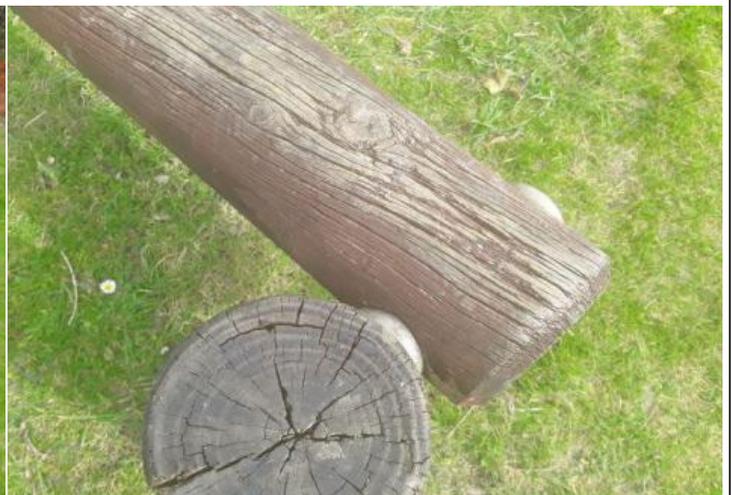
**Finding:** Parts of the timber are rough or splintered

**Action:** Remove all rough or sharp edges

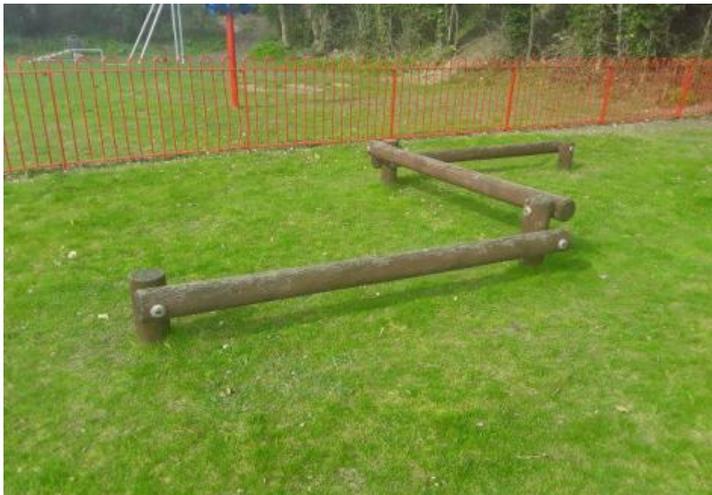
**Finding:** There is some evidence of rot in the posts  
**Action:** Monitor for any further deterioration and replace as required

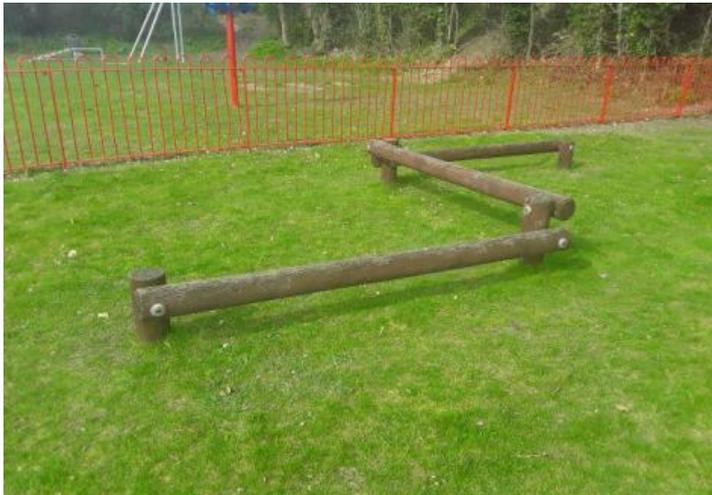
**i** 6 - Low Risk (Finding 3)

**Item:** Activity Equipment - Balance Beam  
**Manufacturer:** Lappset UK Ltd  
**Risk Level:** L - Low Risk  
**Surface:** Grass

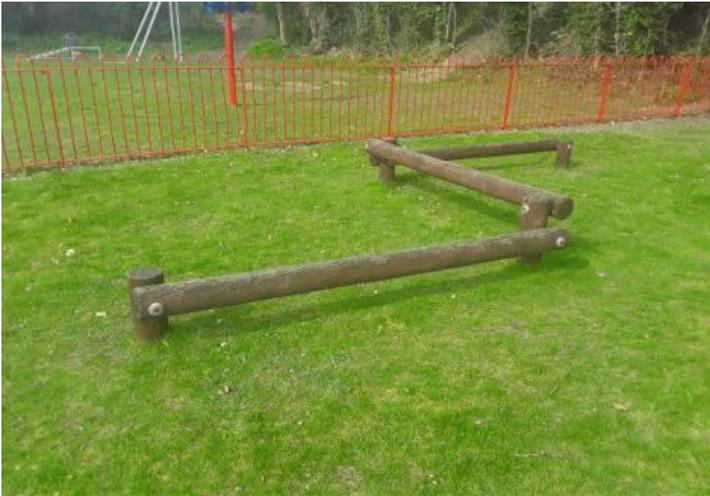
**i** 6 - Low Risk (Finding 4)

**Finding:** There is some evidence of rot in the timber  
**Action:** Monitor for any further deterioration and replace as required
