# the **play inspection** company

## Annual Inspection

Winchester City Council

Sun Hill Recreation Ground (New Alresford)

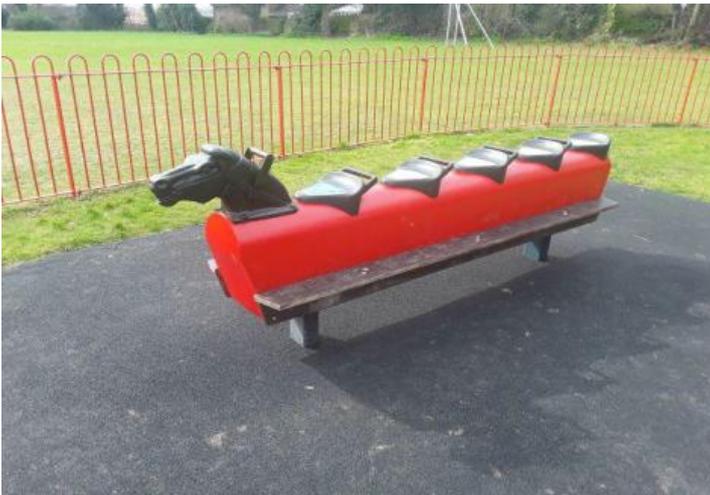
**Item:** Rocking Equipment - Rocking Horse  
**Manufacturer:** Wicksteed Playgrounds

**Risk Level:** V - Very Low Risk  
**Surface:** Wet Pour

**Finding:** There is no gaiter protection for accessible moving parts (possible shear trap) as recommended in BS EN 1176 Part 1; 4.2.6 Moving Parts

**Action:** Monitor - No remedial work recommended

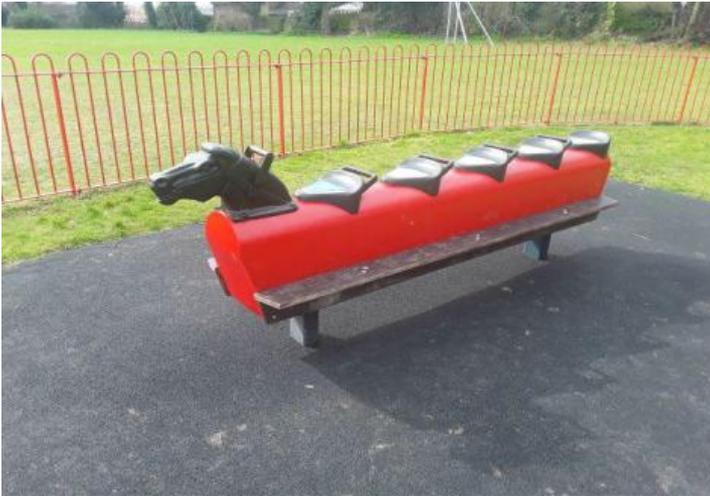
**Item:** Rocking Equipment - Rocking Horse  
**Manufacturer:** Wicksteed Playgrounds

**Risk Level:** L - Low Risk  
**Surface:** Wet Pour

**Finding:** There is some evidence of rot in the timber

**Action:** Monitor for any further deterioration and replace as required

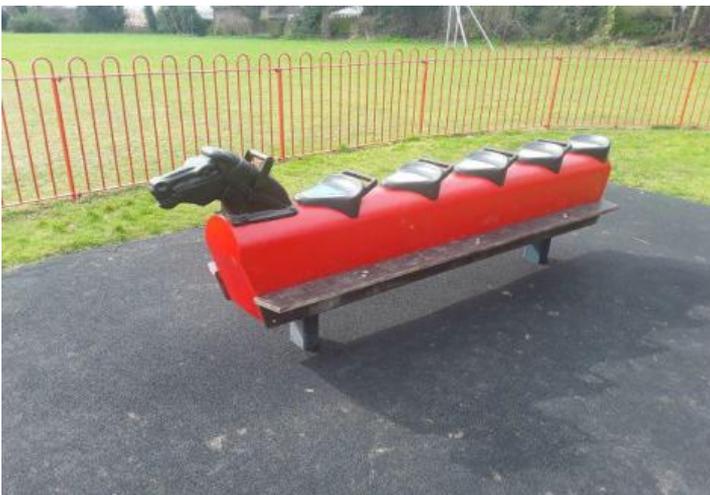
**Item:** Rocking Equipment - Rocking Horse  
**Manufacturer:** Wicksteed Playgrounds

**Risk Level:** L - Low Risk  
**Surface:** Wet Pour

**Finding:** There is some evidence of fire damage to the item

**Action:** Monitor for any further deterioration and repair as required

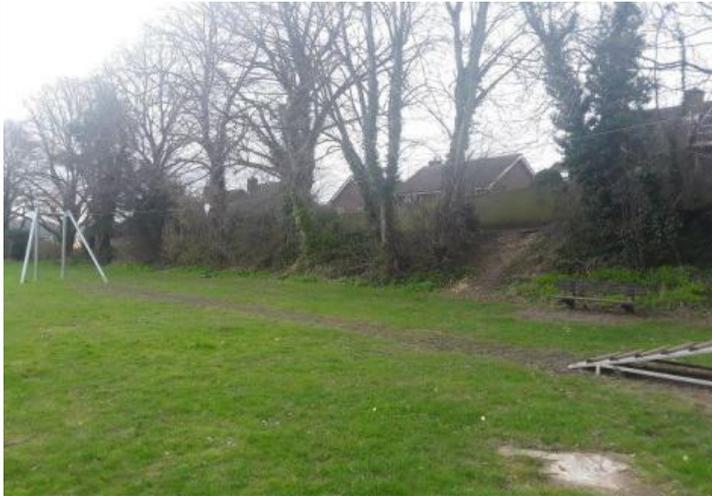
**Item:** Other - Cable Runway  
**Manufacturer:** Wicksteed Playgrounds

**Risk Level:** V - Very Low Risk  
**Surface:** Grass Matrix Tiles

**Finding:** We have completed a visual inspection of the cable and fixing points from ground level, however it is not possible to fully inspect the cable and fixings without either hiring equipment to gain access or removing the cable and inspecting at ground level. We recommend that the main cable and fixing security is thoroughly inspected at least in accordance with the manufacturers recommendations to check for damage, security or internal rusting, this will help to ensure the continued safe use of the equipment

**Action:** Inspect in accordance with the manufacturers recommendations

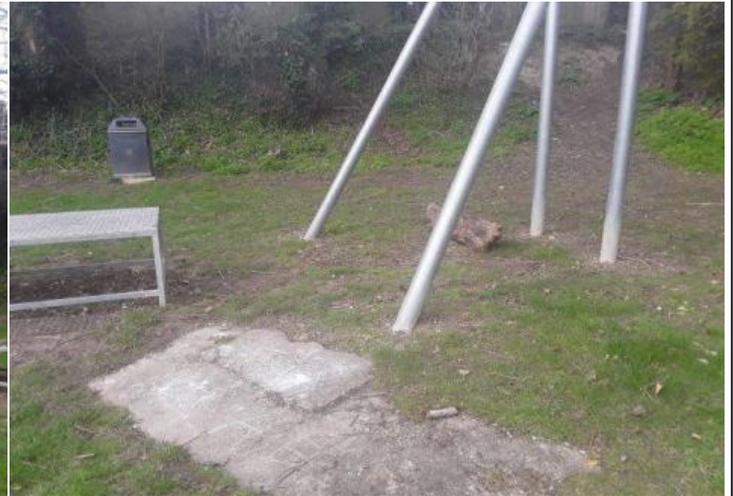
**Item:** Other - Cable Runway  
**Manufacturer:** Wicksteed Playgrounds

**Risk Level:** L - Low Risk  
**Surface:** Grass Matrix Tiles

**Finding:** There is some tree debris on the surfacing

**Action:** Remove and maintain

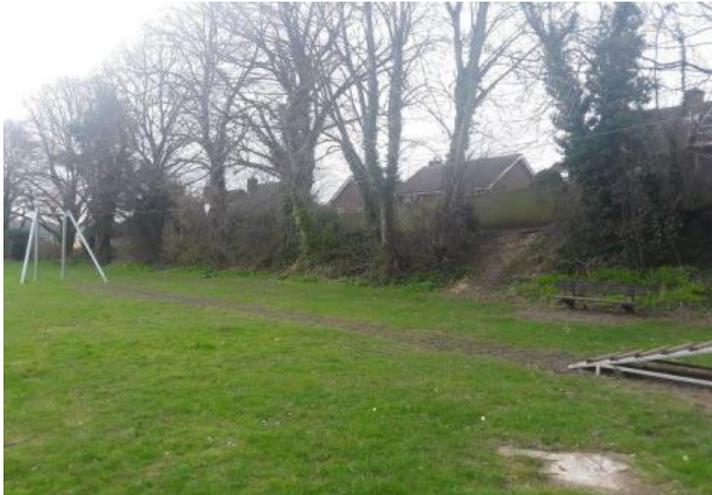
**Item:** Other - Cable Runway  
**Manufacturer:** Wicksteed Playgrounds

**Risk Level:** L - Low Risk  
**Surface:** Grass Matrix Tiles

**Finding:** There is some notable evidence of chain wear

**Action:** Monitor for any further deterioration and replace when 40% worn

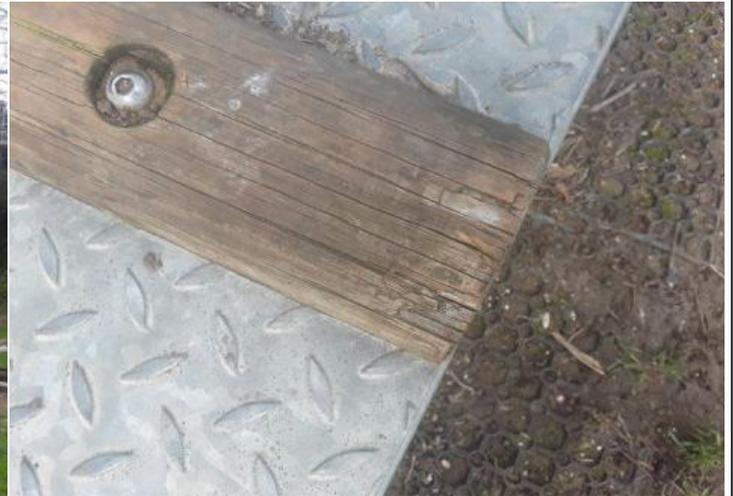
**Item:** Other - Cable Runway  
**Manufacturer:** Wicksteed Playgrounds

**Risk Level:** L - Low Risk  
**Surface:** Grass Matrix Tiles

**Finding:** Parts of the timber are rough or splintered

**Action:** Remove all rough or sharp edges
