## Annual Inspection

Winchester City Council

Arlebury Park, Skate Park & Tennis(New Alresford)

The Avenue, Alresford, SO24 9EP

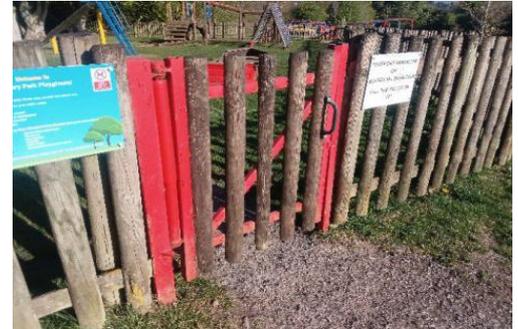
**Item:** Gate - Self Closing  
**Manufacturer:** Not Identified  
**Surface Type:** Mixed Surface  
**Item Quantity:** 3  
**Equipment Compliance:** N/A  
**Surface Area Compliance:** N/A

There is / are post or end caps missing / damaged on the item - Replace missing / damaged post or end caps

The rubber buffer is missing from the latch plate - Replace rubber buffer

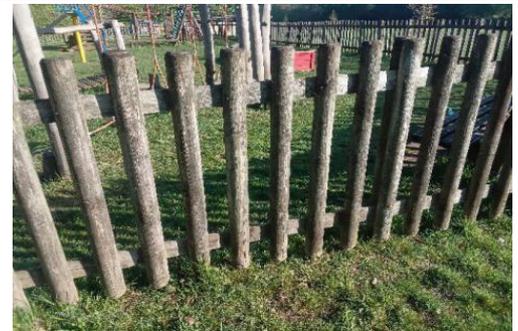
**Item:** Fencing - Timber  
**Manufacturer:** Not Identified  
**Surface Type:** Grass  
**Item Quantity:** 1  
**Equipment Compliance:** N/A  
**Surface Area Compliance:** N/A

There are a number of loose posts around the fence - Monitor for any further deterioration and reset as required

There are areas or parts of the timber on the structure that have rotted - Replace all affected timbers

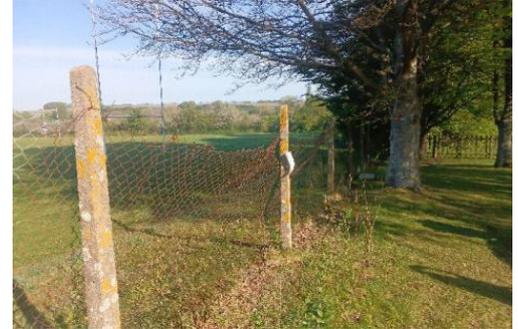
**Item:** Fence - Chainlink  
**Manufacturer:** Not Identified  
**Surface Type:** Grass  
**Item Quantity:** 1  
**Equipment Compliance:** N/A  
**Surface Area Compliance:** N/A

The fence is severely damaged in places - Repair or replace all affected sections

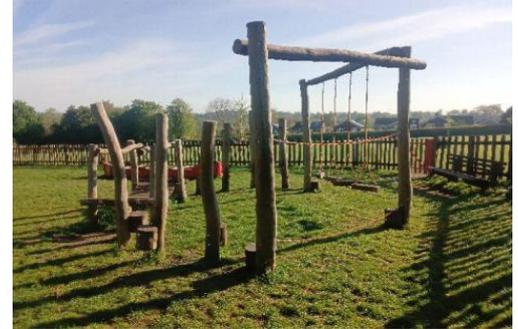
**Item:** Activity Trail  
**Manufacturer:** Dylan Group Ltd  
**Surface Type:** Mixed Surface  
**Item Quantity:** 1  
**Equipment Compliance:** Yes  
**Surface Area Compliance:** Yes

There is/are bolt cap covers missing or damaged on the item - Replace missing or damaged bolt cap covers

The surface has eroded in some areas and may be slippery in wet conditions - Reinstate the surface

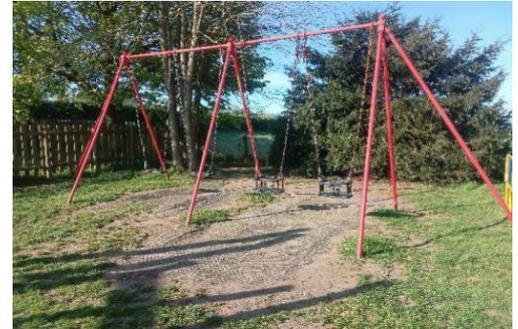
**Item:** 2 Bay (2 Flat, 2 Cradle)  
**Manufacturer:** Wicksteed Playgrounds  
**Surface Type:** Mixed Surface  
**Item Quantity:** 1  
**Equipment Compliance:** No  
**Surface Area Compliance:** No

The surface has subsided in some areas - Monitor for any further deterioration and repair as required

BS EN 1176 requires an additional 0.5m of unobstructed space at each end of the swing surfacing area. This is a relatively low risk finding and no remedial action is recommended at this point. - Monitor - No action given the risk assessment

The chain openings are in excess of the 8.6mm as recommended by BS EN 1176 - Monitor - No action given the risk assessment

The seats are too close to each other as defined in BS EN 1176 Part 2; this is a low risk failure and no remedial action is required - Monitor - No action given the risk assessment

<b>Finding 13</b> There is some notable evidence of chain wear - Monitor for any further deterioration and replace when 40% worn	<b>Finding 14</b> There is some wear to the connecting links - Monitor for any further deterioration and replace when 40% worn
<b>Finding 15</b> There is some wear to the chain bars - Monitor for any further deterioration and replace when 40% worn	<b>Finding 16</b> The bush / bushes is / are worn or missing - Replace worn or missing bushes
<b>Finding 17</b> There is some wear to the shackles. - Monitor for any further deterioration and replace when 40% worn	<b>Finding 18</b> There are excessive chain tails - Cut back excessive chain links
<b>Finding 19</b> There are excessive chain tails provided, however a minimum of 2 additional links should always be provided with crucifix connectors - Cut back excess chain tails but ensure a minimum of 2 additional links remain through the crucifix	<b>Finding 20</b> Cable ties are present and there are sharp projecting ends - Remove

<b>Finding 21</b> The fixings or components for this item were in excess of 2.5m above the standing surface and could not be fully accessed by the inspector. We have completed a visual inspection of the fixings from ground level but a maintenance inspection should be undertaken to assess the condition, security and wear of the components at intervals in accordance with the manufacturers recommendations. - Inspect in accordance with the manufacturers recommendations

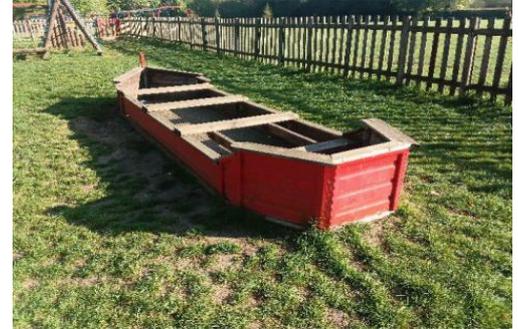
**Item:** Boat  
**Manufacturer:** Not Identified  
**Surface Type:** Grass  
**Item Quantity:** 1  
**Equipment Compliance:** Yes  
**Surface Area Compliance:** Yes

The surface has eroded in some areas and may be slippery in wet conditions - Reinstate the surface

There is some evidence of fire damage to the item - Monitor for any further deterioration and repair as required

There are areas or parts of the timber on the structure that have rotted - Replace all affected timbers

There is some evidence of rot in the timber - Monitor for any further deterioration and replace as required

The decking is damaged exposing ground fixings - Repair affected areas

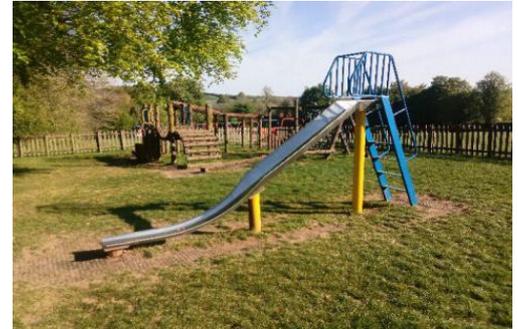
**Item:** Free Standing Slide  
**Manufacturer:** Wicksteed Playgrounds  
**Surface Type:** Grass Matrix Tiles  
**Item Quantity:** 1  
**Equipment Compliance:** No  
**Surface Area Compliance:** Yes

The grass mats are silted up and the soil is compacted; this may have an effect on the impact absorbing properties of the surface. Consideration should be given to HIC testing the surface to verify impact attenuating properties ( <https://playinspections.co.uk/inspection-services/safety-surface-testing/> ) - Contact our office for a quotation for this service

There is / are toggle entrapment/s present in contravention of the recommendations set out in BS EN 1176 Part 1 - Monitor - No action given the risk assessment

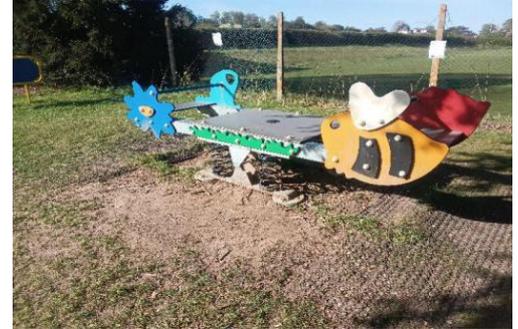
**Item:** Spring See-Saw  
**Manufacturer:** Kompan Ltd  
**Surface Type:** Mixed Surface  
**Item Quantity:** 1  
**Equipment Compliance:** Yes  
**Surface Area Compliance:** Yes

The grass has eroded within the impact area of the equipment and may not provide the necessary impact attenuating properties for the equipment fall height; the surface may also be slippery in wet weather - Reinstate the grass or provide an all weather surface

There is/are bolt cap covers missing or damaged on the item - Replace missing or damaged bolt cap covers

The spring mounting plate is slightly loose in the ground - Monitor for any further deterioration and repair as required

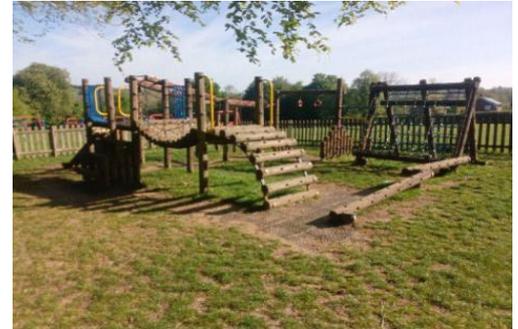
**Item:** Multi Play (Junior)  
**Manufacturer:** Not Identified  
**Surface Type:** Grass Matrix Tiles  
**Item Quantity:** 1  
**Equipment Compliance:** No  
**Surface Area Compliance:** Yes

There are falls in excess of 600mm between adjacent components on the structure, in contravention of the recommendations set out in BS EN 1176 Part 1; 4.2.8.4 - Monitor - No action given the risk assessment

The item fails to meet the requirements of BS EN 1176 Part 1 4.2.7.2 for head and neck entrapment between the log climber - Consider removing entrapments

There is/are finger entrapment/s above the net climber and the item fails to meet the requirements of BS EN 1176 Part 1 4.2.7.6 Entrapment of fingers - Monitor - No action given the risk assessment

The connecting links are in excess of 8.6mm and less than 12mm and fail the requirements of BS EN 1176 Part 1; clause 4.2.13, Chains - Monitor - No action given the risk assessment

The item fails to meet the requirements of BS EN 1176 Part 1 4.2.7.2 head and neck entrapment in the barriers and/or steps - Monitor - No action given the risk assessment

The surface has subsided in some areas - Monitor for any further deterioration and repair as required

The rope has worn and wire strands are exposed - Replace rope or net

There is some wear to the shackles. - Monitor for any further deterioration and replace when 40% worn

The chain links are worn excessively (50%) and require renewing - Replace worn chains

There is some notable evidence of chain wear - Monitor for any further deterioration and replace when 40% worn

<b>Finding 15</b>	<b>Finding 16</b>
The paintwork on this item has been damaged or worn exposing the metal underneath which is rusting / corroding - Treat affected areas and repaint	There is some evidence of rot in the timber - Monitor for any further deterioration and replace as required
<b>Finding 17</b>	<b>Finding 18</b>
The connecting lugs are showing signs of wear - Monitor for any further deterioration and repair as required	The timber has a number of splits/shakes or air cracks and this may affect the stability or allow water ingress which will accelerate the rotting process - Monitor to ensure the splits do not cross through fixing points of the structure and/or cause any instability
<b>Finding 19</b>	<b>Finding 20</b>
Parts of the timber are rough or splintered - Remove all rough or sharp edges	The fixing plates are not flush with the posts - Rectify installation

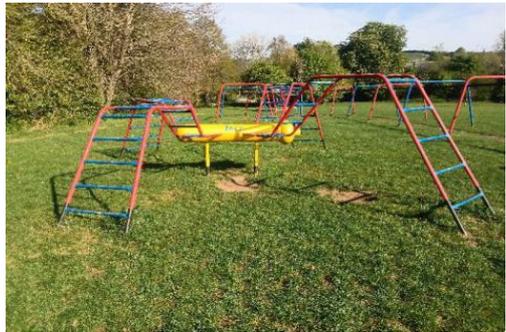
10 - Low Risk	
<p><b>Item:</b> Climbing Frame  <b>Manufacturer:</b> Not Identified  <b>Surface Type:</b> Grass  <b>Item Quantity:</b> 1  <b>Equipment Compliance:</b> No  <b>Surface Area Compliance:</b> Yes</p> <p><b>Total Findings:</b> 4</p>

<b>Finding 1</b>	<b>Finding 2</b>
The surface has subsided in some areas - Monitor for any further deterioration and repair as required	The surface has eroded and the foundations are exposed - Reinstate surrounding surfaces to cover the foundations
<b>Finding 3</b>	<b>Finding 4</b>
The item fails to meet the requirements of BS EN 1176 Part 1 4.2.7.2 for head and neck entrapment in the framework - Monitor - No action given the risk assessment	The paint is flaking off the metalwork - Rub down and re-paint

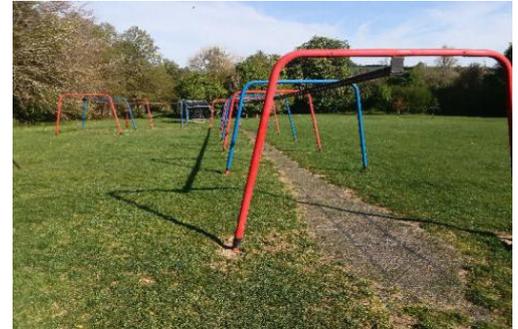
**Item:** Overhead Glider  
**Manufacturer:** Not Identified  
**Surface Type:** Grass Matrix Tiles  
**Item Quantity:** 1  
**Equipment Compliance:** No  
**Surface Area Compliance:** Yes

The surface has eroded and the foundations are exposed - Reinstate surrounding surfaces to cover the foundations

The paintwork on this item has been damaged or worn exposing the metal underneath which is rusting / corroding - Treat affected areas and repaint

The connecting links are worn excessively (70%) and require renewing - Replace

There is some wear to the chain bars - Monitor for any further deterioration and replace when 40% worn

There is/are finger entrapment/s in the traveller and the item fails to meet the requirements of BS EN 1176 Part 1 4.2.7.6 Entrapment of fingers - Monitor - No action given the risk assessment

There is some notable evidence of chain wear - Monitor for any further deterioration and replace when 40% worn

There is or are fixings missing on the item - Replace all missing fixings

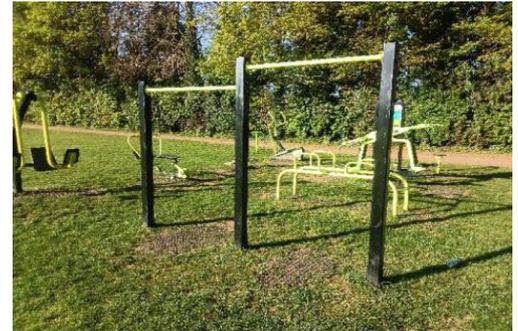
**Item:** Pull Up Station  
**Manufacturer:** Hags  
**Surface Type:** Grass Matrix Tiles  
**Item Quantity:** 1  
**Equipment Compliance:** Yes  
**Surface Area Compliance:** Yes

There is no instruction label provided; an instruction label should be provided with each item of equipment in accordance with the requirements of BS EN 16630 - Provide appropriate instruction label/s

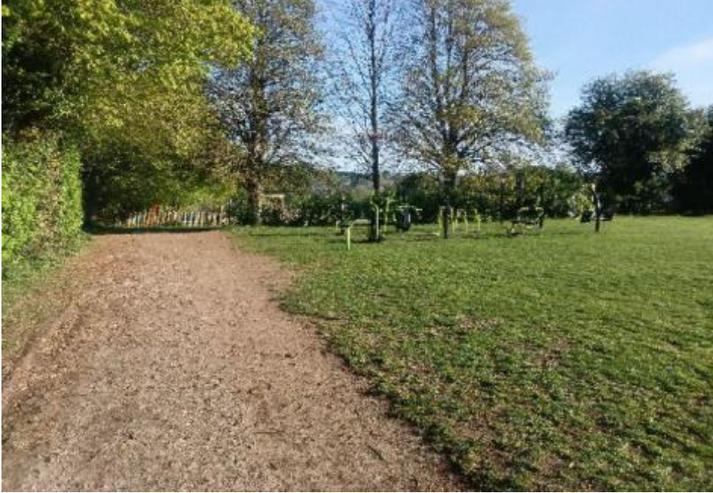
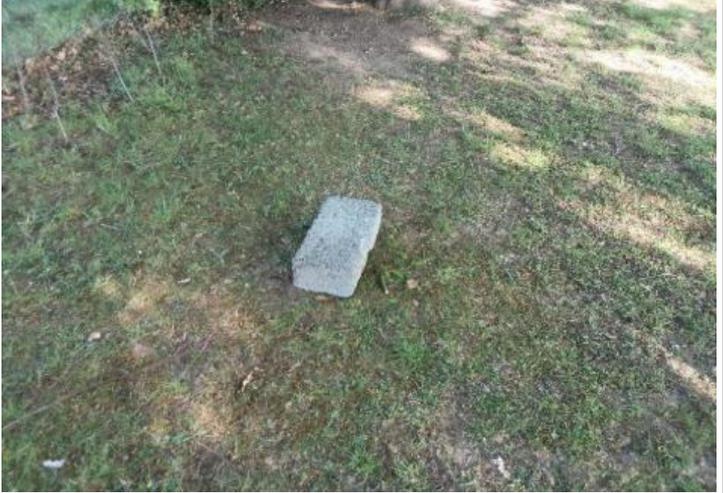
<span style="font-size: 1.2em; font-weight: bold;">i</span> 8 - Low Risk (Finding 1)			
<b>Item:</b>	Ancillary Items - Site General	<b>Risk Level:</b>	L - Low Risk
<b>Manufacturer:</b>	Owner/Operator	<b>Surface:</b>	N/A

<b>Finding:</b> There is a discarded breeze block within the play area		<b>Action:</b> Remove from site

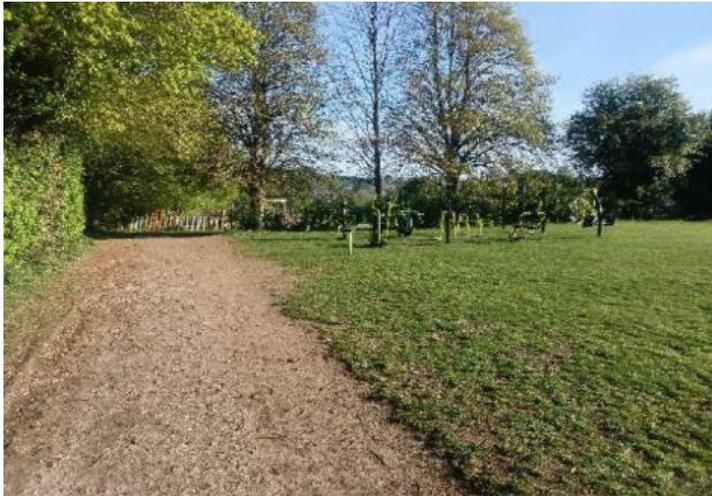
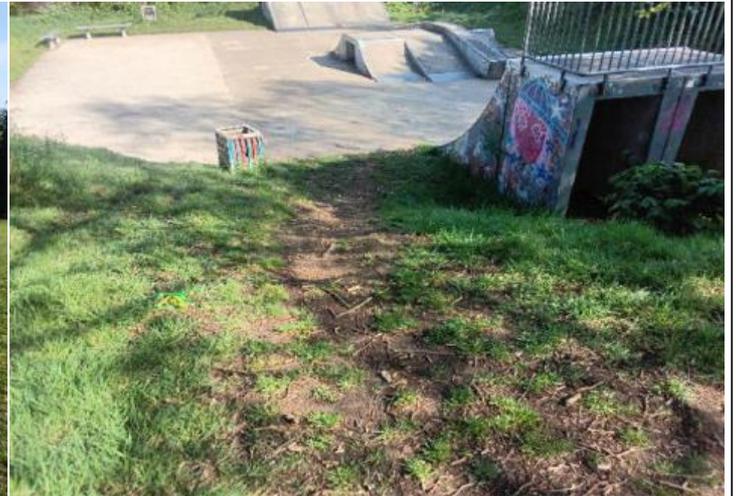
**i** 9 - Low Risk (Finding 2)

**Finding:** The pathway to the skatepark has eroded and is slippery, making egress via this path extremely difficult

**Action:** Reinststate eroded area

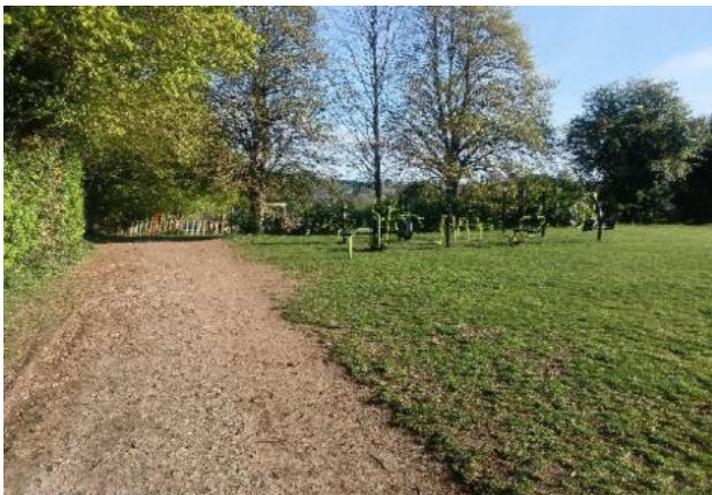
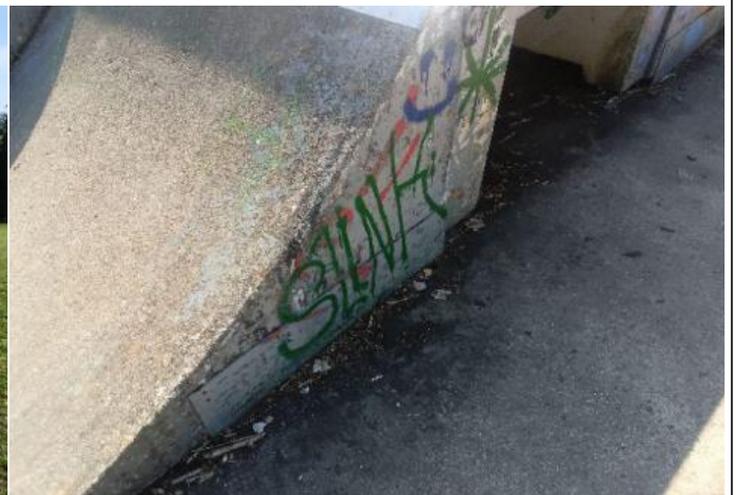
**Item:** Ancillary Items - Site General  
**Manufacturer:** Owner/Operator

**Finding:** There is some graffiti present on the skate ramps

**Action:** Remove the graffiti if deemed appropriate

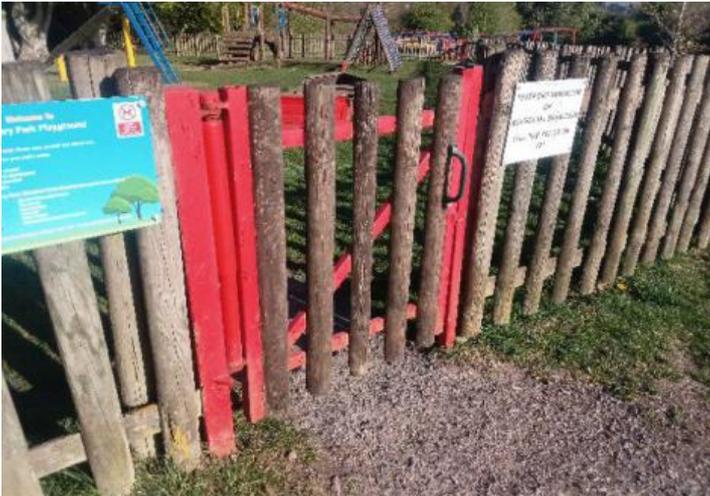
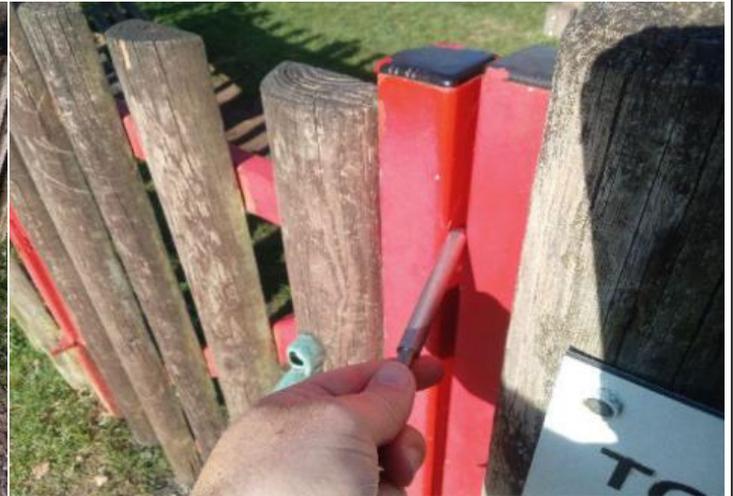
**Item:** Gates - Gate - Self Closing  
**Manufacturer:** Not Identified

**Finding:** There are openings that are less than 12mm that could trap or crush fingers

**Action:** Provide a 12mm gap throughout full range of motion at both sides of gate

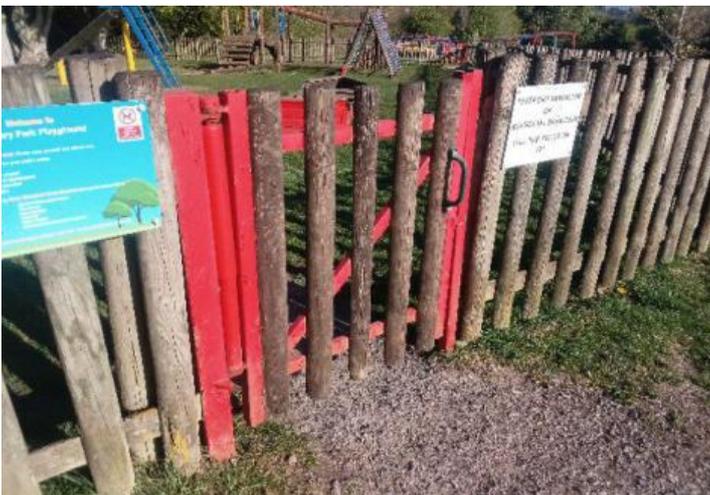
**Item:** Gates - Gate - Self Closing  
**Manufacturer:** Not Identified

**Finding:** There is / are post or end caps missing / damaged on the item

**Action:** Replace missing / damaged post or end caps

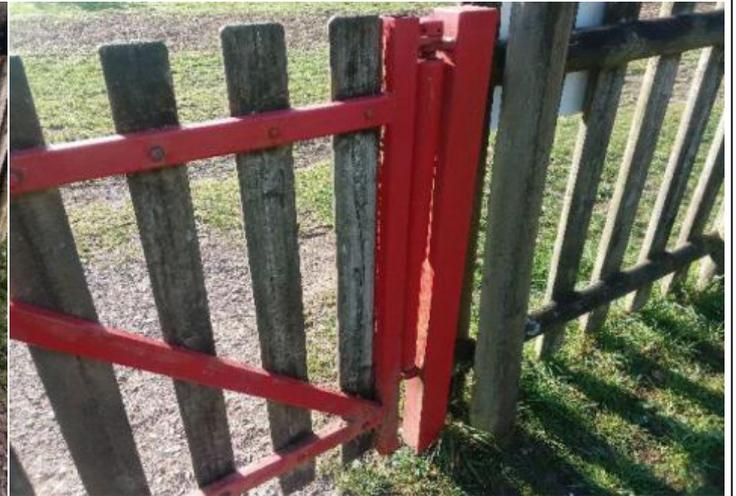
**Finding:** The gate is closing too quickly (less than 4 seconds)

**Action:** Take corrective action to ensure that the gate closes in 4-8 seconds from 90 degrees

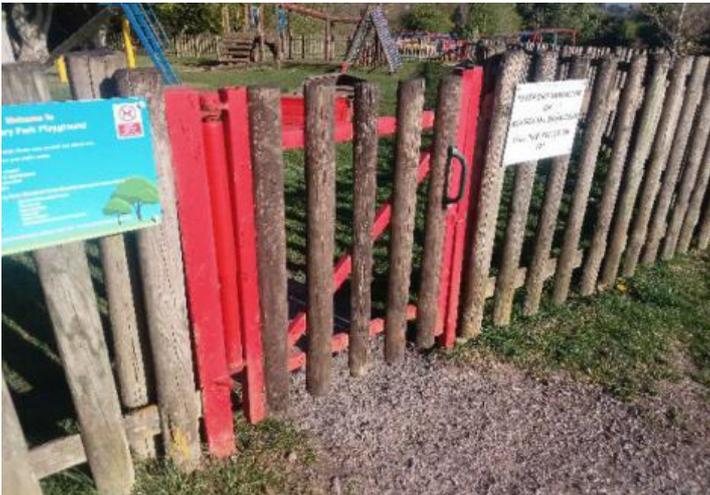
**Finding:** The rubber buffer is missing from the latch plate

**Action:** Replace rubber buffer

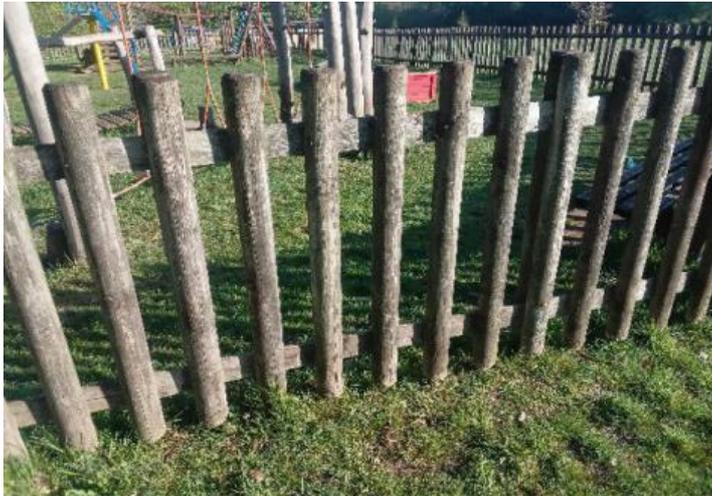
**Finding:** There are a number of loose posts around the fence

**Action:** Monitor for any further deterioration and reset as required

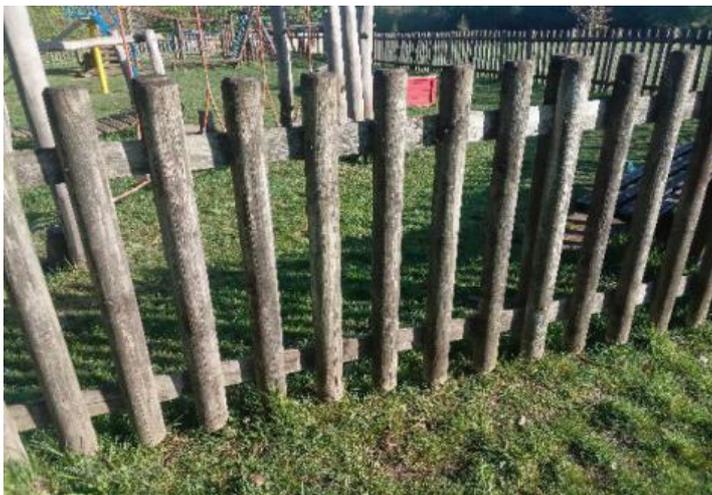
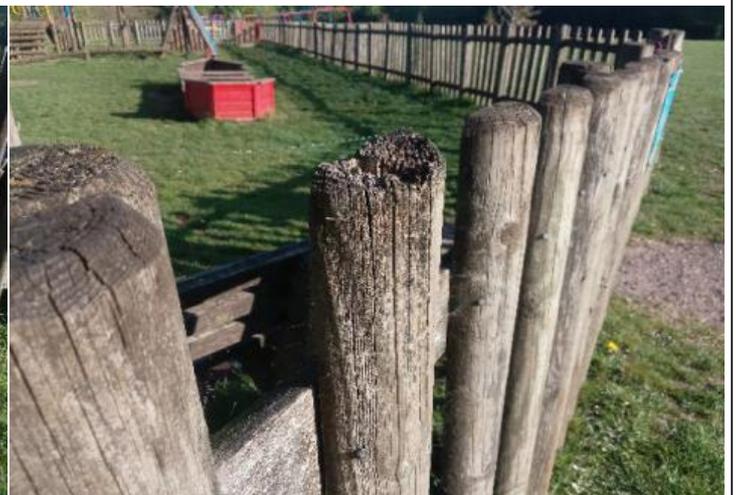
**Finding:** Parts of the timber are rough or splintered

**Action:** Remove all rough or sharp edges

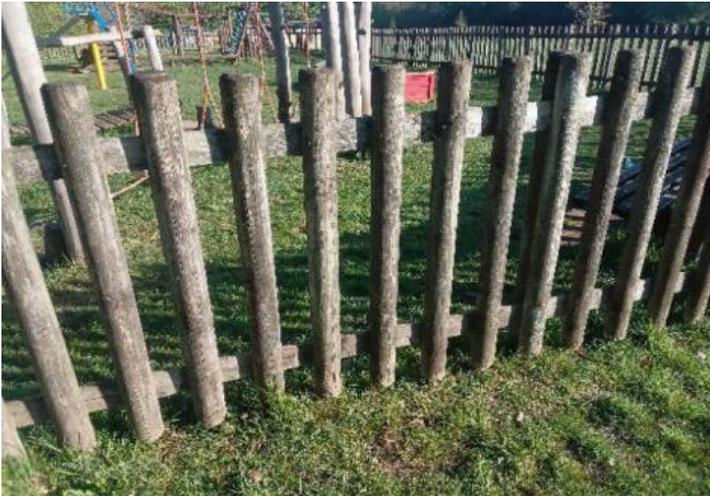
**Finding:** There are areas or parts of the timber on the structure that have rotted

**Action:** Replace all affected timbers

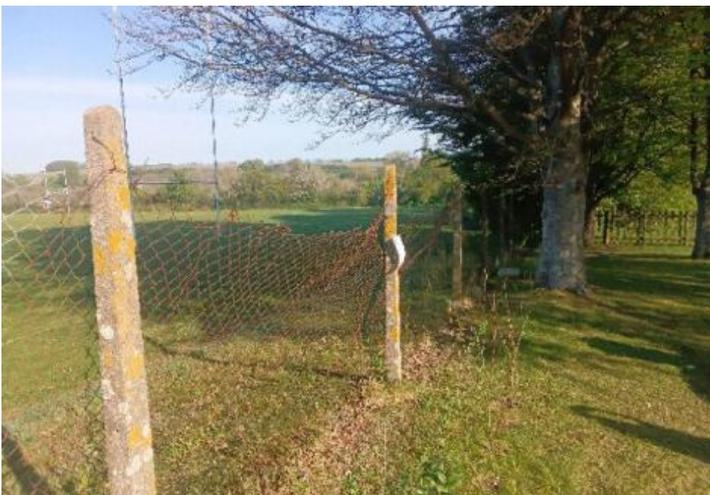
**Finding:** The fence is severely damaged in places

**Action:** Repair or replace all affected sections

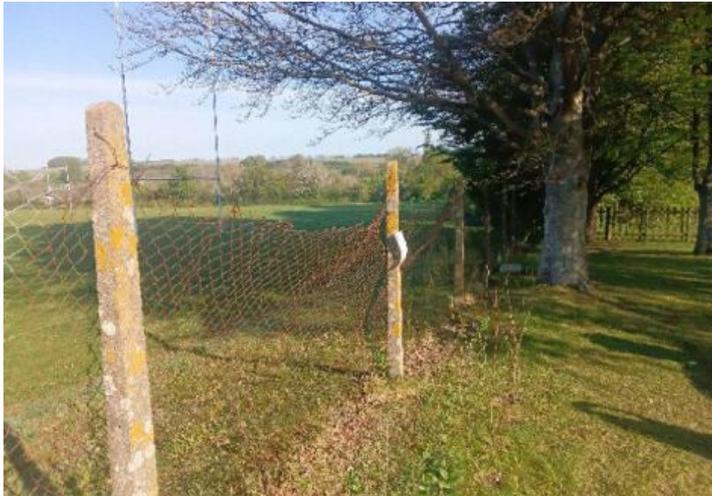
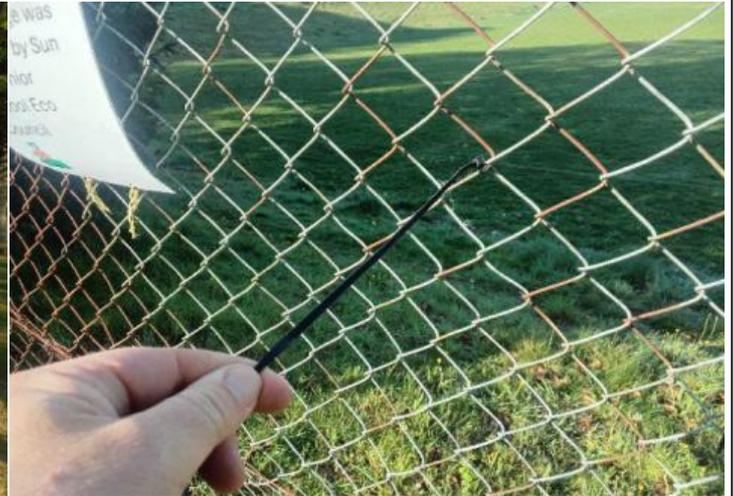
**Finding:** There are redundant cable ties attached to the fencing

**Action:** Remove

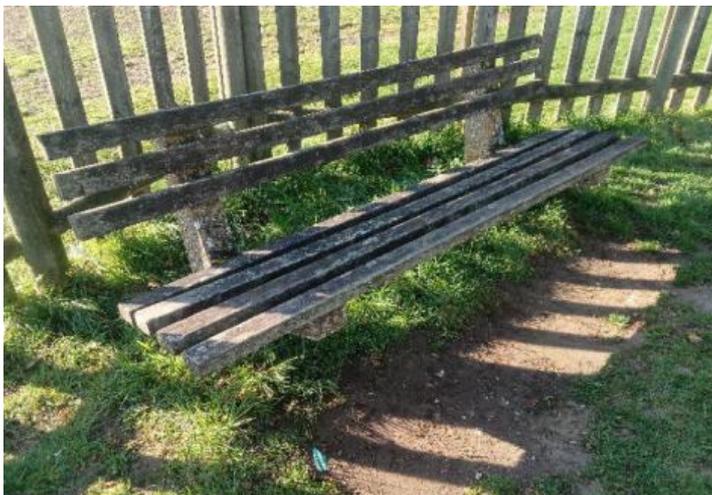
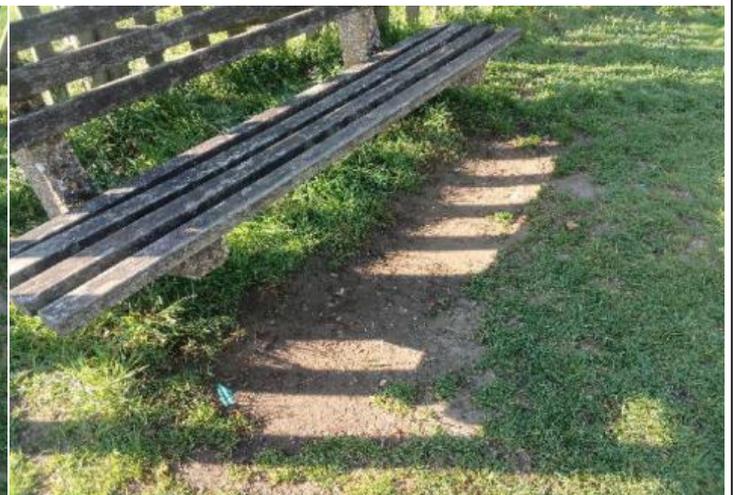
**Finding:** The area around the item has eroded and may become slippery

**Action:** Reinstate eroded area

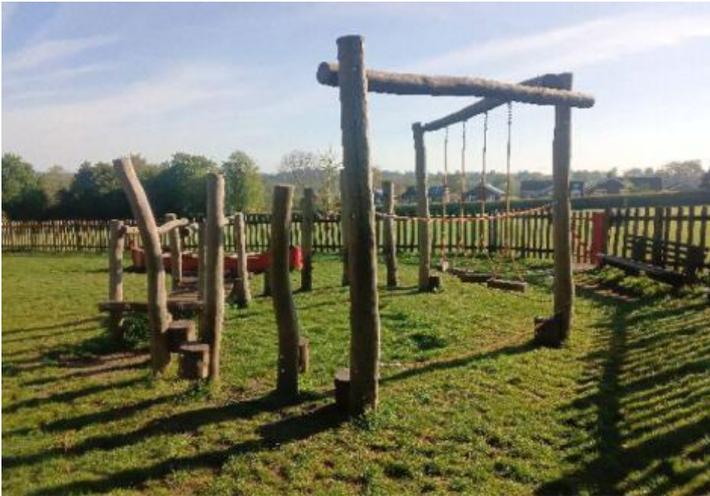
**Finding:** There is/are bolt cap covers missing or damaged on the item

**Action:** Replace missing or damaged bolt cap covers

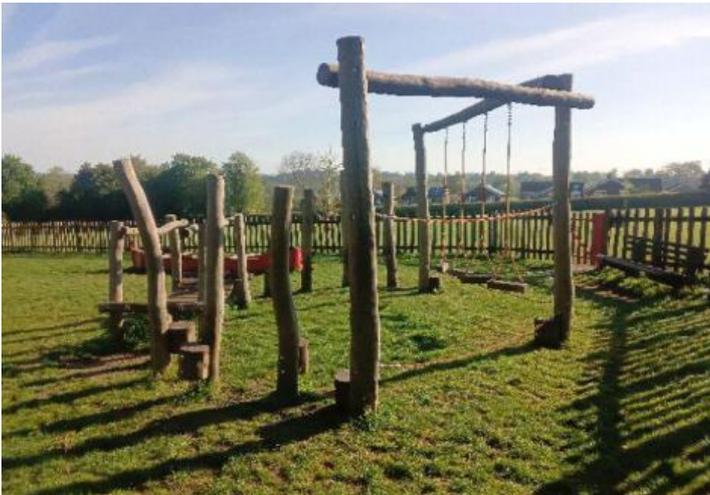
**Finding:** The surface has eroded in some areas and may be slippery in wet conditions

**Action:** Reinstate the surface

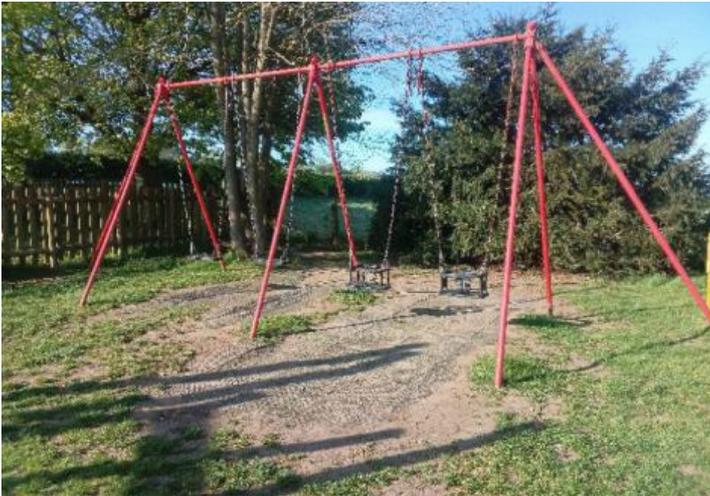
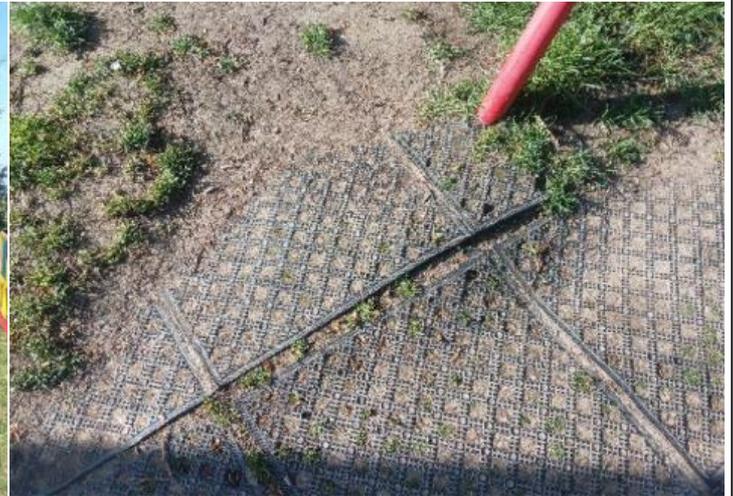
**Finding:** There are gaps opening between the grass mat tiles

**Action:** Provide additional ties or secure / reinstate surface

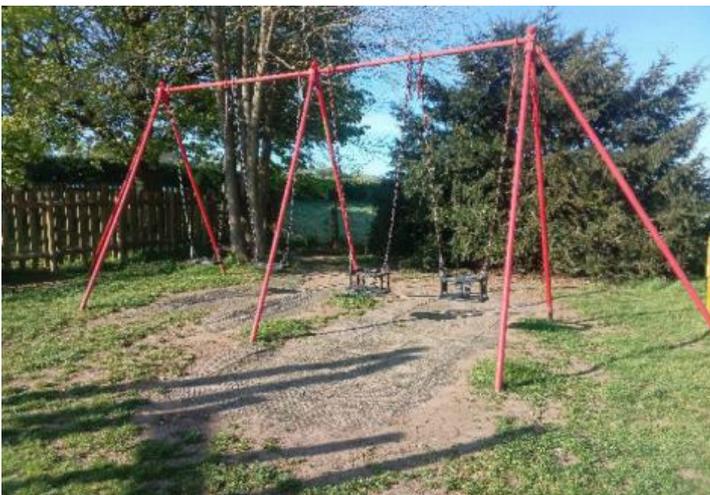
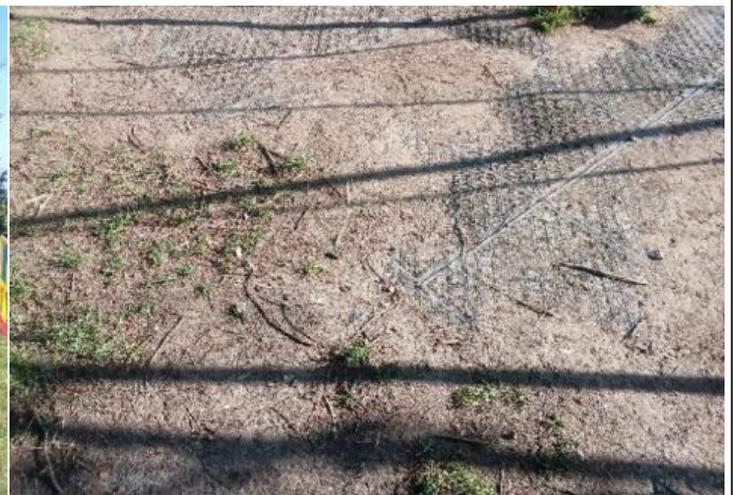
**Finding:** The grass mats are silted up and the soil is compacted; this may have an effect on the impact absorbing properties of the surface. Consideration should be given to HIC testing the surface to verify impact attenuating properties ( <https://playinspections.co.uk/inspection-services/safety-surface-testing/> )

**Action:** Contact our office for a quotation for this service

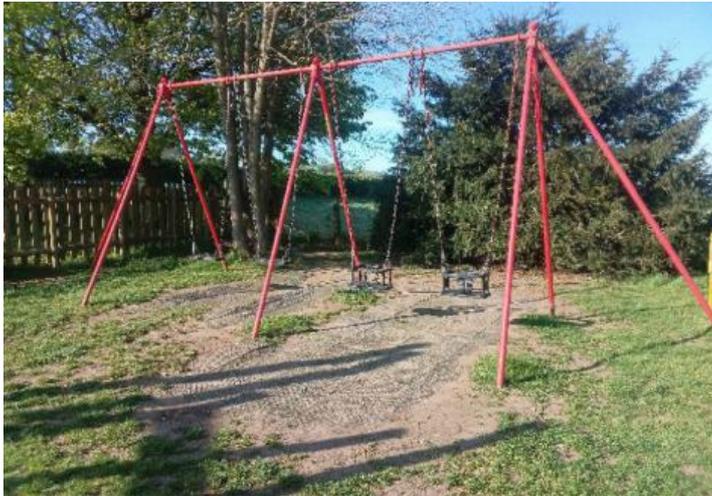
**Finding:** The surface has subsided in some areas

**Action:** Monitor for any further deterioration and repair as required

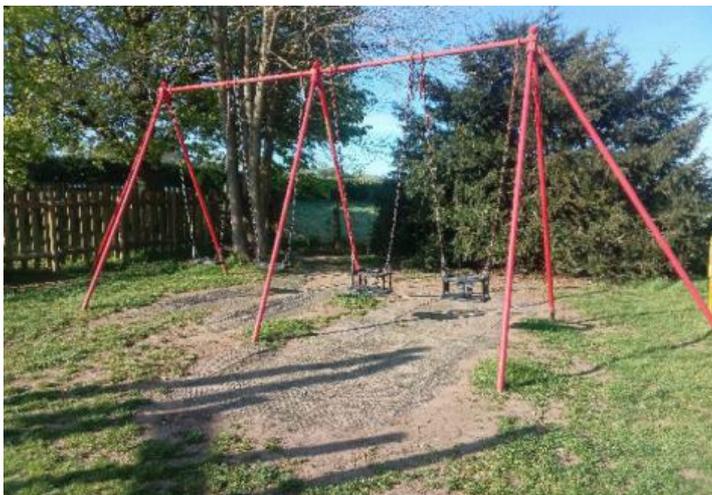
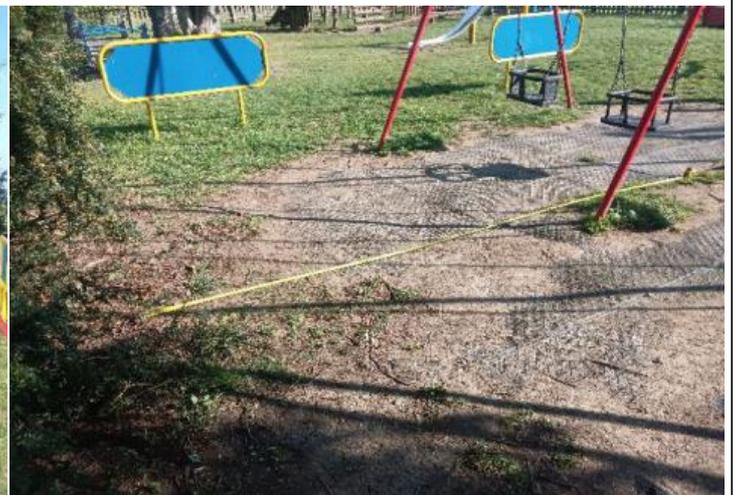
**Finding:** The surfacing dimensions are short and do not meet with the requirements of the current applicable standard

**Action:** Monitor - No action given the risk assessment

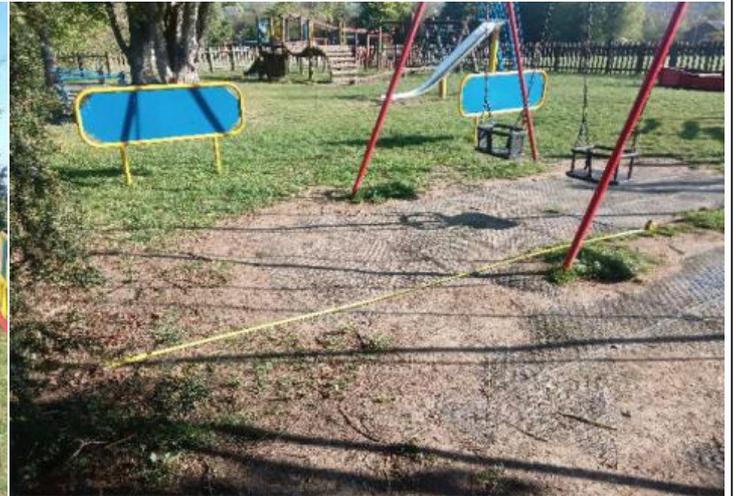
**Finding:** The adjacent foliage is encroaching into the falling space of the equipment  
**Action:** Cut back and maintain

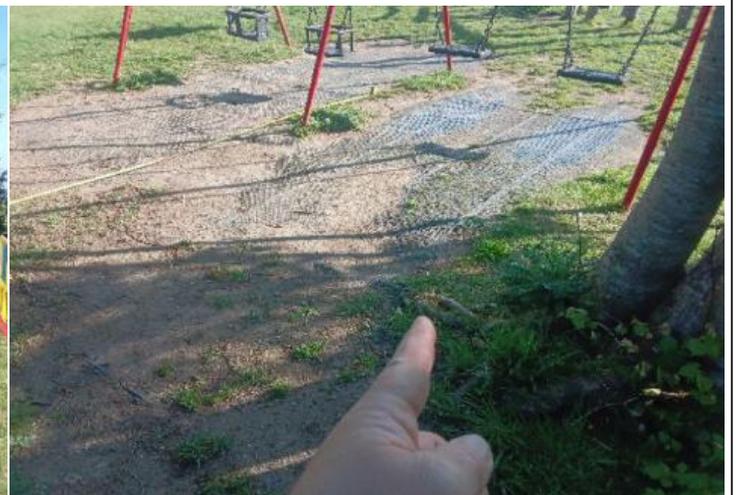
**Finding:** The tree root forms a hard object within the impact area of the equipment in contravention of the requirements of BS EN 1176 Part 1  
**Action:** Monitor - No action given the risk assessment

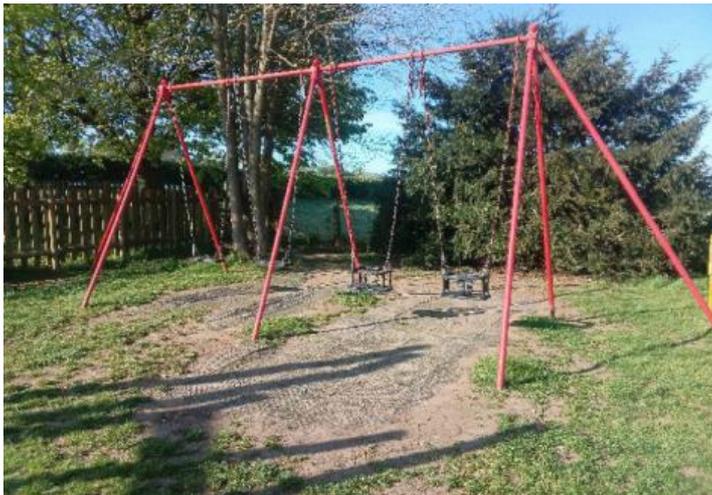
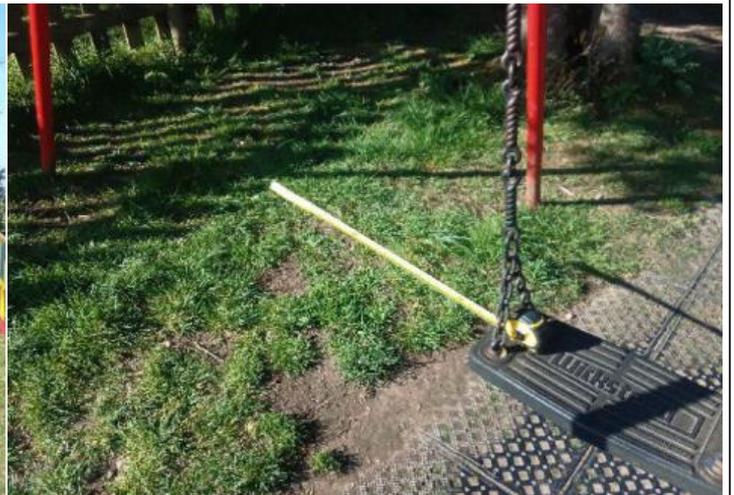
**Finding:** The seat/s is / are too close to the frame as defined in BS EN 1176 Part 2

**Action:** Monitor - No action given the risk assessment

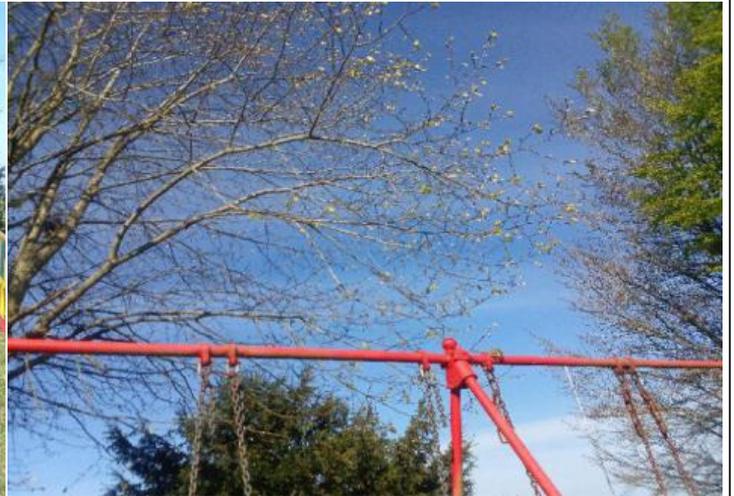
**Finding:** The tree canopy overhangs the equipment and is less than 2.0m away

**Action:** Lift tree canopy to ensure a minimum clearance of 2.0m from the equipment

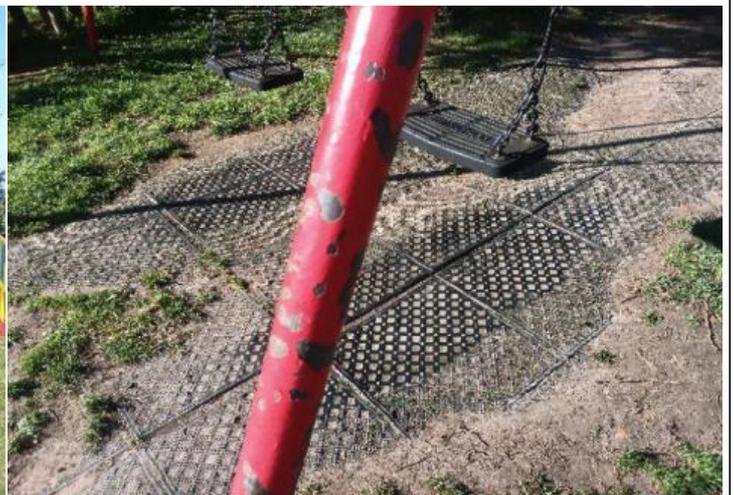
**Finding:** The paint is flaking off the metalwork

**Action:** Rub down and re-paint

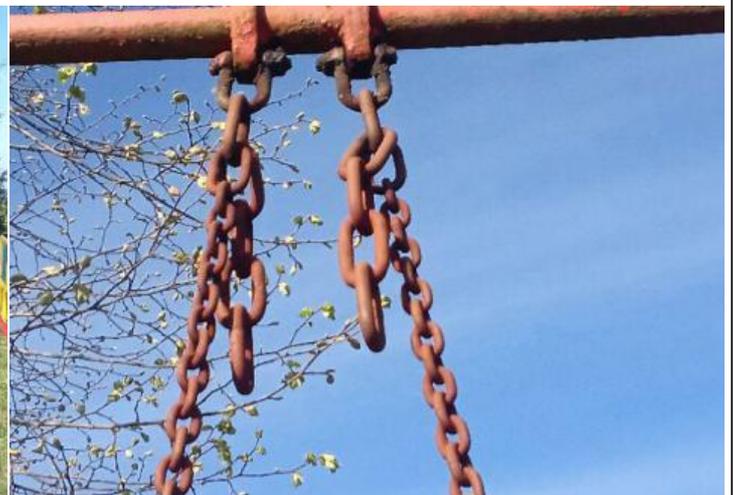
**Finding:** There are excessive chain tails

**Action:** Cut back excessive chain links

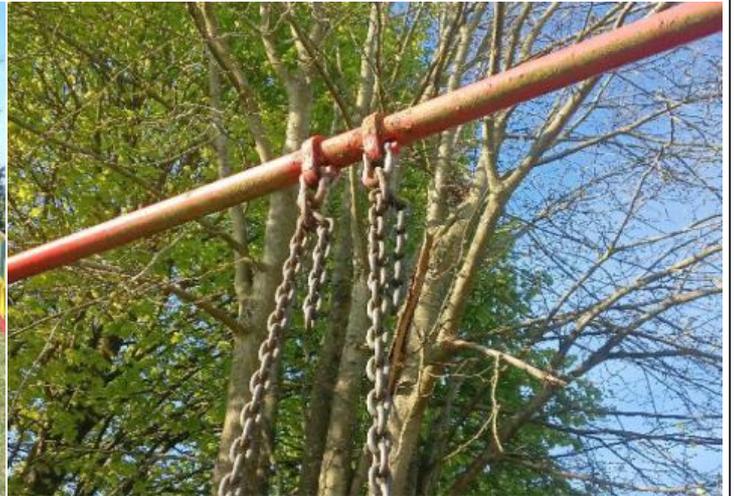
**Finding:** There are excessive chain tails provided, however a minimum of 2 additional links should always be provided with crucifix connectors

**Action:** Cut back excess chain tails but ensure a minimum of 2 additional links remain through the crucifix

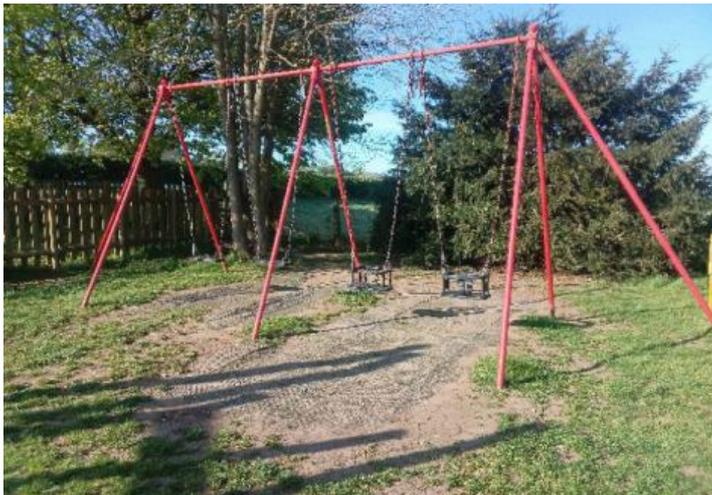
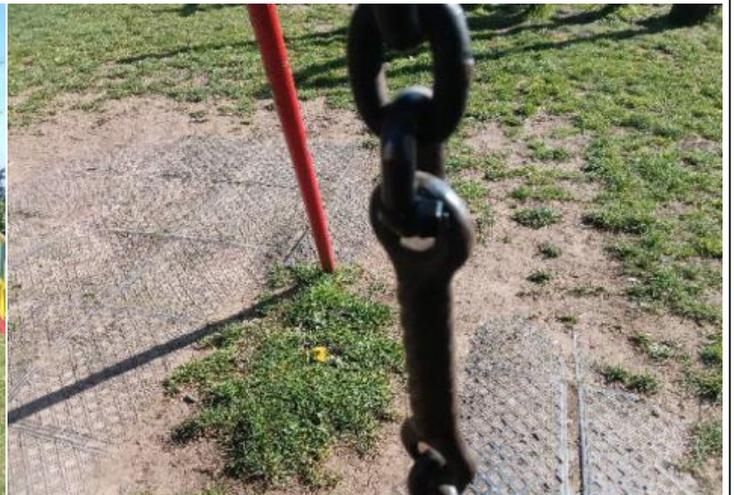
**Finding:** Cable ties are present and there are sharp projecting ends

**Action:** Remove

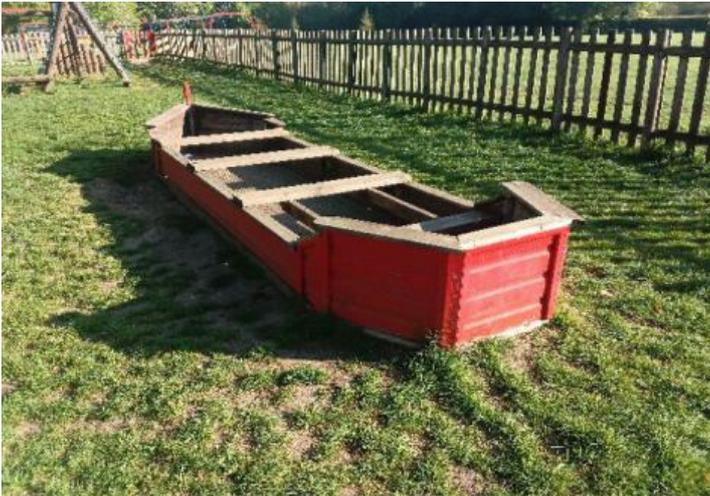
**Finding:** The surface has eroded in some areas and may be slippery in wet conditions  
**Action:** Reinststate the surface

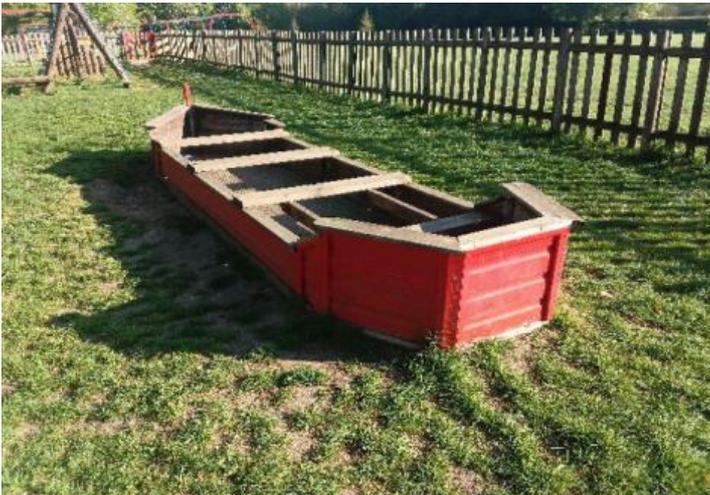
**Finding:** There is some evidence of fire damage to the item  
**Action:** Monitor for any further deterioration and repair as required

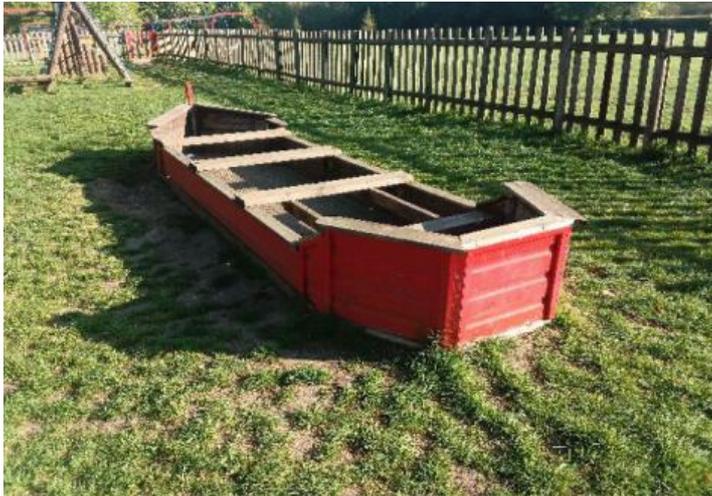
**Finding:** There is some evidence of rot in the timber

**Action:** Monitor for any further deterioration and replace as required

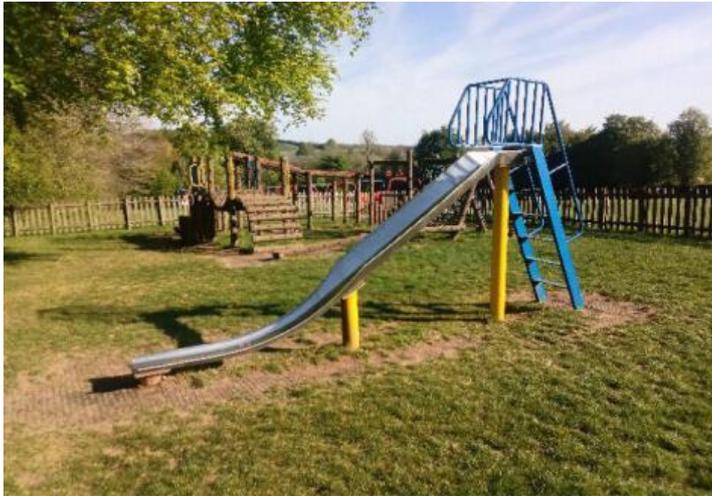
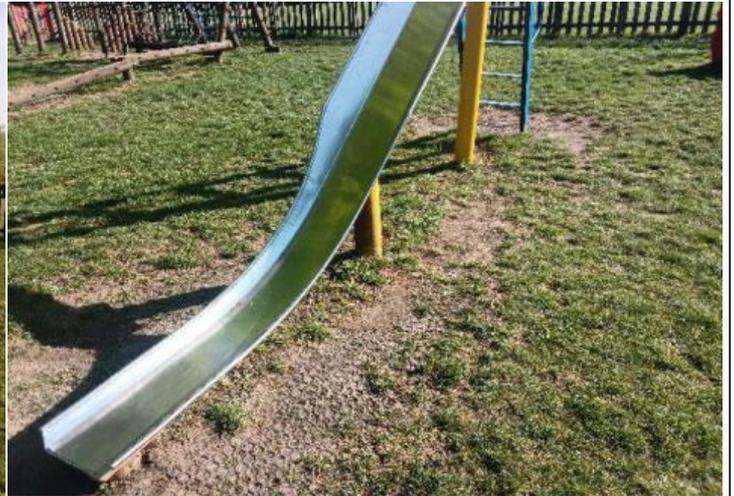
**Finding:** The grass mats are silted up and the soil is compacted; this may have an effect on the impact absorbing properties of the surface. Consideration should be given to HIC testing the surface to verify impact attenuating properties ( <https://playinspections.co.uk/inspection-services/safety-surface-testing/> )

**Action:** Contact our office for a quotation for this service

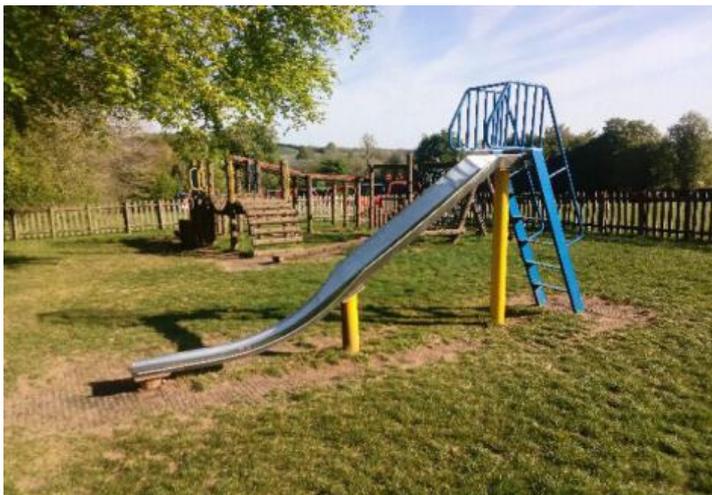
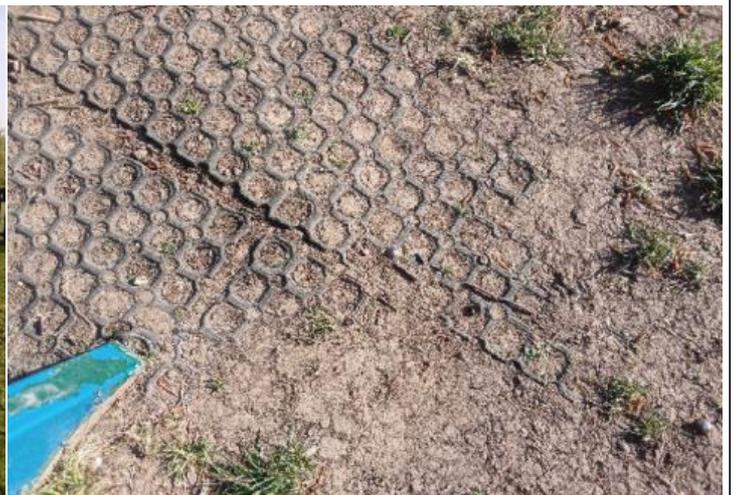
**Finding:** Fixing Pins have been installed in the impact areas of the grass mats

**Action:** Remove pins from impact areas
