## Annual Inspection

Winchester City Council

Arlebury Park, Skate Park & Tennis(New Alresford)

The Avenue, Alresford, SO24 9EP

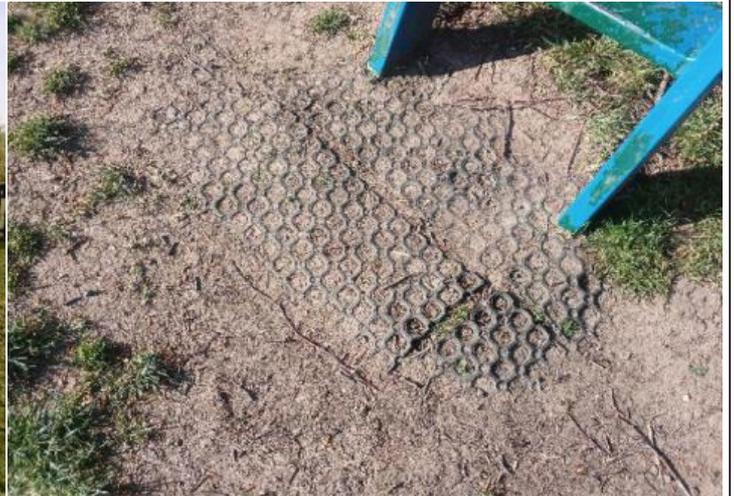
**Finding:** There are gaps opening between the grass mat tiles

**Action:** Provide additional ties or secure / reinstate surface tiles

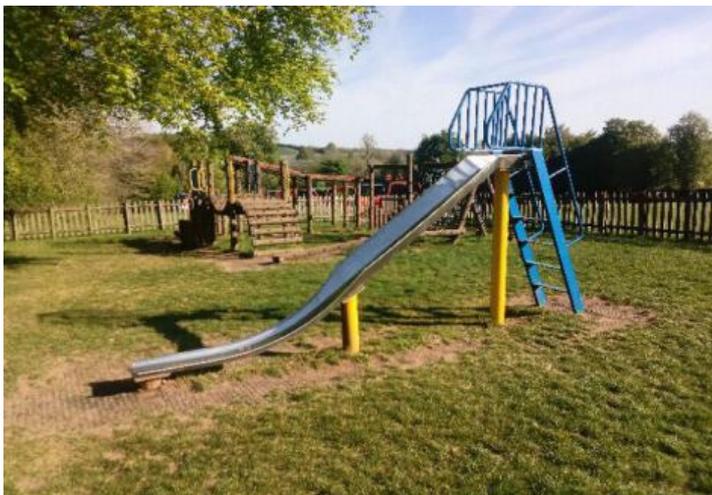
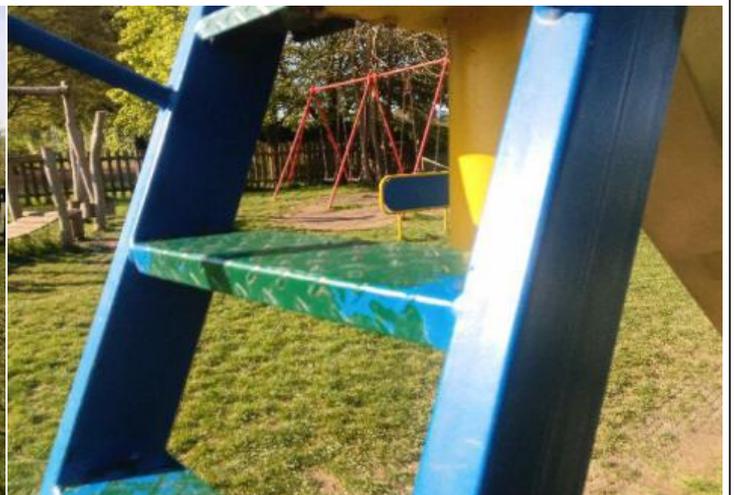
**Finding:** The paint is flaking off the metalwork

**Action:** Rub down and re-paint

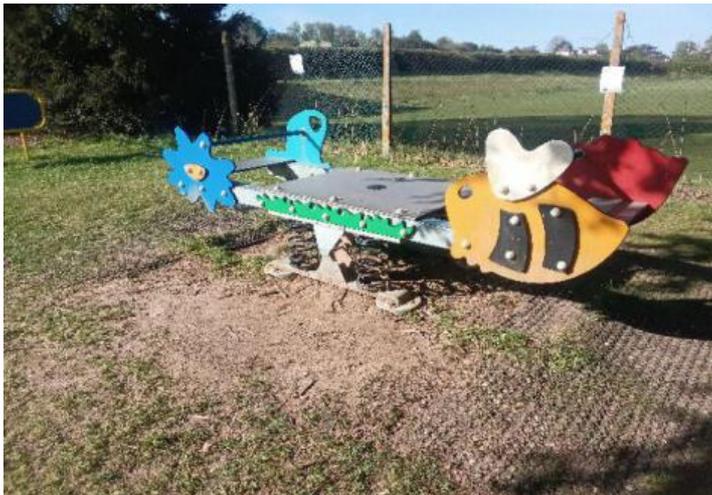
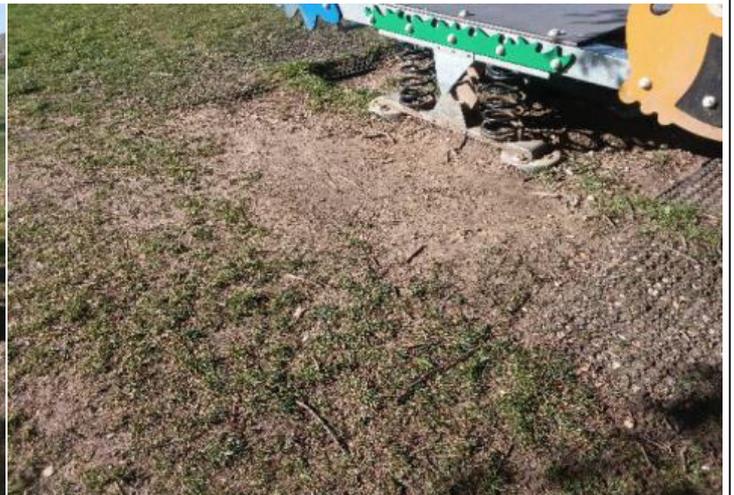
**Finding:** The grass has eroded within the impact area of the equipment and may not provide the necessary impact attenuating properties for the equipment fall height; the surface may also be slippery in wet weather

**Action:** Reinstate the grass or provide an all weather surface

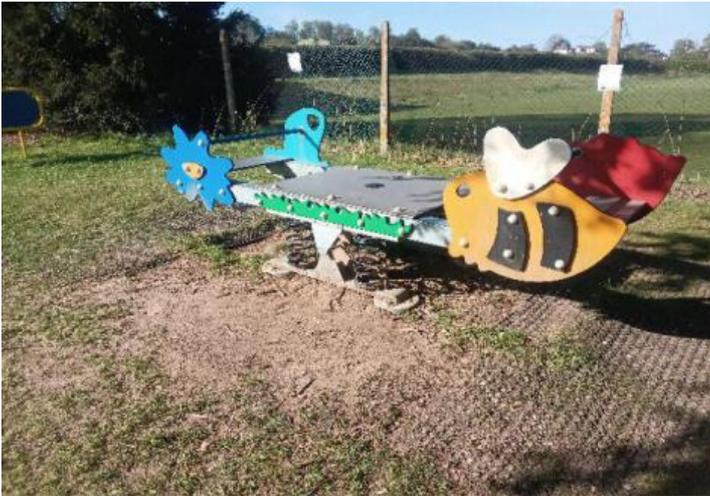
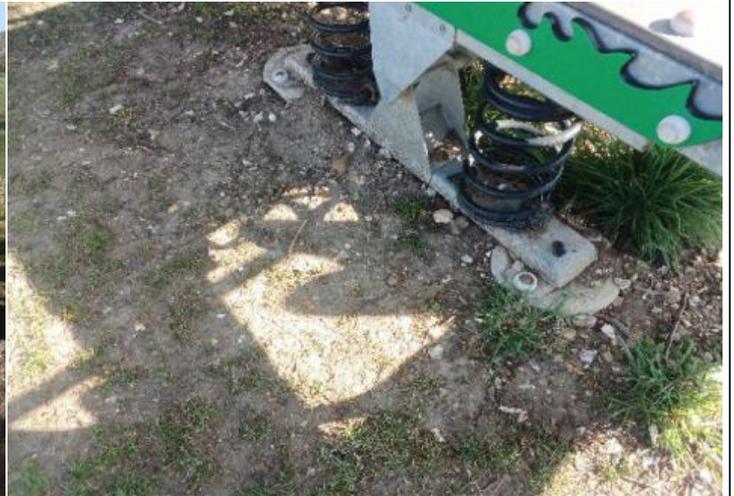
**Finding:** The surfacing has numerous stones present

**Action:** Ensure stones are removed and ground is suitable for use

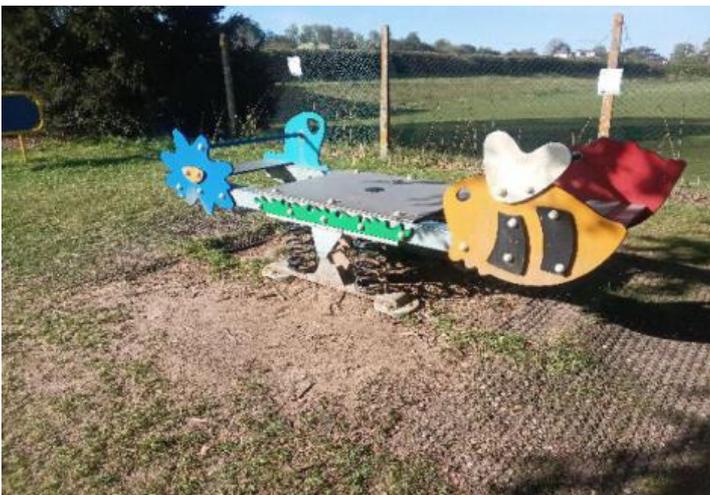
**Finding:** There is/are bolt cap covers missing or damaged on the item

**Action:** Replace missing or damaged bolt cap covers

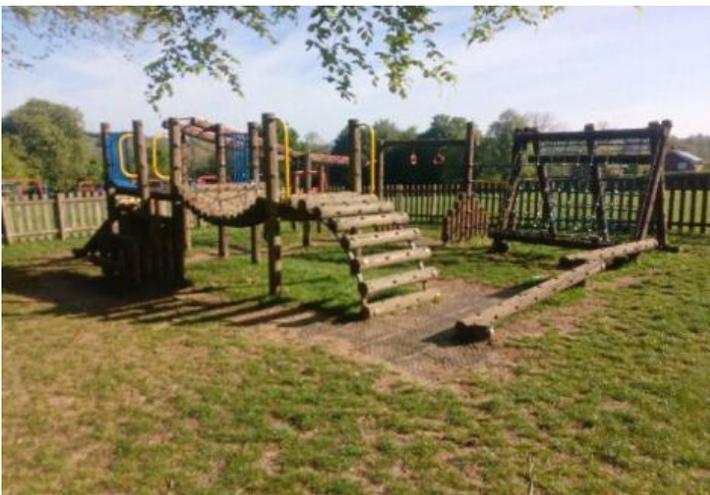
**Finding:** There are falls in excess of 600mm between adjacent components on the structure, in contravention of the recommendations set out in BS EN 1176 Part 1; 4.2.8.4

**Action:** Monitor - No action given the risk assessment

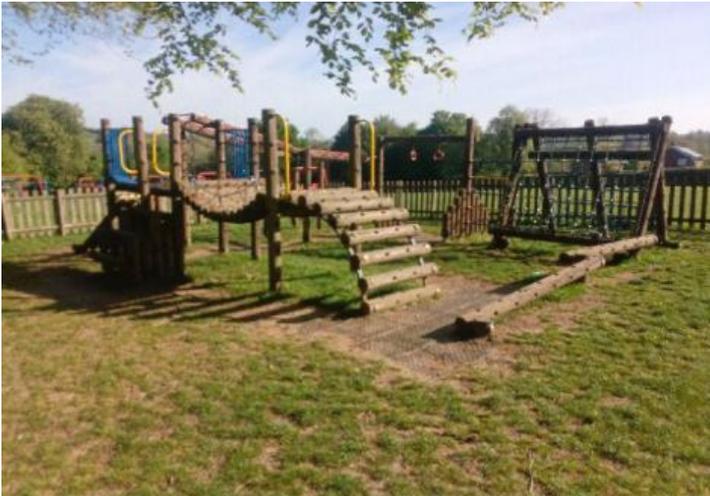
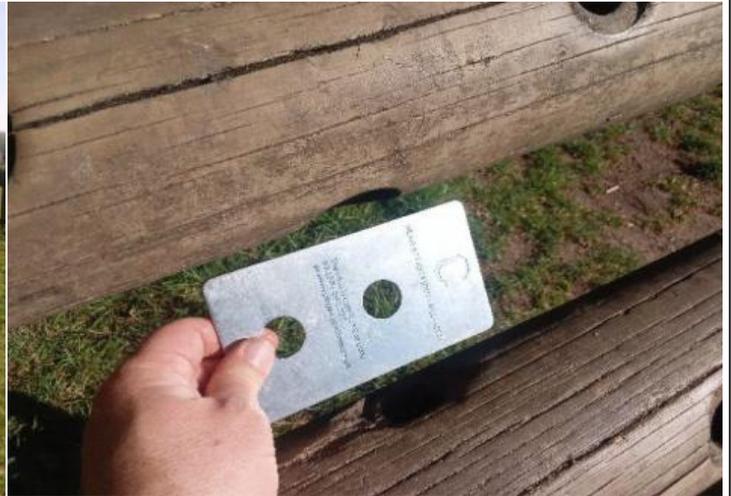
**Finding:** The item fails to meet the requirements of BS EN 1176 Part 1 4.2.7.2 for head and neck entrapment between the log climber

**Action:** Consider removing entrapments

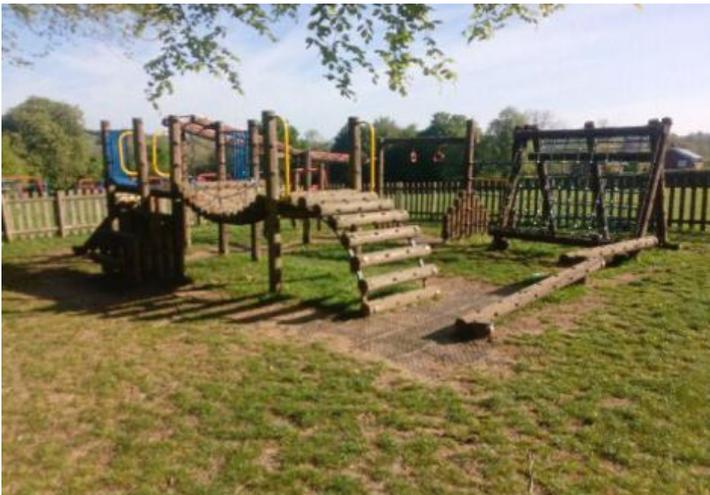
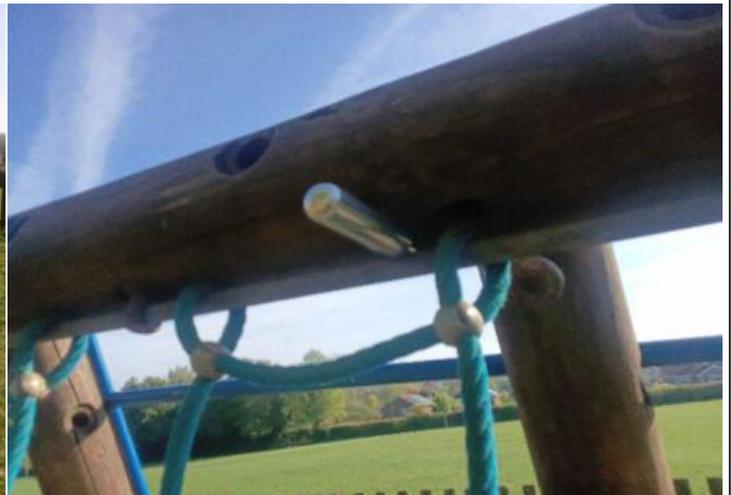
**Finding:** There is/are finger entrapment/s above the net climber and the item fails to meet the requirements of BS EN 1176 Part 1 4.2.7.6 Entrapment of fingers

**Action:** Monitor - No action given the risk assessment

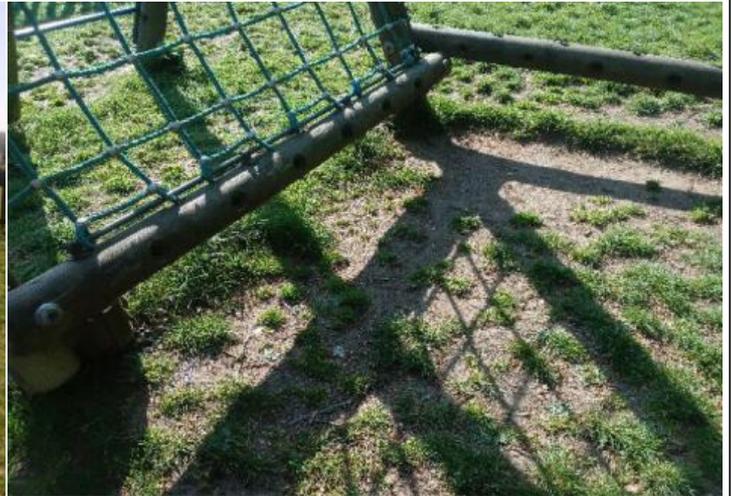
**Finding:** The grass mats are silted up and the soil is compacted; this may have an effect on the impact absorbing properties of the surface. Consideration should be given to HIC testing the surface to verify impact attenuating properties ( <https://playinspections.co.uk/inspection-services/safety-surface-testing/> )

**Action:** Contact our office for a quotation for this service

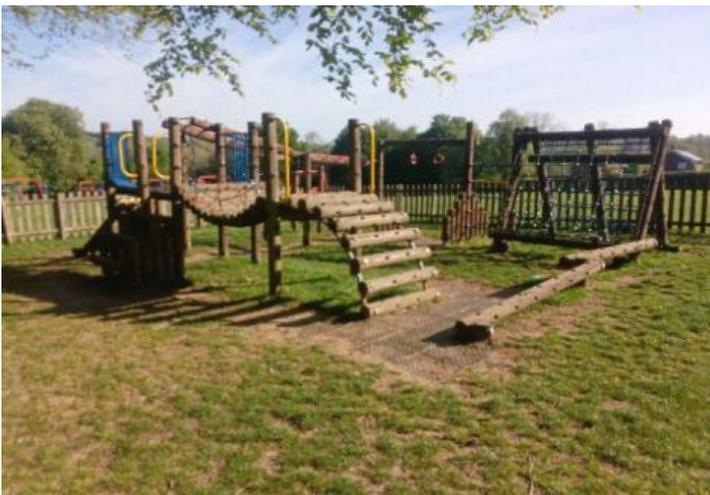
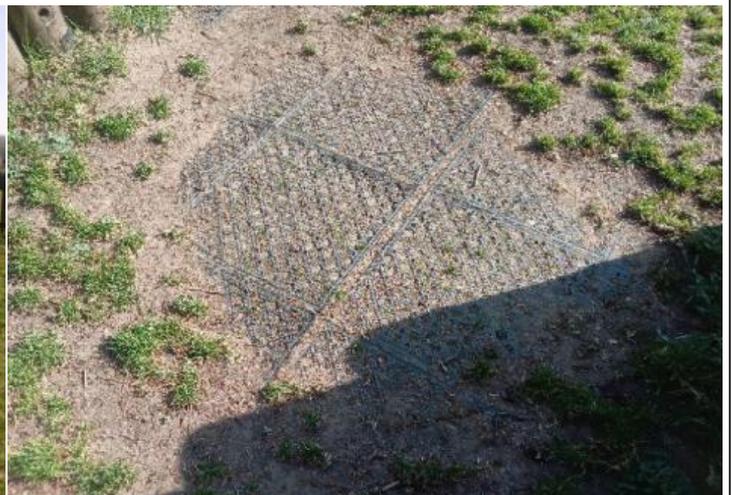
**Finding:** There are gaps opening between the grass mat tiles

**Action:** Provide additional ties or secure / reinstate surface tiles

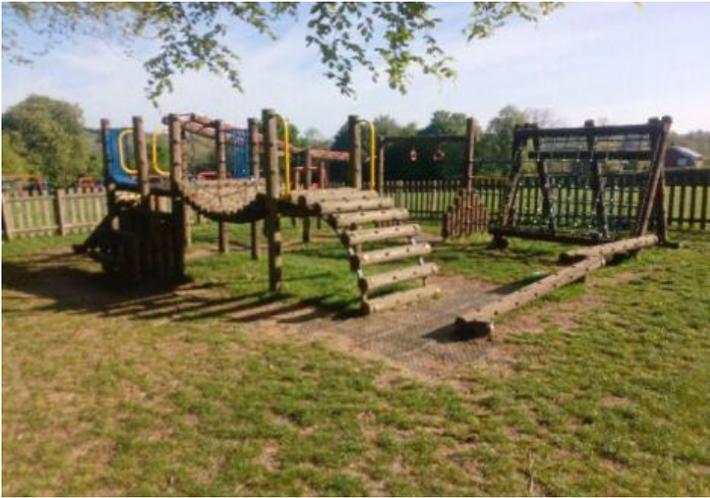
**Finding:** The rope has worn and wire strands are exposed

**Action:** Replace rope or net

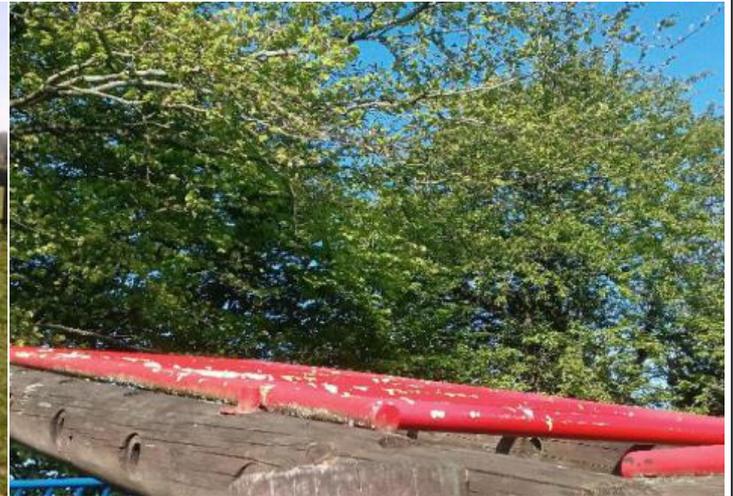
**Finding:** The paint is flaking off the metalwork

**Action:** Rub down and re-paint

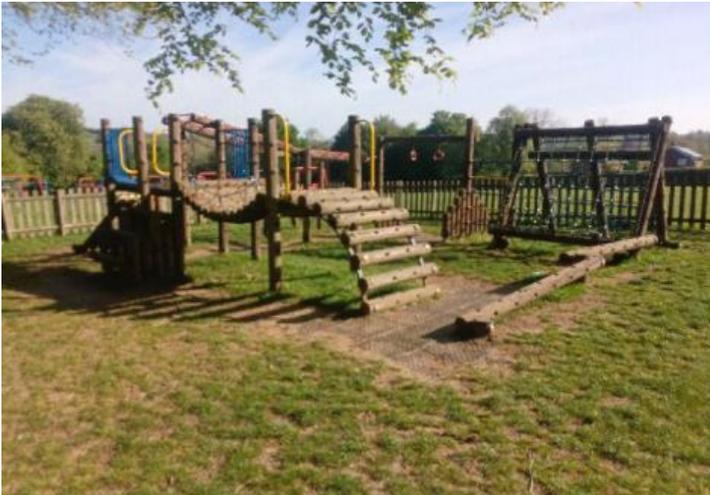
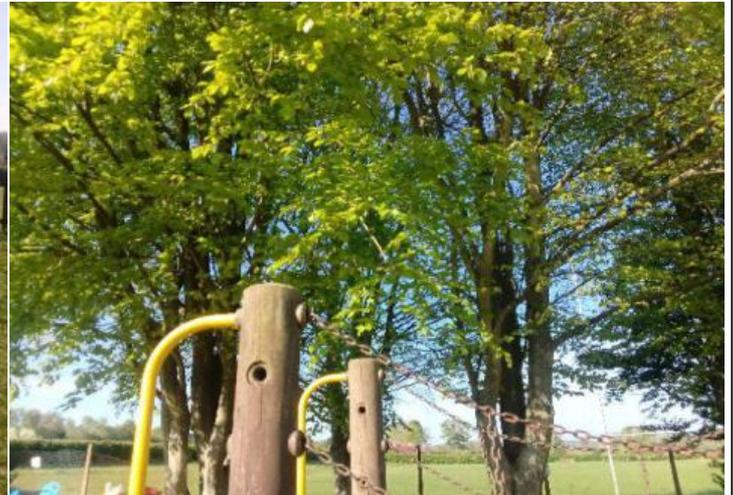
**Finding:** The tree canopy overhangs the equipment and is less than 2.0m away

**Action:** Lift tree canopy to ensure a minimum clearance of 2.0m from the equipment

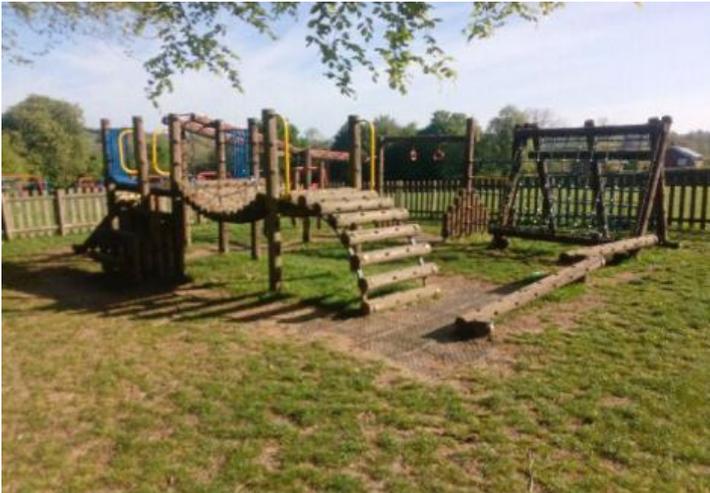
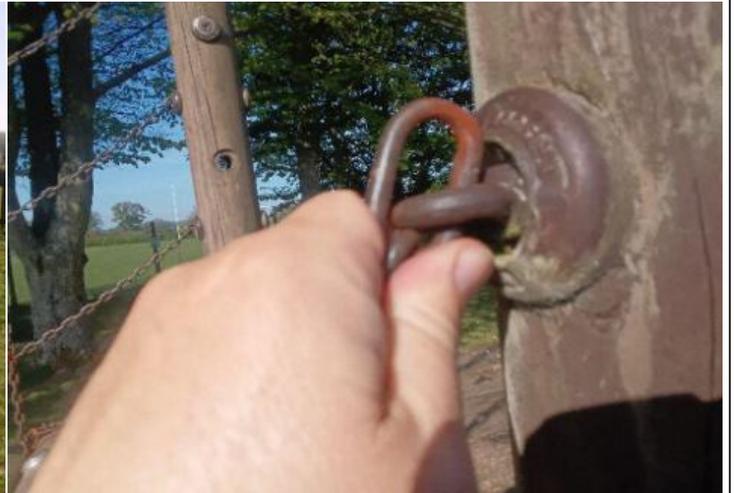
**Finding:** There is some notable evidence of chain wear

**Action:** Monitor for any further deterioration and replace when 40% worn

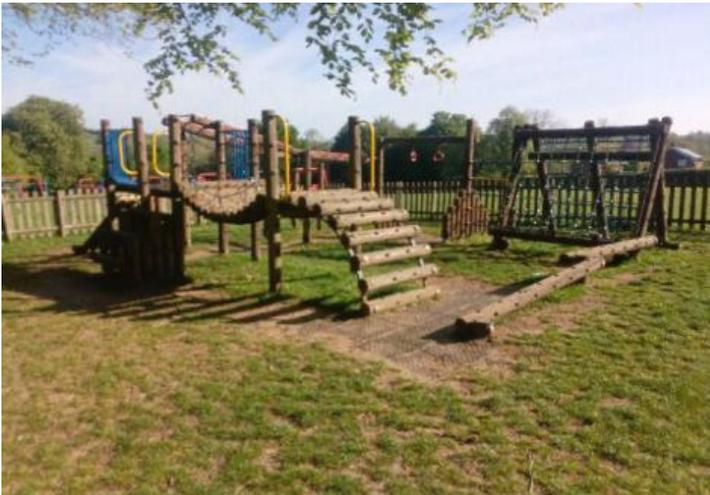
**Finding:** The connecting lugs are showing signs of wear

**Action:** Monitor for any further deterioration and repair as required

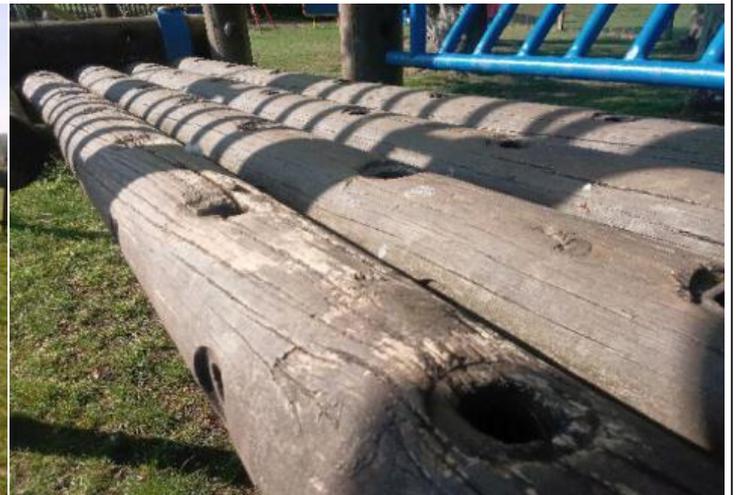
**Finding:** Parts of the timber are rough or splintered  
**Action:** Remove all rough or sharp edges

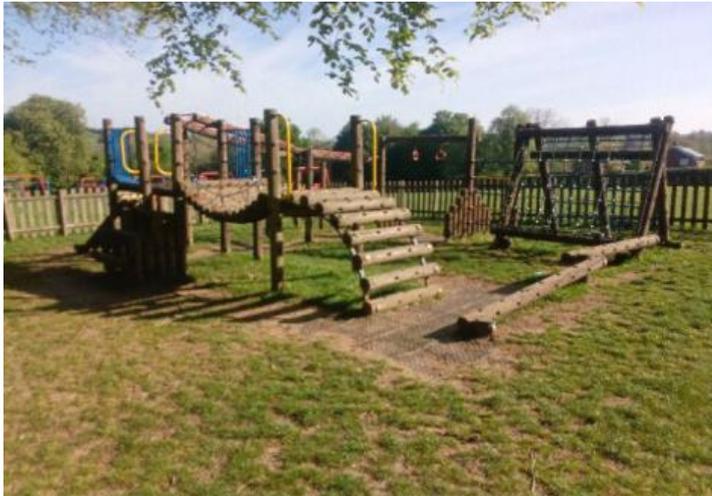
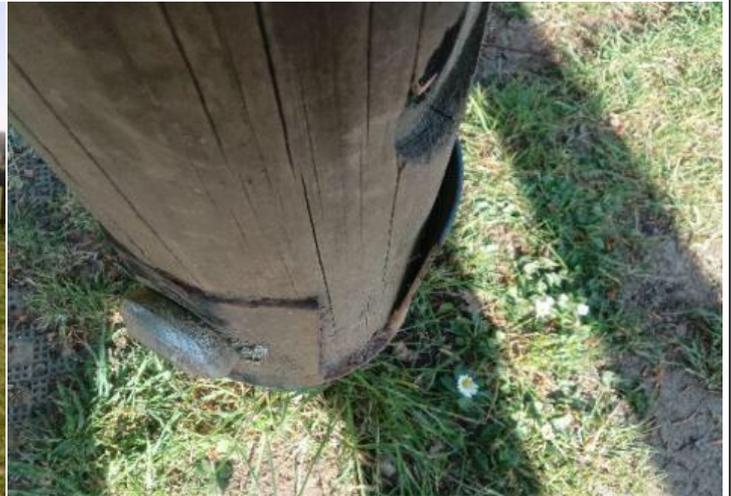
**Finding:** The fixing plates are not flush with the posts

**Action:** Rectify installation

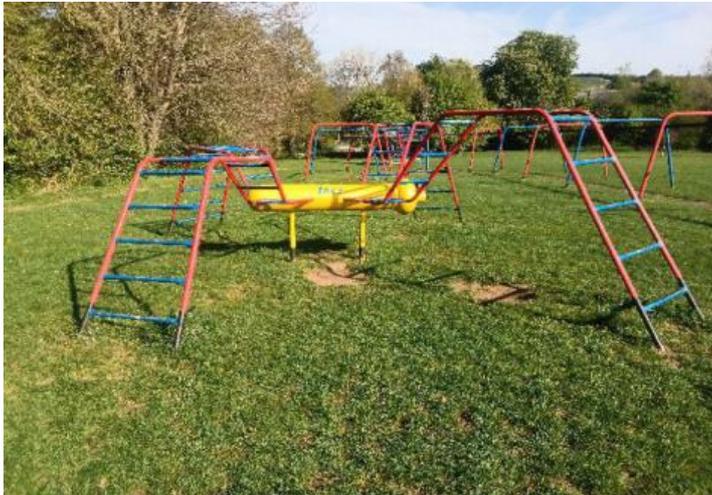
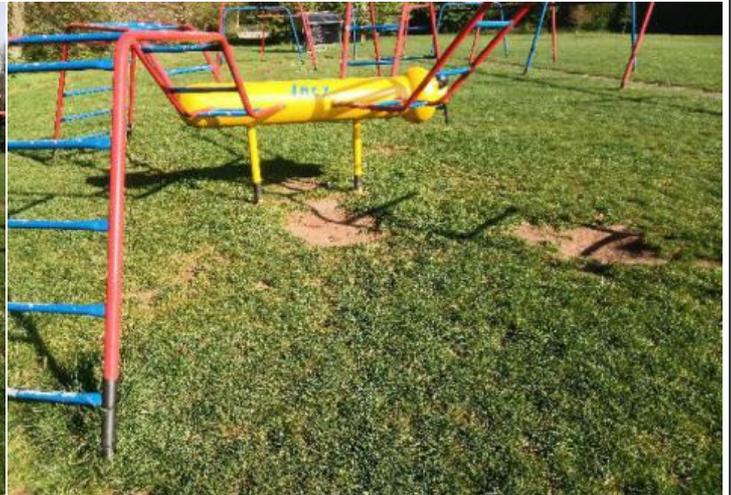
**Finding:** The surface has subsided in some areas

**Action:** Monitor for any further deterioration and repair as required

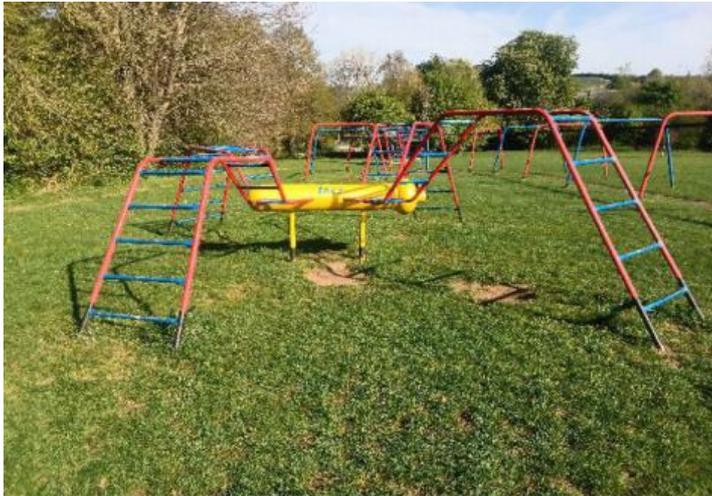
**Finding:** The surface has eroded and the foundations are exposed

**Action:** Reinstall surrounding surfaces to cover the foundations

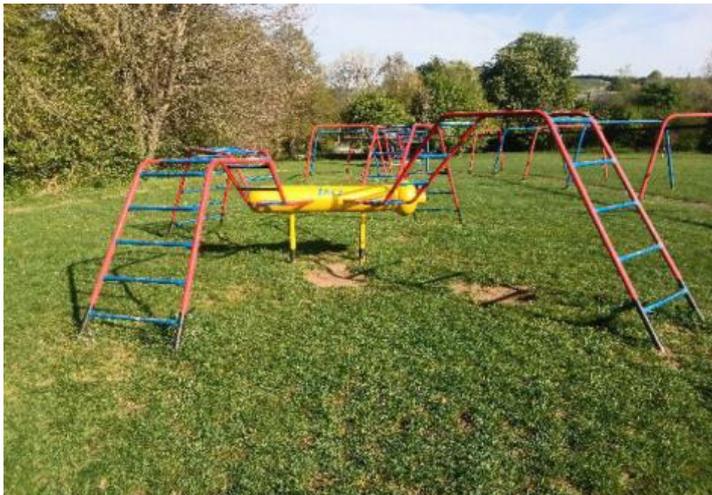
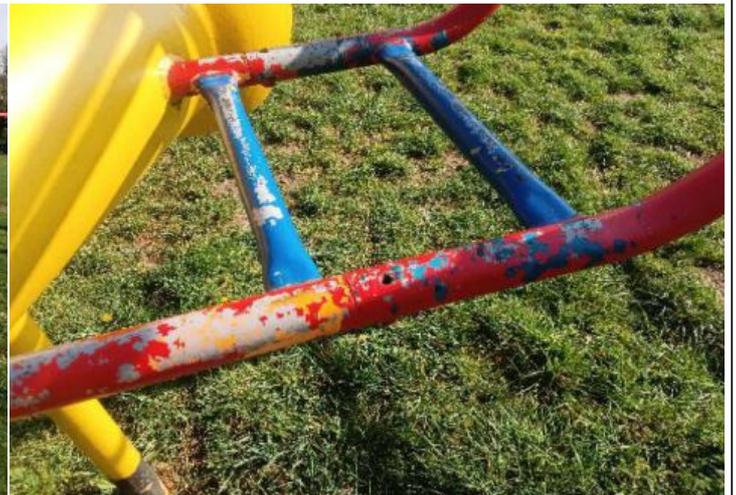
**Finding:** The paint is flaking off the metalwork

**Action:** Rub down and re-paint

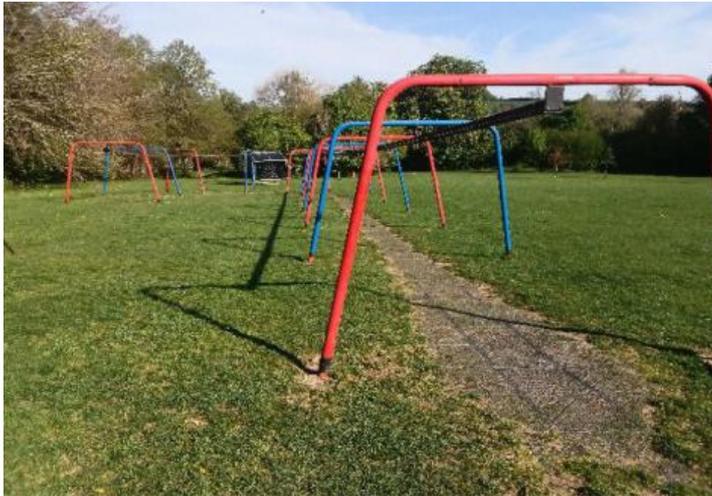
**Finding:** The surface has eroded and the foundations are exposed

**Action:** Reinstate surrounding surfaces to cover the foundations

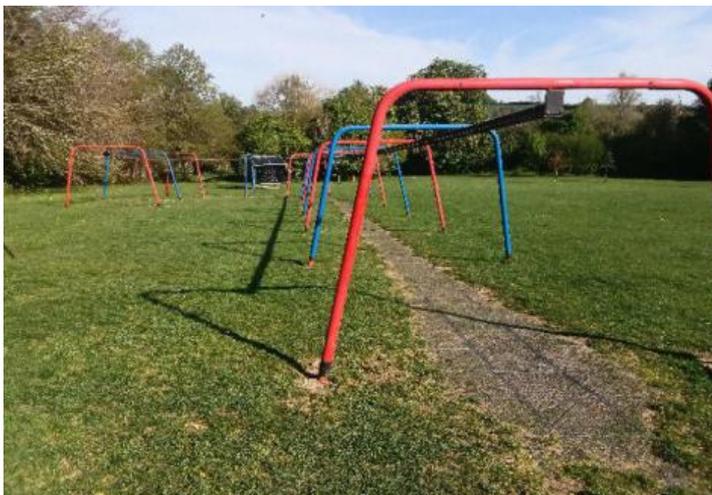
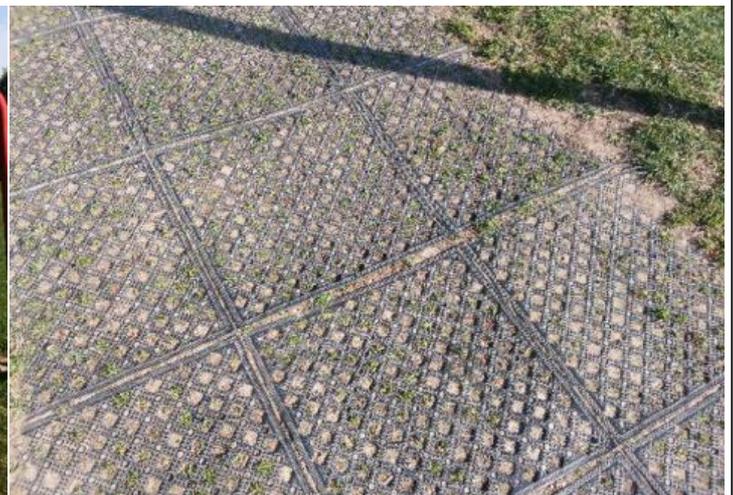
**Finding:** There are gaps opening between the grass mat tiles

**Action:** Provide additional ties or secure / reinstate surface

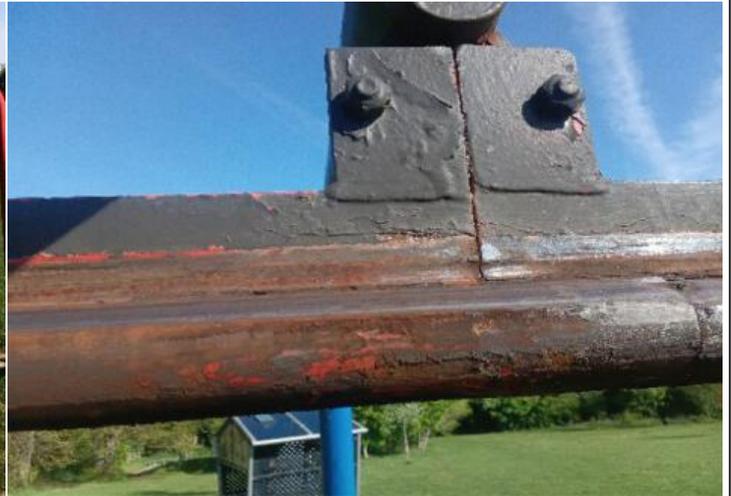
**Finding:** The paintwork on this item has been damaged or worn exposing the metal underneath which is rusting / corroding

**Action:** Treat affected areas and repaint

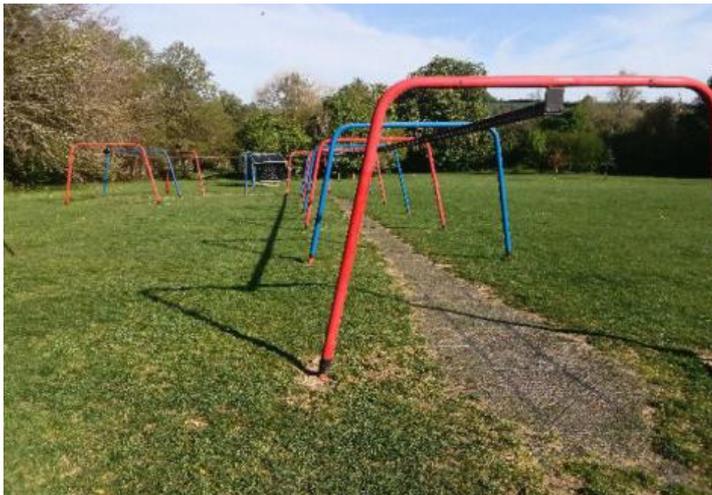
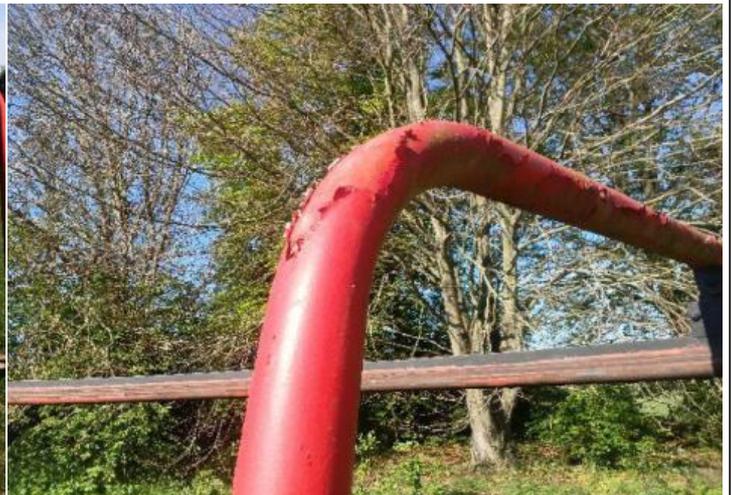
**Finding:** The paint is flaking off the metalwork

**Action:** Rub down and re-paint

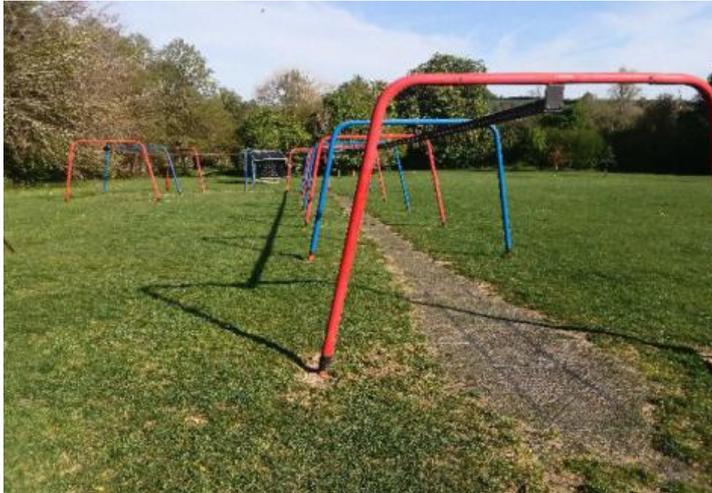
**Finding:** The connecting links are worn excessively (70%) and require renewing

**Action:** Replace

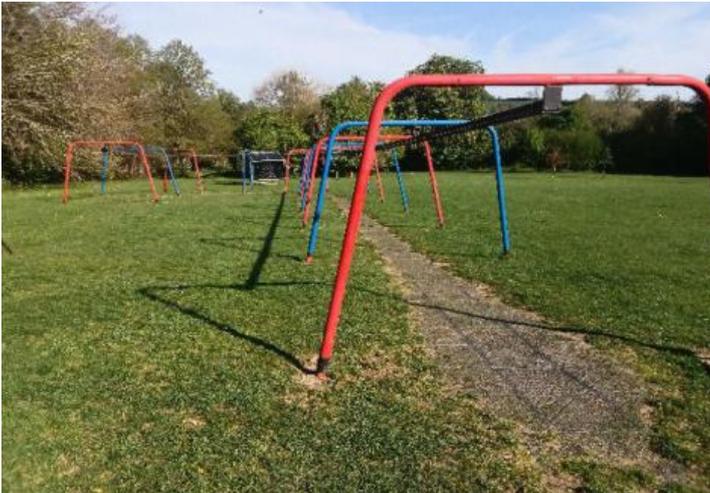
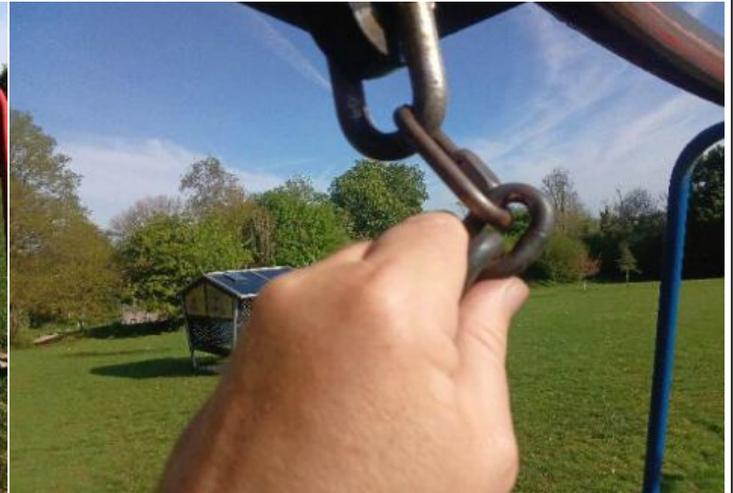
**Finding:** There is some notable evidence of chain wear

**Action:** Monitor for any further deterioration and replace when 40% worn

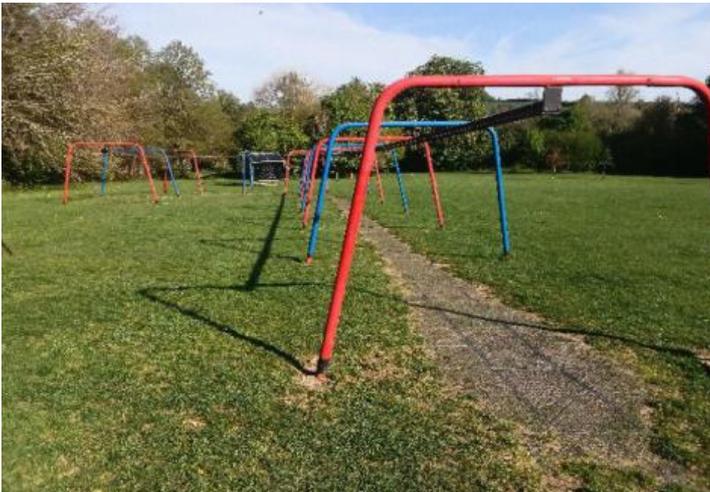
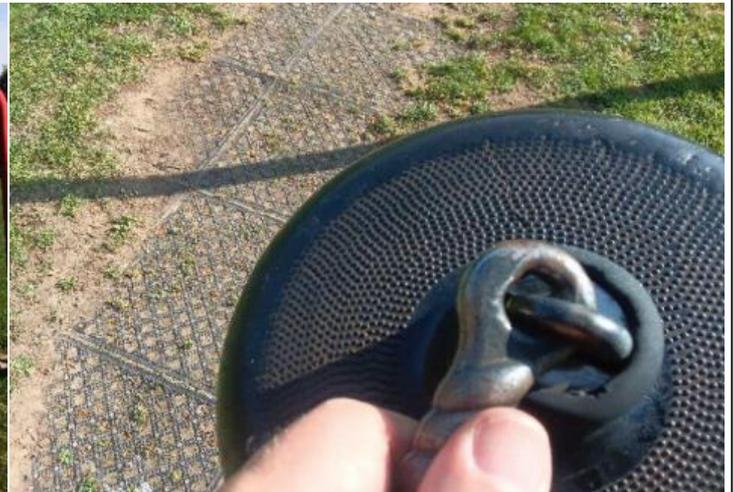
**Finding:** There is some wear to the chain bars

**Action:** Monitor for any further deterioration and replace when 40% worn

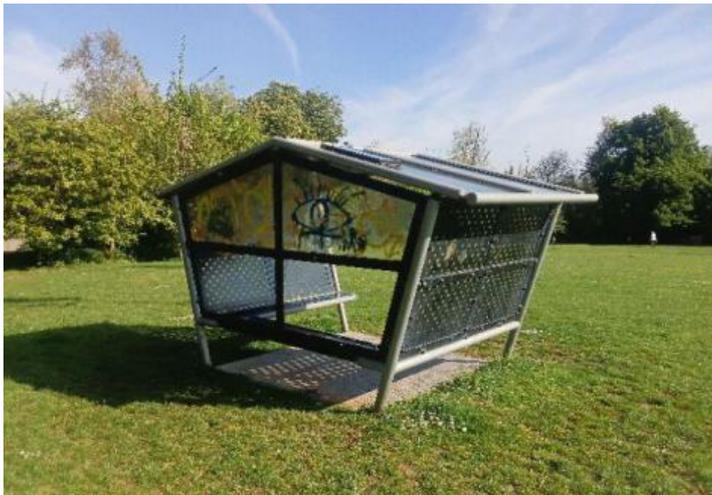
**Finding:** The item has missing component(s)

**Action:** Replace missing perspex windows

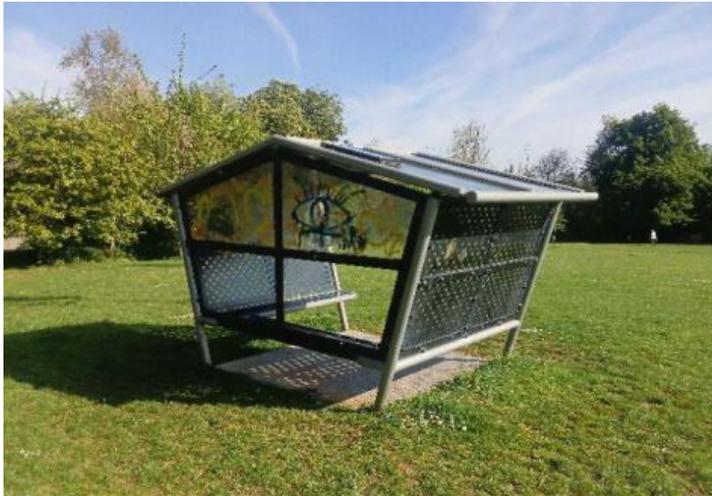
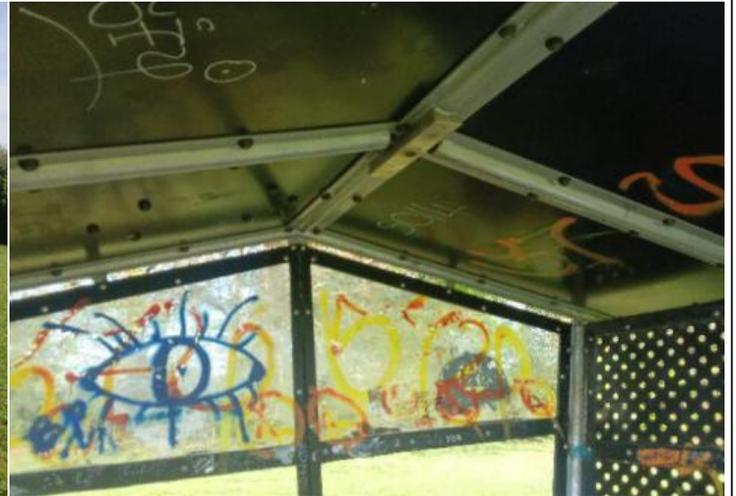
**Item:** Ancillary Items - Teenage Shelter  
**Manufacturer:** Monster Play Systems

**Finding:** There is some graffiti present

**Action:** Remove the graffiti

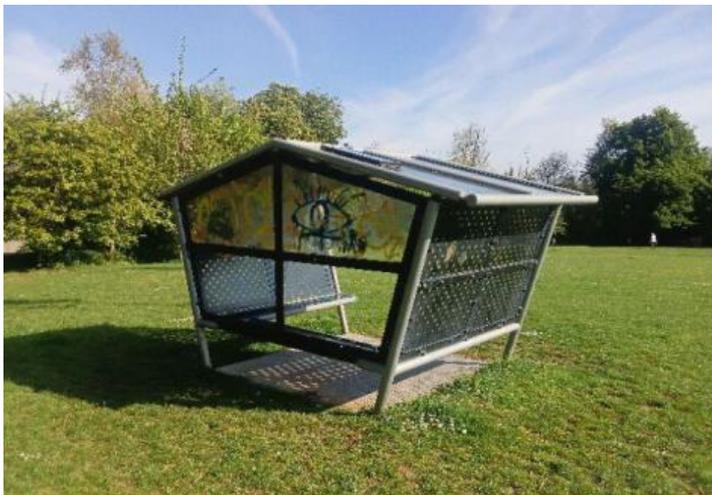
**Item:** Ancillary Items - Teenage Shelter  
**Manufacturer:** Monster Play Systems

**Finding:** The communication panel is damaged

**Action:** Repair / replace

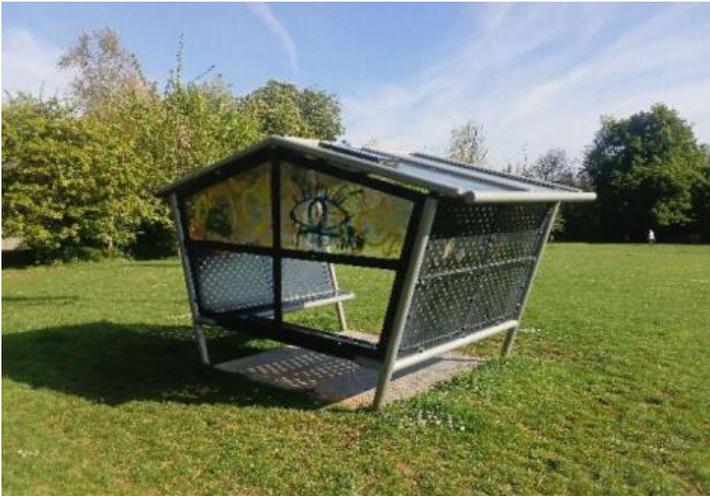
**Item:** Ancillary Items - Teenage Shelter  
**Manufacturer:** Monster Play Systems

**Finding:** There is/are bolt cap covers missing or damaged on the item

**Action:** Replace missing or damaged bolt cap covers

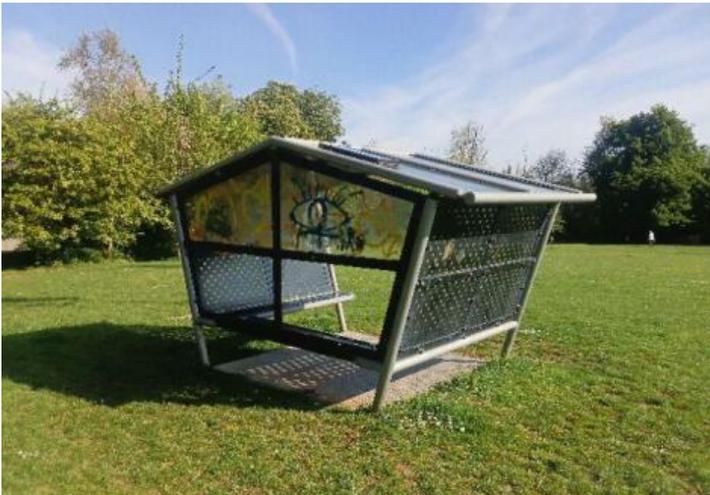
**Item:** Ancillary Items - Teenage Shelter  
**Manufacturer:** Monster Play Systems

**Finding:** There are trip hazards at the edges of the surface

**Action:** Remove trip hazard

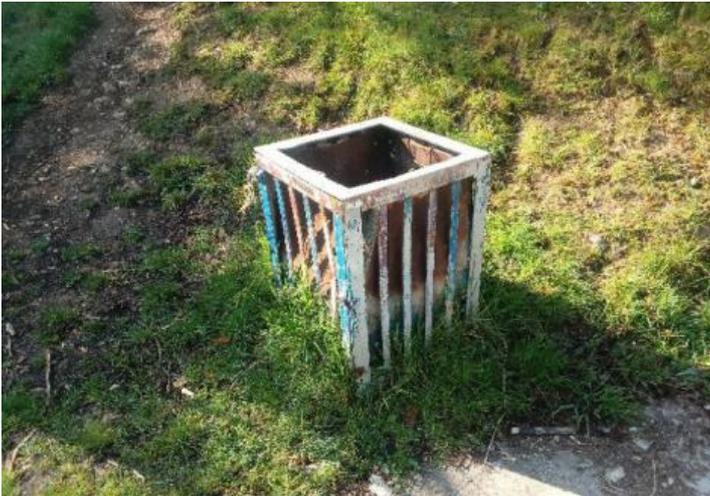
**Item:** Ancillary Items - Litter Bin  
**Manufacturer:** Not Identified

**Finding:** Parts of the steel on this item have corroded excessively and the metal has perforated in places

**Action:** Replace bin liner

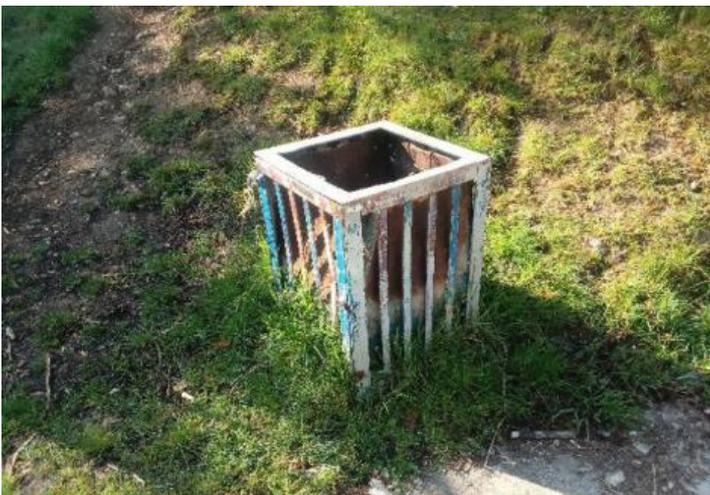
**Item:** Ancillary Items - Litter Bin  
**Manufacturer:** Not Identified

**Finding:** The bin has been damaged

**Action:** Monitor for any further deterioration and replace as required

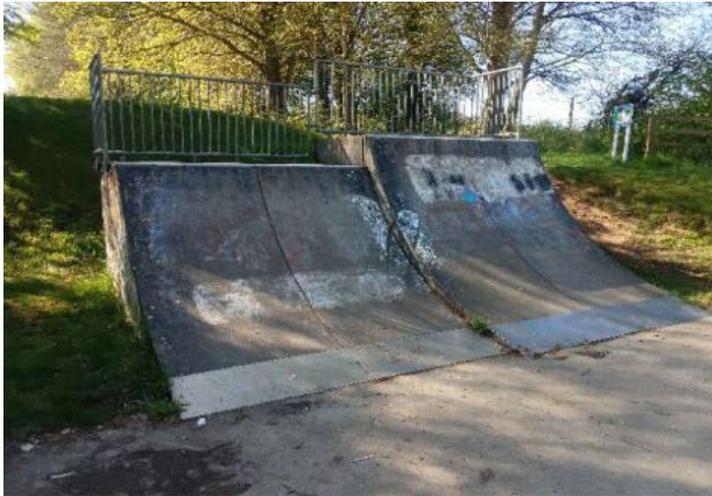
**Item:** Wheeled Sports - Start Ramp  
**Manufacturer:** Not Identified

**Finding:** The riding surface has minor damage apparent

**Action:** Monitor for any further deterioration and repair as required

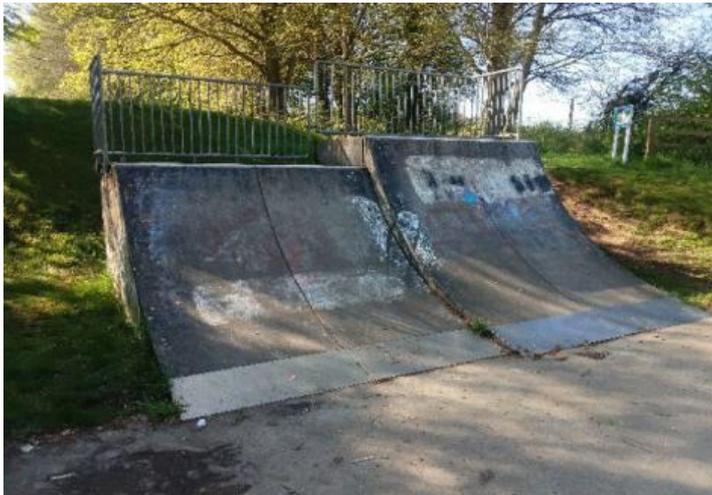
**Item:** Wheeled Sports - Start Ramp  
**Manufacturer:** Not Identified

**Finding:** The rear panels are missing

**Action:** Replace

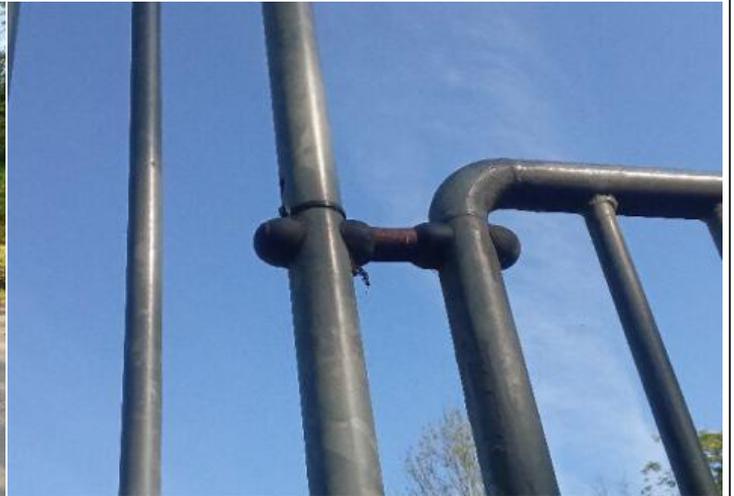
**Item:** Wheeled Sports - Start Ramp  
**Manufacturer:** Not Identified

**Finding:** Cable ties are present and there are sharp projecting ends

**Action:** Remove

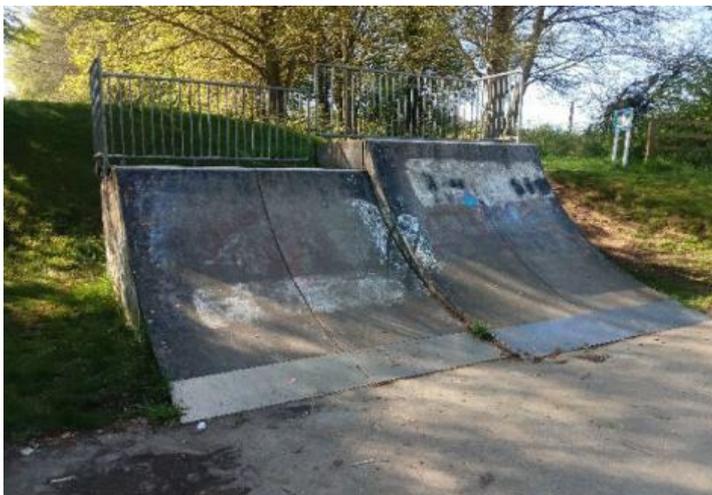
**Item:** Wheeled Sports - Start Ramp  
**Manufacturer:** Not Identified

**Finding:** A number of fixing(s) have worked loose

**Action:** Secure all loose fixings

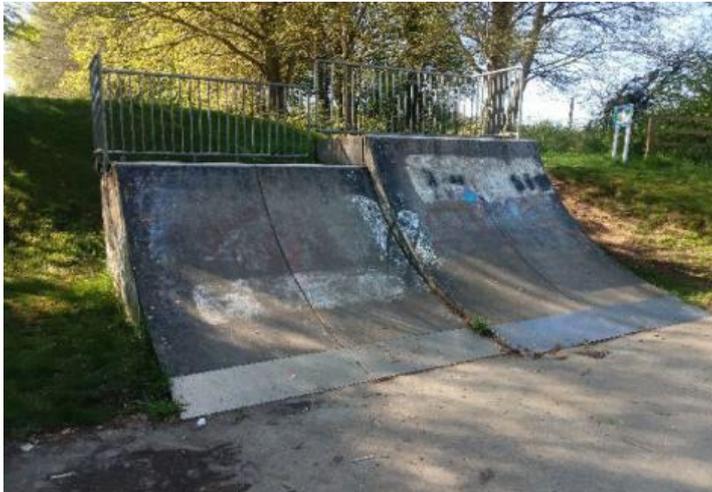
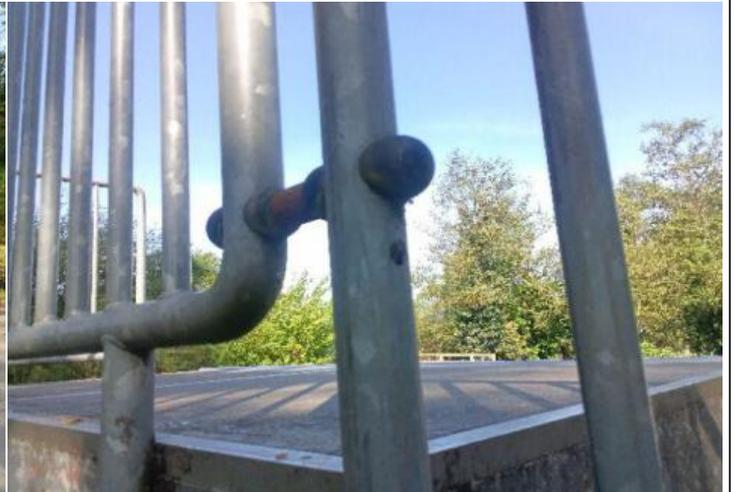
**Item:** Wheeled Sports - Start Ramp  
**Manufacturer:** Not Identified

**Finding:** There is/are inserts missing

**Action:** Replace missing inserts

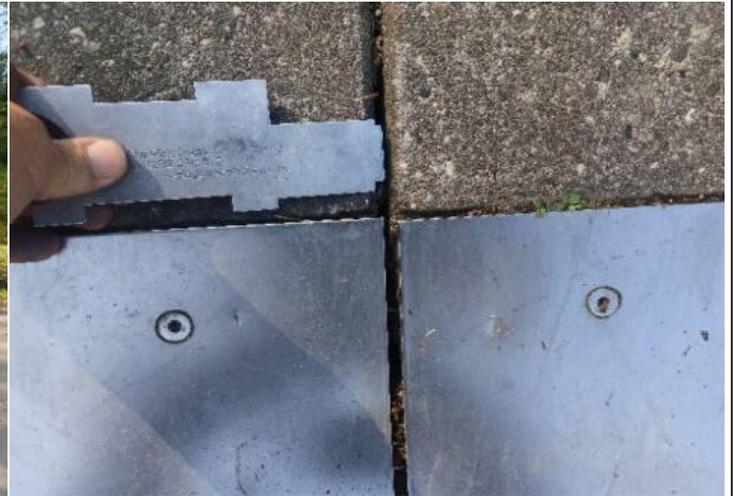
**Item:** Wheeled Sports - Start Ramp  
**Manufacturer:** Not Identified

**Finding:** Joints between the riding / rolling surfaces shall not be greater than 5mm in contravention of the requirements of BS EN 14974 – 6.2.4  
**Action:** Take corrective action to ensure that the gaps between the joints do not exceed 5mm

**i** 6 - Low Risk (Finding 8)

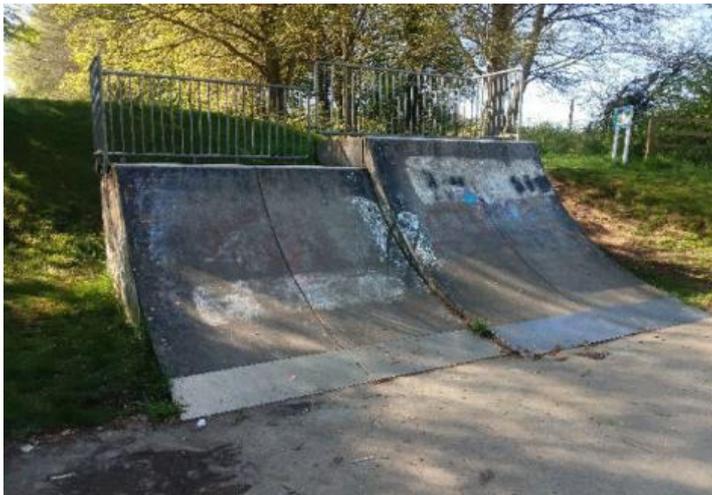
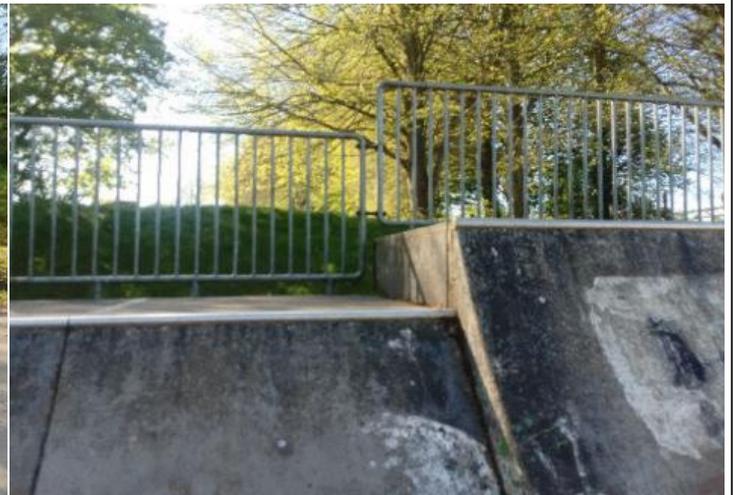
**Item:** Wheeled Sports - Start Ramp  
**Manufacturer:** Not Identified

**Finding:** The barrier has not been extended at the upper part of the platform by at least 1000mm in contravention of the requirements of BS EN 14974 - 6.2.6  
**Action:** Monitor - no reasonably practicable action given the risk assessment

**i** 6 - Low Risk (Finding 9)
