## Annual Inspection

Winchester City Council

Arlebury Park, Skate Park & Tennis(New Alresford)

The Avenue, Alresford, SO24 9EP

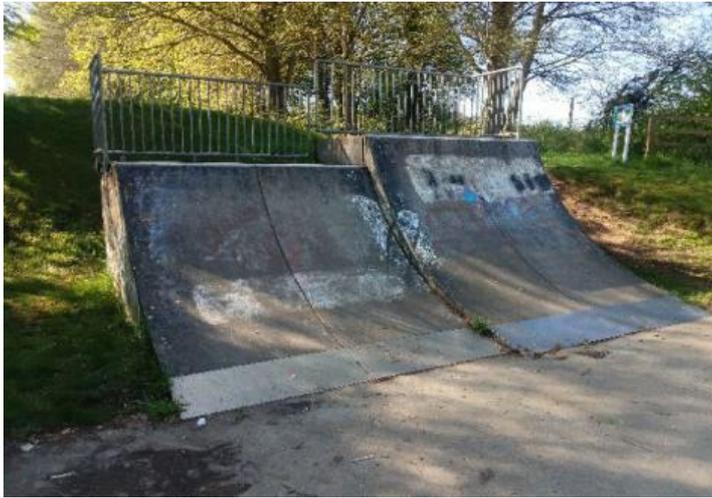
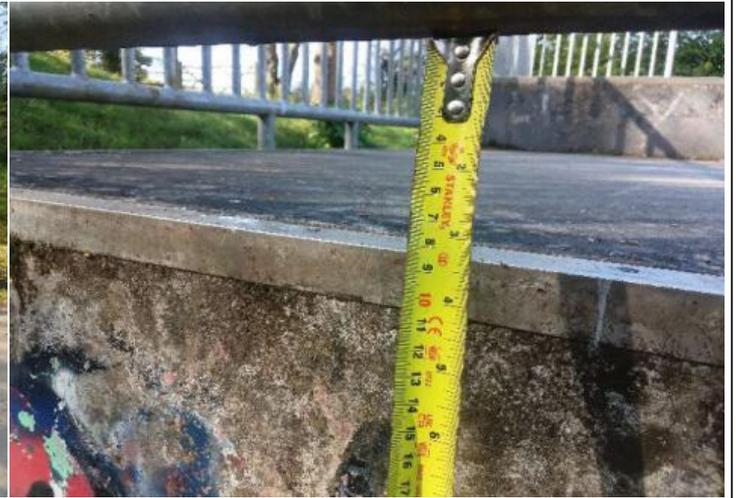
**Item:** Wheeled Sports - Start Ramp  
**Manufacturer:** Not Identified

**Finding:** The distance between the barrier and the platform exceeds 60mm in contravention of the requirements of BS EN 14974 - 6.2.6

**Action:** Monitor - no reasonably practicable action given the risk assessment

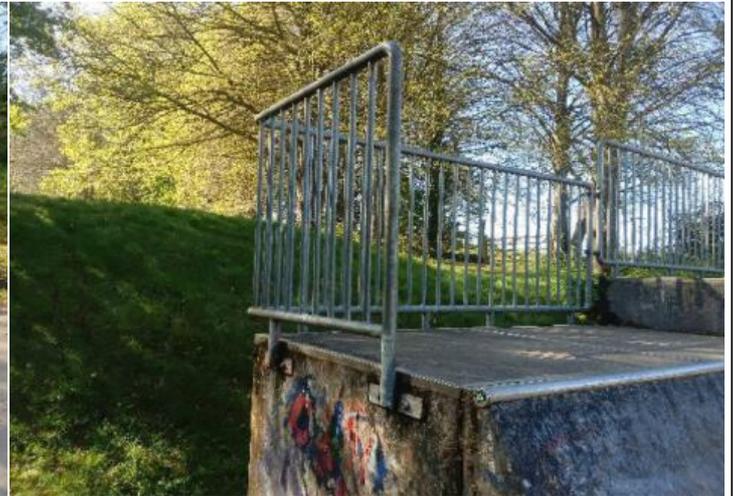
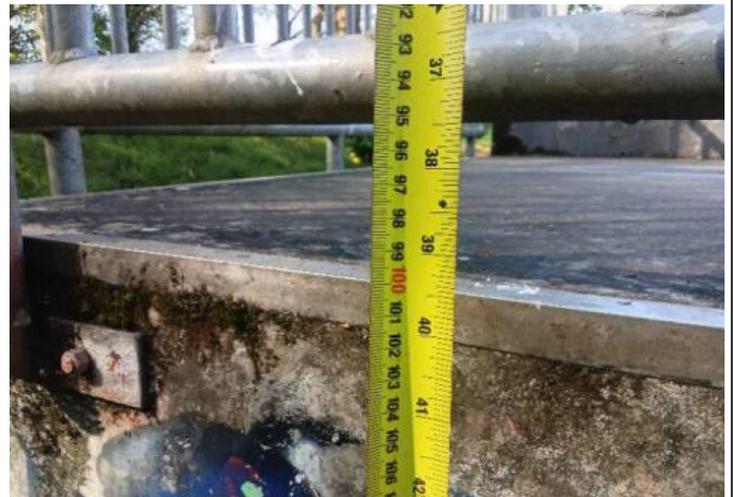
**Item:** Wheeled Sports - Start Ramp  
**Manufacturer:** Not Identified

**Finding:** The height of the barrier is less than 1200mm in contravention of BS EN 14974 - 6.2.6. This height must be achieved all around the platform and at a maximum distance of 300mm from the front of the platform.

**Action:** Monitor - no reasonably practicable action given the risk assessment

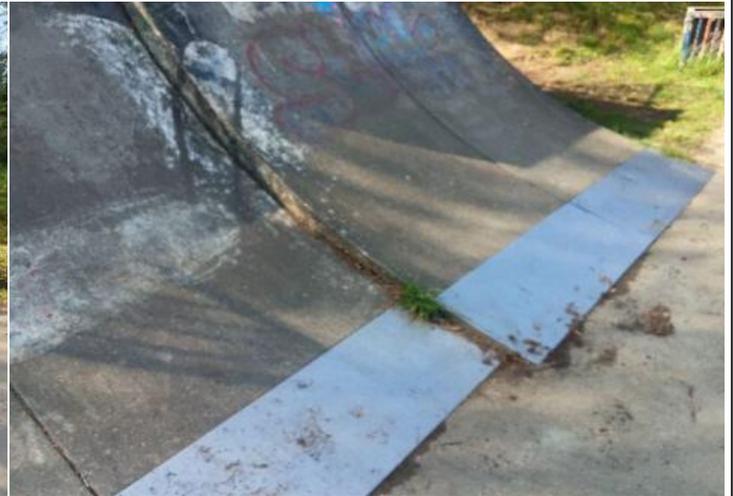
**Item:** Wheeled Sports - Start Ramp  
**Manufacturer:** Not Identified

**Finding:** There is weed / vegetation growth within the surface

**Action:** Remove weed / vegetation growth

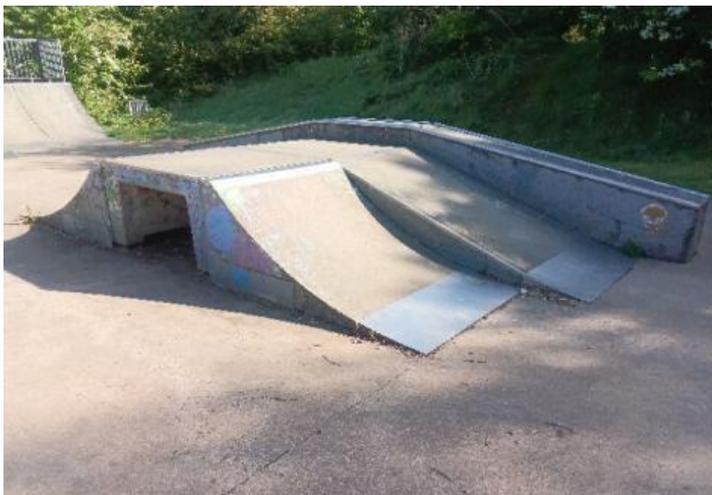
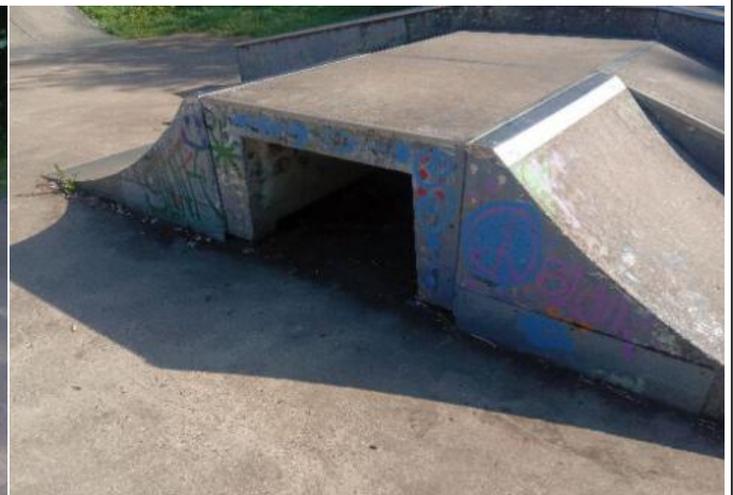
**Item:** Wheeled Sports - Fun Box  
**Manufacturer:** Not Identified

**Finding:** The side panel is missing

**Action:** Replace

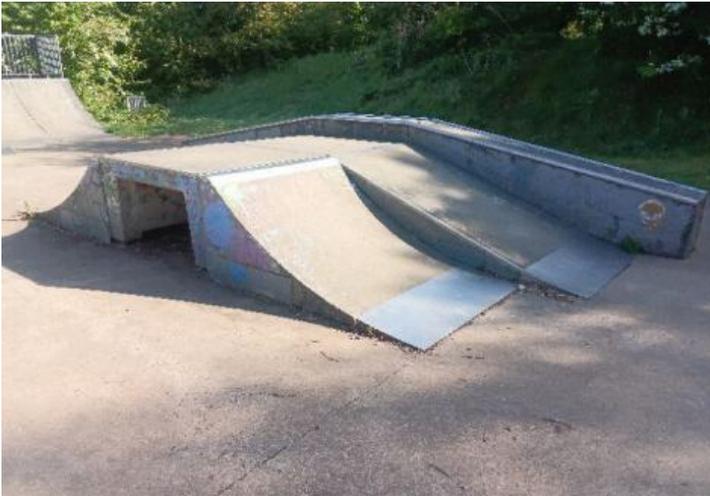
**Item:** Wheeled Sports - Fun Box  
**Manufacturer:** Not Identified

**Finding:** The riding surface has minor damage apparent

**Action:** Monitor for any further deterioration and repair as required

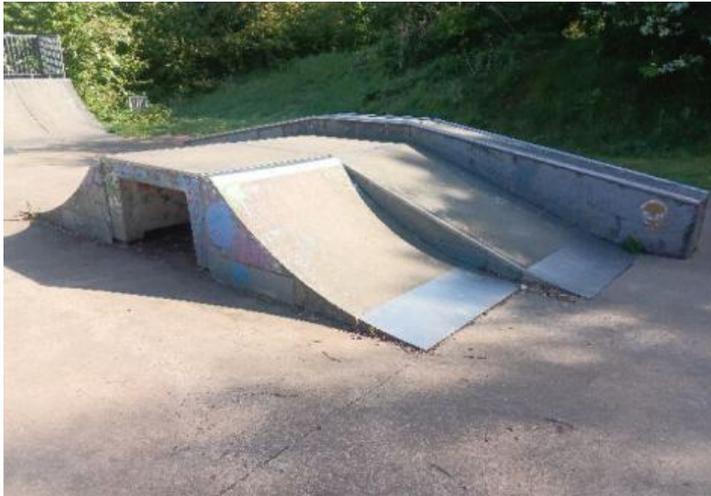
**Item:** Wheeled Sports - Fun Box  
**Manufacturer:** Not Identified

**Finding:** There is or are fixings missing on the item

**Action:** Replace all missing fixings

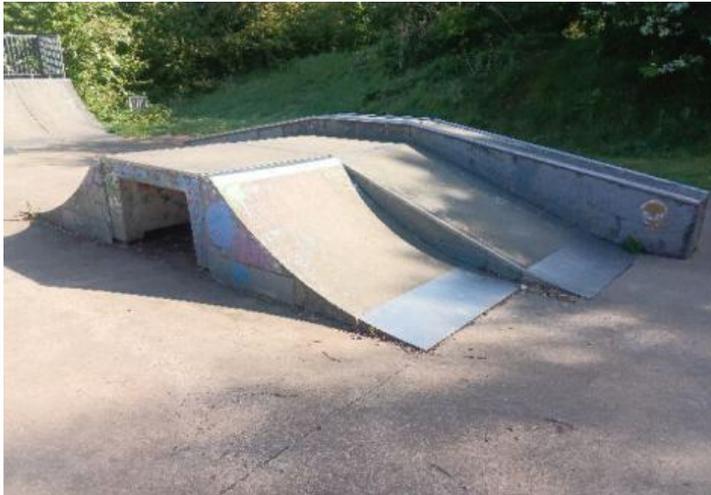
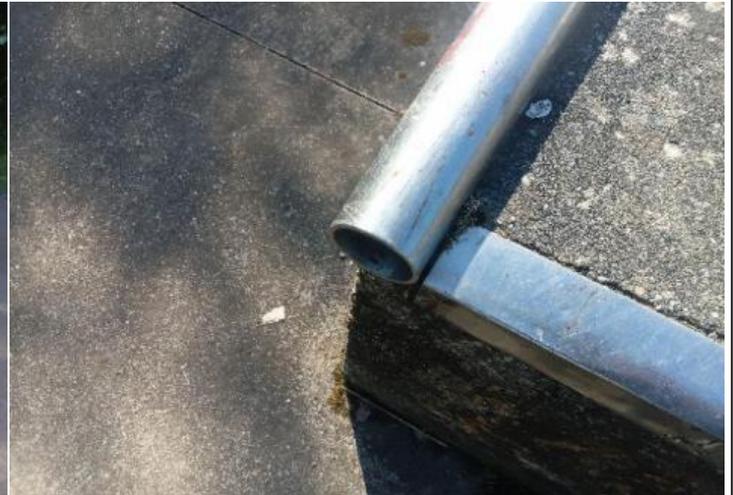
**Item:** Wheeled Sports - Fun Box  
**Manufacturer:** Not Identified

**Finding:** The ends of tubular parts / copings are not capped, in contravention of the requirements of BS EN 14974 - 6.1.8

**Action:** Ensure all coping ends are sealed

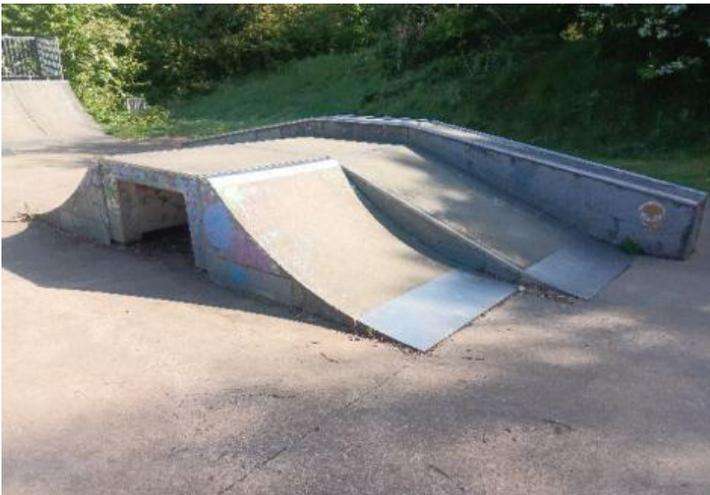
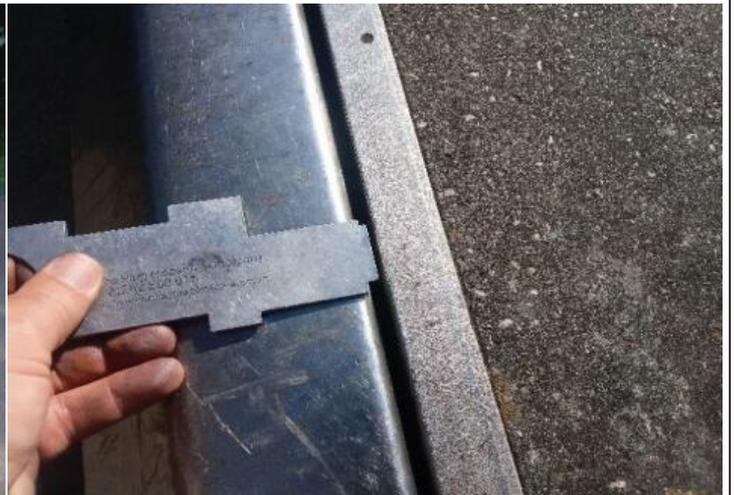
**Item:** Wheeled Sports - Fun Box  
**Manufacturer:** Not Identified

**Finding:** Joints between the riding / rolling surfaces shall not be greater than 5mm in contravention of the requirements of BS EN 14974 – 6.2.4

**Action:** Take corrective action to ensure that the gaps between the joints do not exceed 5mm

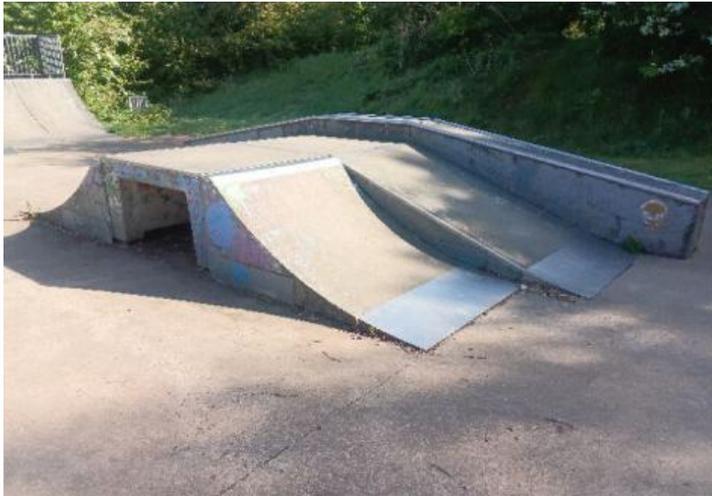
**Item:** Wheeled Sports - Fun Box  
**Manufacturer:** Not Identified

**Finding:** The kicker plate protrudes more than 5mm above the surrounding surface level, BS EN 14974 - 6.1.4 recommends a maximum of 5mm

**Action:** Adjust height to ensure a maximum of 5mm change in level

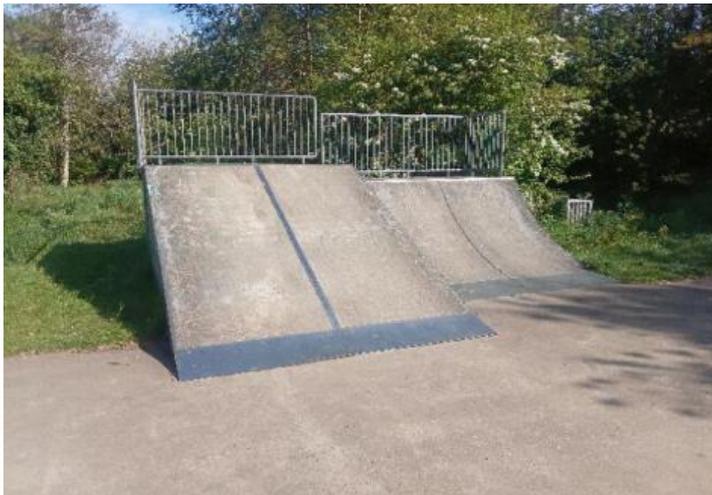
**Item:** Wheeled Sports - End Transition & Wall Ramp  
**Manufacturer:** Not Identified

**Finding:** The riding surface has minor damage apparent

**Action:** Monitor for any further deterioration and repair as required

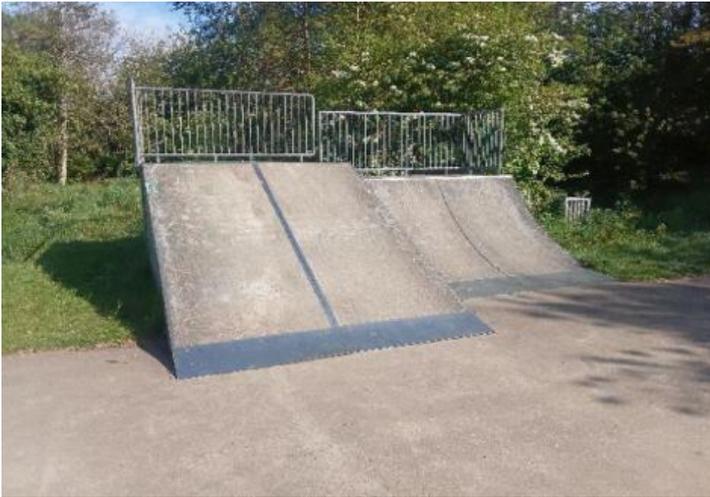
**Item:** Wheeled Sports - End Transition & Wall Ramp  
**Manufacturer:** Not Identified

**Finding:** The end panels are missing

**Action:** Replace

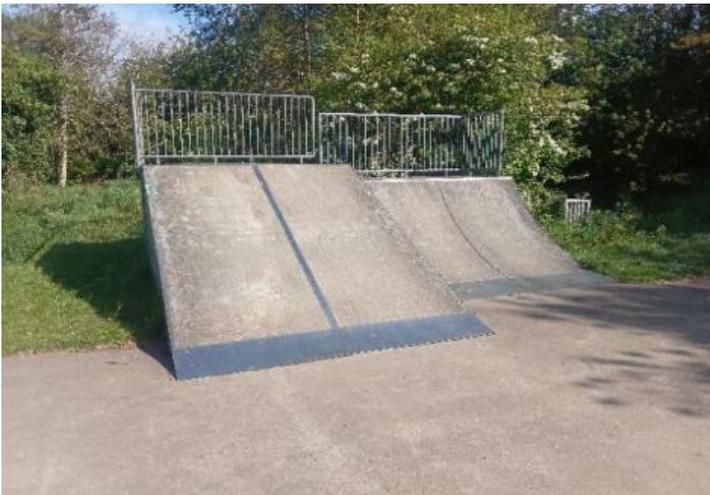
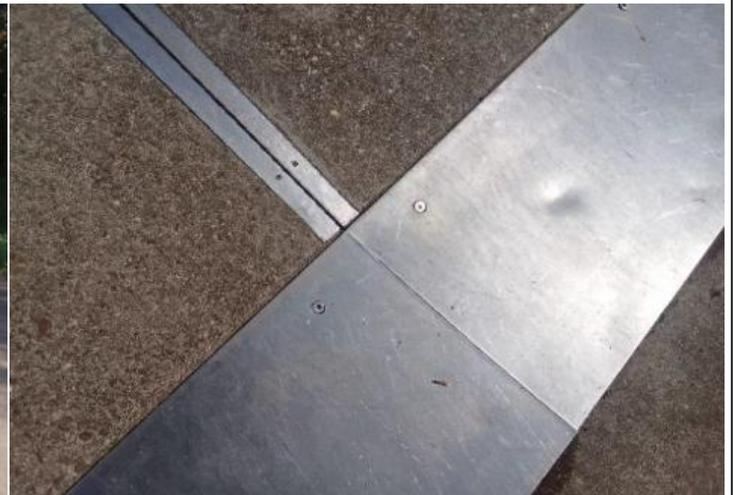
**Item:** Wheeled Sports - End Transition & Wall Ramp  
**Manufacturer:** Not Identified

**Finding:** A number of fixing(s) have worked loose

**Action:** Secure all loose fixings

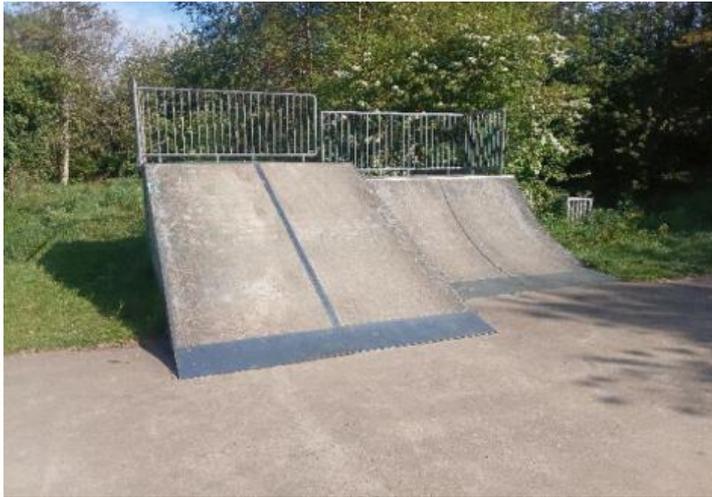
**Item:** Wheeled Sports - End Transition & Wall Ramp  
**Manufacturer:** Not Identified

**Finding:** There is or are fixings missing on the item

**Action:** Replace all missing fixings

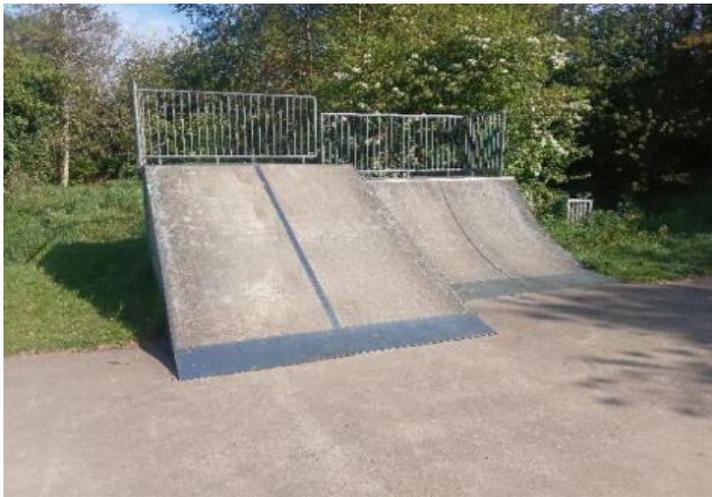
**Item:** Wheeled Sports - End Transition & Wall Ramp  
**Manufacturer:** Not Identified

**Finding:** There is/are inserts missing

**Action:** Replace missing inserts

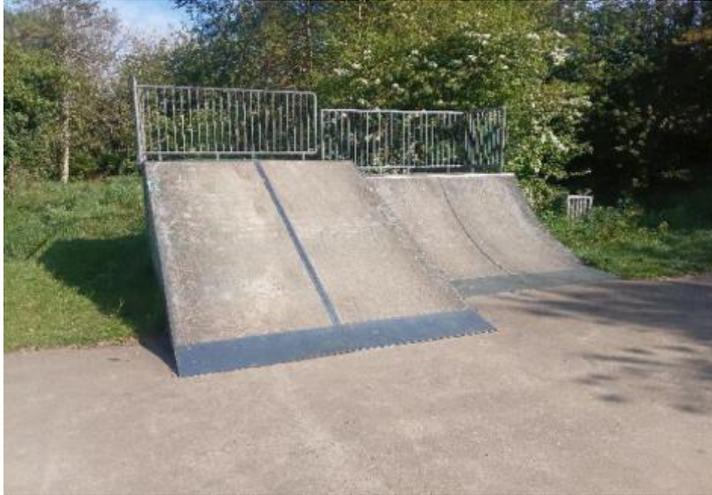
**Item:** Wheeled Sports - End Transition & Wall Ramp  
**Manufacturer:** Not Identified

**Finding:** There is broken glass present on site

**Action:** Remove the broken glass and maintain the area

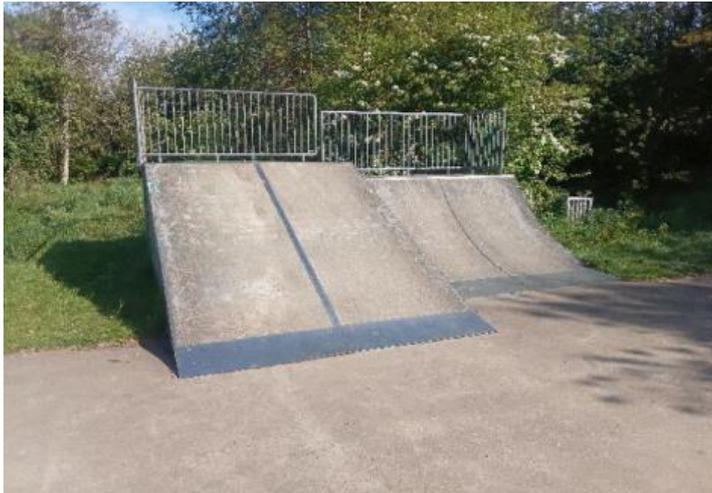
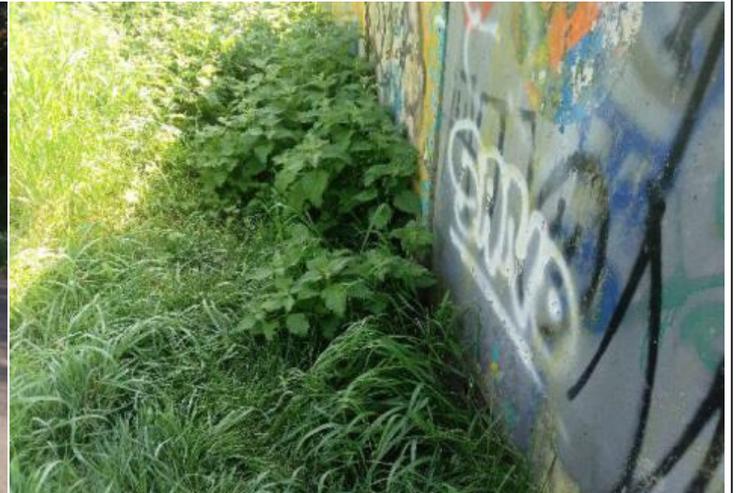
**Item:** Wheeled Sports - End Transition & Wall Ramp  
**Manufacturer:** Not Identified

**Finding:** There is weed / vegetation growth within the surface

**Action:** Remove weed / vegetation growth

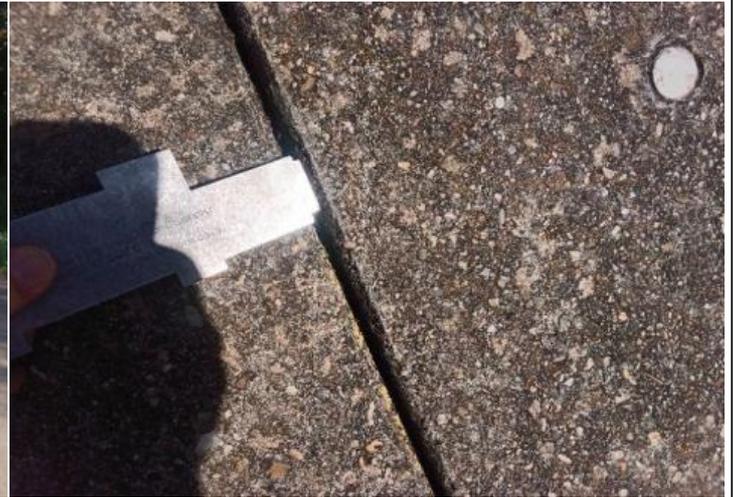
**Item:** Wheeled Sports - End Transition & Wall Ramp  
**Manufacturer:** Not Identified

**Finding:** Joints between the riding / rolling surfaces shall not be greater than 5mm in contravention of the requirements of BS EN 14974 – 6.2.4  
**Action:** Take corrective action to ensure that the gaps between the joints do not exceed 5mm

**i** 6 - Low Risk (Finding 9)

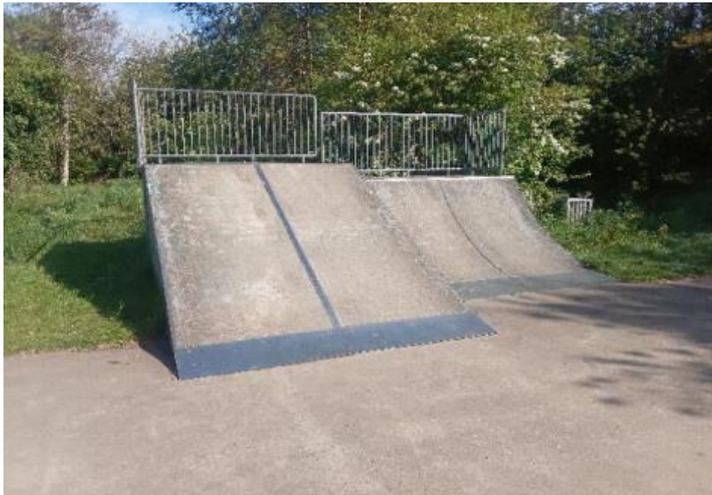
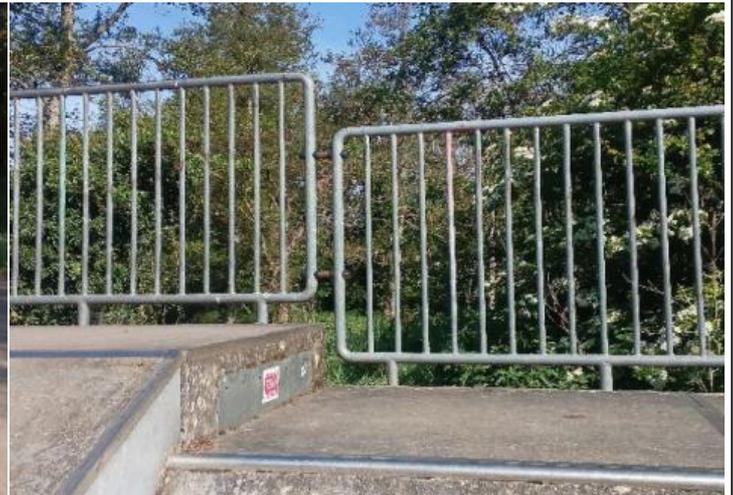
**Item:** Wheeled Sports - End Transition & Wall Ramp  
**Manufacturer:** Not Identified

**Finding:** The barrier has not been extended at the upper part of the platform by at least 1000mm in contravention of the requirements of BS EN 14974 - 6.2.6  
**Action:** Monitor - no reasonably practicable action given the risk assessment

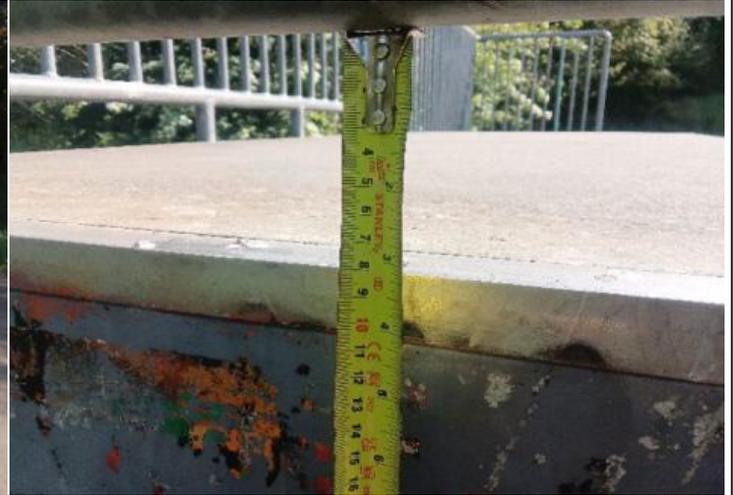
**Item:** Wheeled Sports - End Transition & Wall Ramp  
**Manufacturer:** Not Identified

**Finding:** The distance between the barrier and the platform exceeds 60mm in contravention of the requirements of BS EN 14974 - 6.2.6

**Action:** Monitor - no reasonably practicable action given the risk assessment

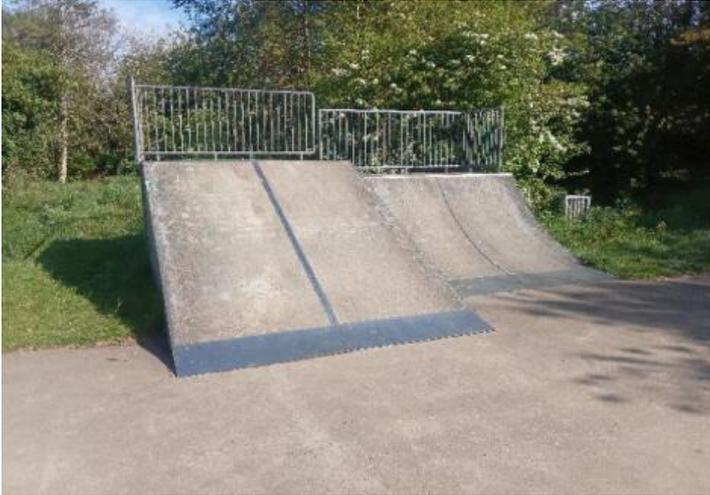
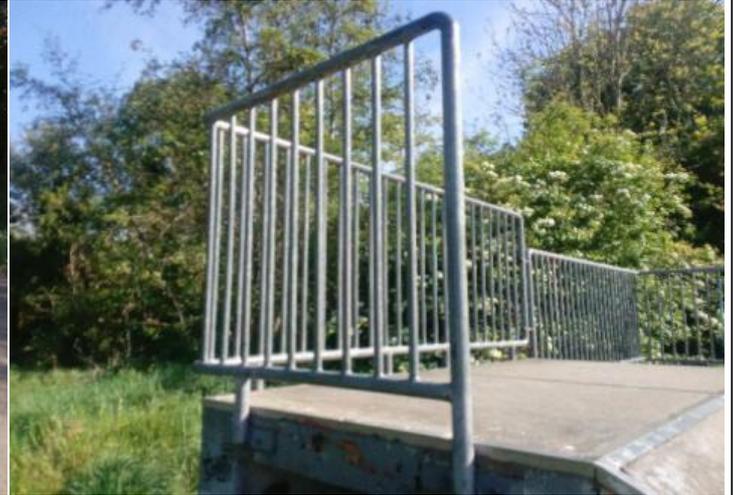
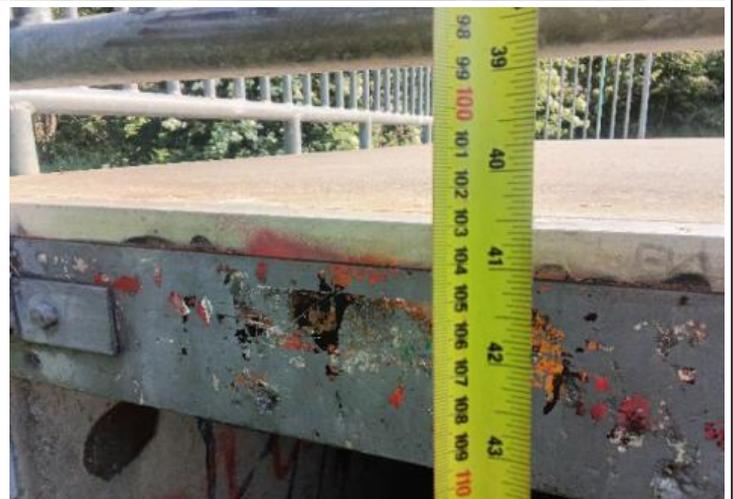
**Item:** Wheeled Sports - End Transition & Wall Ramp  
**Manufacturer:** Not Identified

**Finding:** The height of the barrier is less than 1200mm in contravention of BS EN 14974 - 6.2.6. This height must be achieved all around the platform and at a maximum distance of 300mm from the front of the platform.

**Action:** Monitor - no reasonably practicable action given the risk assessment

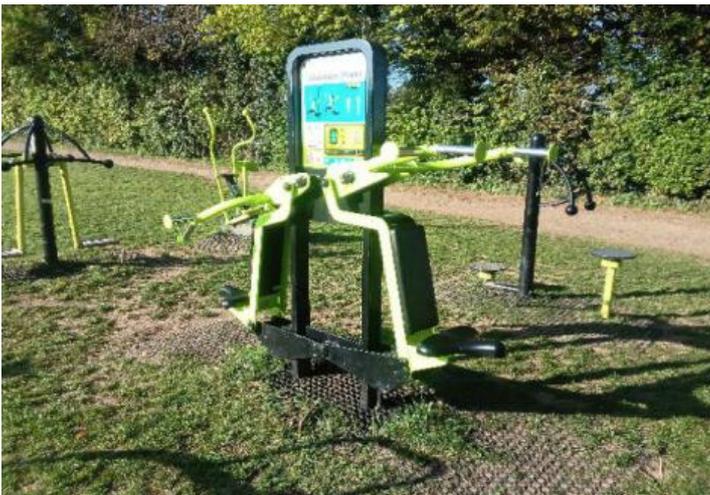
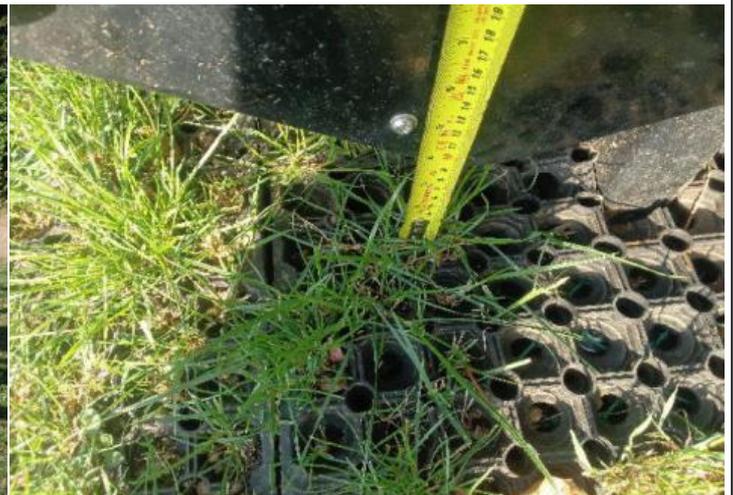
**Item:** Outdoor Fitness Equipment - Shoulder Press  
**Manufacturer:** Hags

**Finding:** The distance between the underside of the item and the ground is less than the 110mm required by BS EN 16630

**Action:** Monitor - No action given the risk assessment

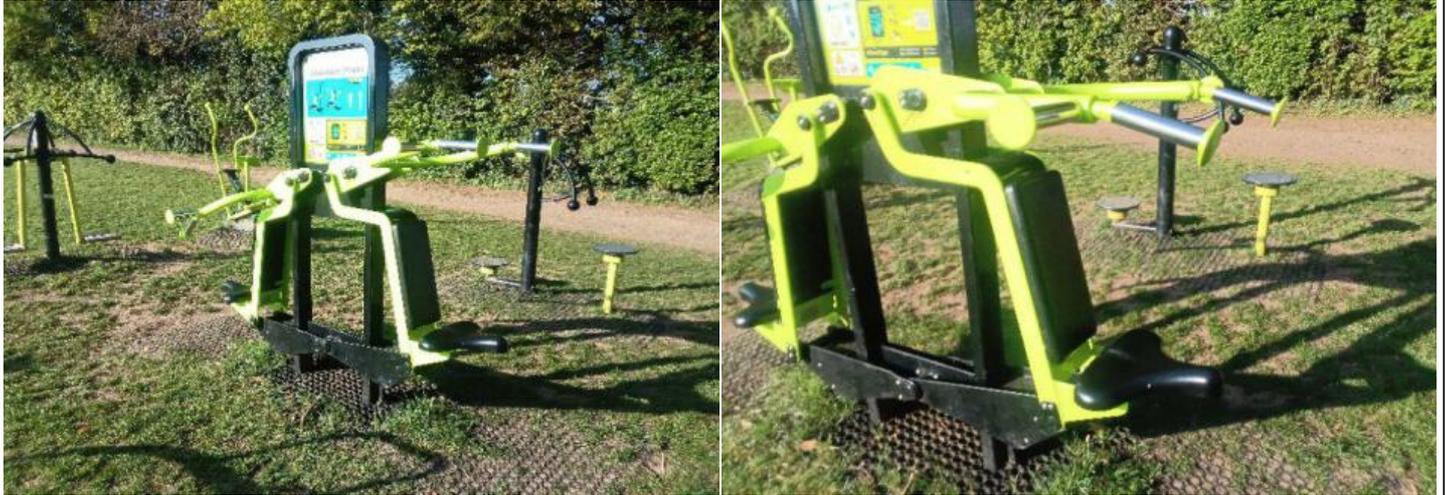
**Item:** Outdoor Fitness Equipment - Shoulder Press  
**Manufacturer:** Hags

**Finding:** BS EN 16630 - 4.3.1 states that fitness equipment shall be designed so when at rest, the equipment shall automatically adjust so that the equipment is ready for the next user  
**Action:** Service the item

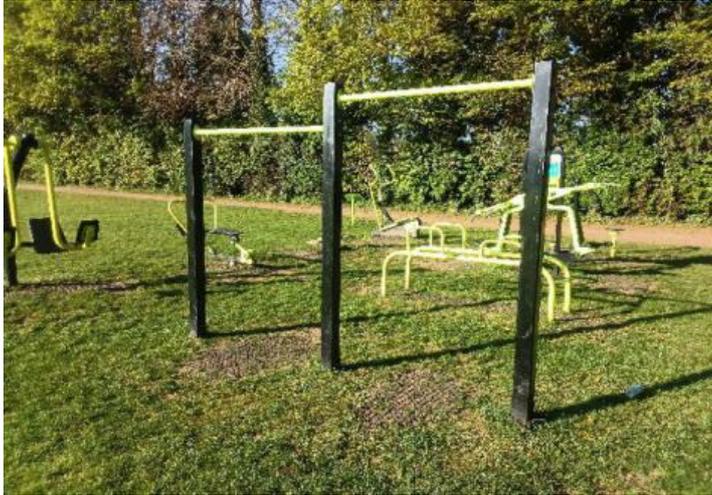
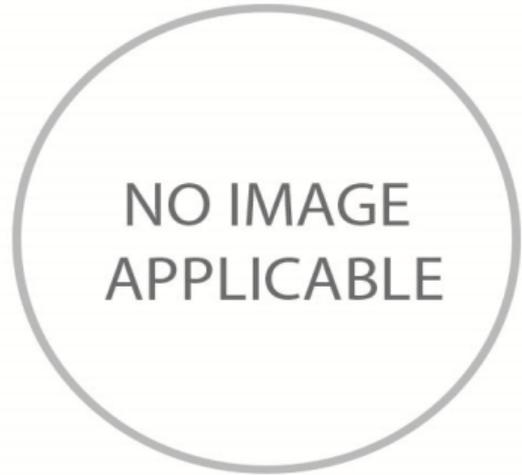
**Item:** Outdoor Fitness Equipment - Pull Up Station  
**Manufacturer:** Hags

**Finding:** There is no instruction label provided; an instruction label should be provided with each item of equipment in accordance with the requirements of BS EN 16630

**Action:** Provide appropriate instruction label/s

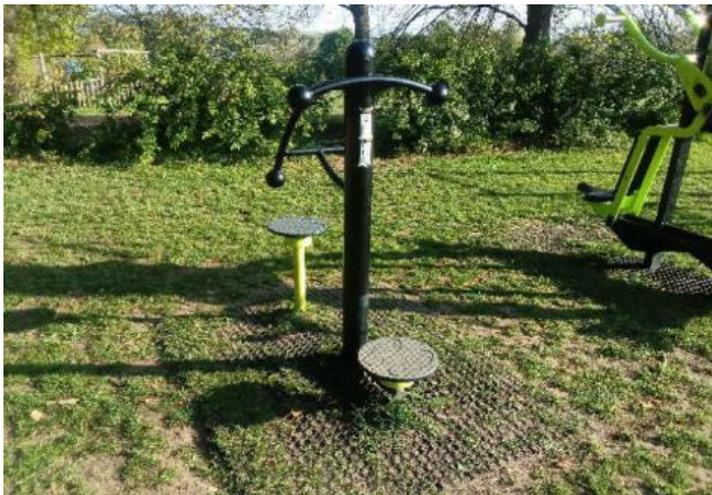
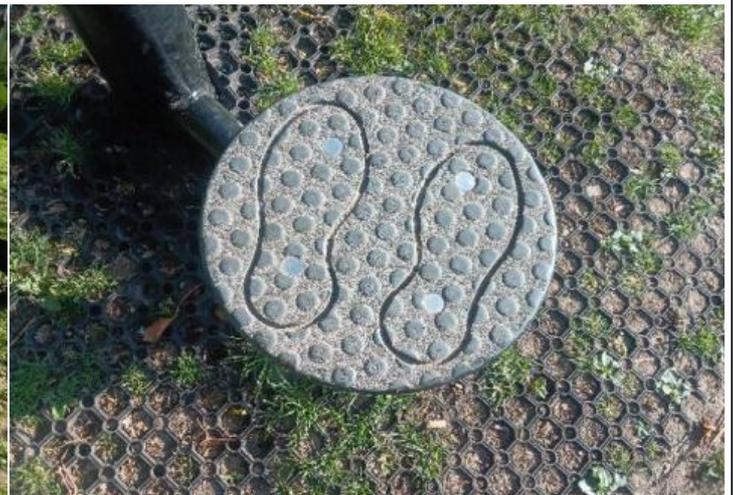
**Item:** Outdoor Fitness Equipment - Hip Twister  
**Manufacturer:** Hags

**Finding:** The rotating user station is not appropriately marked with a guideline of user direction and/or the original position as required by BS EN 16630

**Action:** Monitor - No action given the risk assessment

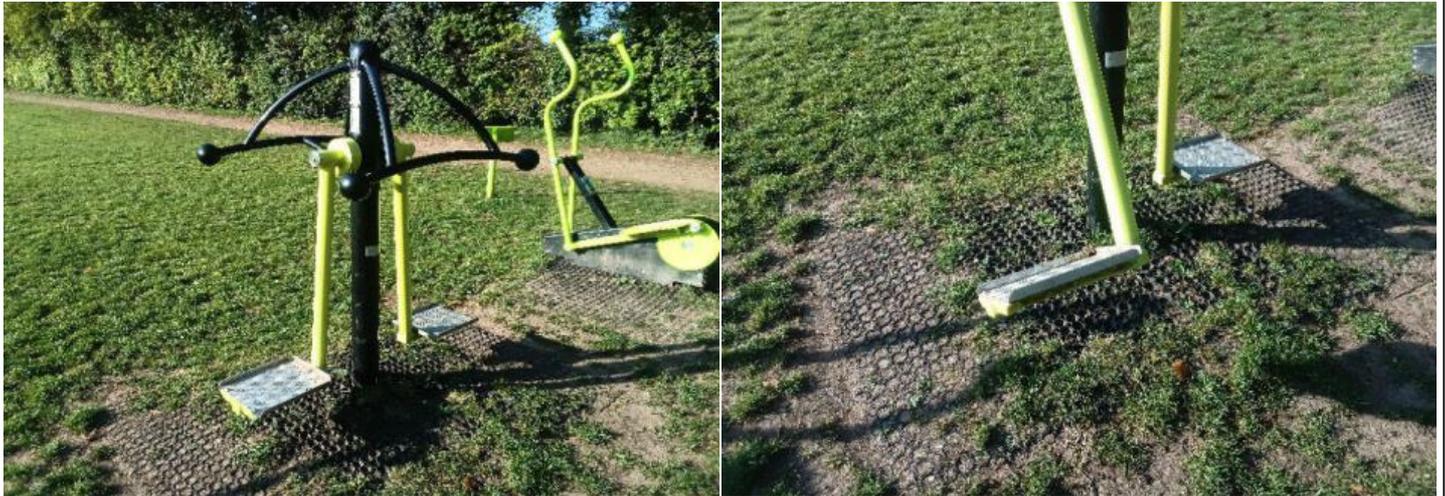
**Item:** Outdoor Fitness Equipment - Skier  
**Manufacturer:** Hags

**Finding:** The swinging movement of the footplate exceeds the maximum 55 degrees from the vertical required by BS EN 16630

**Action:** Monitor - No action given the risk assessment
