# the **play inspection** company

## Annual Inspection

Winchester City Council

Stratton Bates Recreation Ground (New Alresford)

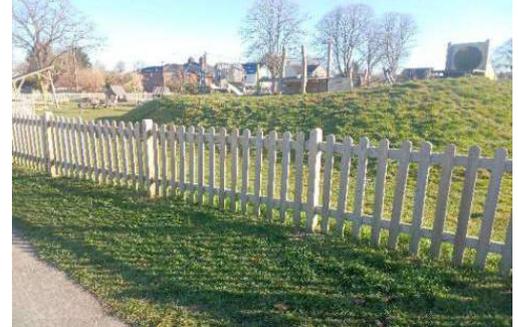
The surface has eroded in some areas and may be slippery in wet conditions - Reinstate the surface

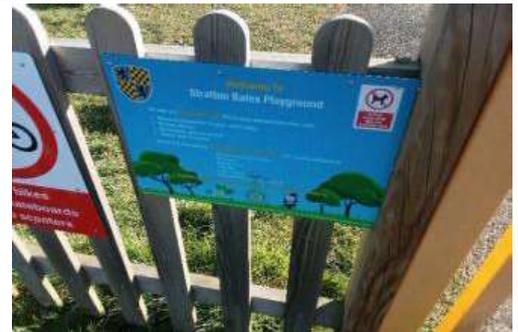
This item is satisfactory - no work required -

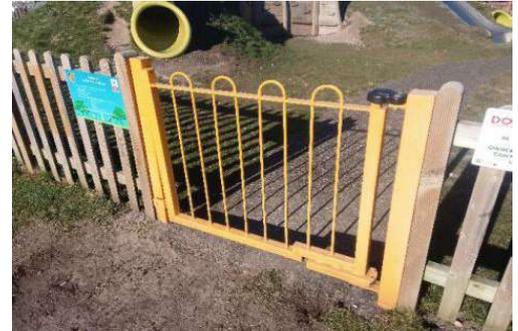
The surface has eroded in some areas and may be slippery in wet conditions - Reinstate the surface

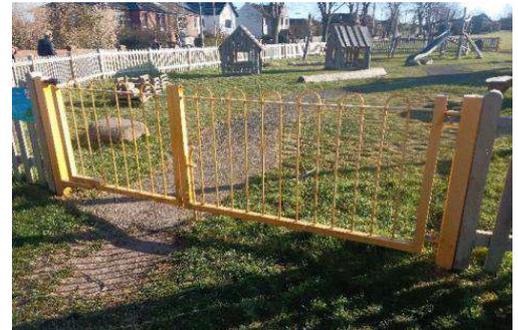
The surface has eroded in some areas and may be slippery in wet conditions - Reinstate the surface

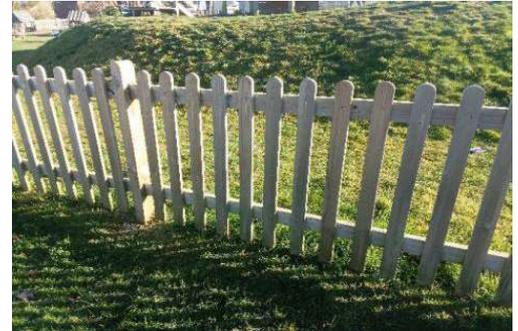
There are potential head and neck entrapments in the fencing - Monitor - No action given the risk assessment

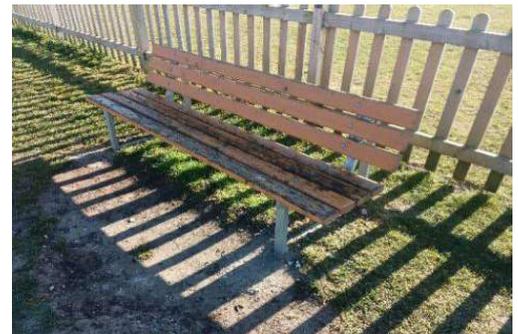
The area around the item has eroded and may become slippery - Reinstate eroded area

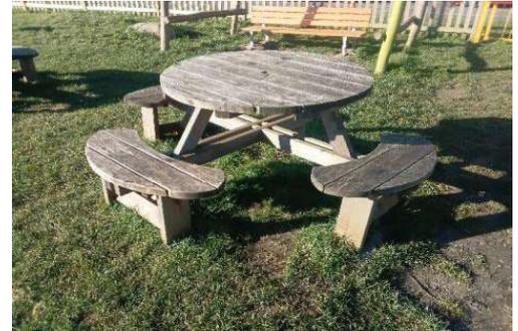
There is some strimmer / machinery damage apparent on the posts, this can penetrate the preservative applied to the timber and accelerate the rotting process - Monitor for any deterioration (rot) and replace as required

There is or are fixings missing on the item - Replace all missing fixings

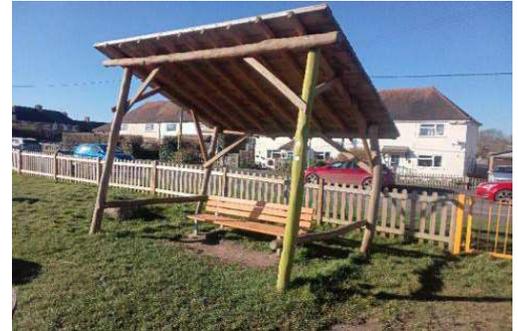
The surface has eroded and the foundations are exposed - Reinstate surrounding surfaces to cover the foundations

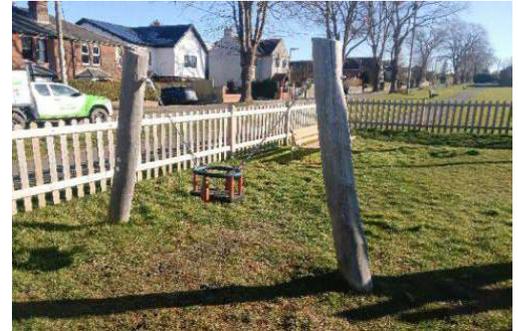
This design of swing joint has been known to fail on the weld connecting the joint to the threaded stud - We would recommend that the joint be dismantled and checked on a regular basis or consulting with manufacturer on whether a Secondary Safety Device can be fitted

There is some notable evidence of chain wear - Monitor for any further deterioration and replace when 40% worn

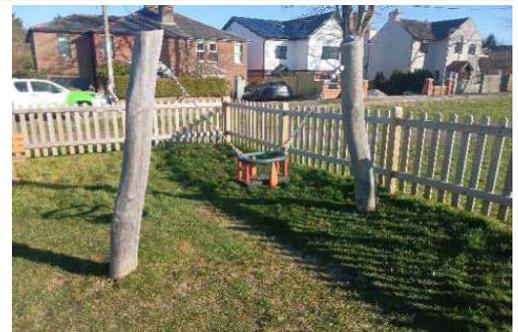
This design of swing joint has been known to fail on the weld connecting the joint to the threaded stud - We would recommend that the joint be dismantled and checked on a regular basis or consulting with manufacturer on whether a Secondary Safety Device can be fitted

There is some notable evidence of chain wear - Monitor for any further deterioration and replace when 40% worn

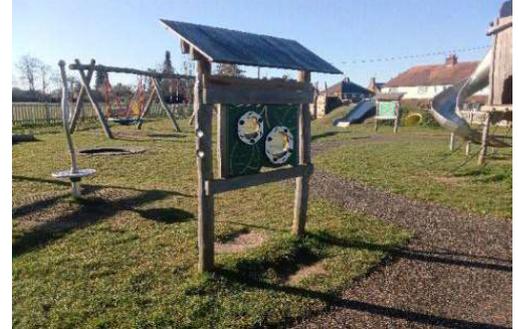
The item fails to meet the requirements of BS EN 1176 Part 1 4.2.7.2 for head and neck entrapment in the framework - Monitor - No action given the risk assessment

The surface has eroded in some areas and may be slippery in wet conditions - Reinstate the surface

The timber has a number of splits/shakes or air cracks and this may affect the stability or allow water ingress which will accelerate the rotting process - Monitor to ensure the splits do not cross through fixing points of the structure and/or cause any instability

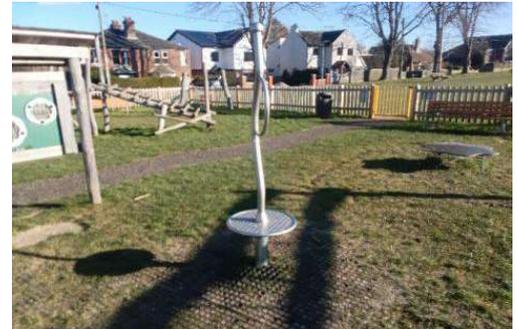
The bearing is showing signs of wear - Monitor for any further deterioration and replace as required

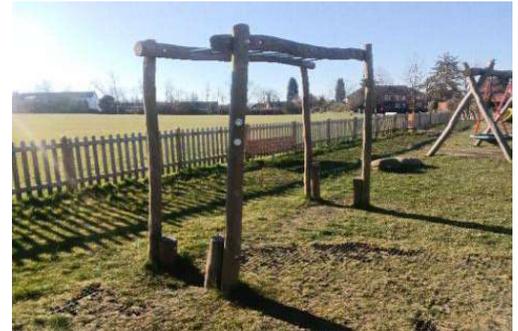
The timber has a number of splits/shakes or air cracks and this may affect the stability or allow water ingress which will accelerate the rotting process - Monitor to ensure the splits do not cross through fixing points of the structure and/or cause any instability

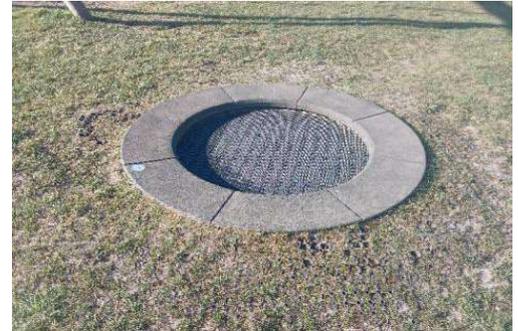
On site visits it is not possible to test the ground clearance of the Bouncing Facility bed as specified in BS EN 1176; ensure that the clearance between the Bouncing Facility Bed and the ground underneath is in accordance with the manufacturers recommendations (recorded nominal depth at time of inspection 330mm measured unloaded). - Refer to the manufacturers recommendations

There are trip hazards at the edges of the surface - Remove trip hazard

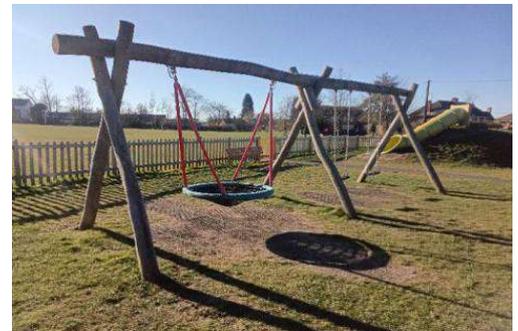
The chain openings are in excess of the 8.6mm as recommended by BS EN 1176 - Monitor - No action given the risk assessment

There is some notable evidence of chain wear - Monitor for any further deterioration and replace when 40% worn

The seat bush / bushes is / are showing signs of wear - Monitor for any further deterioration and replace as required

The timber has a number of splits/shakes or air cracks and this may affect the stability or allow water ingress which will accelerate the rotting process - Monitor to ensure the splits do not cross through fixing points of the structure and/or cause any instability

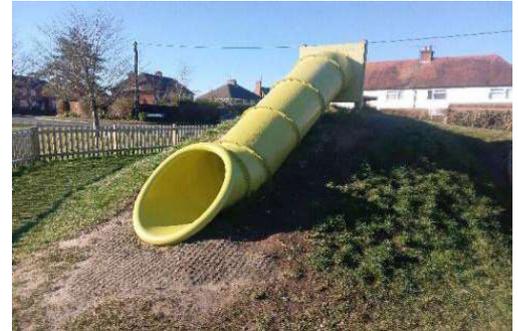
The surface has eroded in some areas and may be slippery in wet conditions - Reinstate the surface

The gel coat on the slide surface is worn - Re-dress the surface

The surface is lifting at the edges and creating trip points - Repair perimeter of surfacing to remove trip points

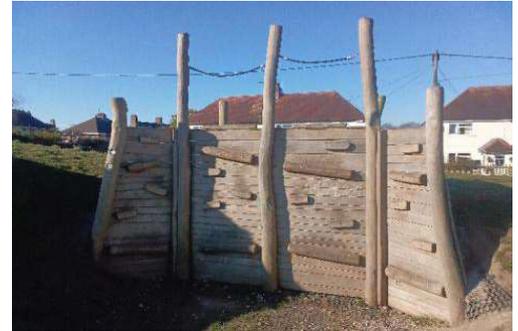
The surface has eroded in some areas and may be slippery in wet conditions - Reinstate the surface

There is/are finger entrapment/s in the climbing panel and the item fails to meet the requirements of BS EN 1176 Part 1 4.2.7.6 Entrapment of fingers - Monitor - No action given the risk assessment

The timber has a number of splits/shakes or air cracks and this may affect the stability or allow water ingress which will accelerate the rotting process - Monitor to ensure the splits do not cross through fixing points of the structure and/or cause any instability

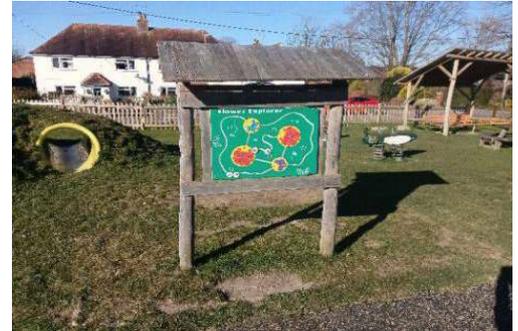
There are trip hazards at the edges of the surface - Remove trip hazard

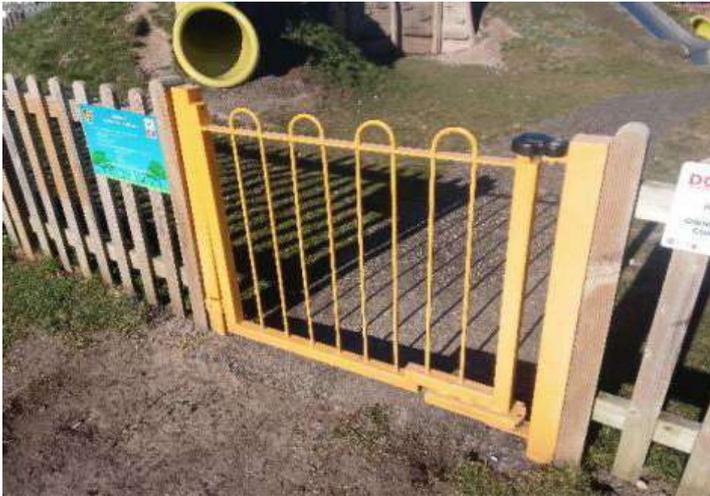
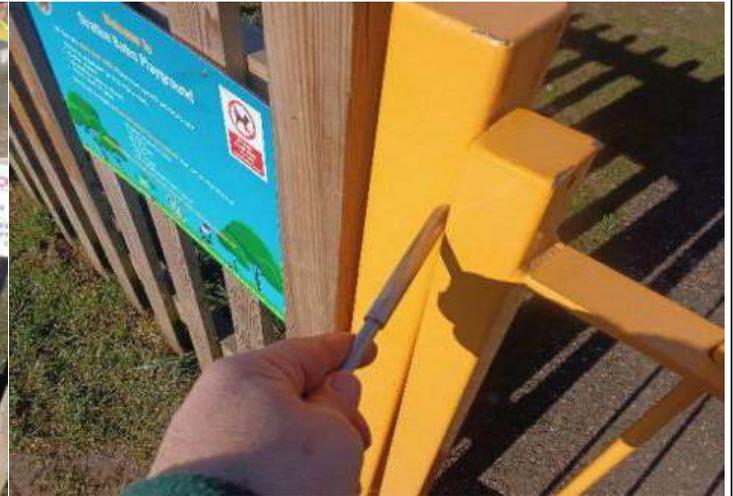
**Finding:** There are openings that are less than 12mm that could trap or crush fingers

**Action:** Provide a 12mm gap throughout full range of motion at both sides of gate

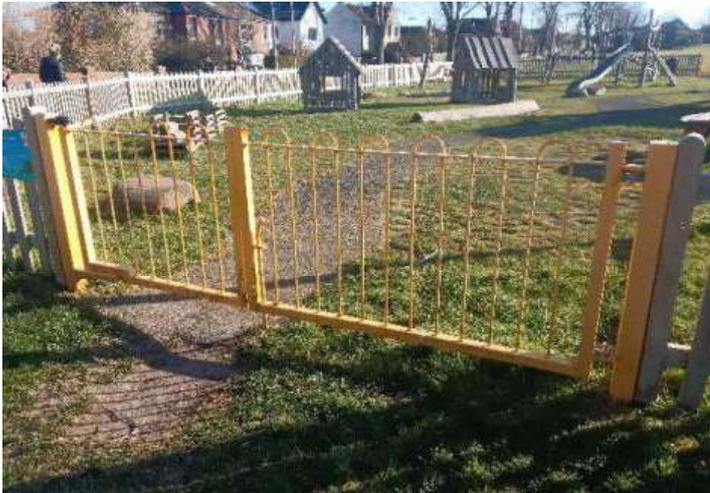
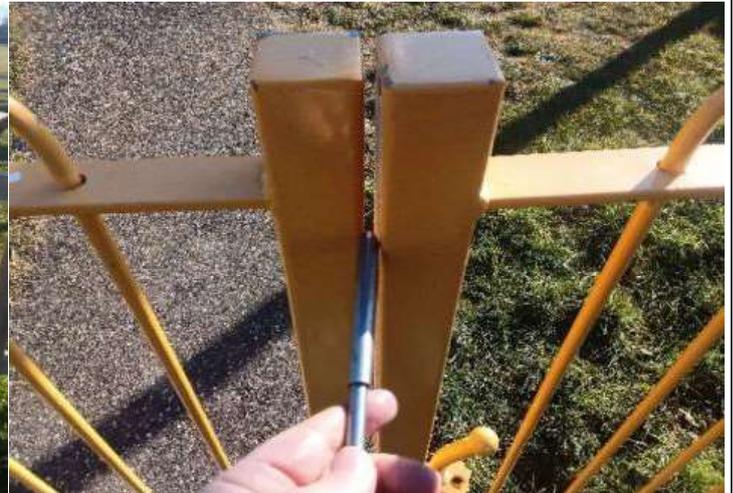
**Finding:** There are openings that are less than 12mm that could trap or crush fingers

**Action:** Provide a 12mm gap throughout full range of motion at both sides of gate

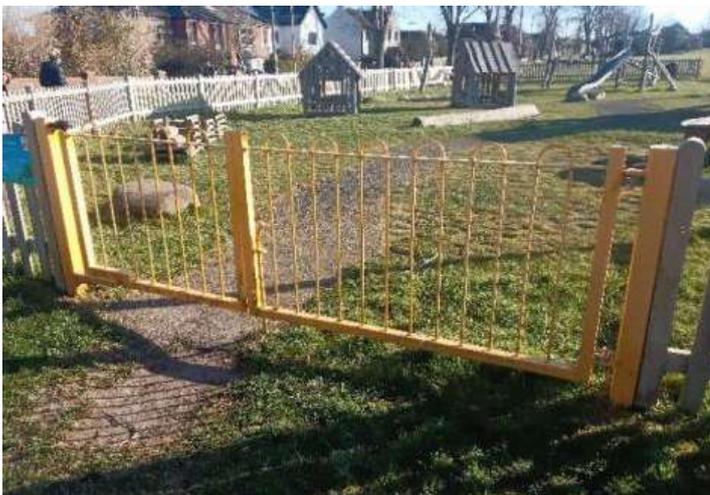
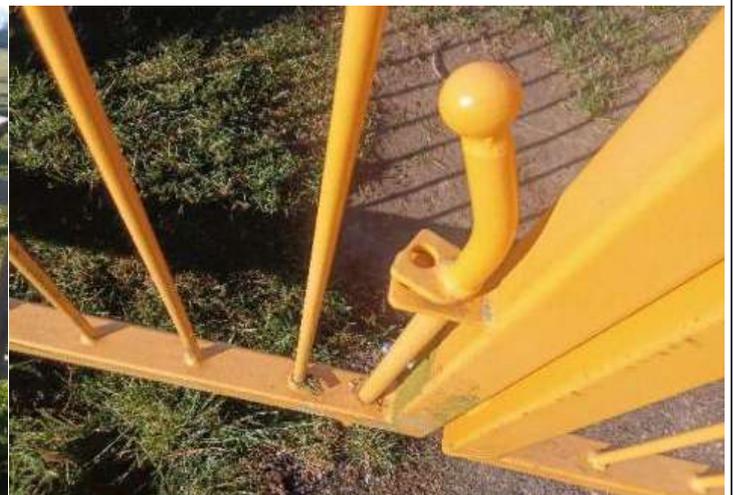
**Finding:** There is no padlock on the maintenance gate

**Action:** Provide a padlock to secure the gate

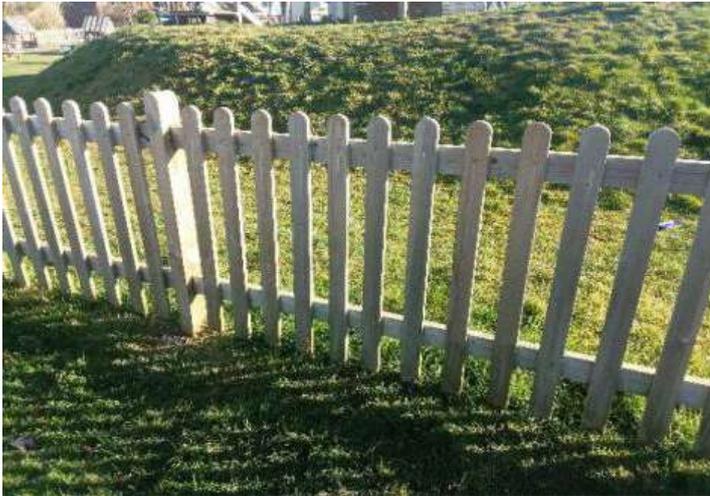
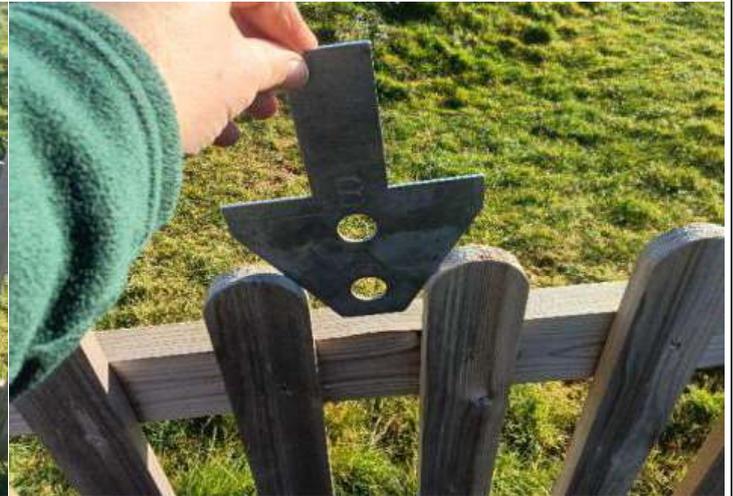
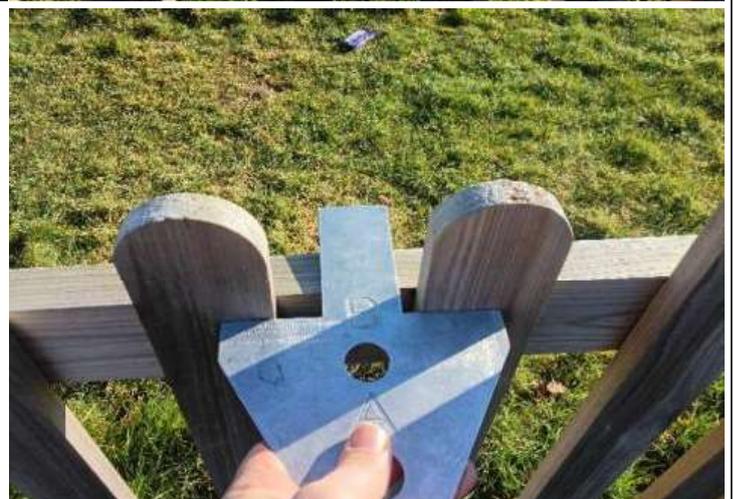
**Item:** Fences - Fencing - Timber  
**Manufacturer:** Jacksons Fencing

**Finding:** There are potential head and neck entrapments in the fencing  
**Action:** Monitor - No action given the risk assessment

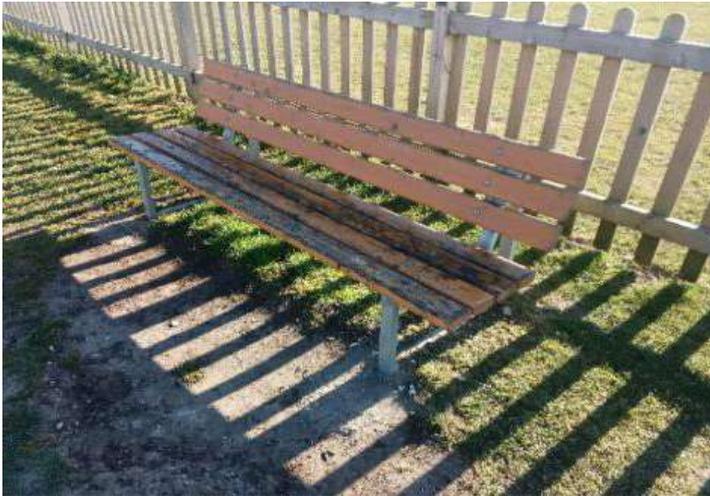
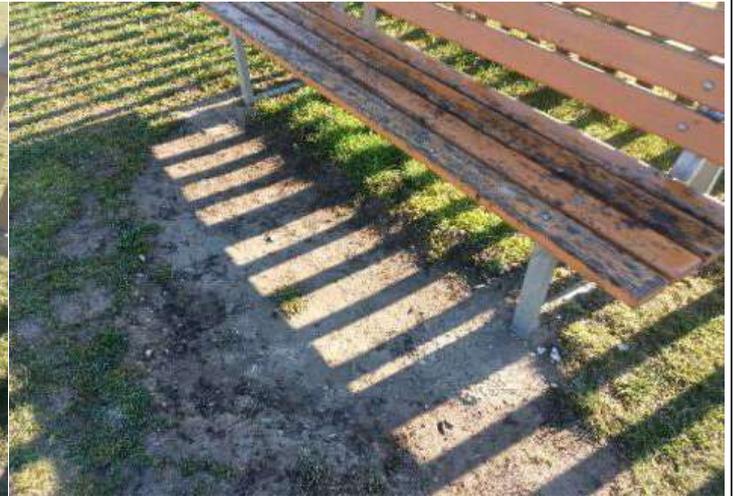
**Item:** Ancillary Items - Bench  
**Manufacturer:** Not Identified

**Finding:** The area around the item has eroded and may become slippery

**Action:** Reinstate eroded area

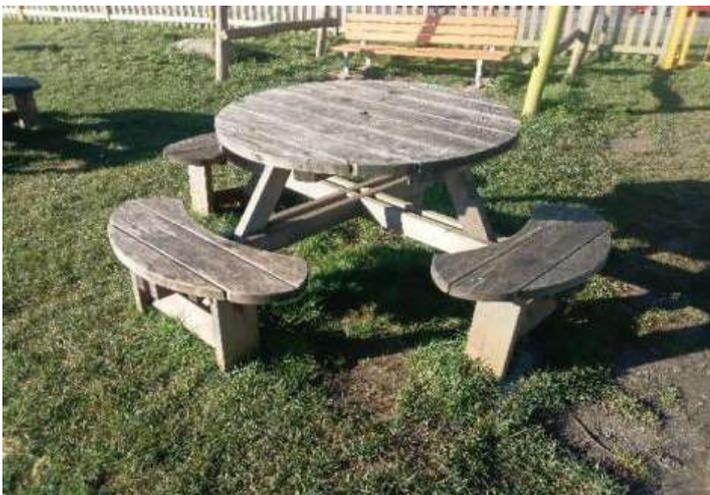
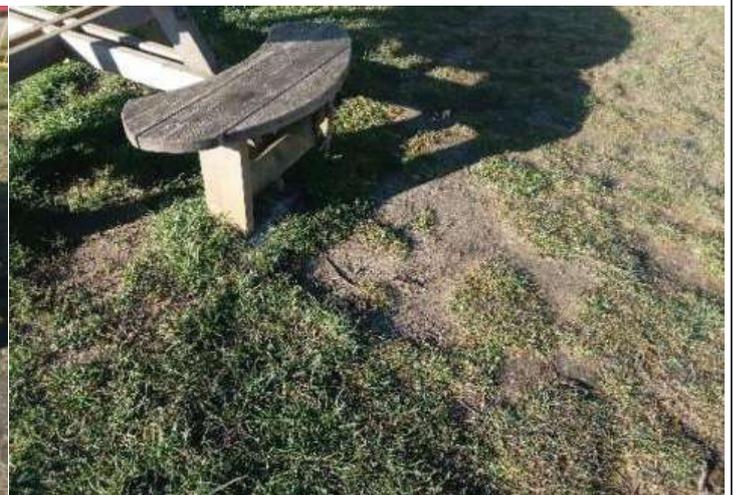
**Item:** Ancillary Items - Picnic Table  
**Manufacturer:** Not Identified

**Finding:** The area around the item has eroded and may become slippery

**Action:** Reinstate eroded area

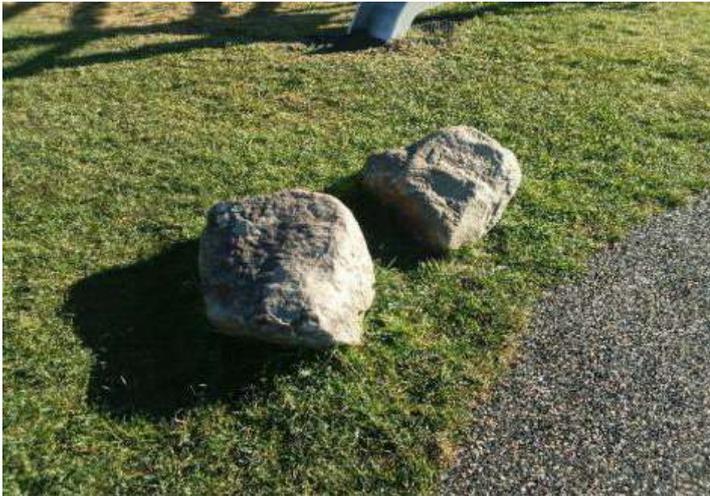
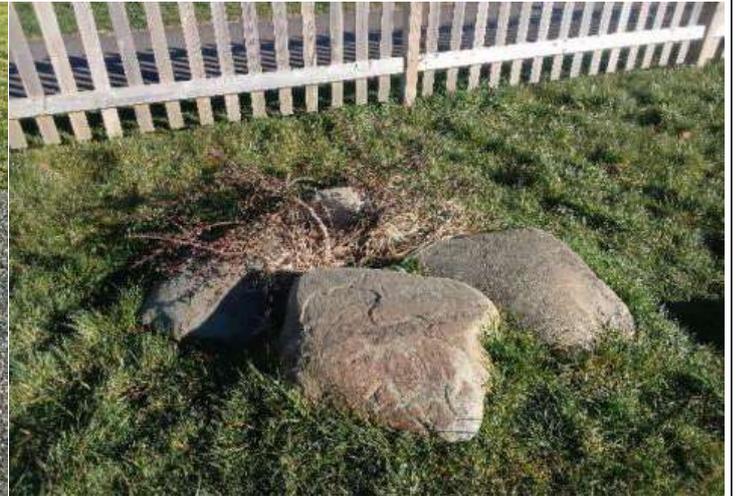
**Item:** Ancillary Items - Boulders  
**Manufacturer:** Natural Feature

**Finding:** There is weed / vegetation growth within the surface

**Action:** Remove weed / vegetation growth

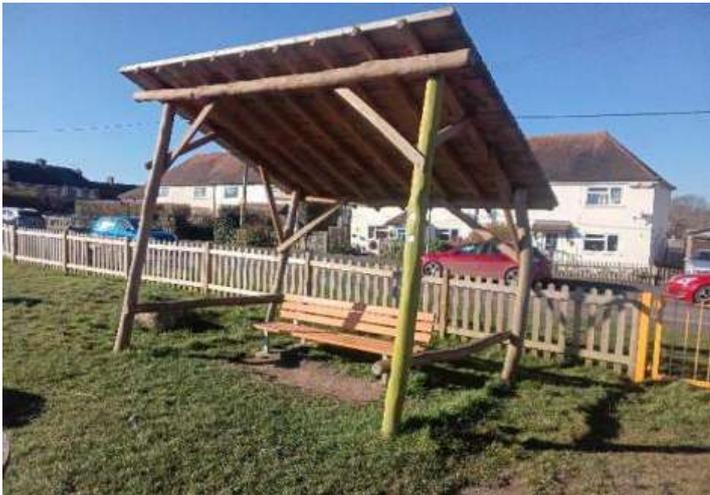
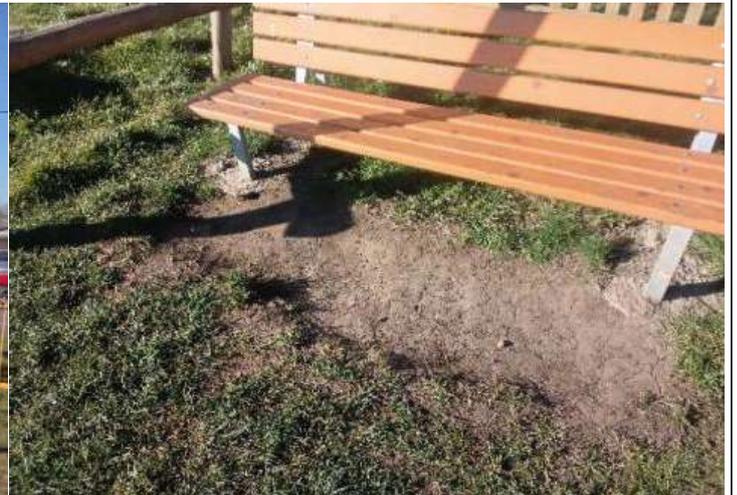
**Item:** Ancillary Items - Shelter  
**Manufacturer:** Eibe Play Ltd

**Finding:** The area around the item has eroded and may become slippery

**Action:** Reinstate eroded area

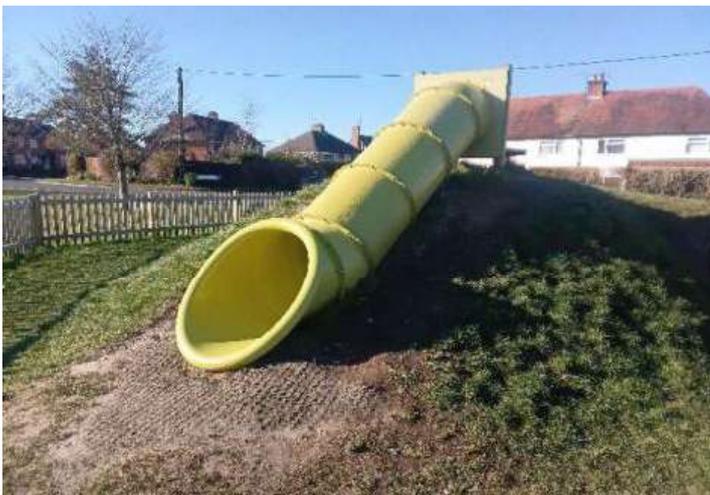
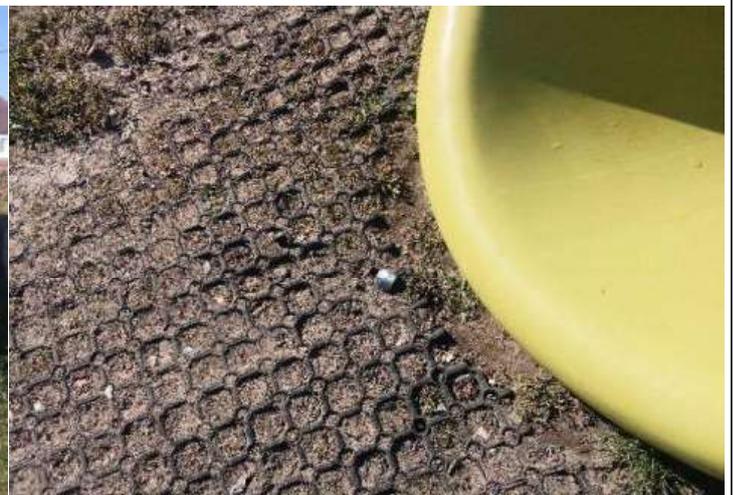
**Item:** Other - Tube Slide  
**Manufacturer:** Eibe Play Ltd

**Finding:** Fixing Pins have been installed in the impact areas of the grass mats  
**Action:** Remove pins from impact areas

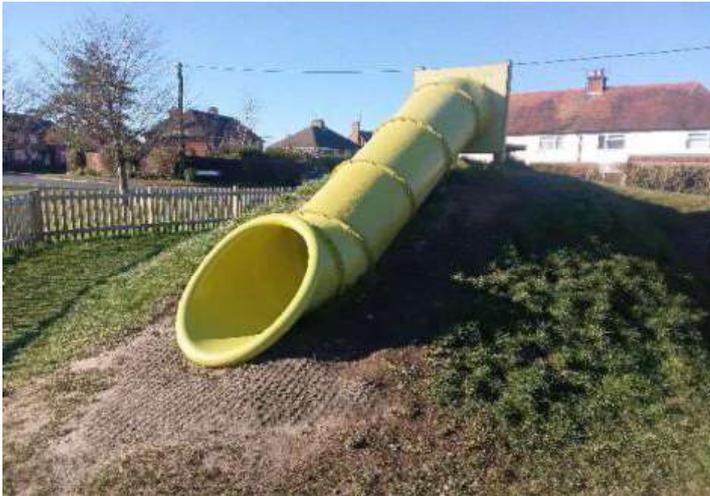
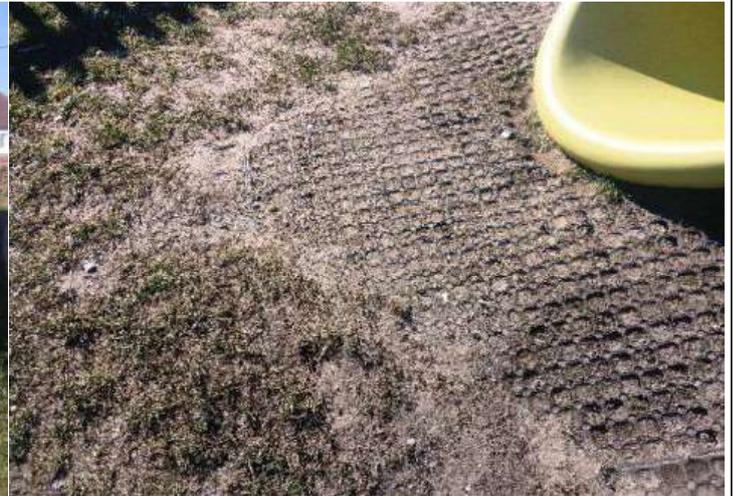
**Item:** Other - Tube Slide  
**Manufacturer:** Eibe Play Ltd

**Finding:** The grass mats are silted up, the soil is compacted and the area will become very slippery when the soil is wet. **Action:** Reinstate as required

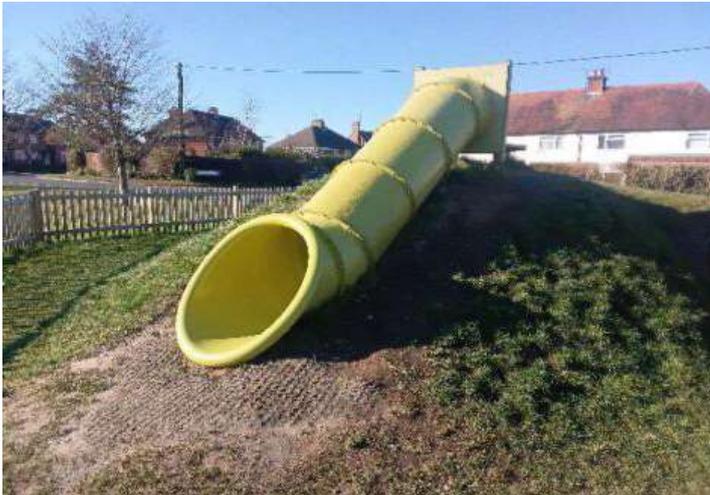
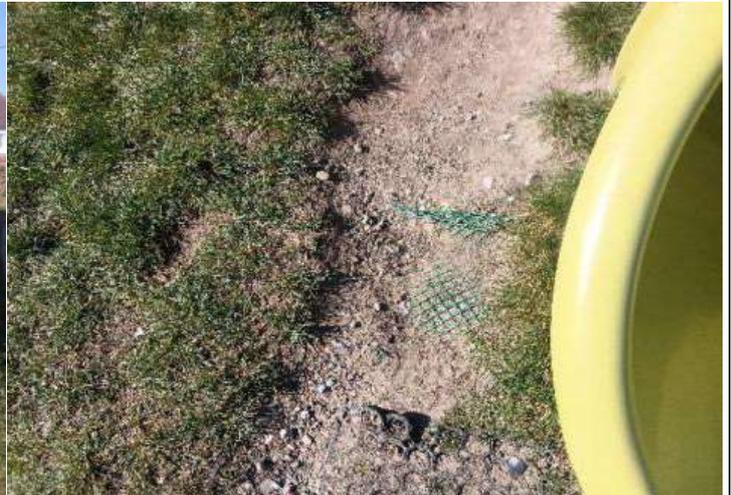
**Item:** Other - Tube Slide  
**Manufacturer:** Eibe Play Ltd

**Finding:** The surface has eroded and the membrane is exposed creating trip points

**Action:** Remove or resecure the exposed membrane and reinstate surface

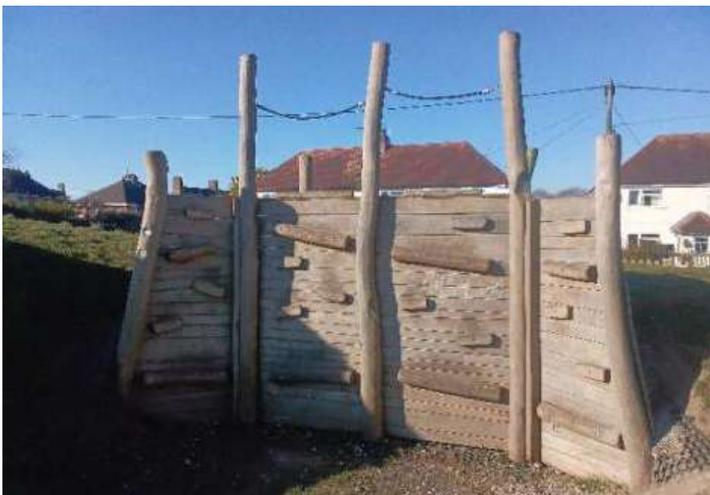
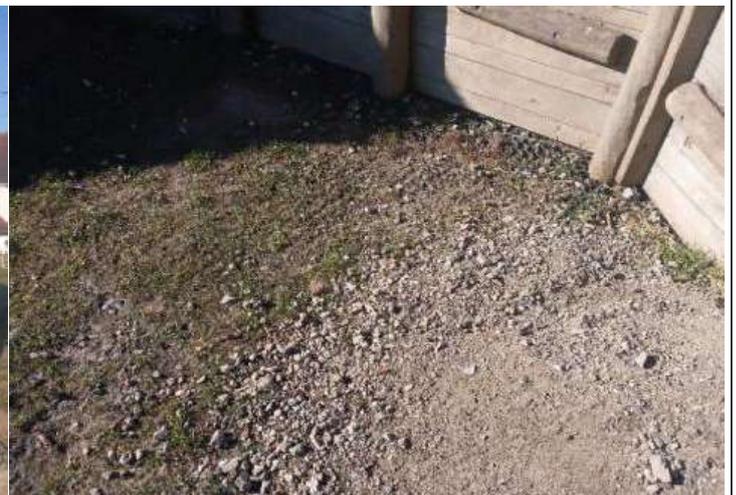
**Item:** Activity Equipment - Climbing Wall  
**Manufacturer:** Eibe Play Ltd

**Finding:** The grass mat surfacing has numerous stones present within the surface and will not perform as intended in relation to Head Injury Criterion testing  
**Action:** Lift mats and ensure stones are removed and ground is suitable prior to re-laying

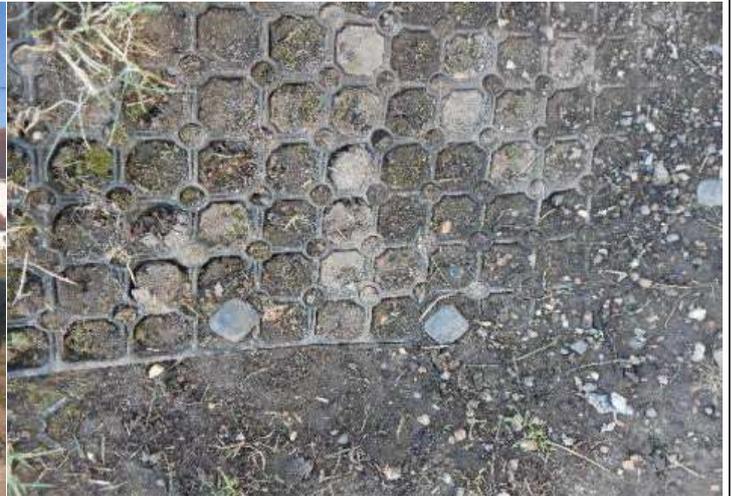
**Item:** Activity Equipment - Climbing Wall  
**Manufacturer:** Eibe Play Ltd

**Finding:** Fixing Pins have been installed in the impact areas **Action:** Remove pins from impact areas of the grass mats

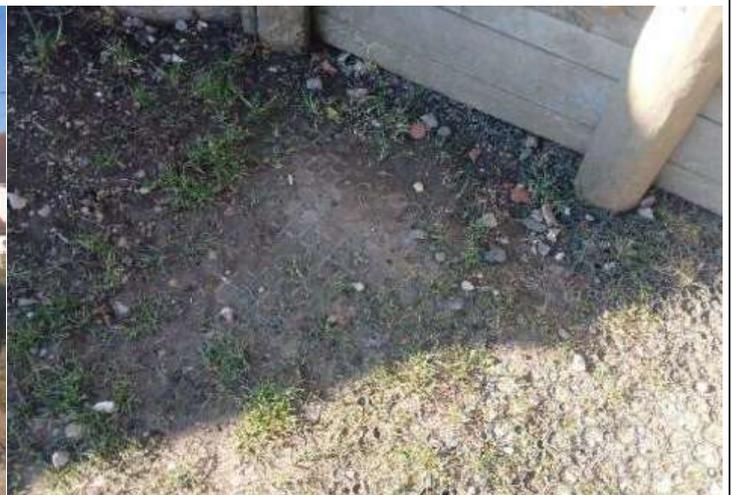
**Item:** Activity Equipment - Climbing Wall  
**Manufacturer:** Eibe Play Ltd

**Finding:** The grass mats are silted up and the soil is compacted; this may have an effect on the impact absorbing properties of the surface. Consideration should be given to HIC testing the surface to verify impact attenuating properties ( <https://playinspections.co.uk/inspection-services/safety-surface-testing/> )

**Action:** Contact our office for a quotation for this service

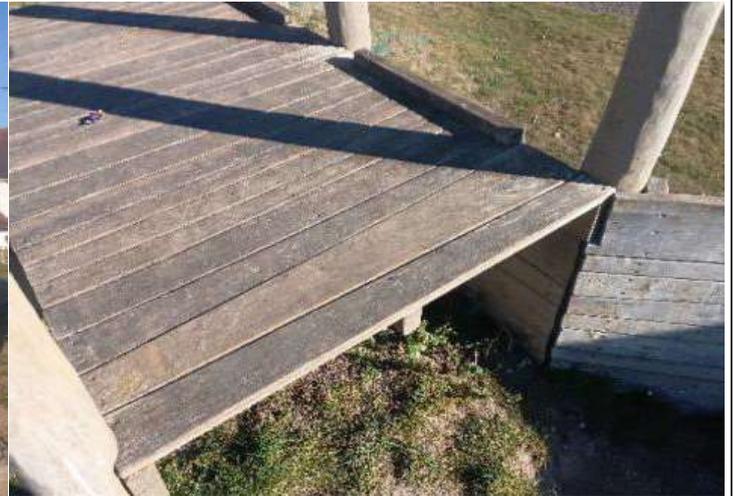
**Item:** Activity Equipment - Climbing Wall  
**Manufacturer:** Eibe Play Ltd

**Finding:** The platform is easily accessible and should have the appropriate barriers installed to meet the requirements of BS EN 1176 Part 1 as the height of the unit exceeds 600mm  
**Action:** Monitor - No action given the risk assessment

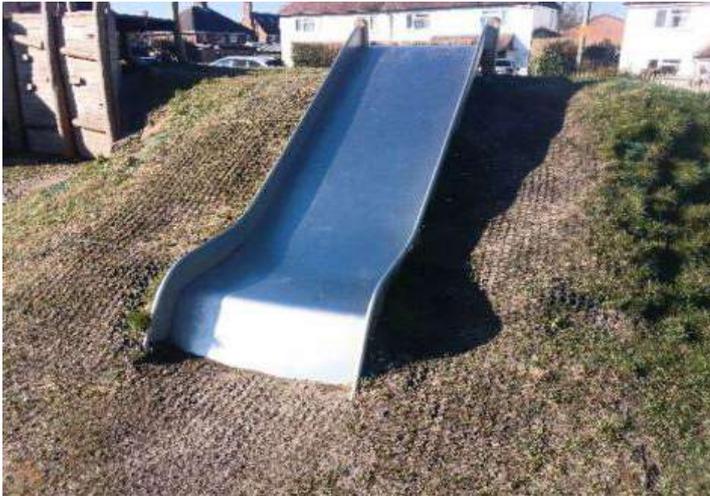
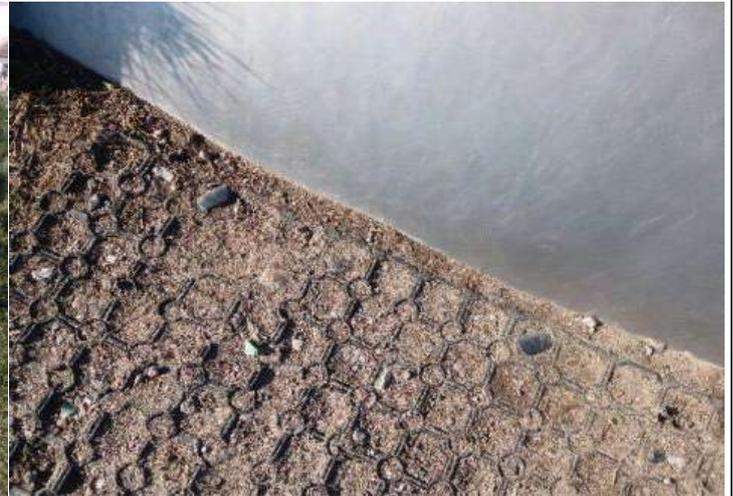
**Item:** Other - Embankment Slide  
**Manufacturer:** Eibe Play Ltd

**Finding:** Fixing Pins have been installed in the impact areas of the grass mats  
**Action:** Remove pins from impact areas

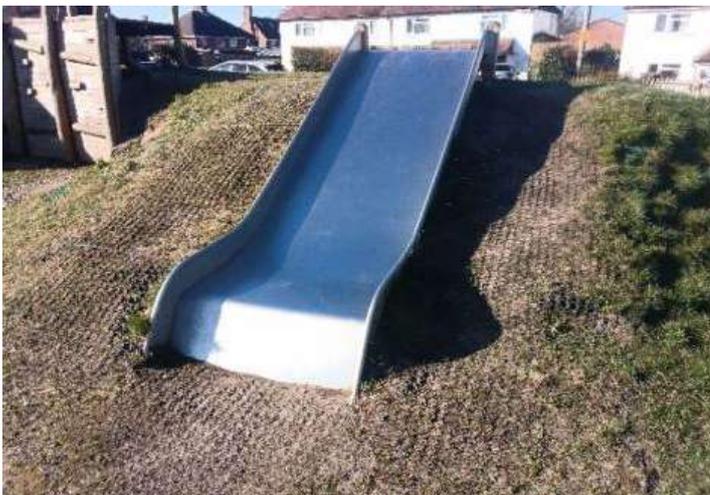
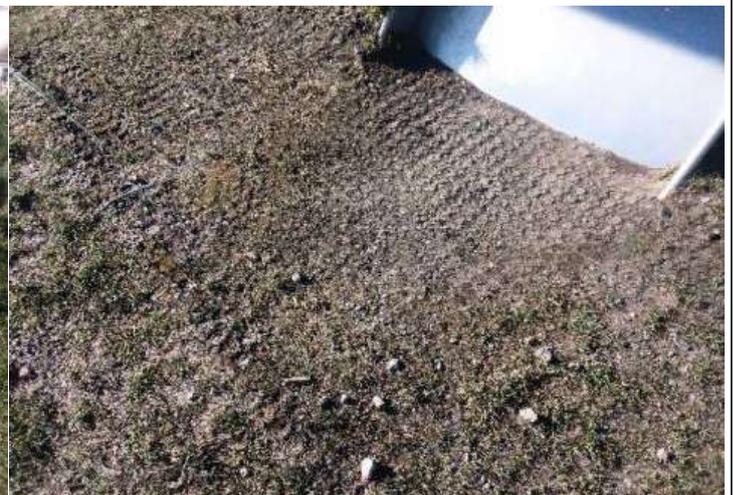
**Item:** Other - Embankment Slide  
**Manufacturer:** Eibe Play Ltd

**Finding:** The grass mat surfacing has numerous stones present within the surface and will not perform as intended in relation to Head Injury Criterion testing  
**Action:** Lift mats and ensure stones are removed and ground is suitable prior to re-laying

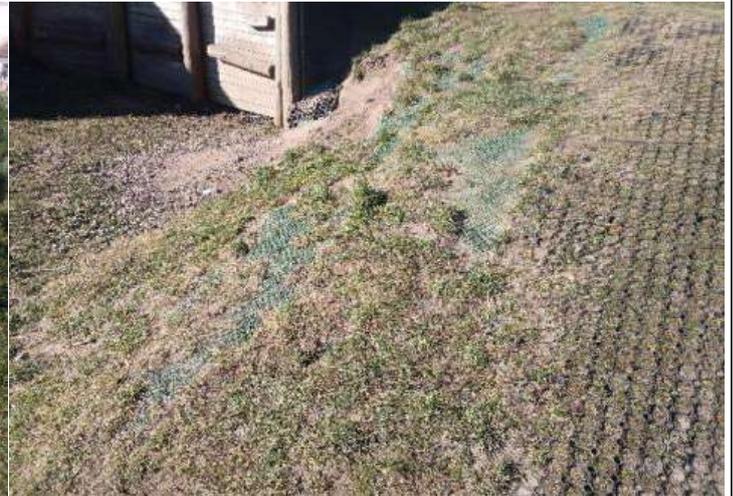
**Item:** Other - Embankment Slide  
**Manufacturer:** Eibe Play Ltd

**Finding:** The surface has eroded and the membrane is exposed creating trip points

**Action:** Remove or resecure the exposed membrane and reinstate surface

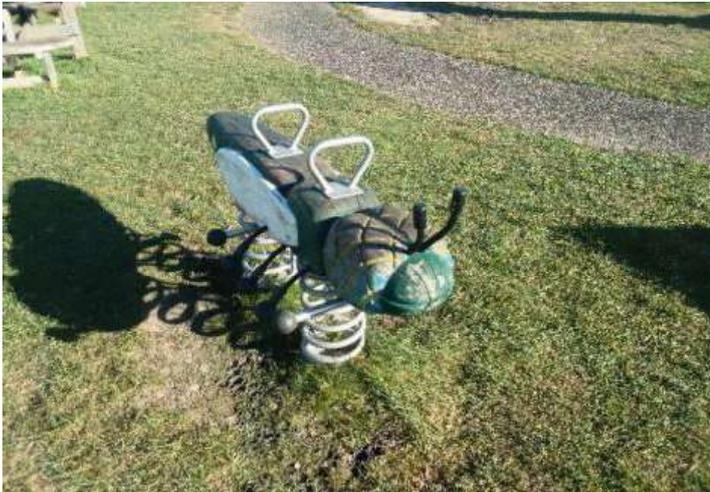
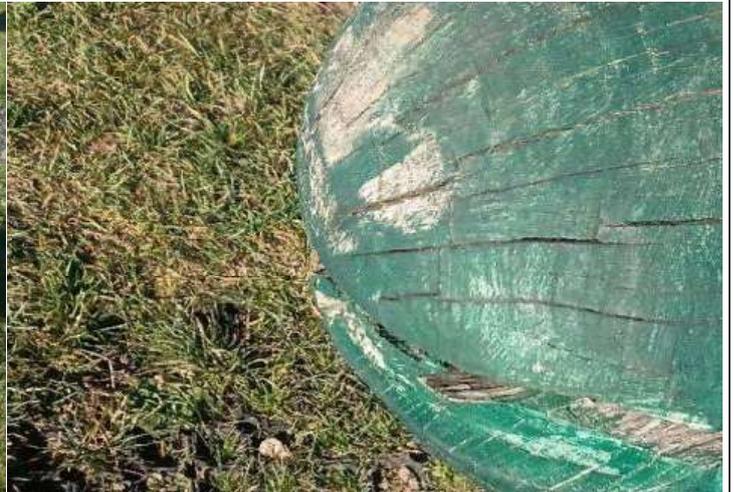
**Item:** Rocking Equipment - Spring Grasshopper  
**Manufacturer:** Eibe Play Ltd

**Finding:** Parts of the timber are rough or splintered **Action:** Remove all rough or sharp edges

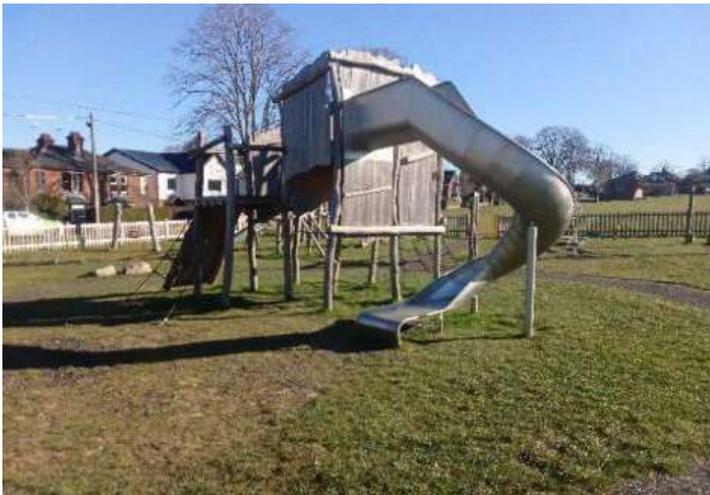
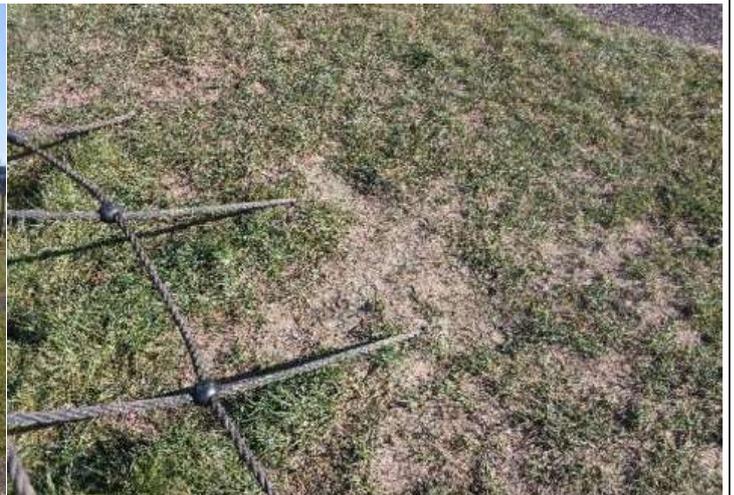
**Item:** Activity Equipment - Multi Play (Junior)  
**Manufacturer:** Eibe Play Ltd

**Finding:** The grass mats are silted up, the soil is compacted and the area will become very slippery when the soil is wet.

**Action:** Reinstate as required

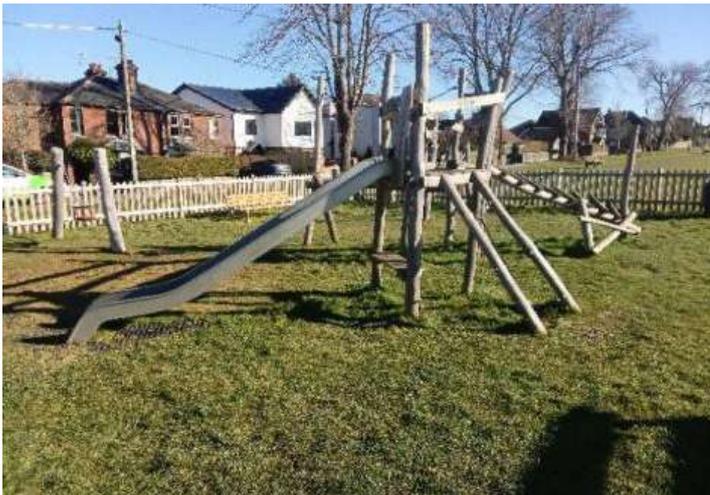
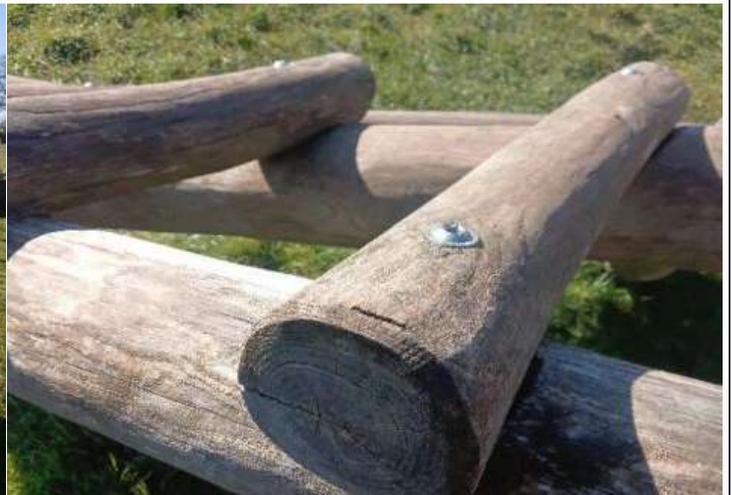
**Item:** Activity Equipment - Multi Play (Junior)  
**Manufacturer:** Eibe Play Ltd

**Finding:** Parts of the timber are rough or splintered  
**Action:** Remove all rough or sharp edges
