## Annual Inspection

Winchester City Council

Sun Hill Recreation Ground (New Alresford)

Derwent Gardens, Alresford, SO24 9NQ

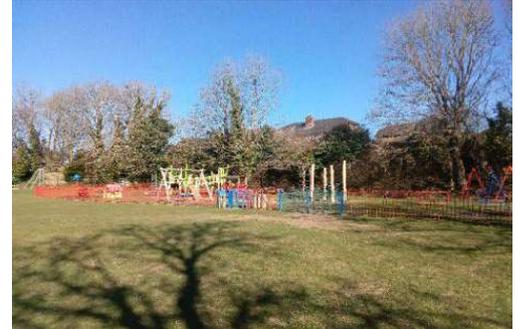
**Item:** Site General  
**Manufacturer:** Owner/Operator  
**Surface Type:** N/A  
**Item Quantity:** 1  
**Equipment Compliance:** N/A  
**Surface Area Compliance:** N/A

The surface has eroded in some areas and may be slippery in wet conditions - Reinstate the surface

There is algae, silt or moss growth on the wet pour surfacing resulting in slippery conditions - Clean and treat appropriately

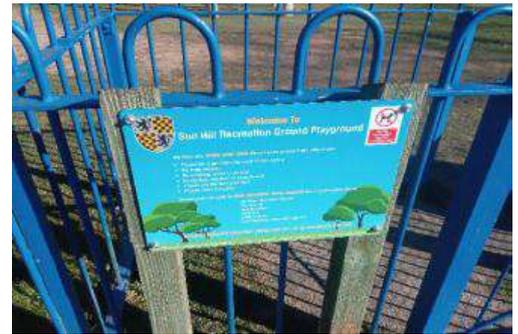
**Item:** Sign  
**Manufacturer:** Not Identified  
**Surface Type:** N/A  
**Item Quantity:** 1  
**Equipment Compliance:** N/A  
**Surface Area Compliance:** N/A

This item is satisfactory - no work required -

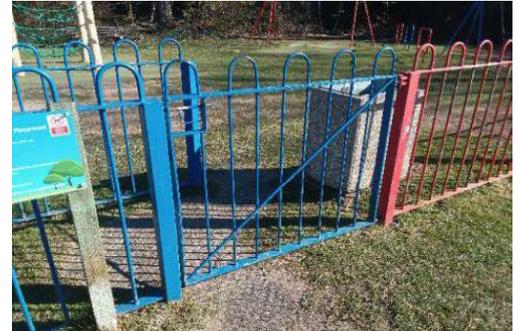
**Item:** Kissing Gate  
**Manufacturer:** Not Identified  
**Surface Type:** Grass Matrix Tiles  
**Item Quantity:** 1  
**Equipment Compliance:** N/A  
**Surface Area Compliance:** N/A

The paintwork on this item has been damaged or worn exposing the metal underneath which is rusting / corroding - Treat affected areas and repaint

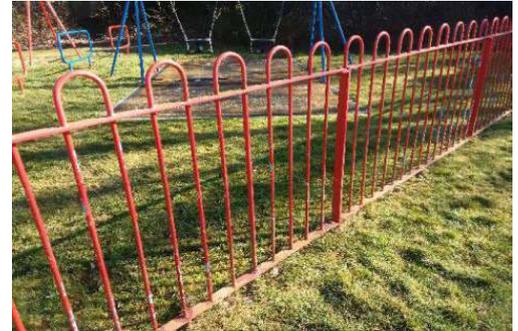
**Item:** Fence - Bow Top  
**Manufacturer:** Not Identified  
**Surface Type:** Grass  
**Item Quantity:** 1  
**Equipment Compliance:** N/A  
**Surface Area Compliance:** N/A

There is some damage to the fence sections - Monitor for any further deterioration and repair as required

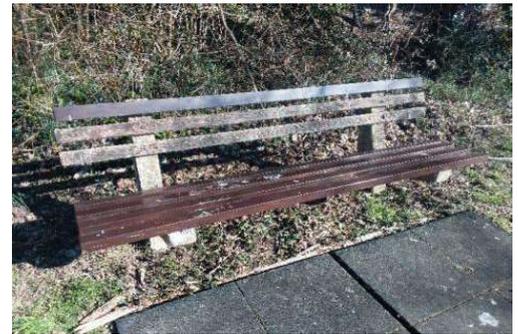
**Item:** Bench  
**Manufacturer:** Not Identified  
**Surface Type:** Mixed Surface  
**Item Quantity:** 2  
**Equipment Compliance:** N/A  
**Surface Area Compliance:** N/A

There are gaps opening in between the tiles - Monitor for any further deterioration and repair as required

There is/are inserts missing - Replace missing inserts

There is some evidence of rot in the timber - Monitor for any further deterioration and replace as required

There are areas or parts of the timber edging that have rotted - Replace all affected timbers

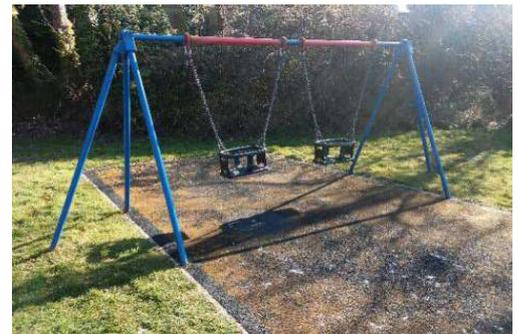
**Item:** 1 Bay 2 Seat (Cradle)  
**Manufacturer:** Wicksteed Playgrounds  
**Surface Type:** Wet Pour  
**Item Quantity:** 1  
**Equipment Compliance:** Yes  
**Surface Area Compliance:** Yes

The Anti Wrap bearings are dry and not moving freely - Lubricate bearings in accordance with the manufacturers recommendations

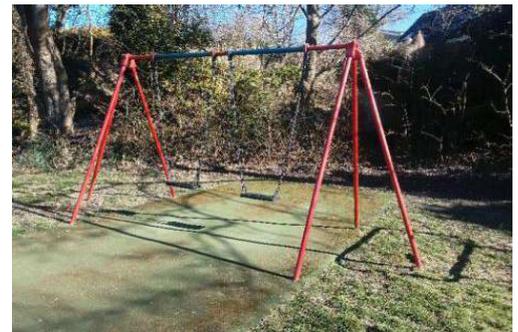
**Item:** 1 Bay 2 Seat (Flat)  
**Manufacturer:** Wicksteed Playgrounds  
**Surface Type:** Carpet System  
**Item Quantity:** 1  
**Equipment Compliance:** Yes  
**Surface Area Compliance:** Yes

The safety surface is beginning to wear - Monitor for any further deterioration and repair as required

The anti wrap hanger bush / bushes is / are showing signs of wear - Monitor for any further deterioration and replace as required

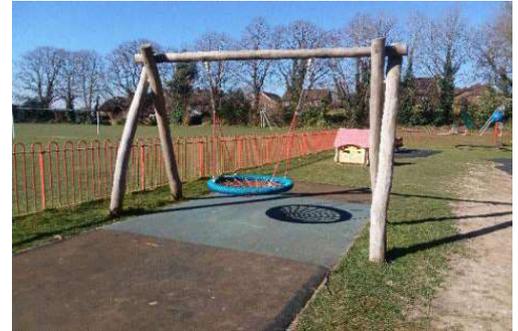
**Item:** Basket Swing - Type 1  
**Manufacturer:** Dylan Group Ltd  
**Surface Type:** Wet Pour  
**Item Quantity:** 1  
**Equipment Compliance:** No  
**Surface Area Compliance:** Yes

There are gaps opening between the surfacing and the edging surround or between the joints in the surfacing - Monitor for any further deterioration and repair as required

There is some notable evidence of chain wear - Monitor for any further deterioration and replace when 40% worn

The connecting links are in excess of 8.6mm and less than 12mm and fail the requirements of BS EN 1176 Part 1; clause 4.2.13, Chains - Monitor - No action given the risk assessment

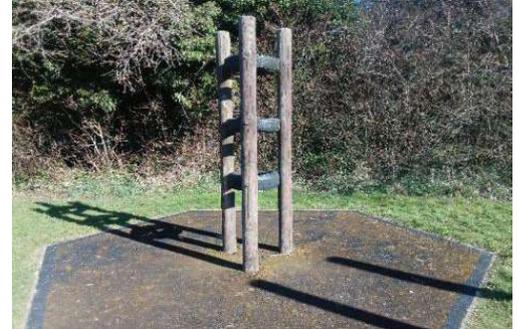
**Item:** Tyre Climber  
**Manufacturer:** Lappset UK Ltd  
**Surface Type:** Wet Pour  
**Item Quantity:** 1  
**Equipment Compliance:** Yes  
**Surface Area Compliance:** No

This item of equipment relies on a single post, or a line of posts, for stability and extra care needs to be taken with equipment of this nature to avoid the potential for catastrophic failure; it has been checked at the time of inspection however its important that particular attention is applied on all interim inspections - Ensure that regular detailed inspections are undertaken to assess for rot, corrosion and general stability

The tyres are losing their integrity - Monitor for any further deterioration and replace as required

The timber stain is in poor condition - Prepare all affected parts and re-stain with an appropriate preservative

There is some evidence of rot in the posts - Monitor for any further deterioration and replace as required

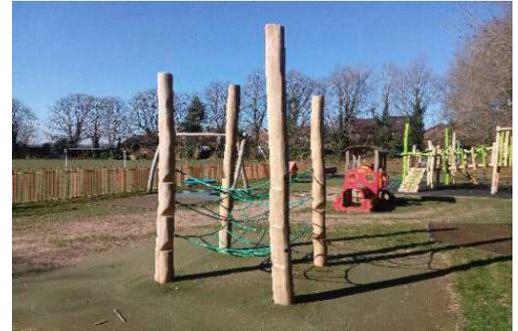
**Item:** Net Climber  
**Manufacturer:** Dylan Group Ltd  
**Surface Type:** Artificial Grass  
**Item Quantity:** 1  
**Equipment Compliance:** Yes  
**Surface Area Compliance:** Yes

This item of equipment relies on a single post, or a line of posts, for stability and extra care needs to be taken with equipment of this nature to avoid the potential for catastrophic failure; it has been checked at the time of inspection however its important that particular attention is applied on all interim inspections - Ensure that regular detailed inspections are undertaken to assess for rot, corrosion and general stability

There is some evidence of fire damage to the surfacing - Monitor for any further deterioration and repair as required

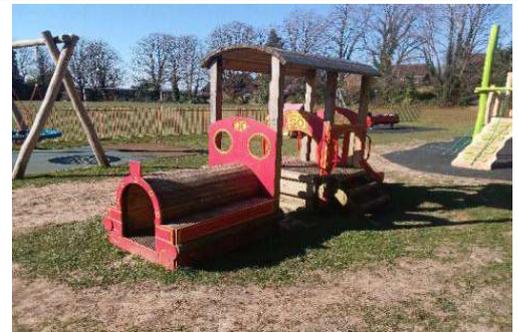
**Item:** Train  
**Manufacturer:** Not Identified  
**Surface Type:** Grass  
**Item Quantity:** 1  
**Equipment Compliance:** Yes  
**Surface Area Compliance:** Yes

The timber has a number of splits/shakes or air cracks and this may affect the stability or allow water ingress which will accelerate the rotting process - Monitor to ensure the splits do not cross through fixing points of the structure and/or cause any instability

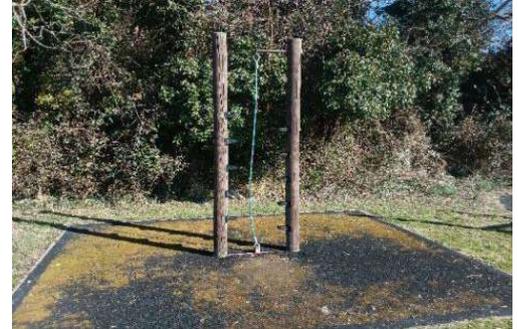
**Item:** Climbing Post  
**Manufacturer:** Lappset UK Ltd  
**Surface Type:** Wet Pour  
**Item Quantity:** 1  
**Equipment Compliance:** No  
**Surface Area Compliance:** Yes

This item of equipment relies on a single post, or a line of posts, for stability and extra care needs to be taken with equipment of this nature to avoid the potential for catastrophic failure; it has been checked at the time of inspection however its important that particular attention is applied on all interim inspections - Ensure that regular detailed inspections are undertaken to assess for rot, corrosion and general stability

There is some evidence of rot in the posts - Monitor for any further deterioration and replace as required

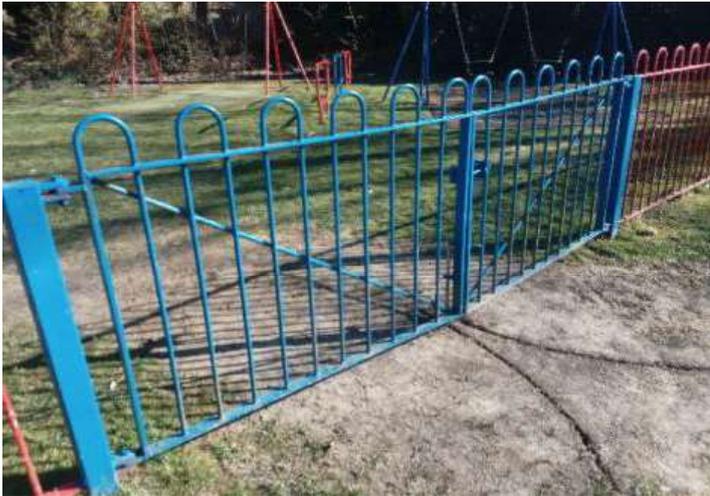
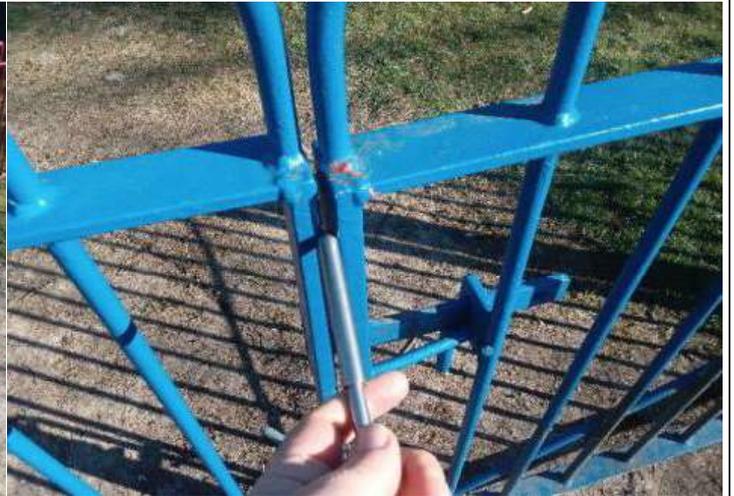
**Item:** Gates - Gate - Maintenance  
**Manufacturer:** Not Identified

**Finding:** There are openings that are less than 12mm that could trap or crush fingers

**Action:** Provide a 12mm gap throughout full range of motion at both sides of gate

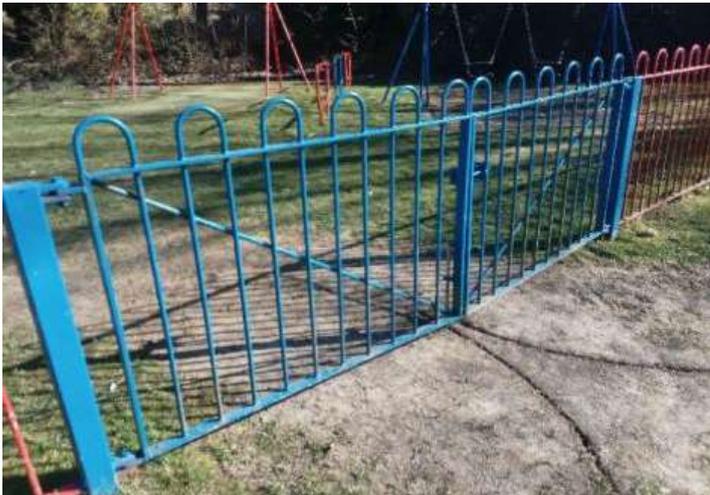
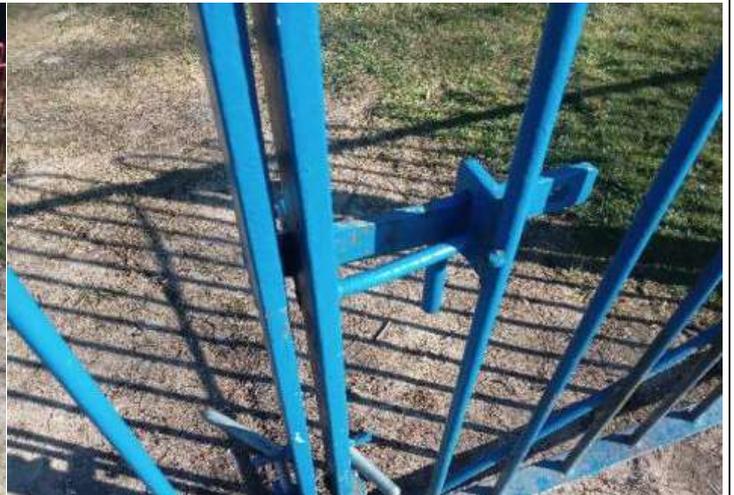
**Item:** Gates - Gate - Maintenance  
**Manufacturer:** Not Identified

**Finding:** There is no padlock on the maintenance gate

**Action:** Provide a padlock to secure the gate

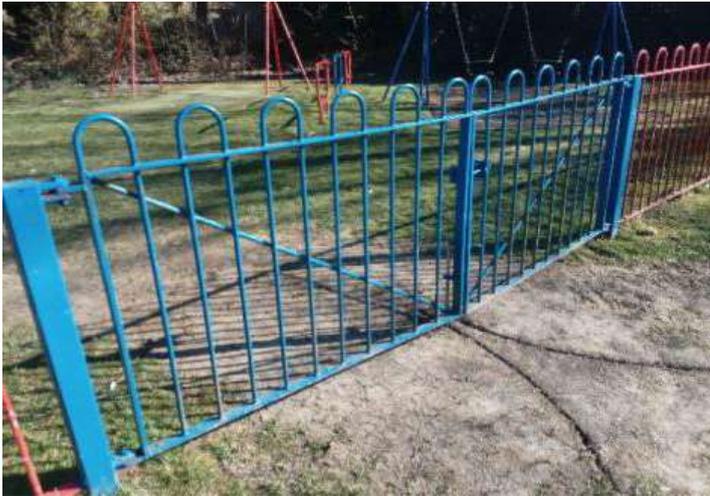
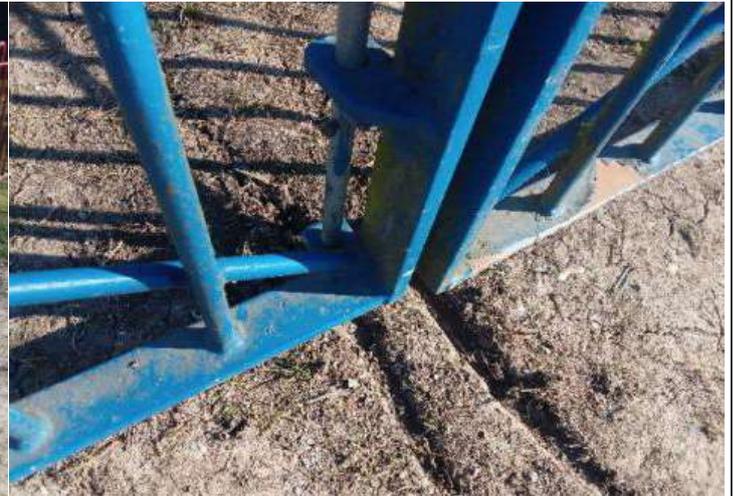
**Item:** Gates - Gate - Maintenance  
**Manufacturer:** Not Identified

**Finding:** The gate has no drop bolt sleeves and/or drop bolts fitted

**Action:** Provide drop bolt sleeves and/or drop bolts

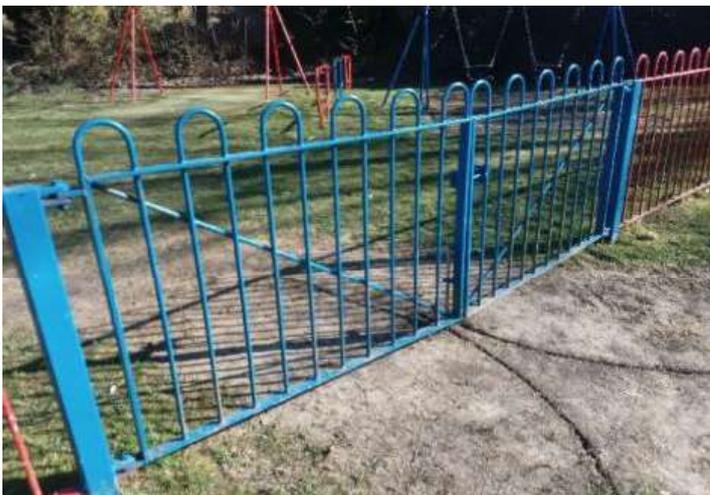
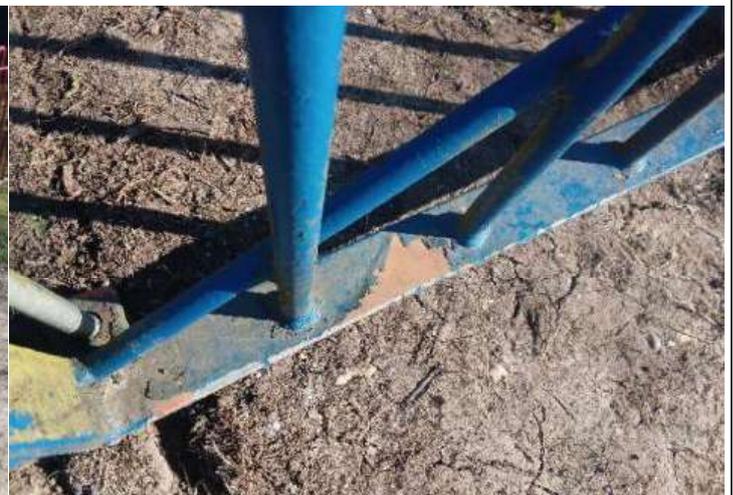
**Item:** Gates - Gate - Maintenance  
**Manufacturer:** Not Identified

**Finding:** The paint is flaking off the metalwork

**Action:** Rub down and re-paint

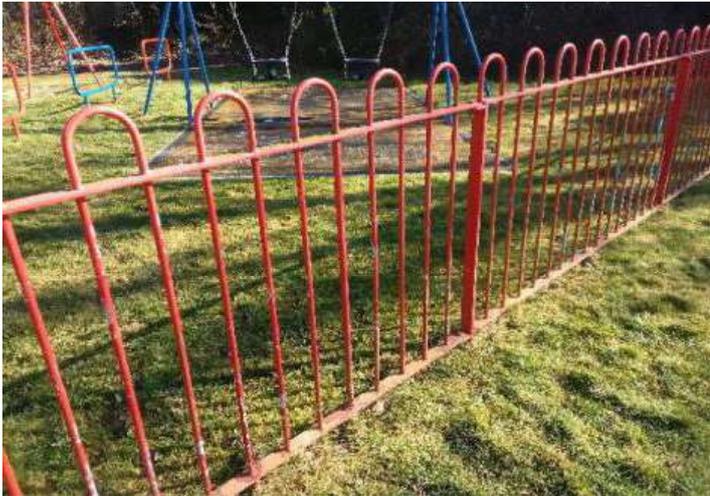
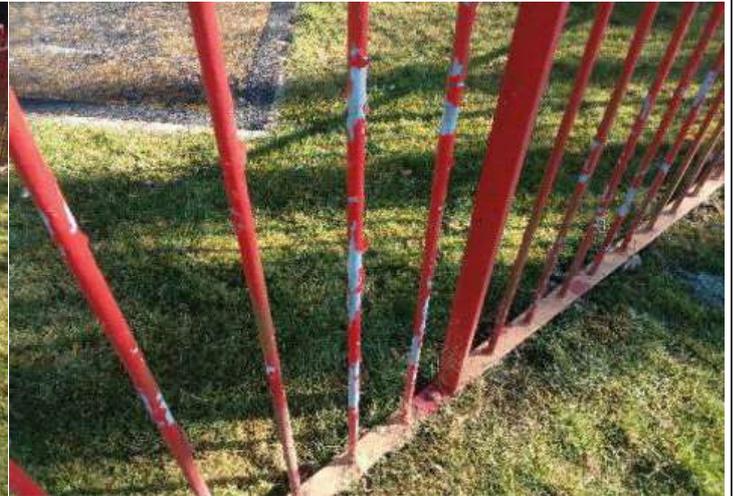
**Item:** Fences - Fence - Bow Top  
**Manufacturer:** Not Identified

**Finding:** The paint is flaking off the metalwork

**Action:** Rub down and re-paint

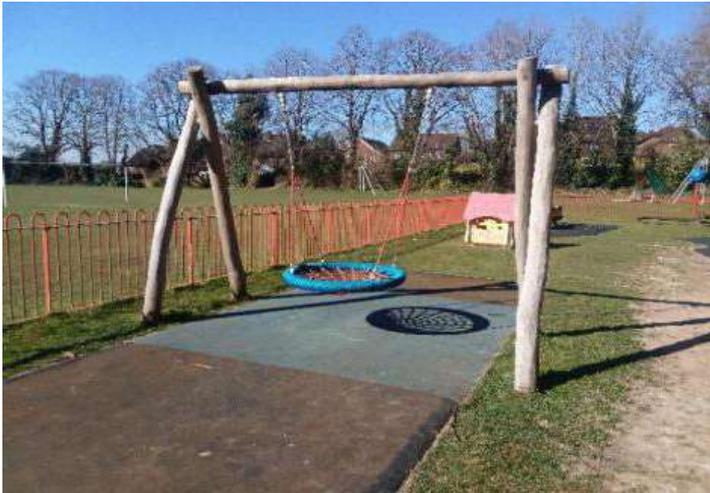
**Item:** Swings - Basket Swing - Type 1  
**Manufacturer:** Dylan Group Ltd

**Finding:** There is some notable evidence of chain wear

**Action:** Monitor for any further deterioration and replace when 40% worn

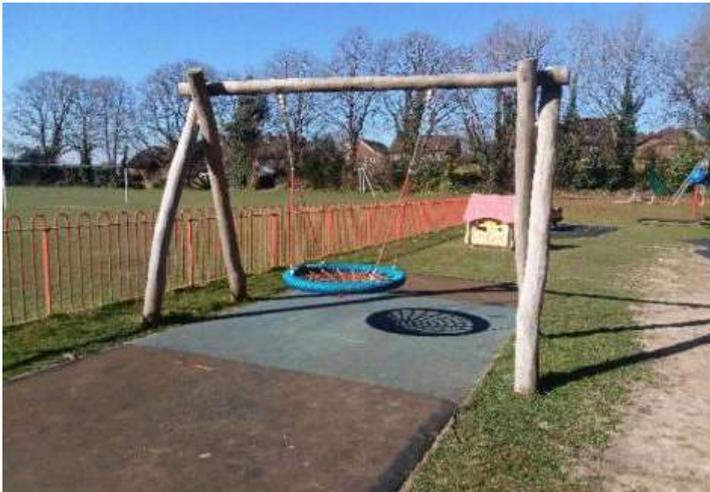
**Item:** Swings - Basket Swing - Type 1  
**Manufacturer:** Dylan Group Ltd

**Finding:** The connecting links are in excess of 8.6mm and less than 12mm and fail the requirements of BS EN 1176 Part 1; clause 4.2.13, Chains

**Action:** Monitor - No action given the risk assessment

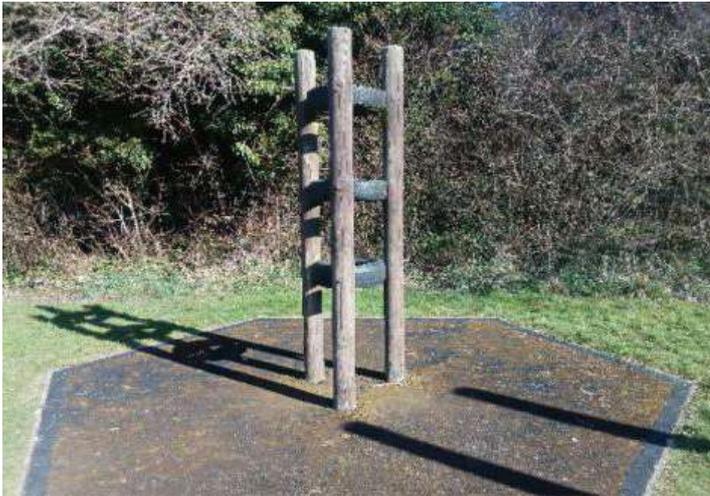
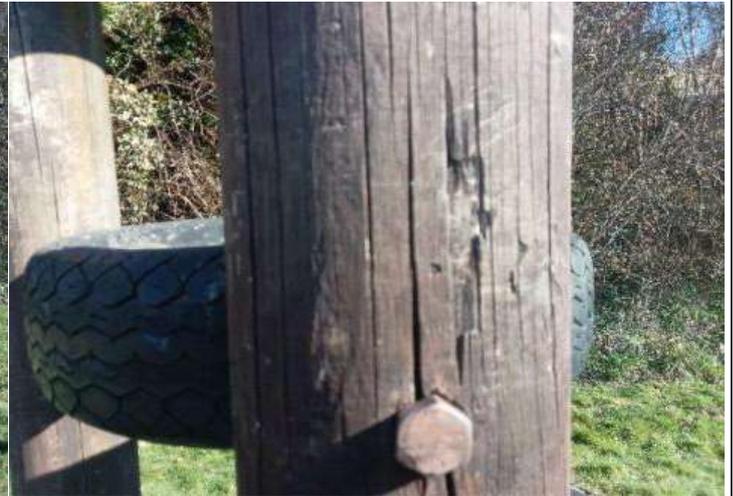
**Item:** Activity Equipment - Tyre Climber  
**Manufacturer:** Lappset UK Ltd

**Finding:** Parts of the timber are rough or splintered

**Action:** Remove all rough or sharp edges

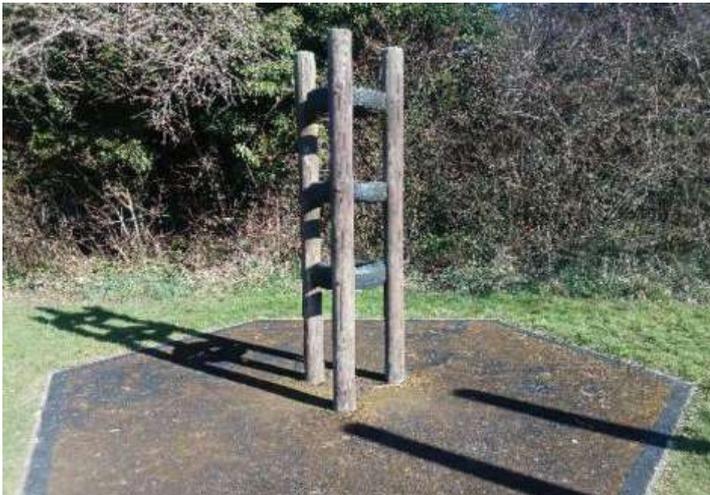
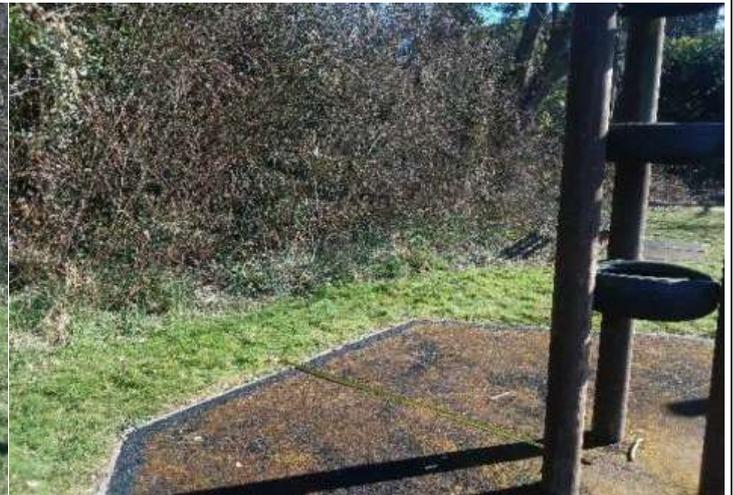
**Item:** Activity Equipment - Tyre Climber  
**Manufacturer:** Lappset UK Ltd

**Finding:** The surfacing dimensions are short and do not meet with the requirements of the current applicable standard

**Action:** Monitor - No action given the risk assessment

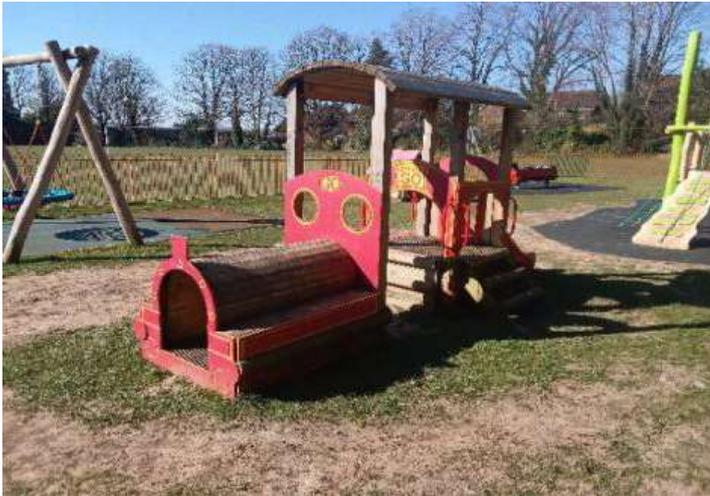
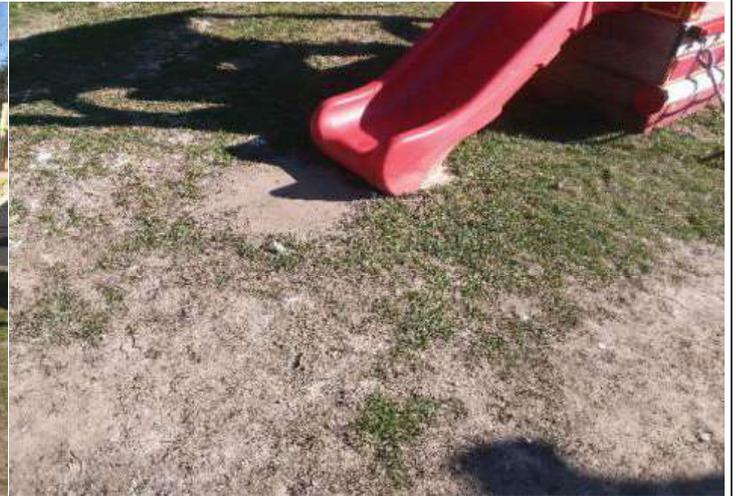
**Item:** Activity Equipment - Train  
**Manufacturer:** Not Identified

**Finding:** The grass has eroded within the impact area of the equipment and may not provide the necessary impact attenuating properties for the equipment fall height; the surface may also be slippery in wet weather  
**Action:** Reinstate the grass or provide an all weather surface

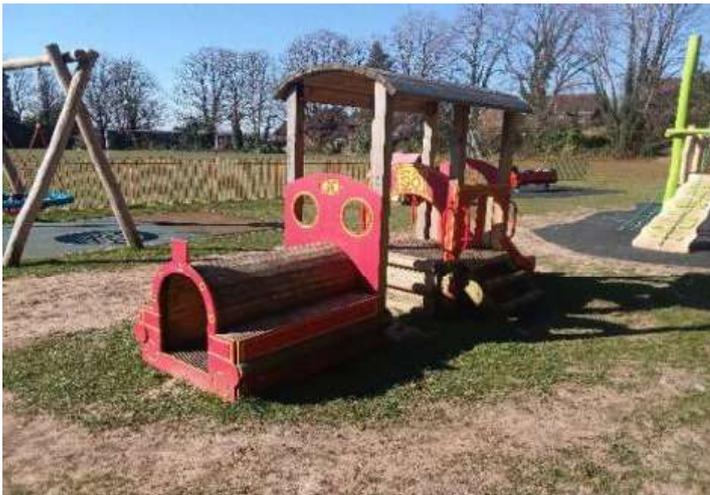
**Item:** Activity Equipment - Train  
**Manufacturer:** Not Identified

**Finding:** The timber has a number of splits/shakes or air cracks and this may affect the stability or allow water ingress which will accelerate the rotting process  
**Action:** Monitor to ensure the splits do not cross through fixing points of the structure and/or cause any instability

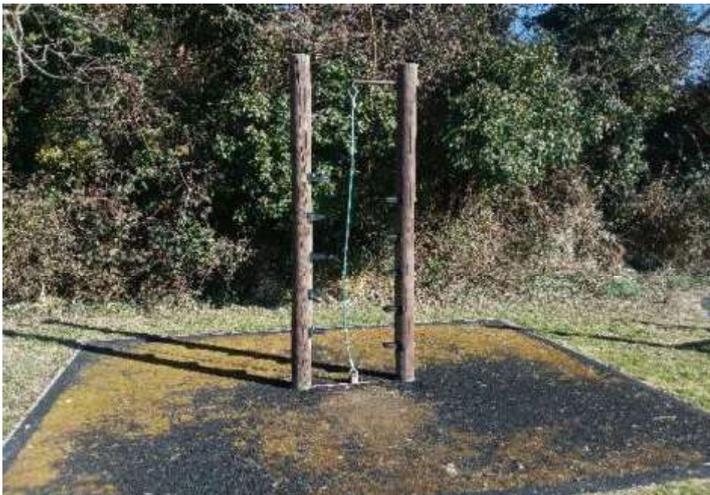
**Item:** Activity Equipment - Climbing Post  
**Manufacturer:** Lappset UK Ltd

**Finding:** There is some evidence of rot in the posts  
**Action:** Monitor for any further deterioration and replace as required

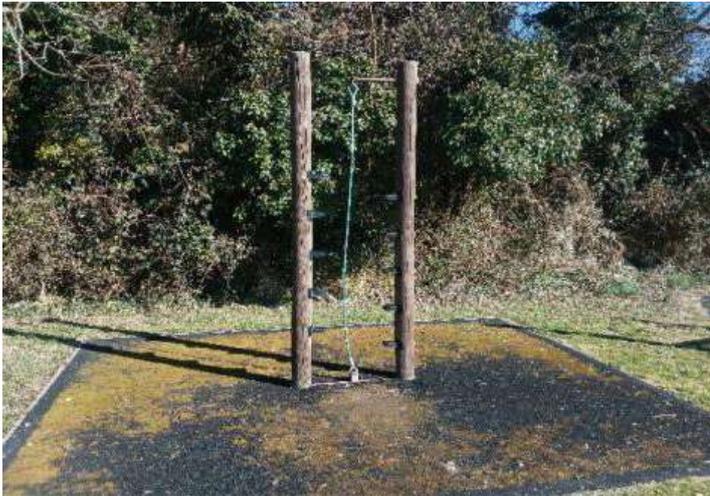
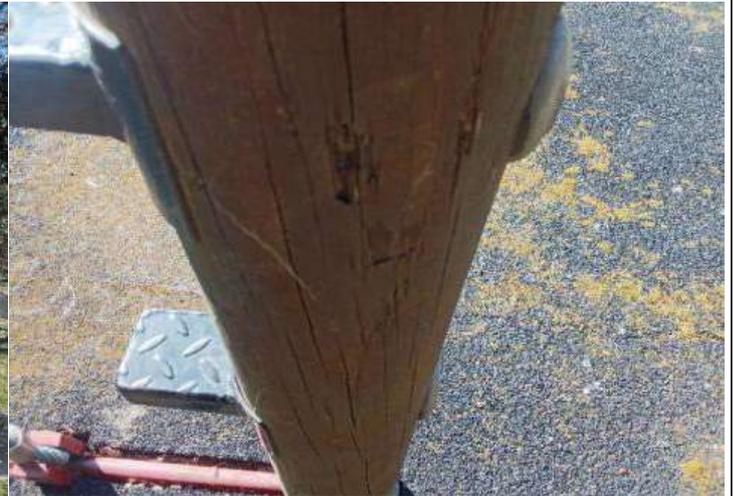
**Finding:** Parts of the timber are rough or splintered

**Action:** Remove all rough or sharp edges

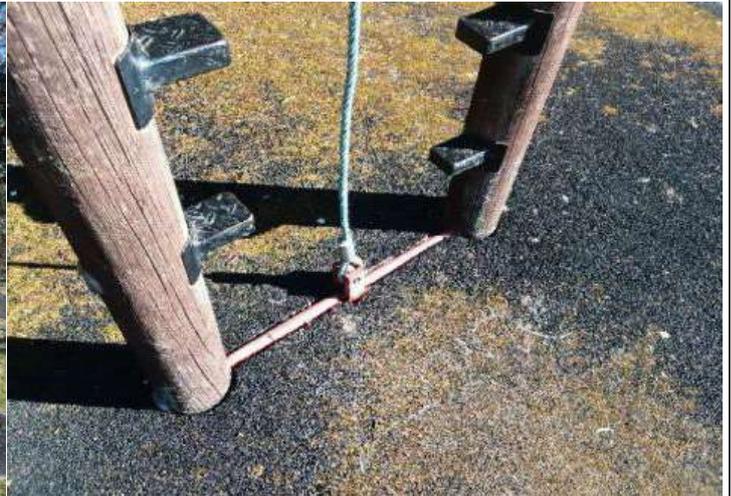
**Finding:** The anchor bar forms a projecting obstacle / hard object within the falling space of the equipment, in contravention of the requirements of BS EN 1176 Part 1

**Action:** Provide an appropriate impact attenuating surface to cover bar

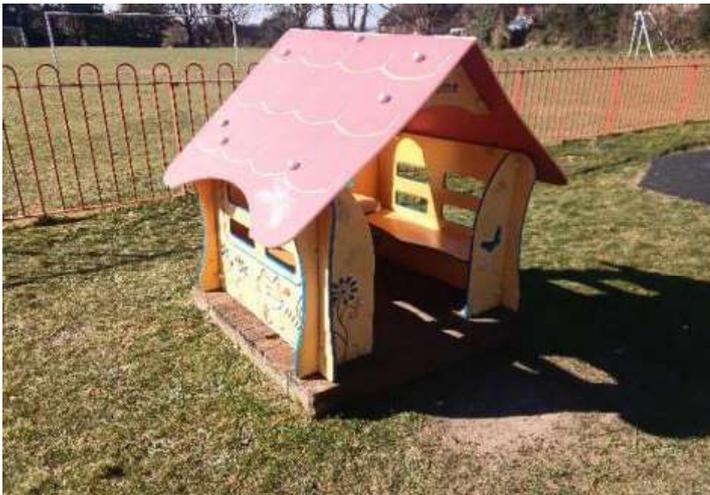
**Finding:** The item fails to meet the requirements of BS EN 1176 Part 1 4.2.7.2 for head and neck entrapment in the playhouse

**Action:** Monitor - No action given the risk assessment

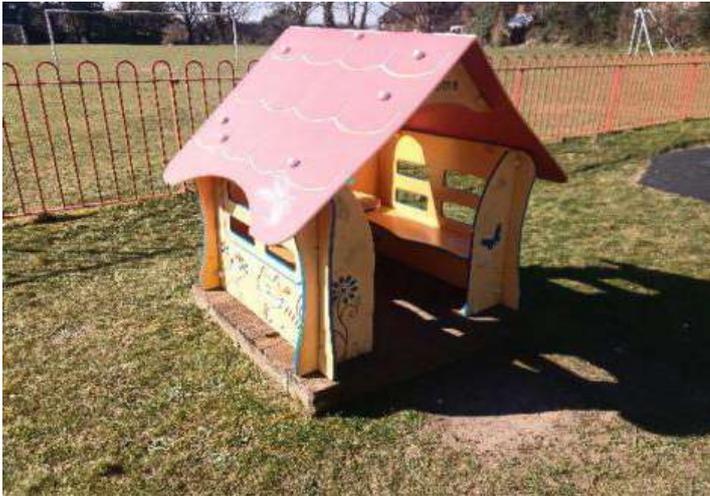
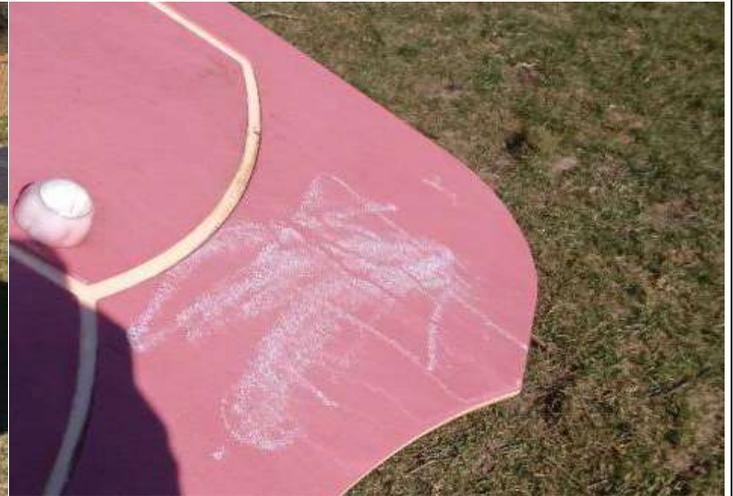
**Finding:** There is some graffiti present

**Action:** Remove the graffiti

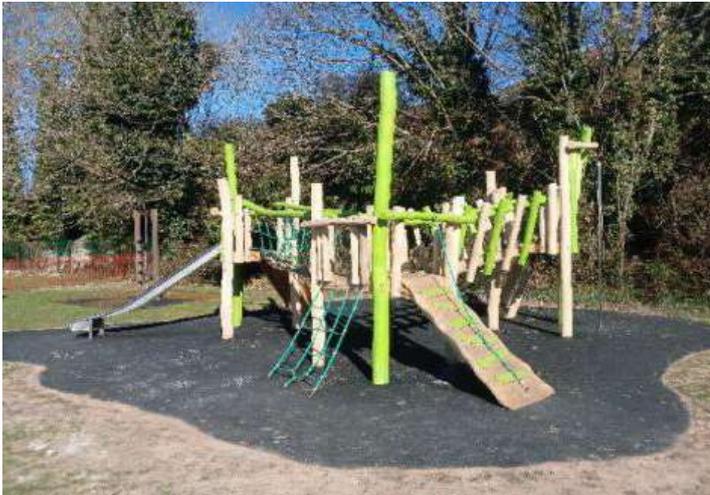
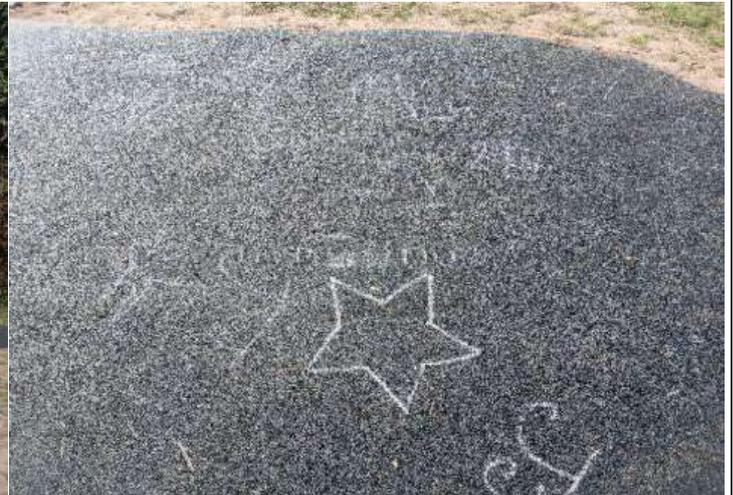
**Finding:** There is some graffiti present on the surface

**Action:** Remove the graffiti

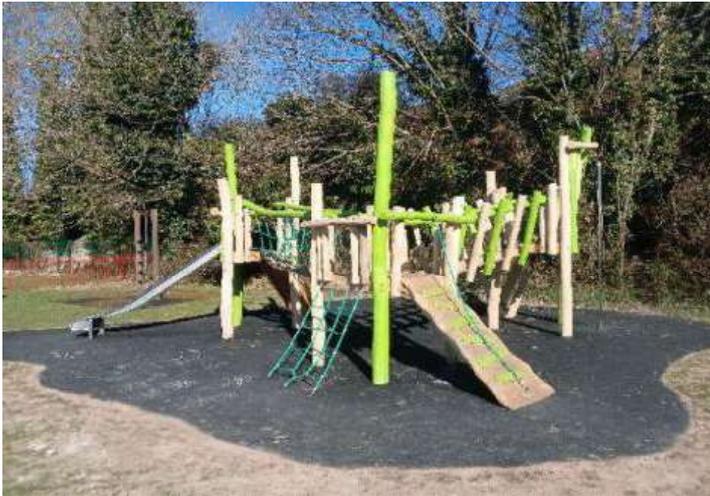
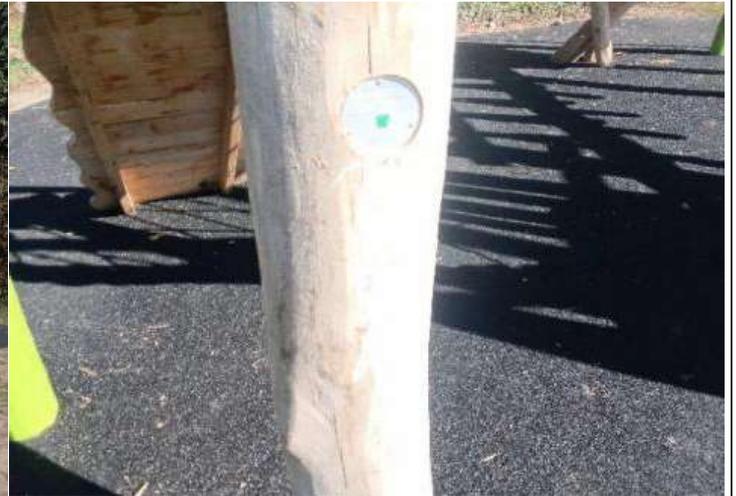
**Finding:** There is some graffiti present

**Action:** Remove the graffiti

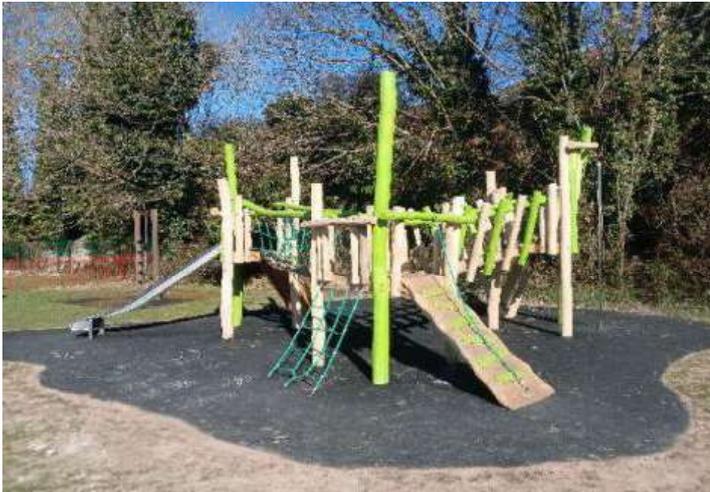
**Finding:** There is/are finger entrapment/s in the framework and the item fails to meet the requirements of BS EN 1176 Part 1 4.2.7.6 Entrapment of fingers

**Action:** Monitor - No action given the risk assessment

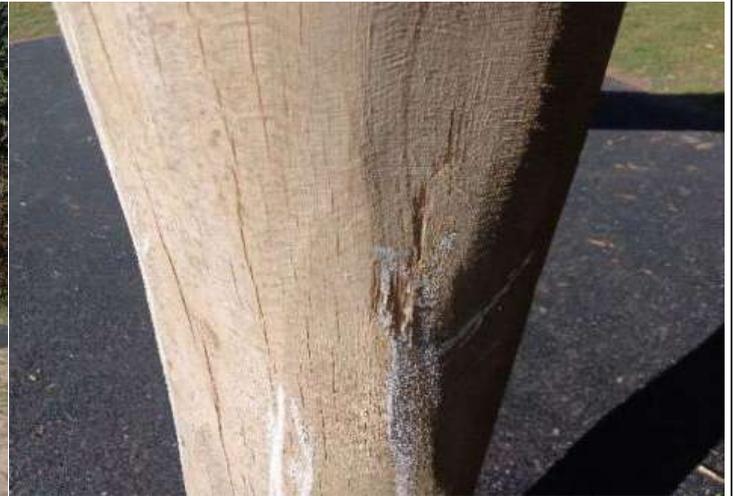
**Finding:** Parts of the timber are rough or splintered

**Action:** Remove all rough or sharp edges

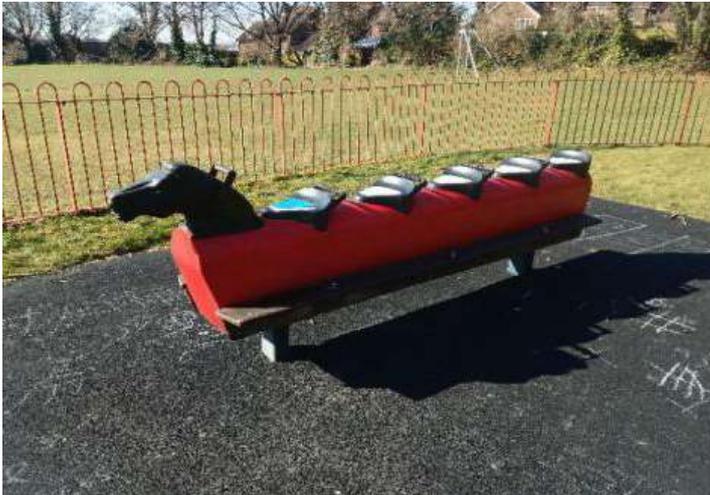
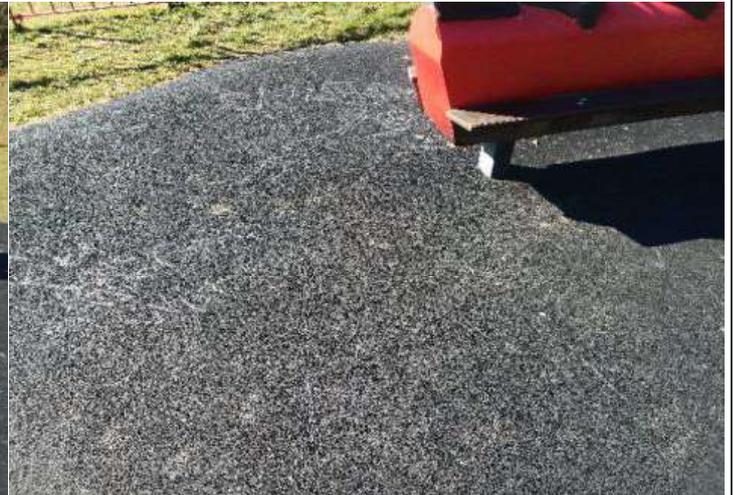
**Finding:** There is some graffiti present on the surface

**Action:** Remove the graffiti

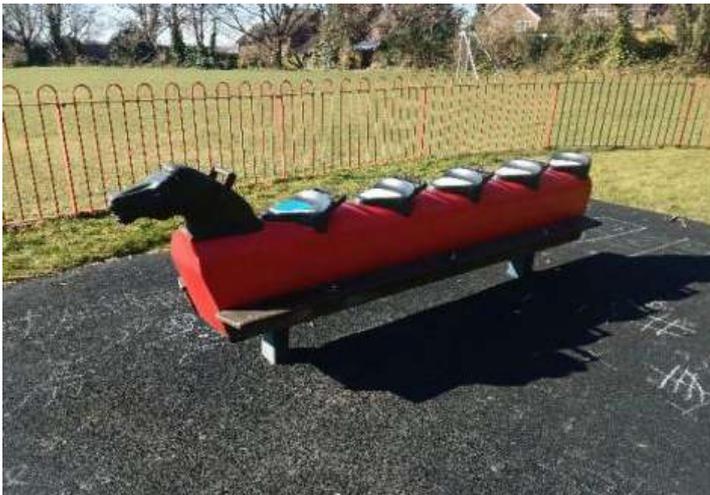
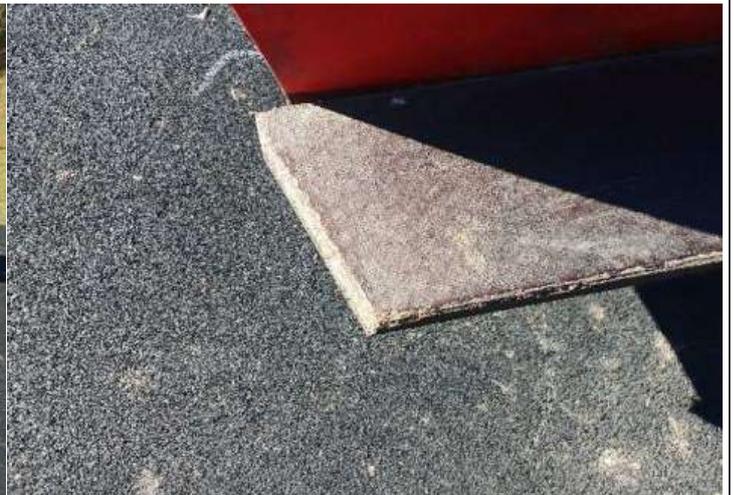
**Finding:** Parts of the timber are rough or splintered

**Action:** Remove all rough or sharp edges

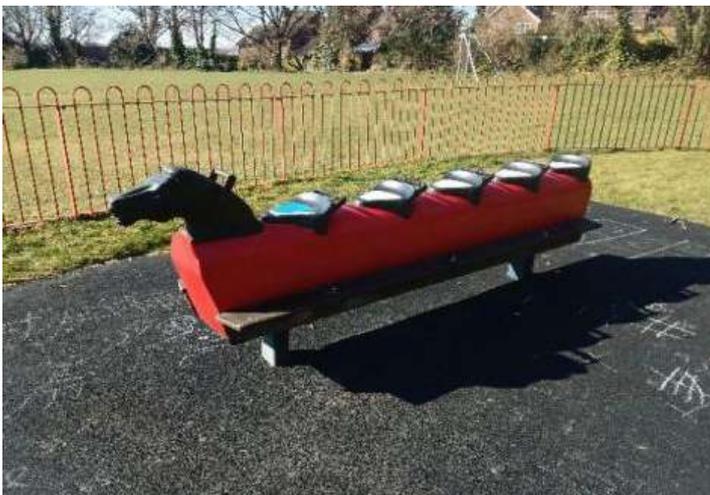
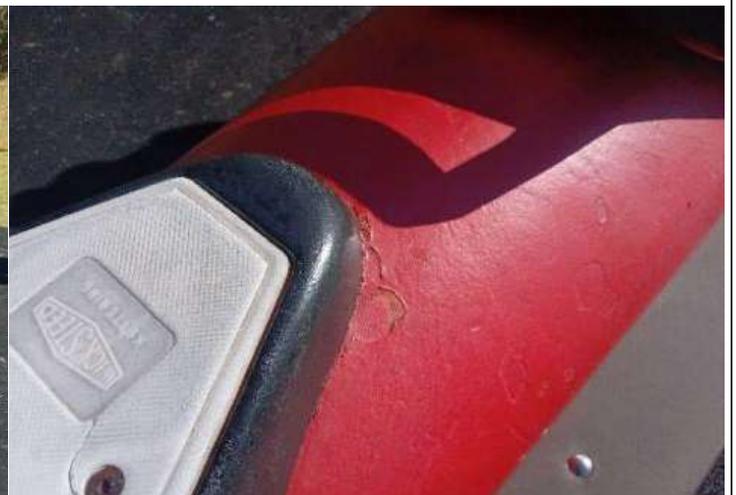
**Finding:** The paint is flaking off the metalwork

**Action:** Rub down and re-paint

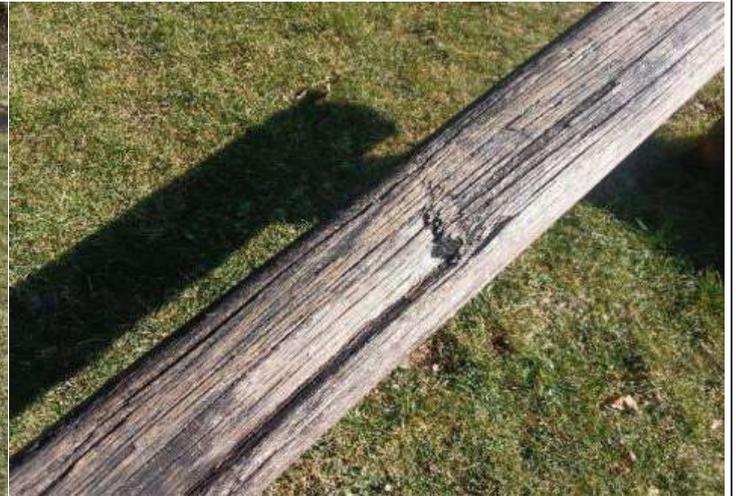
**Finding:** Parts of the timber are rough or splintered

**Action:** Remove all rough or sharp edges

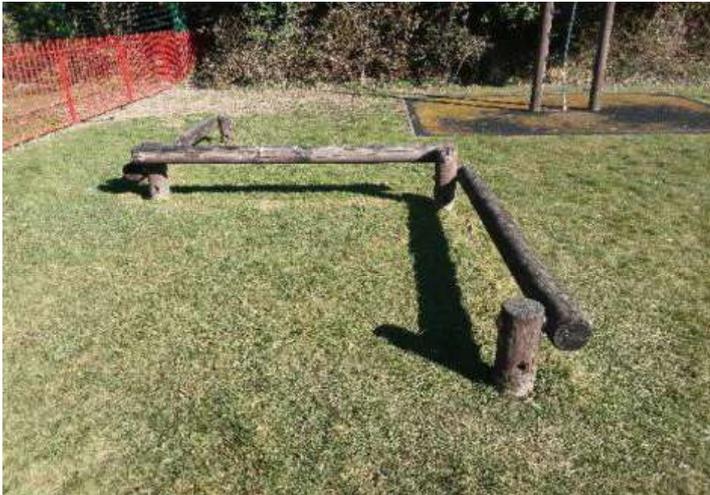
**Finding:** There is some damage to the posts

**Action:** Monitor for any further deterioration and replace as required

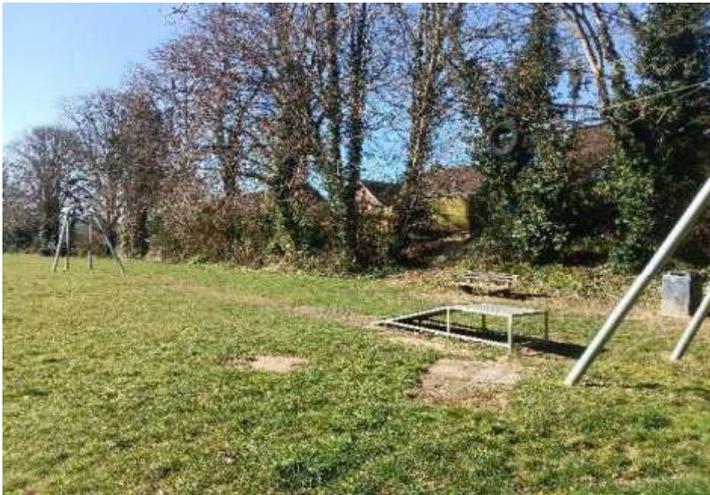
**Finding:** There is some notable evidence of chain wear

**Action:** Monitor for any further deterioration and replace when 40% worn

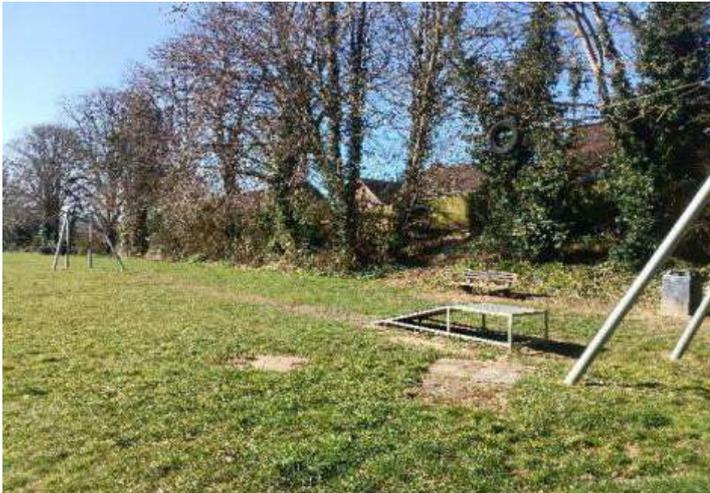
**Finding:** There is some wear to the chain bars

**Action:** Monitor for any further deterioration and replace when 40% worn

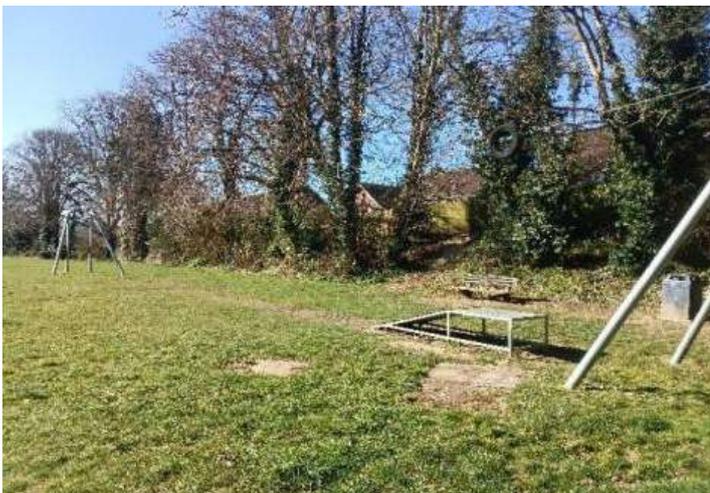
**Finding:** The cableway seat has been damaged

**Action:** Monitor for any further deterioration and replace as required

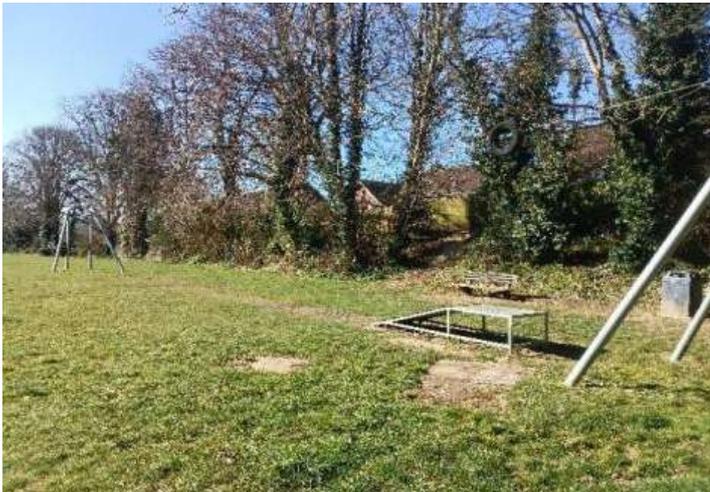
**Finding:** The chain openings are in excess of the 8.6mm as recommended by BS EN 1176  
**Action:** Monitor - No action given the risk assessment

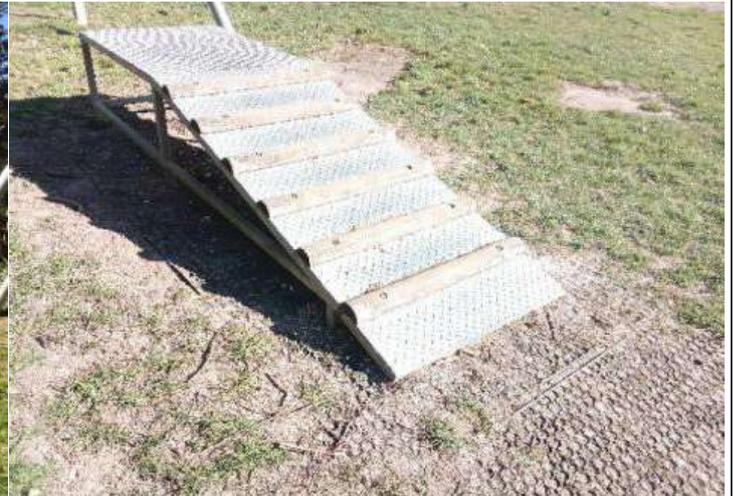
**Finding:** The start platform is easily accessible and should have the appropriate barriers installed to meet the requirements of BS EN 1176 Part 1 as the height of the unit exceeds 600mm

**Action:** Monitor - No action given the risk assessment

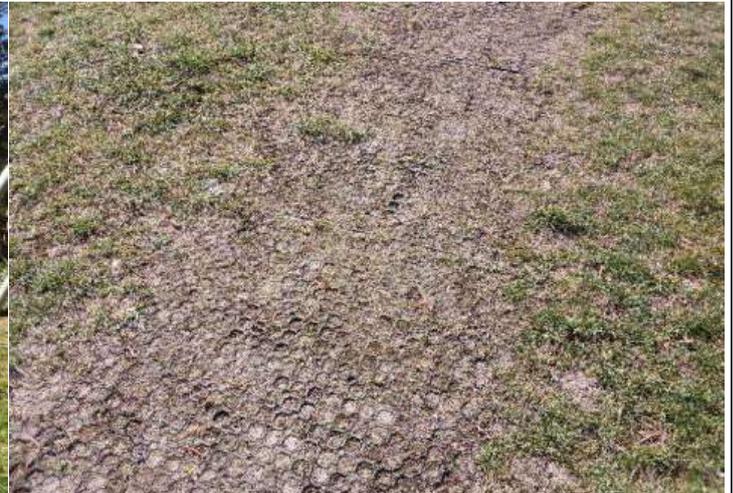
**Finding:** The grass mats are silted up and the soil is compacted; this may have an effect on the impact absorbing properties of the surface. Consideration should be given to HIC testing the surface to verify impact attenuating properties ( <https://playinspections.co.uk/inspection-services/safety-surface-testing/> )

**Action:** Contact our office for a quotation for this service

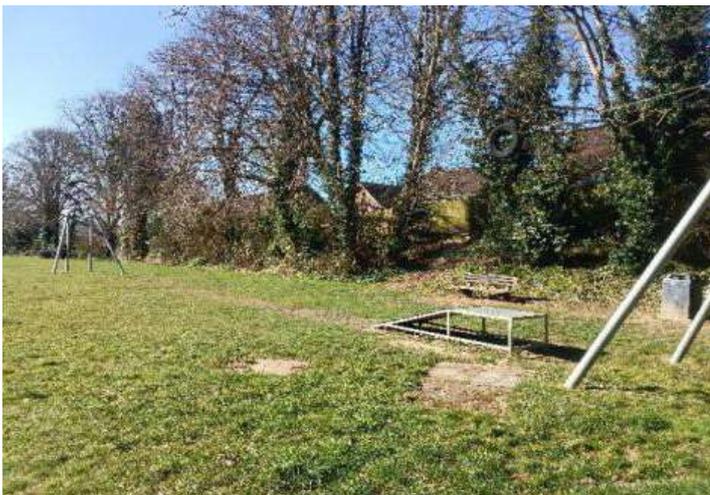
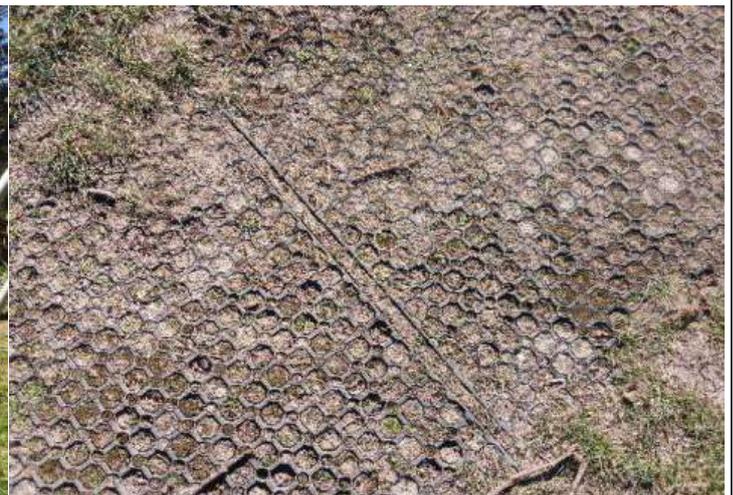
**Finding:** There are gaps opening between the grass mat tiles

**Action:** Provide additional ties or secure / reinstate surface tiles
